## Wills House Photo Log

MSU Wills House

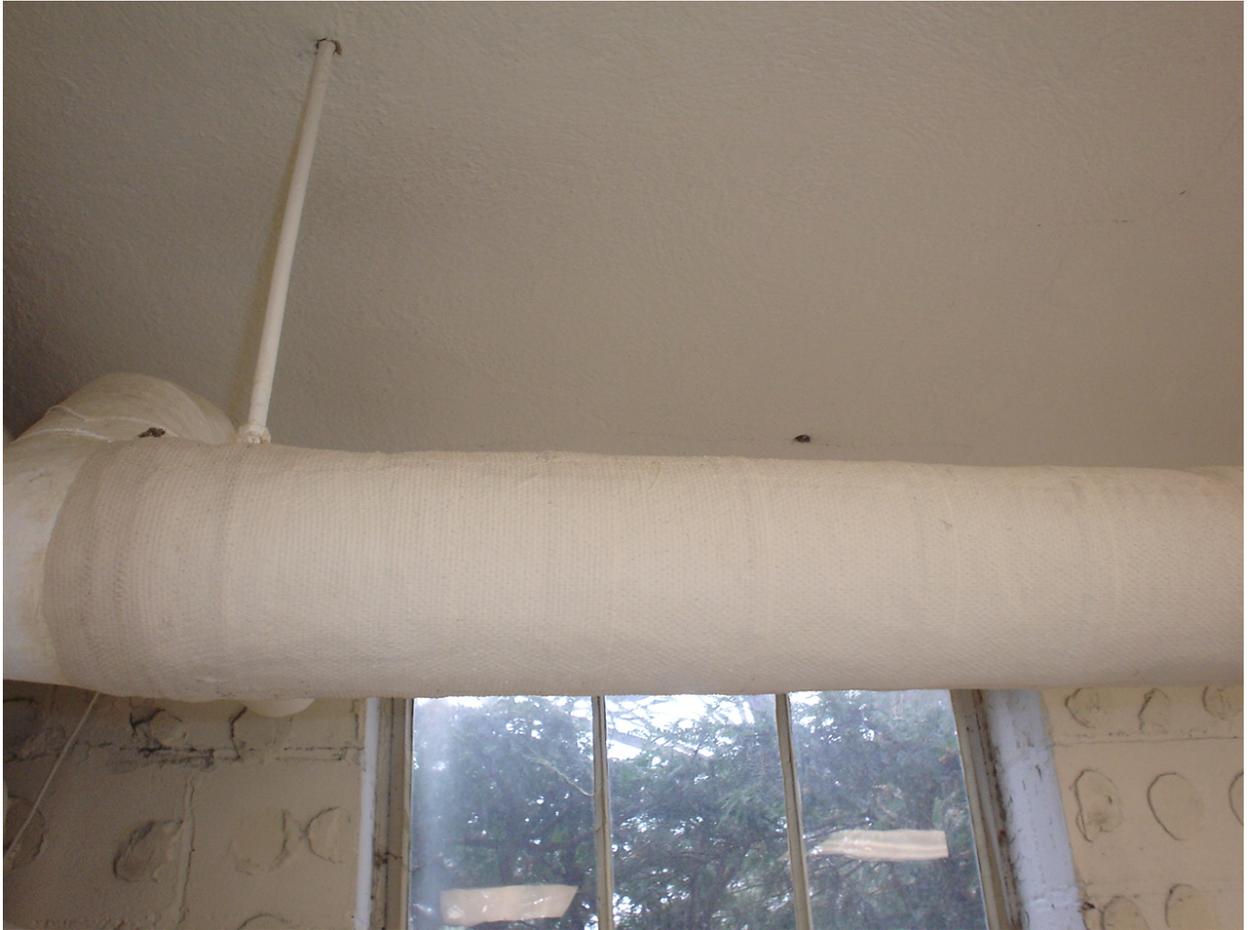
HA #1 – Asbestos-containing steam and condensate supply and return pipe straight insulation

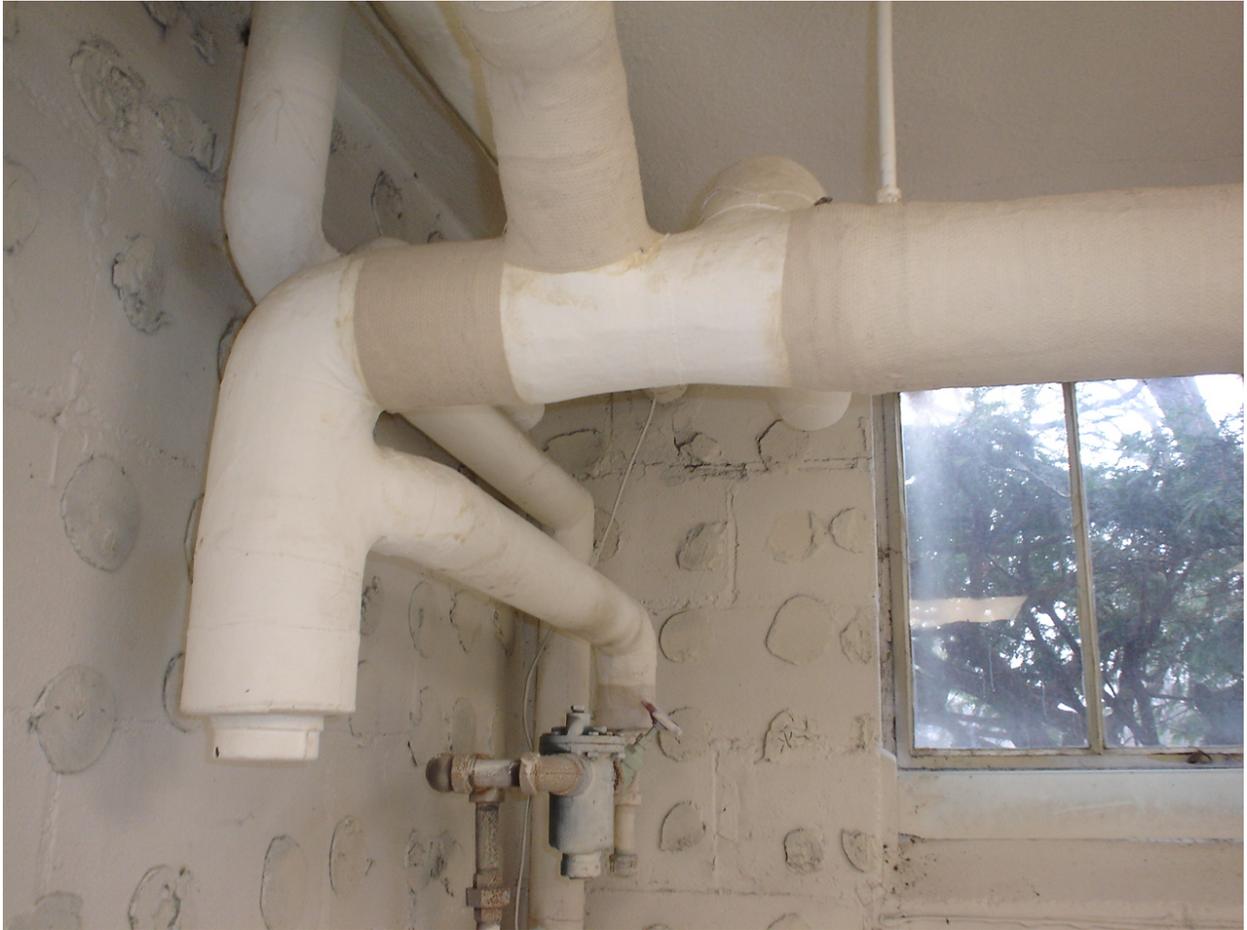
HA #2 – Asbestos-containing steam and condensate supply and return pipe joint and hanger insulation

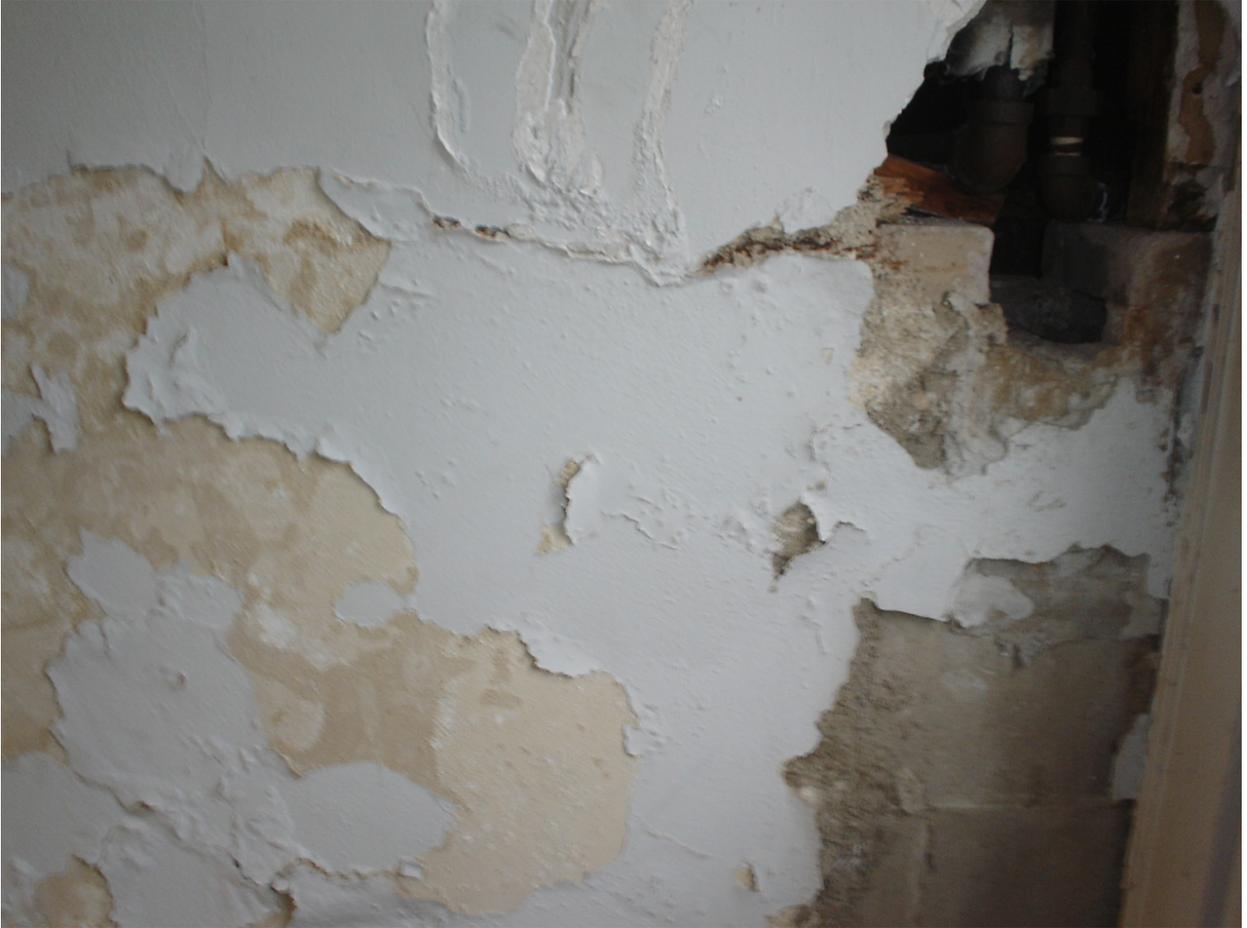
HA #3 – Asbestos-containing smooth wall and ceiling plaster

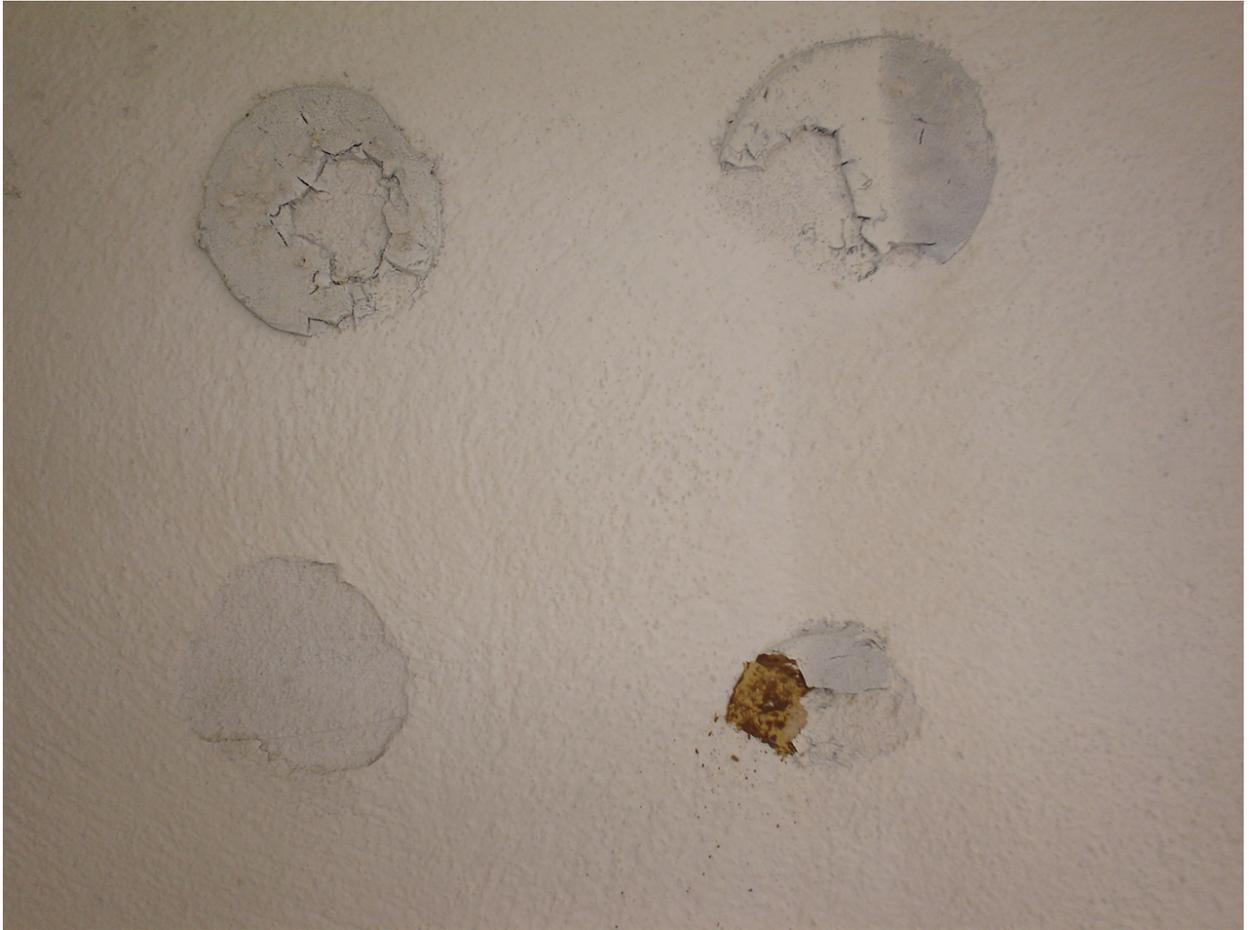
HA #4 – Asbestos-containing dark brown glue pods

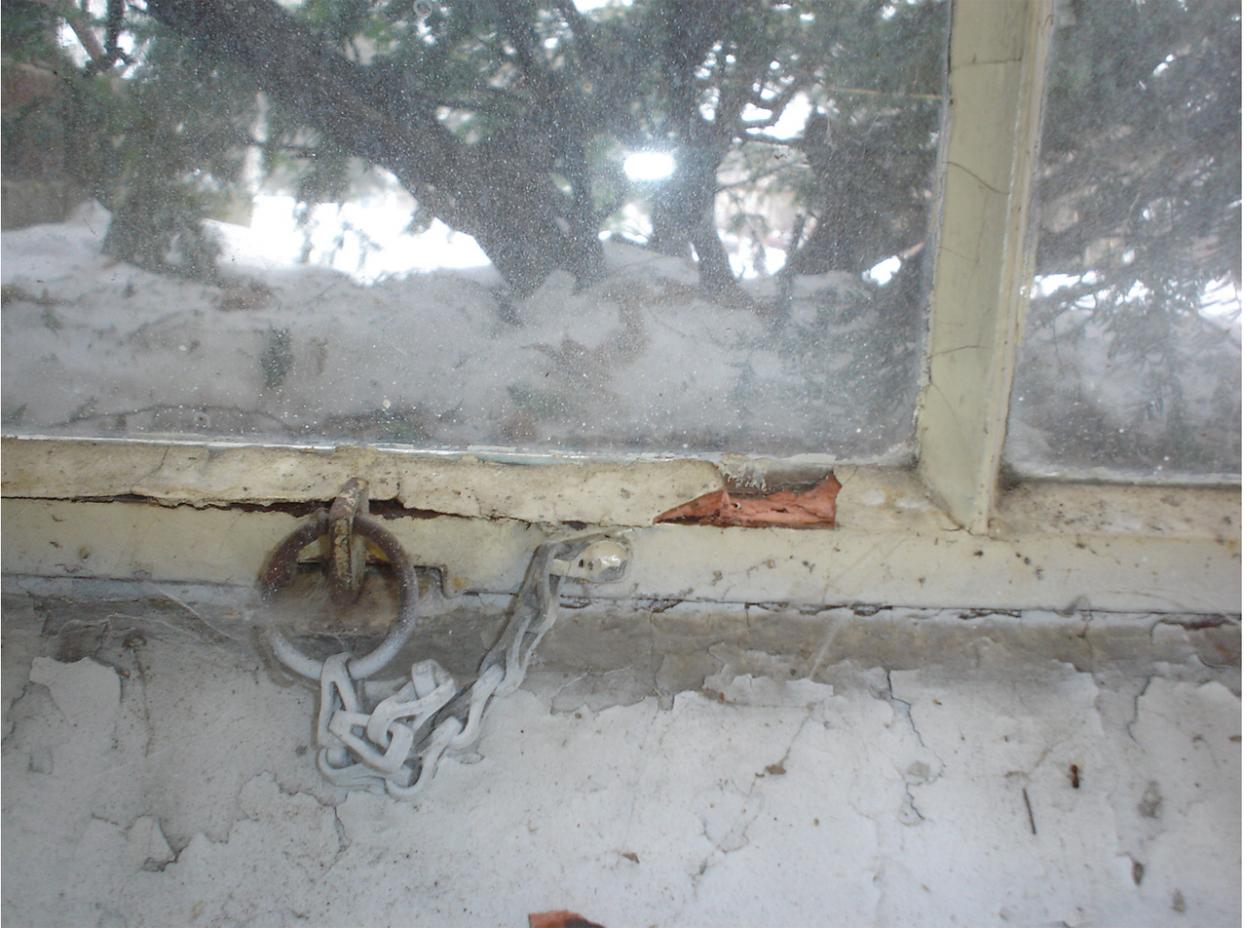
HA #5 – Non asbestos-containing window glazing caulk compound

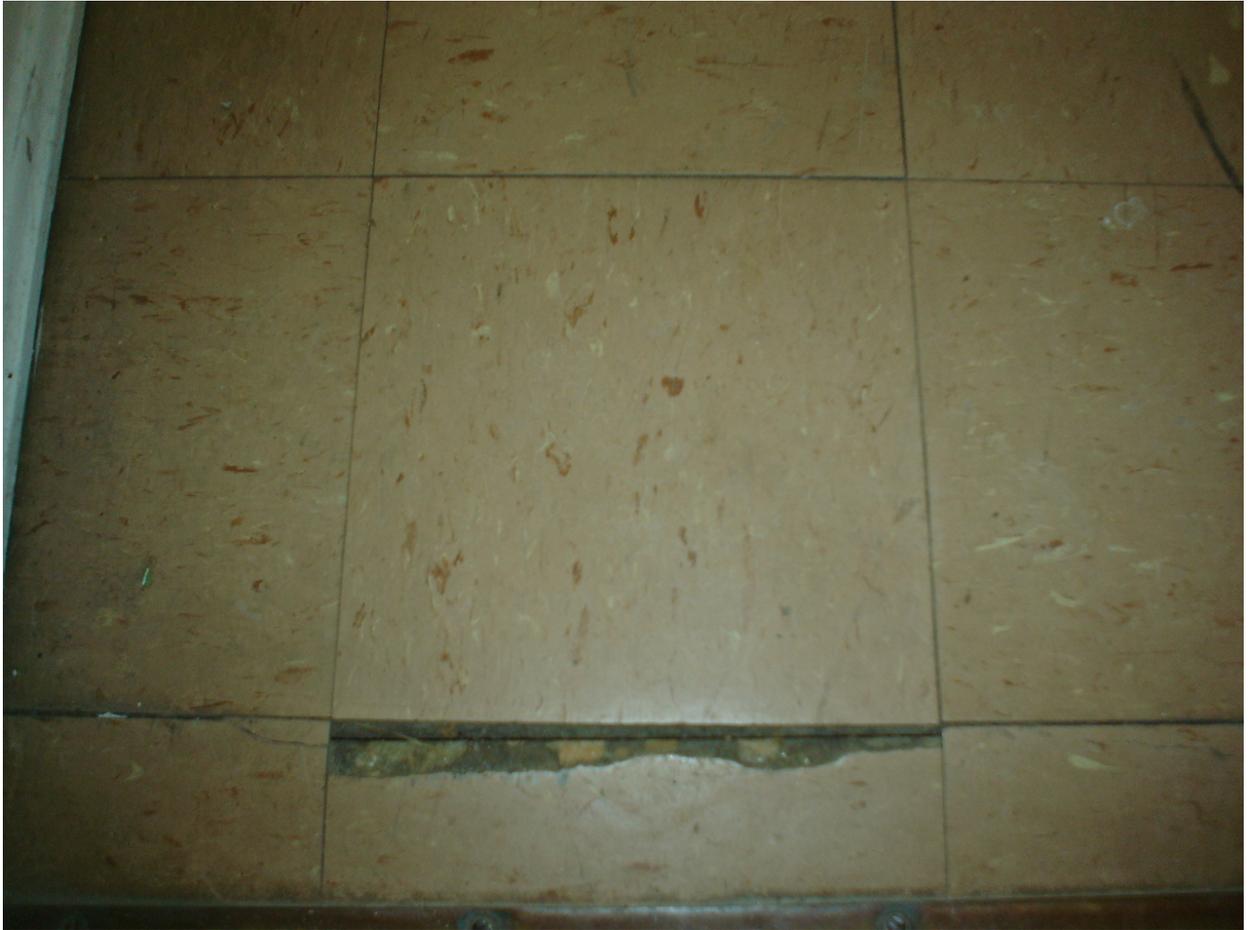
HA #6 – Asbestos-containing 9” x 9” tan floor tile with cream and tan streaks and associated non asbestos-containing mastic

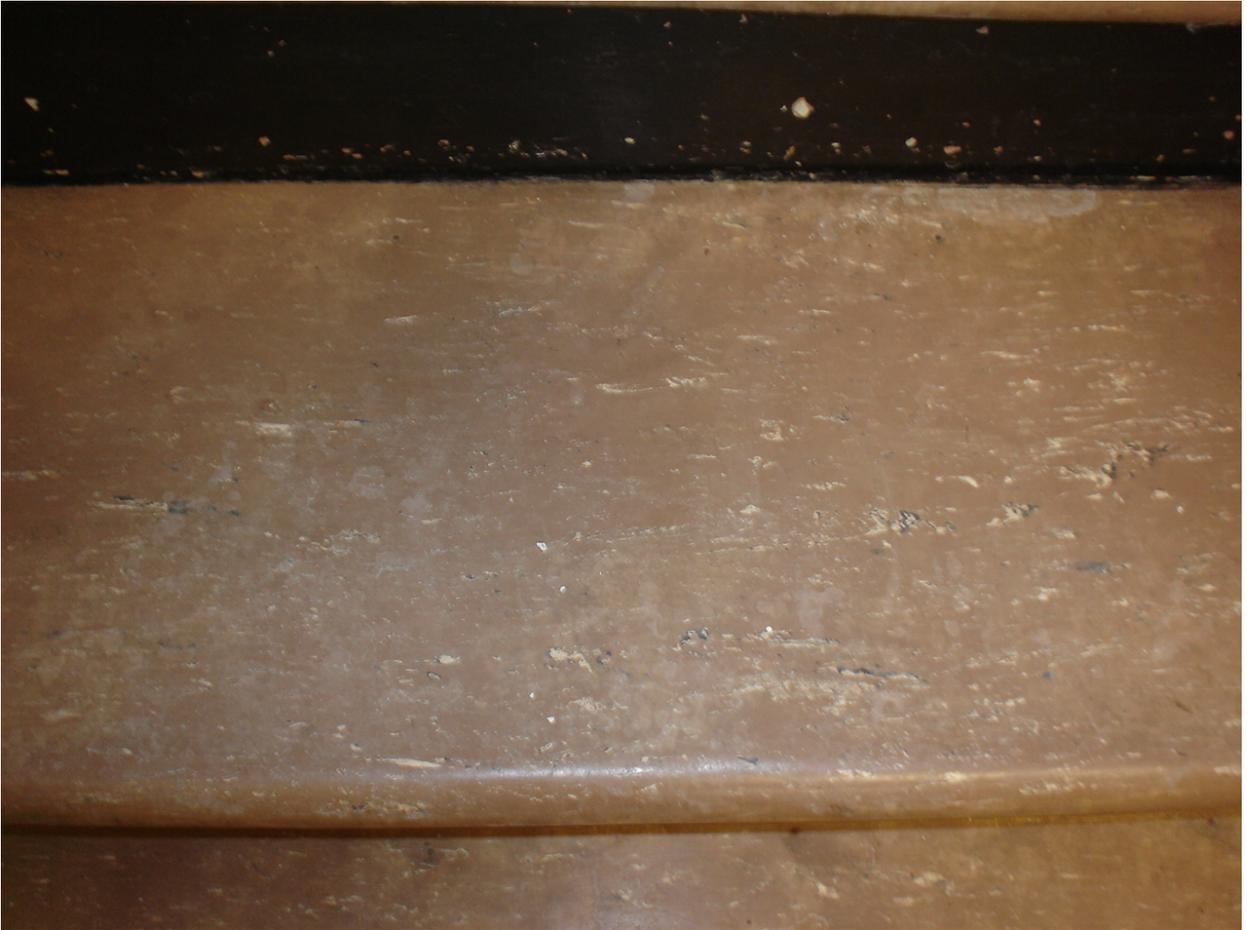
HA #7 – Asbestos-containing brown linoleum with cream and black streaks and associated non asbestos containing mastic

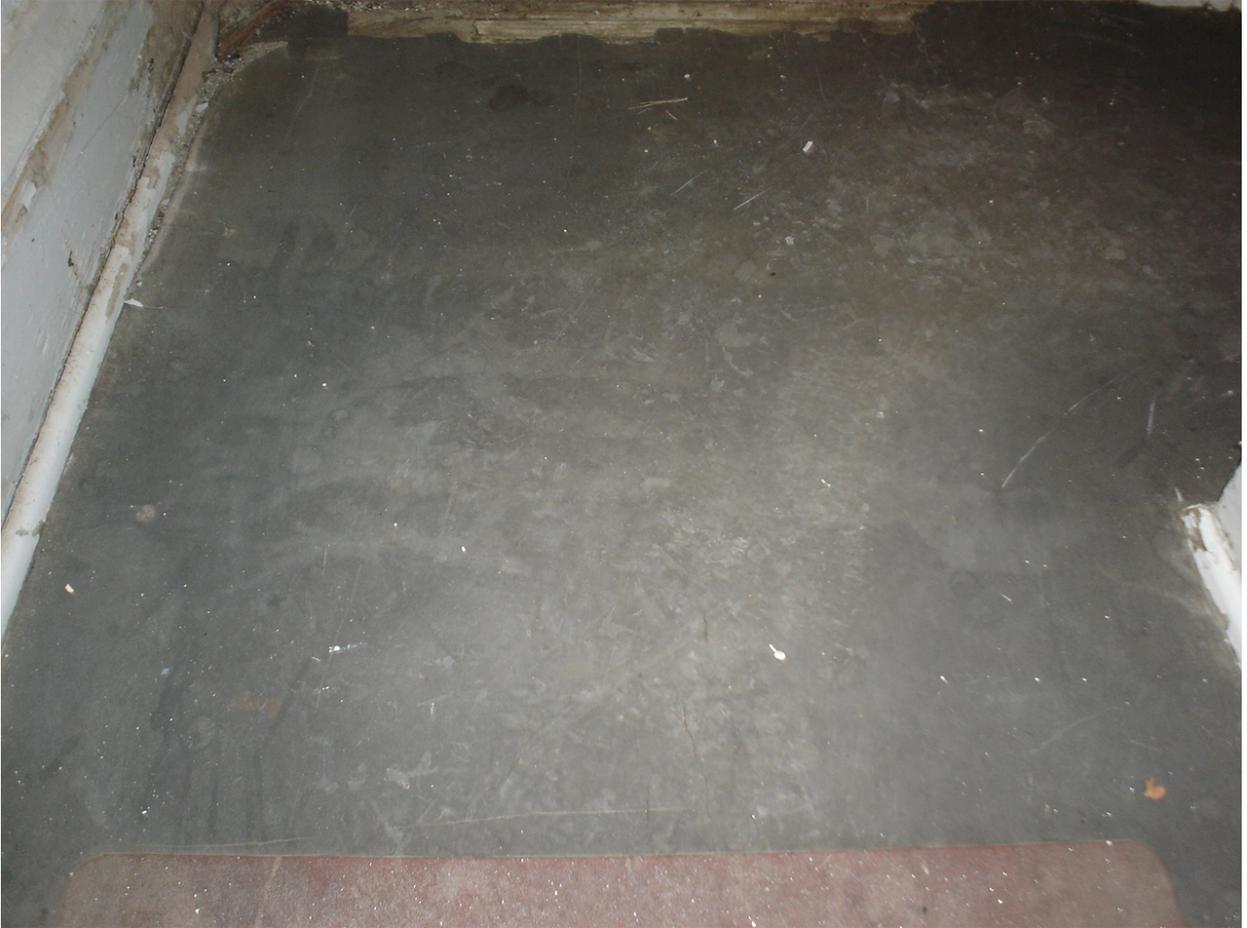
HA #8 – Non asbestos-containing dark green linoleum and associated mastic

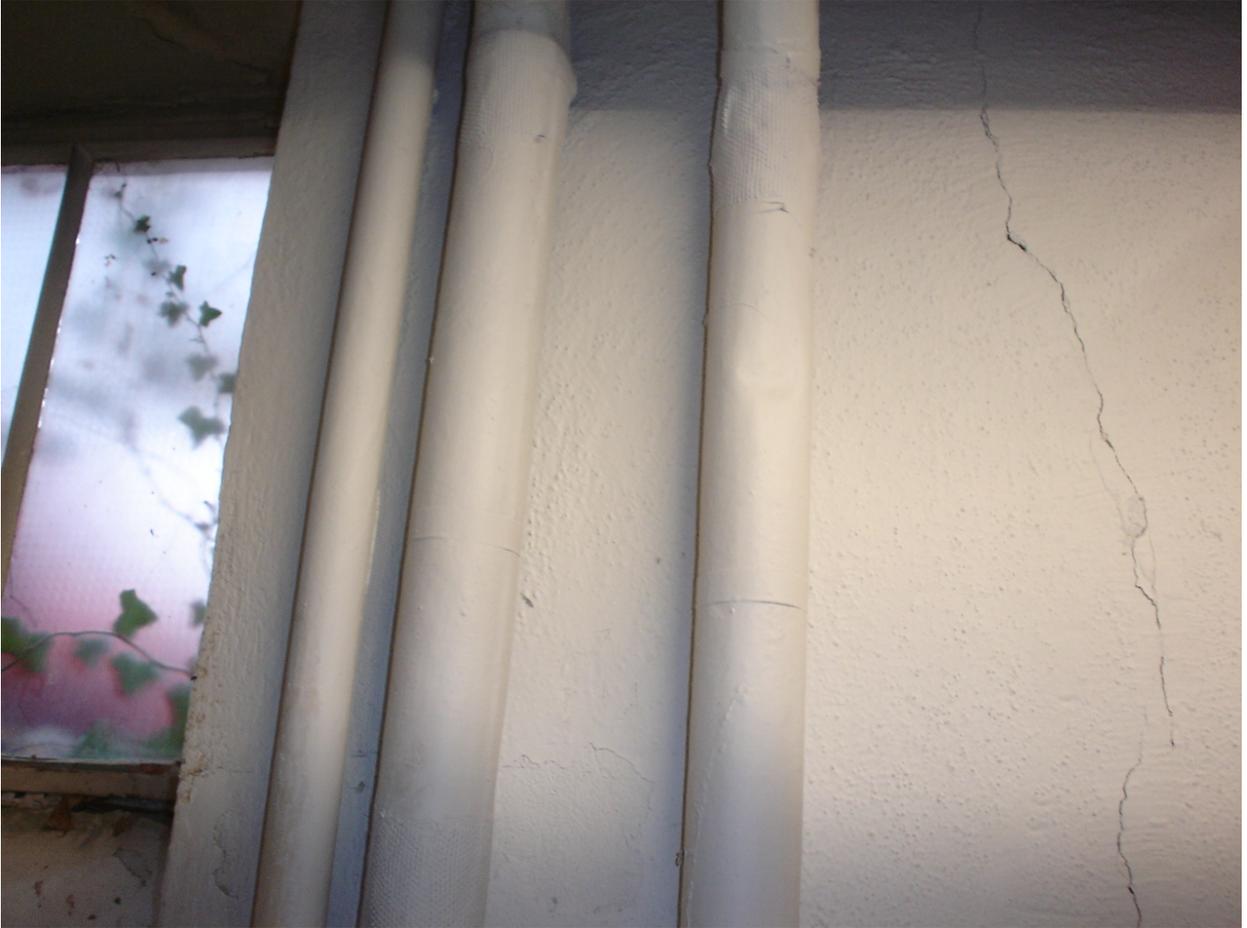
HA #9 – Asbestos-containing domestic water supply pipe straight insulation

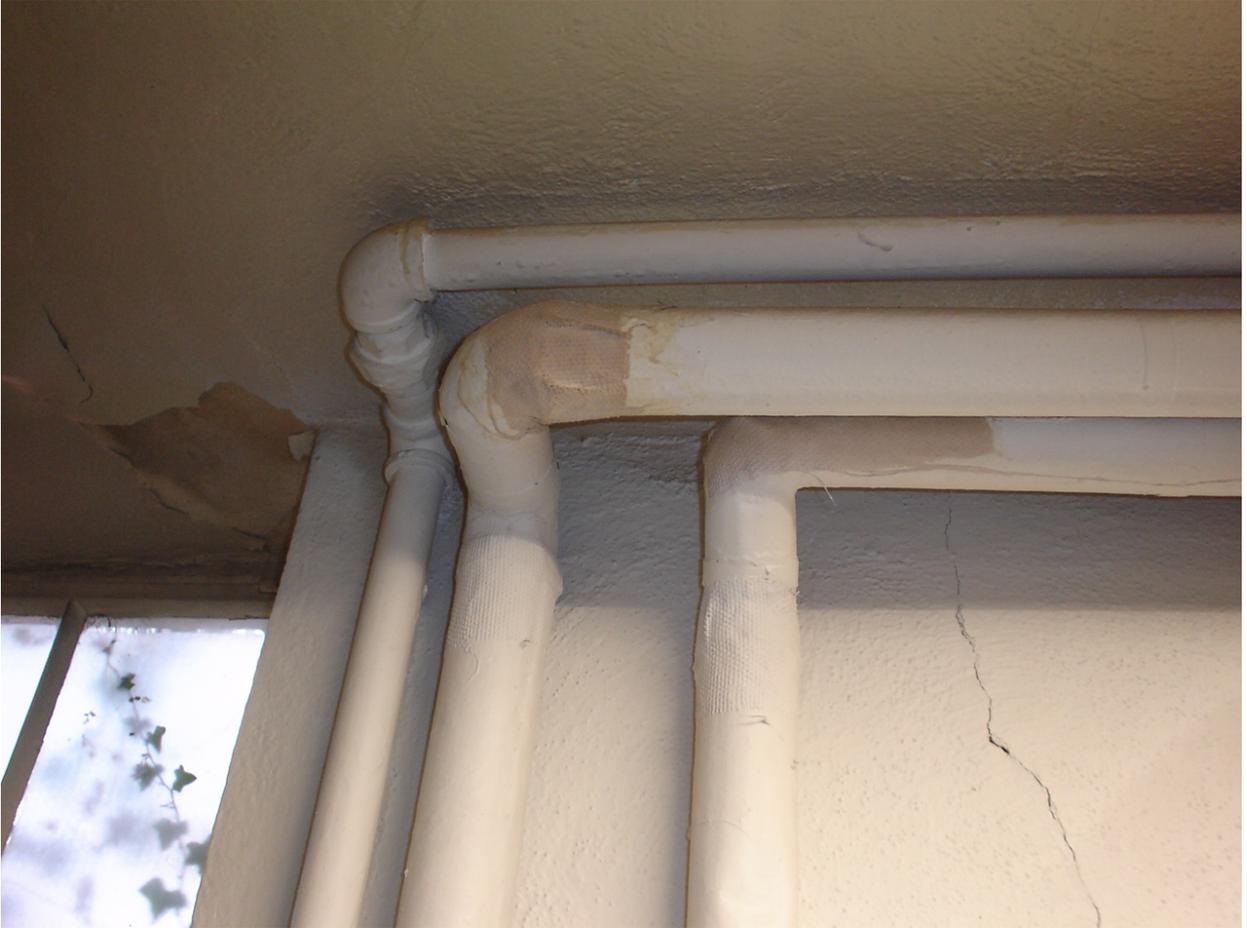
HA #10 – Asbestos-containing domestic water supply pipe joint and hanger insulation

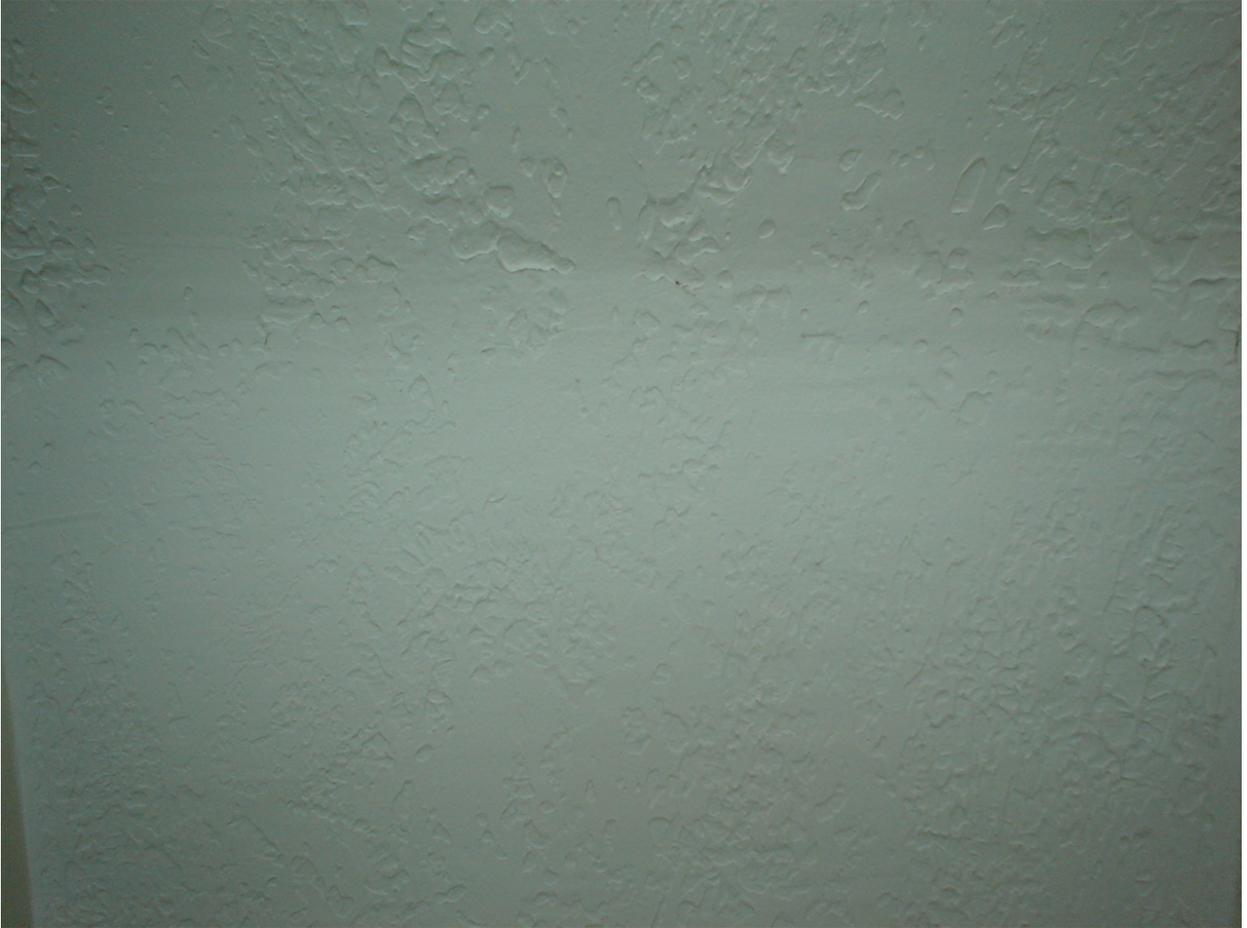
HA #11 – Non asbestos-containing white textured ceiling plaster

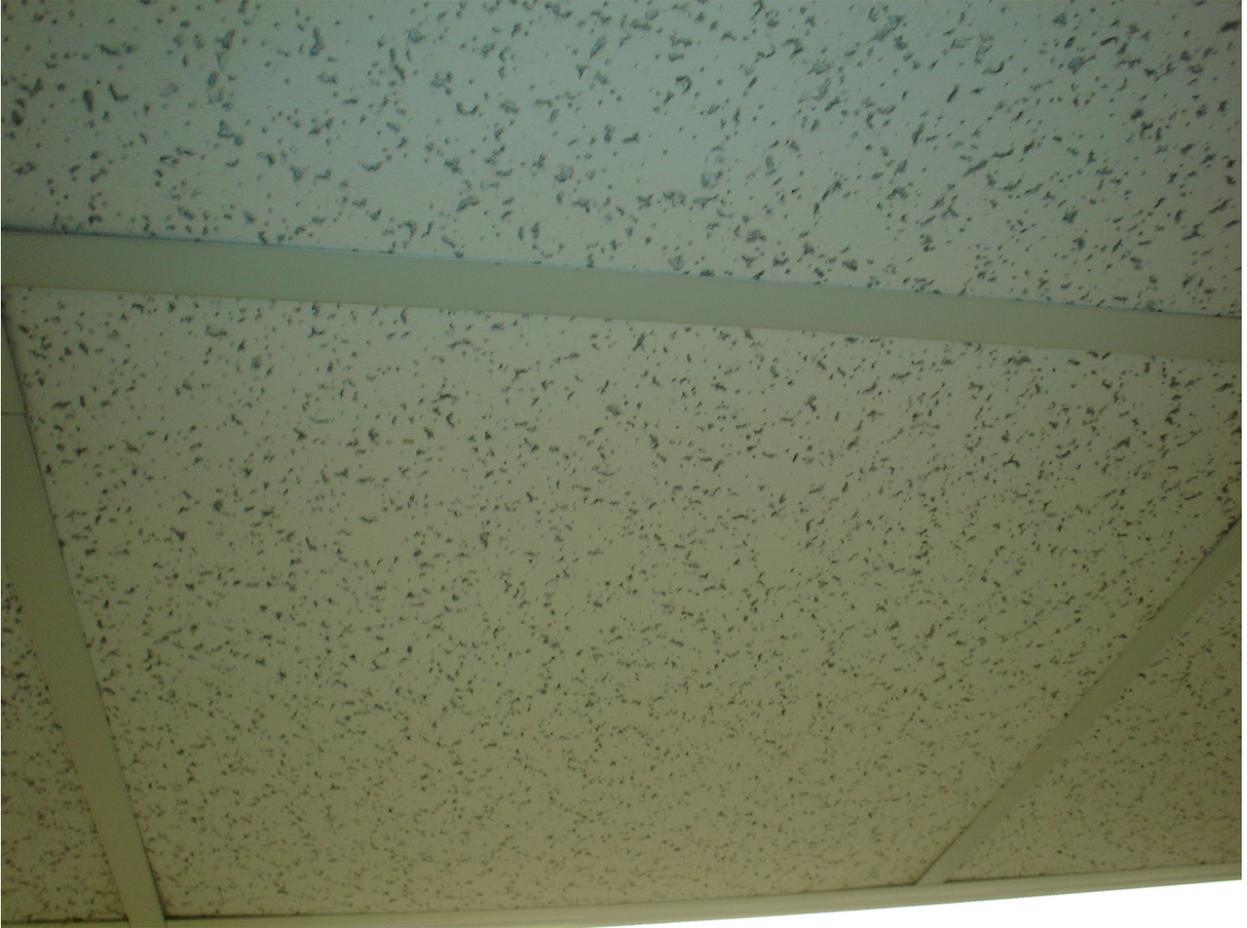
HA #12 – Non asbestos-containing 2' x 2' white lay-in ceiling tile  
with pin holes and fissures

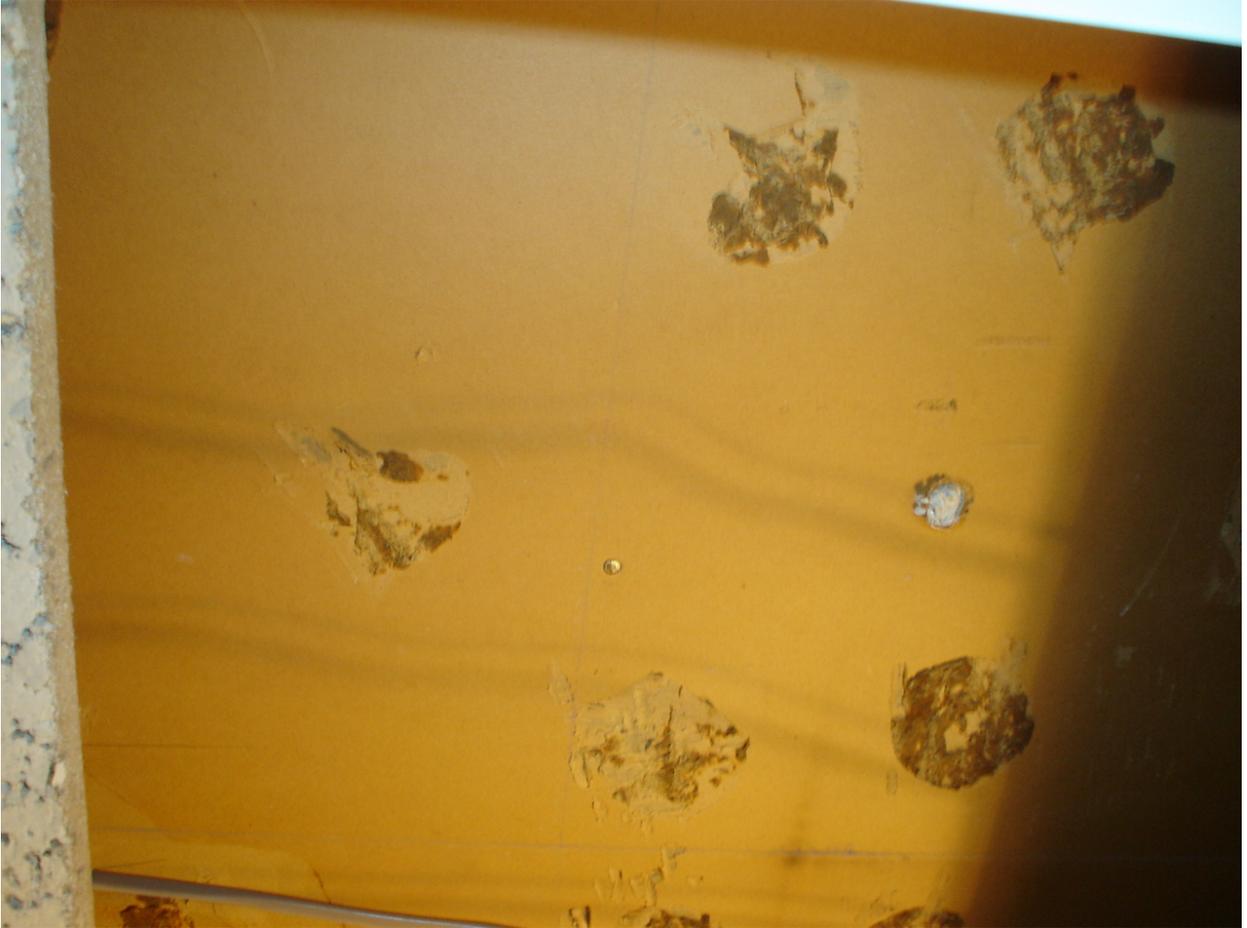
HA #13 – Non asbestos-containing drywall

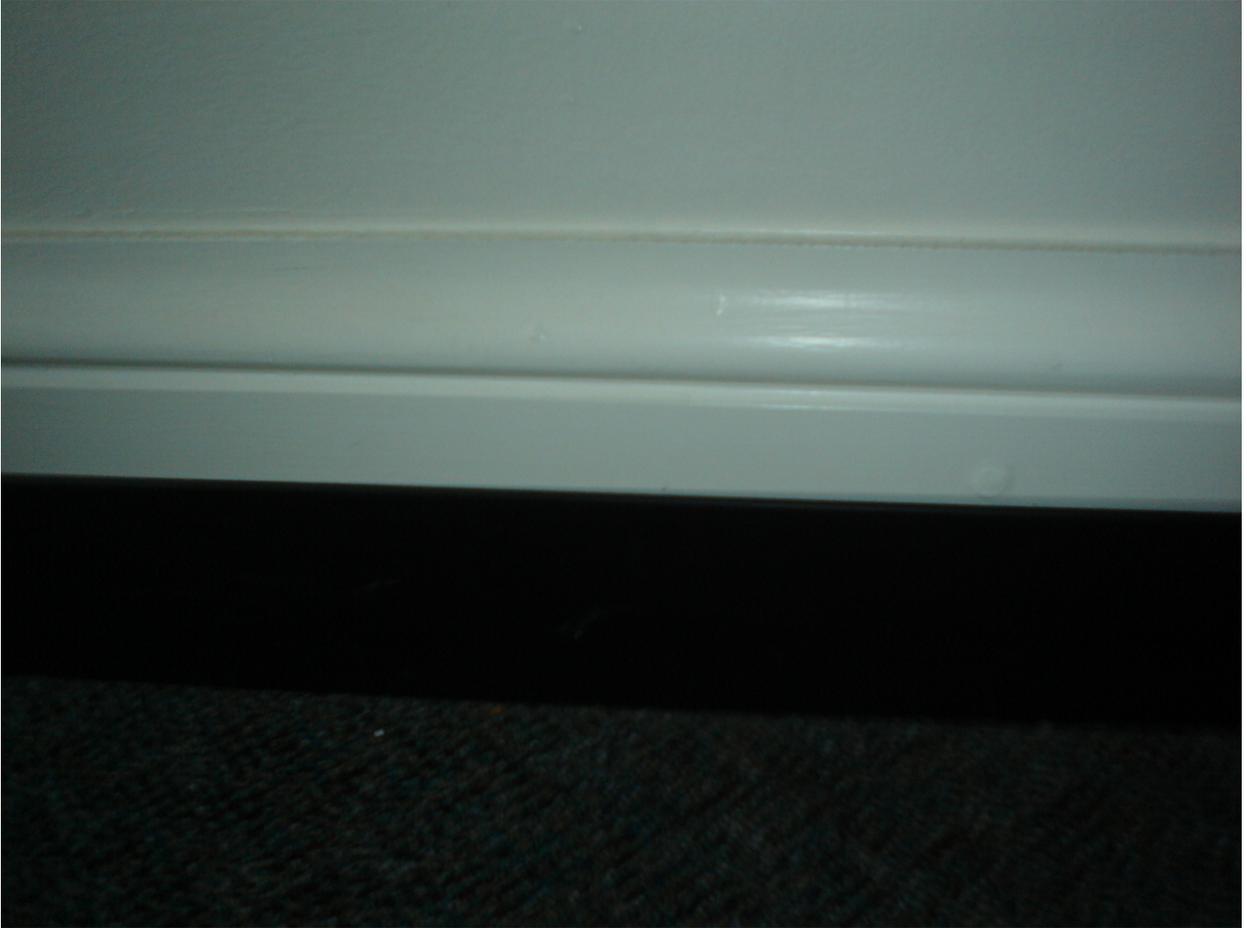
HA #14 – Non asbestos-containing 4” black cove molding  
and associated mastic

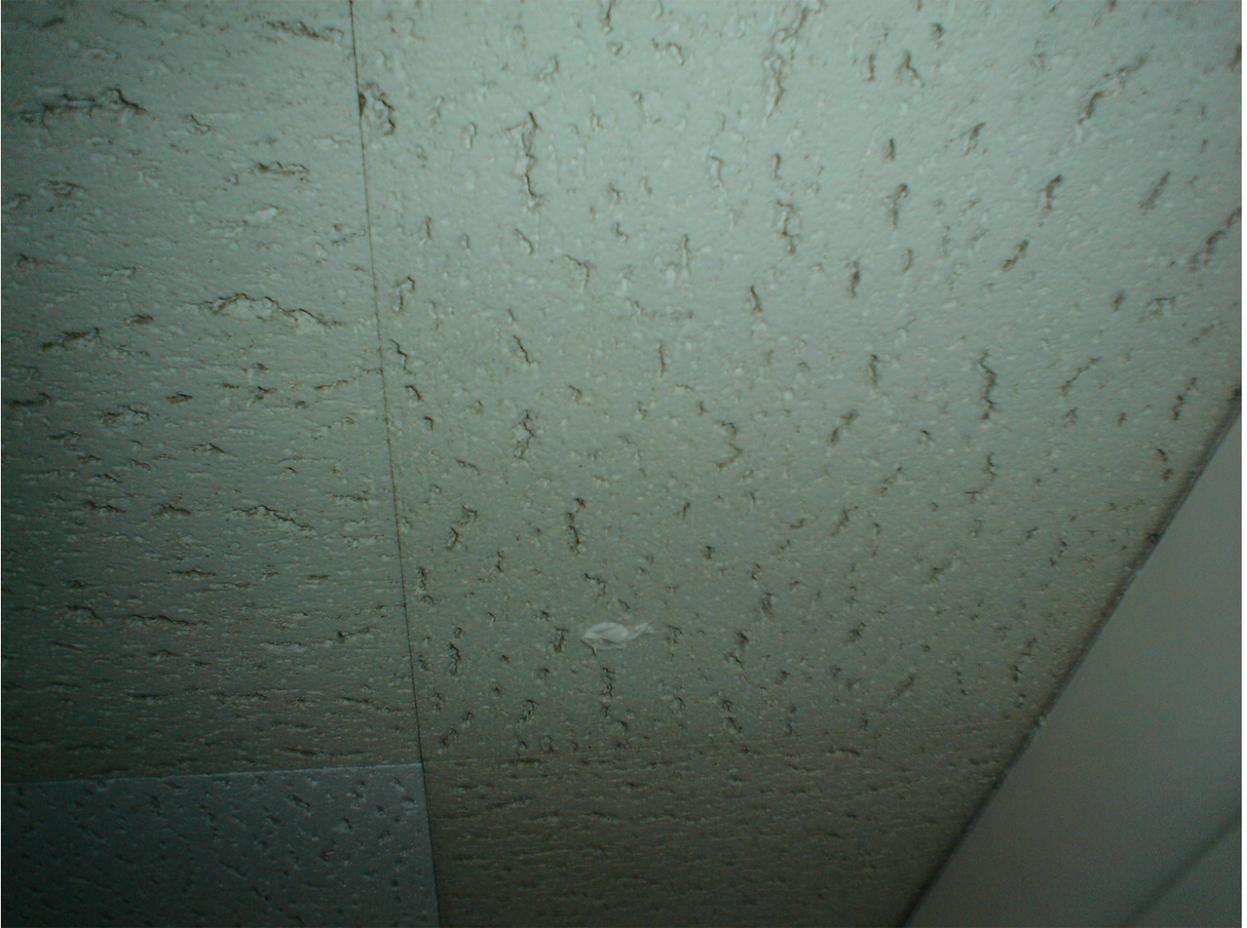
HA #16 – Non asbestos-containing 12” x 12” white ceiling tile with fissures and associated glue pods
