Museum Photo Log

Photo 1 – Asbestos-containing 9” x 9” tan floor tile
with multi-colored streaks (associated mastic is non asbestos-containing)

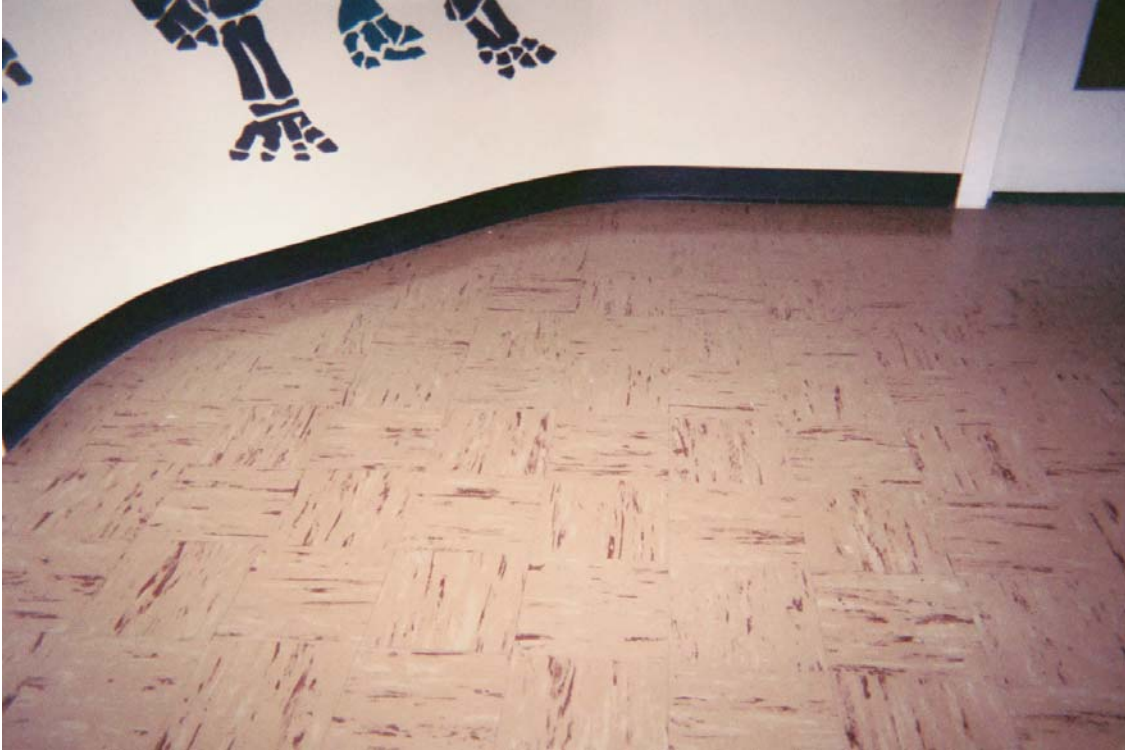
Photo 11 – Asbestos-containing 9” x 9” light brown floor tile with cream and rust streaks (associated mastic is also asbestos-containing)

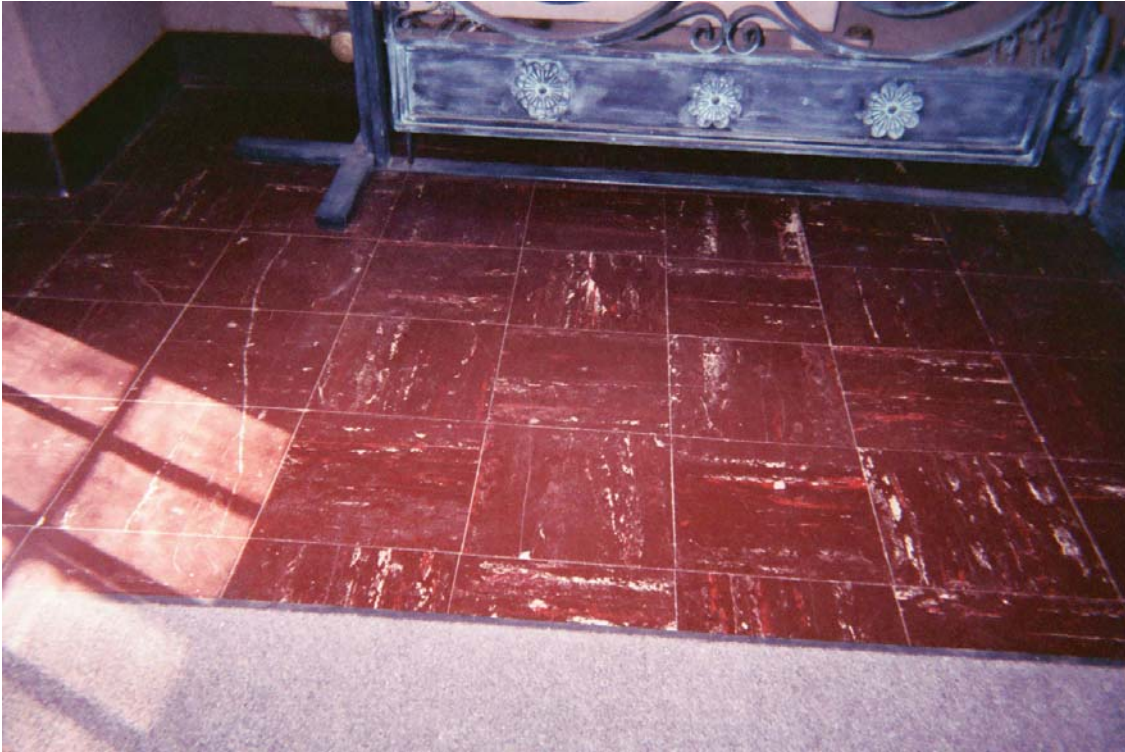
Photo 12 – Asbestos-containing 9” x 9” dark brown floor tile with cream and rust streaks (associated mastic is non asbestos-containing)

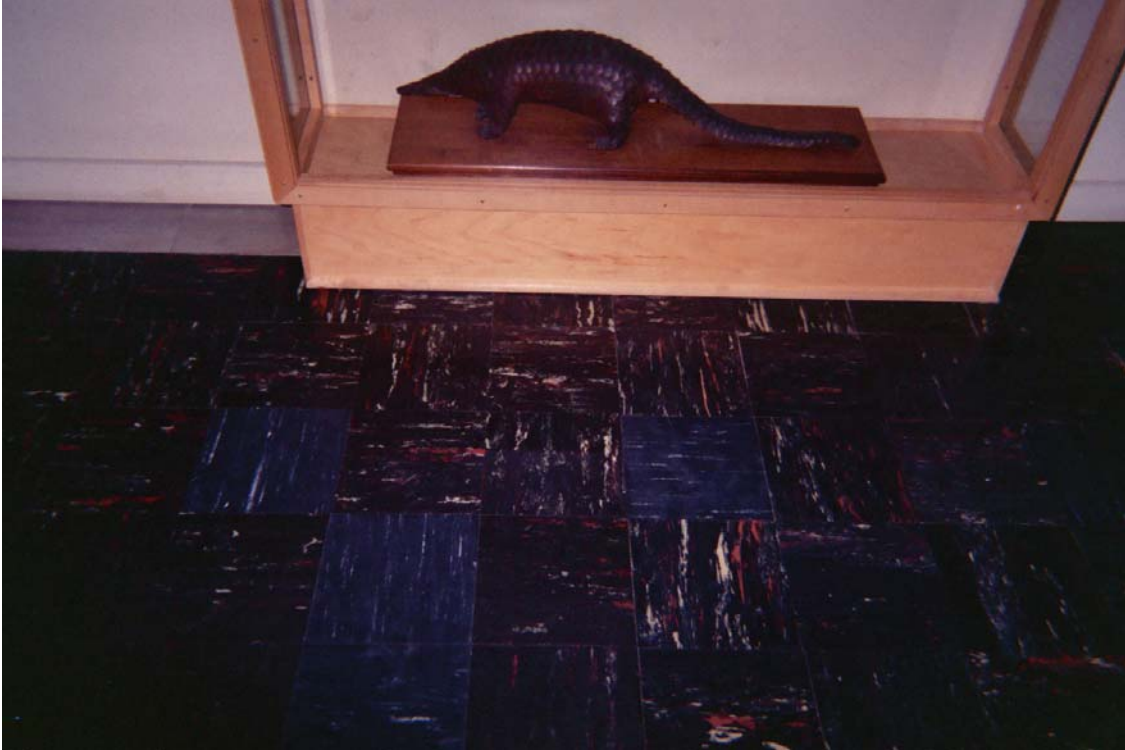
Photo 13 – Asbestos-containing 9” x 9” black floor tile with cream and rust streaks (associated mastic is non asbestos-containing)
