**ASBESTOS-CONTAINING MATERIAL
BUILDING INSPECTION REPORT**

Michigan State University
Eustace-Cole Hall
468 East Circle Drive
East Lansing, Michigan 48824

Fibertec Industrial Hygiene Services, Inc.
1914 Holloway Drive
Holt, Michigan 48842

Project #40413-1

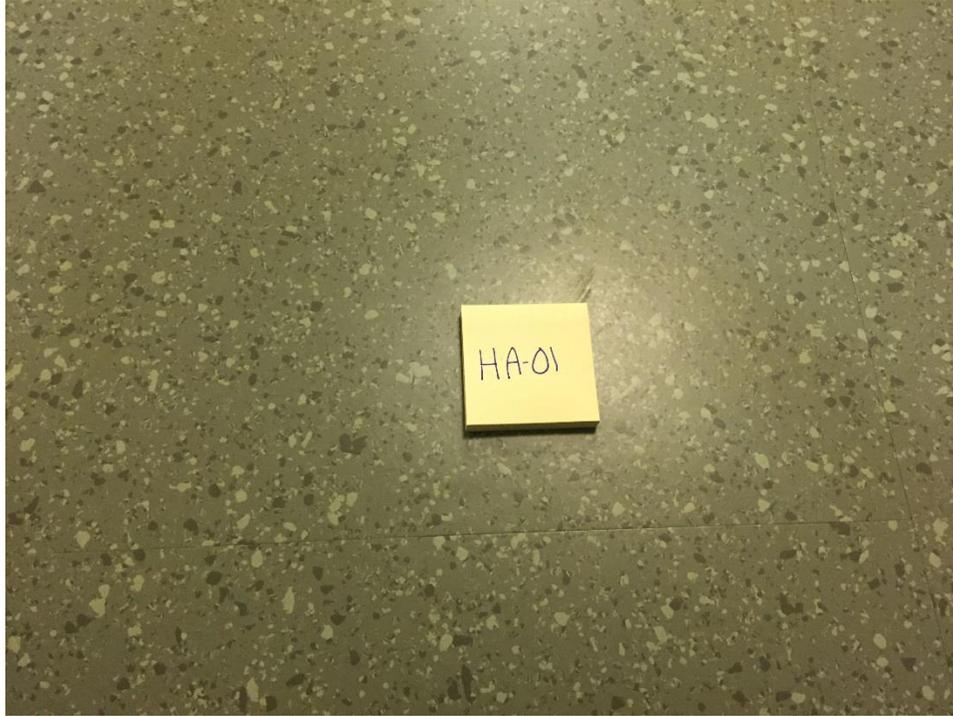
HA-01 Non-asbestos containing green linoleum with marble pattern and associated mastic

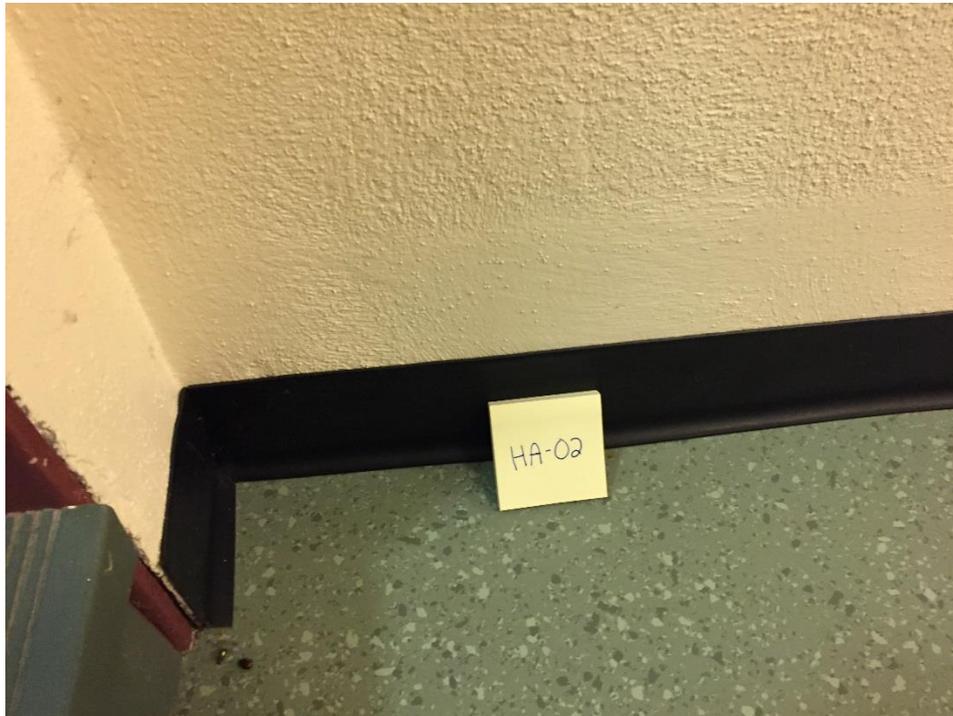
HA-02 Non-asbestos containing 4" black cove molding and associated mastic.

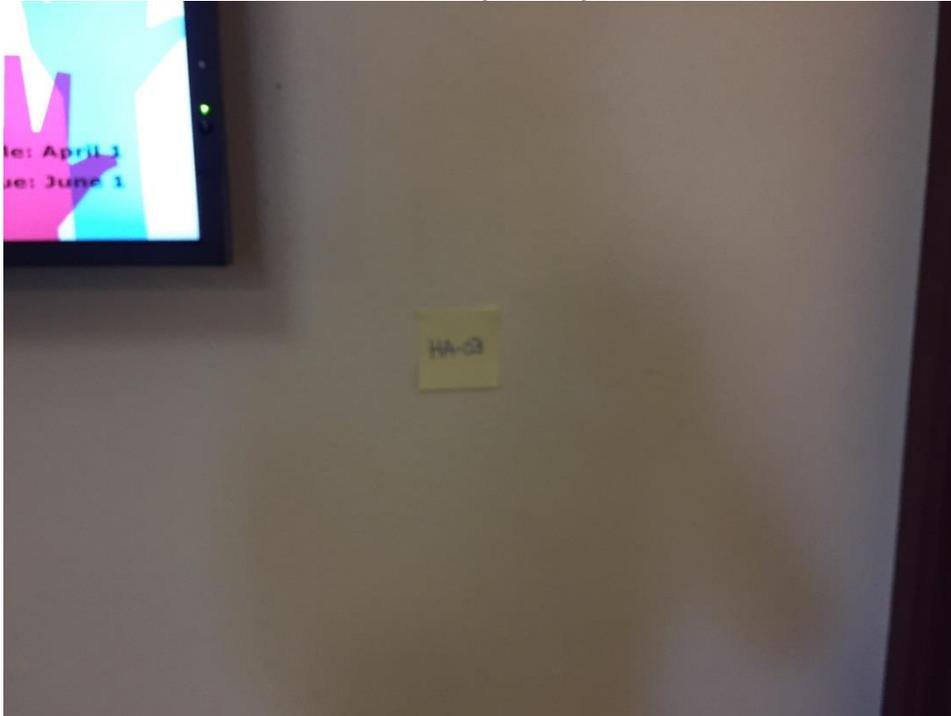
HA-03 Non-asbestos containing white textured wall plaster

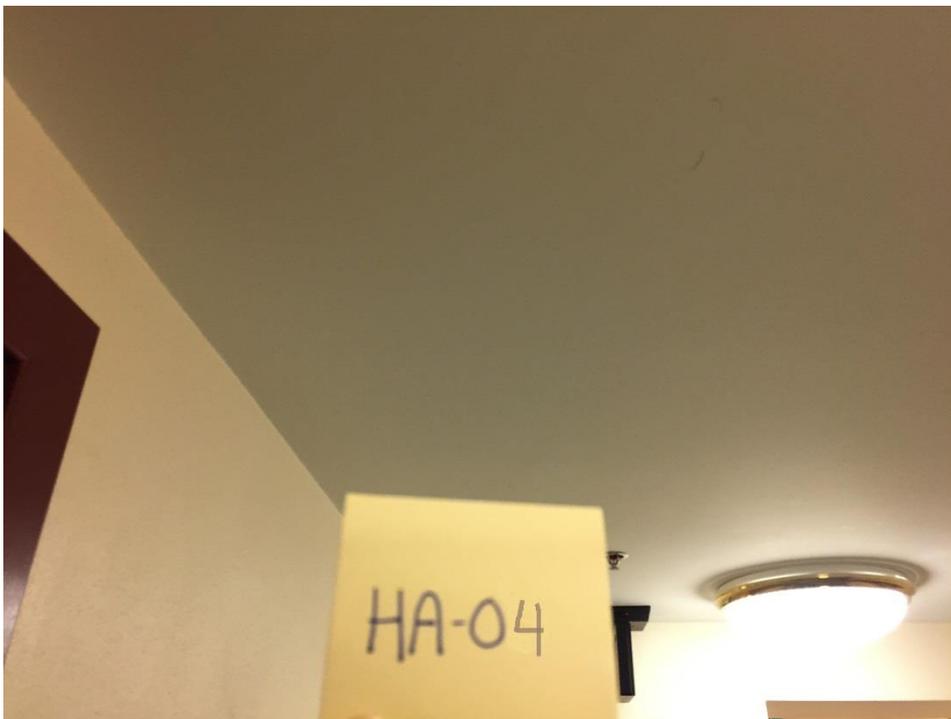
HA-04 Non-asbestos containing white smooth ceiling plaster

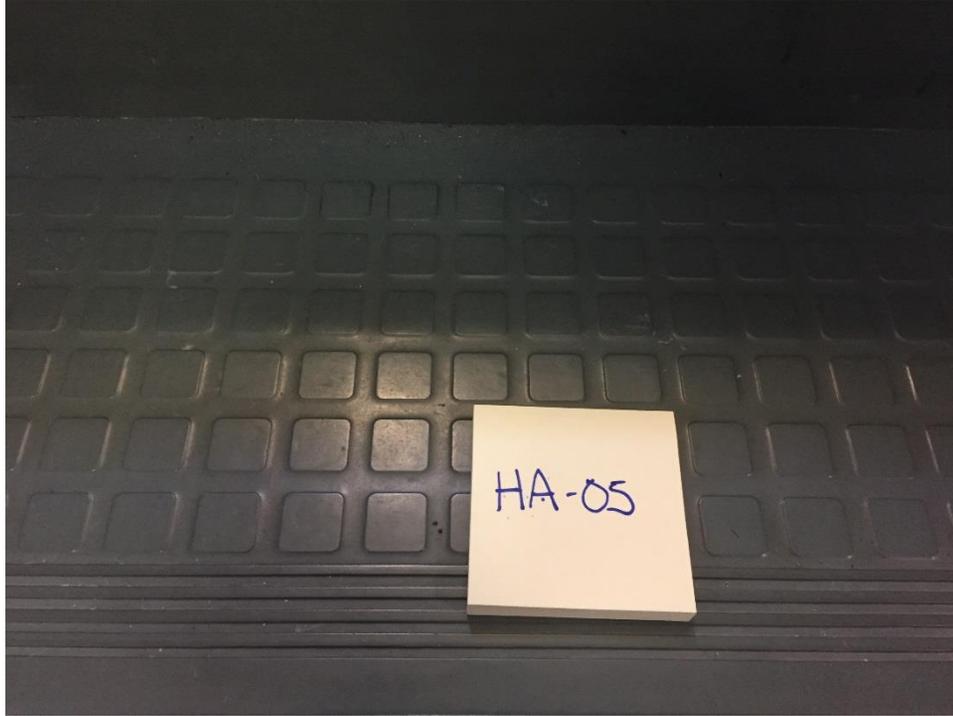
HA-05 Non-asbestos containing green square pattern linoleum stair tread flooring and associated mastic

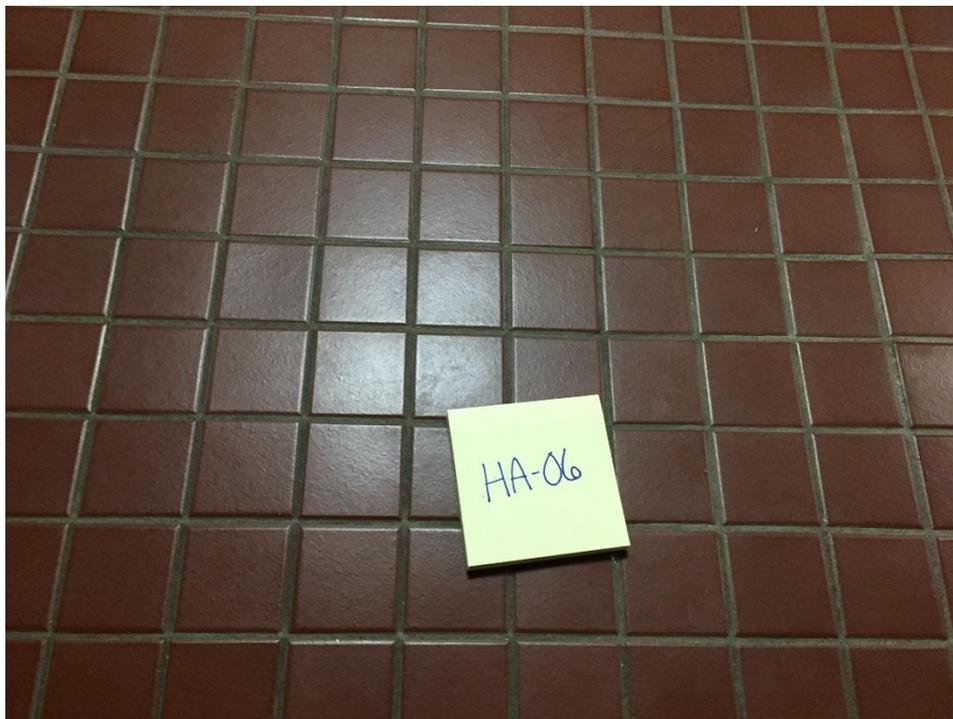
HA-06 Assumed asbestos-containing ceramic floor tile bedding compound and grout

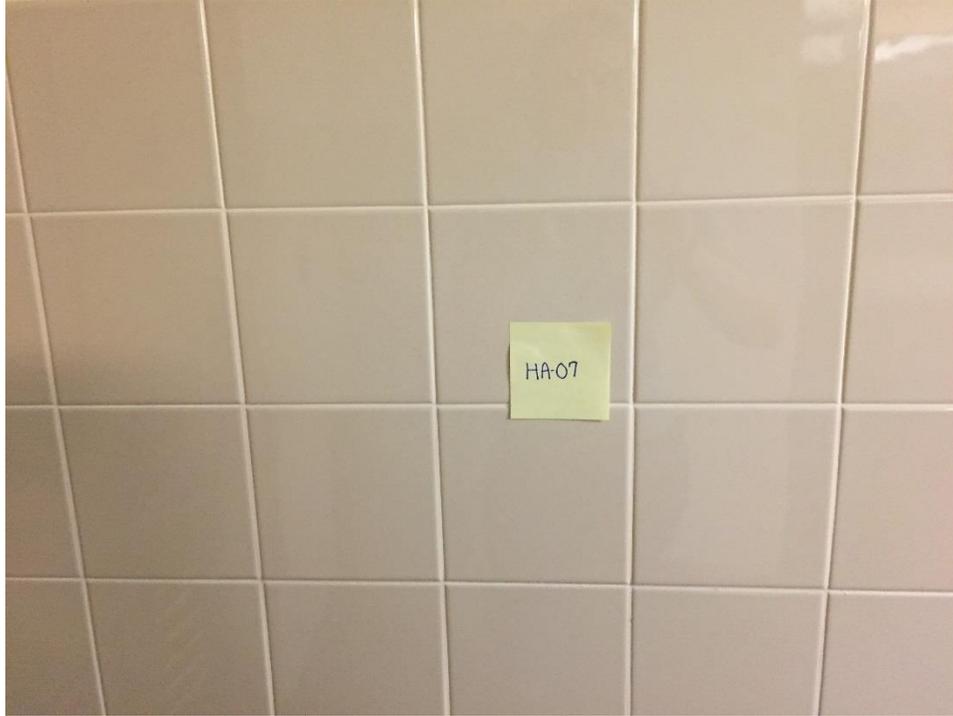
HA-07 Assumed asbestos-containing ceramic wall tile bedding compound and grout

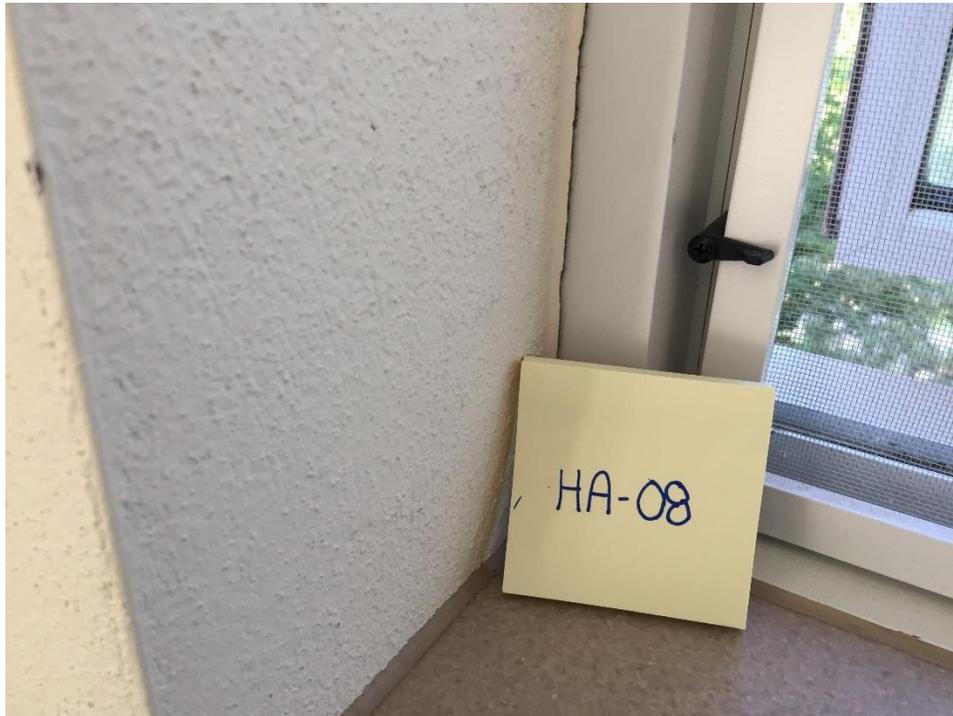
HA-08 Non-asbestos containing interior white window caulk

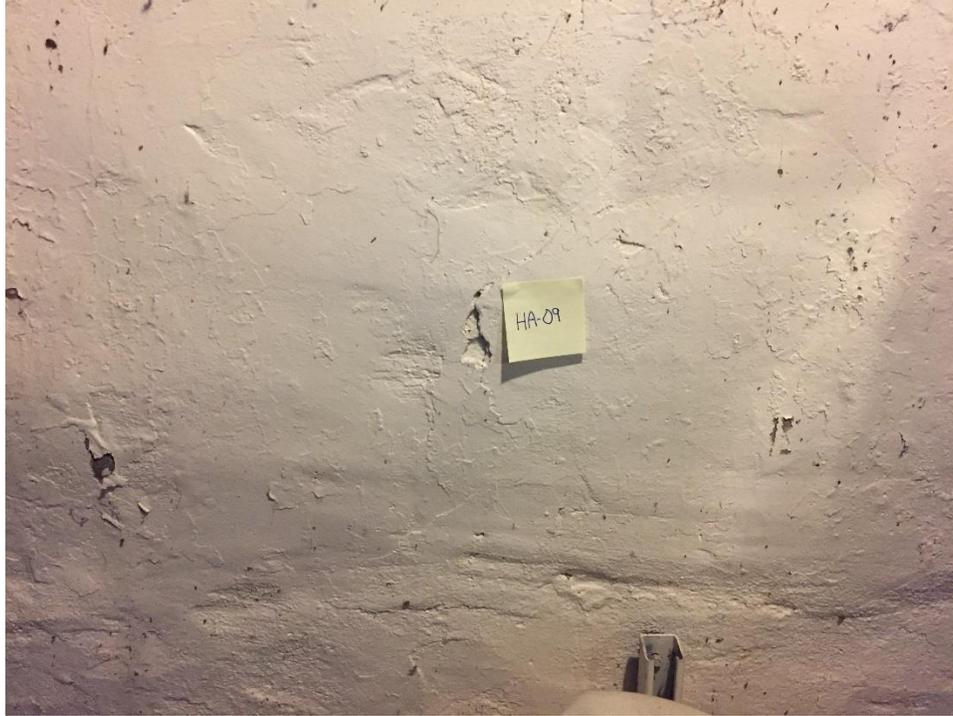
HA-09 Non-asbestos containing white rough texture plaster

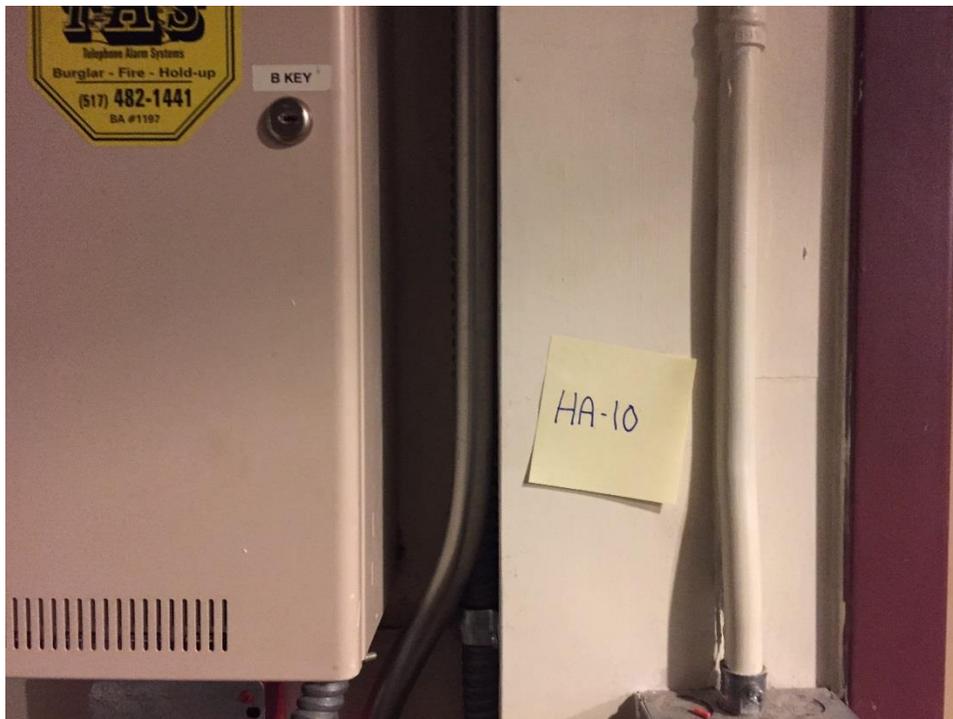
HA-10 Non-asbestos containing drywall

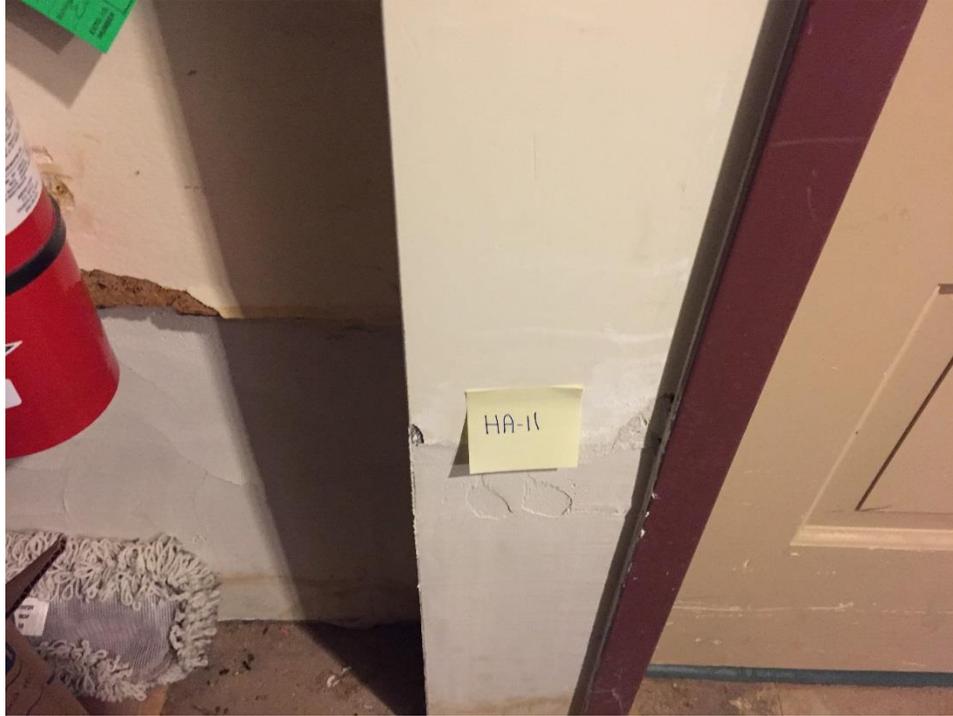
HA-11 Non-asbestos containing drywall joint compound

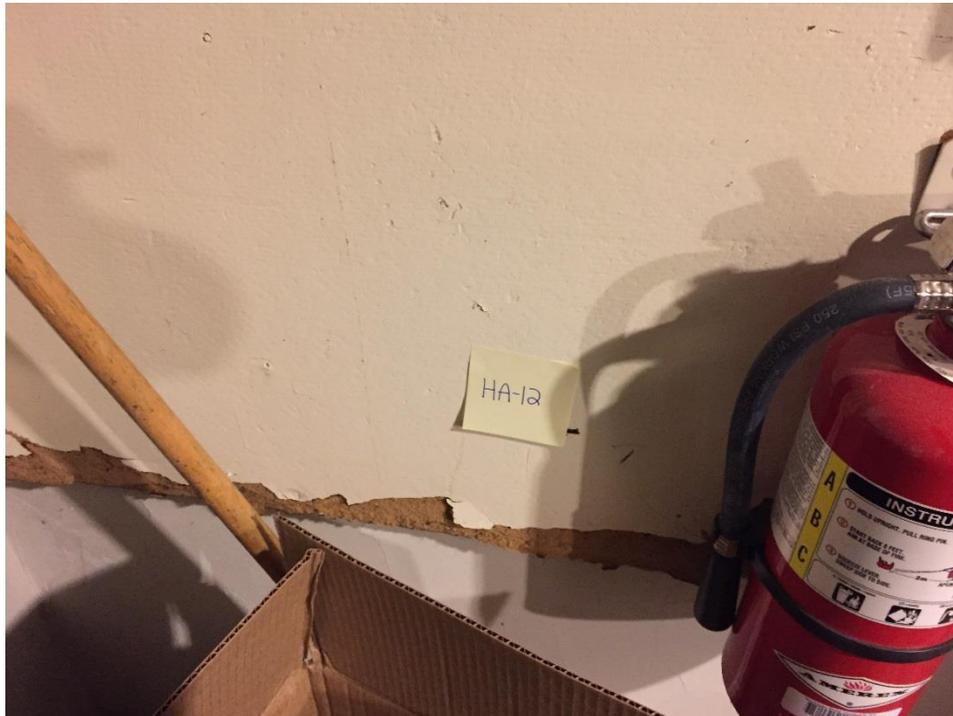
HA-12 Non-asbestos containing fiberboard wall panels and associated mastic

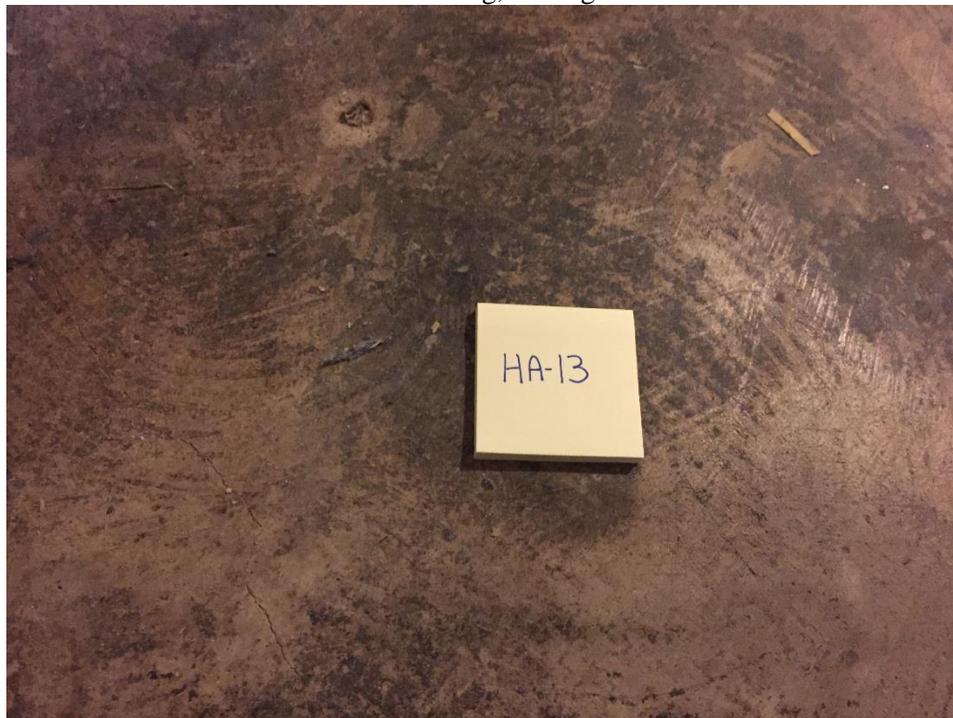
HA-13 Non-asbestos containing black mastic on floor

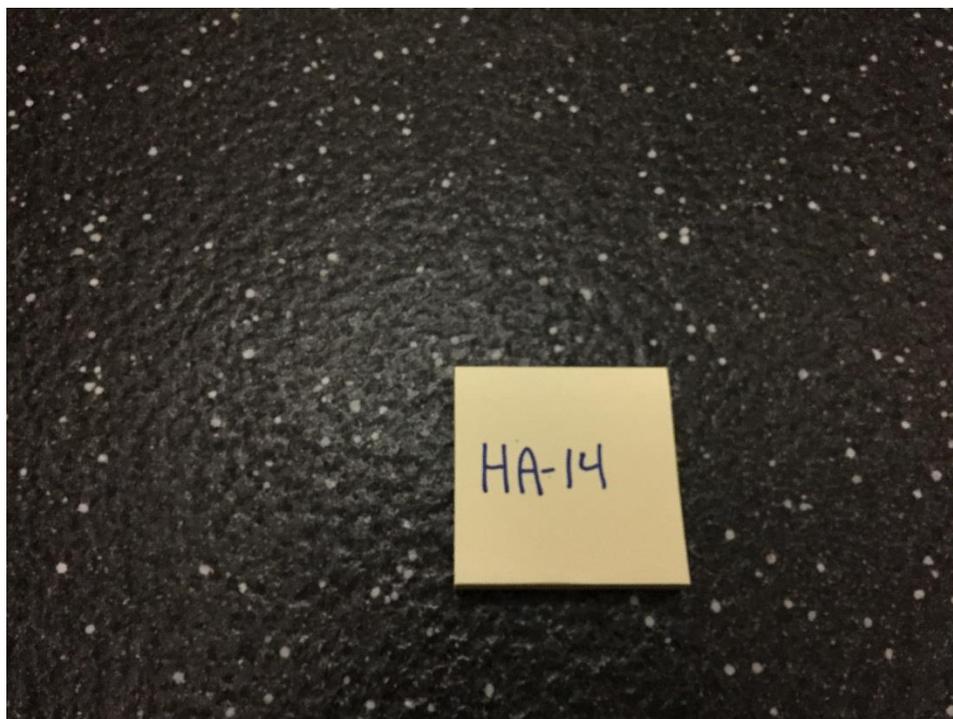
HA-14 Non-asbestos containing black linoleum and associated mastic

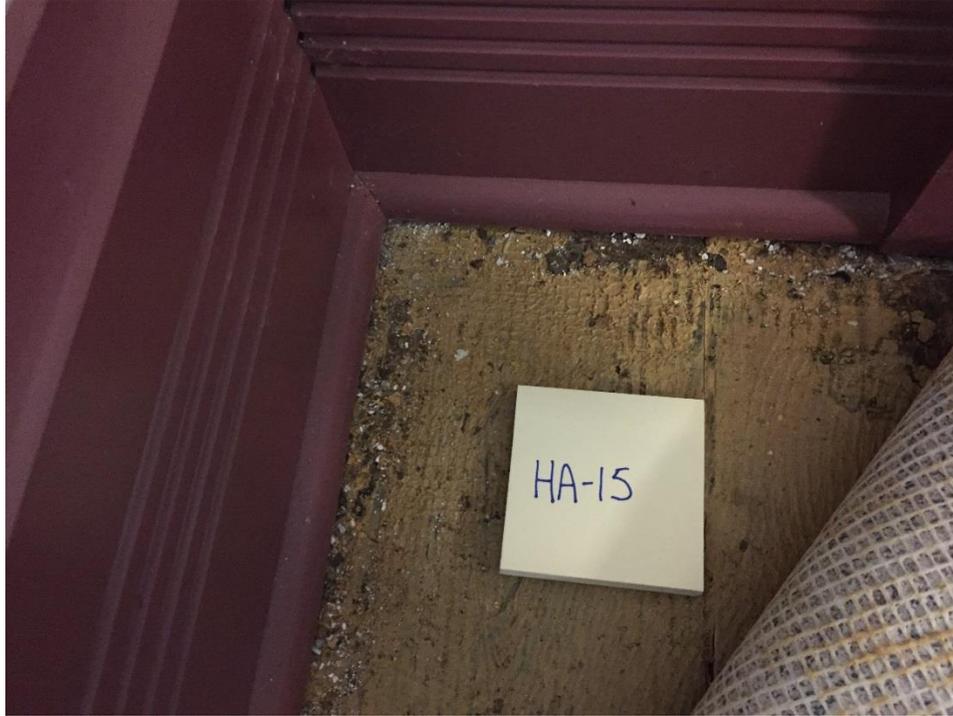
HA-15 Non-asbestos containing yellow carpet mastic

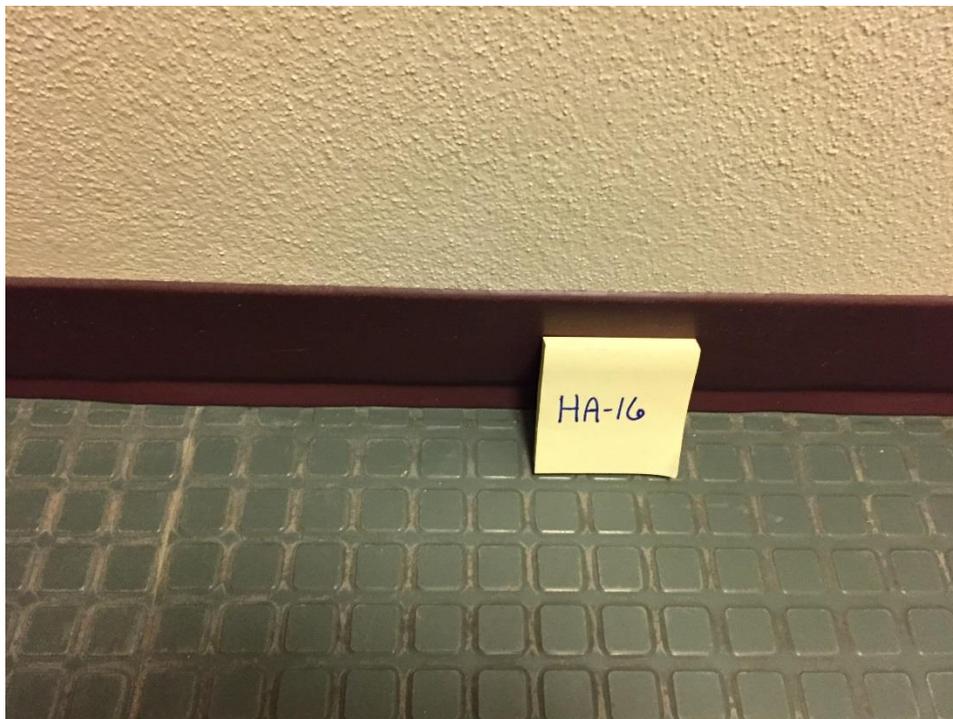
HA-16 Non-asbestos containing 4" maroon cove molding and associated mastic

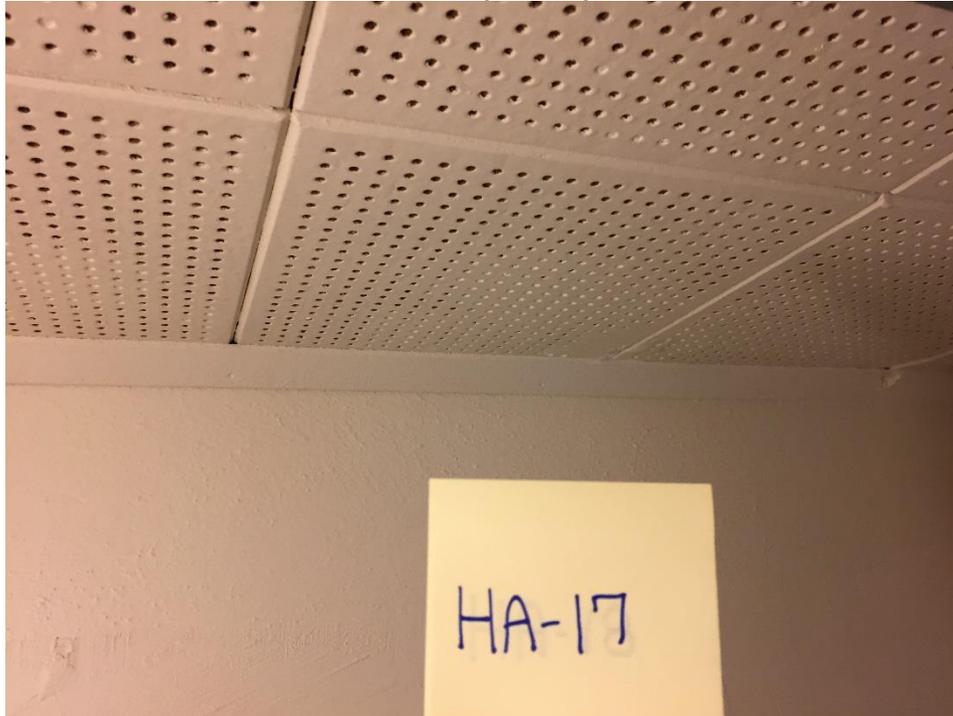
HA-17 Non-asbestos containing white 12" x 12" glued-on ceiling tile with uniform holes and HA-18 Assumed asbestos-containing gluepods

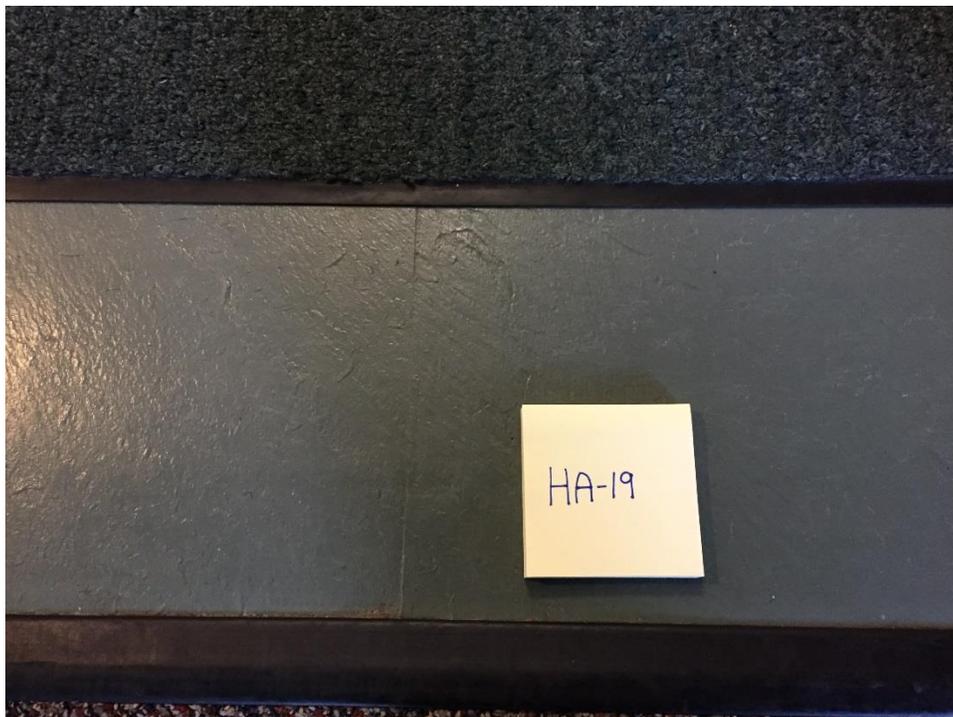
HA-19 Non-asbestos containing green linoleum with texture and associated mastic

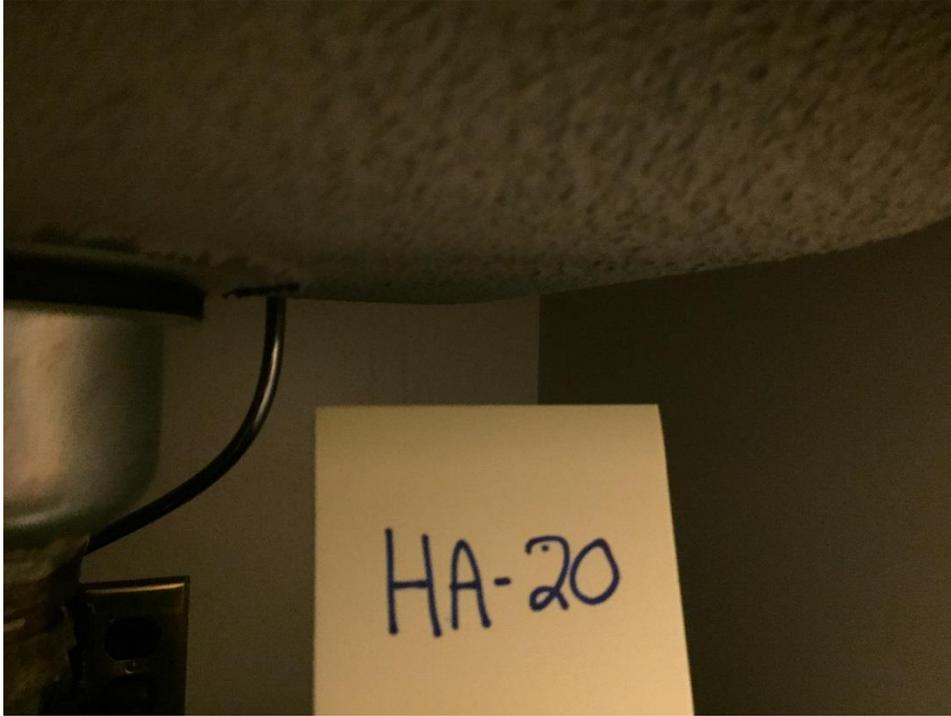
HA-20 Non-asbestos containing gray sink undercoating

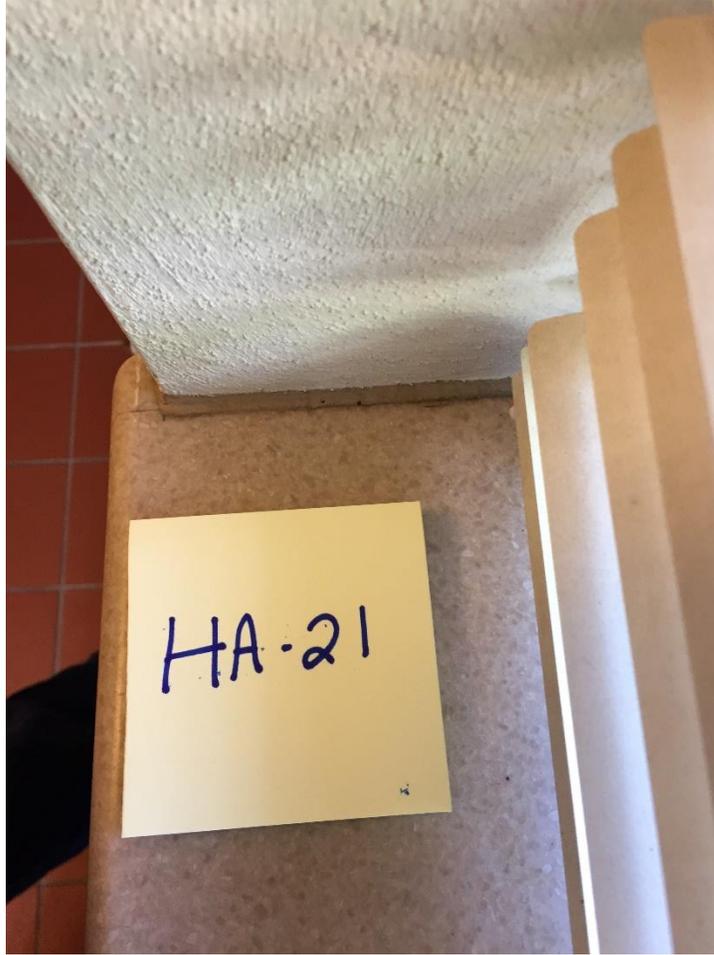
HA-21 Non-asbestos containing interior light brown window sill caulk

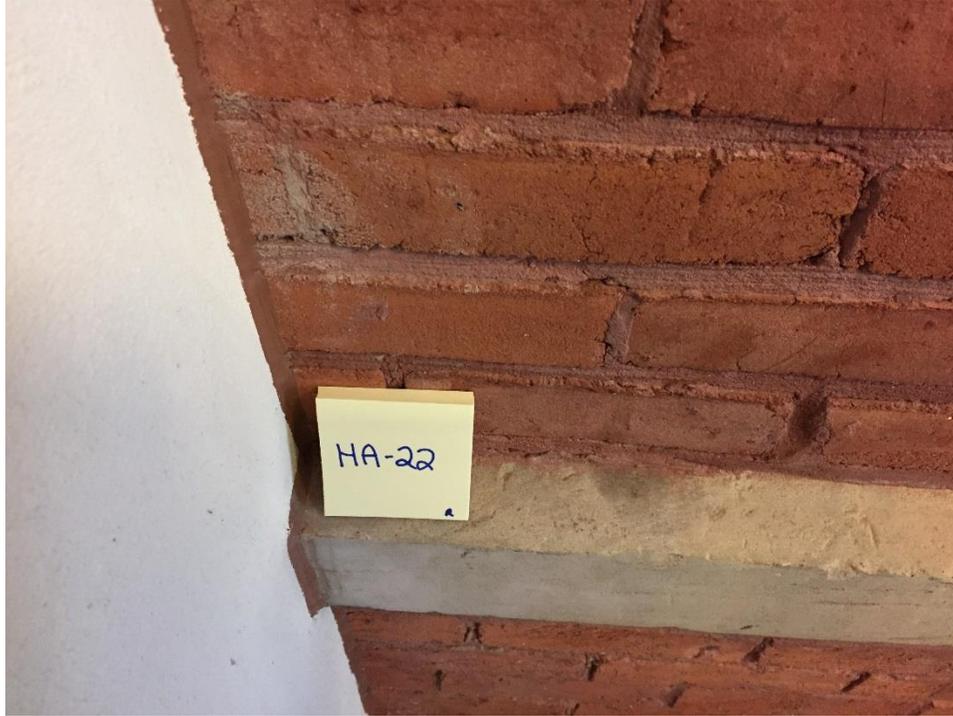
HA-22 Non-asbestos containing interior red brick caulk

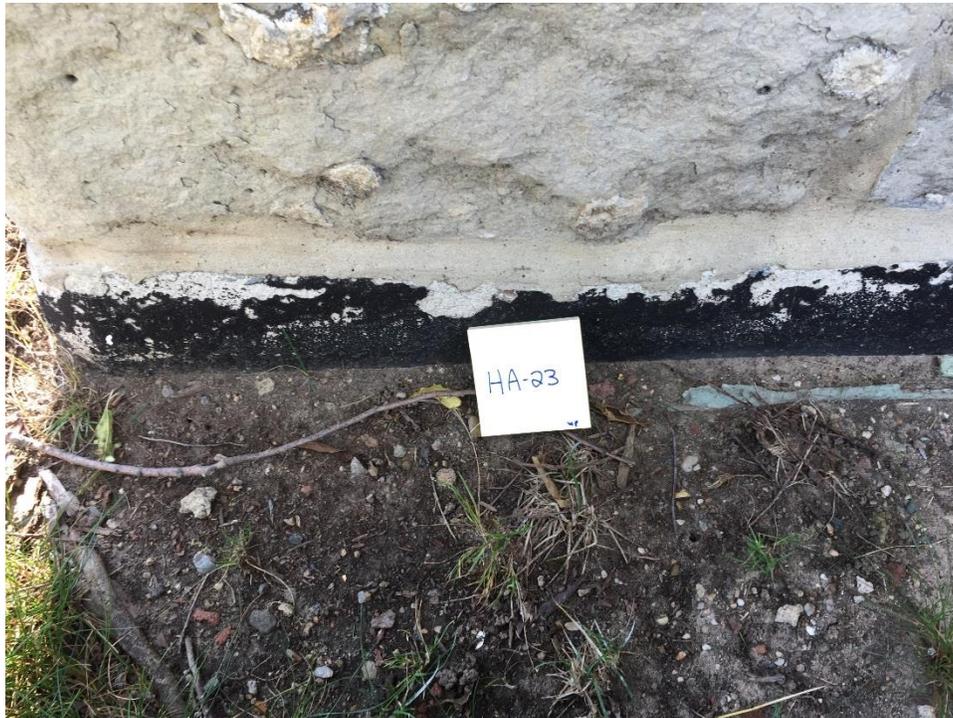
HA 23 Exterior black waterproofing

HA-23 Asbestos containing exterior black waterproofing

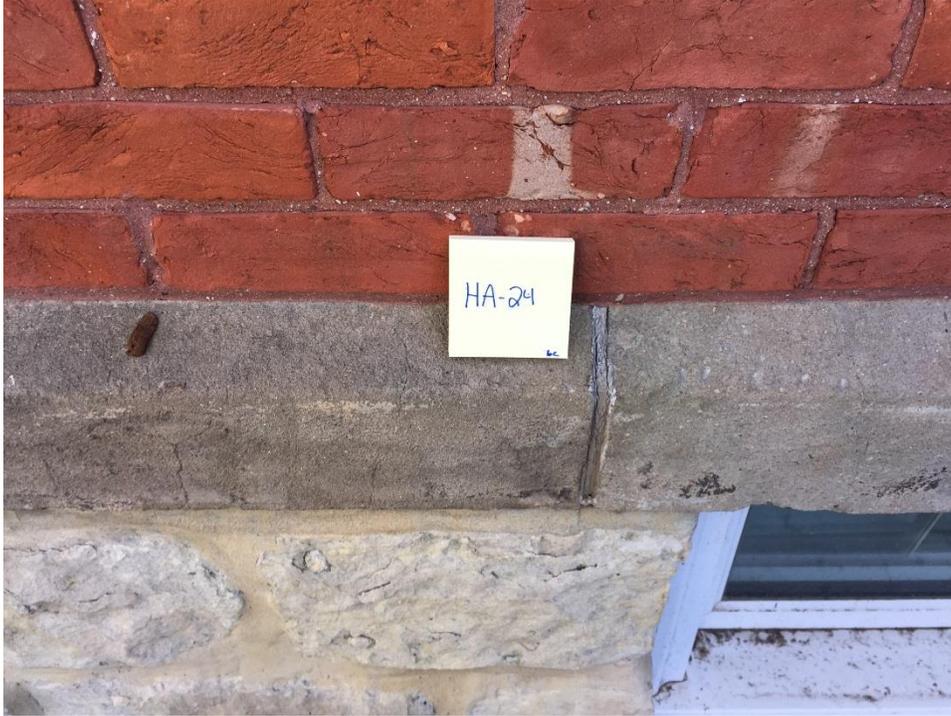
HA-24 Non-asbestos containing exterior brown building caulk

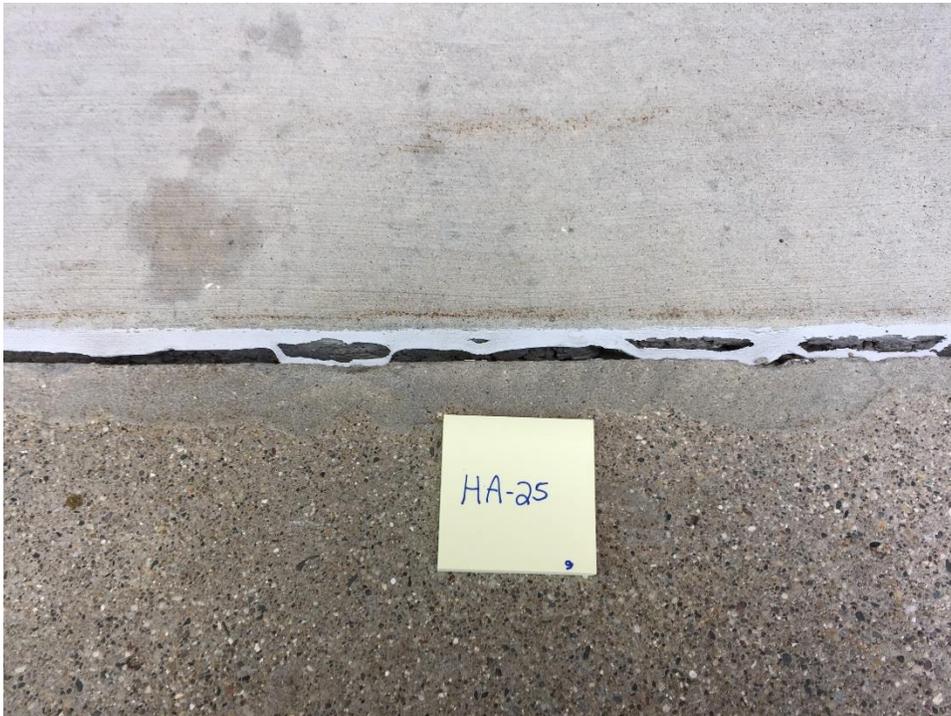
HA-25 Non-asbestos containing exterior gray front steps caulk

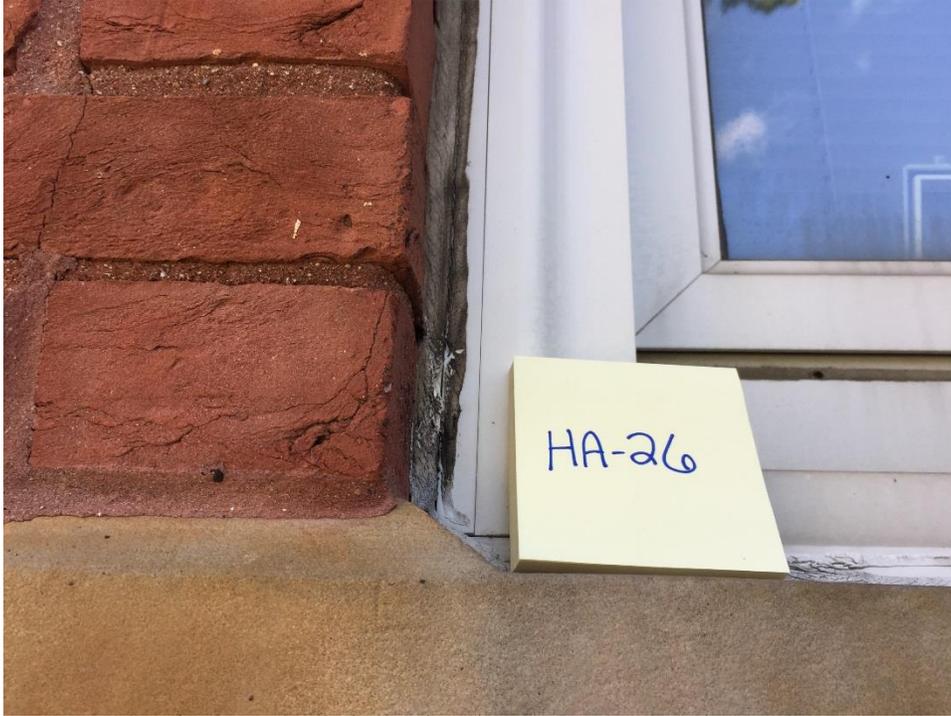
HA-26 Non-asbestos containing exterior white window caulk

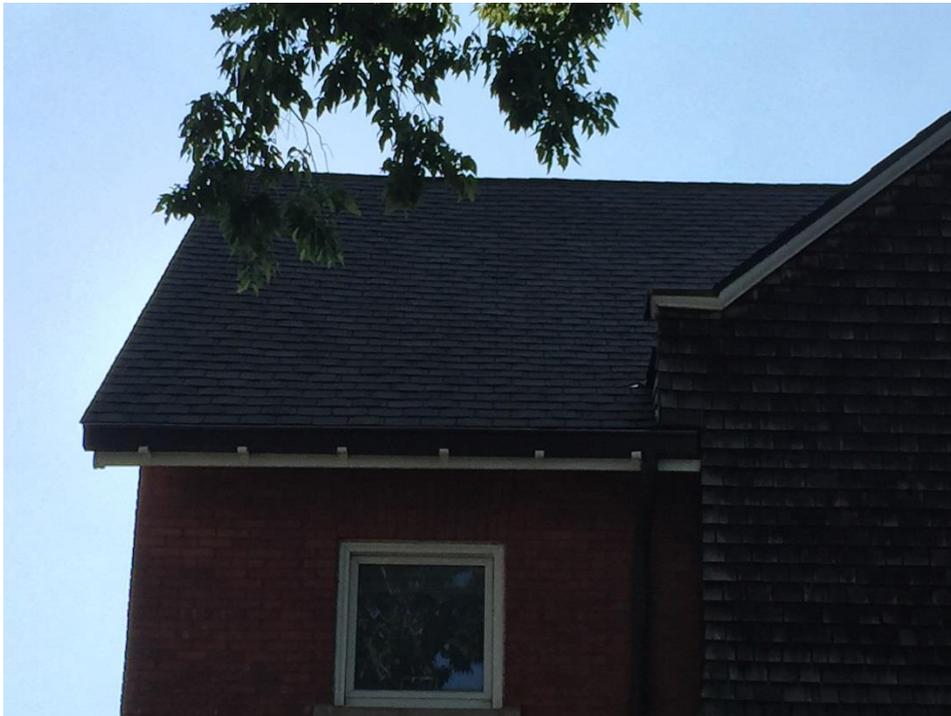
HA-27 Assumed asbestos-containing gray roof shingles and felts (tar paper)

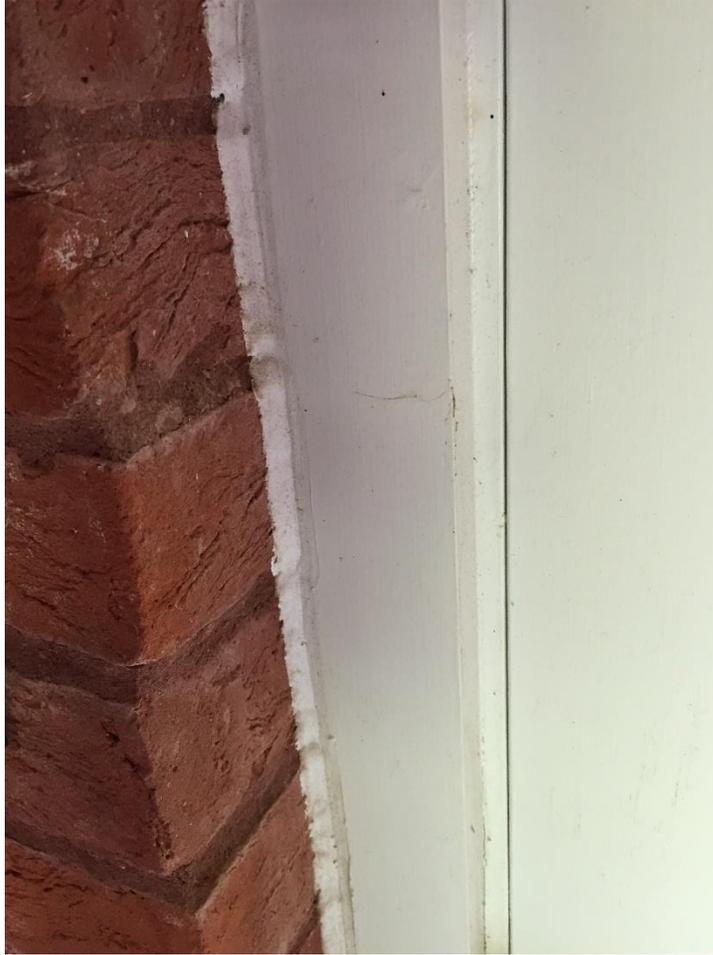
HA-28 Non-asbestos containing exterior white door caulk
