Eustace-Cole Hall
468 East Circle Drive
East Lansing, Michigan

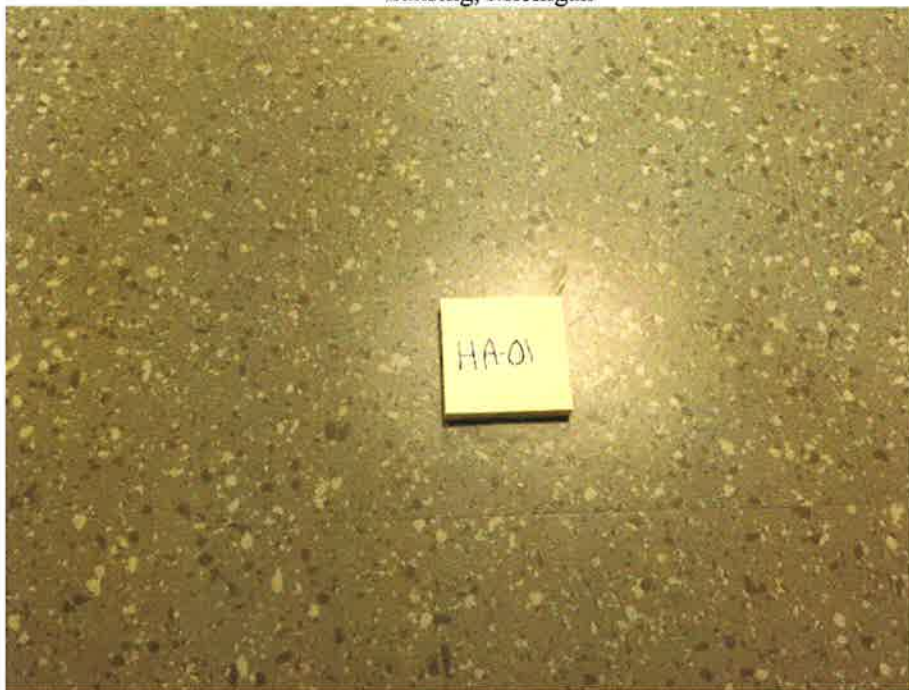
HA-01 Non-asbestos containing green linoleum with marble pattern and associated mastic

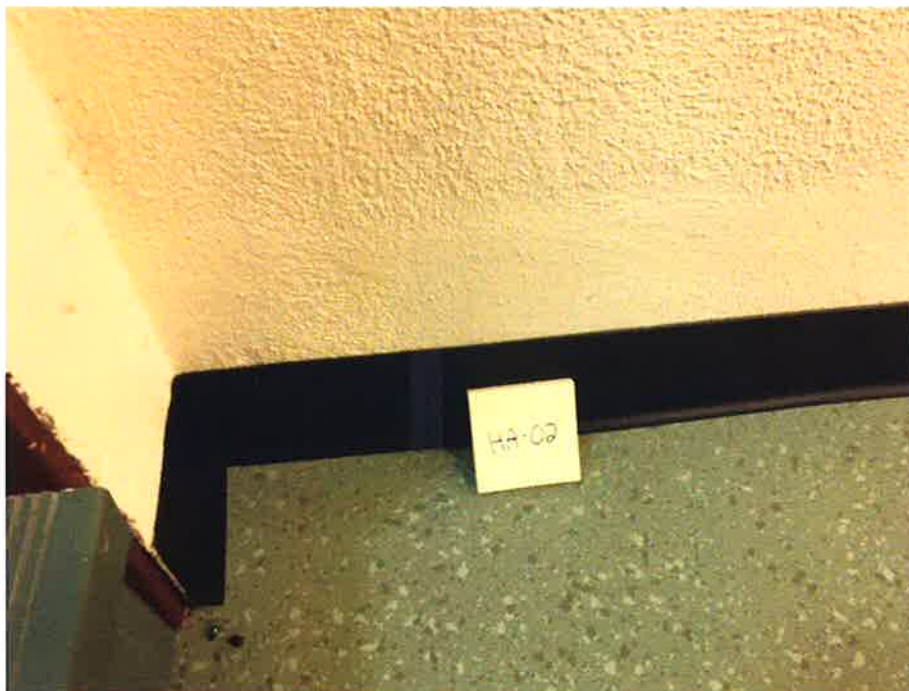
HA-02 Non-asbestos containing 4" black cove molding and associated mastic.

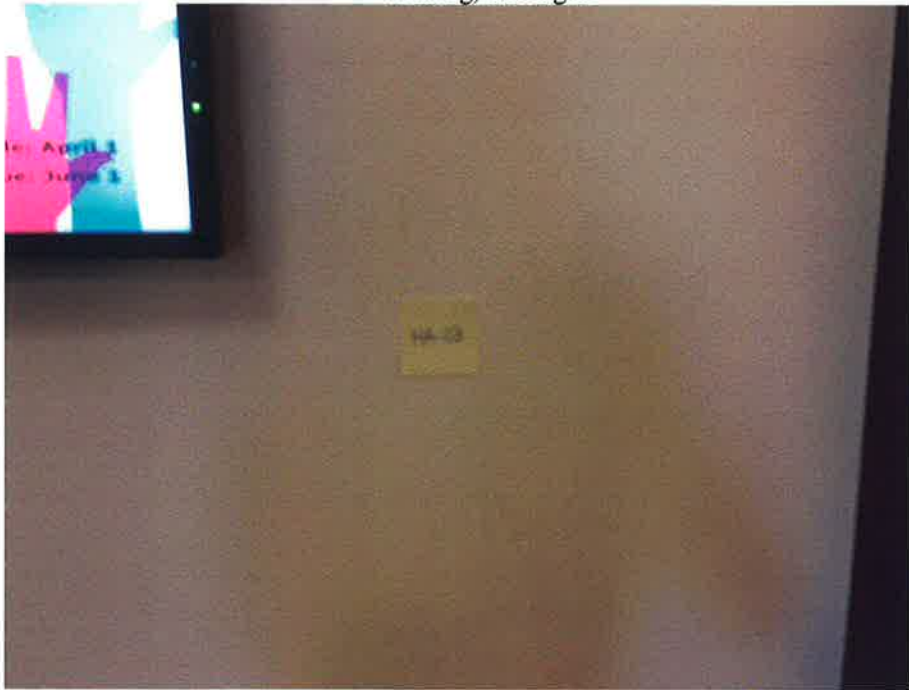
HA-03 Non-asbestos containing white textured wall plaster

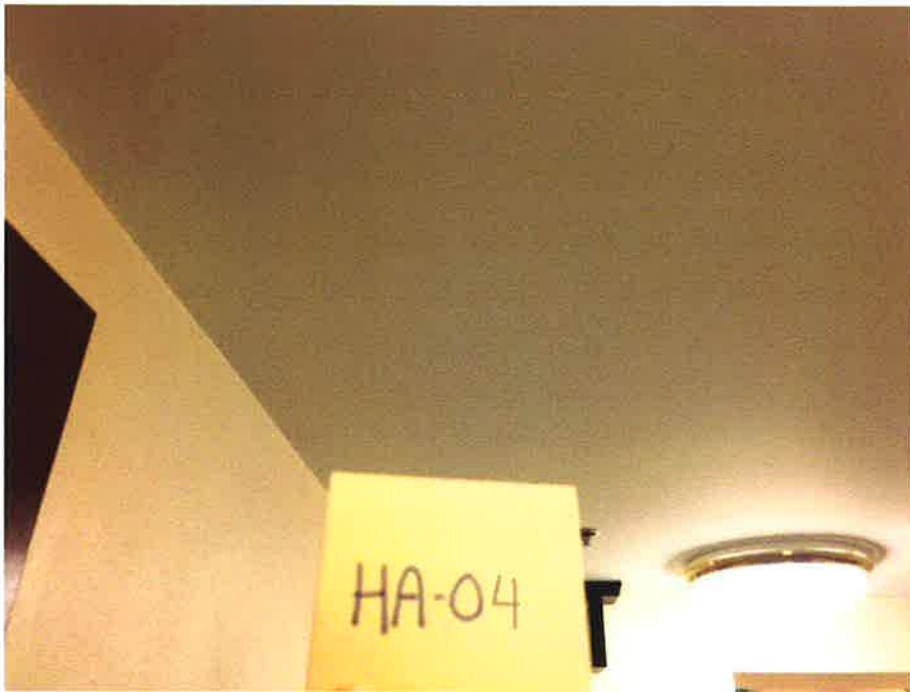
HA-04 Non-asbestos containing white smooth ceiling plaster

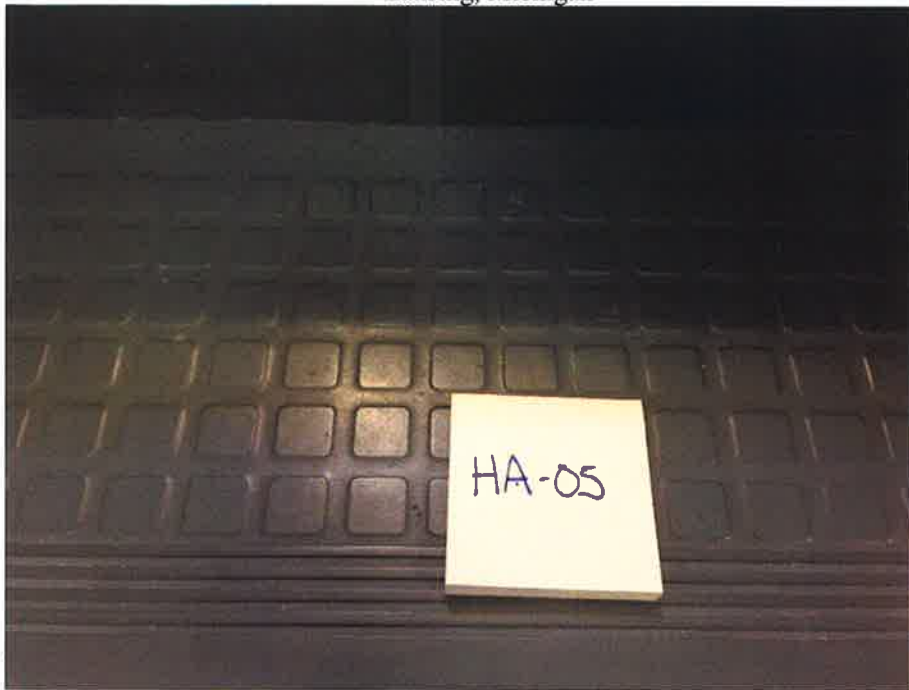
HA-05 Non-asbestos containing green square pattern linoleum stair tread flooring and associated mastic

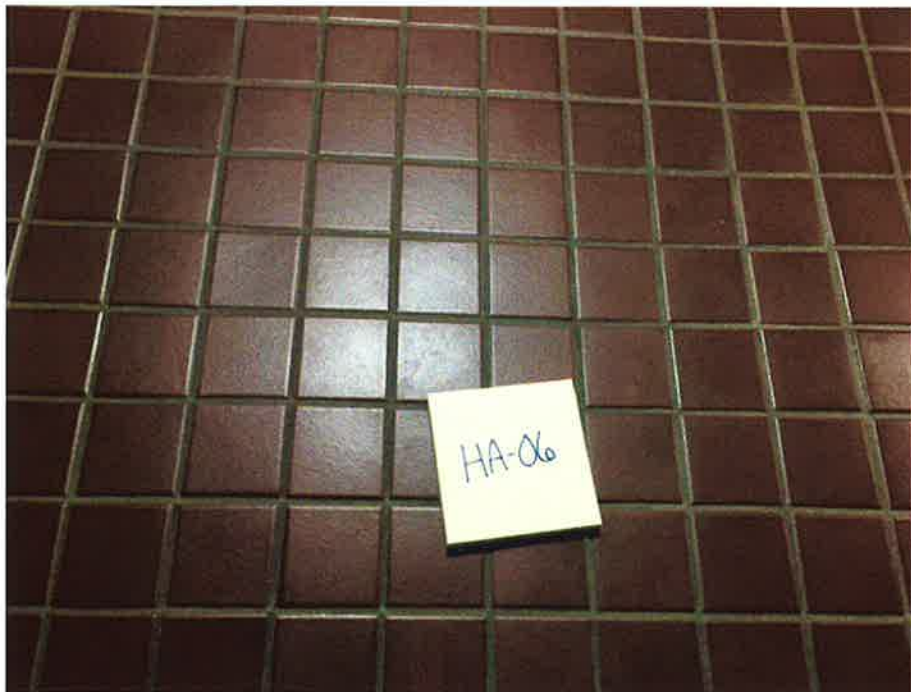
HA-06 Assumed asbestos-containing ceramic floor tile bedding compound and grout

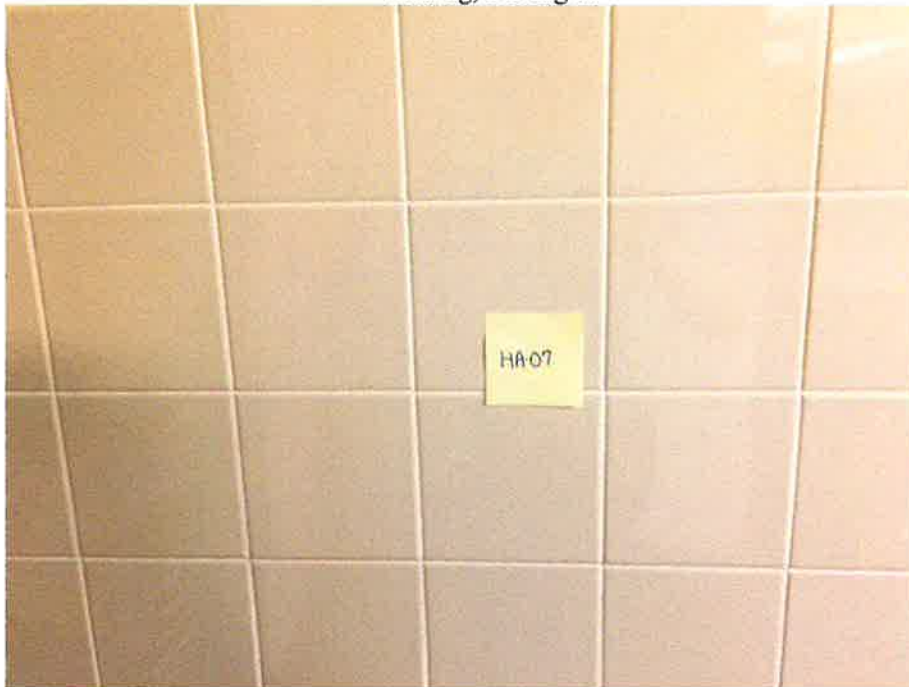
HA-07 Assumed asbestos-containing ceramic wall tile bedding compound and grout

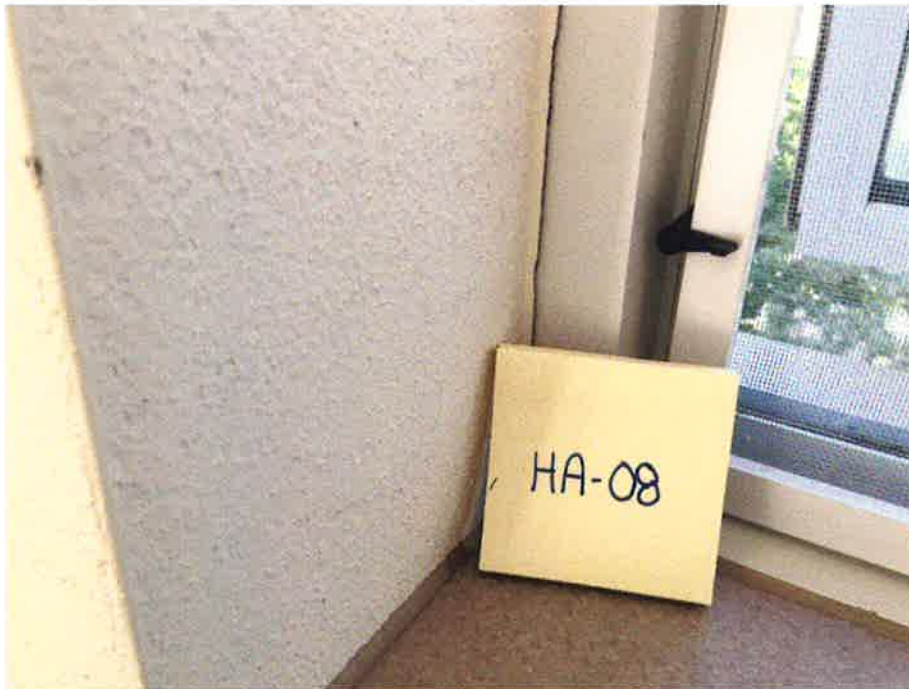
HA-08 Non-asbestos containing interior white window caulk

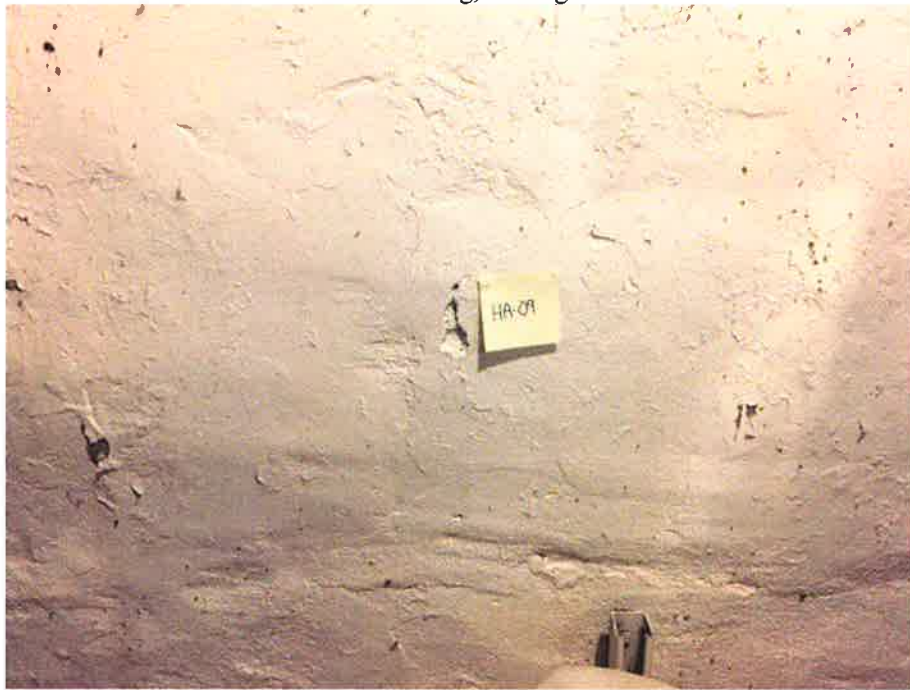
HA-09 Non-asbestos containing white rough texture plaster

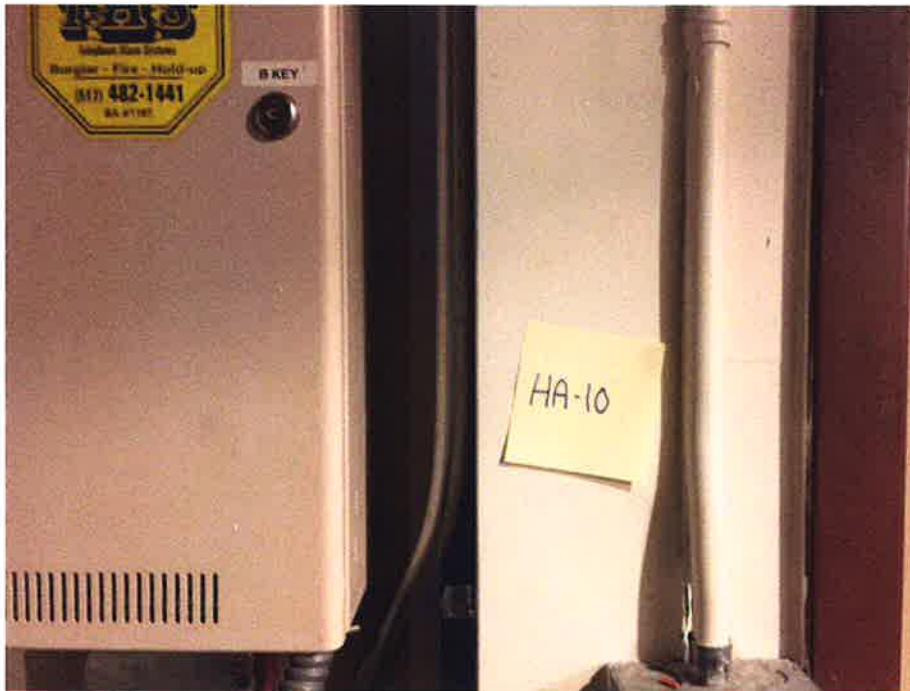
HA-10 Non-asbestos containing drywall

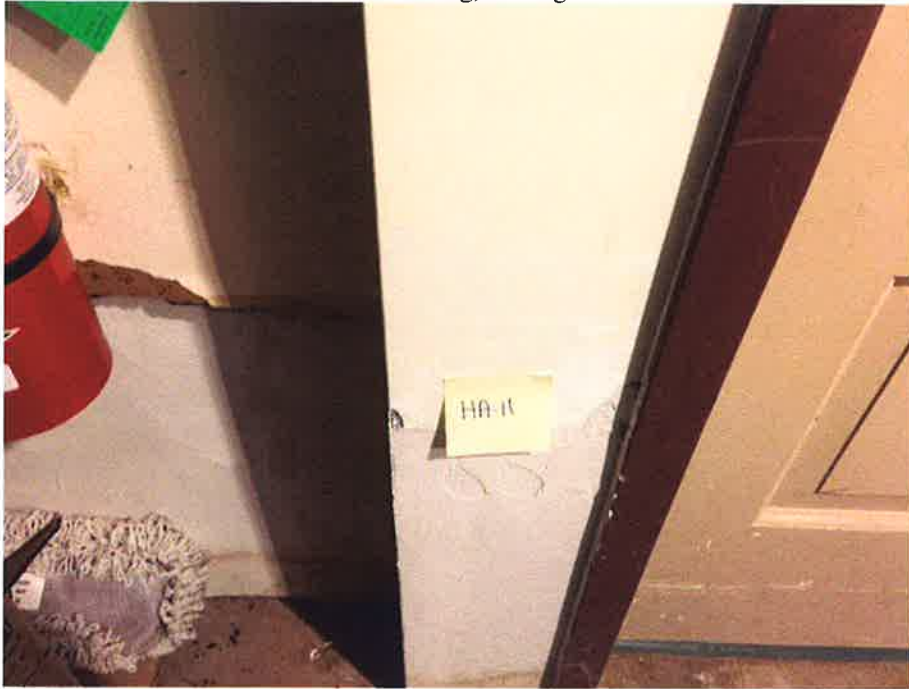
HA-11 Non-asbestos containing drywall joint compound

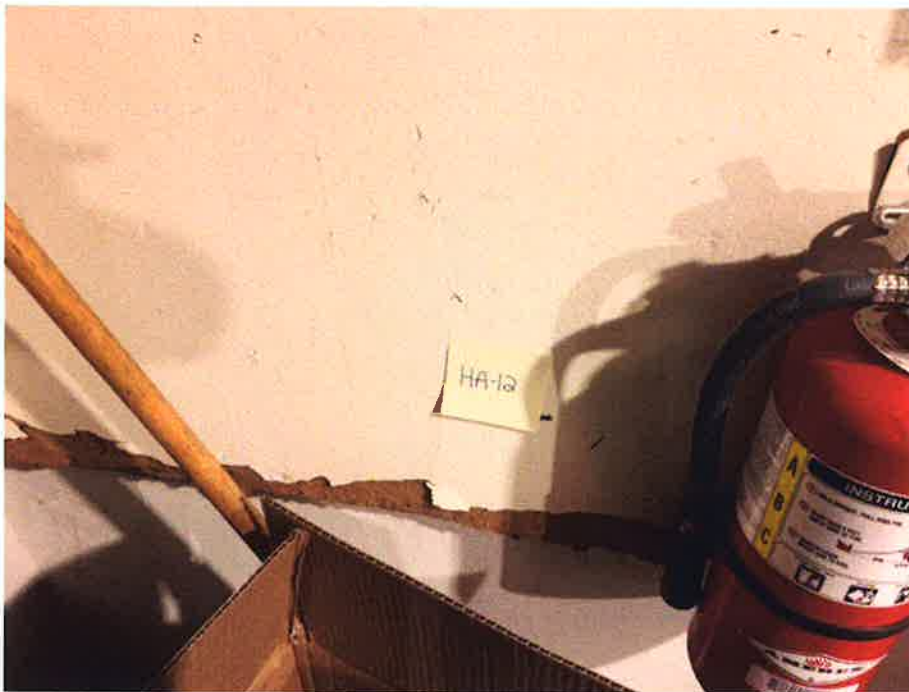
HA-12 Non-asbestos containing fiberboard wall panels and associated mastic

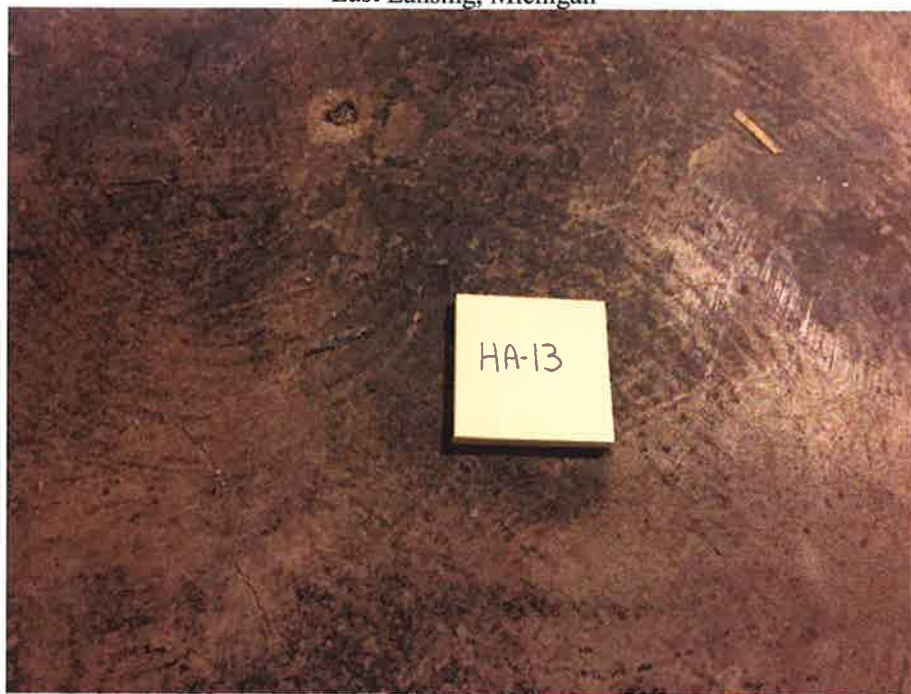
HA-13 Non-asbestos containing black mastic on floor

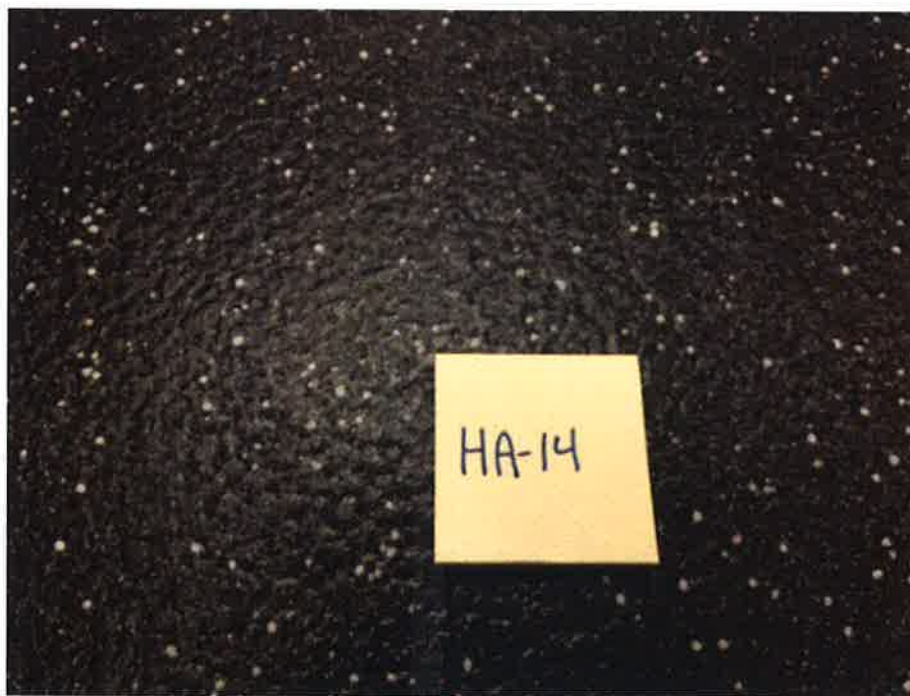
HA-14 Non-asbestos containing black linoleum and associated mastic

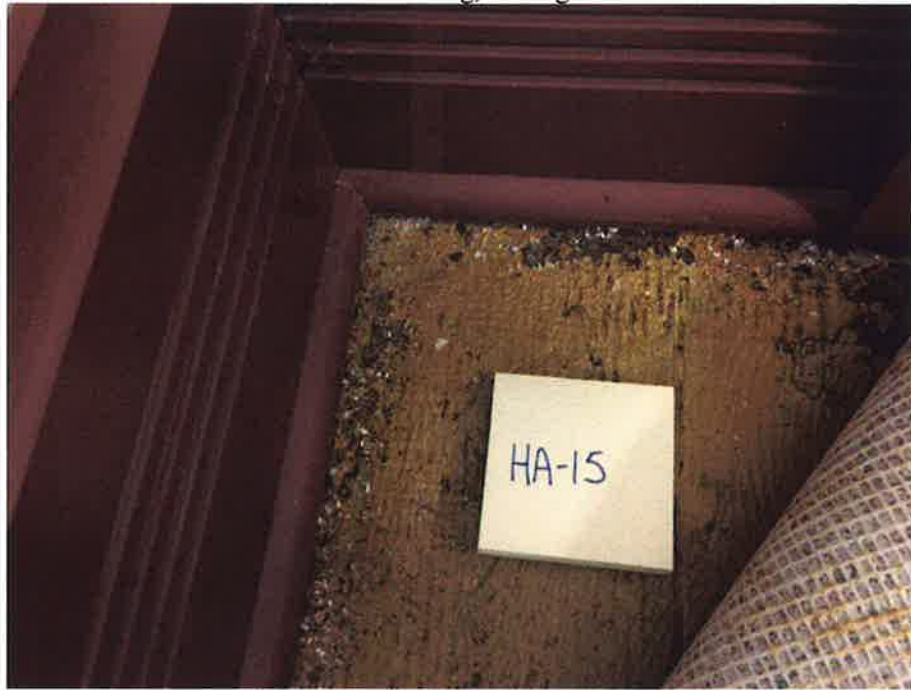
HA-15 Non-asbestos containing yellow carpet mastic

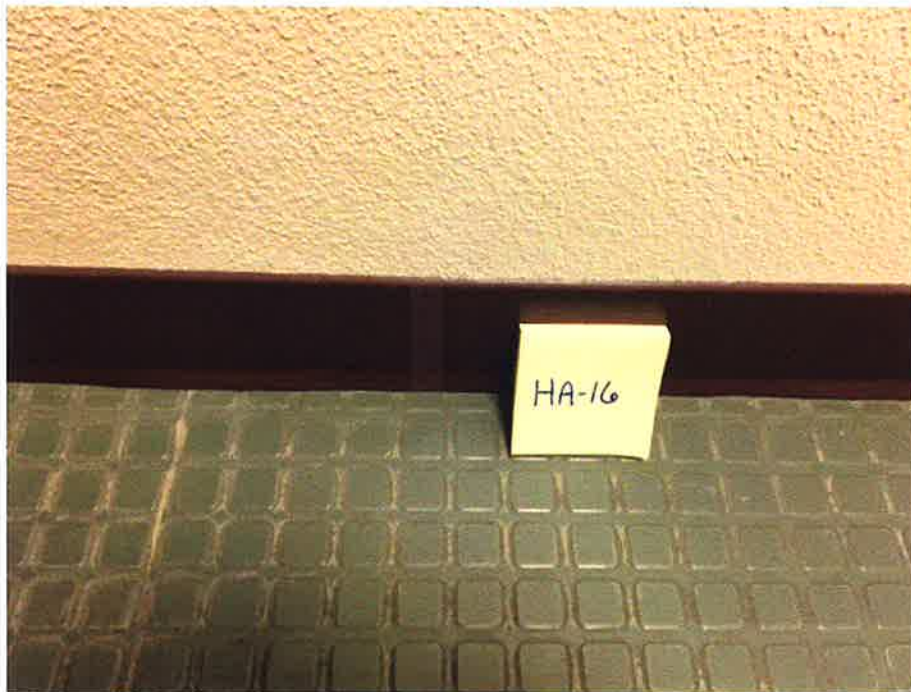
HA-16 Non-asbestos containing 4" maroon cove molding and associated mastic

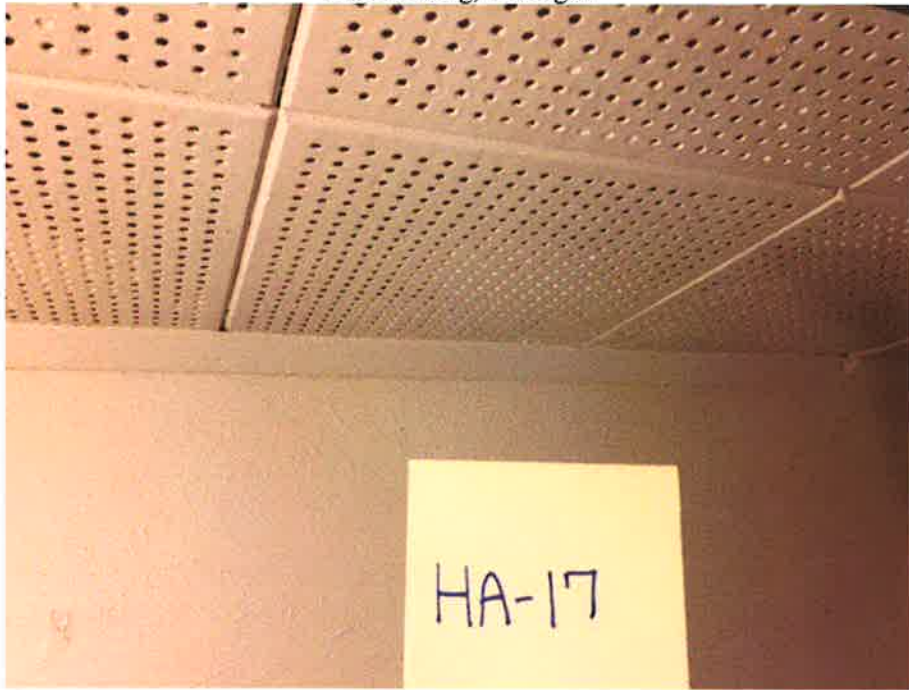
HA-17 Non-asbestos containing white 12" x 12" glued-on ceiling tile with uniform holes and HA-18 Assumed asbestos-containing gluepods

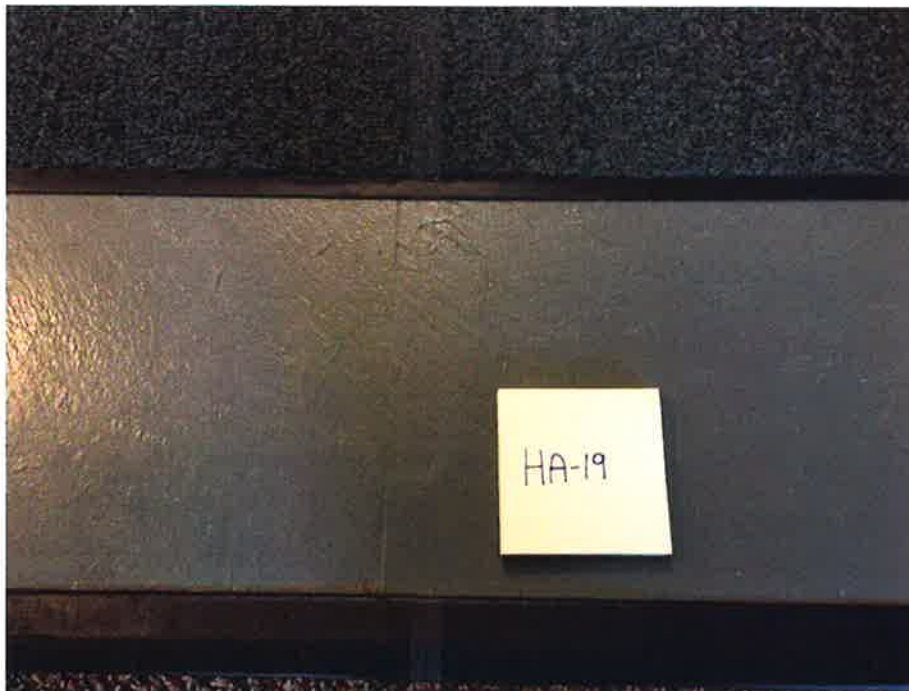
HA-19 Non-asbestos containing green linoleum with texture and associated mastic

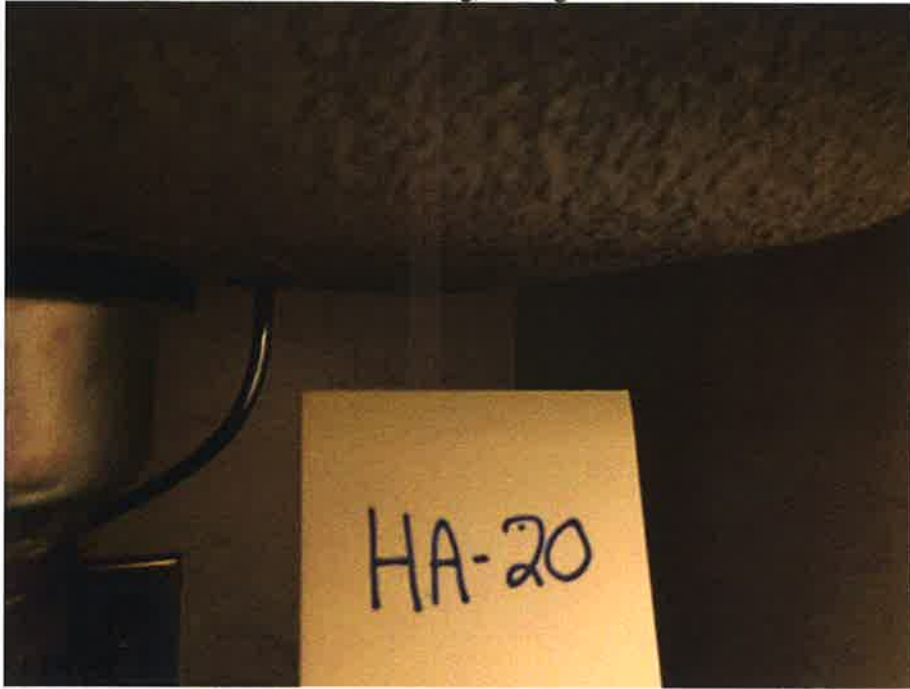
HA-20 Non-asbestos containing gray sink undercoating

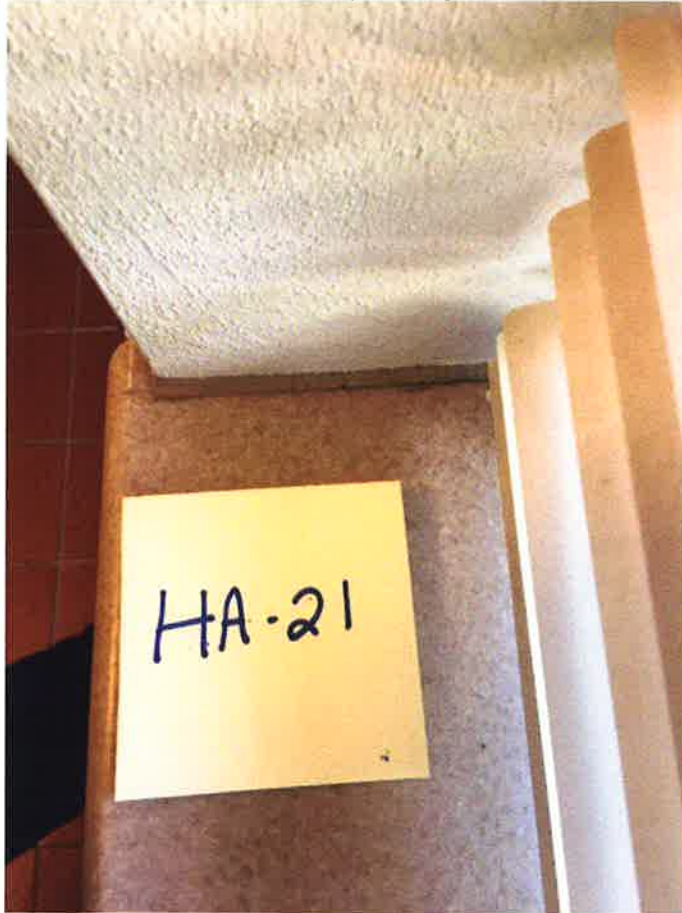
HA-21 Non-asbestos containing interior light brown window sill caulk

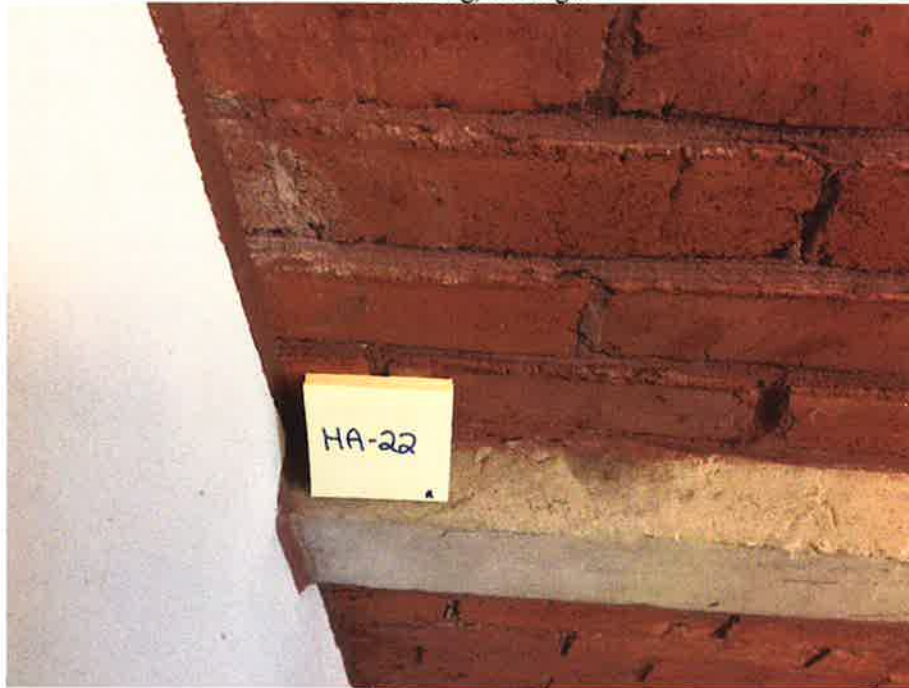
HA-22 Non-asbestos containing interior red brick caulk

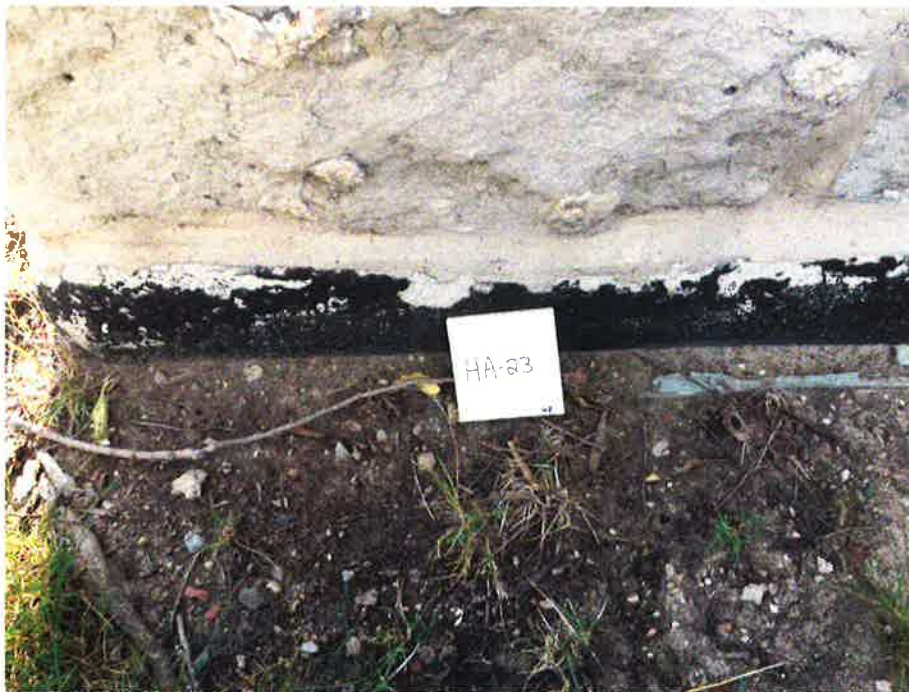
HA-23 Asbestos containing exterior black waterproofing

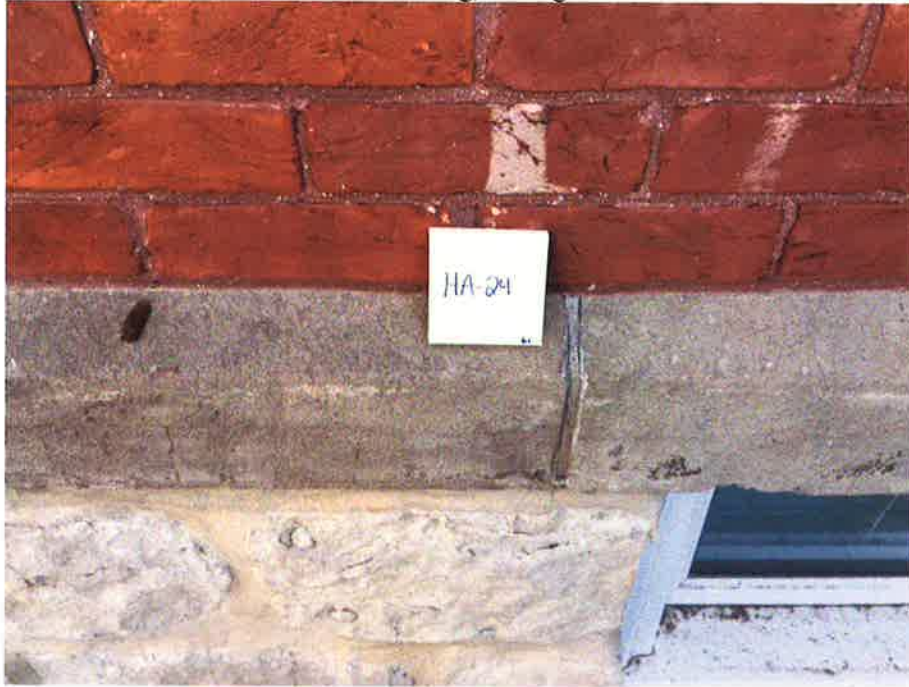
HA-24 Non-asbestos containing exterior brown building caulk

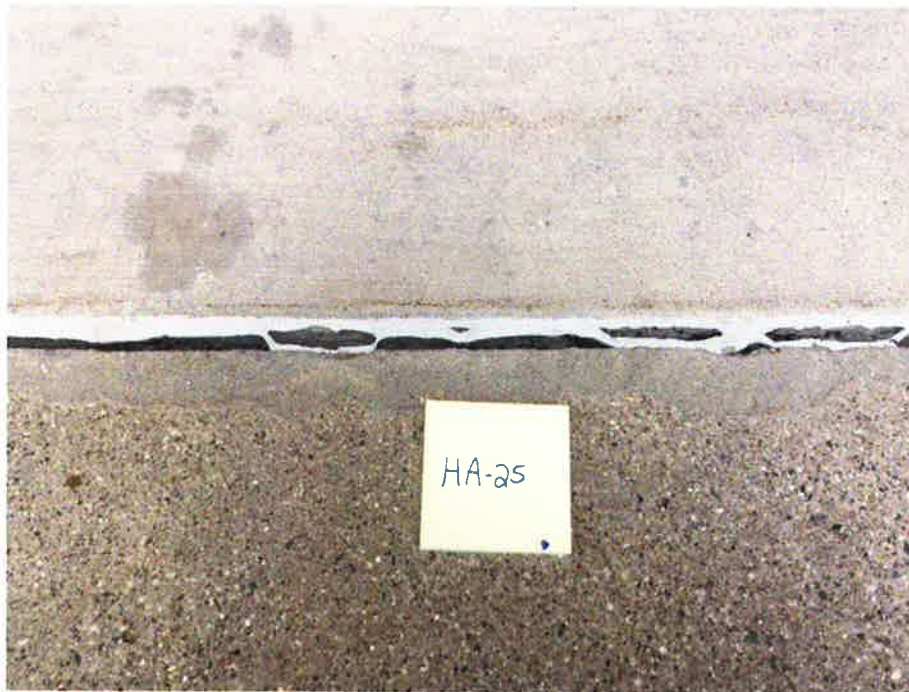
HA-25 Non-asbestos containing exterior gray front steps caulk

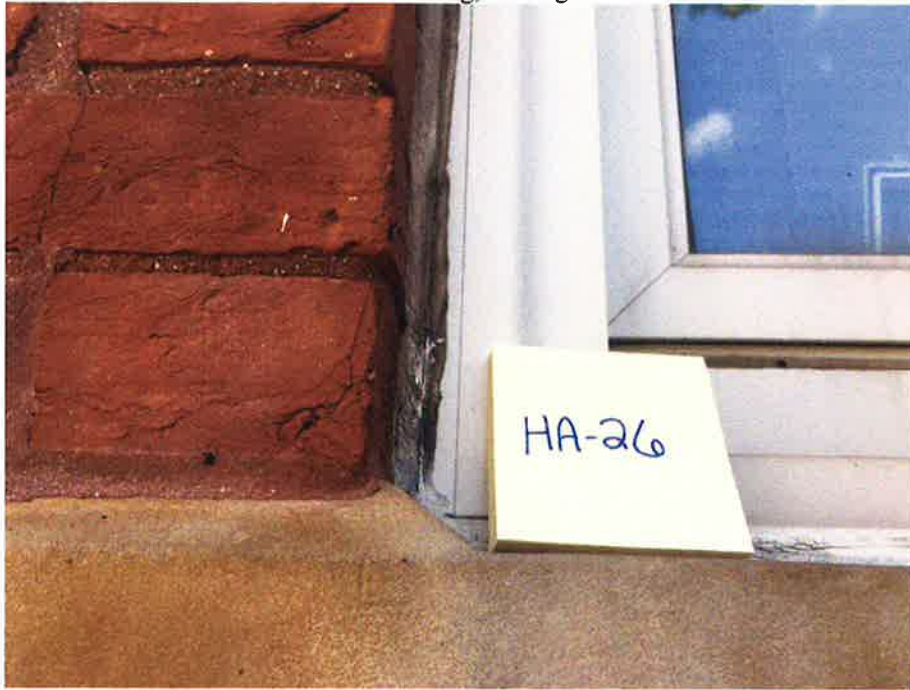
HA-26 Non-asbestos containing exterior white window caulk

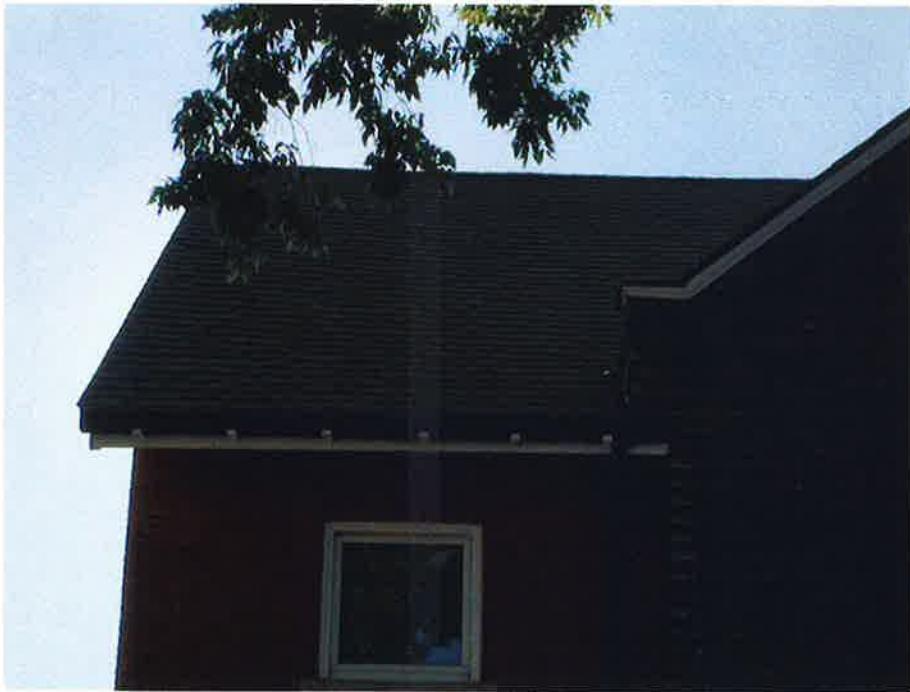
HA-27 Assumed asbestos-containing gray roof shingles and felts (tar paper)

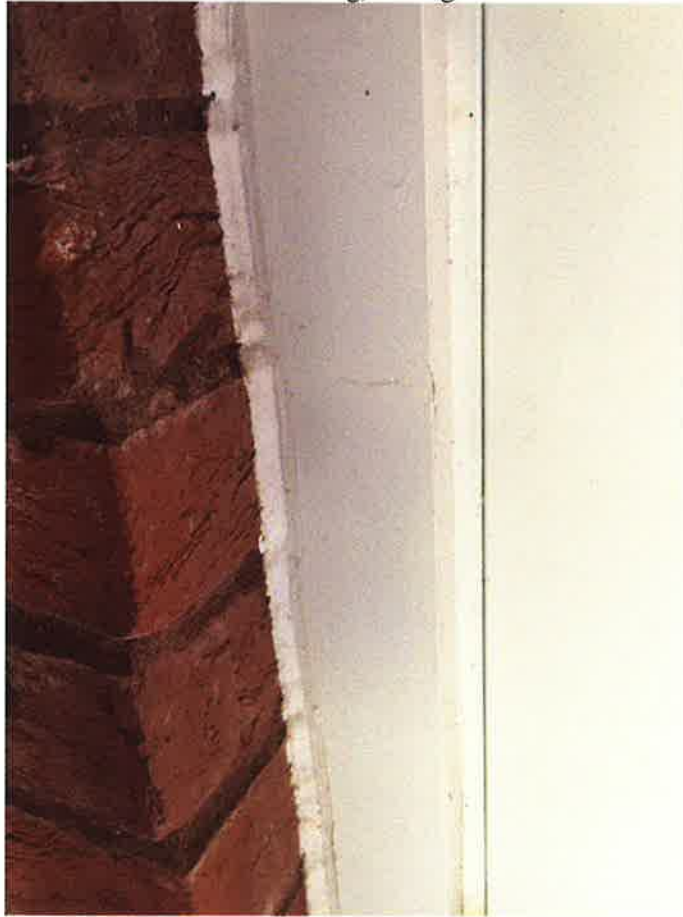
HA-28 Non-asbestos containing exterior white door caulk
