ASBESTOS BUILDING INSPECTION REPORT

Botany Greenhouse Building Number 18

Project Date: March 21, 2008

Final Report Date: April 17, 2008

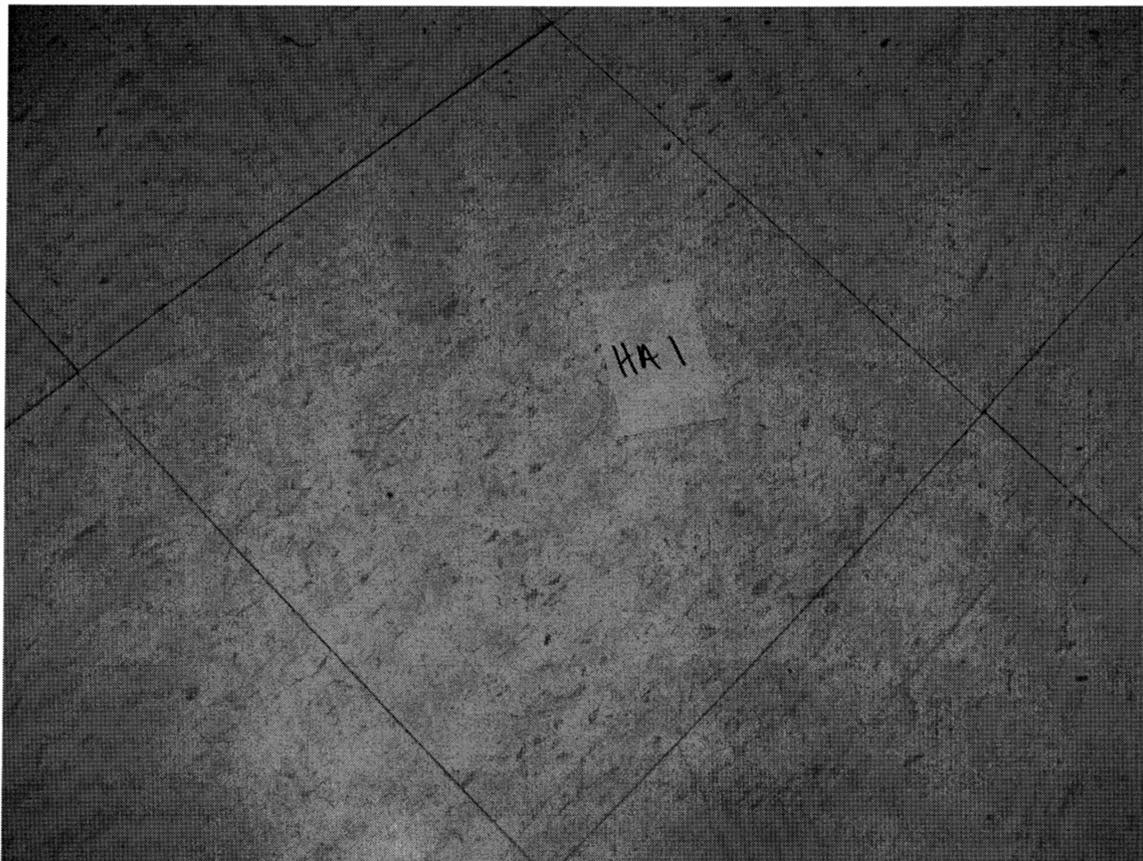
HA #1 – Non asbestos containing 12”x 12” White floor tile with gray and red streaks and associated mastic

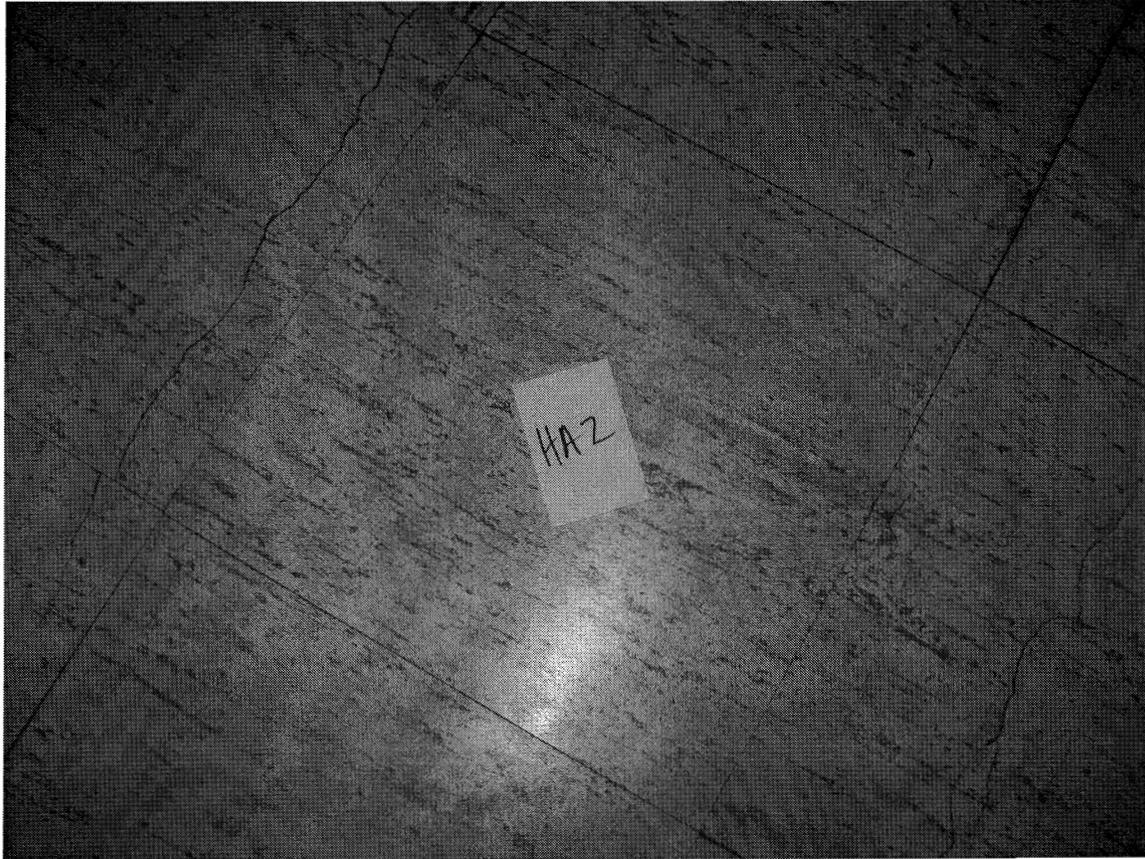
HA #2 – Non asbestos containing 12”x12” Off-white floor tile with gray streaks and associated mastic

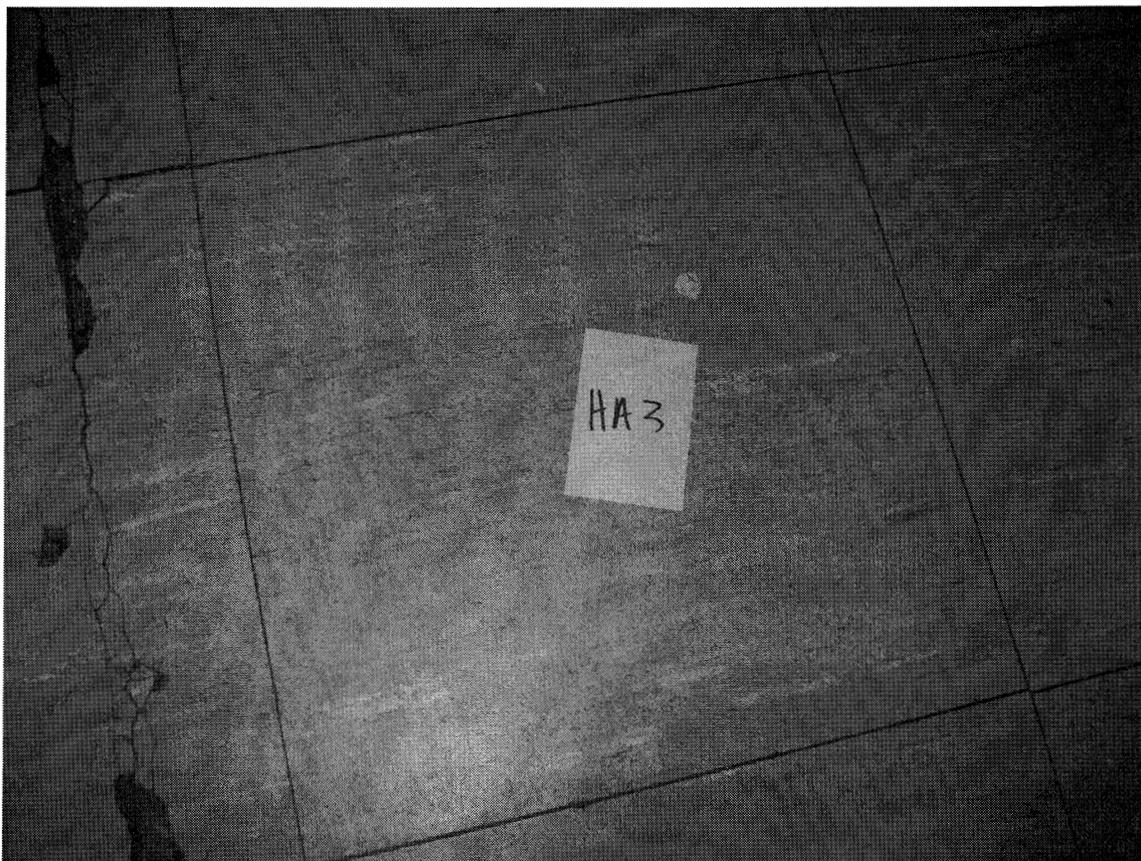
HA #3 – Non asbestos containing 12"x 12" Gray floor tile with dark gray and white streaks and associated mastic

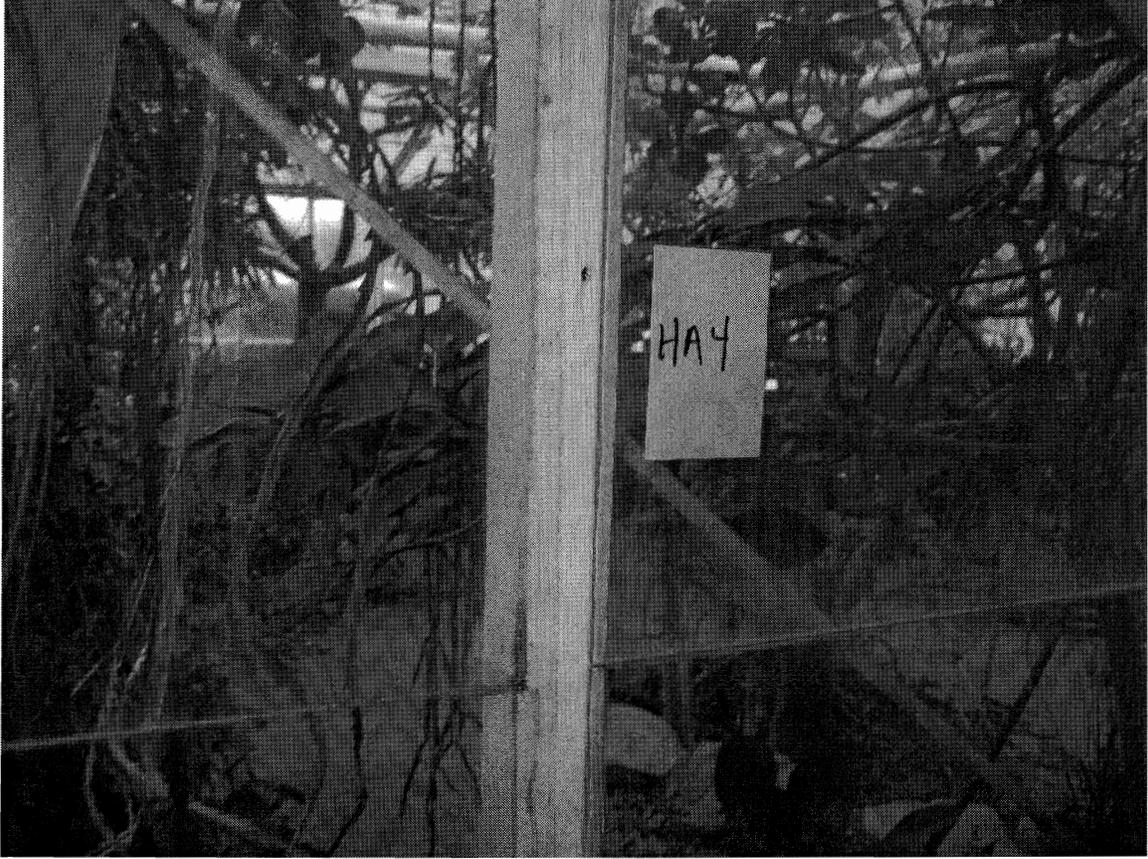
HA #4 – Non asbestos containing white window glazing

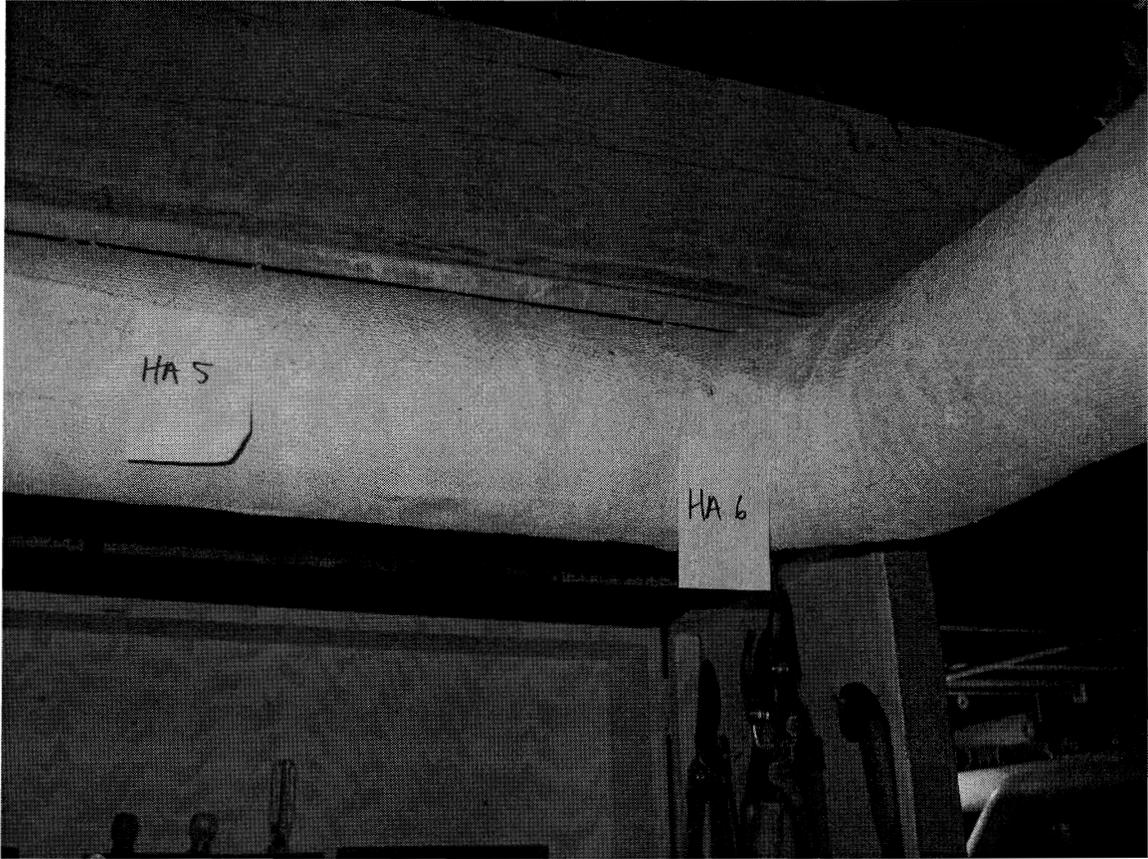
HA #5 – Assumed asbestos containing pipe straight insulation

HA #6 – Assumed asbestos containing pipe fitting and hanger insulation

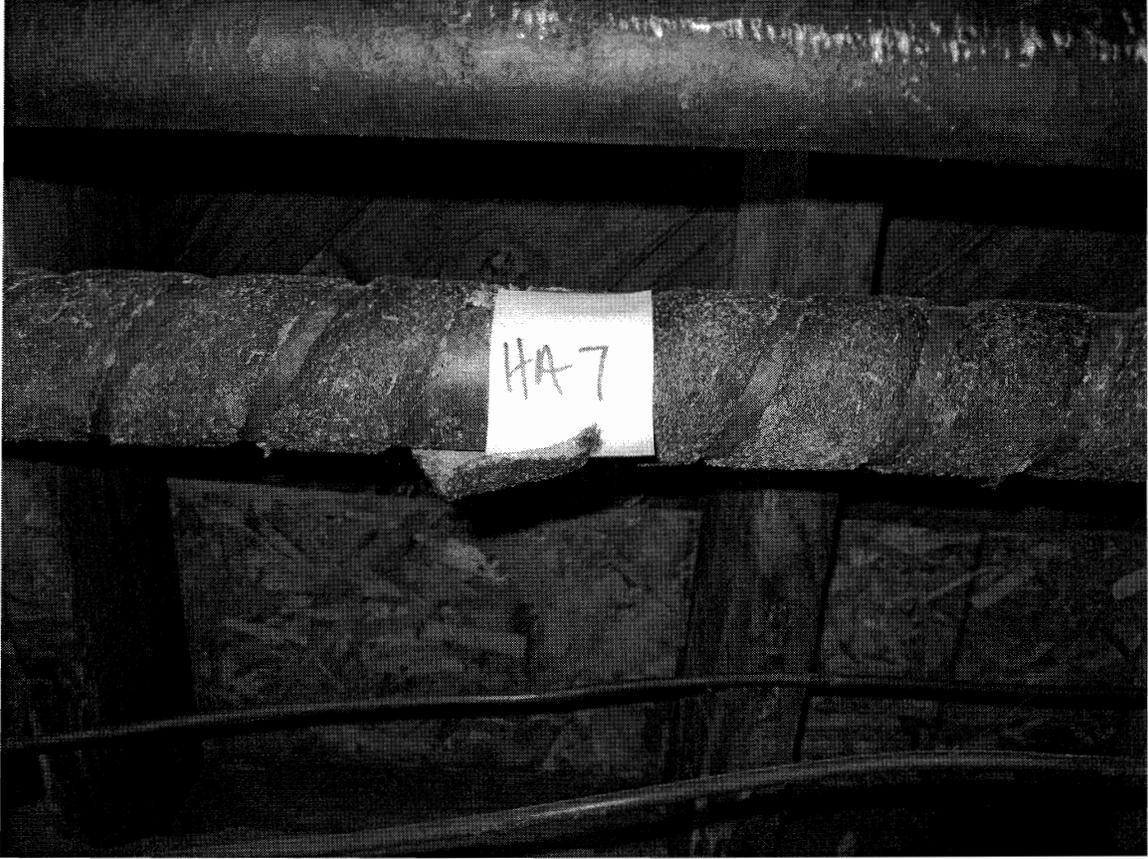
HA #7 – Asbestos containing black and brown pipe wrap

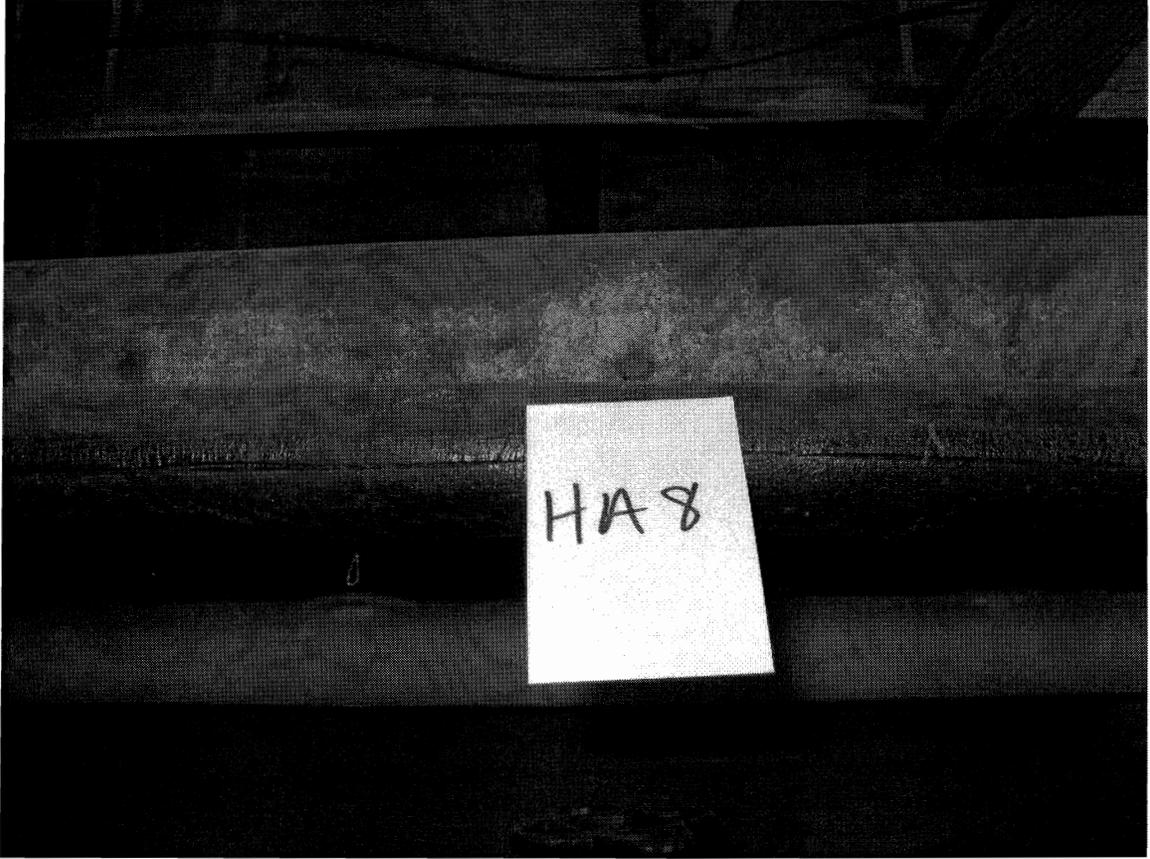
HA #8 – Non asbestos containing black rubber pipe wrap

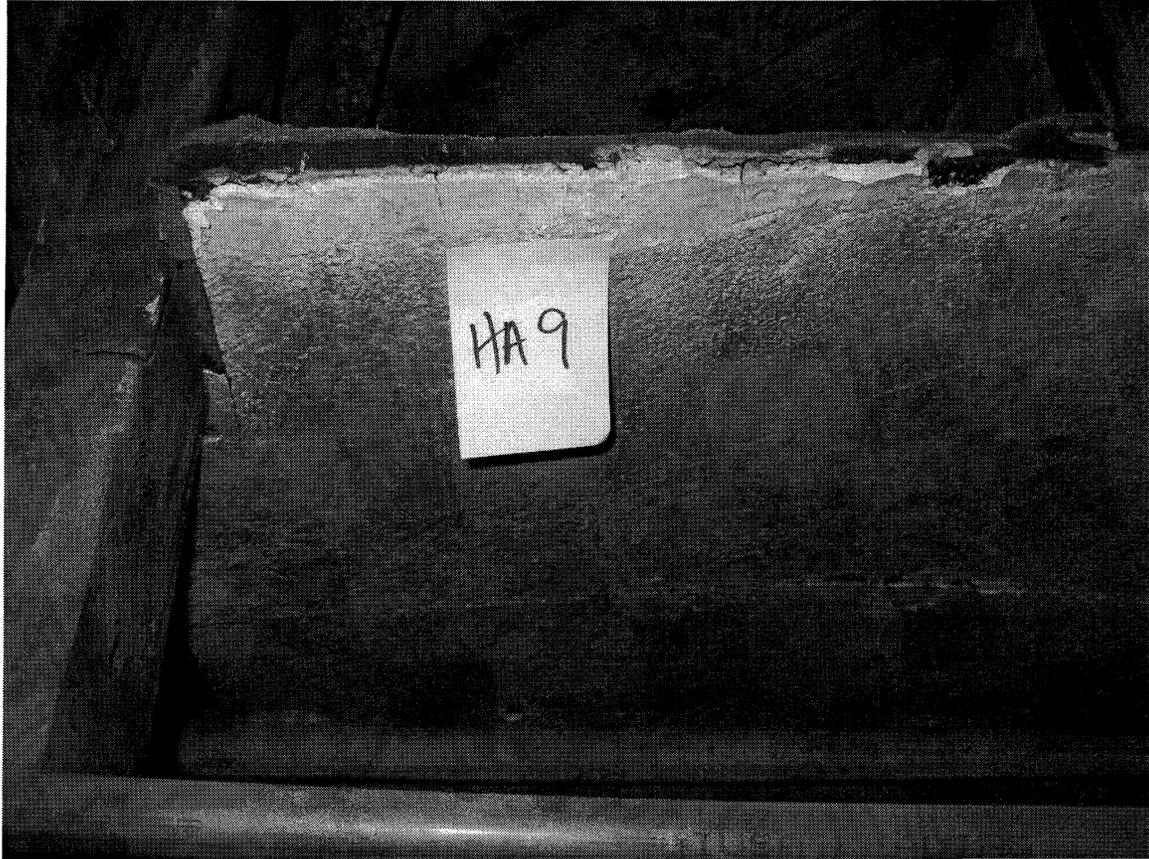
HA #9 – Asbestos containing 2'x 3' ceiling panel

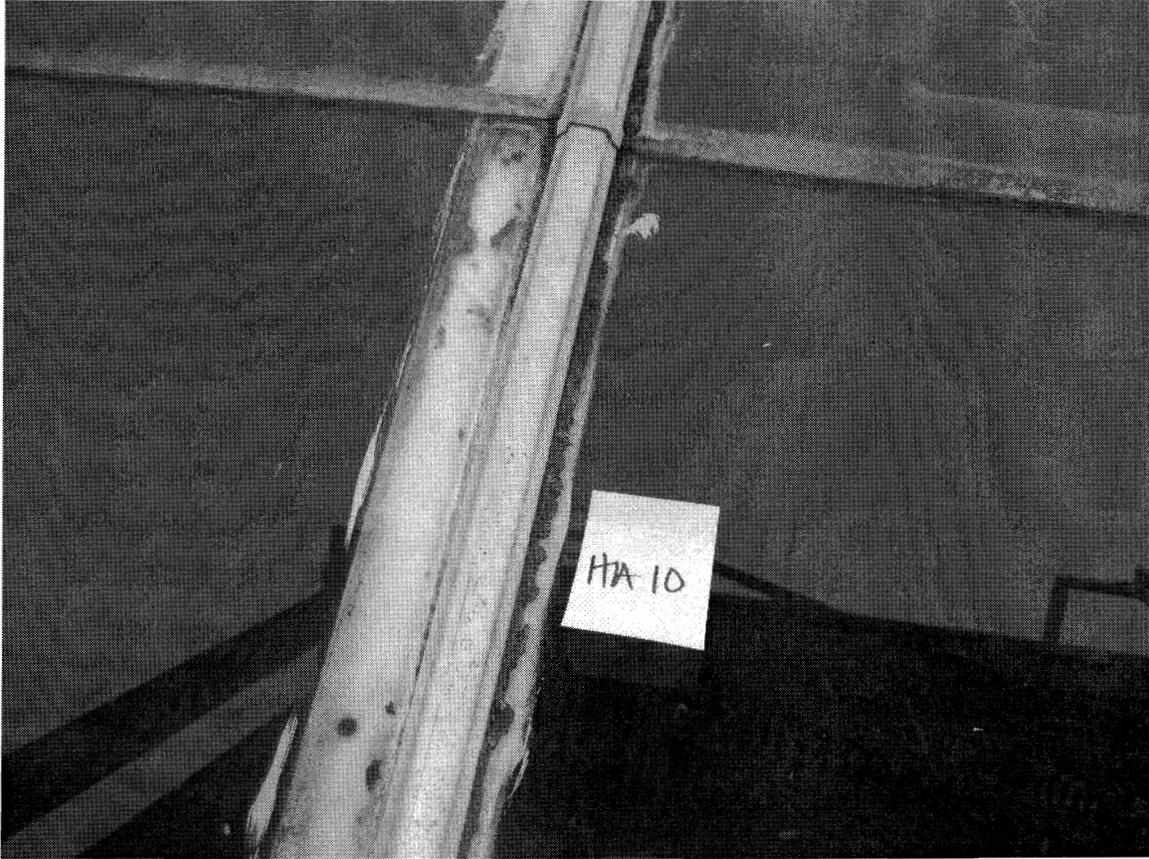
HA #10 – Asbestos containing gray and white exterior glazing compound,
1911 house

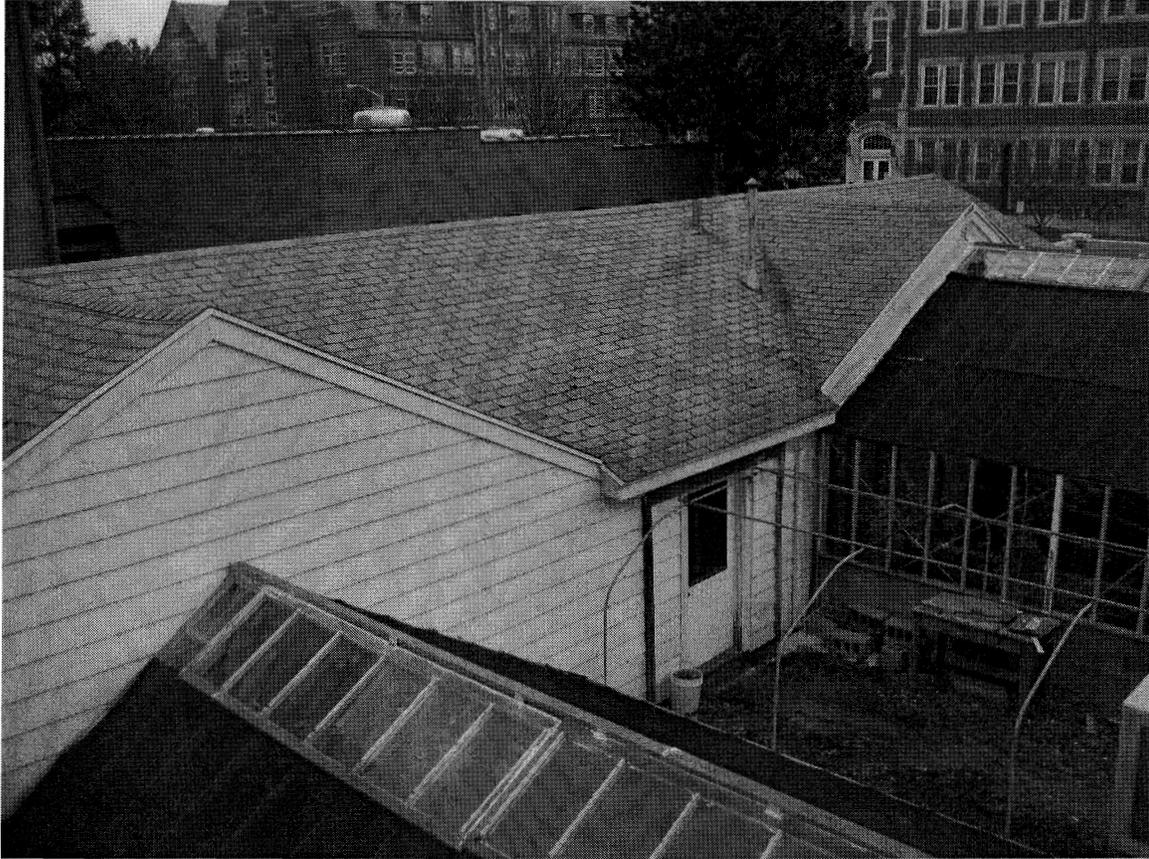
HA #11 – Asbestos containing Gray shingles, flashing, and associated mastics
