Michigan State University  
Botany Greenhouse - Asbestos Inspection Photo Log

Botany Greenhouse (#18)

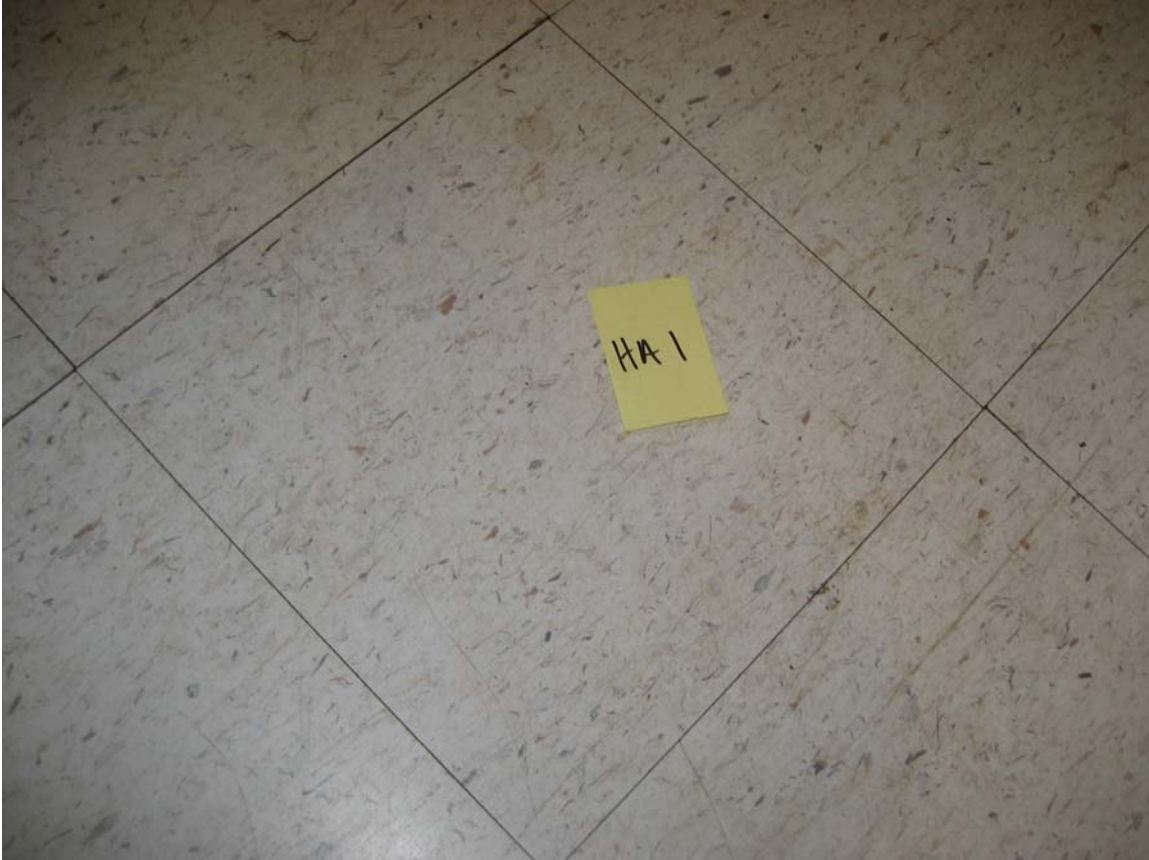
HA #1 – Non asbestos containing 12”x 12” White floor tile with gray and red streaks and associated mastic

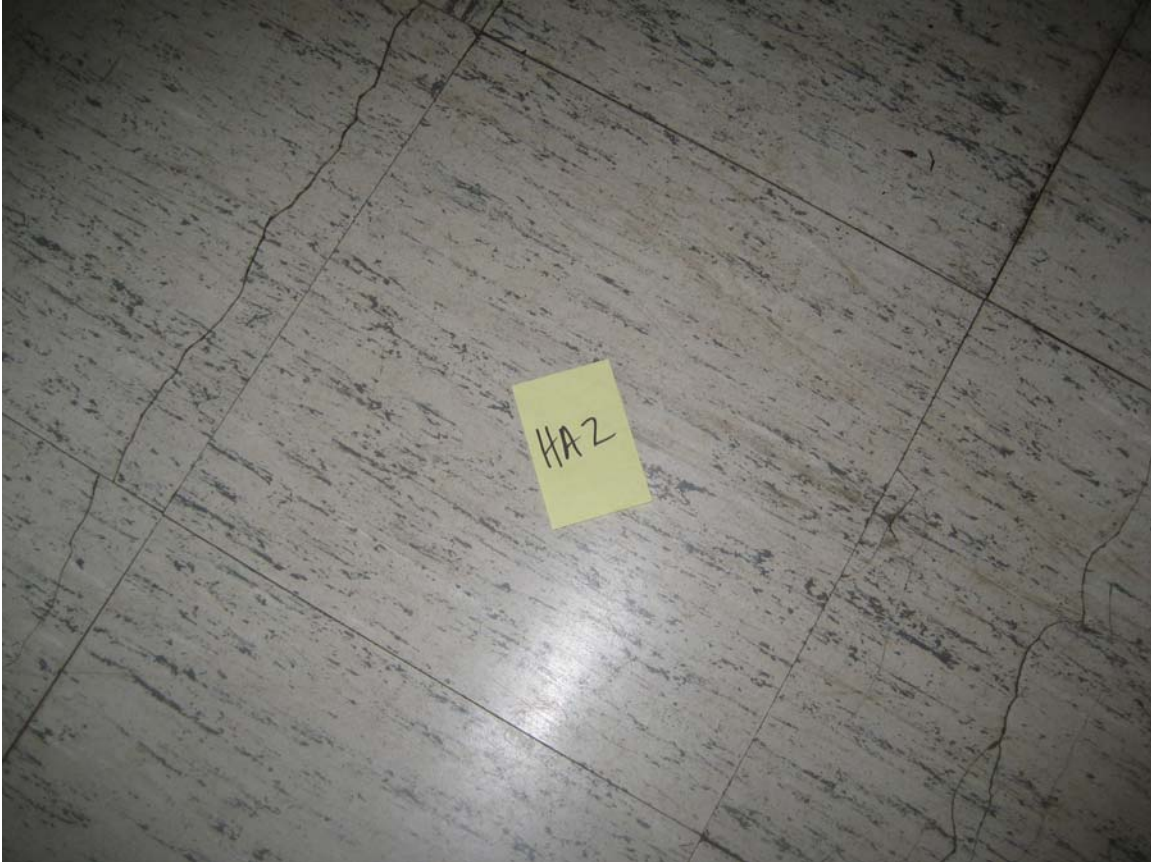
HA #2 – Non asbestos containing 12”x12” Off-white floor tile with gray streaks and associated mastic

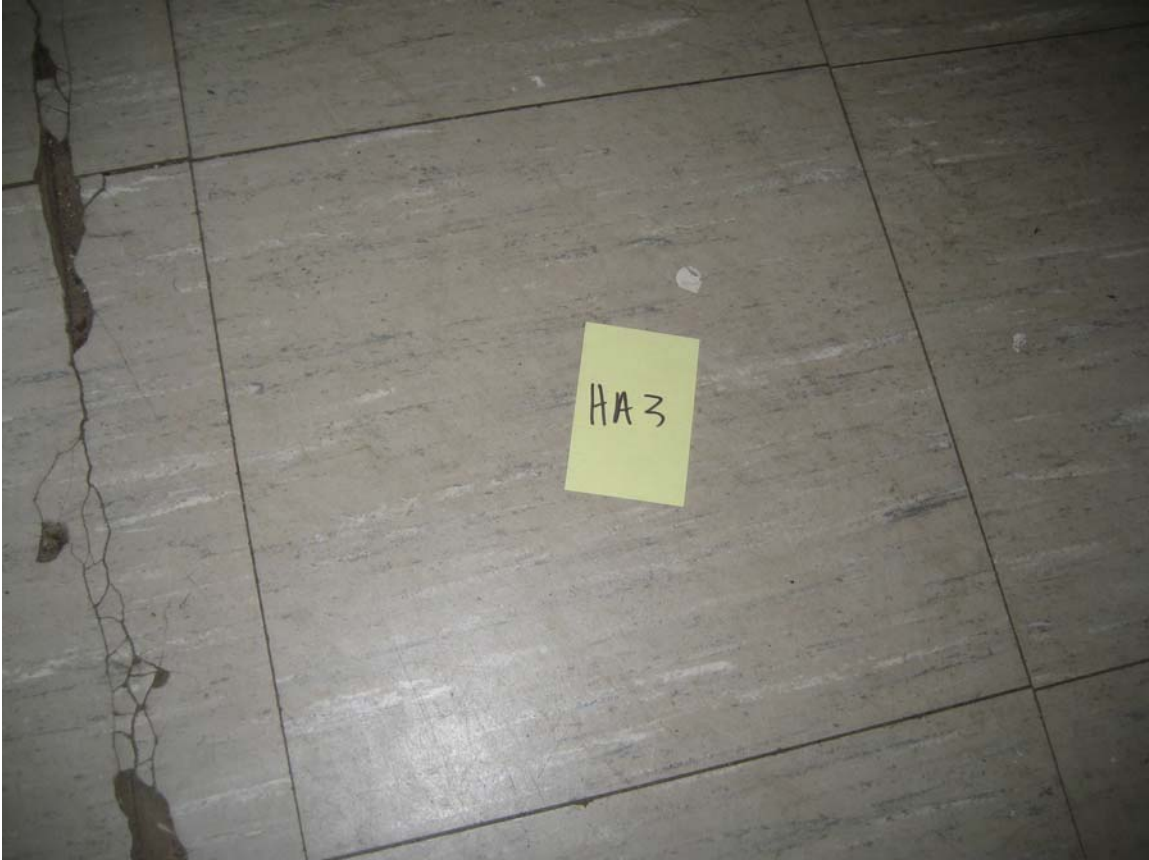
HA #3 – Non asbestos containing 12”x 12” Gray floor tile with dark gray and white streaks and associated mastic

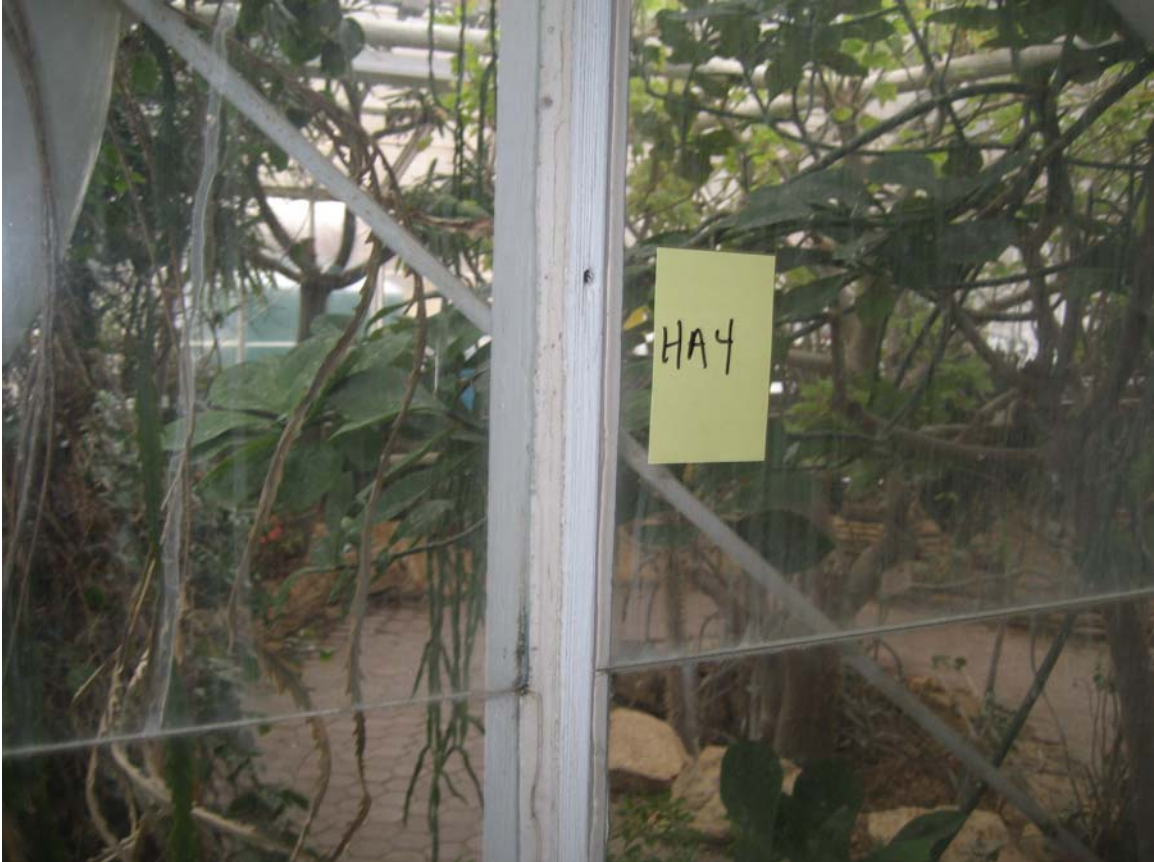
HA #4 – Non asbestos containing white window glazing

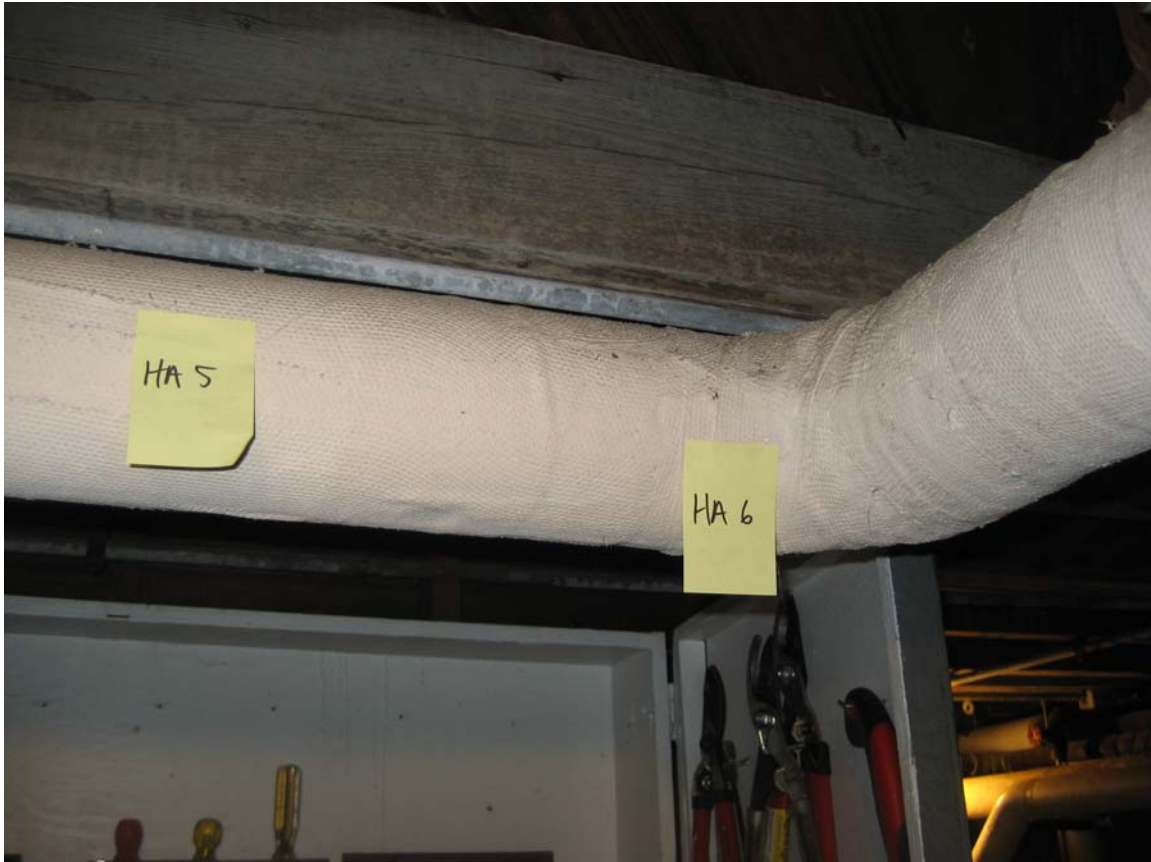
HA #5 – Assumed asbestos containing pipe straight insulation

HA #6 – Assumed asbestos containing pipe fitting and hanger insulation

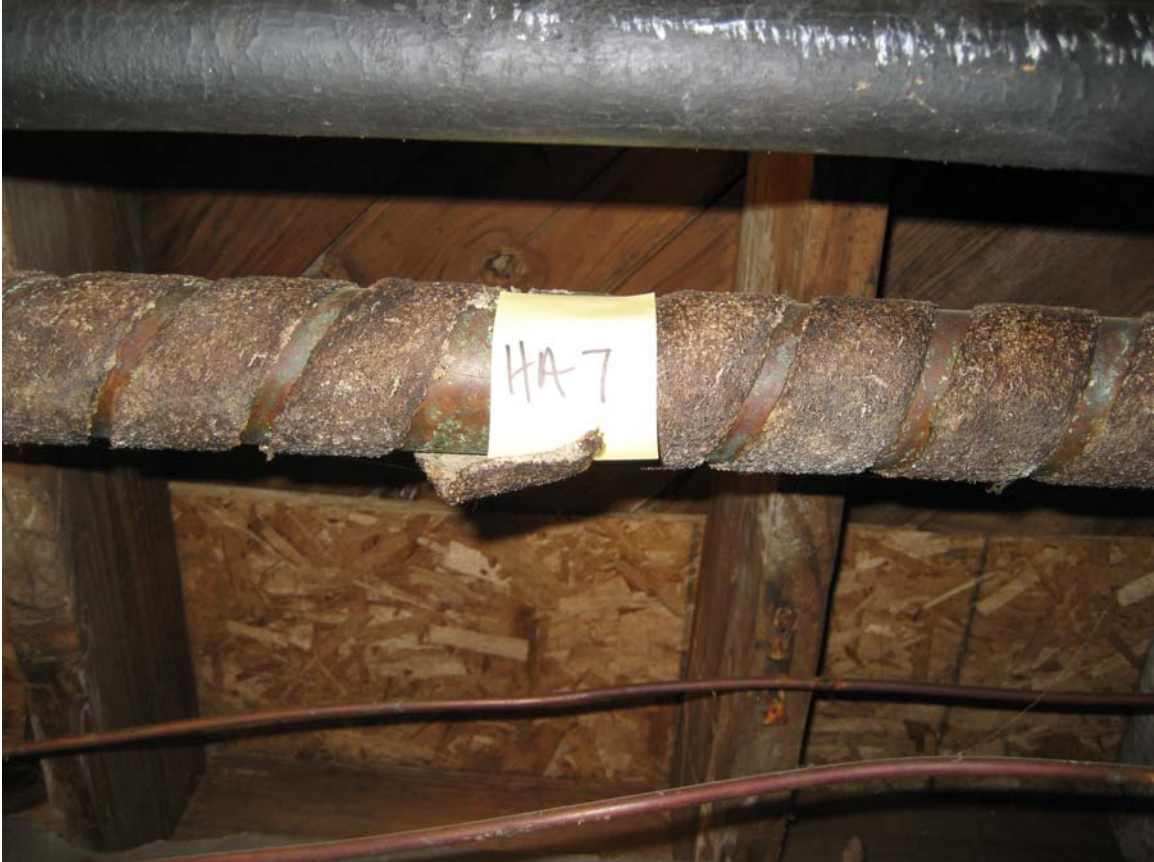
HA #7 – Asbestos containing black and brown pipe wrap

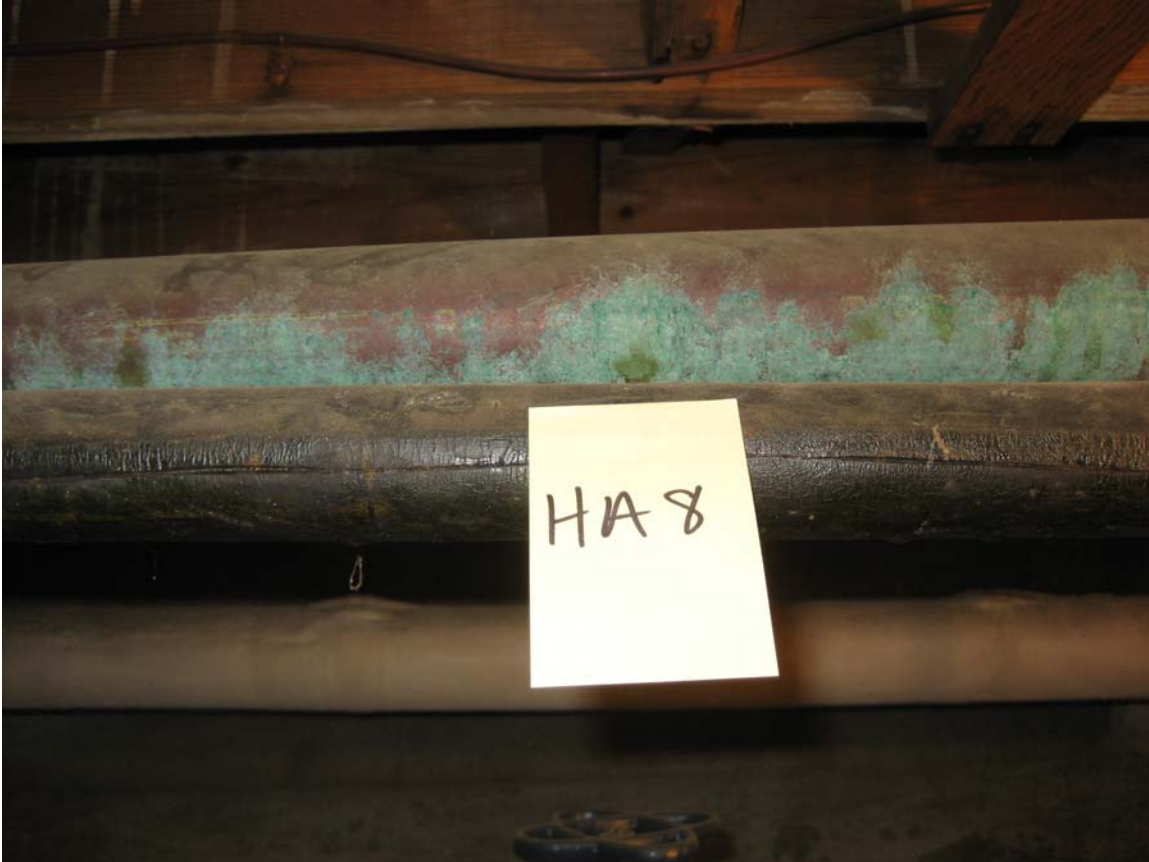
HA #8 – Non asbestos containing black rubber pipe wrap

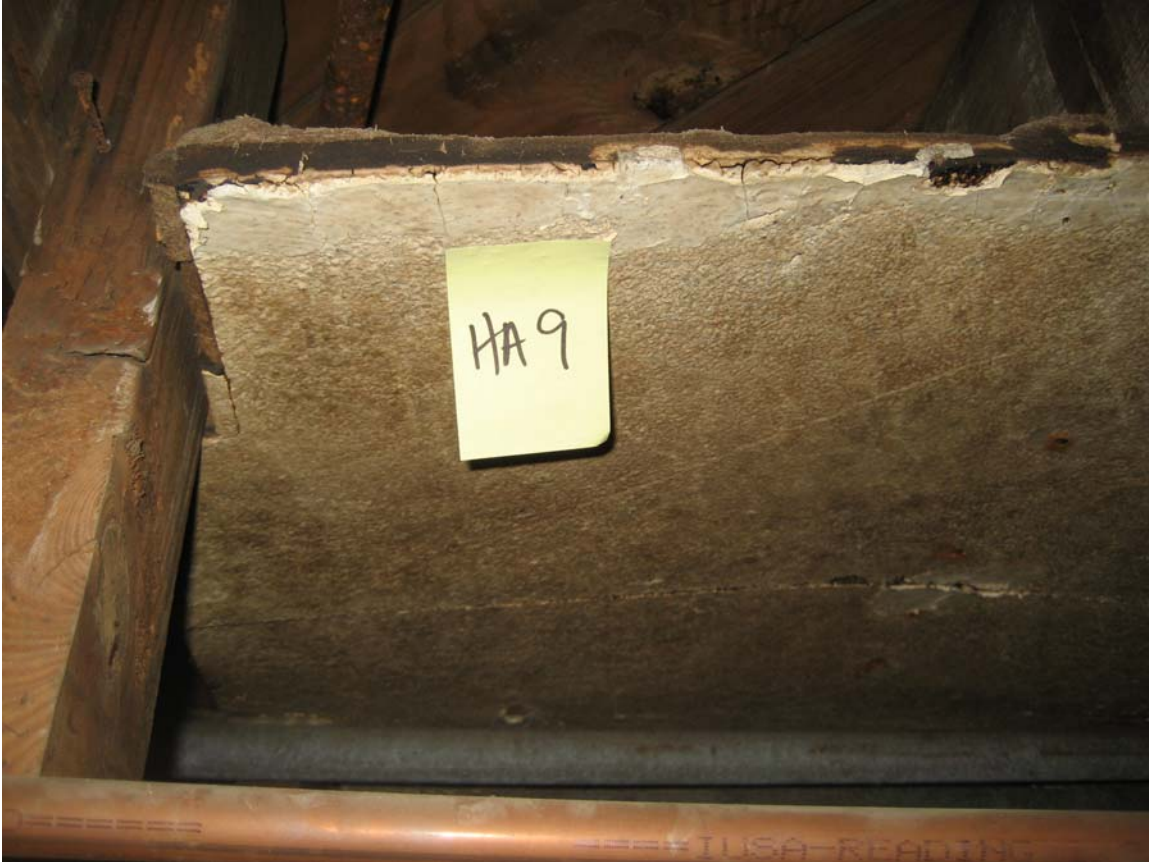
HA #9 – Asbestos containing 2'x 3' ceiling panel

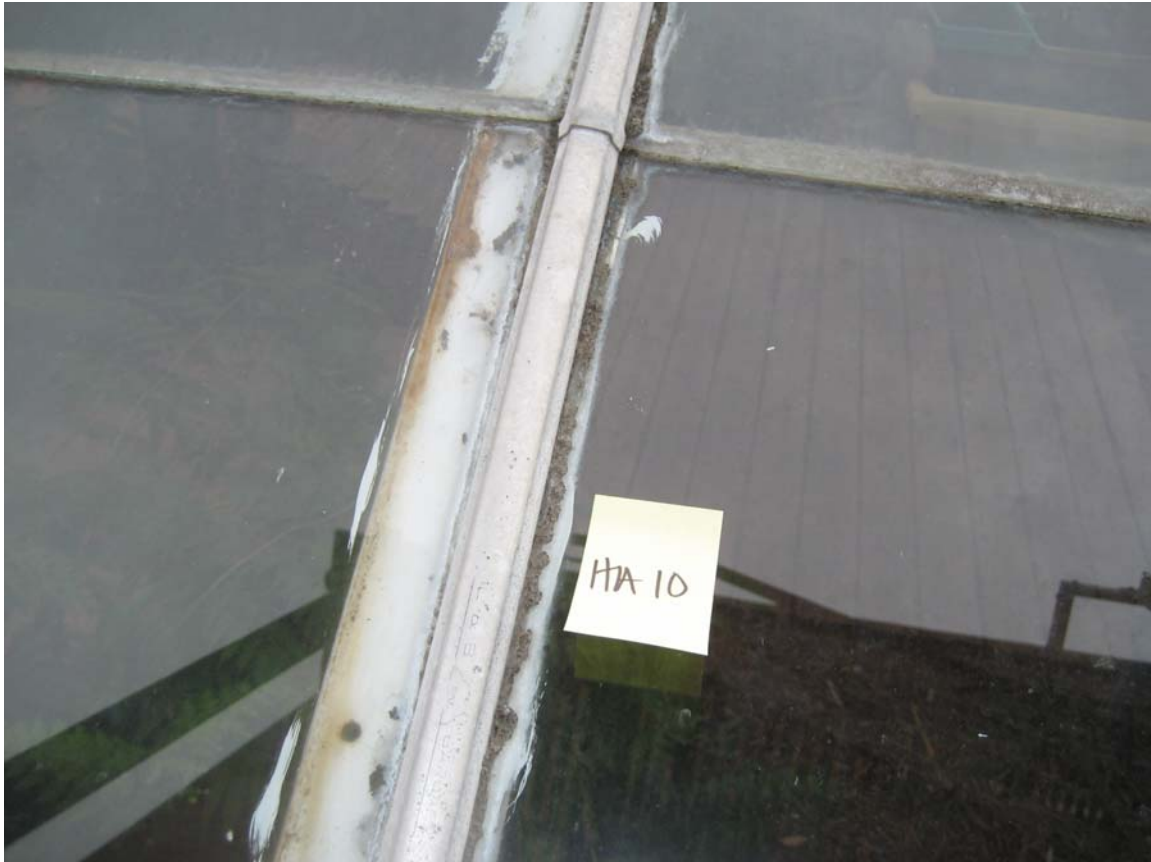
HA #10 – Asbestos containing gray and white exterior glazing compound,  
1911 house

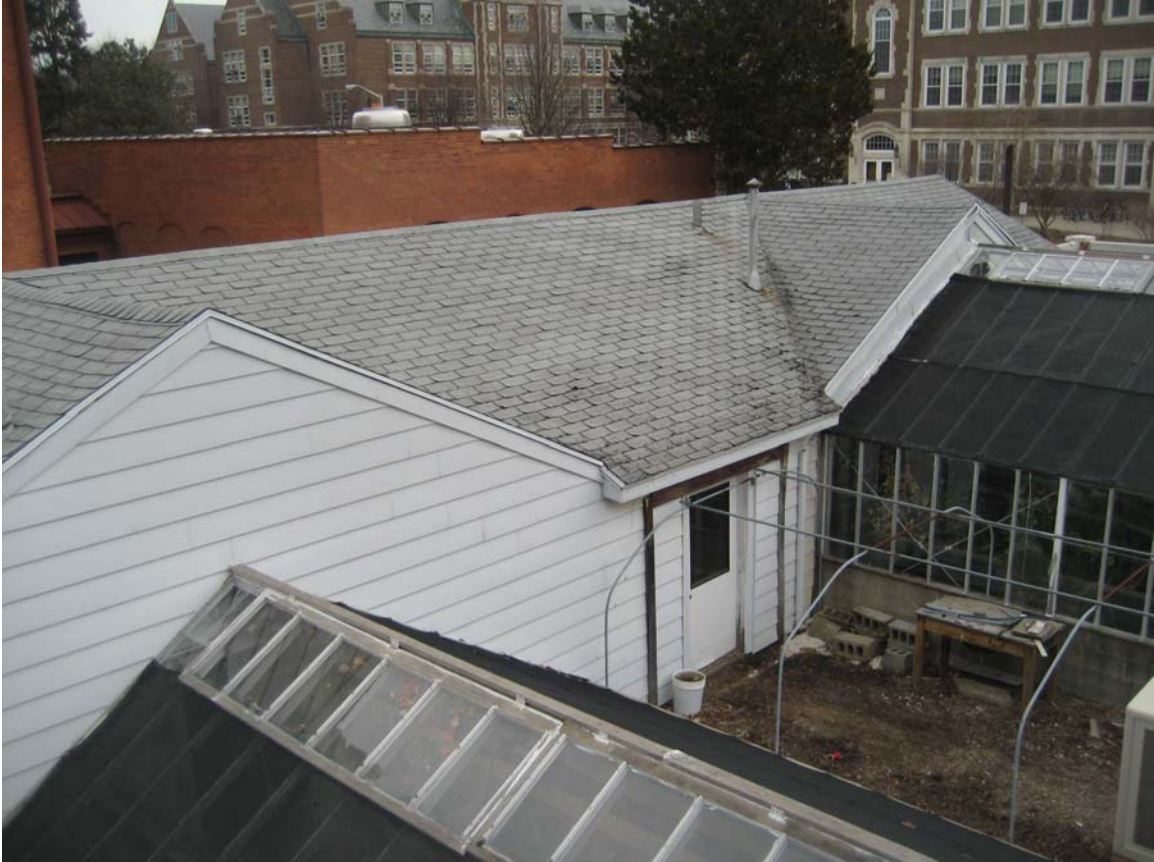
HA #11 – Asbestos containing Gray shingles, flashing, and associated mastics
