Kedzie Hall Photo Log

Exterior of Kedzie Hall

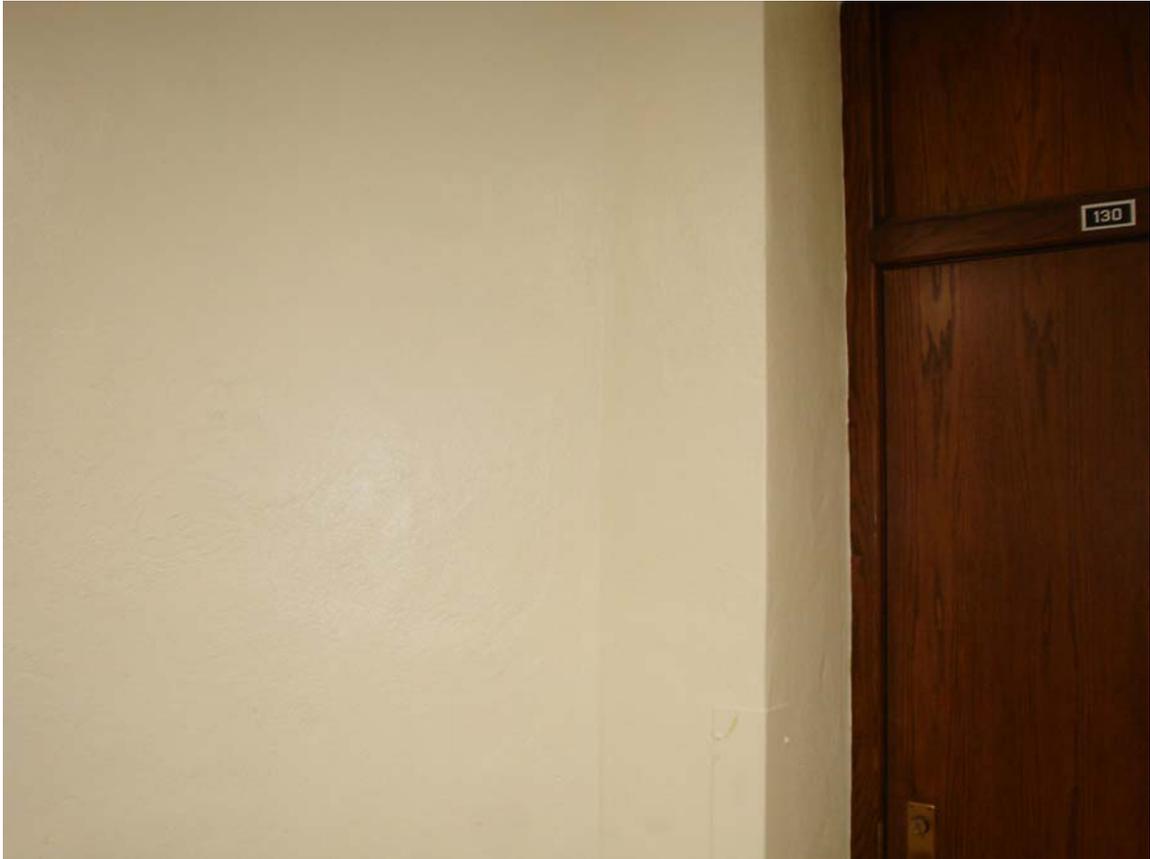
HA #1 – Non asbestos-containing smooth wall and ceiling plaster

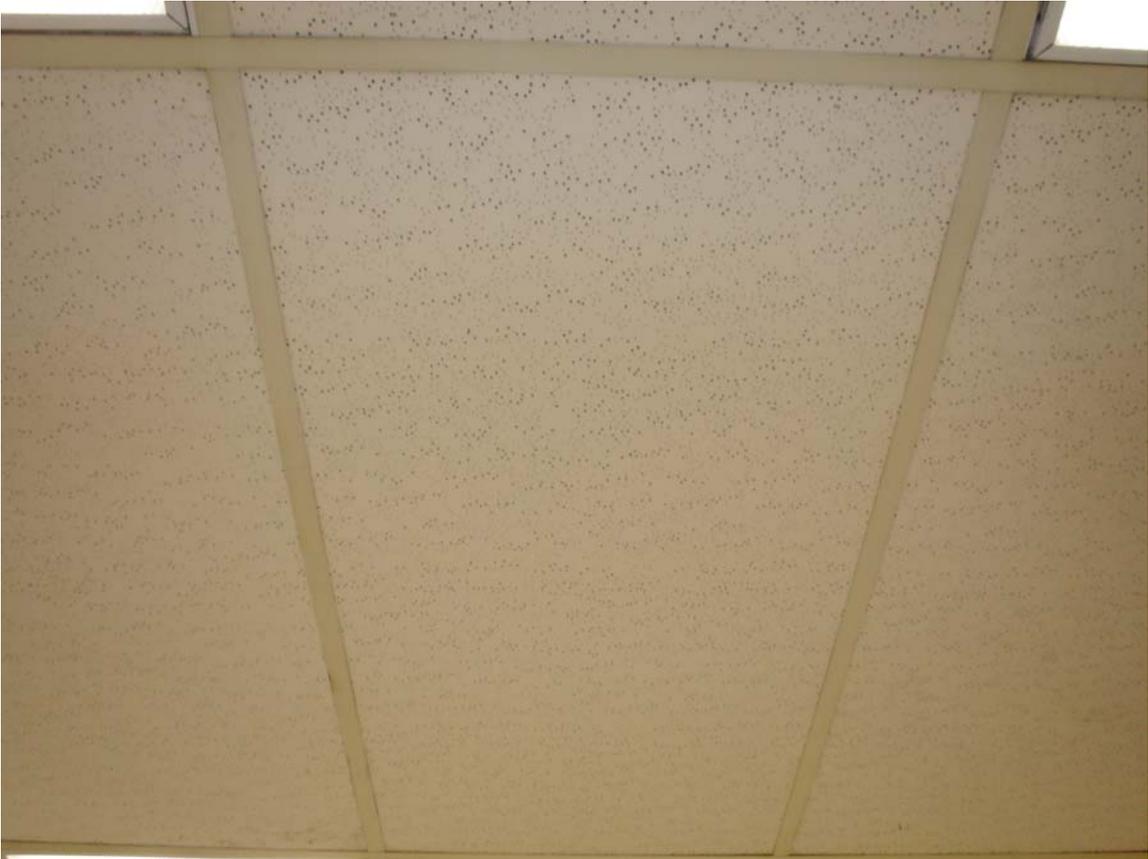
HA #2 – Non asbestos-containing 2' x 4' white lay-in ceiling tile
with pin holes

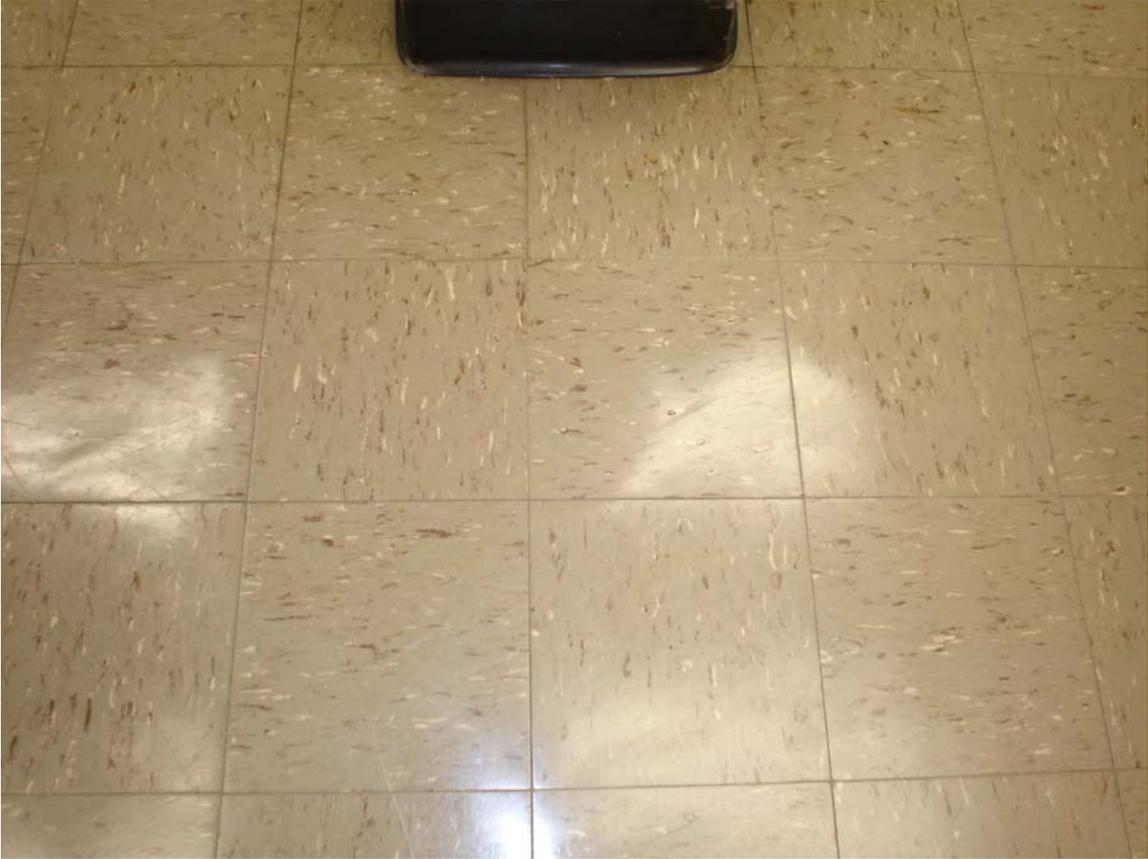
HA #3 – Asbestos-containing 9" x 9" gray floor tile with cream and rust streaks and associated non asbestos-containing mastic

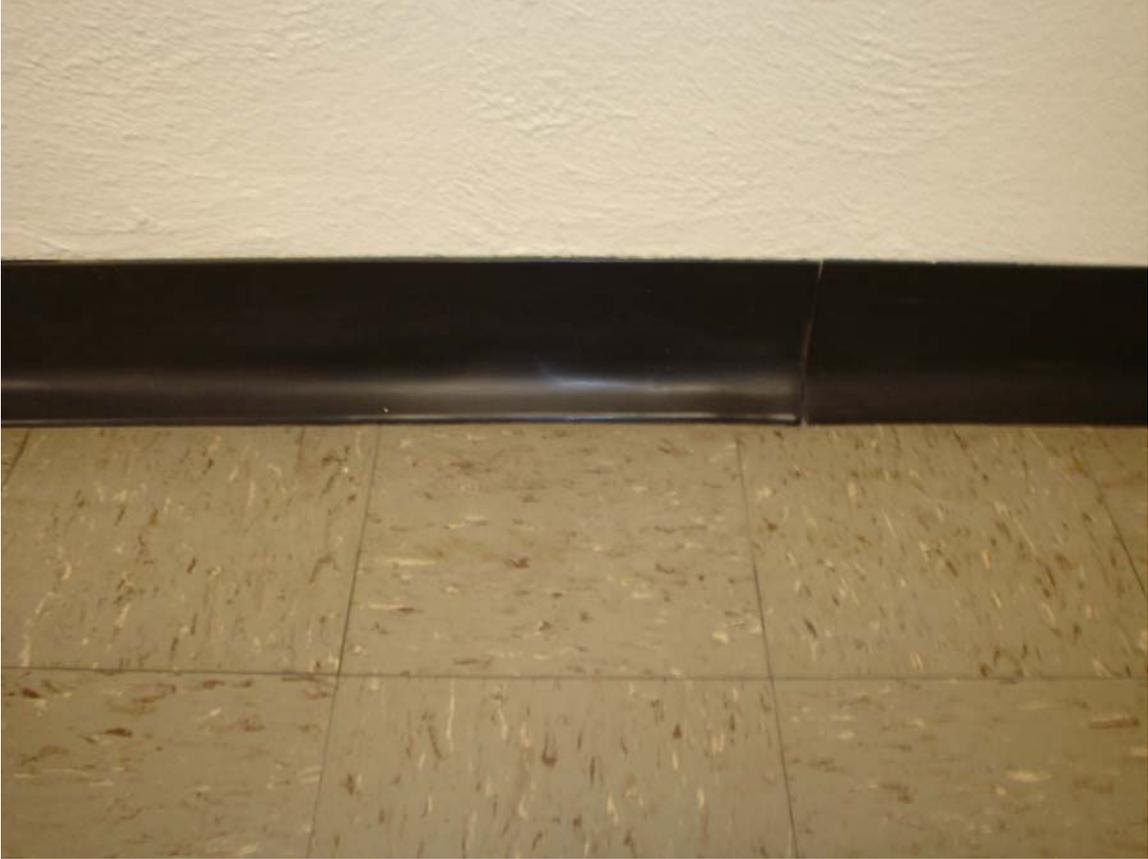
HA #4 – Non asbestos-containing 4" black cove molding
and associated mastic

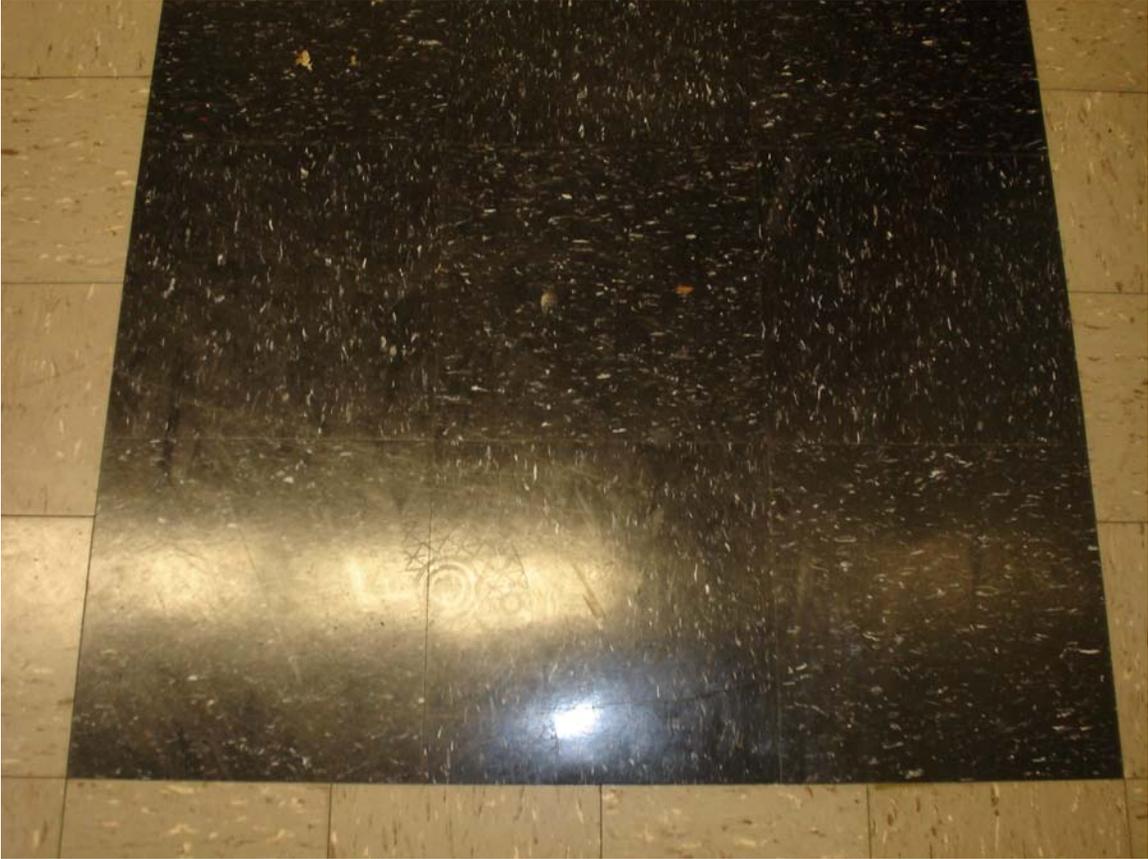
HA #5 – Non asbestos-containing 12" x 12" black floor tile
with white streaks and associated mastic

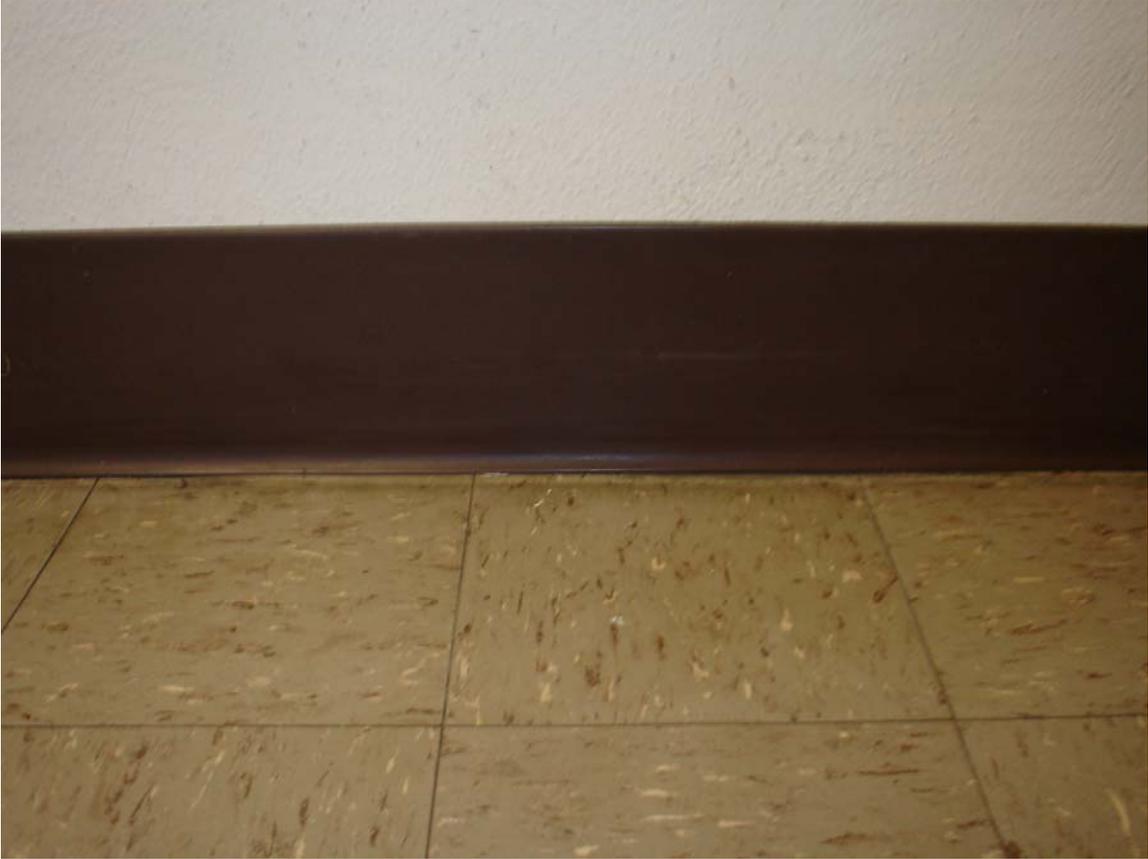
HA #6 – Non asbestos-containing 6" brown cove molding
and associated mastic

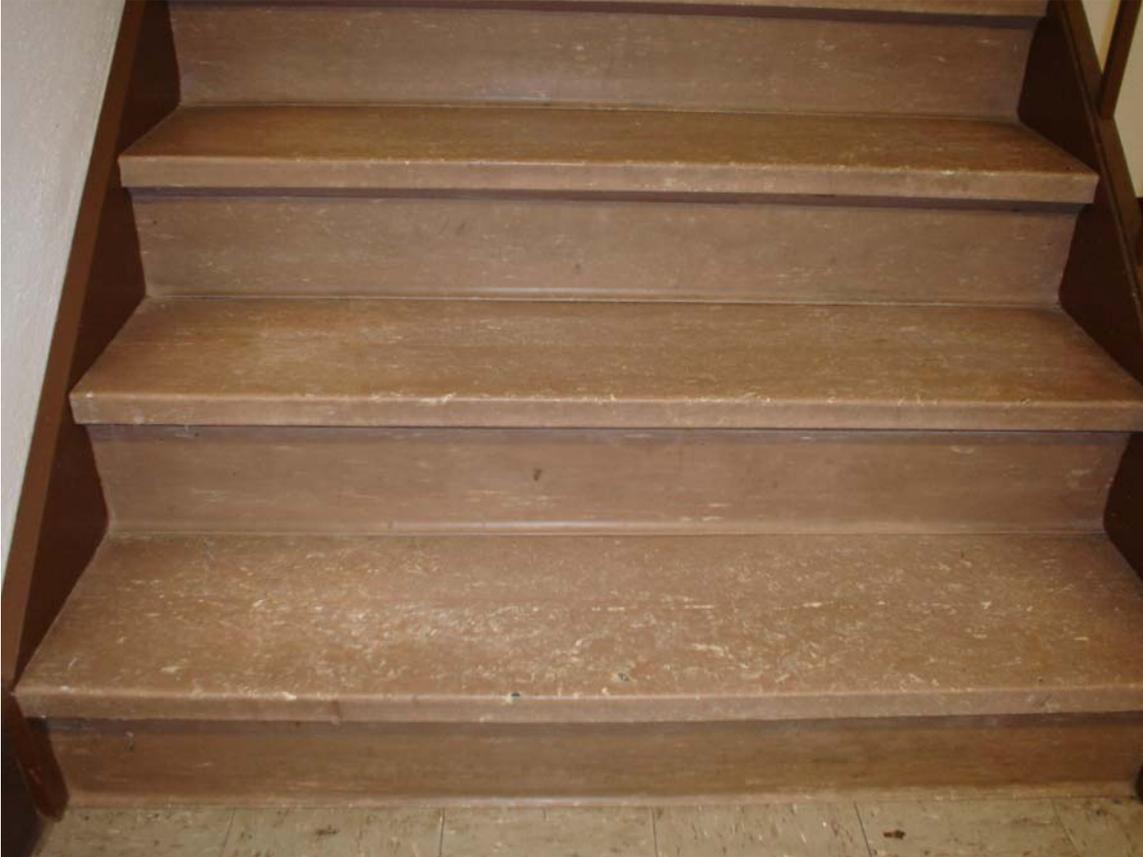
HA #7 – Asbestos-containing tan stair tread with cream, pink and black streaks and associated non asbestos-containing mastic

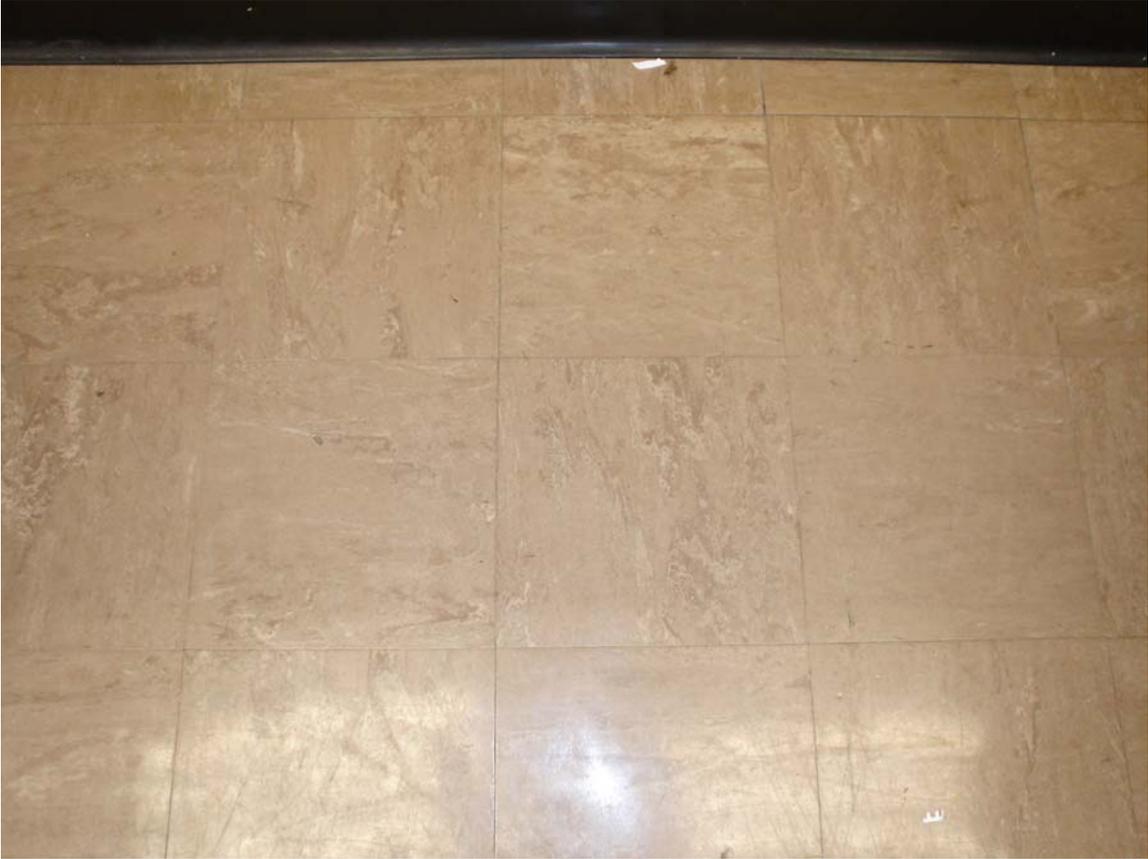
HA #8 – Asbestos-containing 9" x 9" tan floor tile with swirl pattern and associated non asbestos-containing mastic

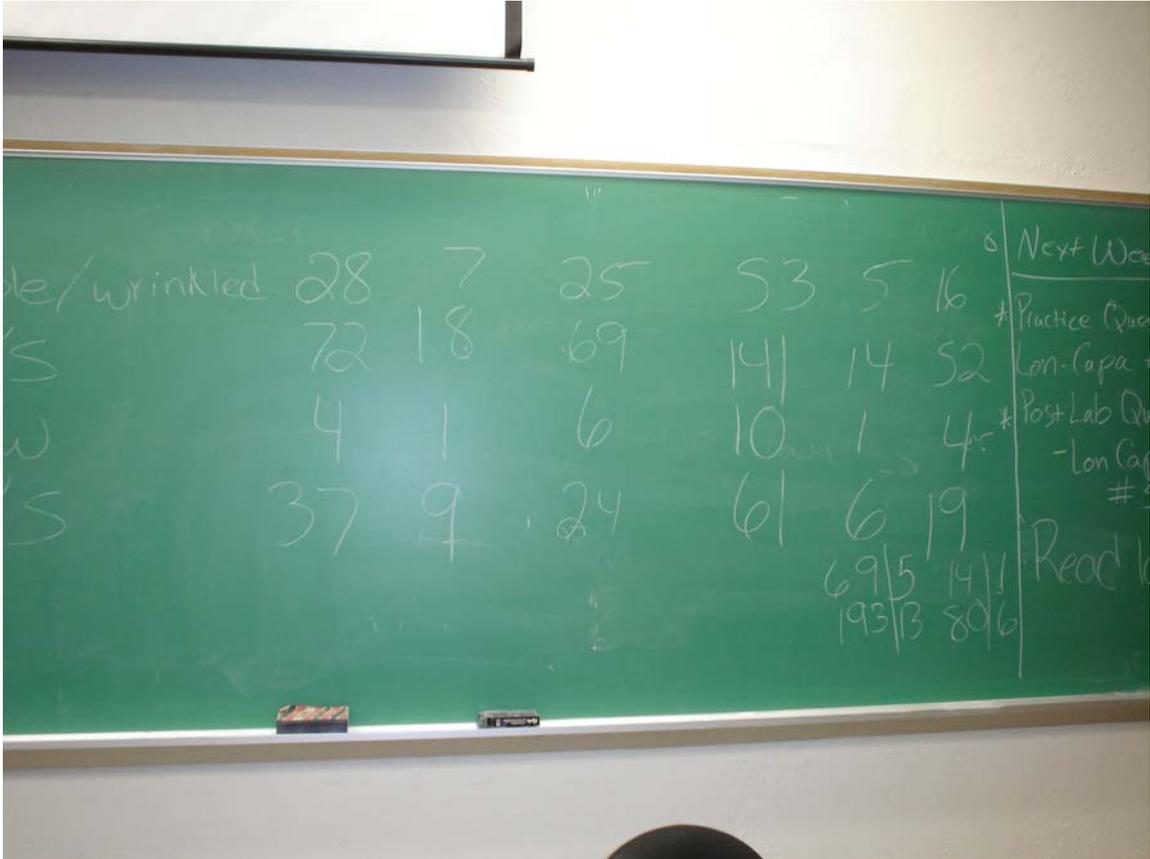
HA #9 – Assumed asbestos-containing chalkboards and associated glue pods

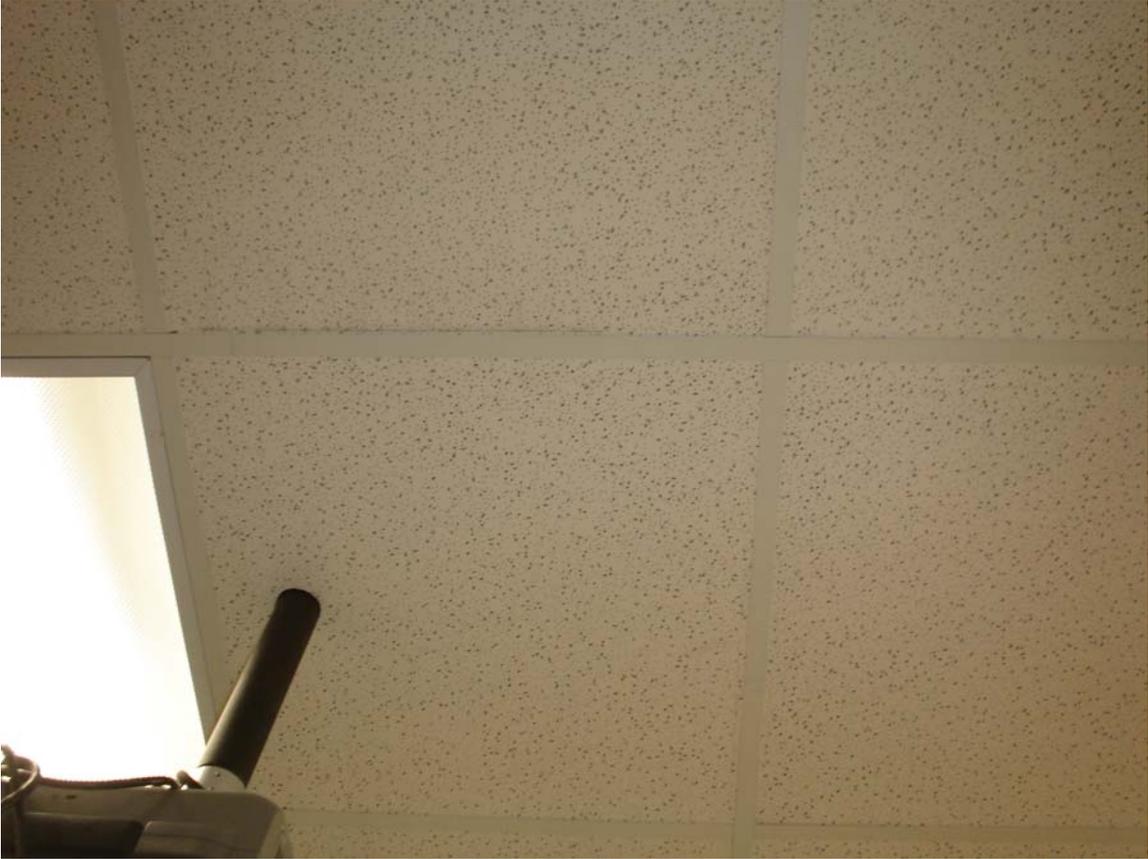
HA #10 – Non asbestos-containing 2' x 2' white lay-in ceiling tile
with pin holes and fissures

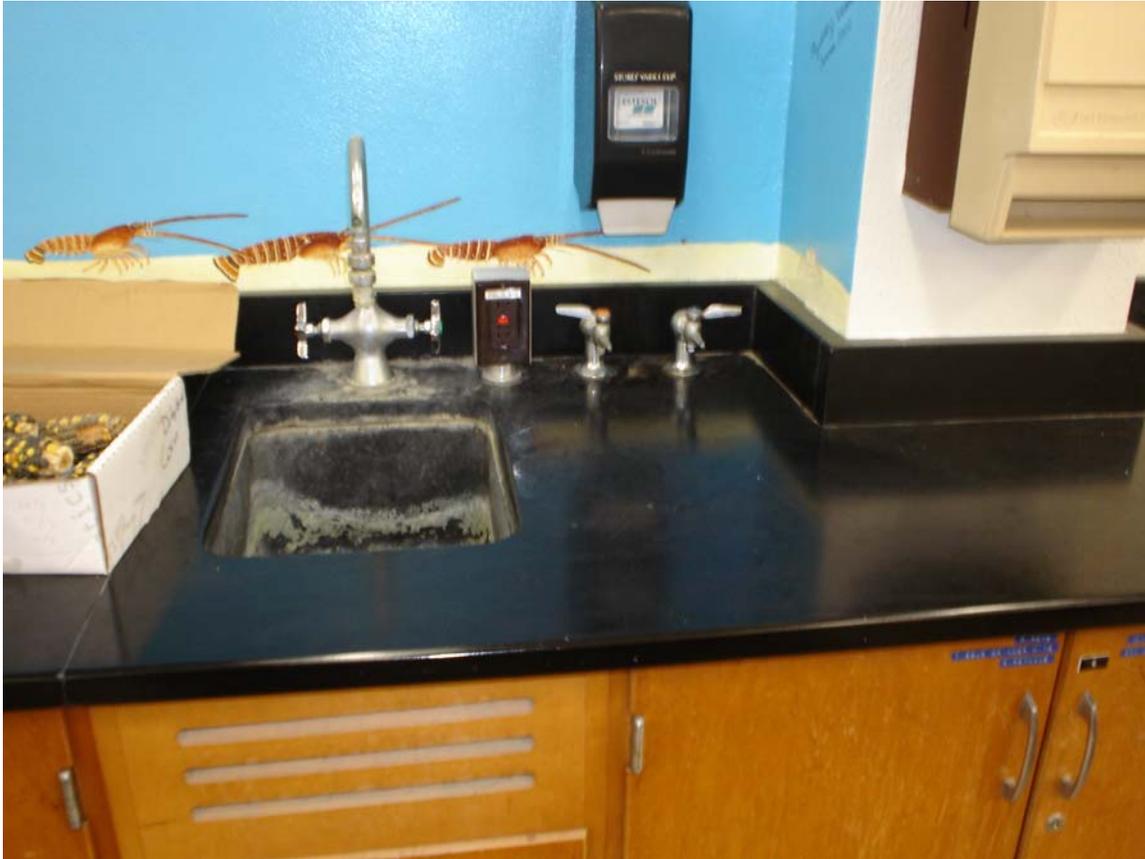
HA #11 – Assumed asbestos-containing black laboratory tables and sinks

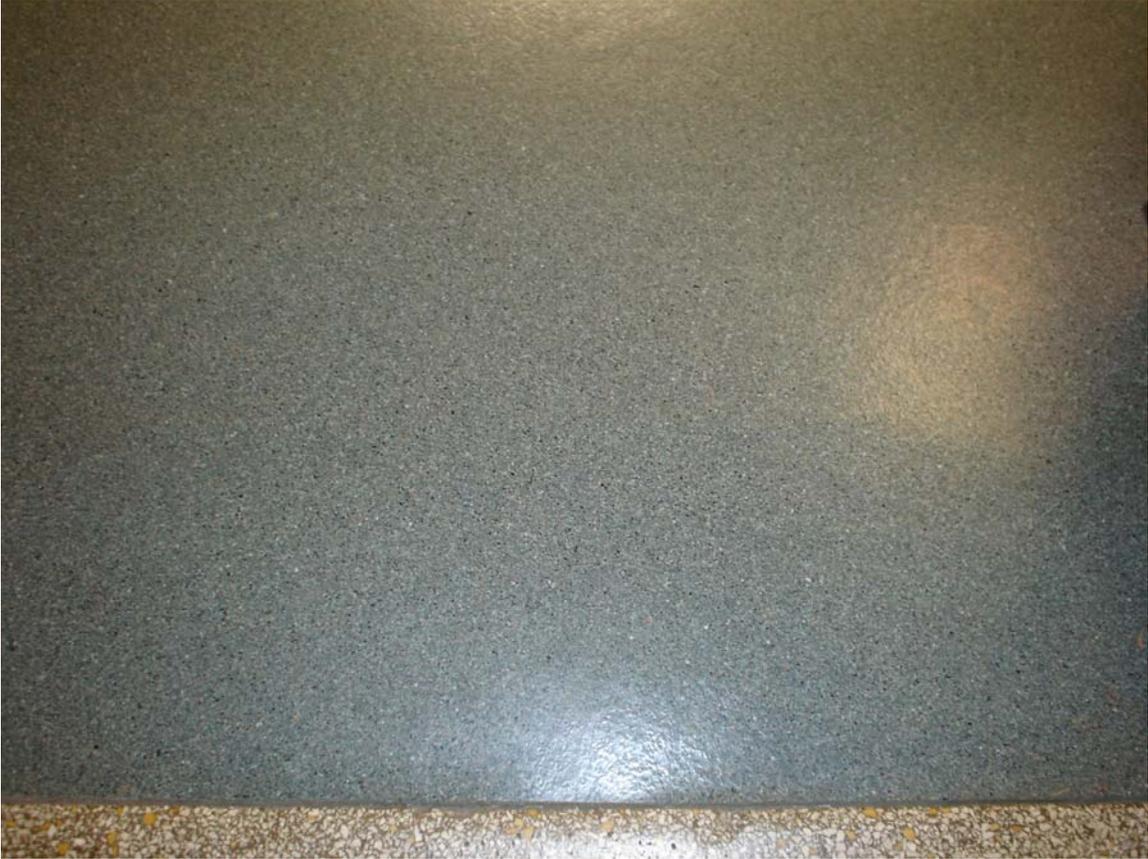
HA #12 – Non asbestos-containing green vinyl flooring with black and white specks and associated mastic

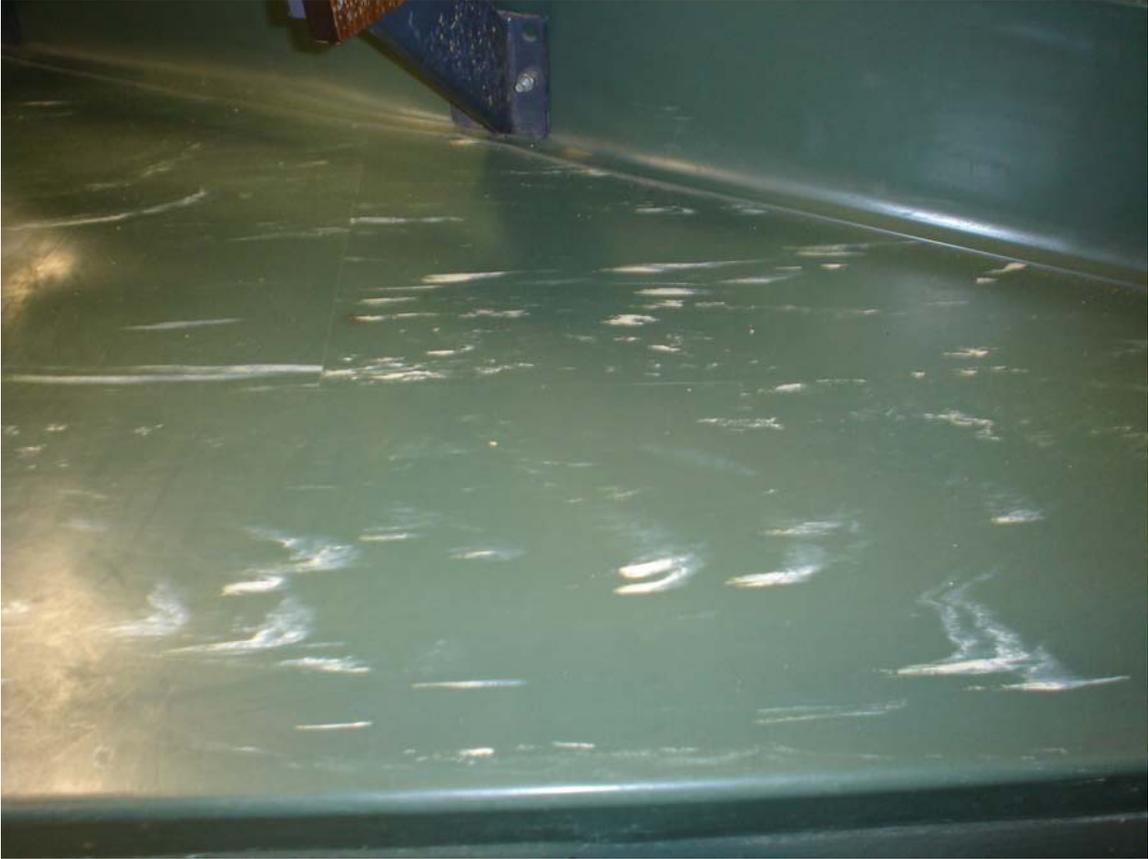
HA #13 – Non asbestos-containing green linoleum flooring with white streaks and associated backing

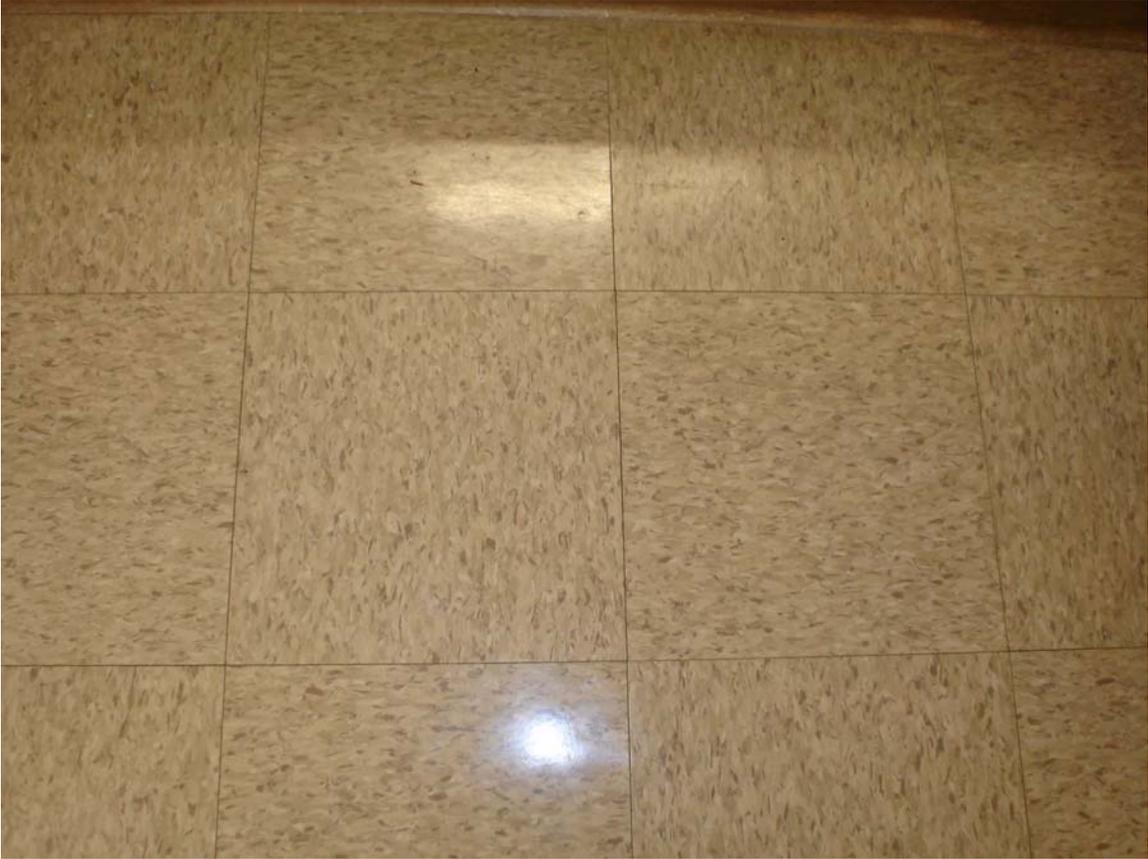
HA #14 – Non asbestos-containing 12" x 12" cream floor tile
with marble pattern and associated mastic

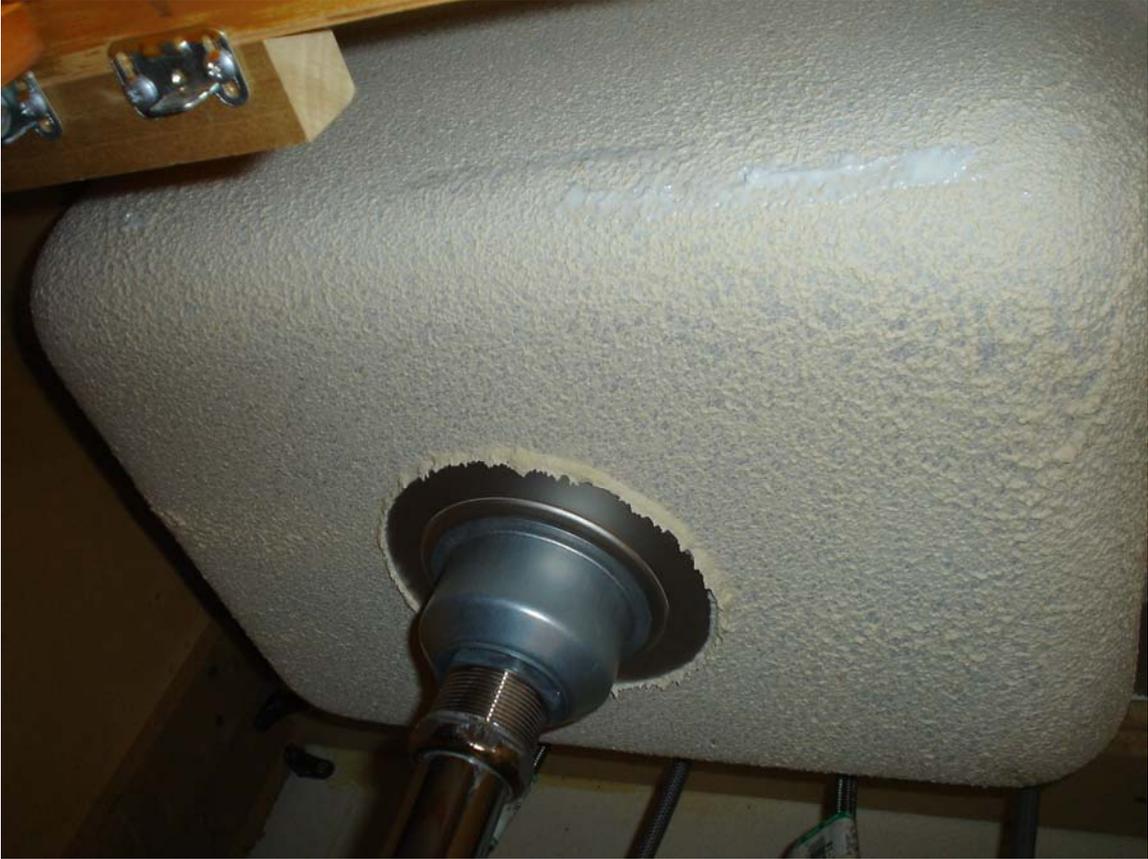
HA #15 – Non asbestos-containing white sink undercoating

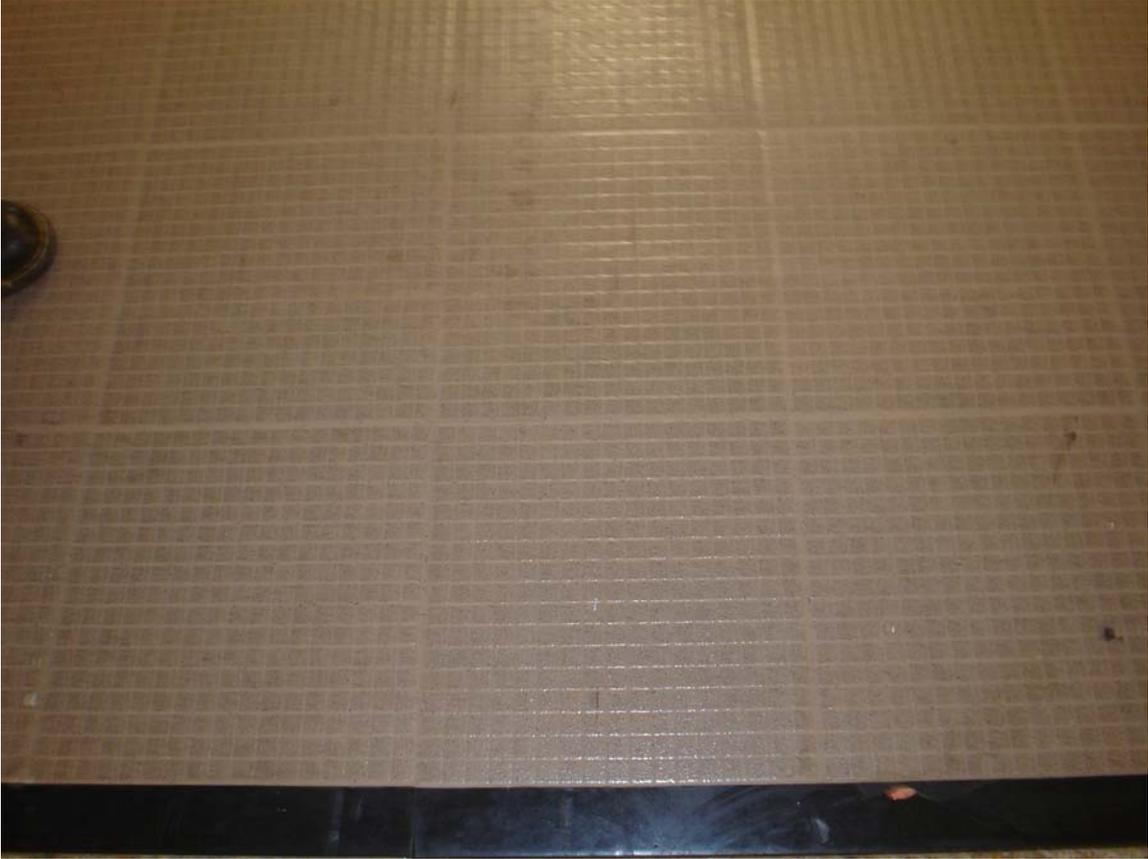
HA #16 – Non asbestos-containing 12" x 12" tan linoleum
with small square pattern and associated backing

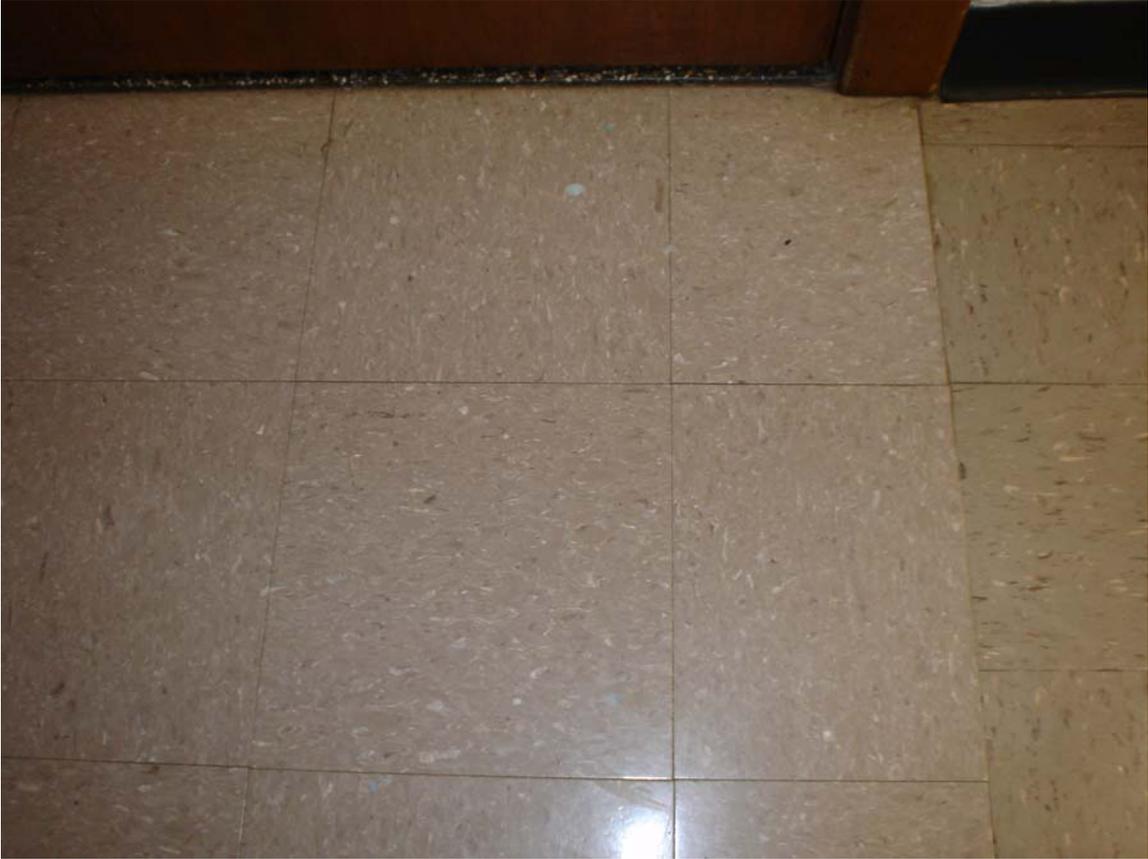
HA #17 – Non asbestos-containing 12" x 12" beige floor tile
with tan and white streaks and associated mastic

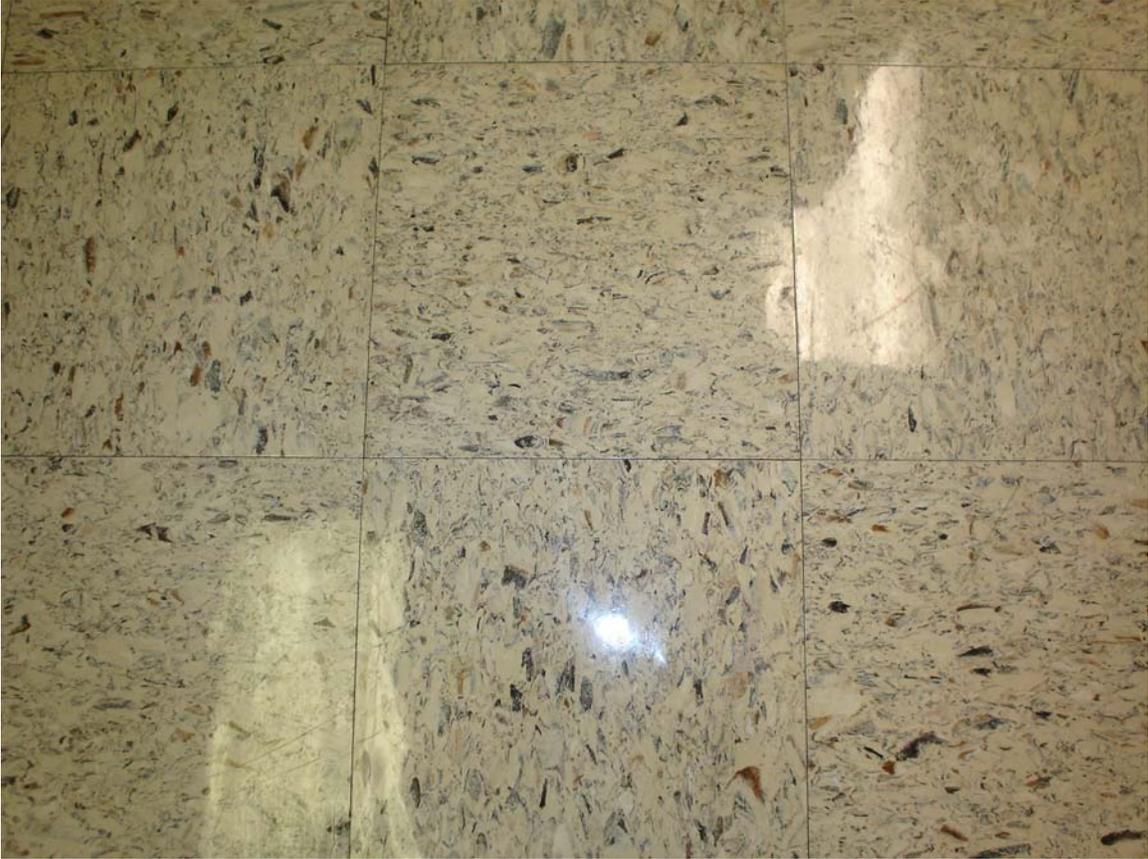
HA #18 – Non asbestos-containing 12" x 12" cream floor tile
with black and tan streaks and associated mastic

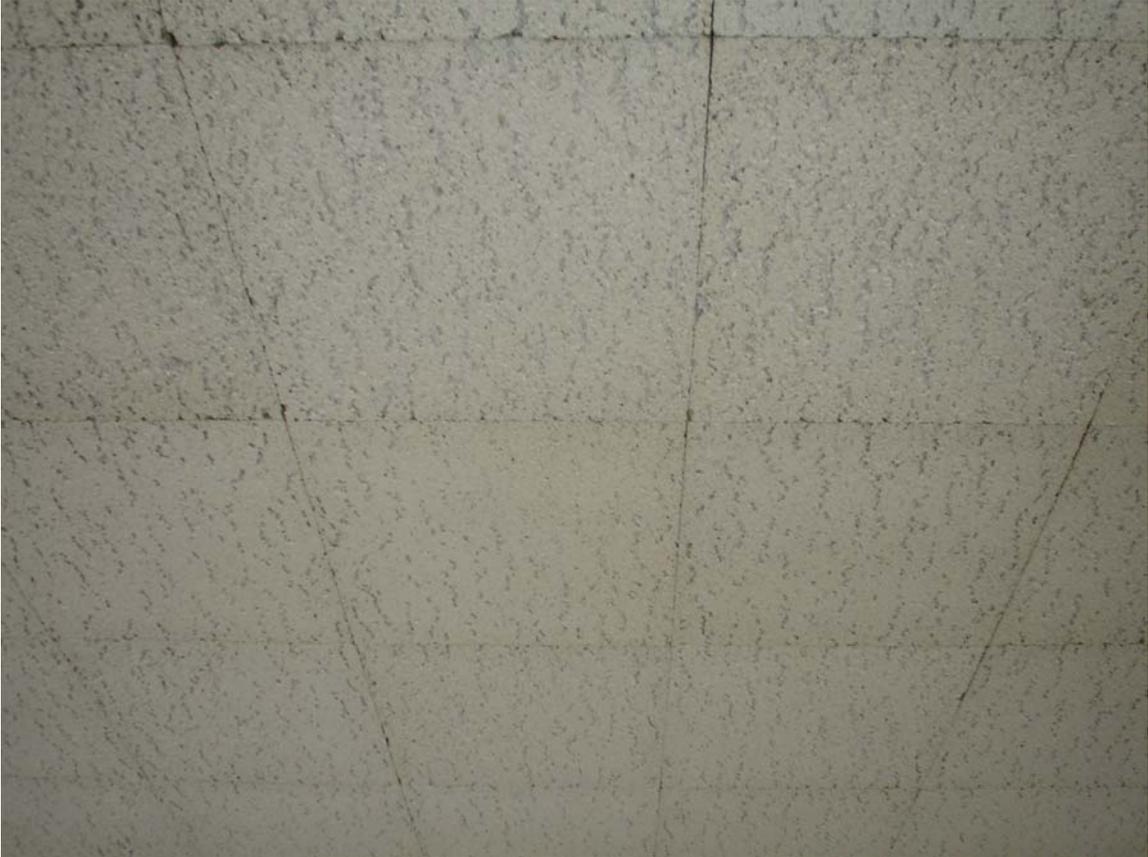
HA #19 – Non asbestos-containing 12" x 12" white spline ceiling tile with fissures and associated glue pods

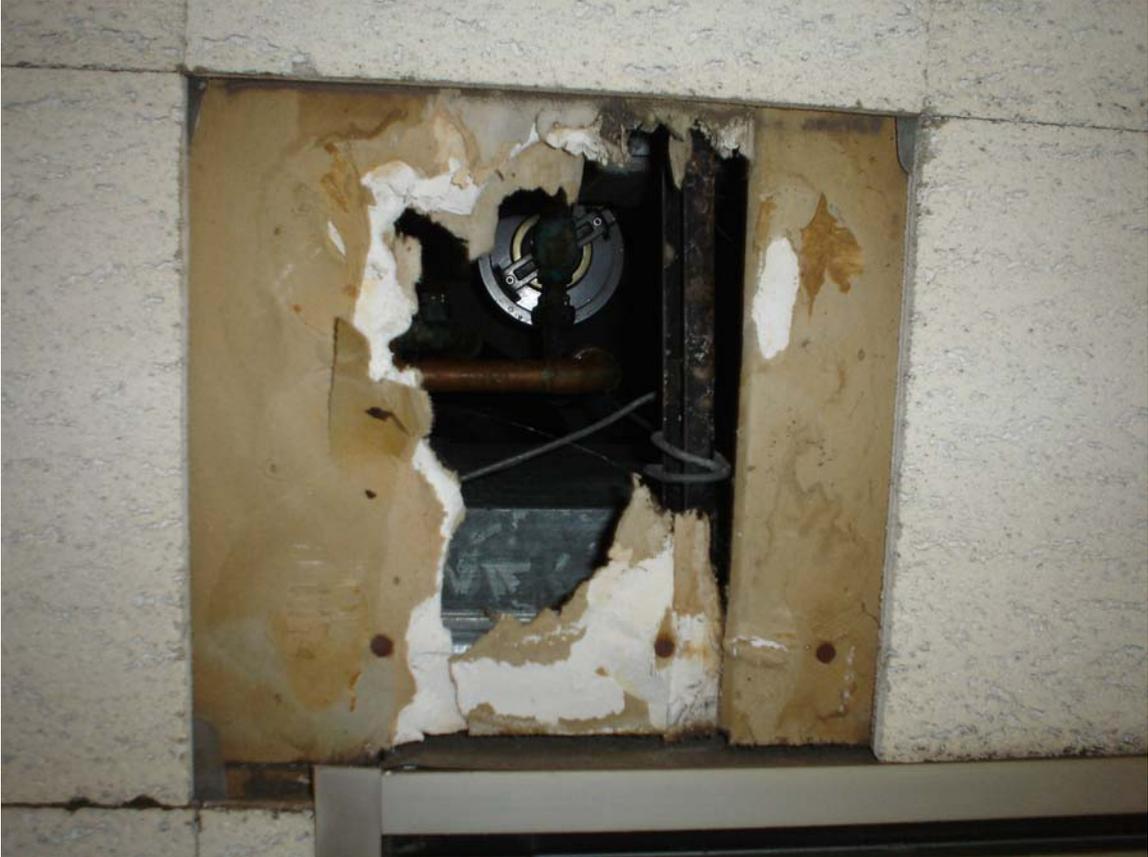
HA #20 – Non asbestos-containing fireboard
(behind 12" x 12" white spline ceiling tile)

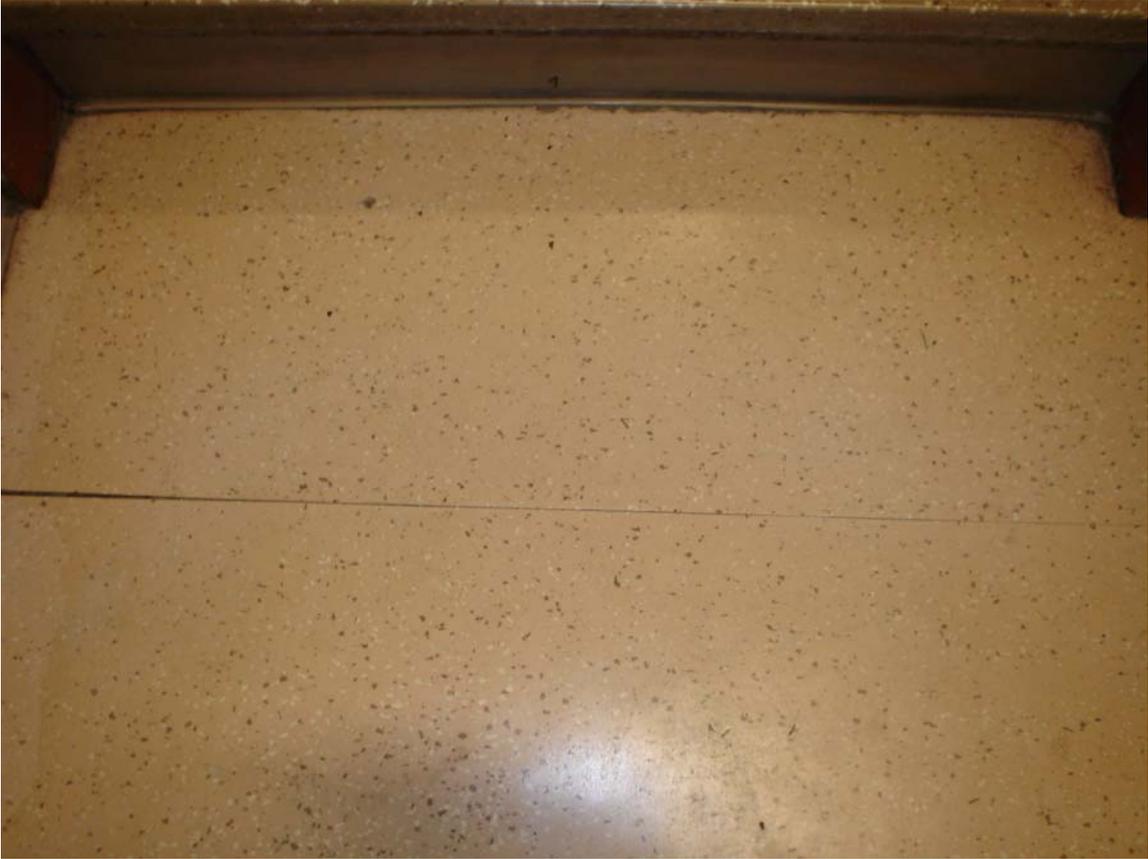
HA #21 – Asbestos-containing tan linoleum with brown and white specks
and associated non asbestos-containing mastic

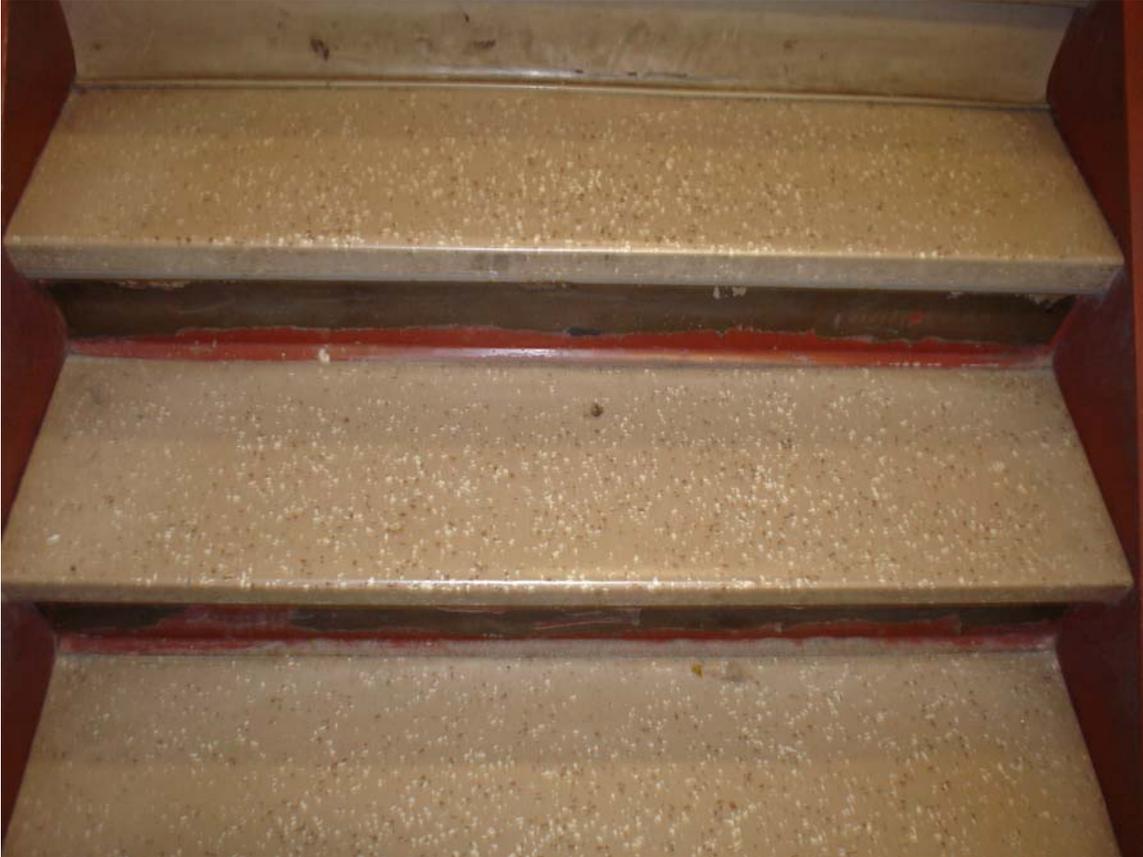
HA #22 – Asbestos-containing tan stair tread with brown and white specks
and associated non asbestos-containing mastic

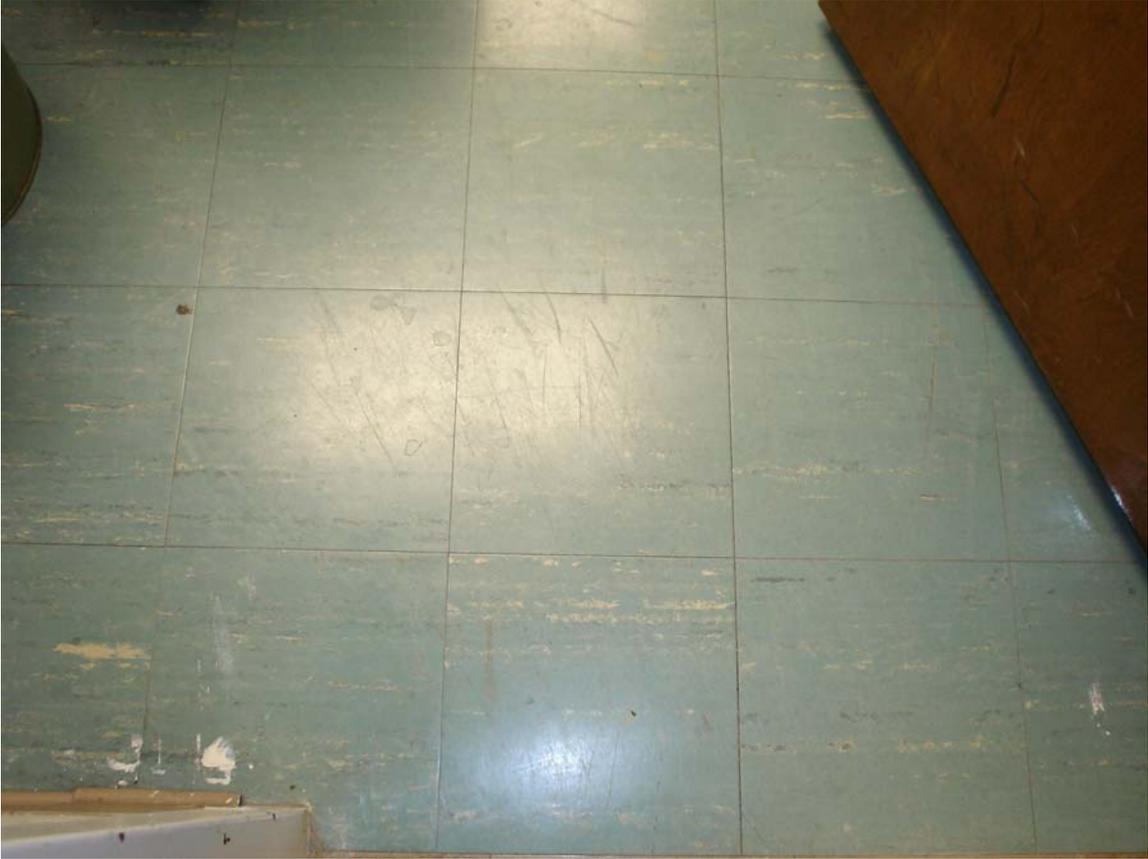
HA #23 – Asbestos-containing 9" x 9" blue floor tile with white and black streaks and associated non asbestos-containing mastic
