Kedzie Hall Photo Log

Exterior of Kedzie Hall

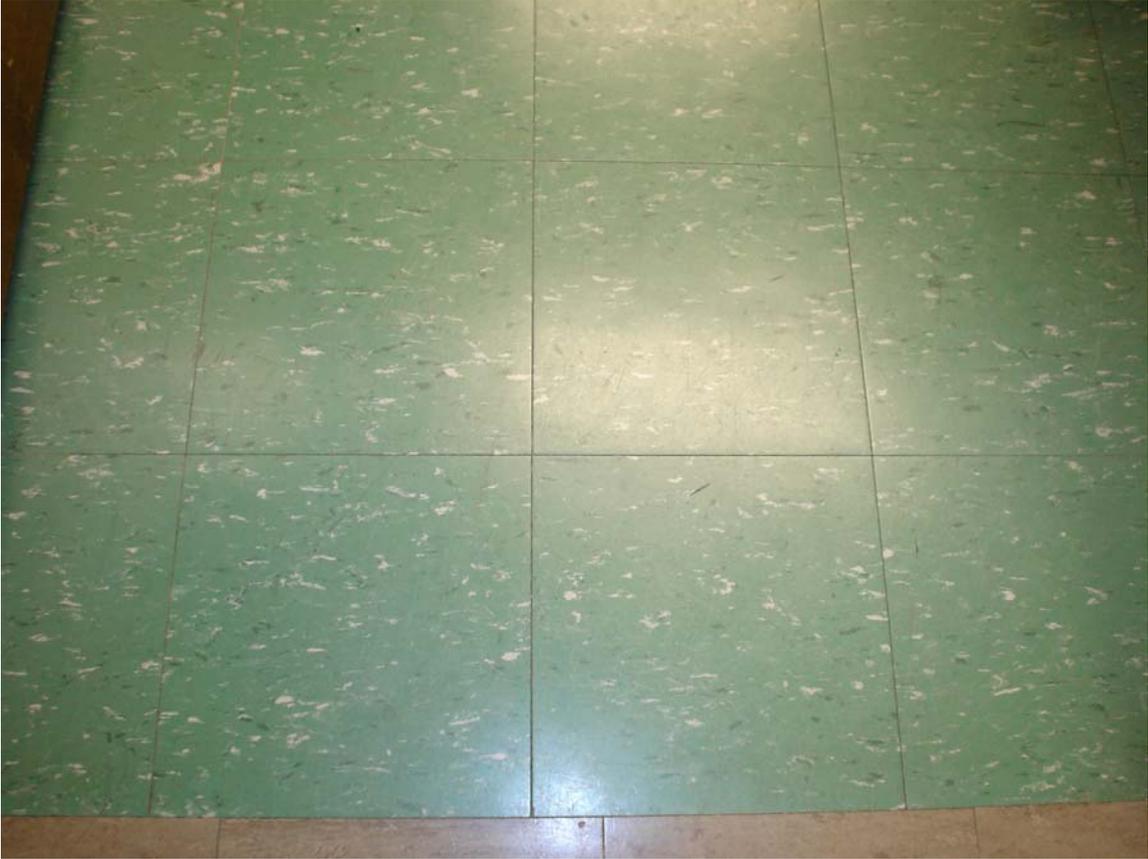
HA #24 – Asbestos-containing 9" x 9" green floor tile with white and green streaks and associated non asbestos-containing mastic

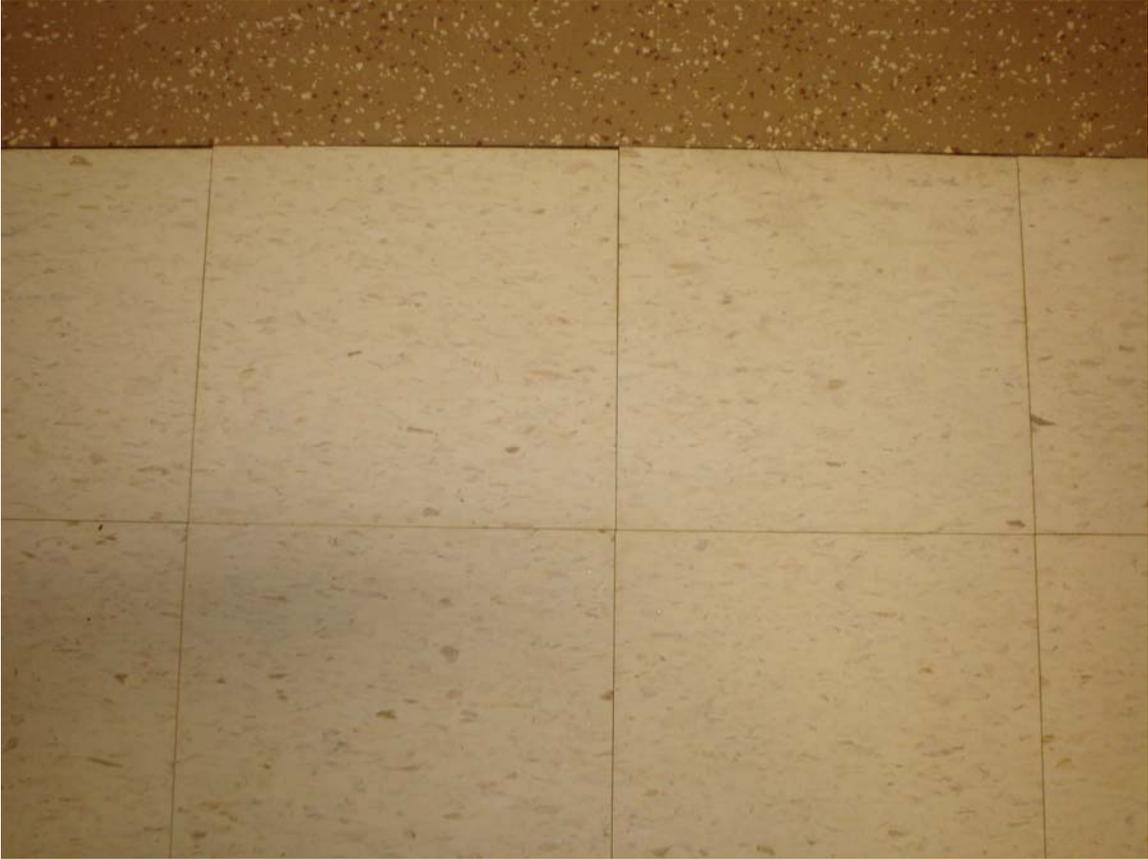
HA #25 – Non asbestos-containing 12" x 12" white floor tile with tan and gray marble pattern and associated mastic

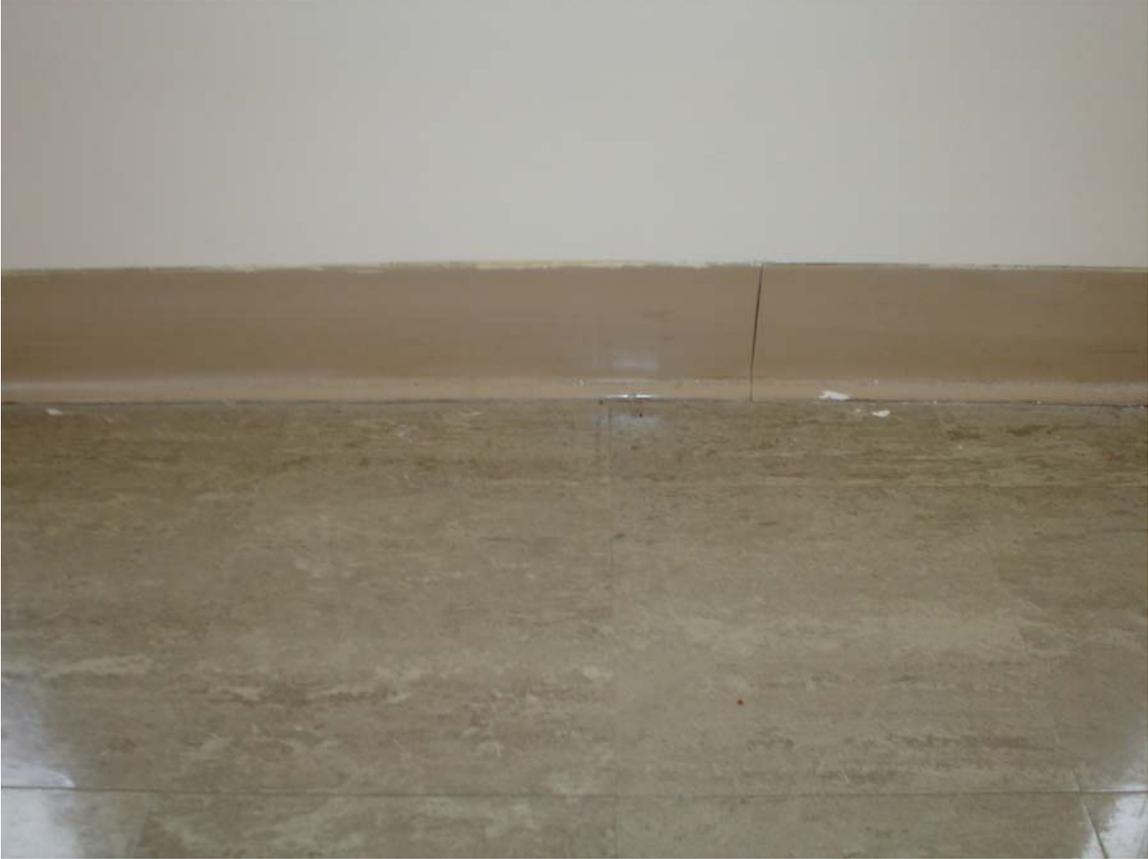
HA #26 – Non asbestos-containing 4" tan cove molding
and associated mastic

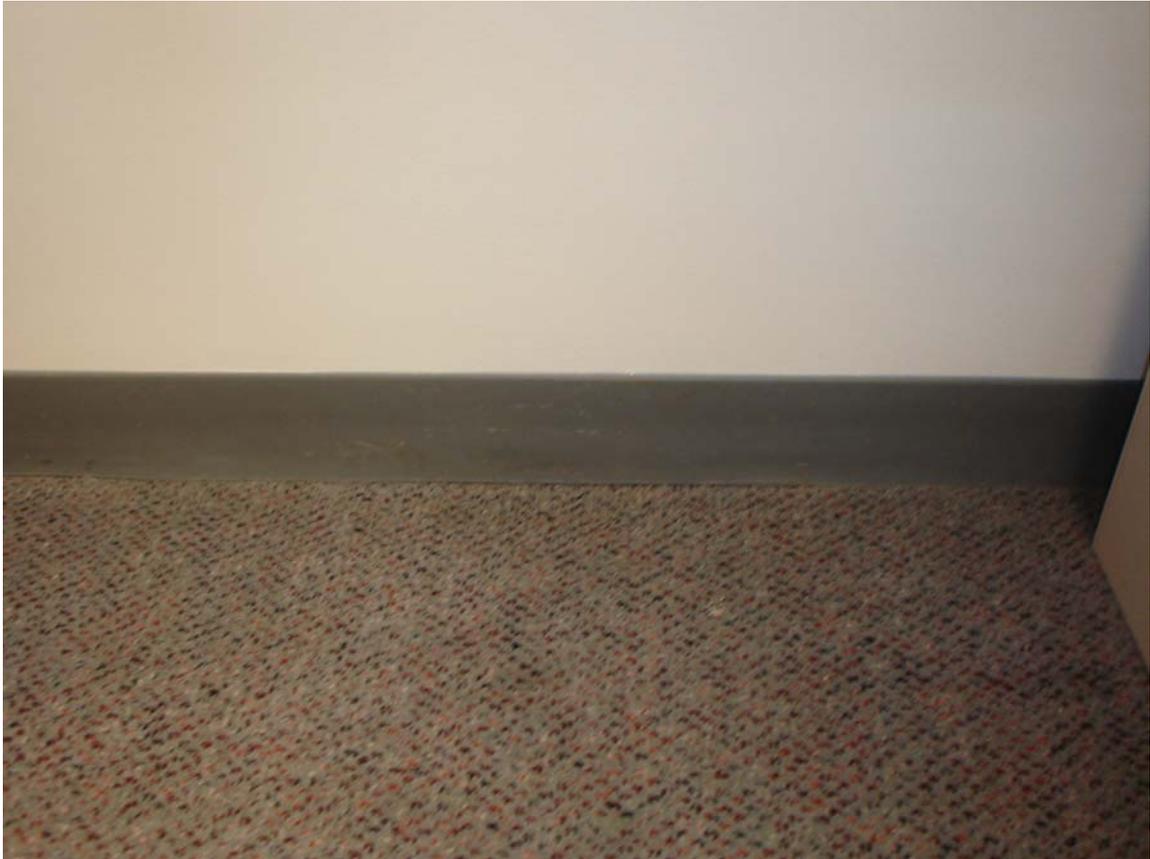
HA #27 – Non asbestos-containing 4" gray cove molding
and associated mastic

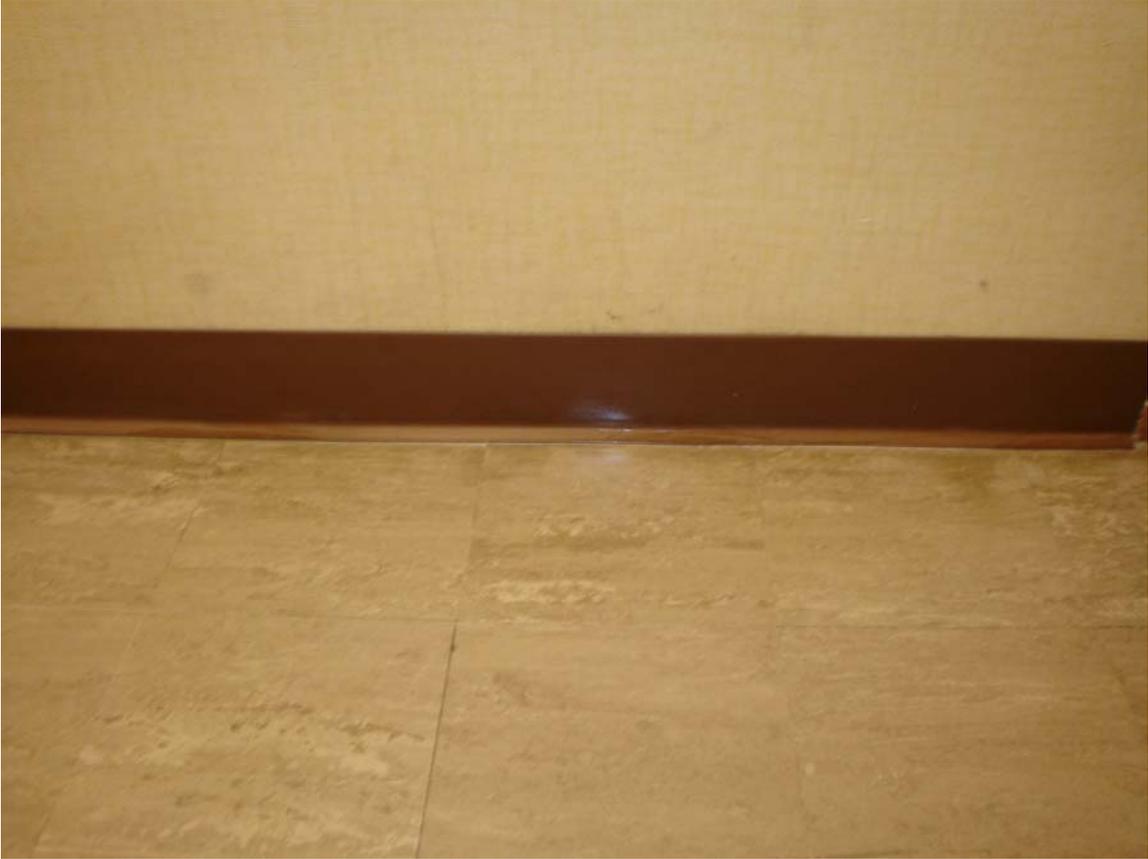
HA #28 – Non asbestos-containing 4" brown cove molding
and associated mastic

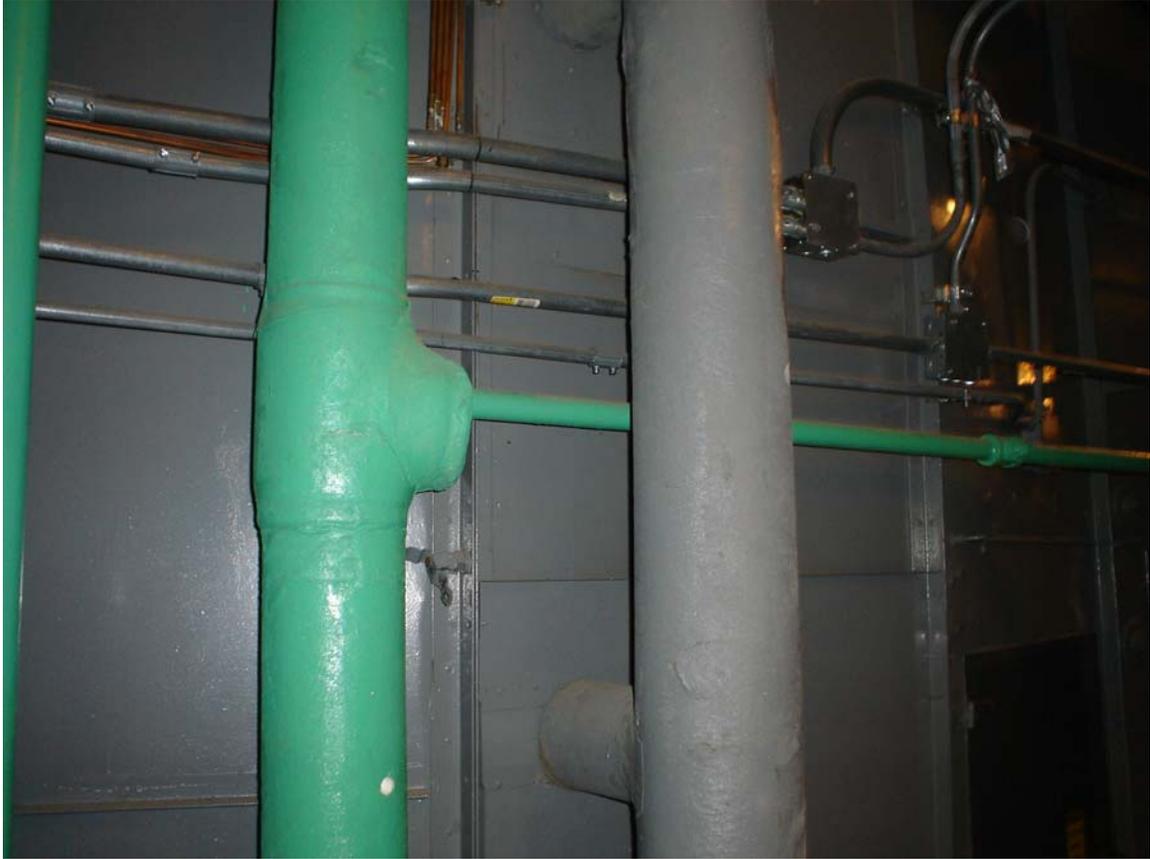
HA #29 – Asbestos-containing steam/condensate supply and return pipe straight insulation

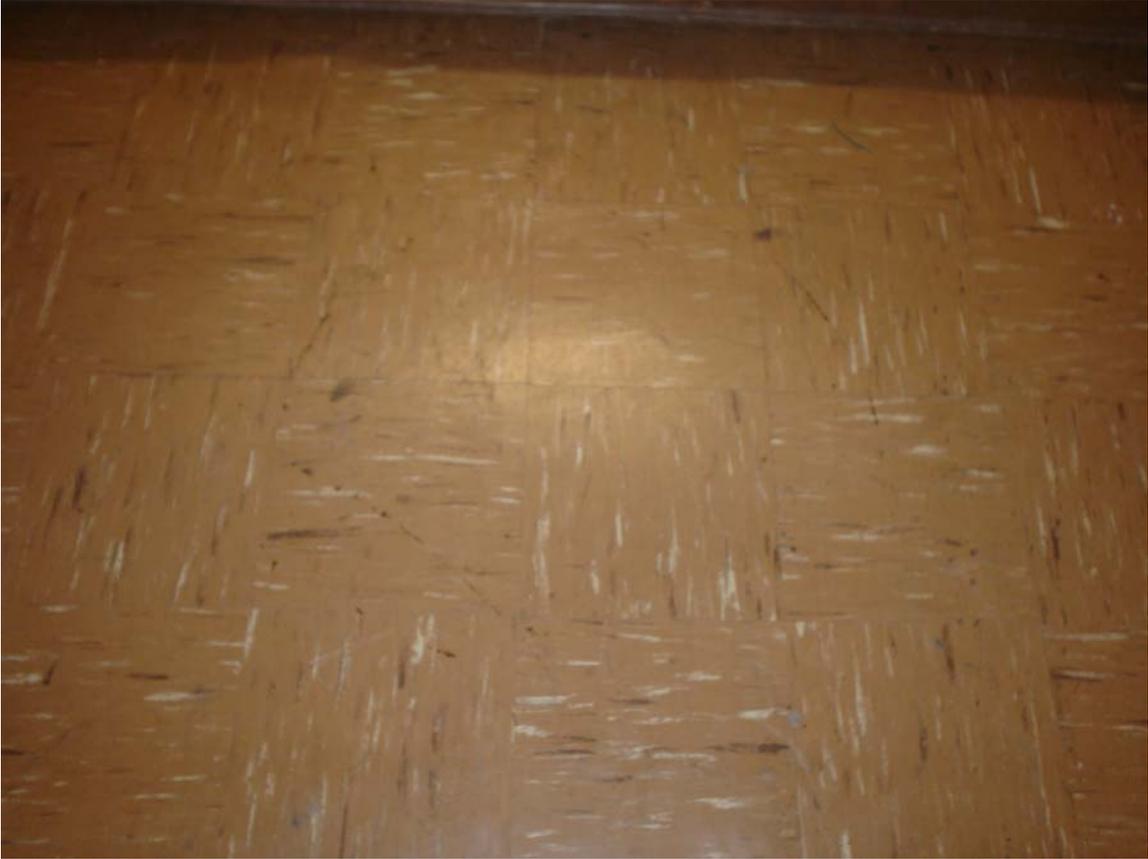
HA #31 – Asbestos-containing 9" x 9" tan floor tile with cream and rust streaks and associated non asbestos-containing mastic

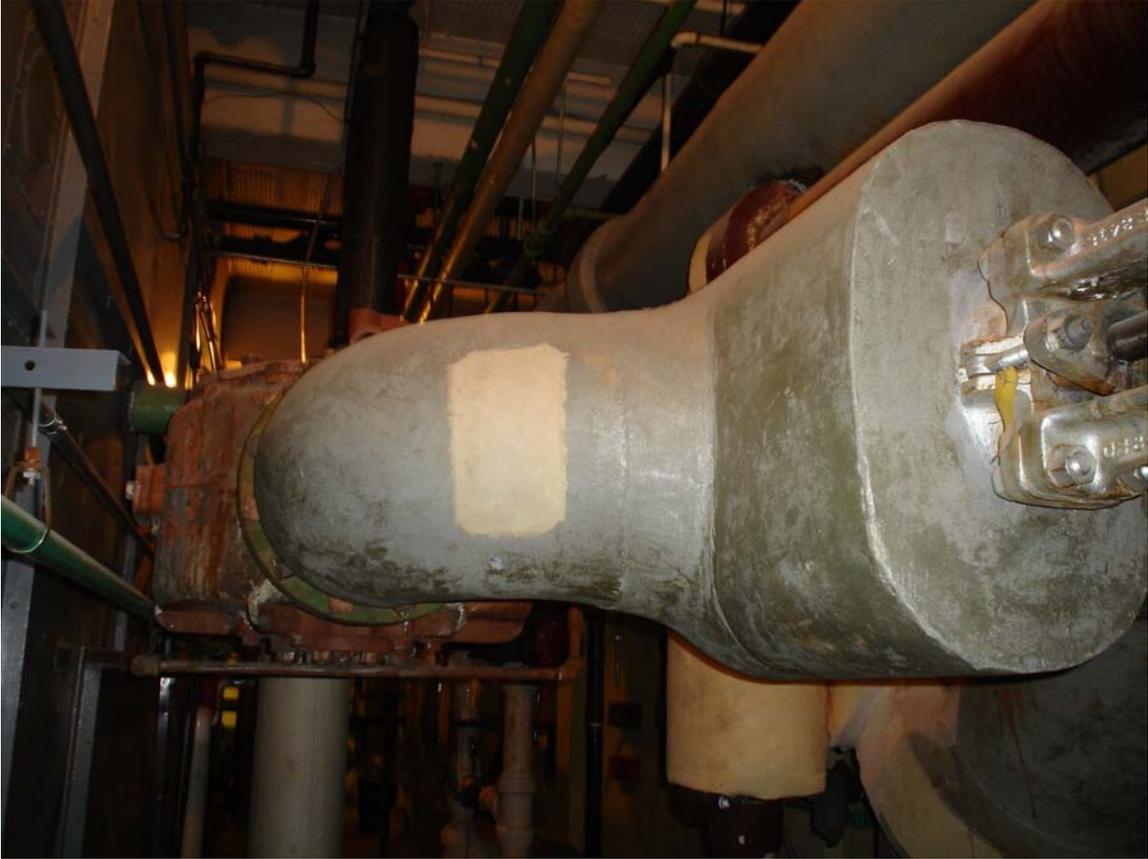
HA #32 – Asbestos-containing steam/condensate supply and return pipe joint and hanger insulation

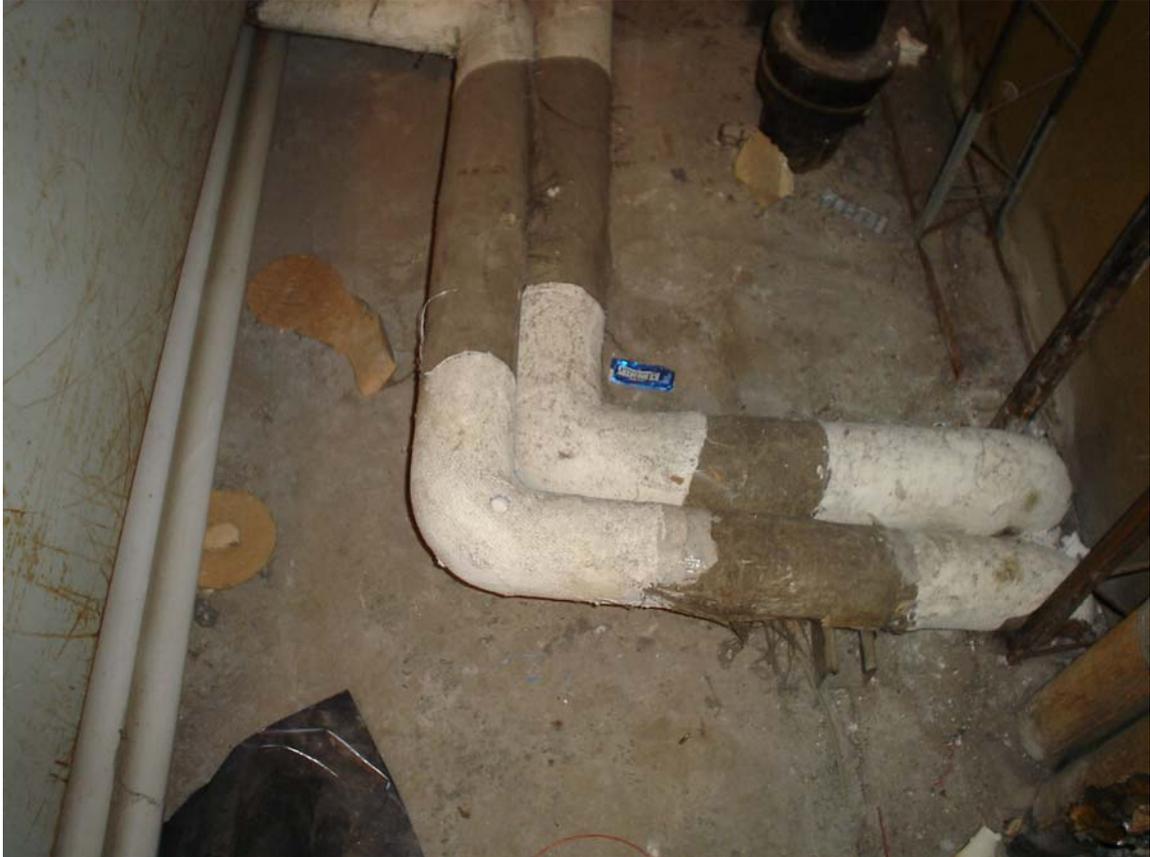
HA #35 – Asbestos-containing domestic water supply pipe joint and hanger insulation

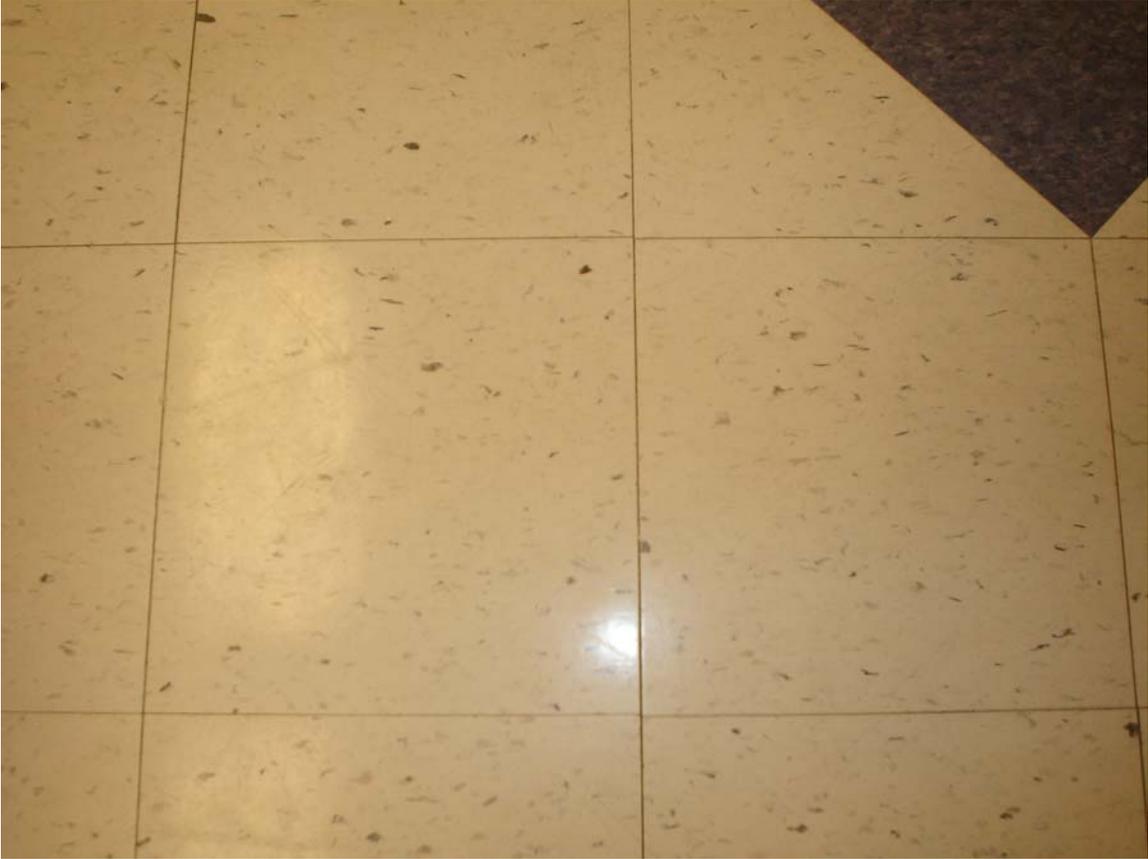
HA #36 – Non asbestos-containing 12" x 12" white floor tile
with black specks and associated mastic

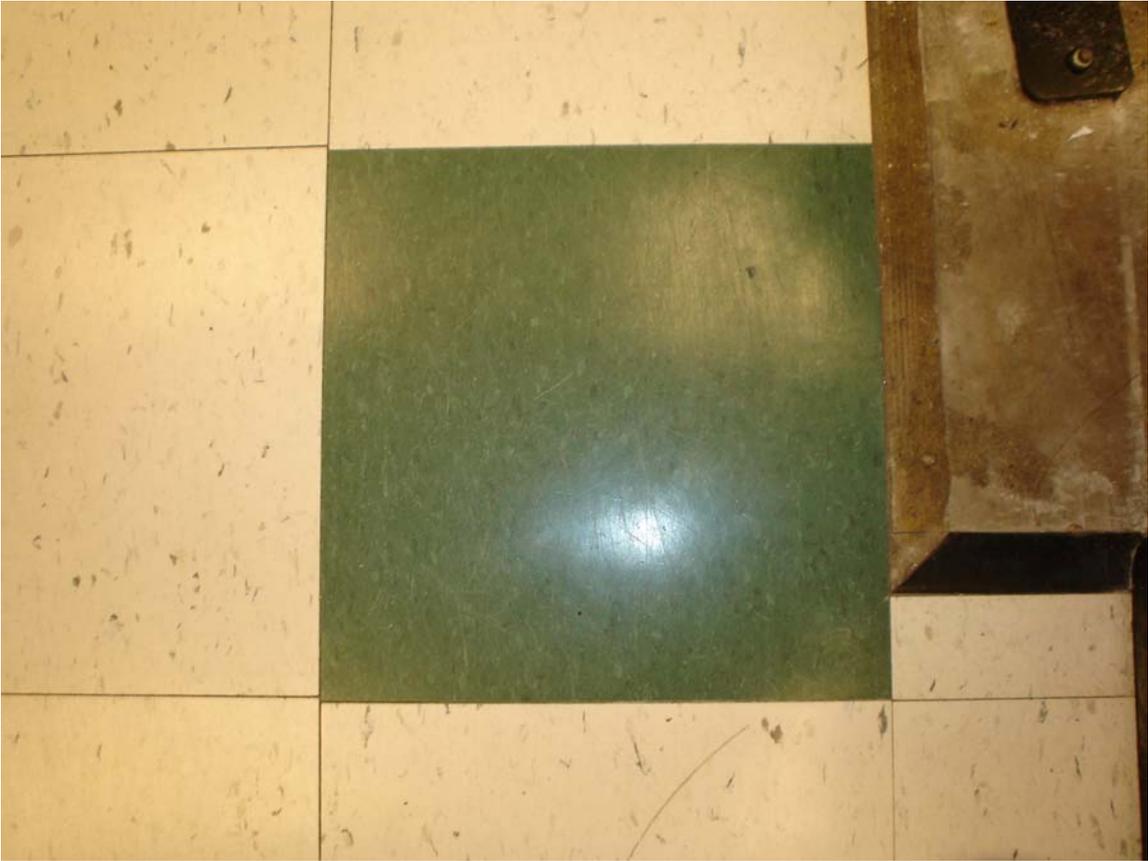
HA #37 – Non asbestos-containing 12" x 12" dark green floor tile
and associated mastic

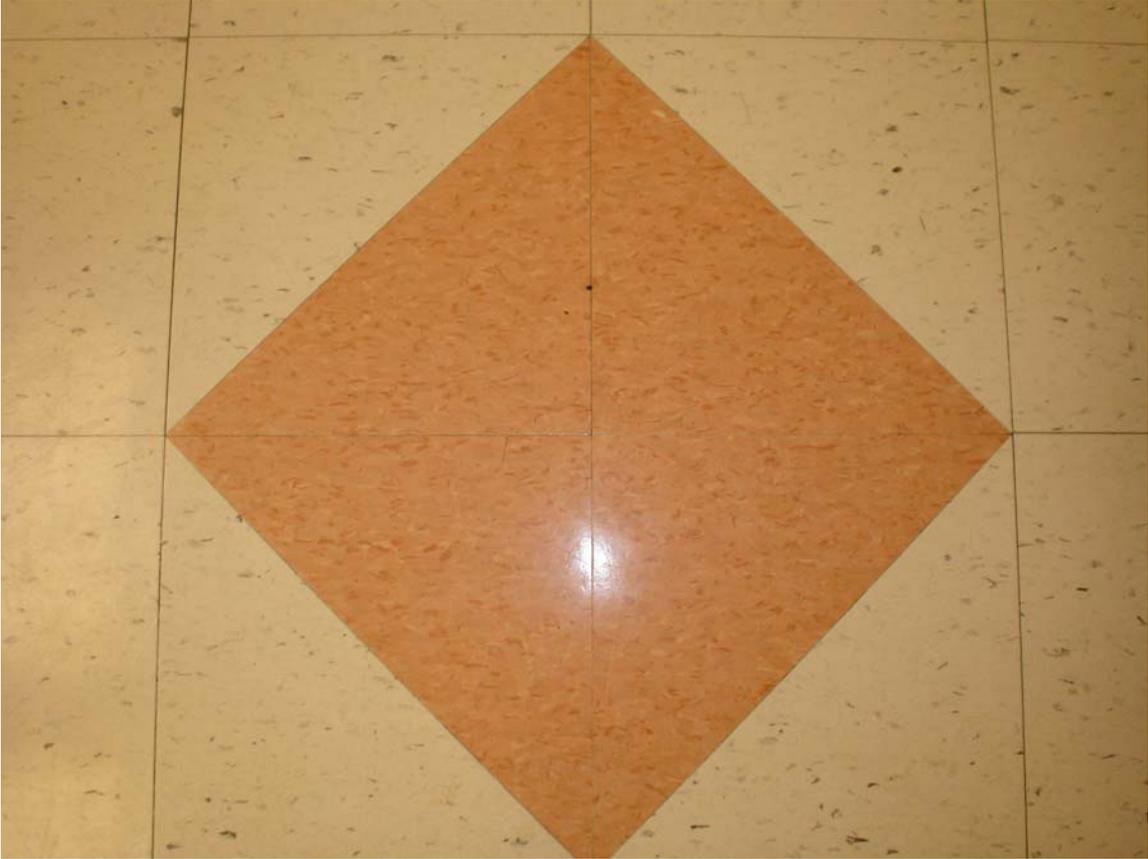
HA #38 – Non asbestos-containing 12" x 12" pink marble pattern floor tile
and associated mastic

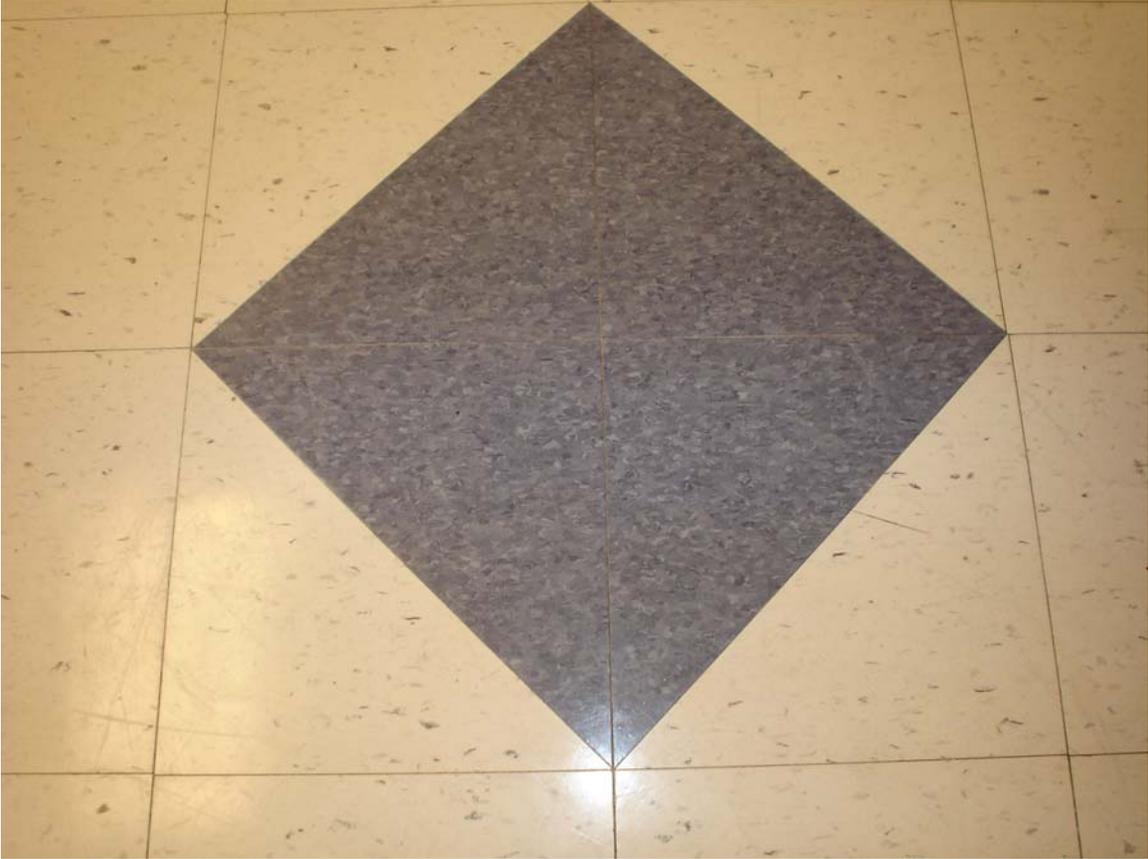
HA #40 – Non asbestos-containing 12" x 12" blue marble pattern floor tile
and associated mastic

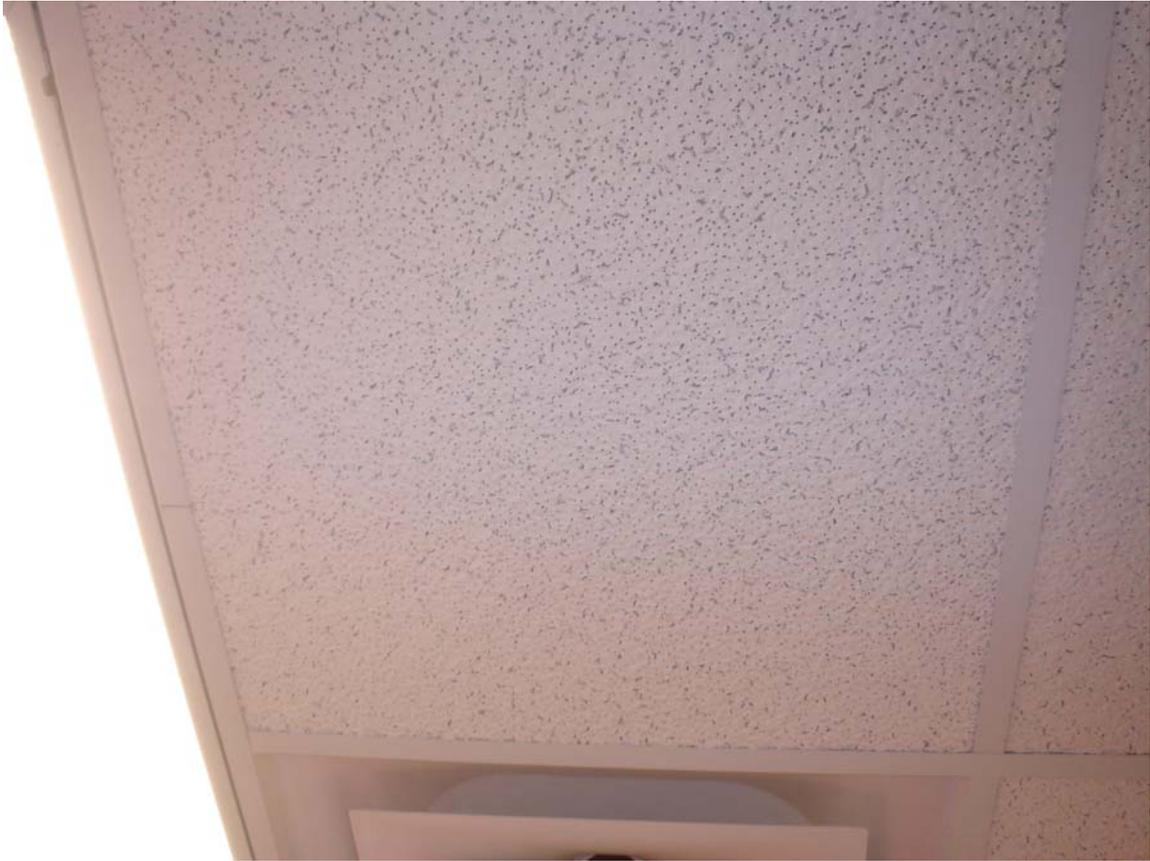
HA #41 – Non asbestos-containing 2' x 2' white lay-in ceiling tile with texture

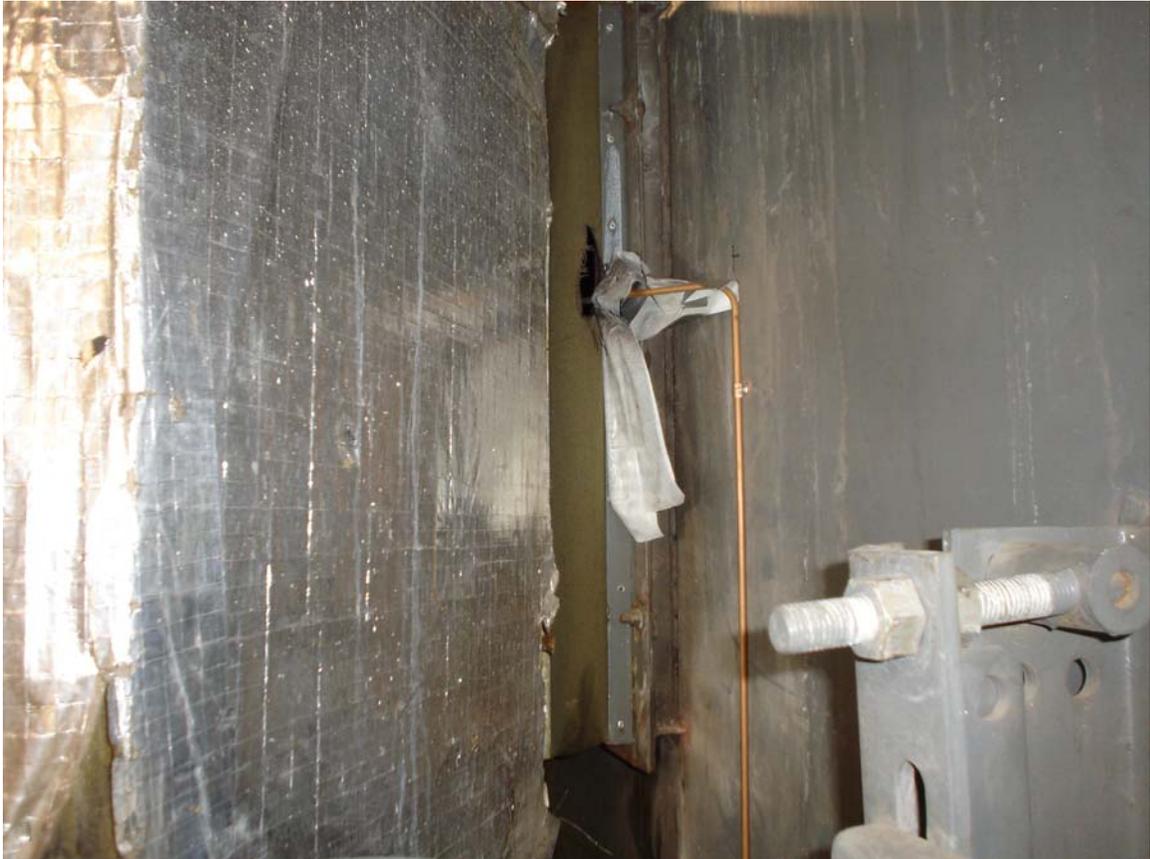
HA #42 – Non asbestos-containing ventilation duct expansion cloth

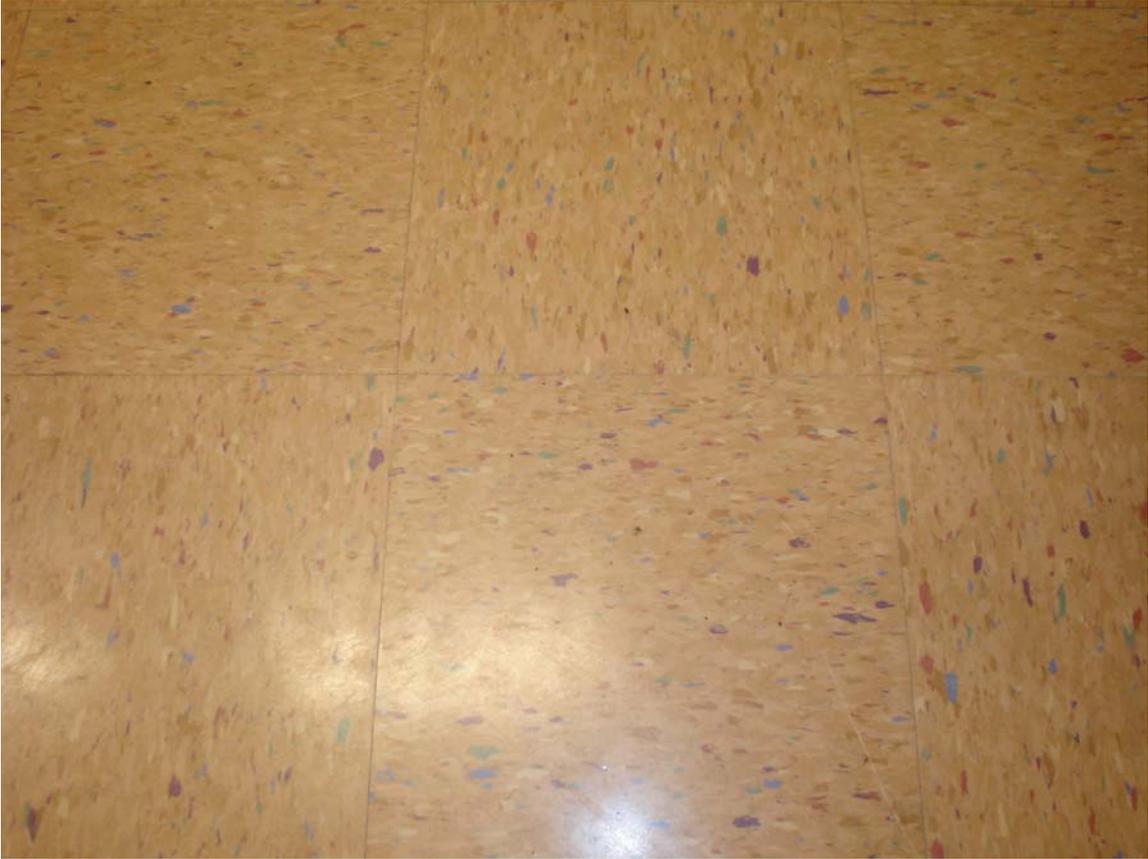
HA #43 – Non asbestos-containing 12" x 12" tan multi-colored marble pattern floor tile and associated mastic

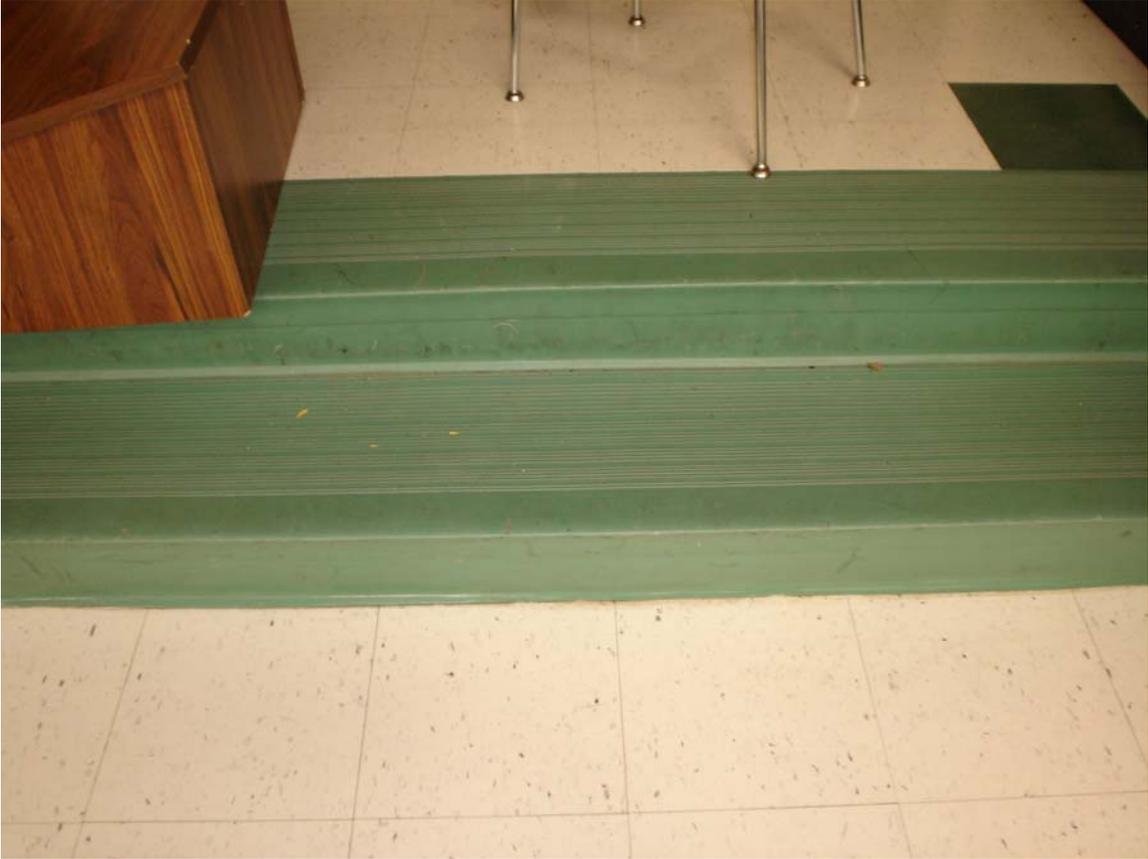
HA #44 – Non asbestos-containing light green vinyl stair tread
and associated mastic

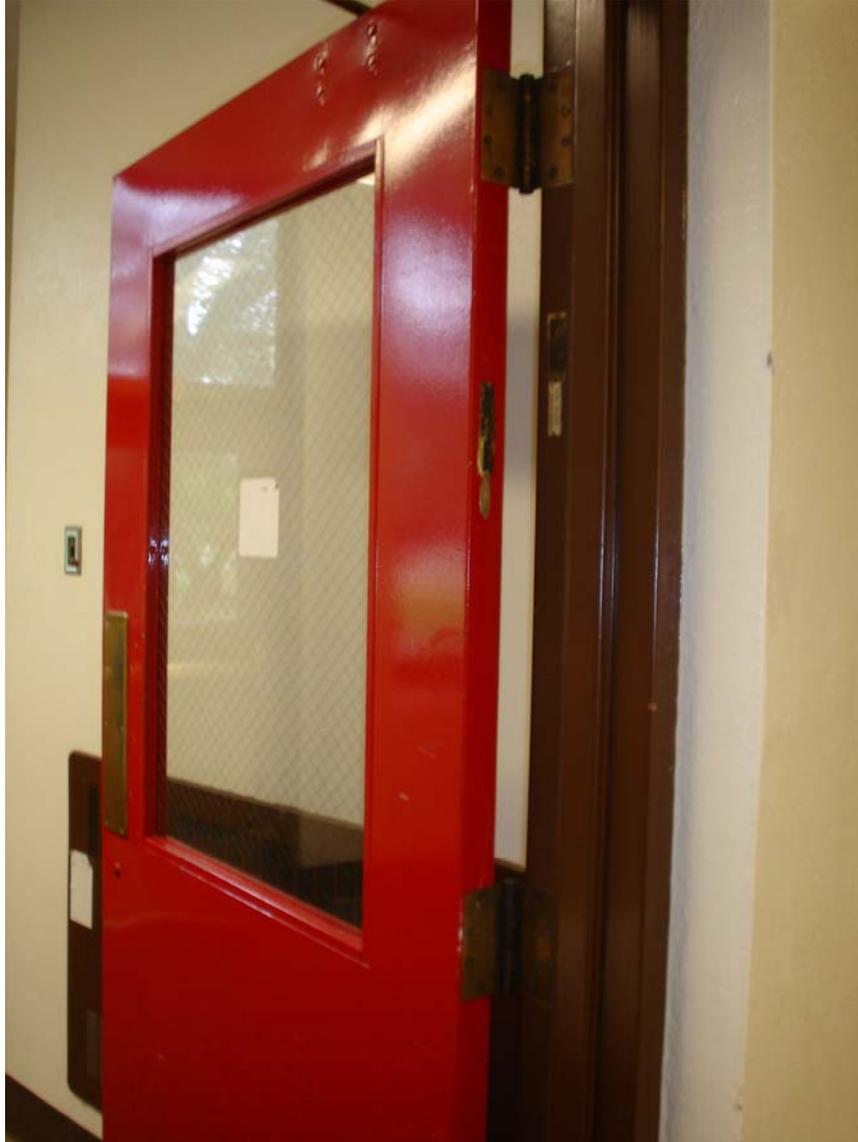
HA #46 – Assumed asbestos-containing fire door and frame
