Michigan State University
Alumni Memorial Chapel - Asbestos Inspection Photo Log

MSU Alumni Chapel (#30)

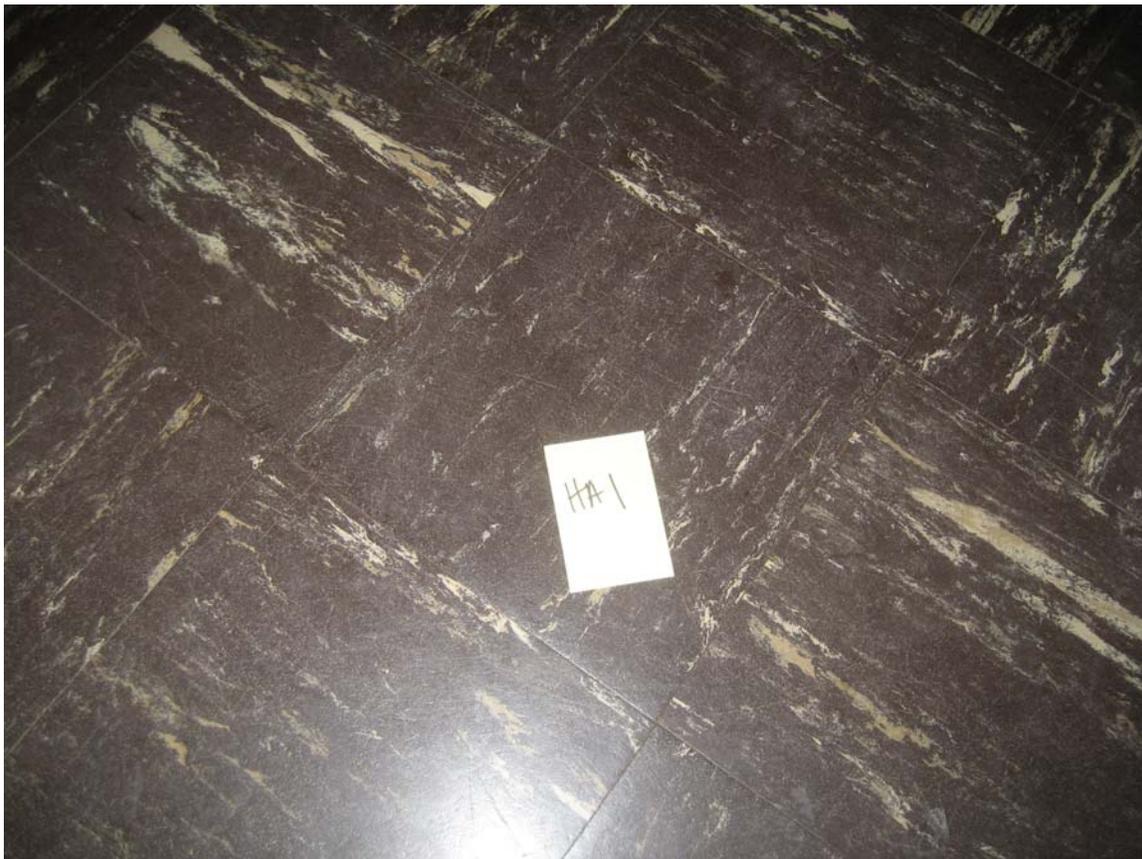
HA #1 –Asbestos containing 9”x 9” Dark brown floor tile with white and cream streaks (mastic negative)

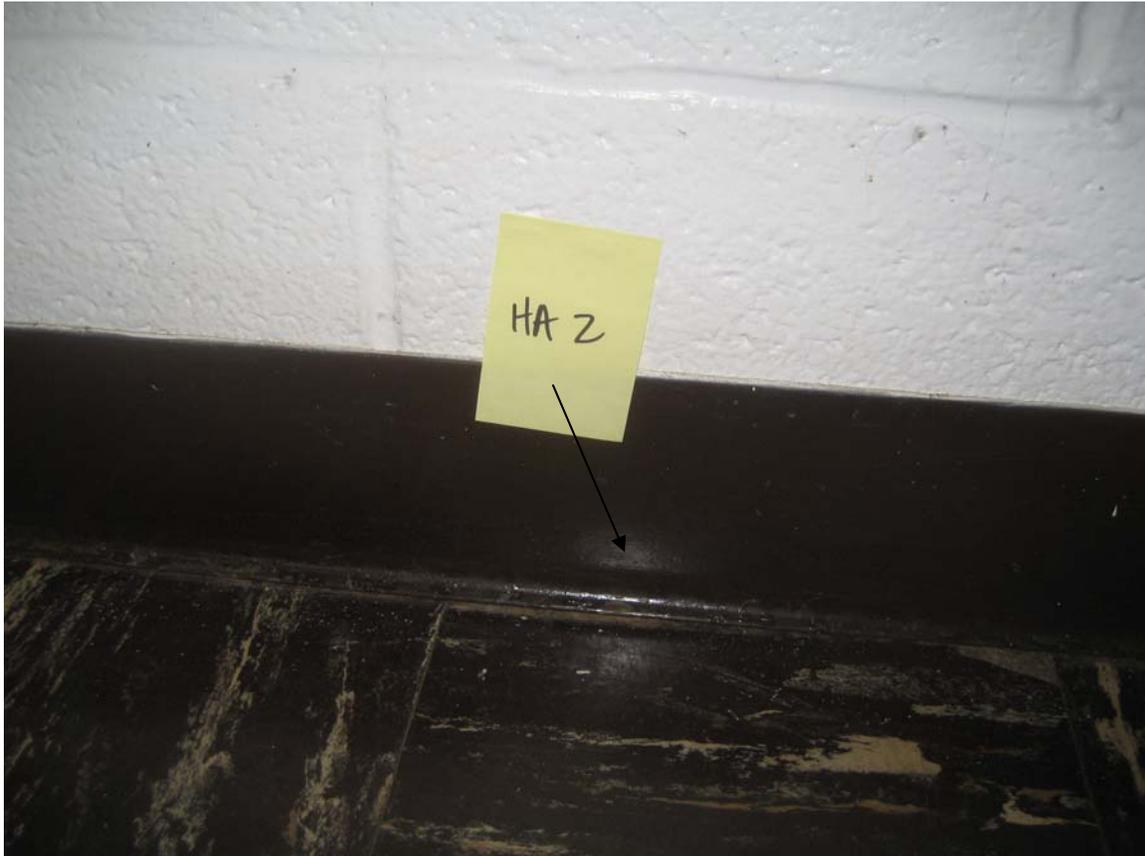
HA #2 – Non asbestos containing 4” Brown cove molding and associated mastic

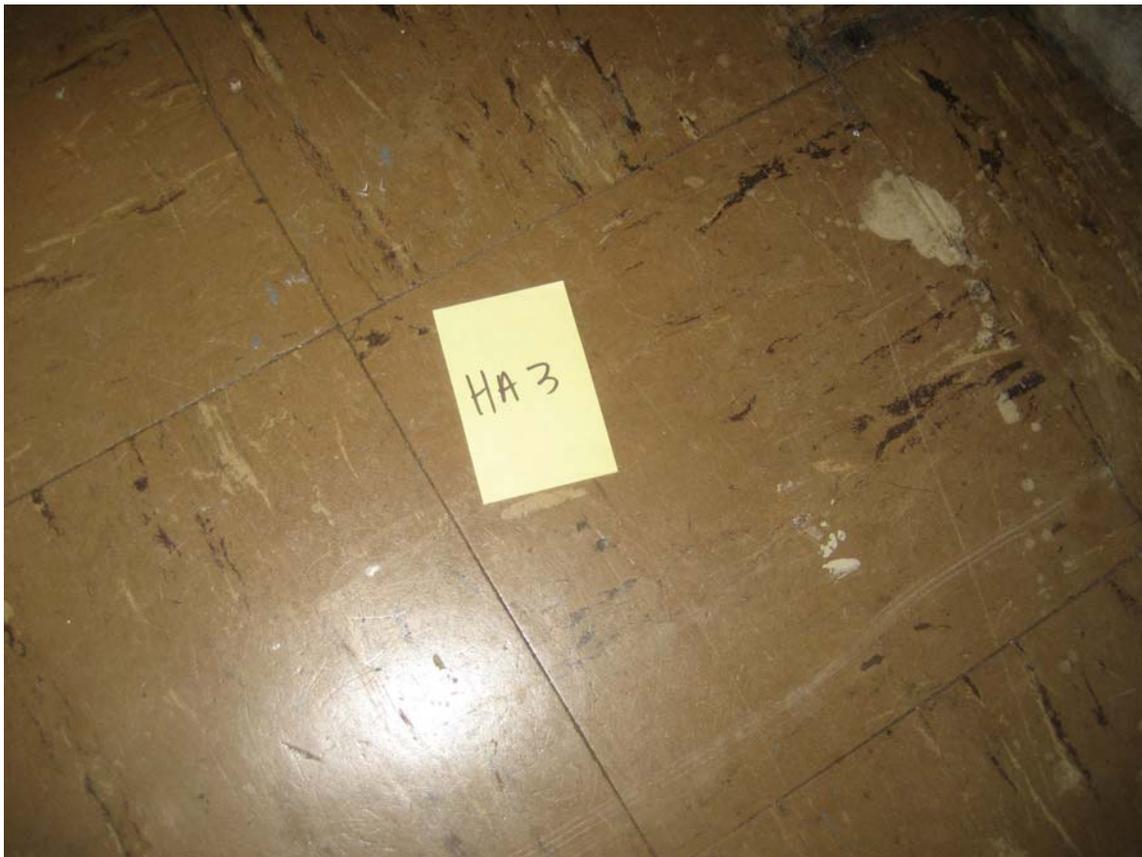
HA #3 – Asbestos containing 9”x 9” Light brown floor tile with white and black streaks (mastic negative)

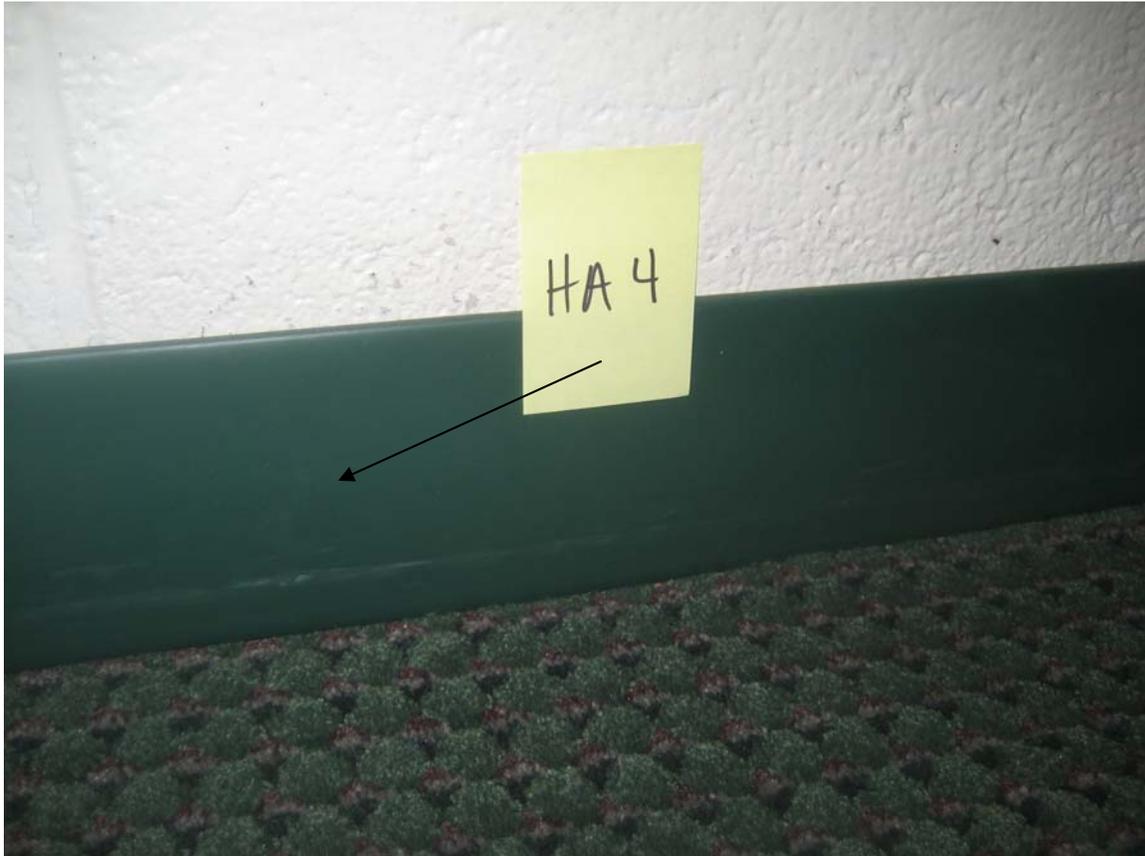
HA #4 – Non asbestos containing 4” Green cove molding and associated mastic

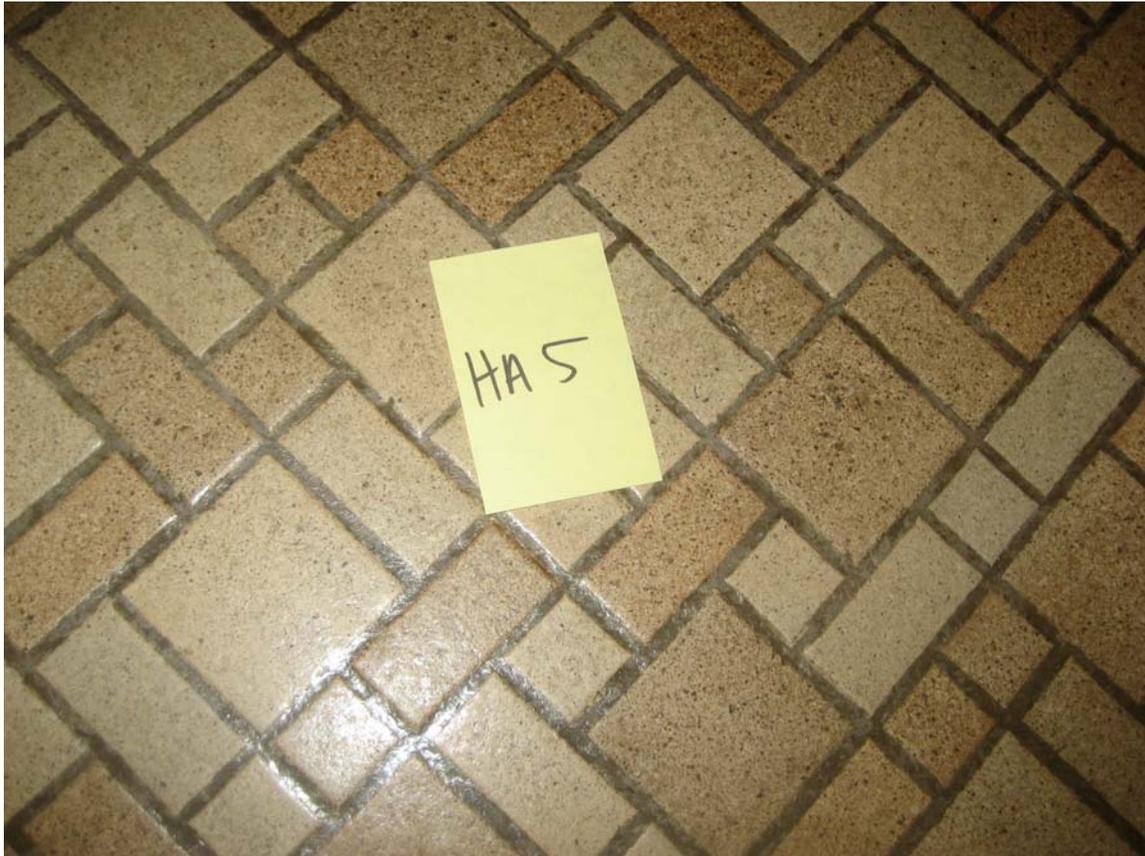
HA #5 – Assumed asbestos containing Multi shade and size brown ceramic tile and bedding compound

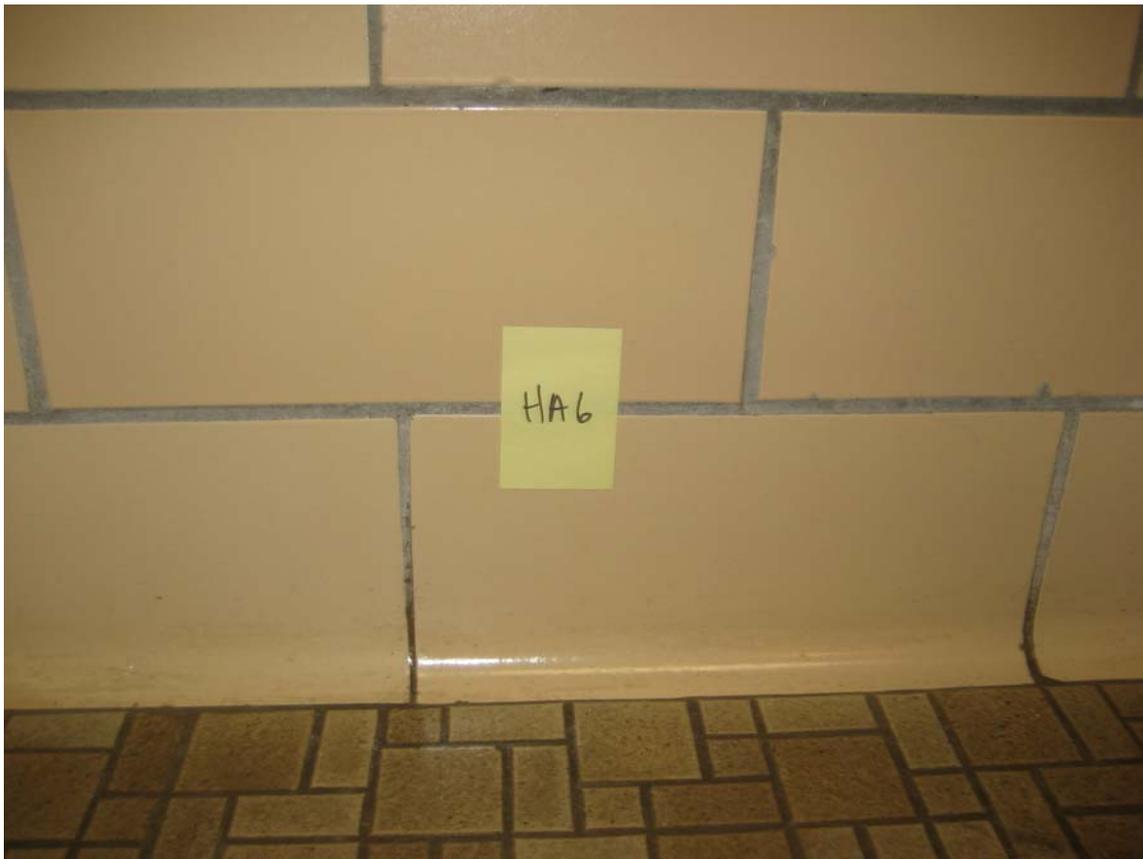
HA #6 – Assumed asbestos containing Tan ceramic wall tile and associated bedding compound

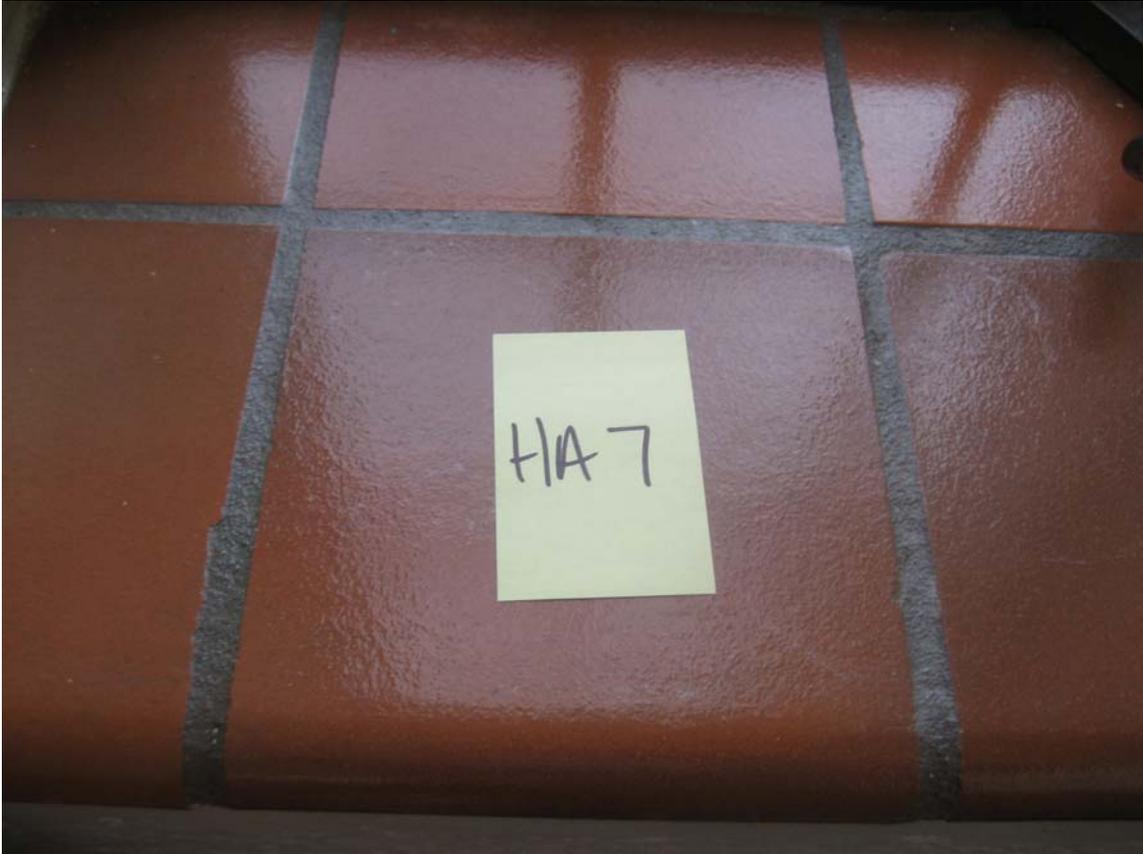
HA #7 – Assumed asbestos containing Orange ceramic tile and associated bedding compound

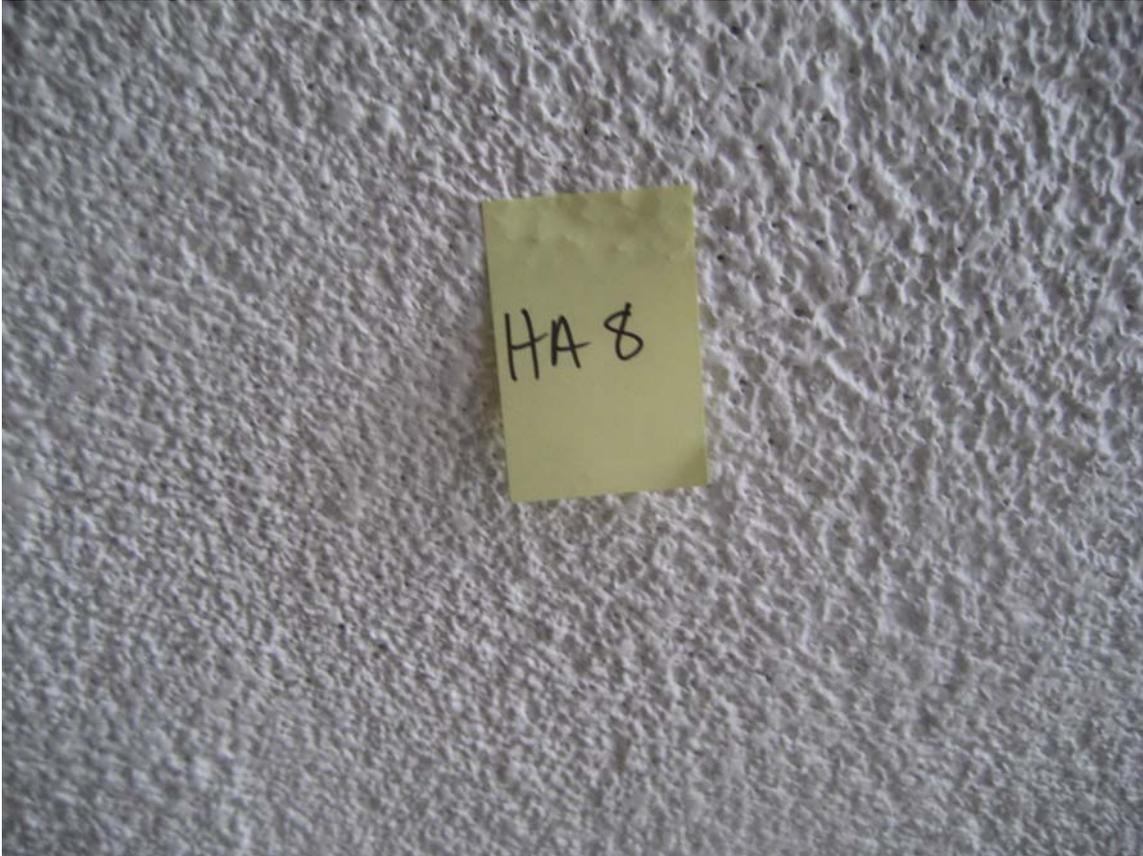
HA #8 – Asbestos Containing Medium textured plaster

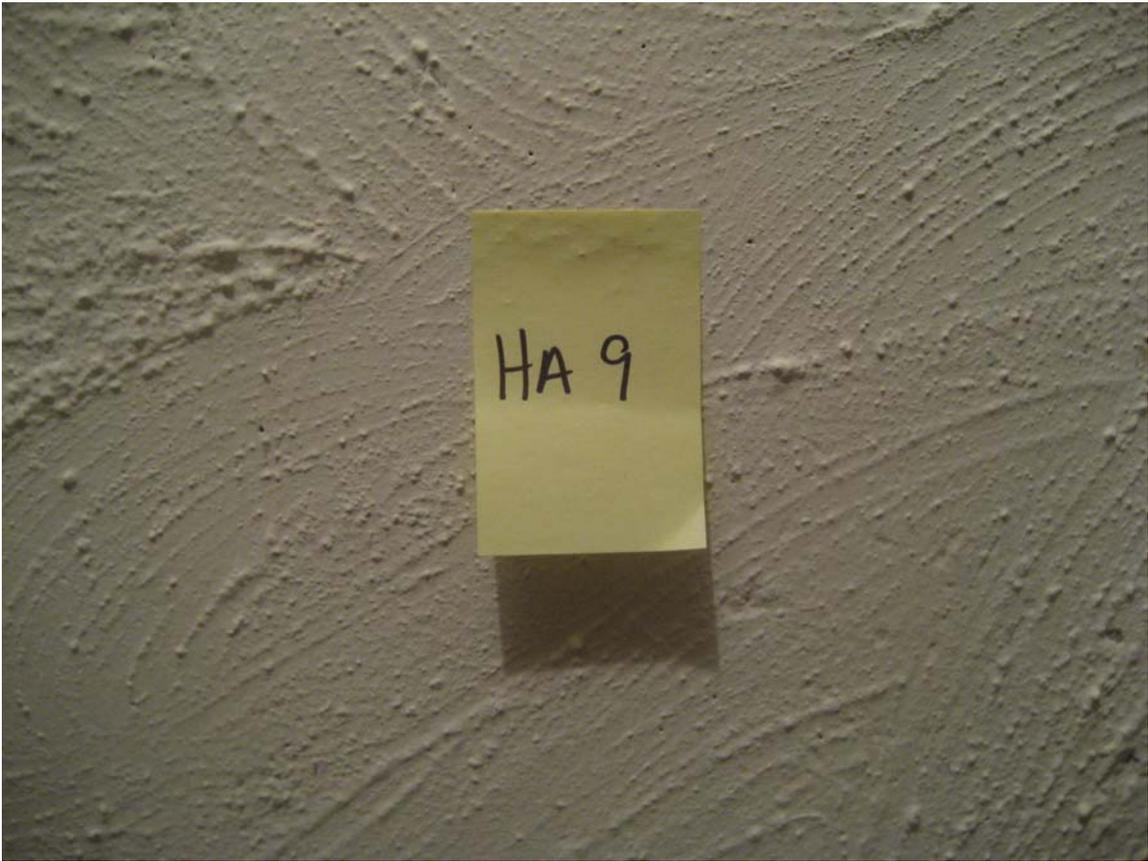
HA #9 – Non asbestos containing light texture skim coat plaster

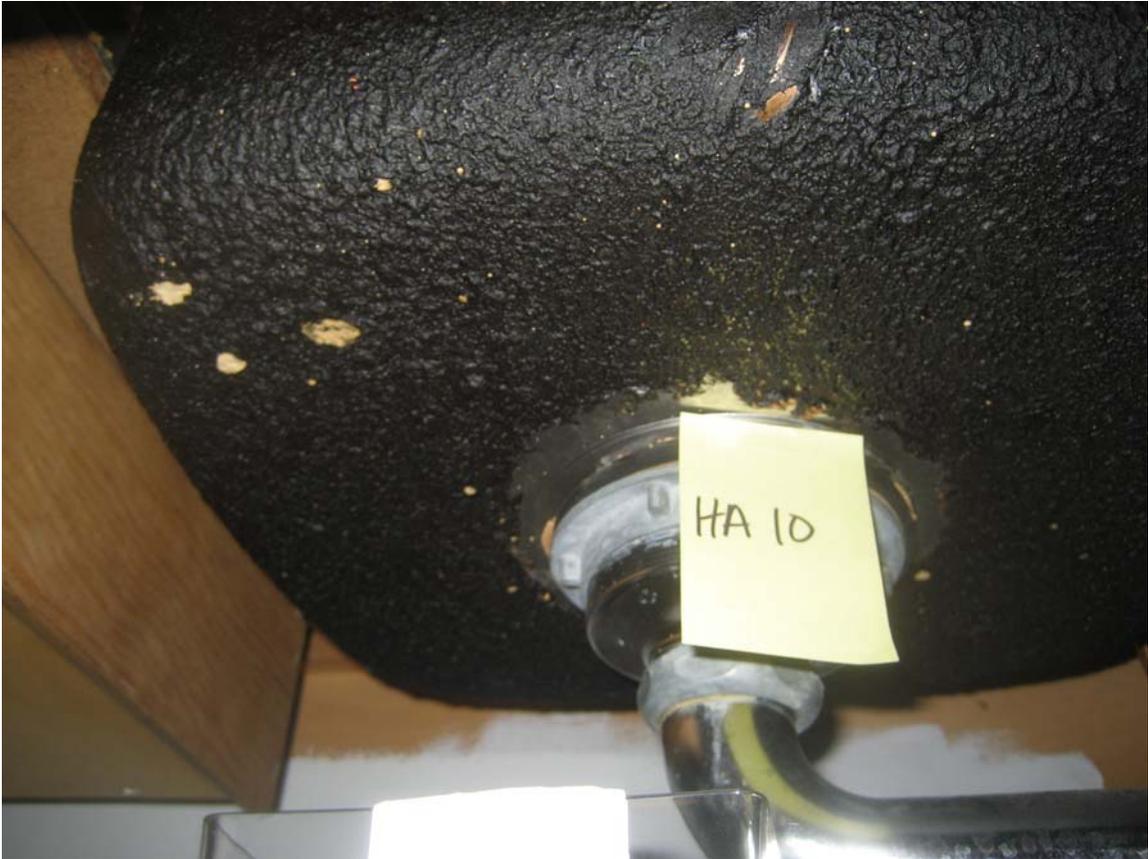
HA #10 –Asbestos containing Black sink undercoating

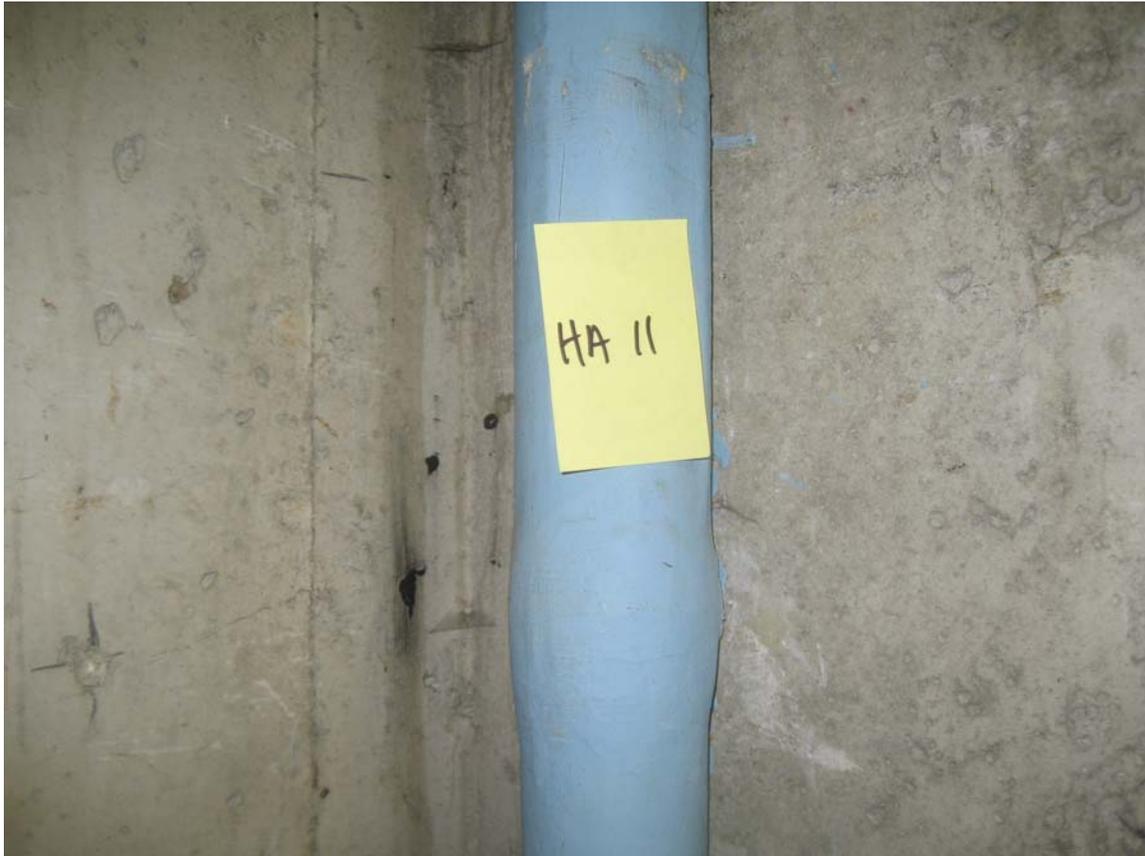
HA #11 –Asbestos containing Straight pipe insulation

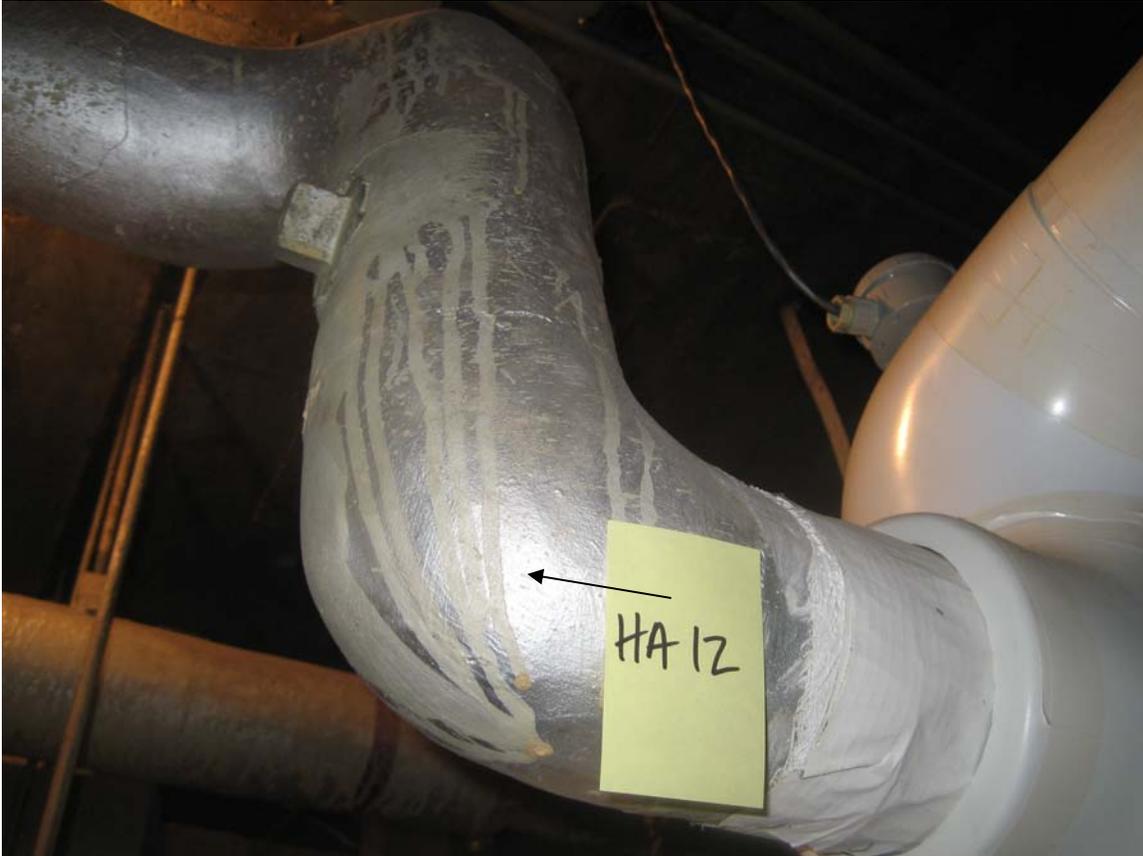
HA #12 – Asbestos containing pipe joint and hanger insulation

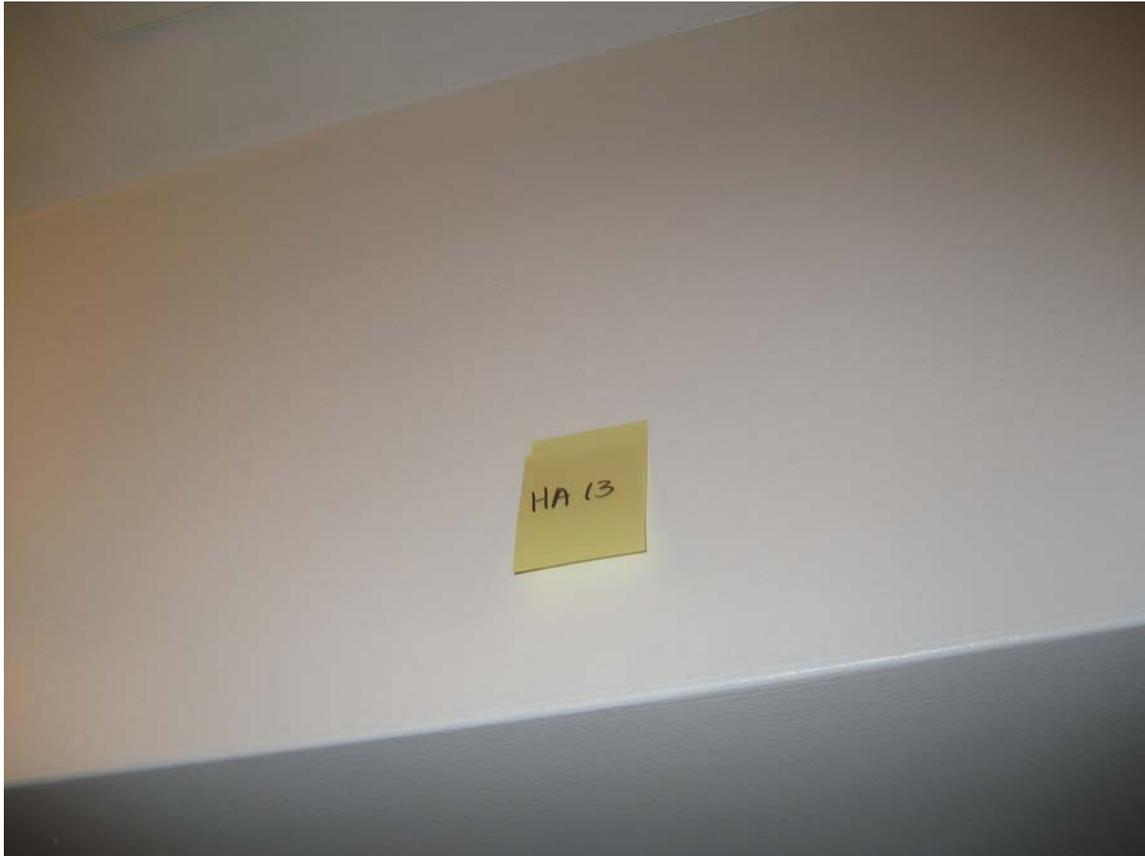
HA #13 – Non asbestos containing Smooth white plaster

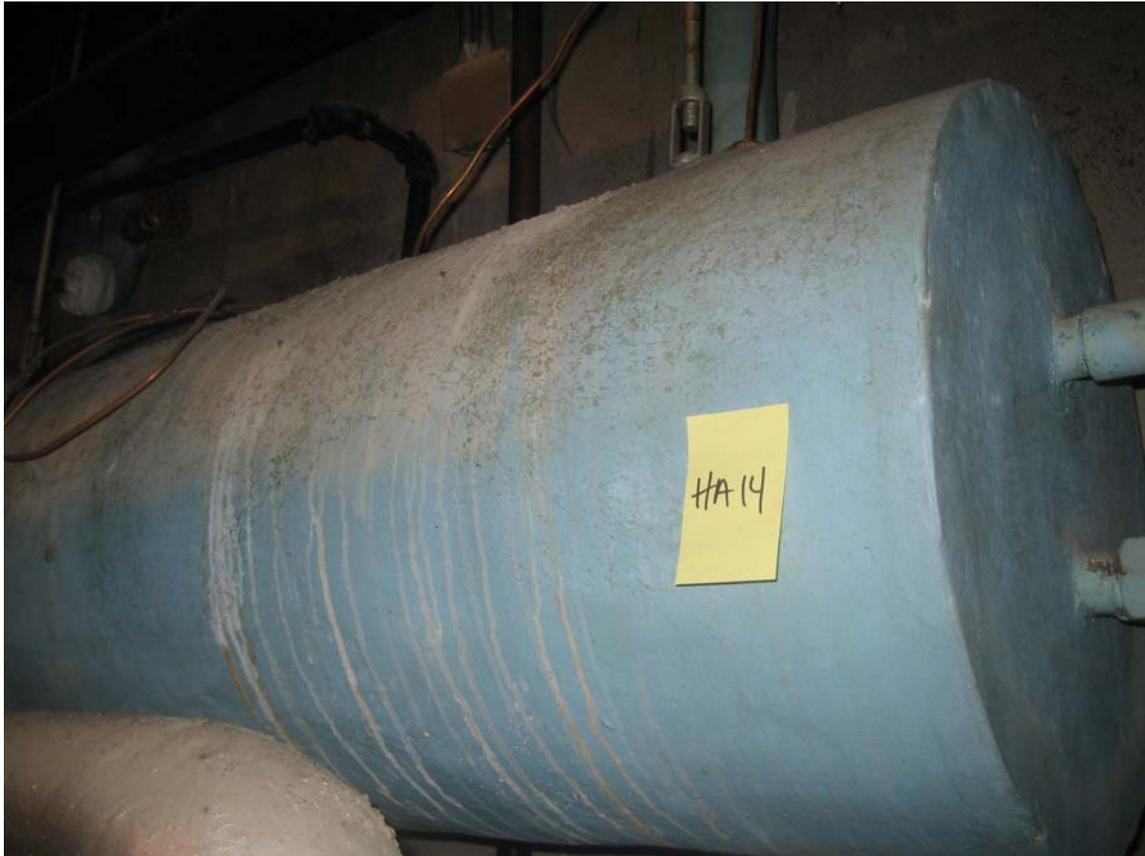
HA #14 – Asbestos containing Mag tank insulation

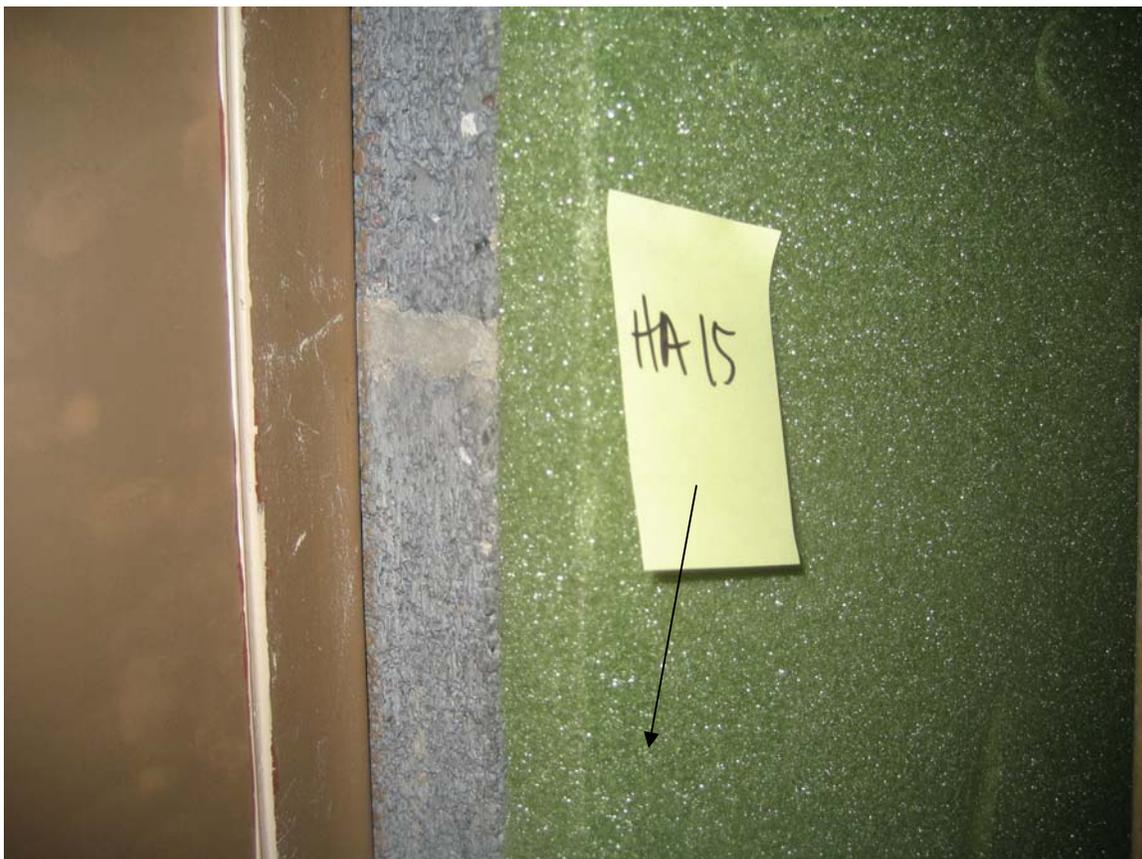
HA #15 –asbestos containing black gluepods on Green soundproofing
(Green soundproofing NON-ACM)

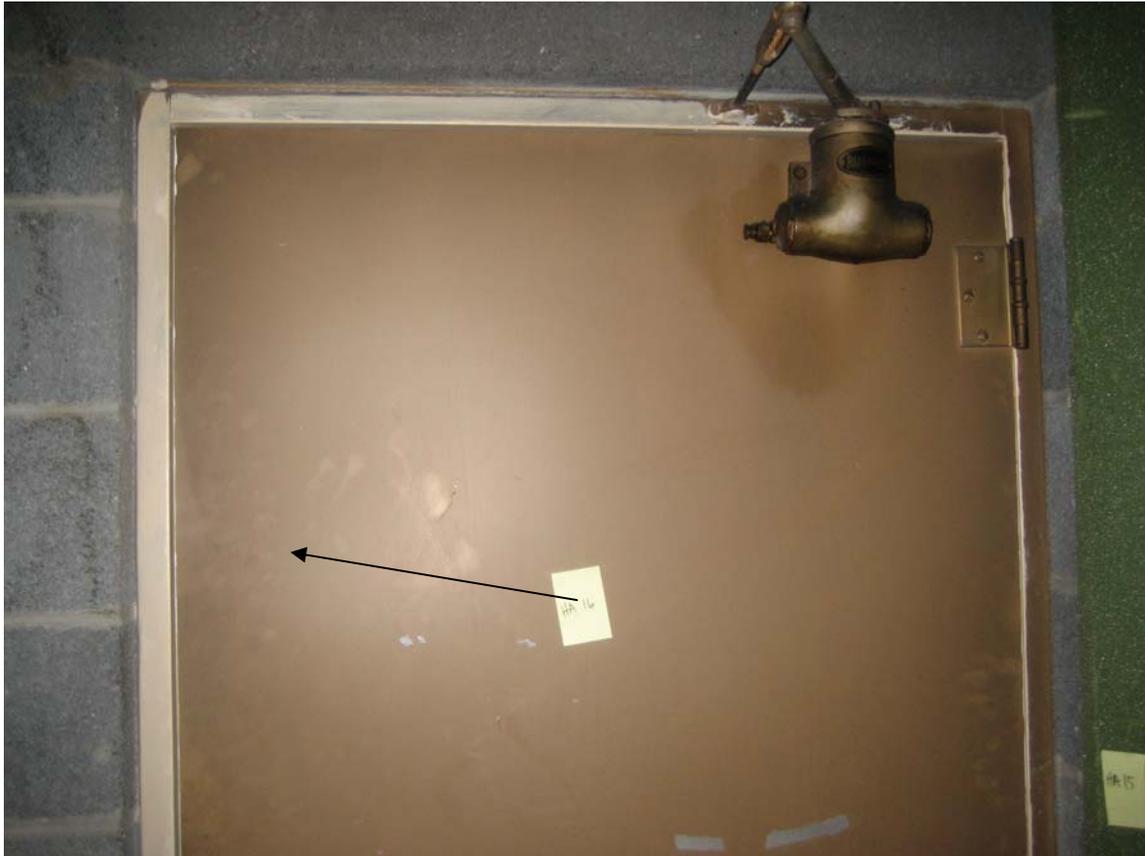
HA #16 – Assumed asbestos containing Fire door and frames

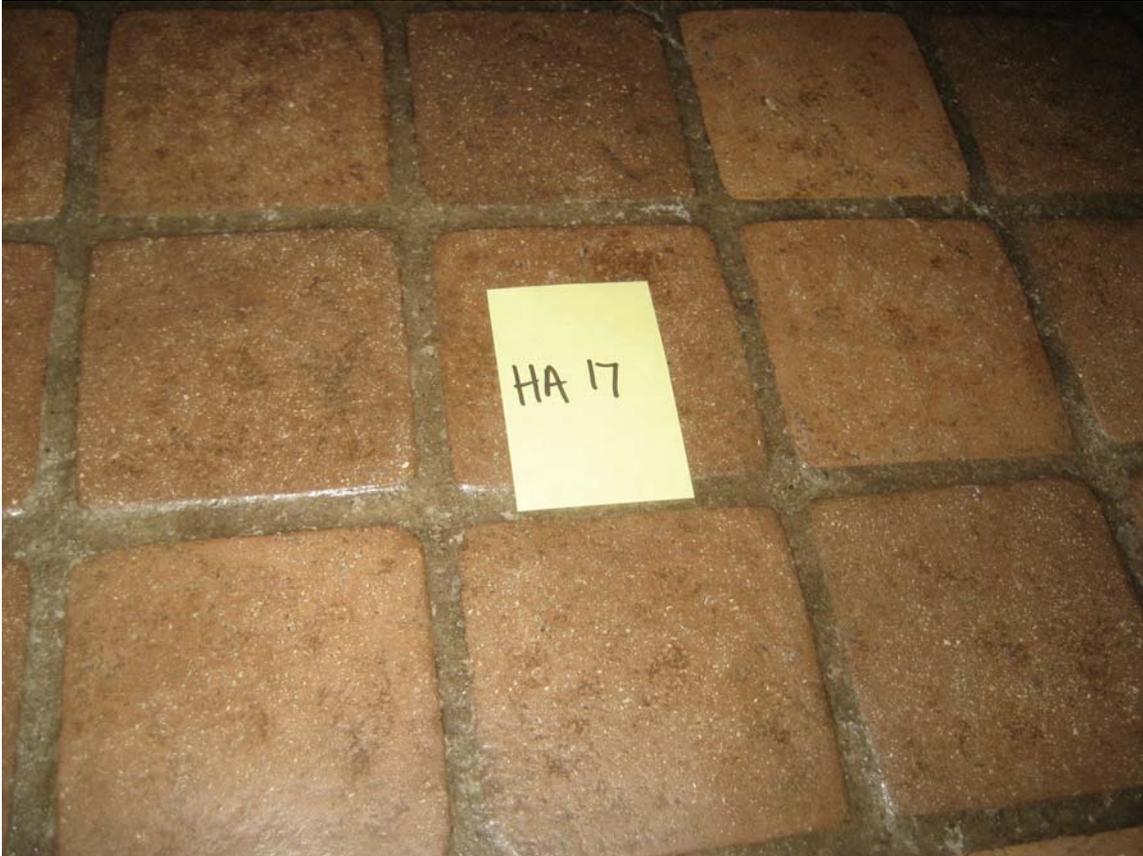
HA #17 – Assumed asbestos containing 2”x 2” Brown ceramic tile and bedding compound

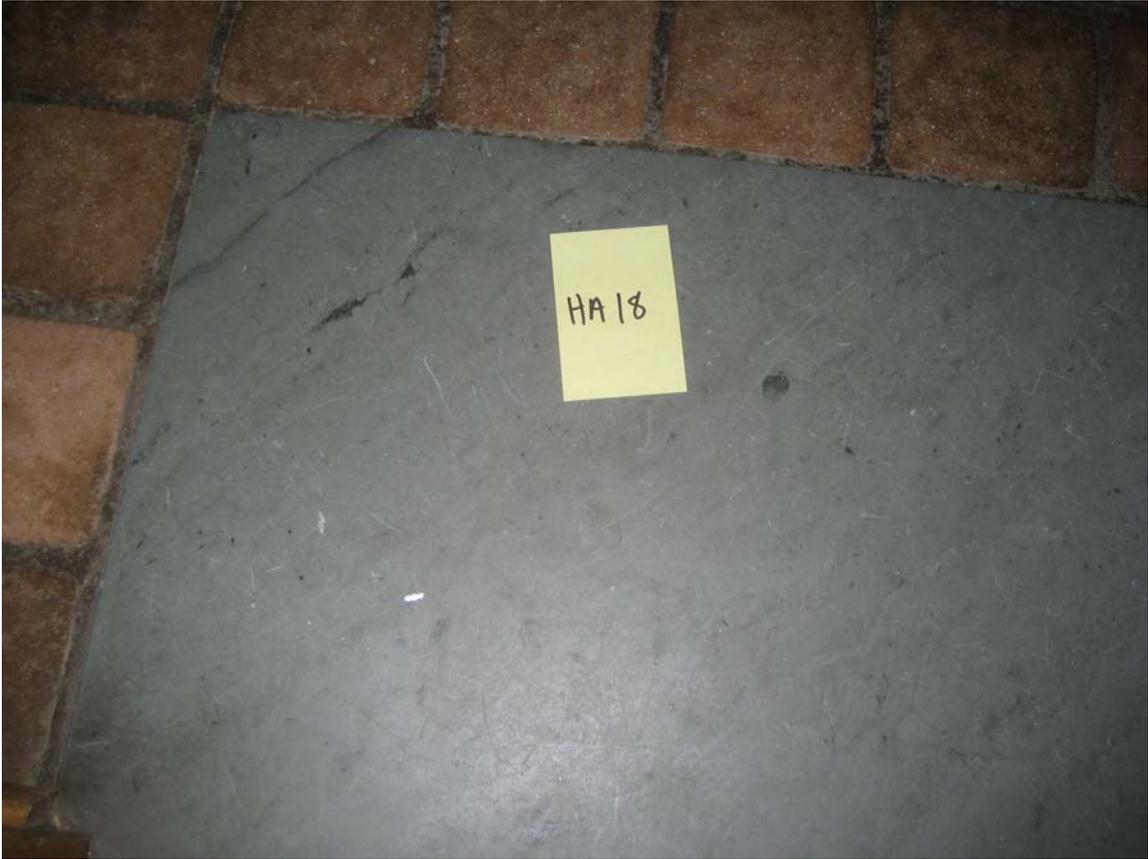
HA #18 – Assumed asbestos containing Green marble tile and bedding compound

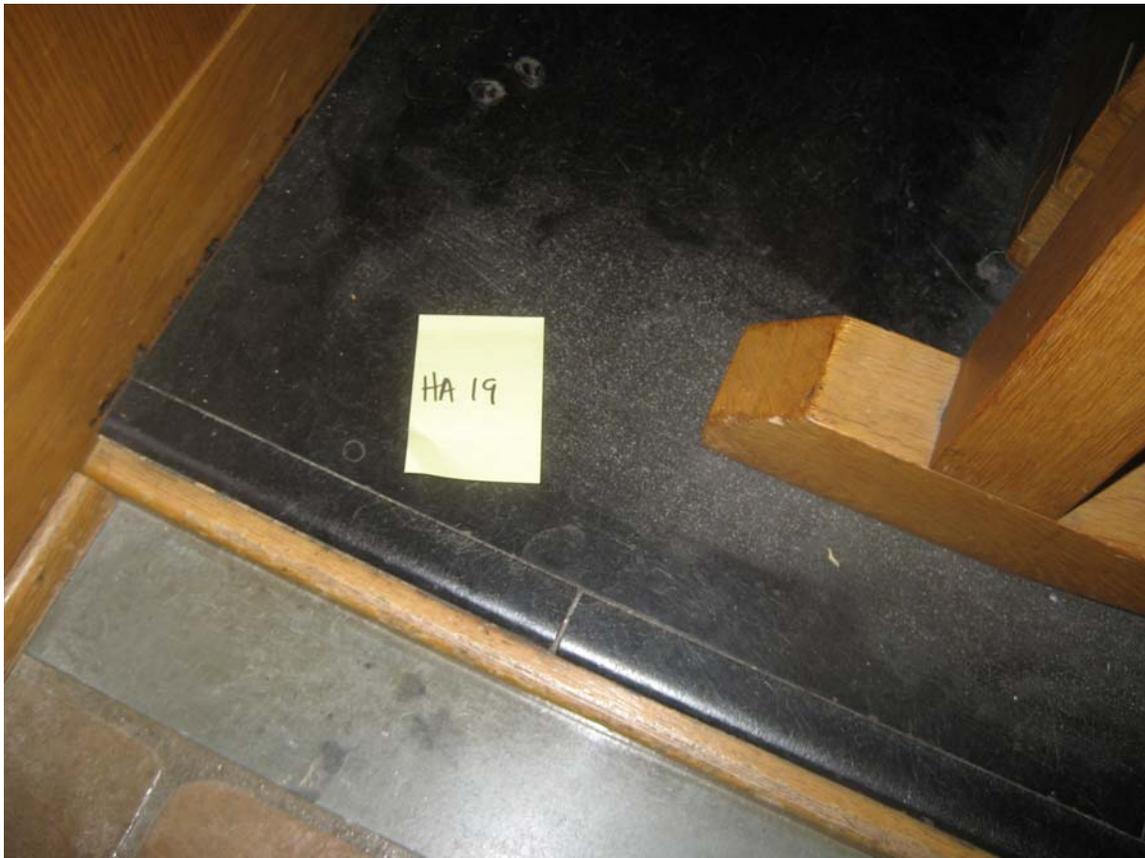
HA #19 – Assumed asbestos containing black vinyl sheet flooring and associated mastic

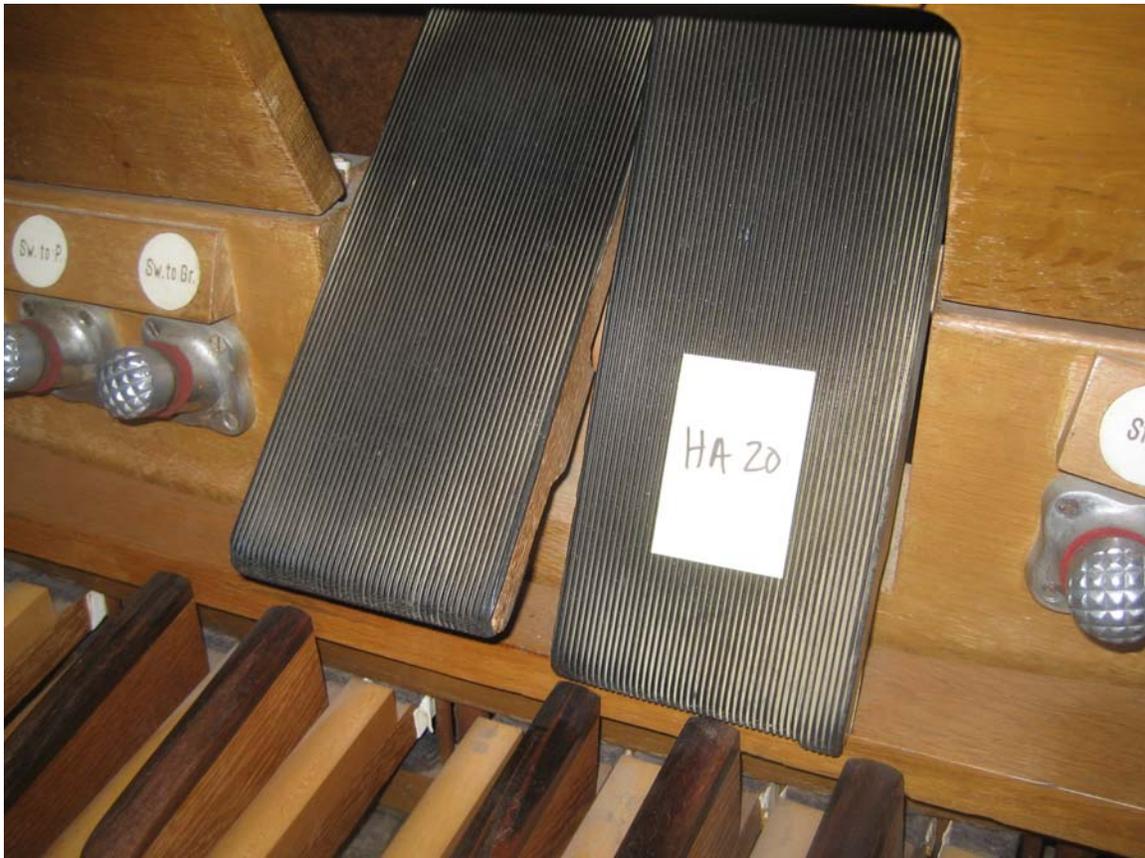
HA #20 – Assumed asbestos containing Black vinyl pedal tread and associated mastic

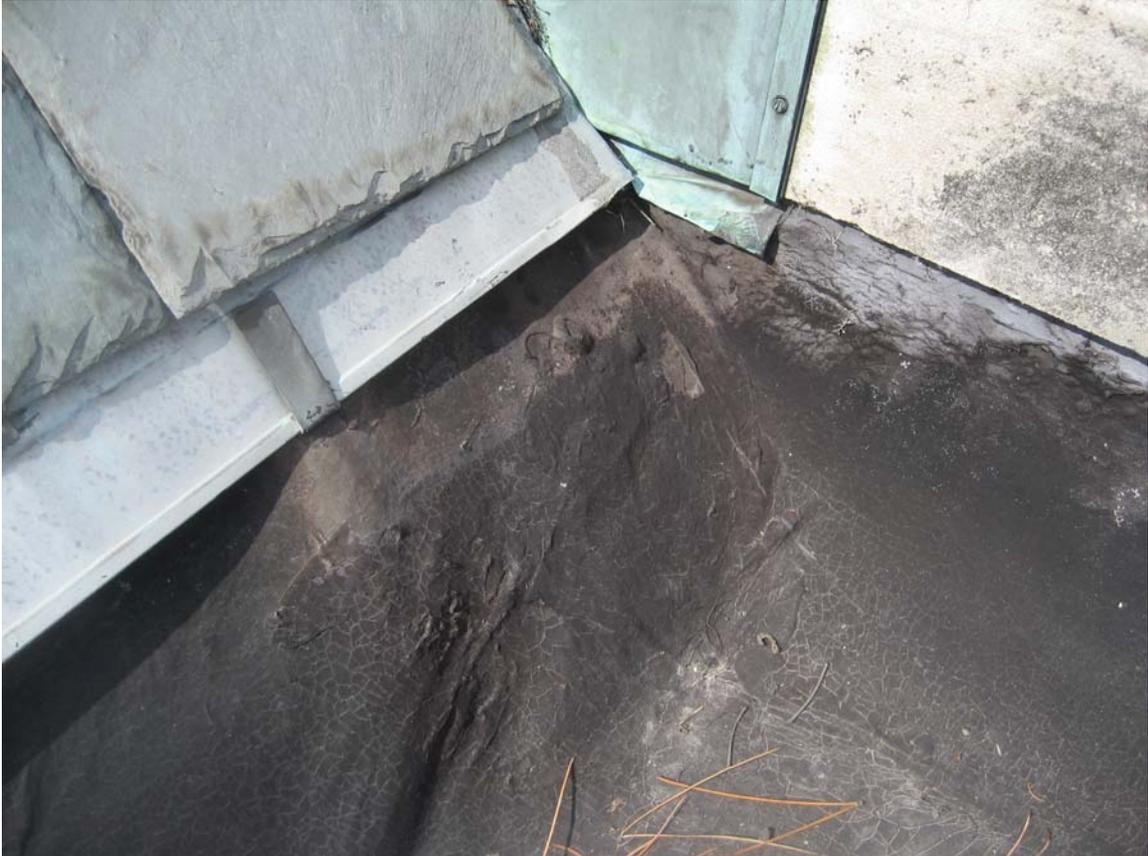
HA #21 – Assumed asbestos containing Roofing materials and products

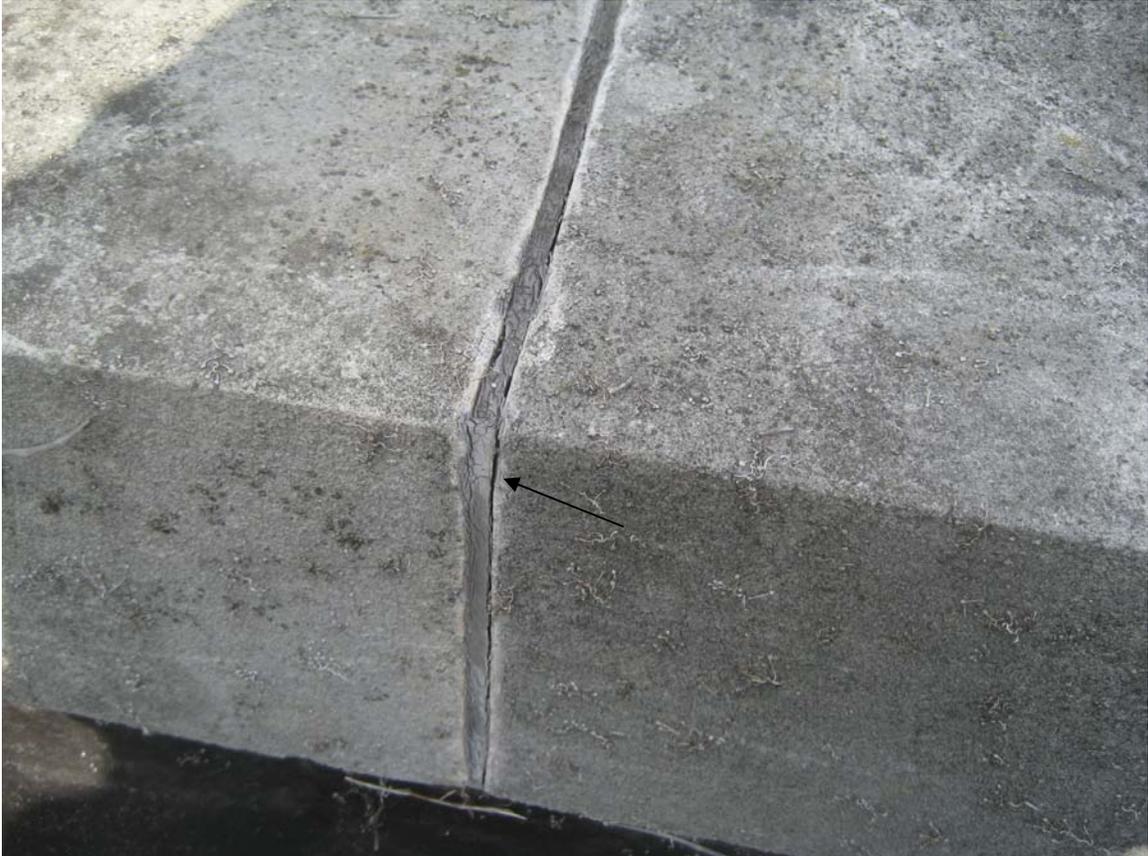
HA #22 – Assumed asbestos containing Light gray masonry caulk

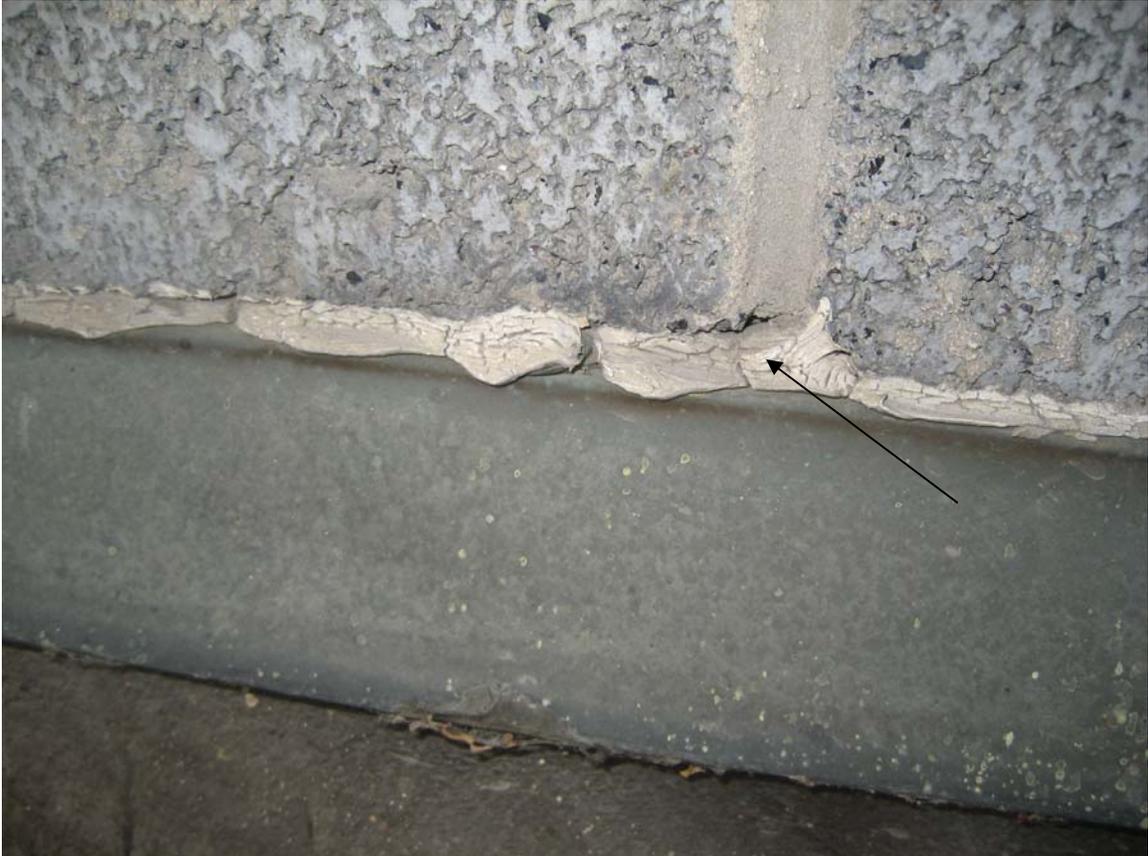
HA #23 – Asbestos containing White bell tower building caulk
