Michigan State University
Alumni Memorial Chapel - Asbestos Inspection Photo Log

MSU Alumni Chapel (#30)

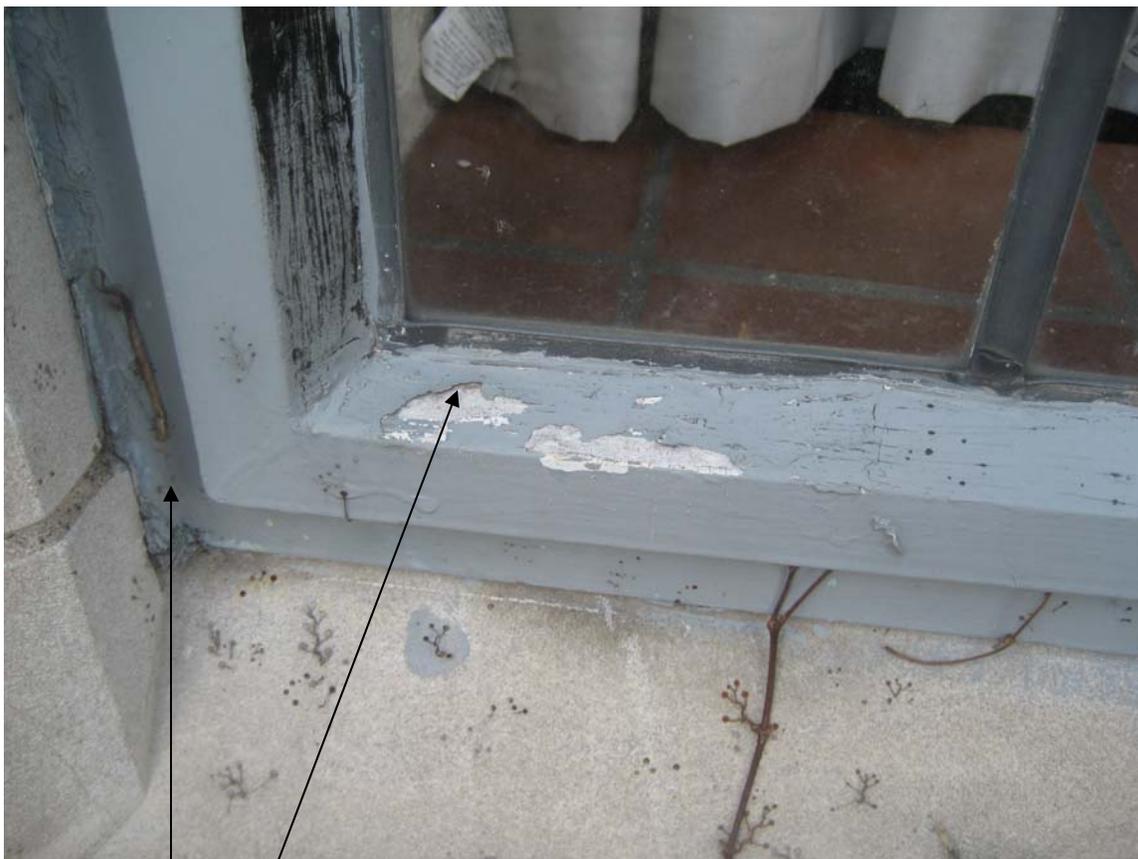
HA #24 – Assumed asbestos containing White window glazing

HA #25 – Assume asbestos containing White window caulk
