I.M. Circle Photo Log

Main entrance to I.M. Sports Circle

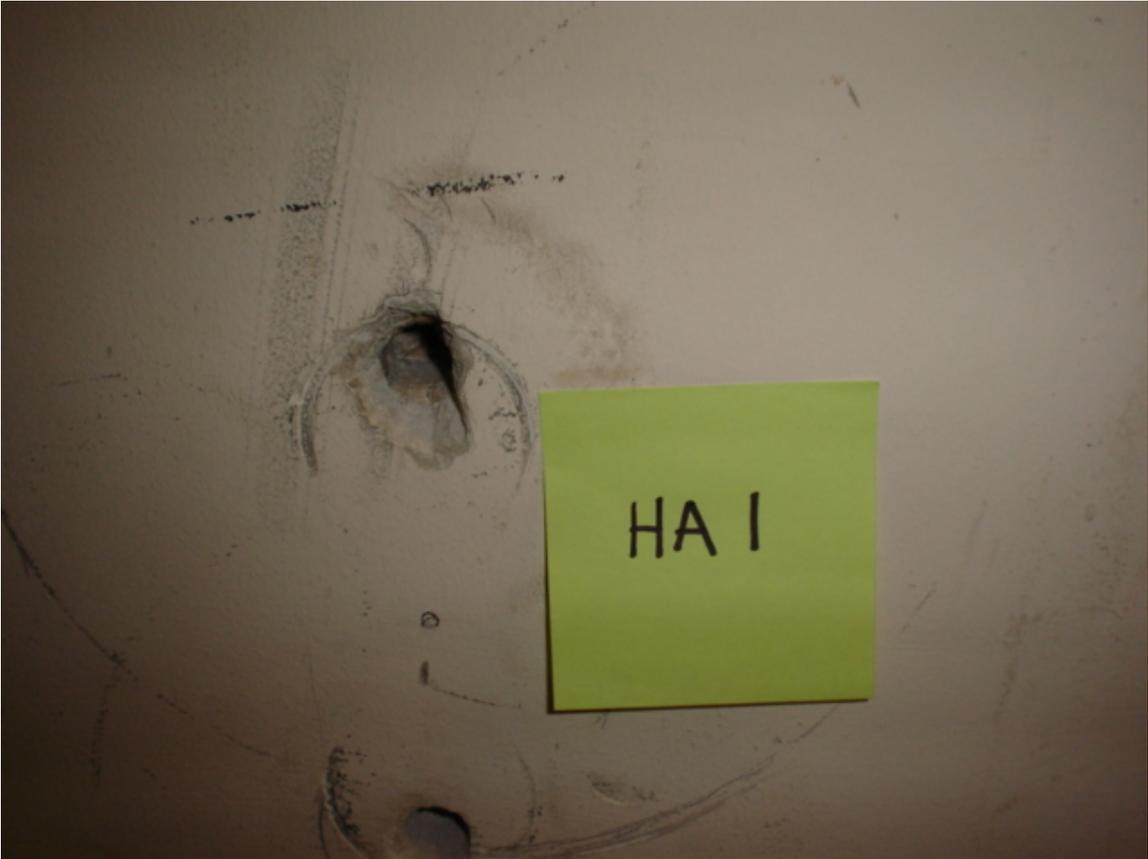
HA #1 – Non asbestos-containing plaster

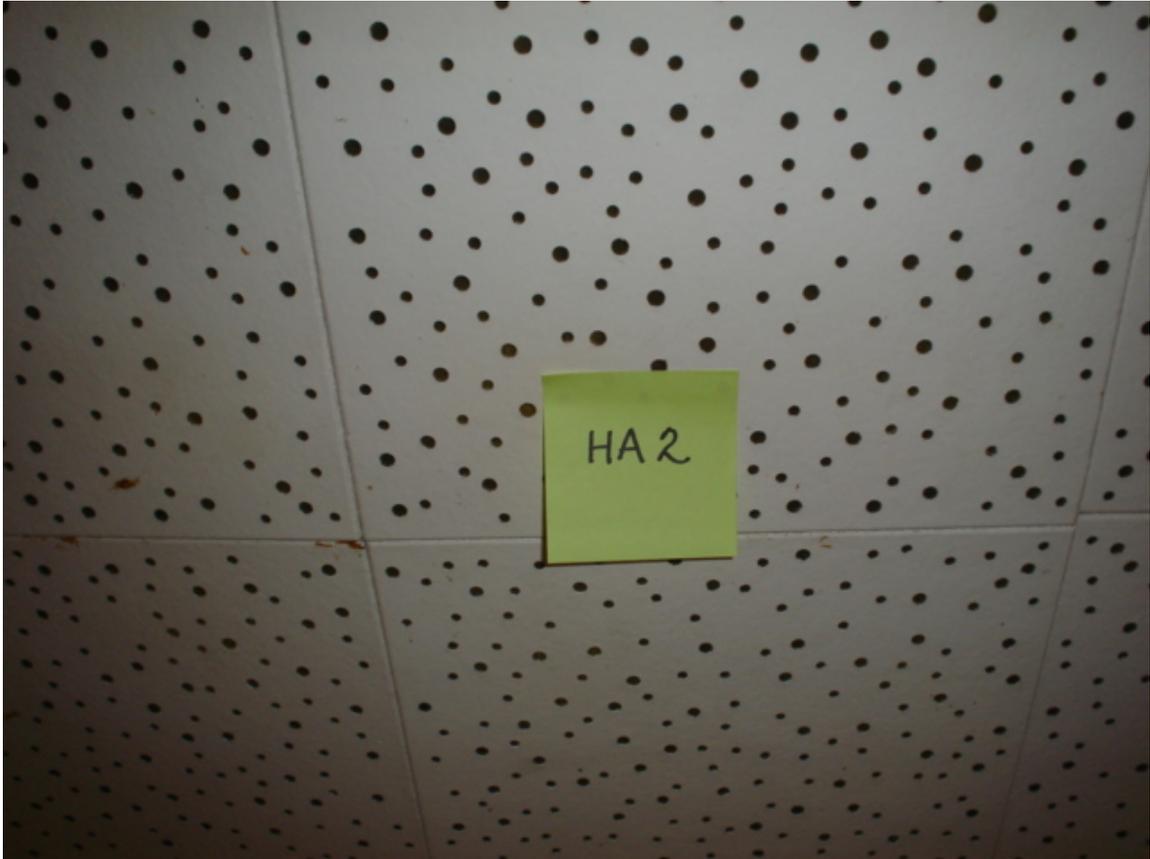
HA #2 – Non asbestos-containing 12" x 12" white ceiling tile
with random holes and associated glue pods

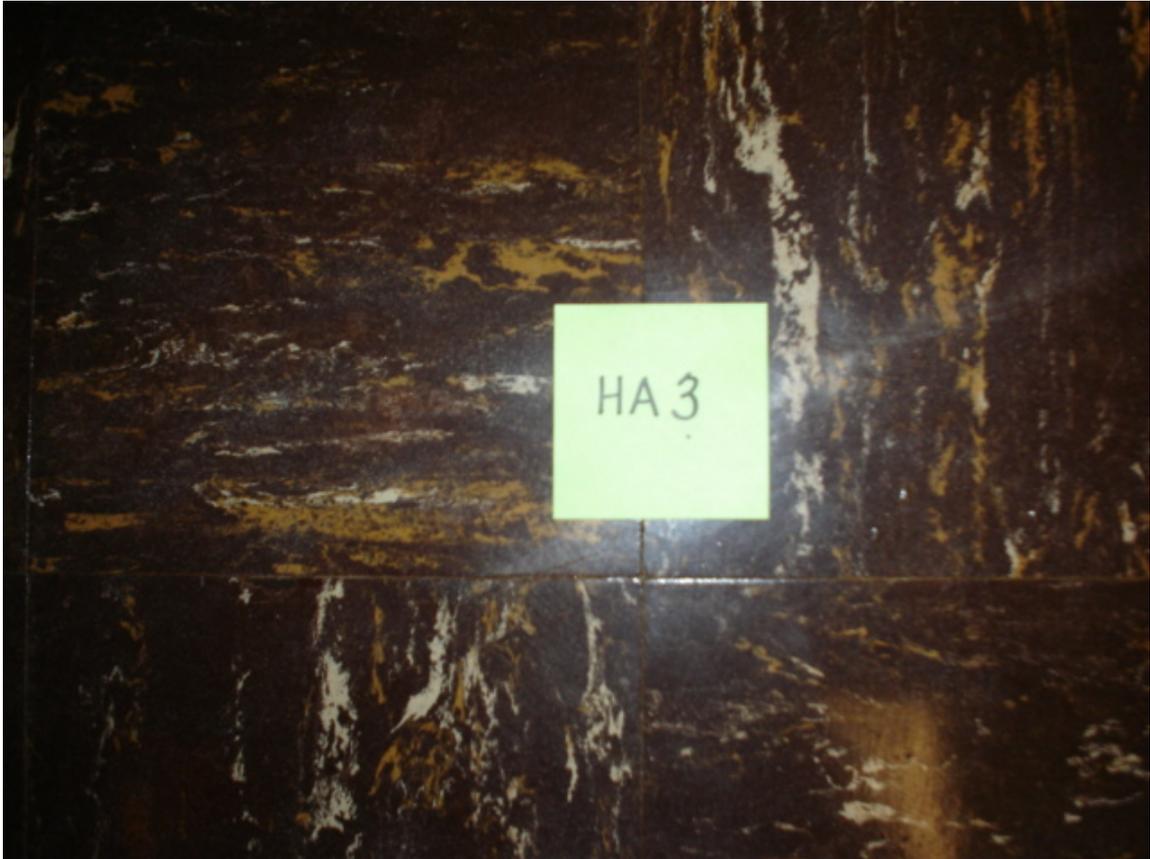
HA #3 – Asbestos-containing 9" x 9" brown floor tile
with cream and rust streaks and associated mastic

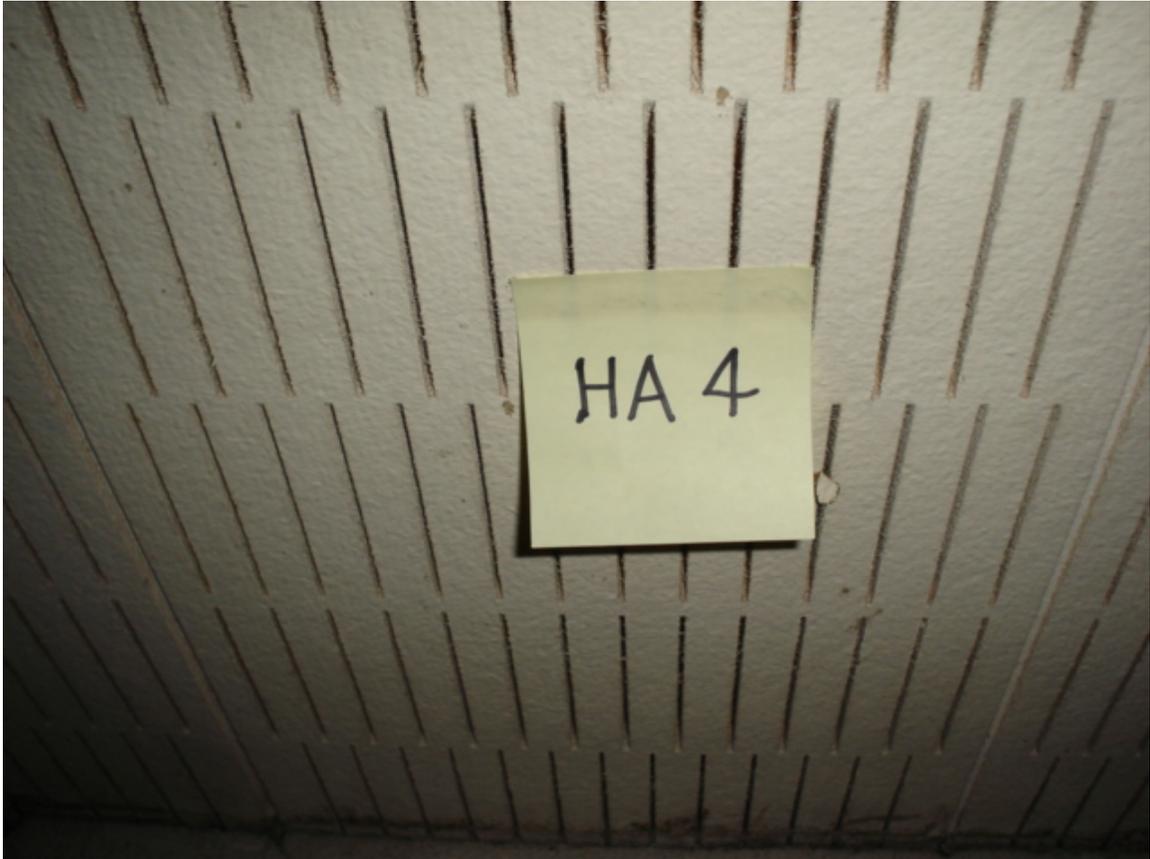
HA #4 – Non asbestos-containing 12" x 12" white slotted ceiling tile
with associated glue pods

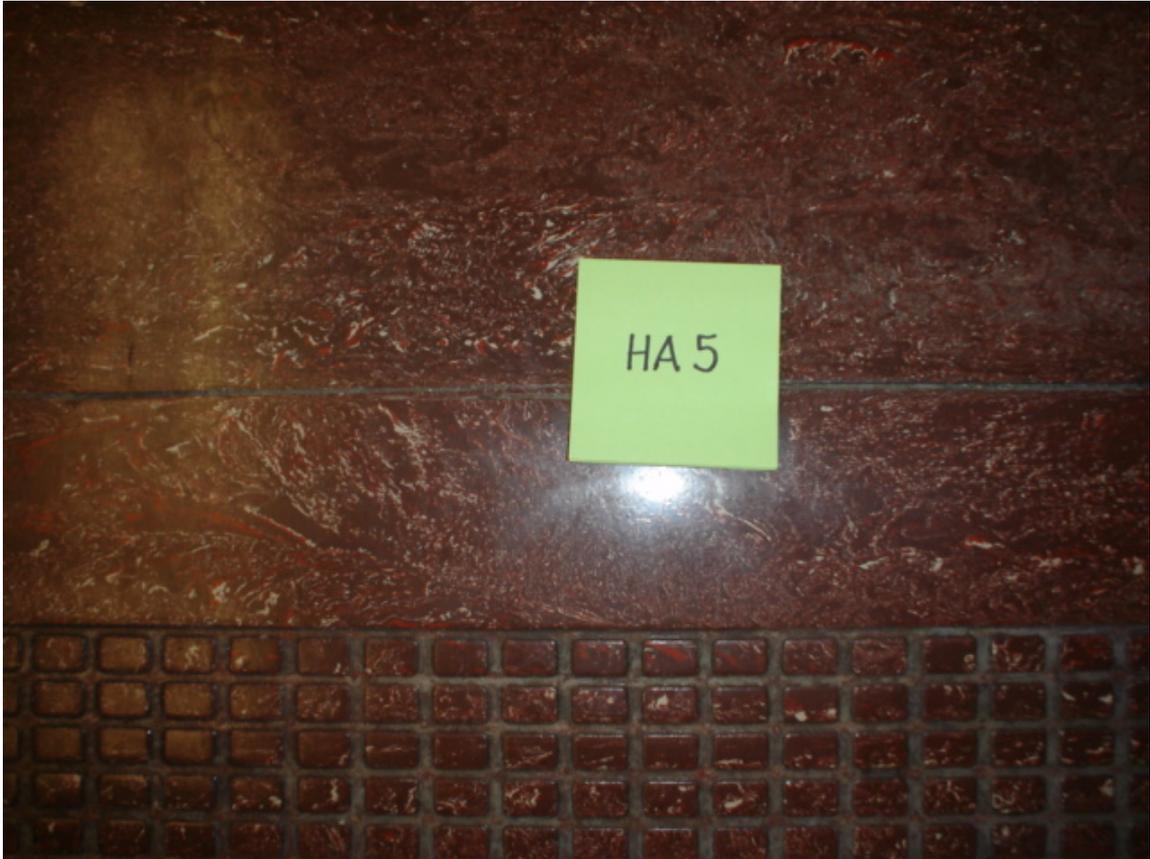
HA #5 – Asbestos-containing reddish linoleum flooring and stair tread with cream streaks and associated non asbestos-containing mastic

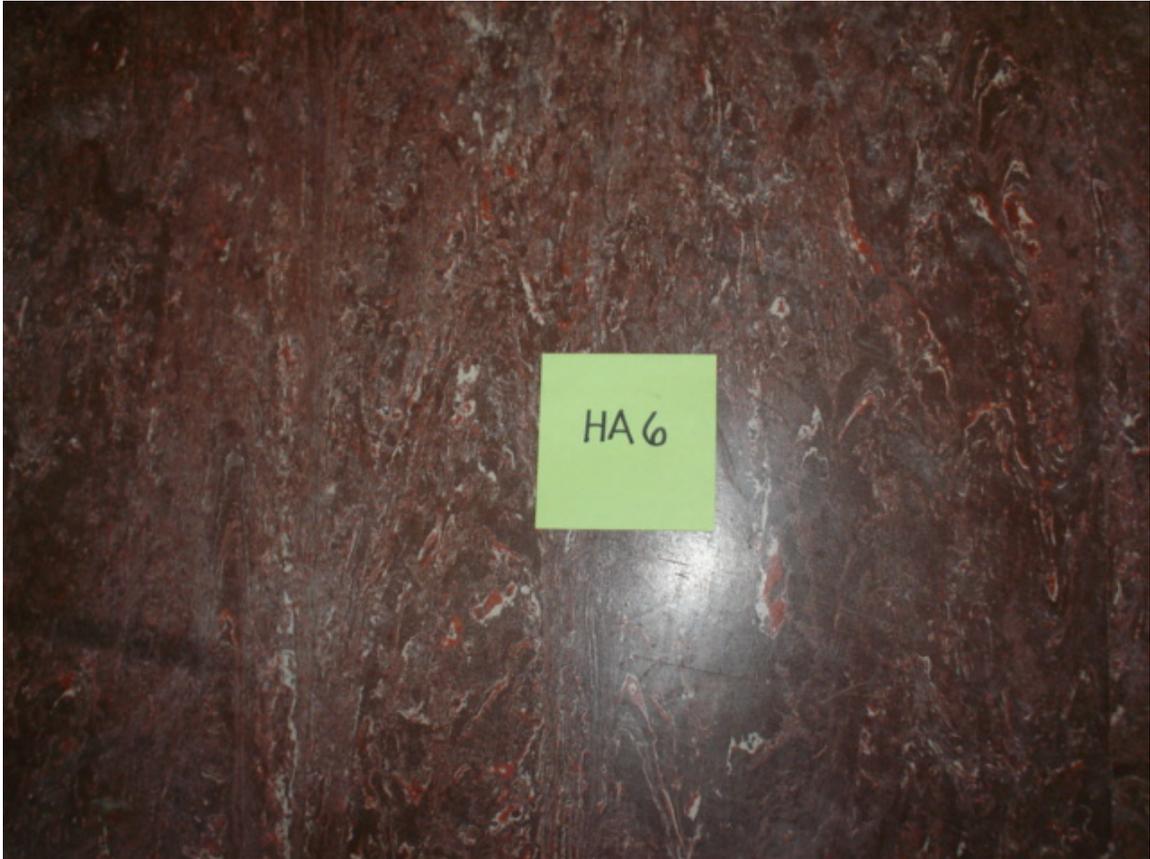
HA #6 – Asbestos-containing brown linoleum flooring and stair tread with cream and rust streaks and associated non asbestos-containing mastic

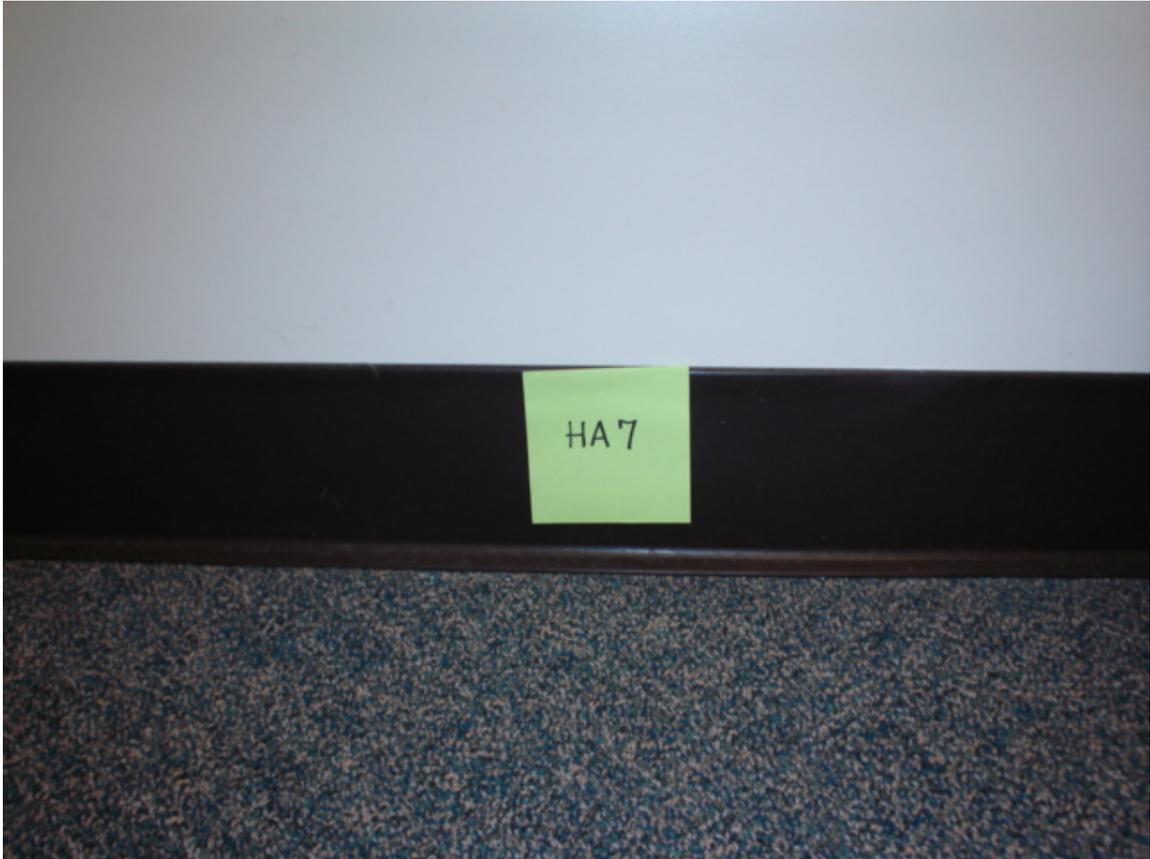
HA #7 – Non asbestos-containing 4" brown cove molding
and associated mastic

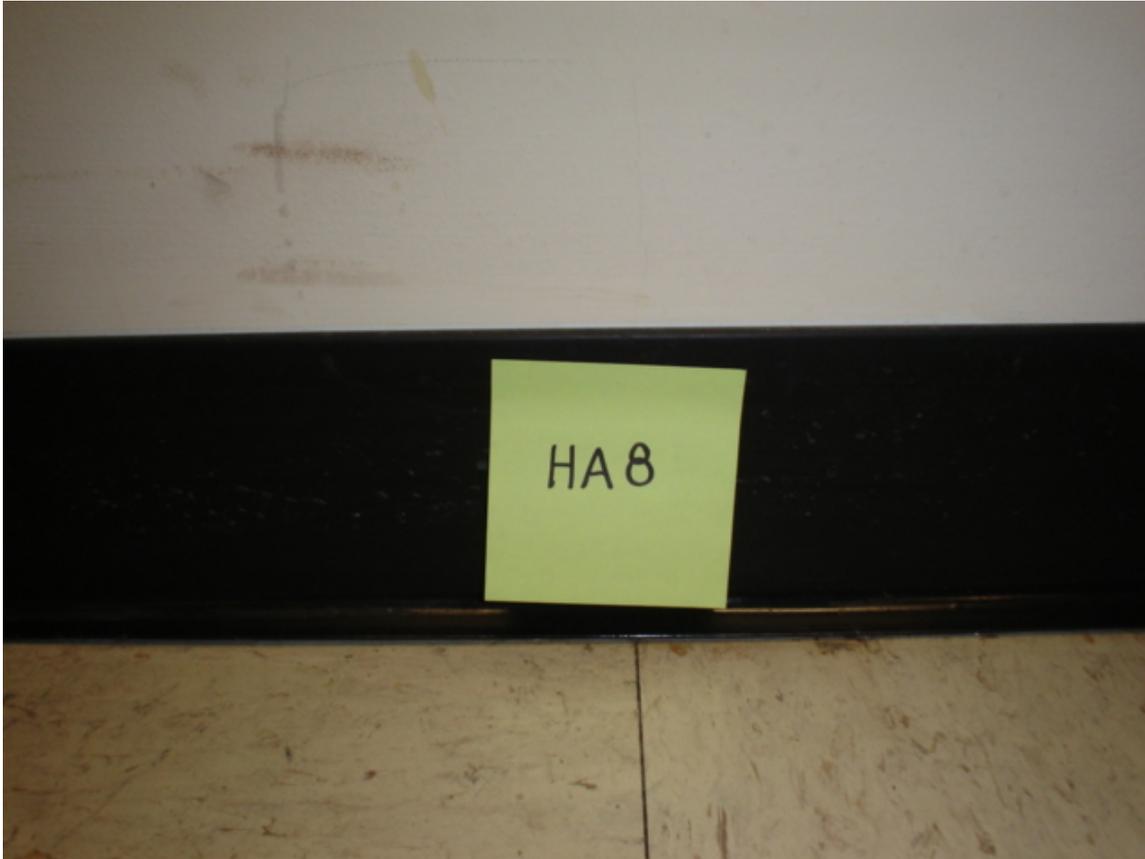
HA # 8 – Non asbestos-containing 4" black cove molding
and associated mastic

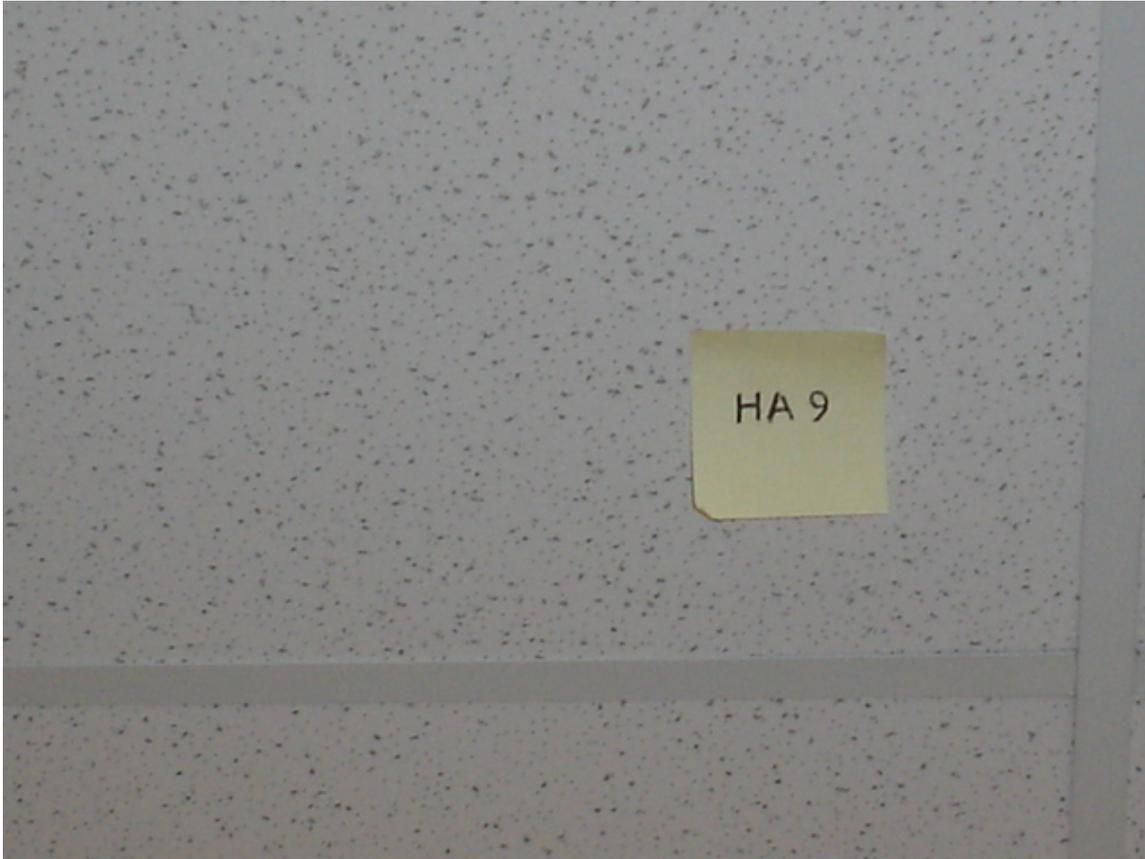
HA #9 – Non asbestos-containing 2' x 2' white lay-in ceiling tile
with pin holes and fissures

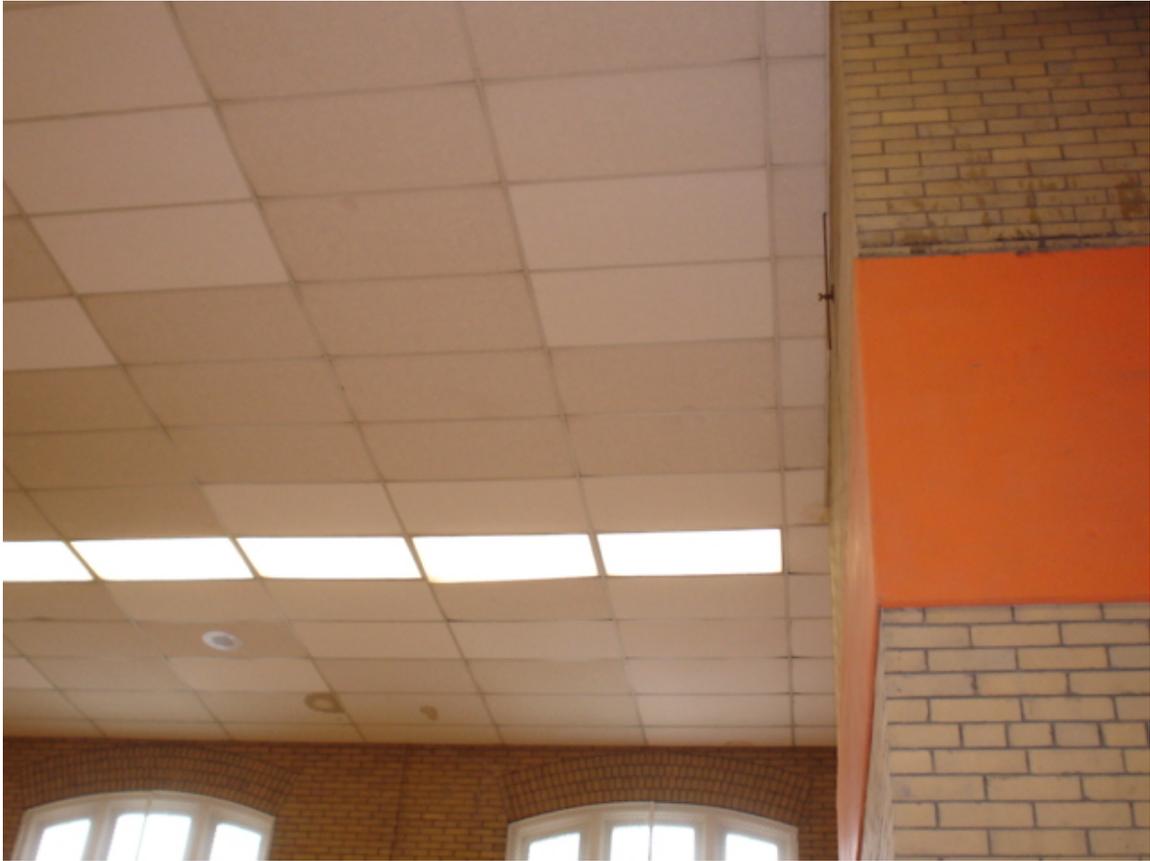
HA #10 – Non asbestos-containing 2' x 4' white lay-in ceiling tile
with pin holes

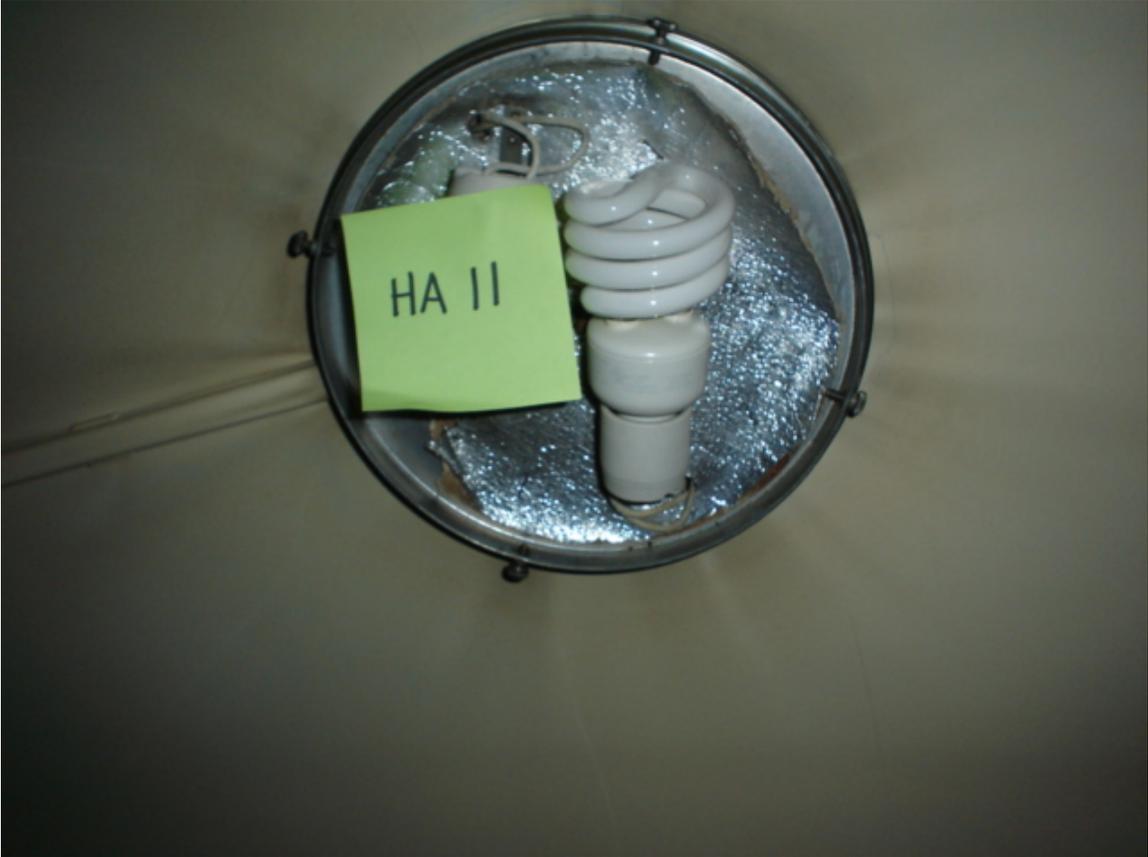
HA #11 – Asbestos-containing light heat shield

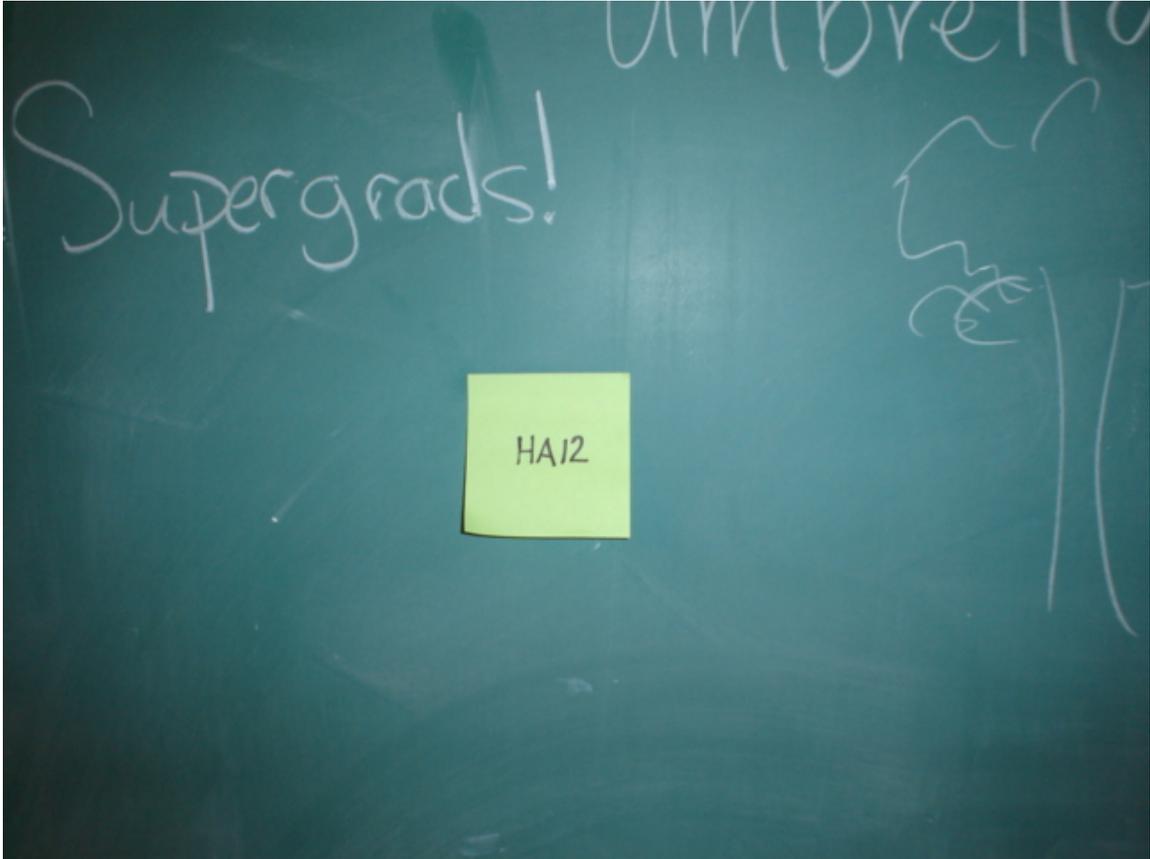
HA #12 – Assumed asbestos-containing chalkboards
and associated glue pods

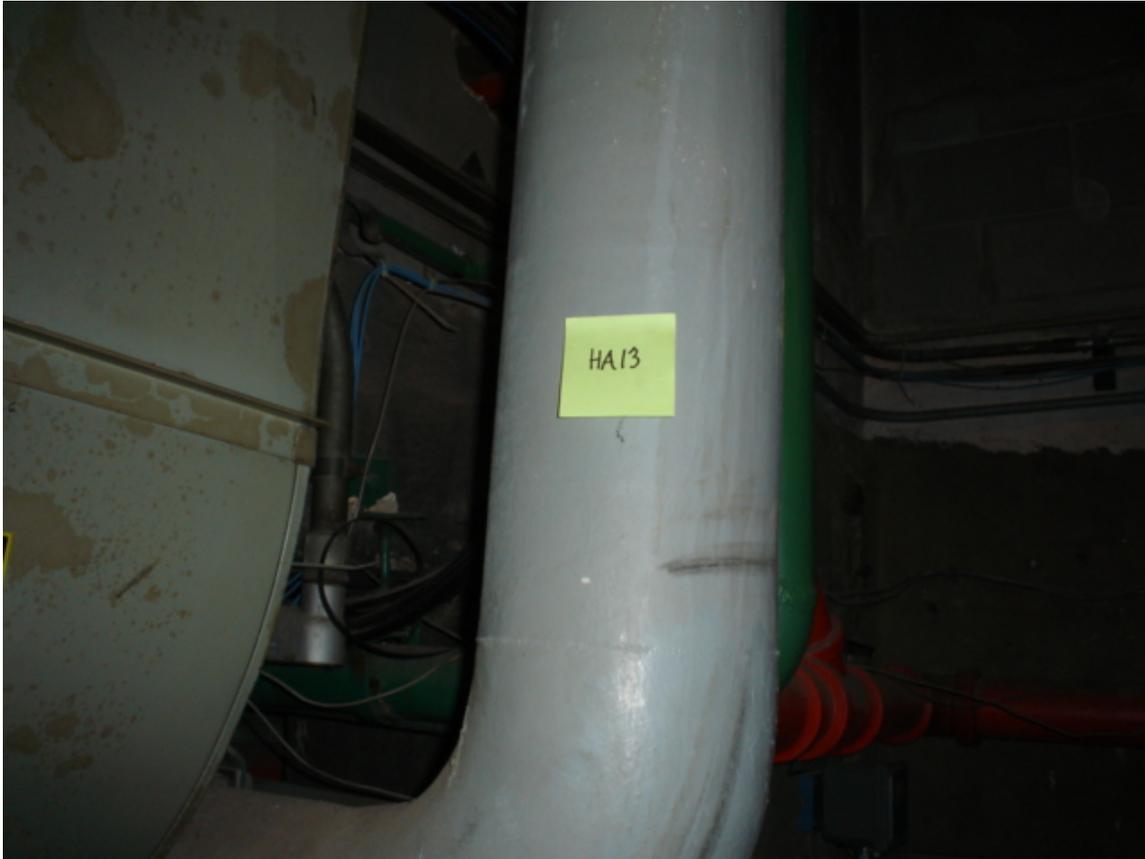
HA #13 – Asbestos-containing steam/condensate supply and return pipe straight insulation

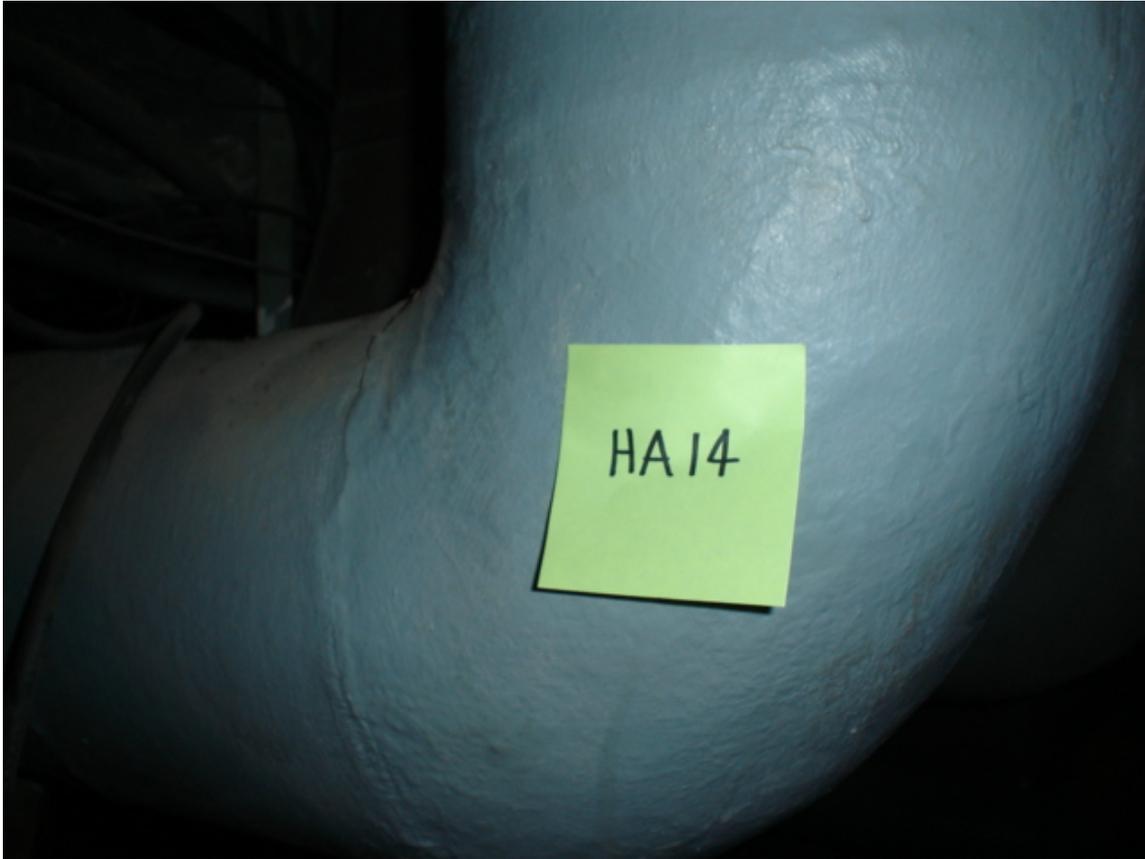
HA #14 – Asbestos-containing steam/condensate supply and return pipe joint and hanger insulation

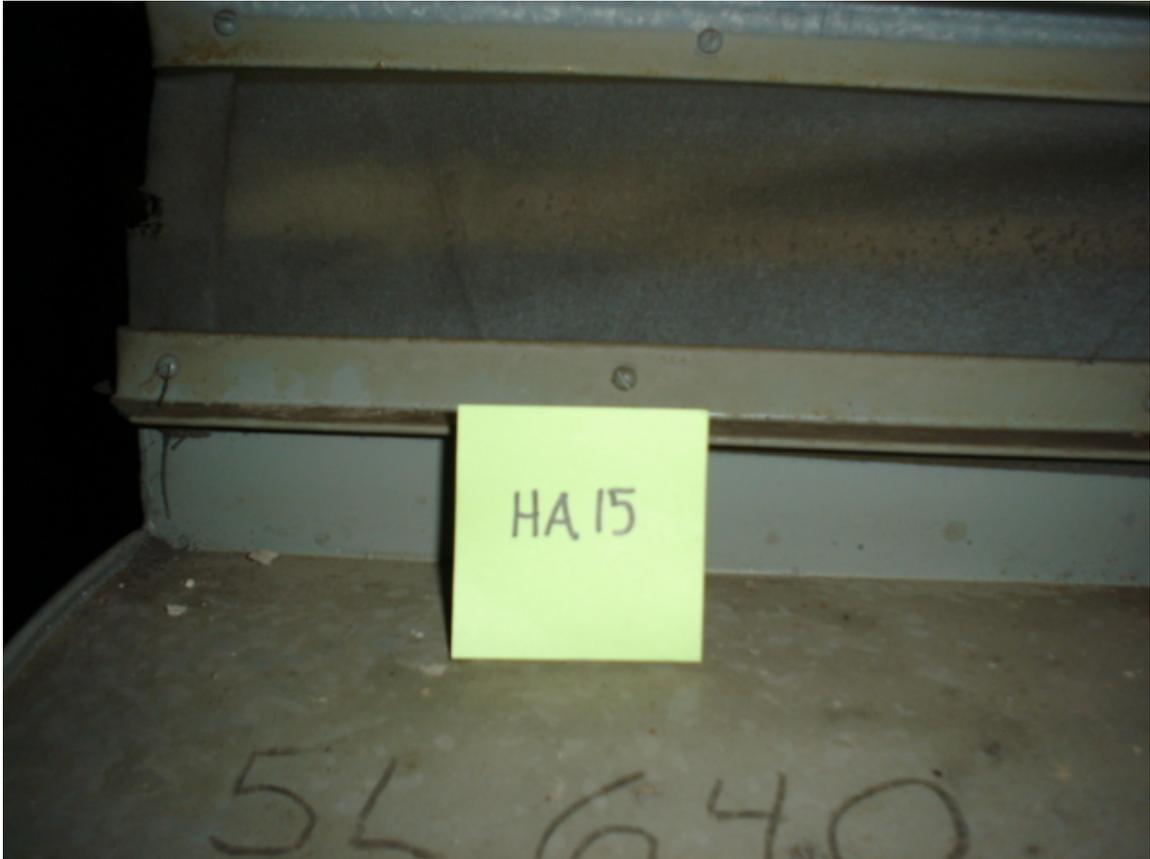
HA #15 – Non asbestos-containing ventilation duct expansion cloth

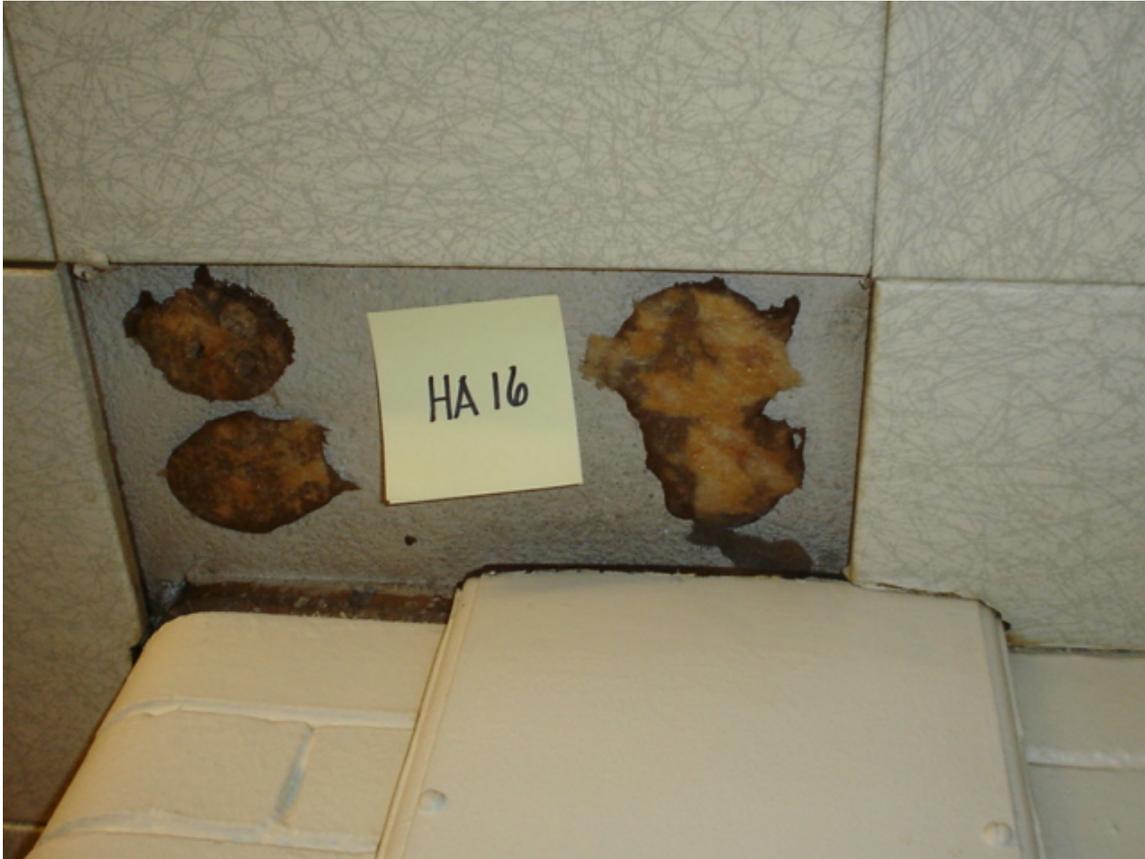
HA #16 – Non asbestos-containing glue pods from
12" x 12" fiberglass ceiling tile

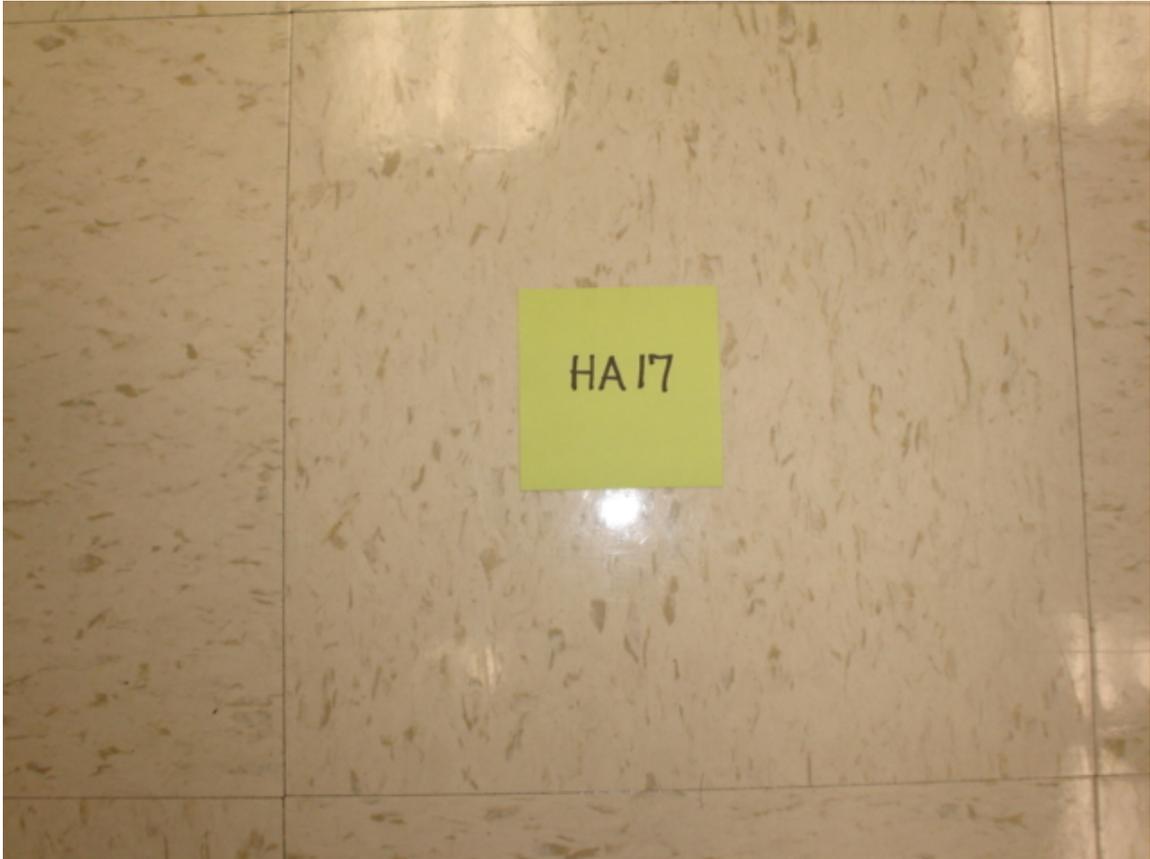
HA #17 – Non asbestos-containing 12" x 12" white floor tile
with green marble pattern and associated mastic

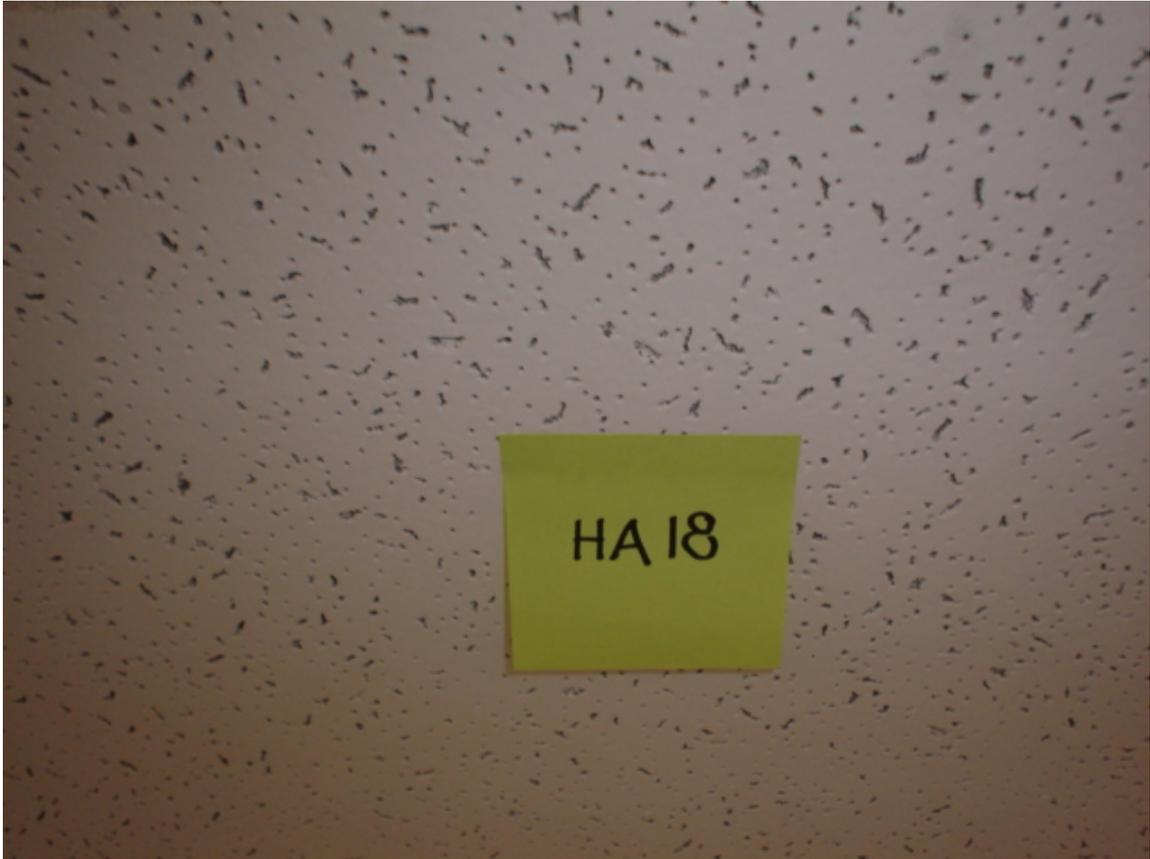
HA #18 – Non asbestos-containing 2' x 2' white drop-in ceiling tile
with pin holes and fissures

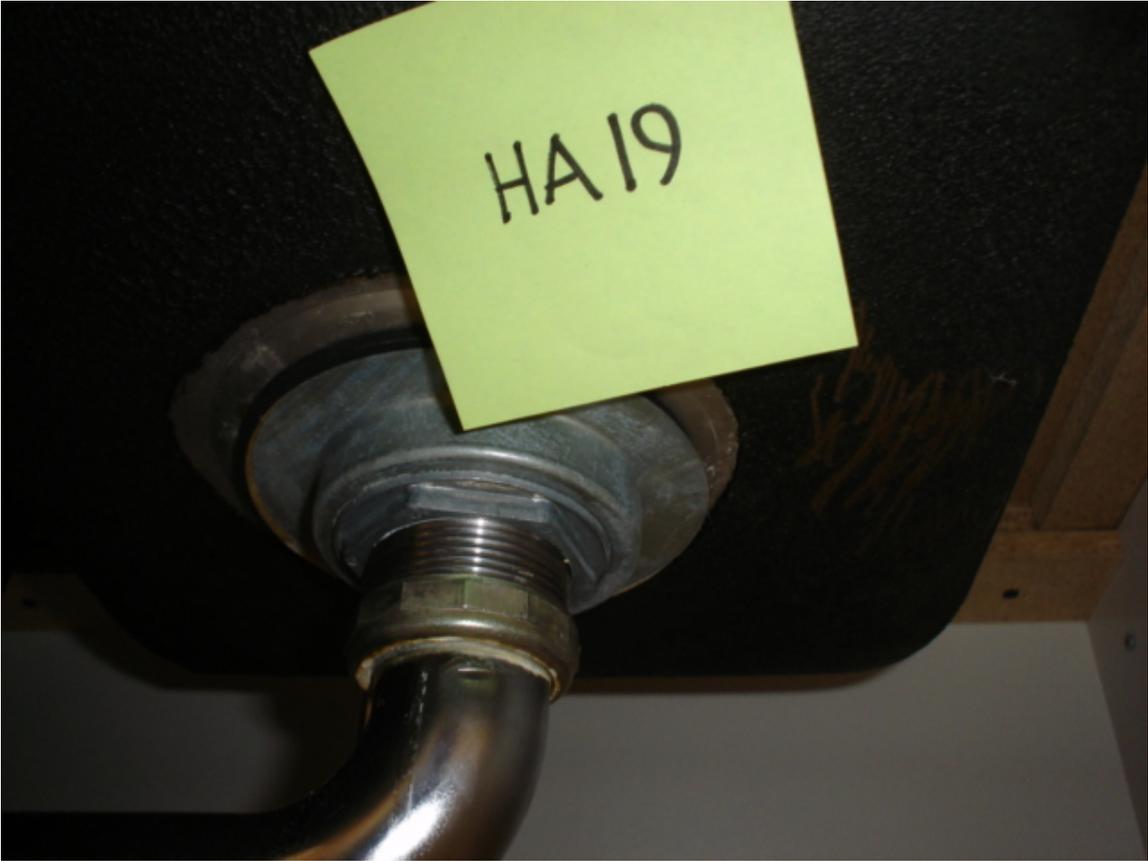
HA #19 – Non asbestos-containing black sink undercoating

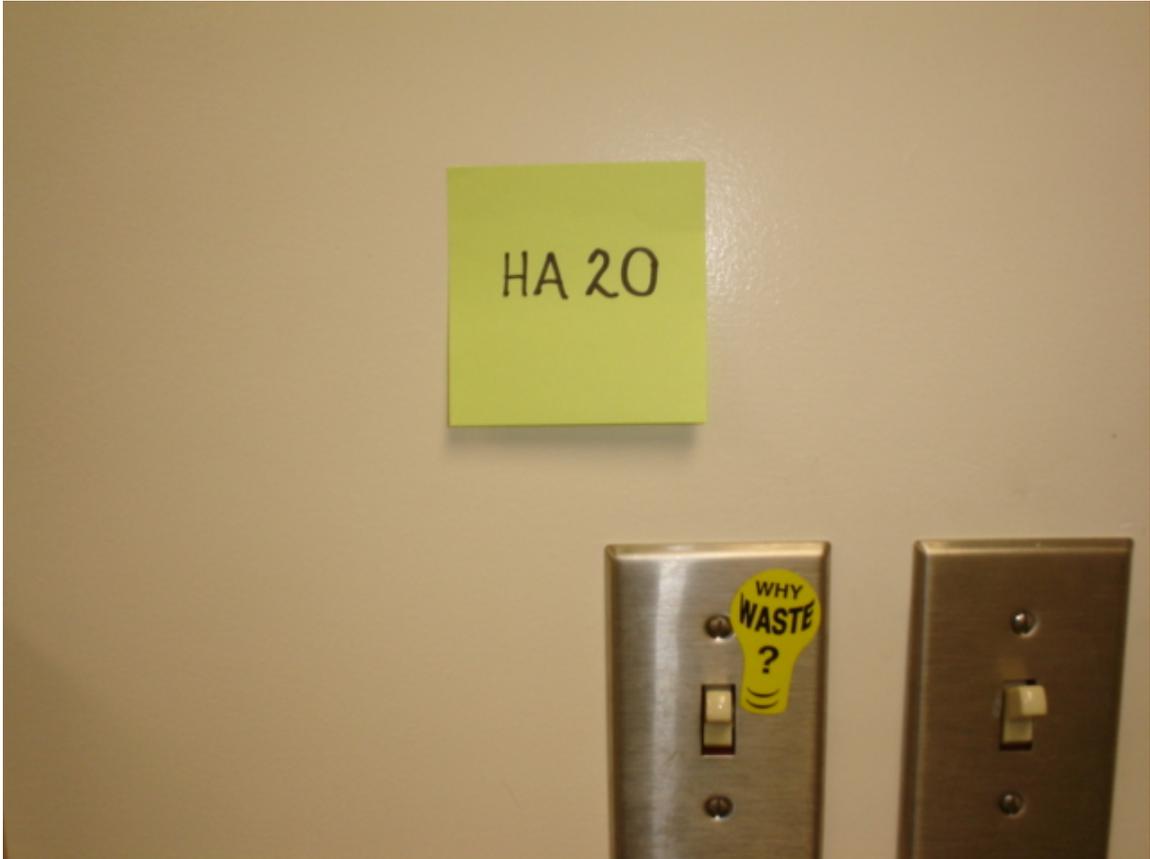
HA #20 – Non asbestos-containing drywall

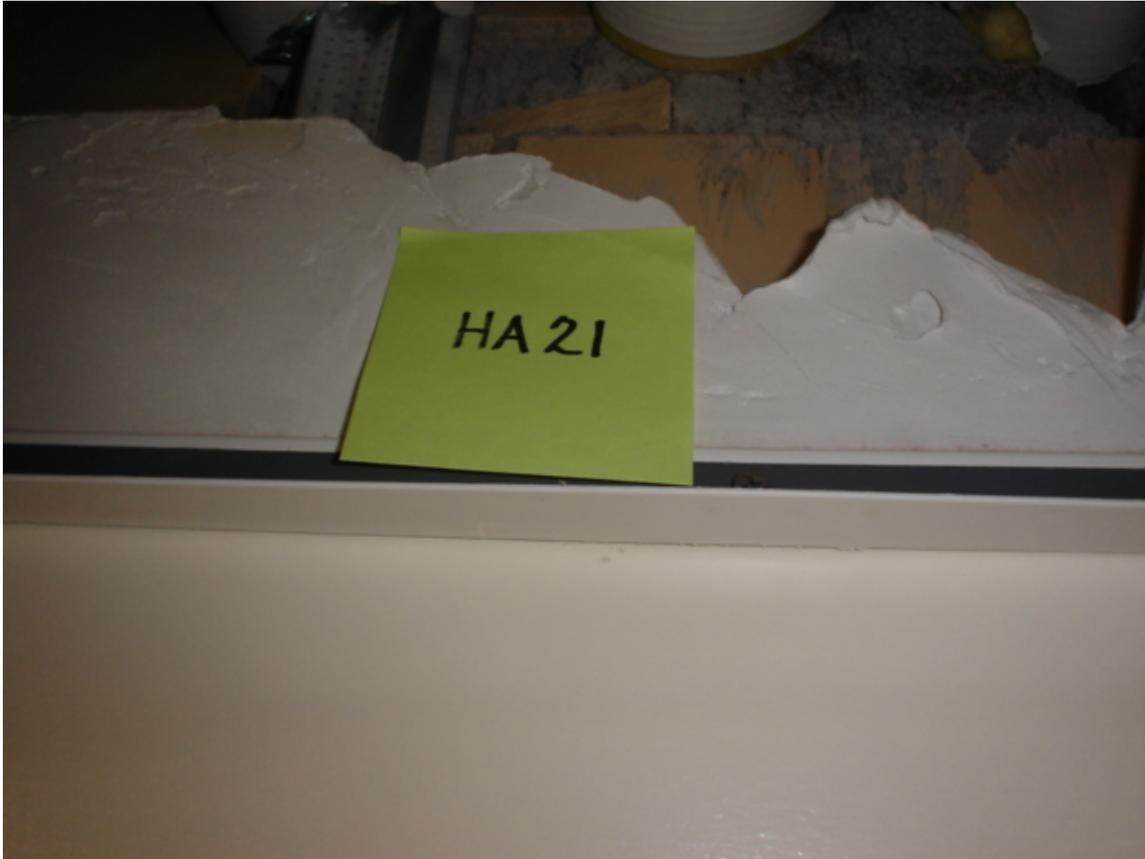
HA #21 – Non asbestos-containing drywall joint compound

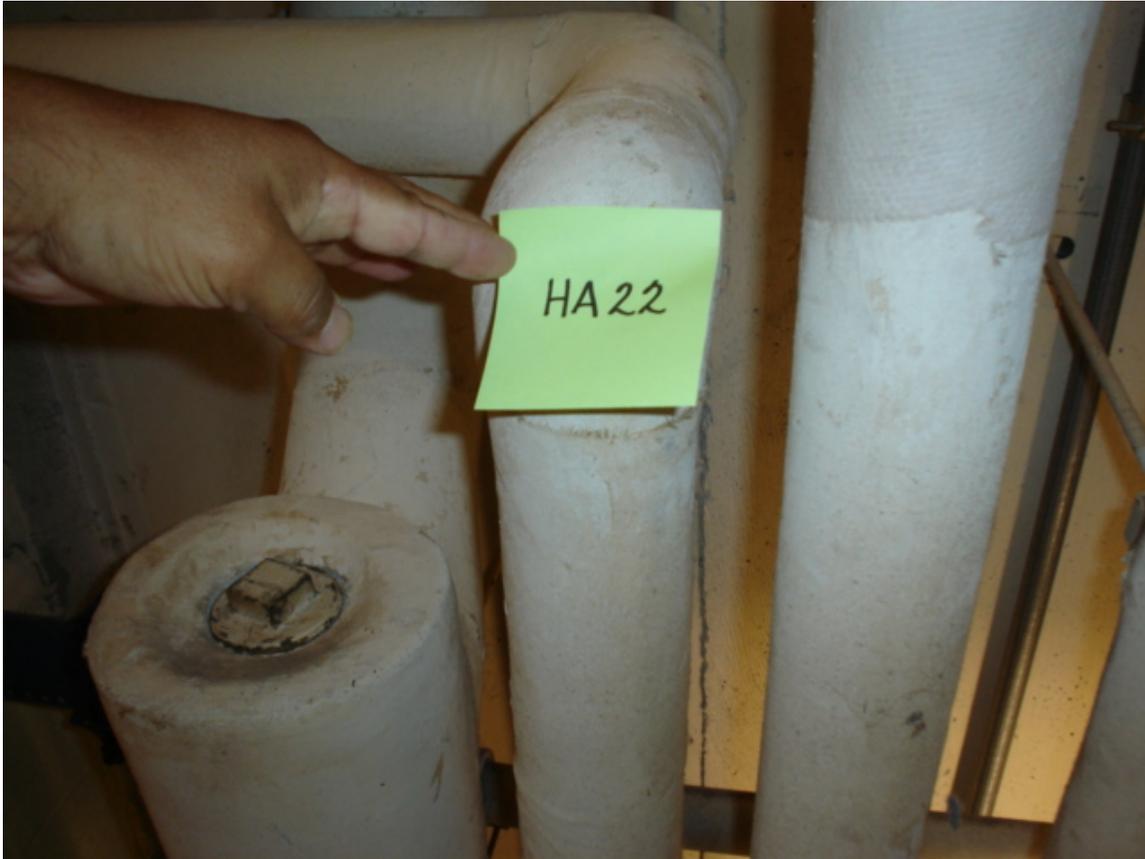
HA #22 – Asbestos-containing domestic water supply
pipe joint and hanger insulation

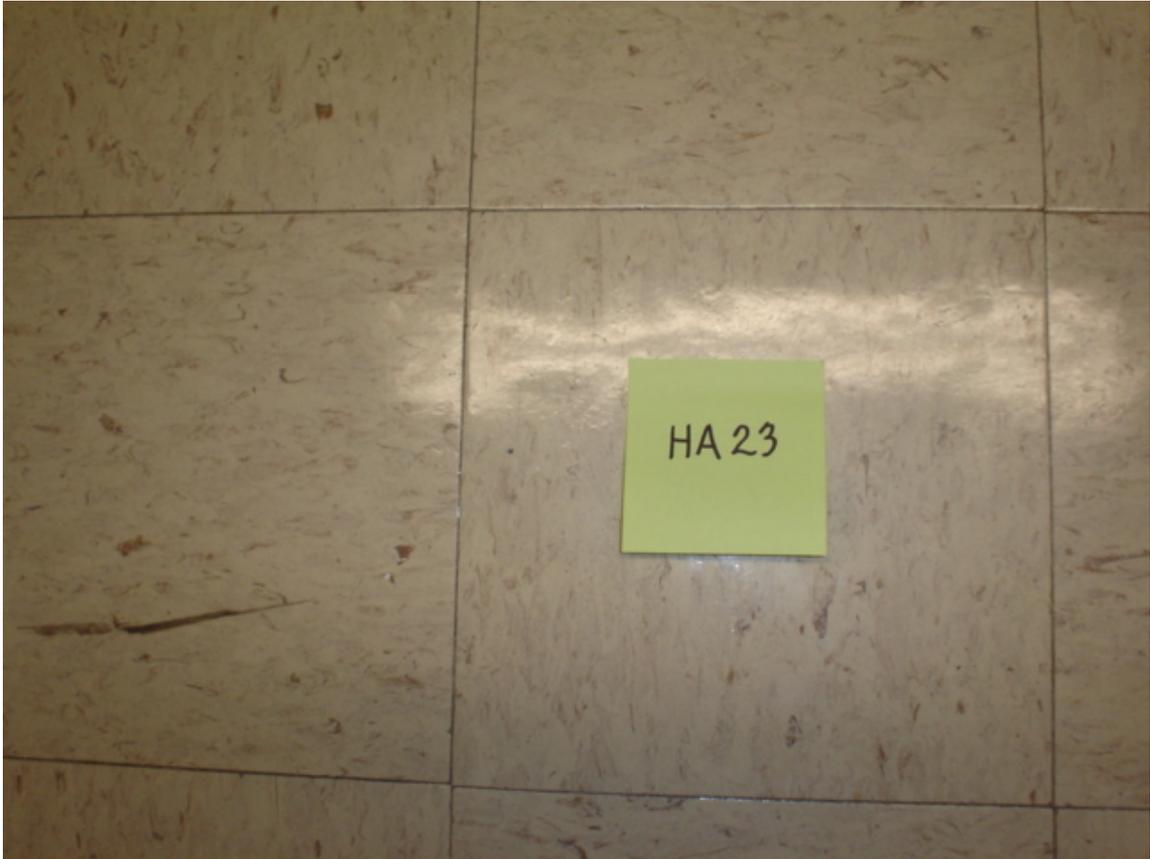
HA #23 – Asbestos-containing 9" x 9" cream floor tile
with pink and tan streaks and associated mastic
