I.M. Circle Photo Log

Main entrance to I.M. Sports Circle

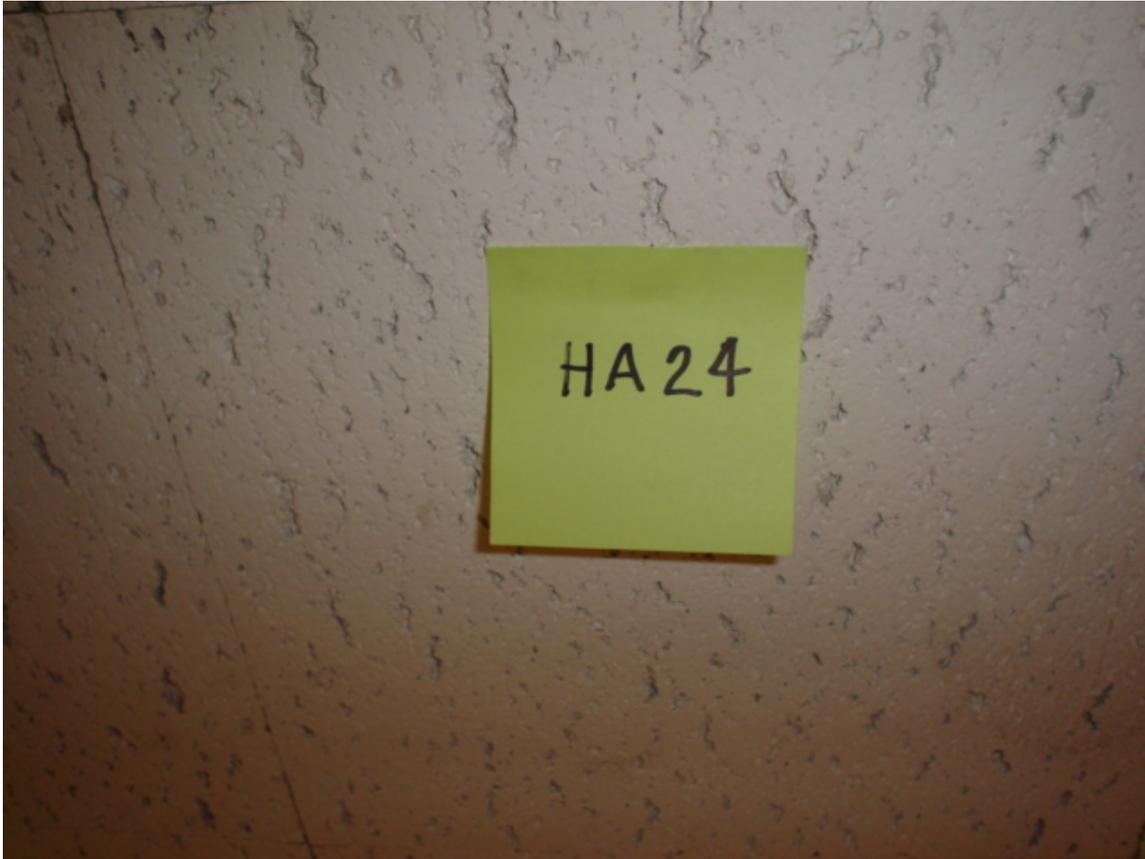
HA #24 – Non asbestos-containing 12" x 12" white ceiling tile with pin holes and fissures and associated glue pods

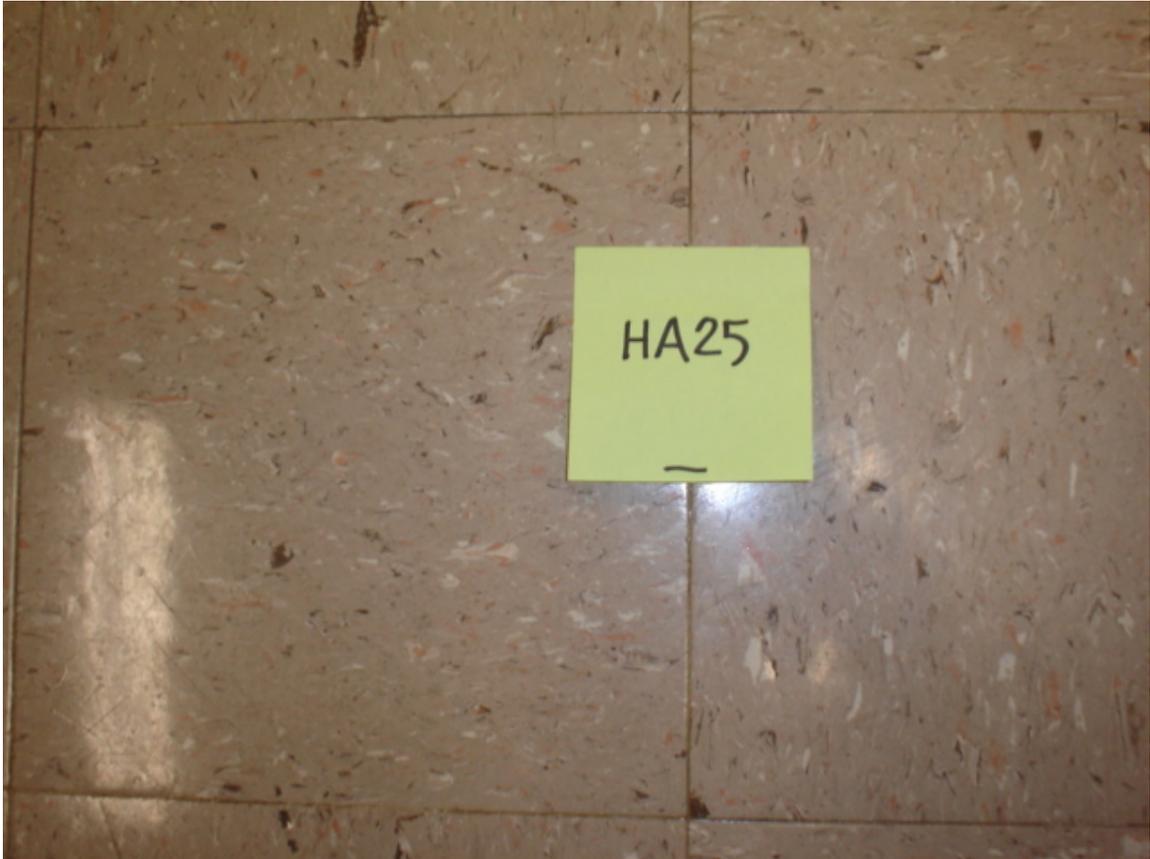
HA #25 – Asbestos-containing 9" x 9" light tan floor tile with pink, cream and brown streaks and associated mastic

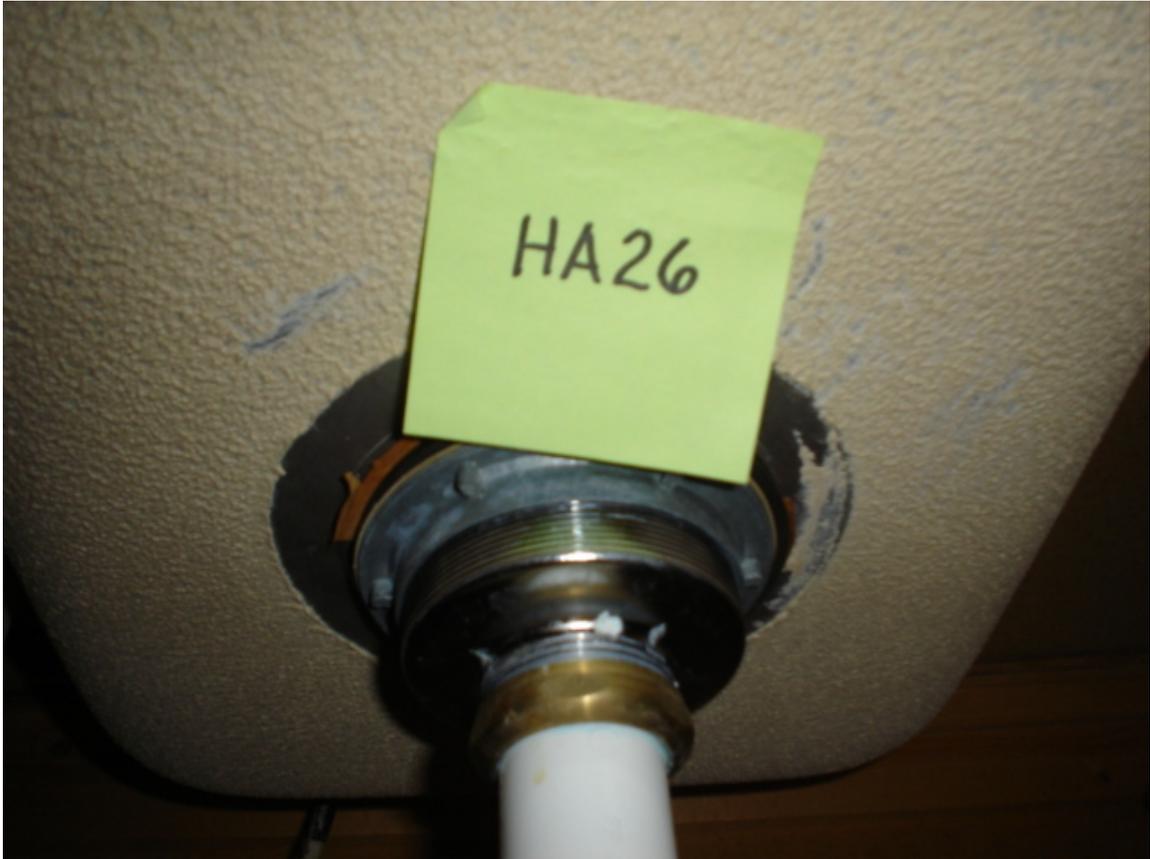
HA #26 – Non asbestos-containing white sink undercoating

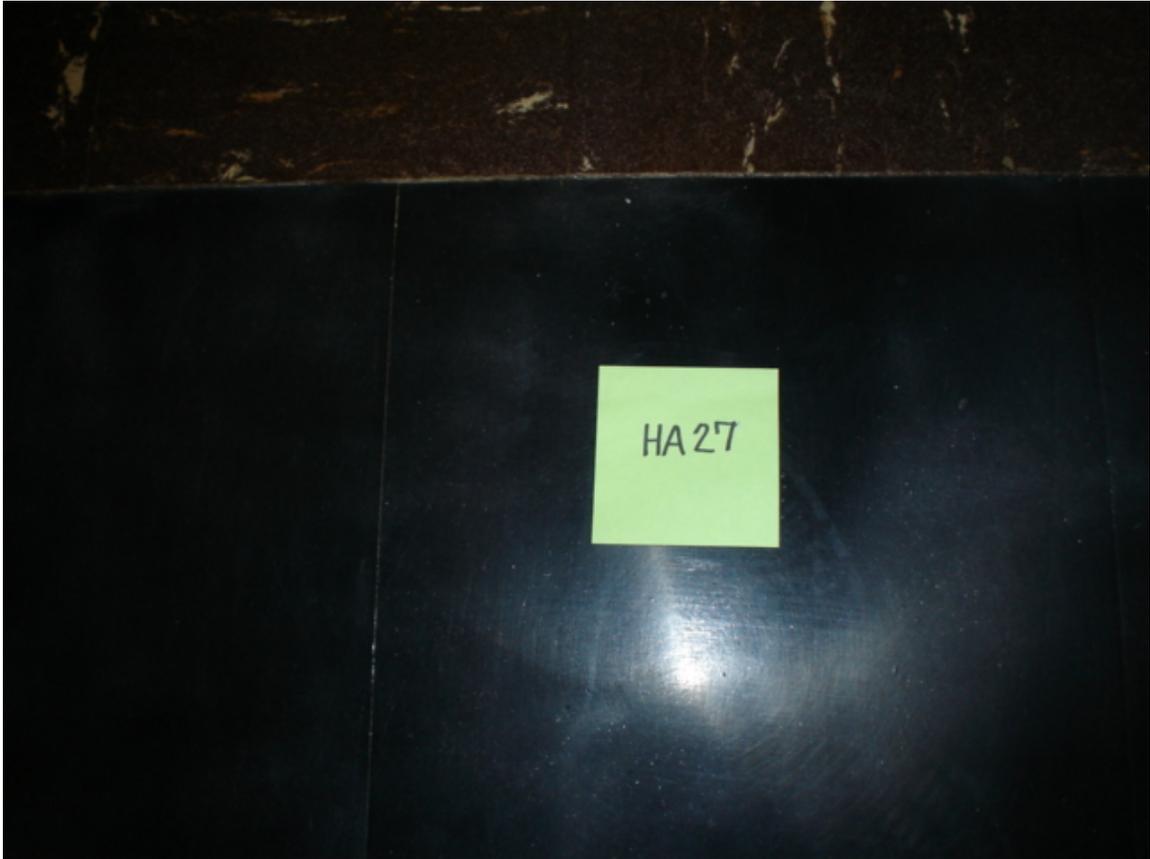
HA #27 – Non asbestos-containing 12" x 12" black floor tile
and associated mastic

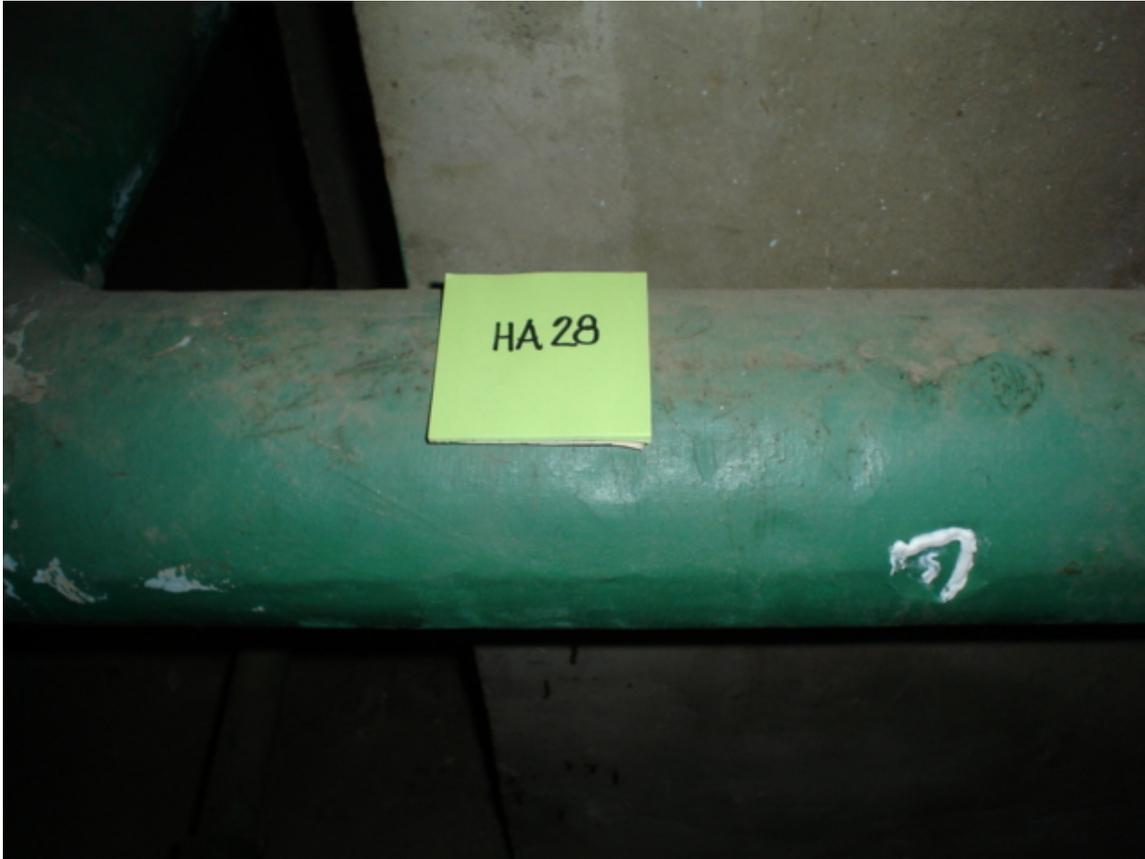
HA #28 – Asbestos-containing domestic water supply
pipe straight insulation

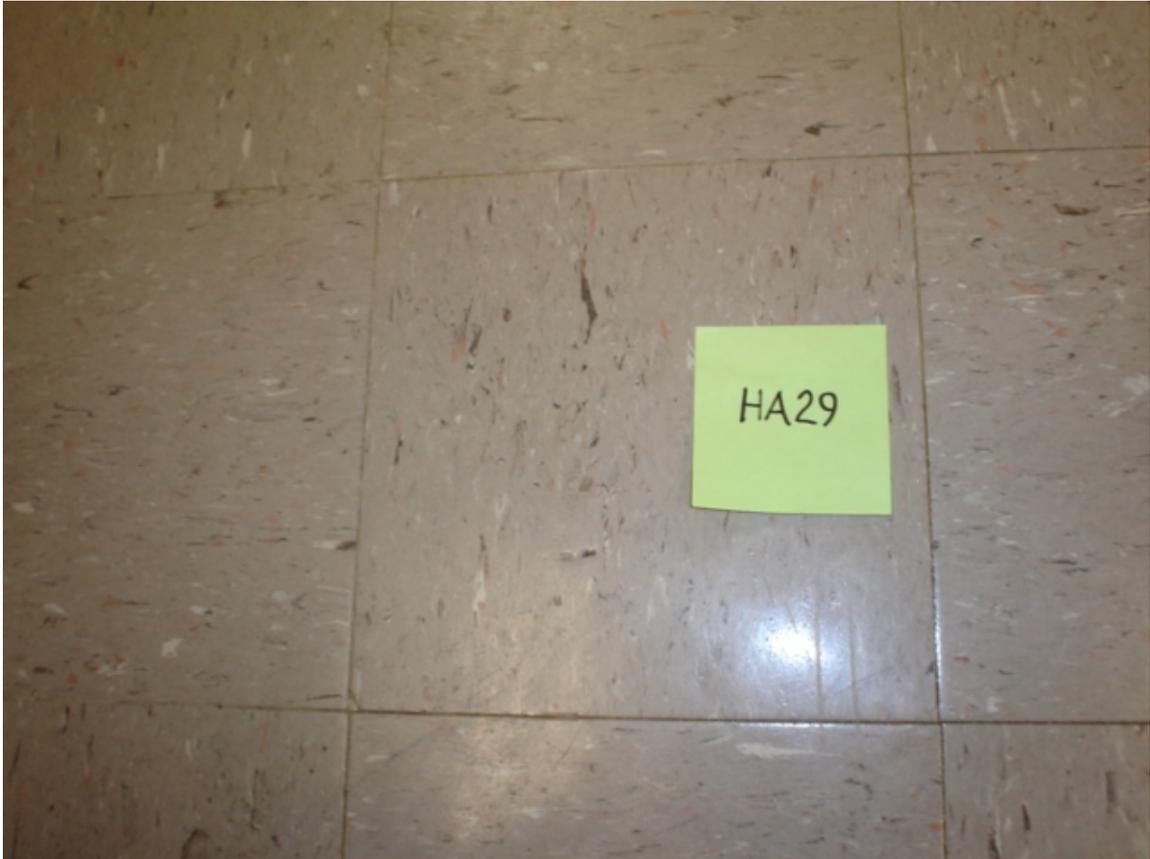
HA #29 – Asbestos-containing 9" x 9" beige floor tile with dark brown and tan marble pattern and associated mastic

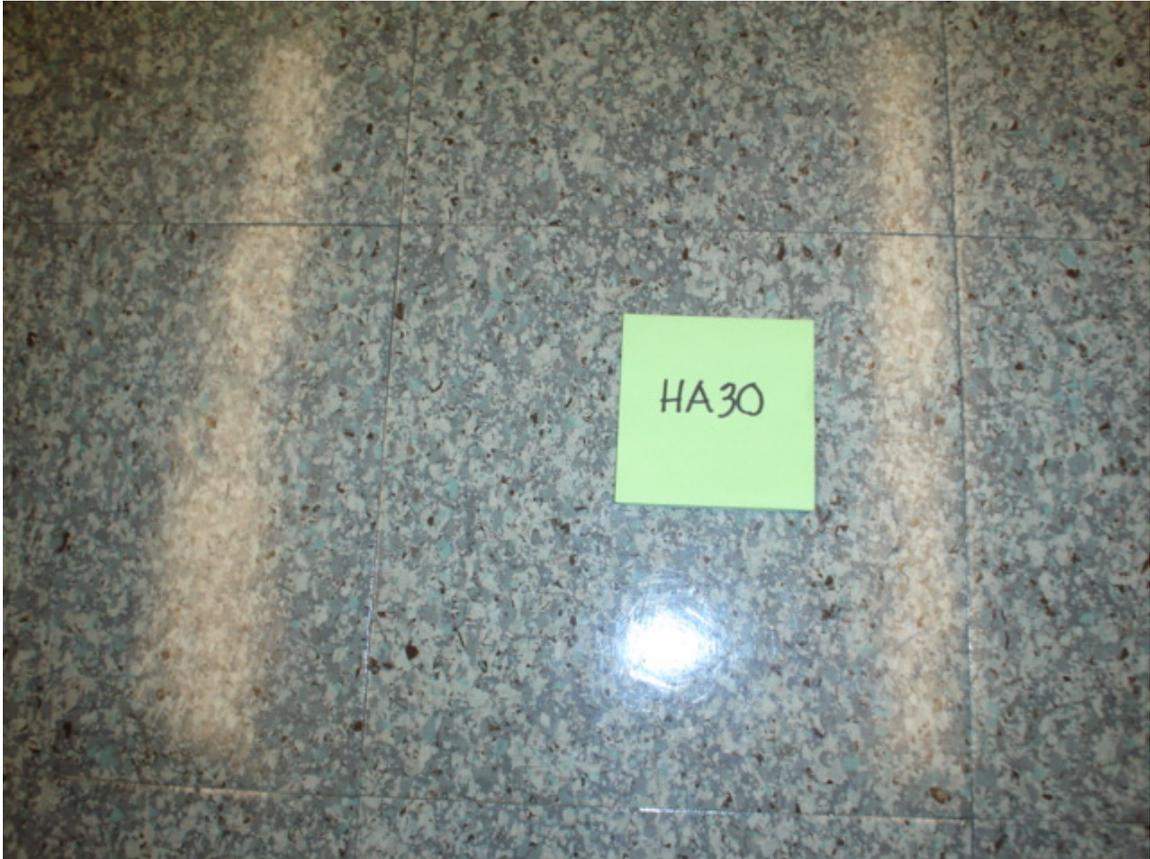
HA #30 – Asbestos-containing 9" x 9" gray floor tile with cream specks and associated mastic

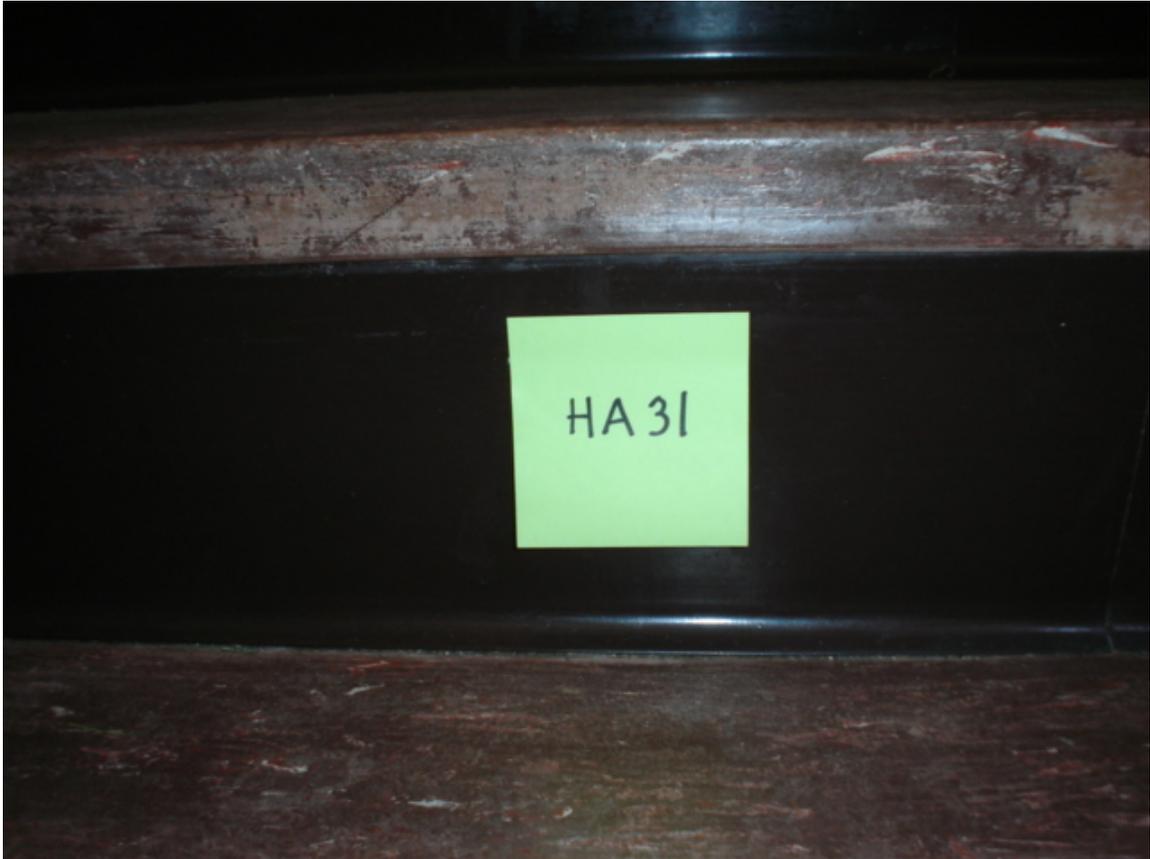
HA #31 – Non asbestos-containing 6" brown cove molding
and associated mastic

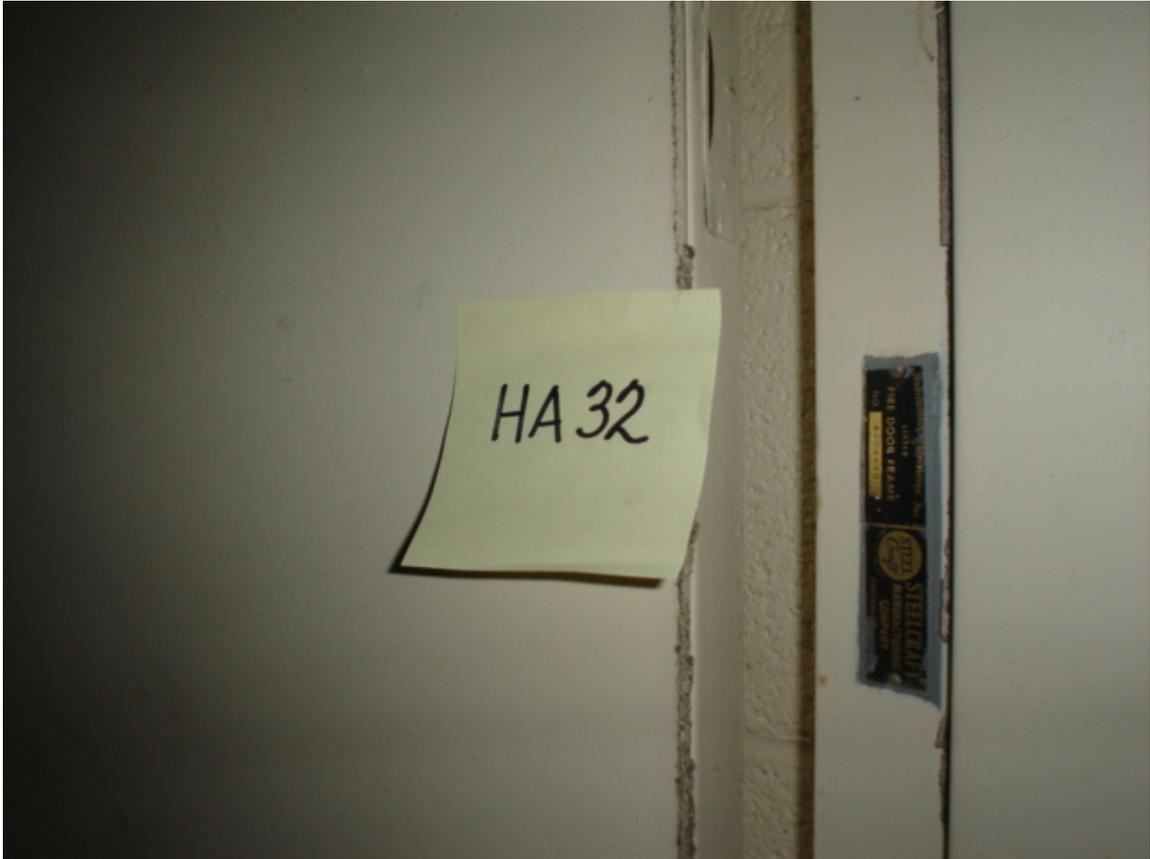
HA #32 – Assumed asbestos-containing fire door and frame

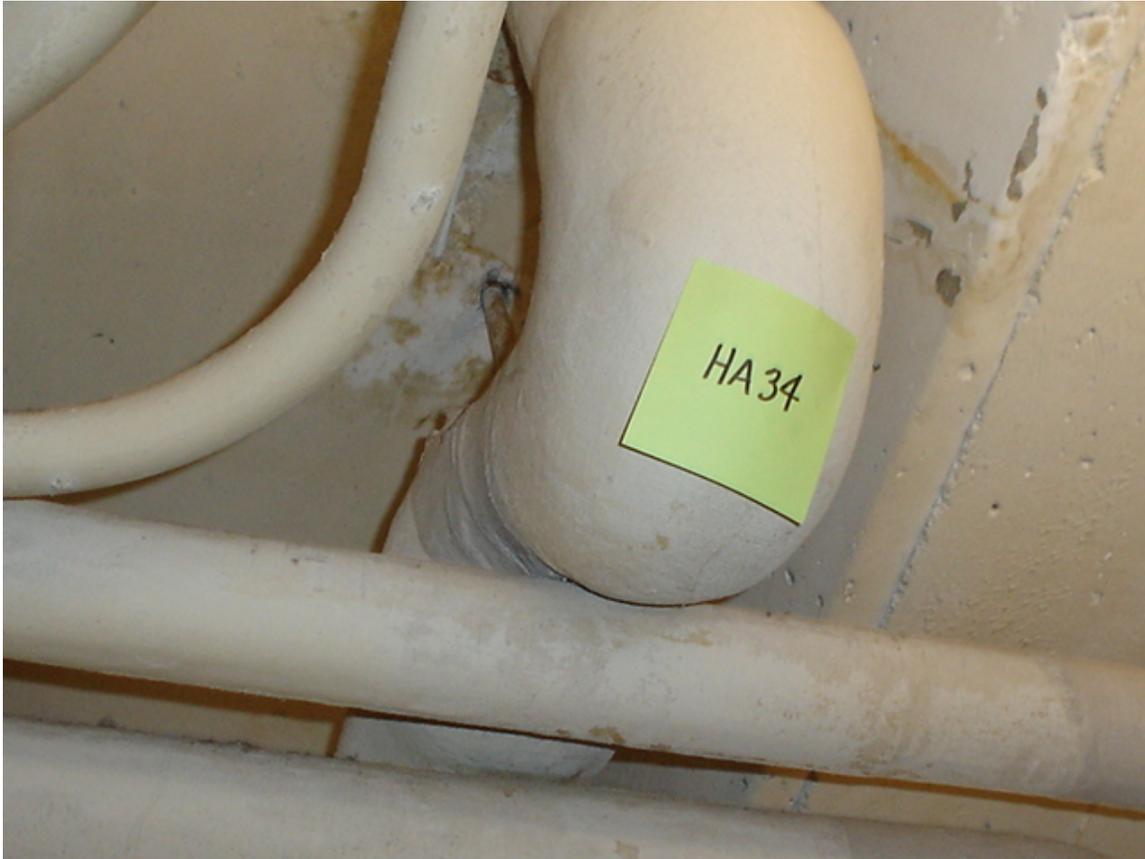
HA #34 – Asbestos-containing drain pipe joint and hanger insulation

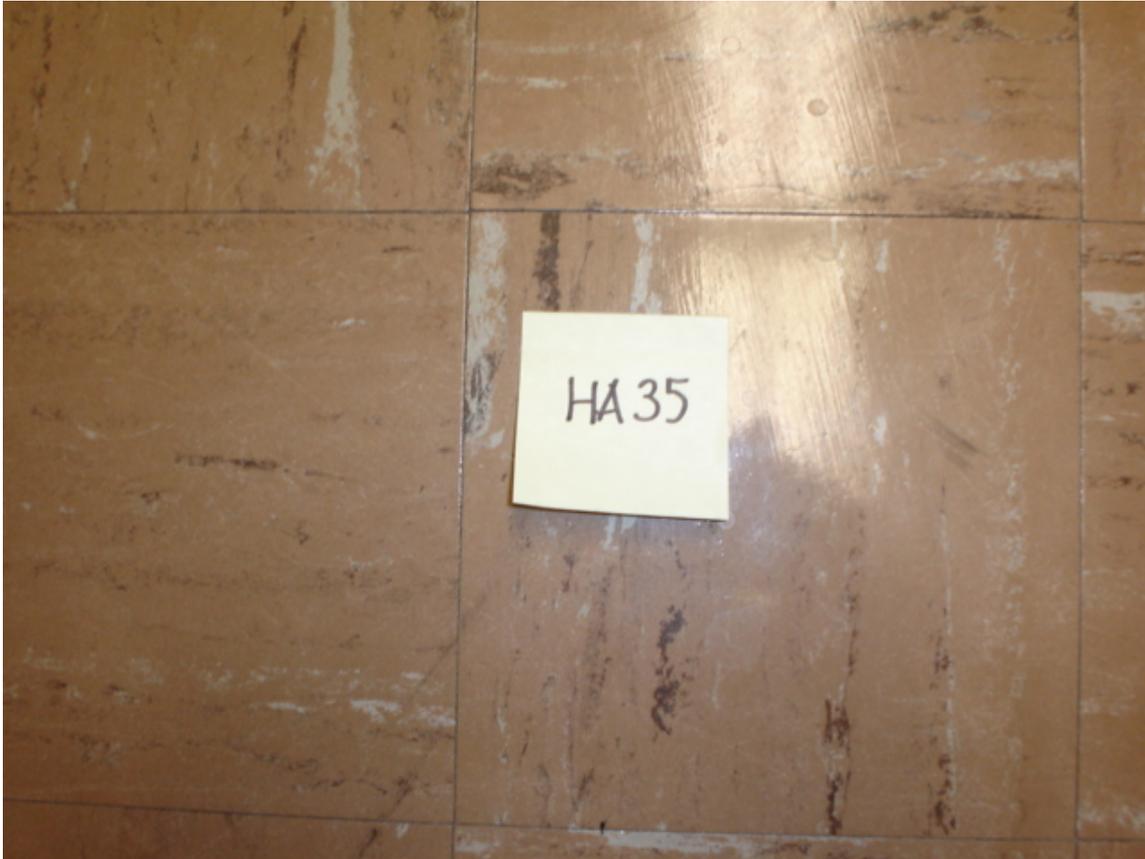
HA #35 – Asbestos-containing 9" x 9" light brown floor tile with cream and rust streaks and associated non asbestos-containing mastic

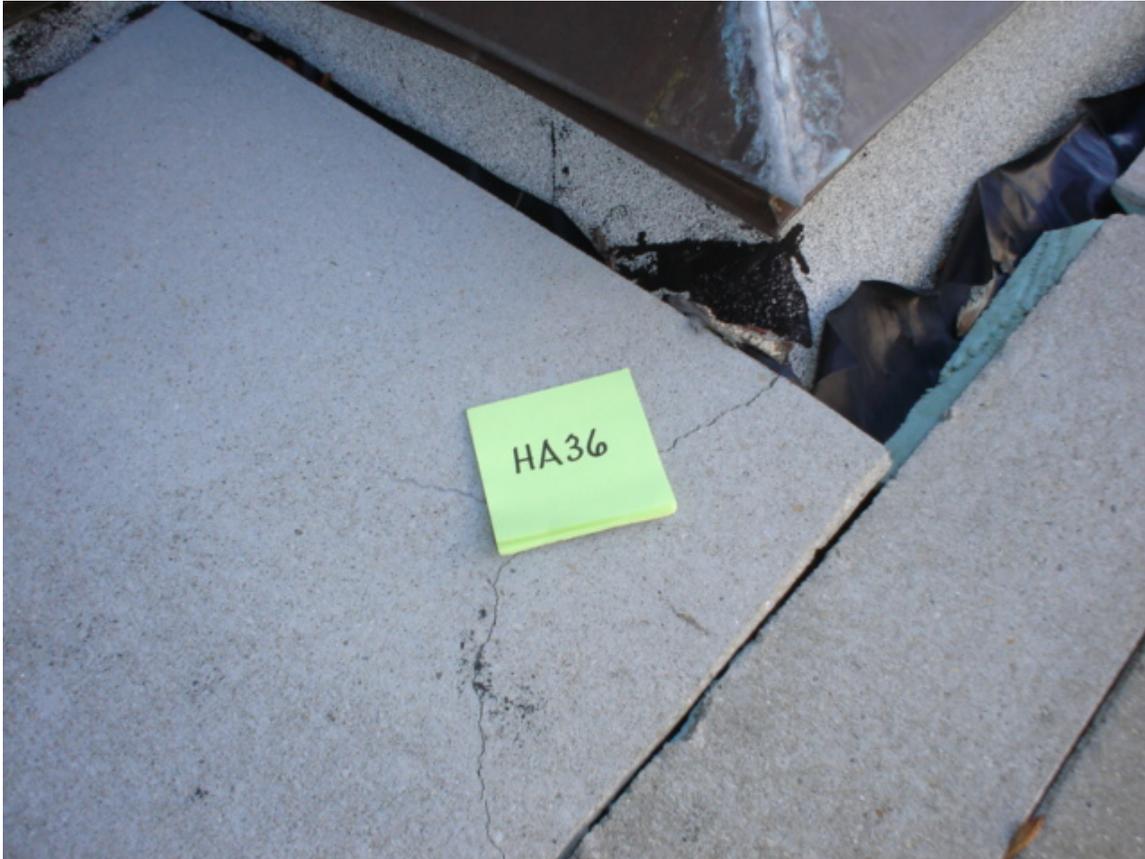
HA #36 – Assumed asbestos-containing roofing materials and products

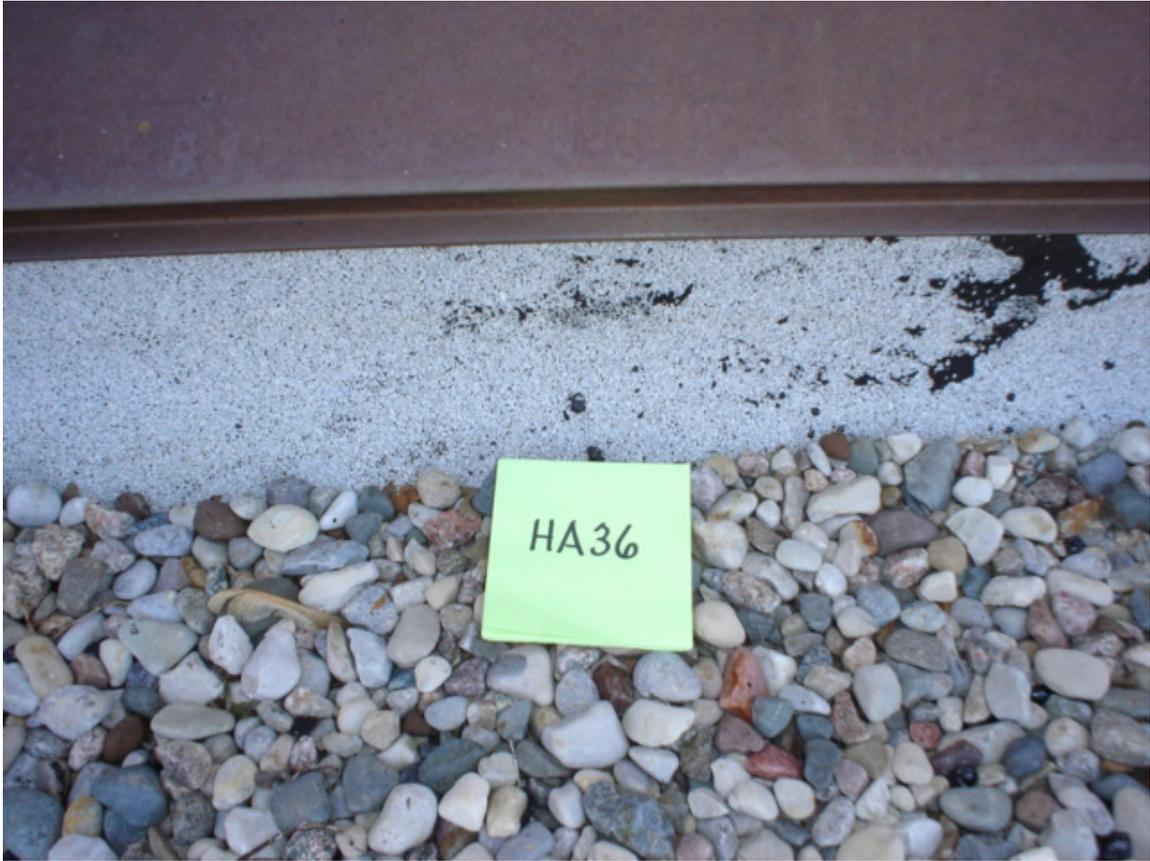
HA #36 – Assumed asbestos-containing roofing materials and products

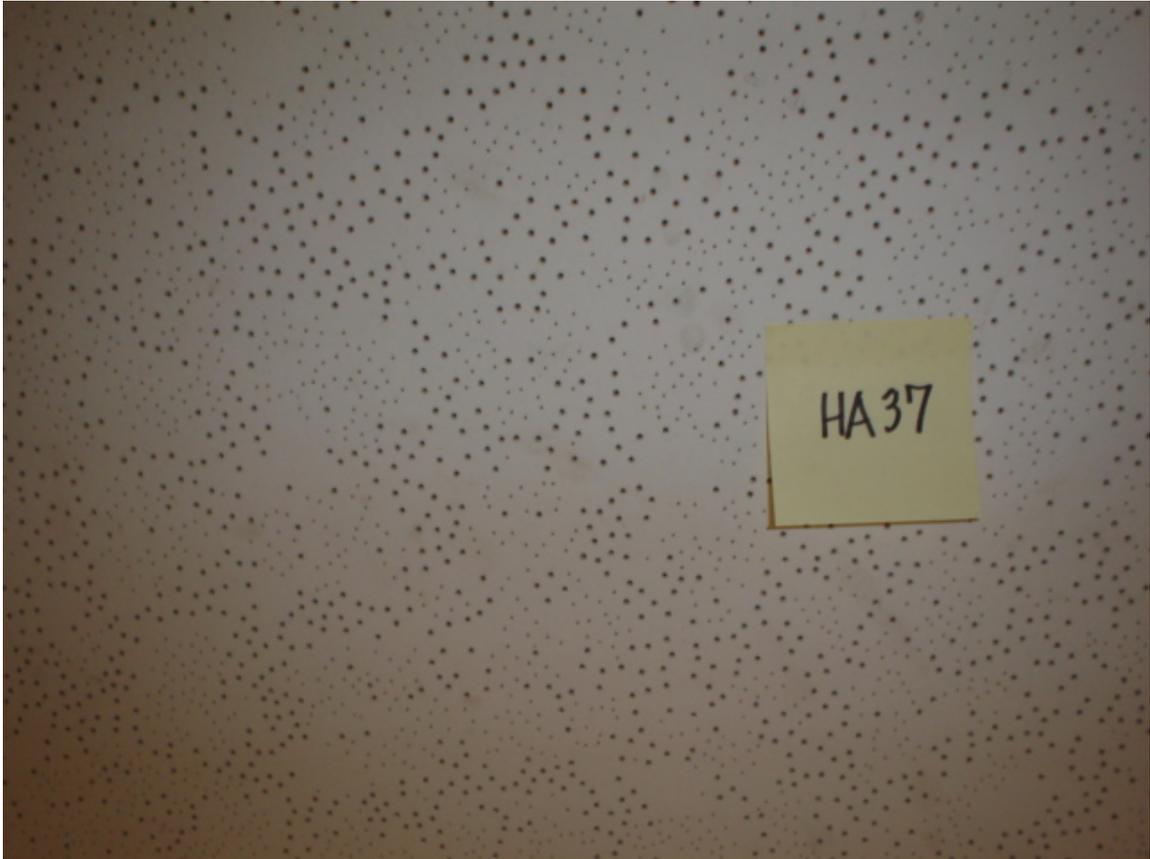
HA #37 – Non asbestos-containing 2' x 2' white lay-in ceiling tile
with pin holes

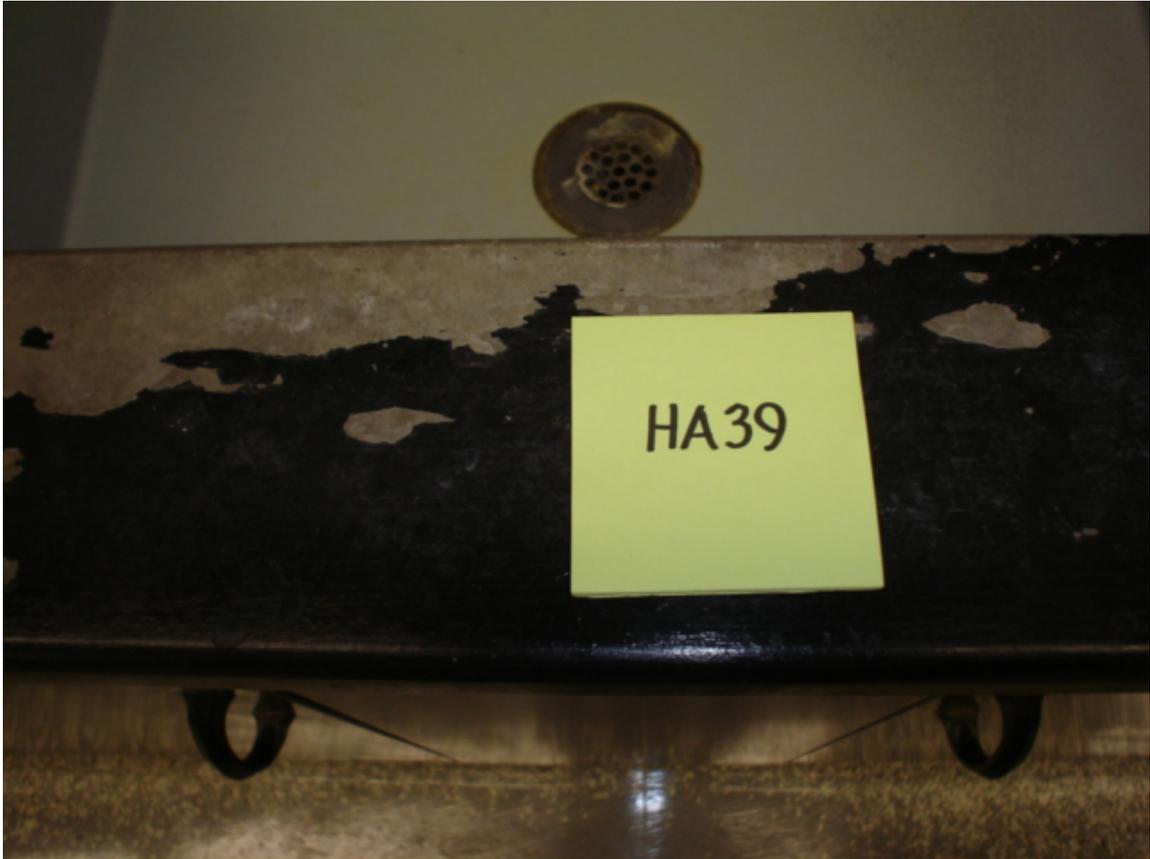
HA #39 – Assumed asbestos-containing black chemistry lab countertop

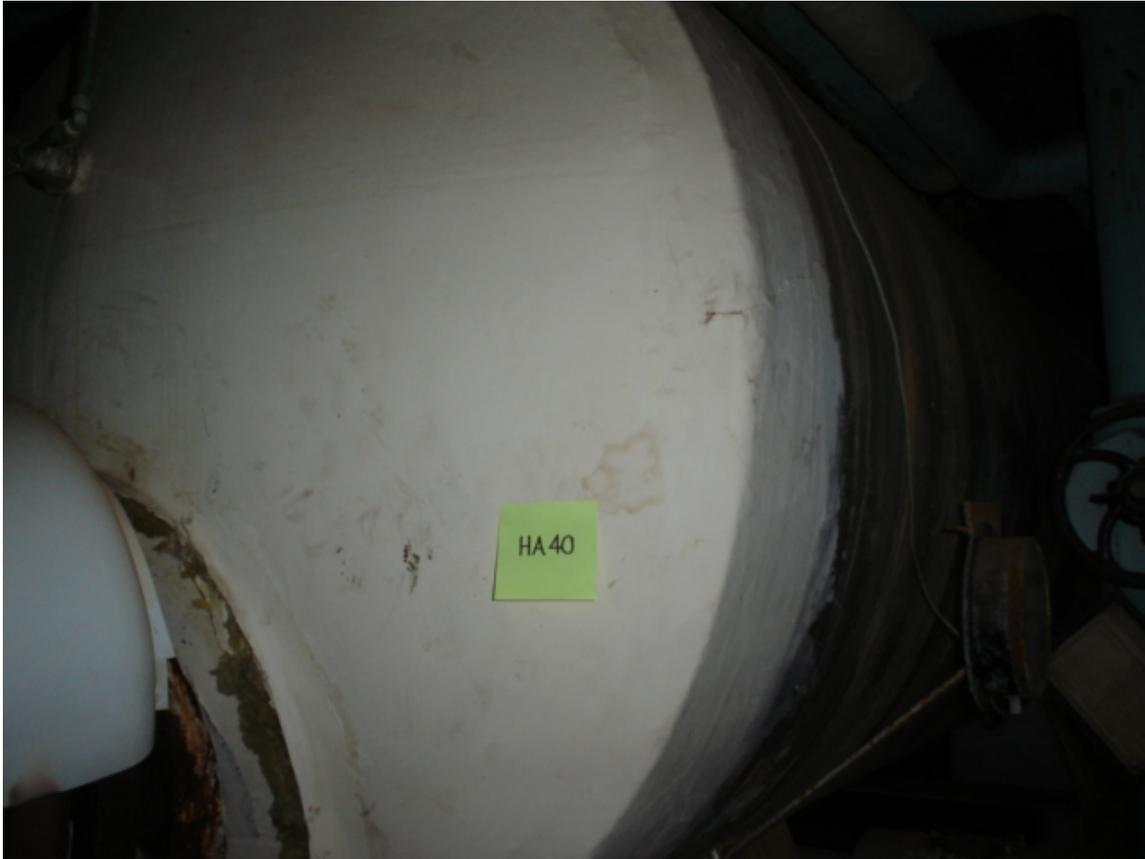
HA #40 – Asbestos-containing expansion tank insulation

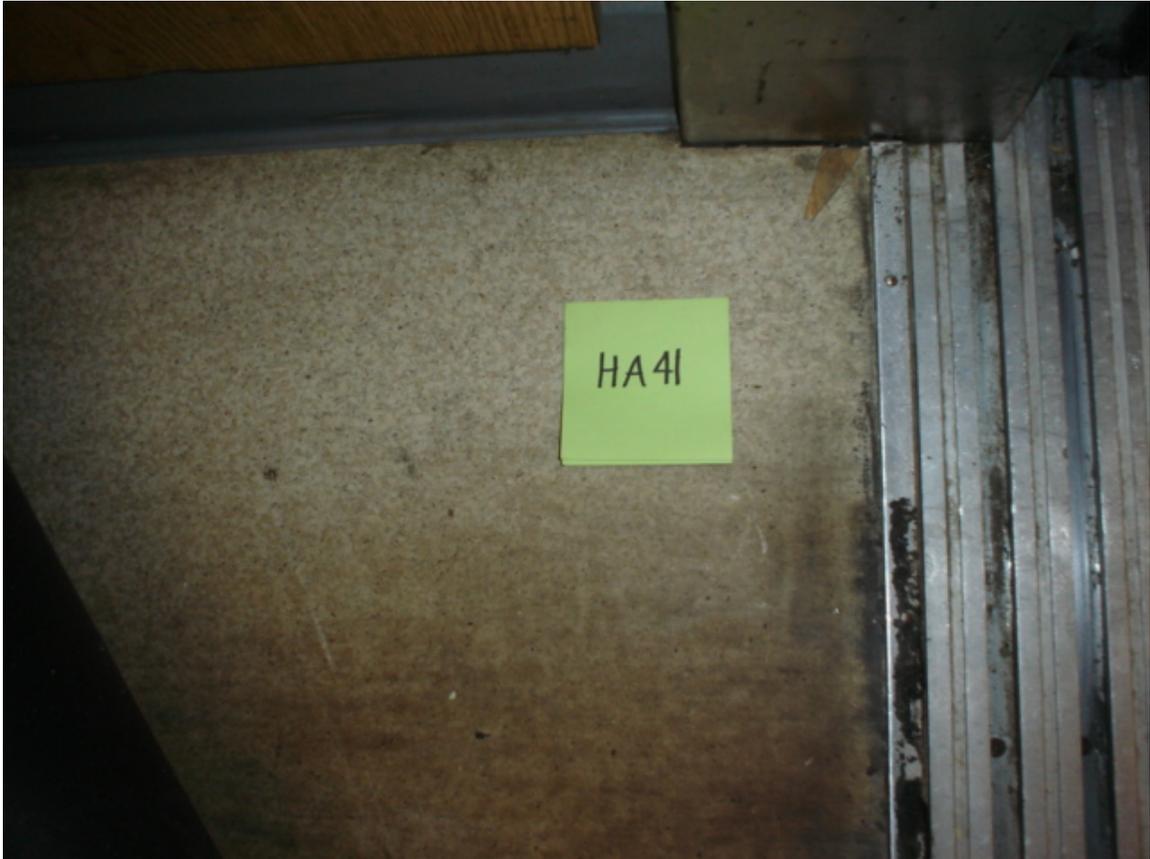
HA #41 – Non asbestos-containing cream vinyl flooring
and associated backing

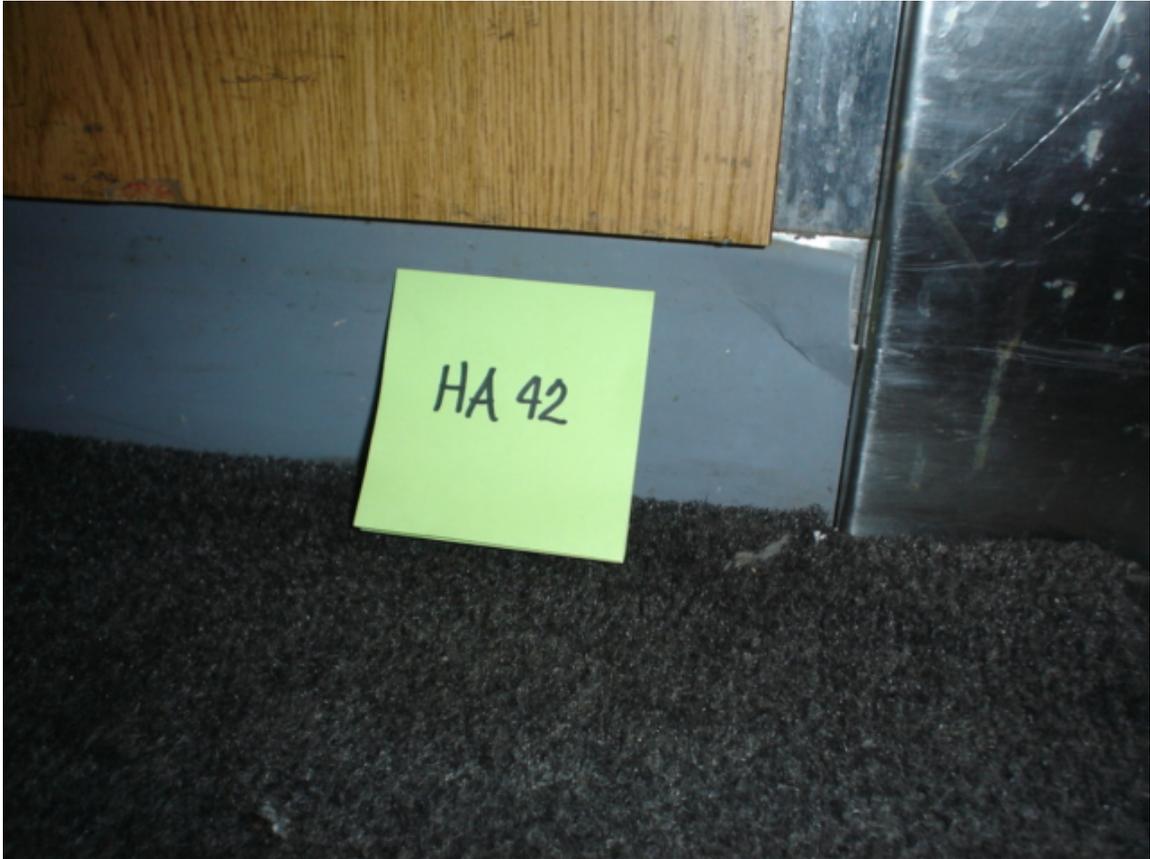
HA #42 – Non asbestos-containing 4" gray cove molding
and associated mastic

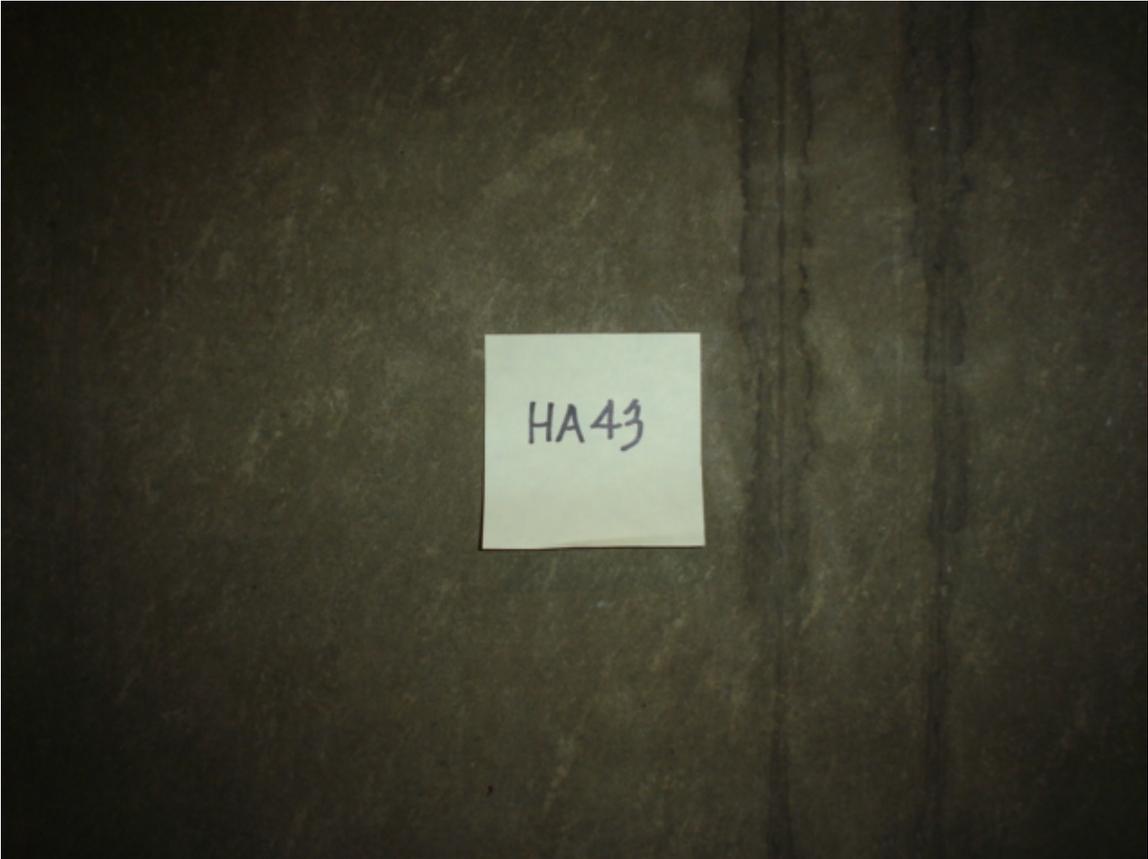
HA #43 – Assumed asbestos-containing transite wall panels

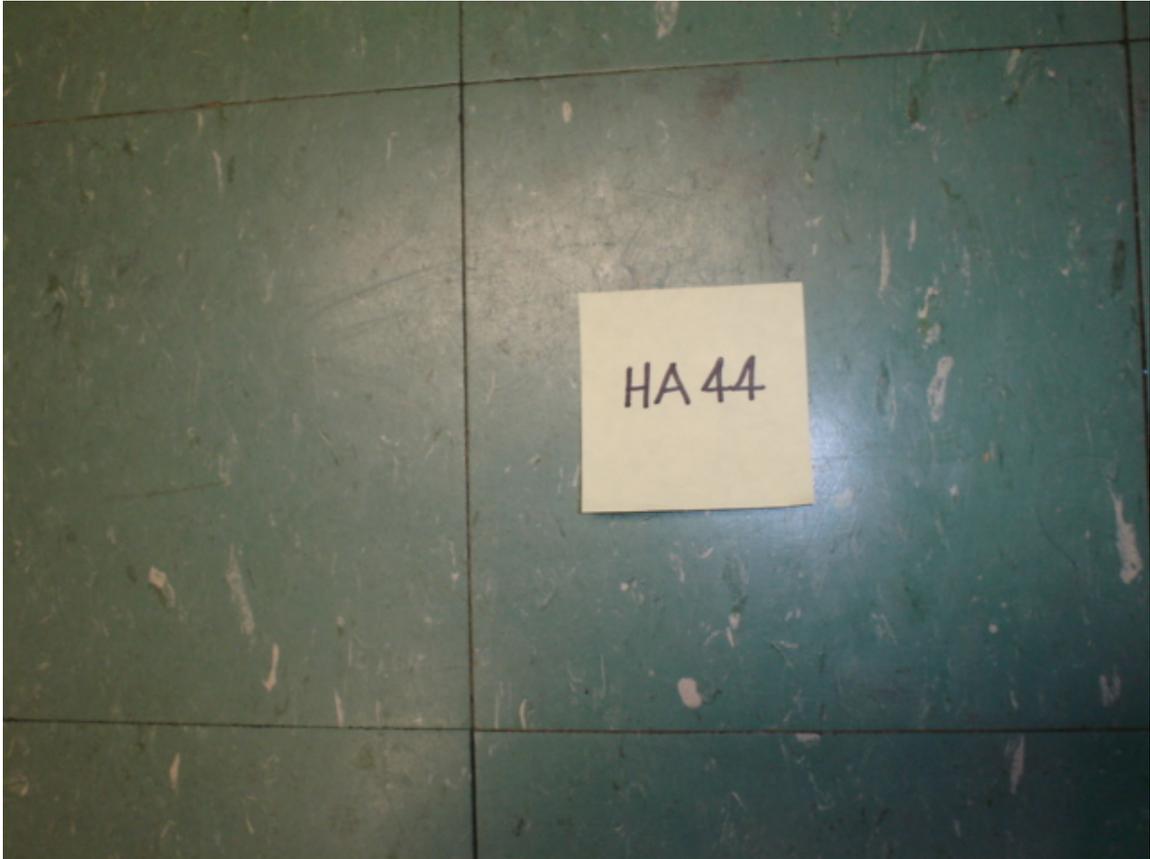
HA #44 – Asbestos-containing 9" x 9" green floor tile with green and white marble pattern and associated mastic

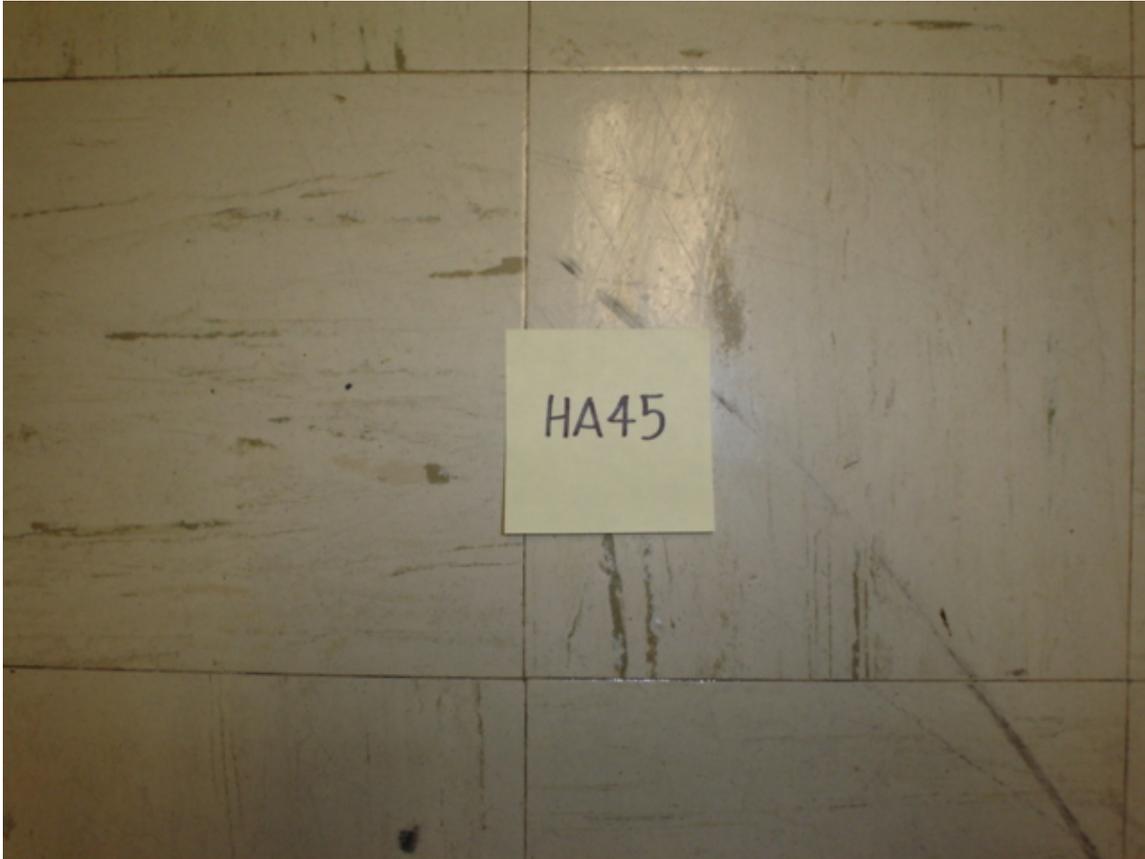
HA #45 – Asbestos-containing 9" x 9" white floor tile with green streaks and associated non asbestos-containing mastic

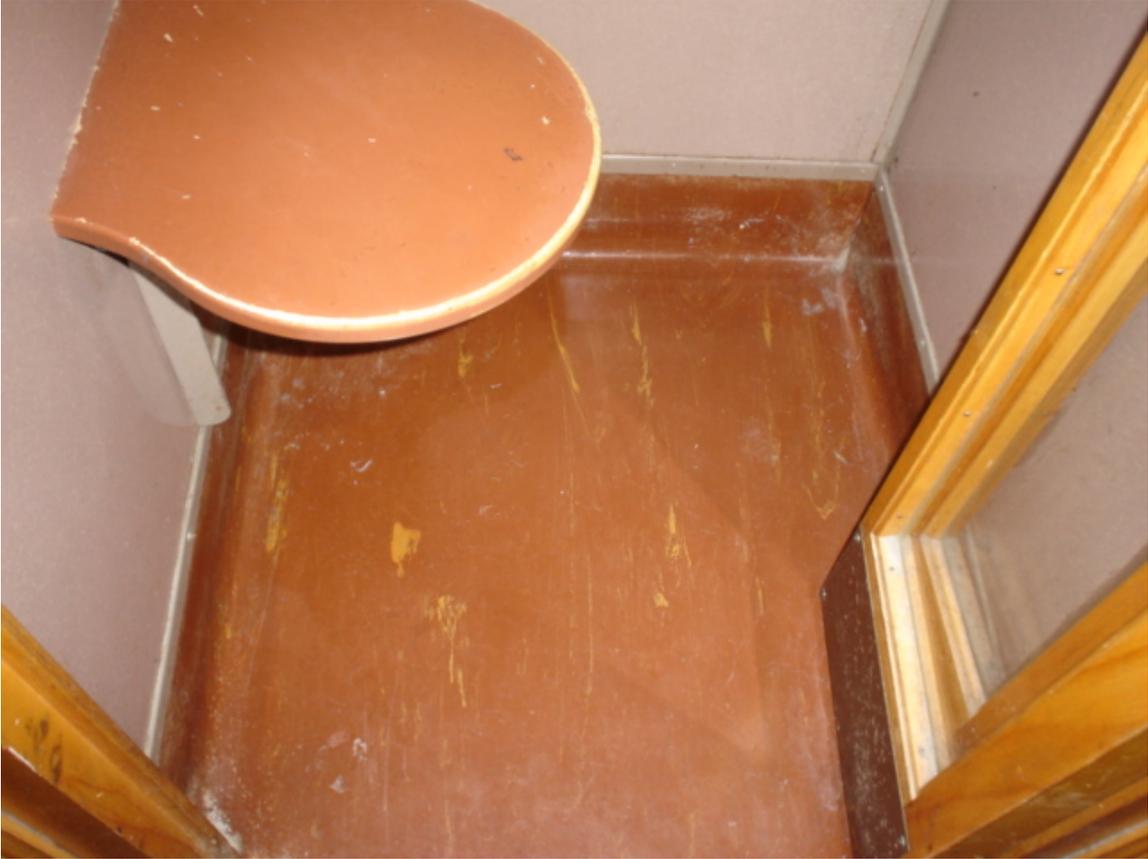
HA #46 – Non asbestos-containing red linoleum with rust streaks
and associated backing

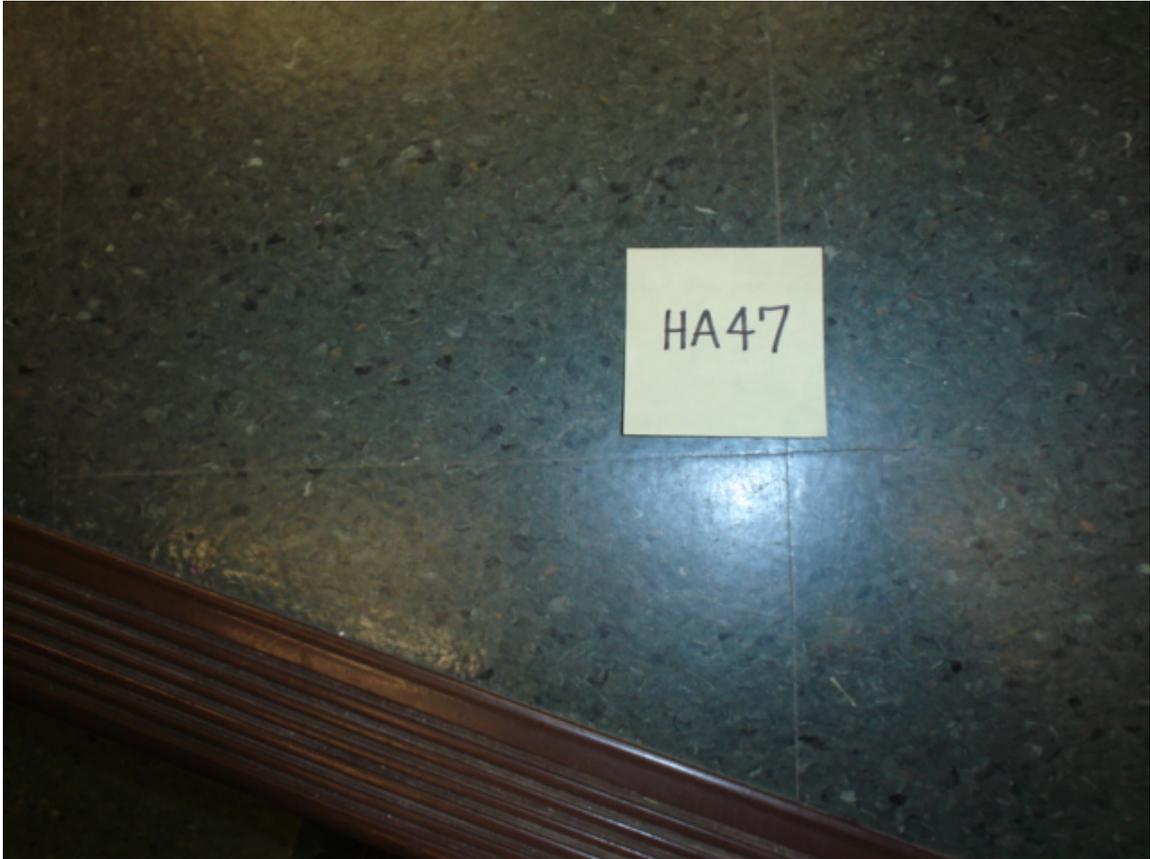
HA #47 – Non asbestos-containing 12" x 12" green floor tile with dark green and tan specks and associated mastic
