I.M. Circle Photo Log

Main entrance to I.M. Sports Circle

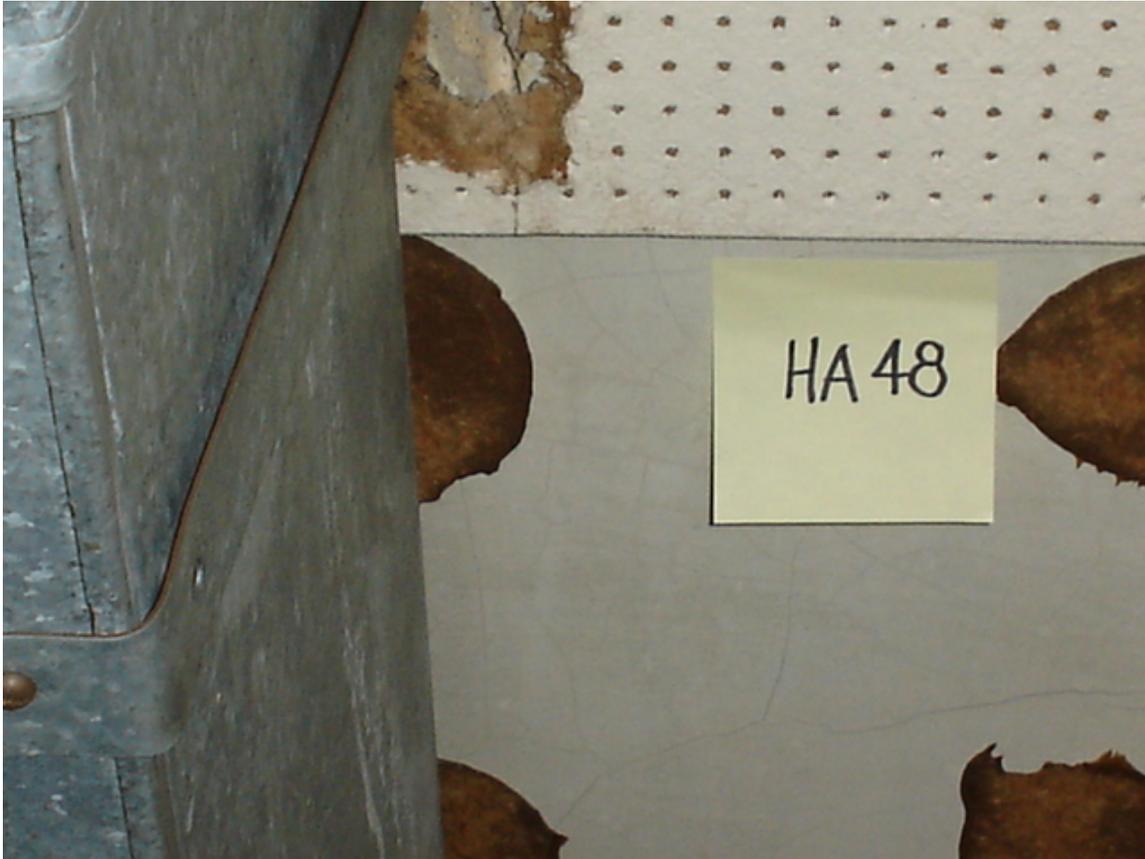
HA #48 – Non asbestos-containing 12" x 12" white ceiling tile
with uniform holes and associated glue pods

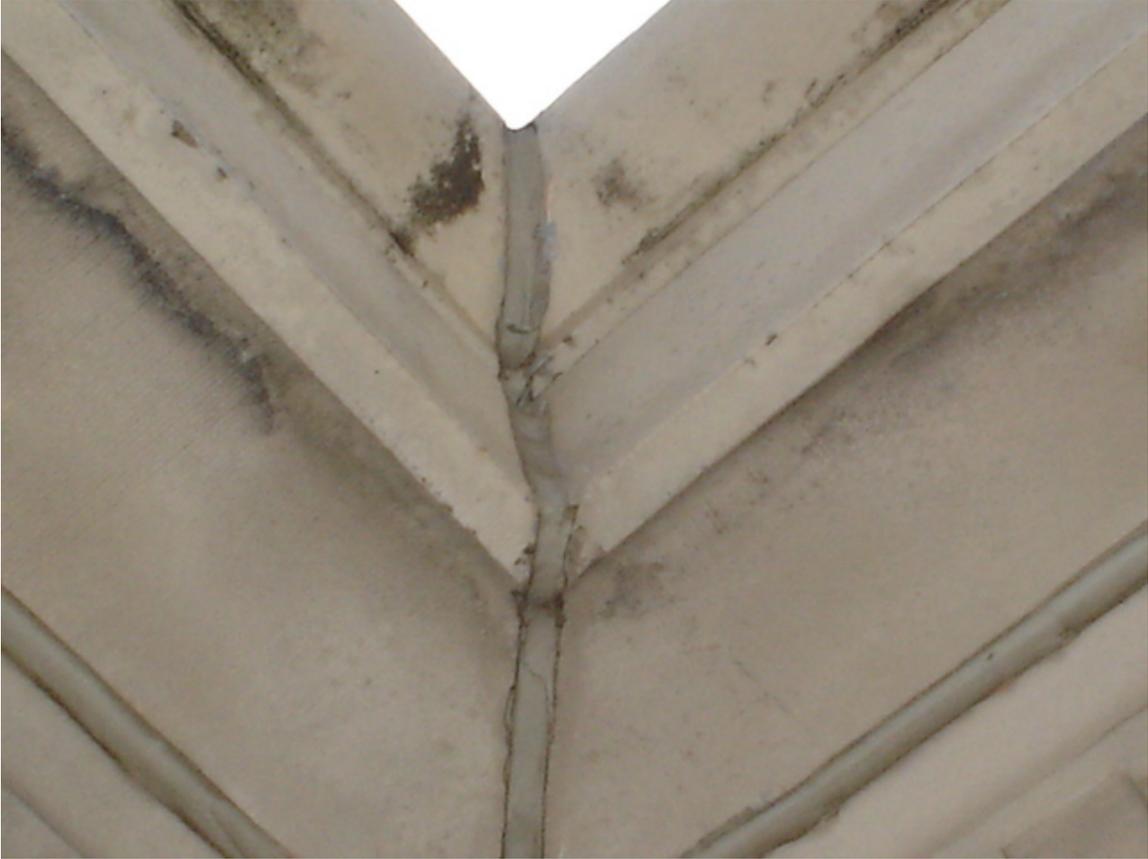
HA #49 – Assumed asbestos-containing building caulk compound
