River Water Research Laboratory Photo Log

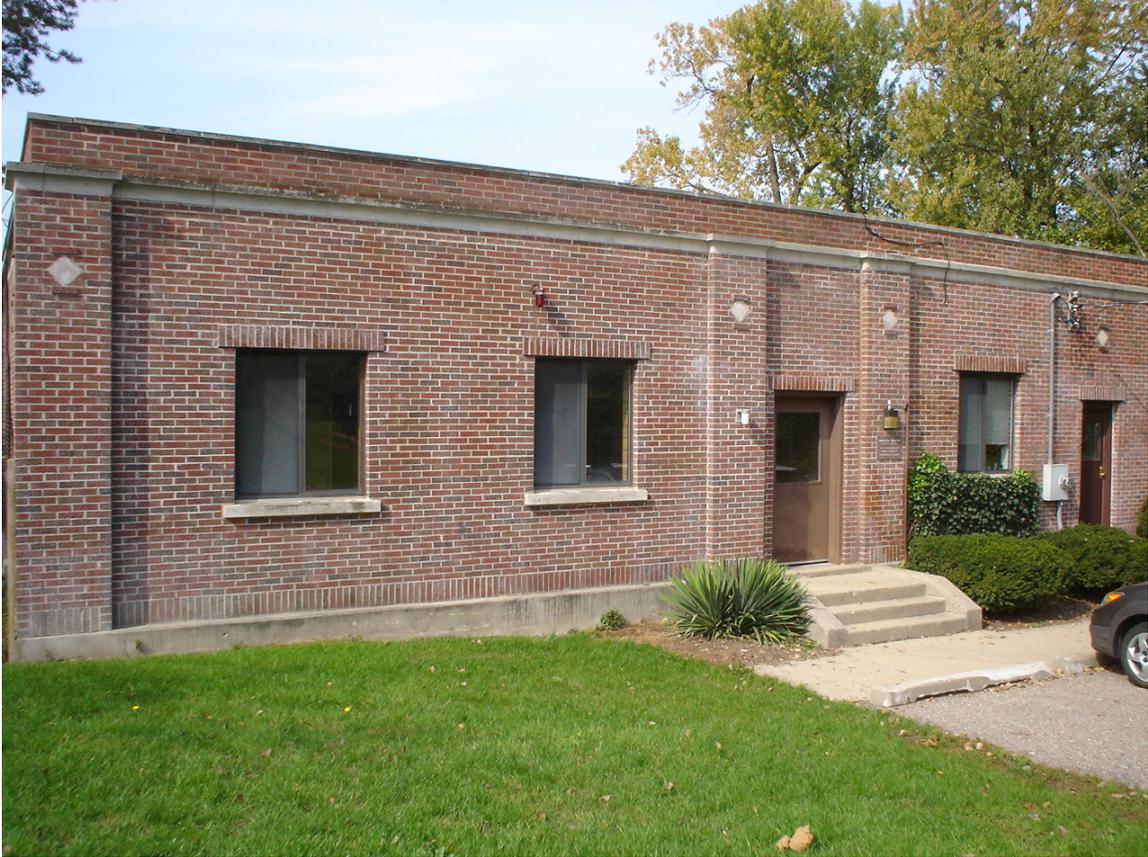
Exterior of the River Water Research Building

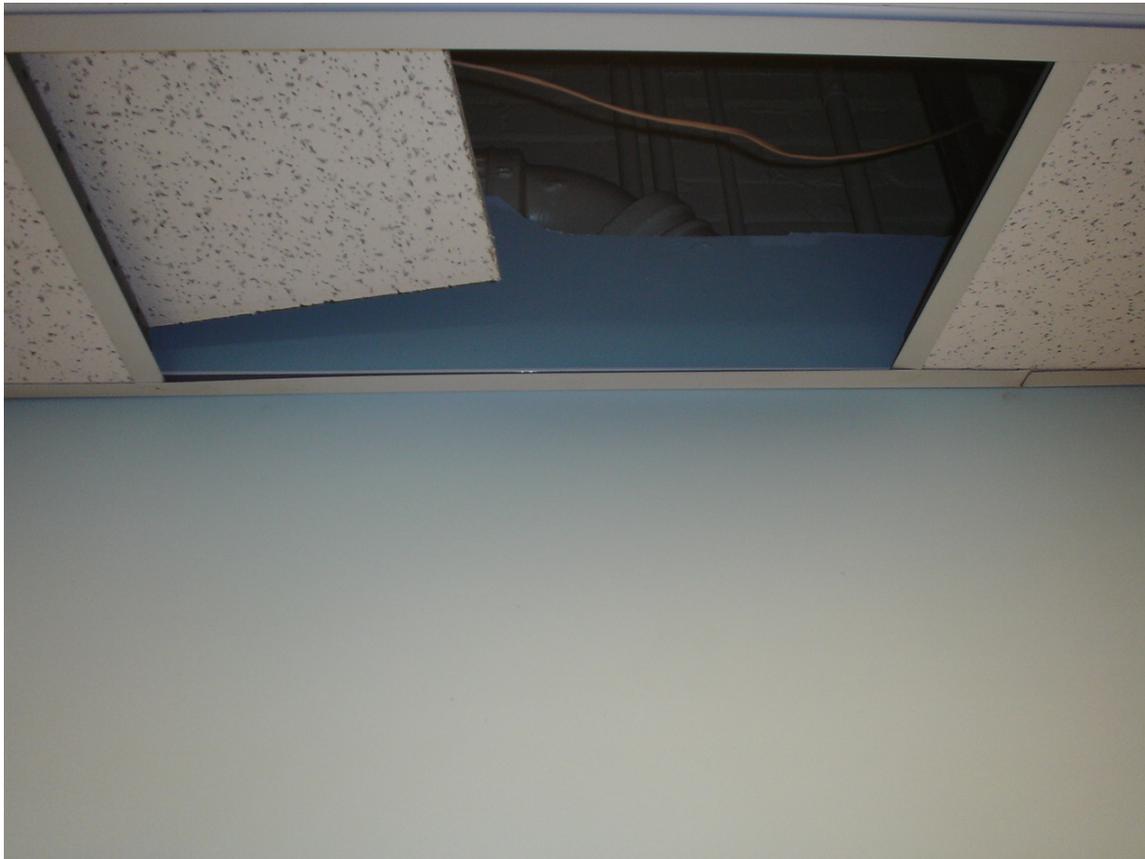
HA #1 – Non asbestos-containing drywall

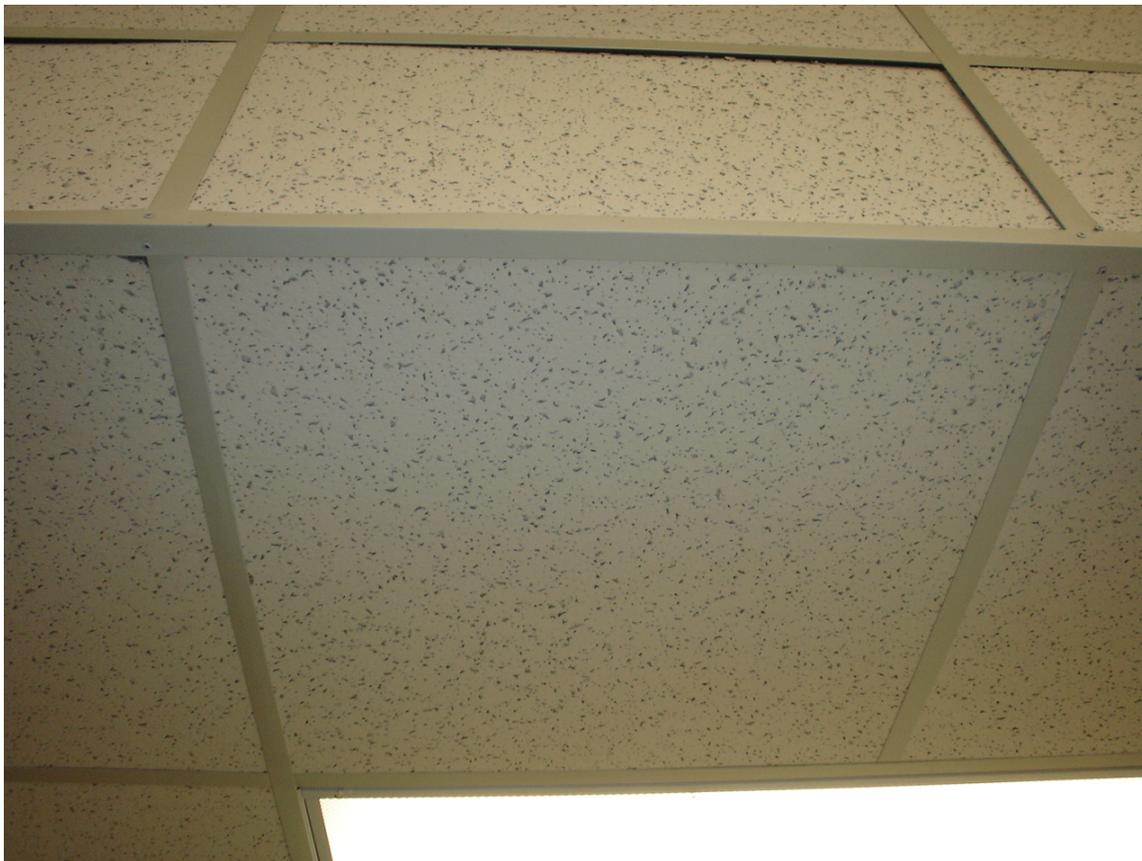
HA #3 – Non asbestos-containing 2' x 2' white lay-in ceiling tile with pin holes and fissures

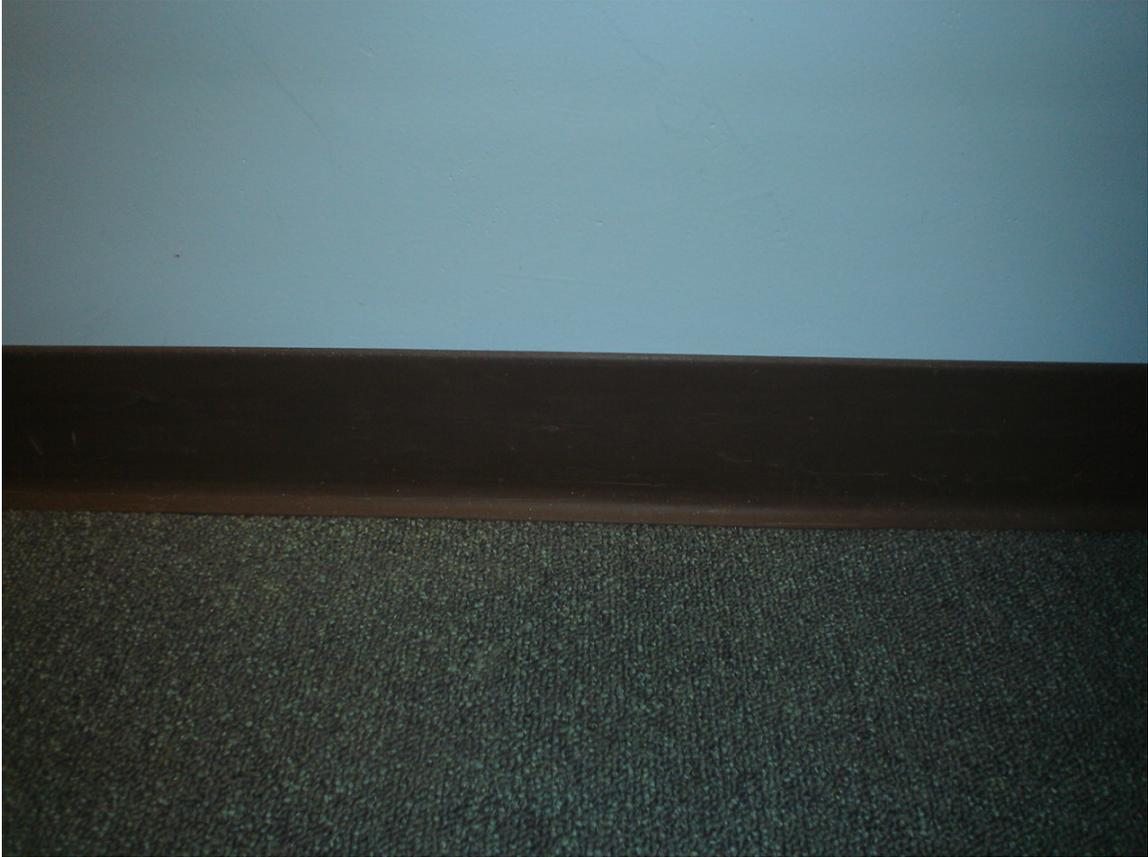
HA #4 – Non asbestos-containing 4” brown cove molding  
and associated mastic

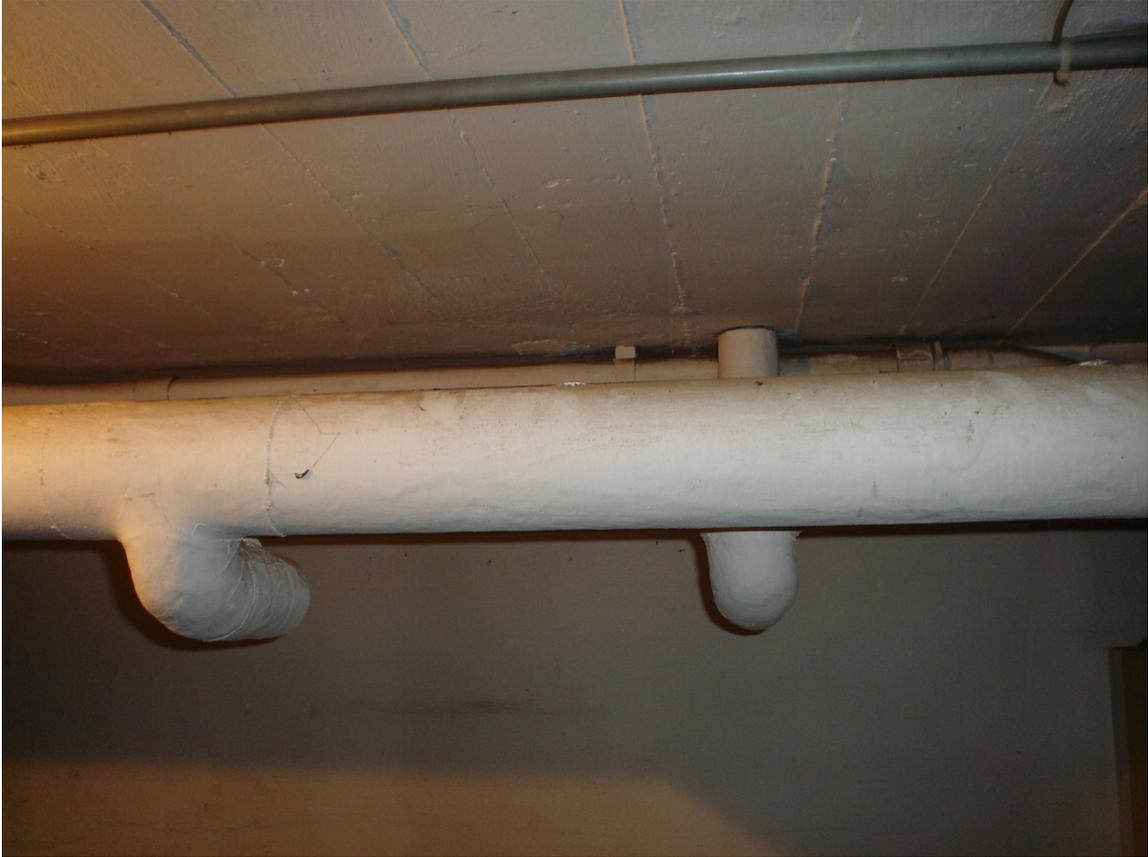
HA #7 – Non asbestos-containing steam/condensate supply and return pipe straight insulation (fiberglass line/canvas cover)

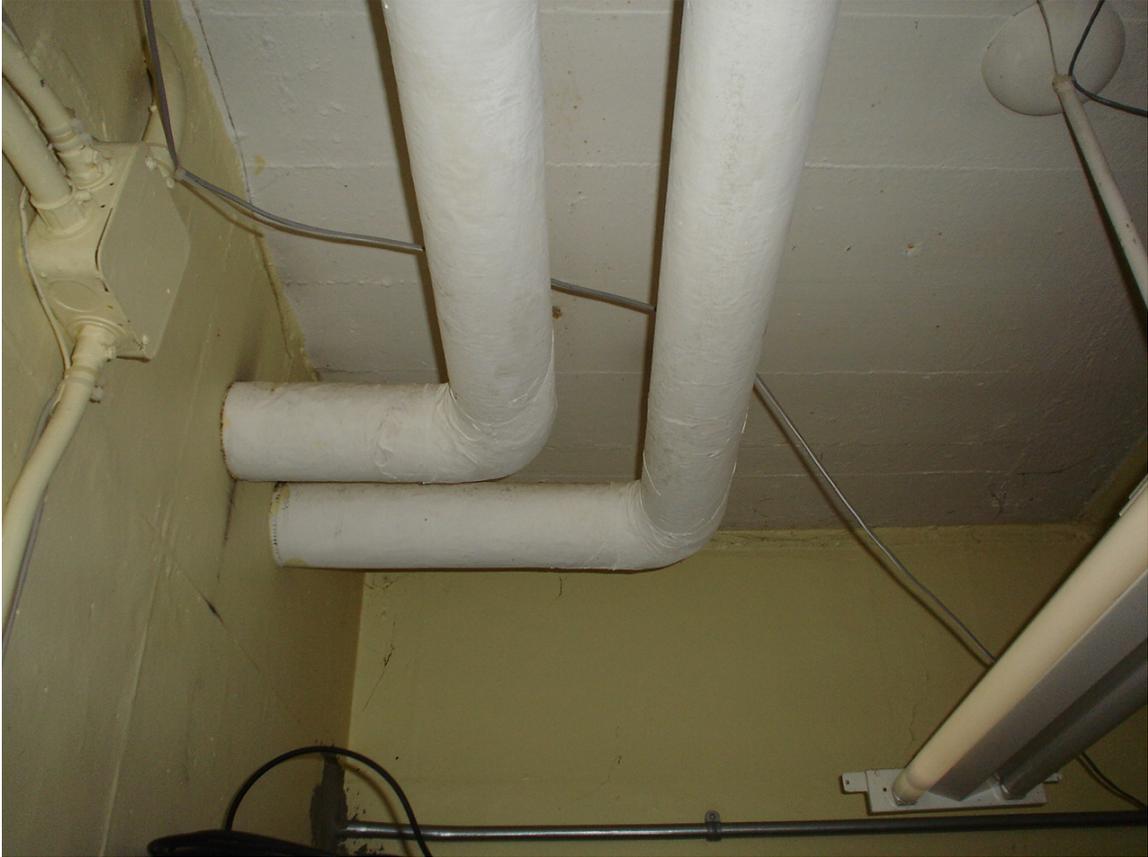
HA #8 – Asbestos-containing steam/condensate supply and return pipe joint insulation (on fiberglass line)

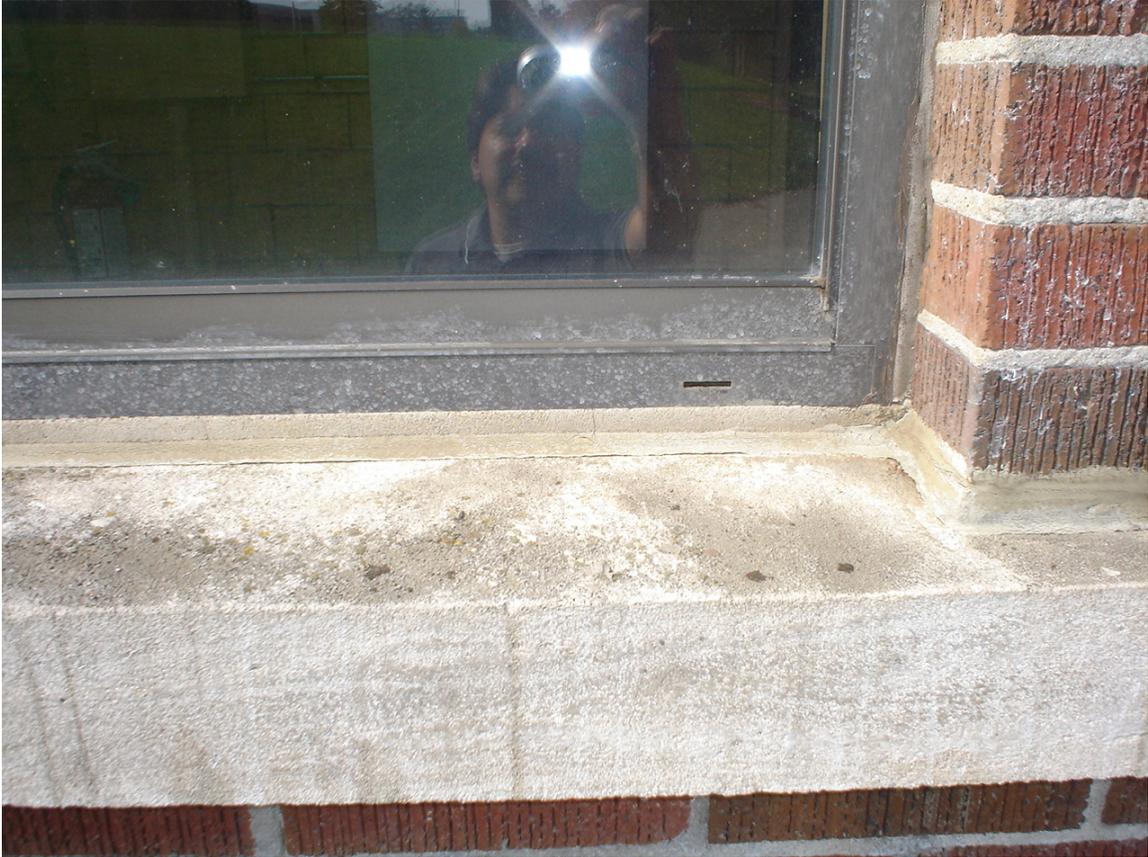
HA #9 – Non asbestos-containing exterior window  
and door frame caulk compound

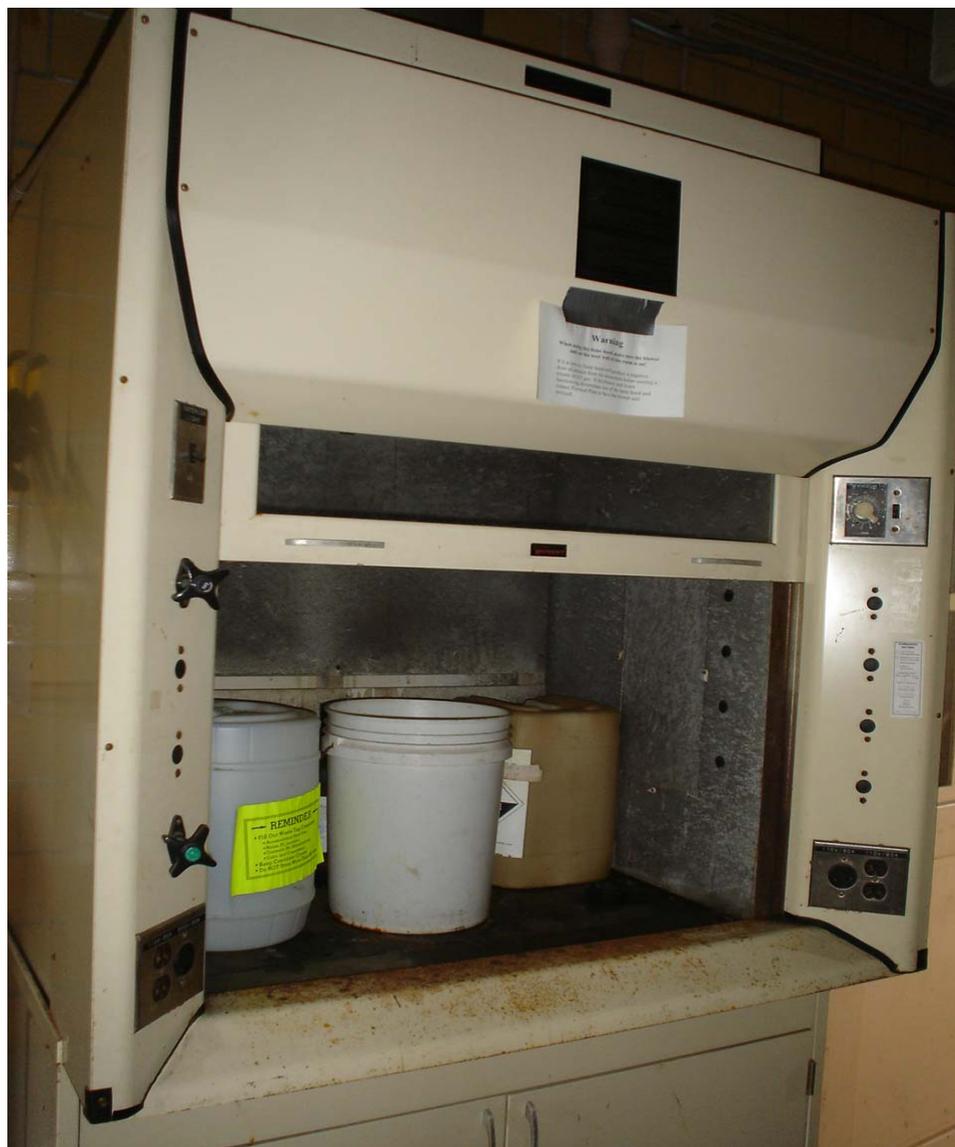
HA #10 – Assumed asbestos-containing laboratory fume hood

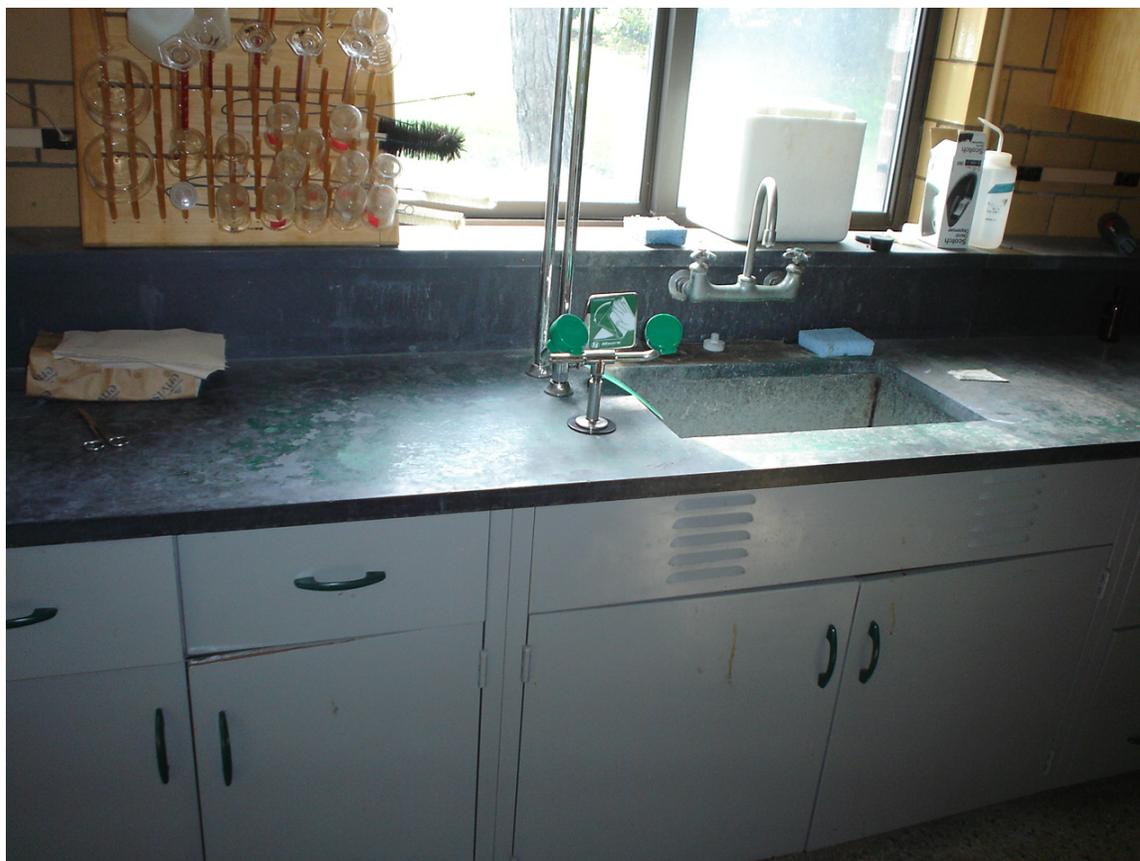
HA #11 – Assumed asbestos-containing laboratory sinks,  
table tops and ledges

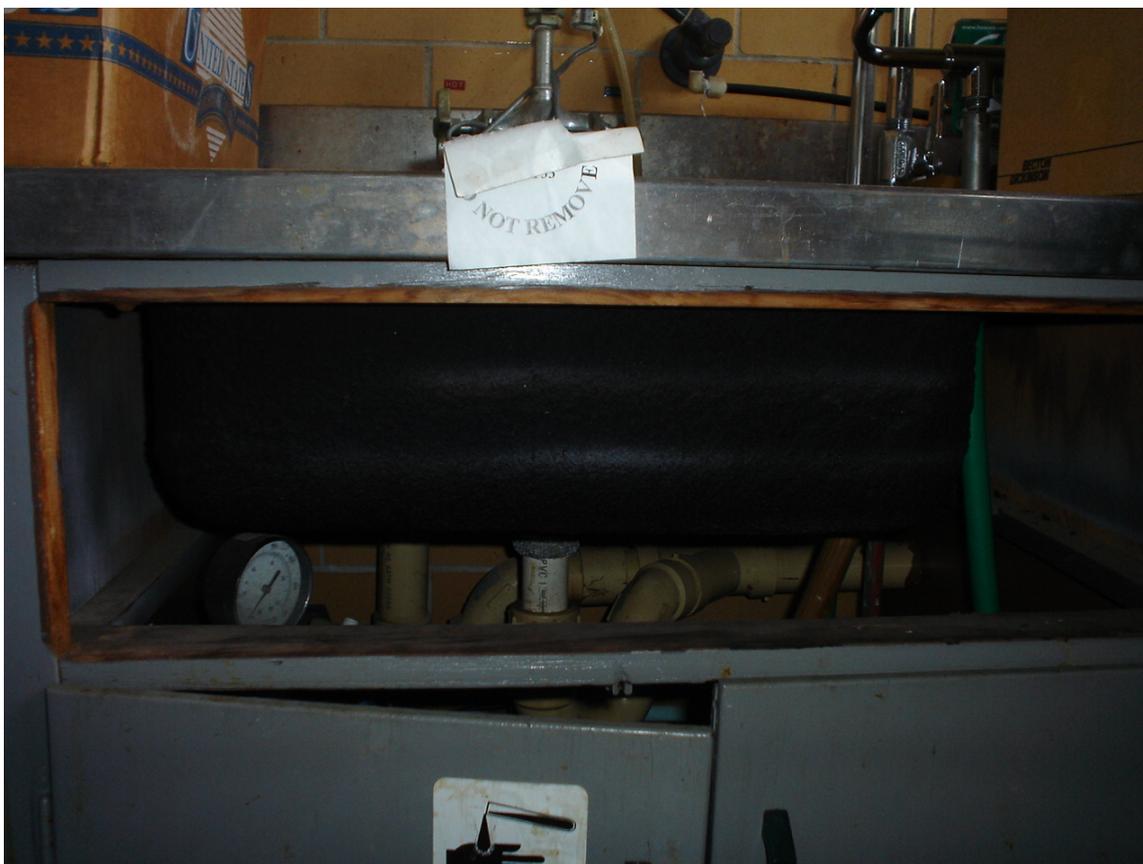
HA #12 – Asbestos-containing black sink undercoating

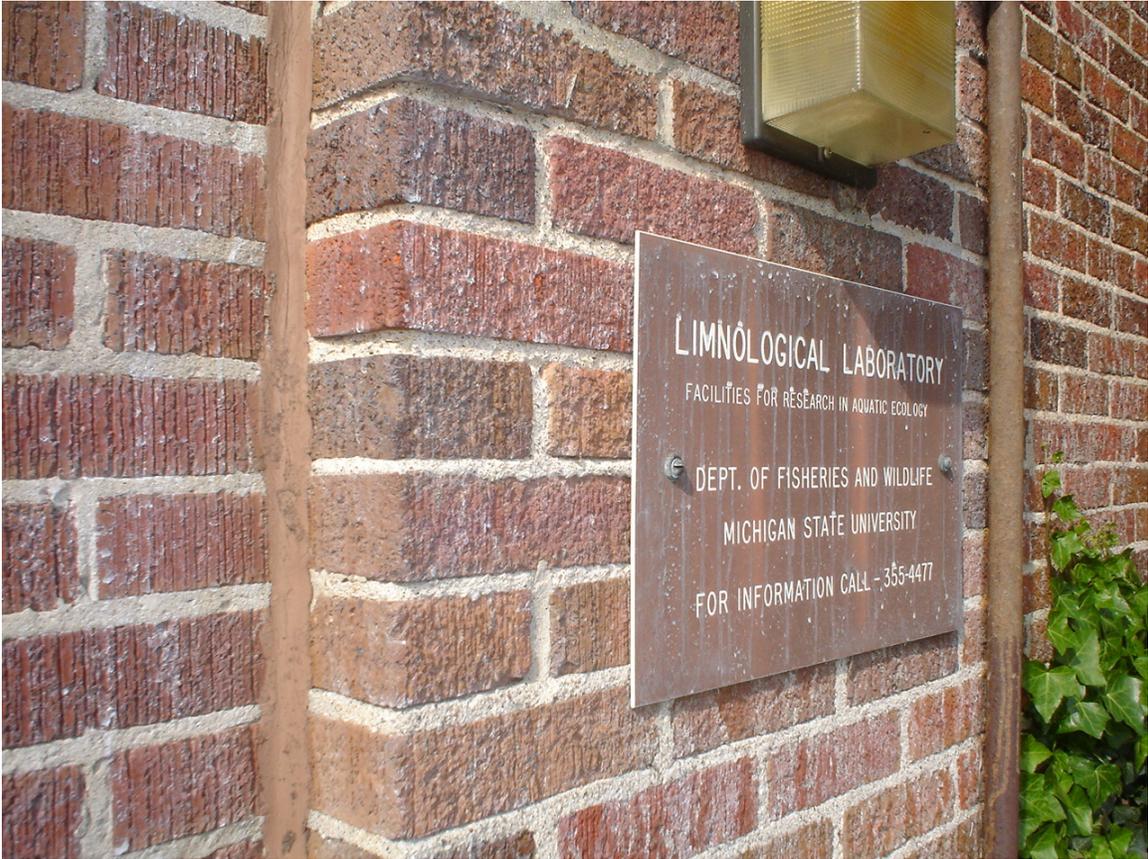
HA #13 – Asbestos-containing building caulk compound
