## River Water Research Center Photo Log

Exterior of the MSU River Water Research Building

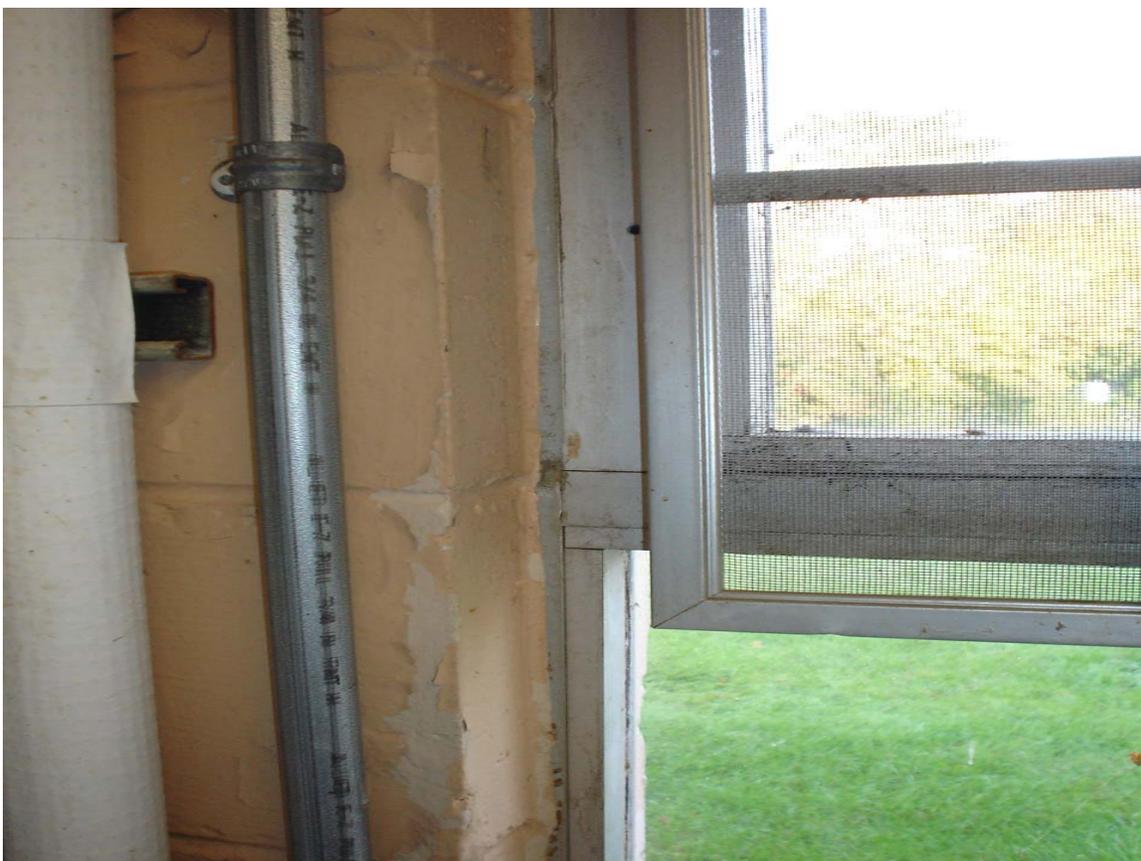
HA #1 – Asbestos-containing window and door frame caulk compound  
(interior)

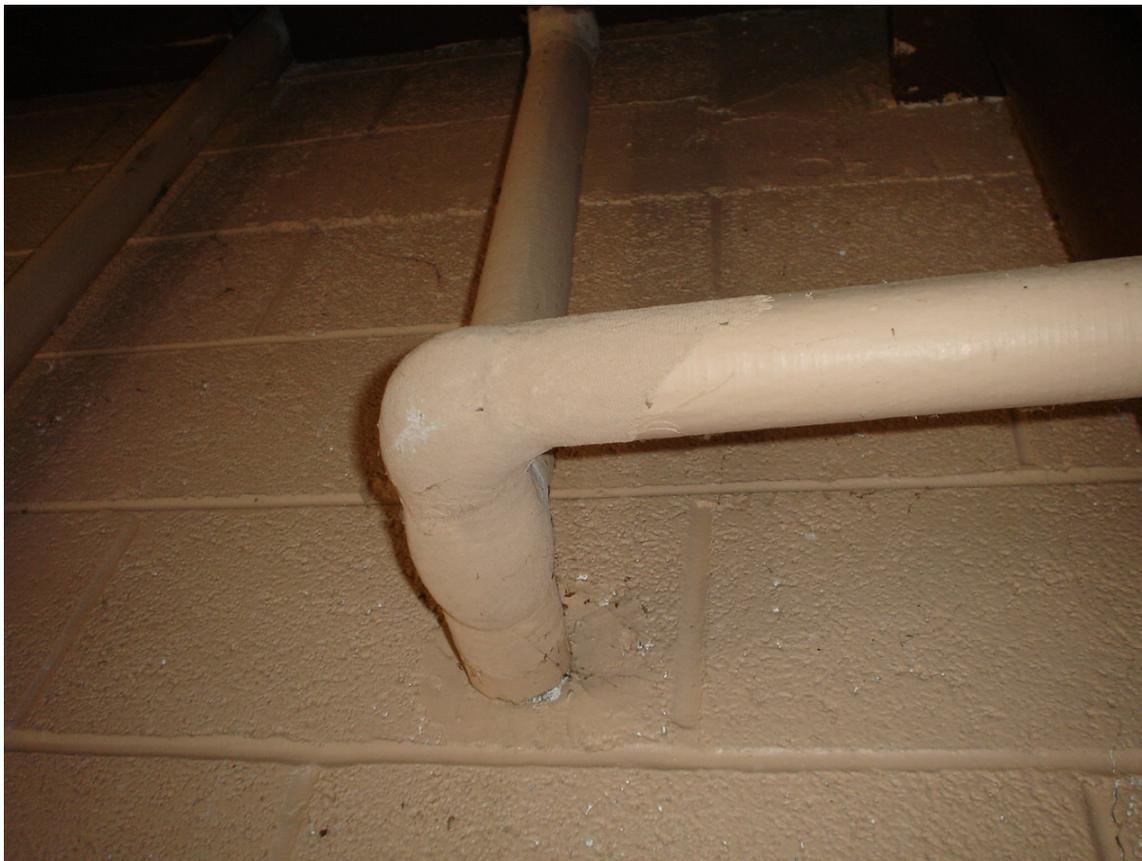
HA #2 – Non asbestos-containing domestic water supply pipe joint insulation (on fiberglass pipe straight insulation)

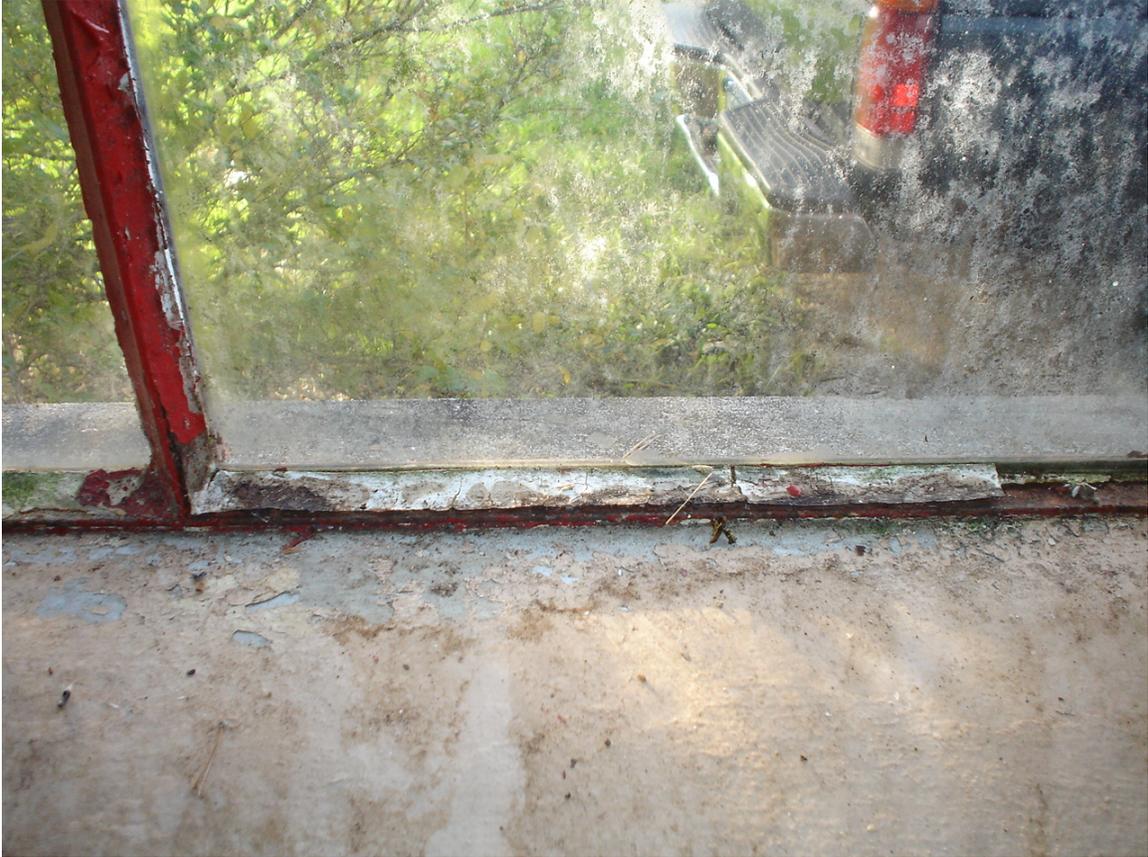
HA #3 – Asbestos-containing window glazing compound

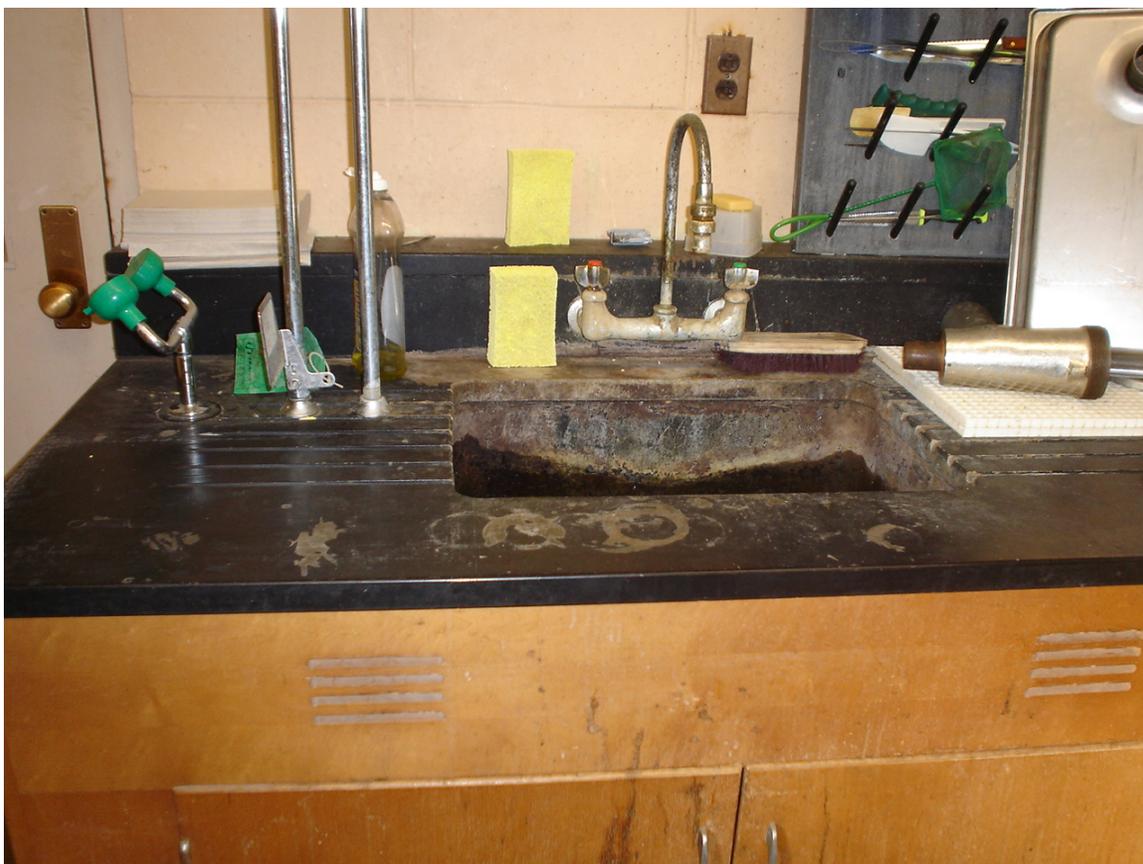
HA #4 – Assumed asbestos-containing laboratory sinks and table tops

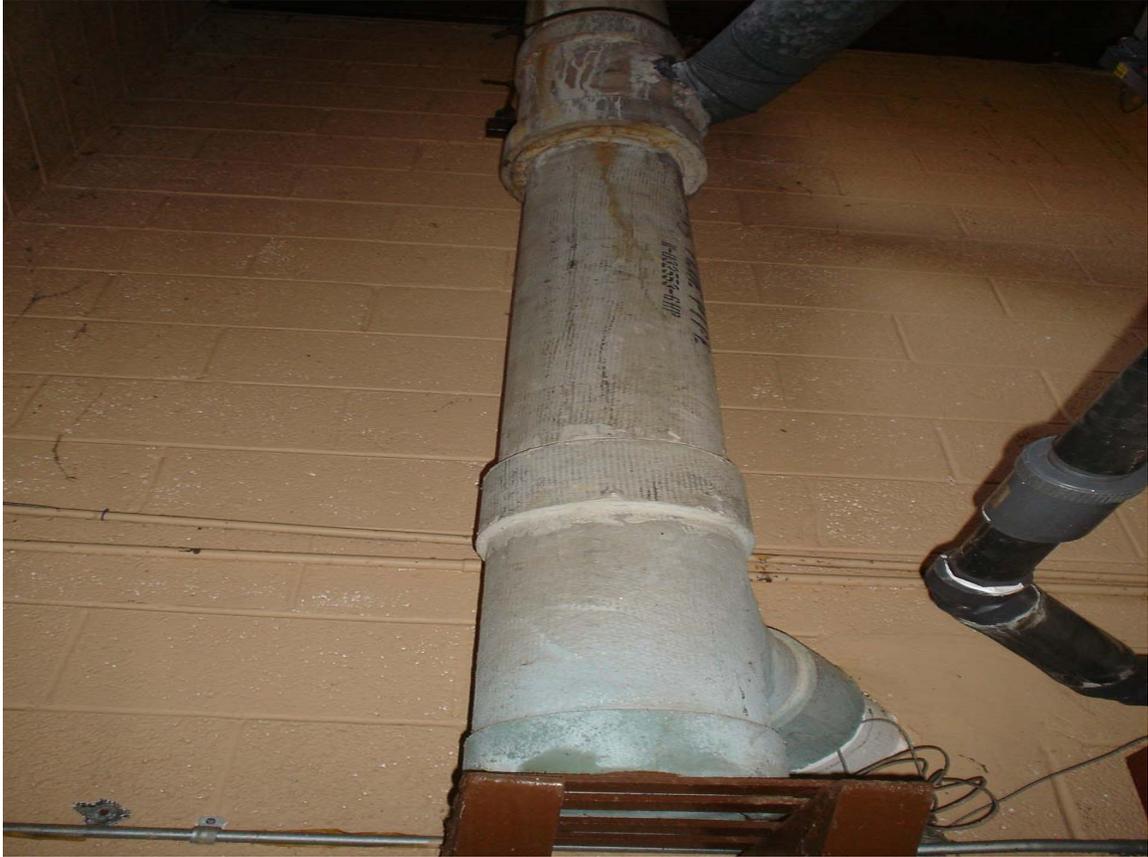
HA #5 – Asbestos-containing transite heat vent pipe

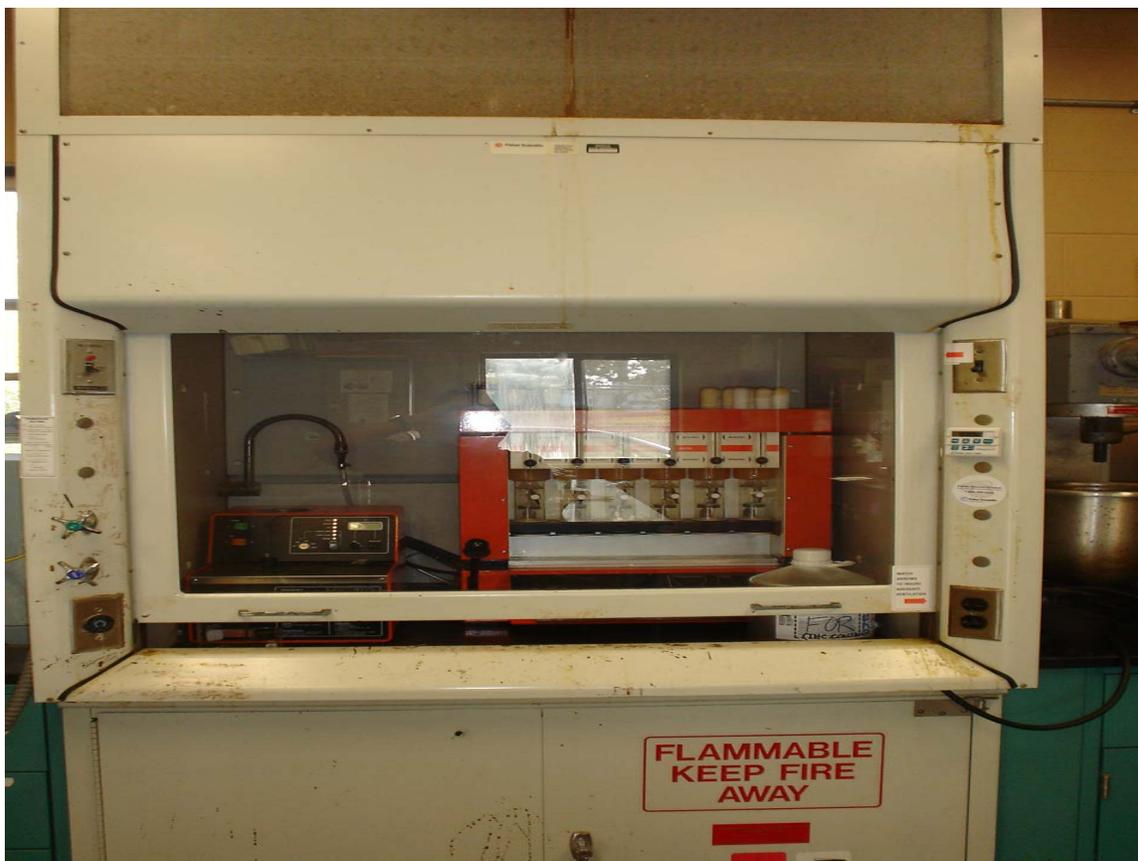
HA #6 – Assumed asbestos-containing laboratory fume hood

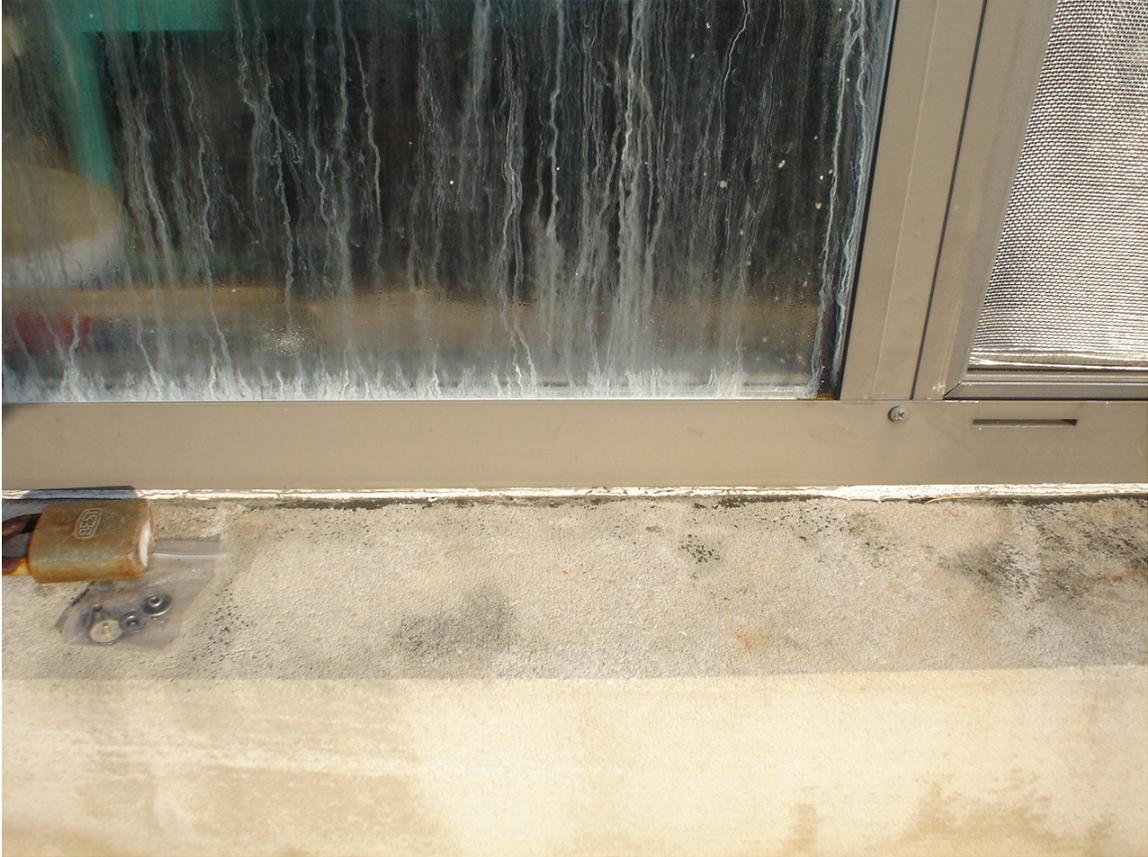
HA #8 – Asbestos-containing window and door frame caulk compound  
(exterior)

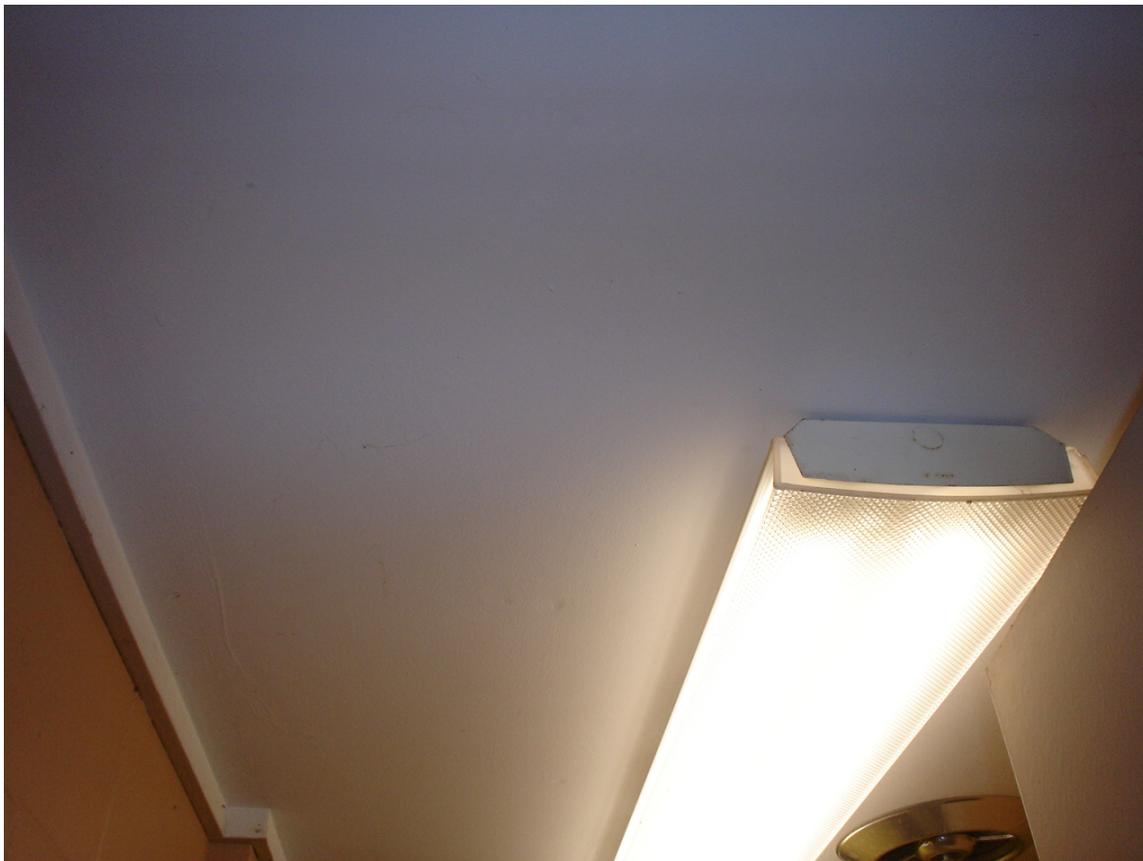
HA #9 – Non asbestos-containing drywall
