Demonstration Hall Photo Log

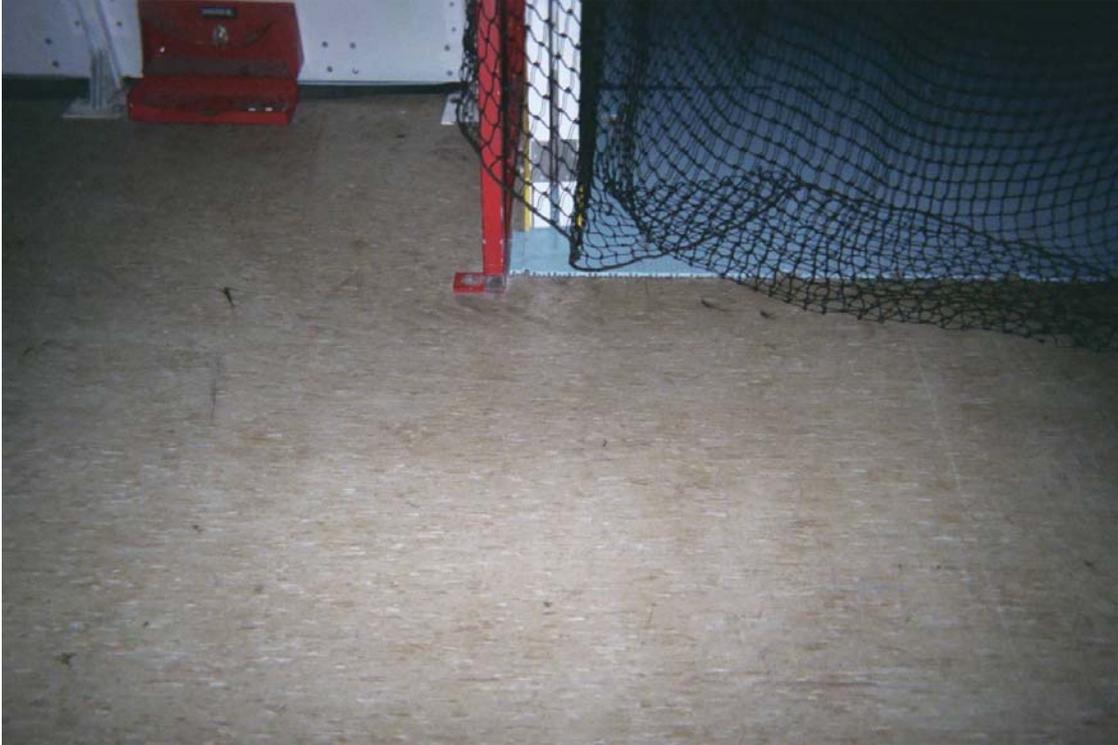
Non-asbestos containing tan linoleum with cream and brown streaks

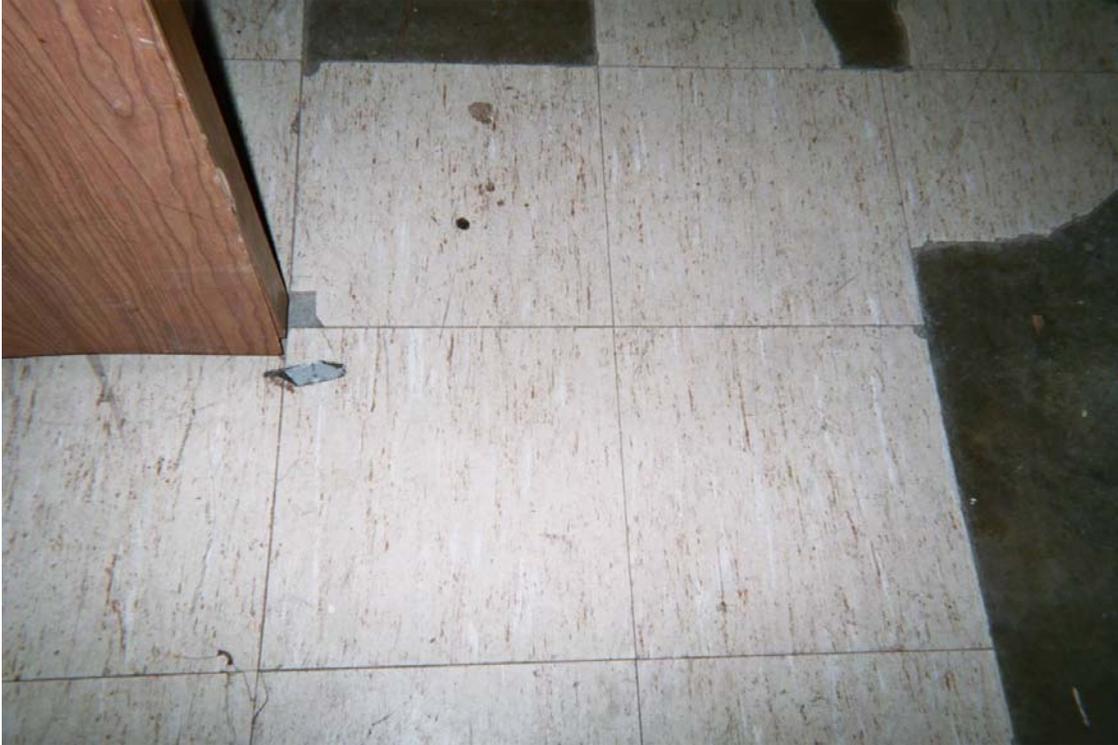
Asbestos-containing 9" x 9" wood grain pattern floor tile

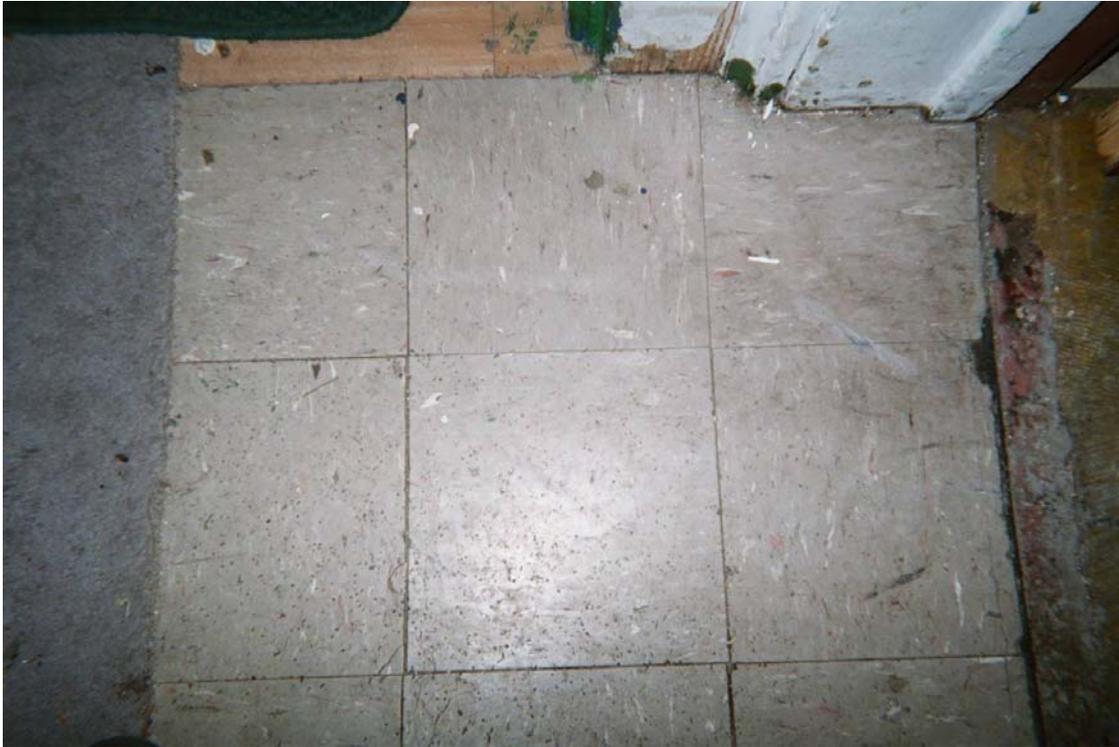
Asbestos-containing 9" x 9" gray floor tile with cream and pink streaks

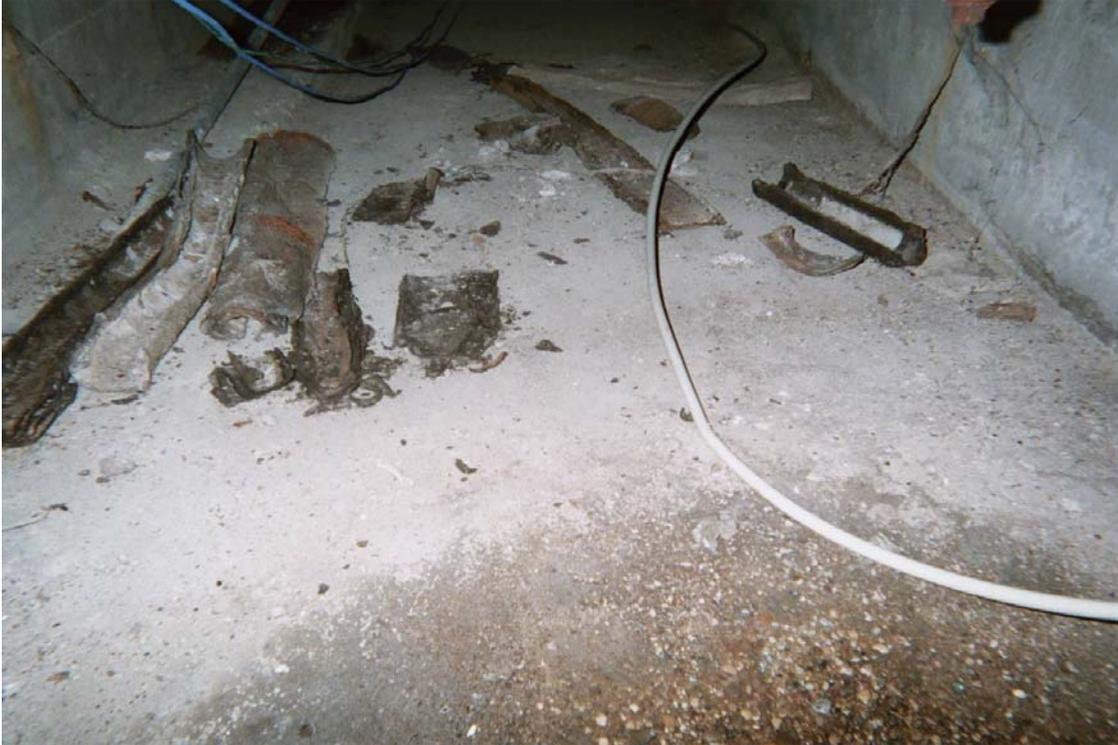
Asbestos-containing steam pipe straight insulation ACM debris
on floor of tunnel area

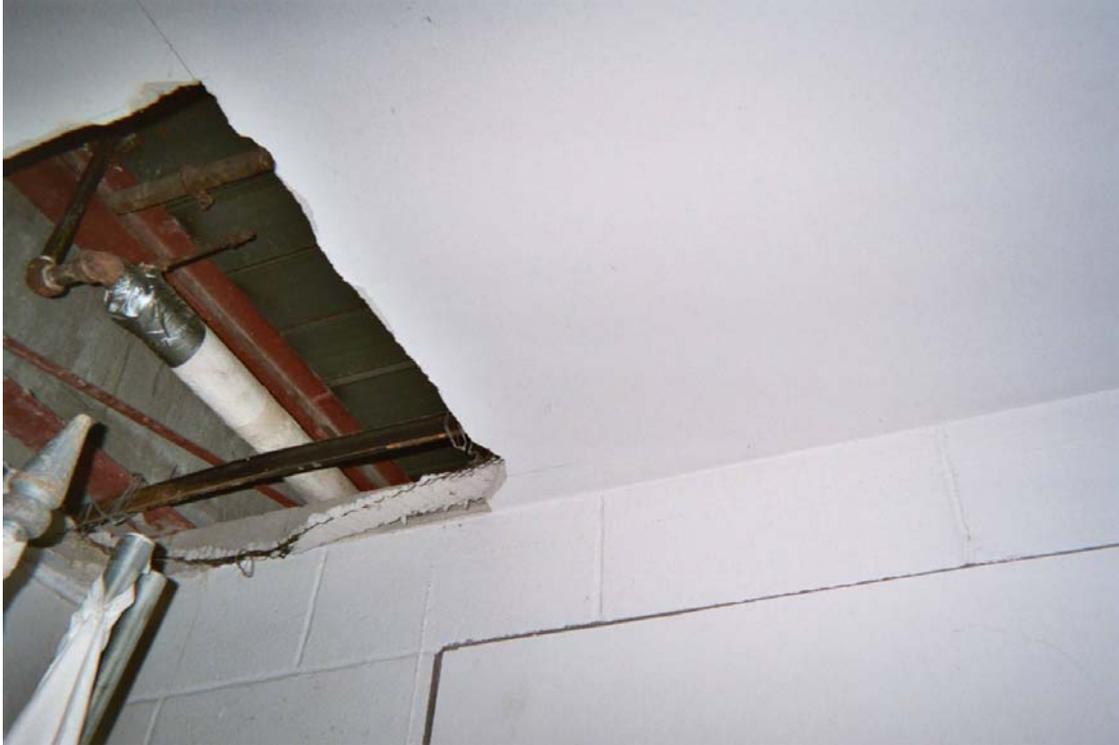
Non-asbestos containing plaster

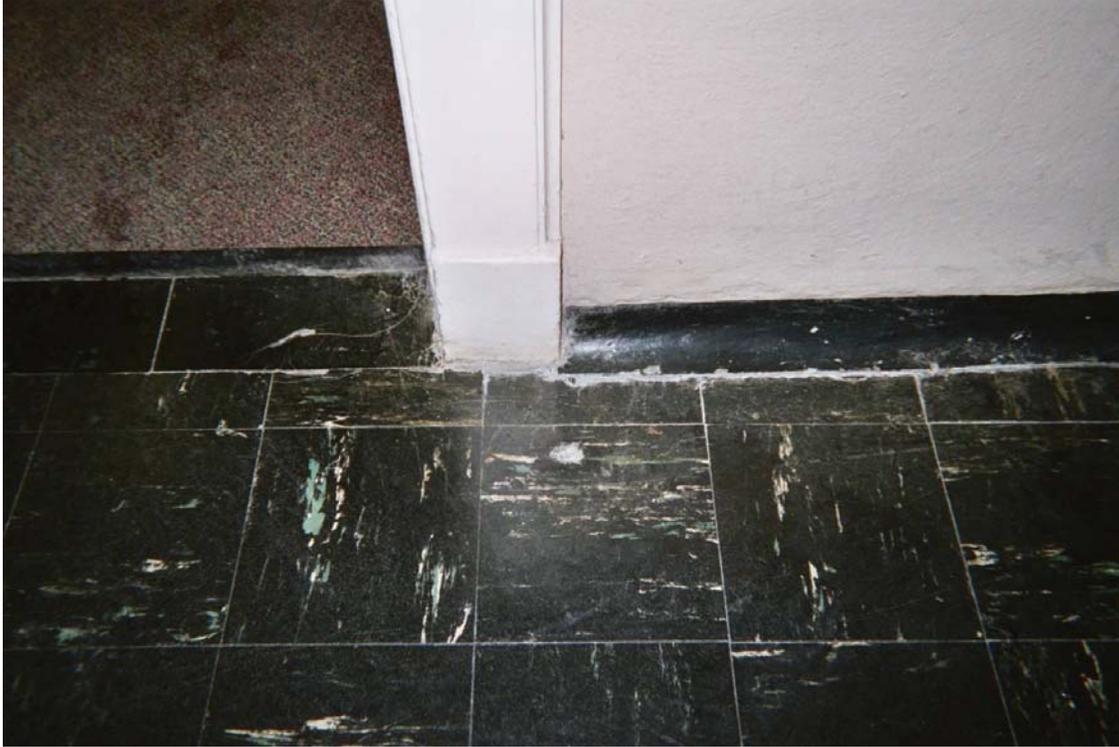
Asbestos-containing 9" x 9" black floor tile with cream and green streaks

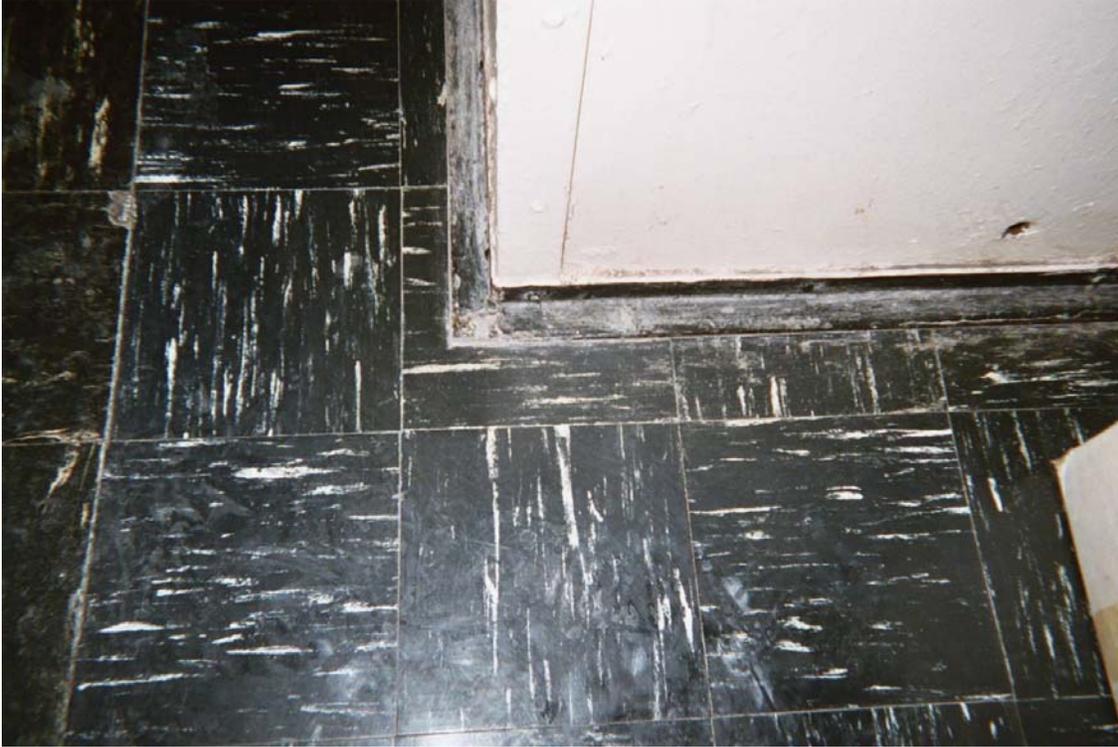
Asbestos-containing 9" x 9" black floor tile with cream streaks

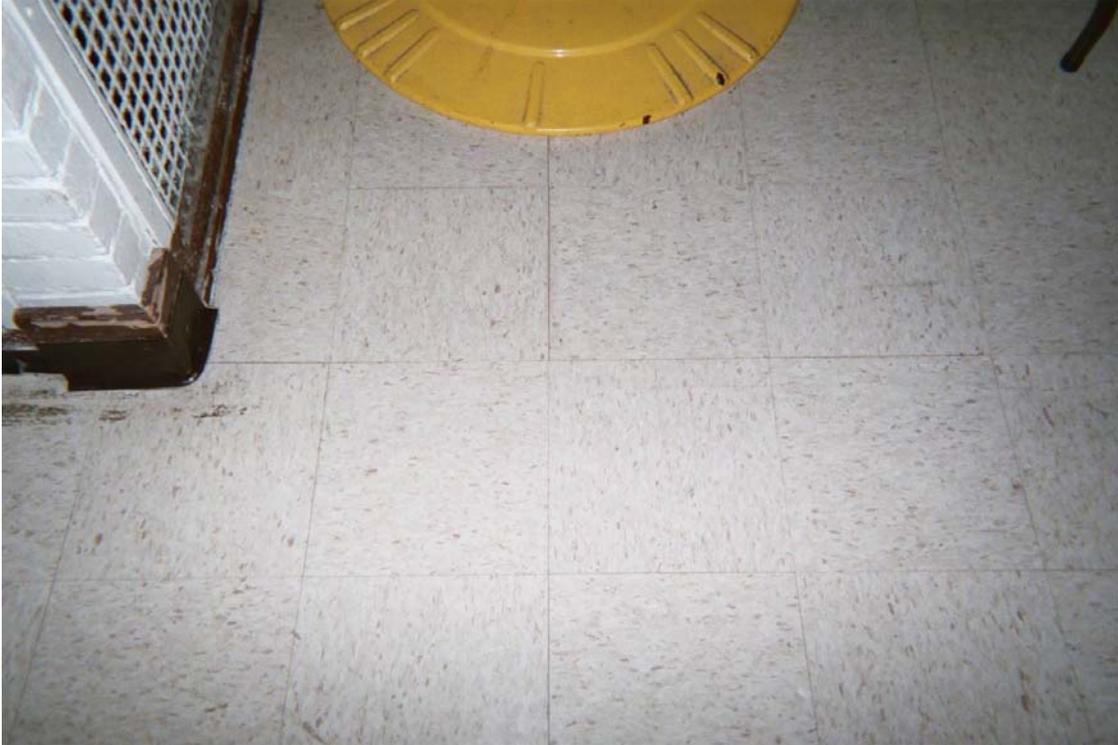
Non-asbestos containing tan linoleum with cream and brown streaks

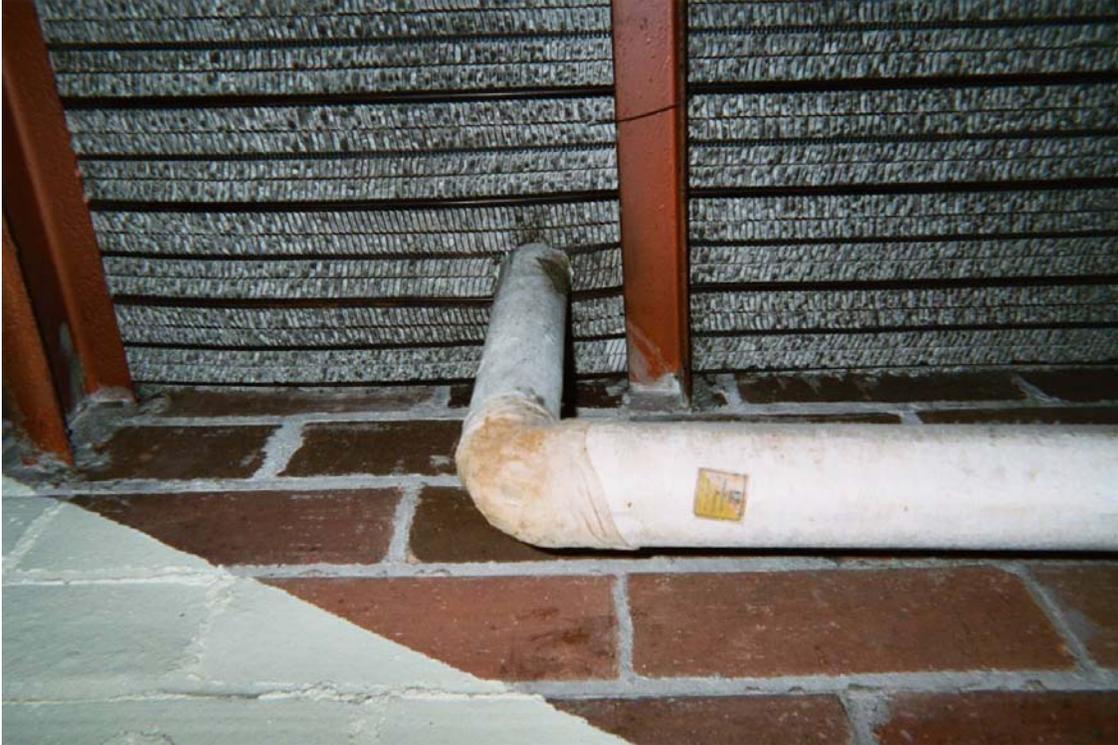
Asbestos-containing steam/condensate pipe straight insulation

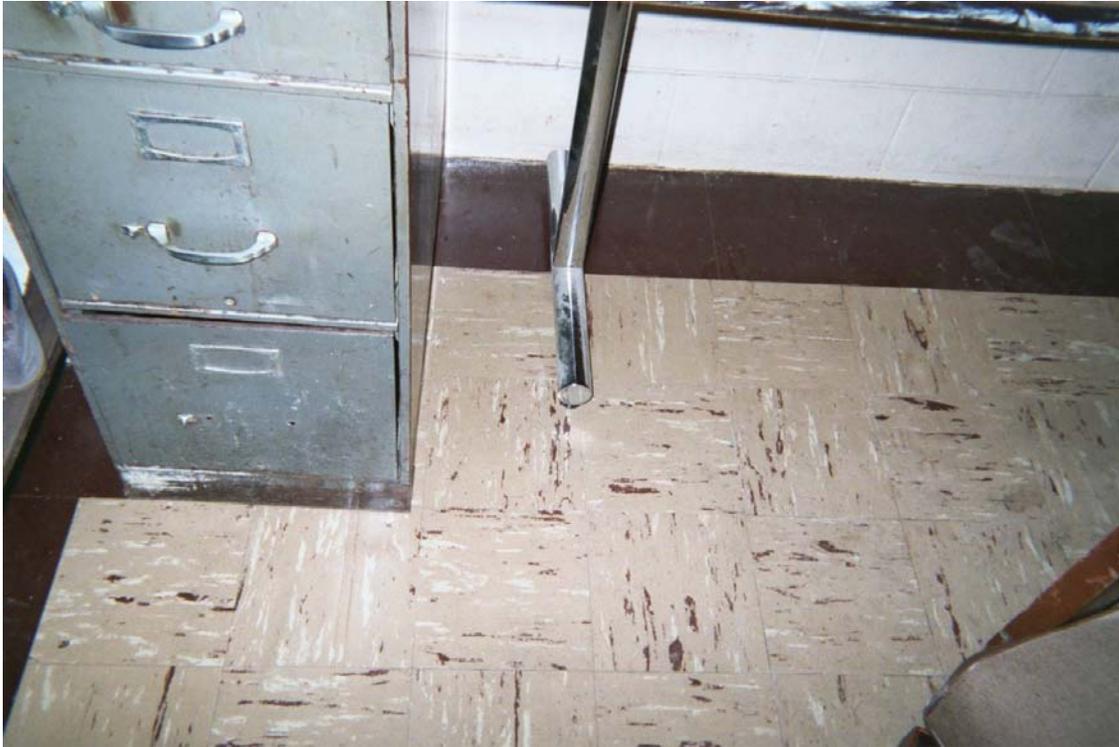
Asbestos-containing 9" x 9" tan floor tile with cream and rust streaks

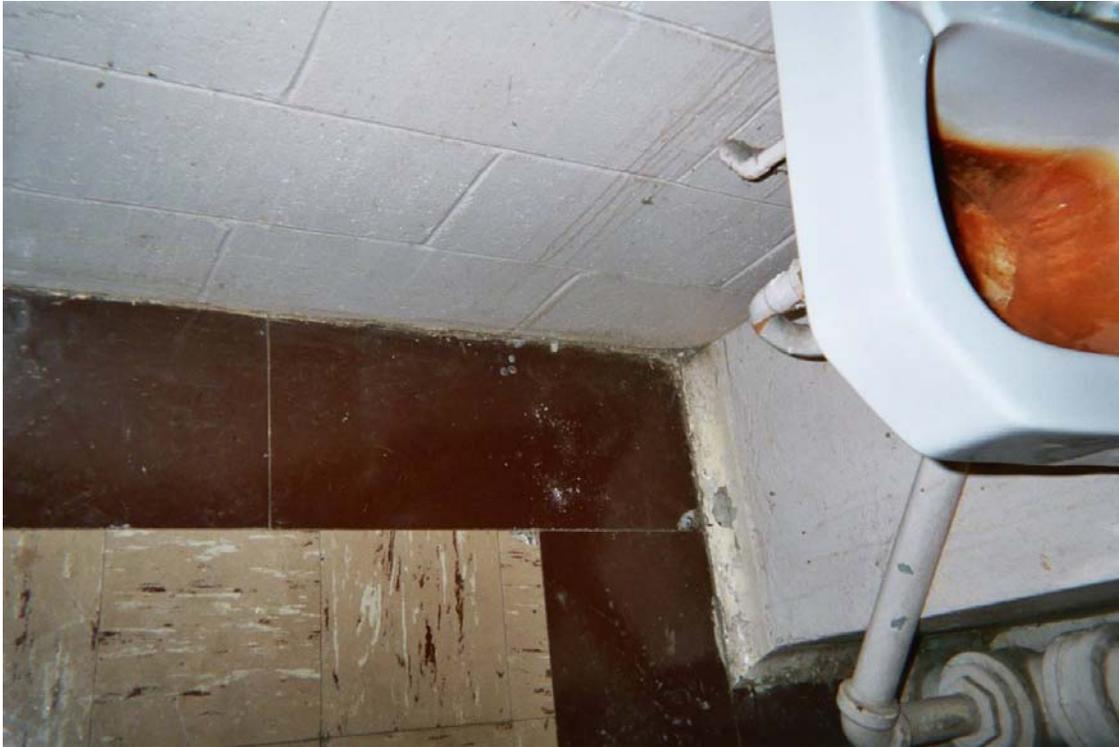
Asbestos-containing 1' x 2' brown floor tile

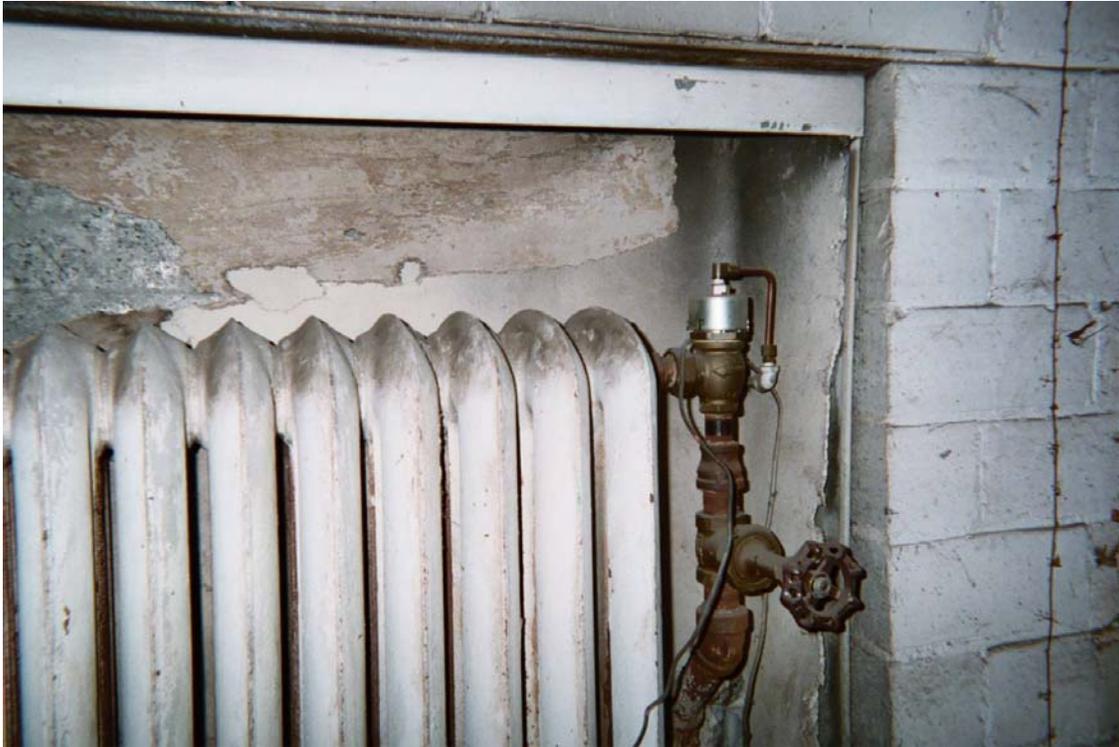
Asbestos-containing radiator backing paper

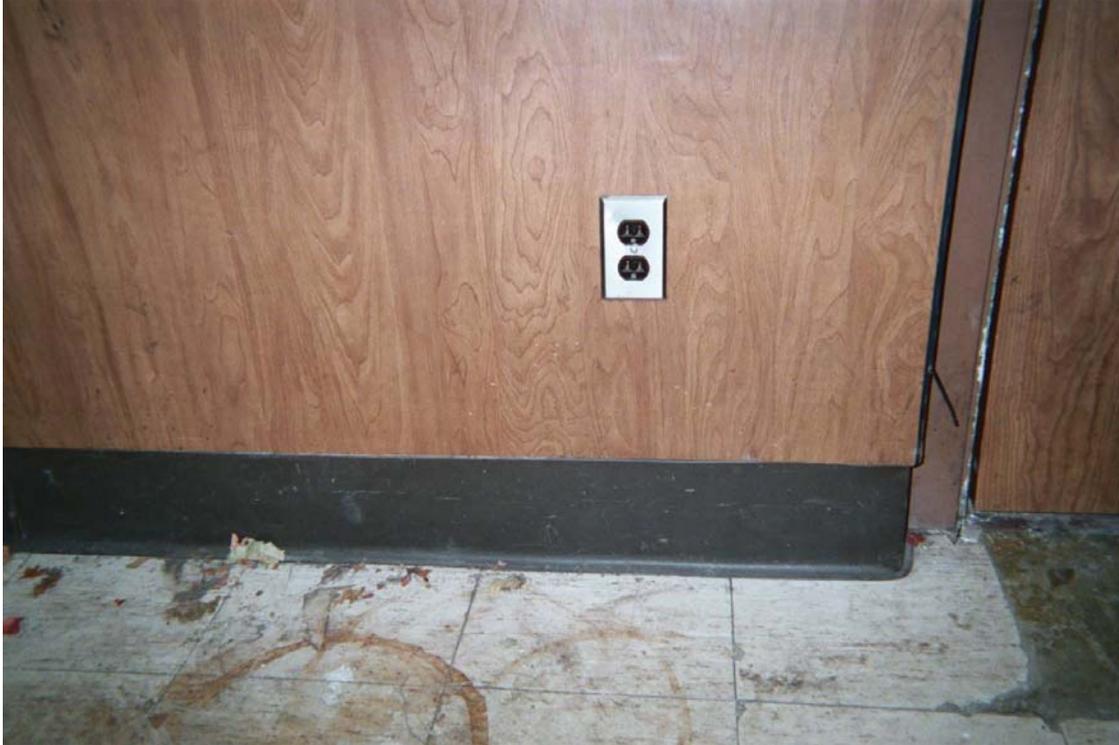
Non-asbestos containing 6" brown cove molding and associated mastic

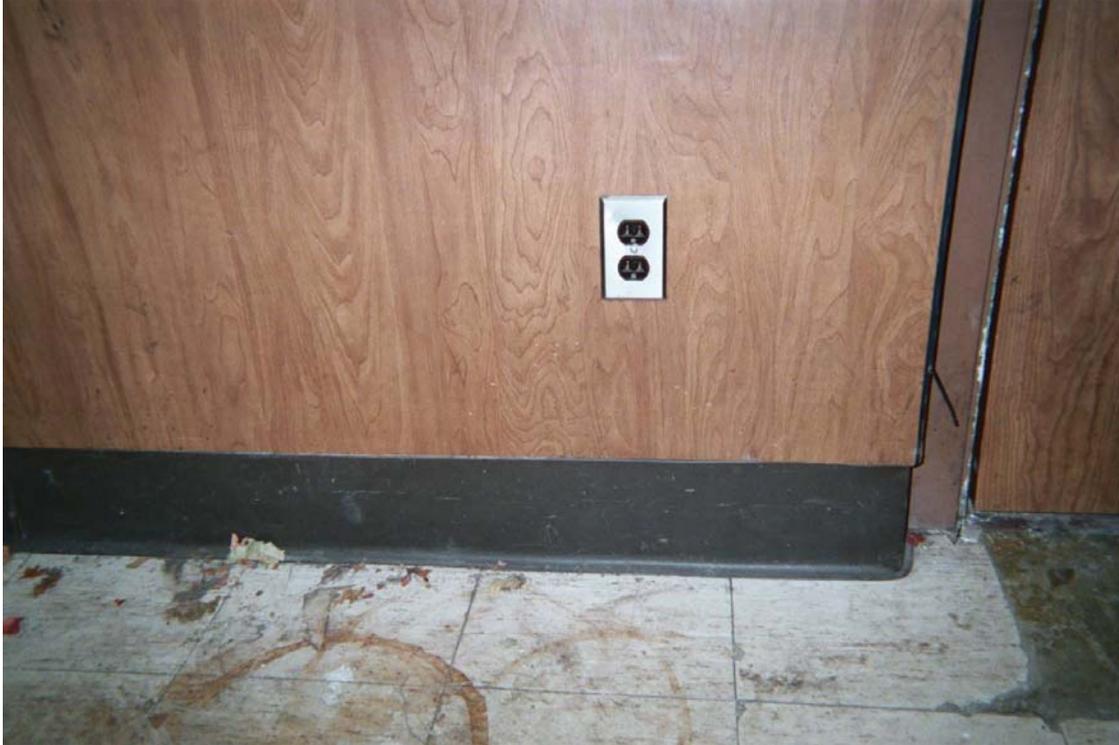
Non-asbestos containing 12" x 12" tan floor tile with cream and rust streaks

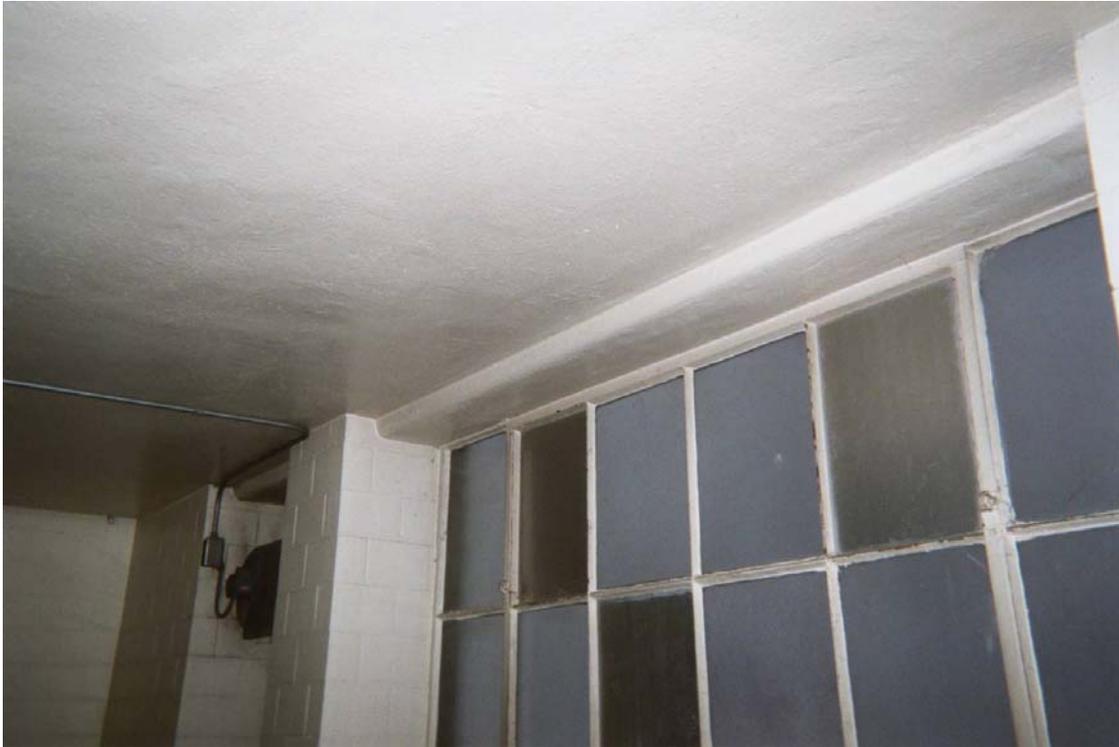
Assumed asbestos-containing window glazing compound

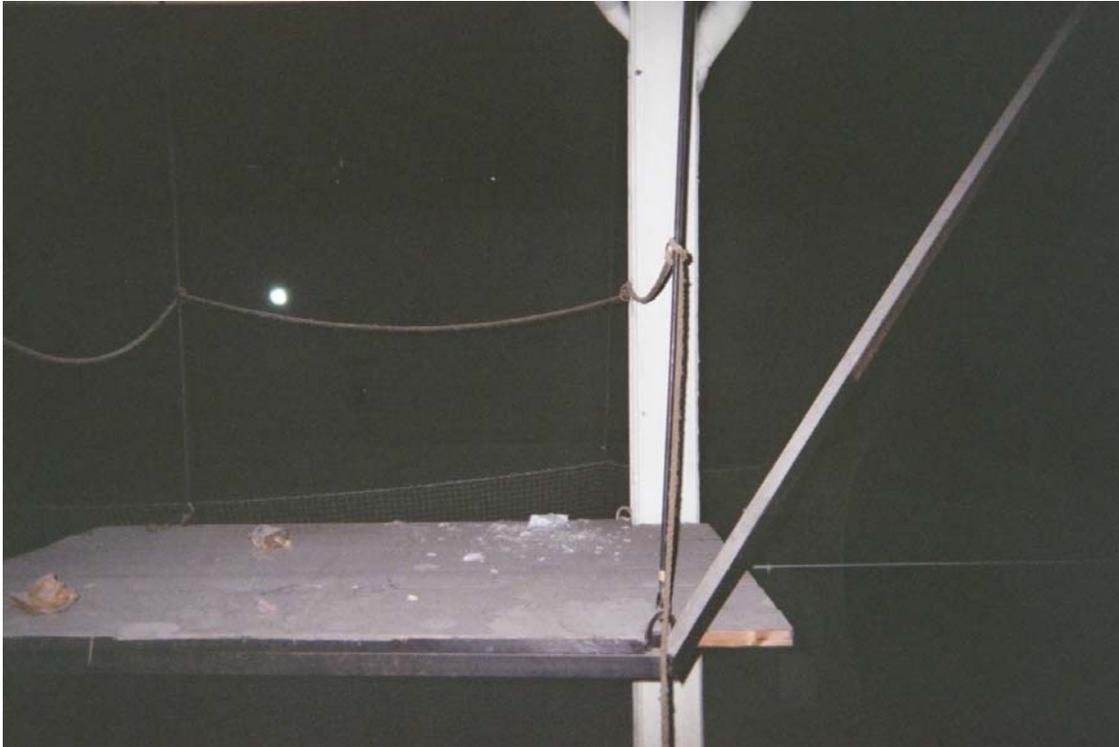
Asbestos-containing raised platform ACM debris

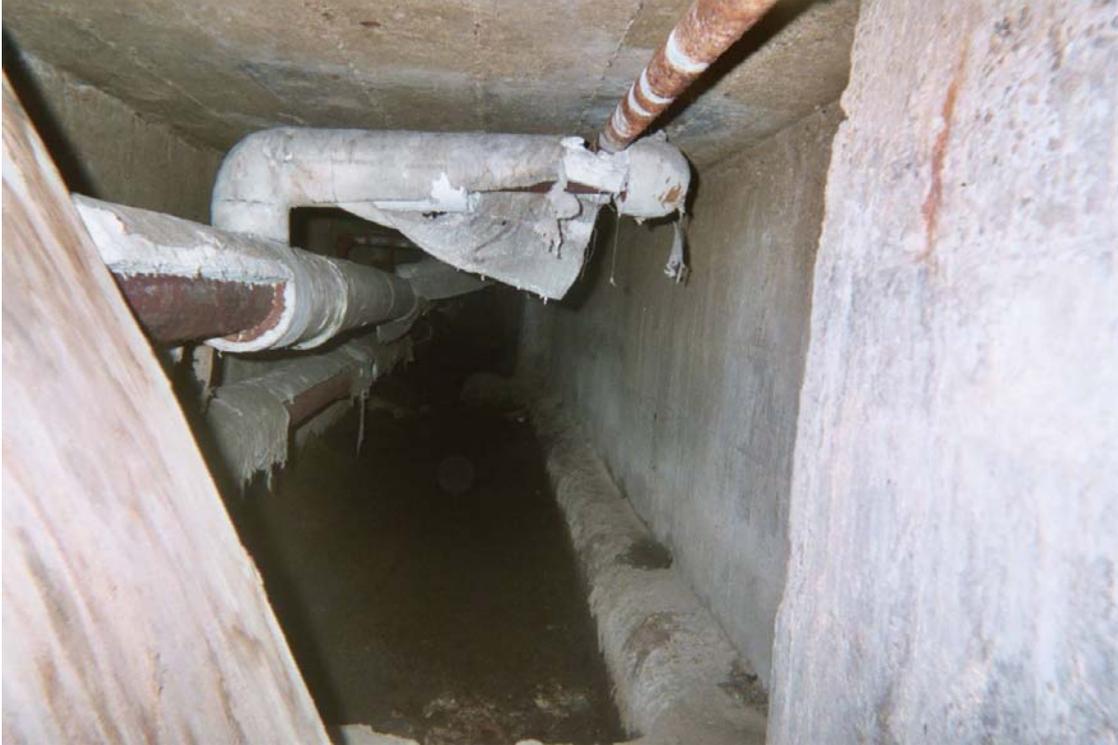
Asbestos-containing steam/condensate pipe joint and hanger insulation

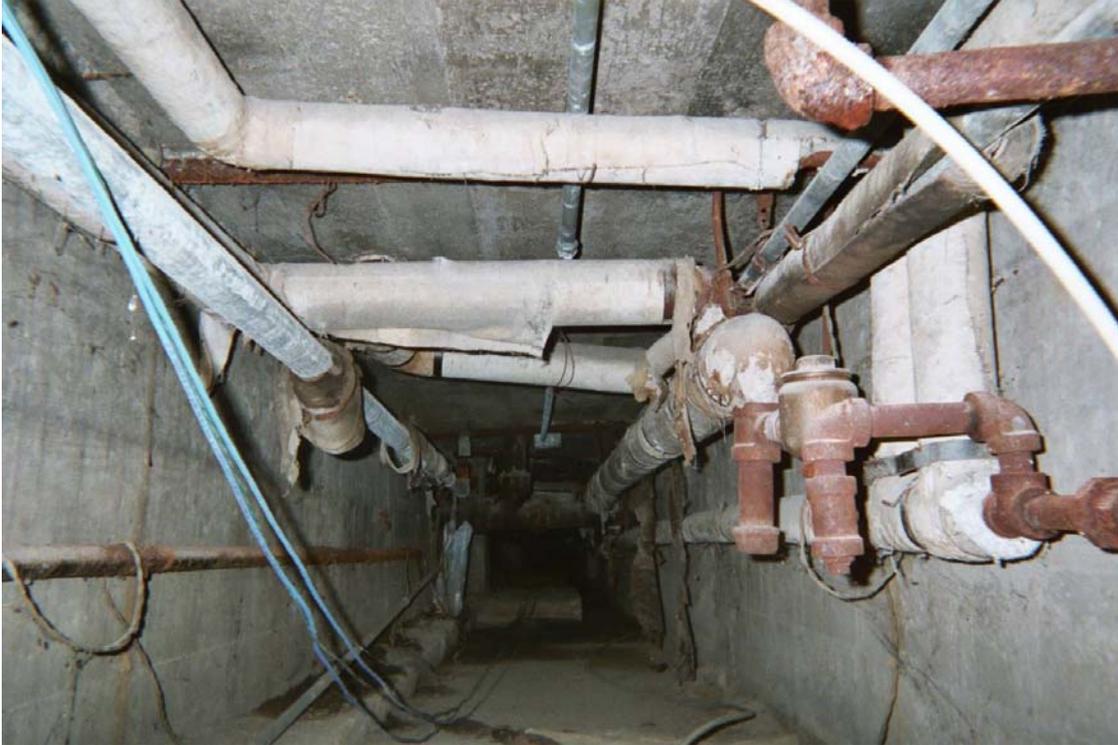
Asbestos-containing steam/condensate pipe straight insulation

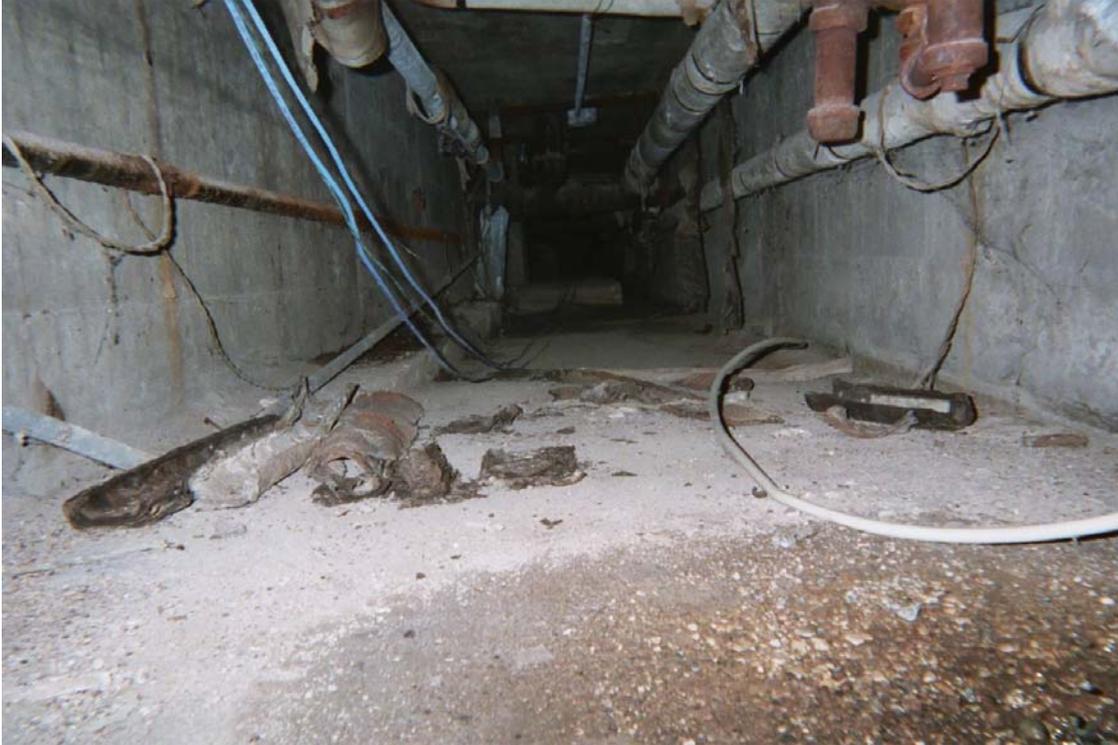
Asbestos-containing steam pipe straight insulation ACM debris
on floor of tunnel area

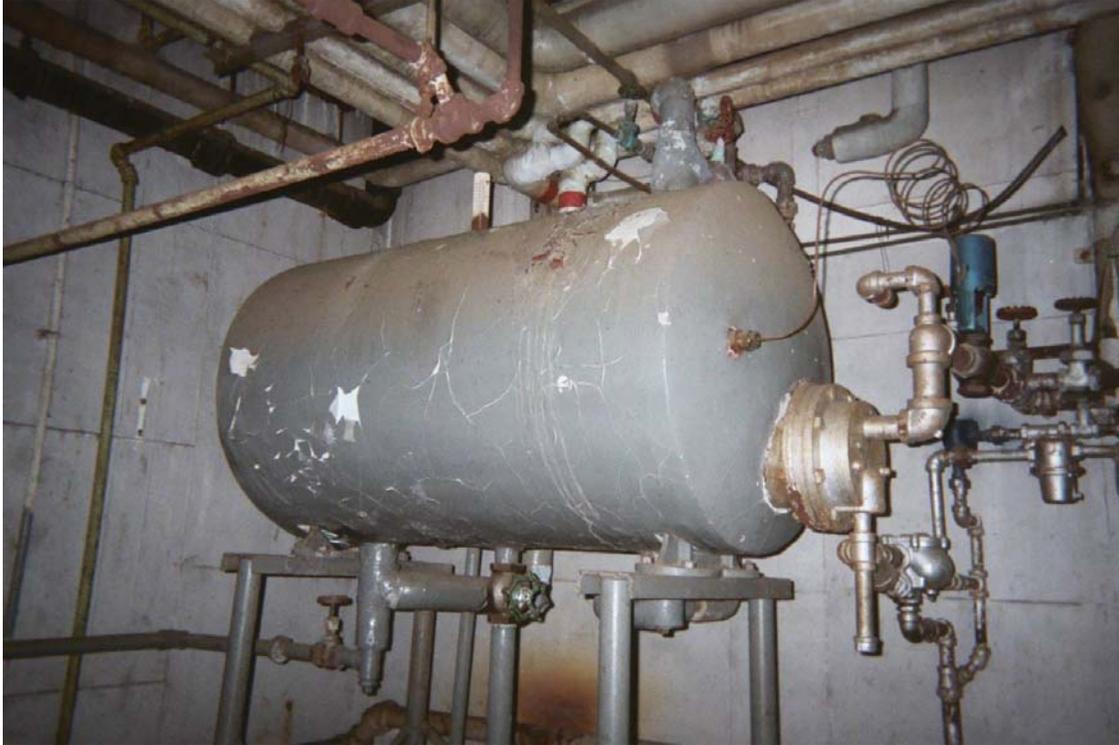
Asbestos-containing hot water holding tank insulation

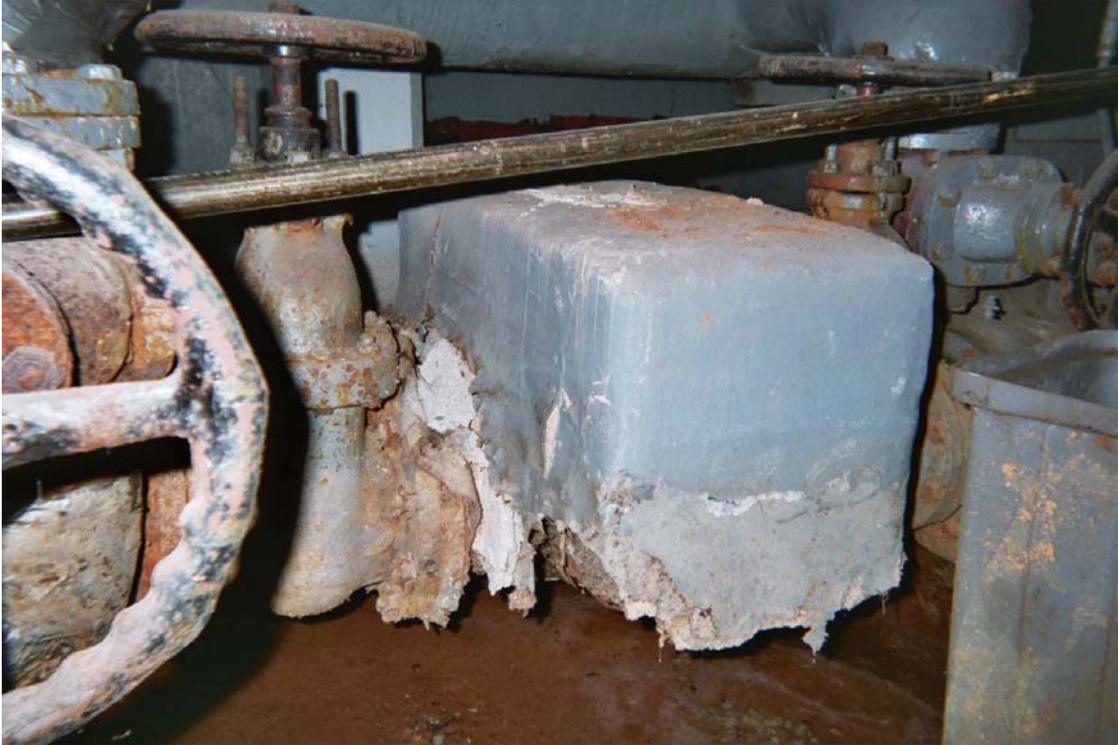
Damaged thermal system insulation, Boiler Room

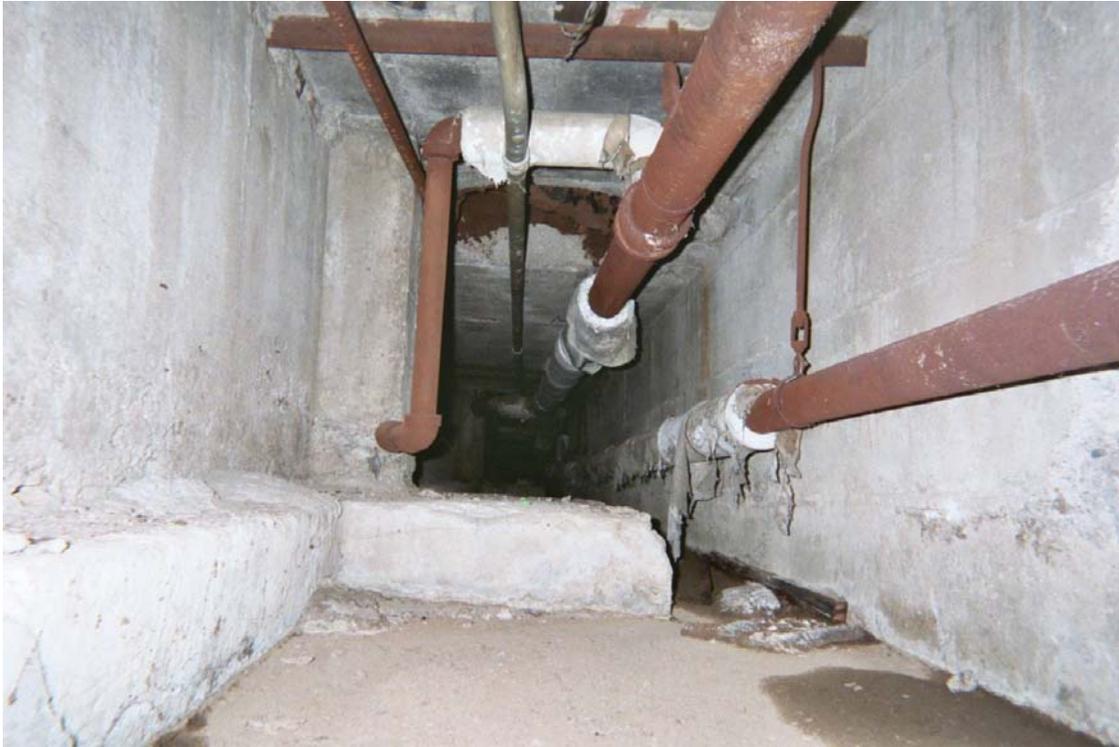
Asbestos-containing steam/condensate pipe straight insulation

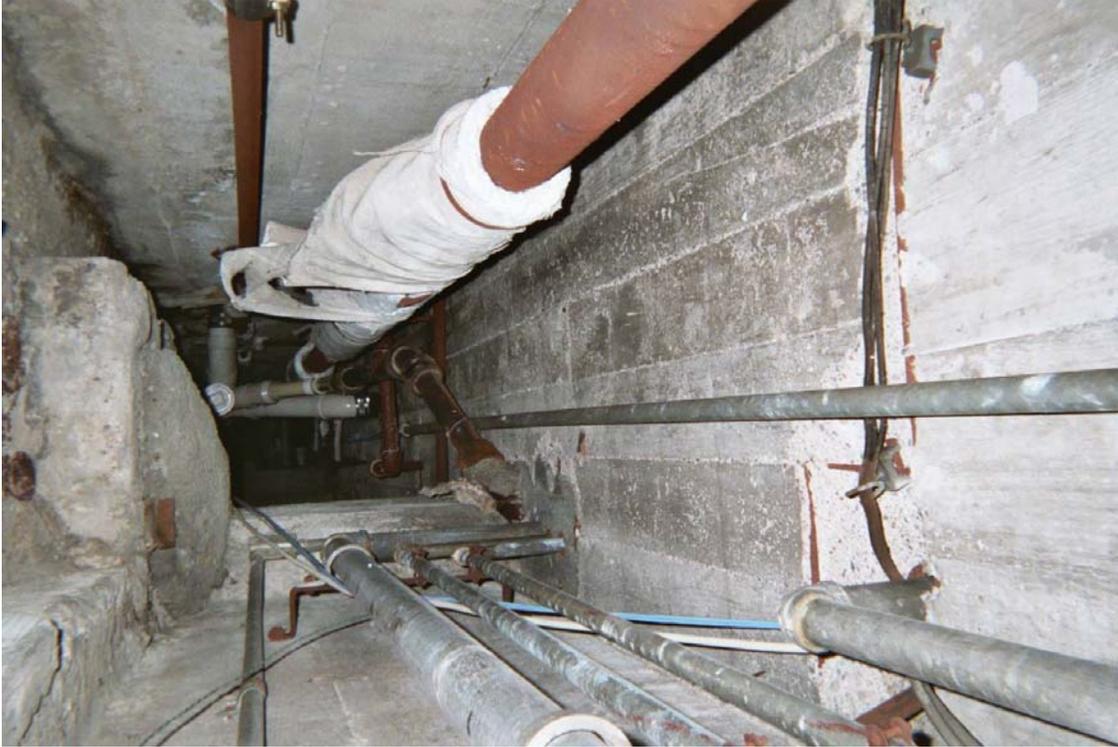
Asbestos-containing steam/condensate pipe straight insulation

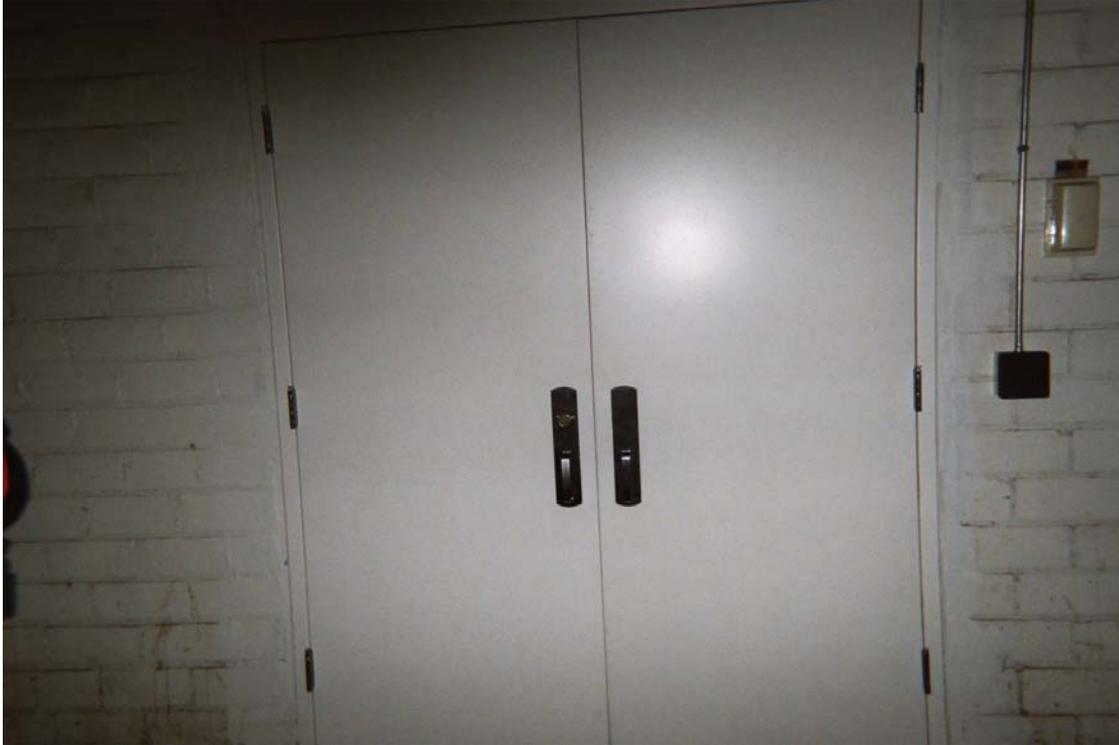
Assumed asbestos-containing fire door and frame

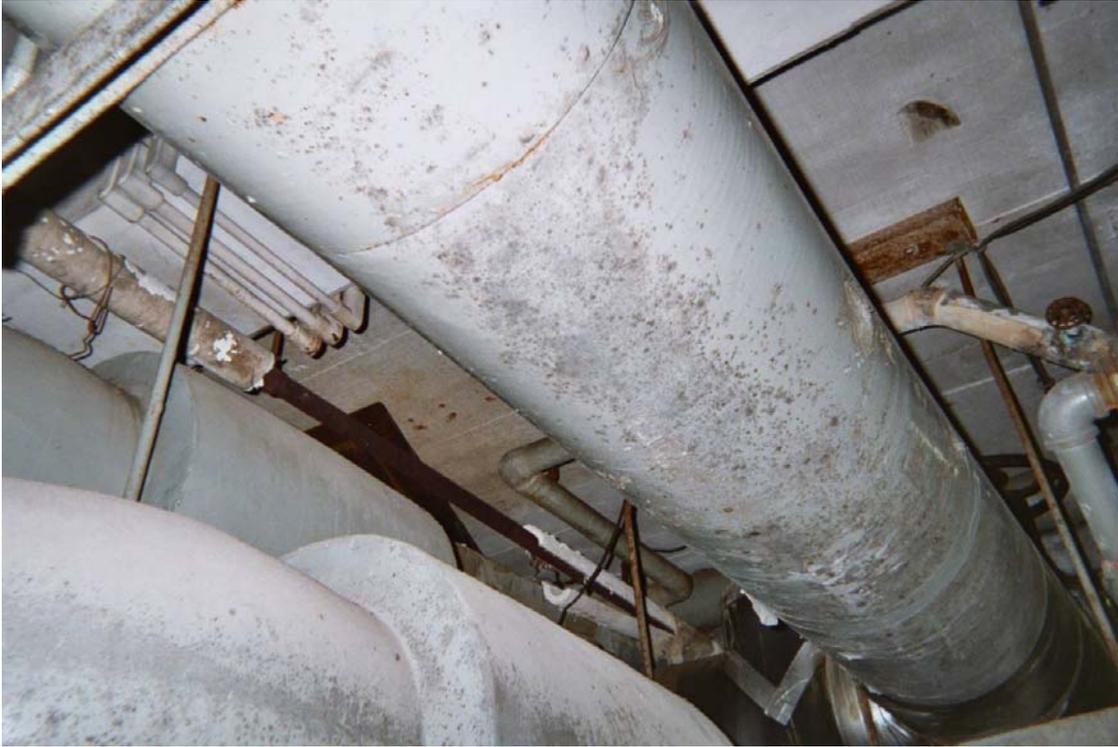
Asbestos-containing Steam/condensate pipe straight insulation

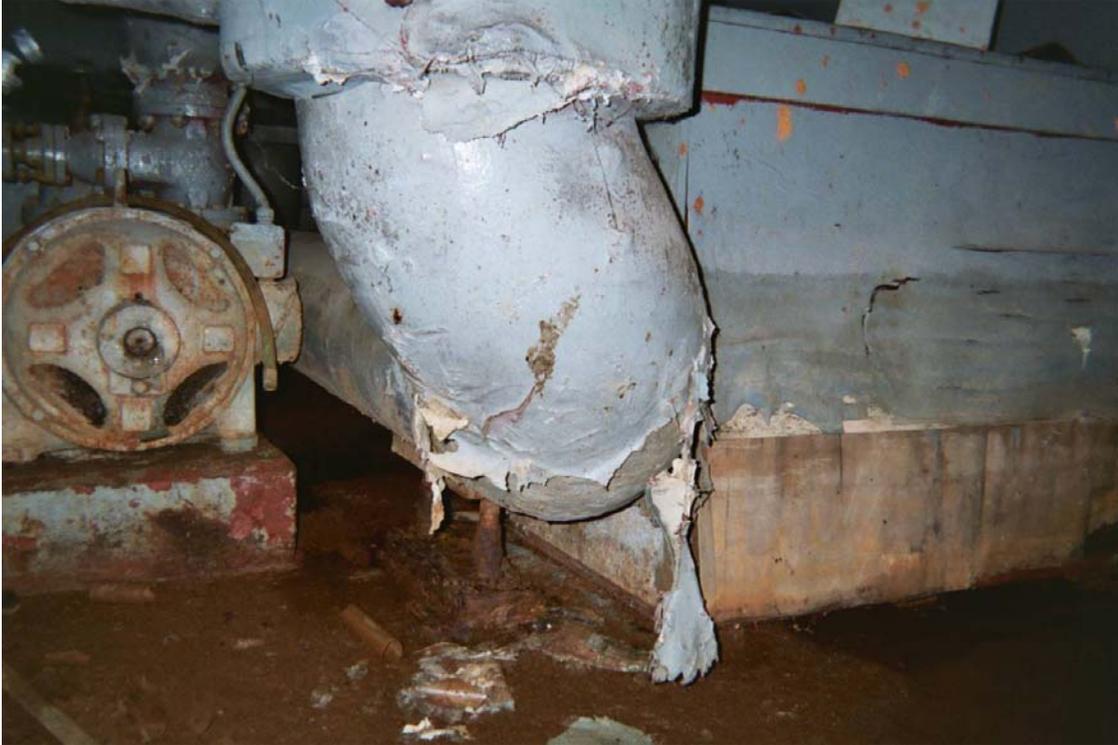
Asbestos-containing steam/condensate pipe joint and hanger insulation

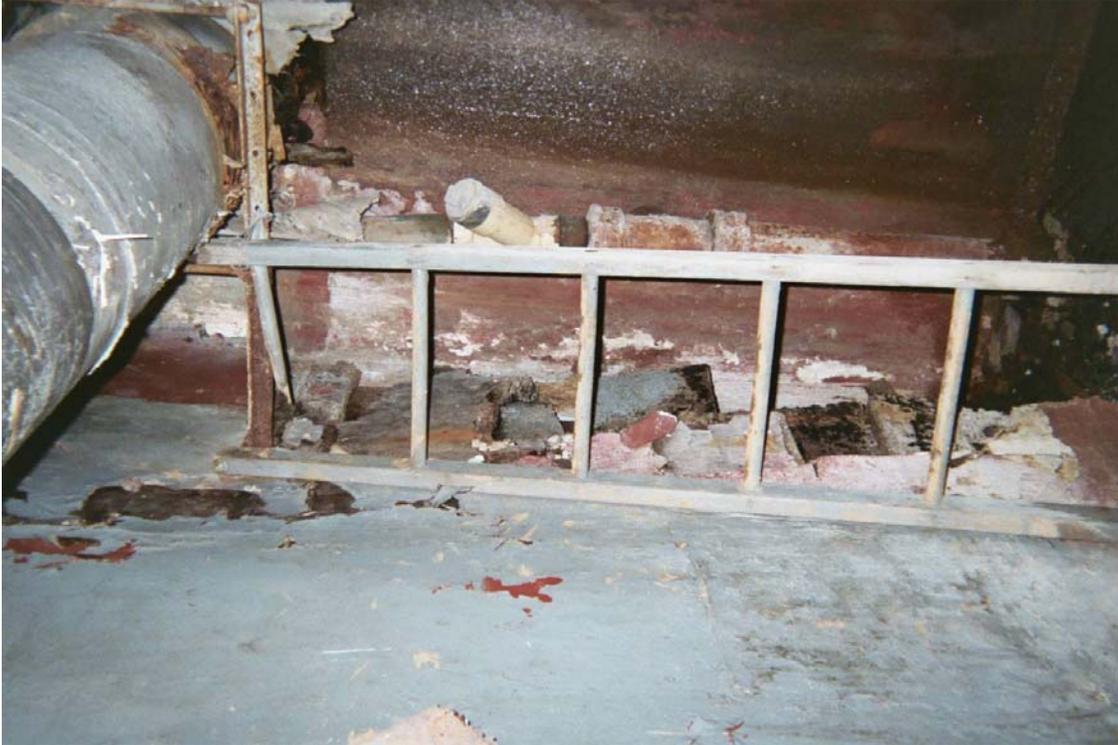
Asbestos-containing boiler thermal system insulation
