Demonstration Hall Photo Log

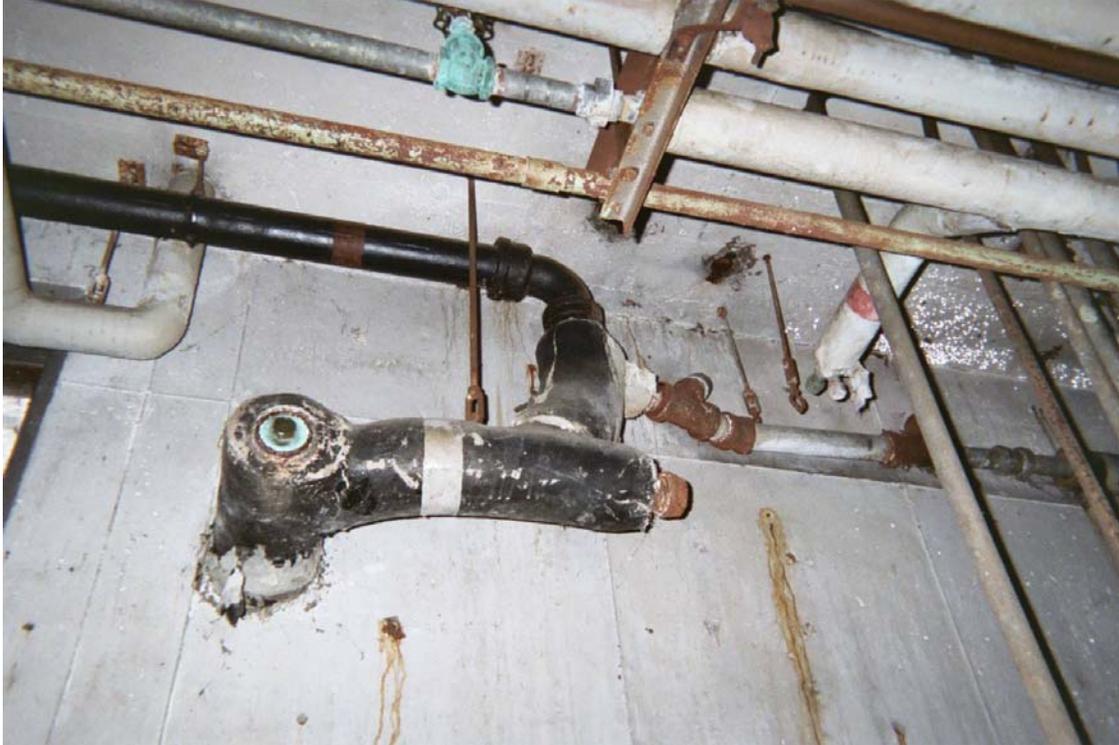
Asbestos-containing sewer drain pipe straight insulation and asbestos-containing sewer drain pipe joint and hanger insulation

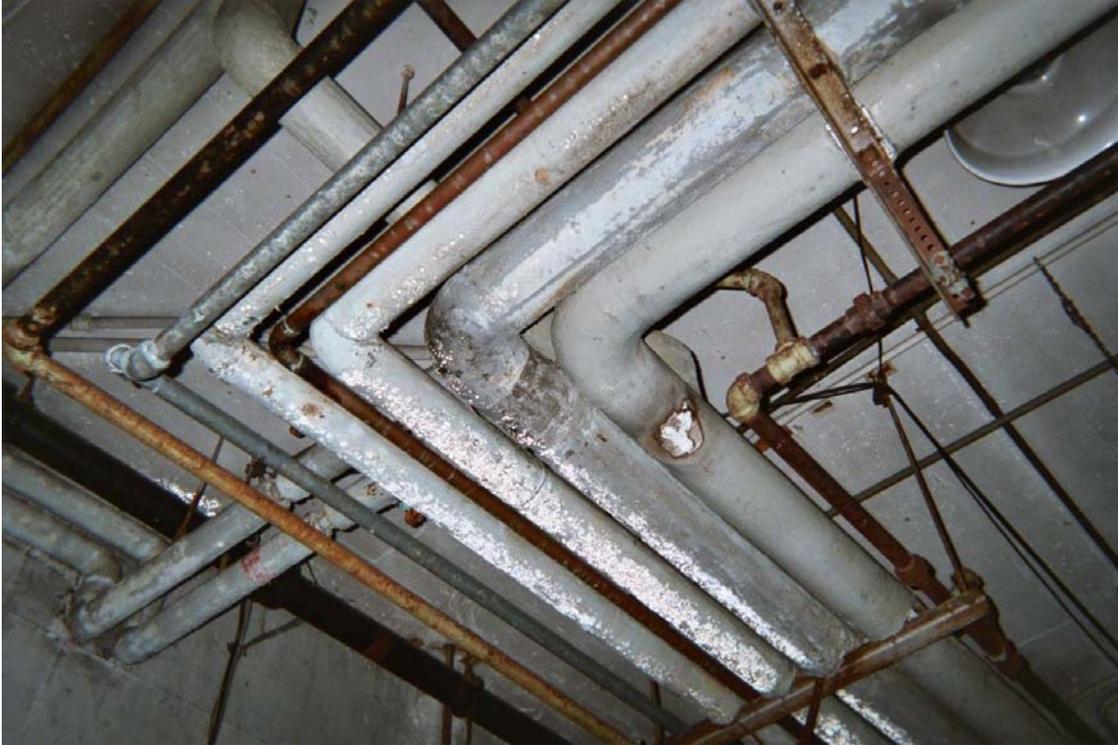
Asbestos-containing domestic water pipe joint and hanger insulation

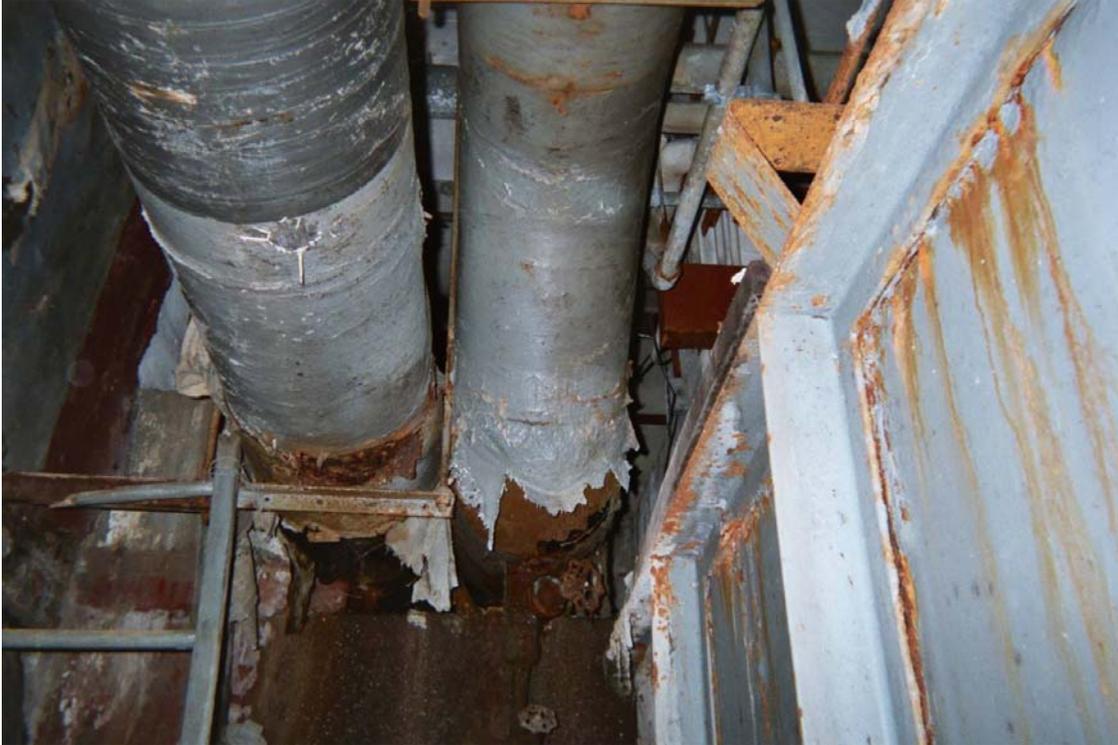
Asbestos-containing steam/condensate pipe straight insulation

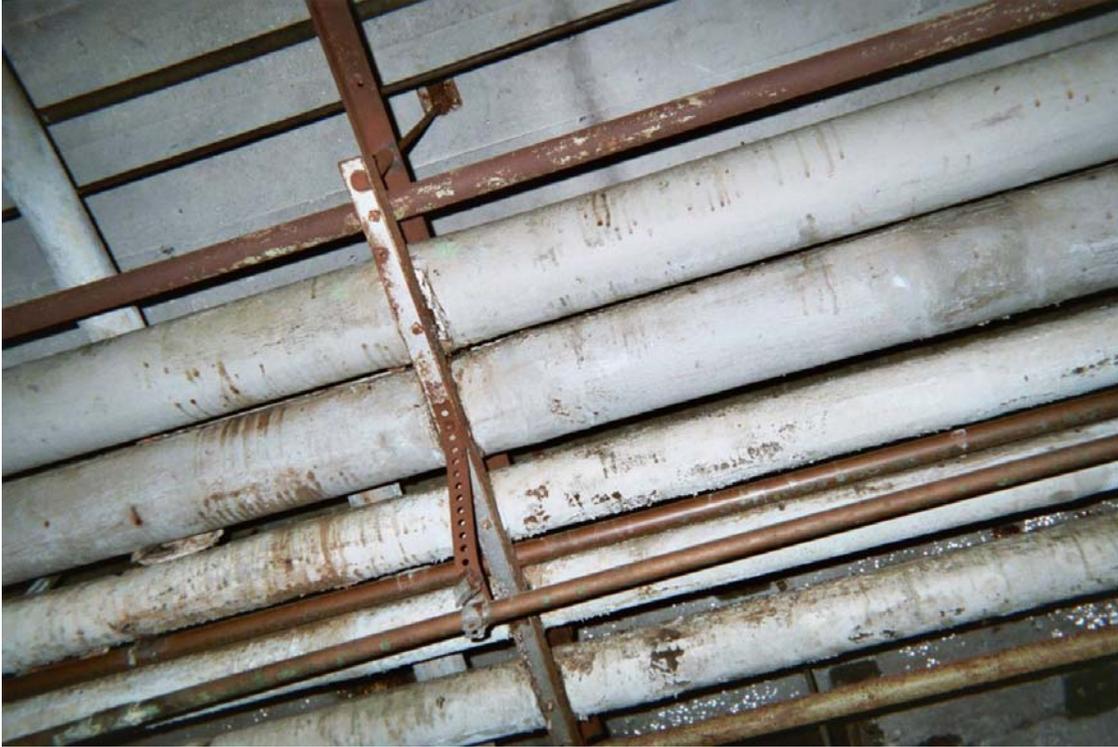
Asbestos-containing domestic water pipe straight insulation

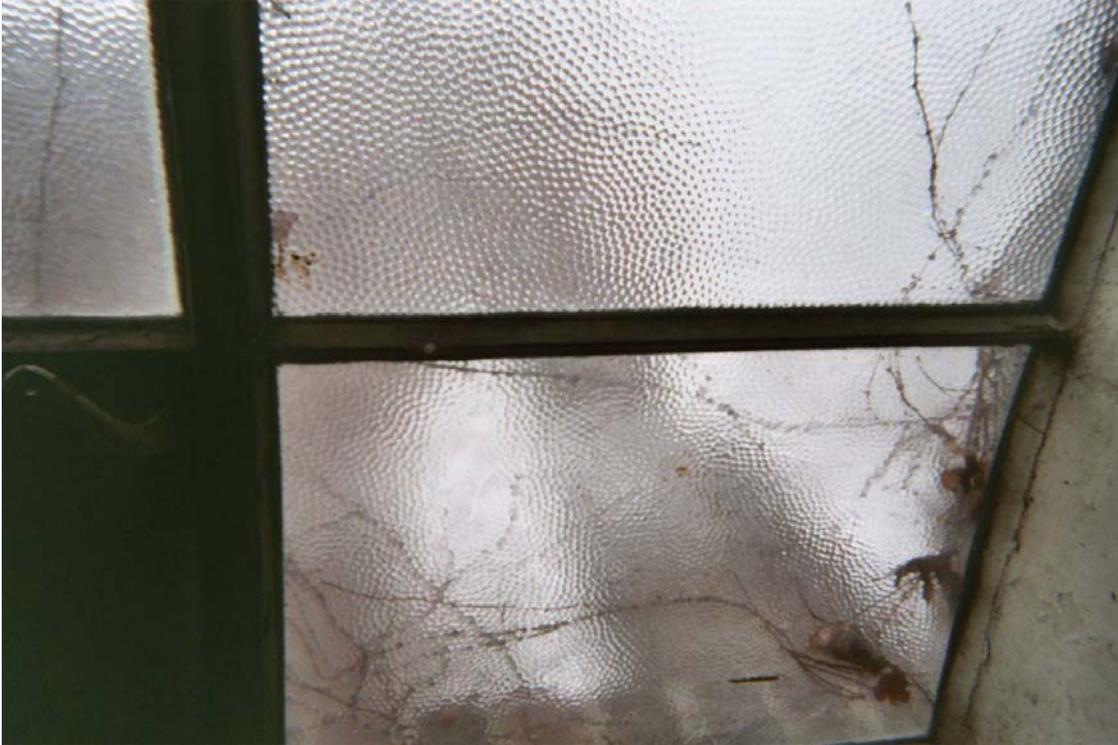
Assumed asbestos-containing window and door frame caulk compound

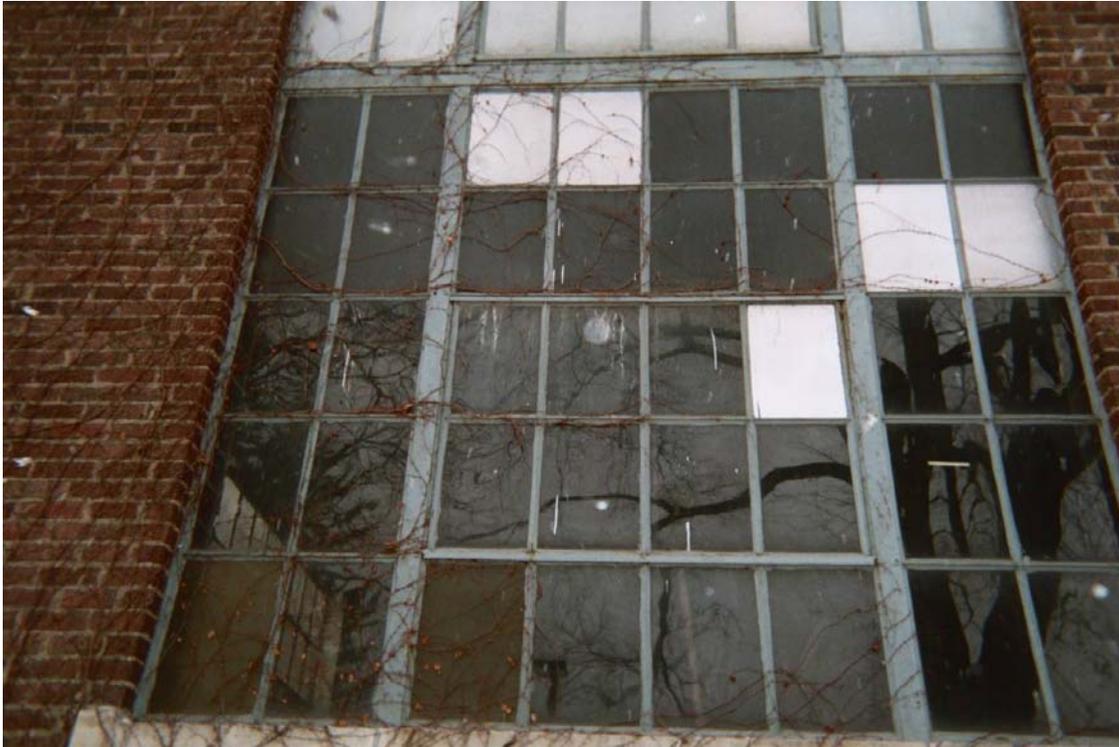
Assumed asbestos-containing window glazing compound

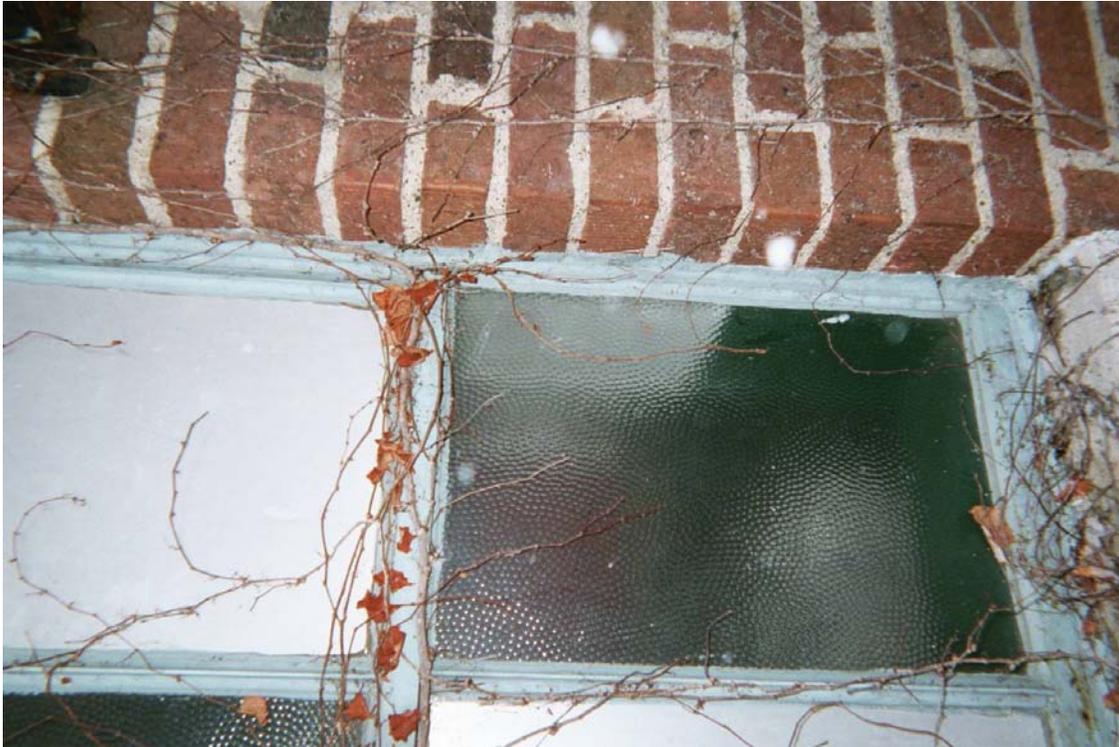
Assumed asbestos-containing window and door frame caulk compound

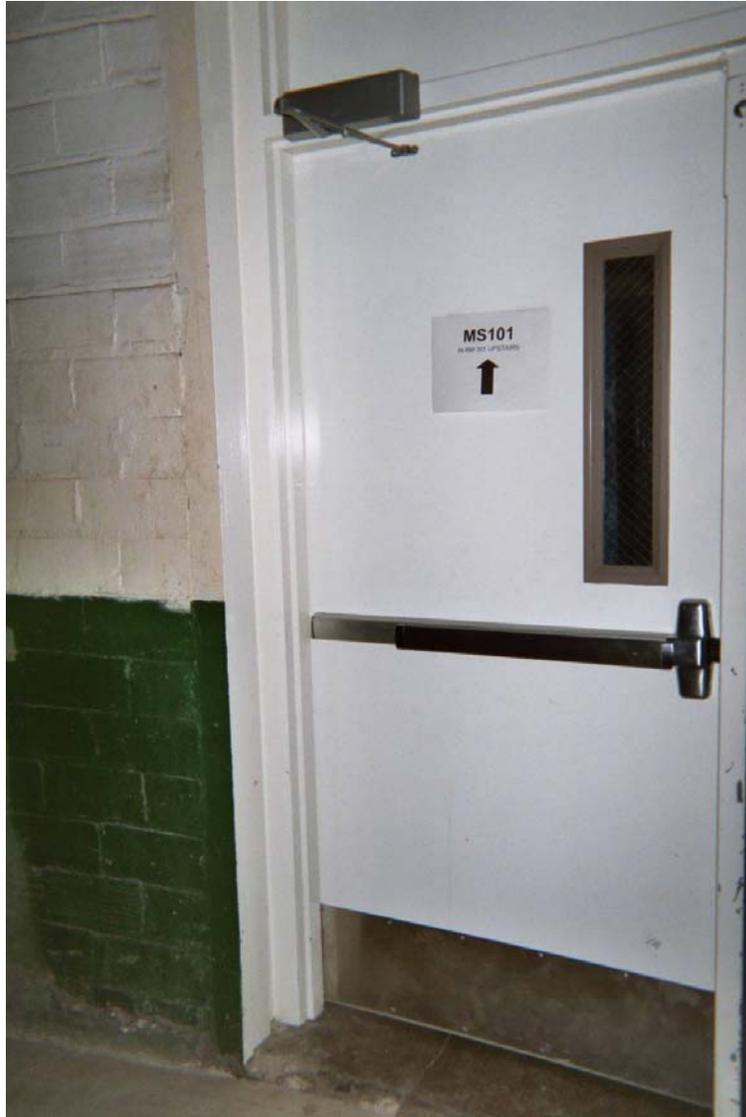
Assumed asbestos-containing fire door and frame
