Bessey Hall Photo Log

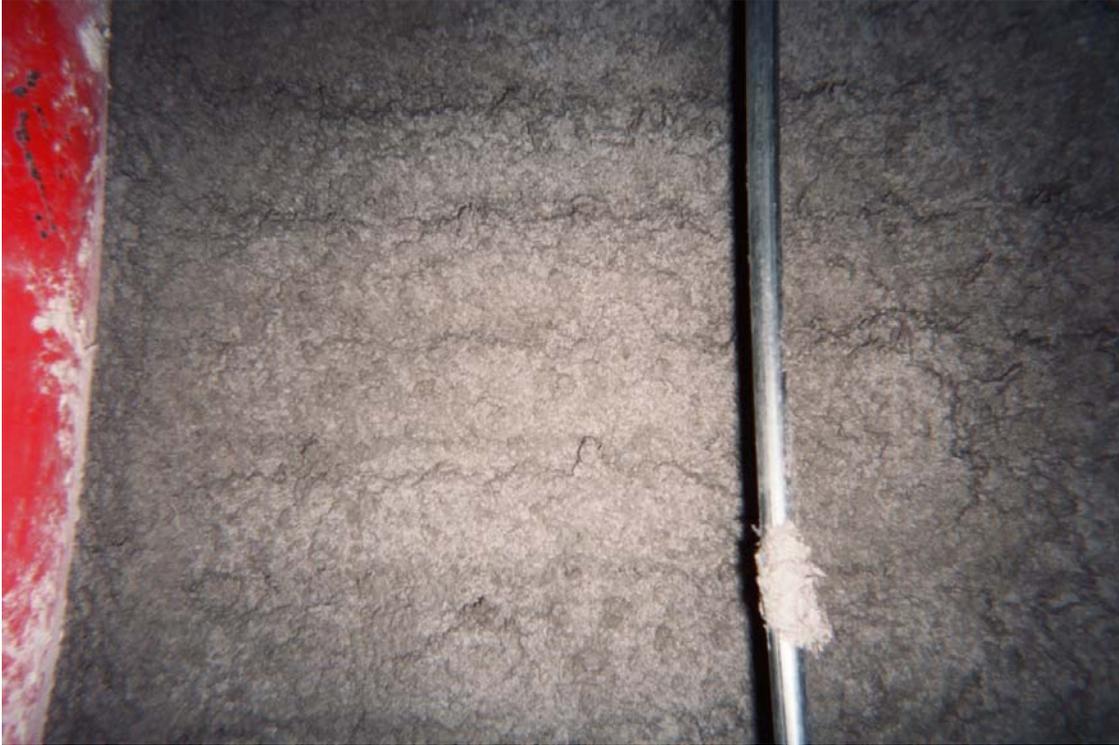
HA #1 – Non asbestos-containing spray-on fireproofing

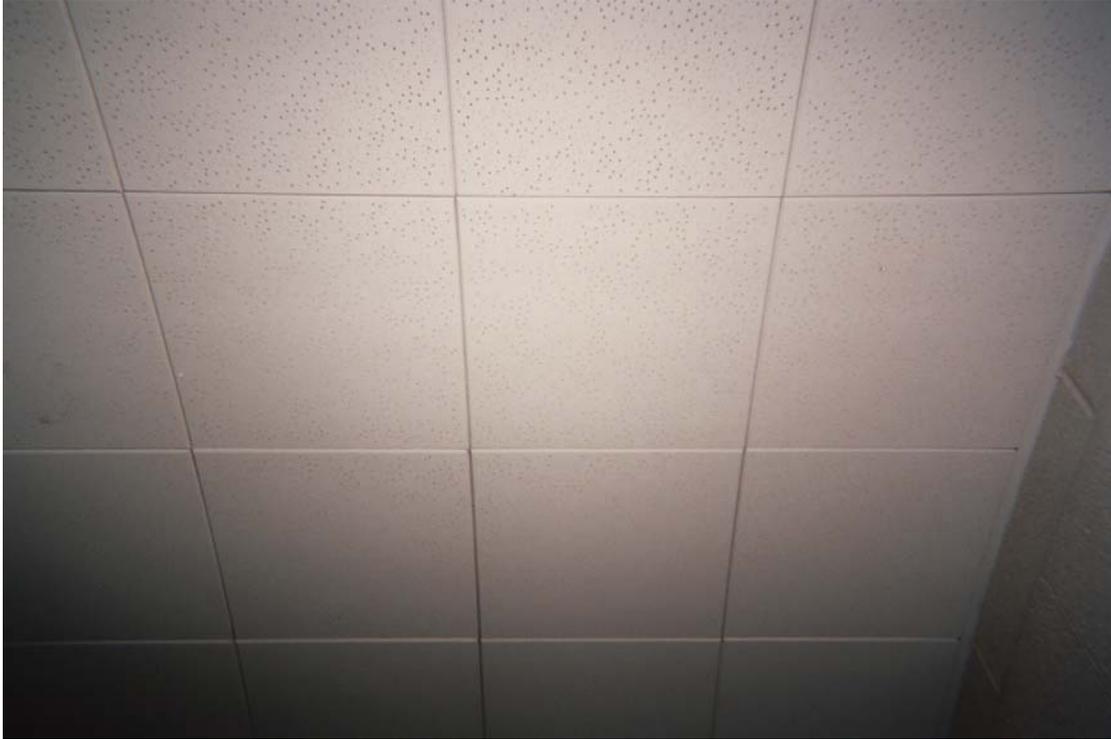
HA #6 – Non asbestos-containing 12” x 12” white ceiling tile
with pin holes and associated glue pods

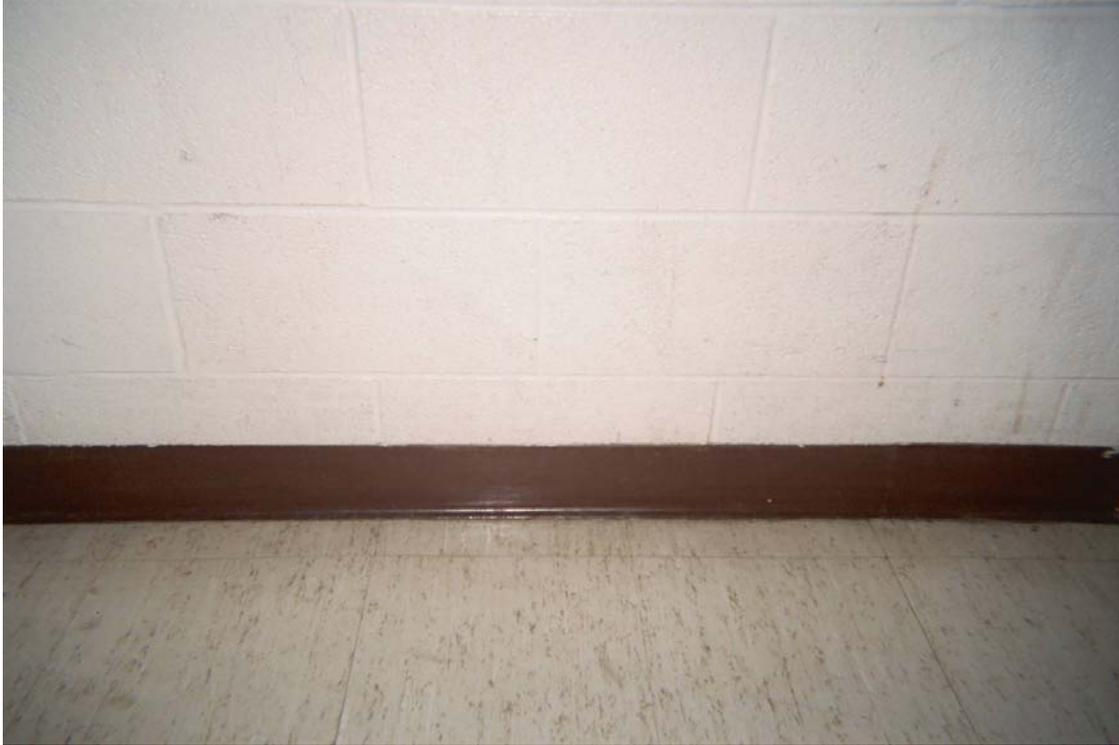
HA #7 – Non asbestos-containing 4” light brown cove molding
and associated mastic

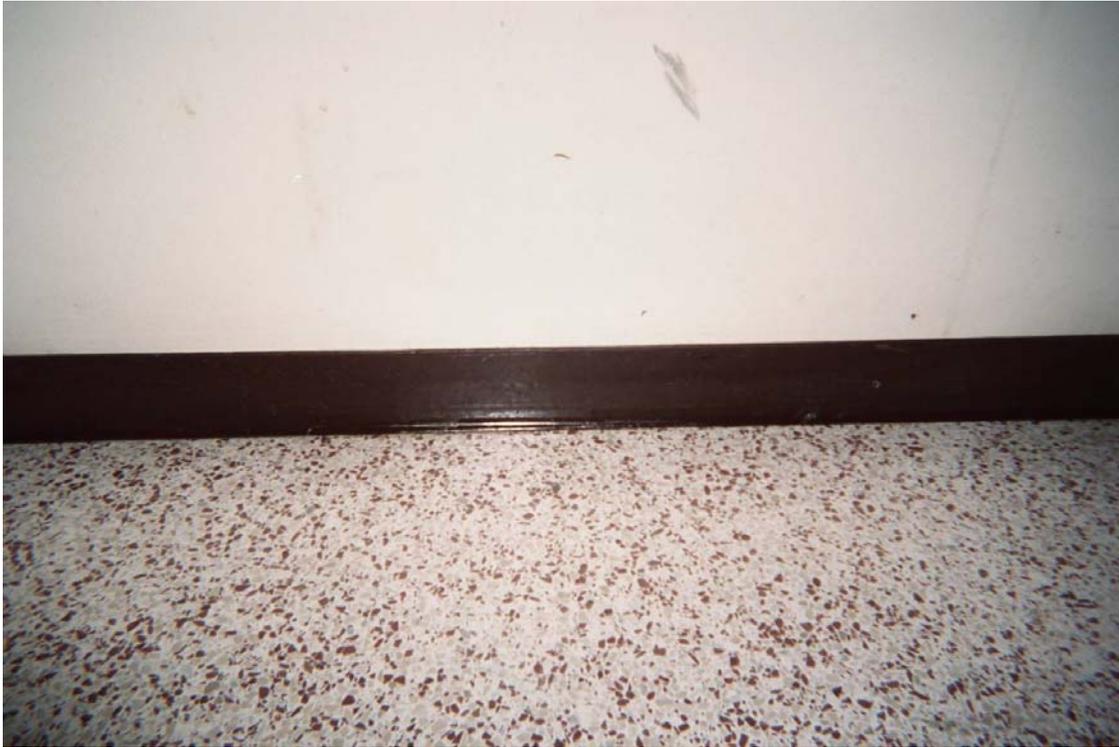
HA #8 – Non asbestos-containing 4” dark brown
cove molding and associated mastic

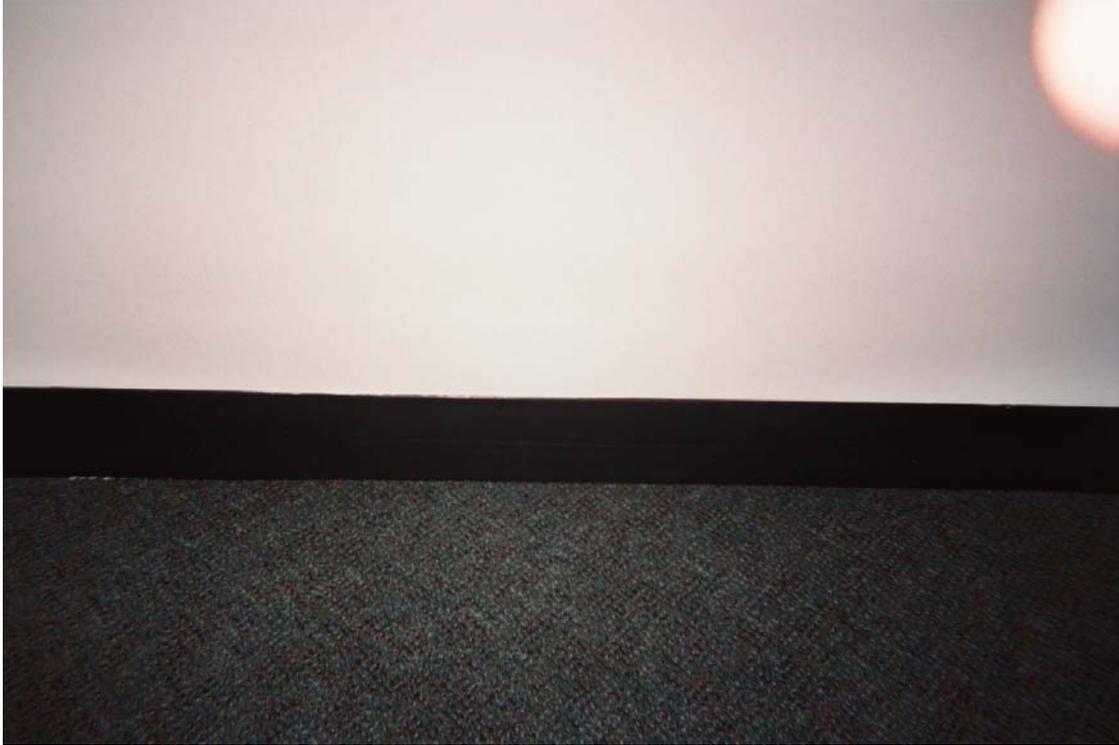
HA #9 – Non asbestos-containing 4” black cove molding
and associated mastic

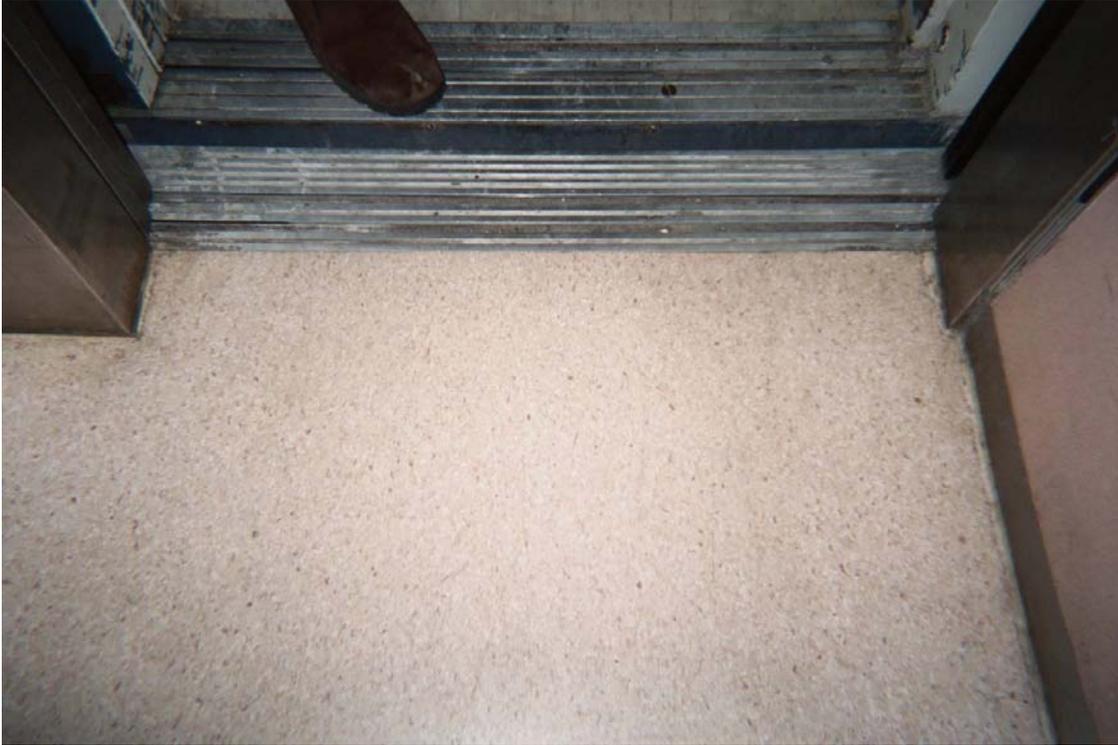
HA #10 – Non asbestos-containing tan vinyl flooring
with blue specks and associated mastic

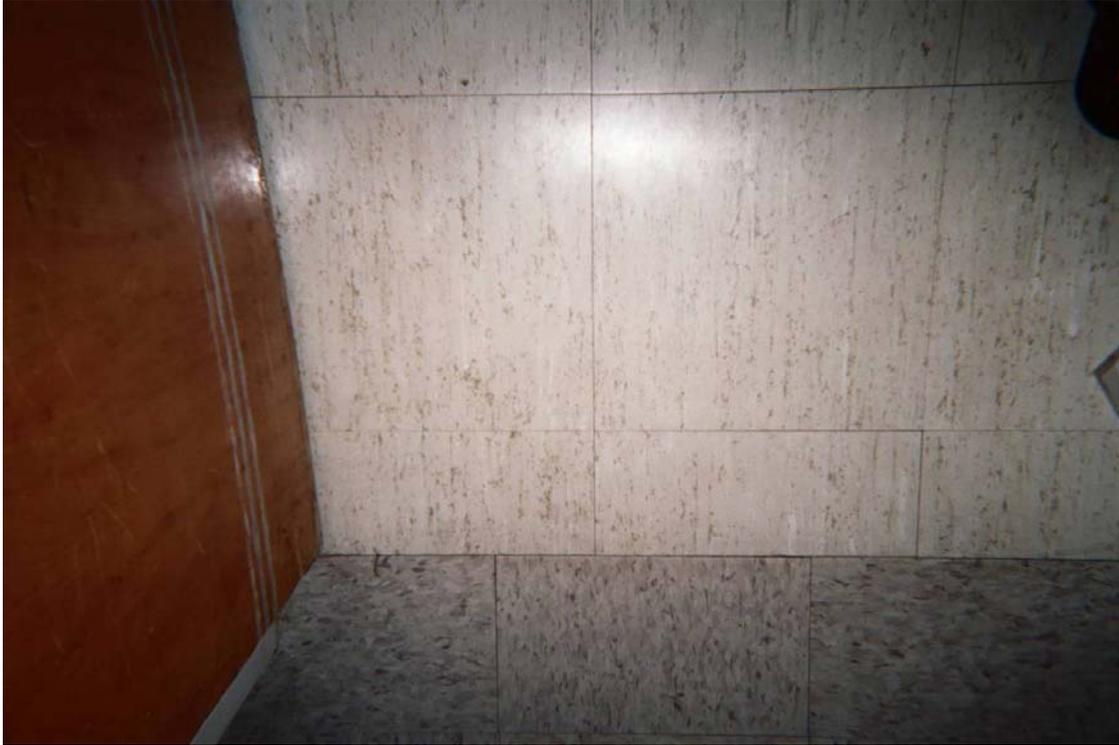
HA #11 – Non asbestos-containing 12” x 12” tan floor tile with marble pattern and associated asbestos-containing mastic

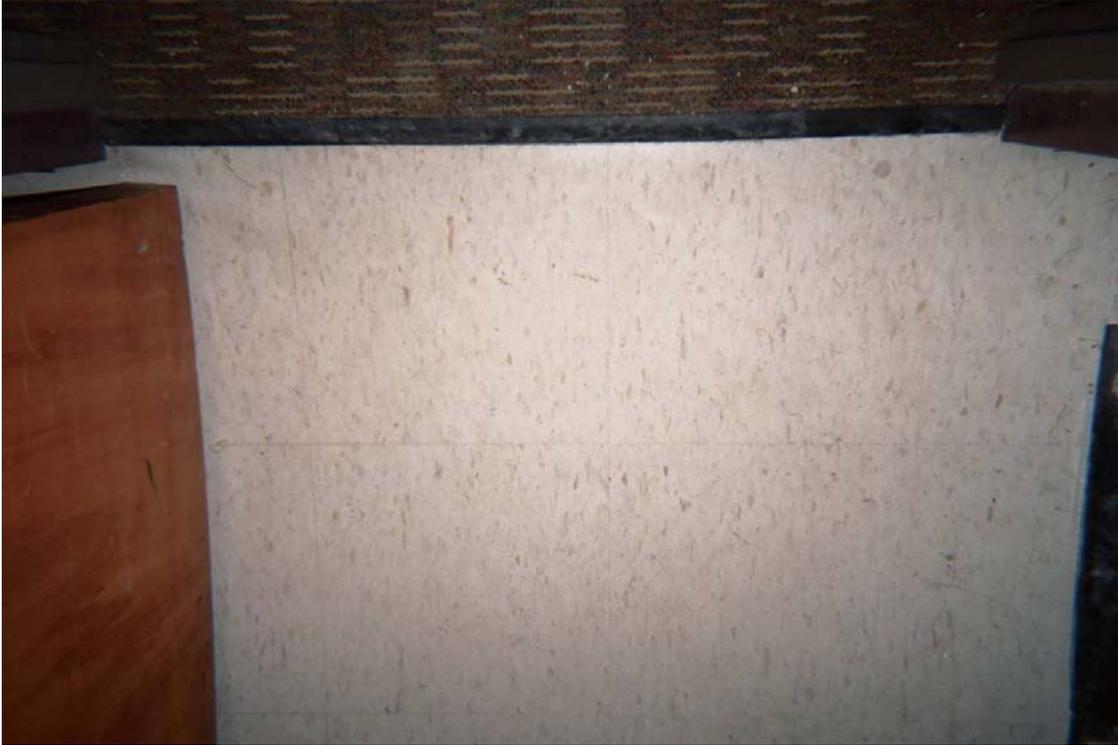
HA #12 – Non asbestos-containing 12” x 12” cream floor tile with white and green streaks and associated asbestos-containing mastic

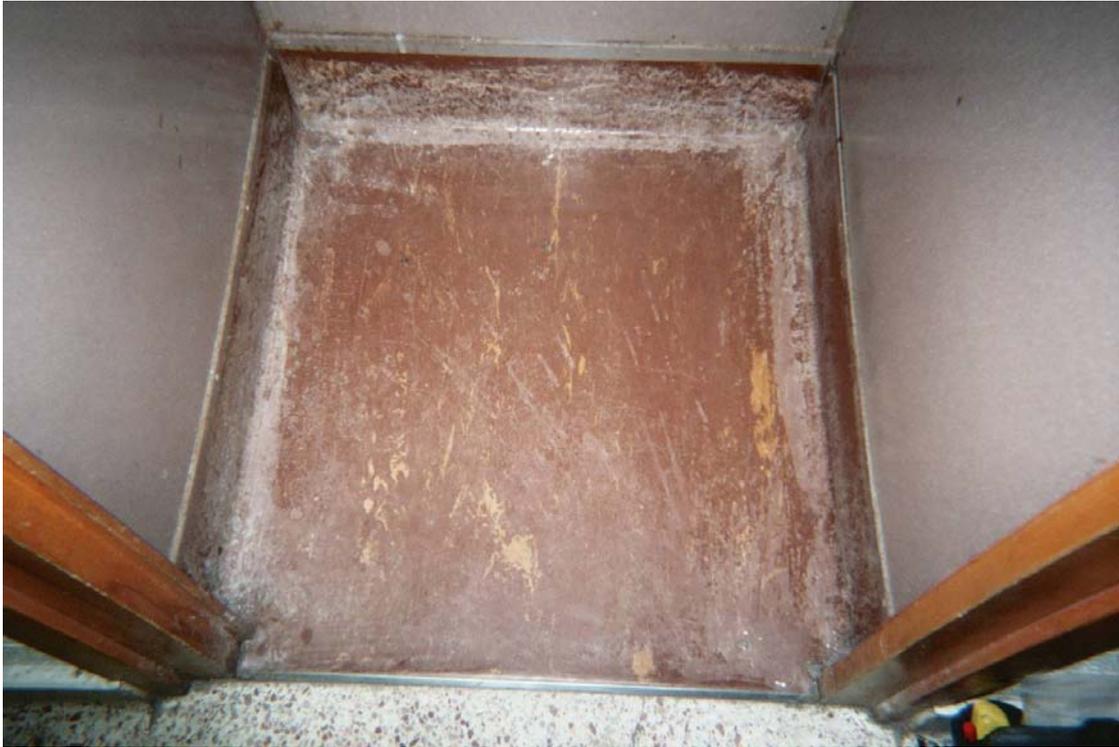
HA #13 – Non asbestos-containing brown linoleum flooring with rust streaks and associated mastic

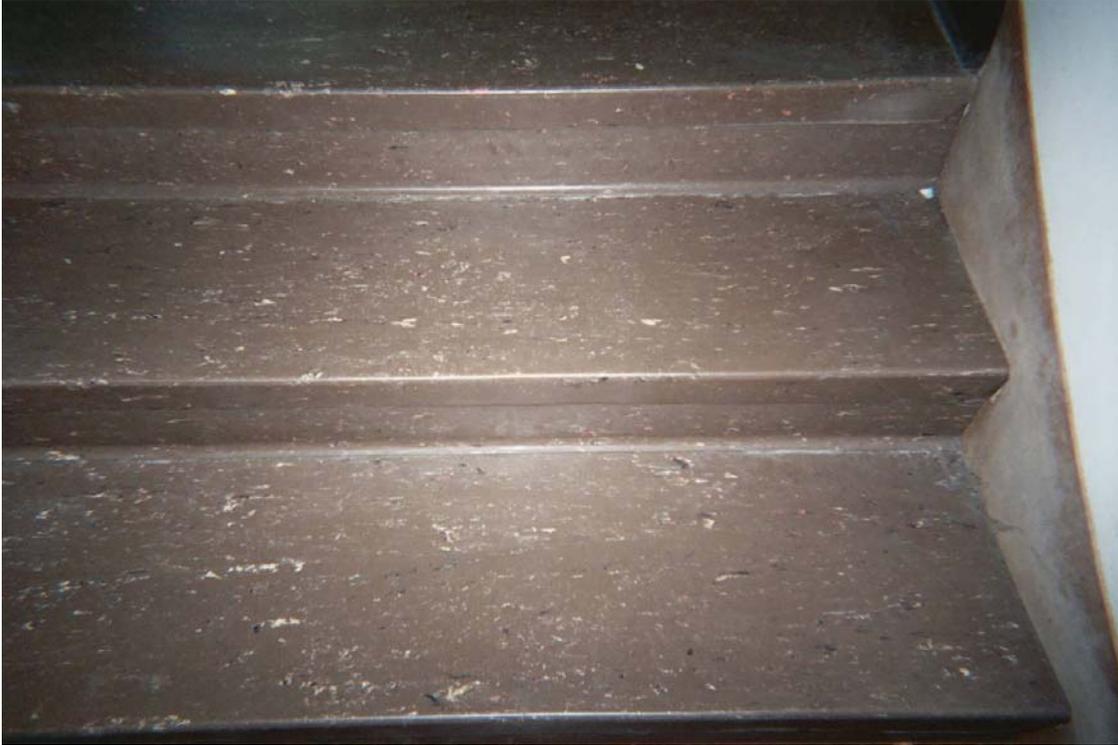
HA #14 – Non asbestos-containing brown stair tread with cream, pink and black streaks and associated mastic

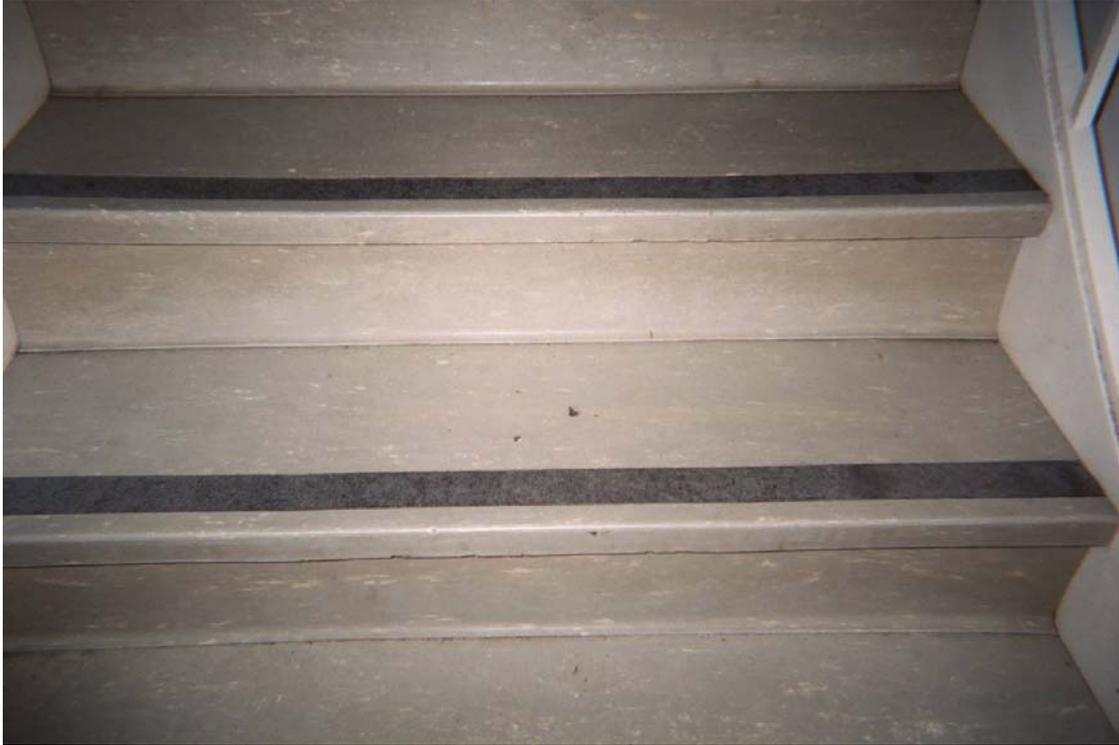
HA #15 – Non asbestos-containing gray stair tread
with cream streaks and associated mastic

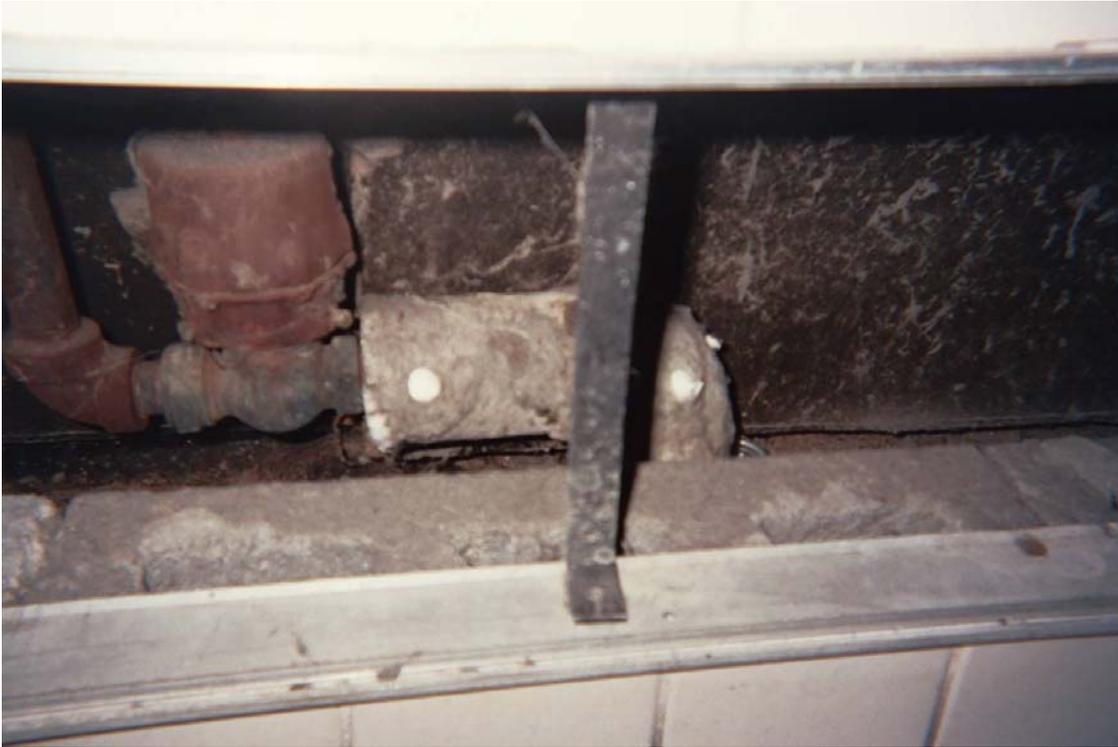
HA #19 – Asbestos-containing steam/condensate supply and return pipe straight insulation

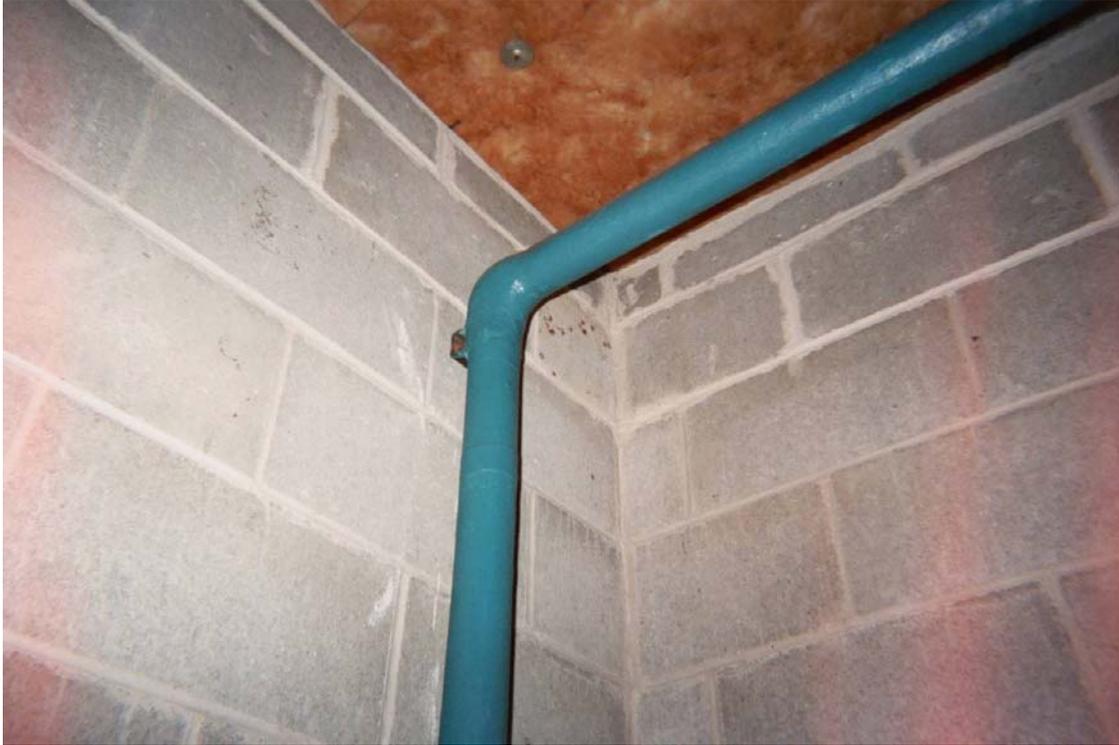
HA #21 – Asbestos-containing domestic water supply
pipe joint and hanger insulation

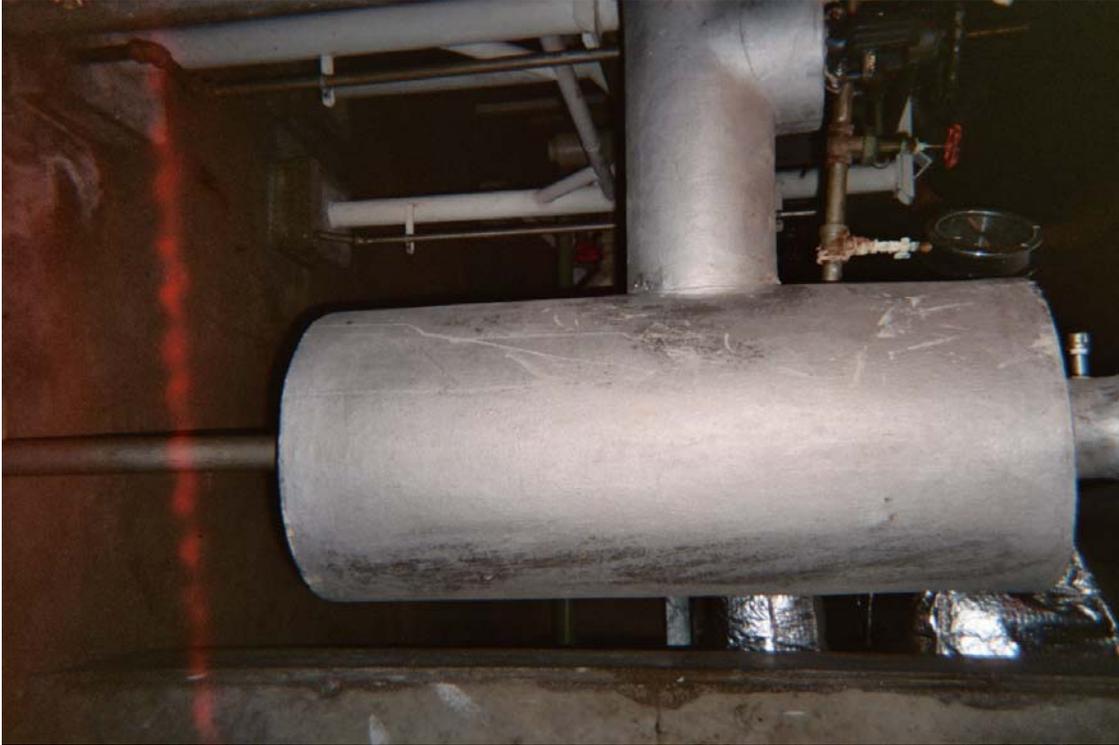
HA #22 – Asbestos-containing hot water heating expansion tank insulation

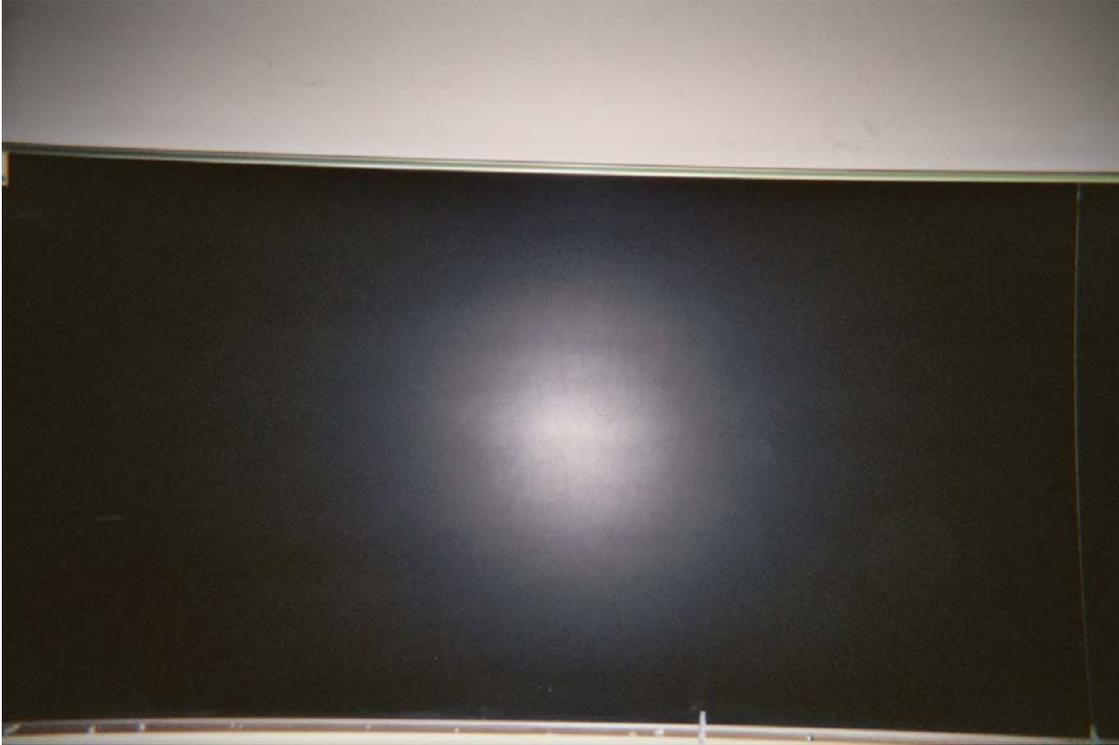
HA #23 – Assumed asbestos-containing chalkboards
and associated glue pods

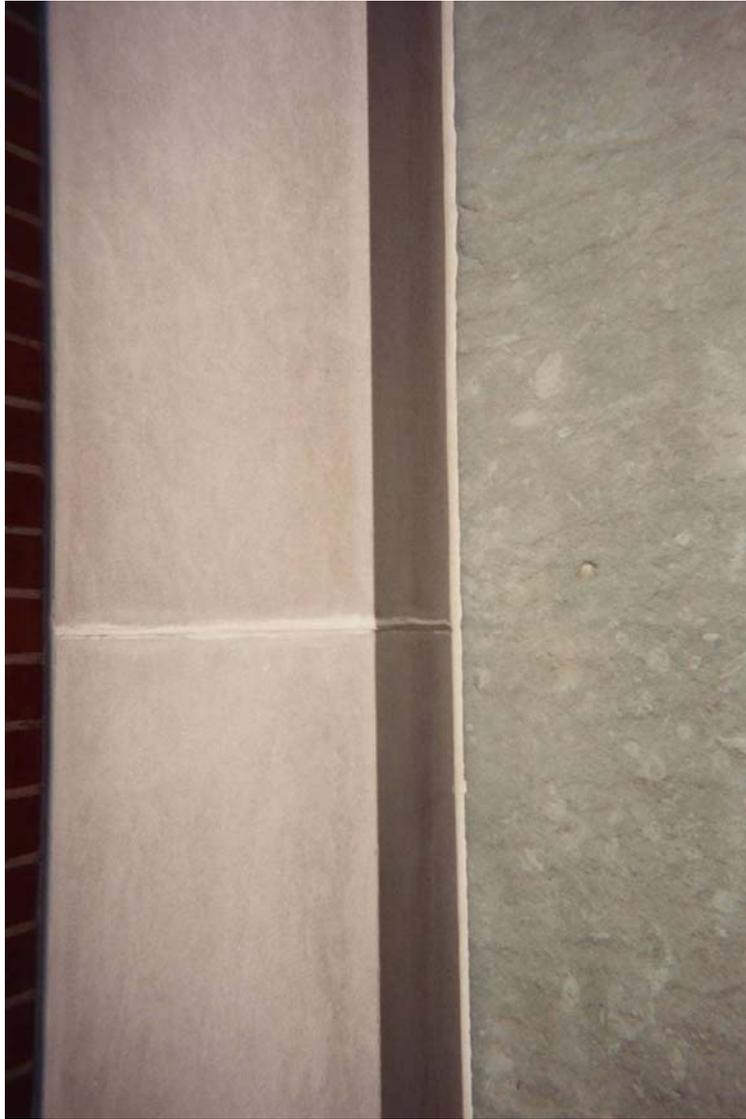
HA #24 – Assumed asbestos-containing building caulk compound

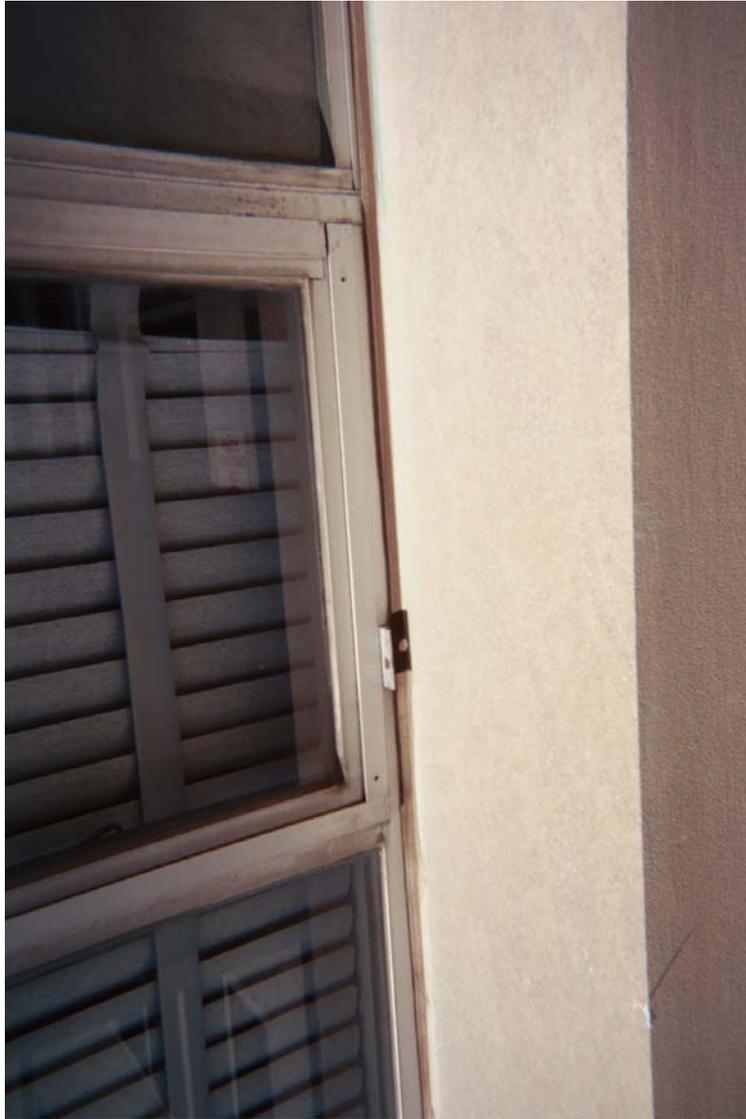
HA #26 – Assumed asbestos-containing window and door frame caulk compound

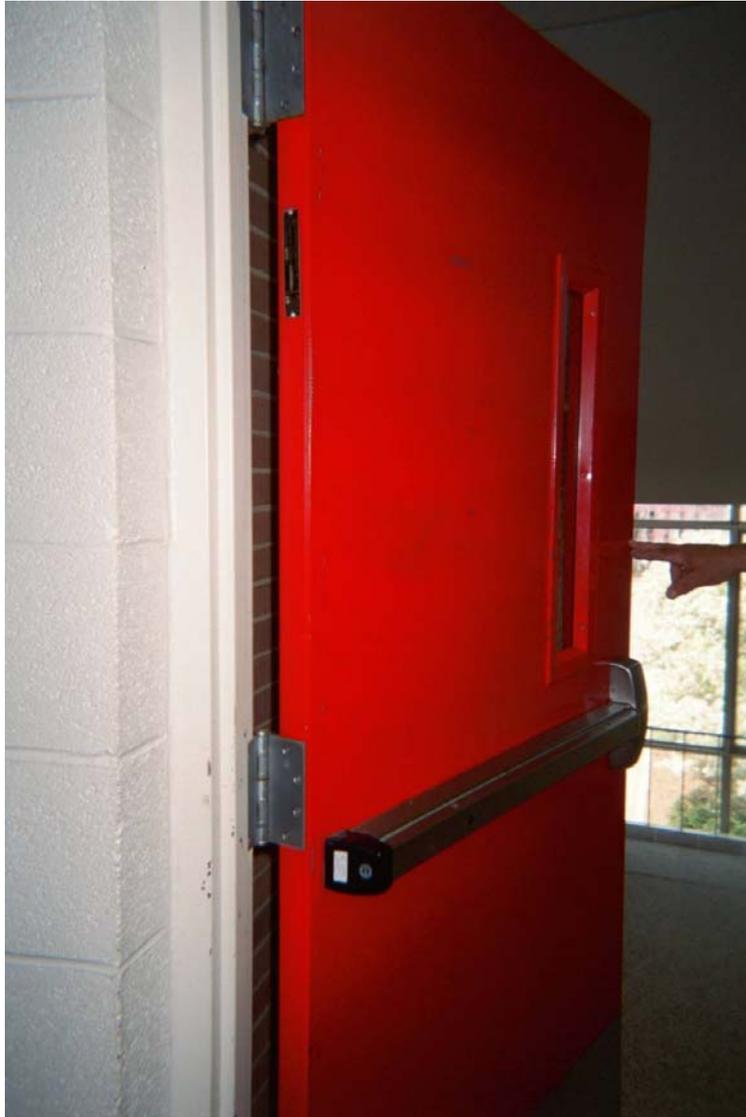
HA #27 – Assumed asbestos-containing fire door and frame

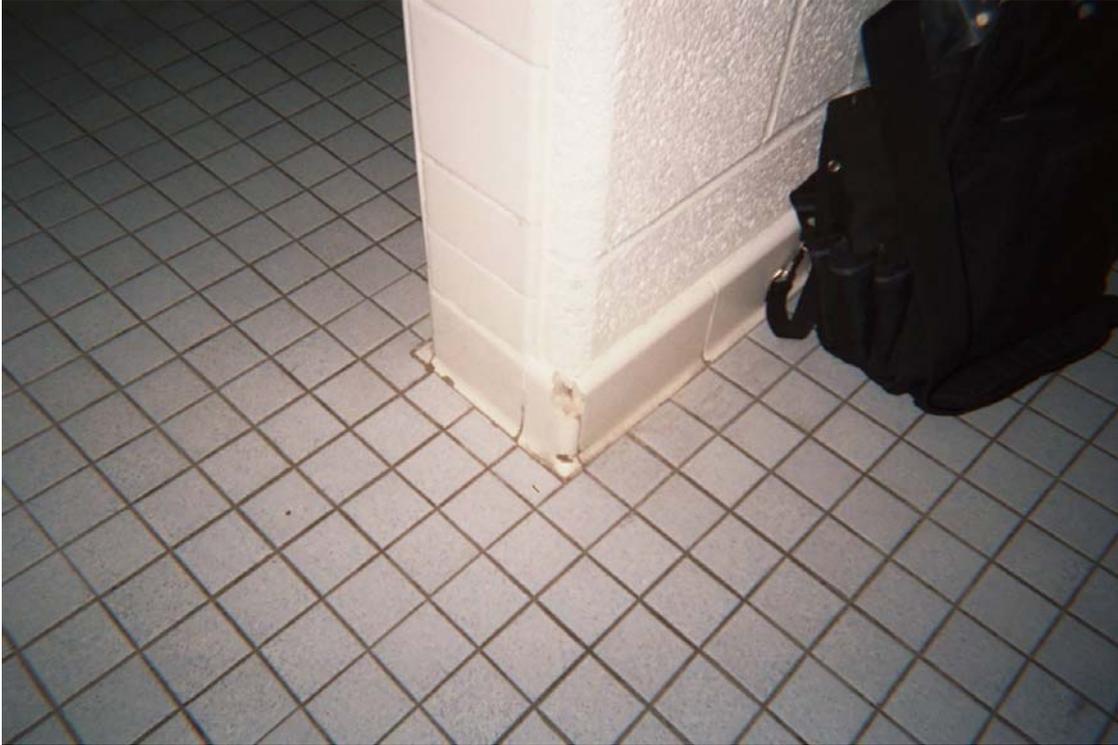
HA #28 – Non asbestos-containing ceramic tile bedding compound

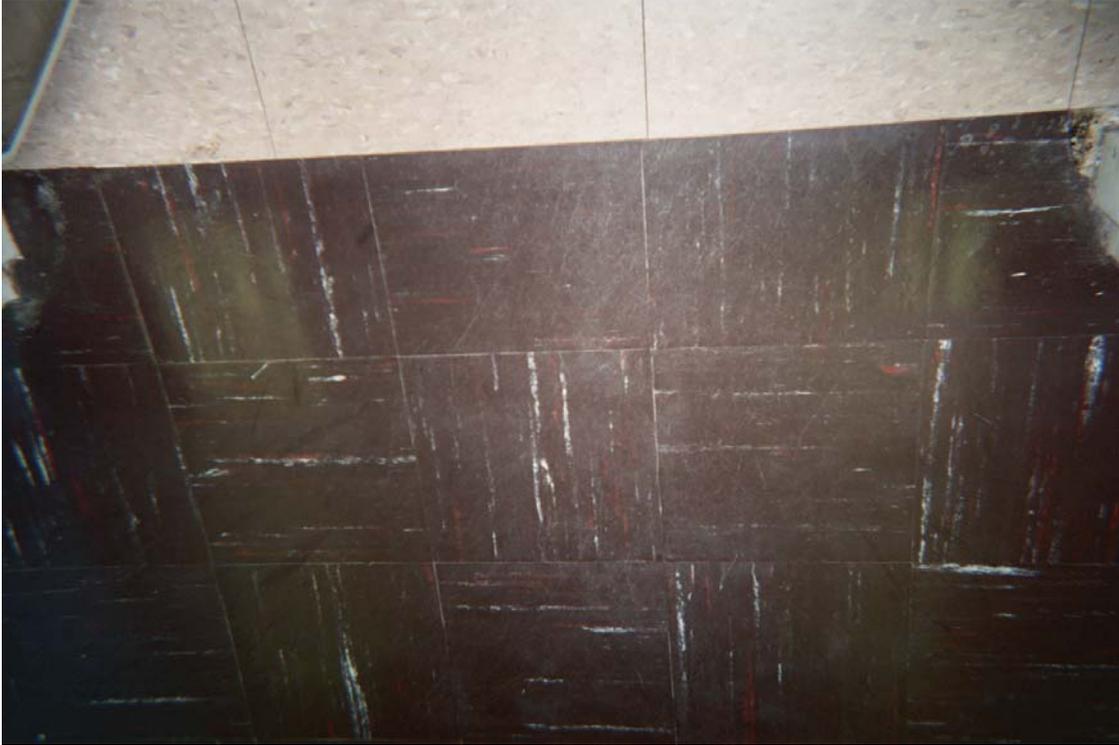
HA #29 – Non asbestos-containing 9” x 9” dark brown floor tile
with cream and rust streaks and associated mastic

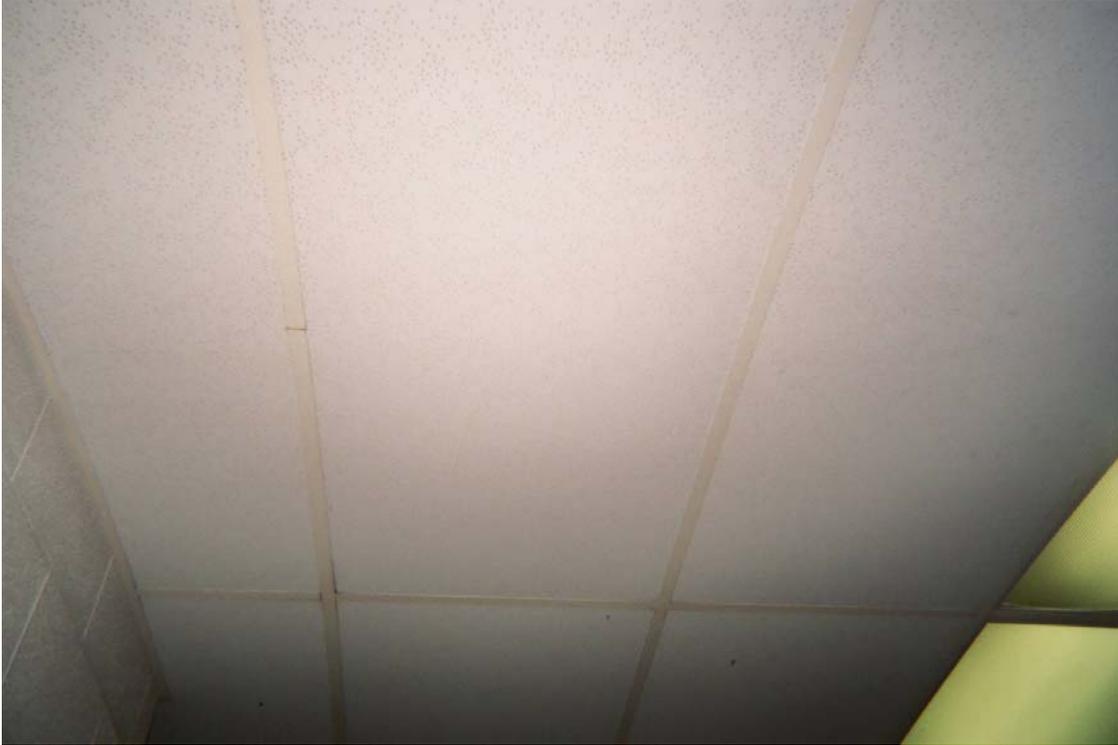
HA #30 – Non asbestos-containing 2' x 4' white lay-in ceiling tile with pin holes

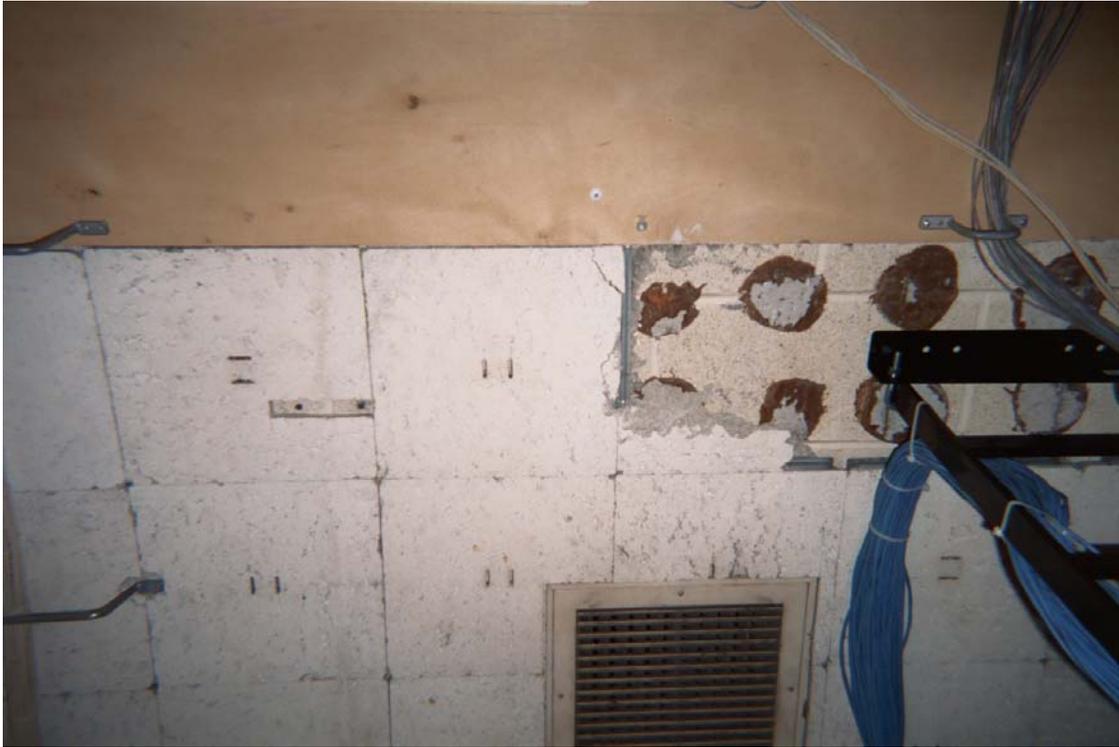
HA #32 – Non asbestos-containing 12” x 12” white spline ceiling tile with pin holes and fissures and associated glue pods

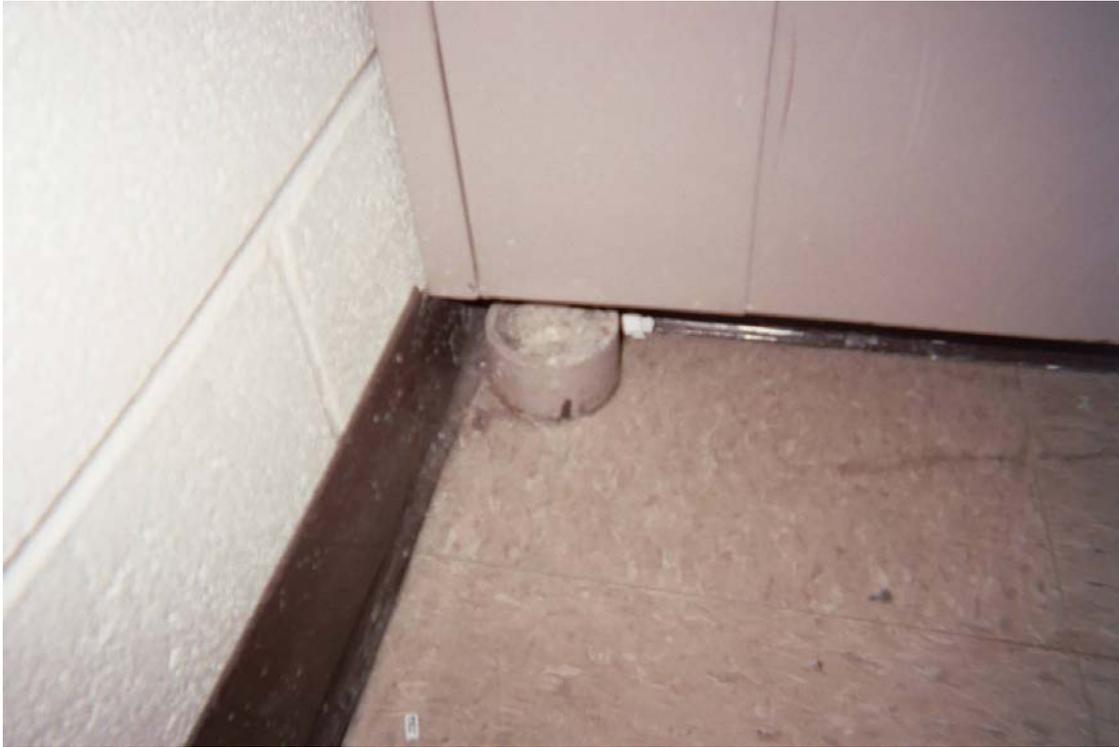
HA #33 – Non asbestos-containing gray pipe chase mud packing compound

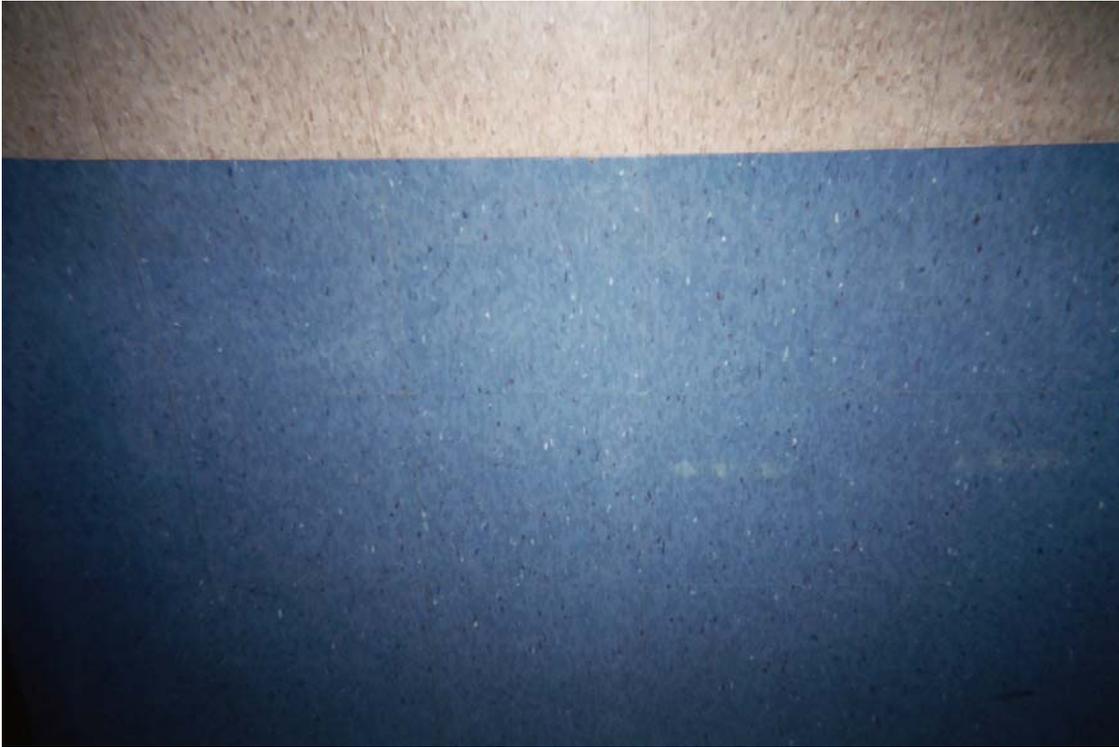
HA #36 – Non asbestos containing 12” x 12” blue floor tile with marble pattern and associated asbestos-containing mastic

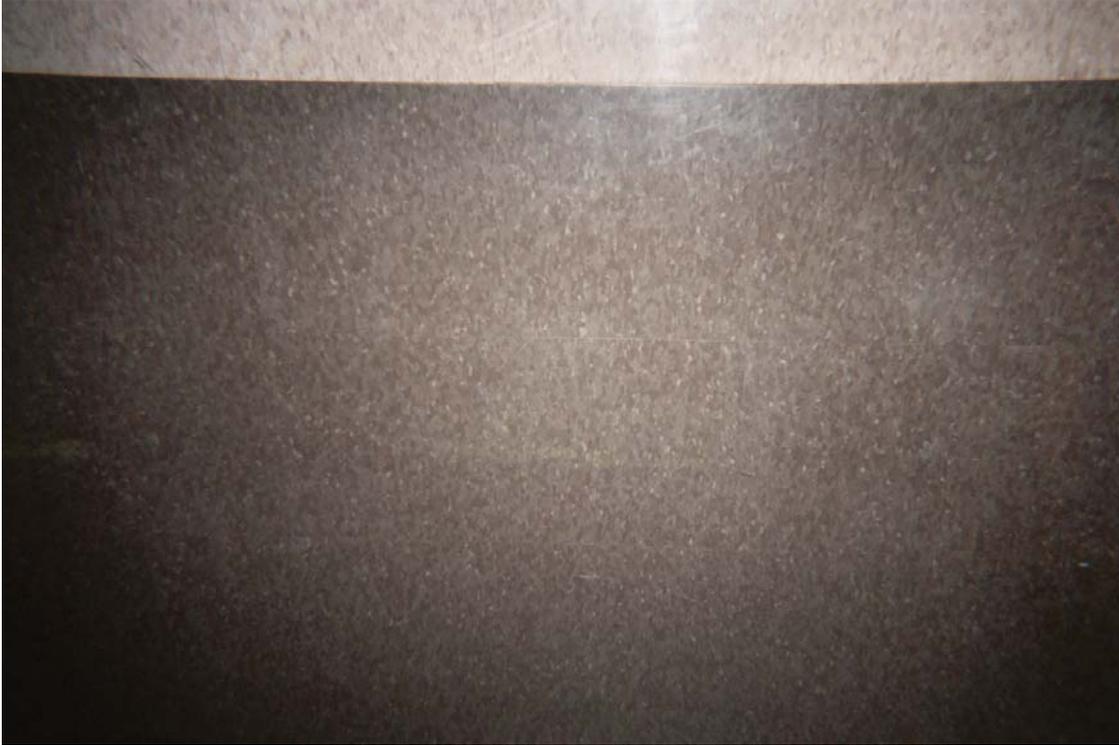
HA #37 – Non asbestos-containing 12” x 12” dark gray floor tile with marble pattern and associated asbestos-containing mastic

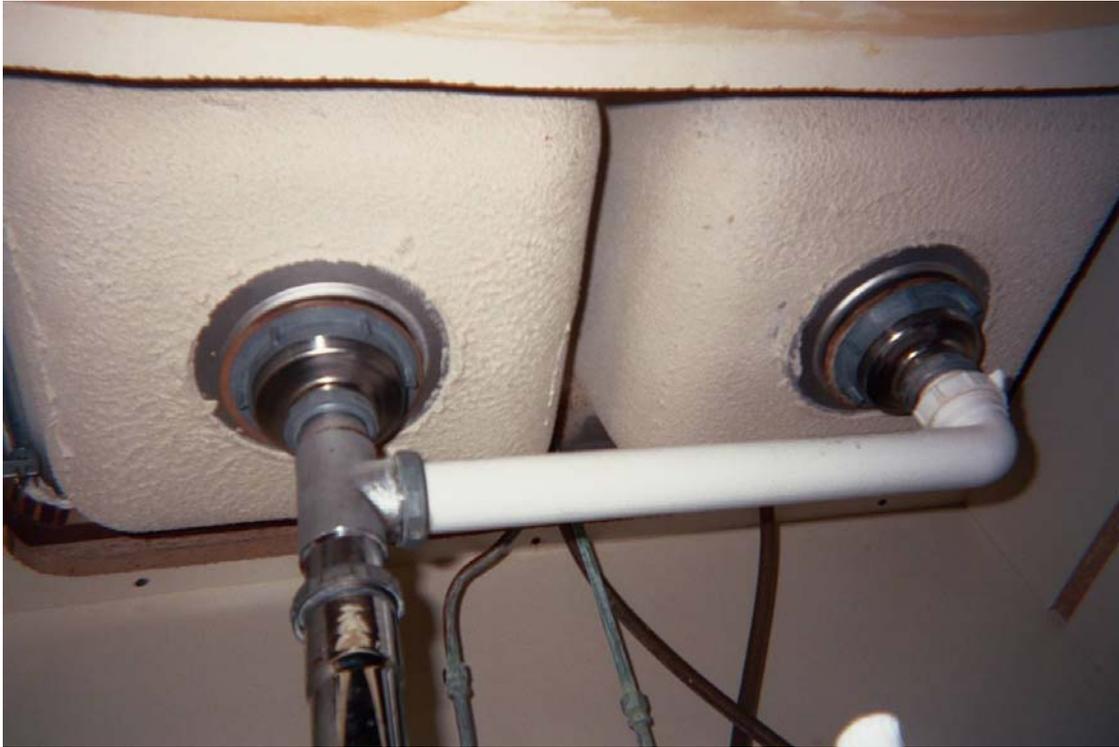
HA #38 – Non asbestos-containing white sink undercoating.

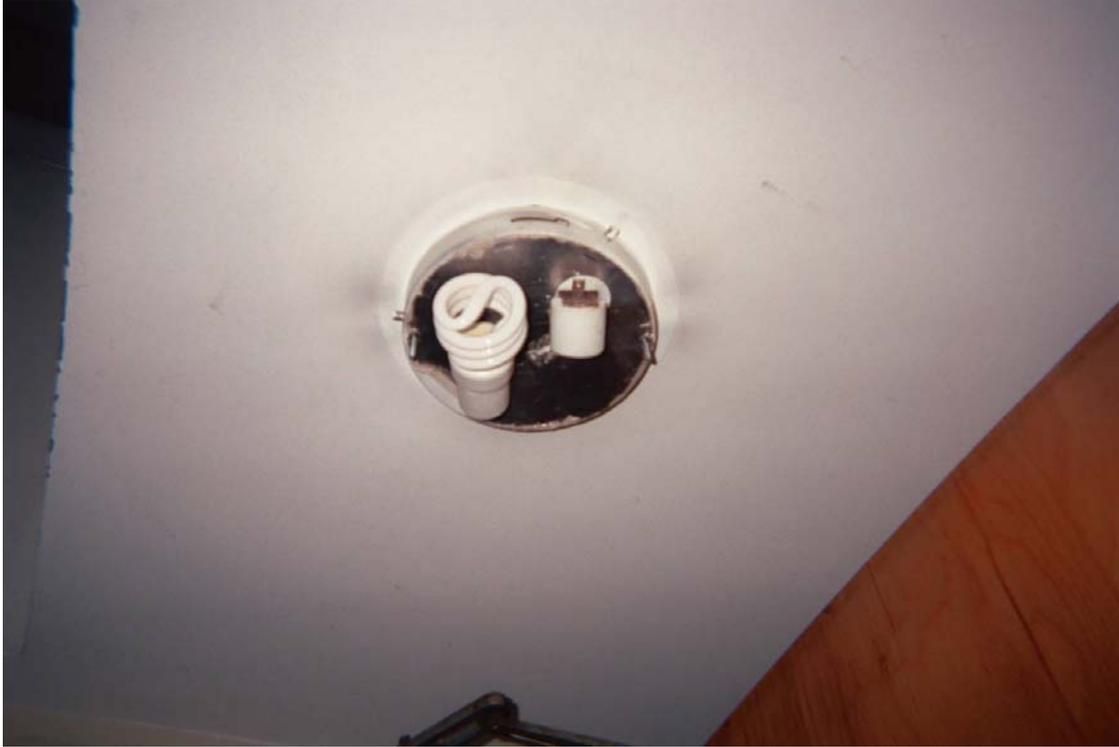
HA #40 – Asbestos-containing light heat shield insulation
