Bessey Hall Photo Log

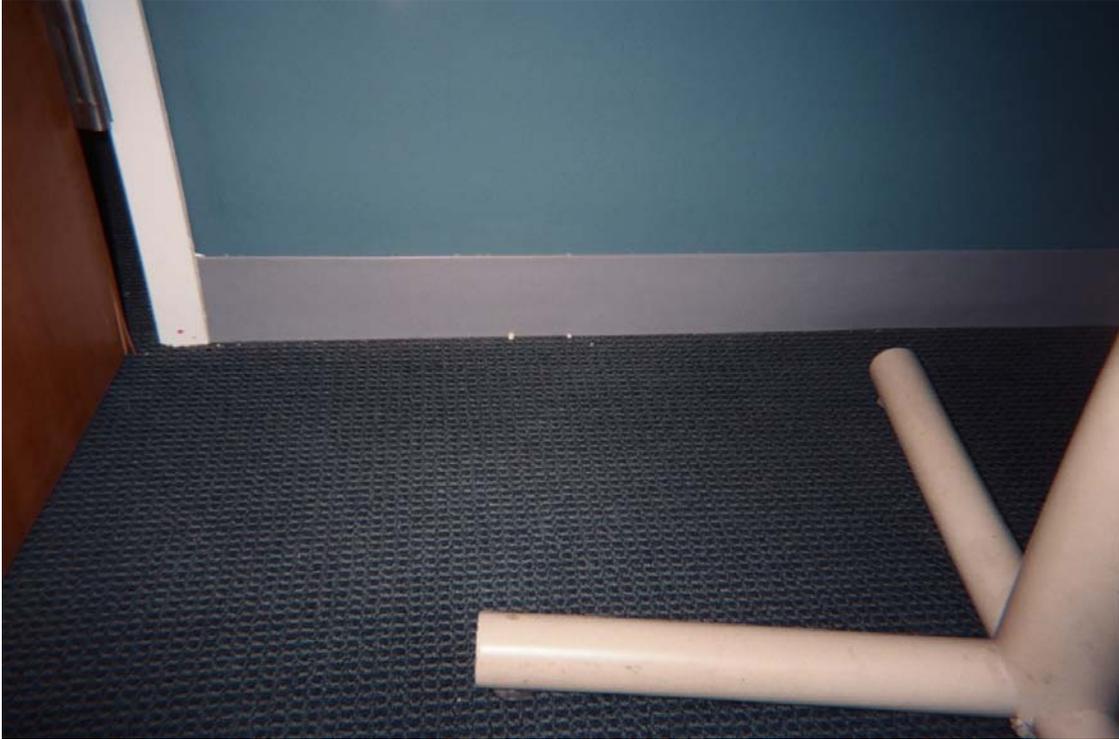
HA #41 – Non asbestos-containing 4” gray cove molding
and associated mastic

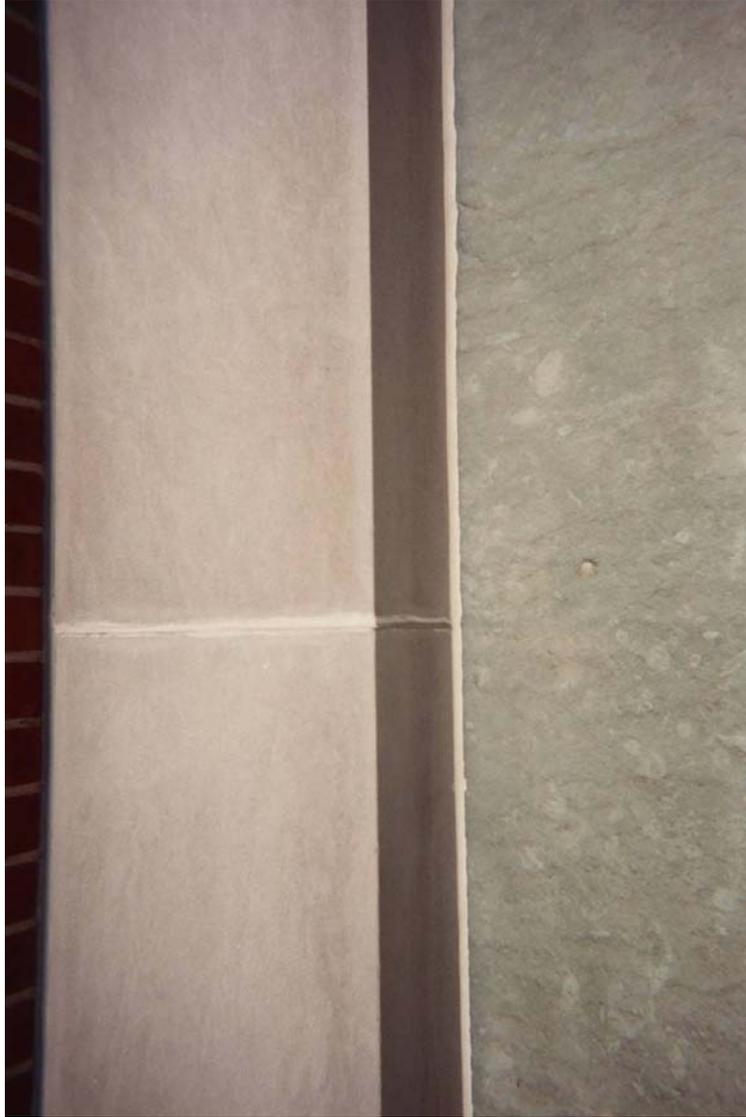
HA #42 – Assumed asbestos-containing gray slate caulk compound
