SITE PHOTOGRAPHS

Michigan State University
Physical Plant Division-Engineering and Architectural Services

Farrall Hall
Asbestos Inspection

G06371

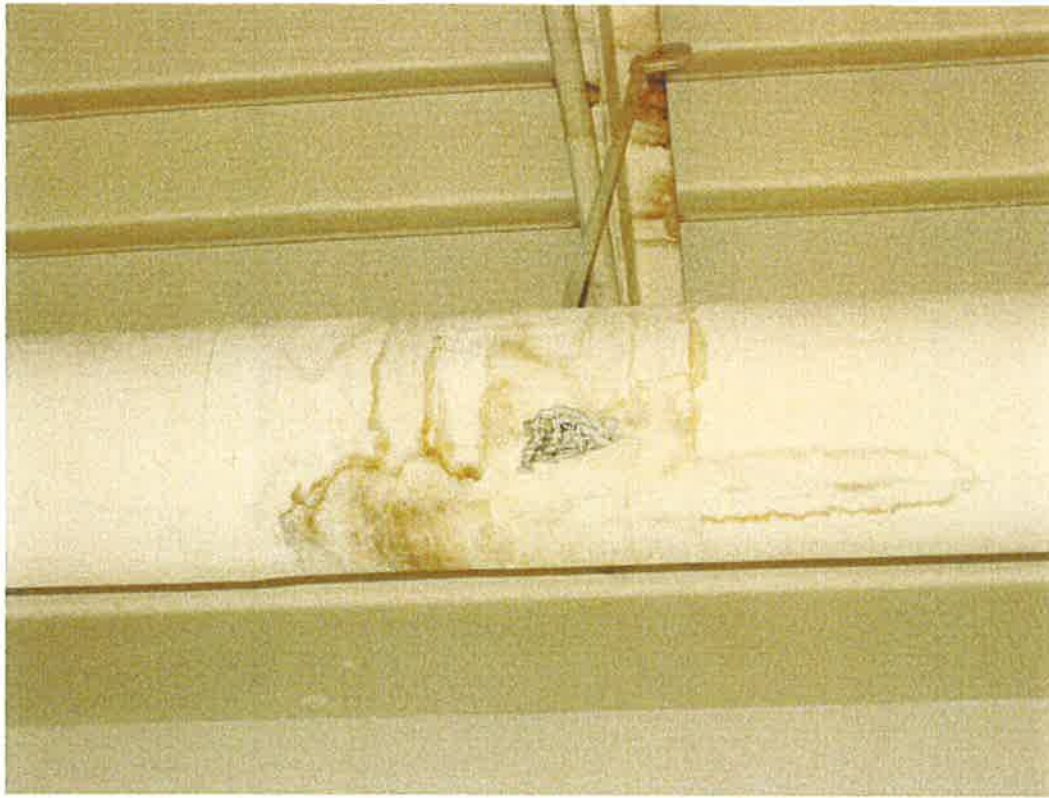
ROOM 125 - WATER DAMAGED AIR CELL

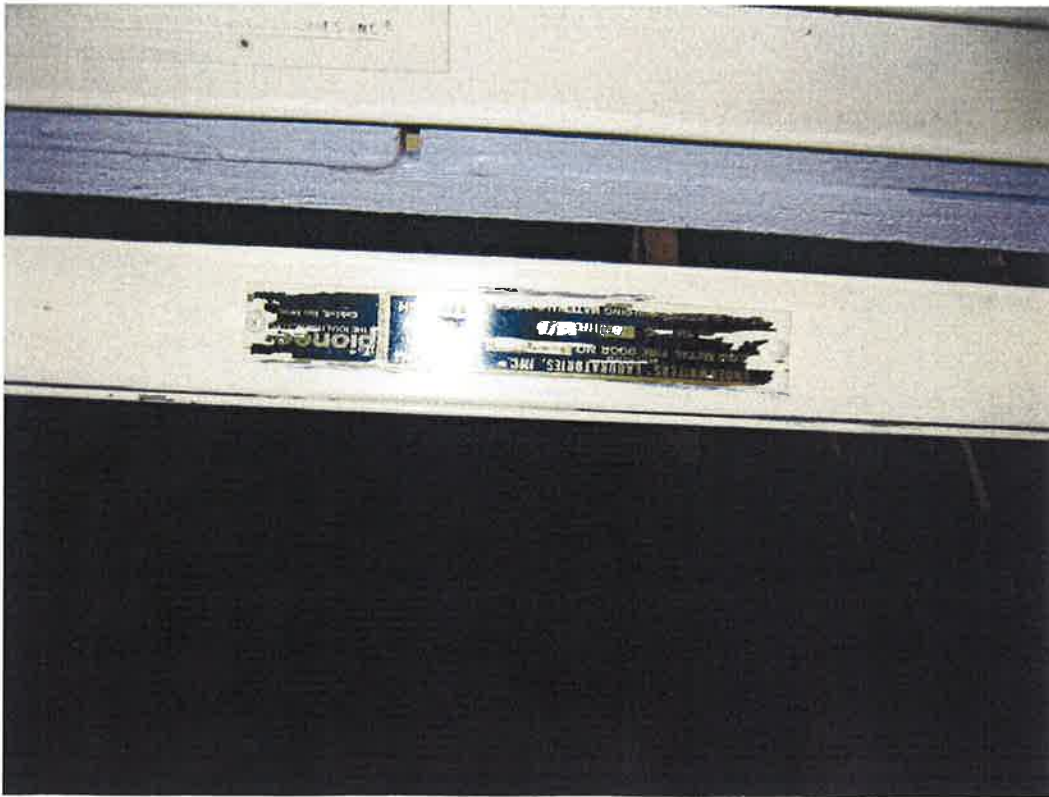
ROOM 114C - FIRE DOOR LABEL

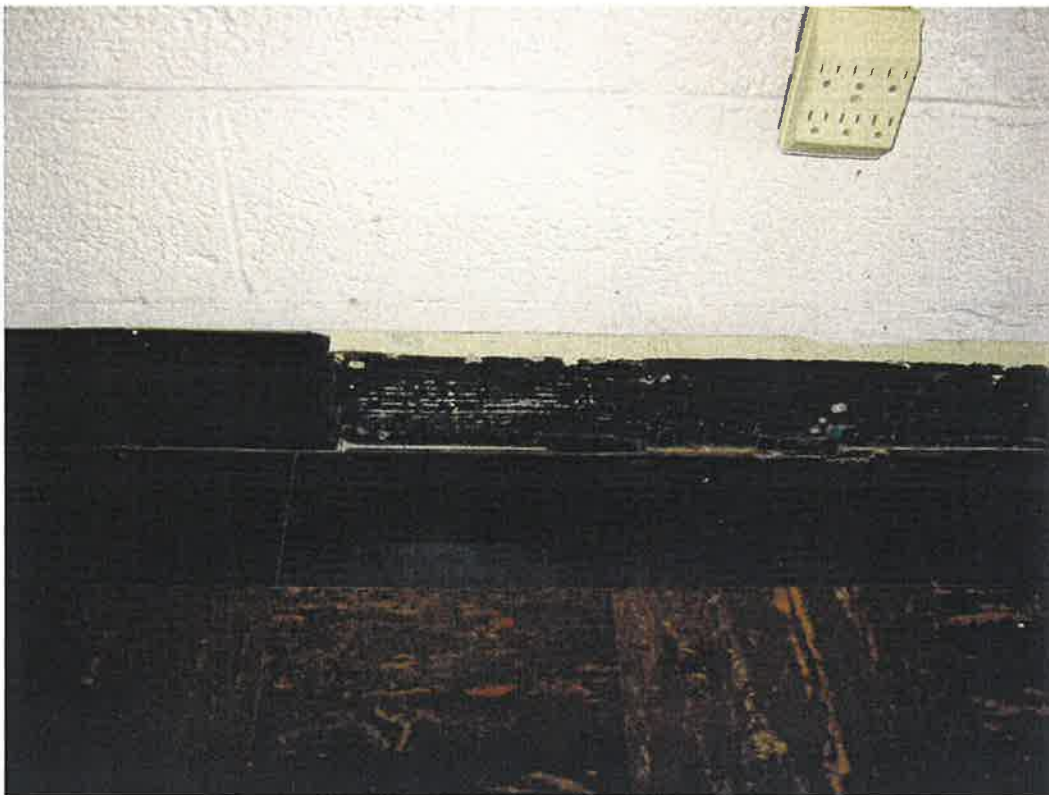
ROOM 210 - DAMAGED 6" BLACK VINYL BASE

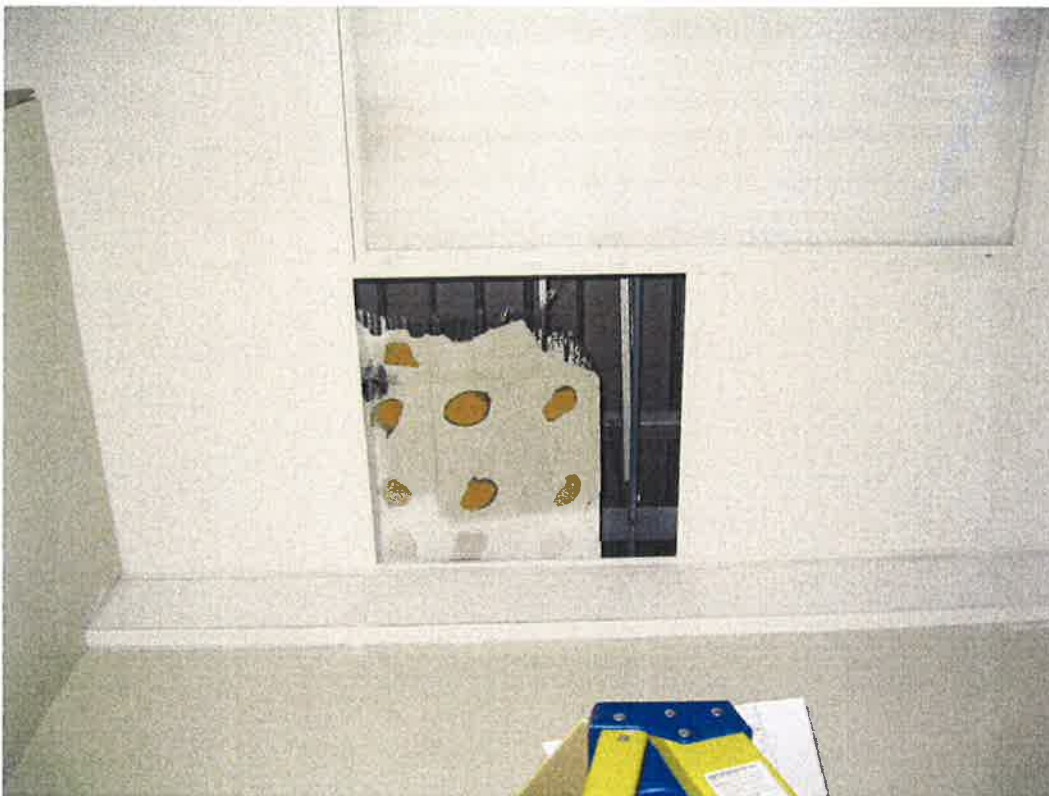
ROOM 116 - OLD CEILING SYSTEM ABOVE DROP CEILING

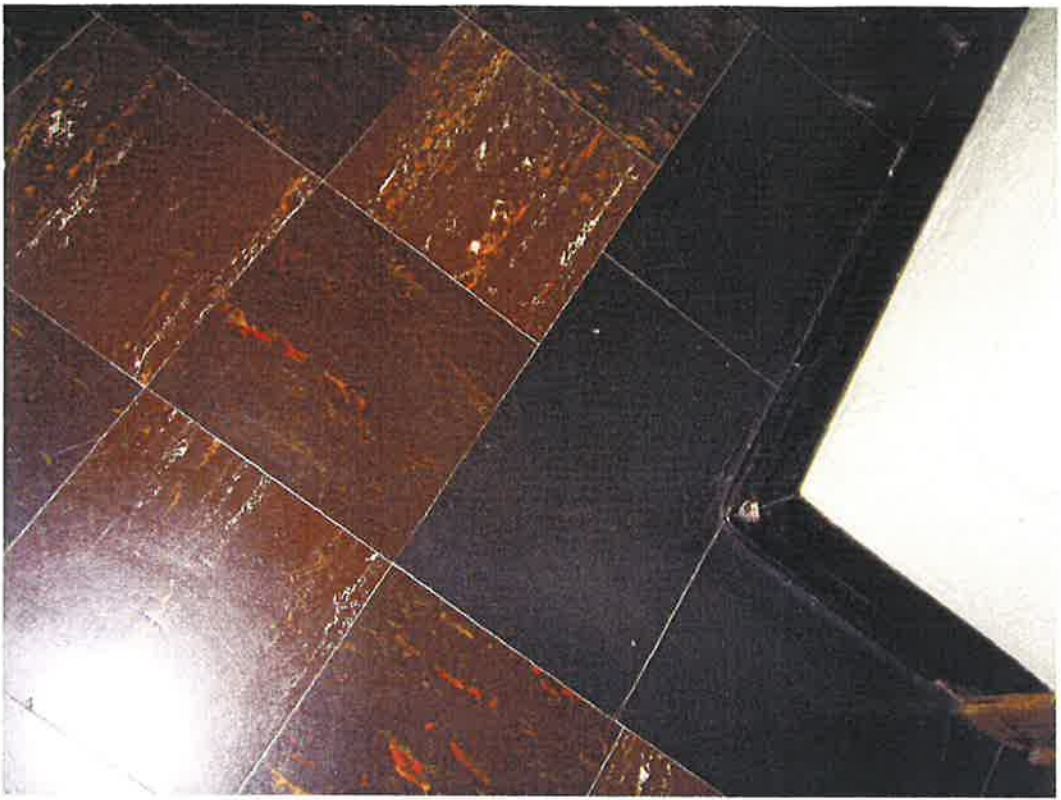
2ND FLOOR – VINYL FLOOR TILE SYSTEM

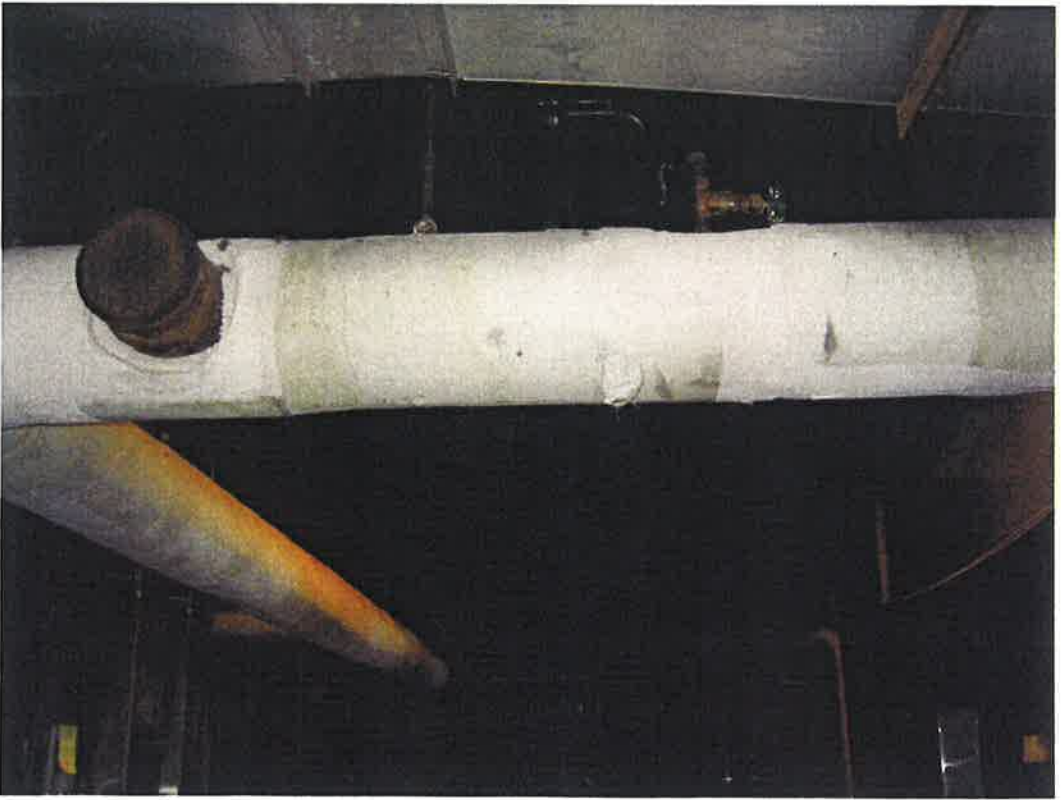
ROOM 300 – DAMAGED AIR CELL

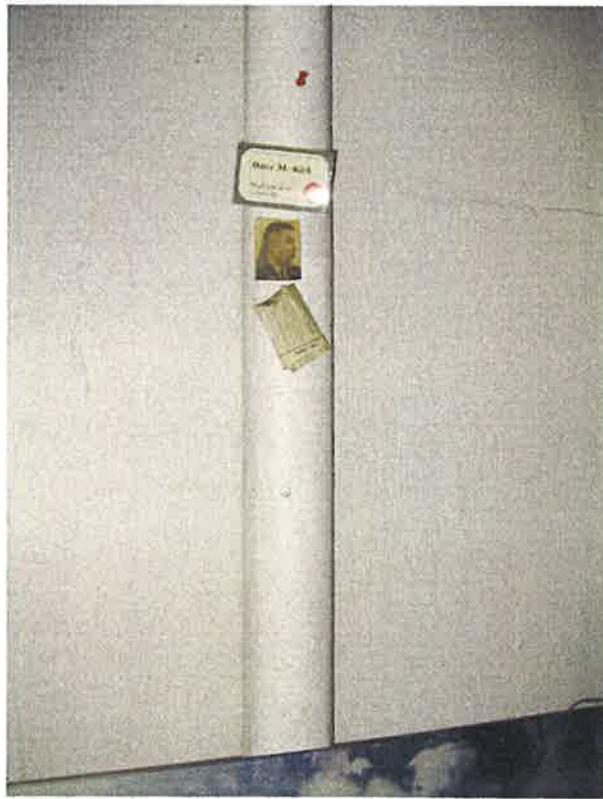
ROOM 5 - AIR CELL USED AS BULLETIN BOARD
