Michigan State University Asbestos Inspection Photo Log

Plant Sciences Greenhouse, West Range (#93)

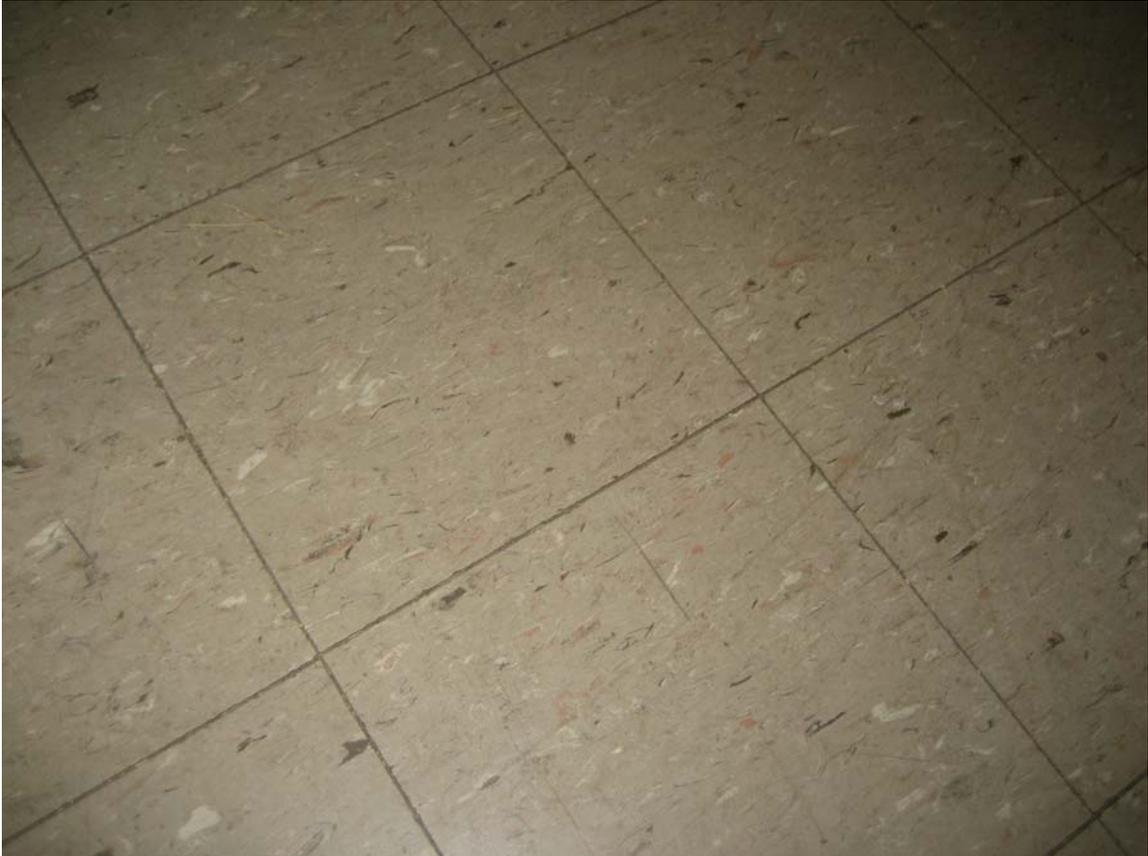
HA #1 – Asbestos containing 9”x 9” Gray floor tile with white and rust streaks and associated mastic

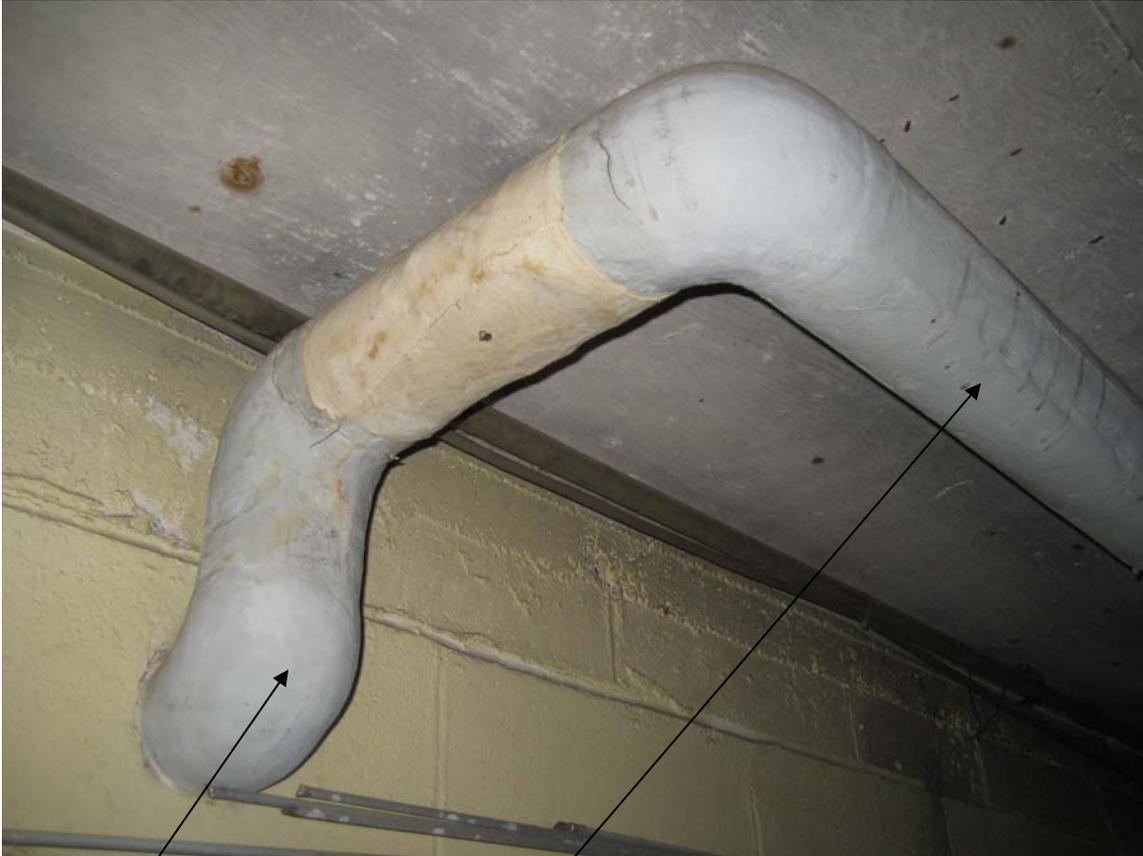
HA #2 – Assumed asbestos containing pipe straight insulation

HA #3 – Assumed asbestos containing pipe fitting insulation

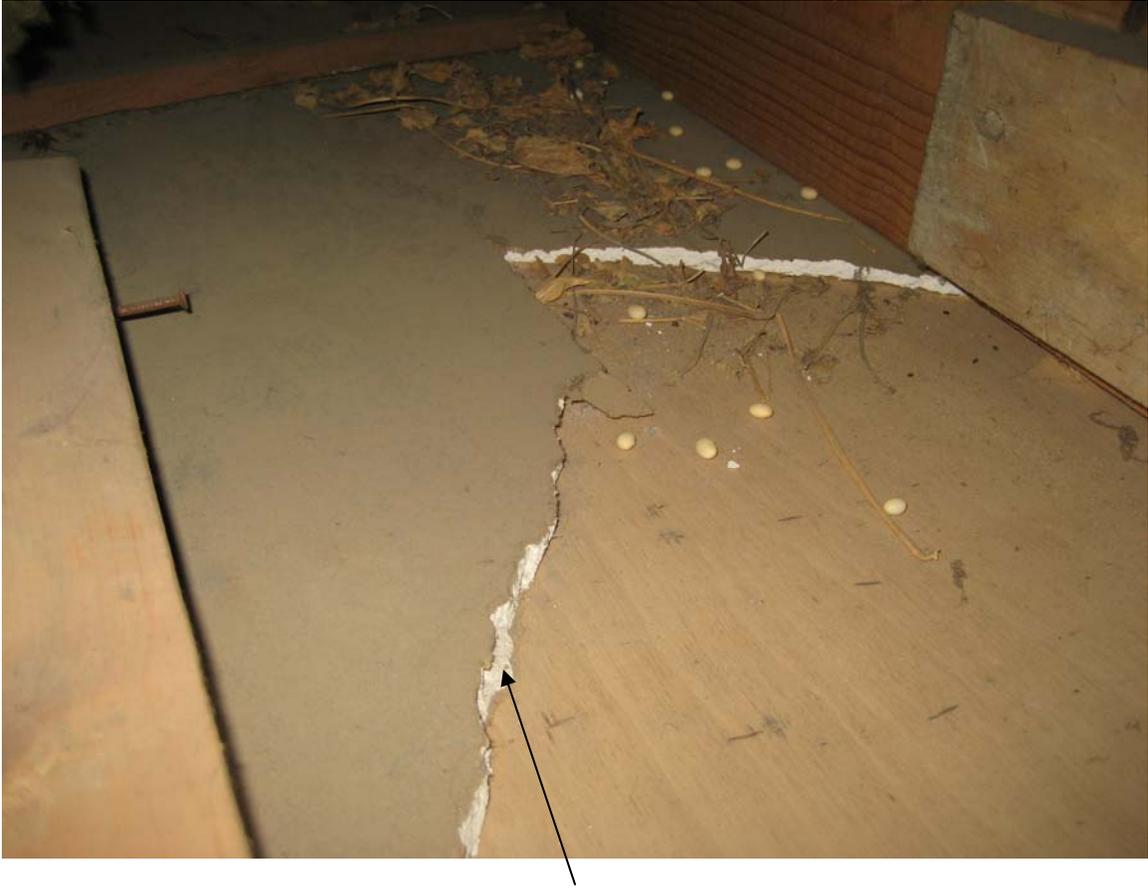
HA #4 – Non asbestos containing unfinished drywall

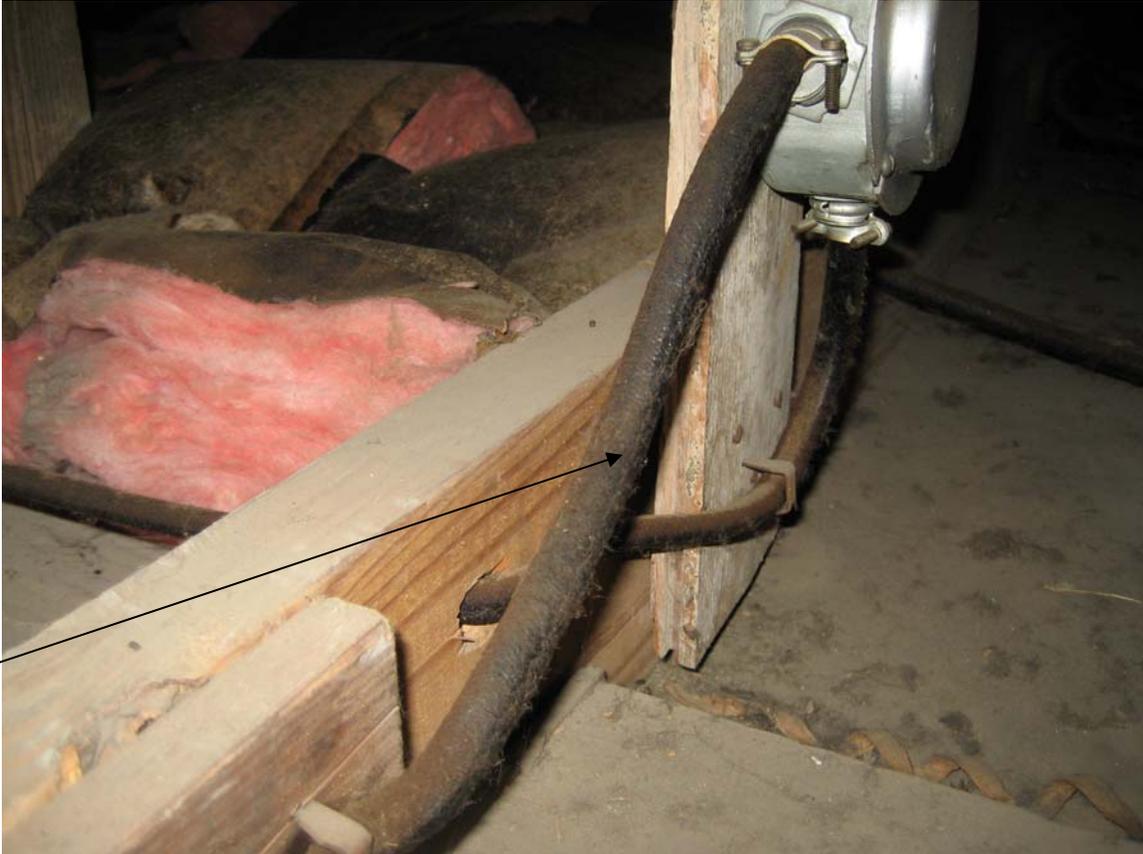
HA #5 – Assumed asbestos containing electrical wire covering

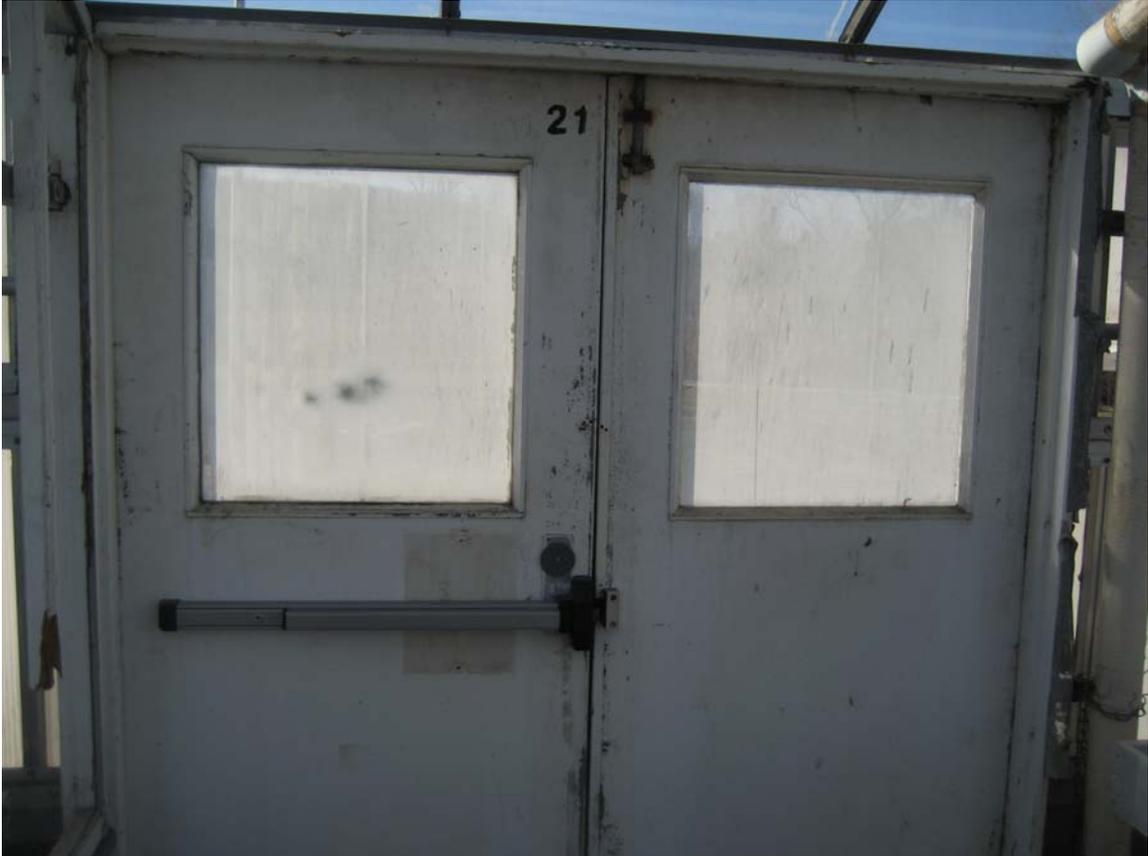
HA #6 – Assumed asbestos containing fire door and frame

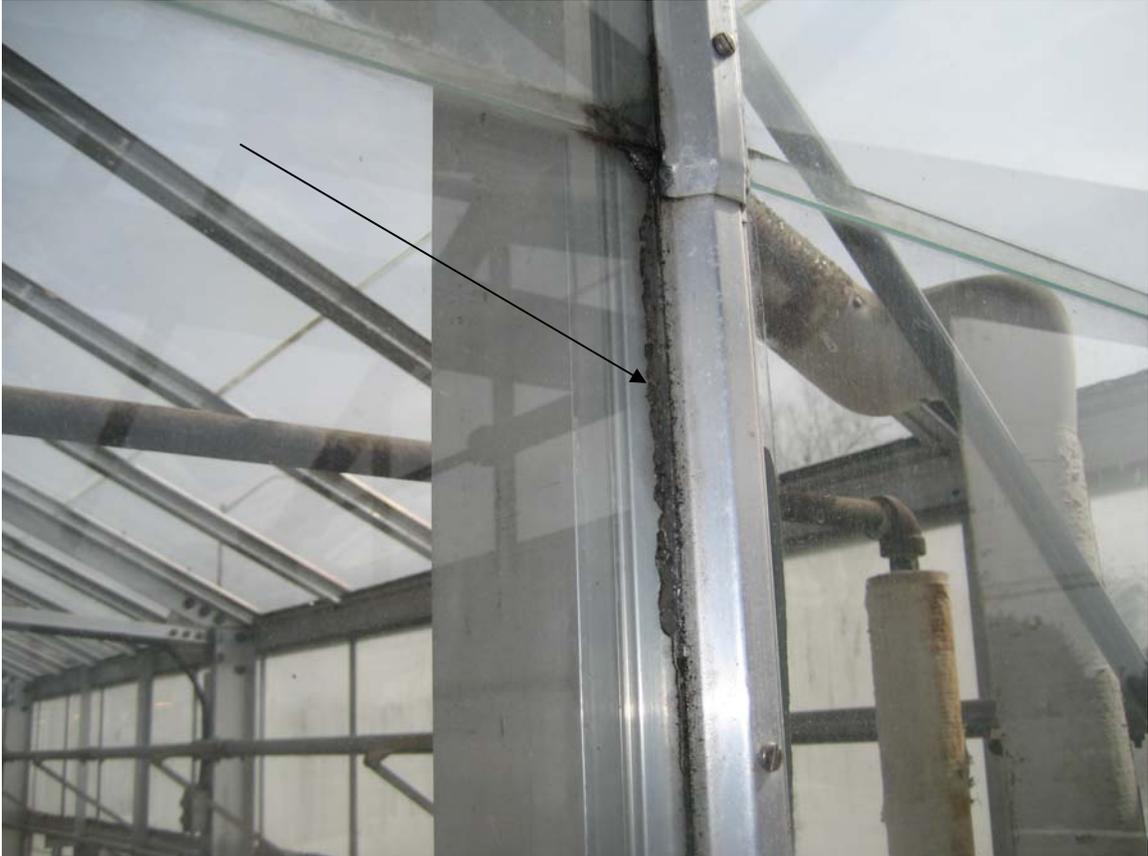
HA #7 – Asbestos containing gray caulk, 1978 addition

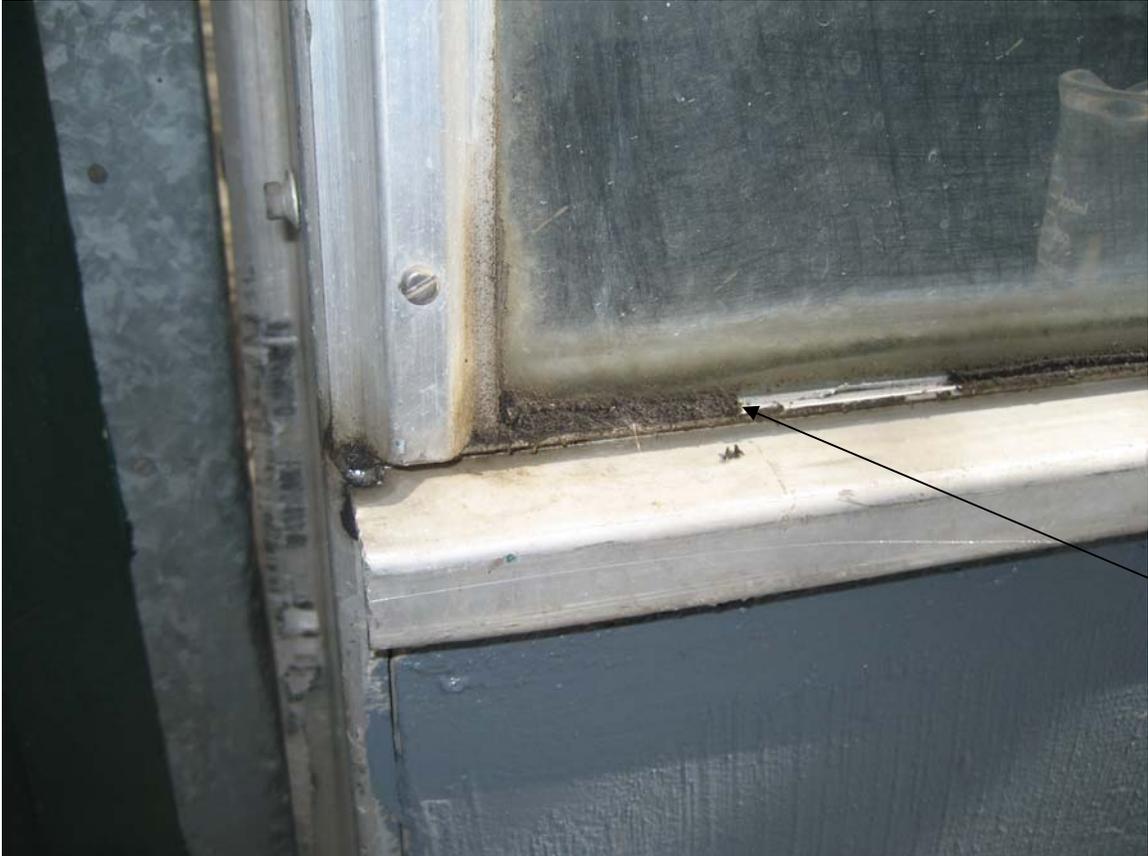
HA #8 – Asbestos containing black caulk and white window glazing layer,
1978 addition

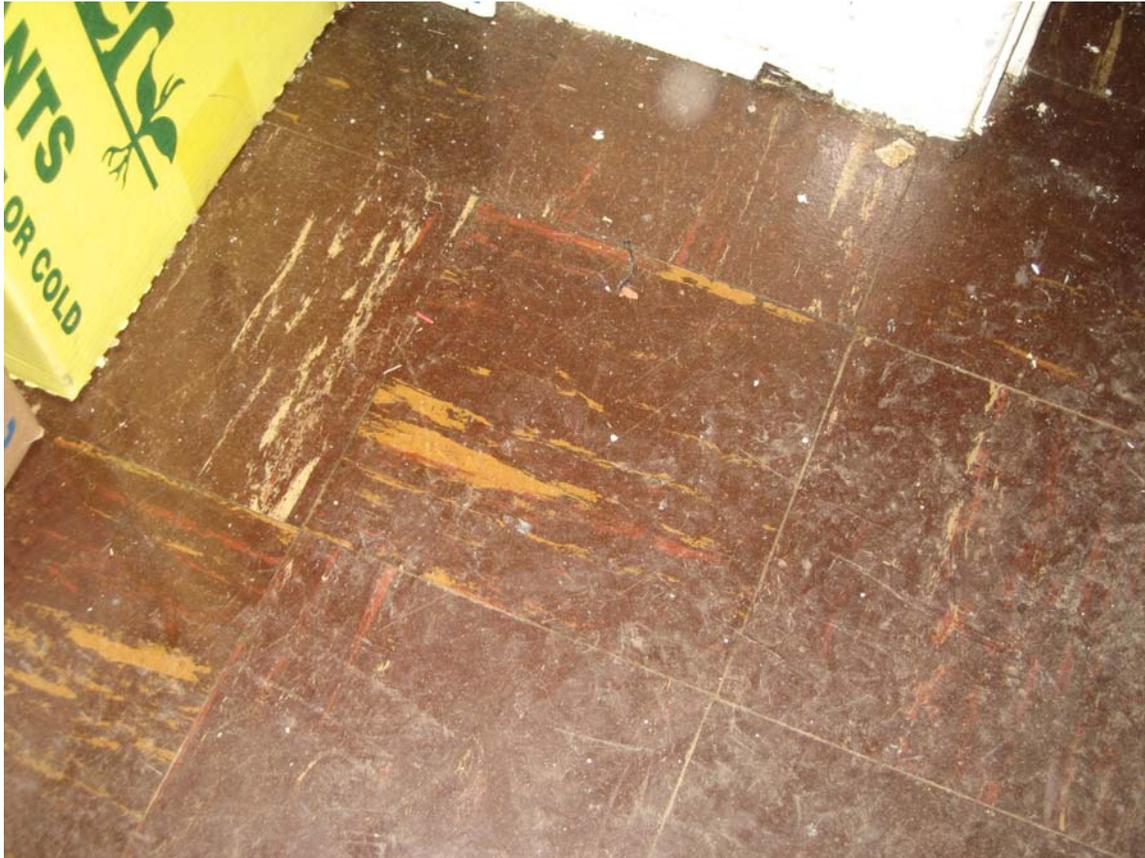
HA #9 – Asbestos containing 9”x 9” Brown floor tile with red and cream streaks

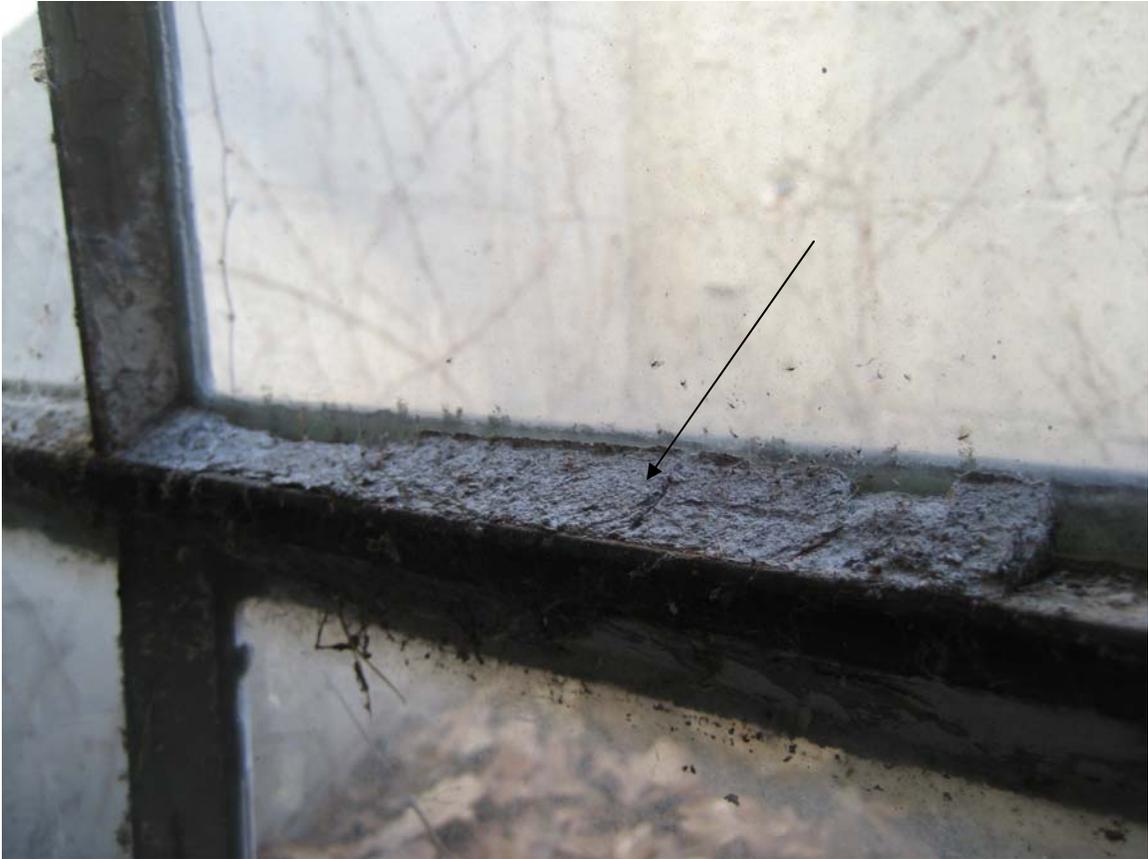
HA #10 – Asbestos containing window glazing on metal window

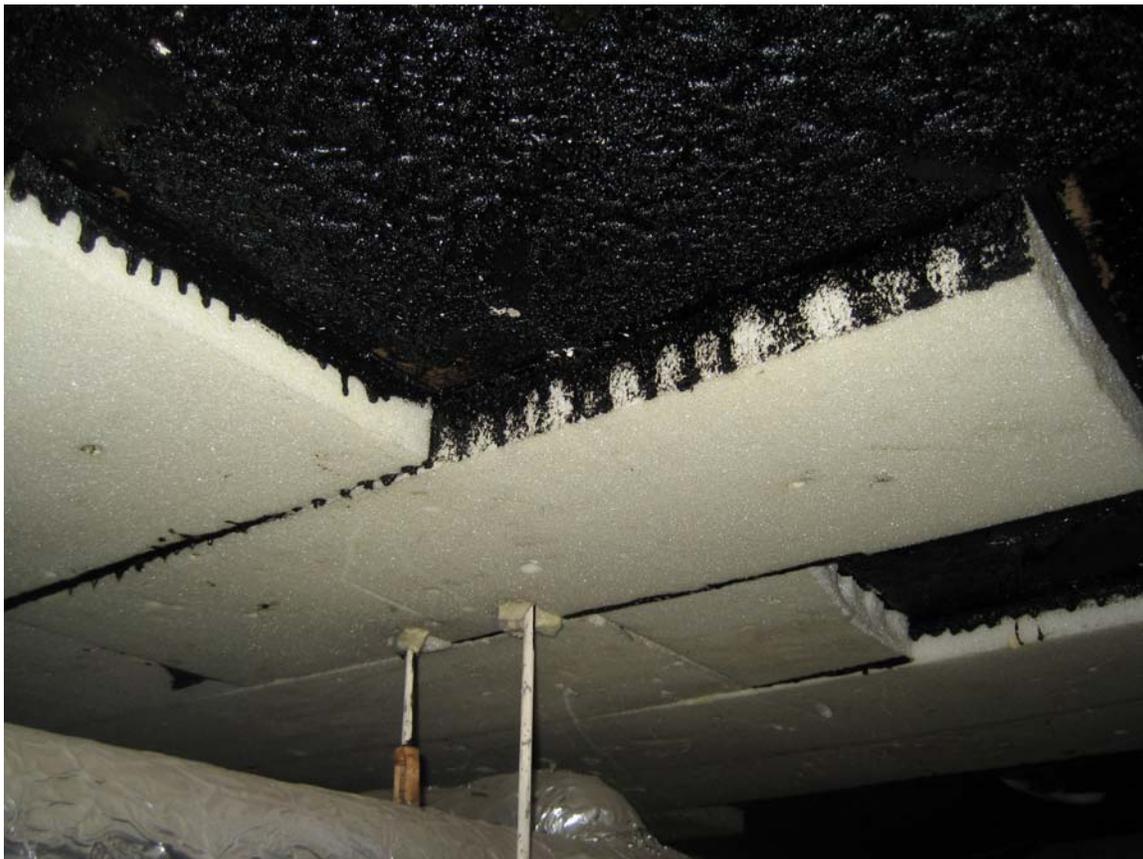
HA #11 – Asbestos containing white Styrofoam insulation and black mastic with associated gluepods

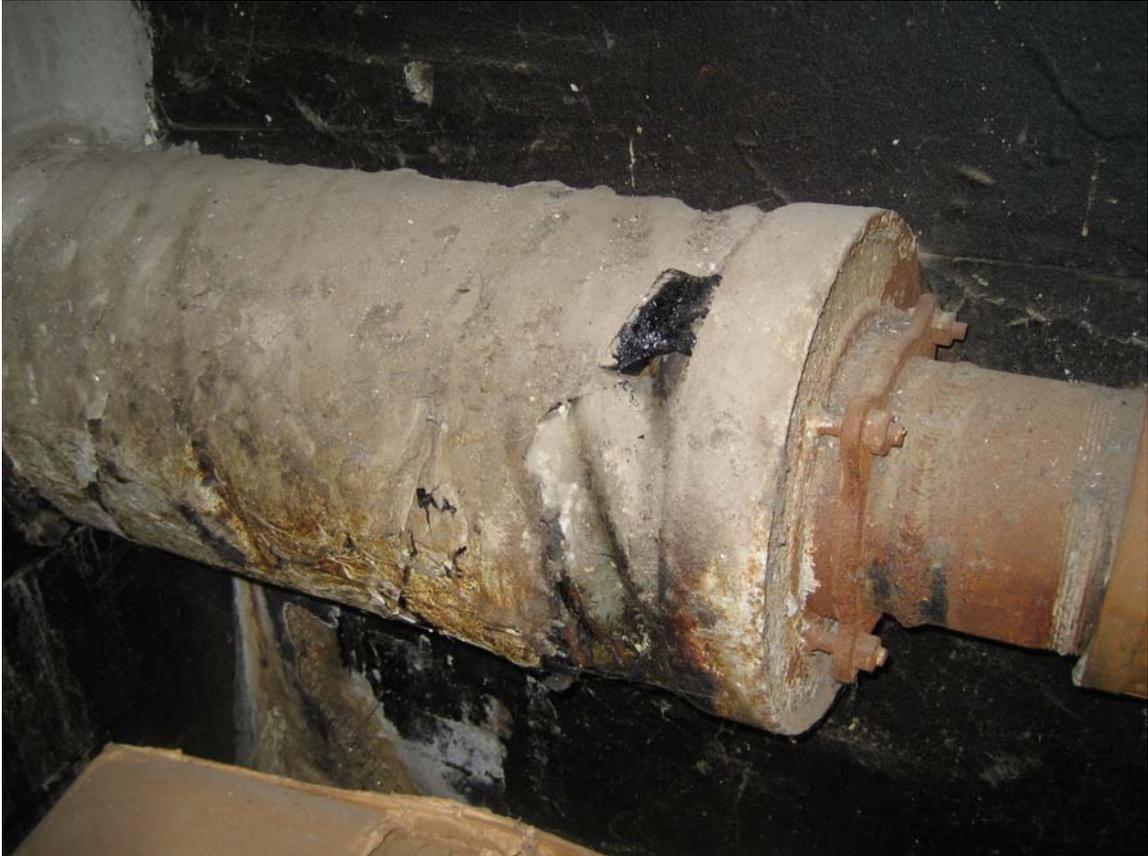
HA #12 – Asbestos containing black covering on metal

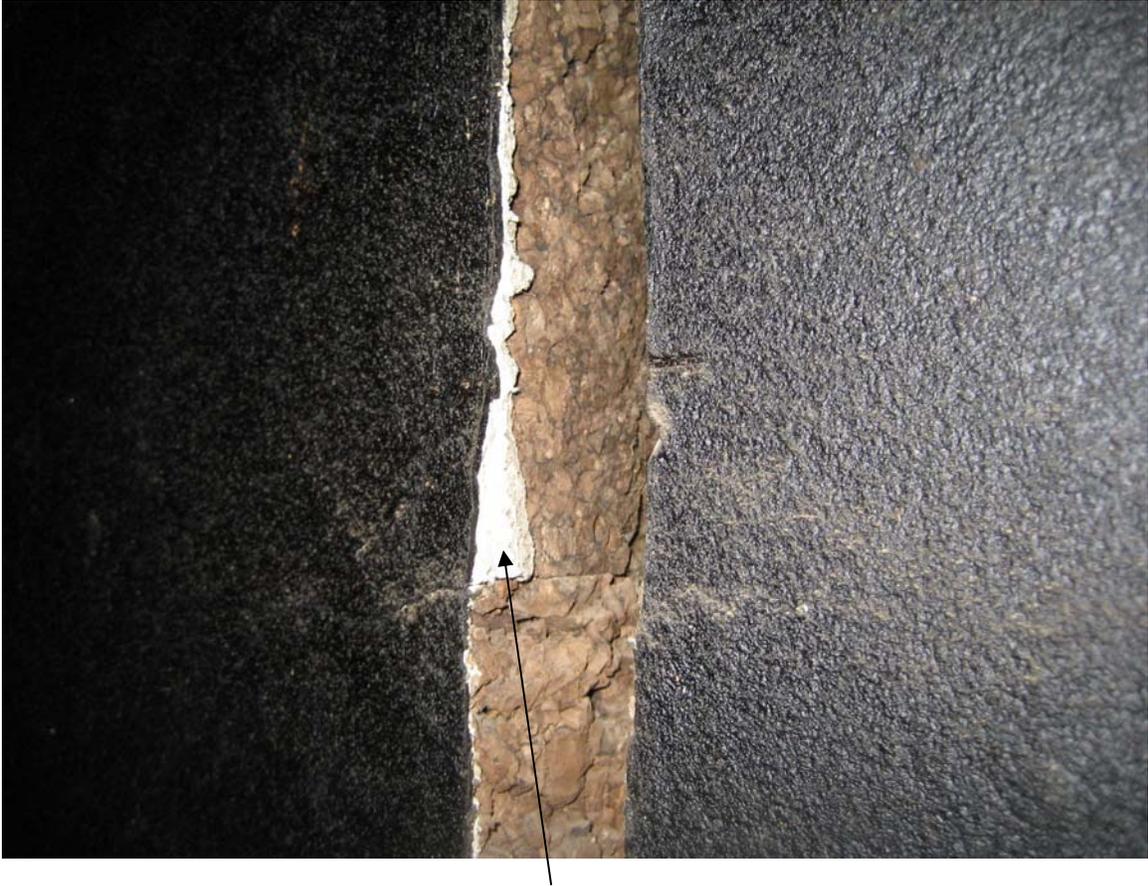
HA #13 – Asbestos containing black wall/ceiling covering on cork

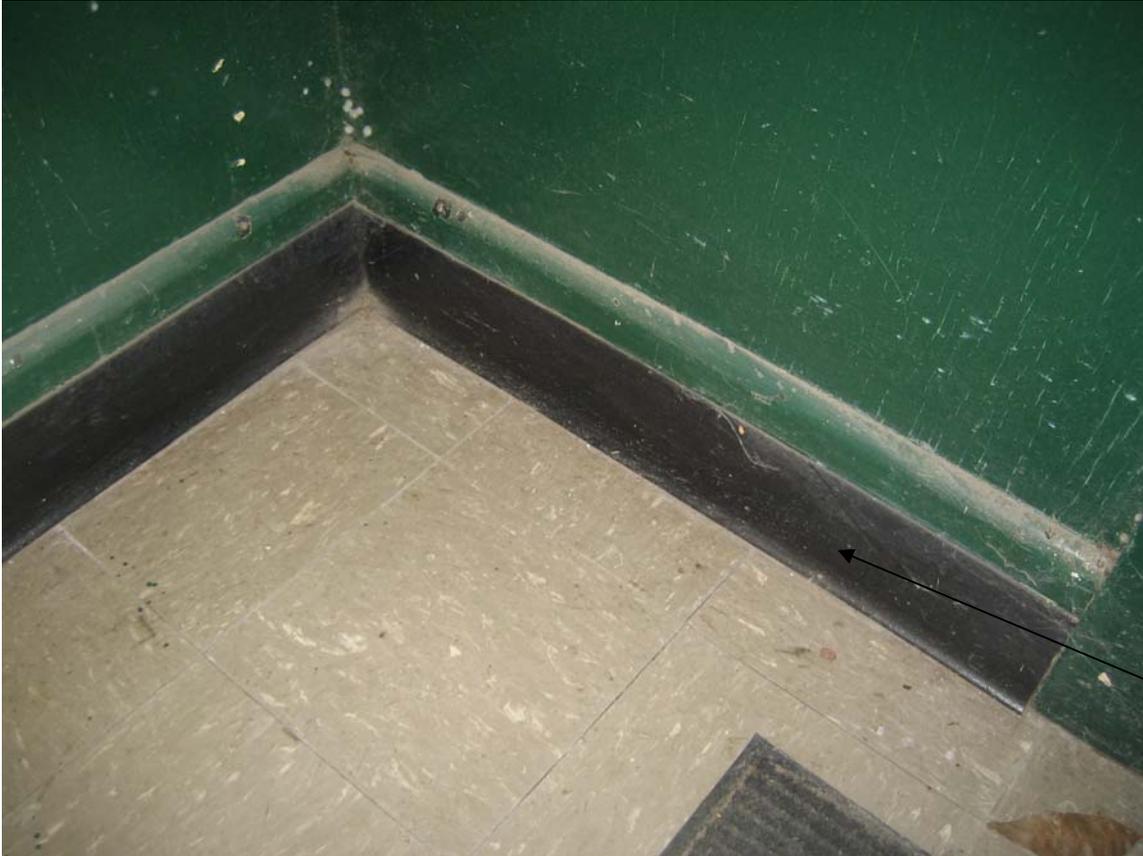
HA #14 – Asbestos containing black cove molding and associated mastic

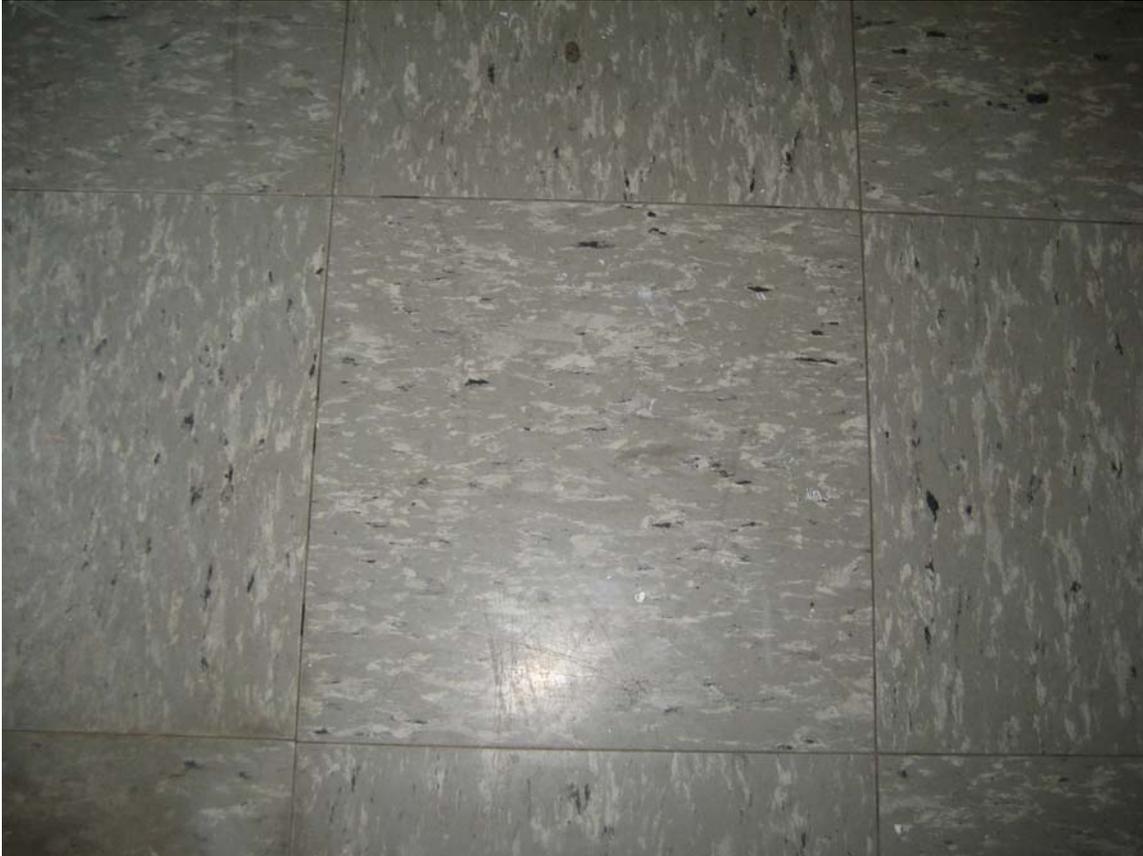
HA #15 – Asbestos containing 12”x 12” gray floor tile with light gray and white streaks and associated mastic

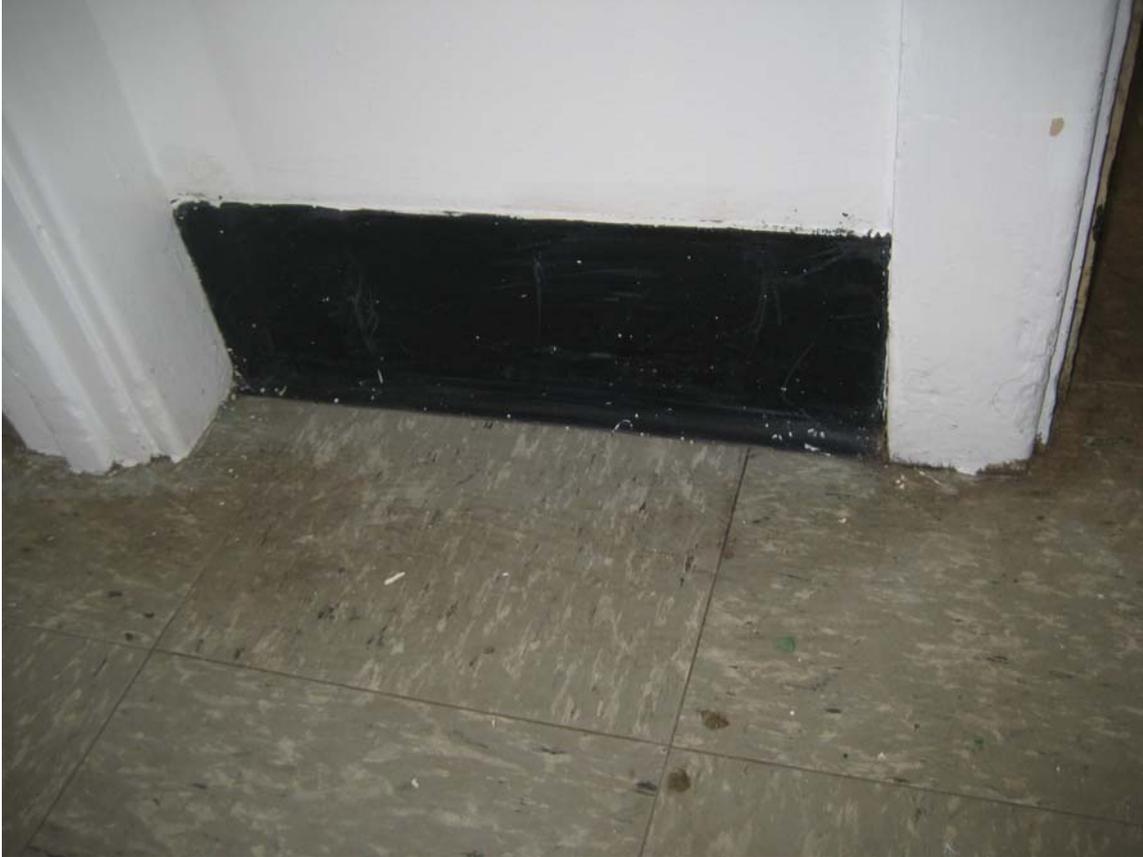
HA #16 – Non asbestos containing 6” black cove molding and associated mastic

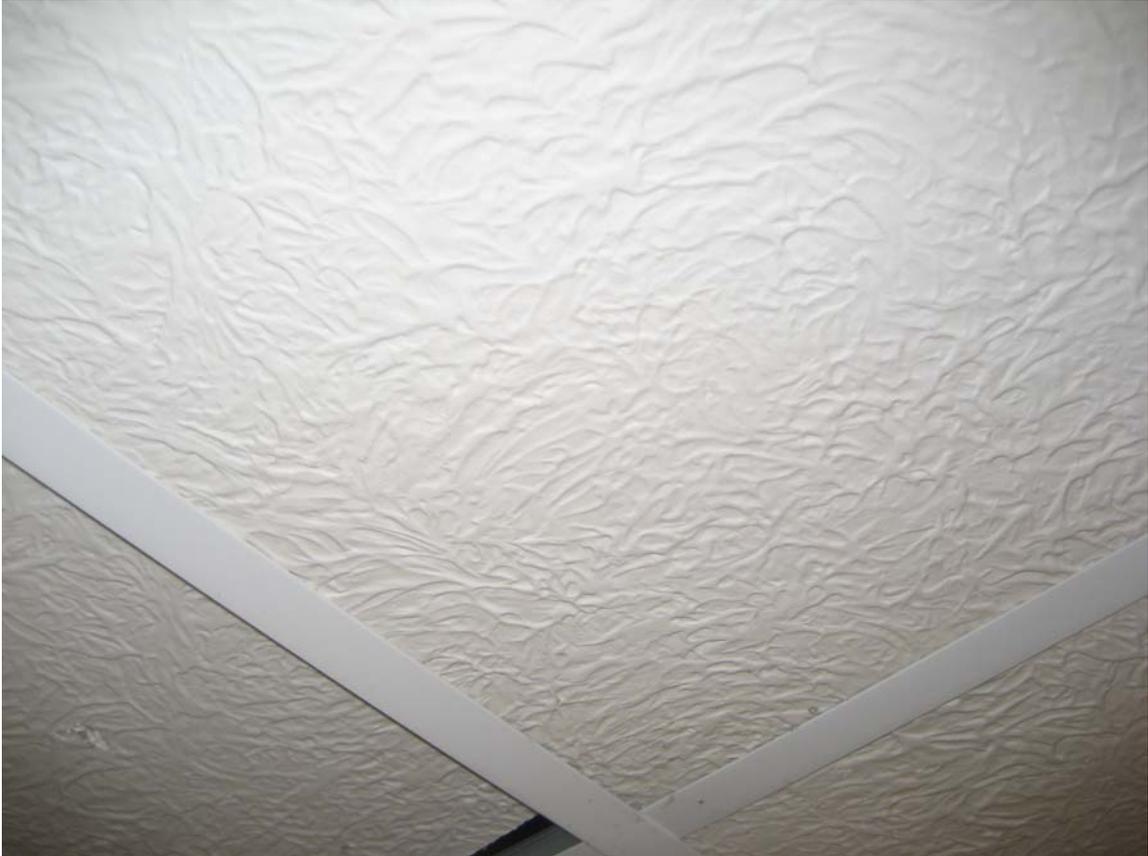
HA #17 – Non-asbestos containing 2' x 4' lay-in ceiling tile with smooth wave pattern

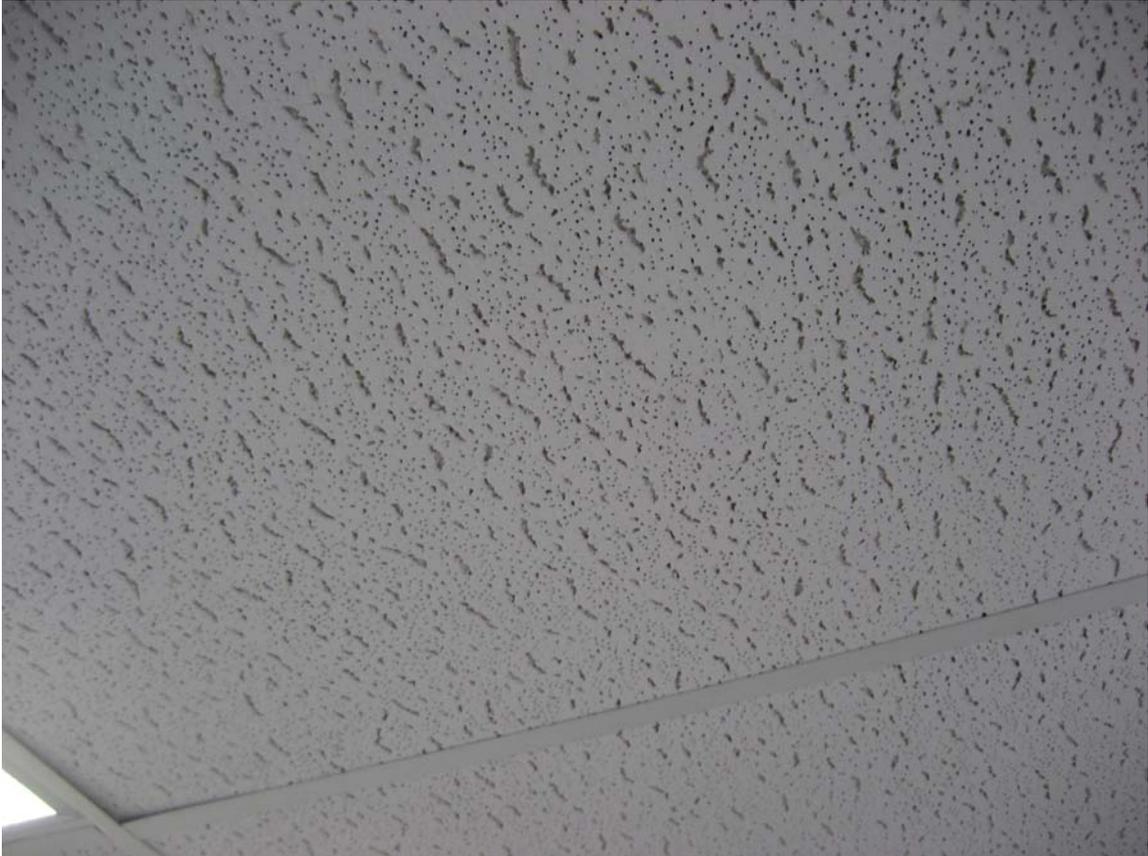
HA #18 – Non-asbestos containing 2' x 4' white lay-in ceiling tile with pinholes and fissures

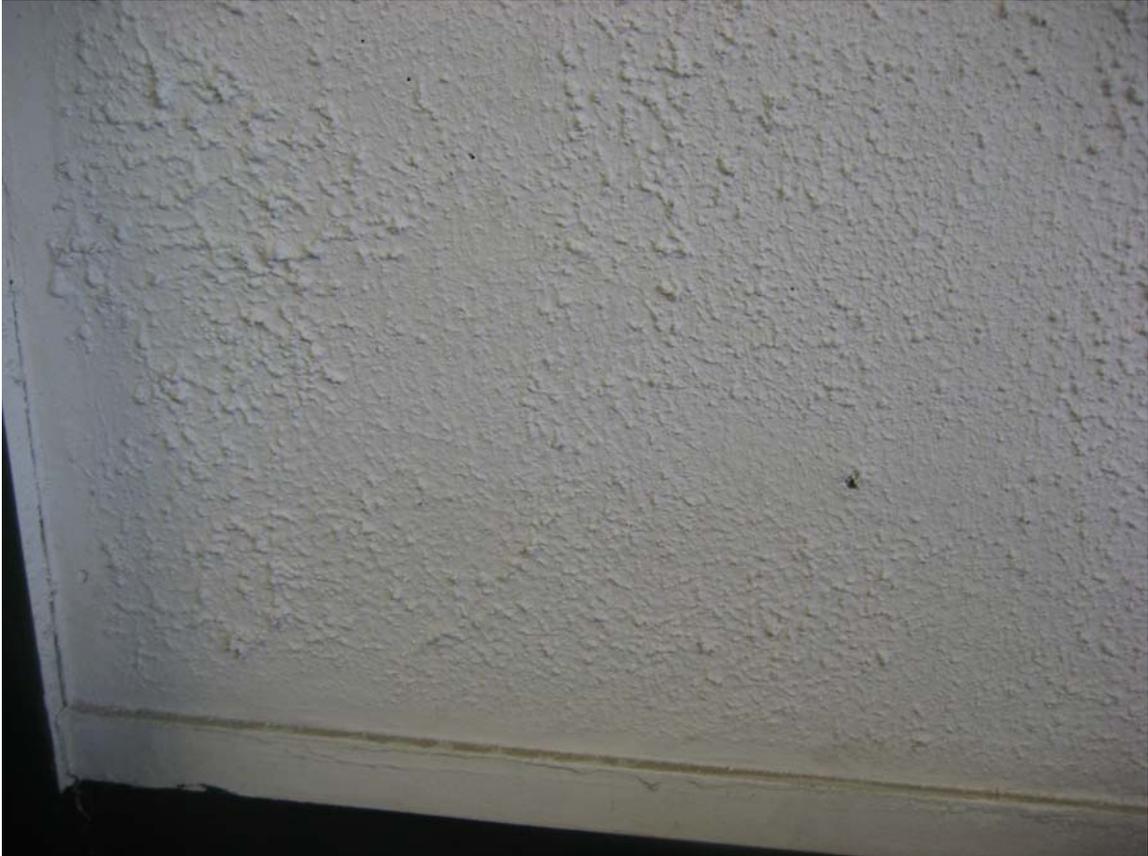
HA #19 – Non-asbestos containing heavy texture plaster skim coat

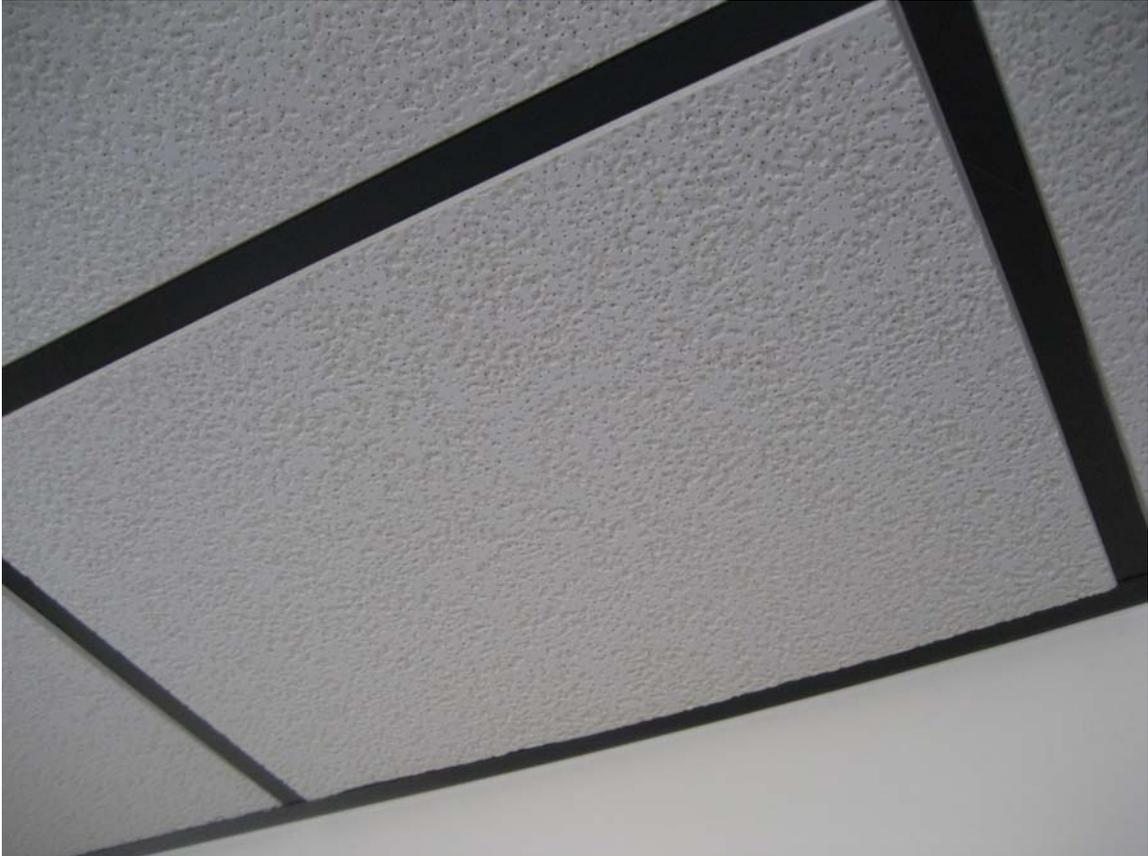
HA #20 – Non asbestos containing 2'x 2' drop-in ceiling tile with pinholes and light fissures

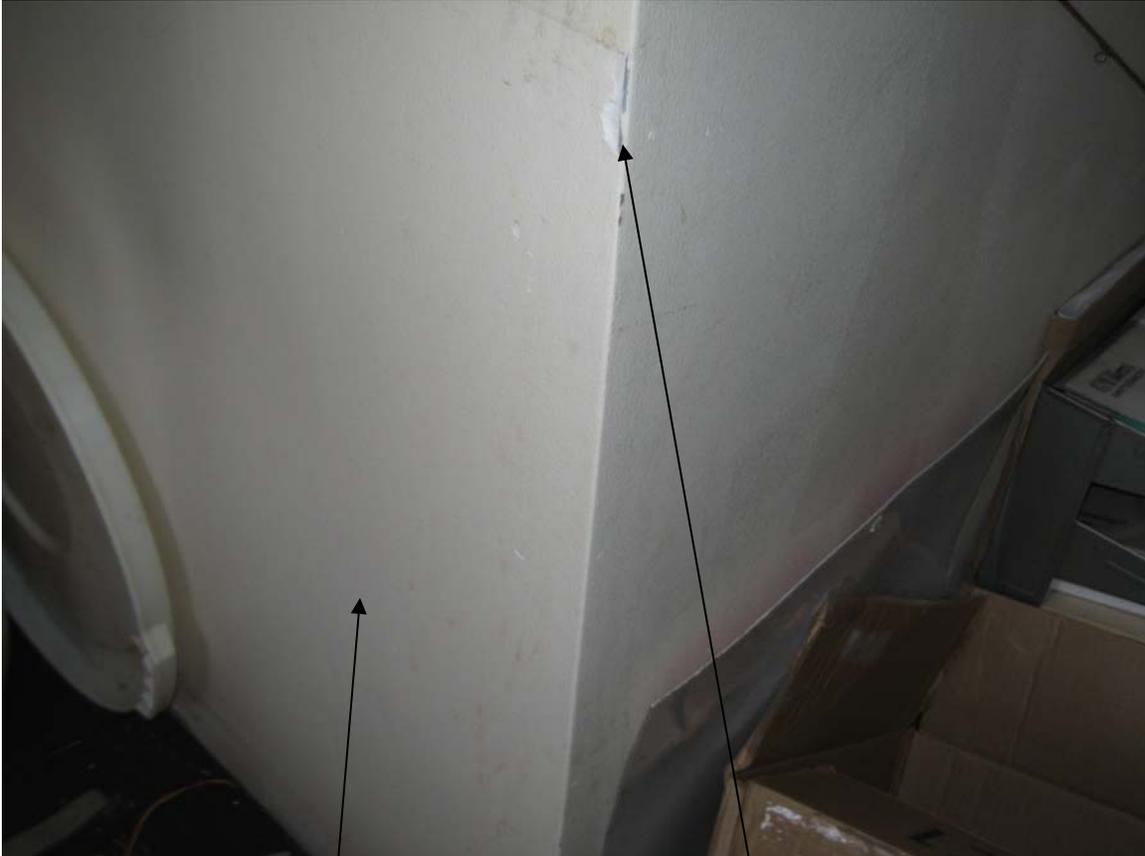
HA #21 – Non-asbestos containing drywall

HA #22 – Non-asbestos containing drywall joint compound

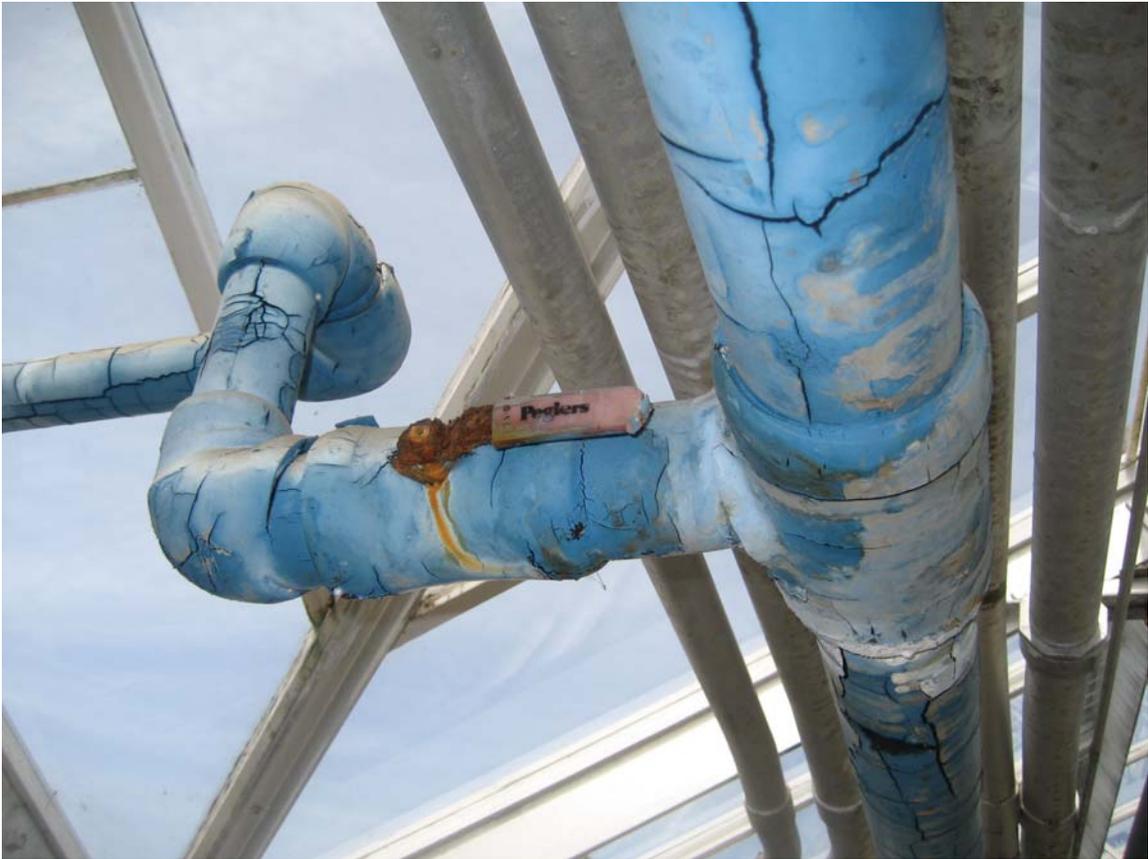
HA #23 – Non asbestos containing blue pipe covering

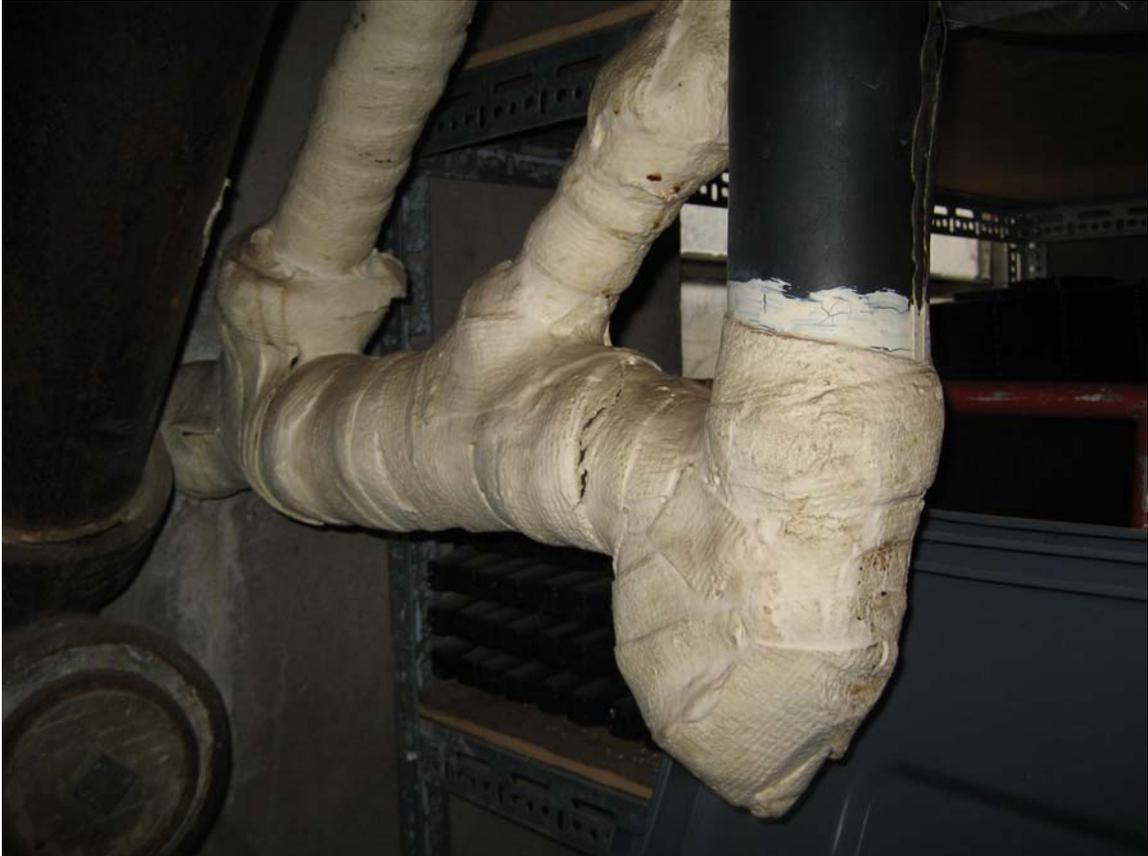
HA #24 – Asbestos containing white pipe coating

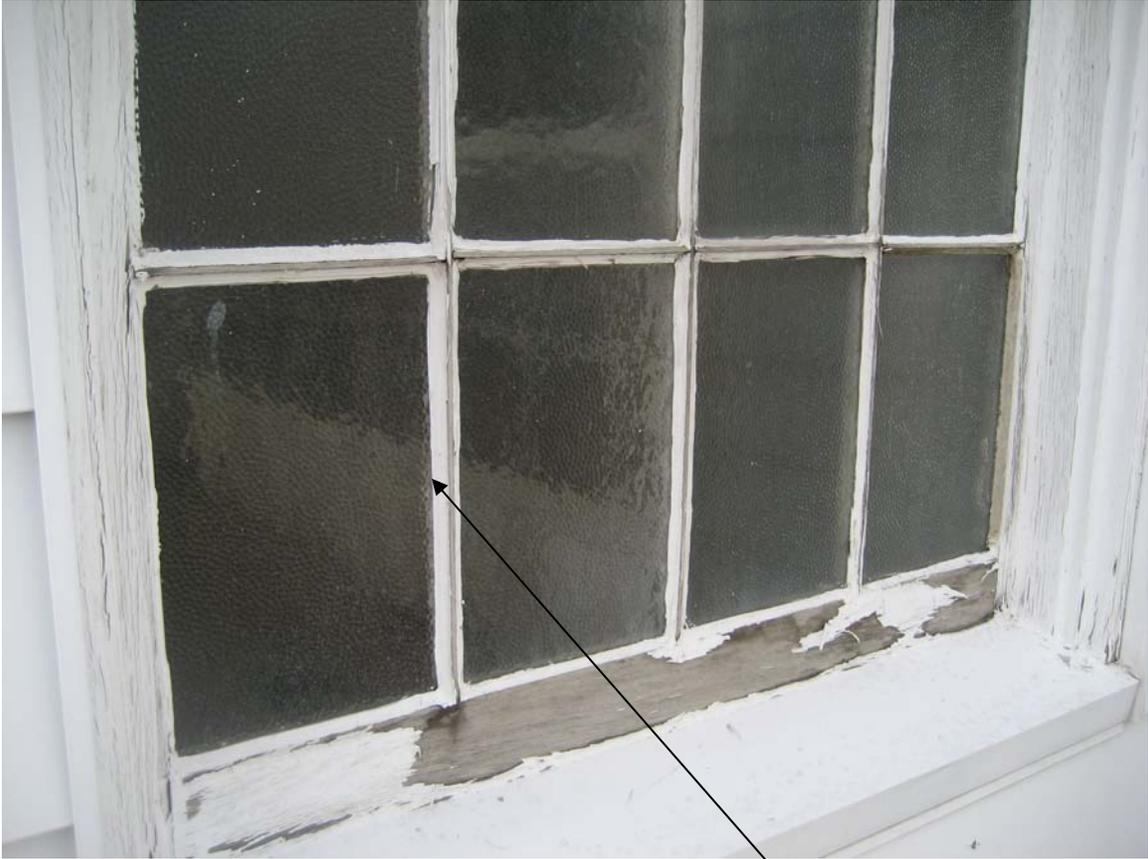
HA #25 – Non-asbestos containing white window glazing
