Michigan State University Asbestos Inspection Photo Log

Plant Sciences Greenhouse, West Range (#93)

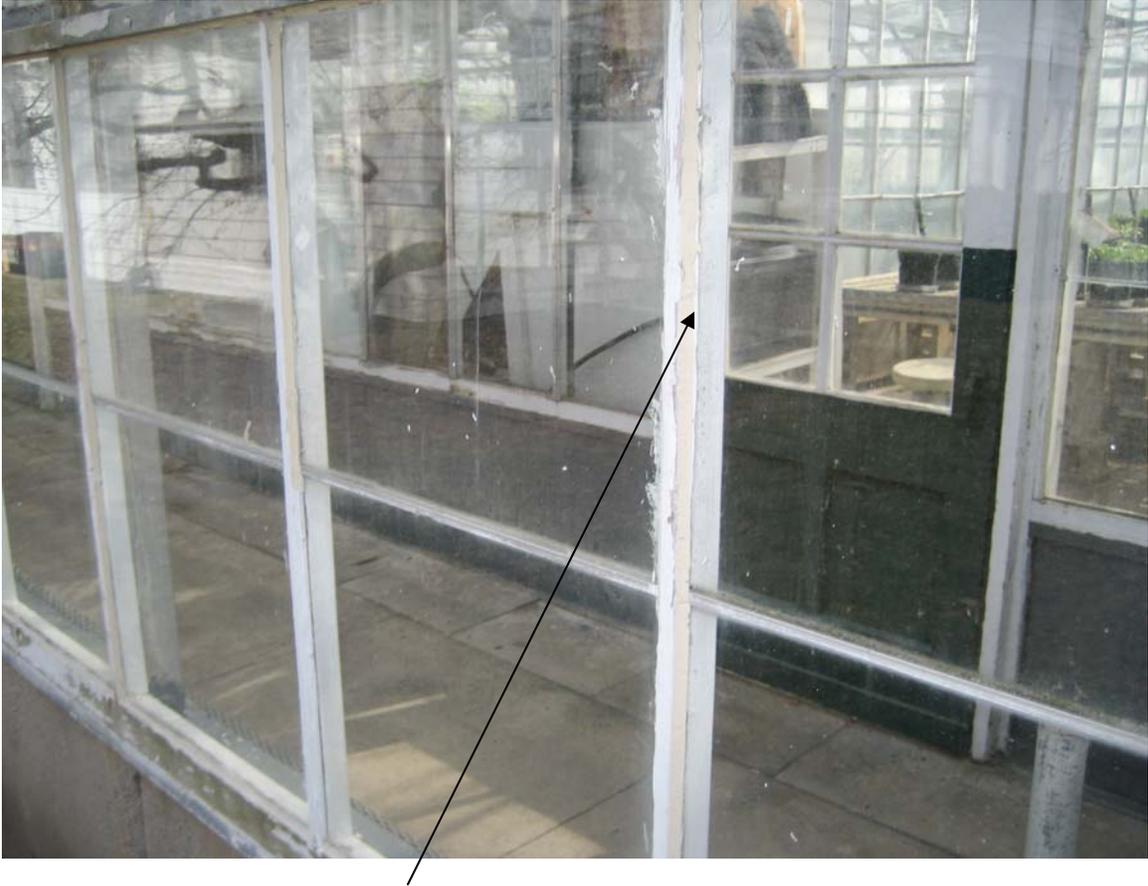
HA #26 – Non-asbestos containing exterior glass wall glazing compound
