Michigan State University
Asbestos Inspection Photo Log

Plant Sciences Greenhouse – East Range (#98)

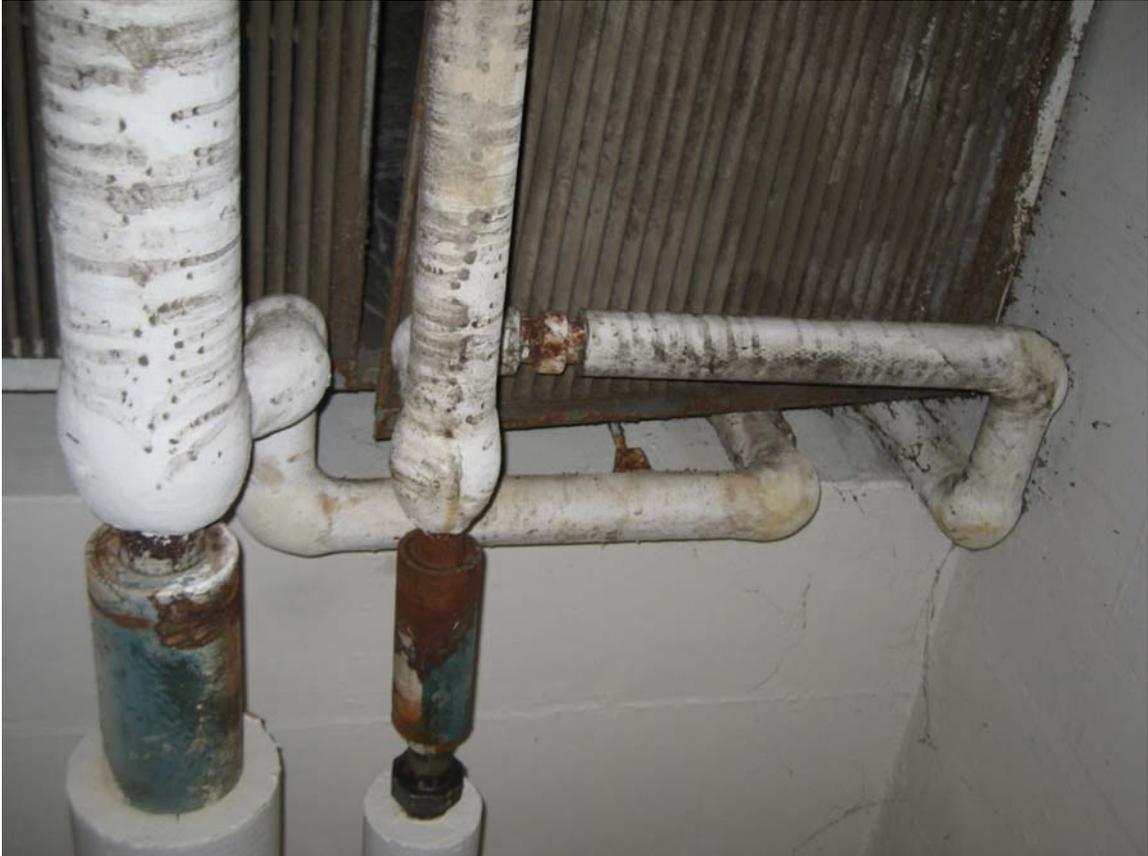
HA #1 – Assumed asbestos containing mud fitting and hanger insulation

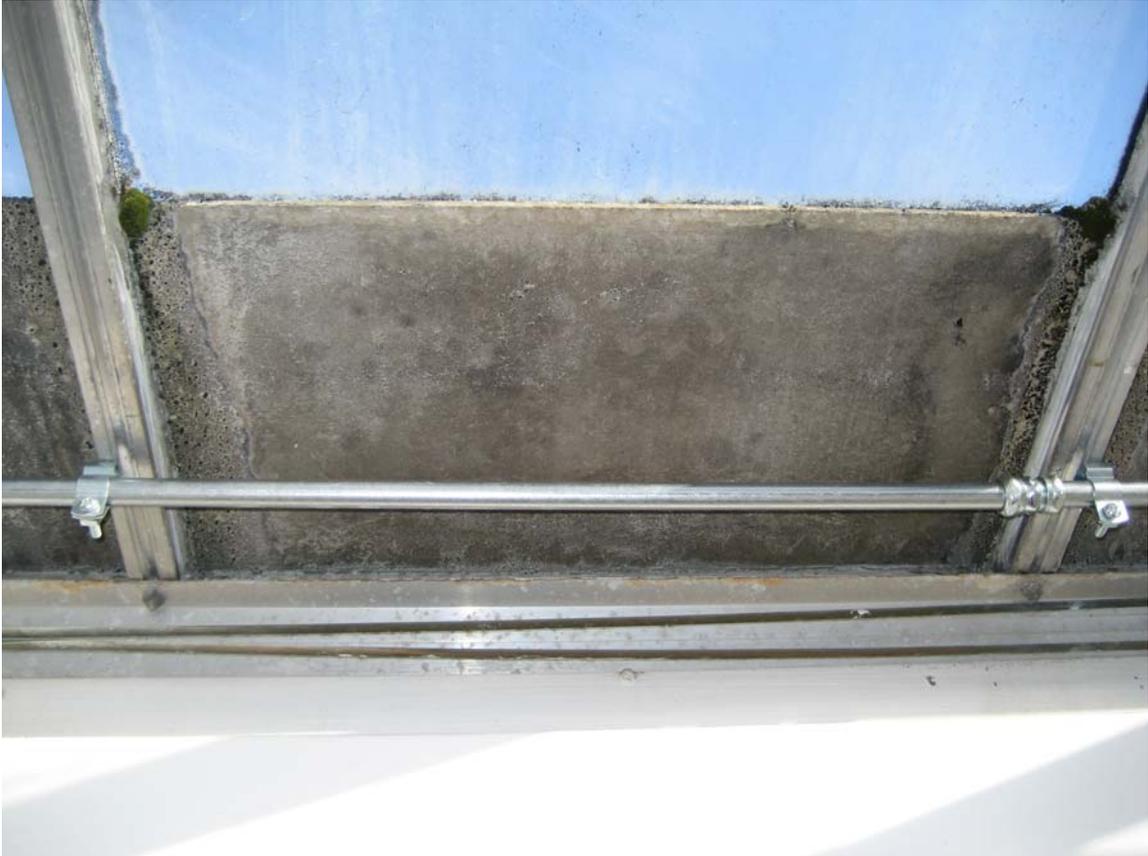
HA #2 – Assumed asbestos containing transite panels

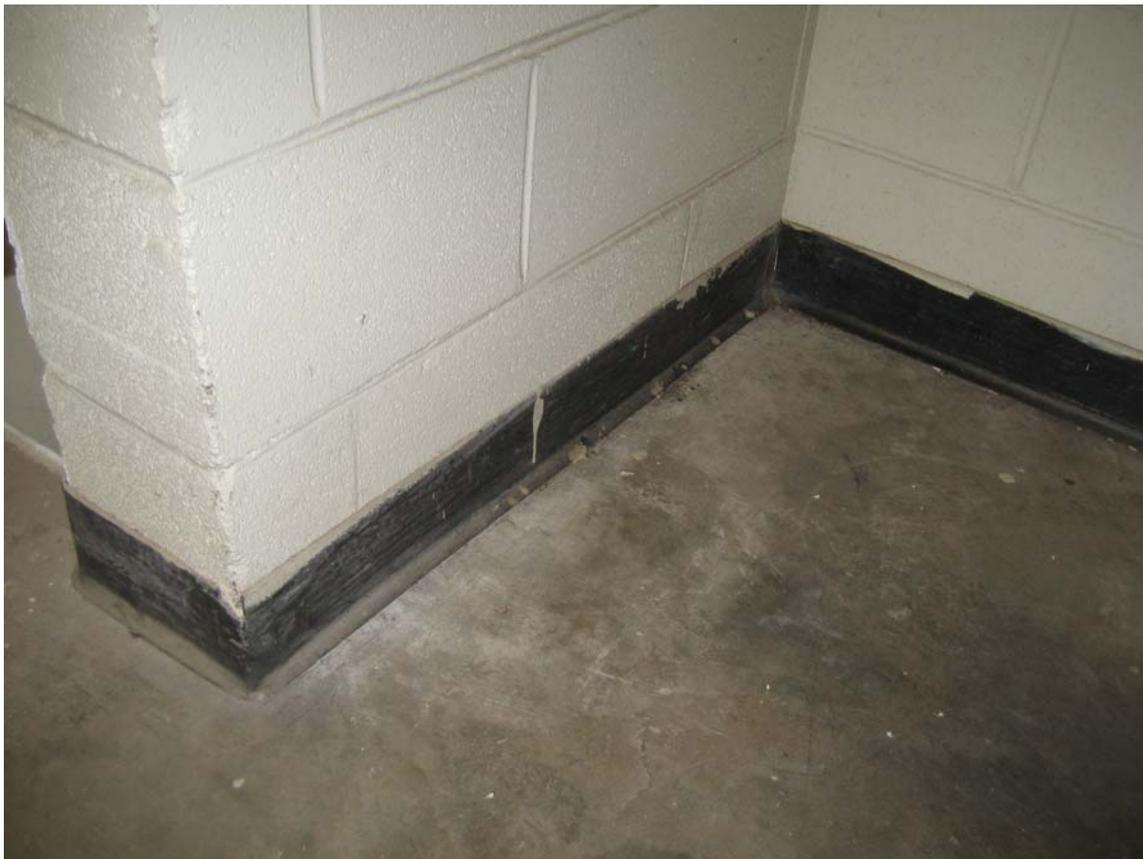
HA #3 – Non asbestos containing 4” black cove molding and associated mastic

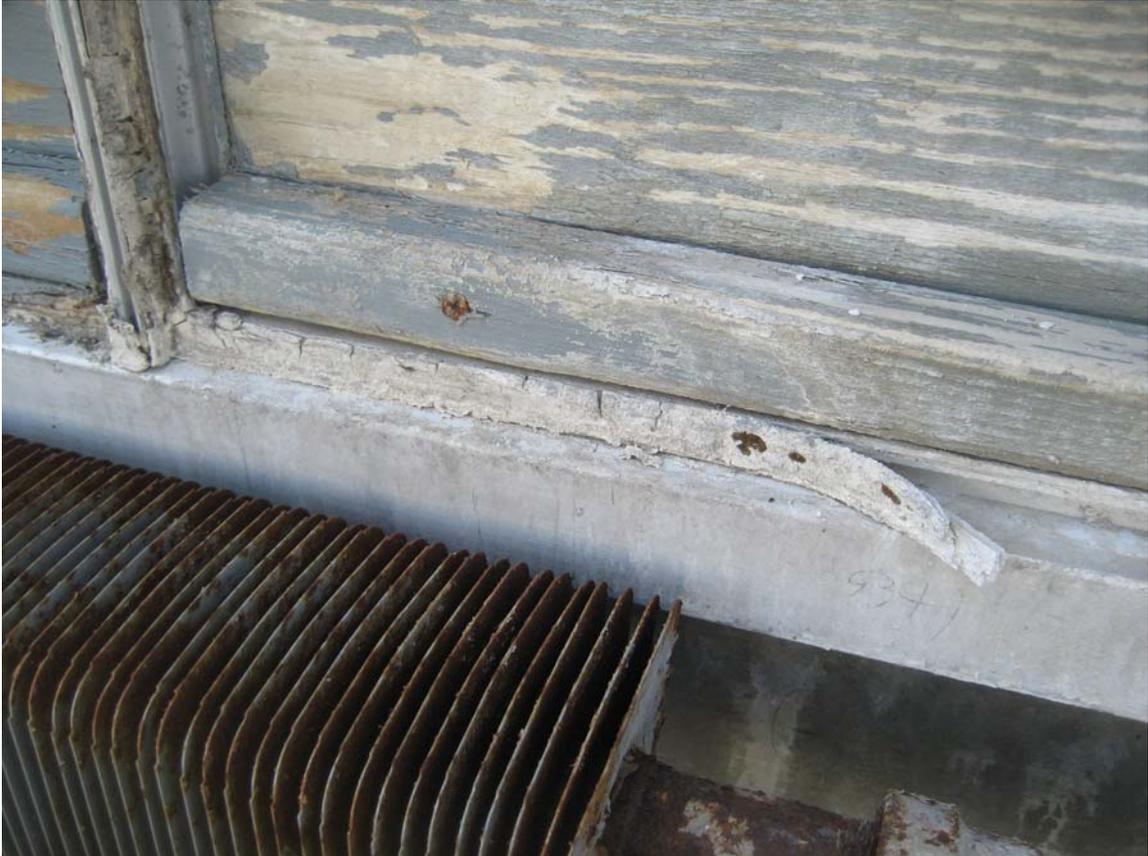
HA #4 – Asbestos containing white window glazing

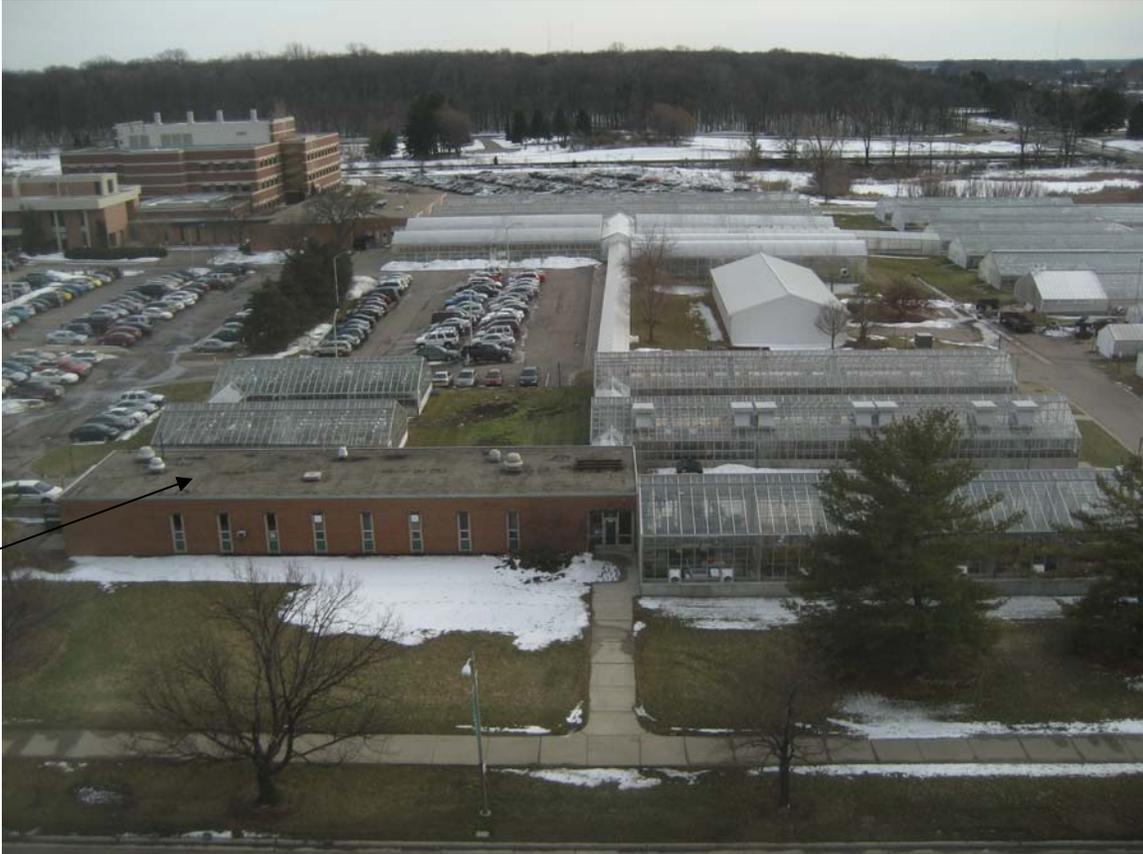
HA #5 – Assumed asbestos containing roofing materials and products

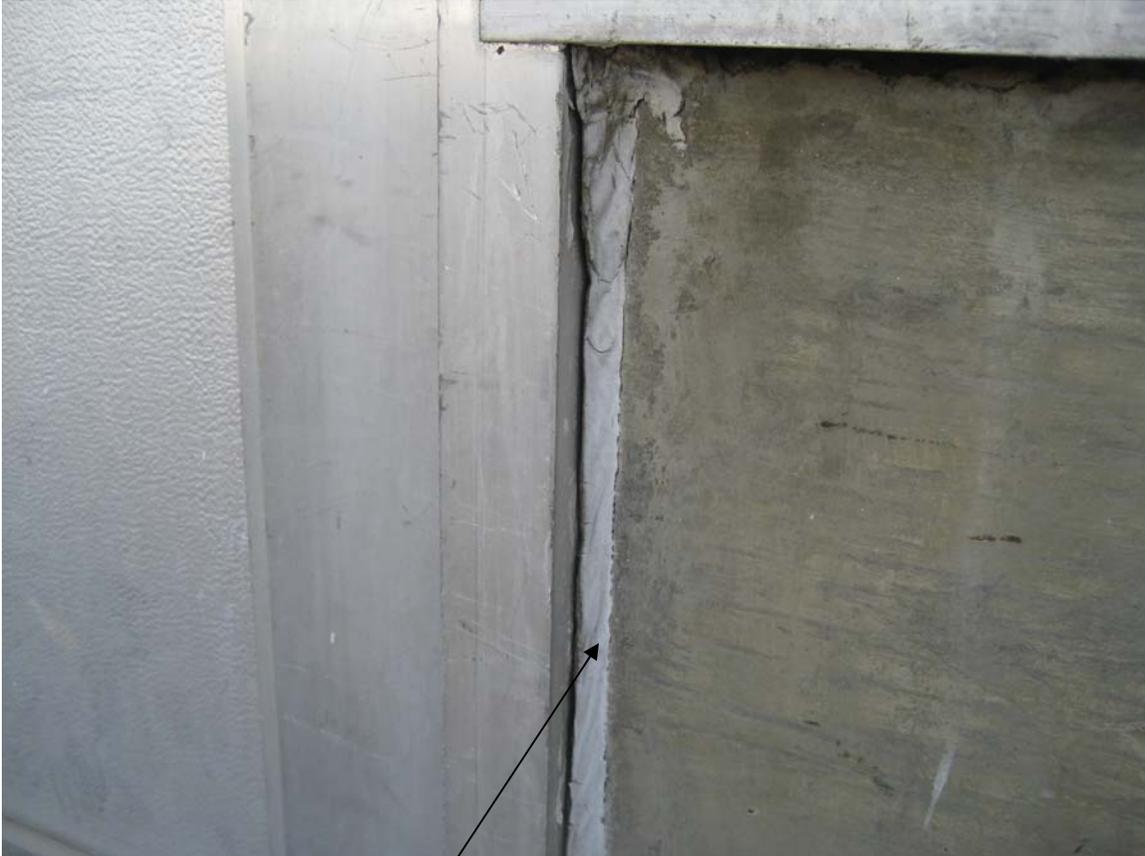
HA #6 – Asbestos containing gray caulk

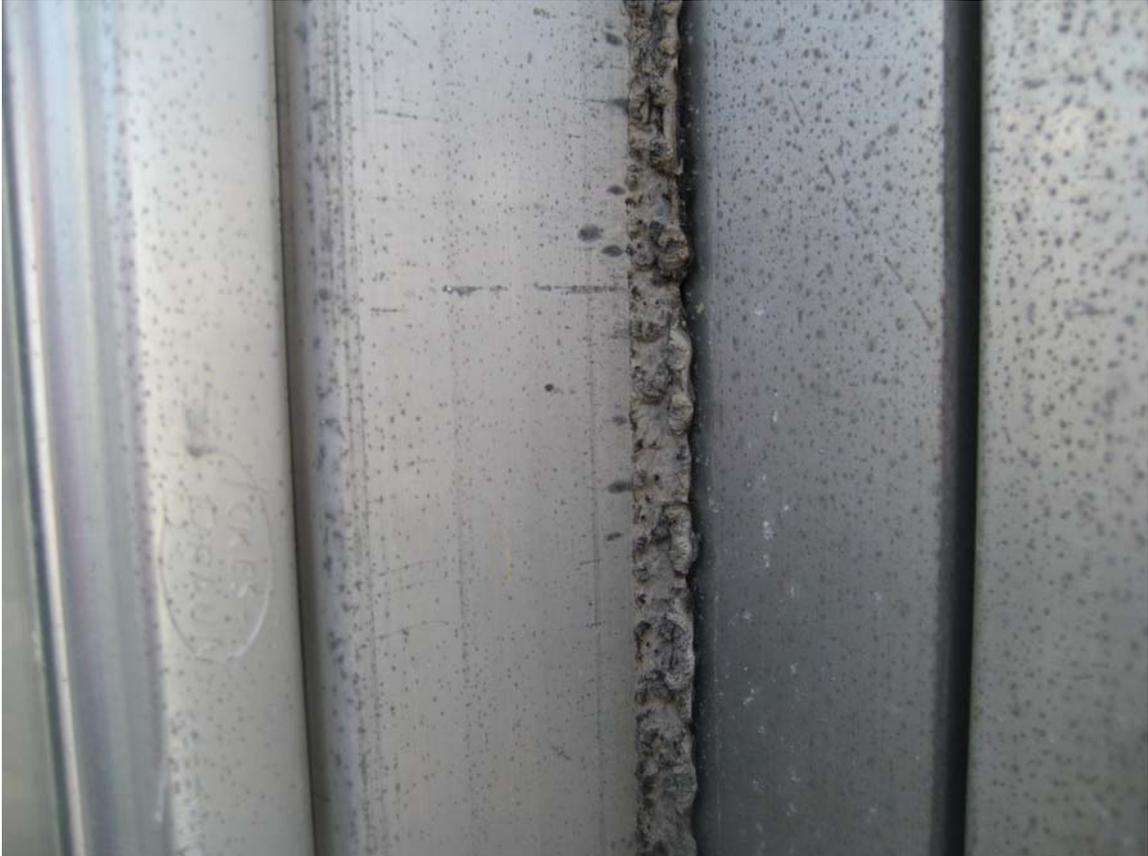
HA #7 – Asbestos containing gray exterior door caulk

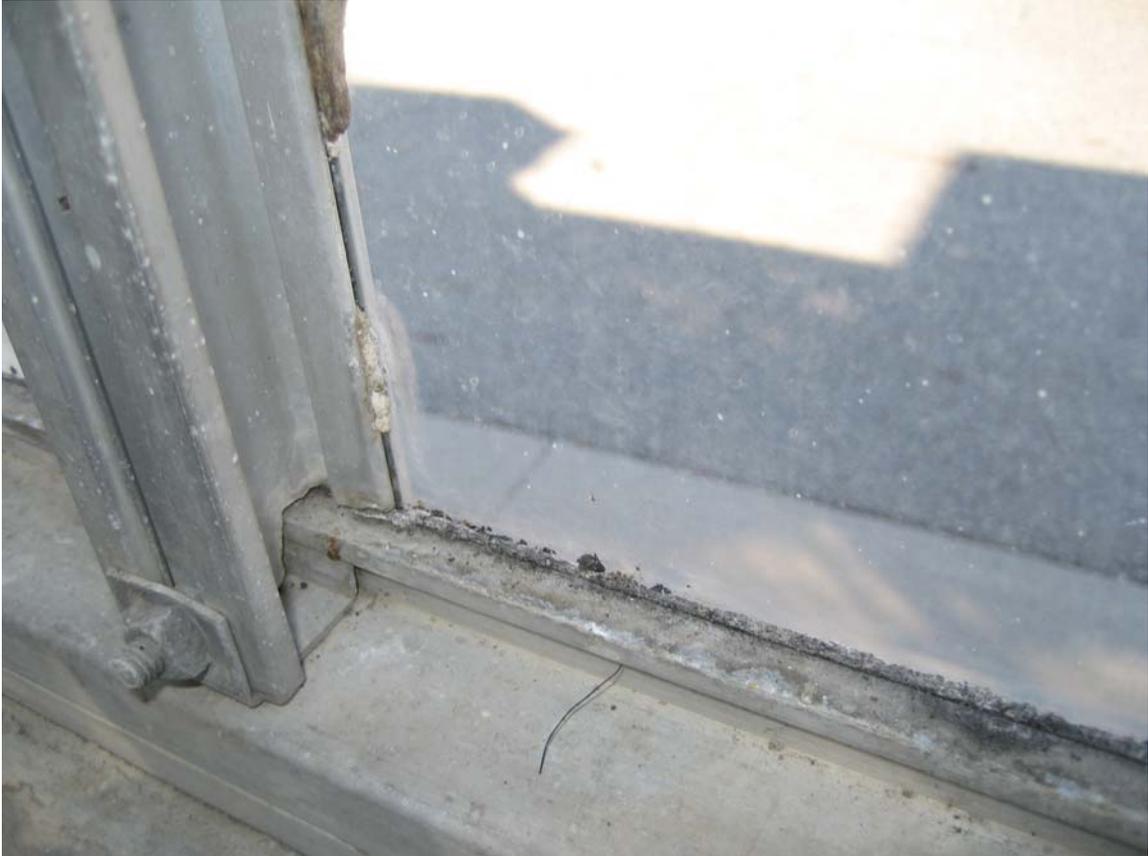
HA #8 – Asbestos containing glass wall panel glazing

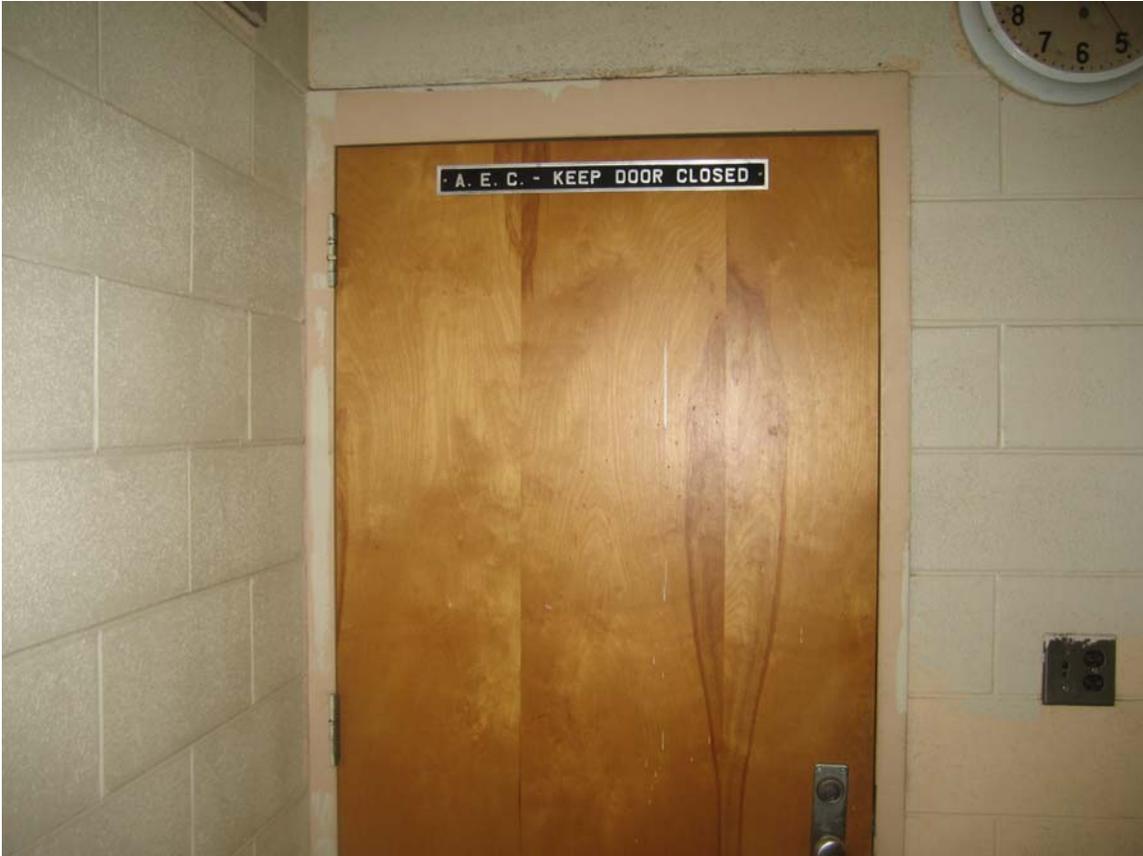
HA #9 – Assumed asbestos containing fire door and frame

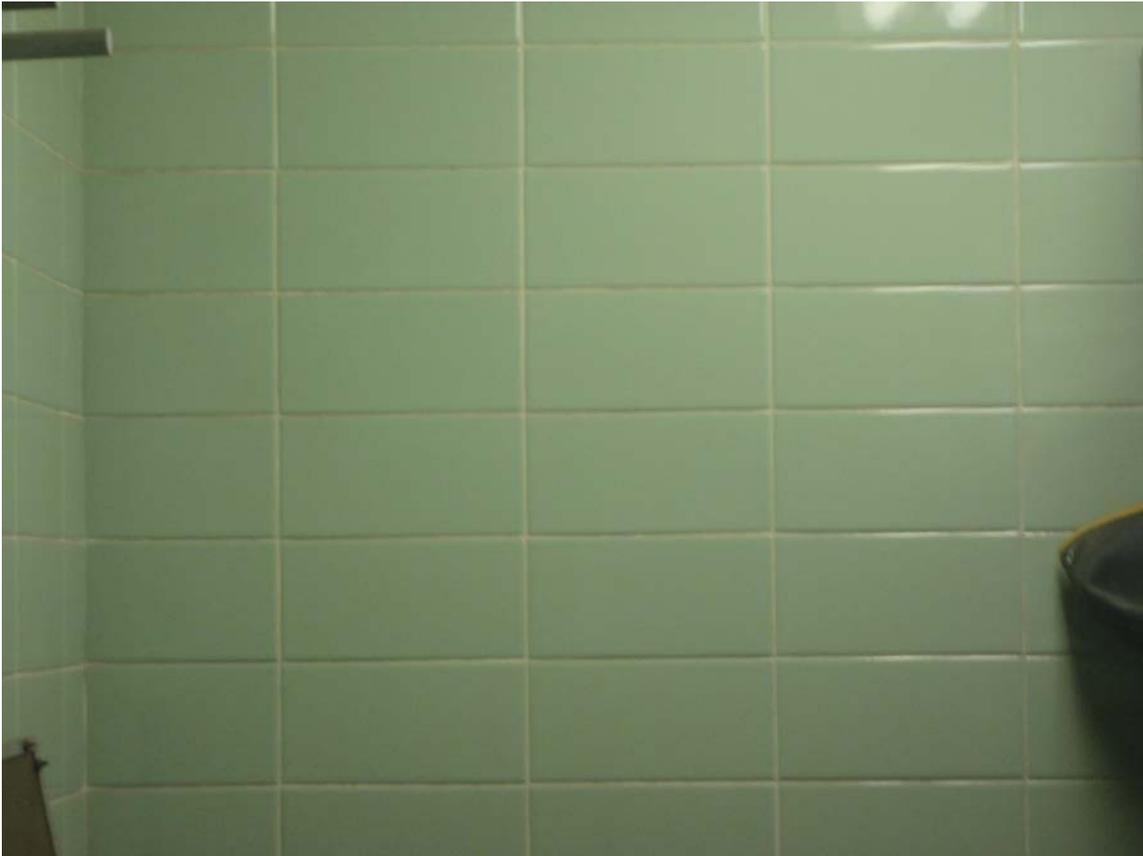
HA #10 – Assumed asbestos containing 3”x 6” green ceramic tile and associated bedding compound

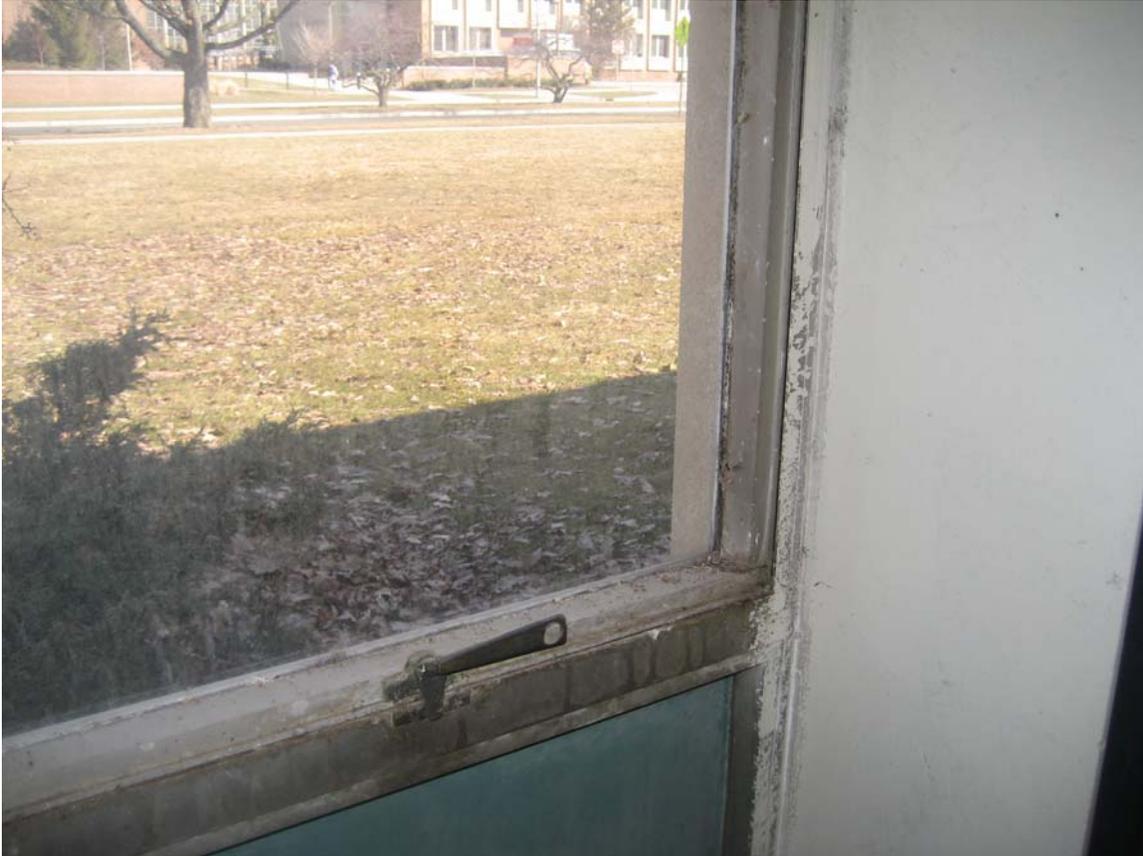
HA #11 – Asbestos containing window glazing, brick building windows

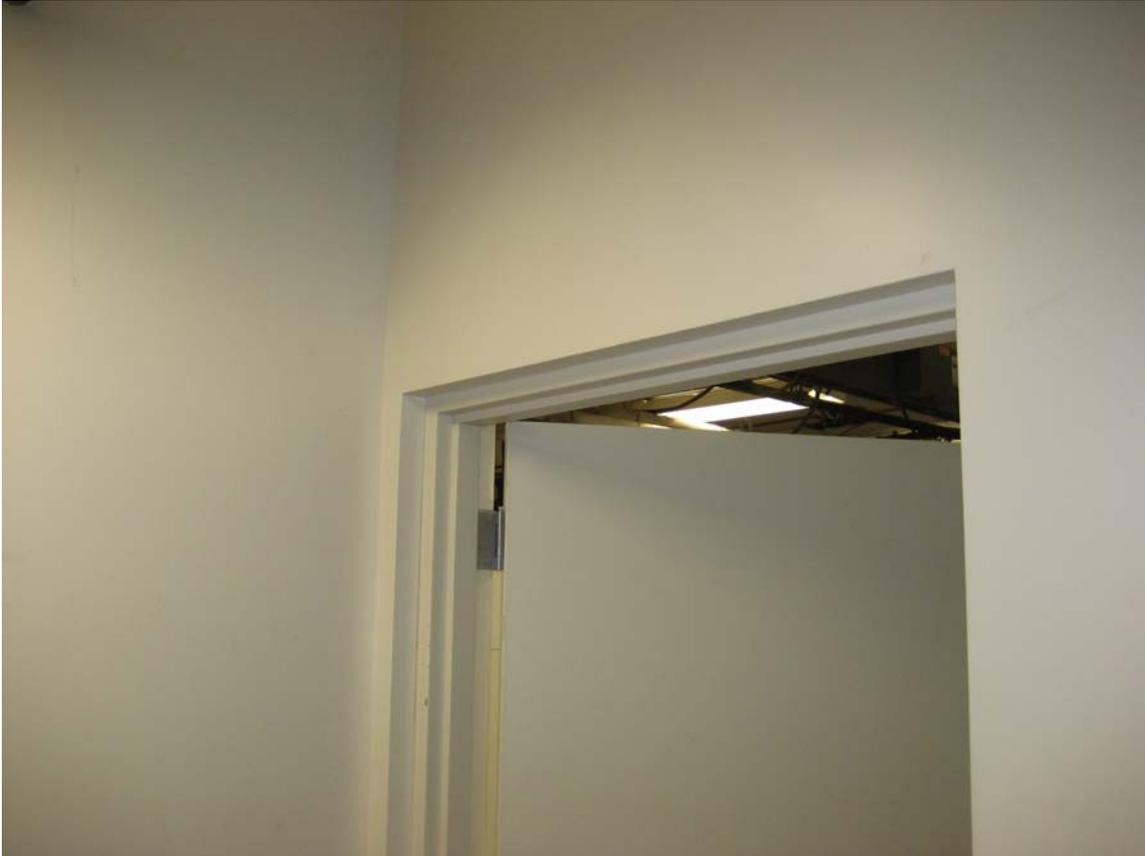
HA #12/13 – Newly installed drywall with drywall joint compound

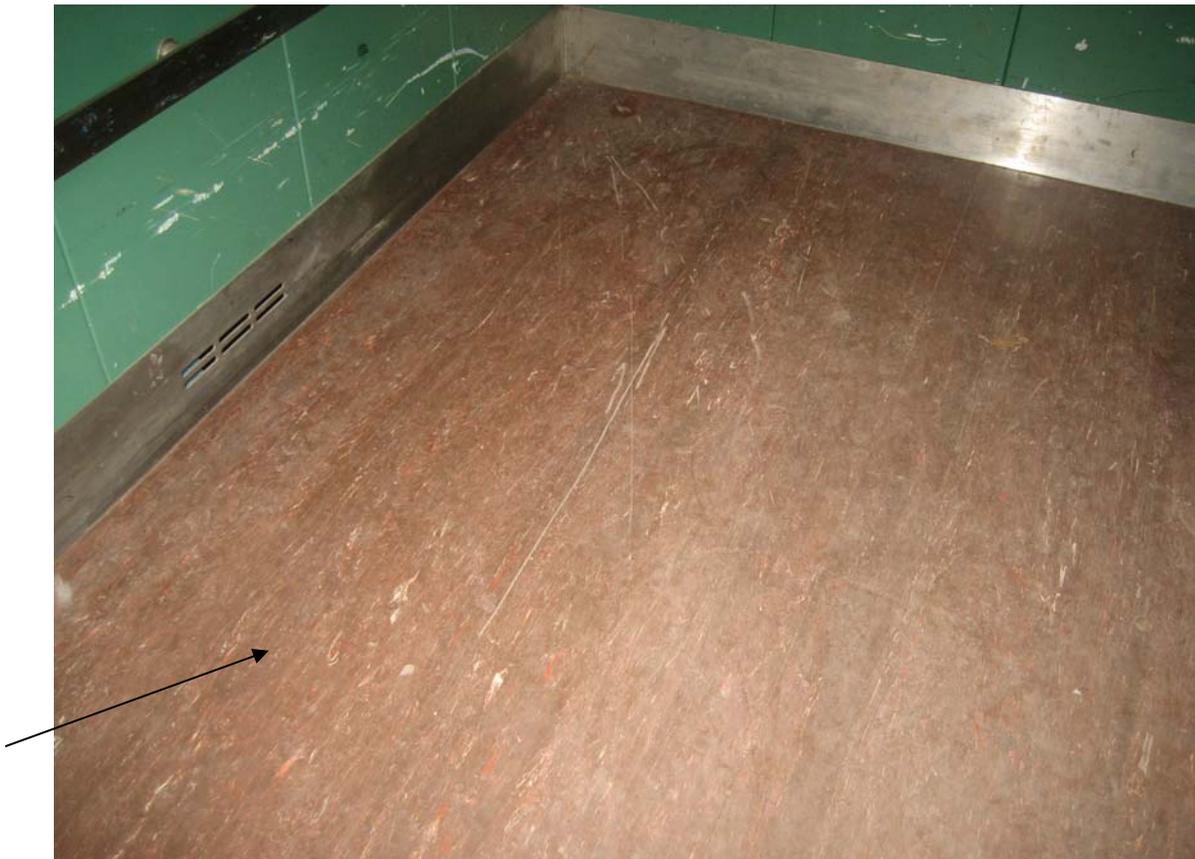
HA #14 – Assumed asbestos containing brown seamless floorcovering

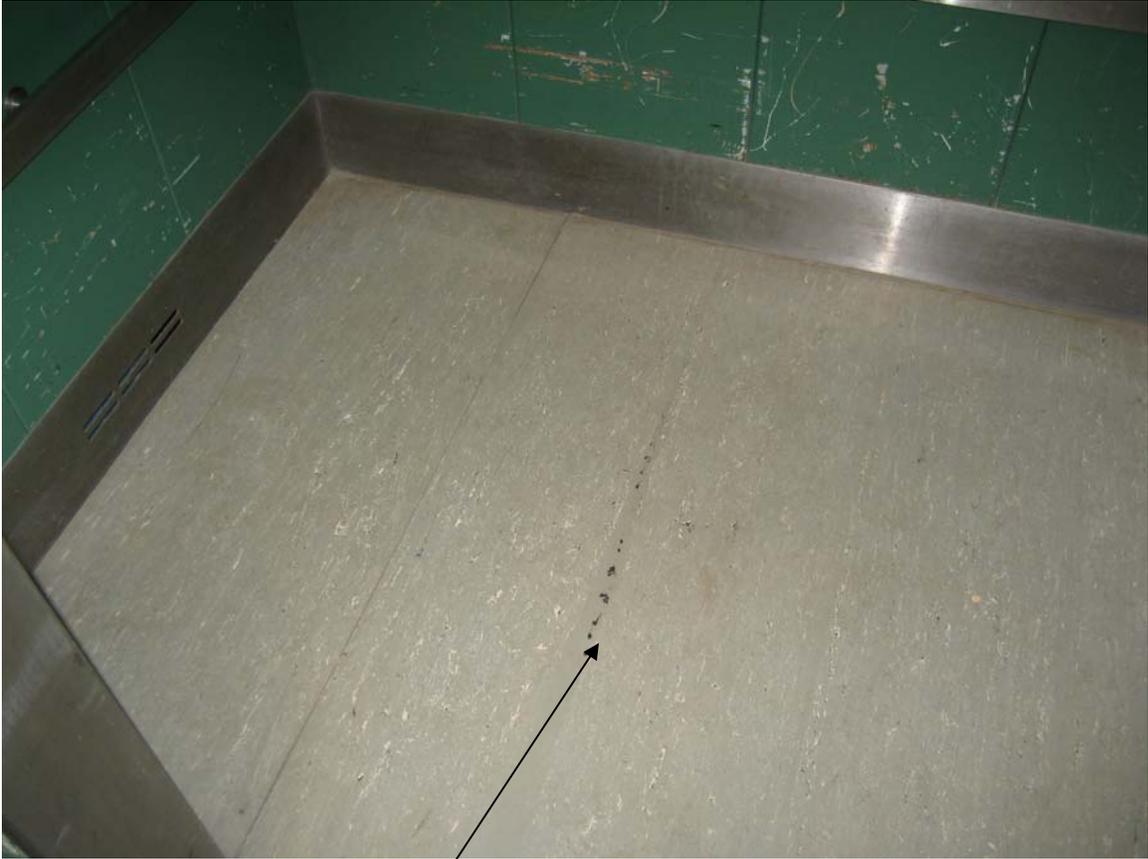
HA #15 – Assumed asbestos containing gray seamless floor covering

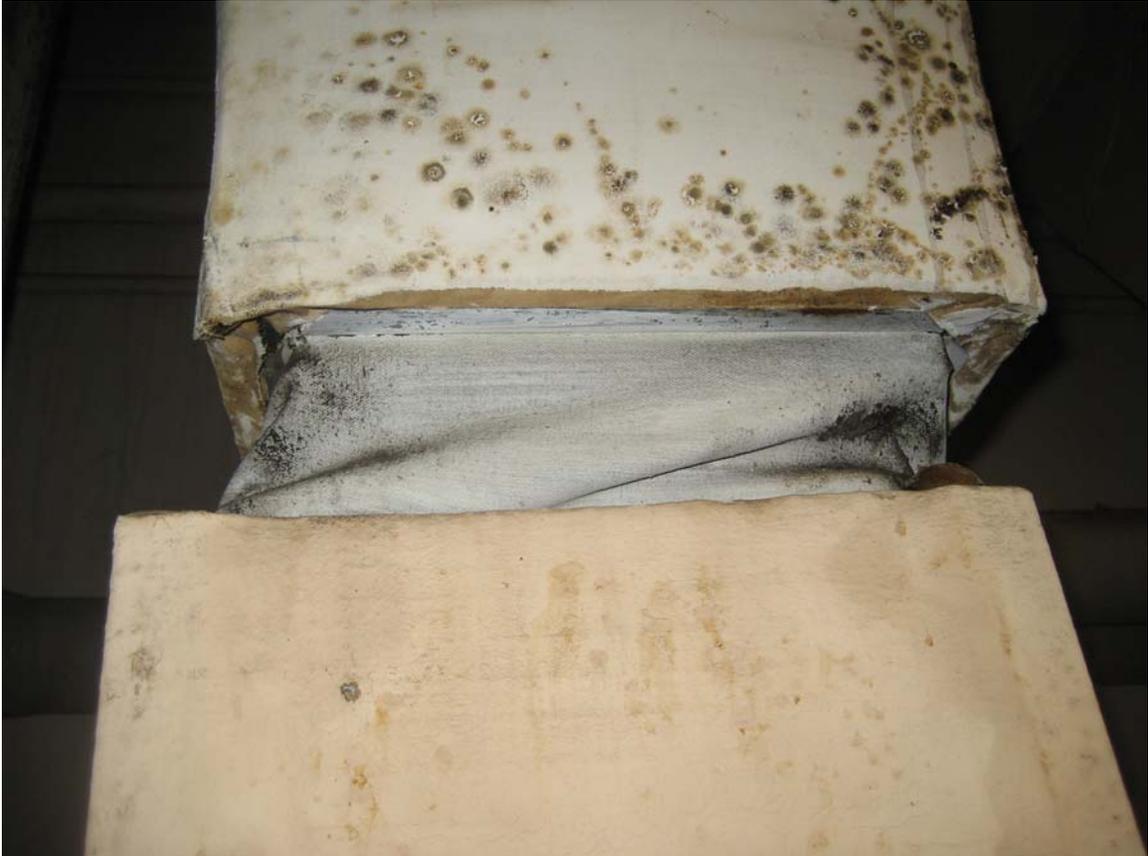
HA #16 – Assumed asbestos containing gray vibration collar

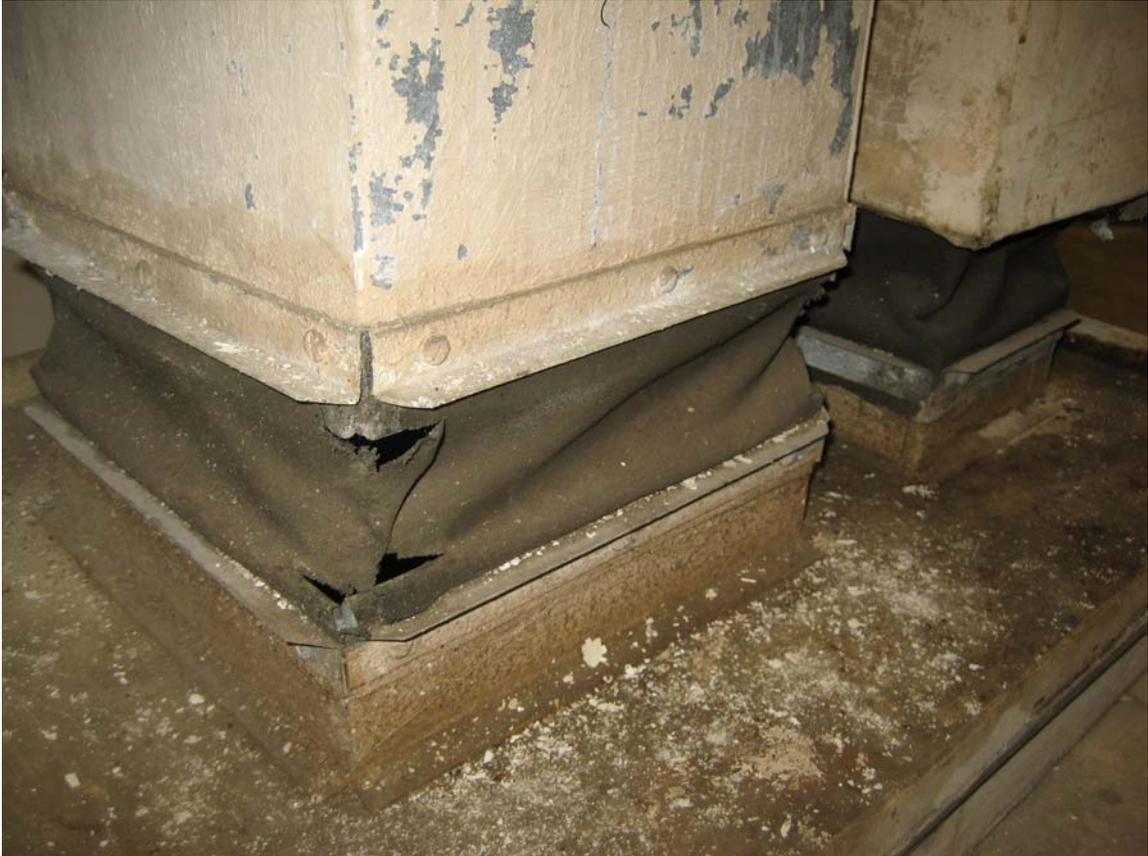
HA #17 – Non-asbestos containing dark brown vibration collar

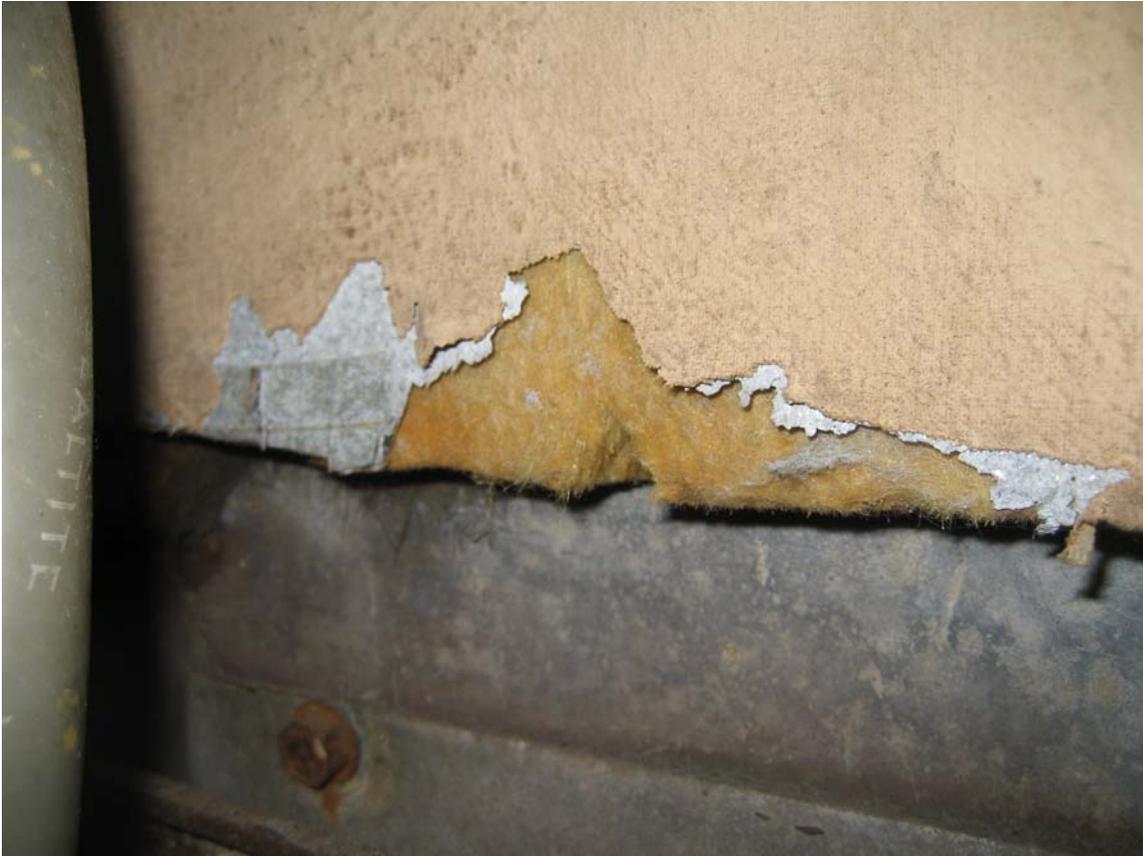
HA #18 – Non-asbestos containing light brown canvas duct wrap on fiberglass

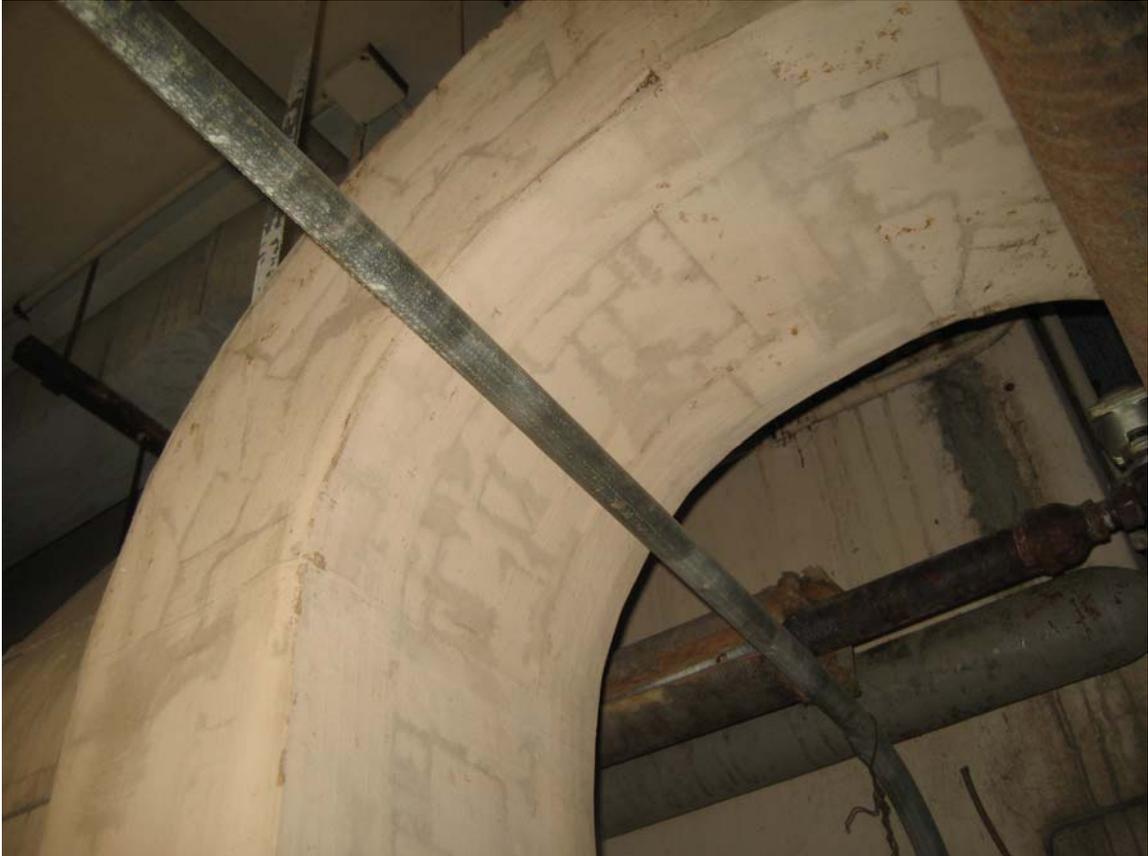
HA #19 – Non-asbestos containing Light brown paper duct wrap

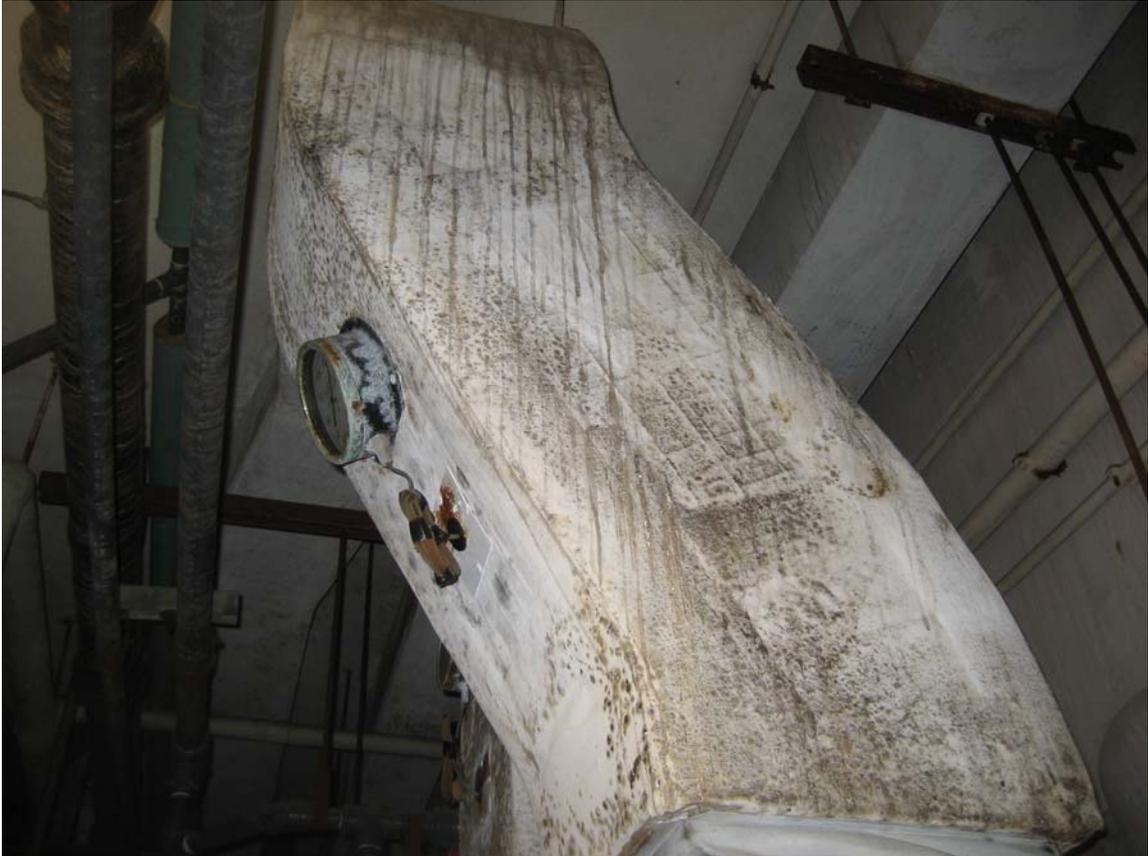
HA #20 – Non asbestos containing white moldy duct wrap

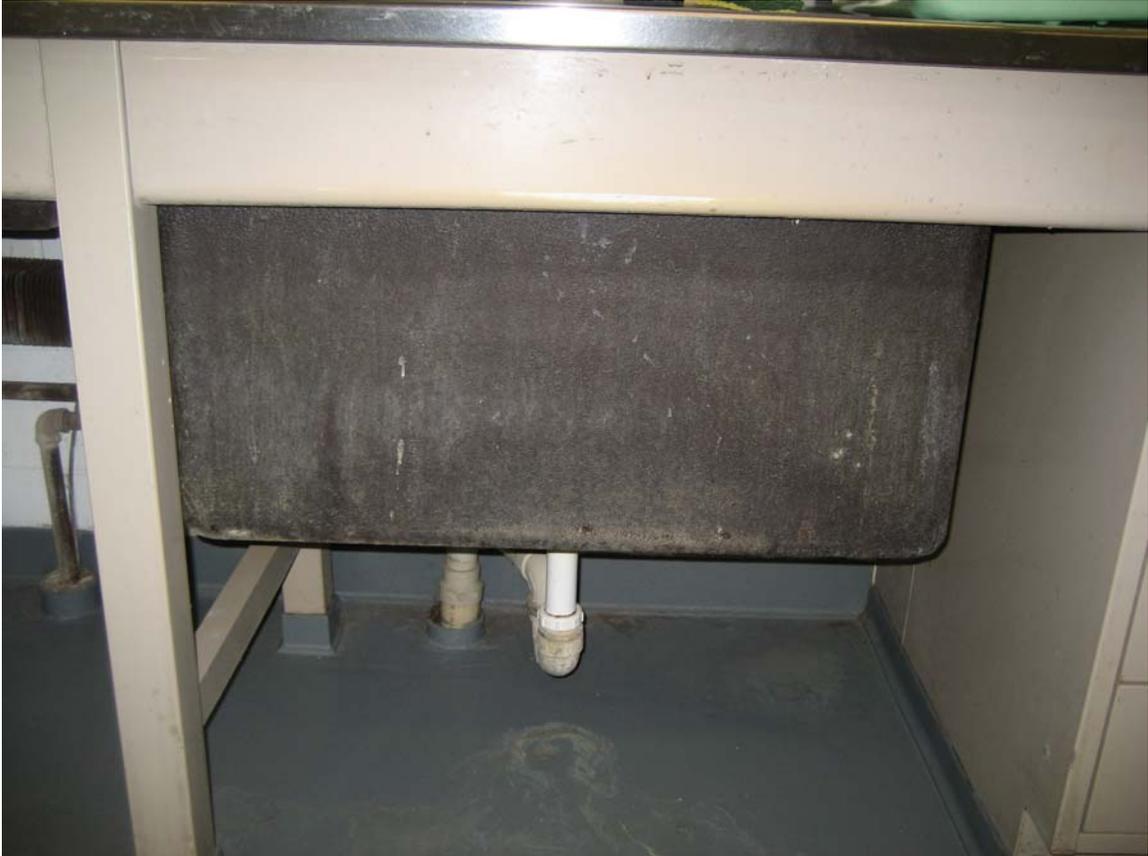
HA #21 – Asbestos containing black sink undercoating
