# PHOTOGRAPHS

**Project Name:** Manly Miles Building

**Address:** A: BasementManly Miles Building, East Lansing, MI

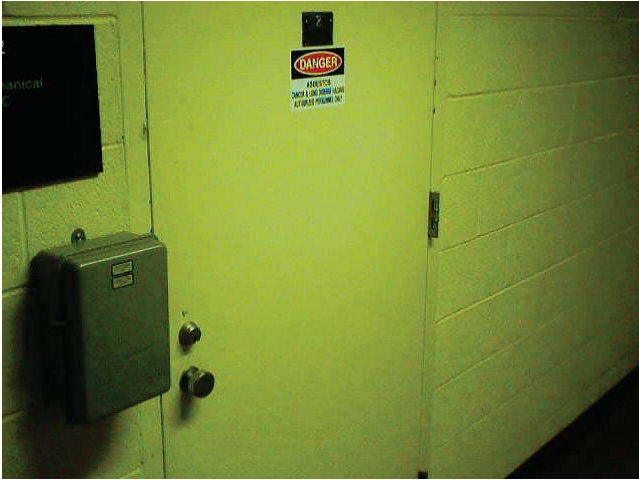
**Photo #:** 19530-1-A-M100-11

**Description:** Beige Fire Door/Frame

B: 1 Mechanical Room

Notes: Assumed asbestos-containing

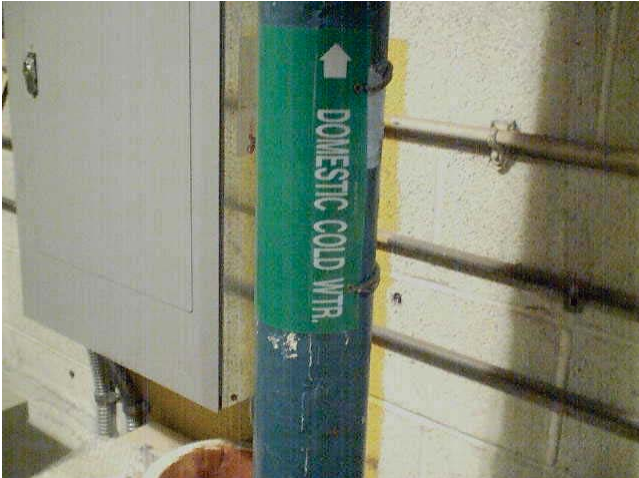
**Photo #:** 19530-1-A-M101-10

**Description:** Domestic water Pipe Straight Insulation

B: 1 Mechanical Room

Notes: Asbestos-containing

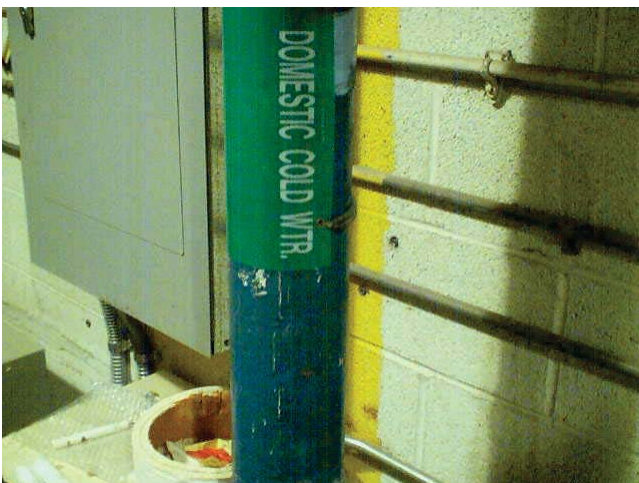
**Photo #:** 19530-1-A-M102-5

**Description:** Domestic water Pipe Joint Insulation

B: 1 Mechanical Room

Notes: Asbestos-containing

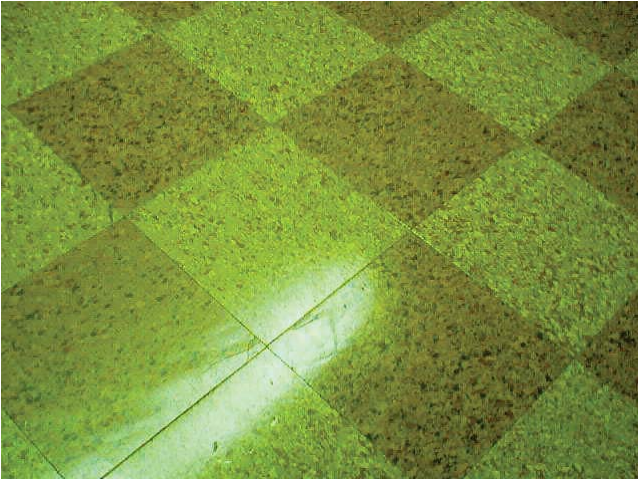
**Photo #:** 19530-1-A-M106-4

**Description:** Rust w/ Beige and Brown specks and assoc. mastic Floor Tile 9x9

B: 3 Storage

Notes: Floor tile is asbestos-containing and associated mastic is non asbestos-containing

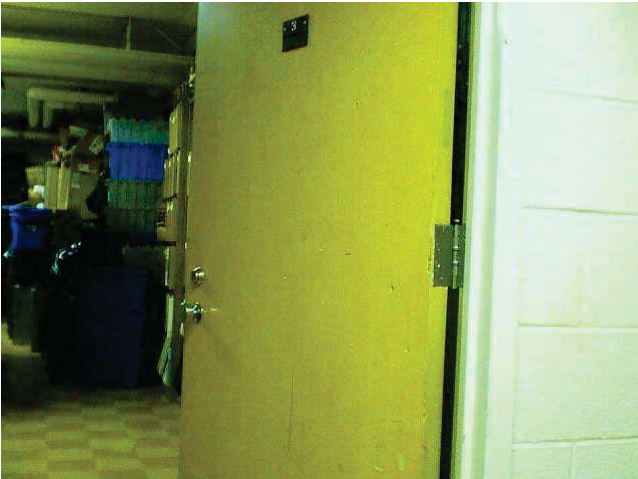
**Photo #:** 19530-1-A-M109-15

**Description:** Wood Fire Door/Frame

B: 3 Storage

Notes: Assumed asbestos-containing

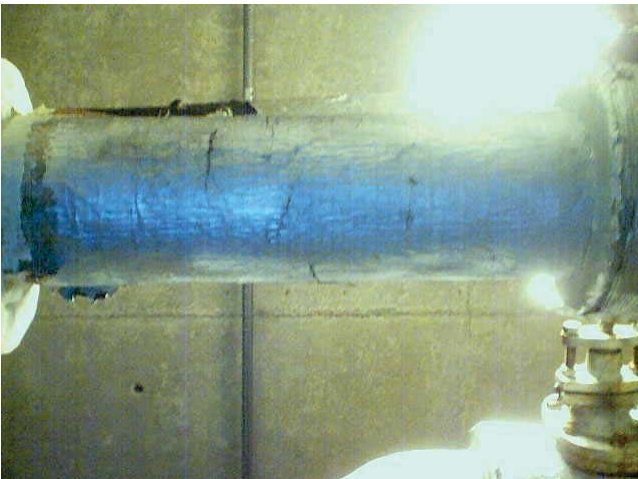
**Photo #:** 19530-1-A-M110-8

**Description:** Steam/condensate Pipe Straight Insulation

B: 1 Mechanical Room

Notes: Non asbestos-containing

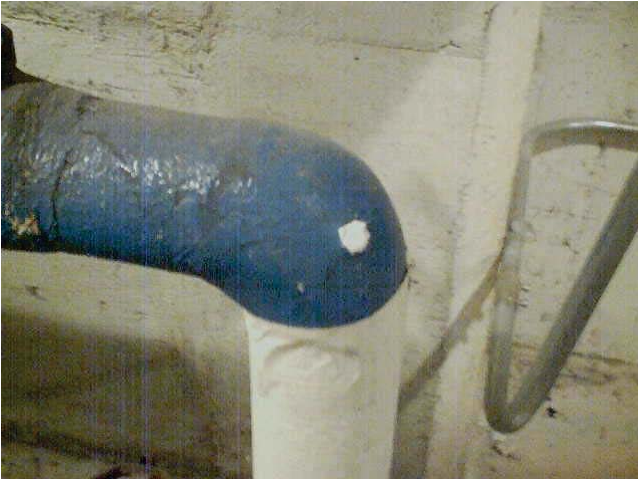
**Photo #:** 19530-1-A-M111-7

**Description:** Steam/condensate Pipe Joint  
Insulation

B: 1 Mechanical Room  
Notes: Asbestos-containing

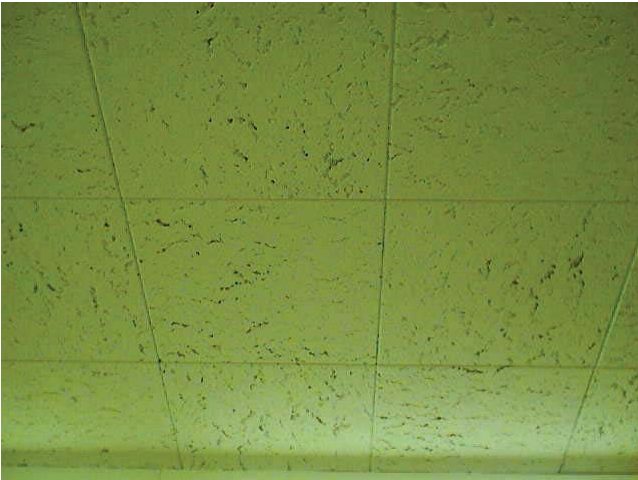
**Photo #:** 19530-1-A-M112-14

**Description:** White w/ fissures and assoc. glue  
pods Ceiling Tile 1X1

B: 5 Storage  
Notes: Glue pods are also non asbestos-containing

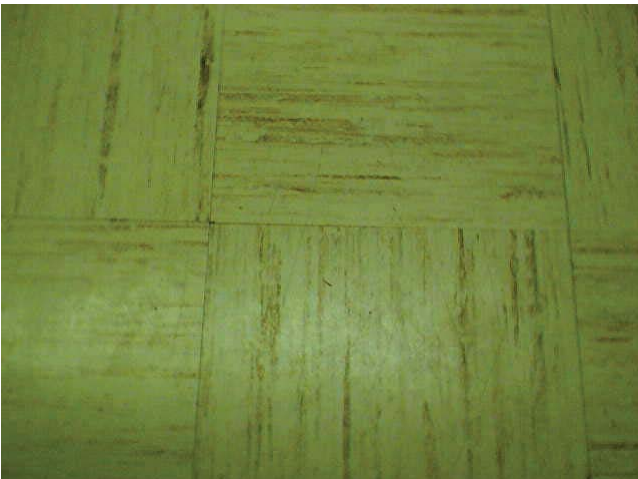
**Photo #:** 19530-1-A-M113-12

**Description:** White w/ Brown streaks and assoc.  
mastic Floor Tile 12x12

B: 5 Storage  
Notes: Floor tile is asbestos-containing and mastic is non  
asbestos-containing

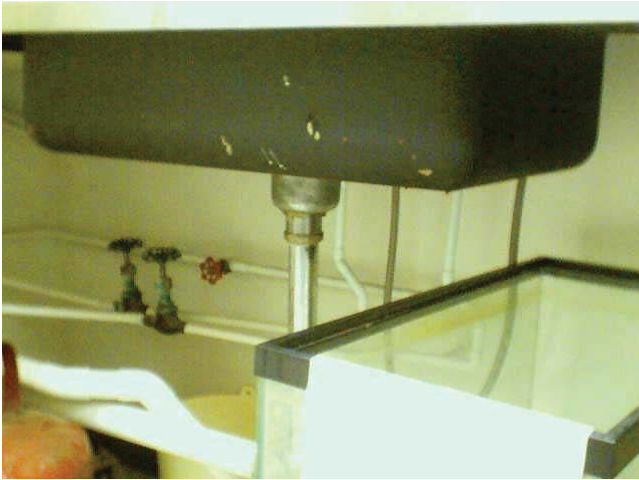
**Photo #:** 19530-1-A-M115-13

**Description:** Black Sink Undercoating  
B: 5 Storage  
Notes: Asbestos-containing

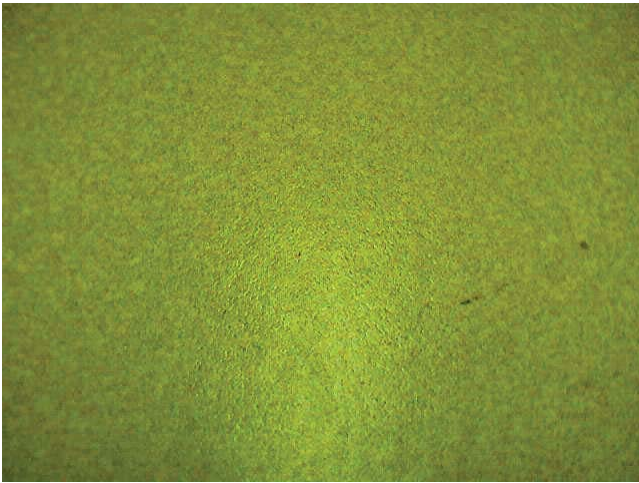
**Photo #:** 19530-1-A-M120-19

**Description:** Tan mosaic pattern and assoc. mastic  
Linoleum  
B: 20 Mailroom  
Notes: Linoleum is non asbestos-containing and mastic is  
asbestos-containing

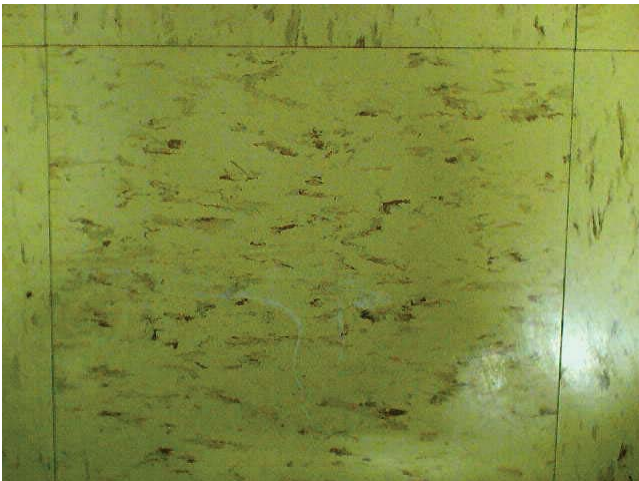
**Photo #:** 19530-1-A-M122-20

**Description:** Tan w/ Rust and Beige streaks and  
assoc. mastic Floor Tile 12x12  
B: 27 Office  
Notes: Floor tile is asbestos-containing and mastic is non  
asbestos-containing

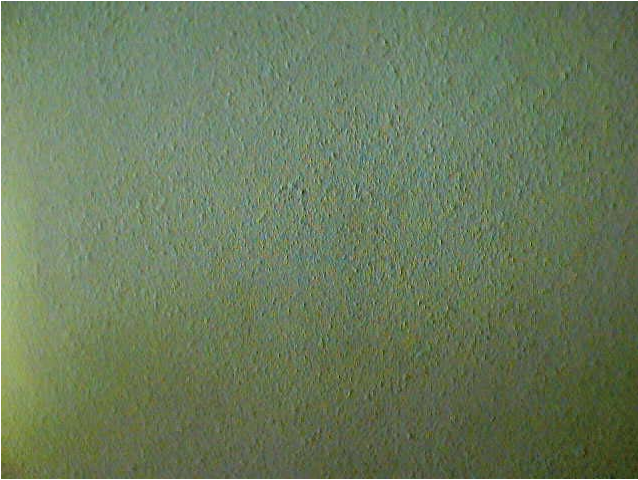
**Photo #:** 19530-1-B-M123-2

**Description:** Popcorn / White Acoustic Ceiling  
Spray on Insulation

1: Lobby

Notes: Asbestos-containing

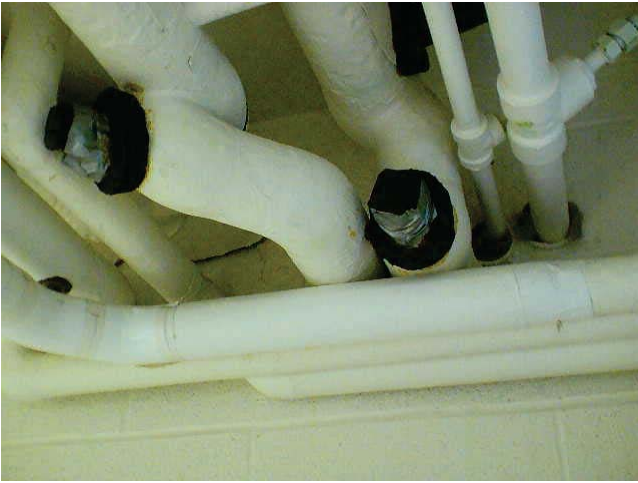
**Photo #:** 19530-1-A-M124-16

**Description:** Chilled water Pipe Joint Insulation

B: 15 Office

Notes: Asbestos-containing

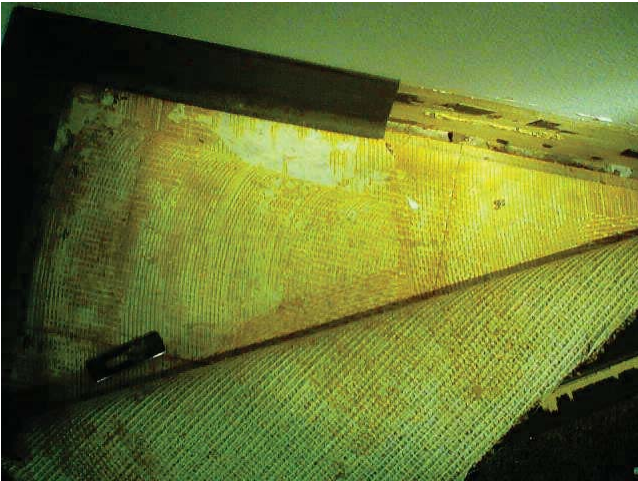
**Photo #:** 19530-1-A-M125-17

**Description:** White w/ Pink swirls and assoc.  
mastic Floor Tile 9x9

B: 25 Office

Notes: Floor tile and associated mastic are asbestos-containing

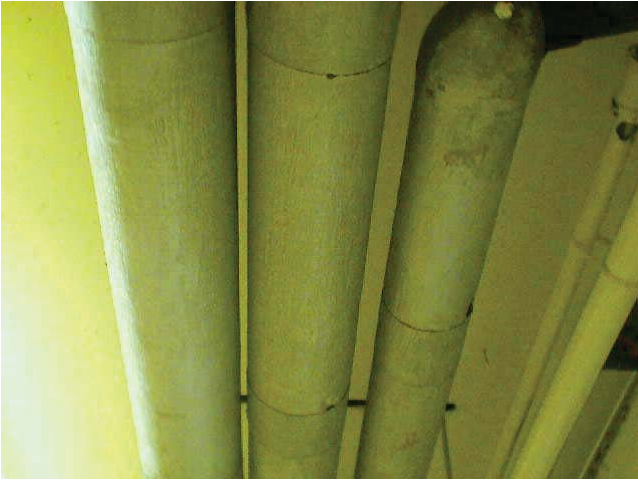
**Photo #:** 19530-1-A-M126-18

**Description:** Chilled water Pipe Straight Insulation

B: 25E Storage

Notes: Non asbestos-containing

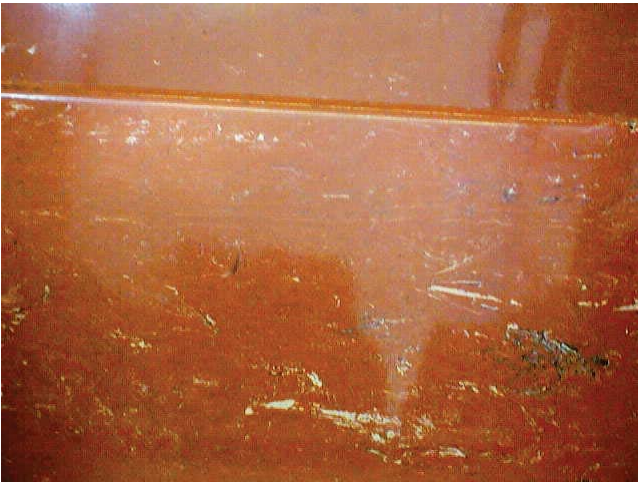
**Photo #:** 19530-1-A-M127-28

**Description:** Rust w/ Cream Brown streaks and assoc. mastic Vinyl floor covering

Stairwell: South stairwell Stairwell

Notes: Vinyl floor covering and associated mastic are non asbestos-containing

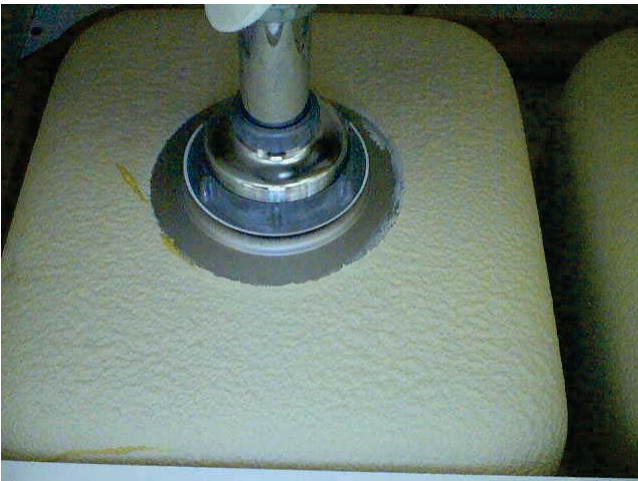
**Photo #:** 19530-1-B-M131-3

**Description:** White Sink Undercoating

1: 115B Kitchenette

Notes: Non asbestos-containing

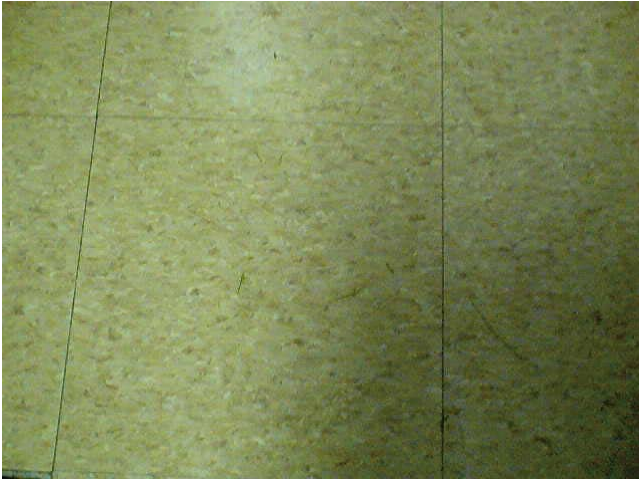
**Photo #:** 19530-1-B-M132-5

**Description:** Tan w/ grey and white streaks and assoc. mastic Floor Tile 12x12

1: 115 Office

Notes: Floor tile and associated mastic are non asbestos-containing

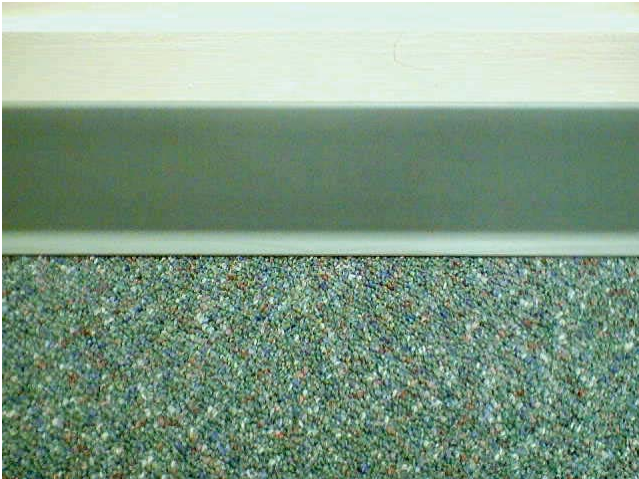
**Photo #:** 19530-1-C-M134-3

**Description:** 4" Teal and assoc. mastic Cove Molding

2: 201 Office

Notes: Cove molding and associated mastic are non asbestos-containing

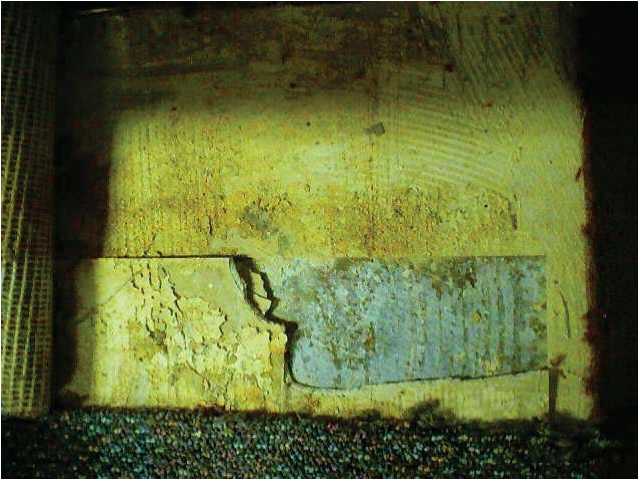
**Photo #:** 19530-1-C-M135-6

**Description:** White and assoc. mastic Vinyl

2: Main E\W hallway Hallway

Notes: Vinyl and associated mastic are non asbestos-containing
