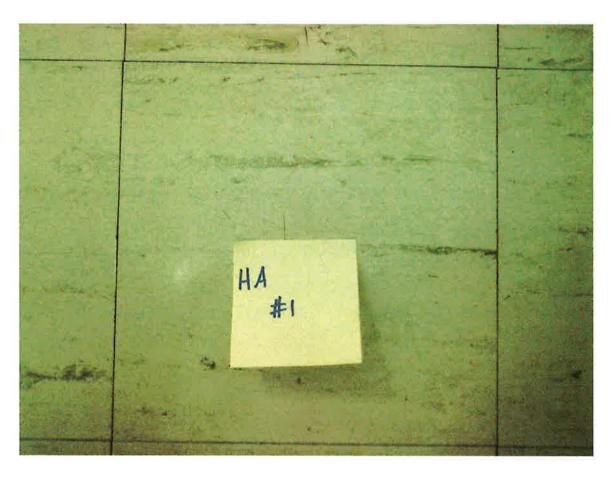
HA #1 – Non asbestos-containing 9" x 9" gray floor tile with dark green streaks and associated mastic

Note: Tile contains <1% asbestos and should be treated as ACM.

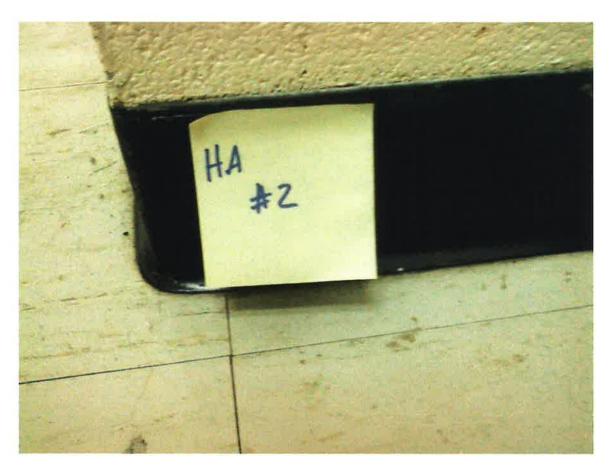
HA #2 – Non asbestos-containing 4" black cove molding and associated mastic

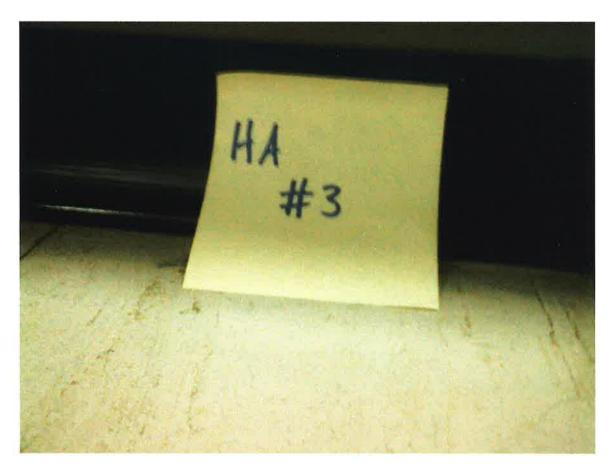
HA #3 – Non asbestos-containing 3" black cove molding and associated mastic

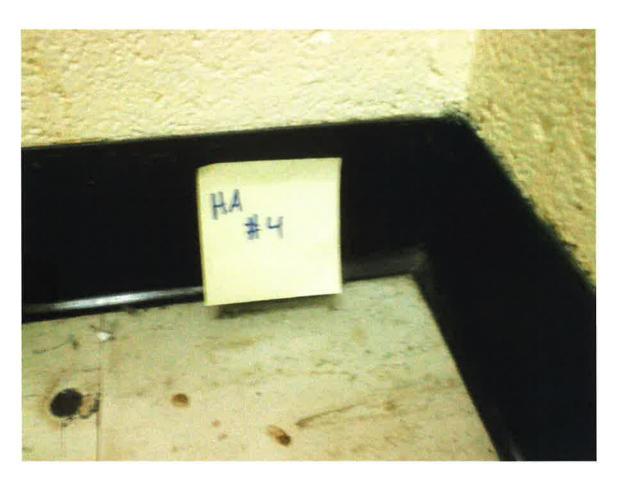
HA #4 – Non asbestos-containing 4" brown cove molding and associated mastic

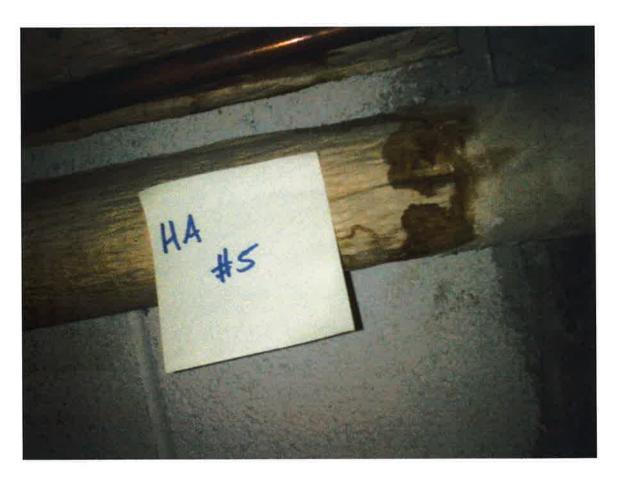
HA #5 – Non asbestos-containing domestic water pipe straight insulation (wrap on fiberglass line)

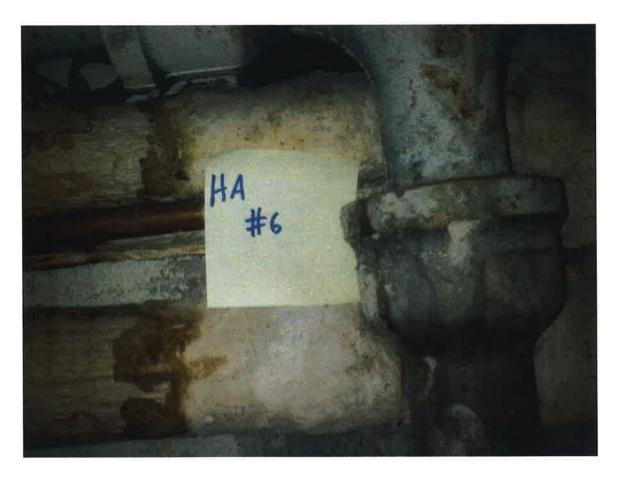
HA #6 – Non asbestos-containing domestic water pipe joint insulation

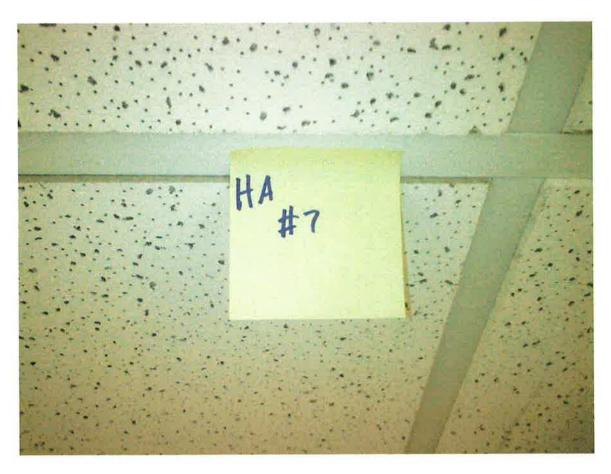
HA #7 – Non asbestos-containing 2' x 2' white drop-in ceiling tile with holes and pin holes

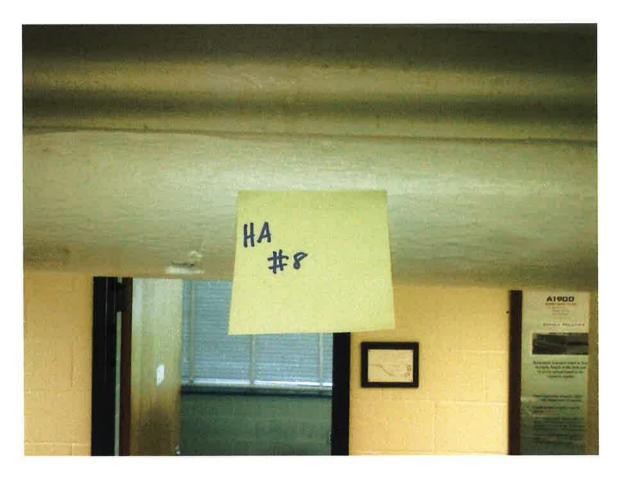
HA #8 – Non asbestos-containing steam and condensate pipe straight insulation (wrap on fiberglass line)

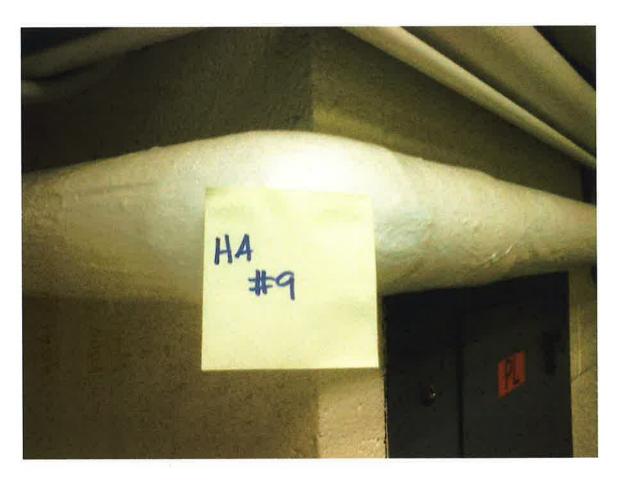
HA #9 – Non asbestos-containing steam and condensate pipe straight insulation (wrap on fiberglass line)

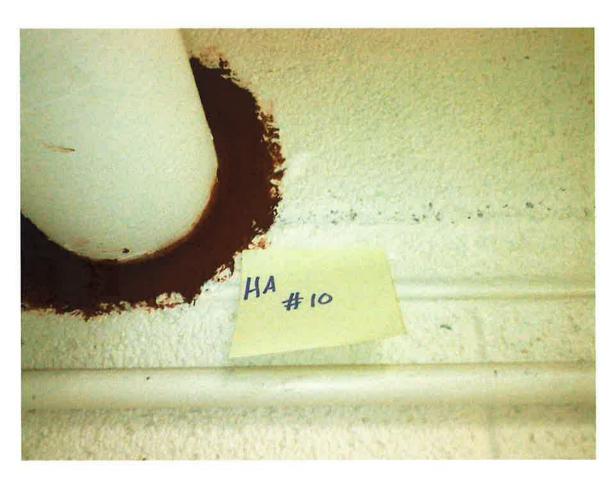
HA #10 – Non asbestos-containing red firestop caulk

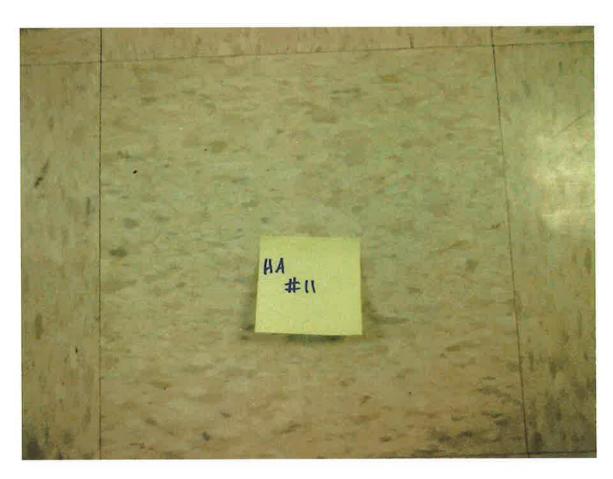
HA #11 – Non asbestos-containing 12" x 12" tan floor tile with marble pattern and associated mastic

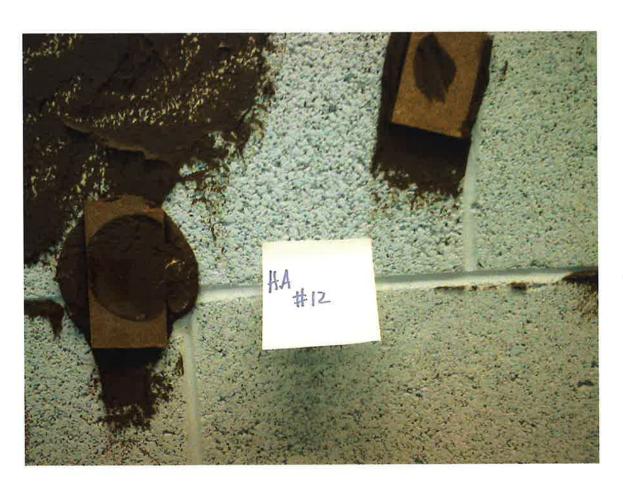
HA #12 – Non asbestos-containing brown glue pods

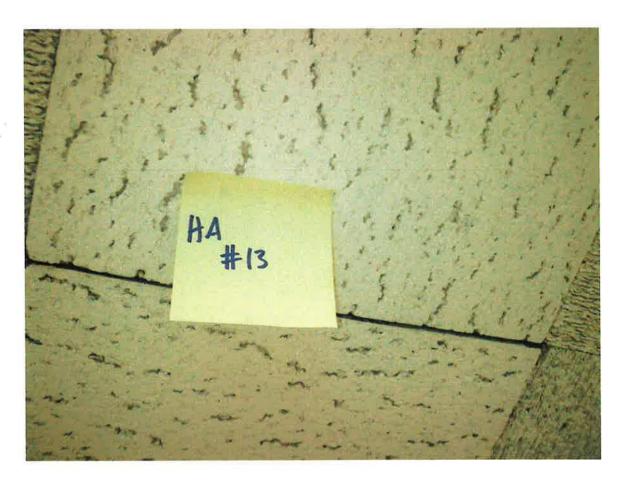
HA #13 – Non asbestos-containing 1' x 1' white spline ceiling tile with fissures

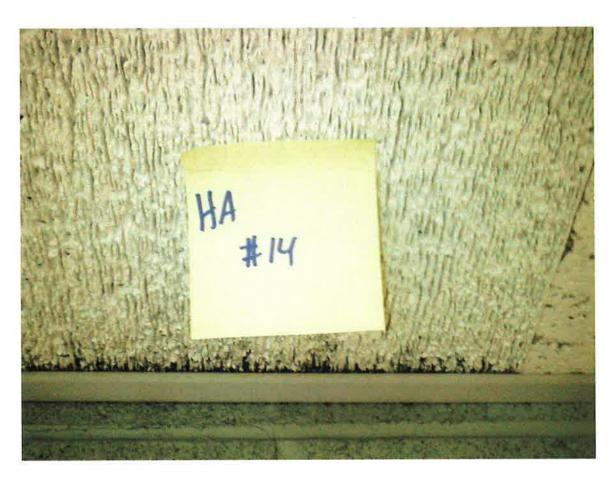
HA #14 – Non asbestos-containing 1' x 1' white spline ceiling tile with lines

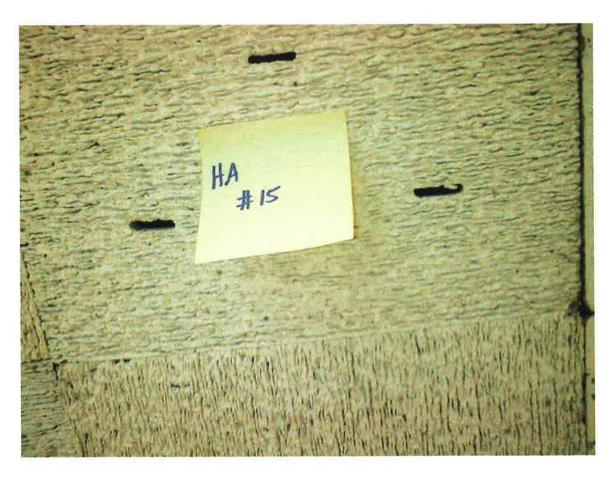
HA #15 – Non as bestos-containing 1' x 1' white spline ceiling tile with lines and five holes

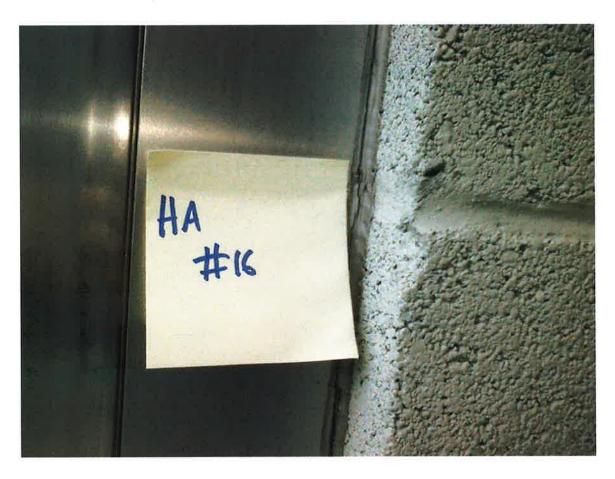
HA #16 – Non asbestos-containing interior silver window caulk compound

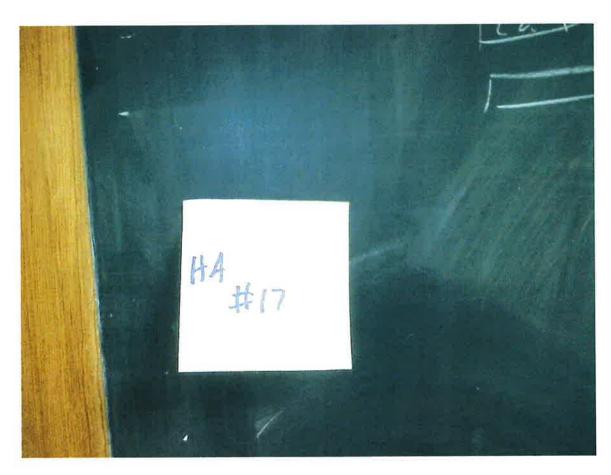
HA #17 – Assumed asbestos-containing black chalkboard

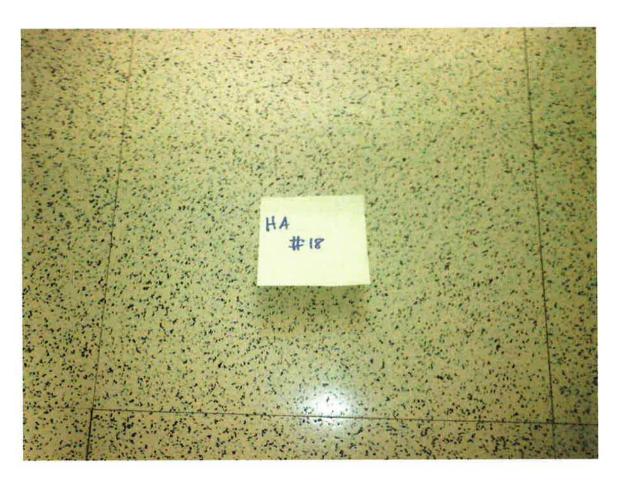
HA #18 – Non asbestos-containing 12" x 12" cream floor tile with black specks and associated mastic (multiple layers)

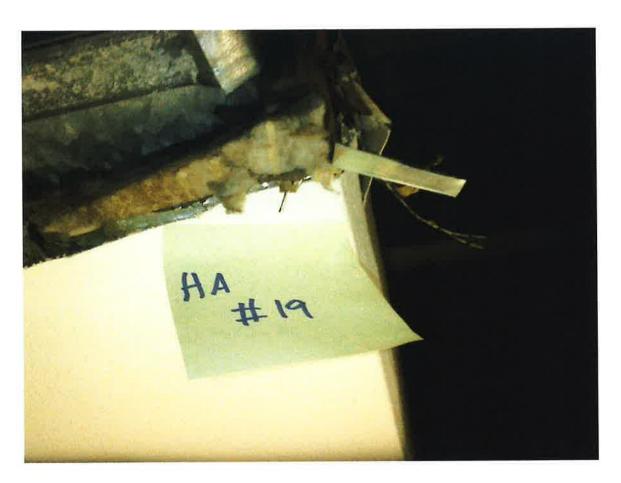
HA #19 – Asbestos-containing white duct wrap

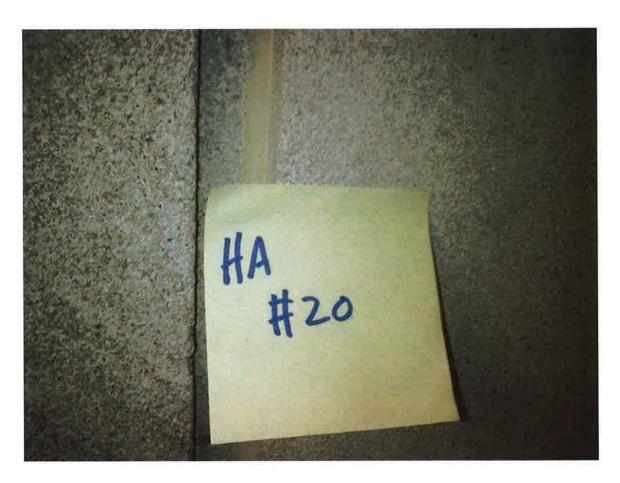
HA #20 - Non asbestos-containing interior cream building caulk compound

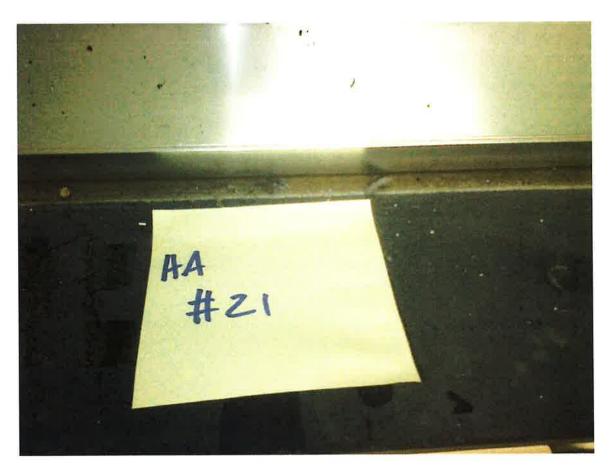
HA #21 - Non asbestos-containing interior gray window caulk compound

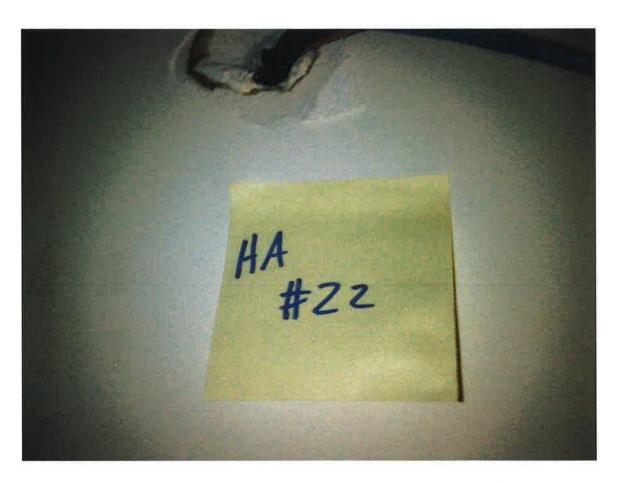
HA #22 – Non asbestos-containing white skimcoat over drywall

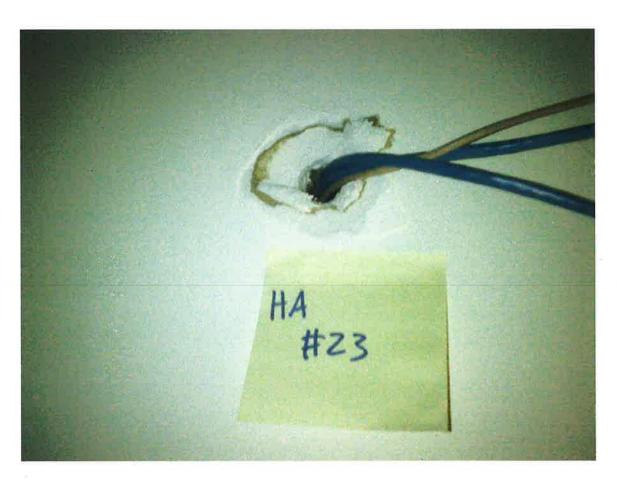
HA #23 – Non asbestos-containing fire-rated drywall

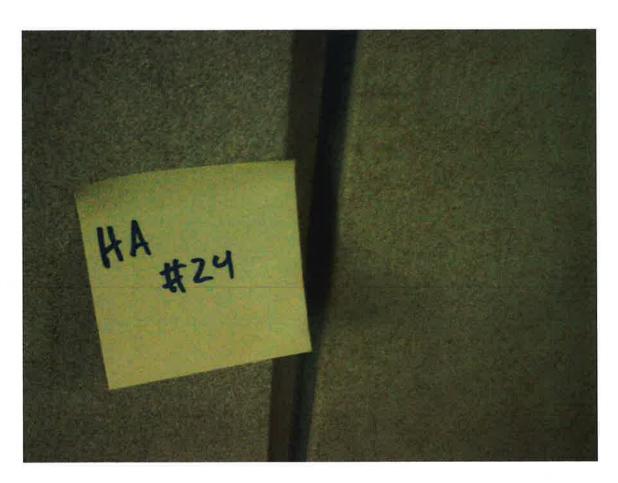
HA #24 – Non asbestos-containing interior (formerly exterior) building caulk compound

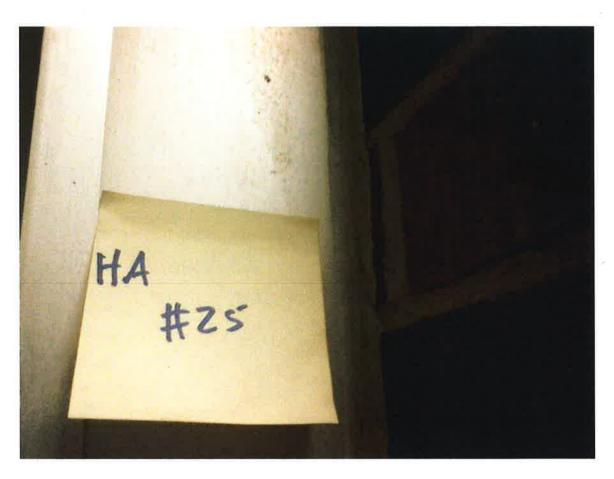
HA #25 – Asbestos-containing interior (formerly exterior) window caulk compound

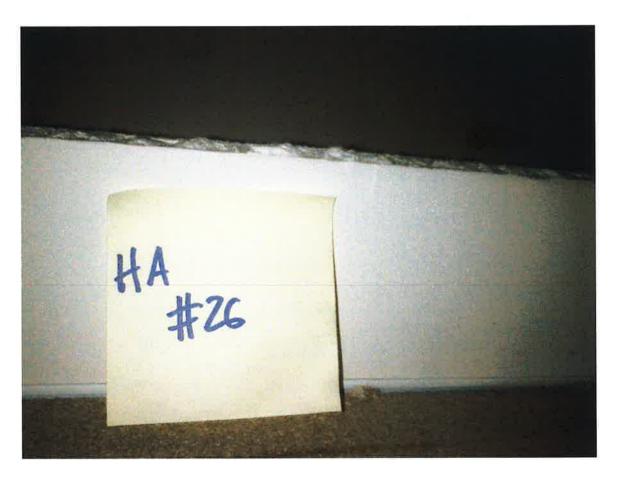
HA #26 – Non asbestos-containing drywall

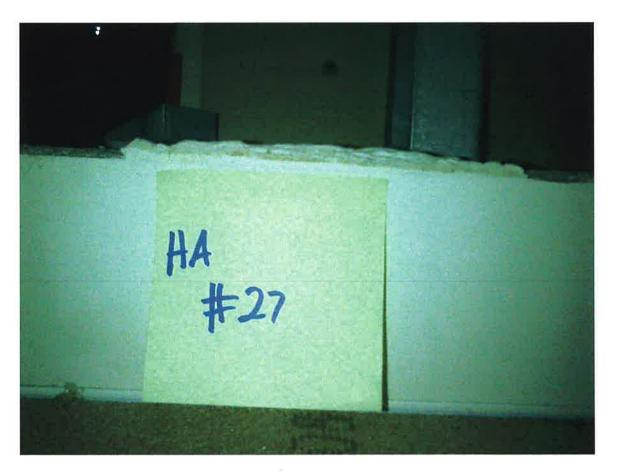
HA #27 – Non asbestos-containing drywall joint compound

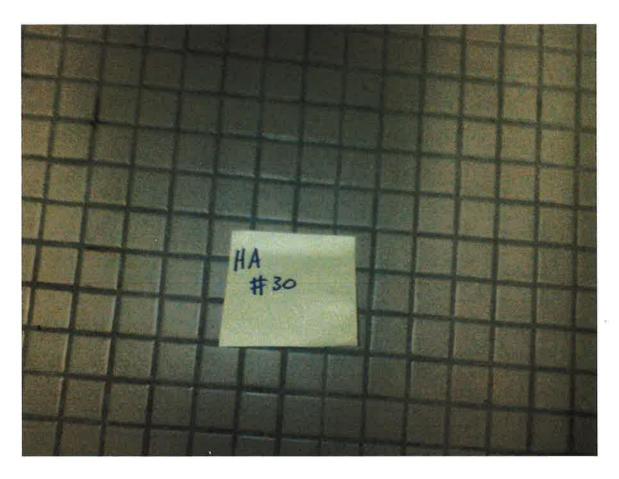
HA #30 – Non asbestos-containing 1/2" x 1/2" solid gray ceramic floor tile bedding compound and grout

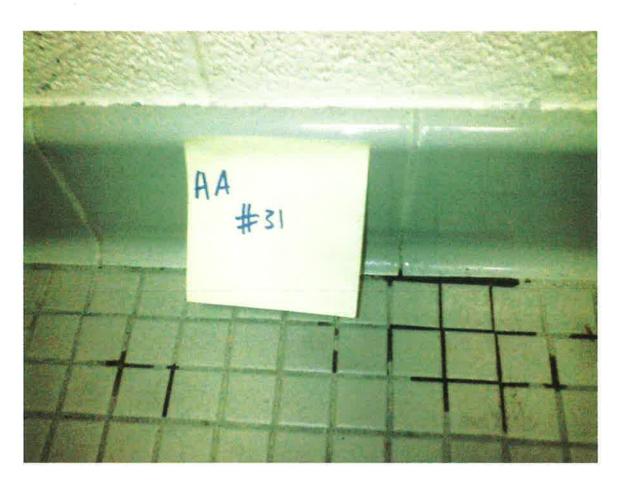
HA #31 – Non asbestos-containing 3" x 5" gray ceramic wall tile bedding compound and grout

Note: Bedding and grout contained <1% asbestos and should be treated as ACM

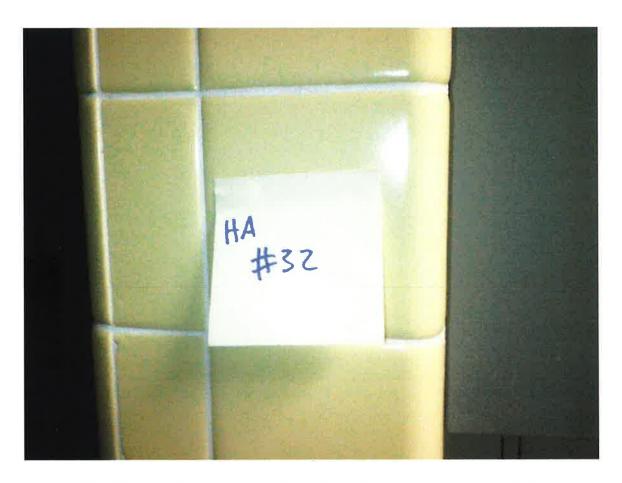
HA #32 – Asbestos-containing 4" x 4" yellow ceramic wall tile bedding compound and grout

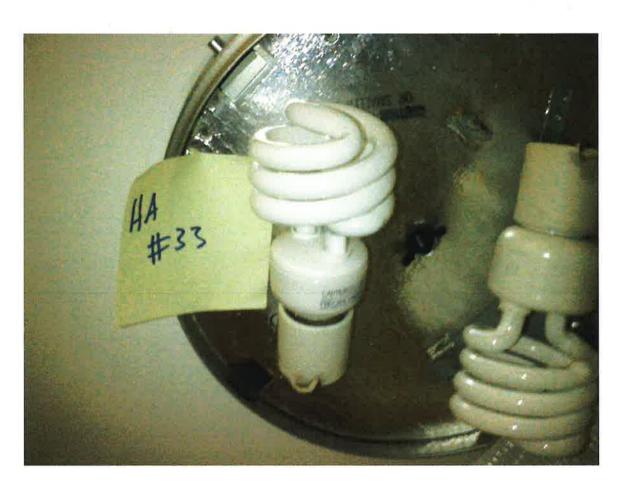
HA #33 – Asbestos-containing light reflector paper

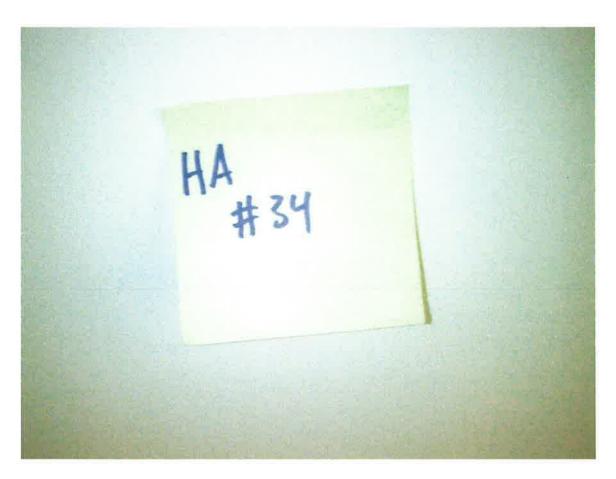
HA #34 – Non asbestos-containing smooth ceiling plaster

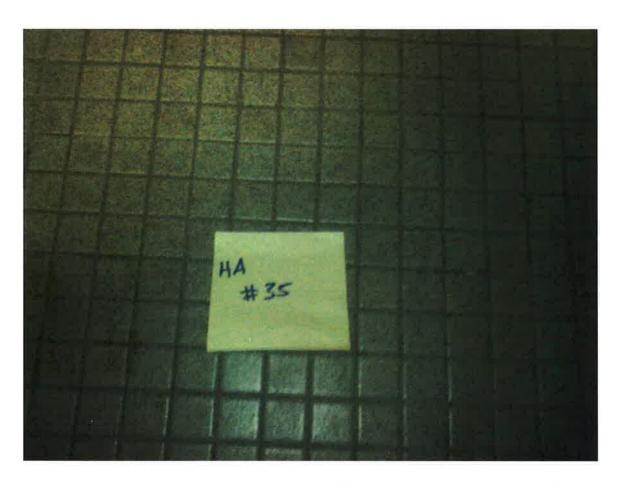
HA #35 – Non asbestos-containing 1/2" x 1/2" gray ceramic floor tile with black specks bedding compound and grout

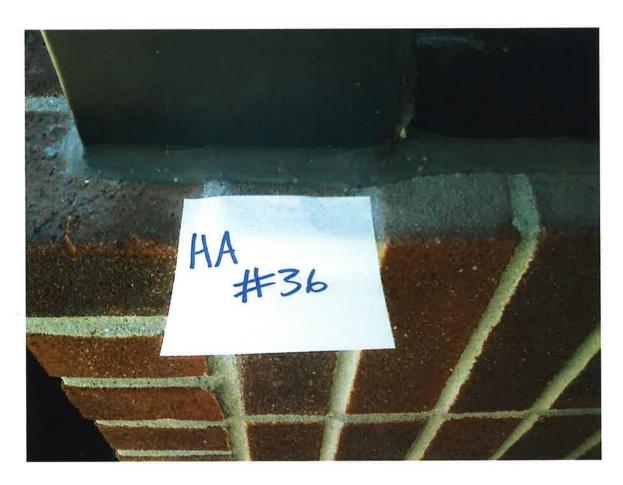
HA #36 – Non asbestos-containing exterior brown window, door and building caulk compound

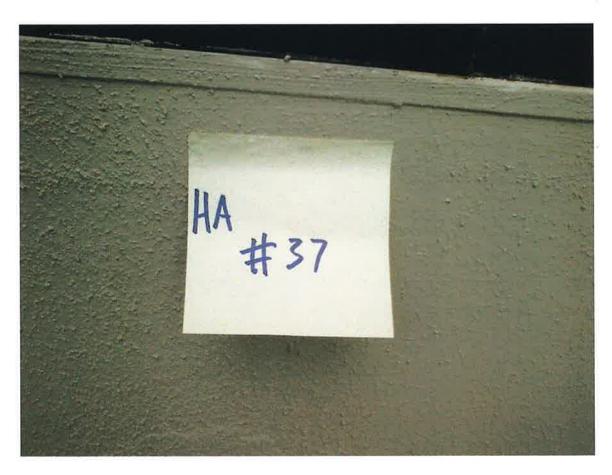
HA #37 – Non asbestos-containing exterior textured plaster

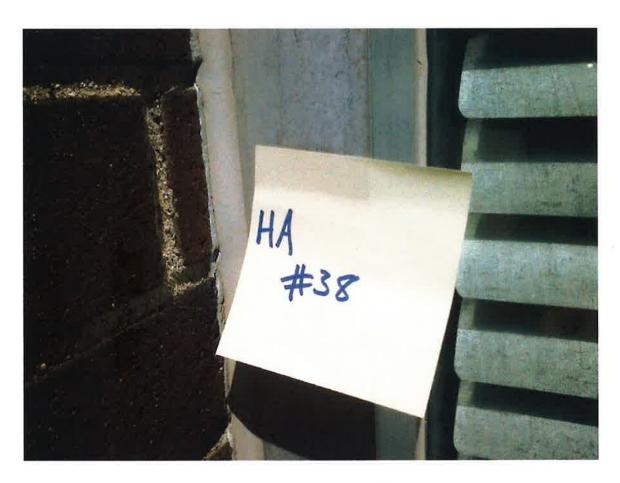
HA #38 - Non asbestos-containing exterior white window caulk compound

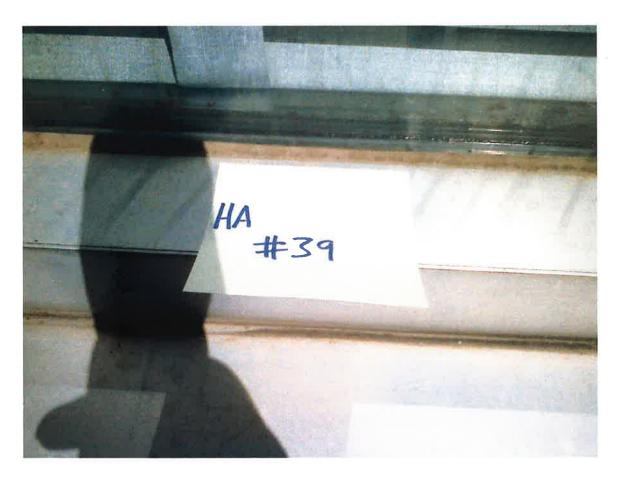
HA #39 – Non asbestos-containing exterior white window glazing compound

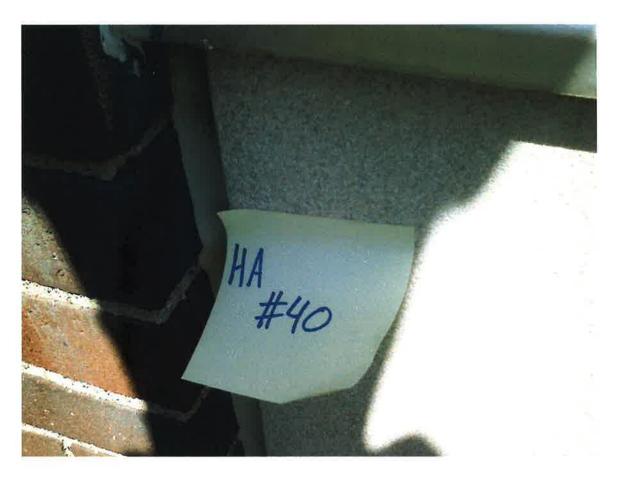
HA #40 – Non asbestos-containing exterior gray building caulk compound

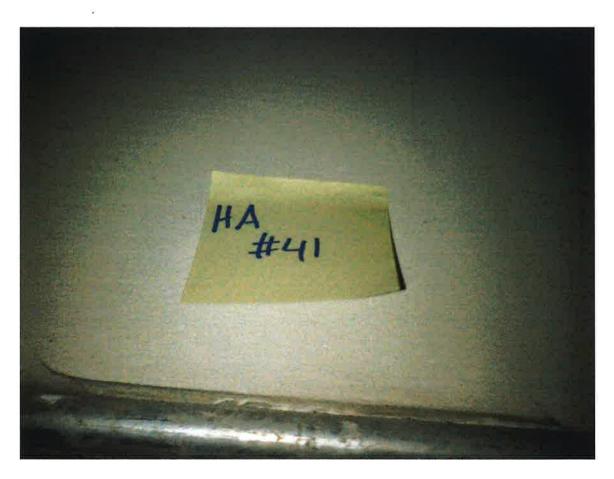
HA #41 – Non asbestos-containing textured firewall plaster

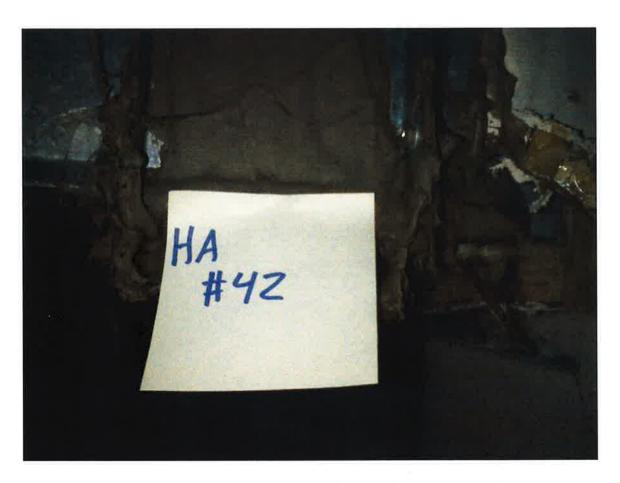
HA #42 – Non asbestos-containing indigo duct caulk (1964 area)

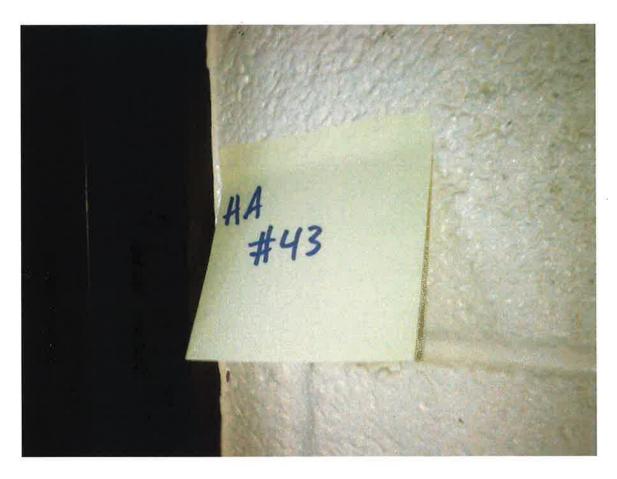
HA #43 – Non asbestos-containing brown door caulk compound (1964 area)

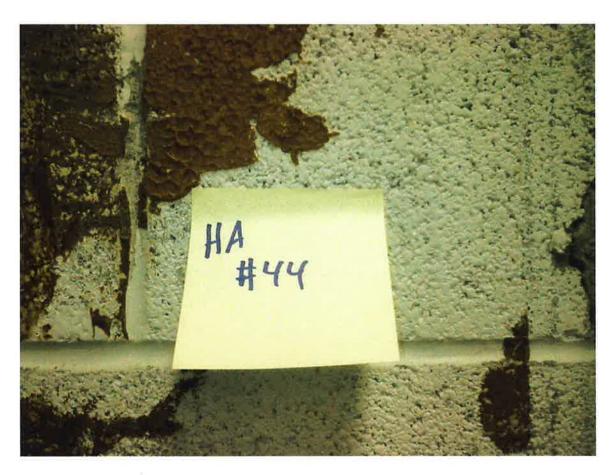
HA #44 – Non asbestos-containing yellow glue pods

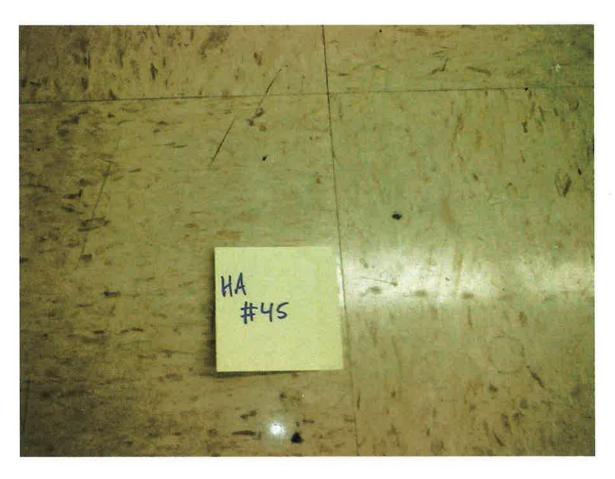
HA #45 – Non asbestos-containing 12" x 12" light brown floor tile with brown streaks and associated mastic

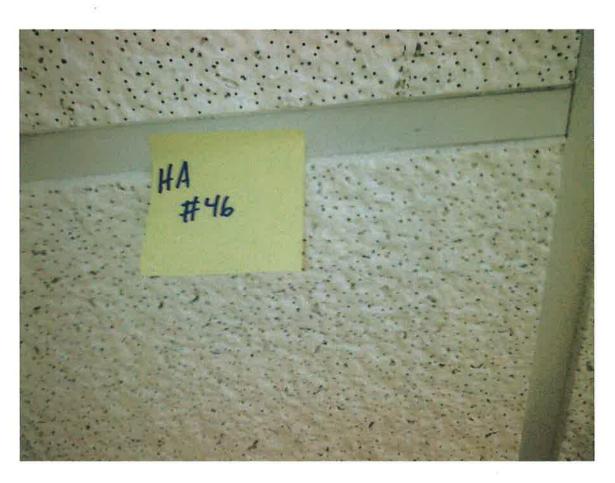
HA #46 – Non asbestos-containing 2' x 2' white drop-in ceiling tile with holes and texture
