Physical Plant Photo Log

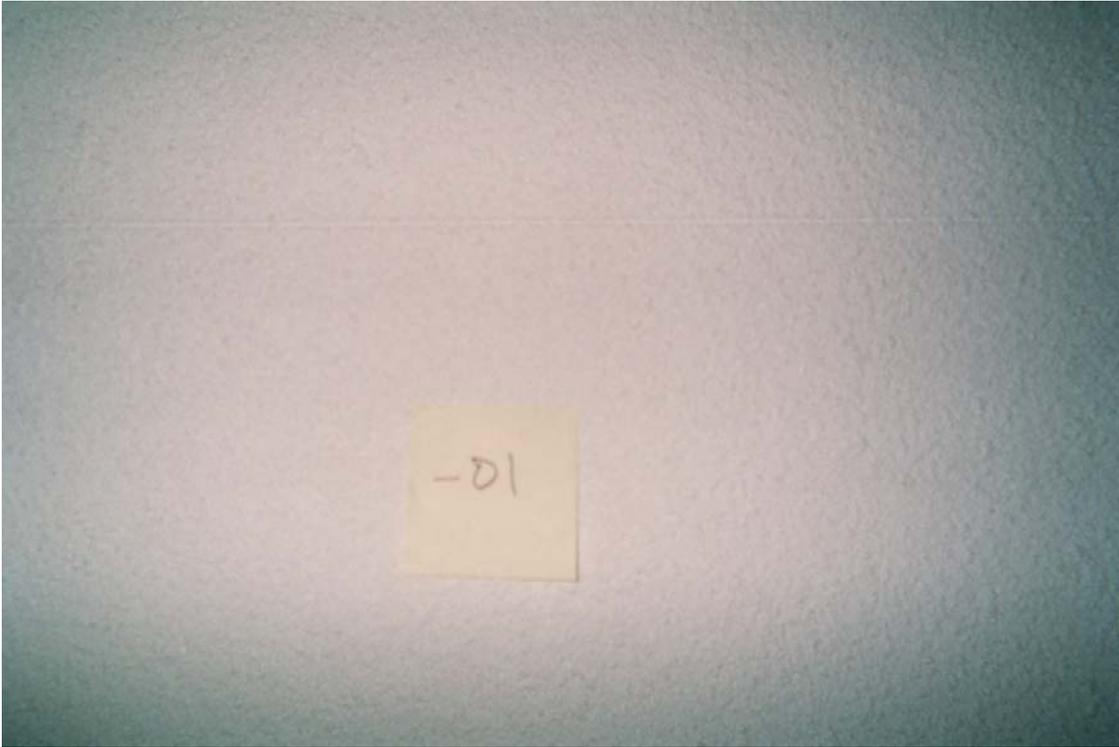
HA #1 – Non asbestos-containing cream textured ceiling and wall paint

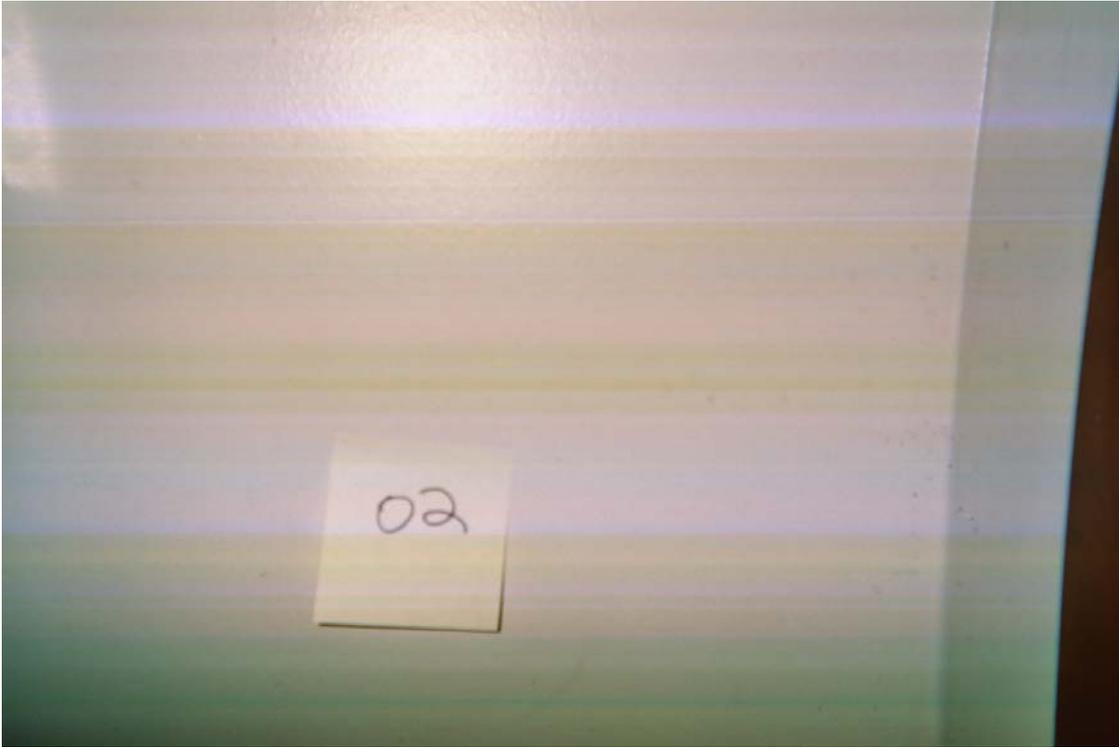
HA #2 – Non asbestos-containing drywall

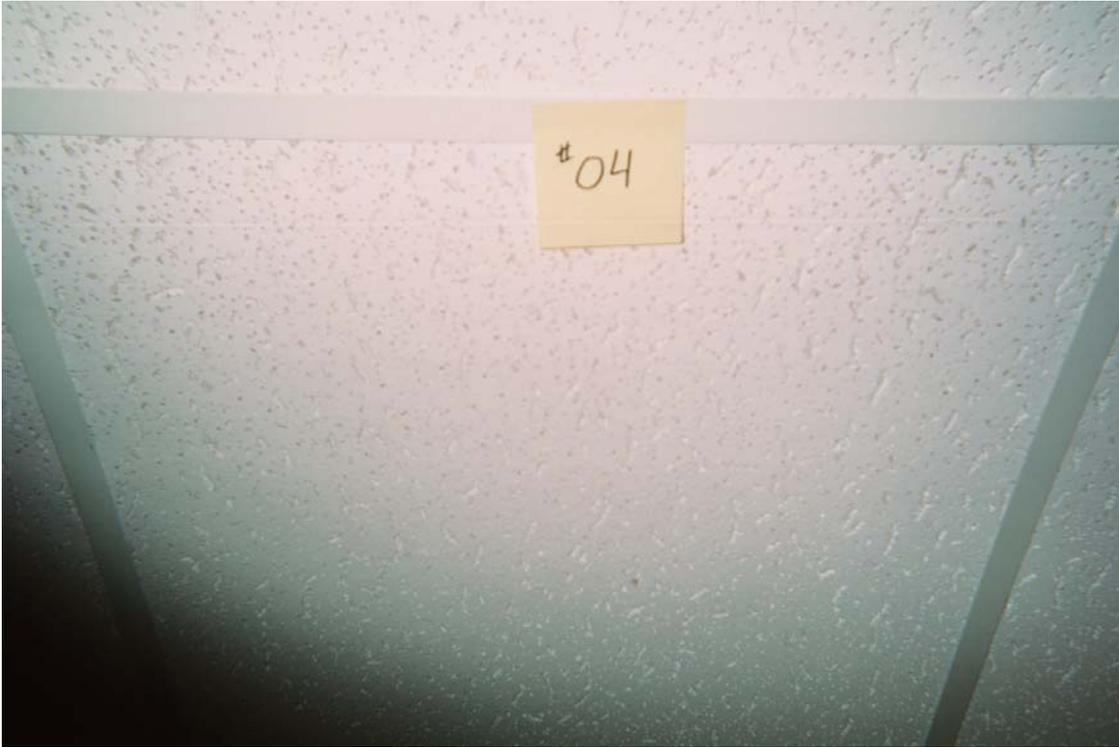
HA #4 – Non asbestos-containing 2' x 2' white lay-in ceiling tile
with pin holes and fissures

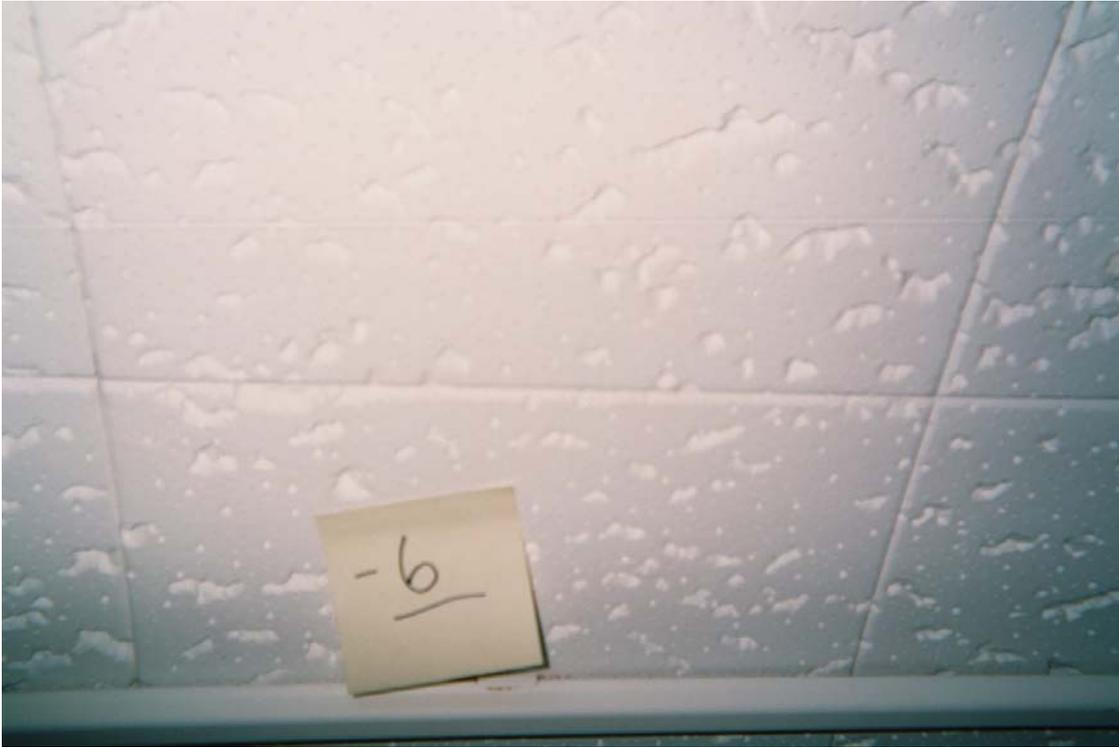
HA #6 – Non asbestos-containing 12" x 12" white ceiling tile with deep fissures and pin holes and non asbestos containing associated glue pods

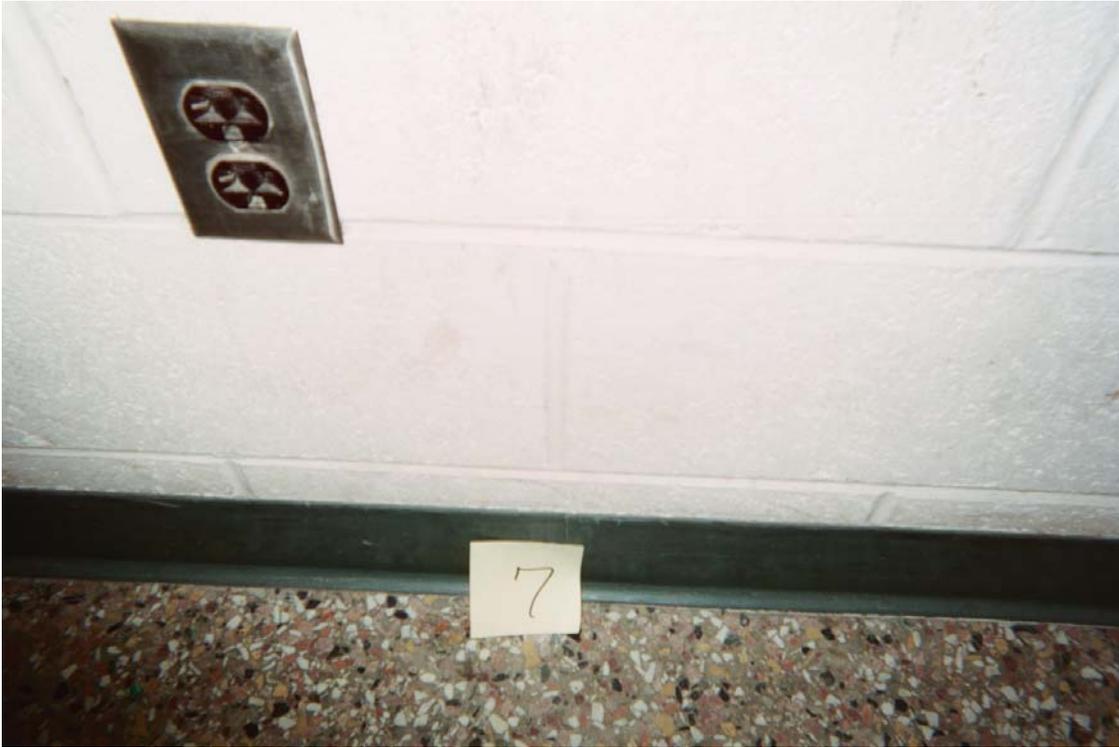
HA #7 – Non asbestos-containing 4" green cove molding
and associated mastic

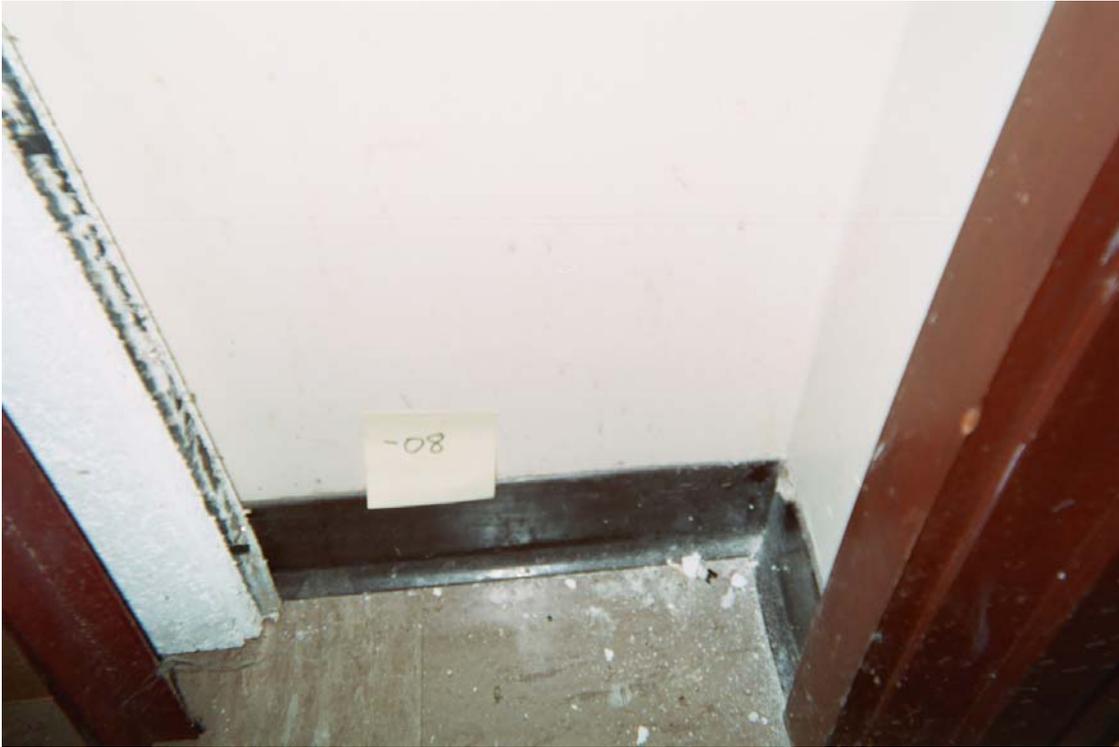
HA #8 – Non asbestos-containing 4" dark brown cove molding
and associated mastic

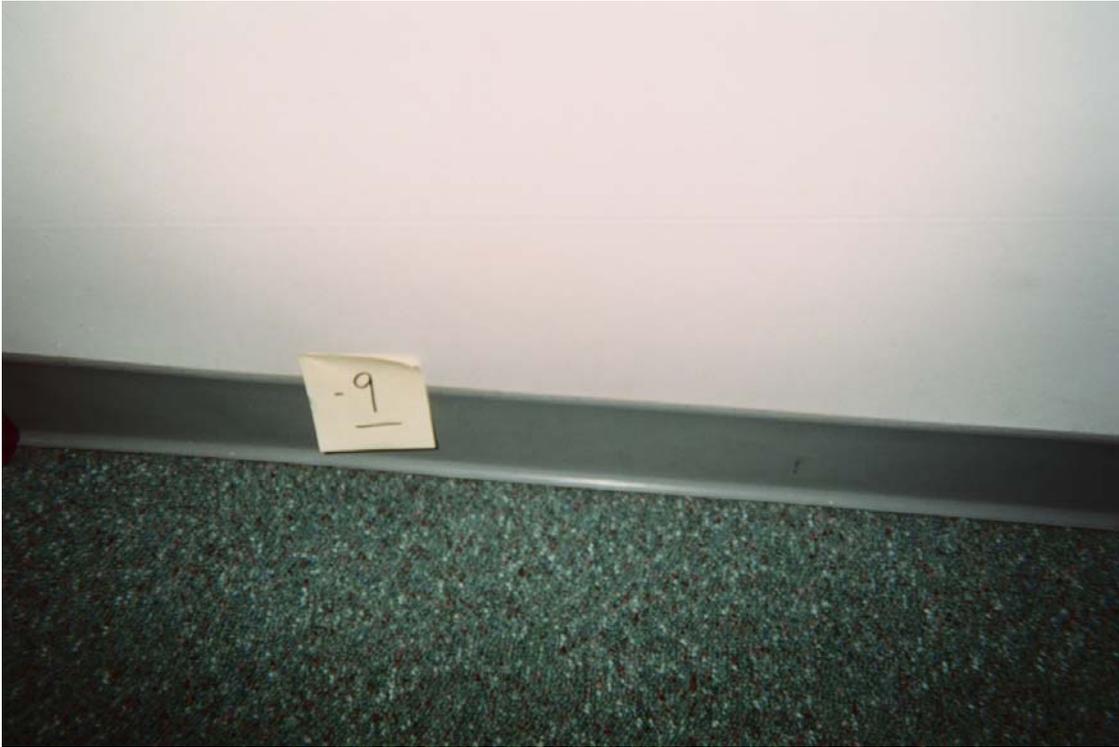
HA #9 – Non asbestos-containing 4" gray cove molding
and associated mastic

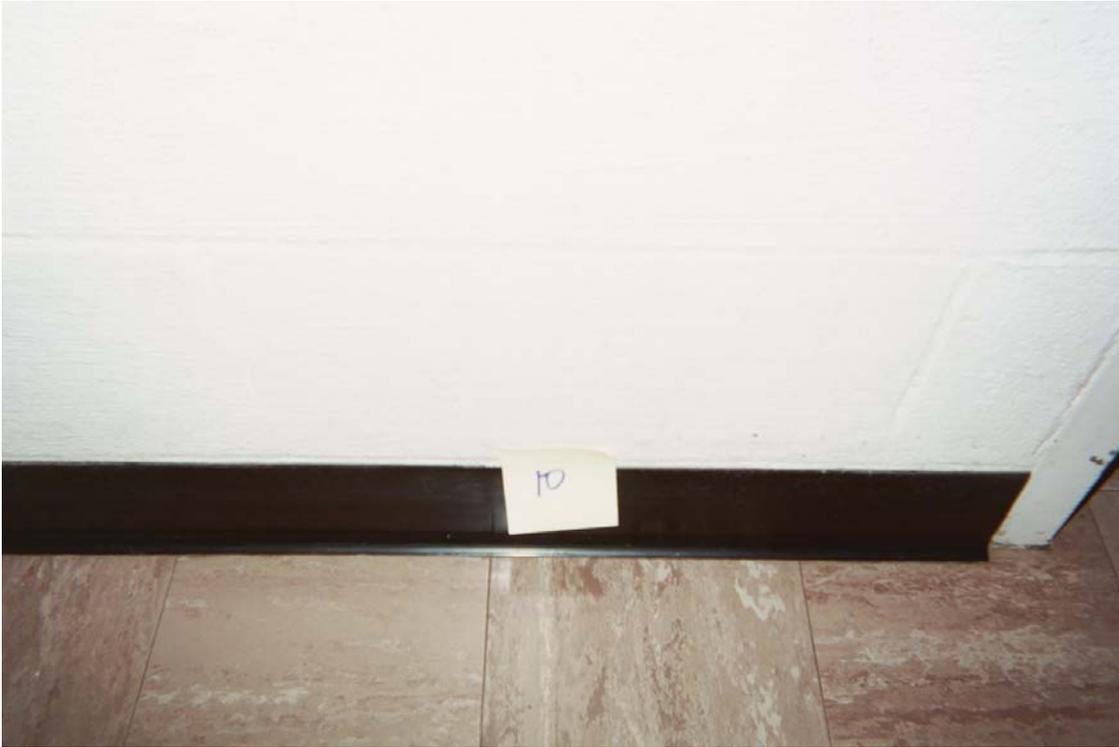
HA #10 – Non asbestos-containing 4" black cove molding
and associated mastic

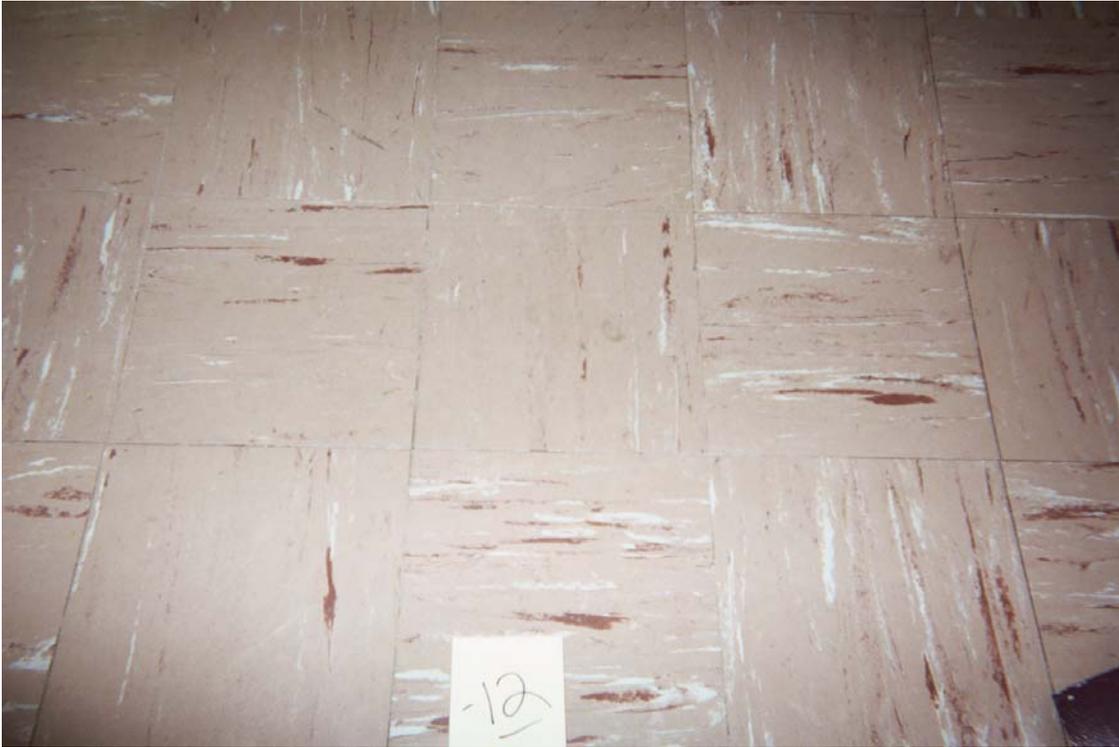
HA #12 – Asbestos-containing 9" x 9" tan floor with cream and rust streaks and associated non asbestos-containing mastic

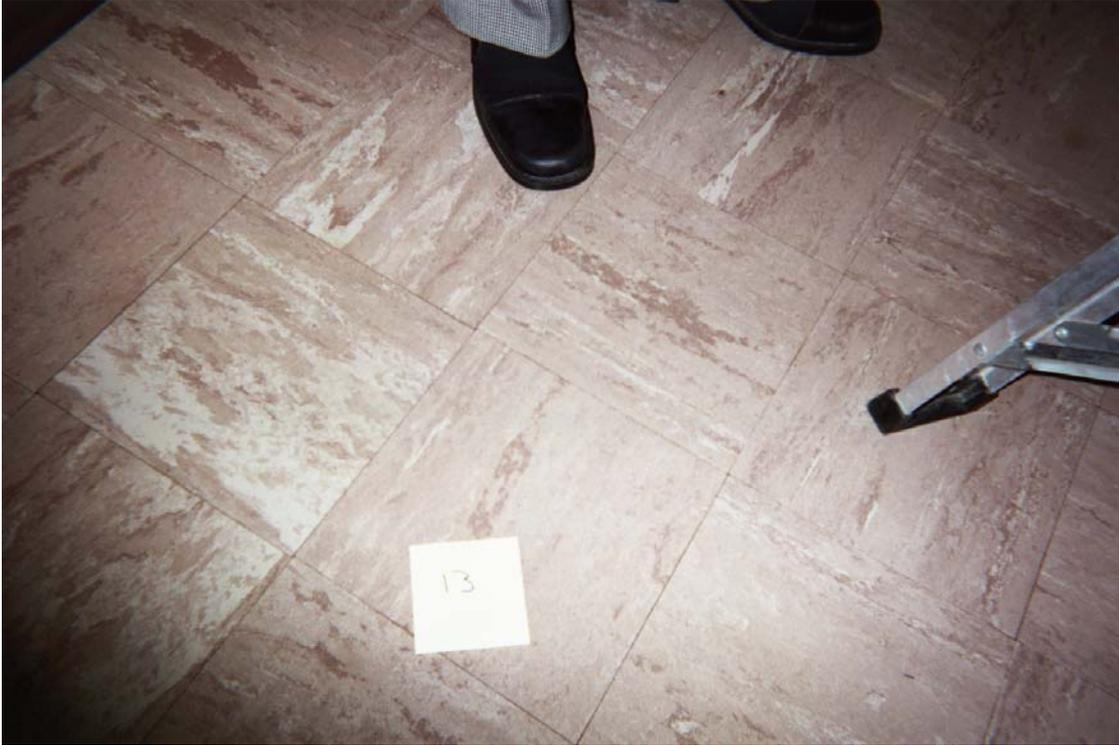
HA #13 – Asbestos-containing 9" x 9" beige floor tile with light and dark brown swirl pattern and associated mastic

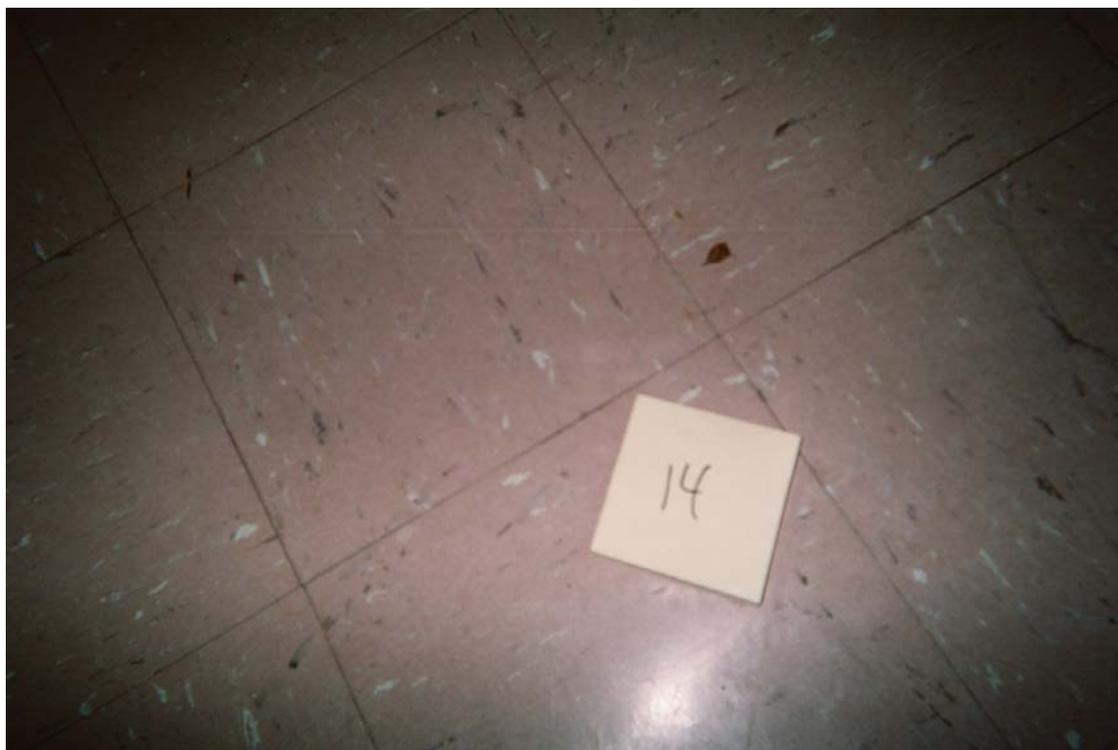
HA #14 – Non asbestos-containing 9" x 9" pink floor tile with cream and brown specks and associated mastic

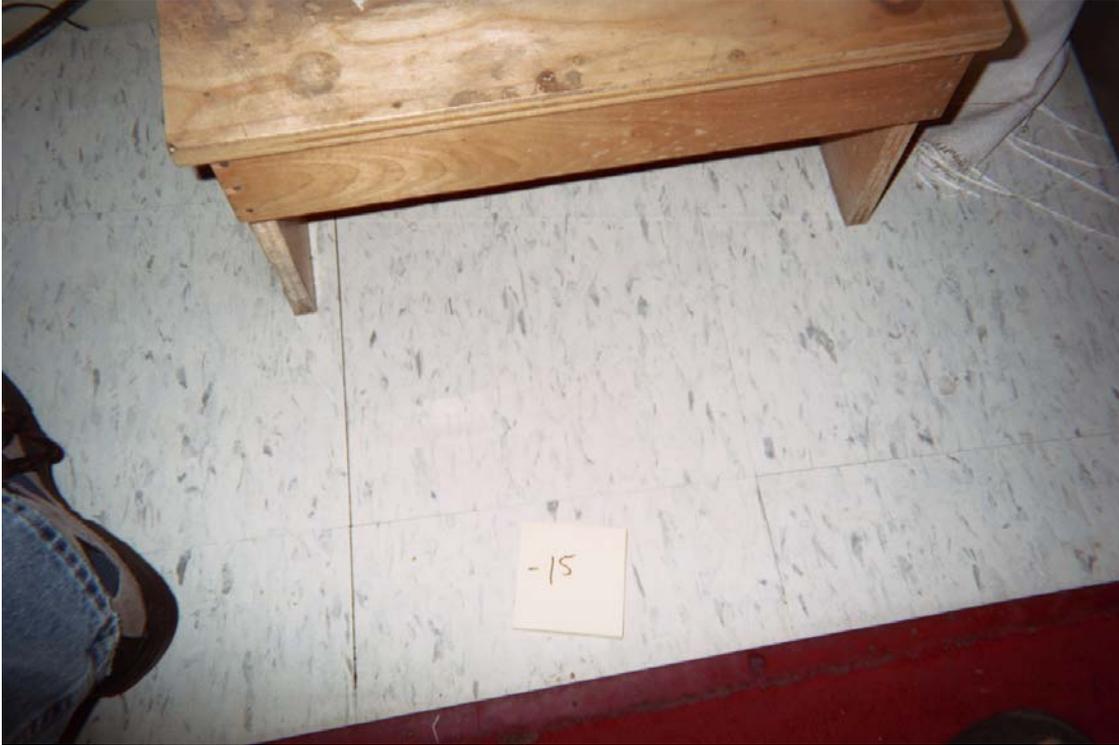
HA #15 – Non asbestos-containing 12" x 12" white floor tile with dark gray and white swirl pattern and associated mastic

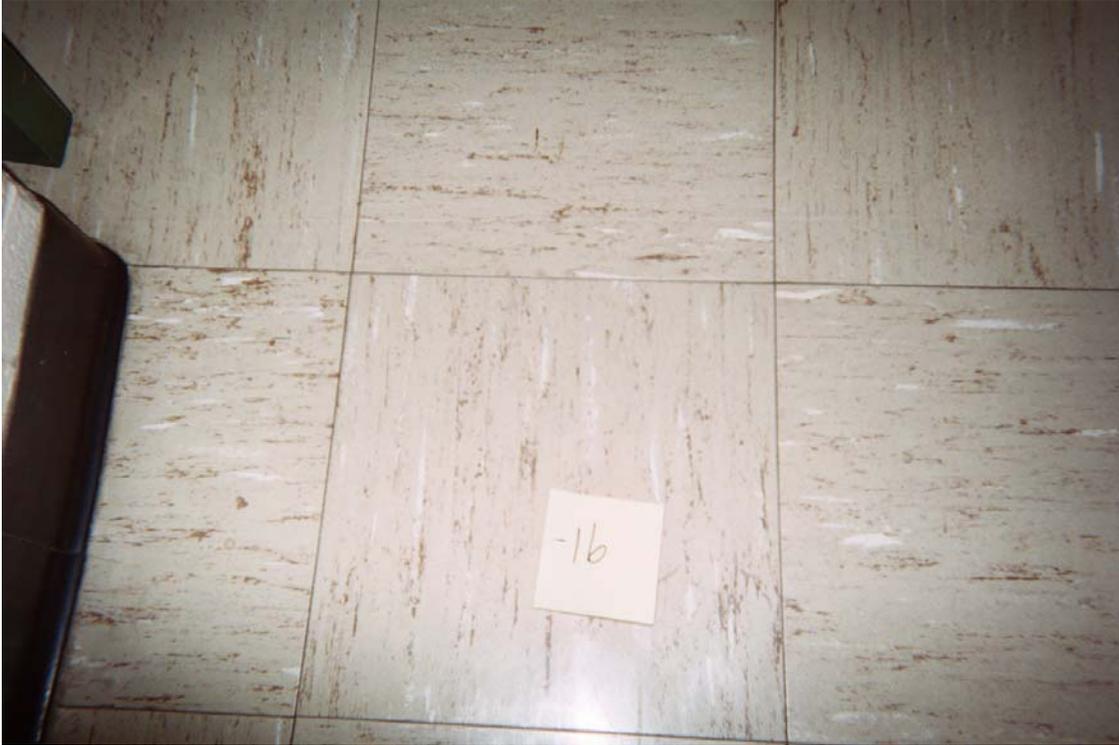
HA #16 – Non asbestos-containing 12" x 12" light brown floor tile with cream and rust streaks and associated asbestos-containing mastic

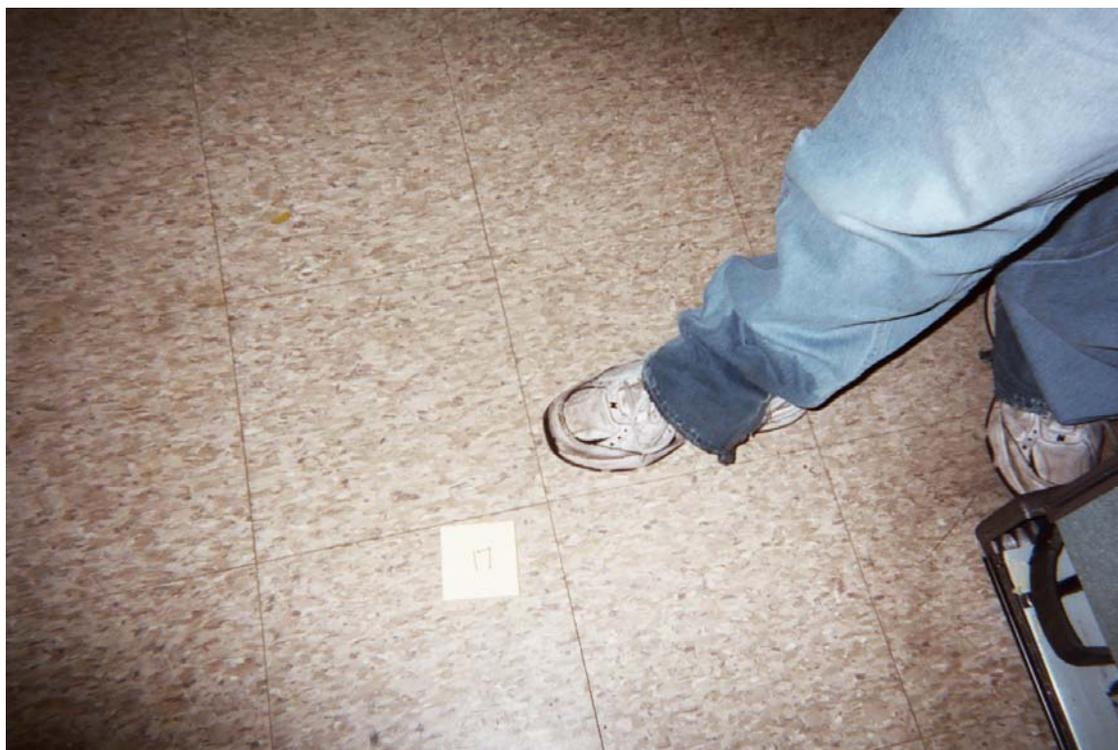
HA #17 – Non asbestos-containing 12" x 12" tan floor tile with marble pattern and associated mastic

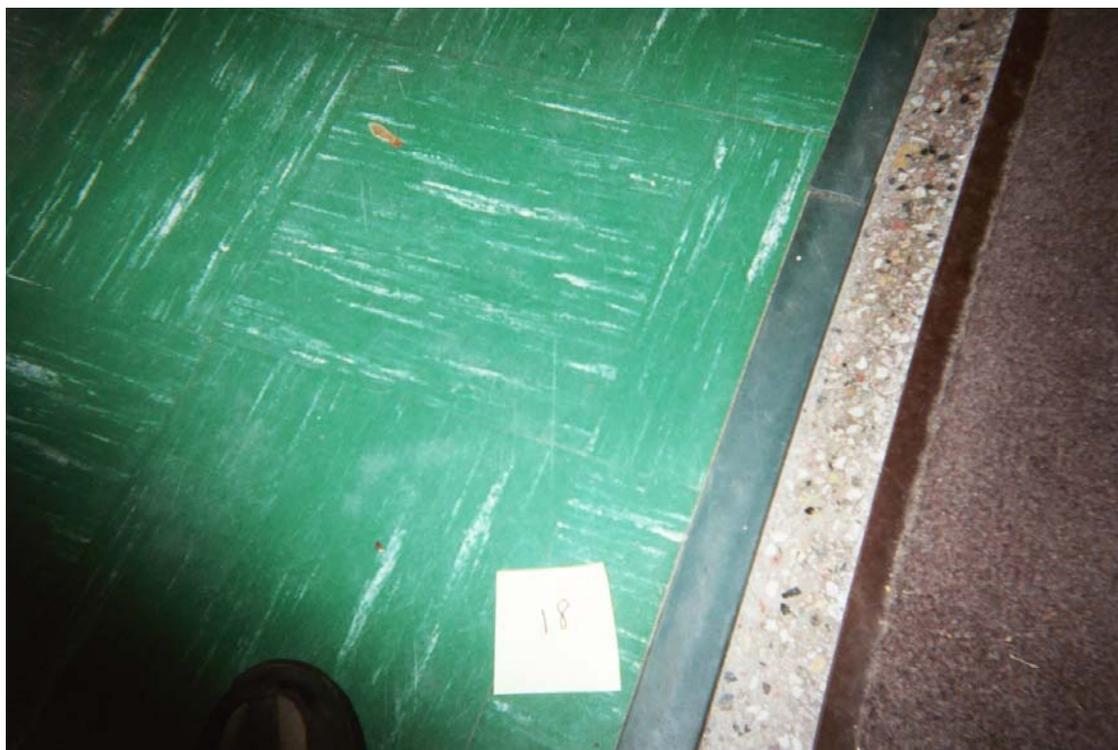
HA #18 – Non asbestos-containing 12" x 12" green floor tile
with white streaks and associated mastic

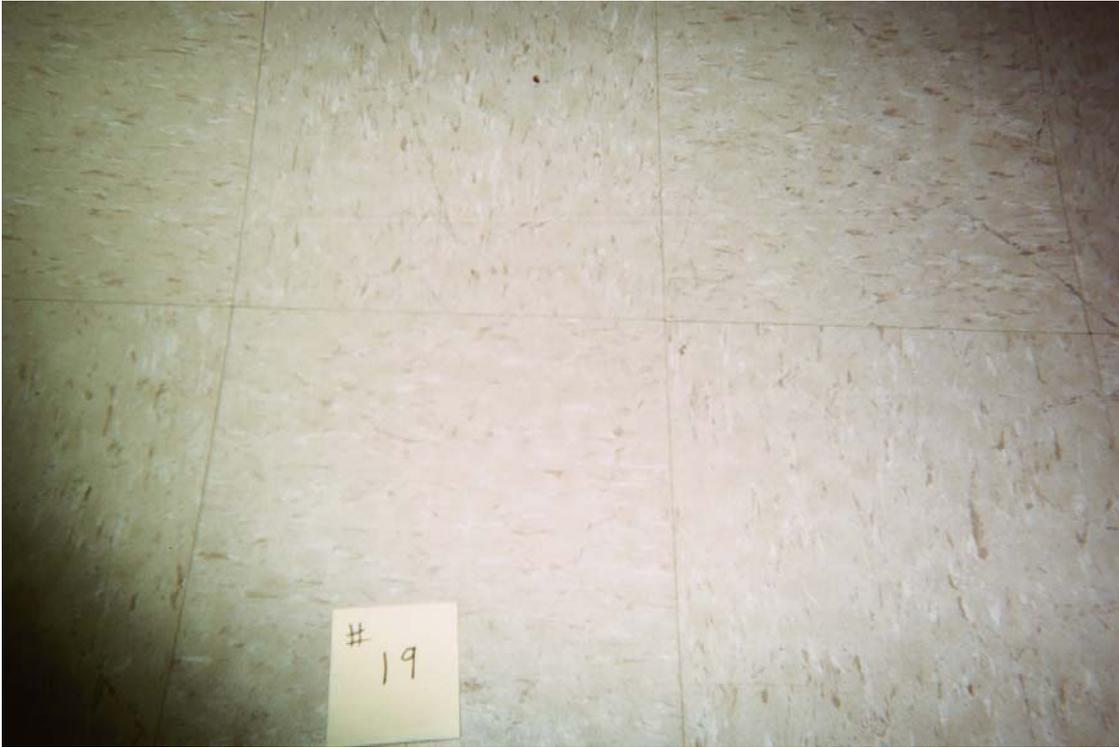
HA #19 – Non asbestos-containing 12" x 12" white floor tile with white and tan streaks and associated asbestos-containing mastic

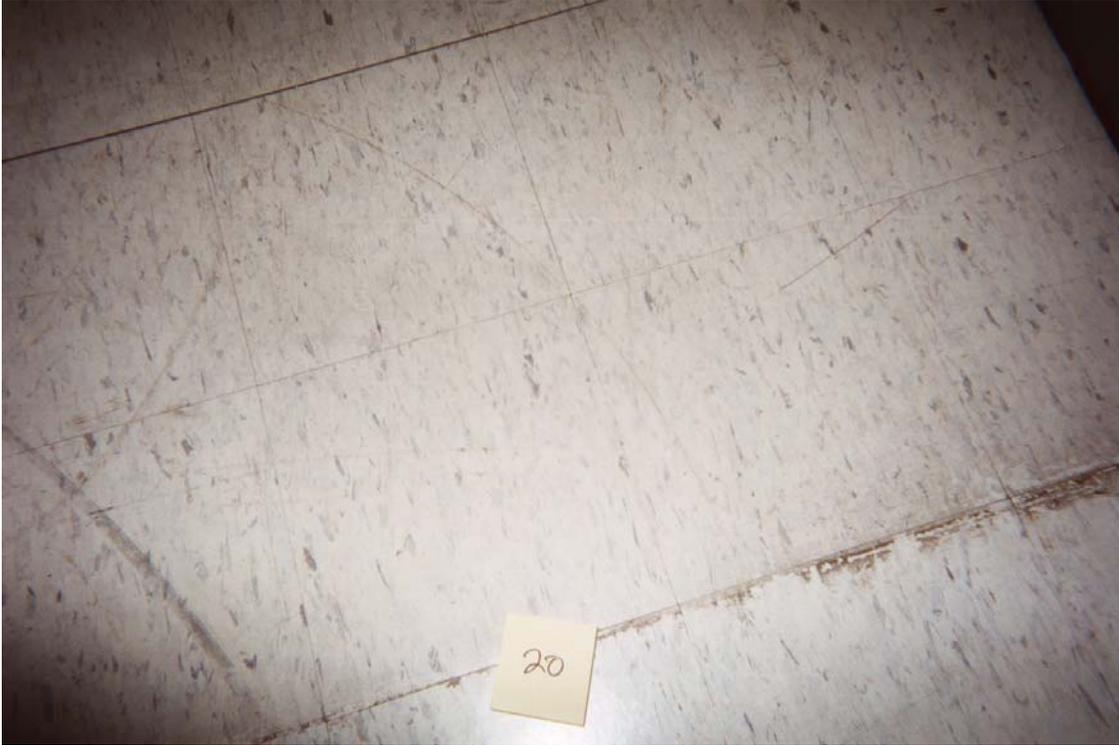
HA #20 – Non asbestos-containing 12" x 12" white floor tile
with gray streaks and associated mastic

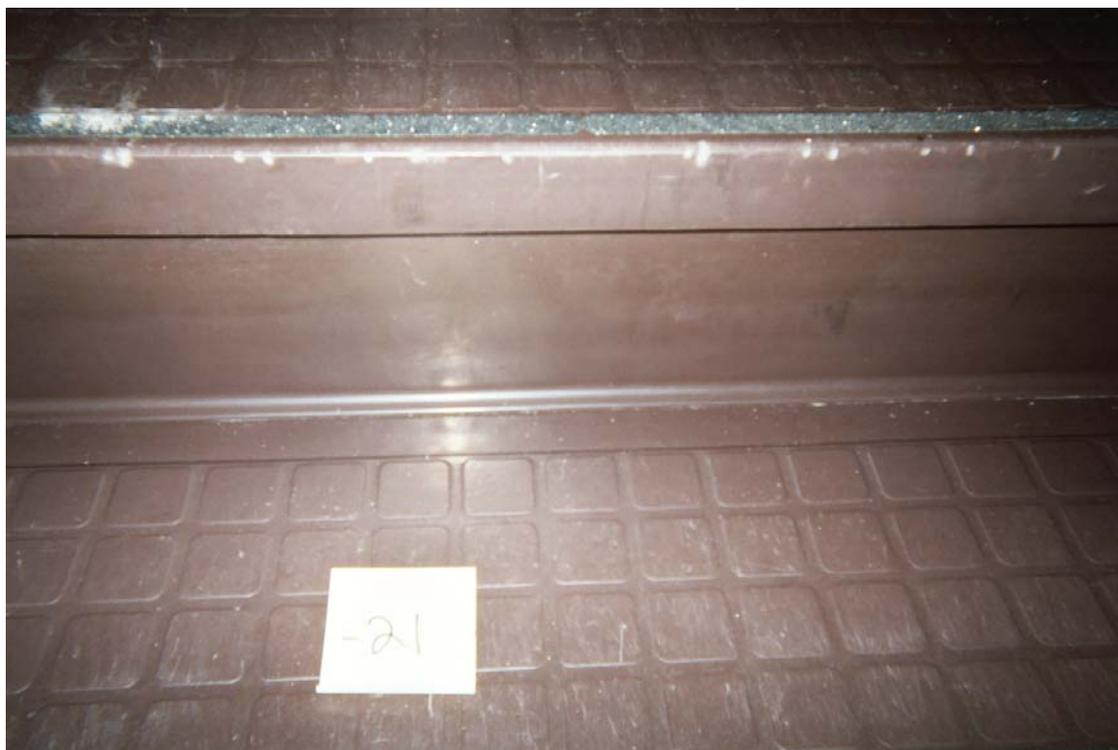
HA #21 – Non asbestos-containing dark brown vinyl stair tread
and associated mastic

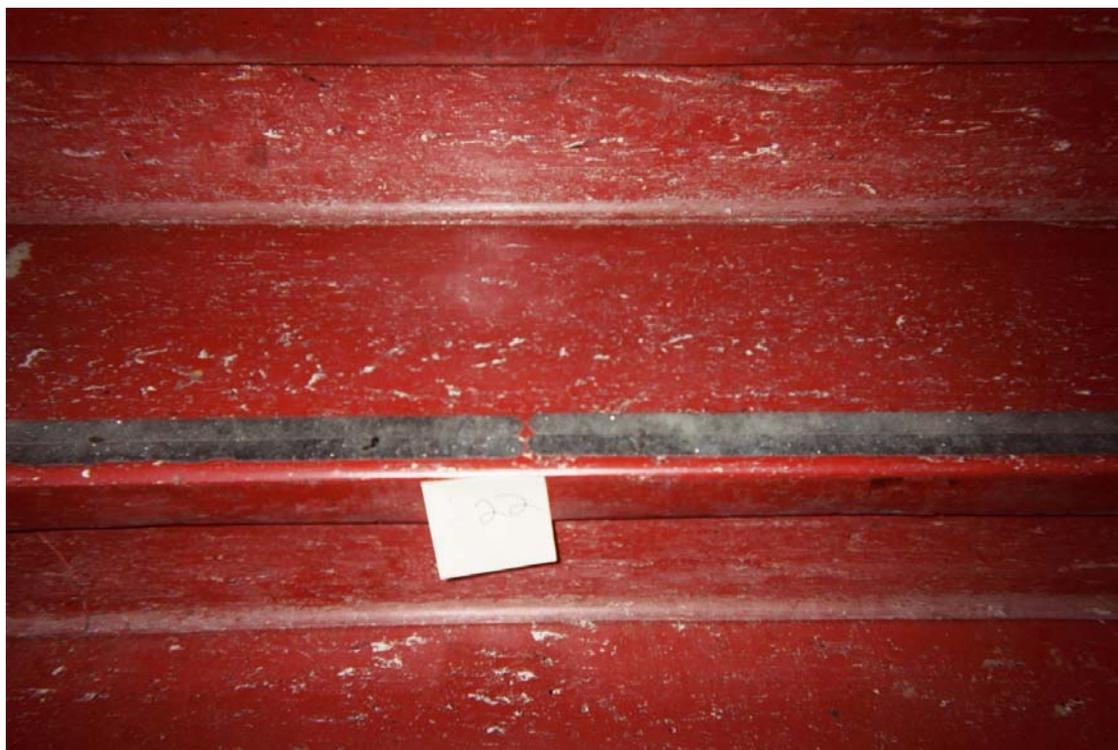
HA #22 – Asbestos-containing orange vinyl stair tread with white and black streaks and associated non asbestos-containing mastic

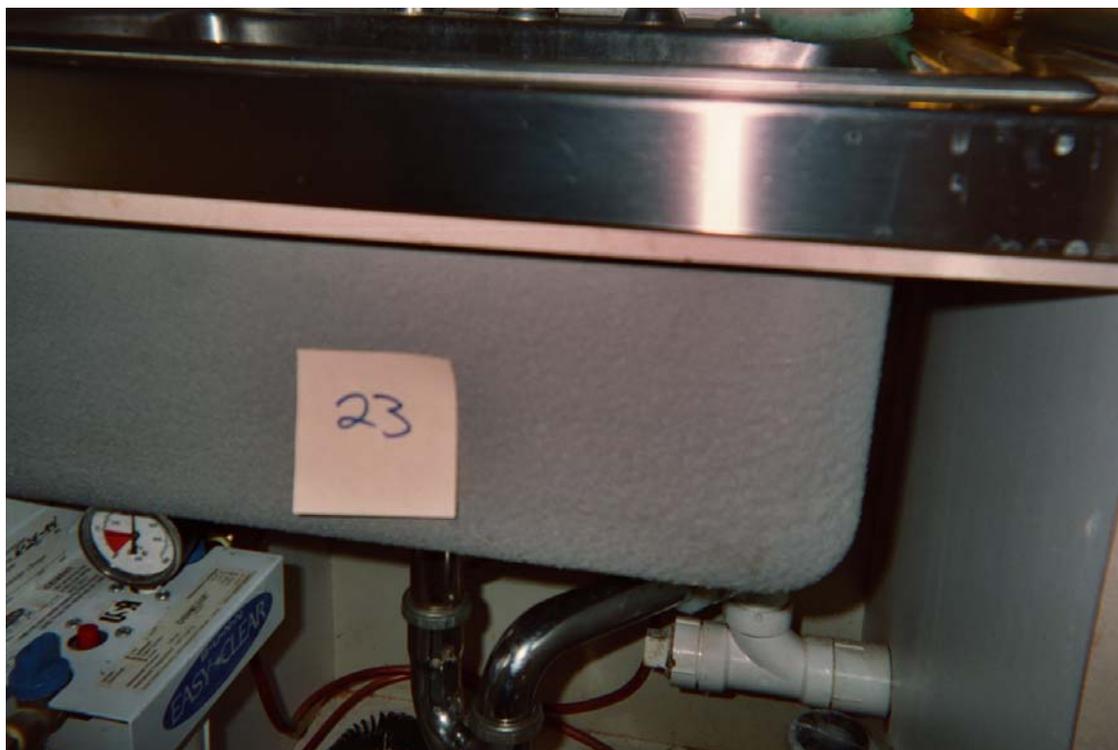
HA #23 – Non asbestos-containing gray sink undercoating

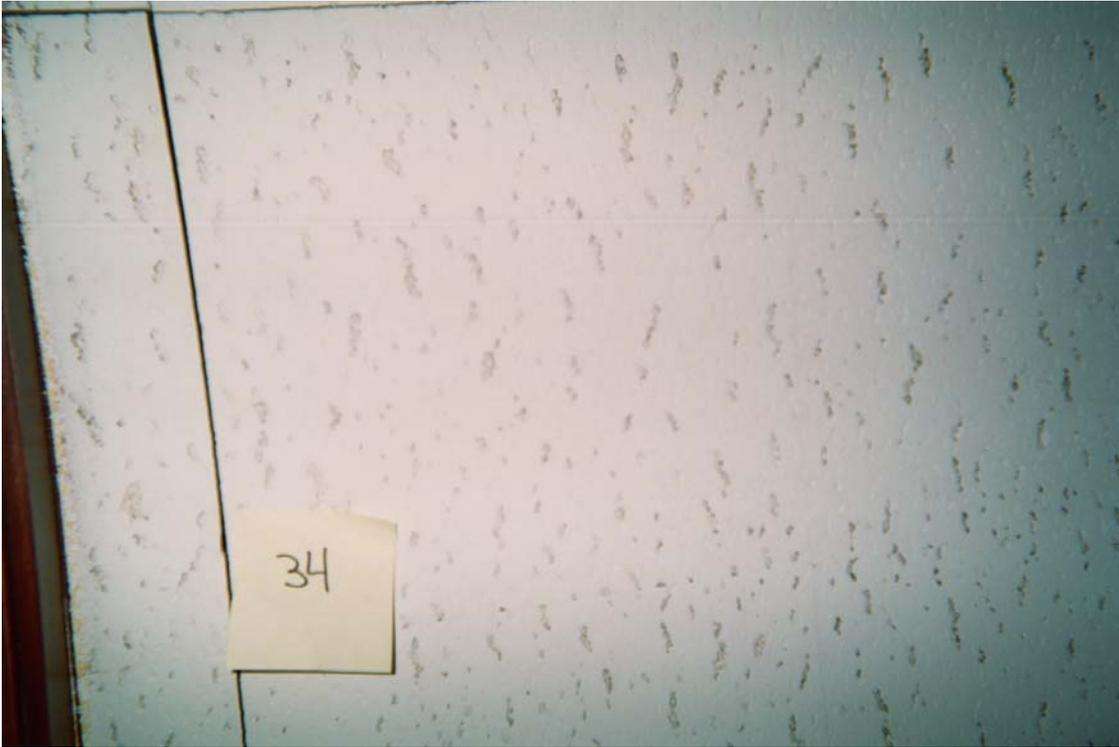
HA #34 – Non asbestos-containing 12" x 12" white spline ceiling tile with pin holes and fissures

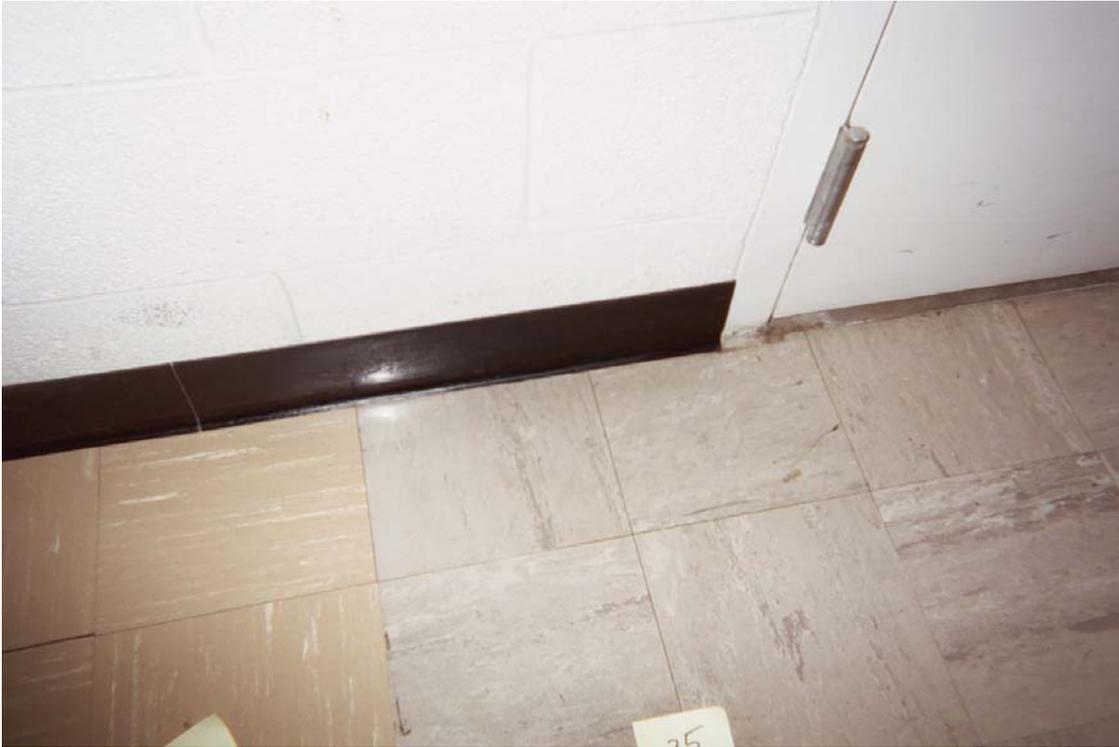
HA #35 – Asbestos-containing 9" x 9" gray floor tile with swirl pattern and associated asbestos-containing mastic

HA #36 – Non asbestos-containing 9" x 9" tan floor tile with cream streaks and associated asbestos-containing mastic

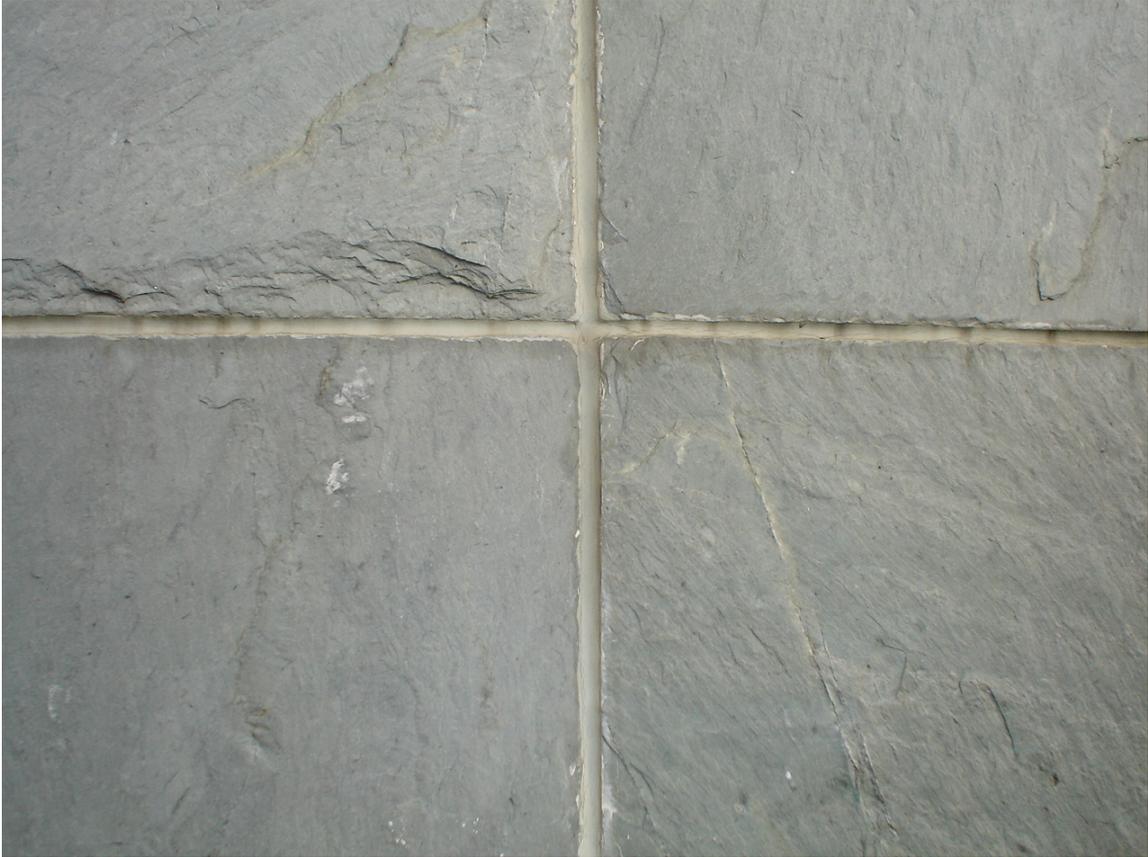
HA #26 – Non asbestos containing building caulk compound

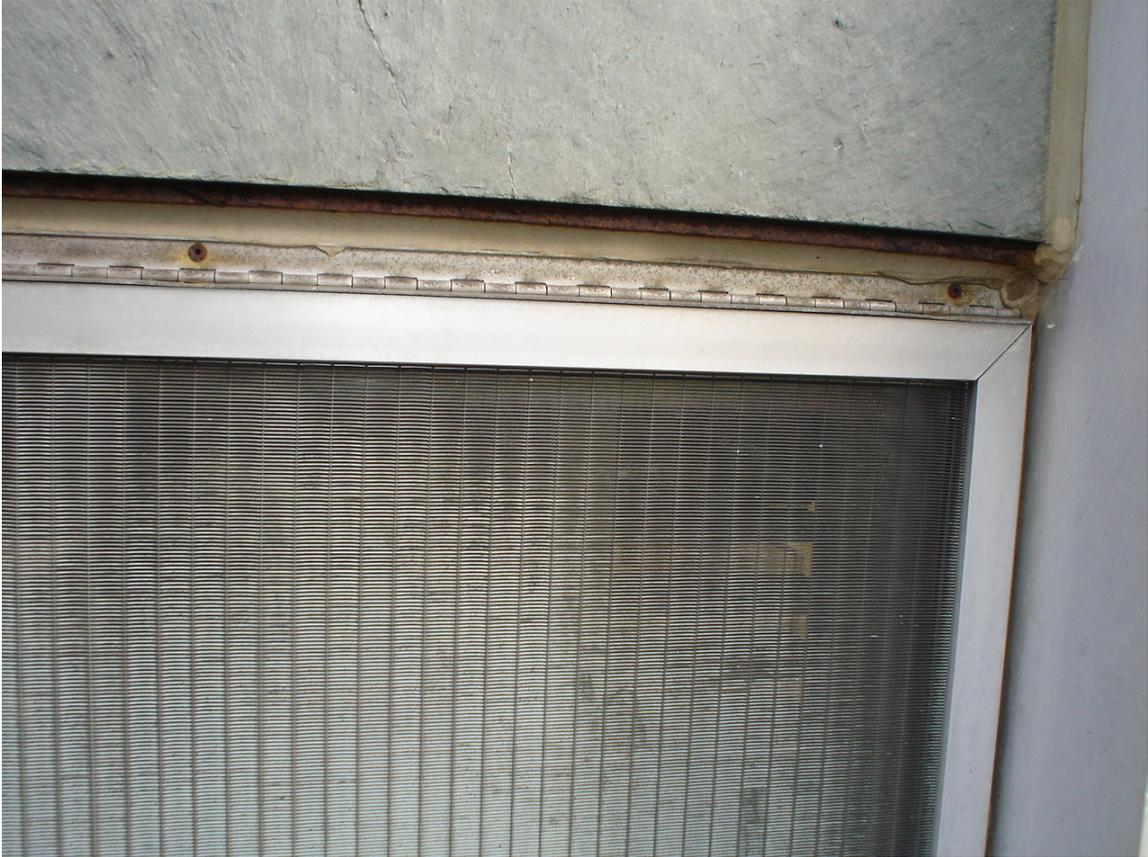
HA #25 – Asbestos containing tan window and door frame
caulk compound
