Natural Resources Photo Log

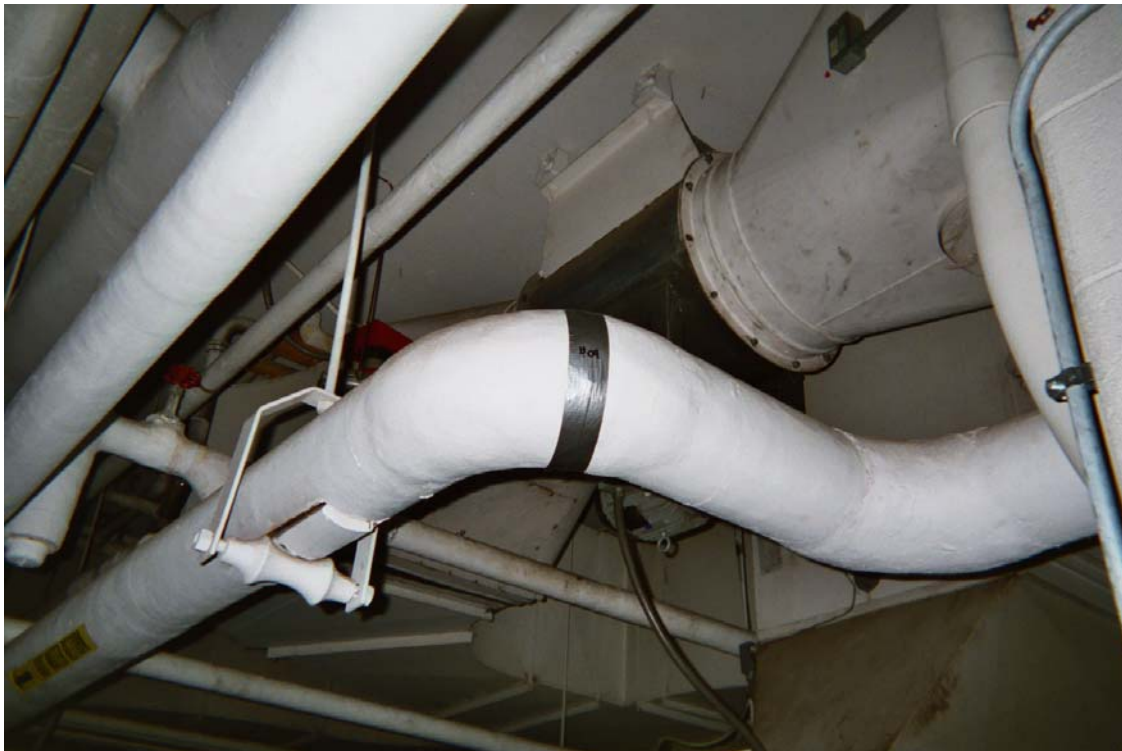
Asbestos-containing domestic water pipe joint and
hanger insulation on fiberglass straight

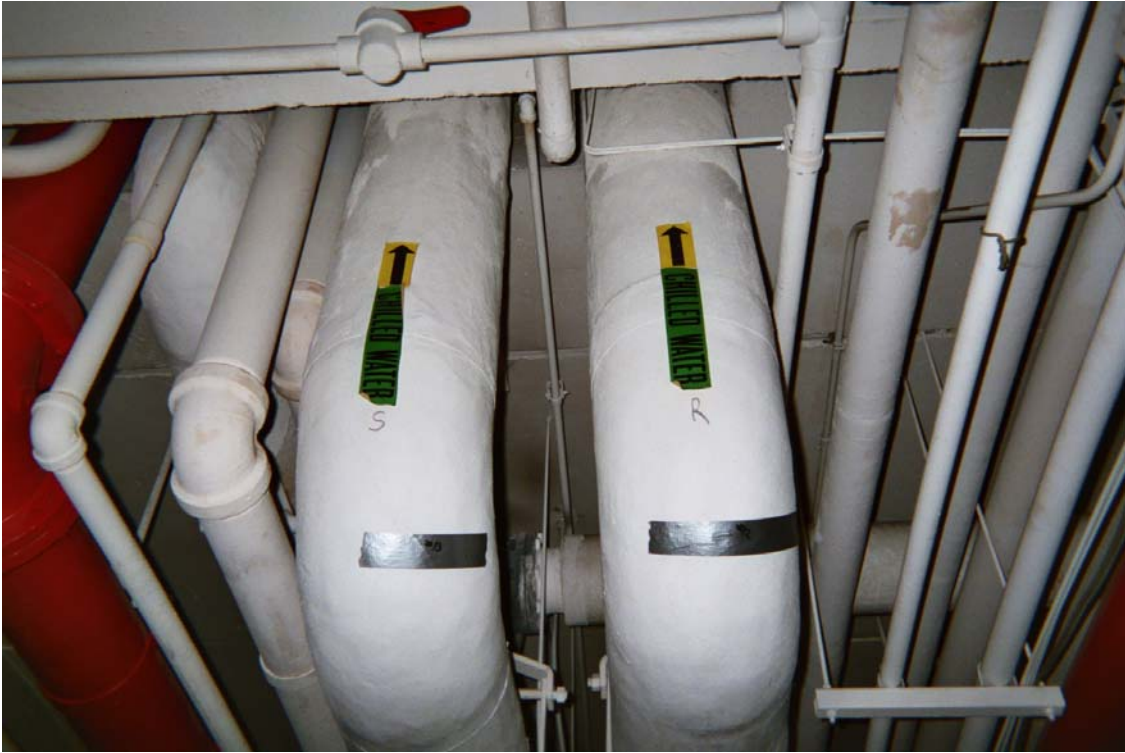
Asbestos-containing chilled water pipe joint/hanger insulation
on fiberglass straight

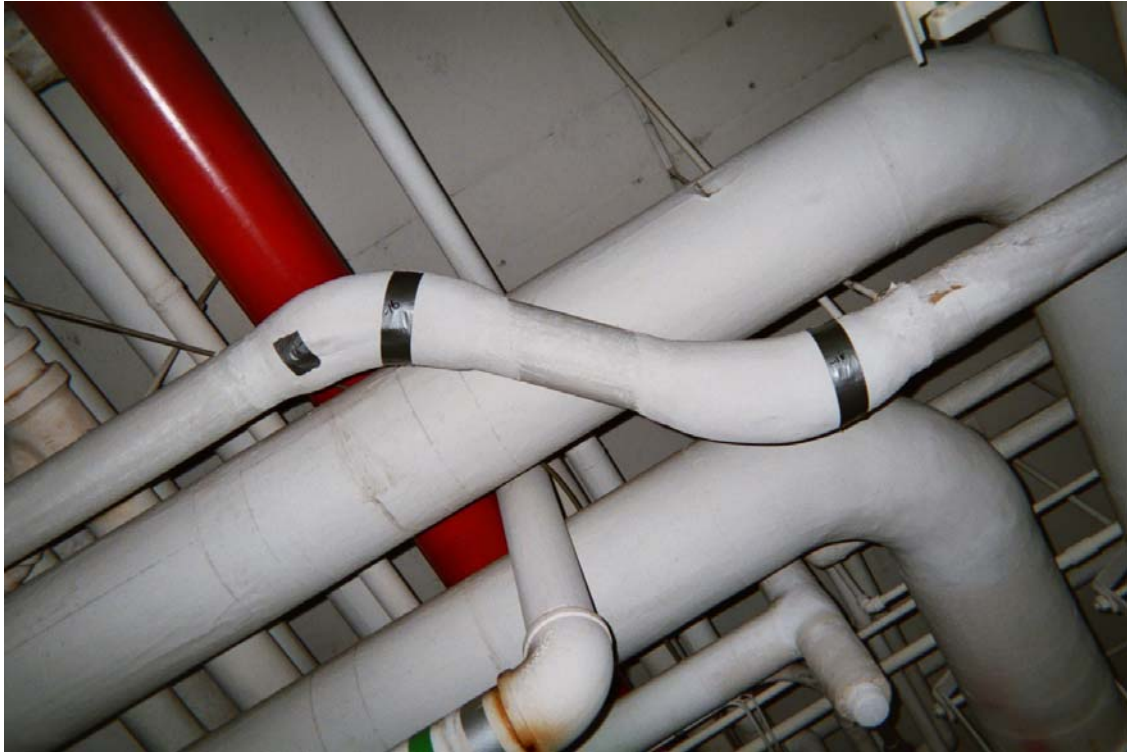
Asbestos-containing wastewater pipe joint/hanger insulation

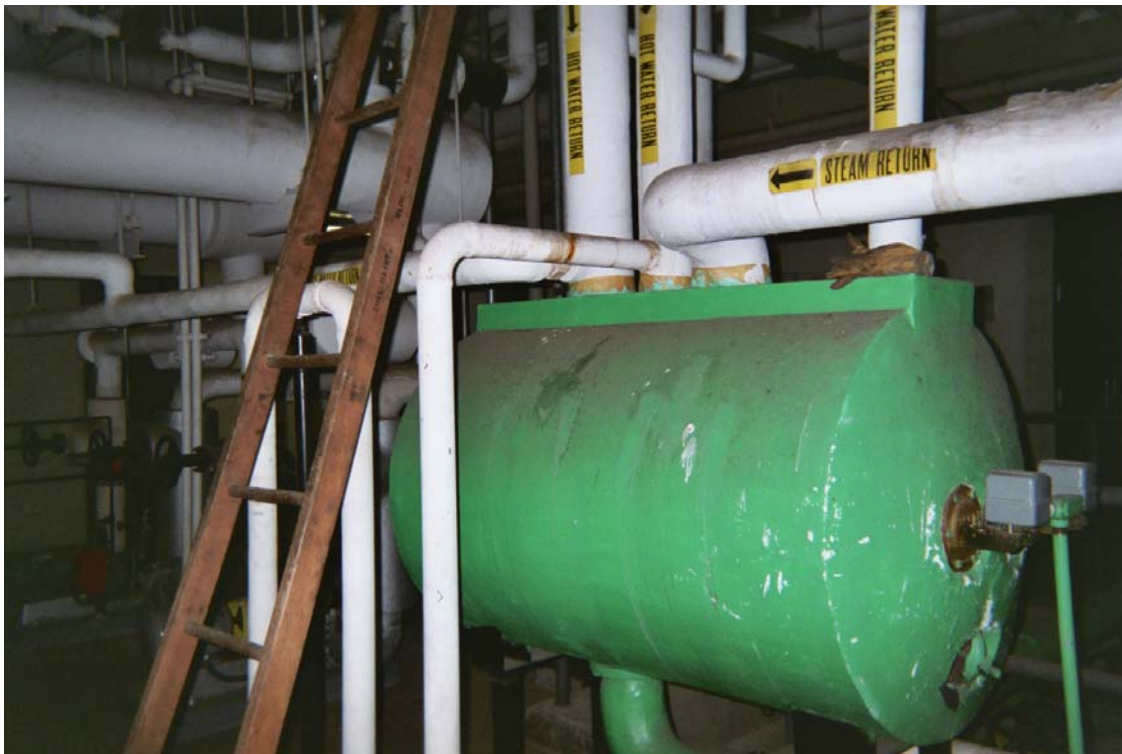
Asbestos-containing hot water holding tank insulation

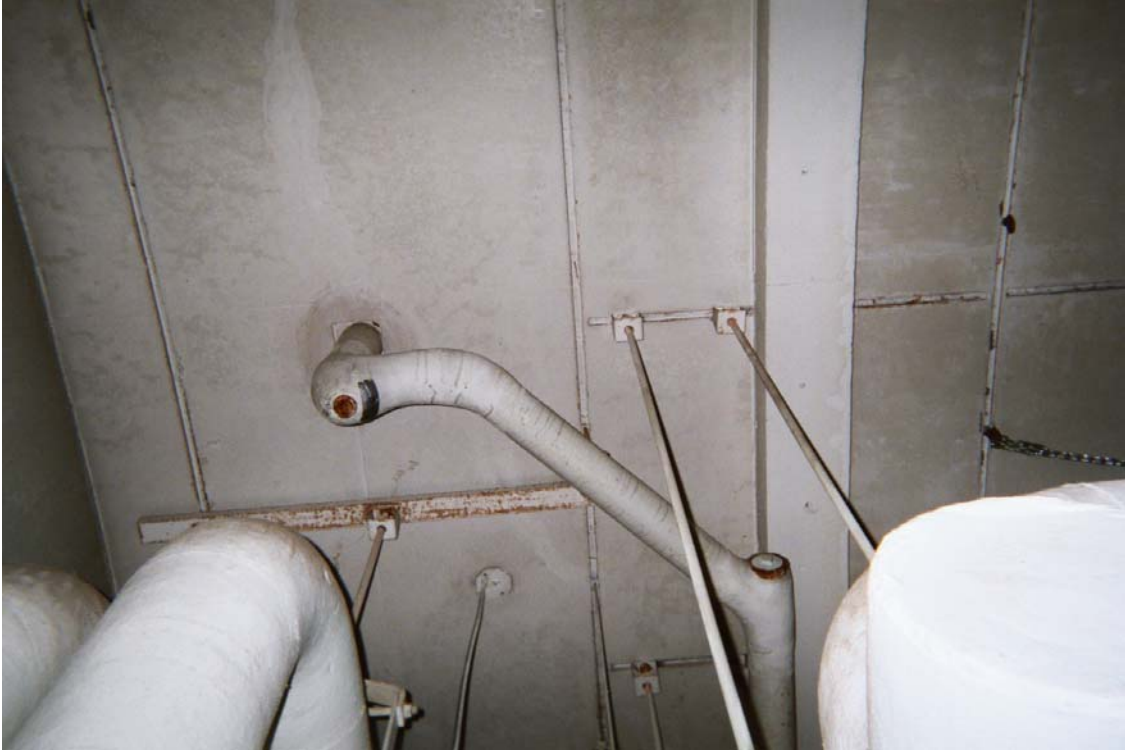
Asbestos-containing drain line pipe joint/hanger insulation on fiberglass

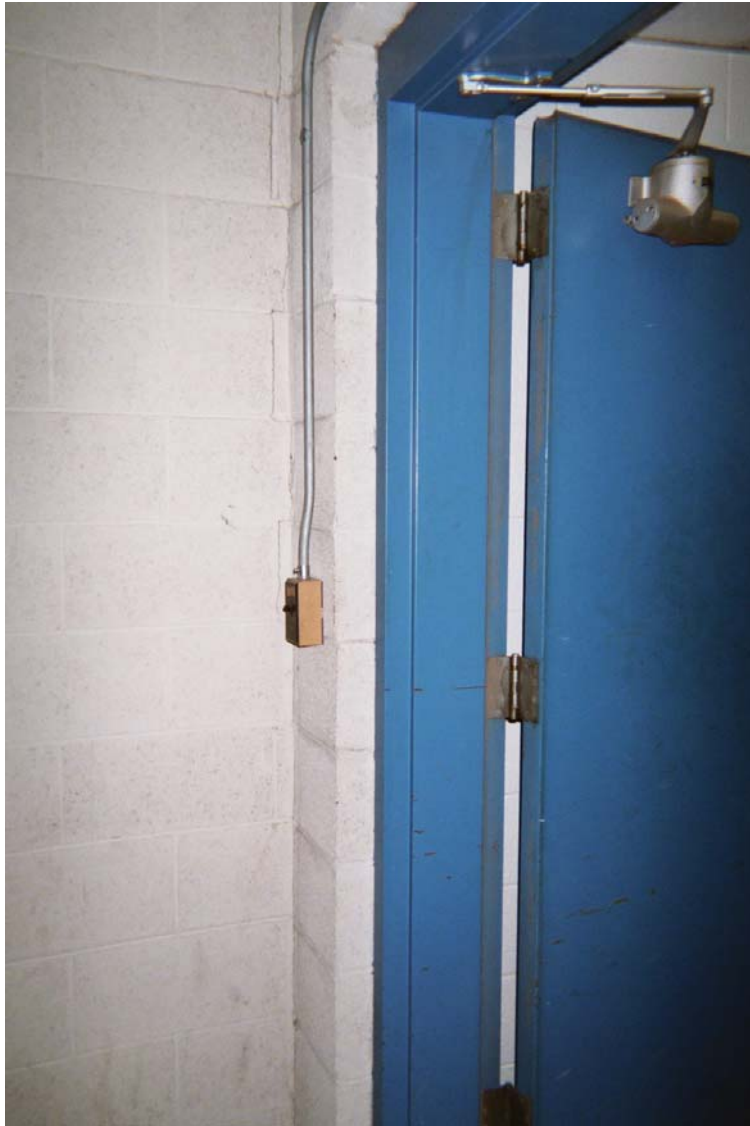
Assumed asbestos-containing fire door and frame

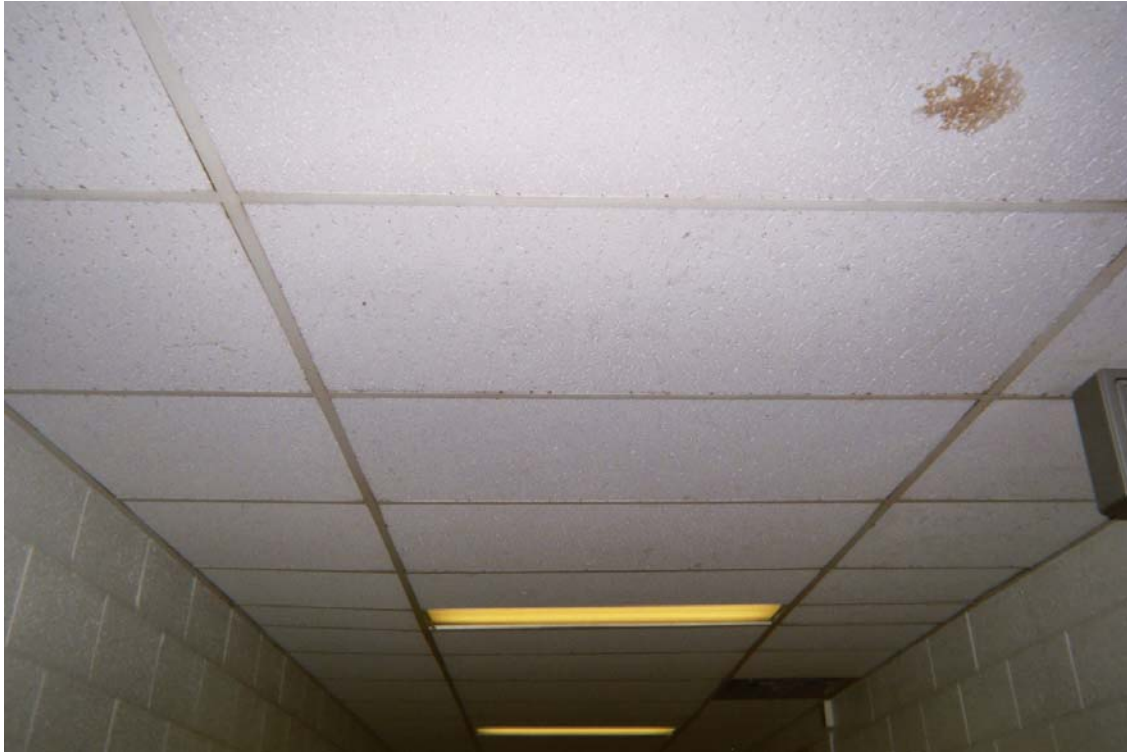
Non asbestos-containing 2' x 4' white lay-in ceiling tile with pin holes and fissures

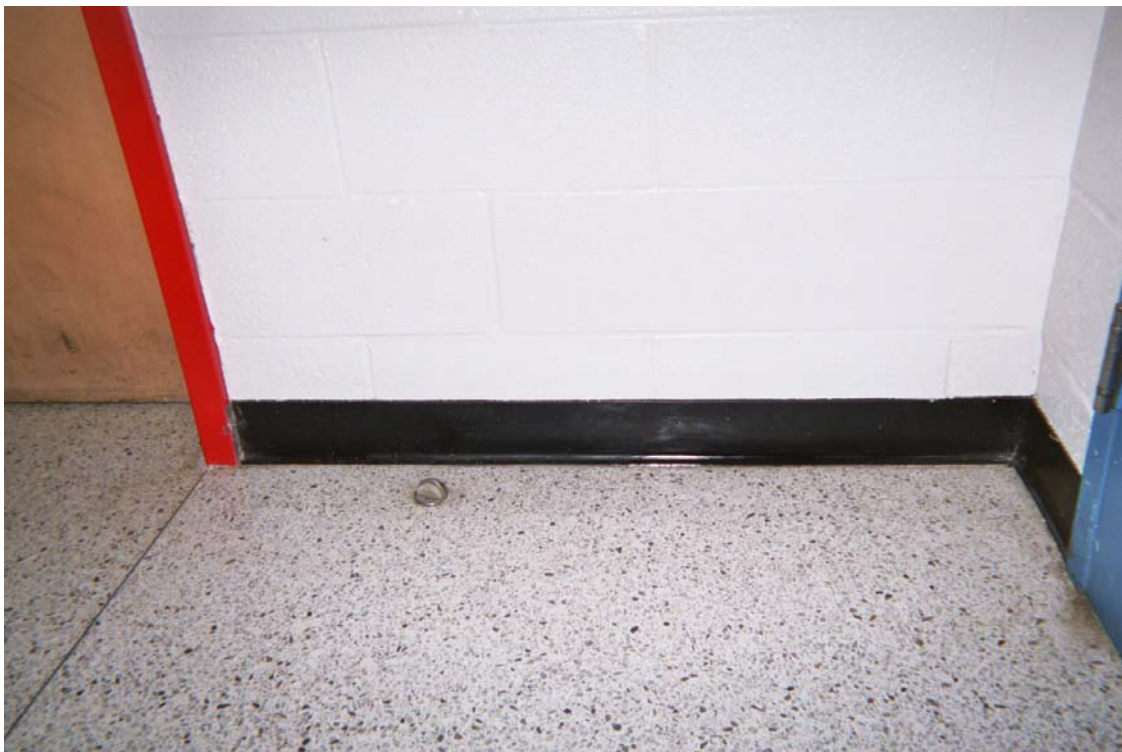
Non asbestos-containing 4" black cove molding and associated mastic

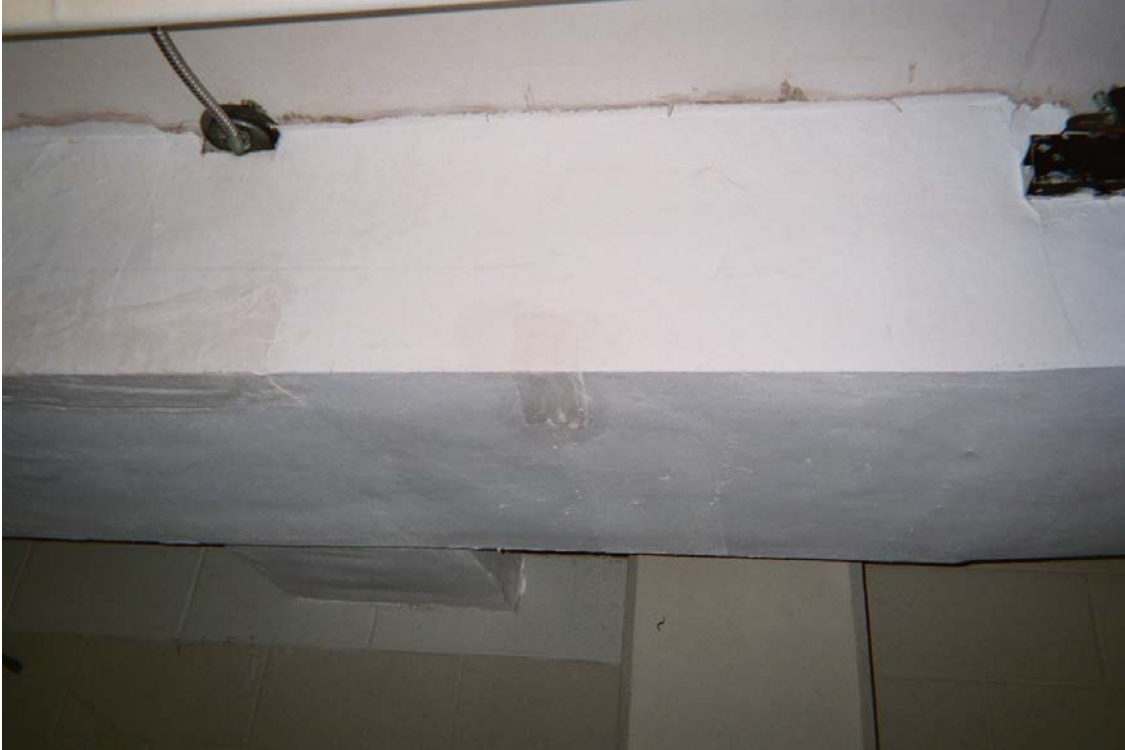
Asbestos-containing duct wrap insulation

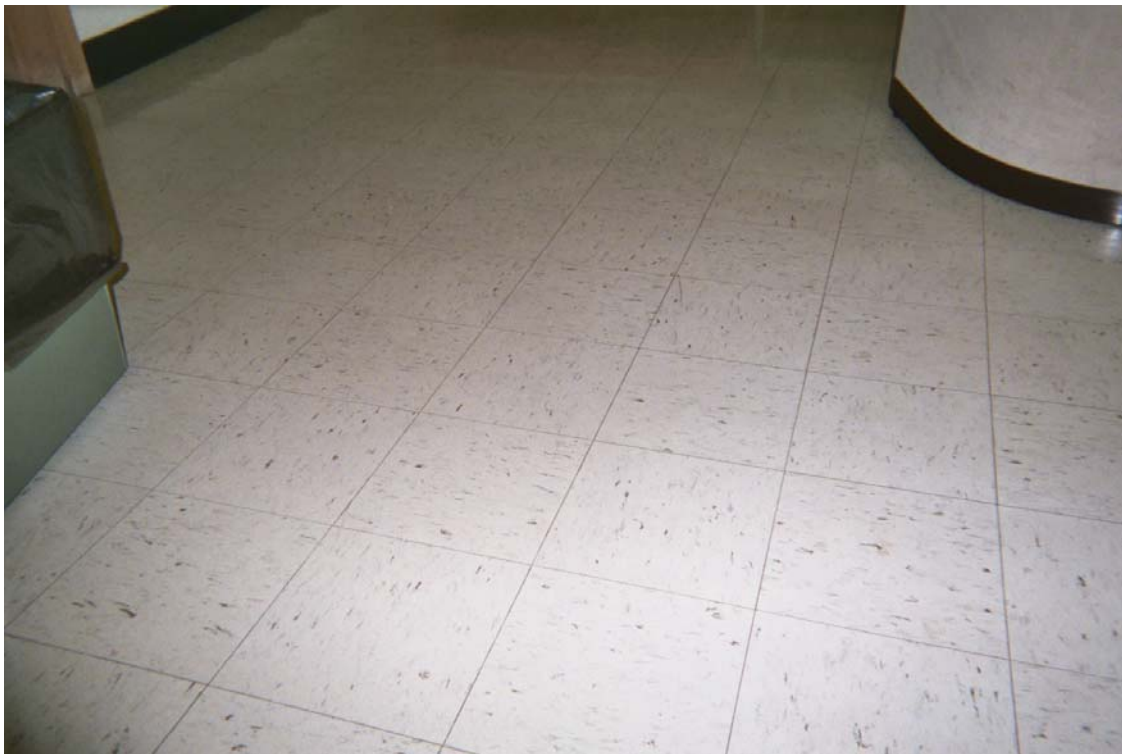
Asbestos-containing 9" x 9" white floor tile
with gray streaks and associated mastic

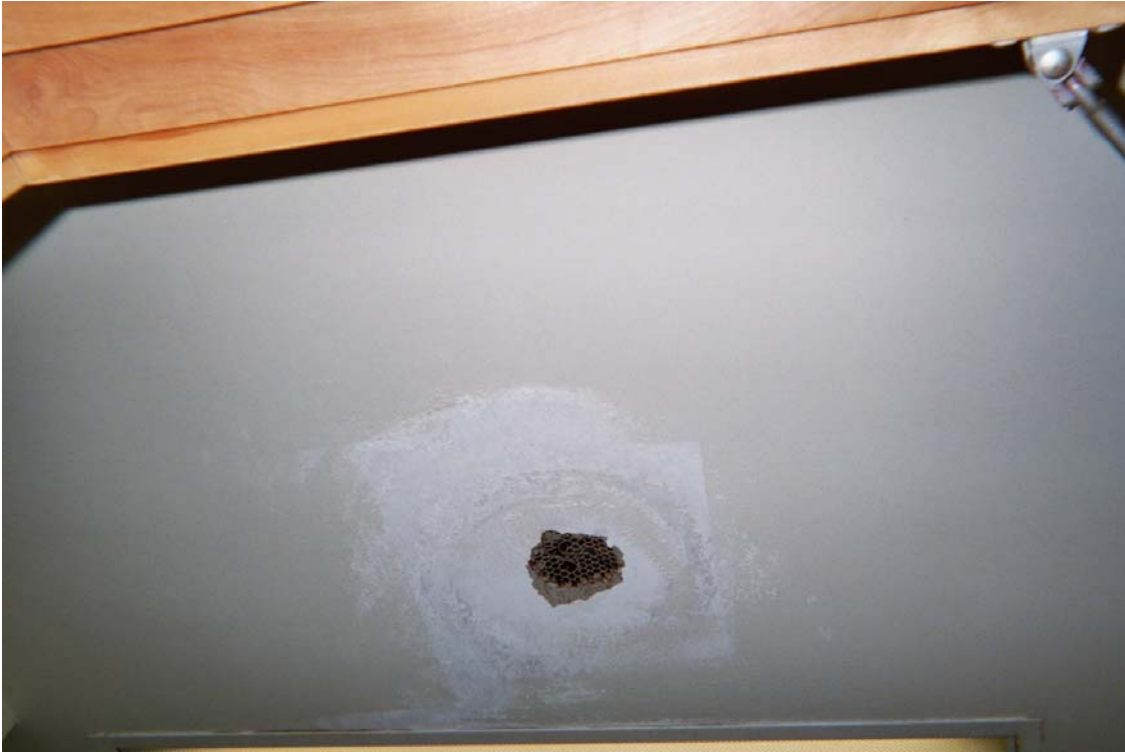
Non asbestos-containing plaster

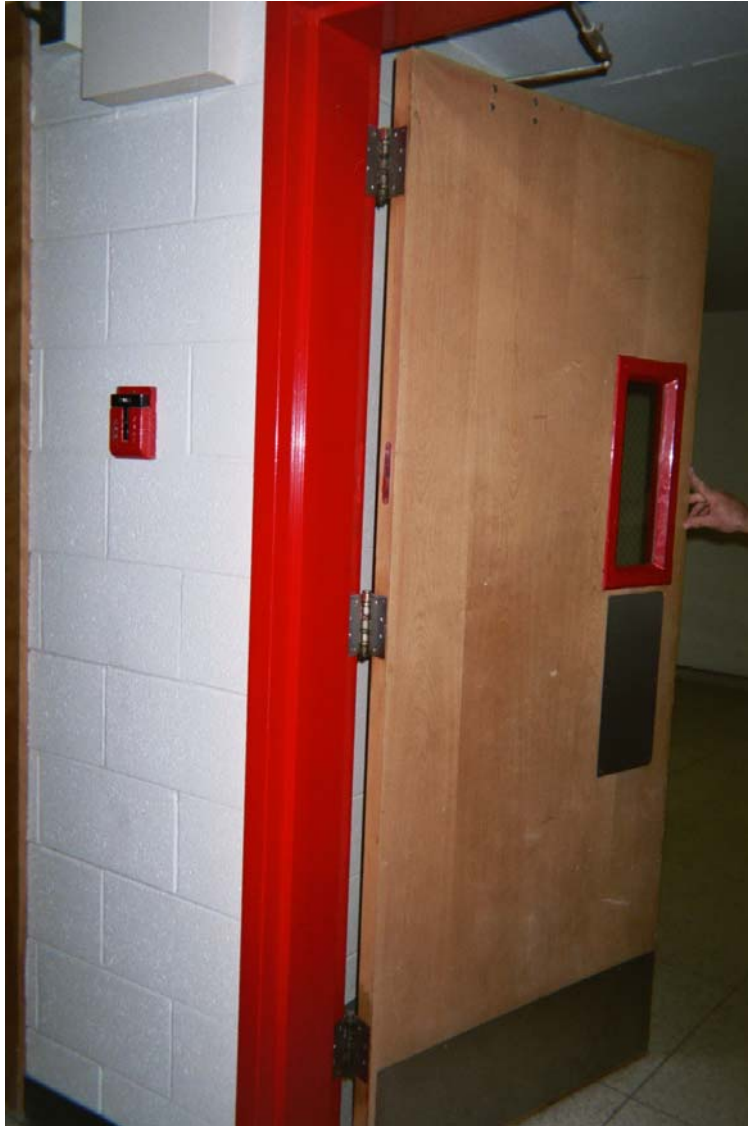
Assumed asbestos-containing fire door and frame

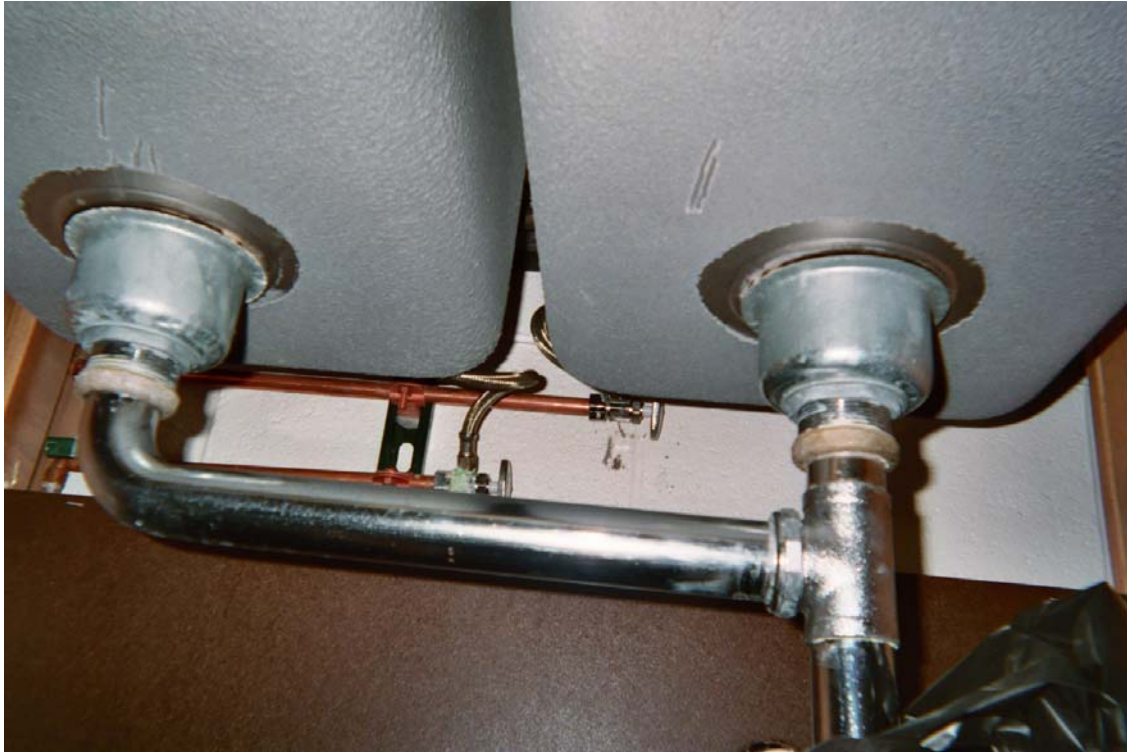
Non asbestos-containing gray sink undercoating

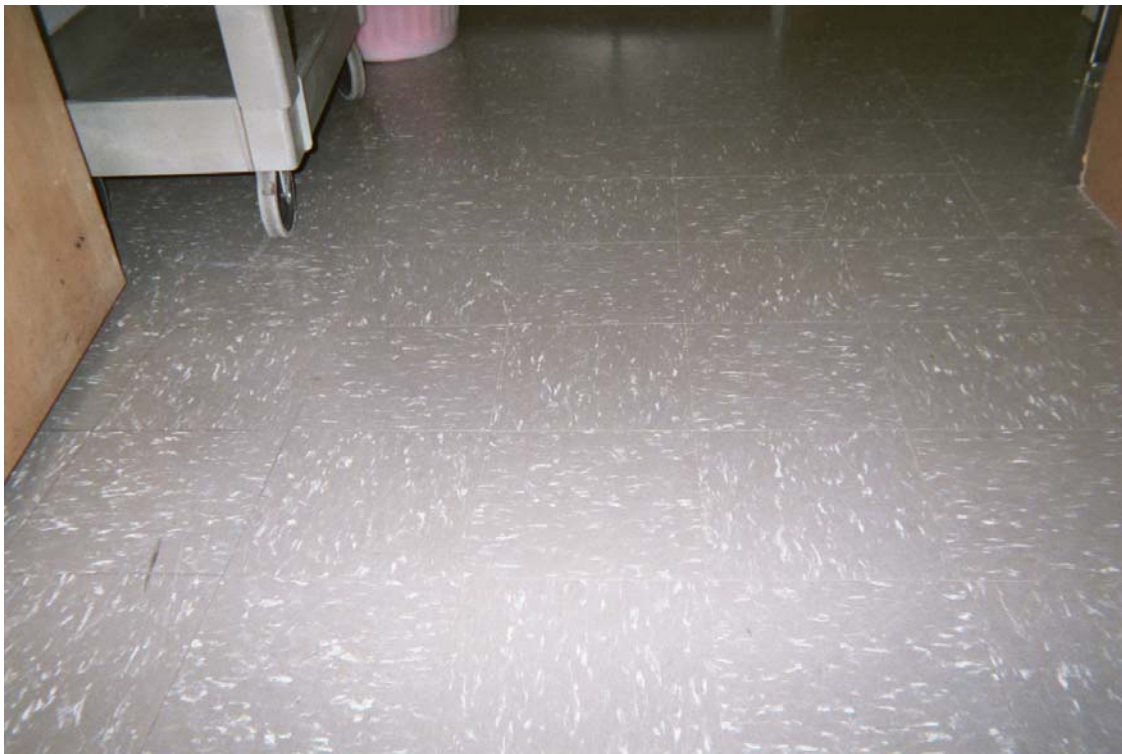
Asbestos-containing 9" x 9" gray floor tile
with white streaks and associated mastic

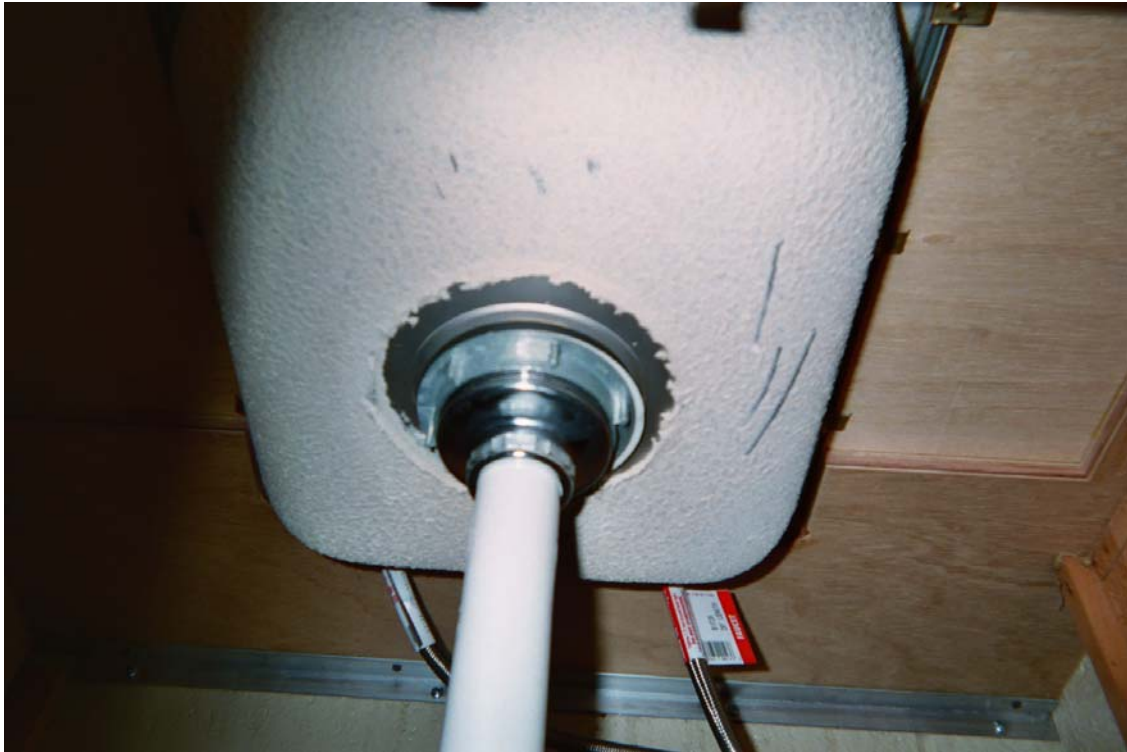
Non asbestos-containing white sink undercoating

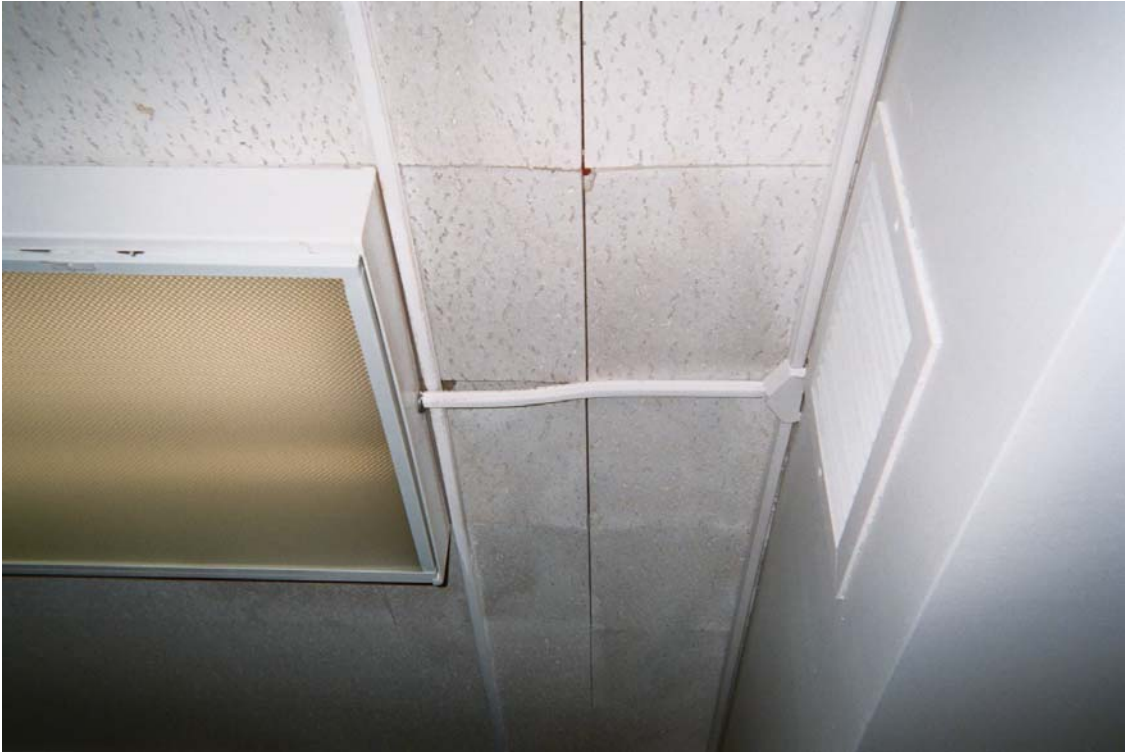
Non asbestos-containing 12" x 12" white ceiling tile with pin holes and fissures and associated glue pods

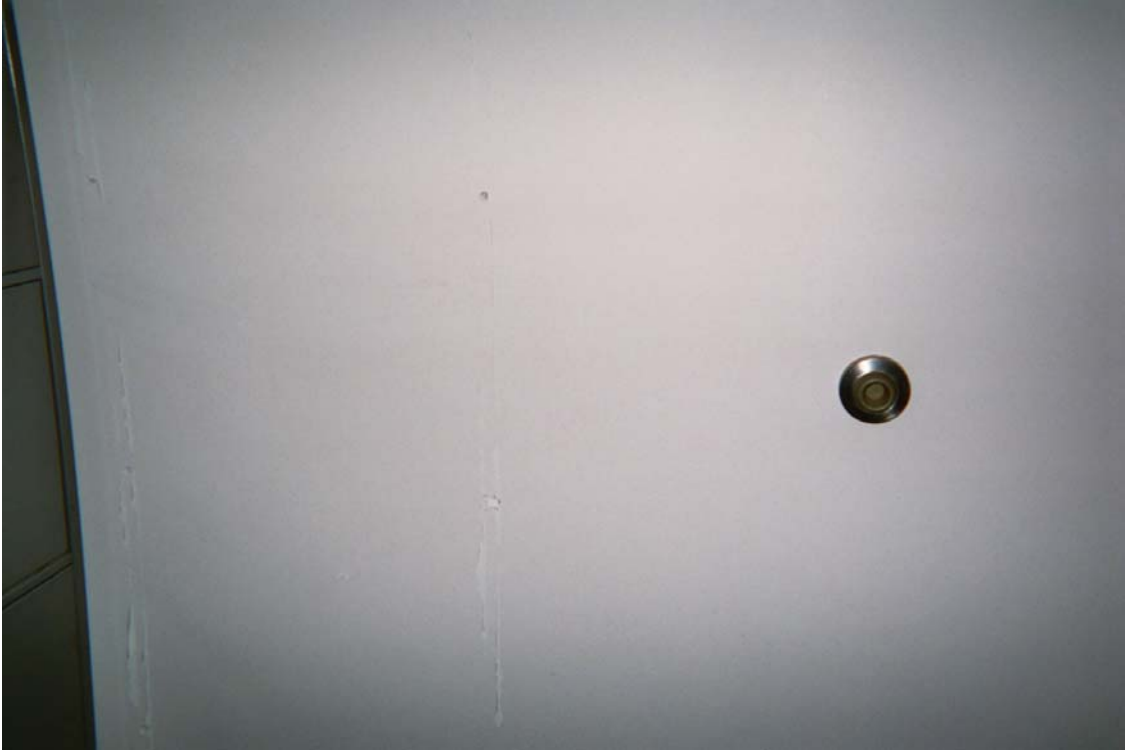
Non asbestos-containing drywall and drywall joint compound

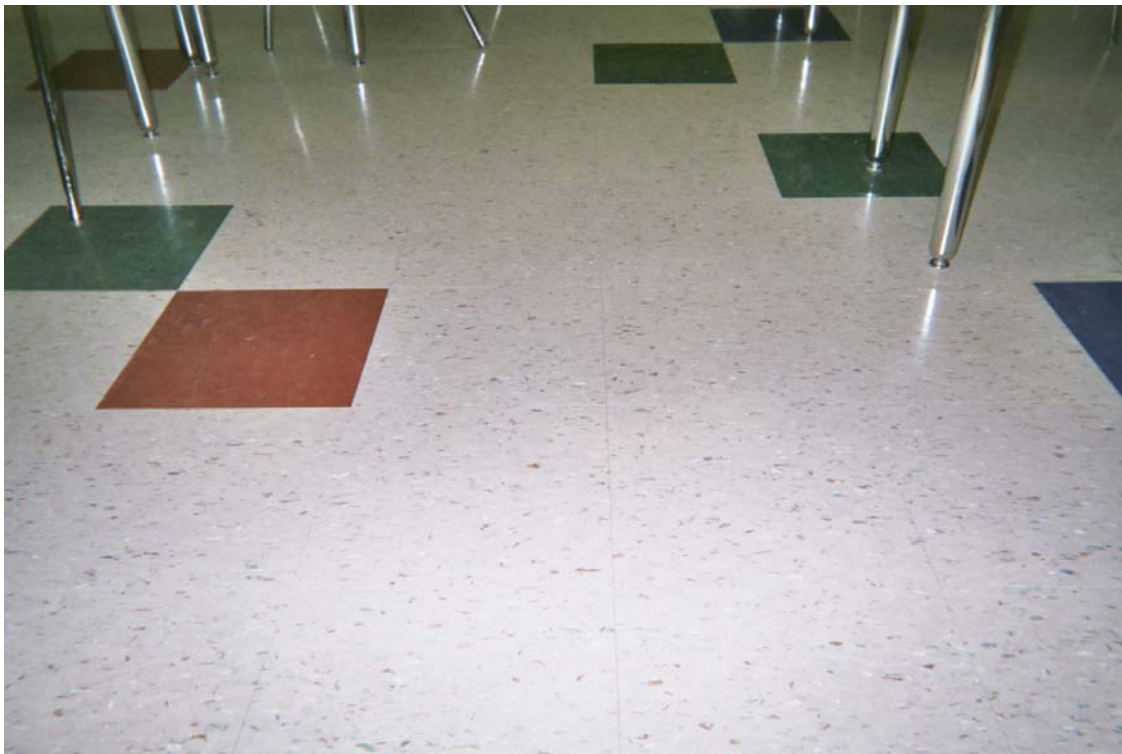
Non asbestos-containing 12" x 12' tan floor tile
with multi-colored specks and associated mastic

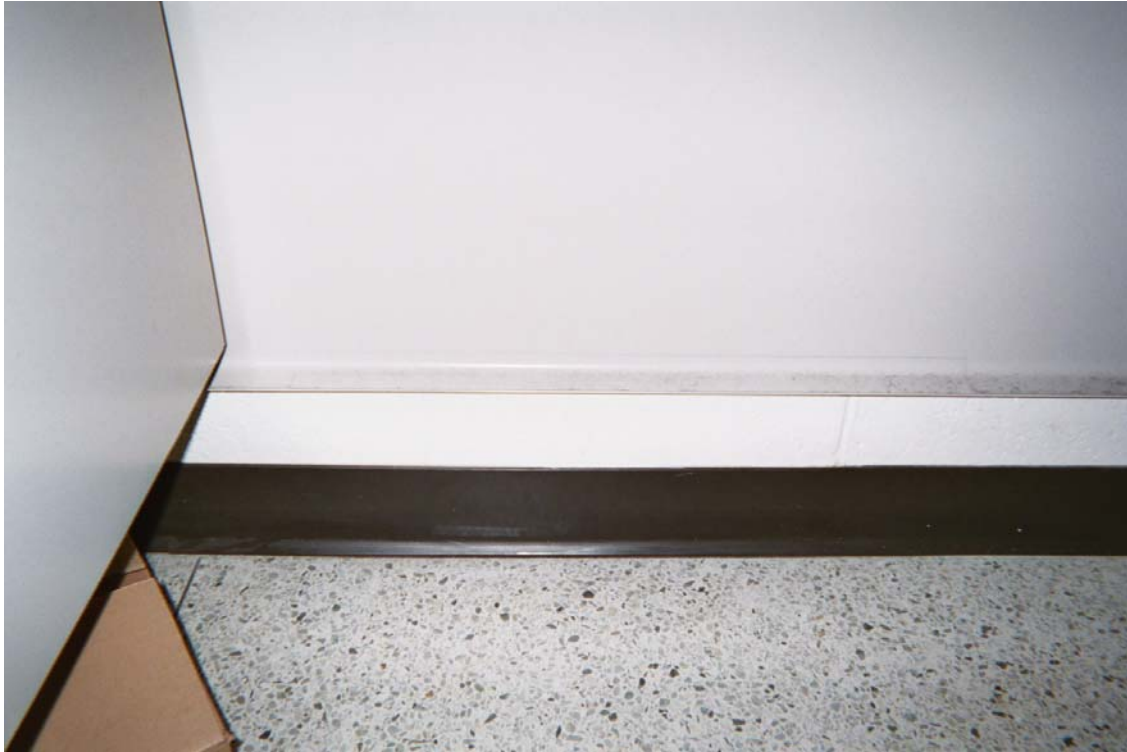
Non asbestos-containing 4" brown cove molding and associated mastic

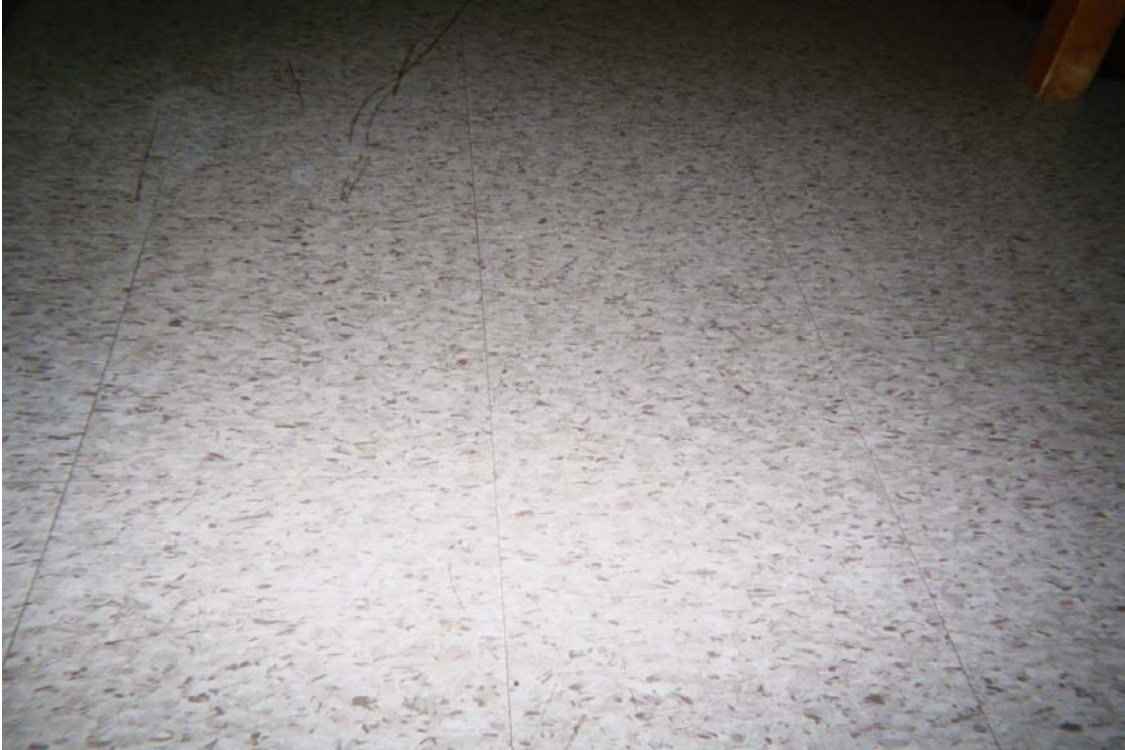
Non asbestos-containing 12" x 12" tan and brown marble floor tile and associated mastic

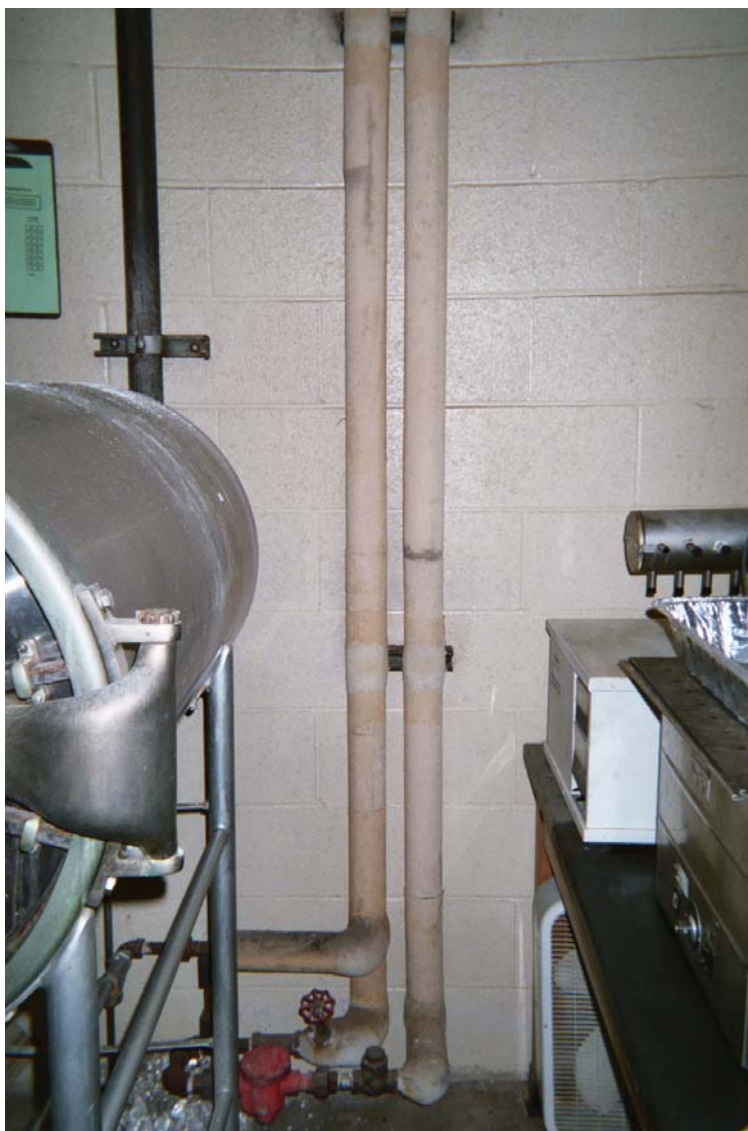
Asbestos-containing steam/condensate pipe straight insulation

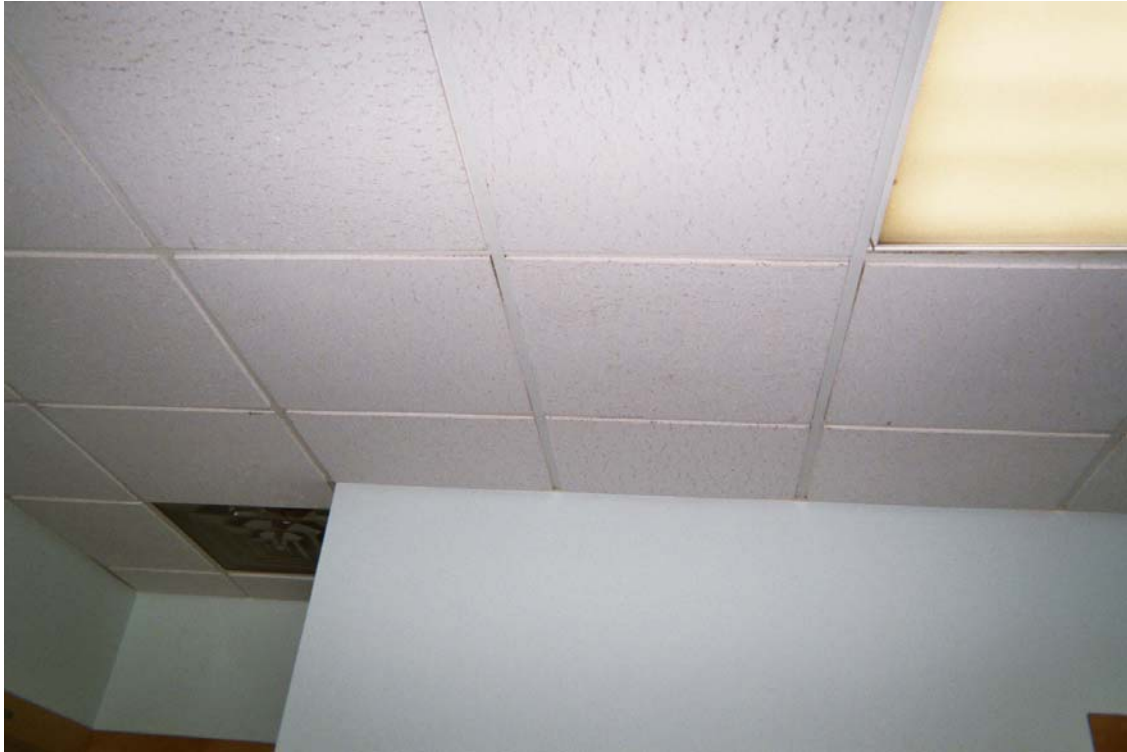
Non asbestos-containing 2' x 2' white drop-in ceiling tile with rough texture

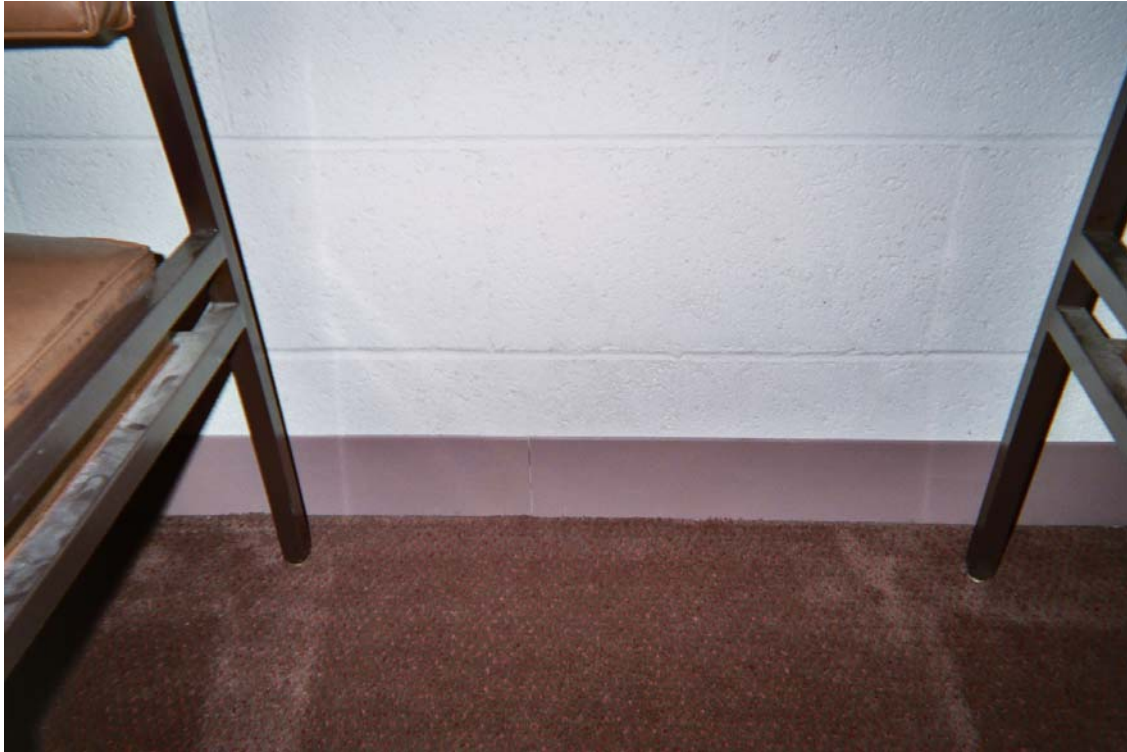
Non asbestos-containing 4" mauve cove molding and associated mastic

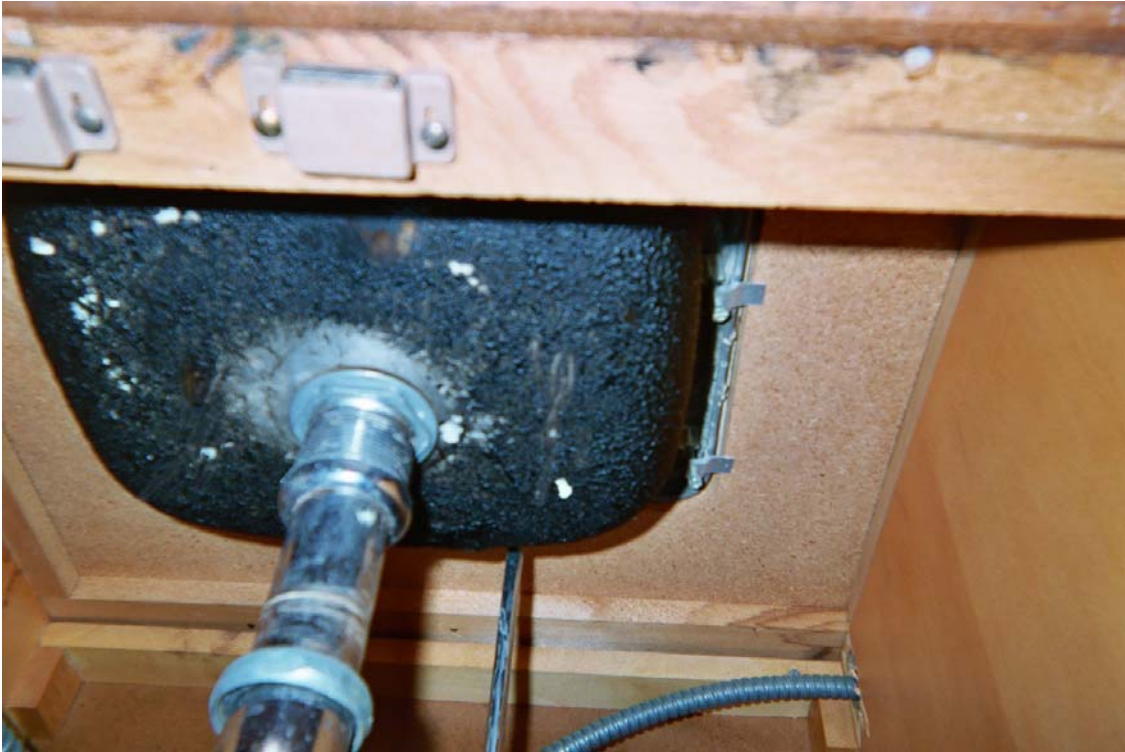
Asbestos-containing black sink undercoating

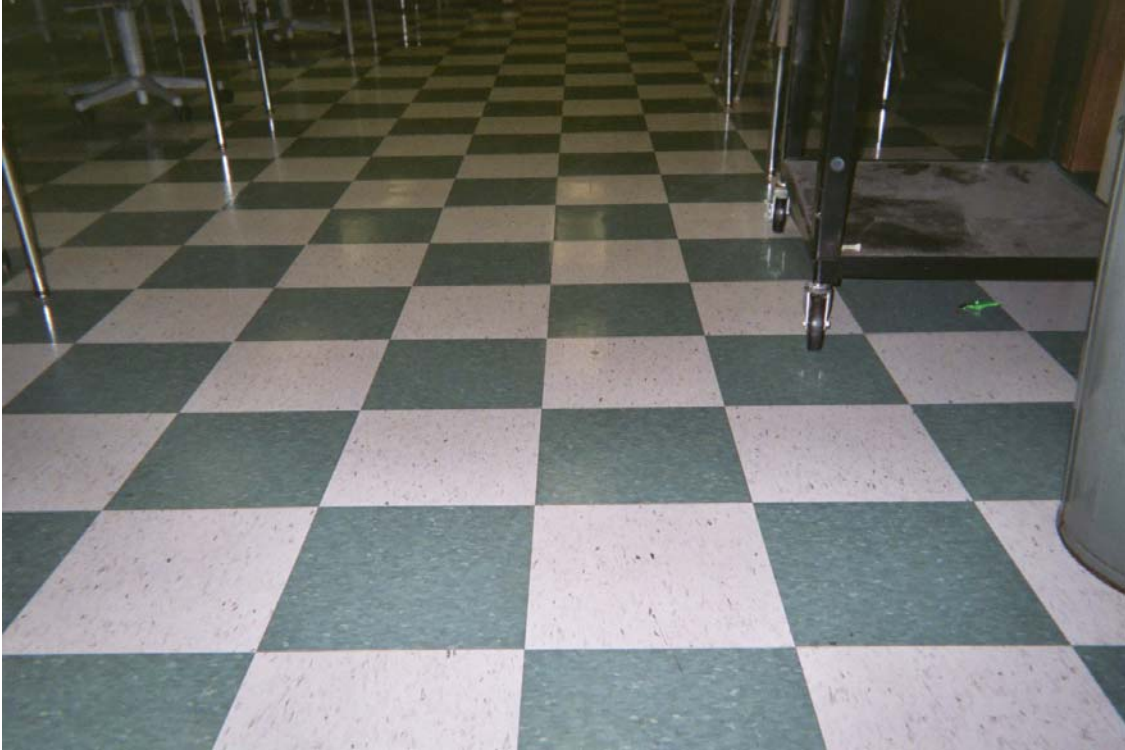
Non asbestos-containing 12" x 12" dark green
marble pattern floor tile and associated mastic

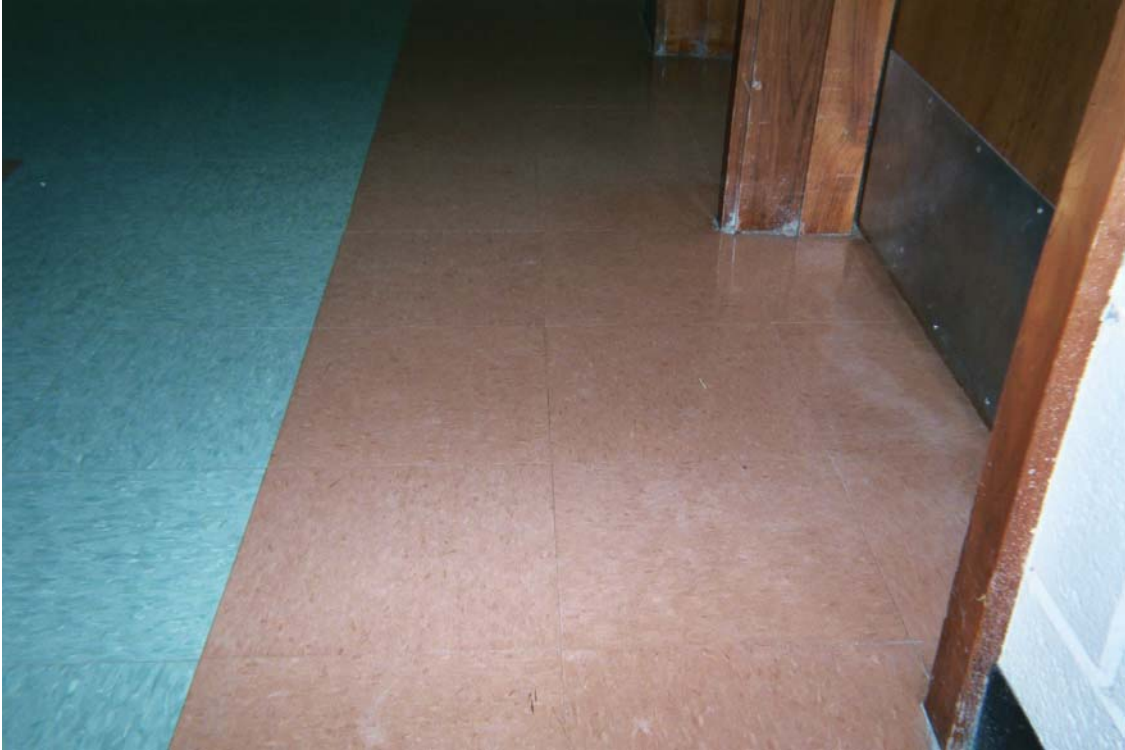
Non asbestos-containing 12" x 12" orange
marble pattern floor tile and associated mastic

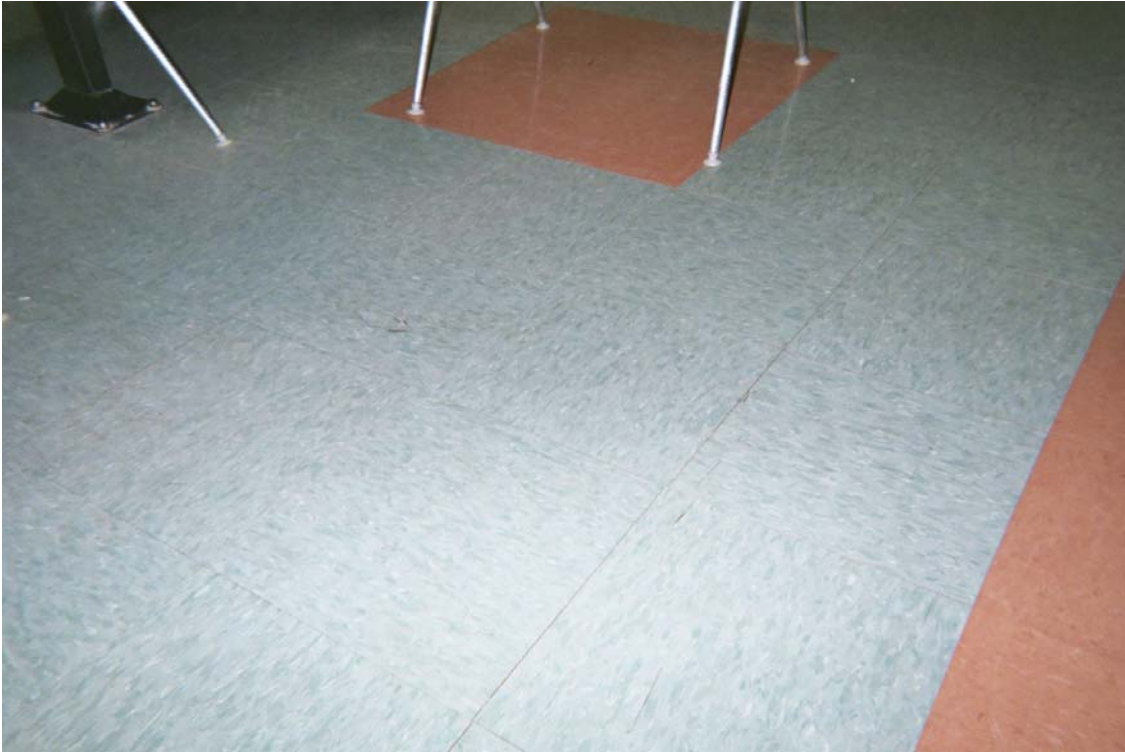
Non asbestos-containing 12" x 12" light green
marble pattern floor tile and associated mastic
