Natural Resources Photo Log

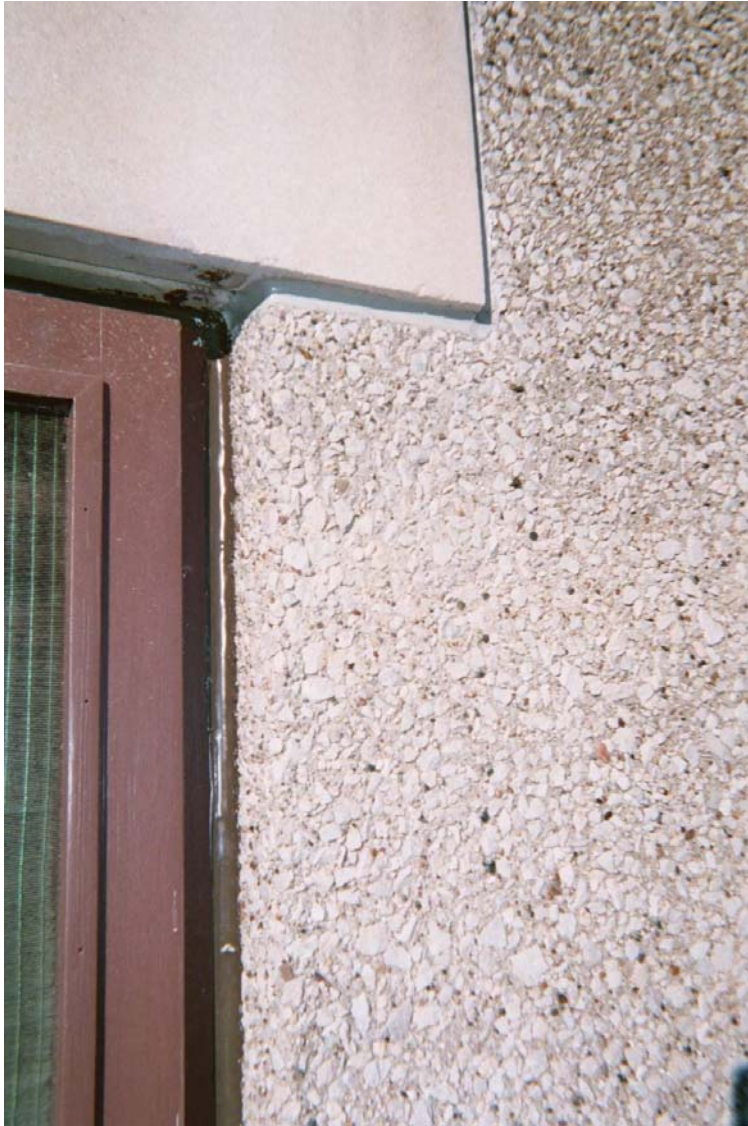
Assumed asbestos-containing gray exterior window and door frame caulk

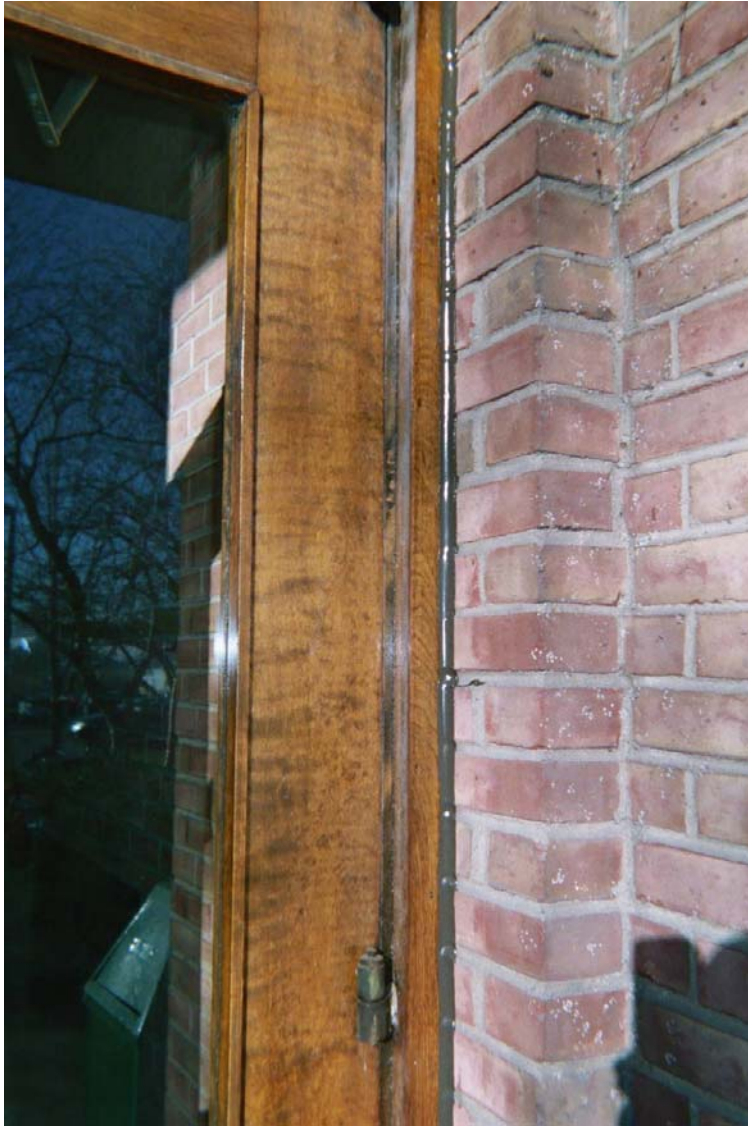
Assumed asbestos-containing gray exterior window and door frame caulk
