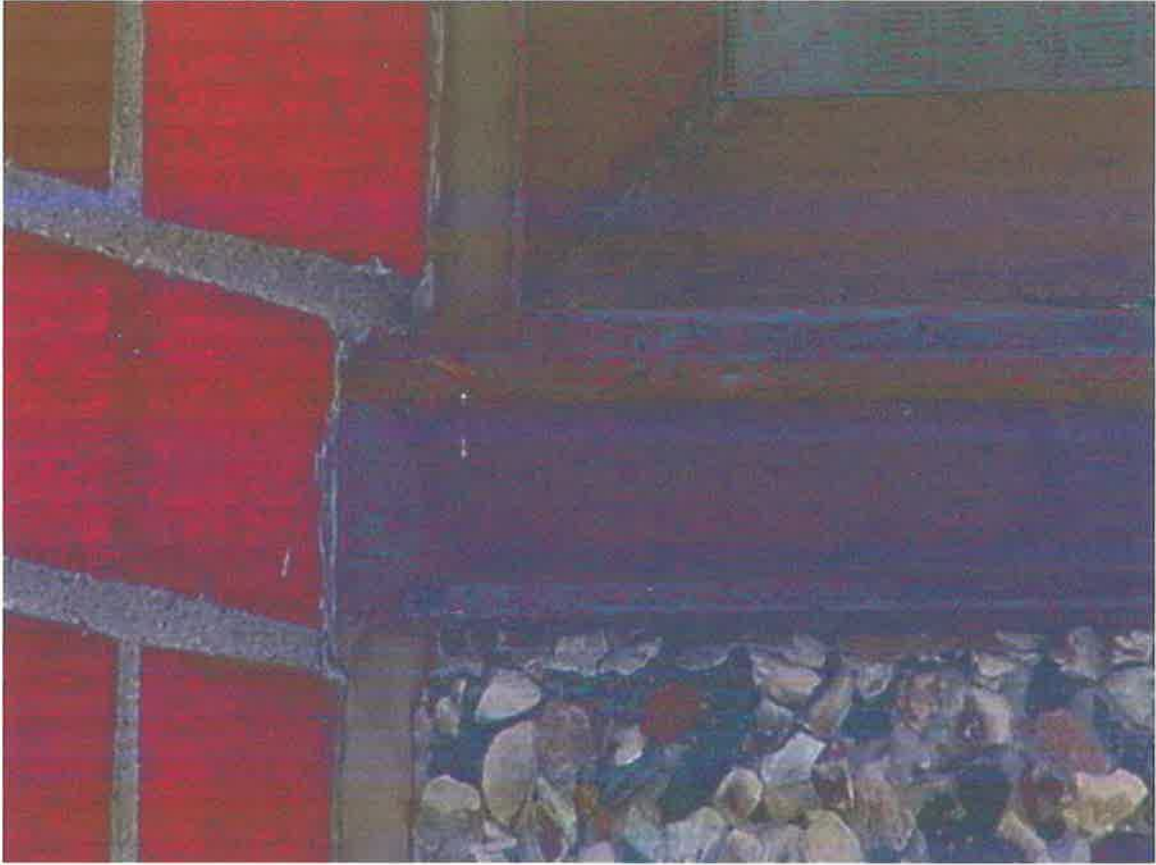
Photo 28 – Window caulk (outside), east side of building

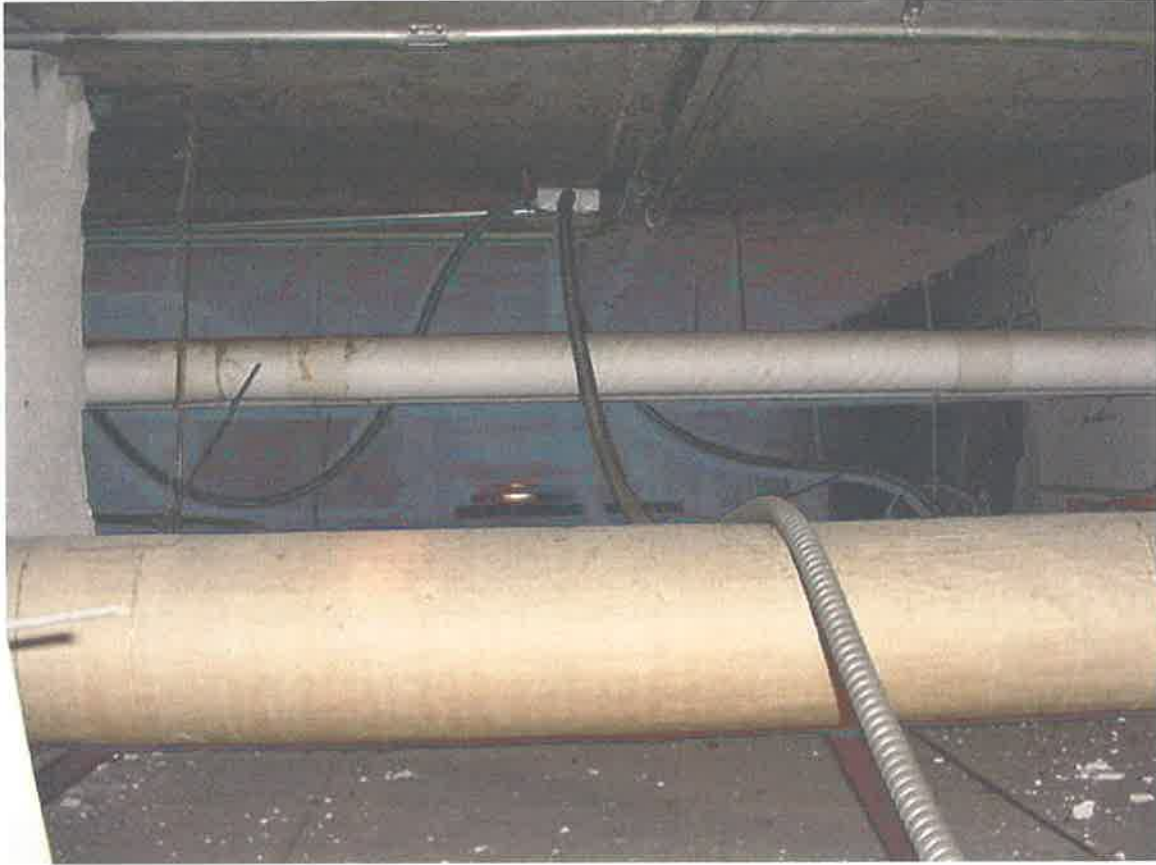
Photo 30 – 5th floor, ceiling plenum access area,
facing east from southwest corner

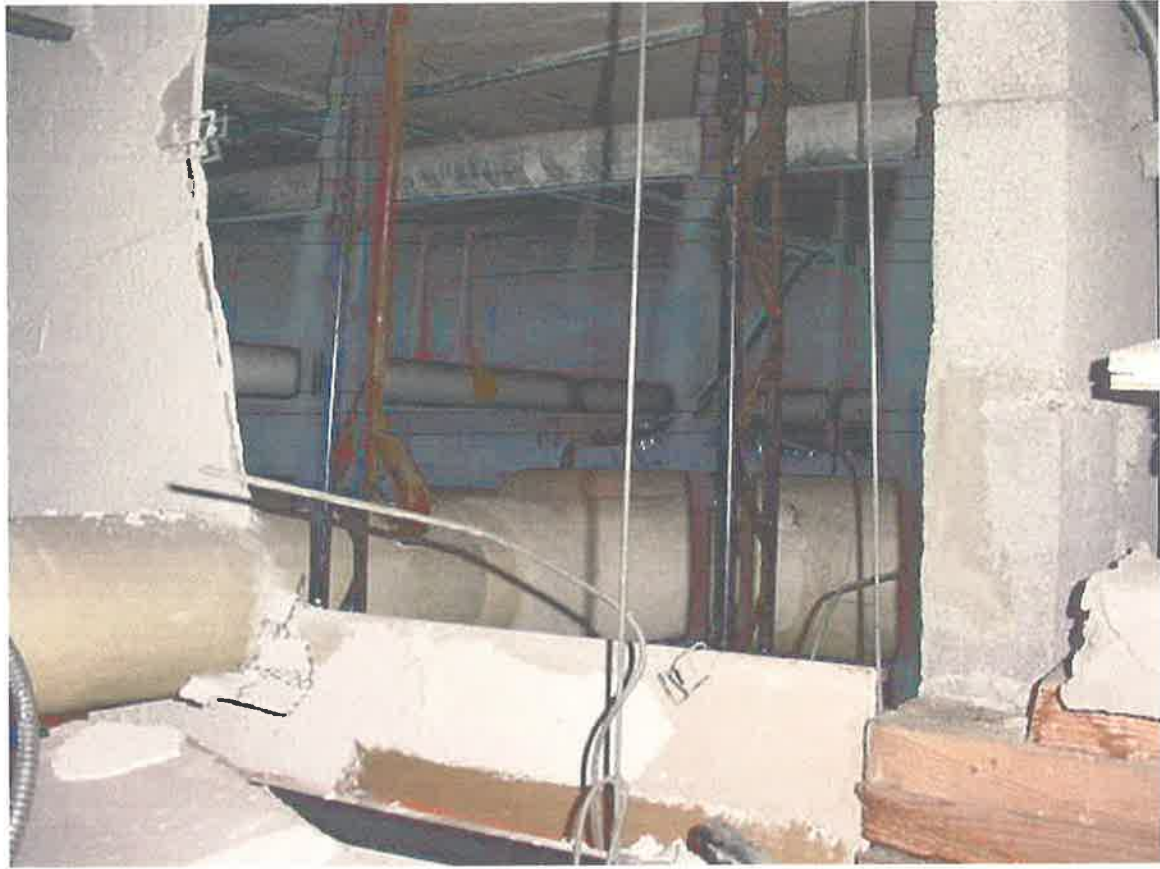
Photo 31 – Fire protection ceiling board in 5th floor ceiling access area

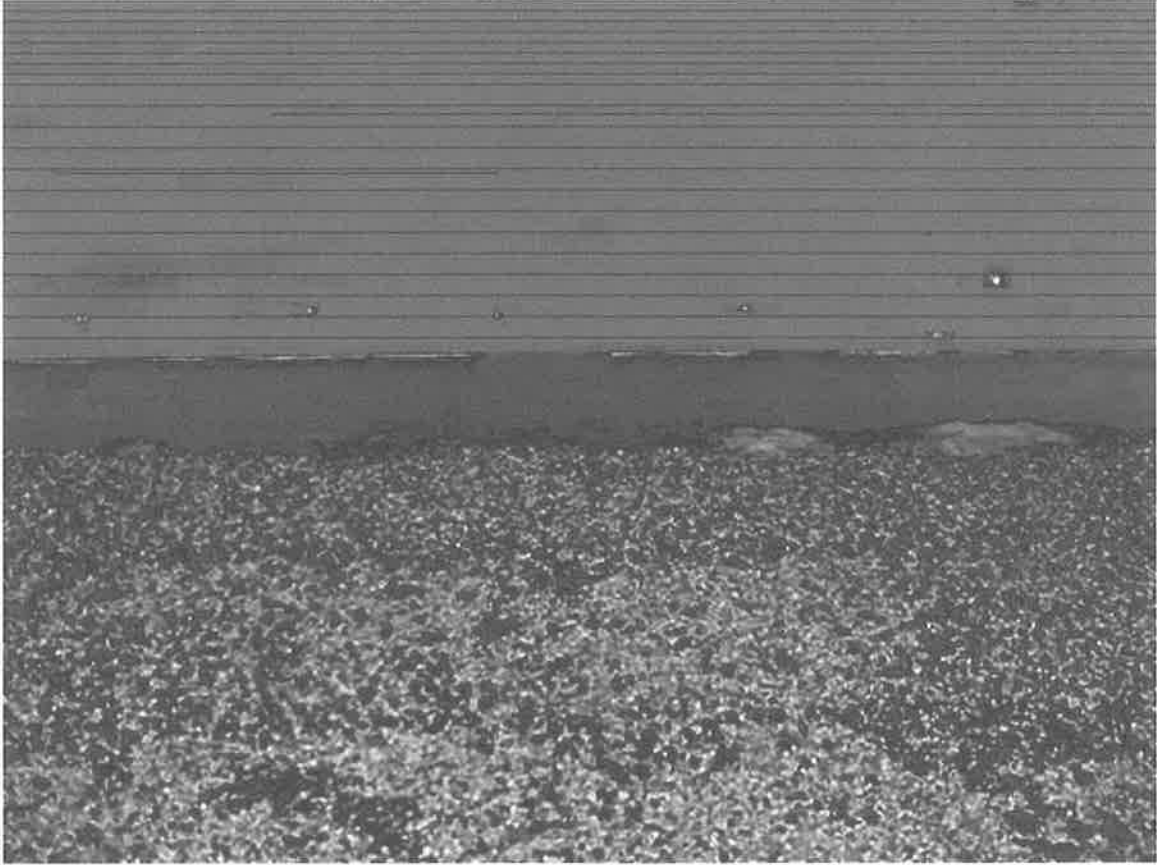
Photo 32 – Roof flashing

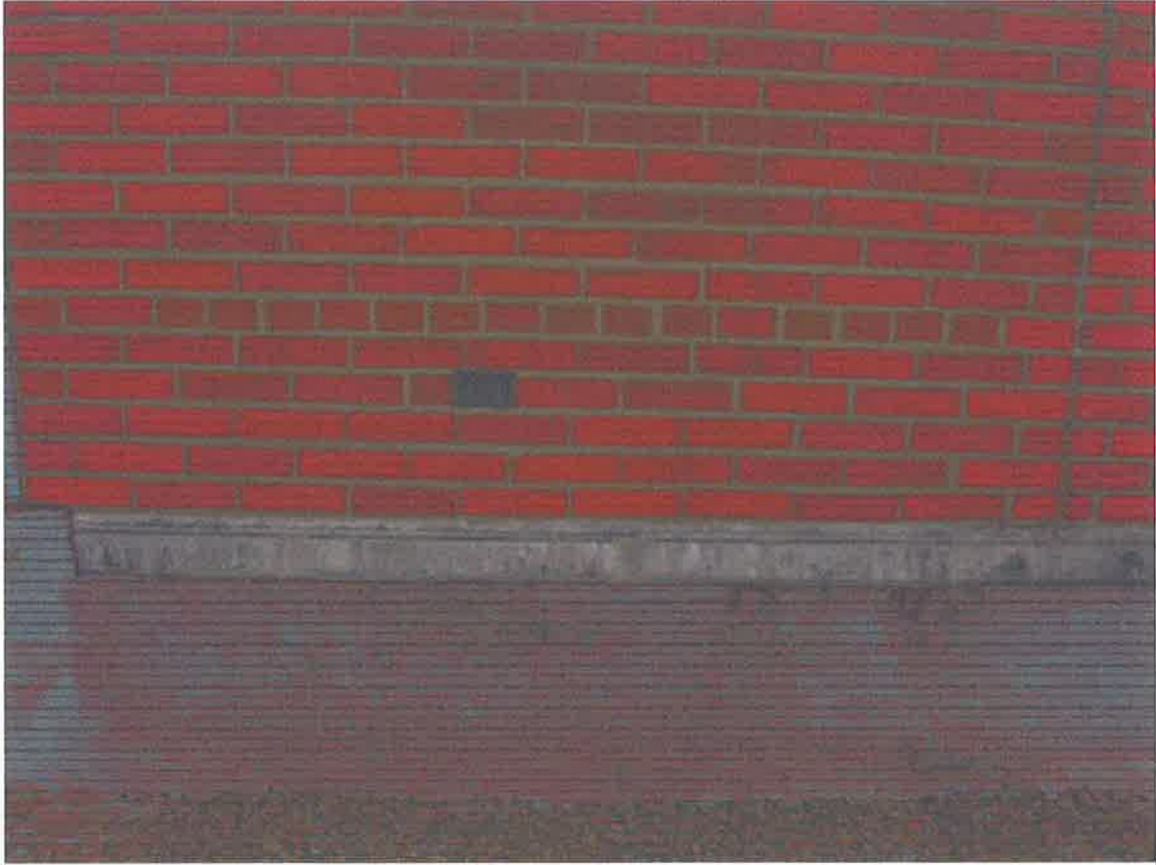
Photo 33 – Roof flashing

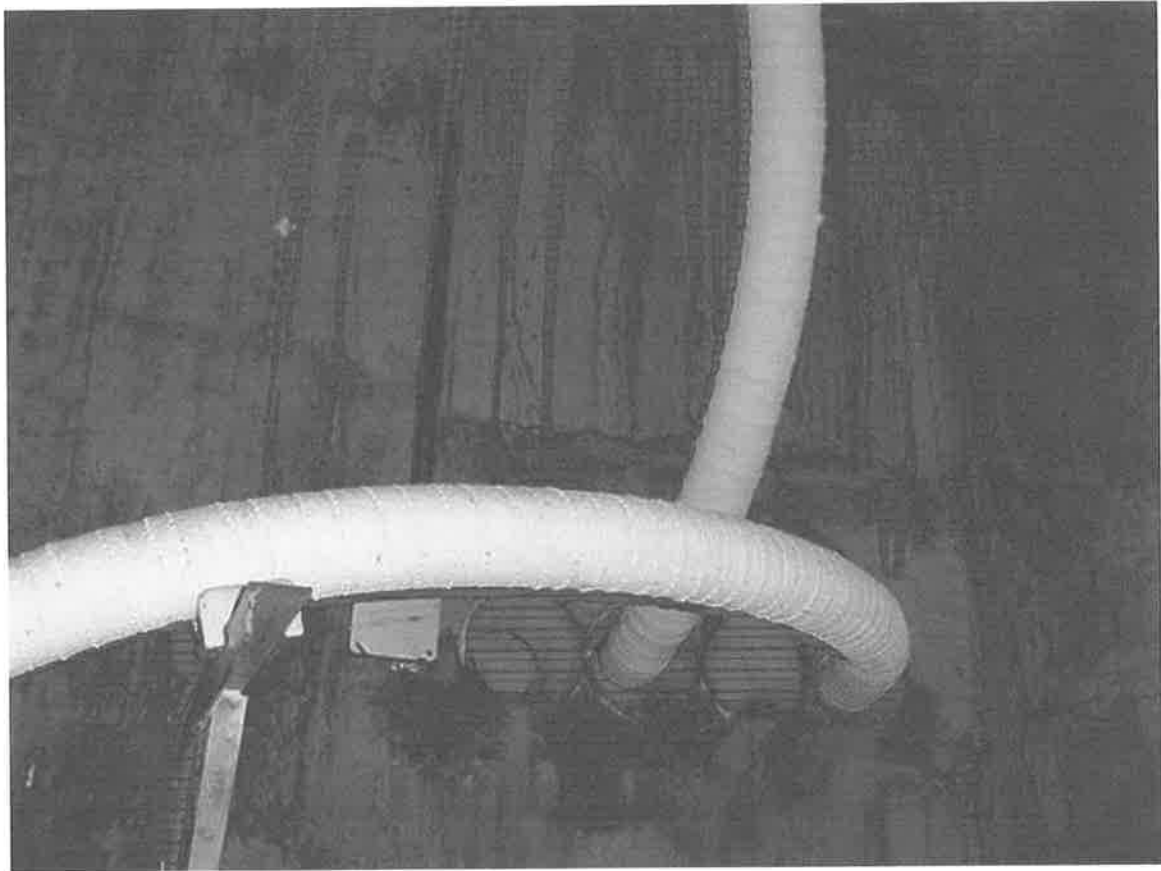
Photo 34 – Room 50A, electrical cable wrap

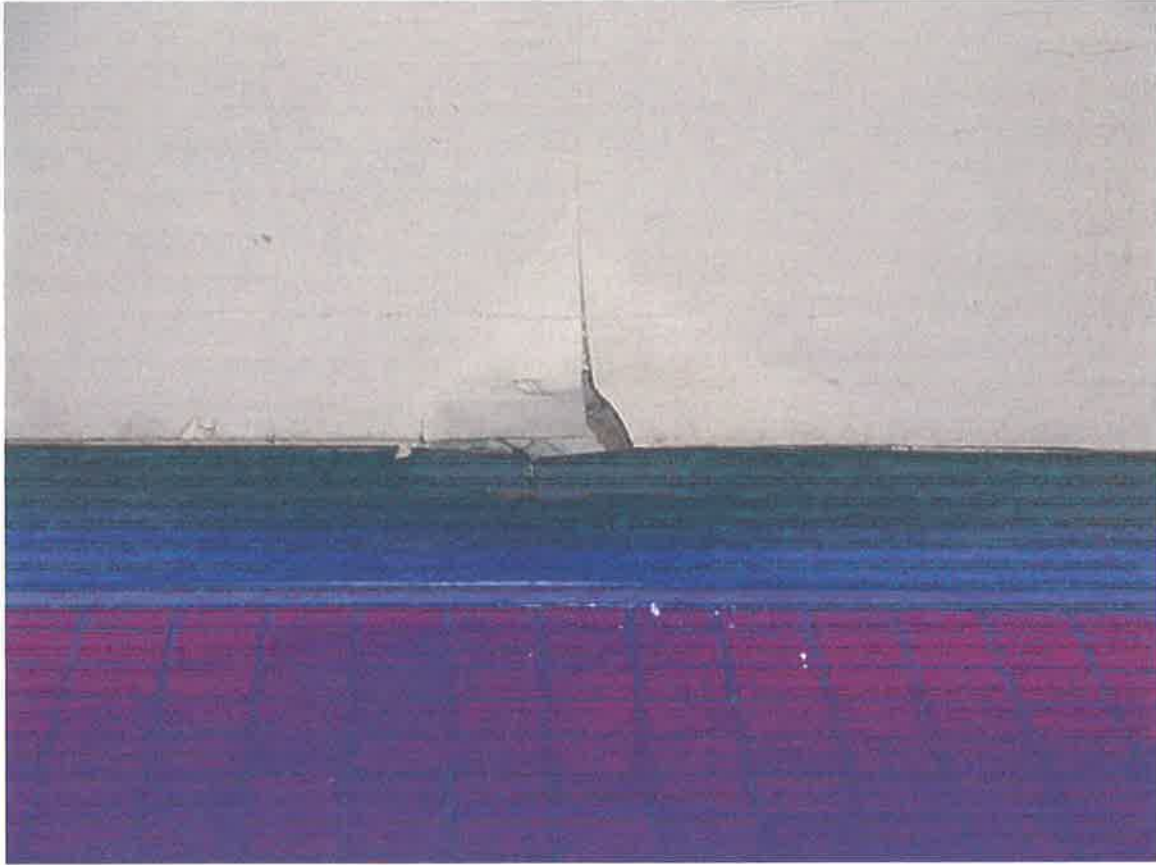
Photo 17 – Plaster, cove molding and vinyl wall covering, 1st floor, hallway, south wall, facing Room 153A

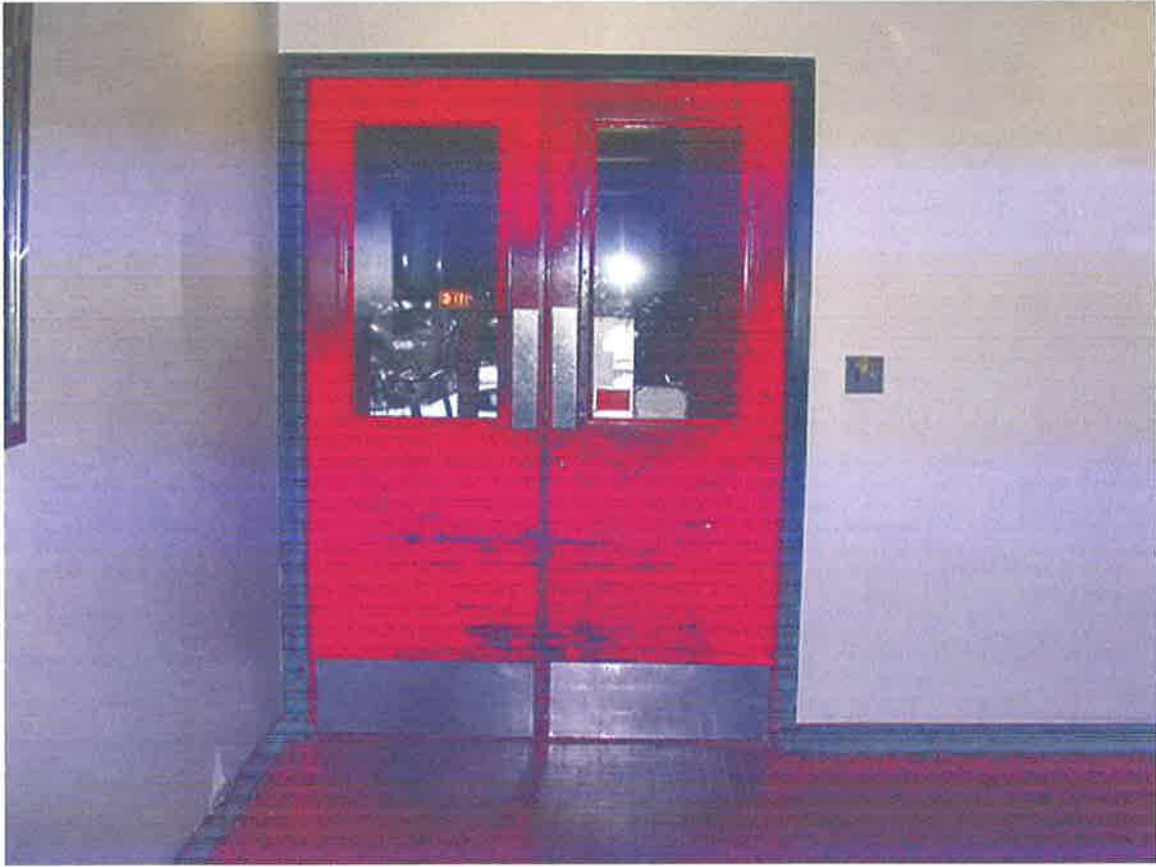
Photo 18 – Fire door, southwest landing to 1st floor entrance

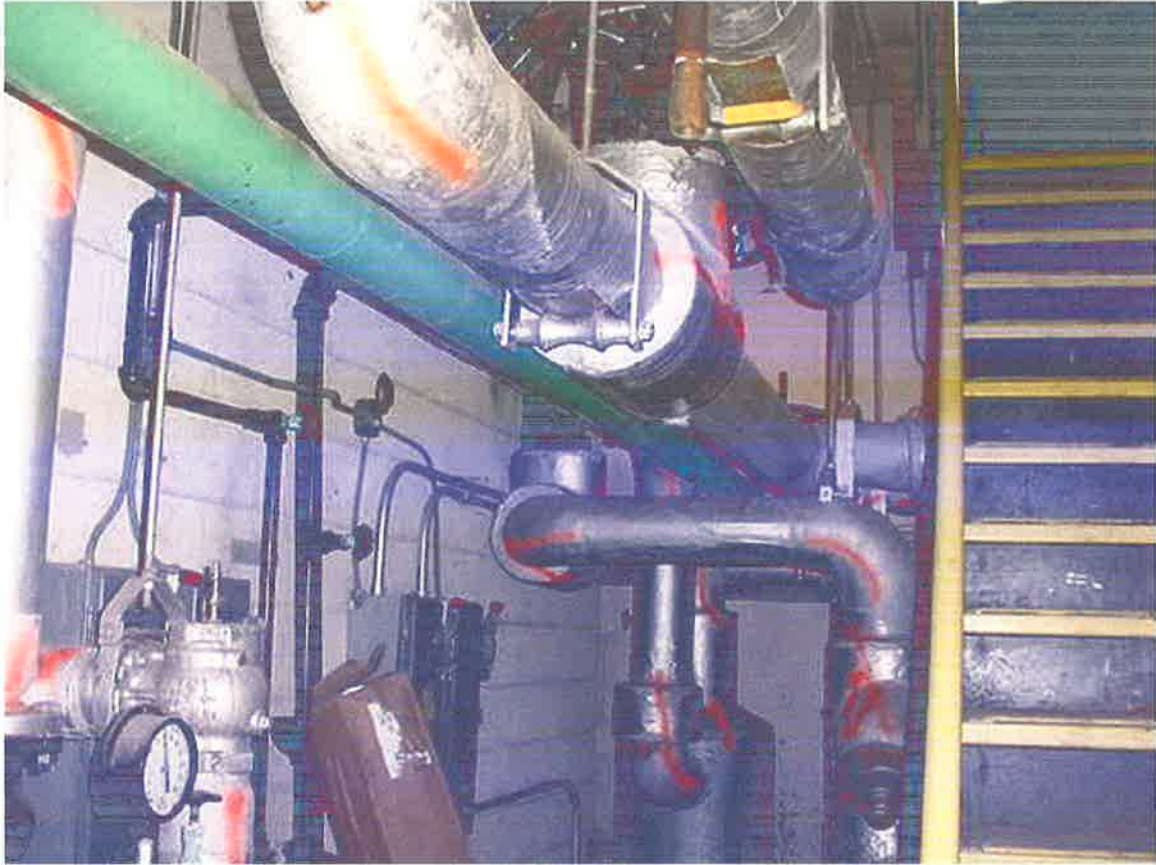
Photo 19 – Mechanical Room 50, silver treated pipe joint insulation

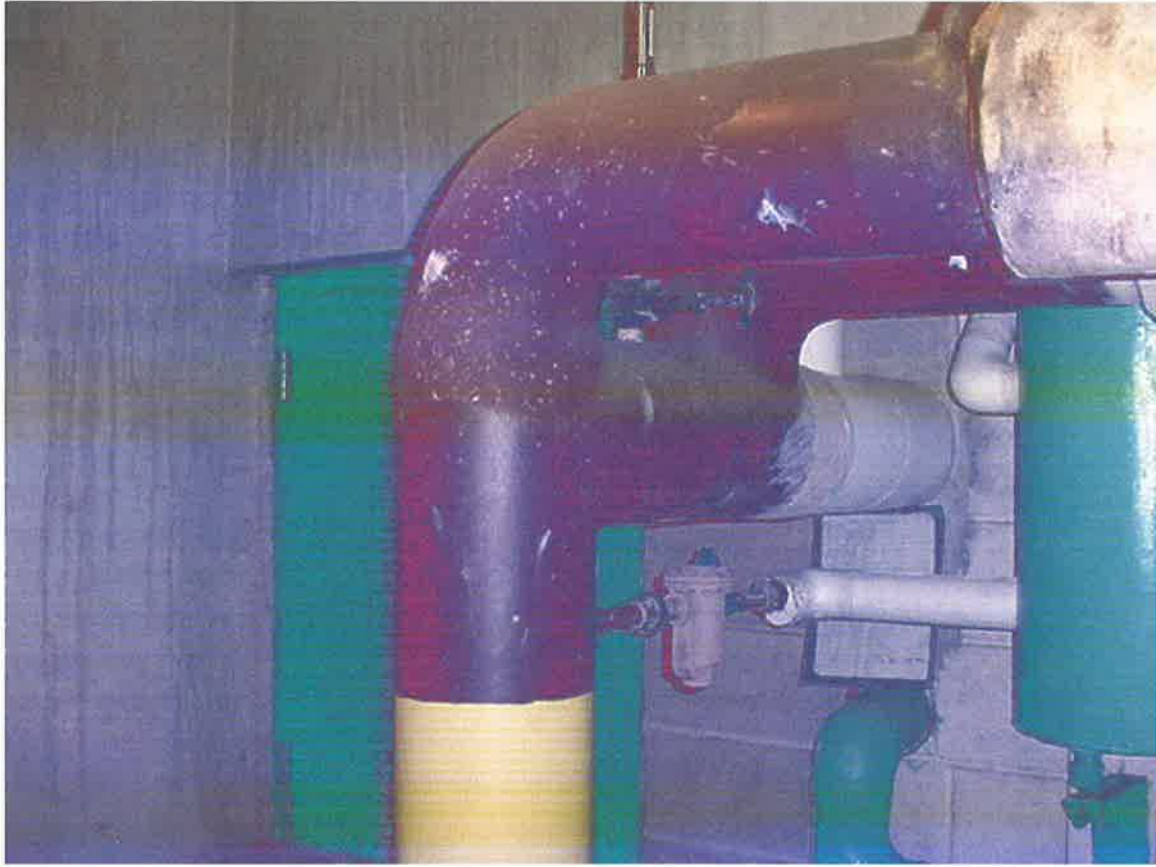
Photo 20 – Mechanical room 50, maroon high pressure steam pipe straight insulation and pipe joint insulation, southwest of tunnel access

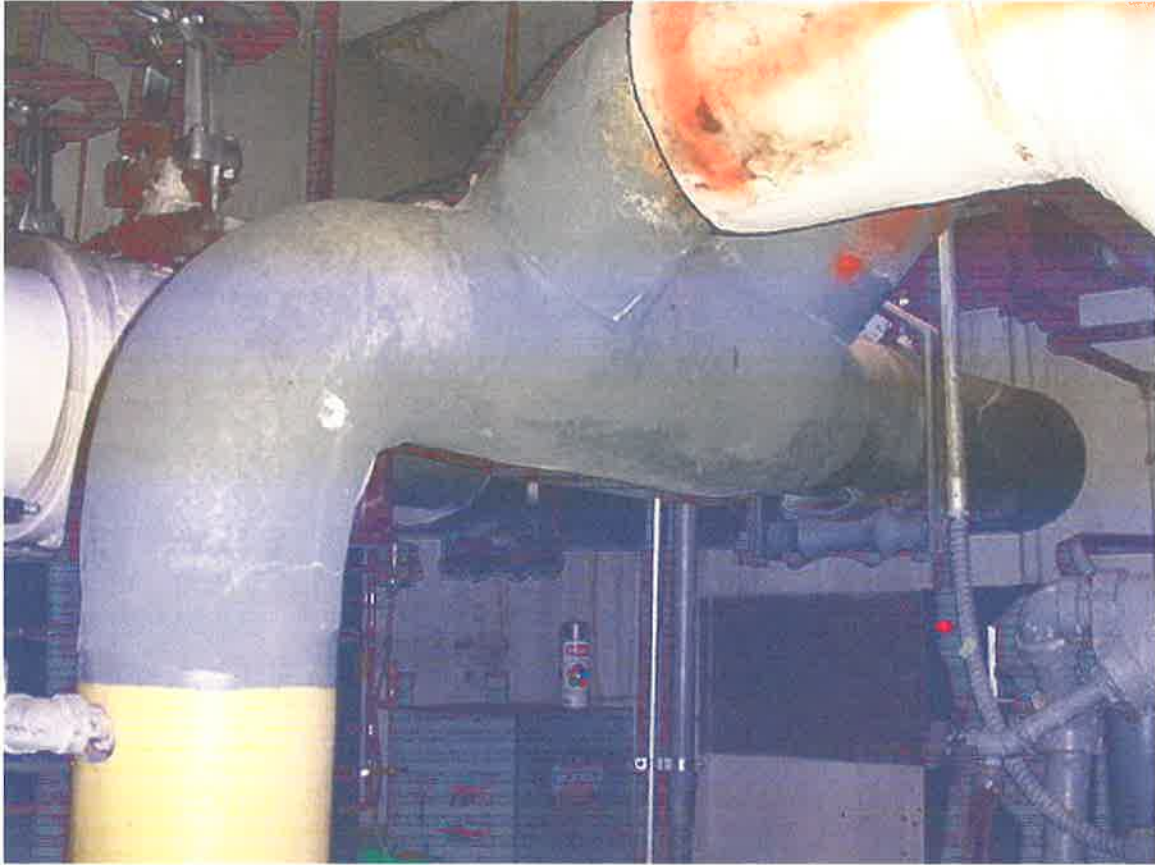
Photo 21 – Mechanical room 50, gray low pressure steam pipe joint insulation, southeast of condensate tank

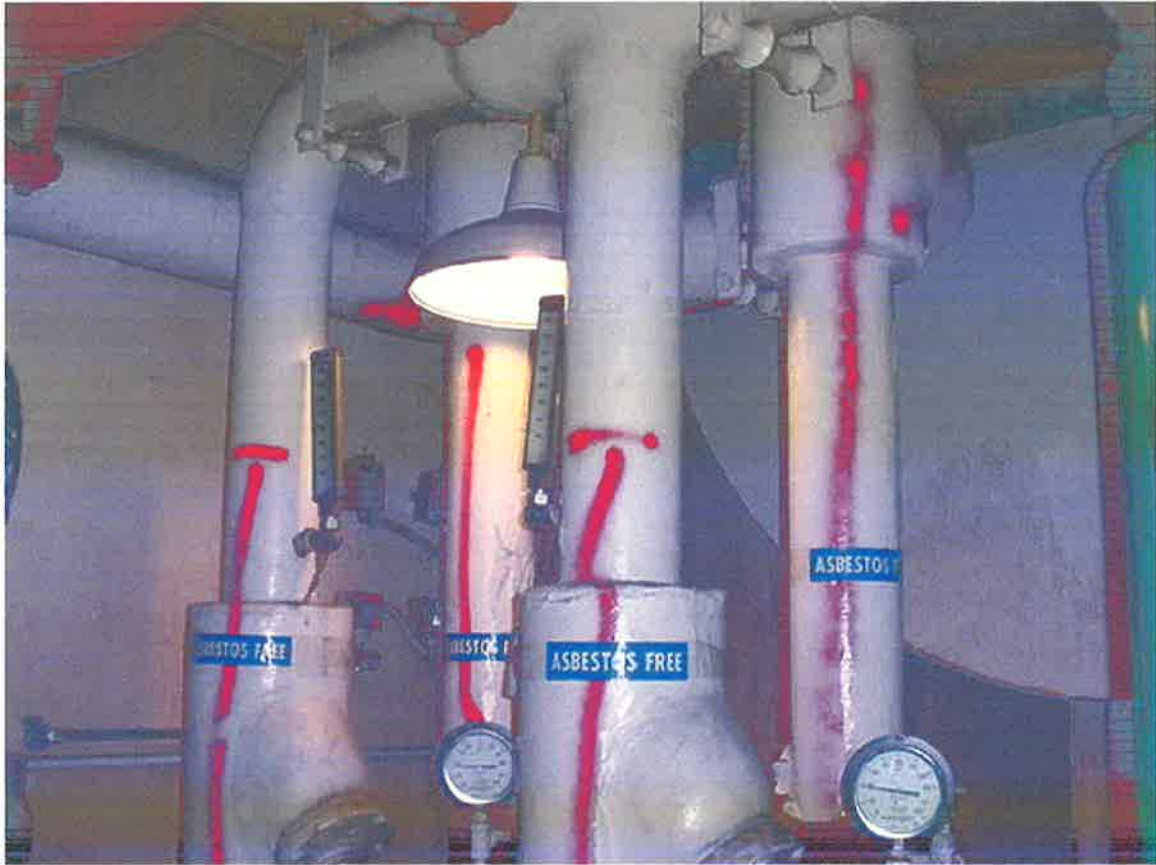
Photo 22 - Mechanical room 50, white chilled water pipe joint insulation, northeast of tunnel entrance

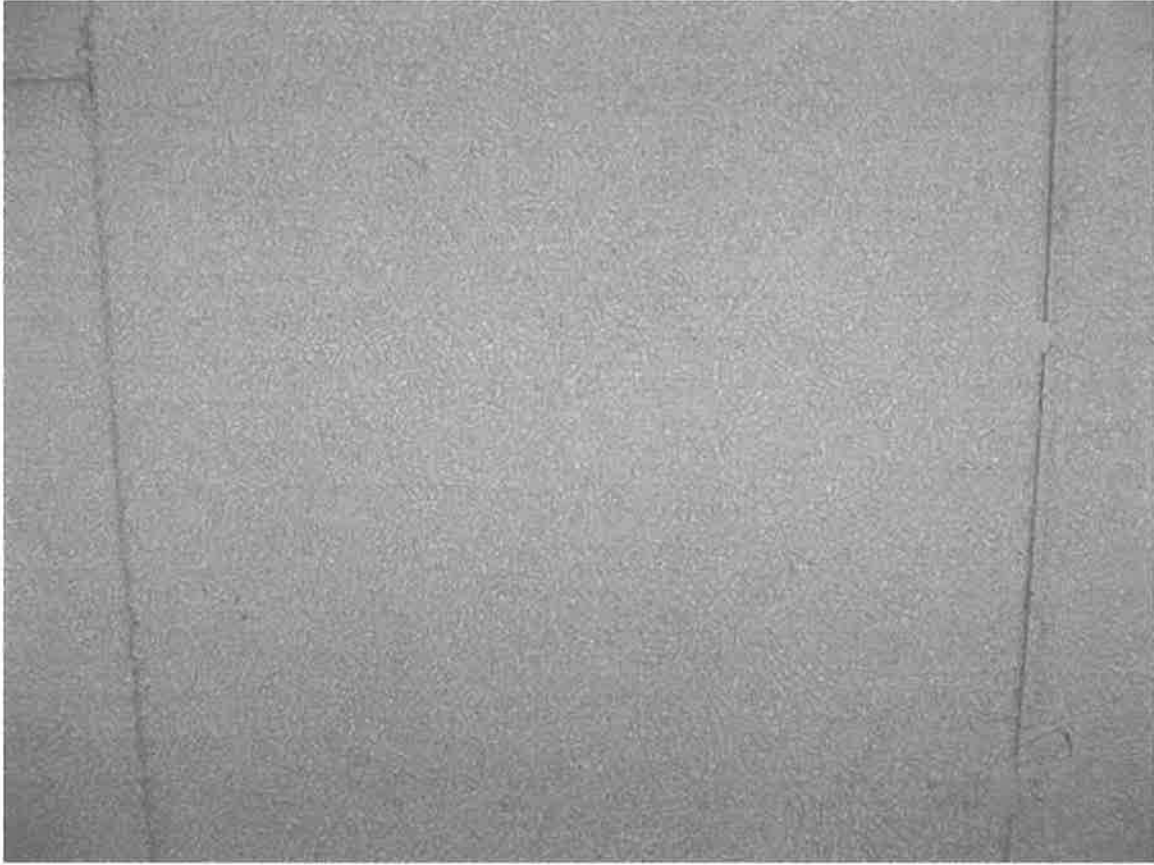
Photo 23 – Ceiling insulation (tectum board), Room 146

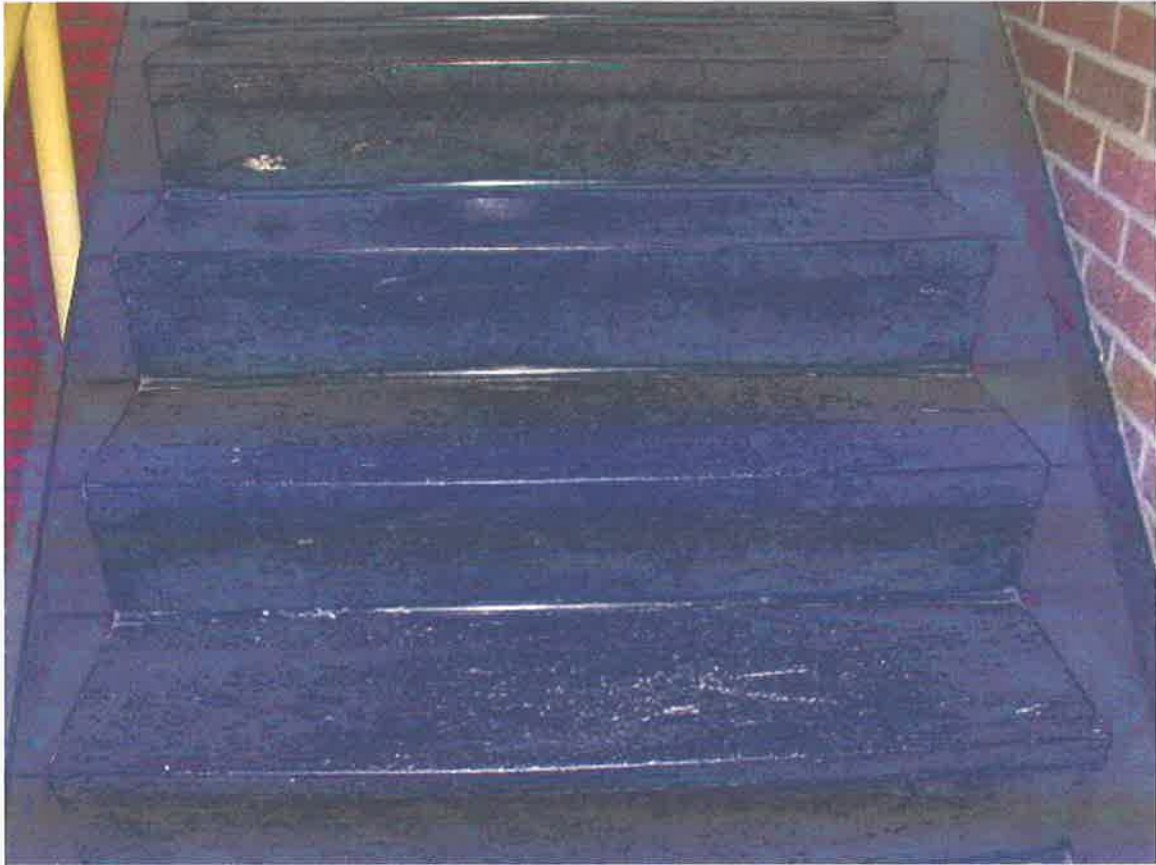
Photo 24 – Black vinyl stair tread with white streaks, southwest stairwell

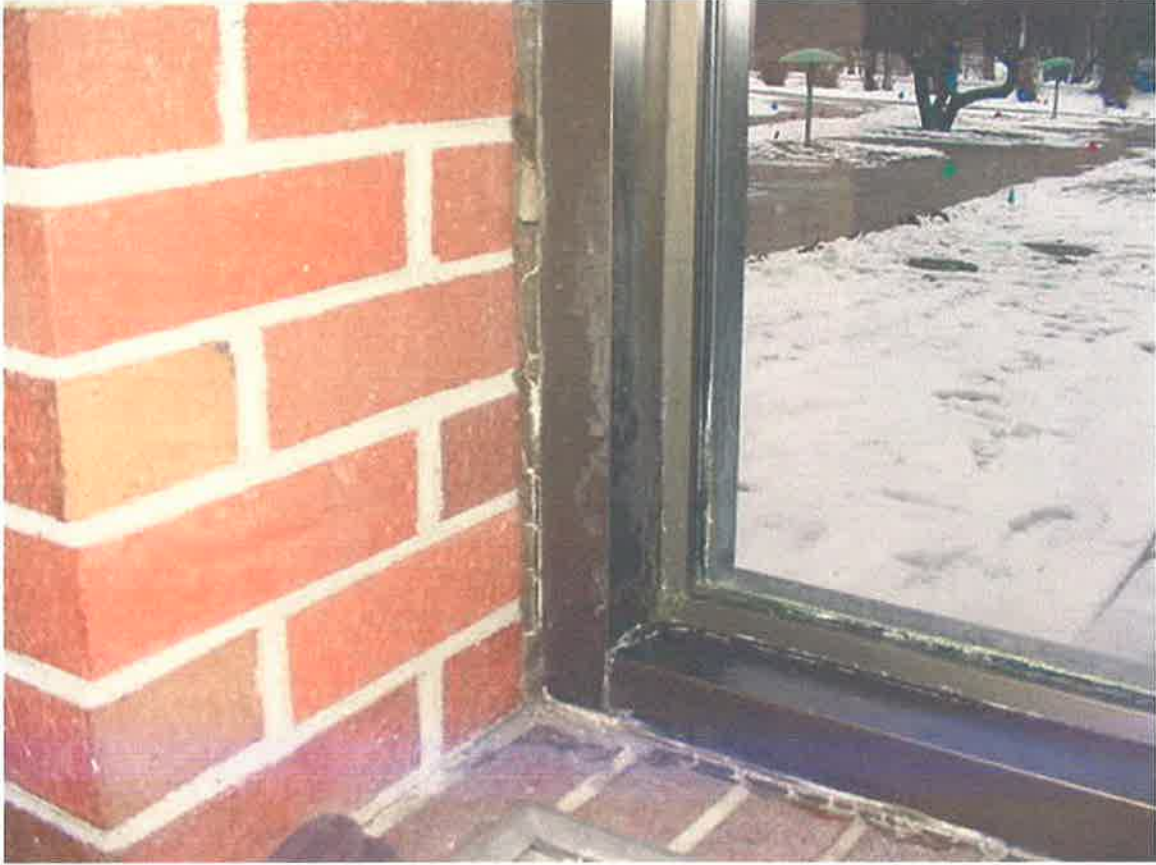
Photo 25 – Window caulk (inside),
northeast landing of 1st floor, facing south

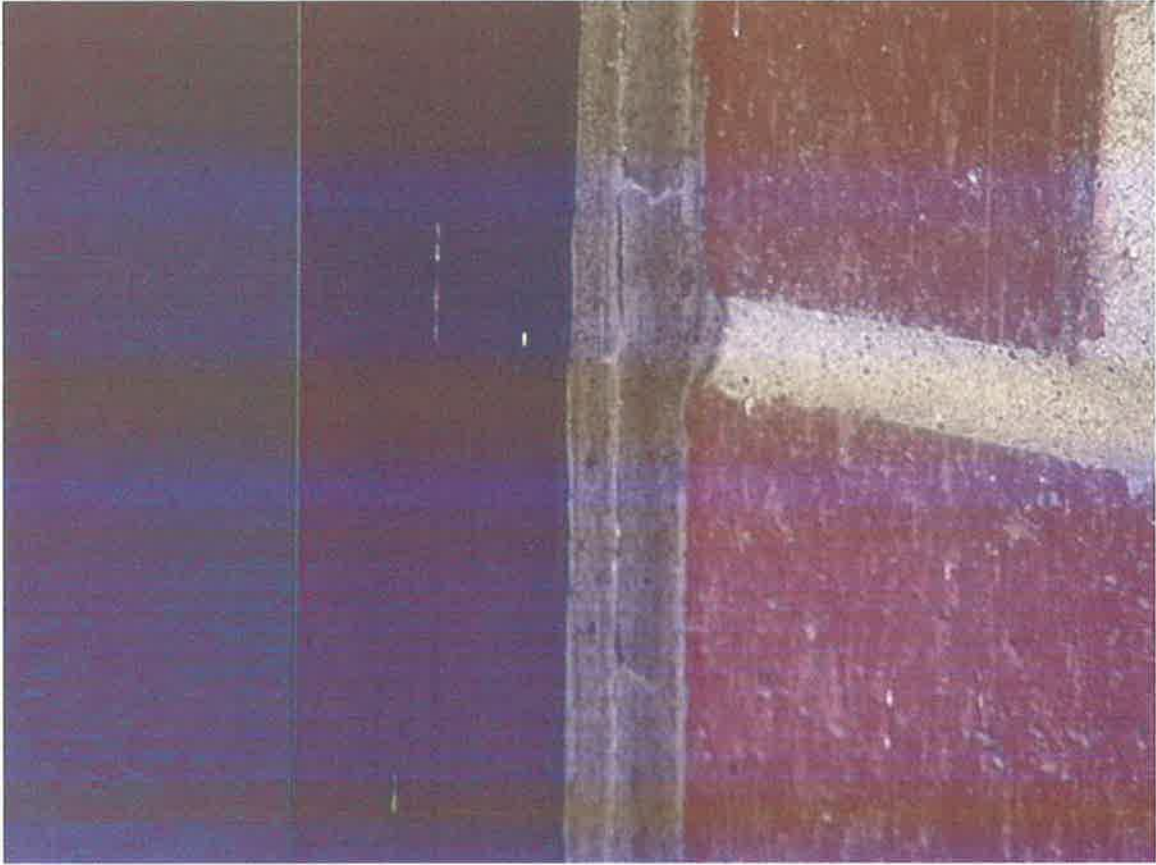
Photo 26 – Door frame caulk (inside), northeast entrance area

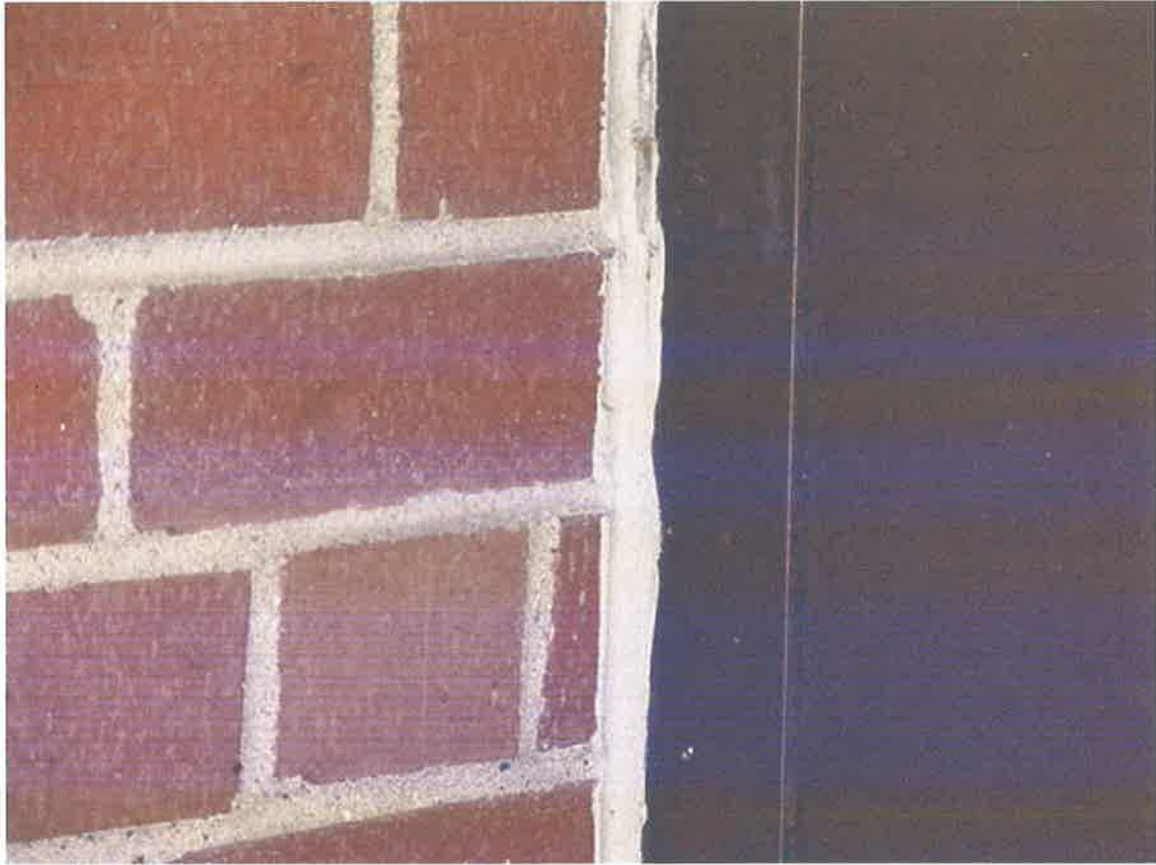
Photo 27 – Door frame caulk (outside), northeast entrance area
