Life Sciences Photo Log

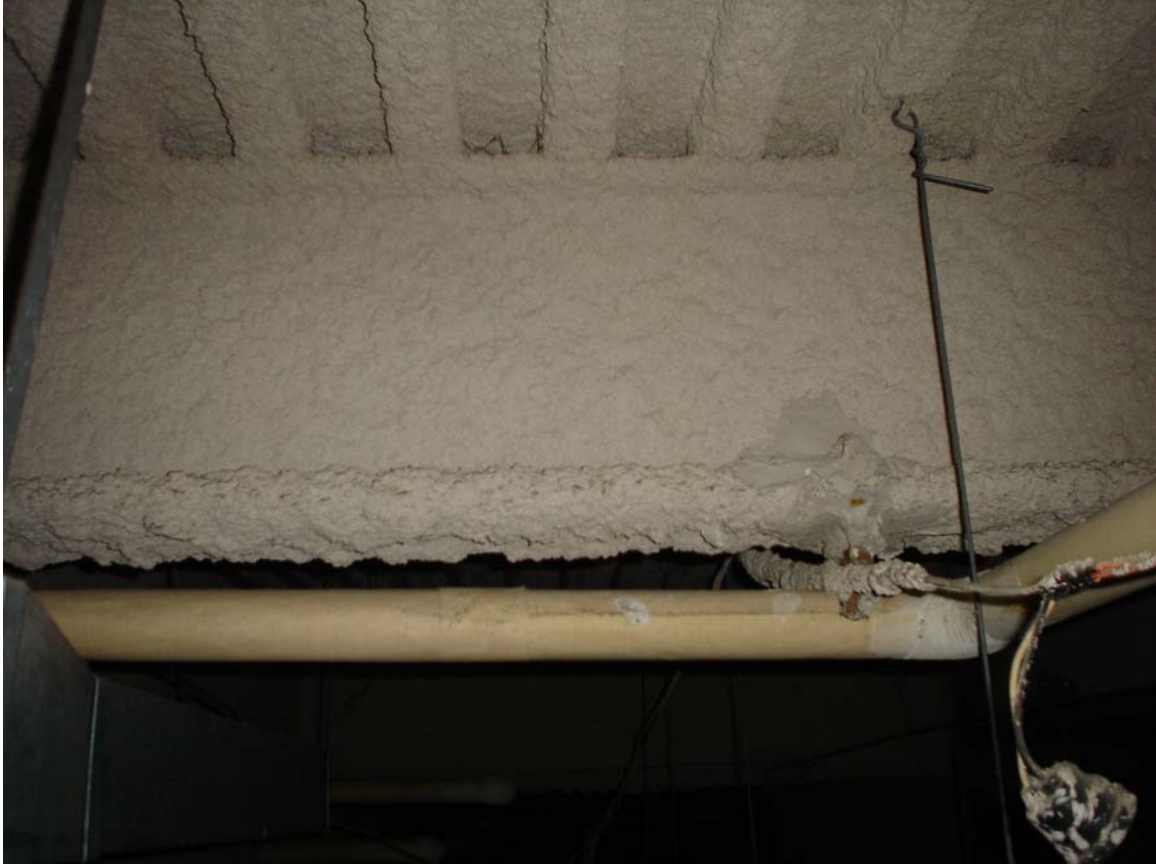
HA #1 – Asbestos-containing spray-on fireproofing

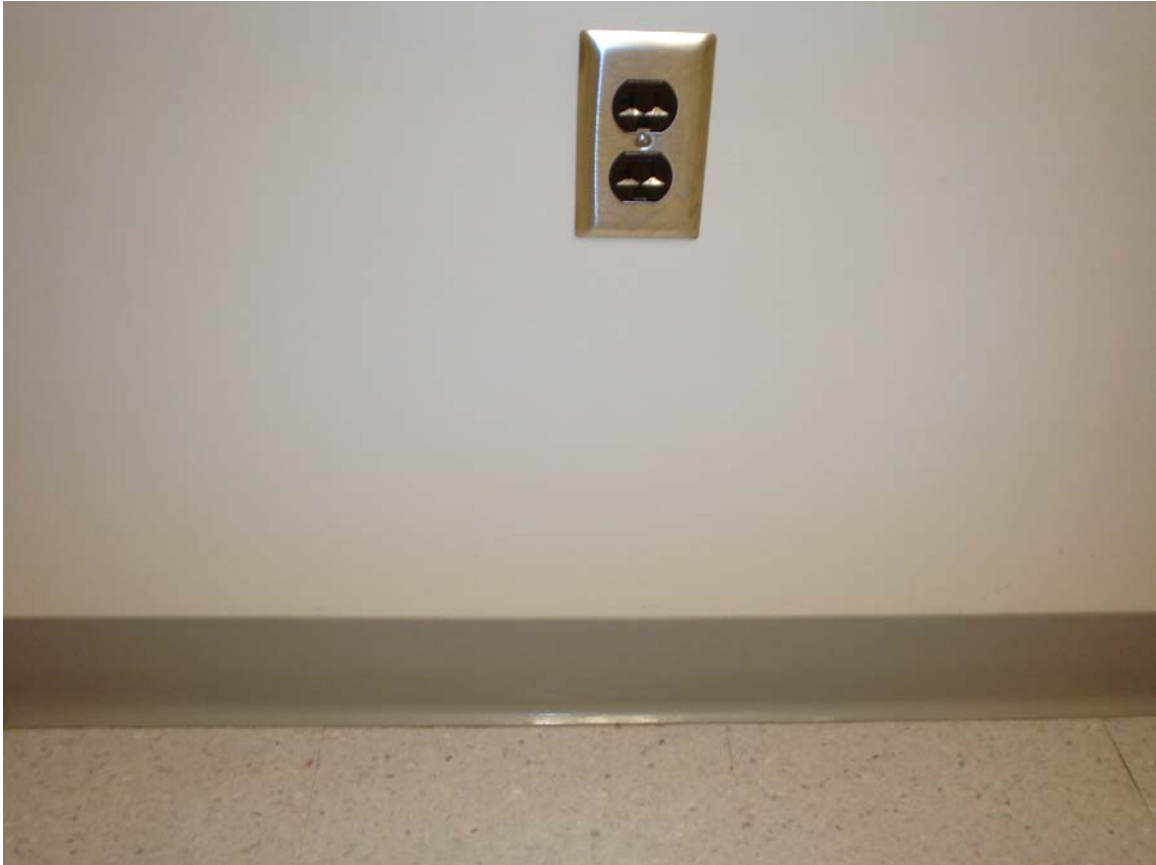
HA #4 – Non asbestos-containing plaster (smooth)

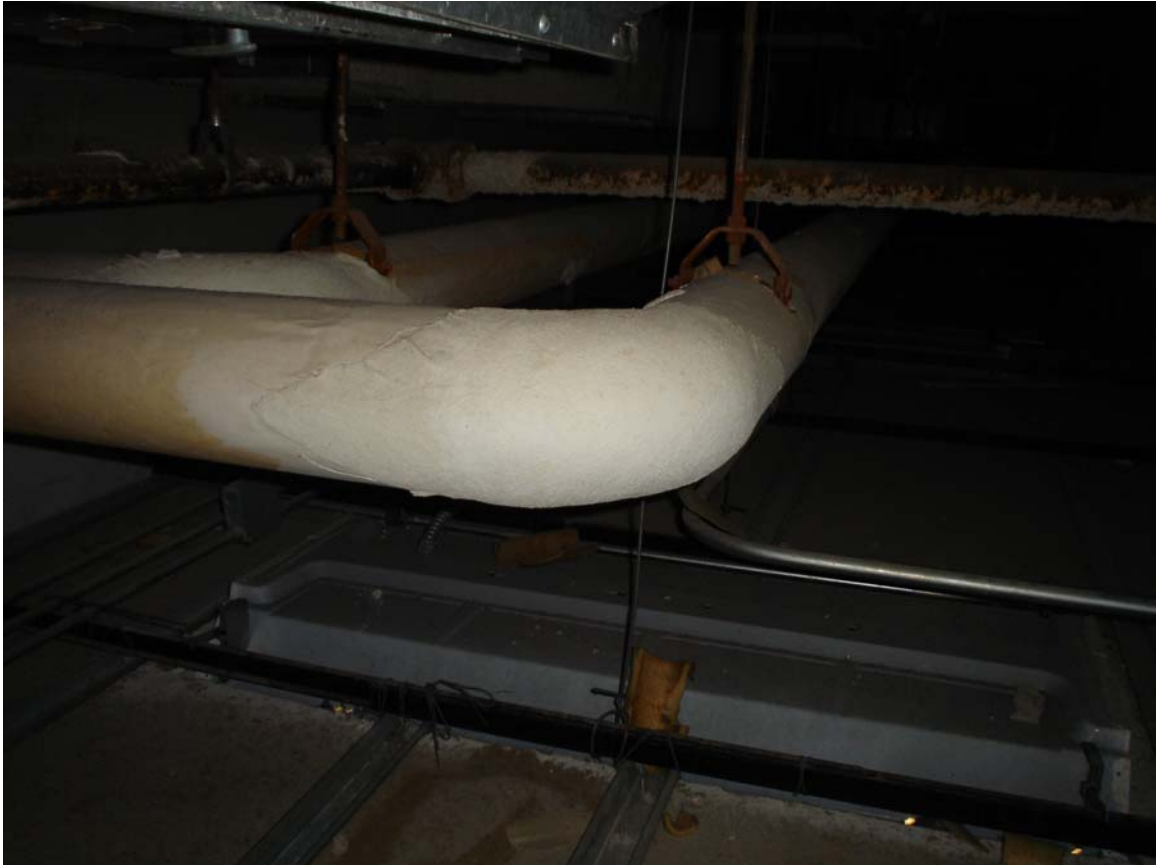
HA #5 – Asbestos-containing steam/condensate supply and return pipe joint and hanger insulation

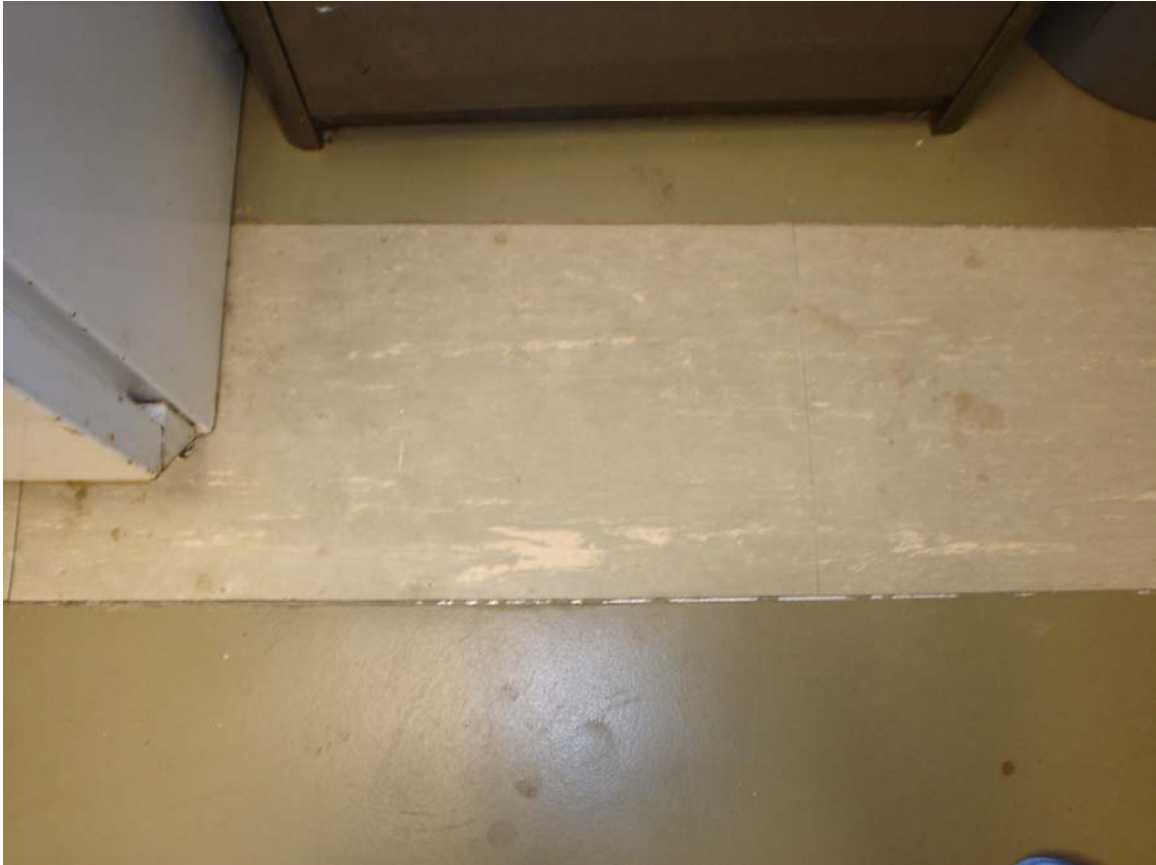
HA #7 – Asbestos-containing 1' x 2' gray floor tile with cream streaks and associated non asbestos-containing mastic

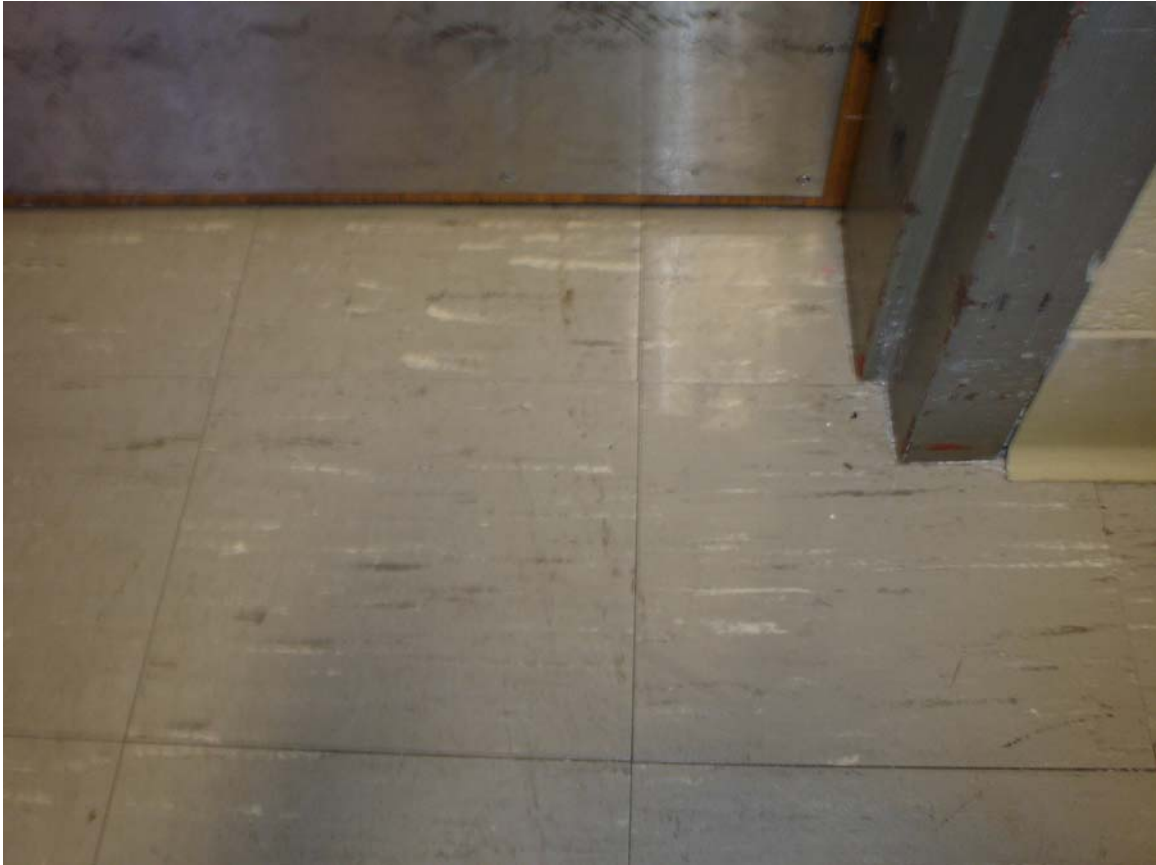
HA #8 – Asbestos-containing 9” x 9” gray floor tile with cream and gray streaks and associated mastic

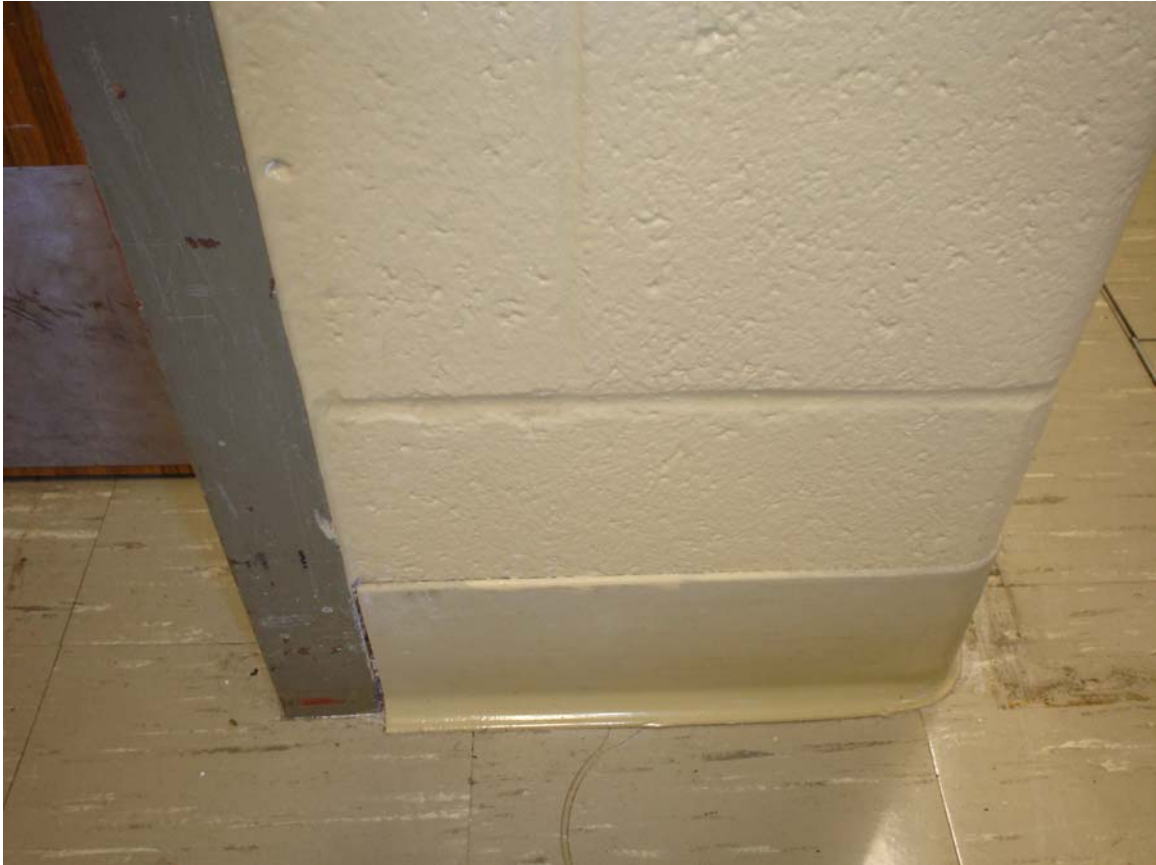
HA #9 – Non asbestos-containing 4” cream cove molding
and associated mastic

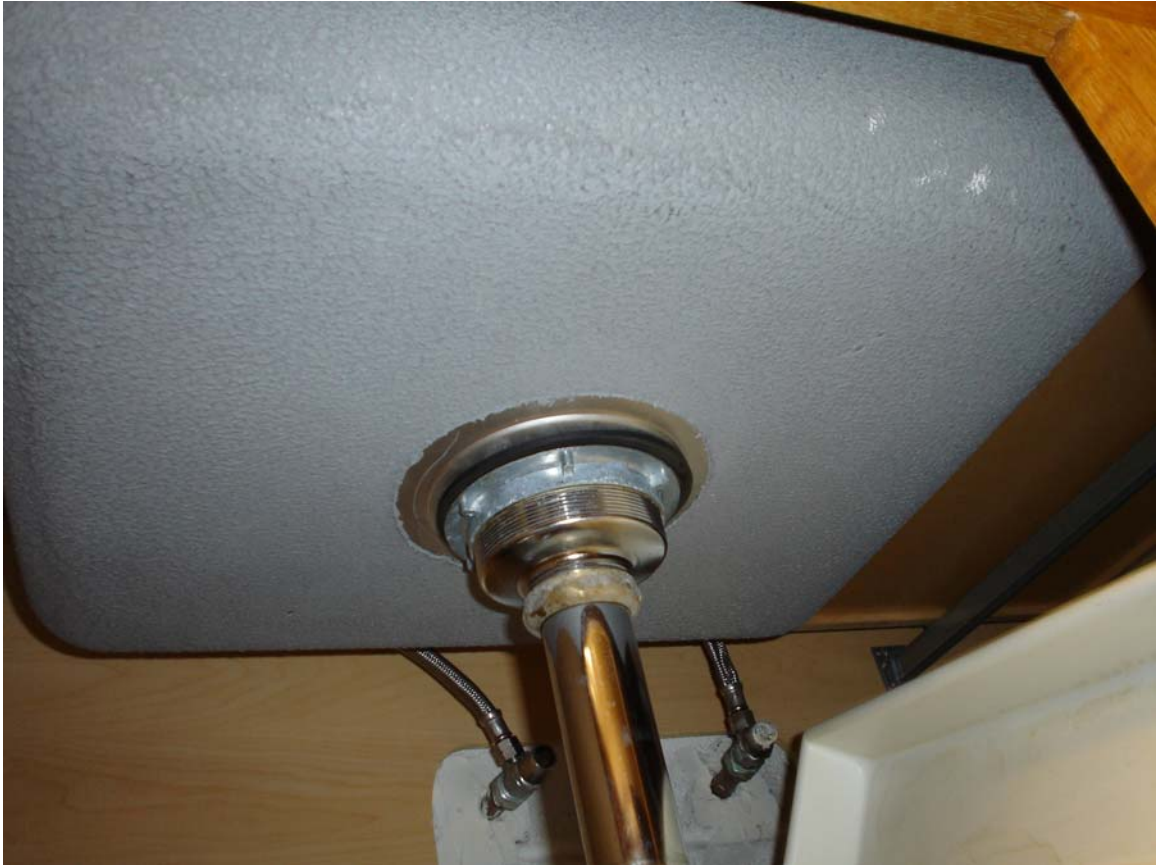
HA #10 – Non asbestos-containing gray sink undercoating insulation

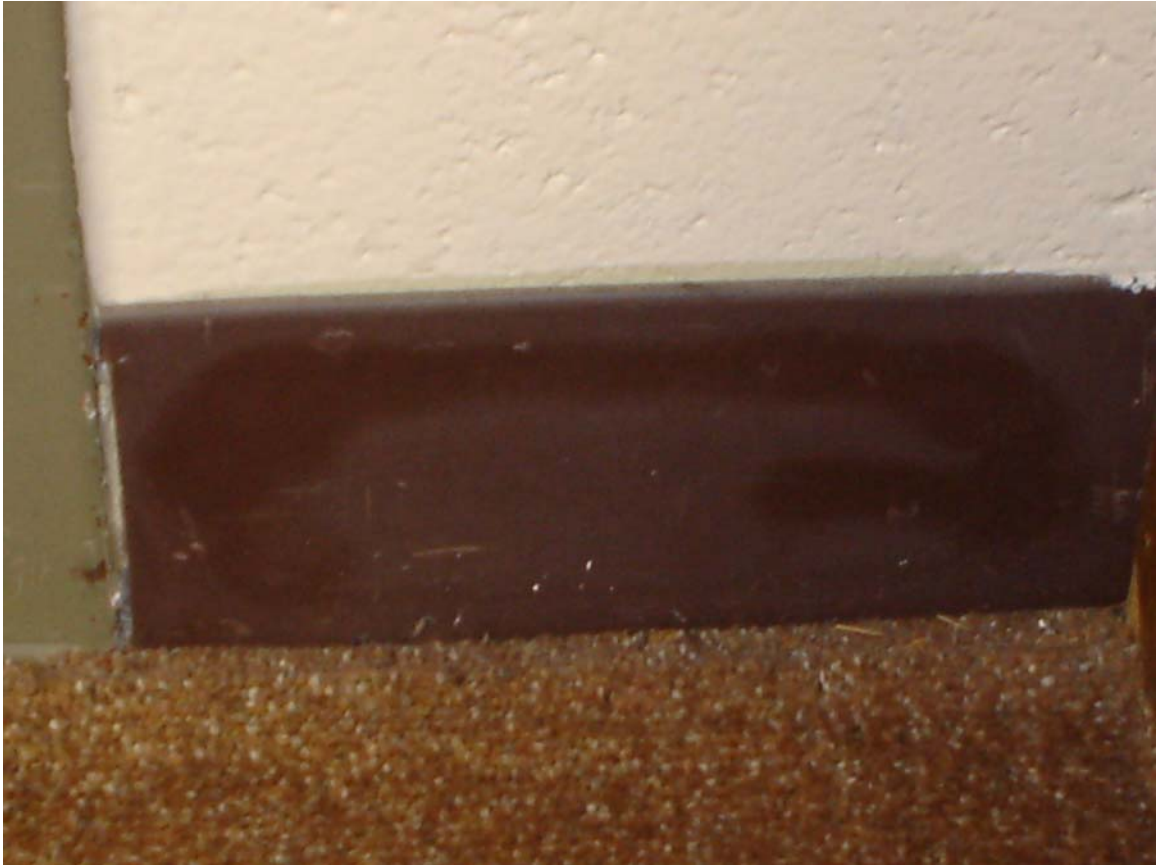
HA #11 – Non asbestos-containing 4” brown cove molding
and associated mastic

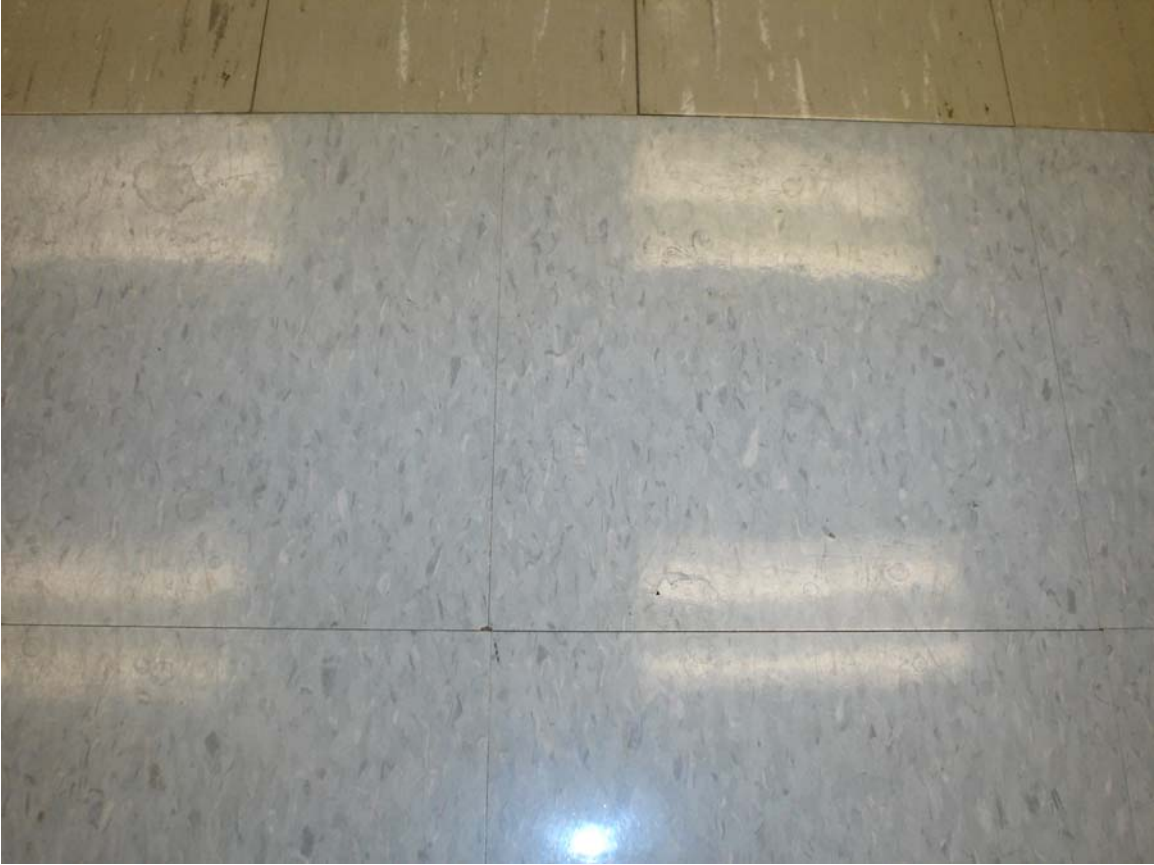
HA #12 – Non asbestos-containing 12” x 12” light blue floor tile with marble pattern and associated asbestos-containing mastic

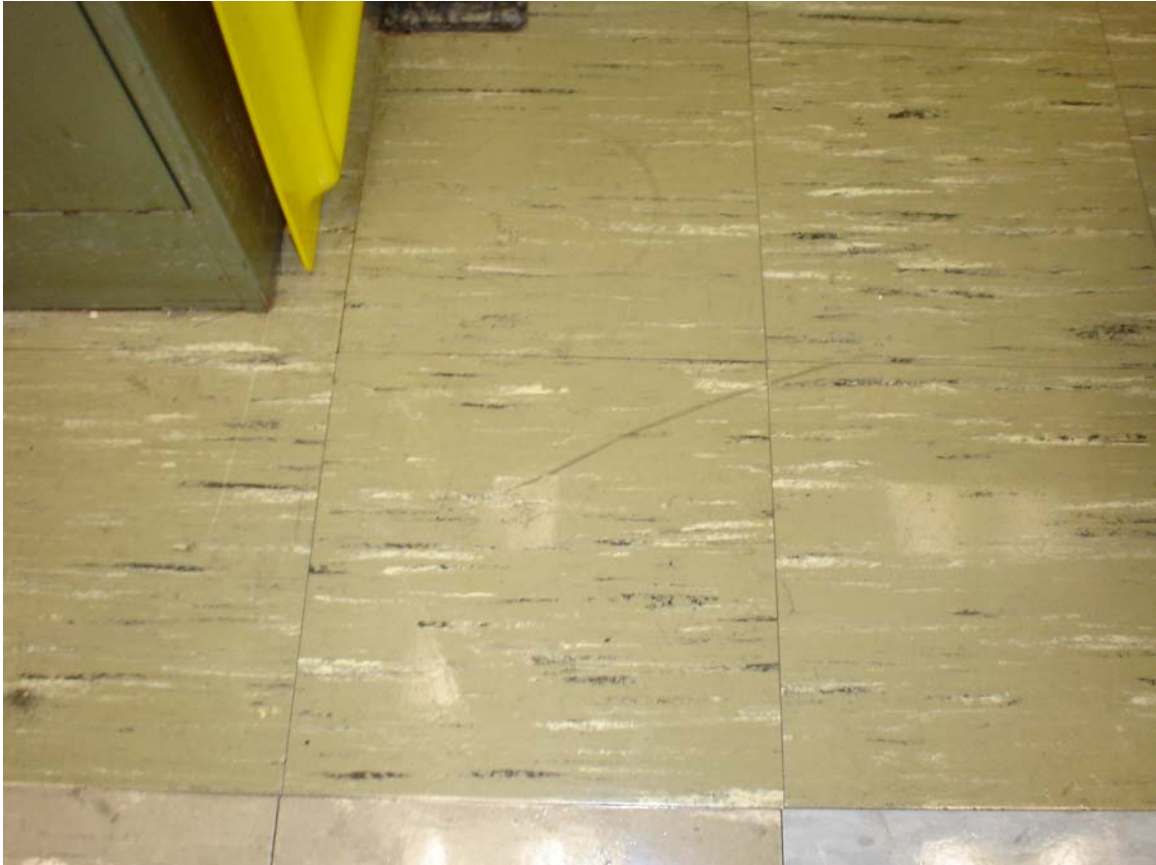
HA #13 – Asbestos-containing 9” x 9” green floor tile with cream and black streaks and associated mastic

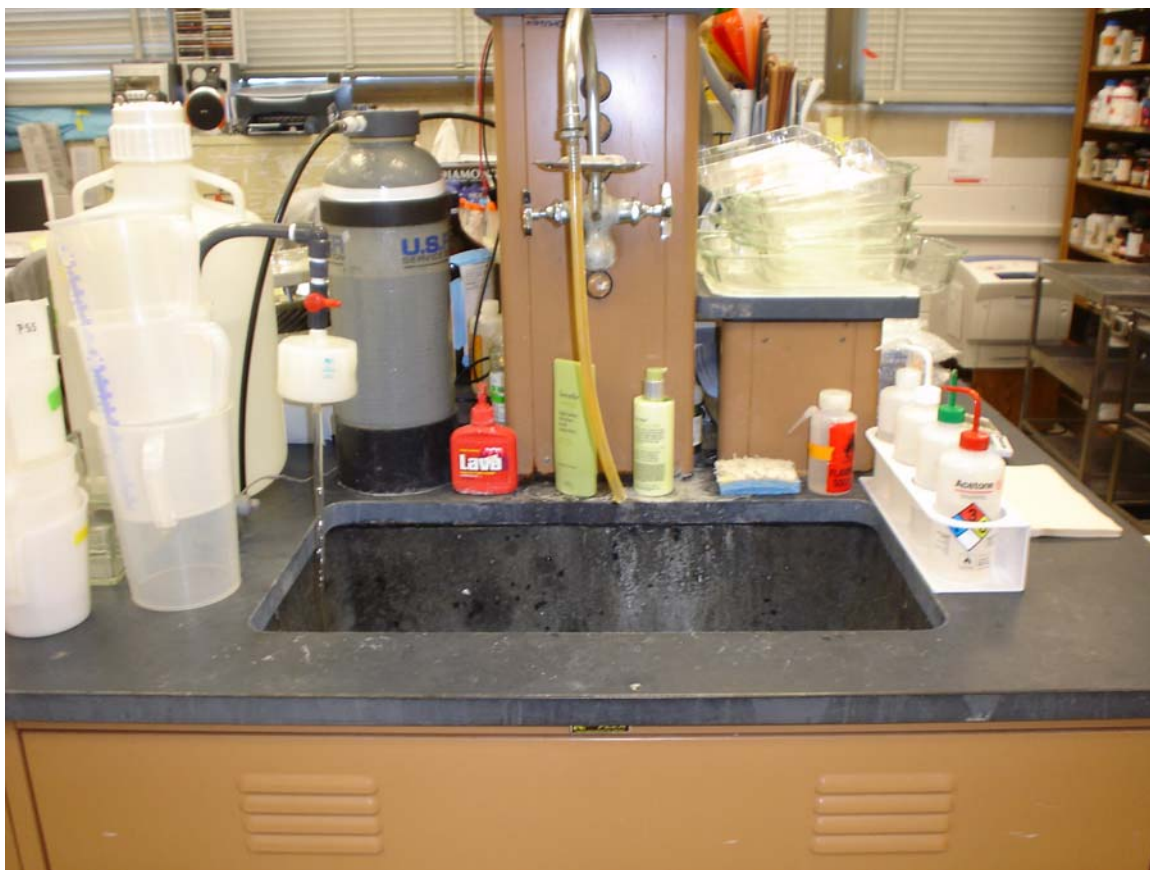
HA #14 – Assumed asbestos-containing black laboratory sink and table tops

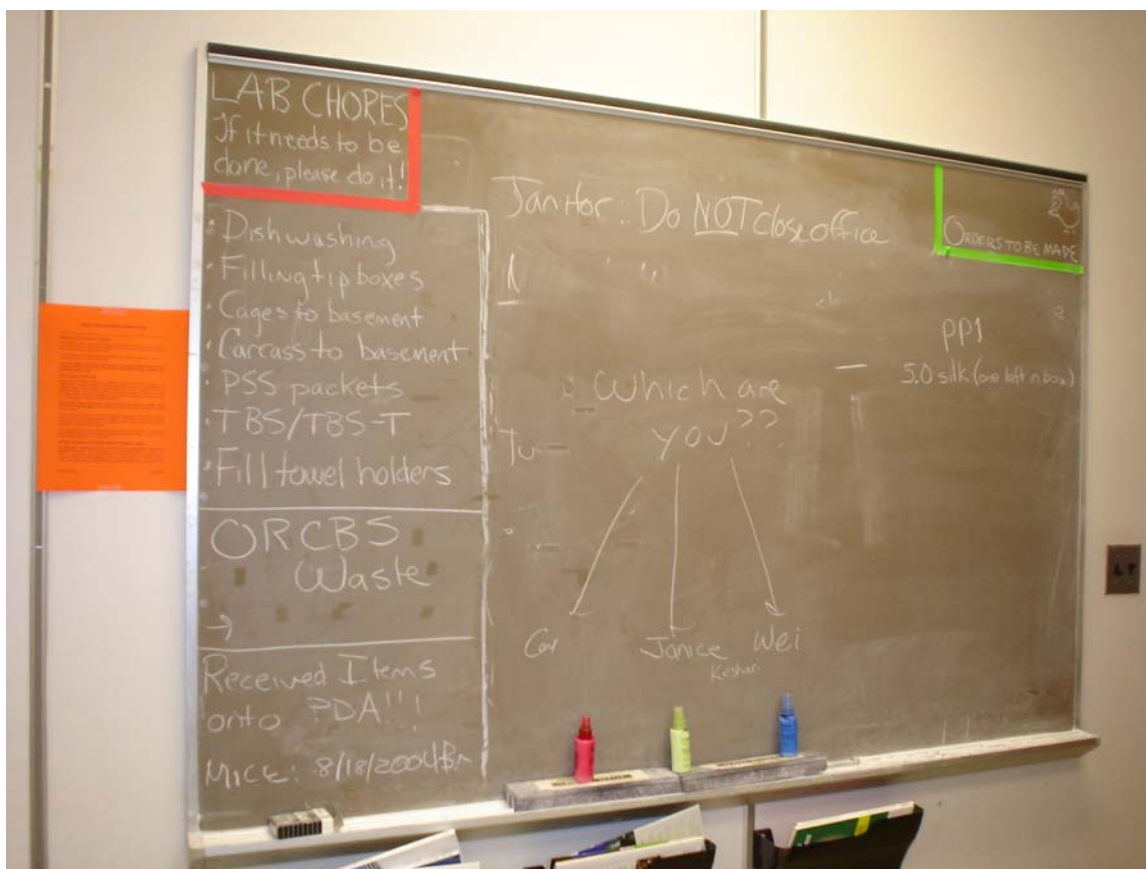
HA #15 – Assumed asbestos-containing chalkboards and associated glue pods

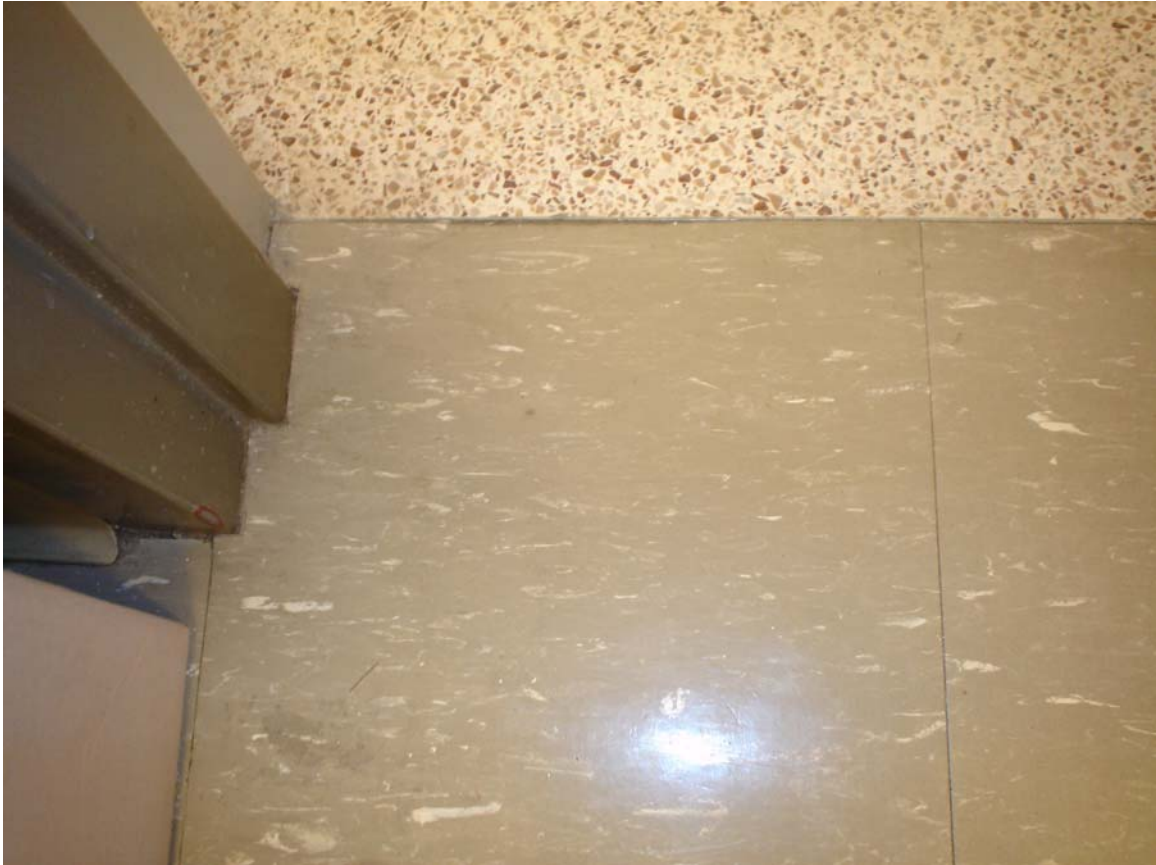
HA #16 – Non asbestos-containing 12” x 12” gray floor tile with white streaks and associated asbestos-containing mastic

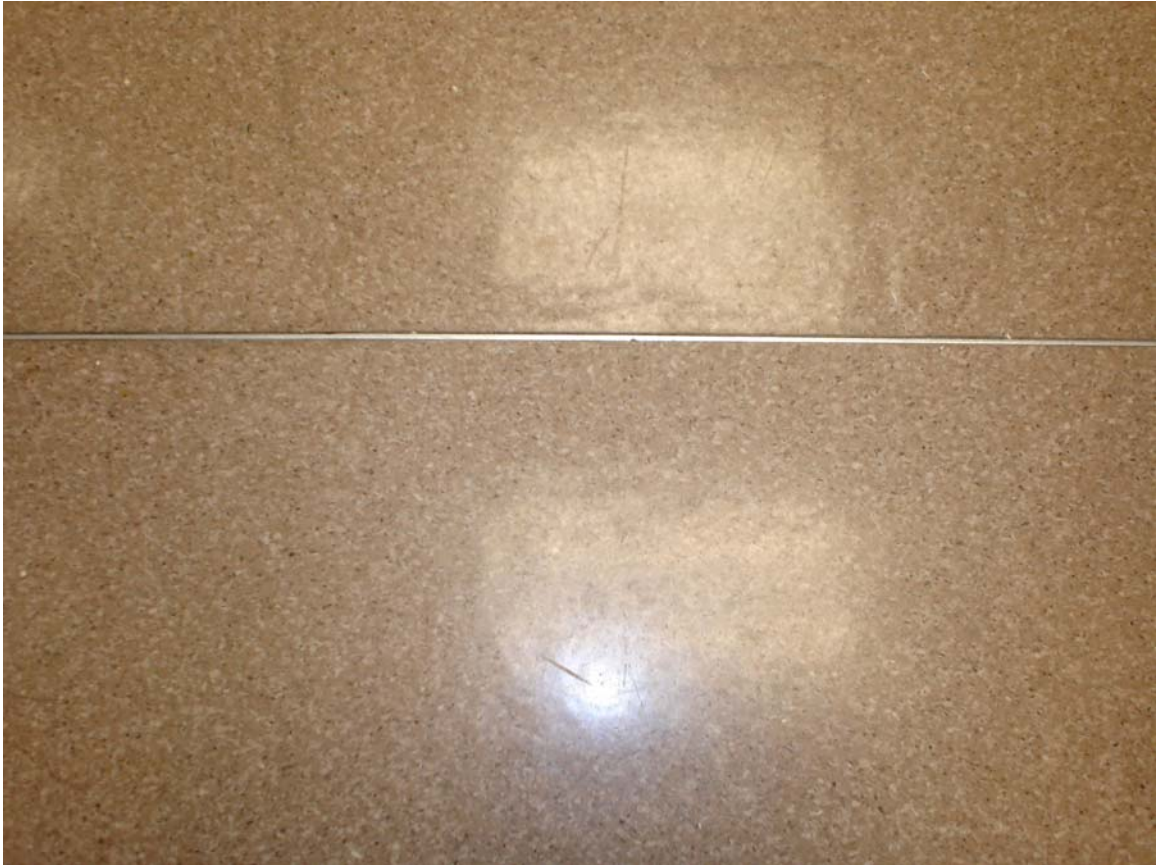
HA #17 – Non asbestos-containing tan linoleum with mosaic pattern
and associated mastic

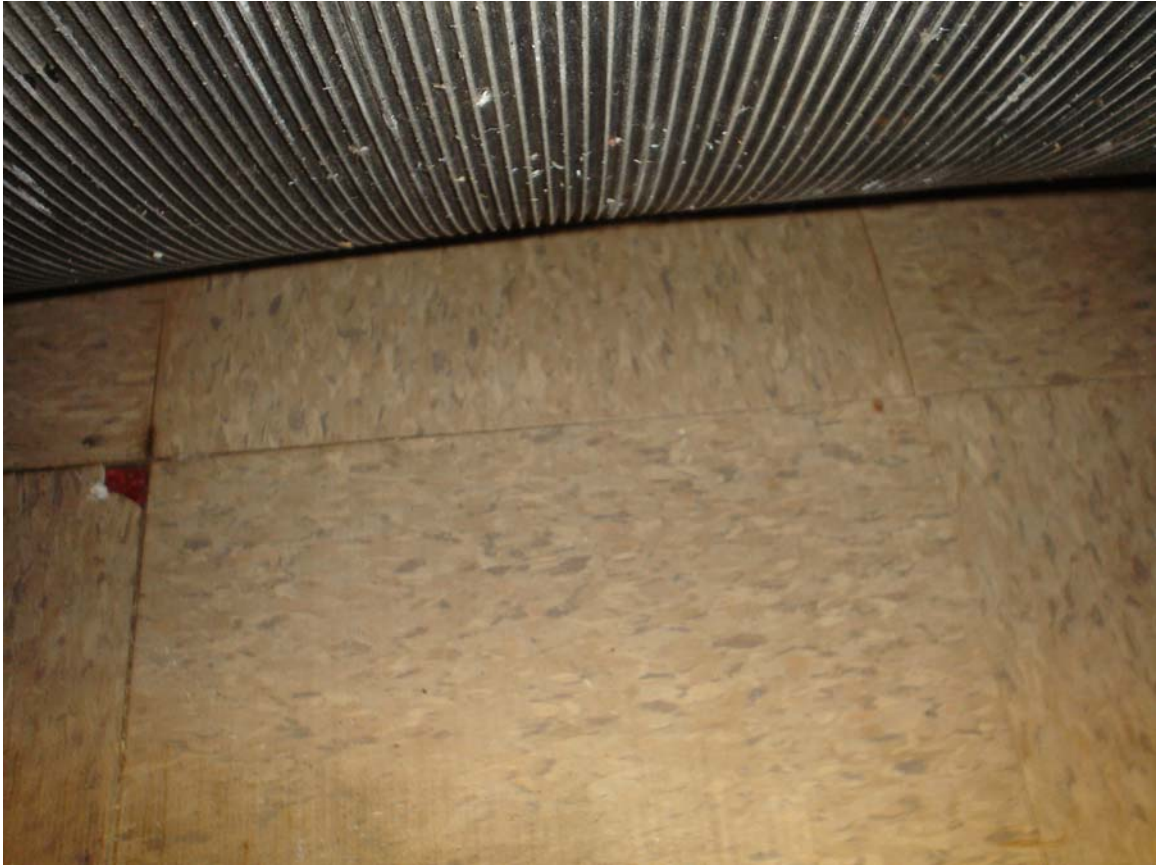
HA #19 – Asbestos-containing 12” x 12” tan floor tile with marble pattern and associated mastic

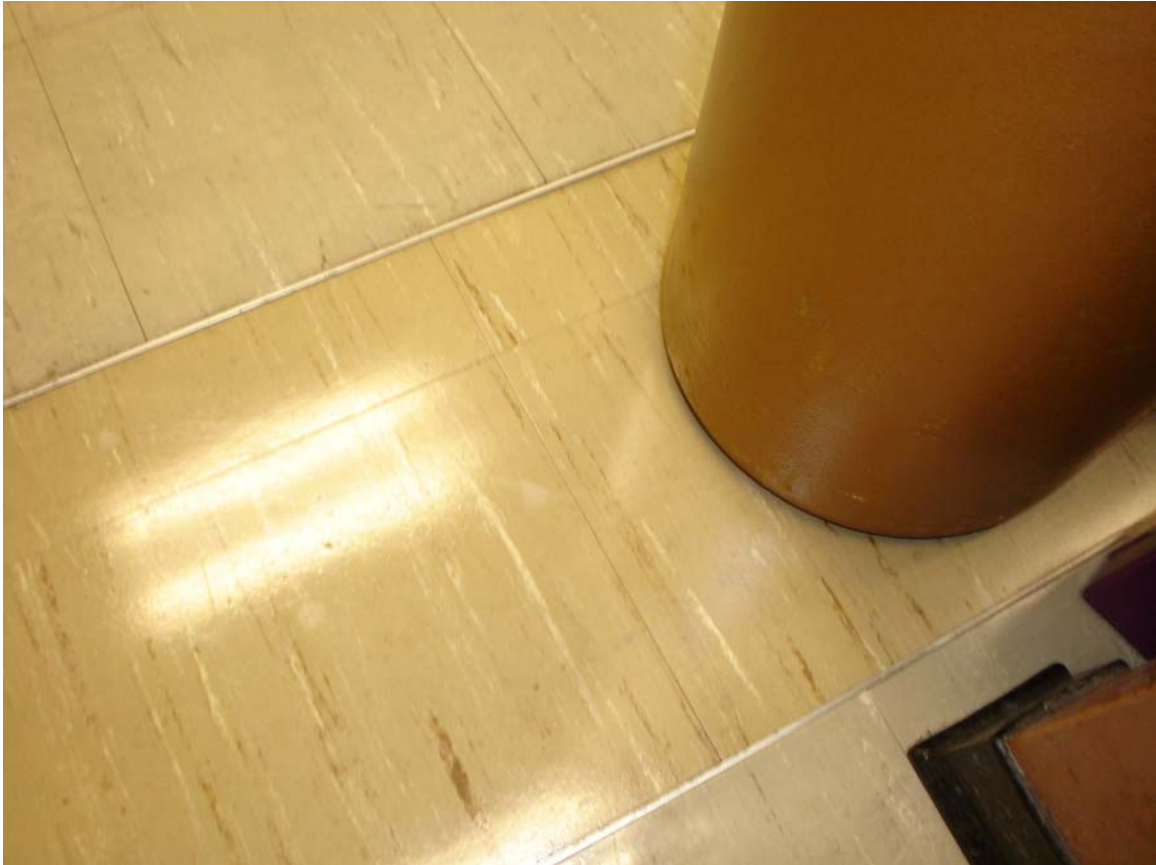
HA #21 – Non asbestos-containing 12” x 12” tan floor tile with cream and brown streaks and associated asbestos-containing mastic

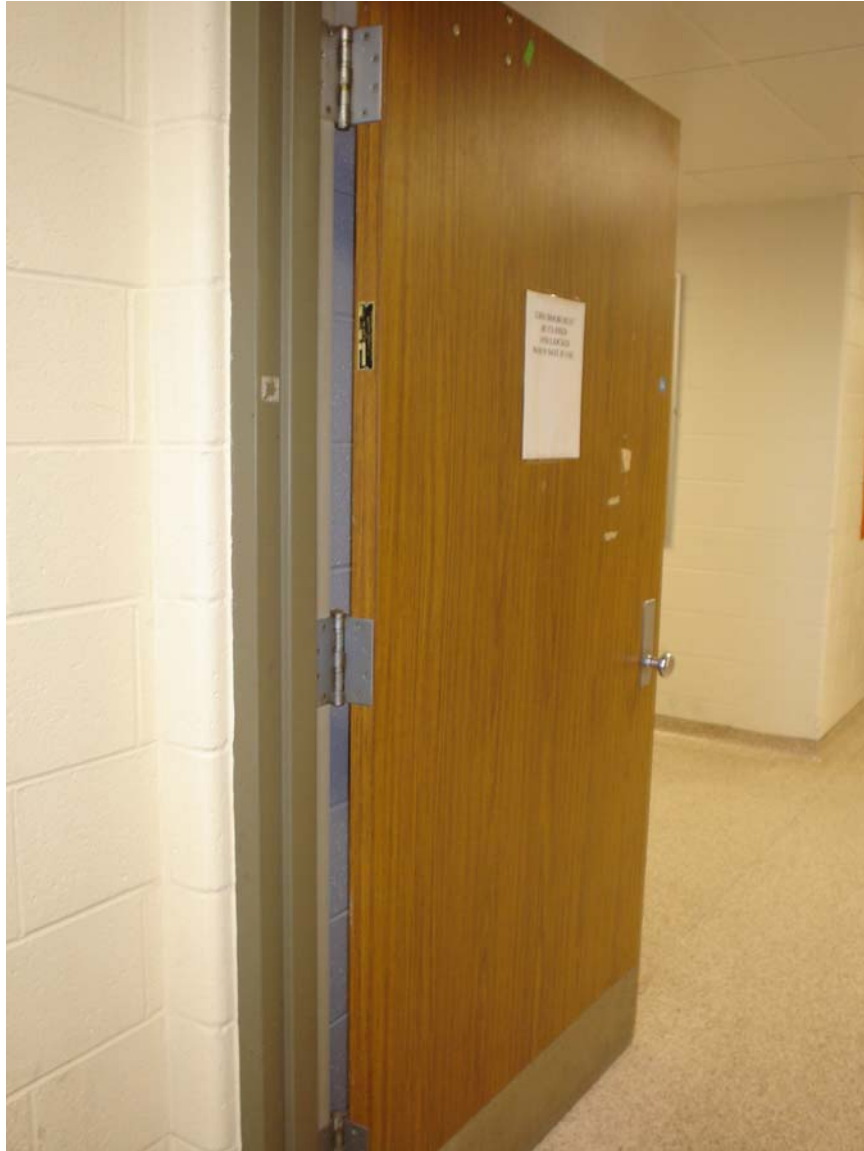
HA #23 – Assumed asbestos-containing fire door and frame

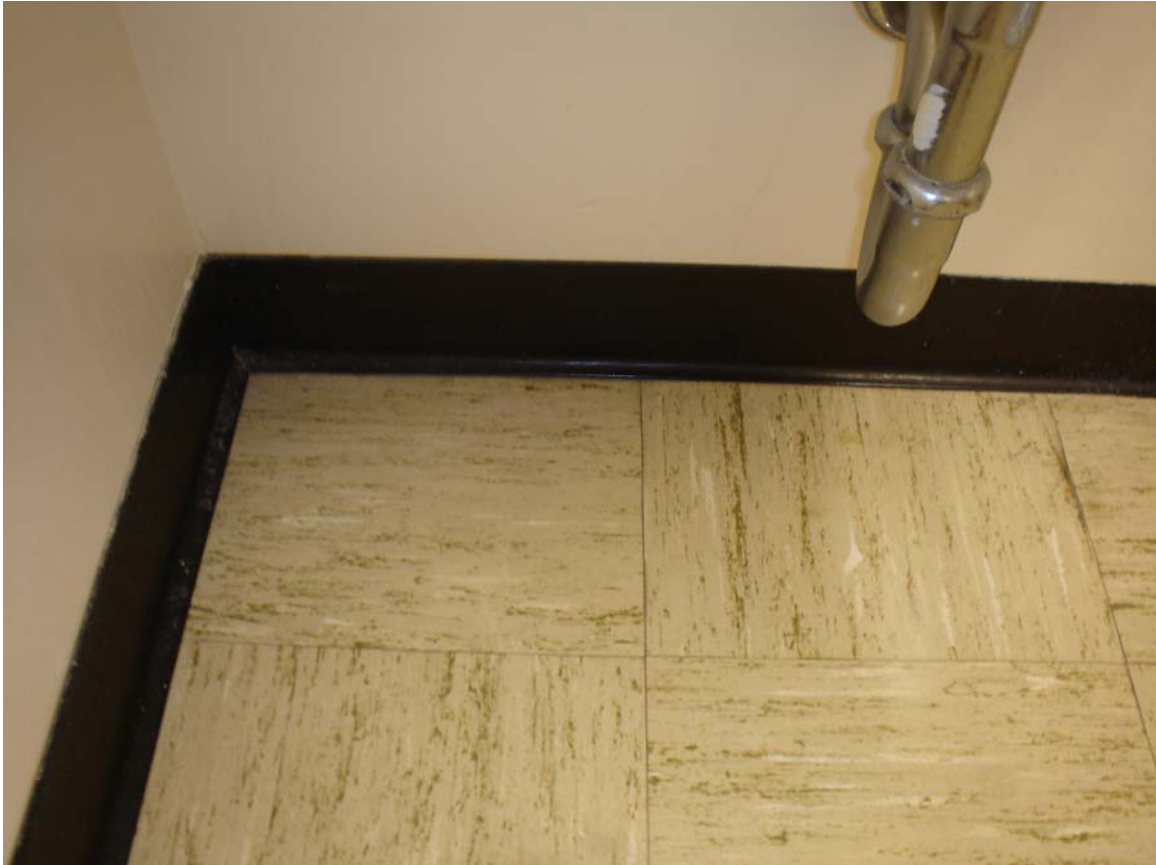
HA #25 – Non asbestos-containing 4” black cove molding
and associated mastic

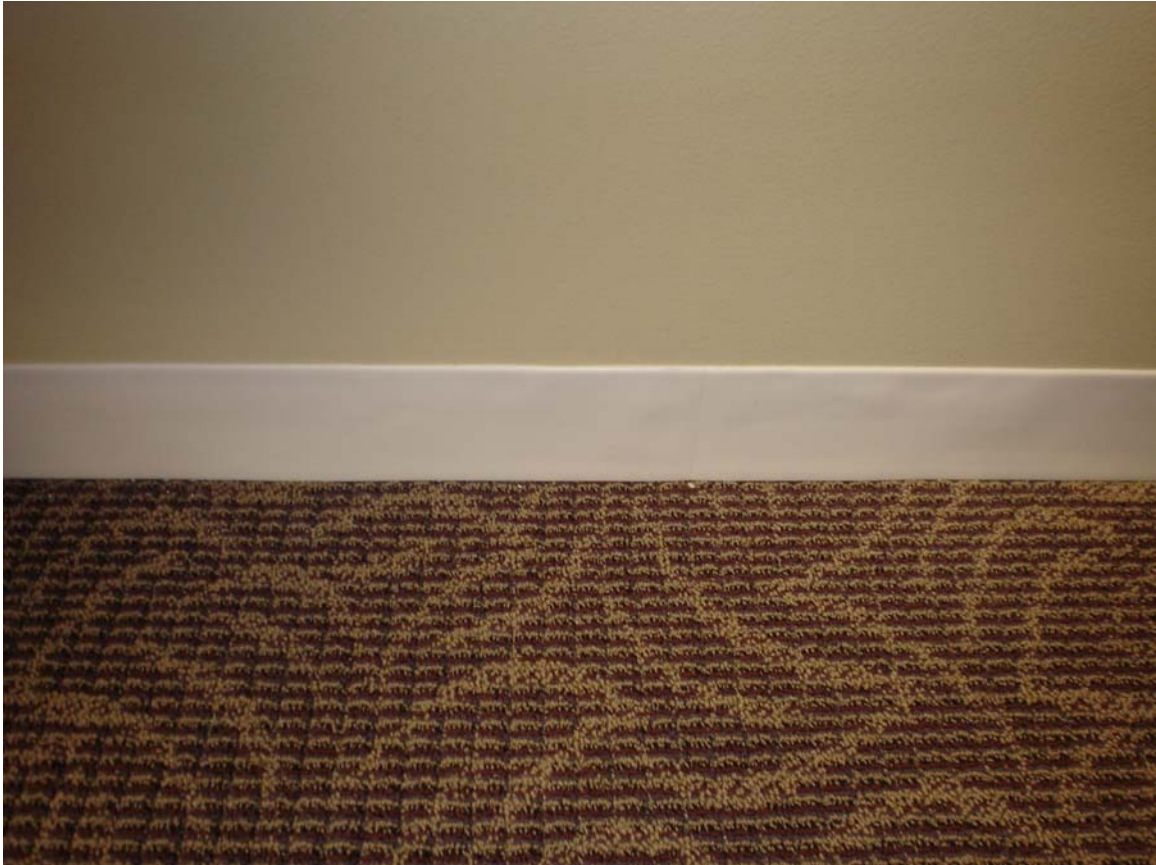
HA #26 – Non asbestos-containing 4” white cove molding
and associated mastic

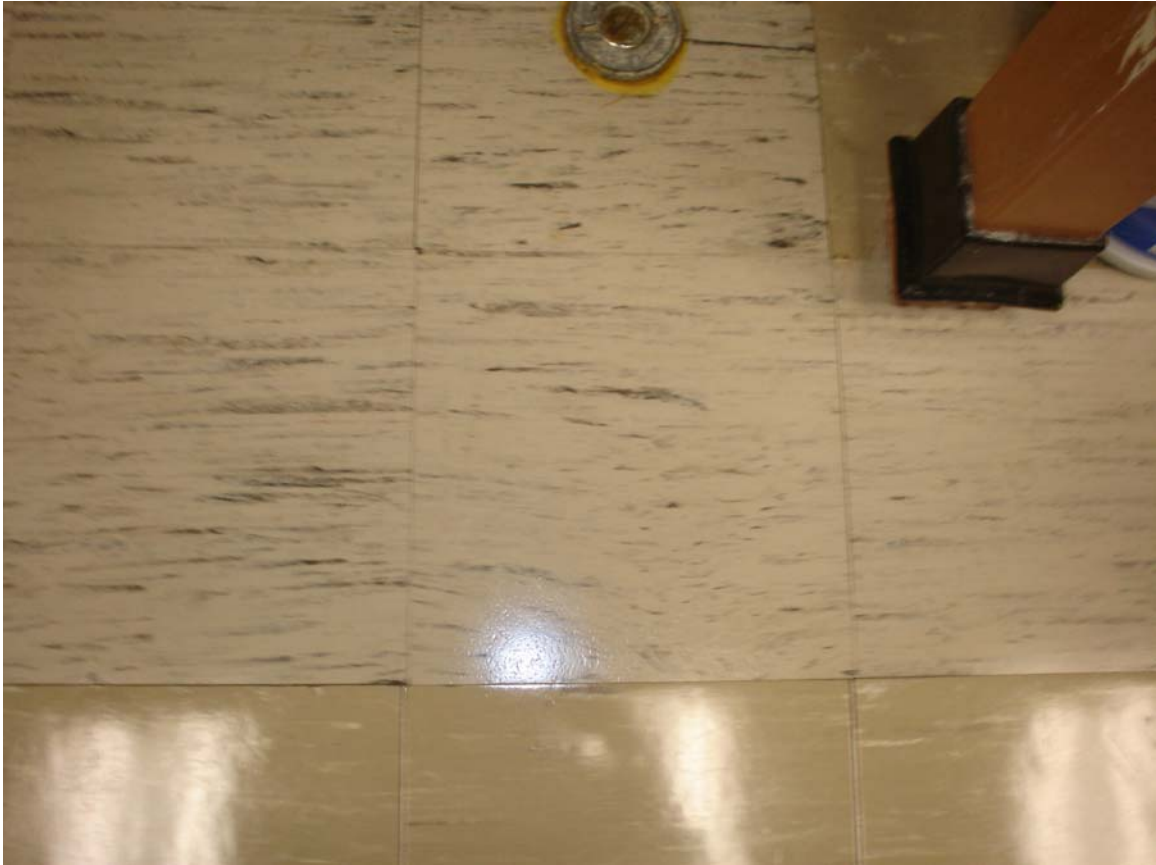
HA #27 – Asbestos-containing 9” x 9” cream floor tile with dark brown streaks and associated mastic

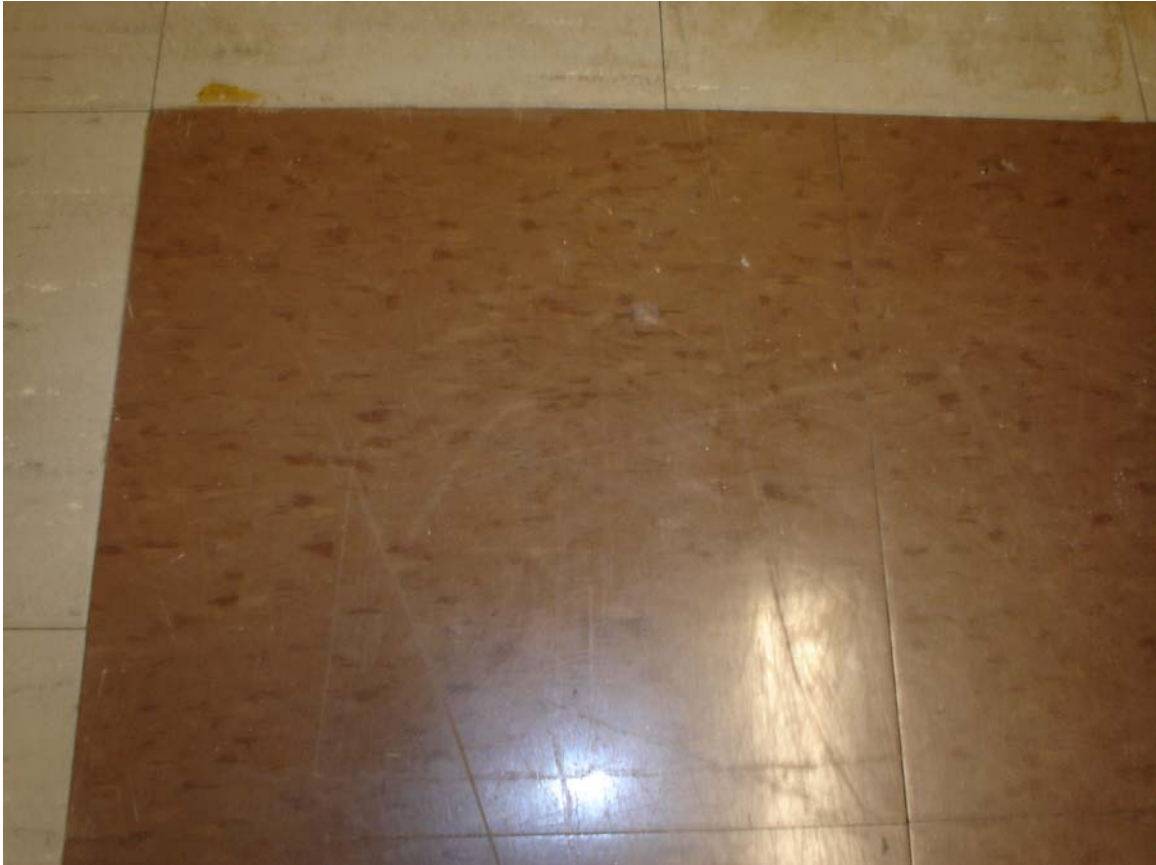
HA #28 – Non asbestos-containing 12” x 12” brown floor tile with marble pattern and associated asbestos-containing mastic

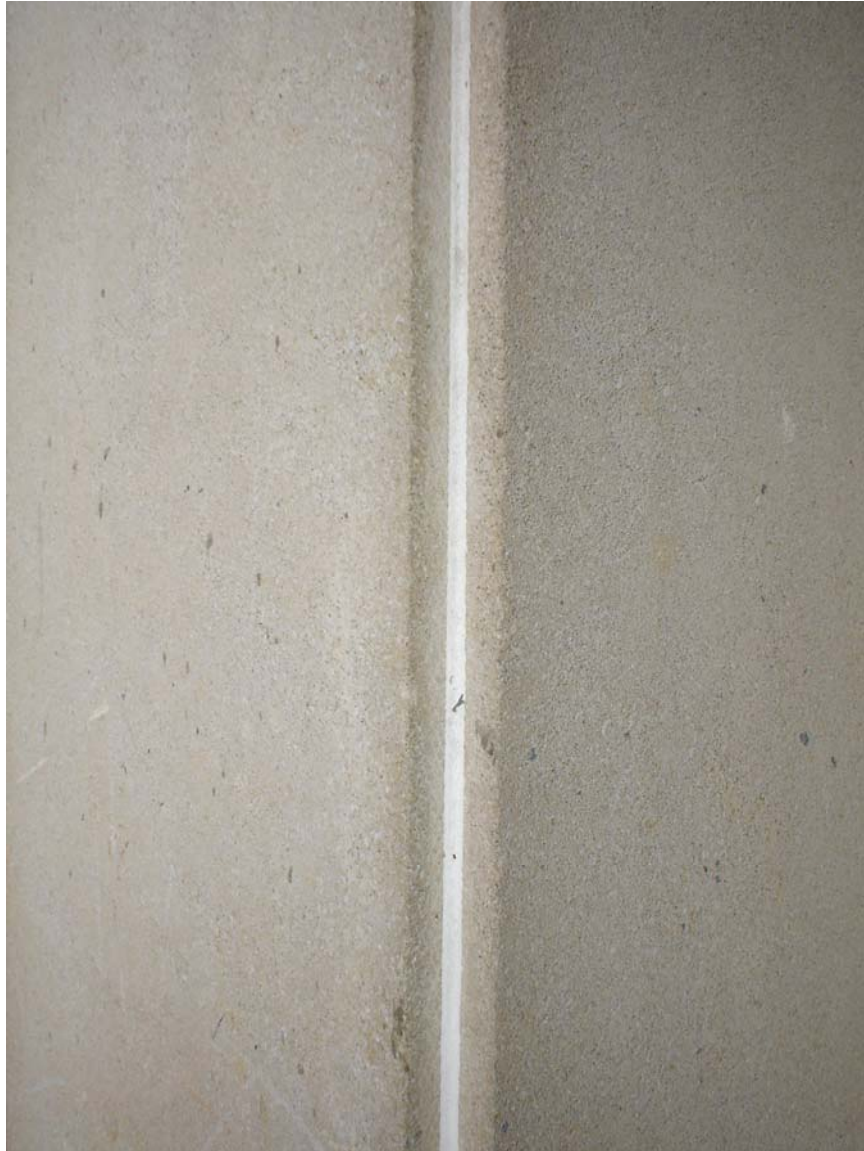
HA #30 – Assumed asbestos-containing window
and door frame caulk compound
