Life Sciences Photo Log

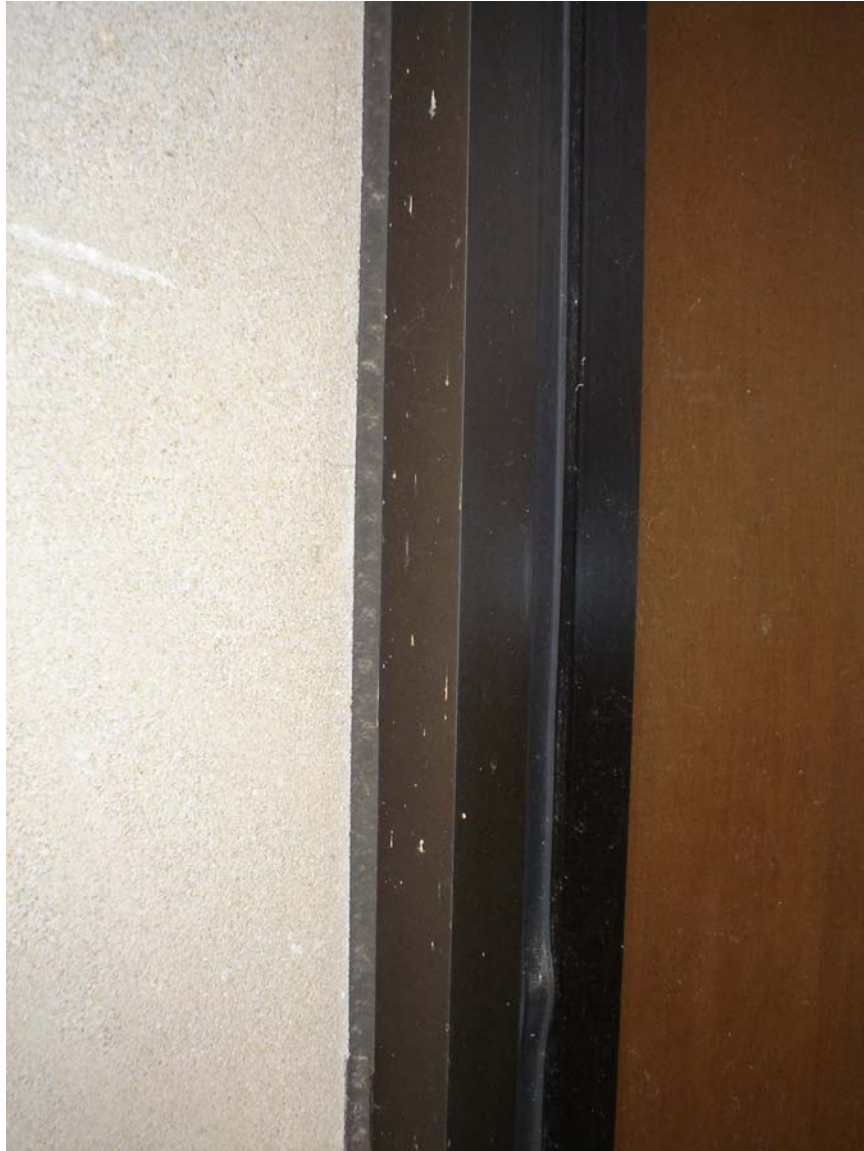
HA #30 – Assumed asbestos-containing window
and door frame caulk compound

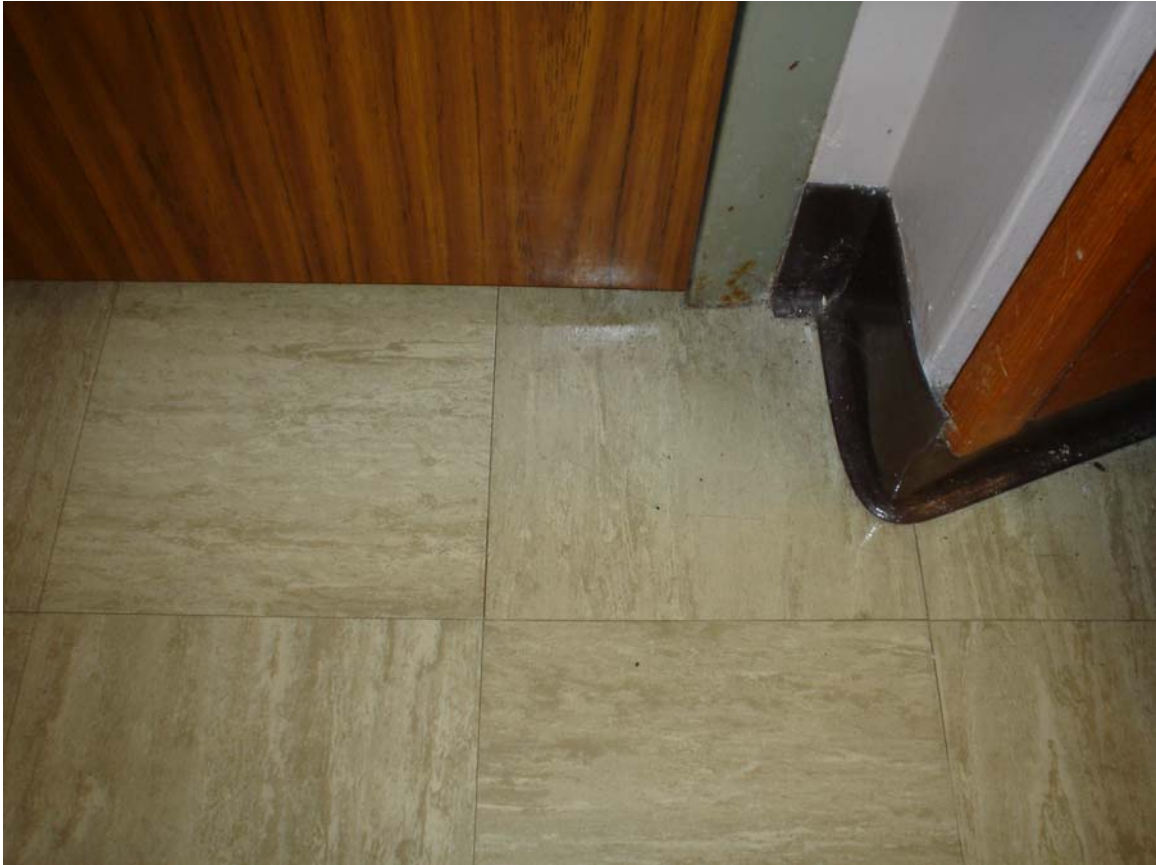
HA #33 – Asbestos-containing 9” x 9” sea-foam green floor tile with swirls and associated mastic

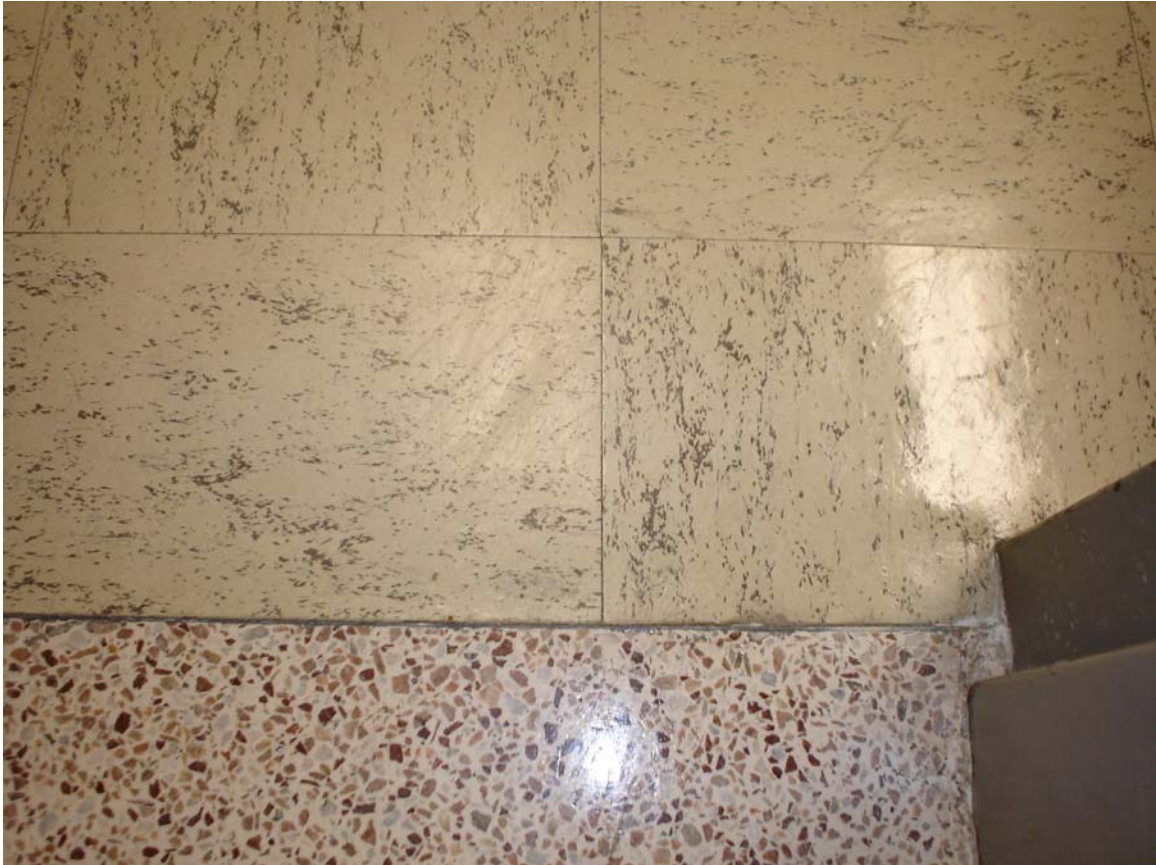
HA #37 – Non asbestos-containing 9” x 9” cream floor tile with black streaks and associated asbestos-containing mastic

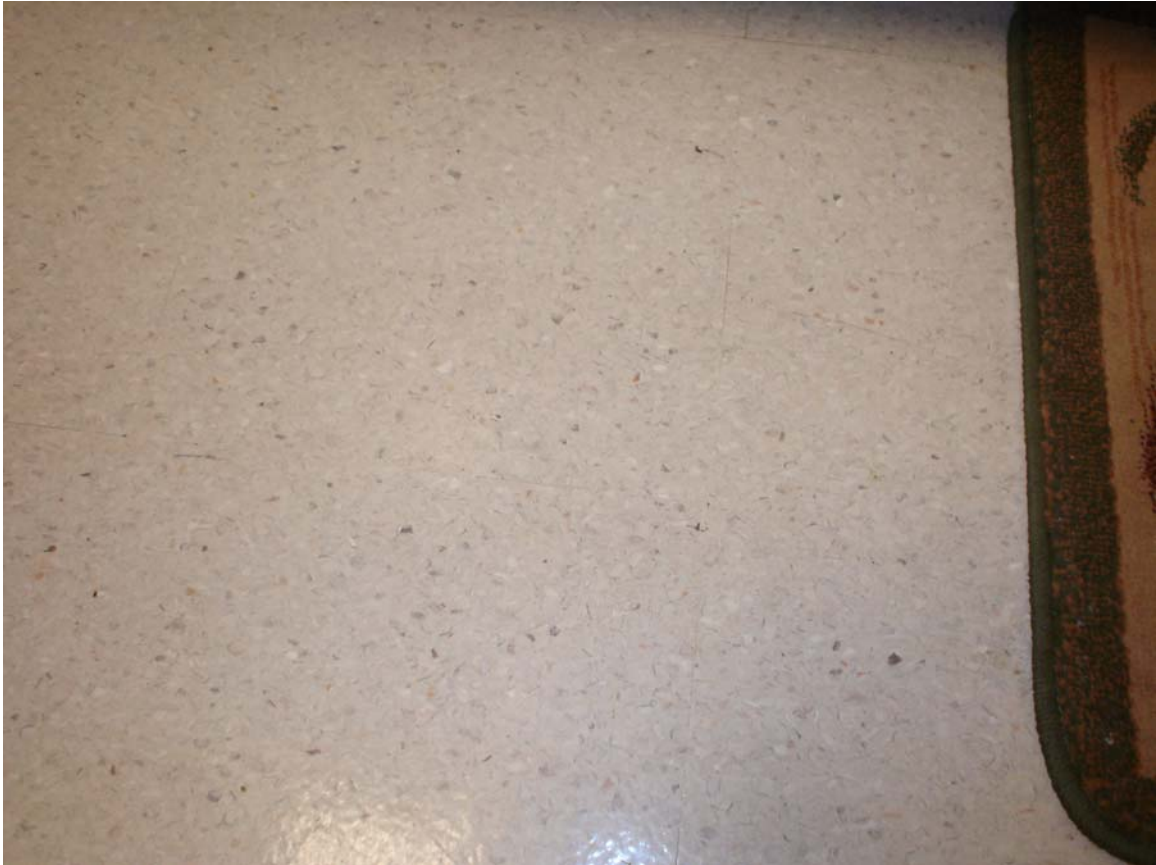
HA #39 – Non asbestos-containing 12” x 12” white floor tile with mosaic pattern and associated mastic

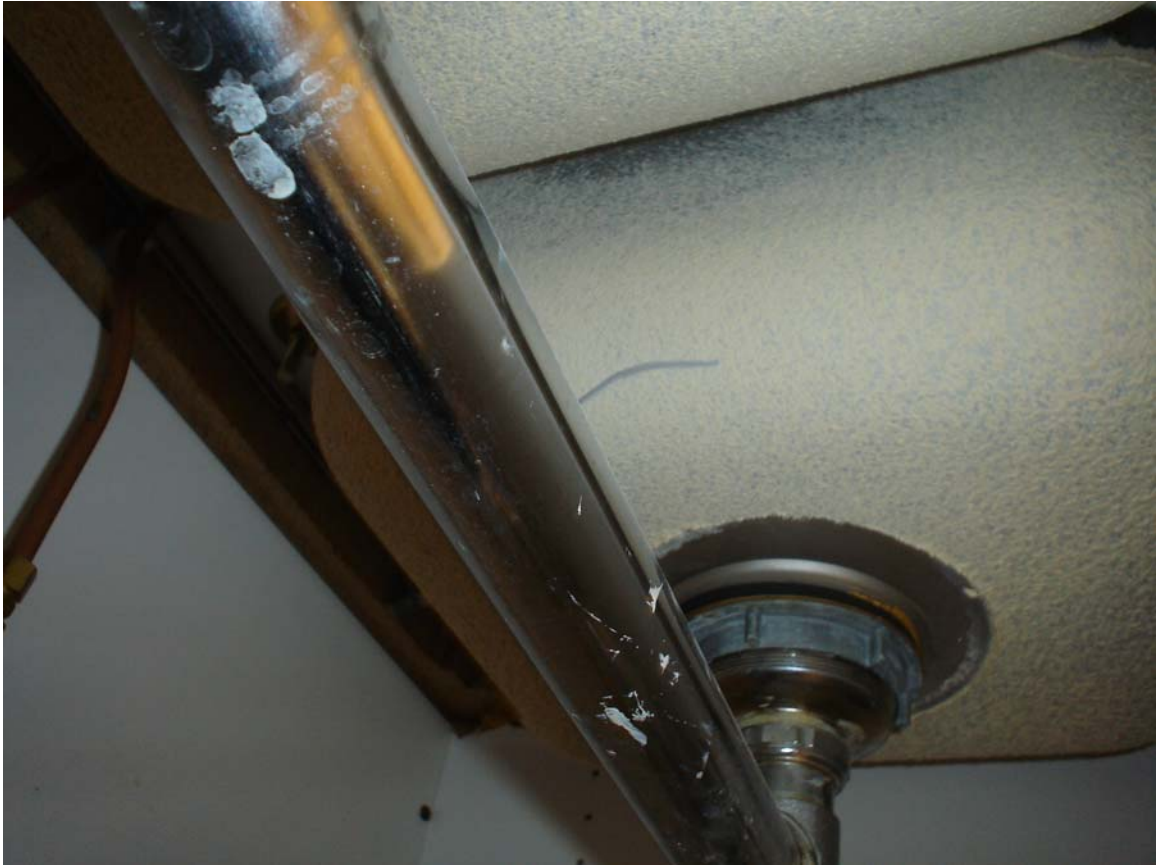
HA #40 – Non asbestos-containing white sink undercoating

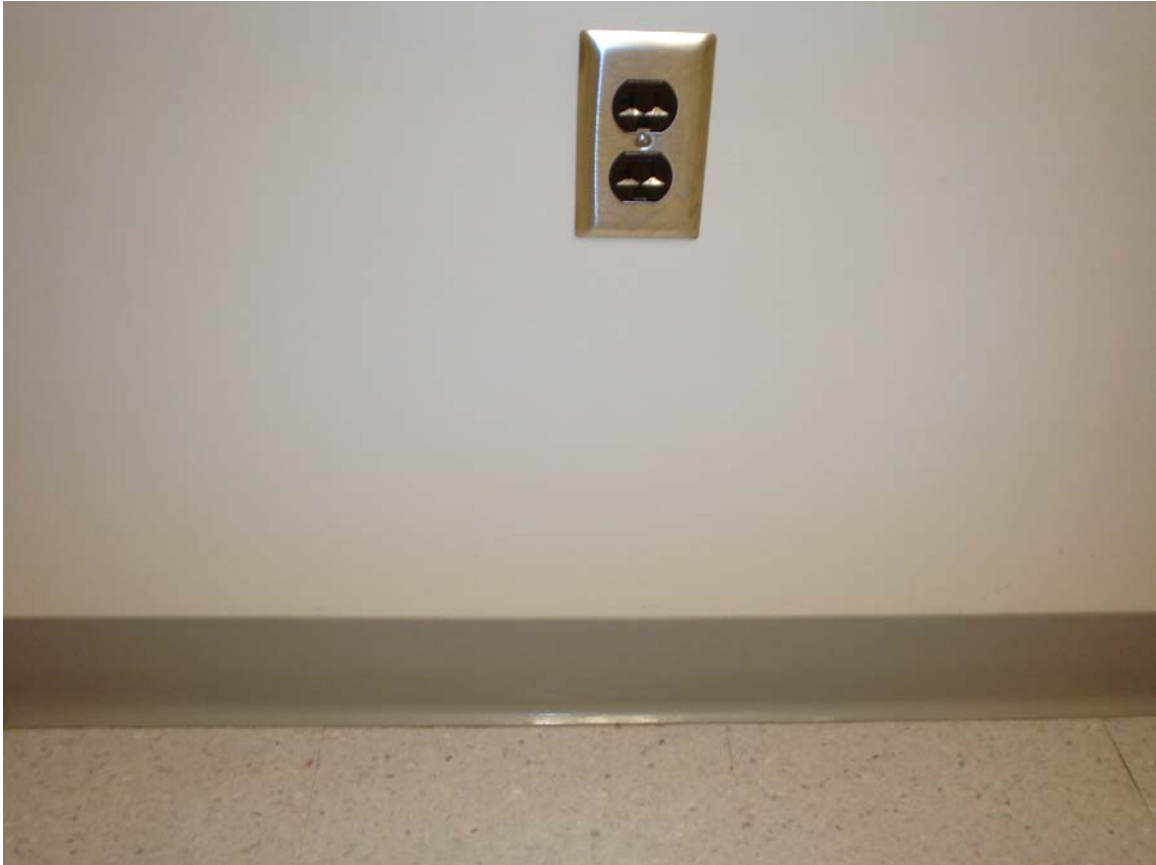
HA #41 – Non asbestos-containing 4” gray cove molding
and associated mastic

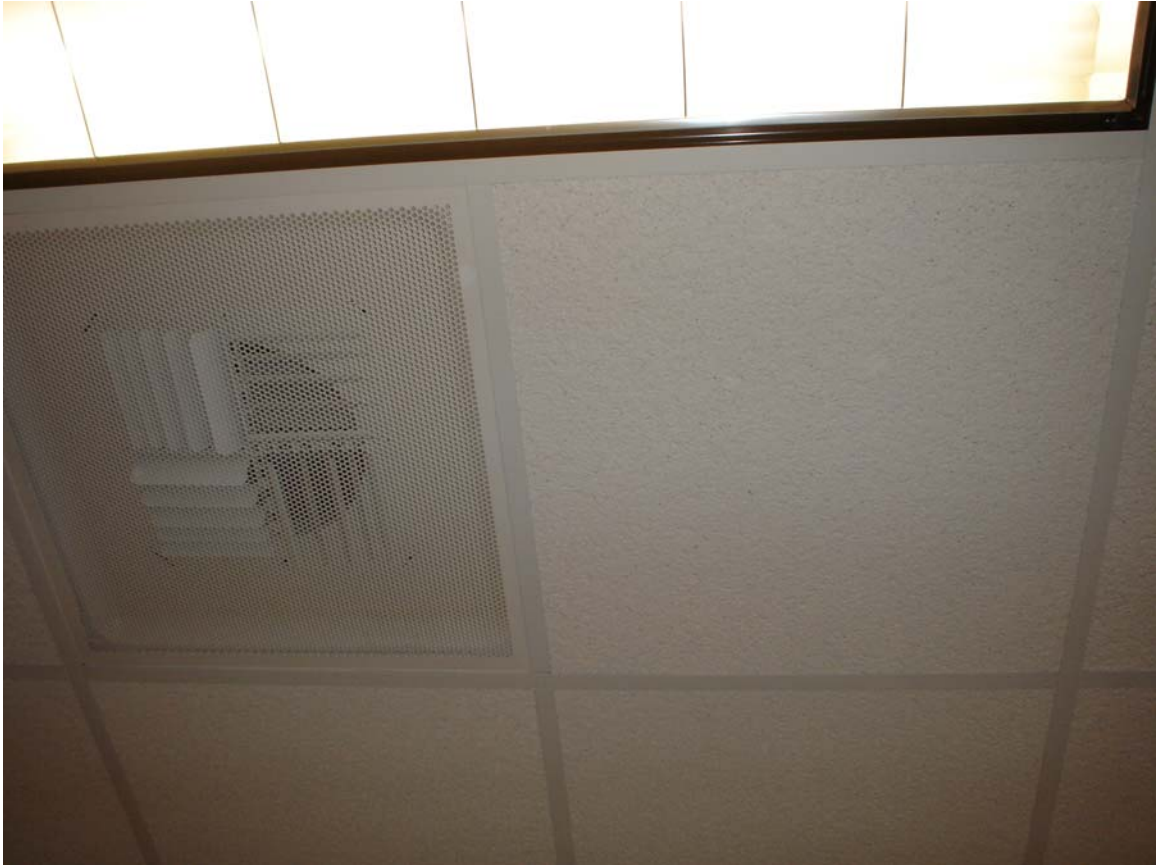
HA #42 – Non asbestos-containing 2' x 2' white lay-in ceiling tile
with pin holes

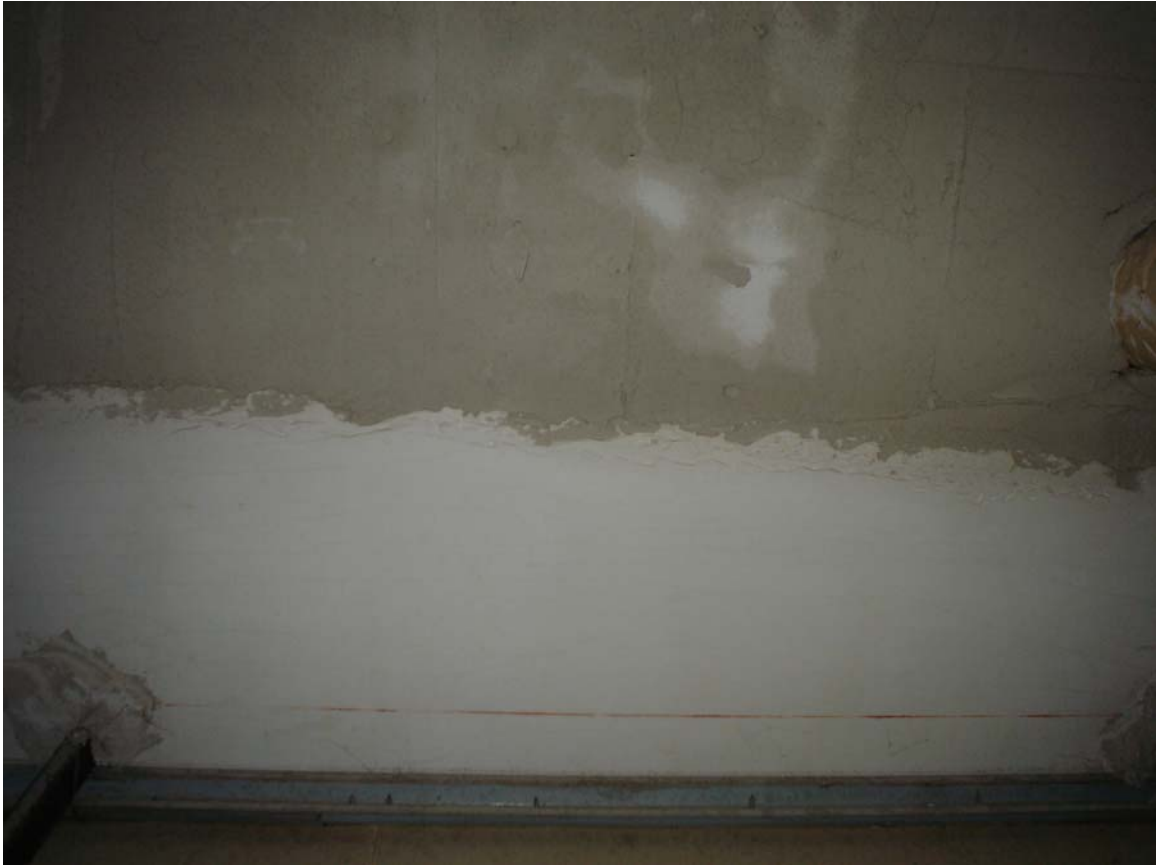
HA #44 – Non asbestos-containing drywall

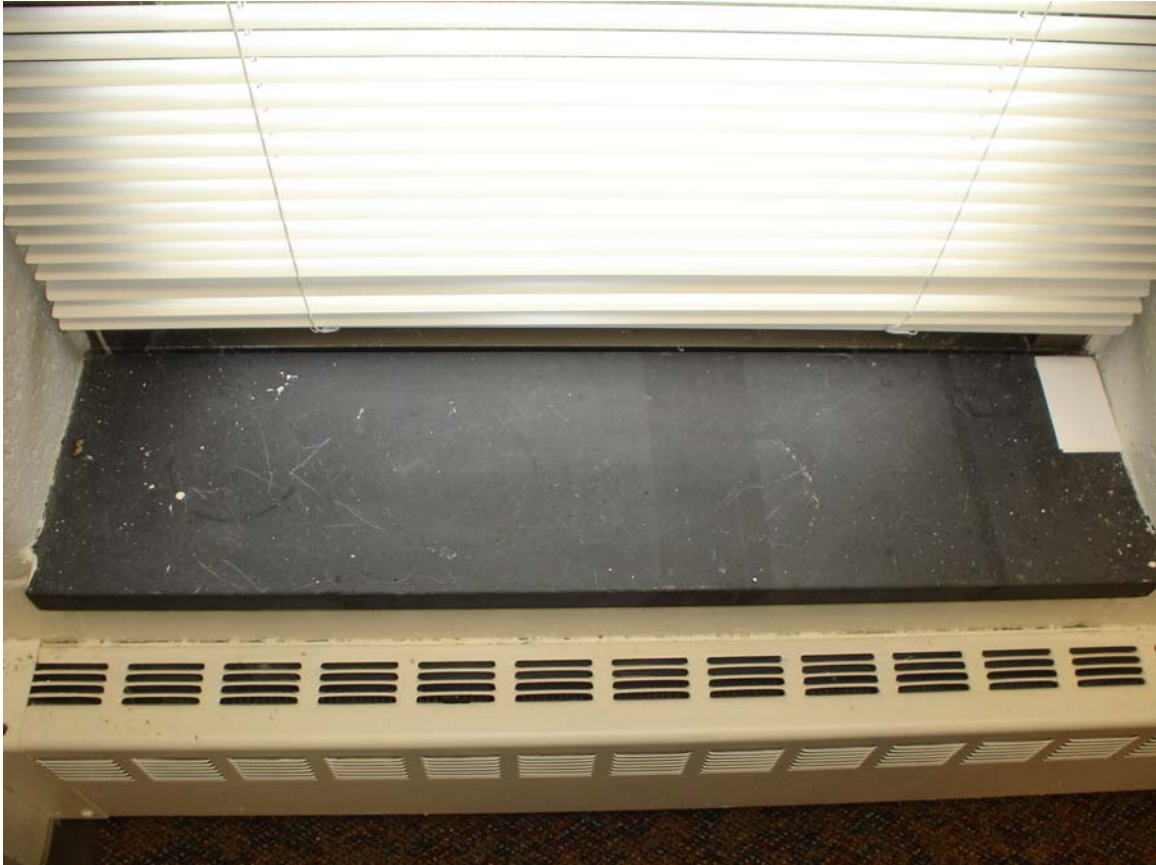
HA #45 – Assumed asbestos-containing black slate window sill

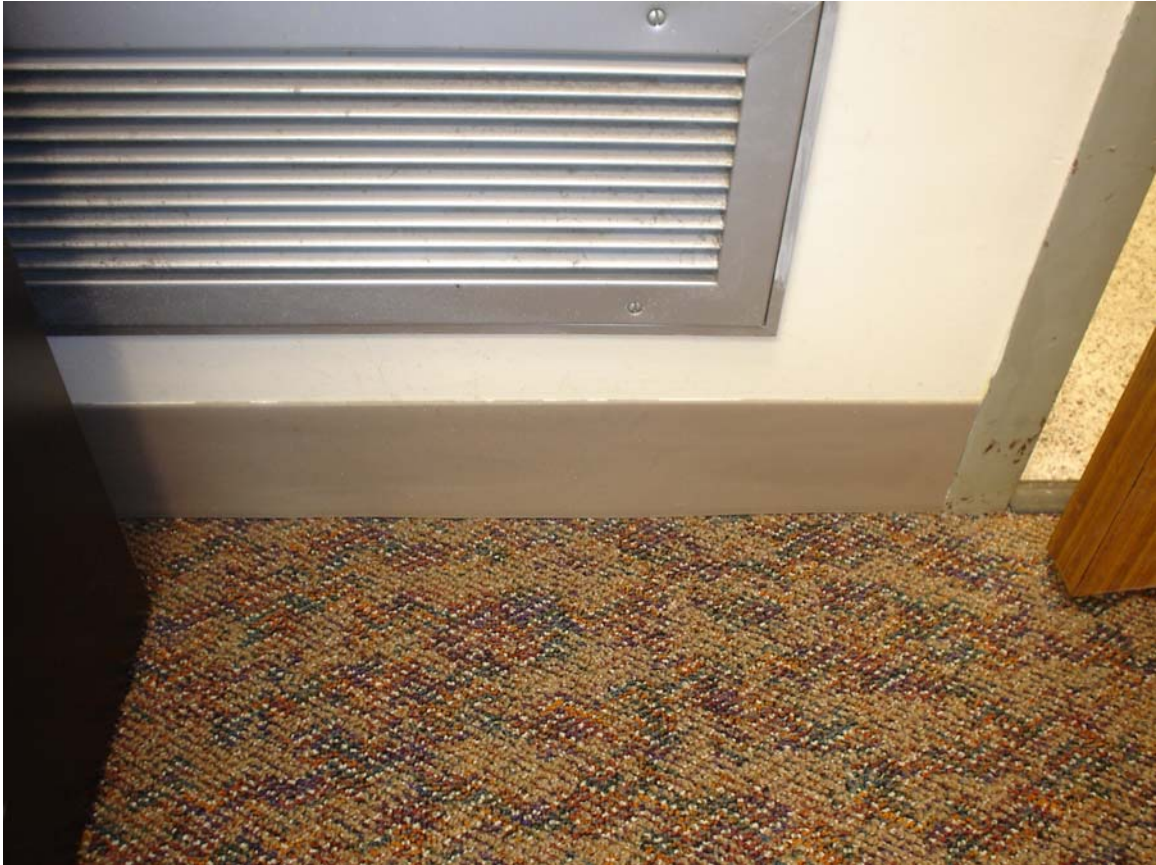
HA #46 – Non asbestos-containing 4” tan cove molding
and associated mastic

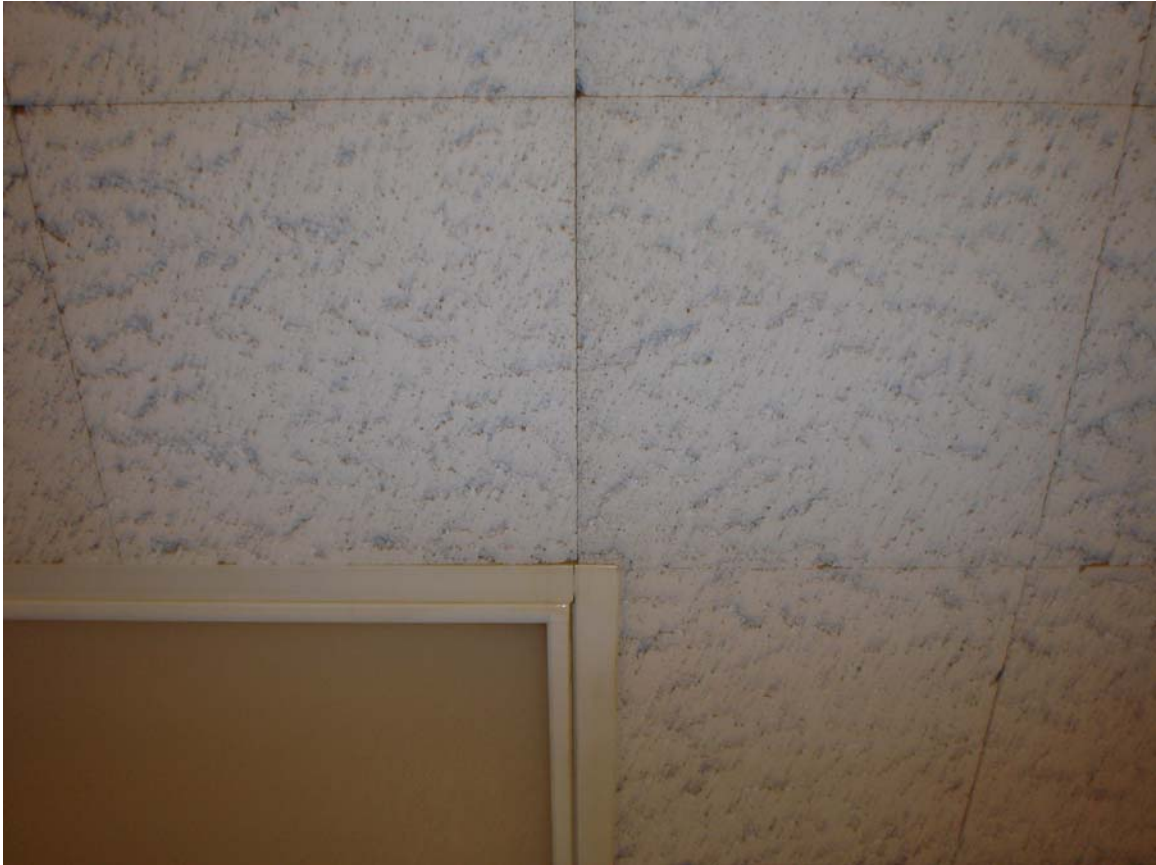
HA #47 – Non asbestos-containing 12” x 12” white spline ceiling tile
with pin holes and fissures

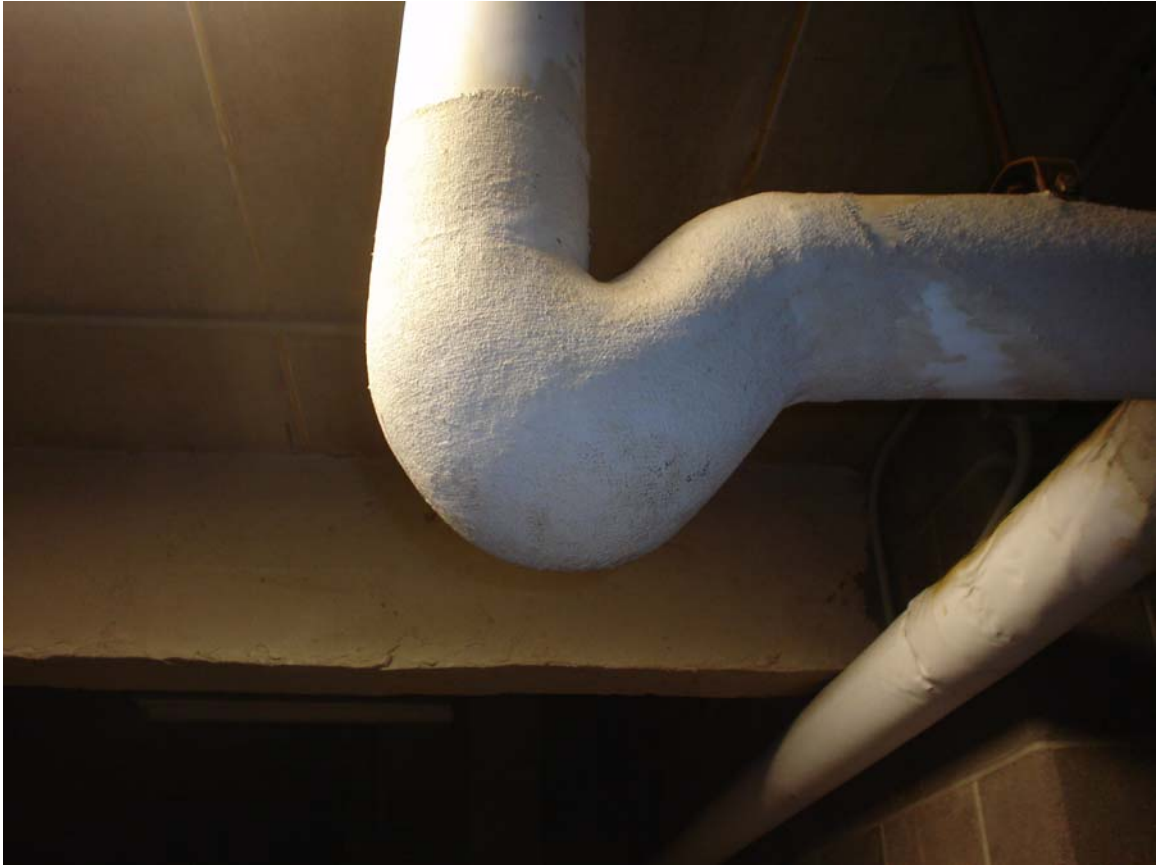
HA #49 – Asbestos-containing drain system pipe joint and hanger insulation

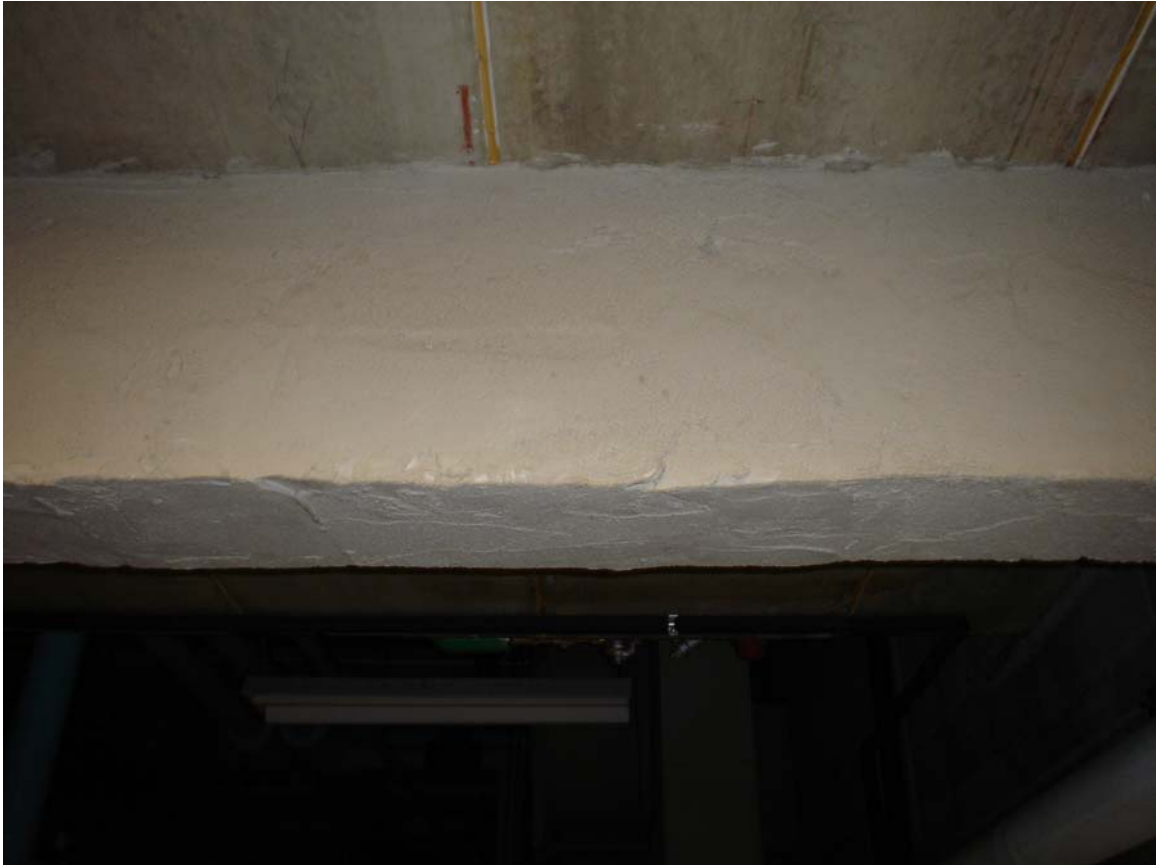
HA #54 – Non asbestos-containing trowelled-on fireproofing

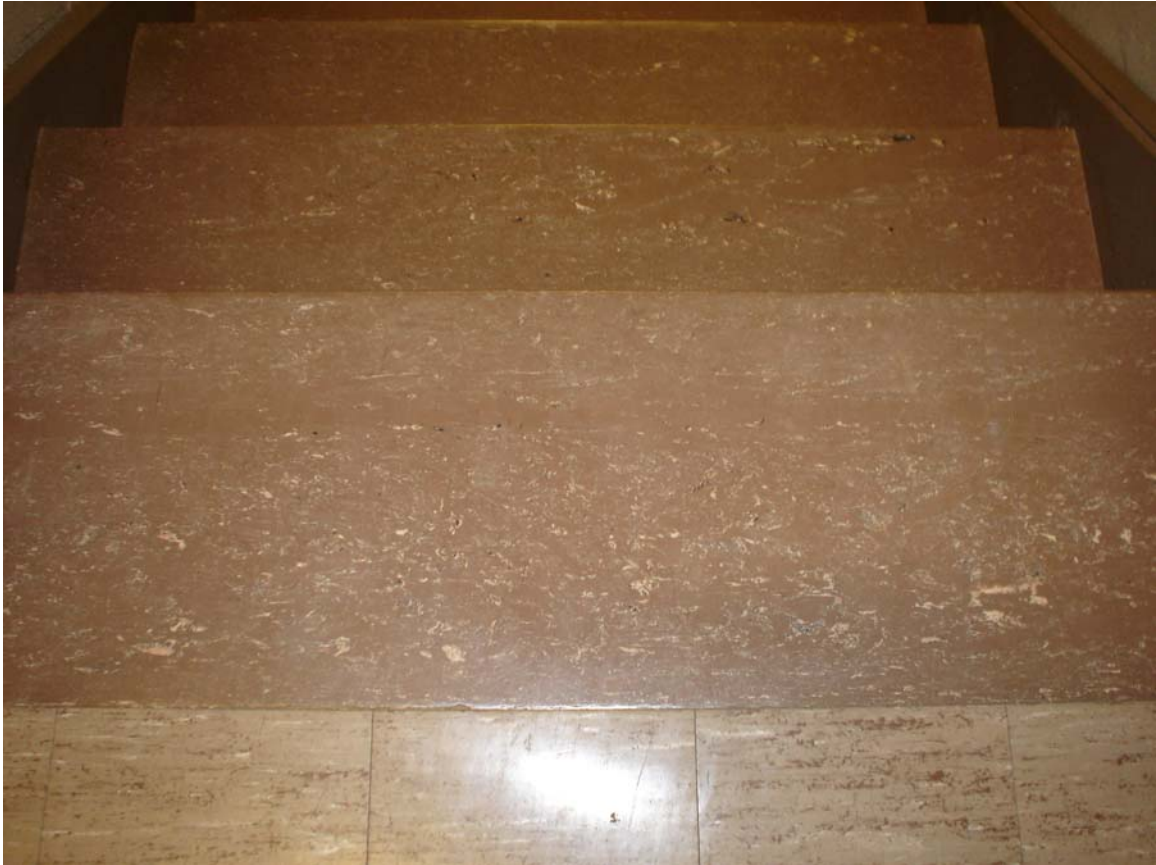
HA #56 – Asbestos-containing tan stair tread with cream, black and pink streaks and associated non asbestos-containing mastic

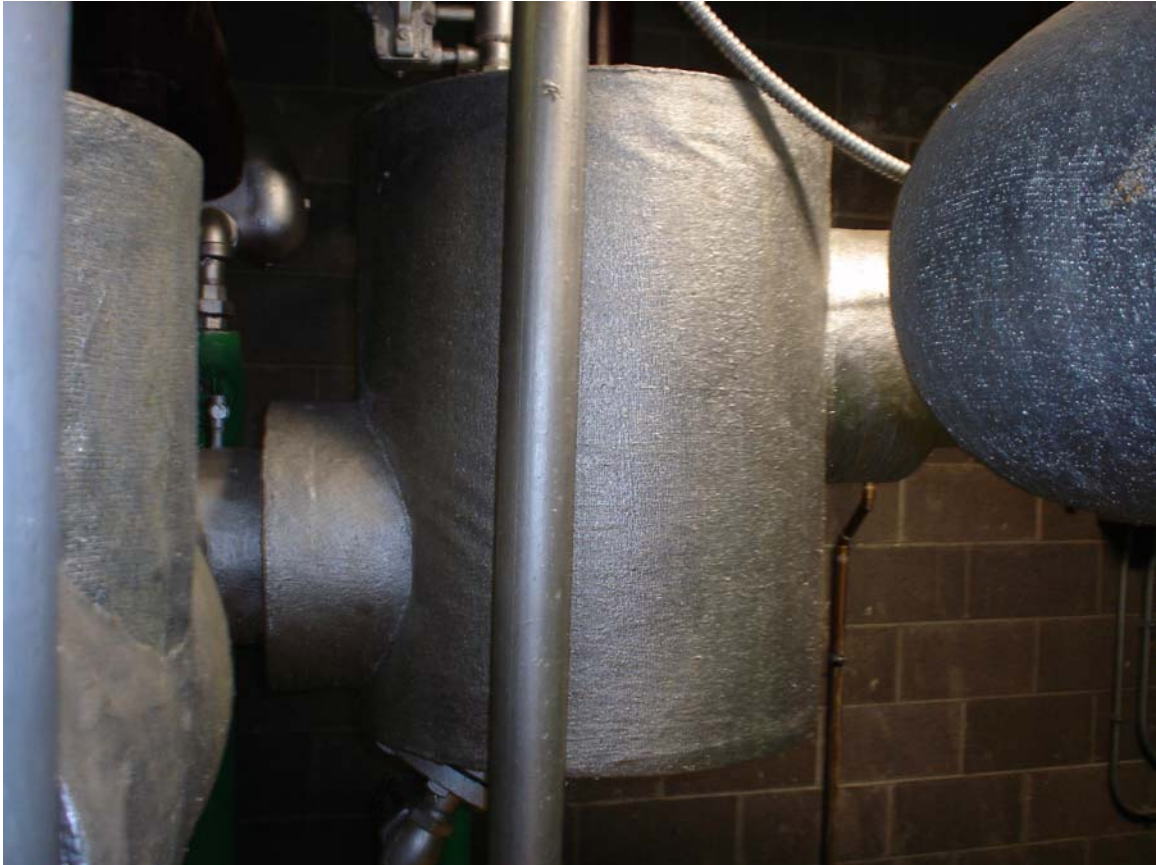
HA #57 – Asbestos-containing canvas wrap on fiberglass insulation

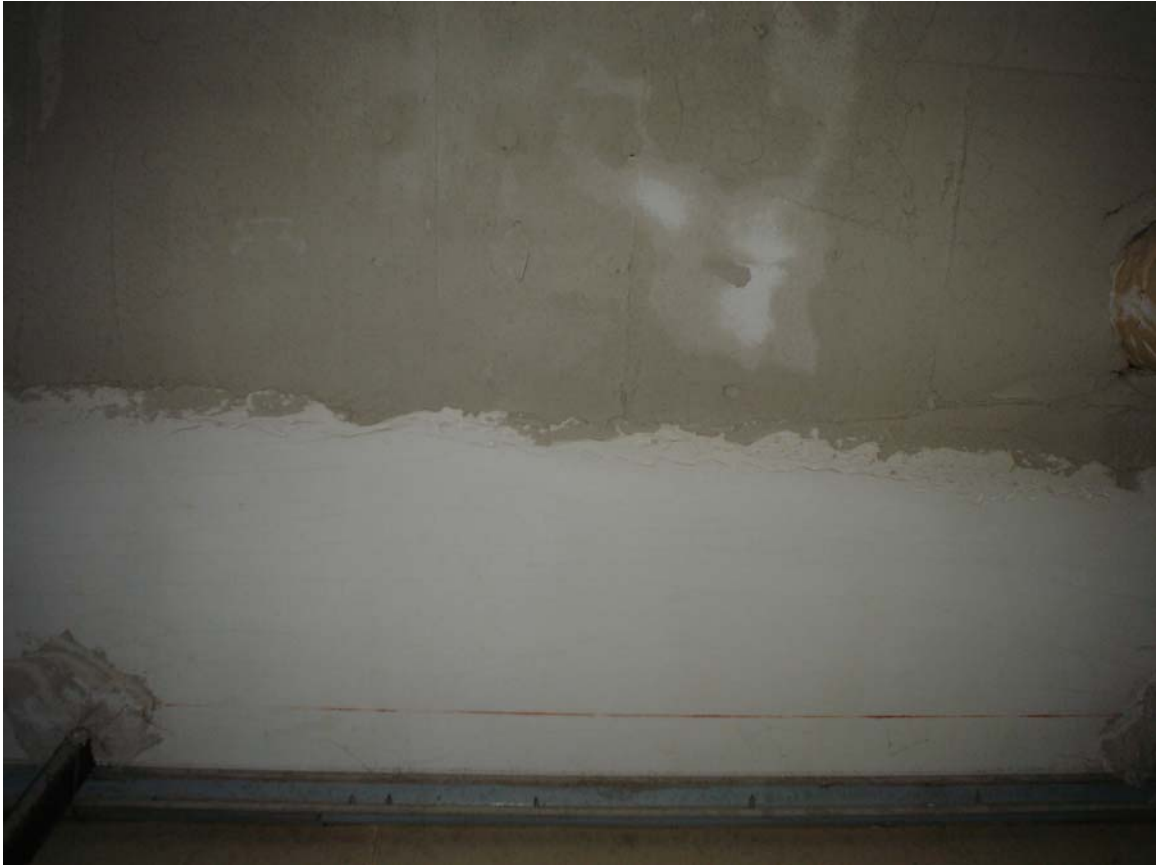
HA #58 – Non asbestos-containing drywall joint compound

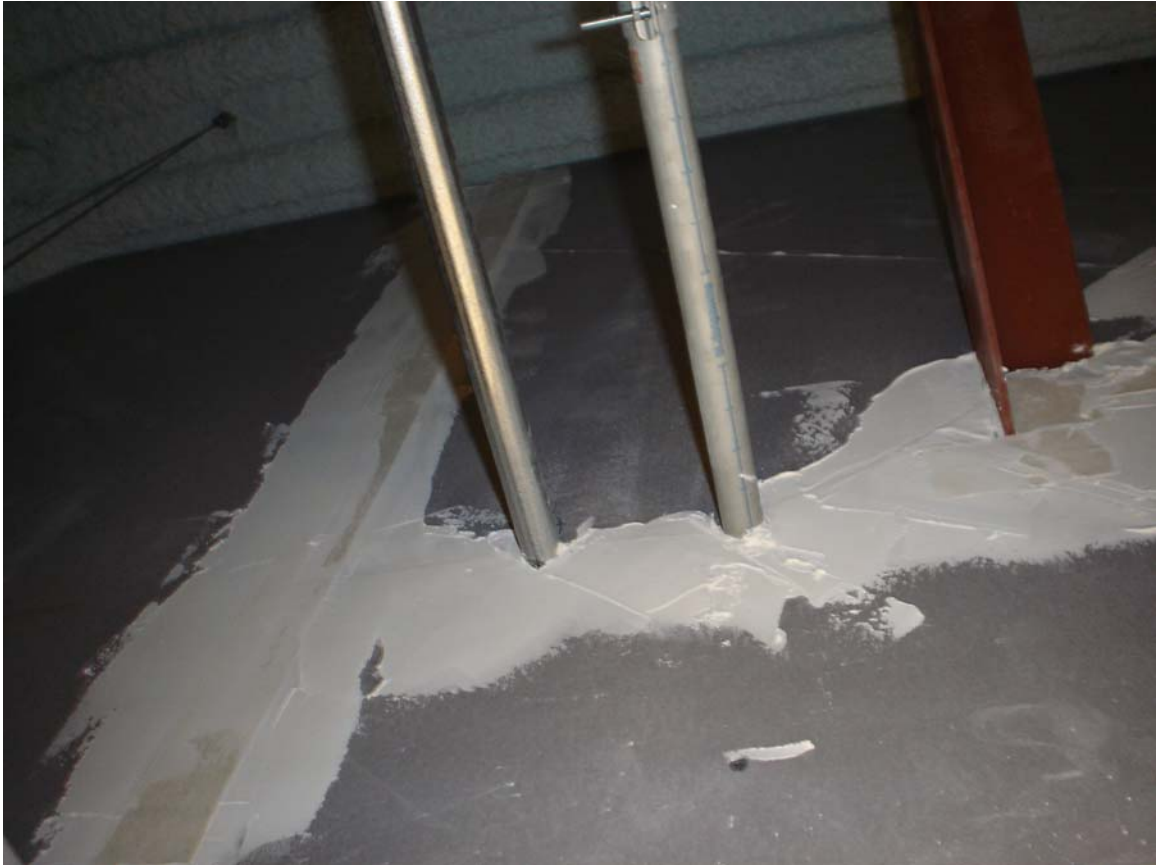
HA #58 – Non asbestos-containing drywall joint compound
