## Amtrak Station Photo Log

Amtrak Station, East Lansing, Michigan

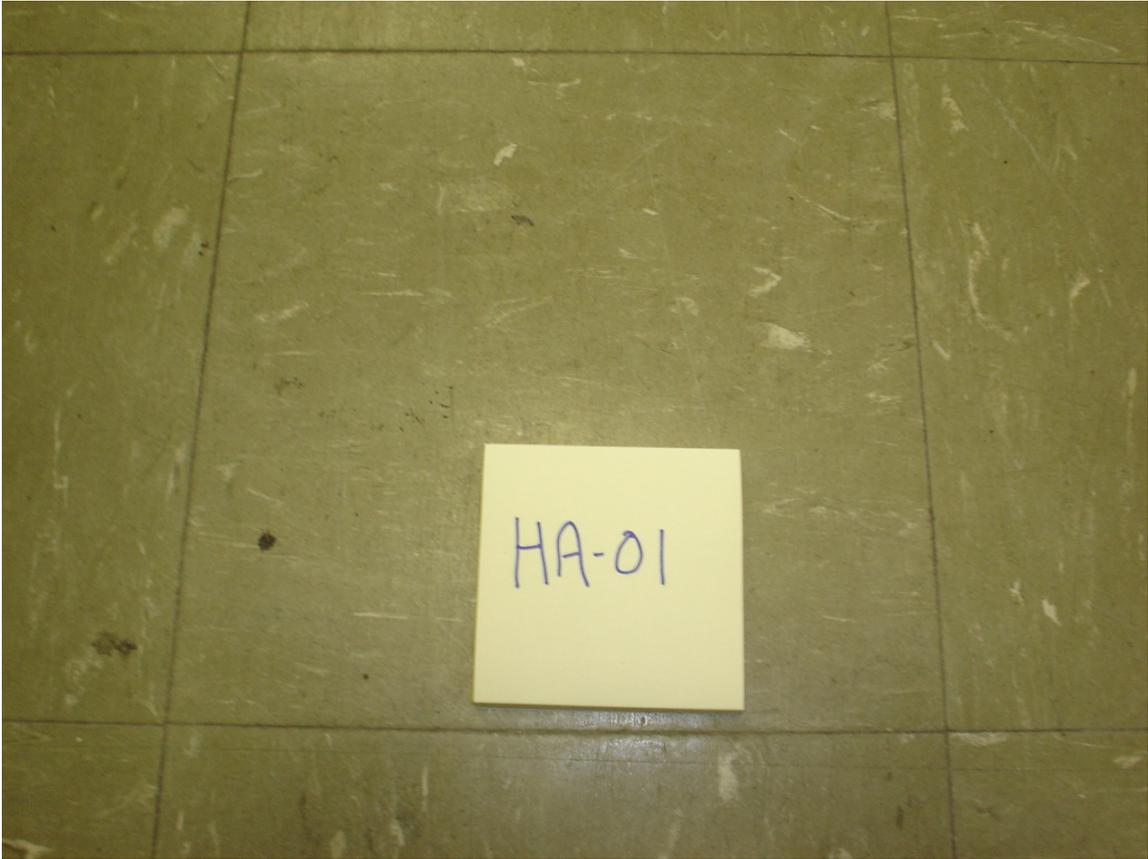
HA #1 – Asbestos-containing 9" x 9" gray floor tile with white streaks  
and associated non asbestos-containing mastic

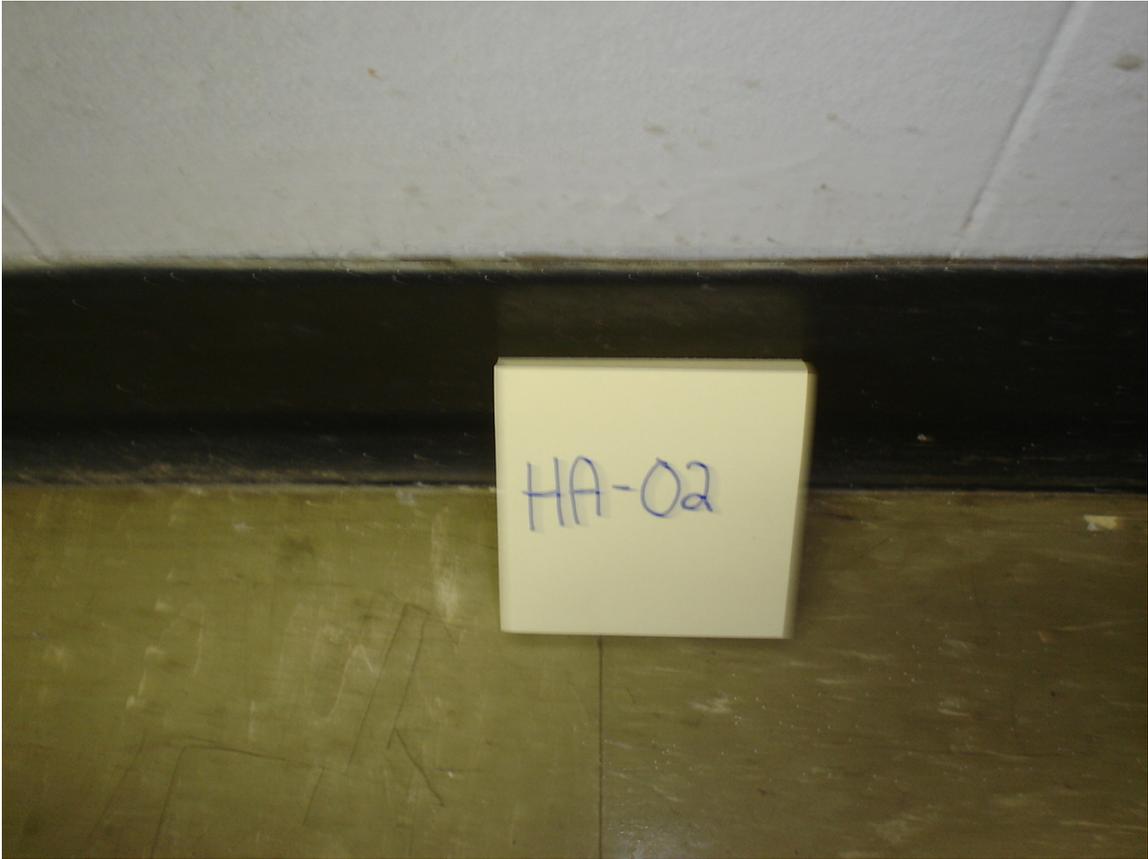
HA #2 – Non asbestos-containing 4" black cove molding  
and associated mastic

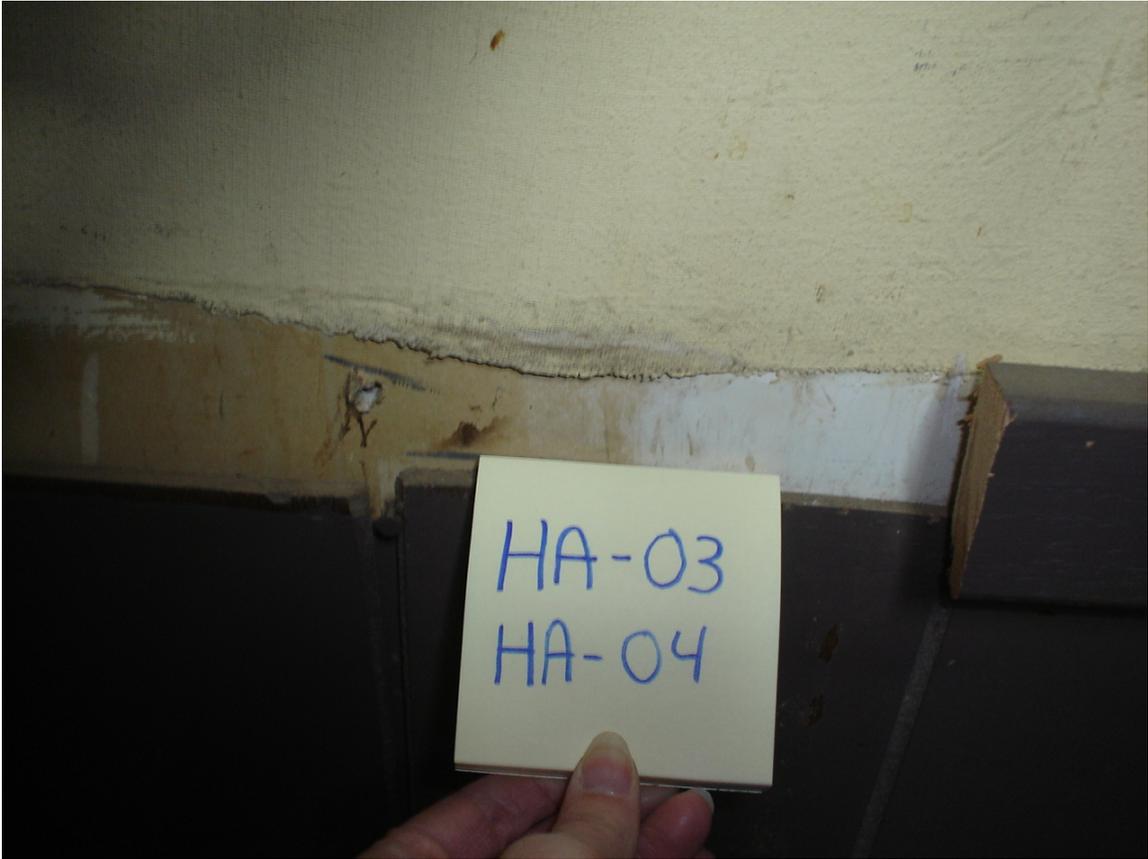
HA #3 – Non asbestos-containing drywall

HA #4 – Asbestos-containing drywall joint compound

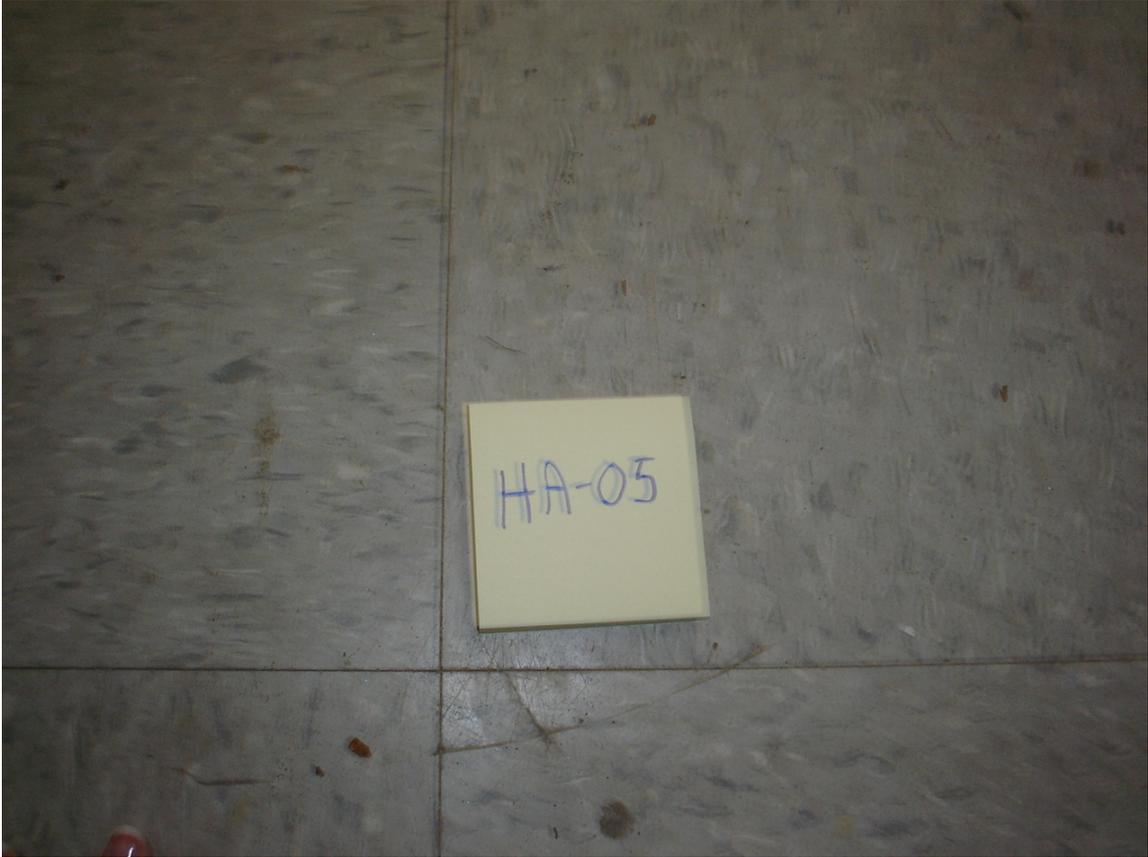
HA #5 – Non asbestos-containing 12" x 12" gray floor tile with gray and white streaks and associated mastic

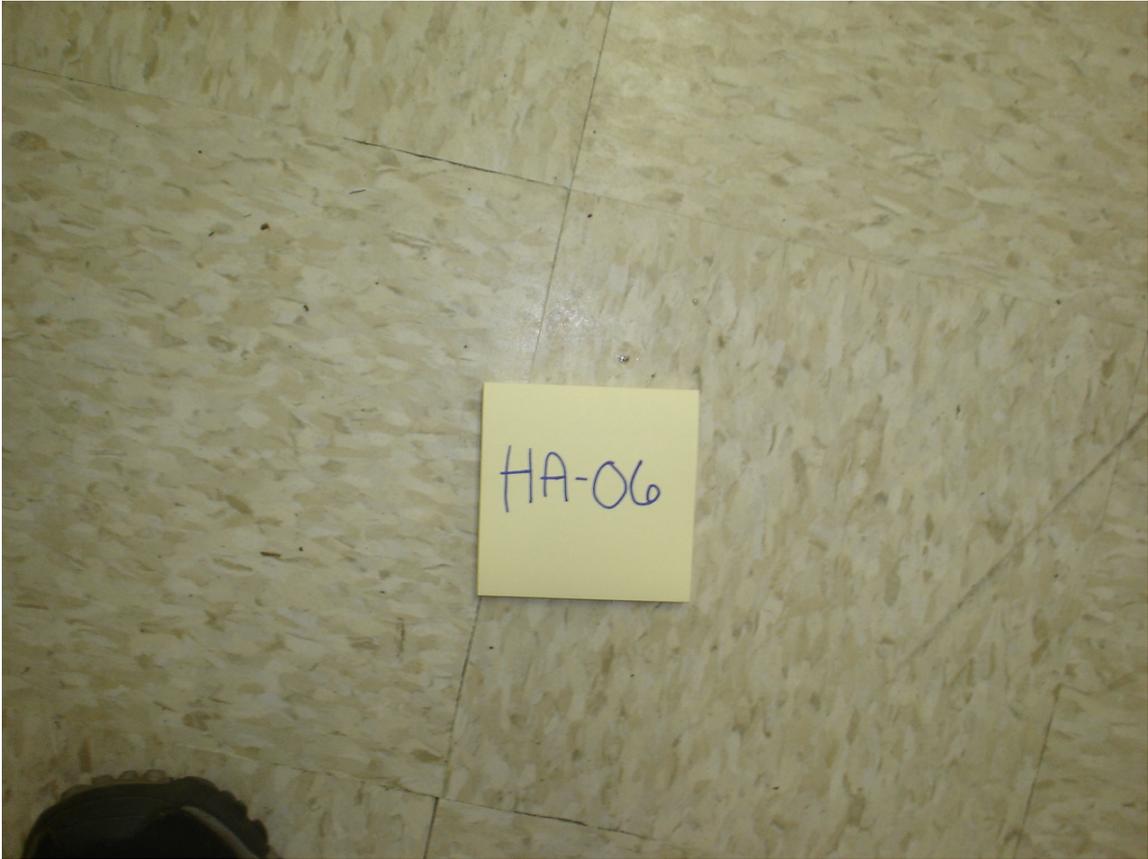
HA #6 – Non asbestos-containing 12" x 12" white floor tile  
with brown and gray streaks and associated mastic

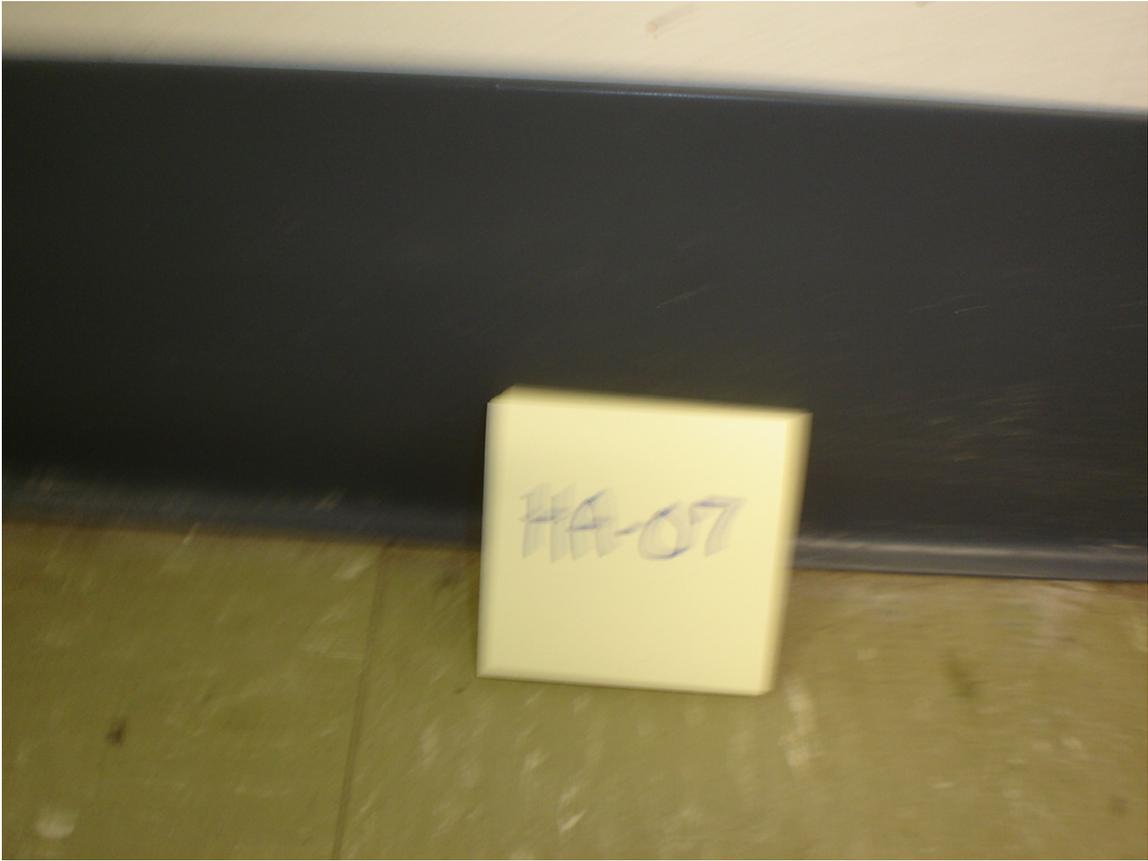
HA #7 – Non asbestos-containing 6" gray cove molding  
and associated mastic

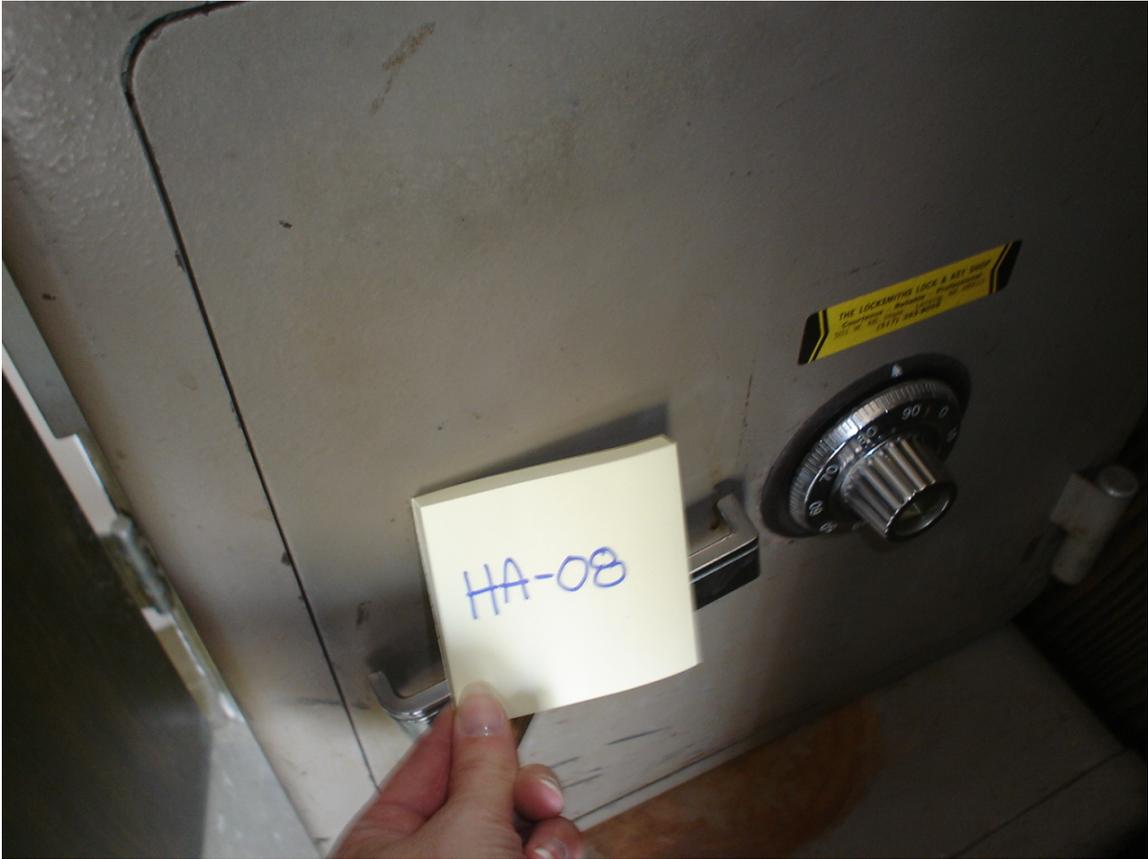
HA #8 – Assumed asbestos-containing safe

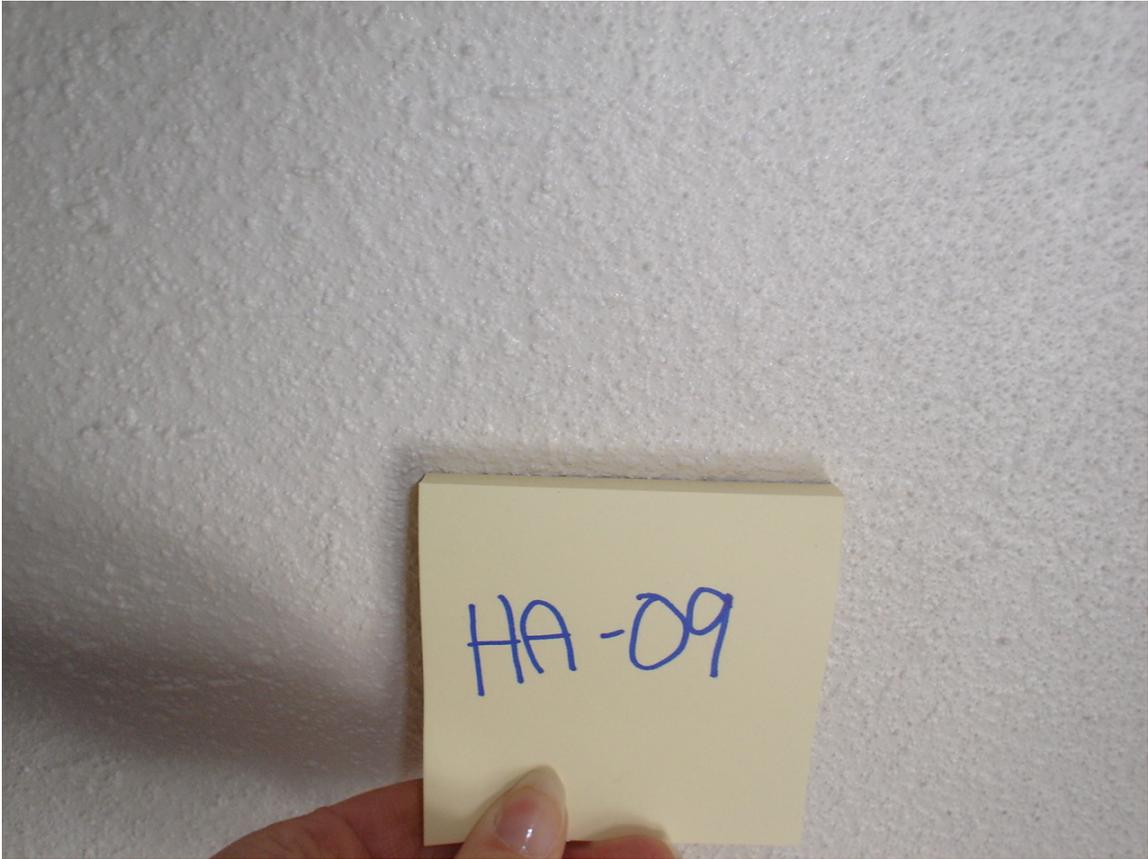
HA #9 – Non asbestos-containing textured ceiling plaster

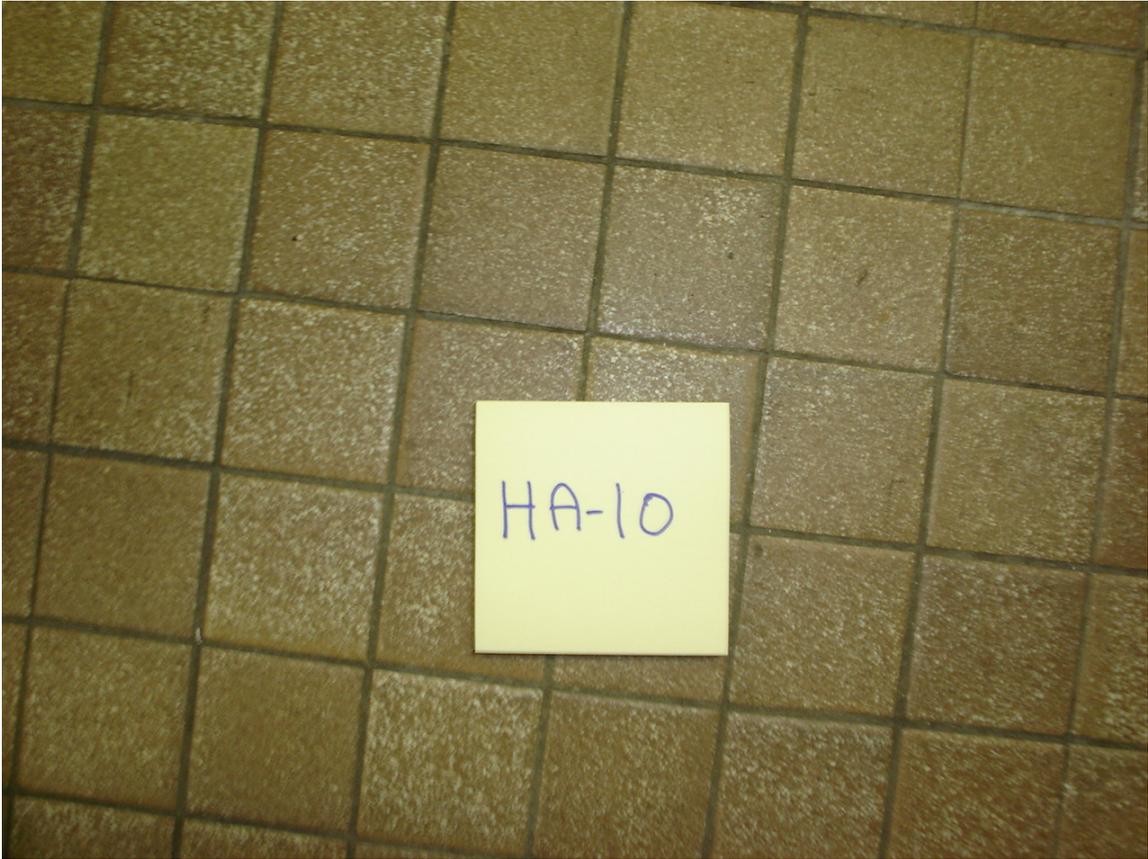
HA #10 – Assumed asbestos-containing ceramic tile bedding compound

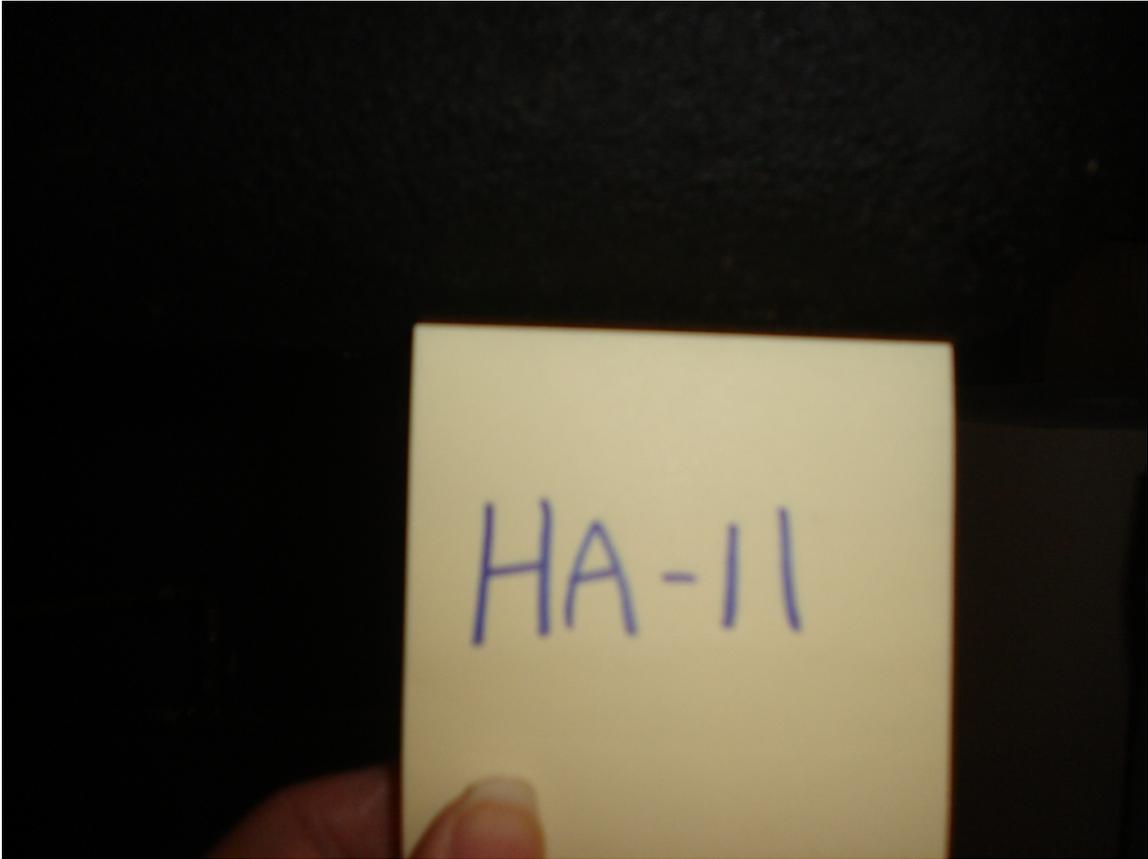
HA #11 – Asbestos-containing black sink undercoating

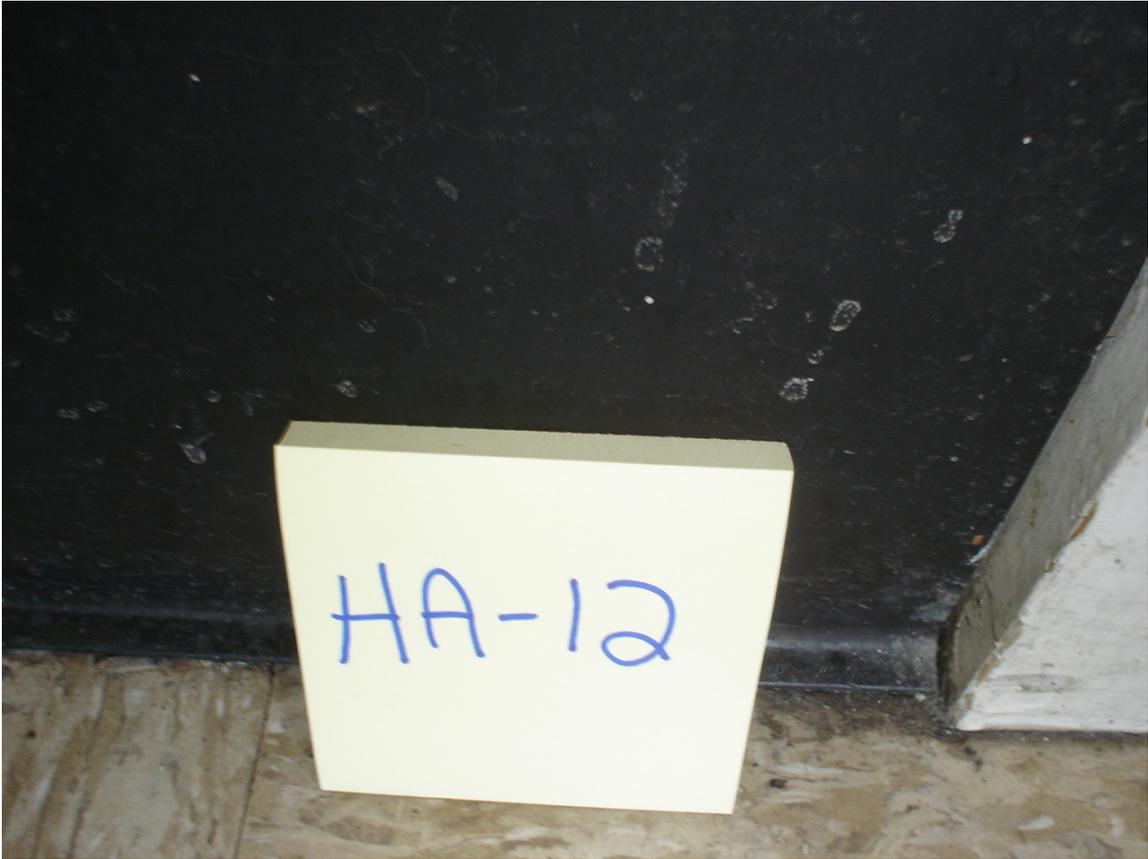
HA #12 – Non asbestos-containing 6” black cove molding  
and associated mastic

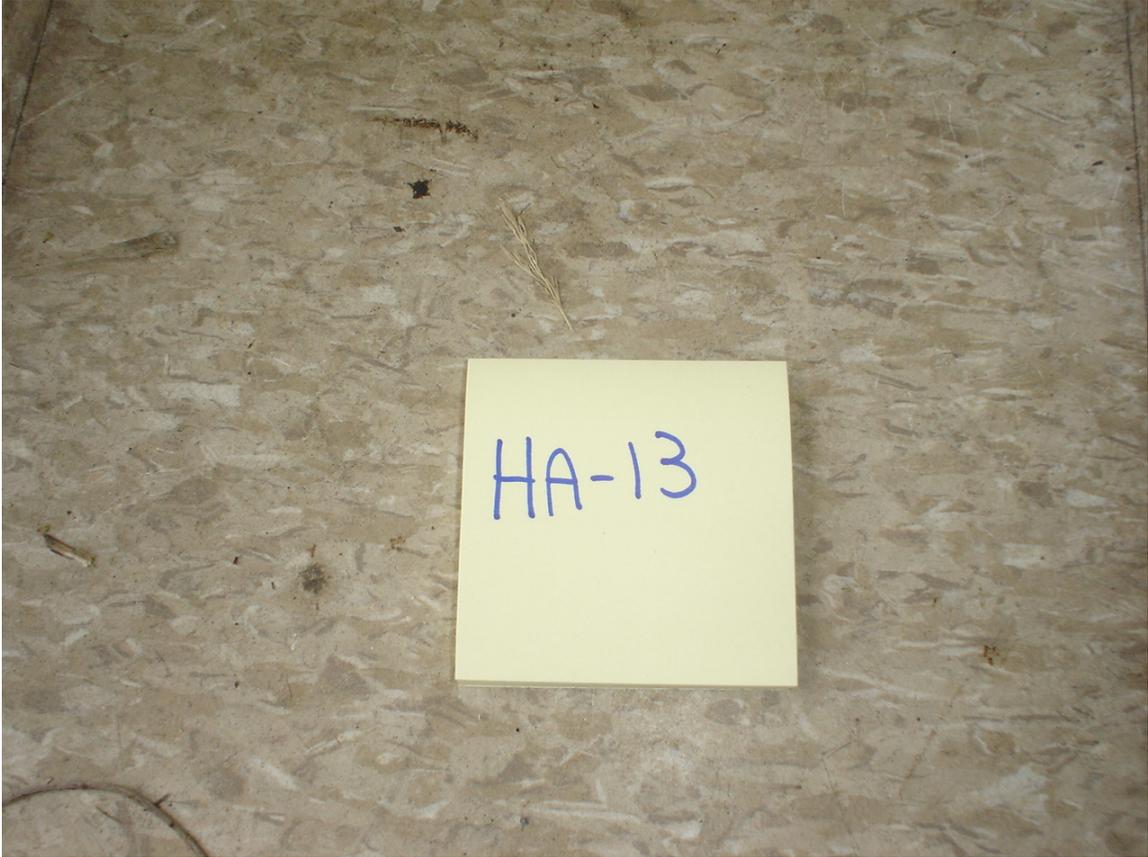
HA #13 – Non asbestos-containing 12" x 12" brown floor tile with brown and white streaks and associated mastic

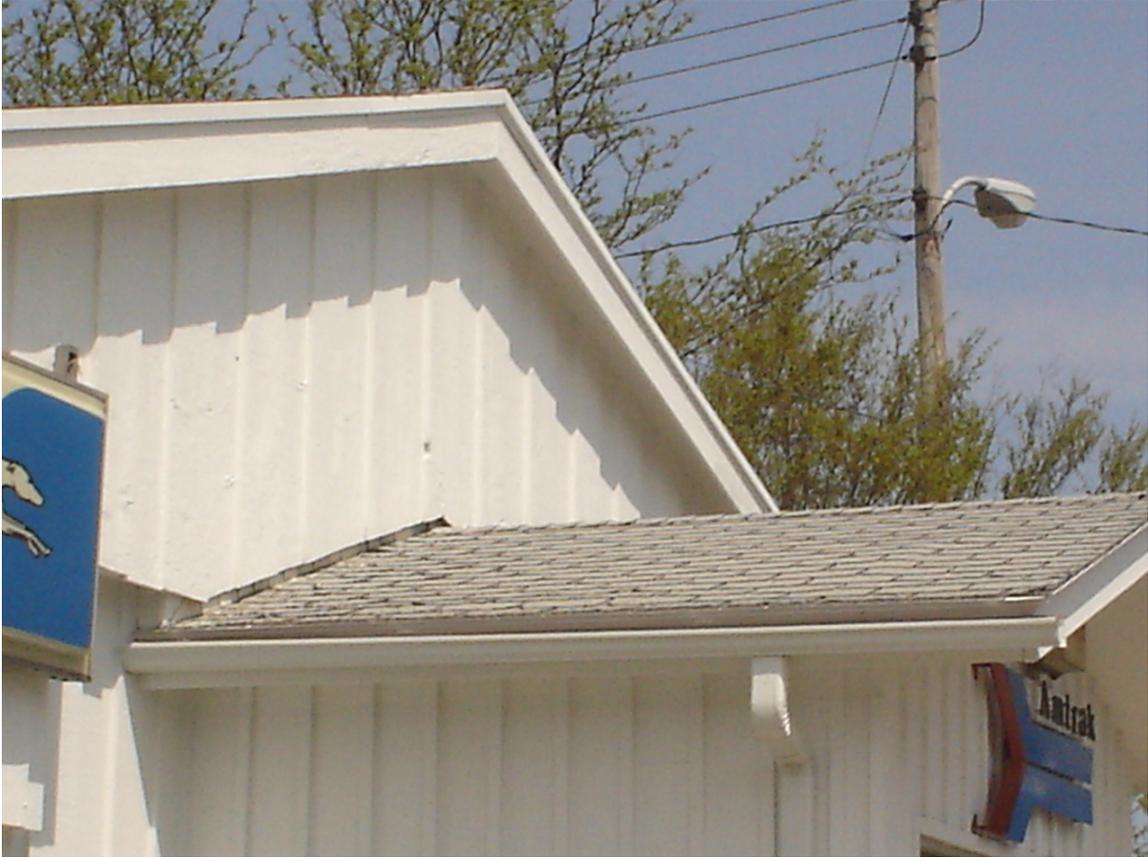
HA #14 – Non asbestos-containing gray roof shingles

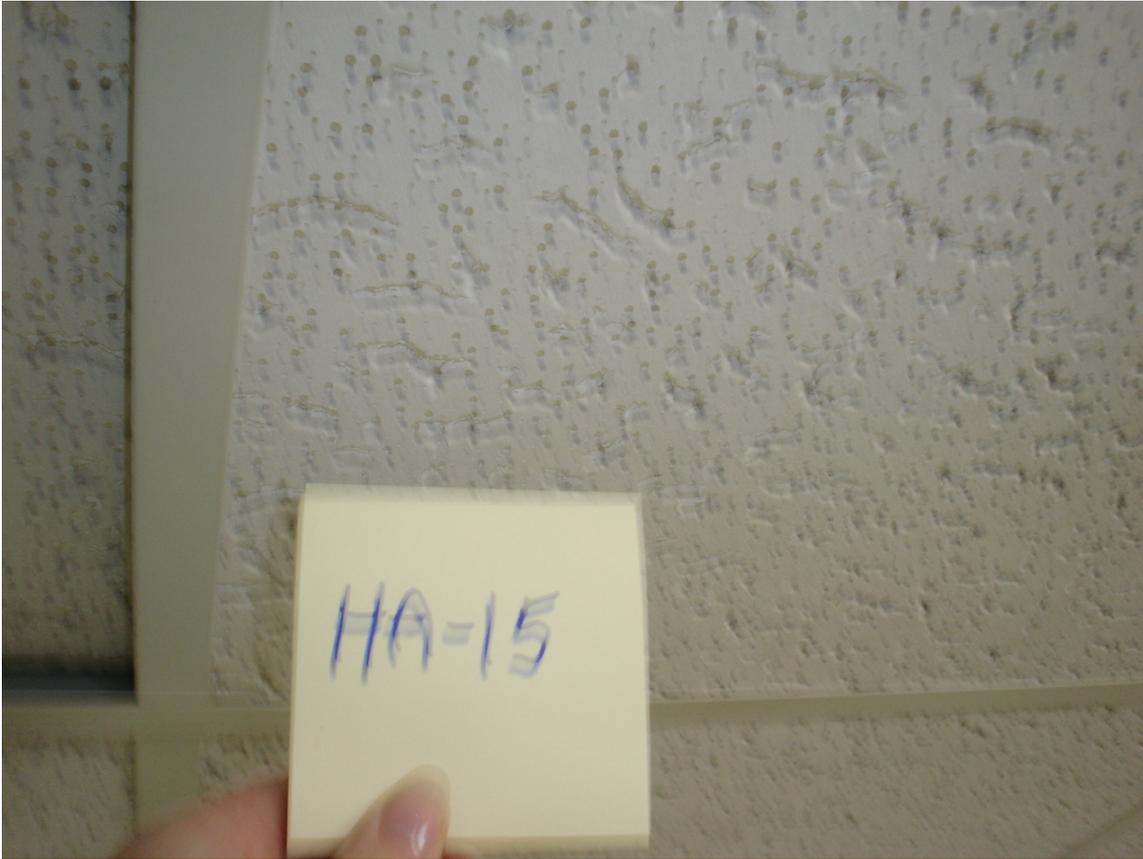
HA #15 – Non asbestos-containing 2' x 4' white lay-in ceiling tile  
with pin holes and fissures

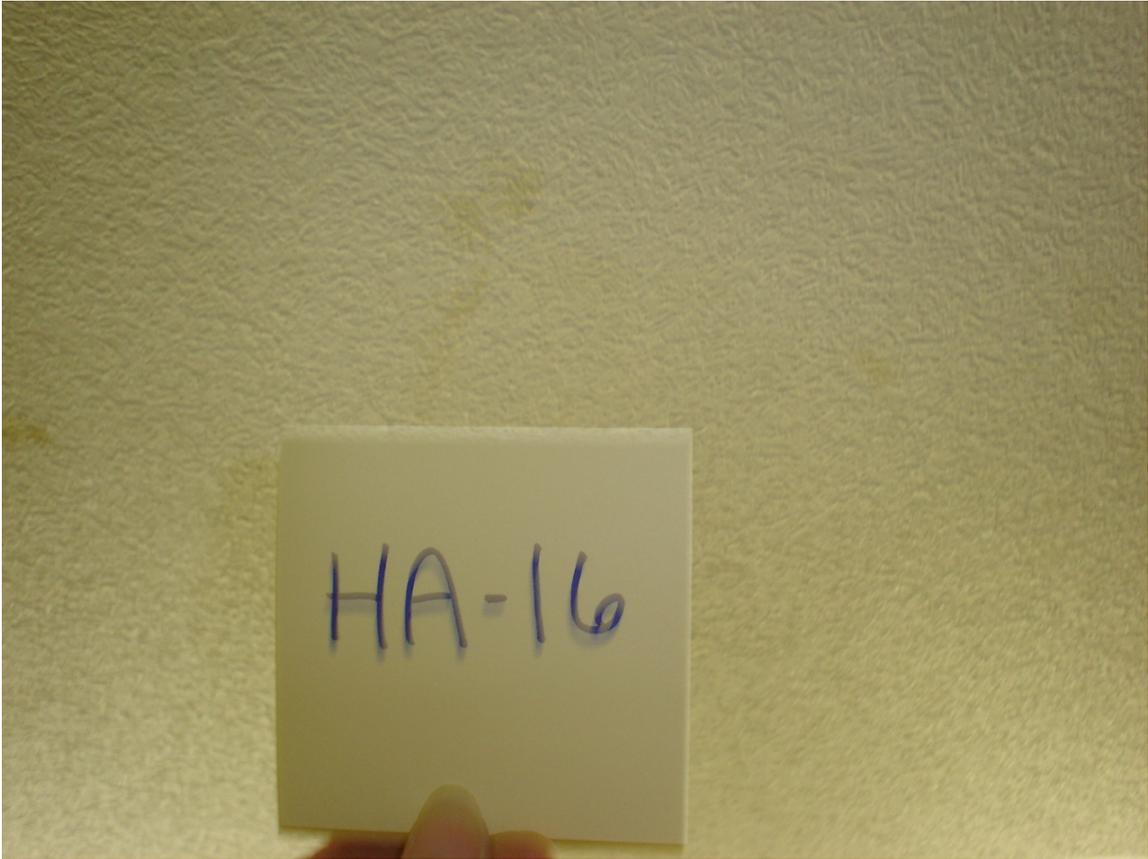
HA #16 – Non asbestos-containing 2' x 4' white textured lay-in ceiling tile
