Van Hoosen Hall Photo Log

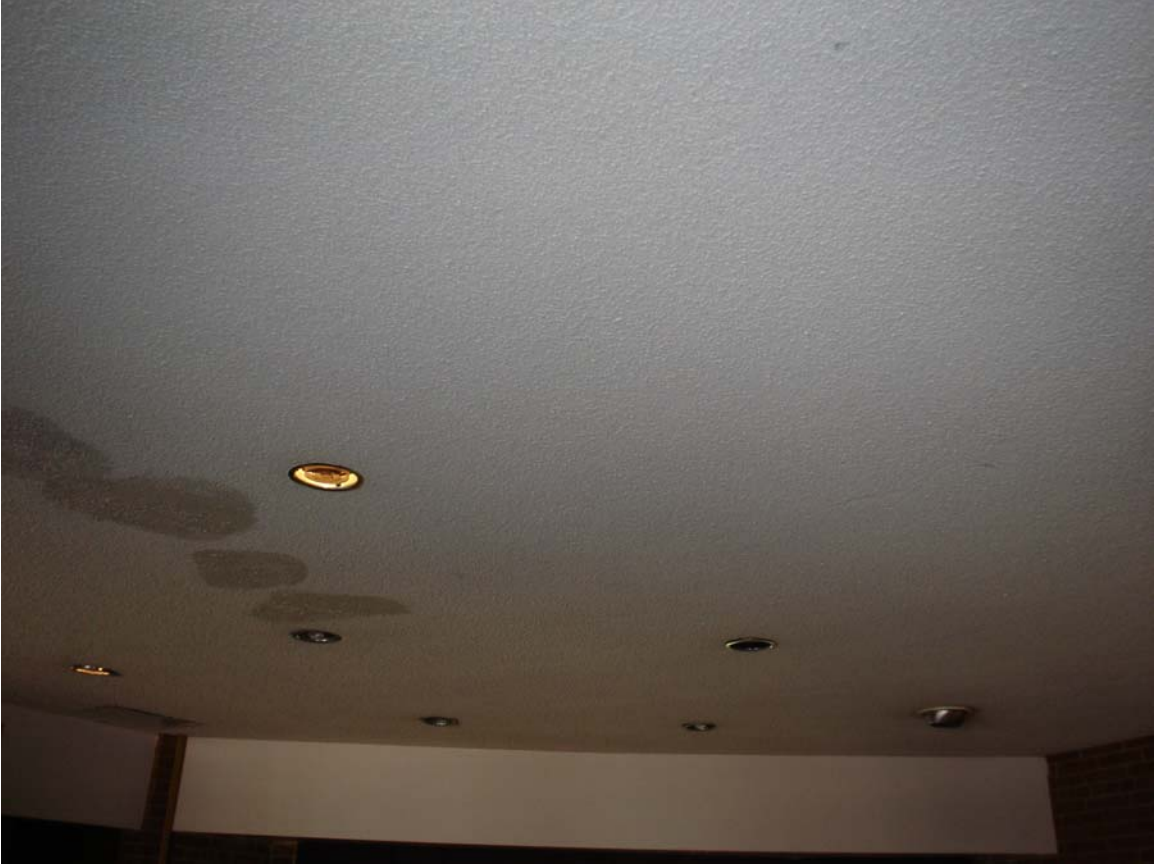
Photo 1 – Asbestos-containing spray-on acoustical ceiling plaster (popcorn)

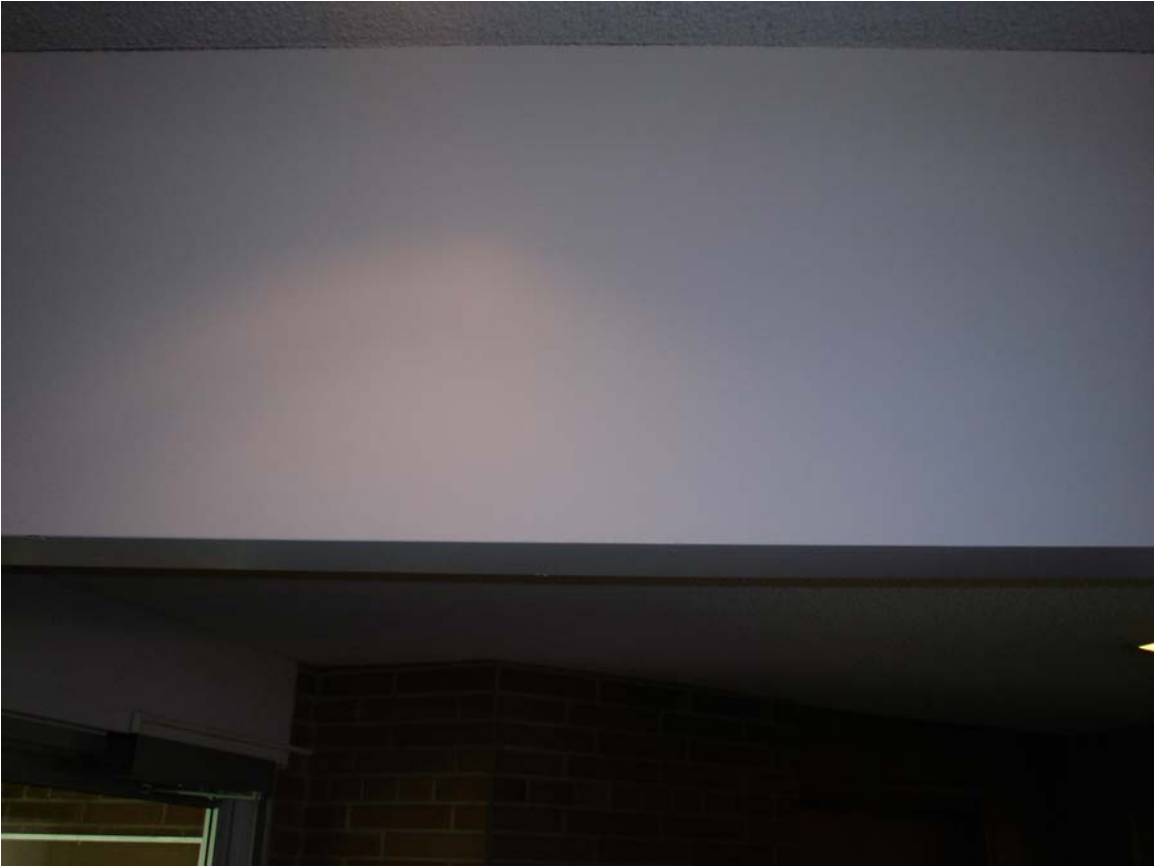
Photo 2 – Non asbestos-containing plaster (smooth)

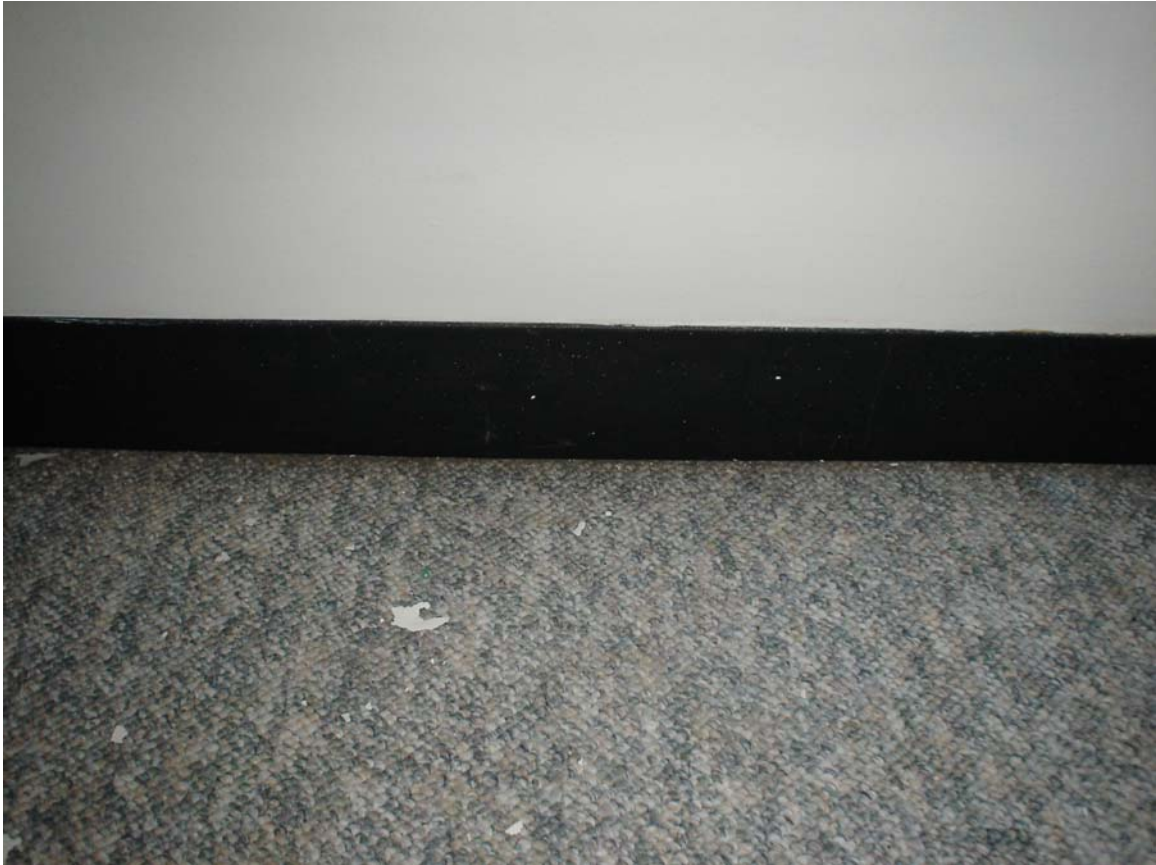
Photo 3 – Non asbestos-containing 4” black cove molding
and associated mastic

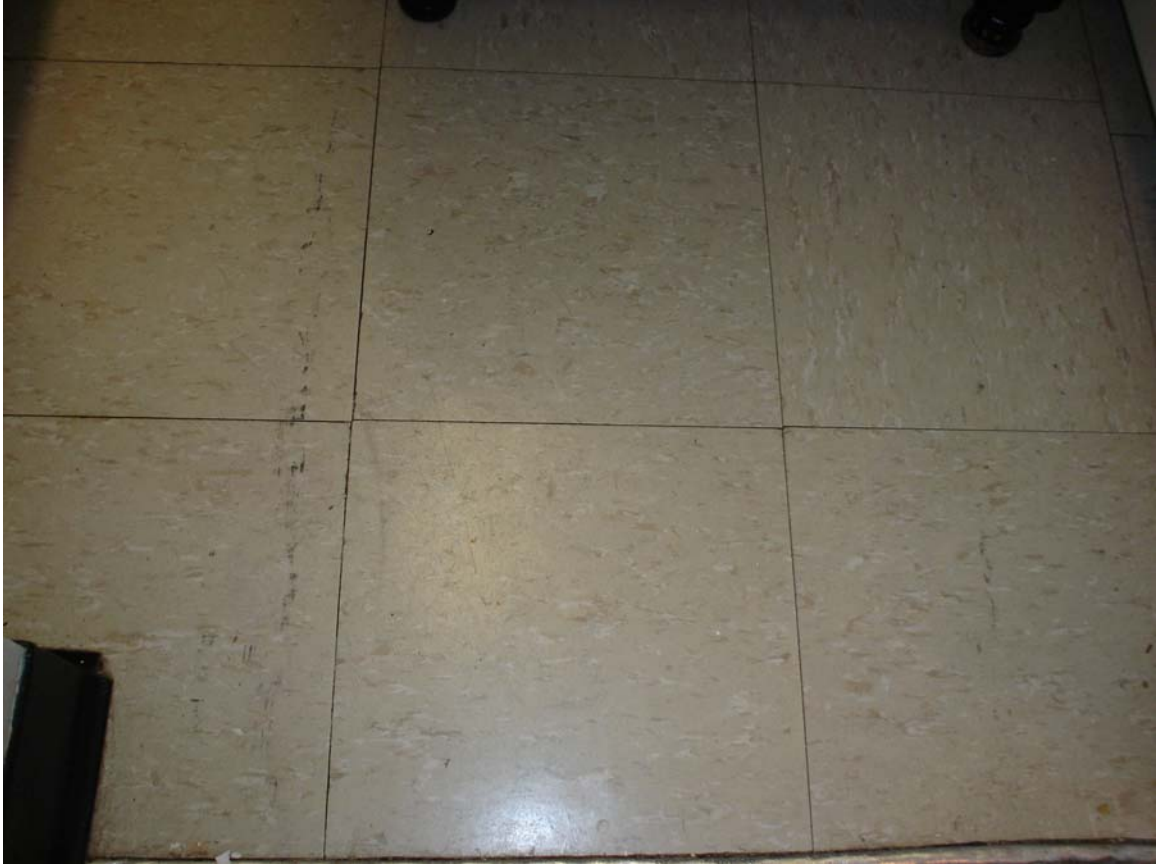
Photo 4 – Non asbestos-containing 12” x 12” cream floor tile with white and tan streaks and associated mastic

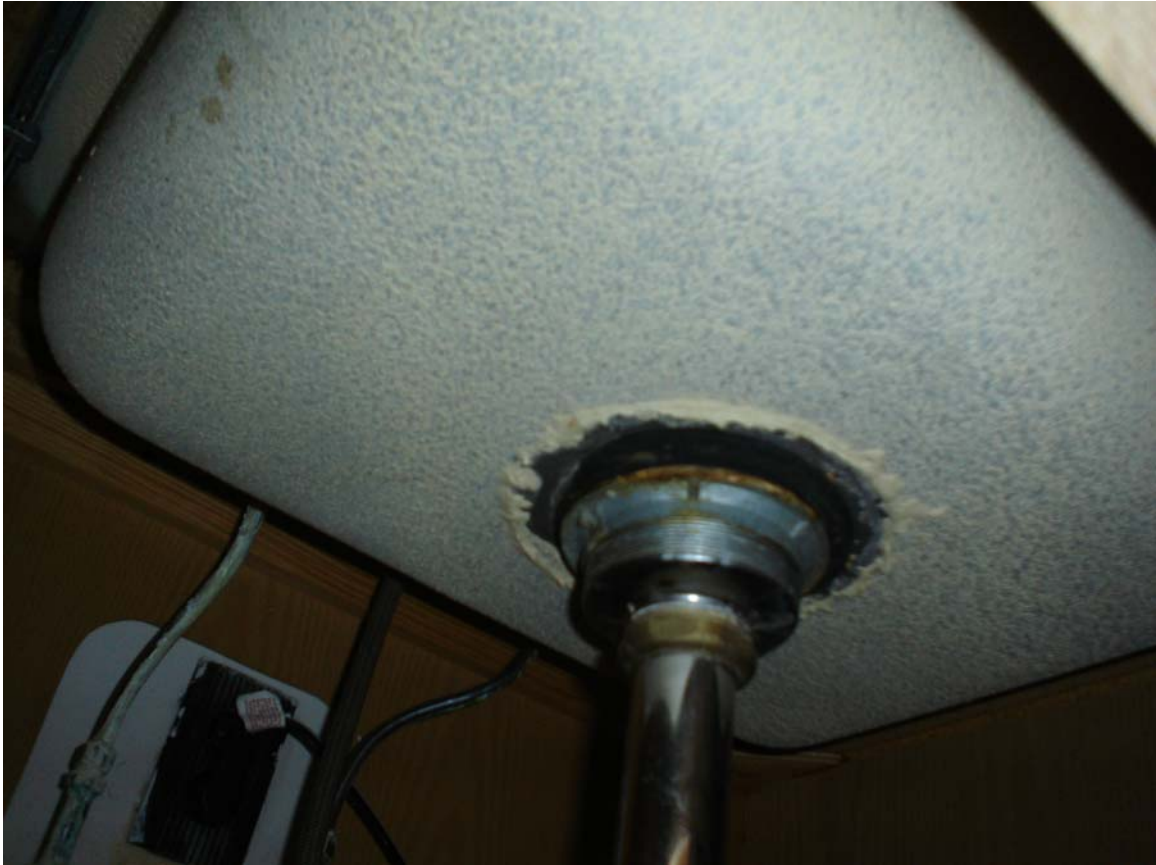
Photo 5 – Non asbestos-containing white sink undercoating

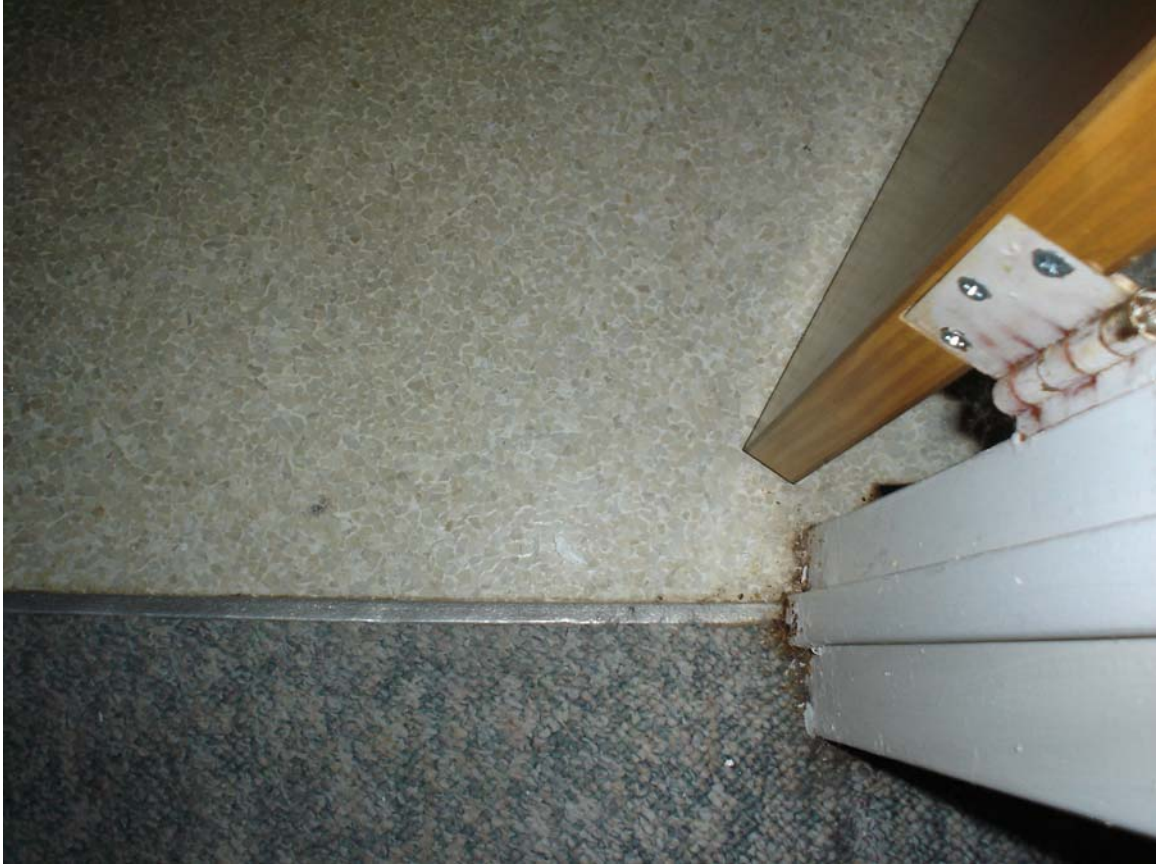
Photo 6 – Asbestos-containing cream linoleum
with mosaic pattern and associated mastic

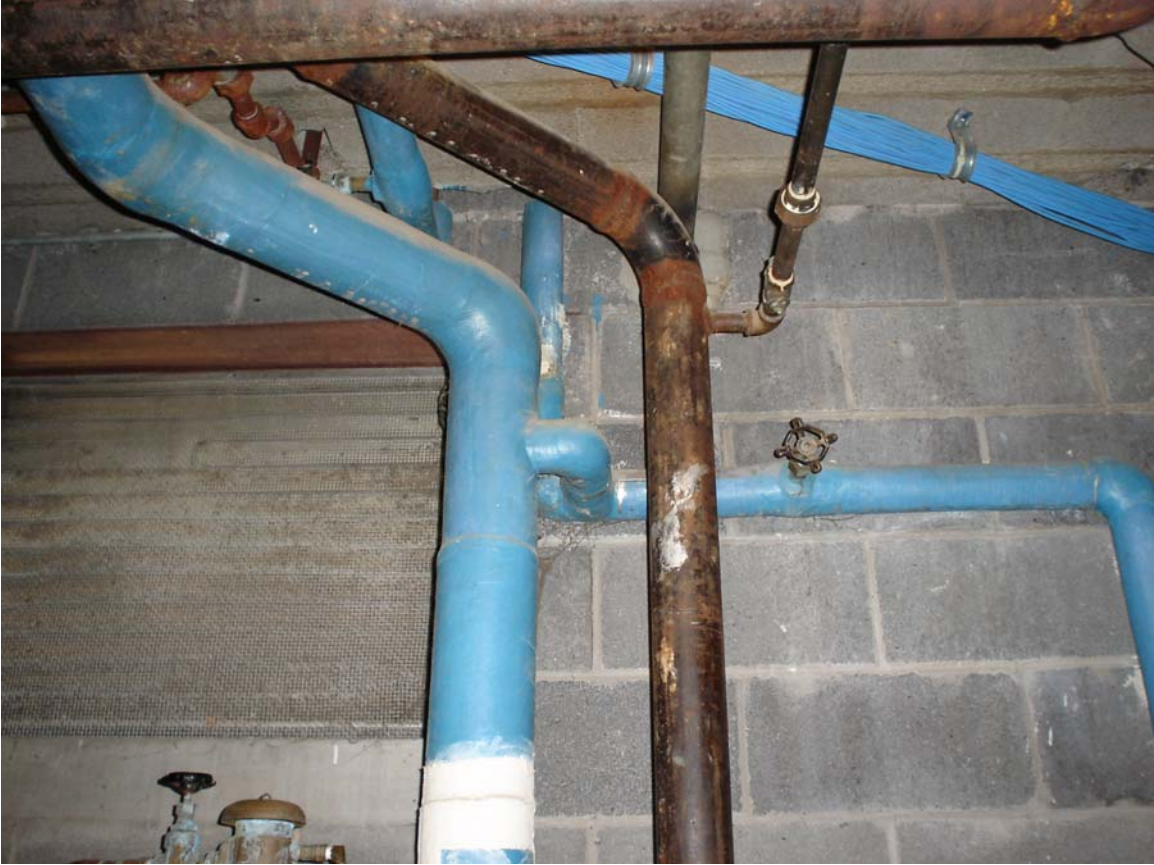
Photo 7 – Non asbestos-containing domestic water supply and
return pipe joint and hanger insulation
and
Asbestos-containing domestic water supply and
return pipe straight insulation

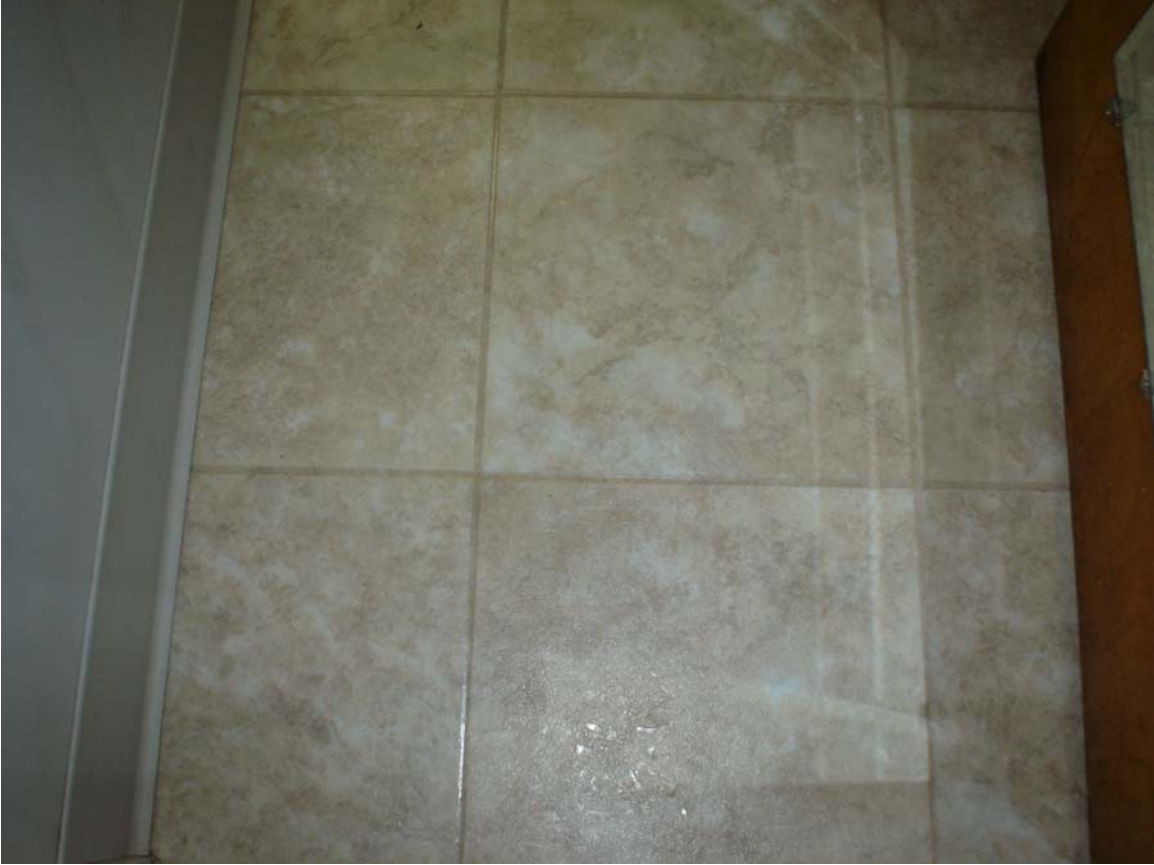
Photo 8 – Non asbestos-containing 12” x 12” tan linoleum
with swirl pattern and associated mastic
and
Non asbestos-containing 4” cream cove molding and associated mastic

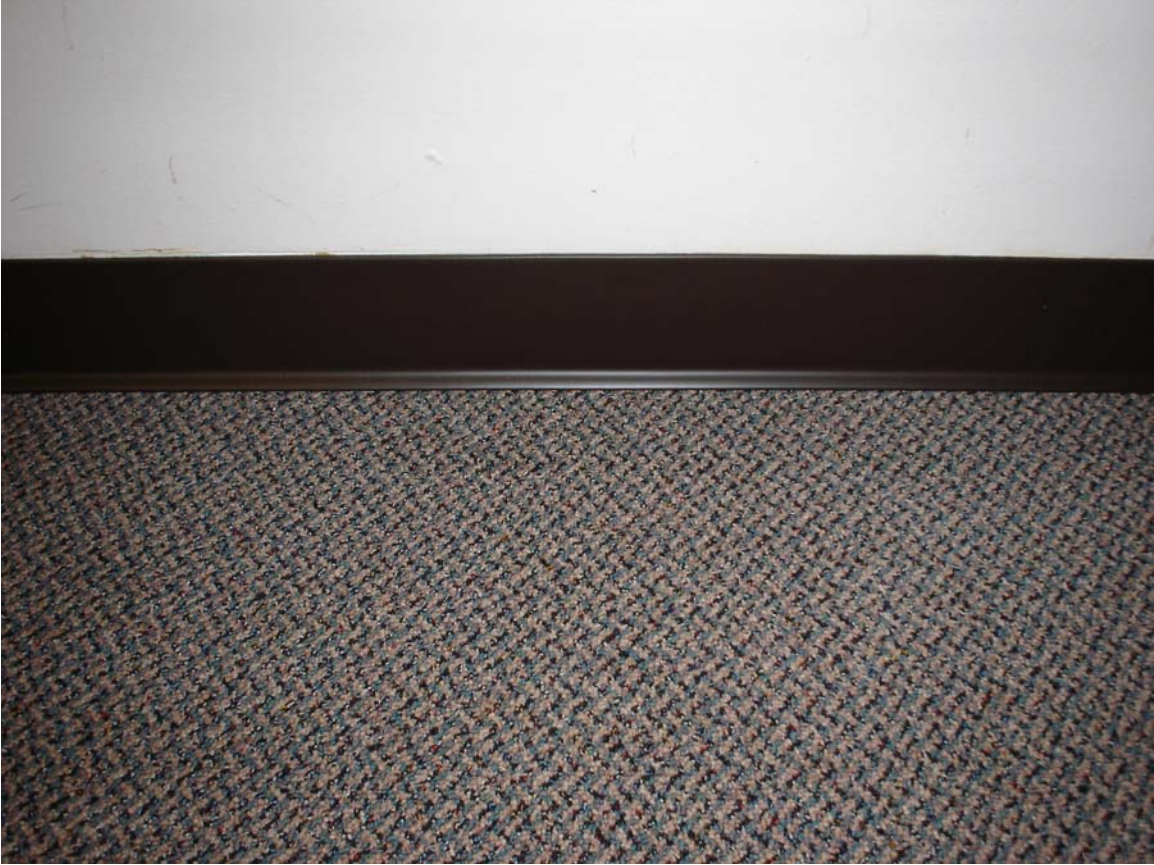
Photo 9 – Non asbestos-containing 4” brown cove molding
and associated mastic

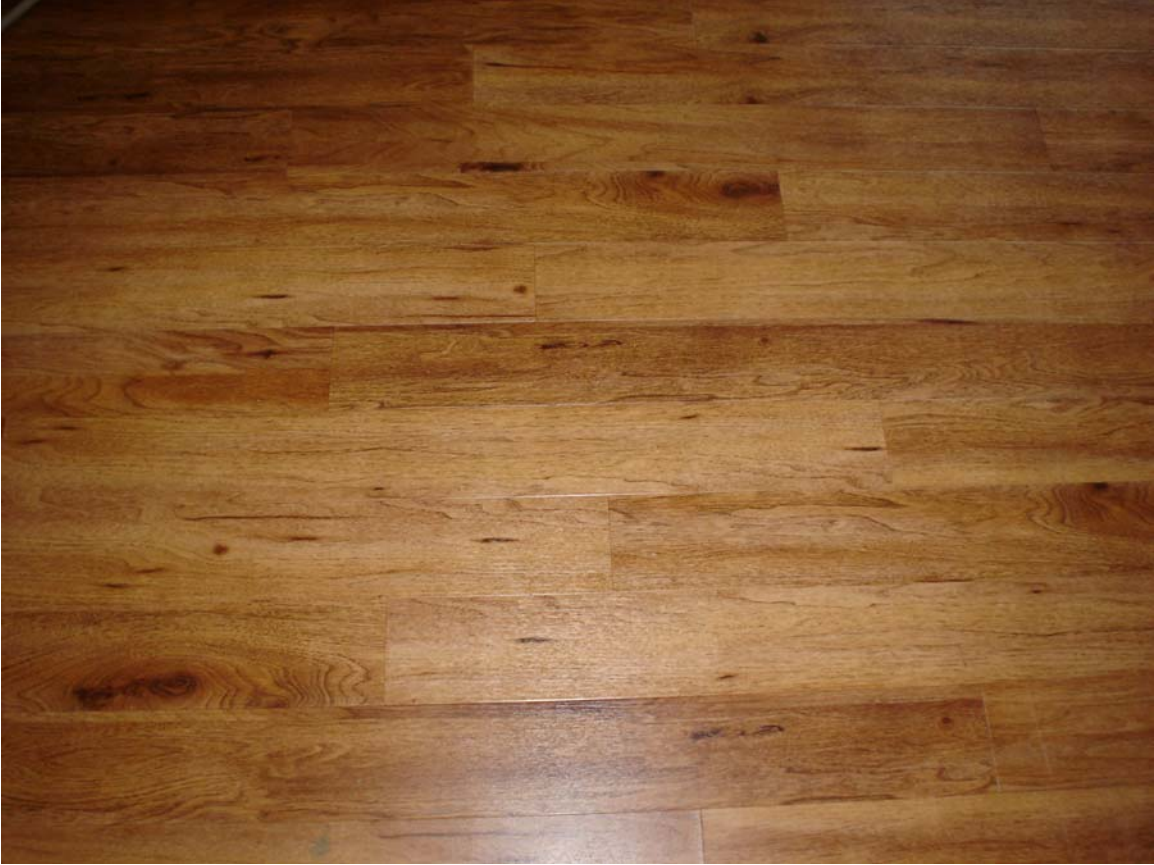
Photo 10 – Non asbestos-containing vinyl wood grain flooring
and associated mastic

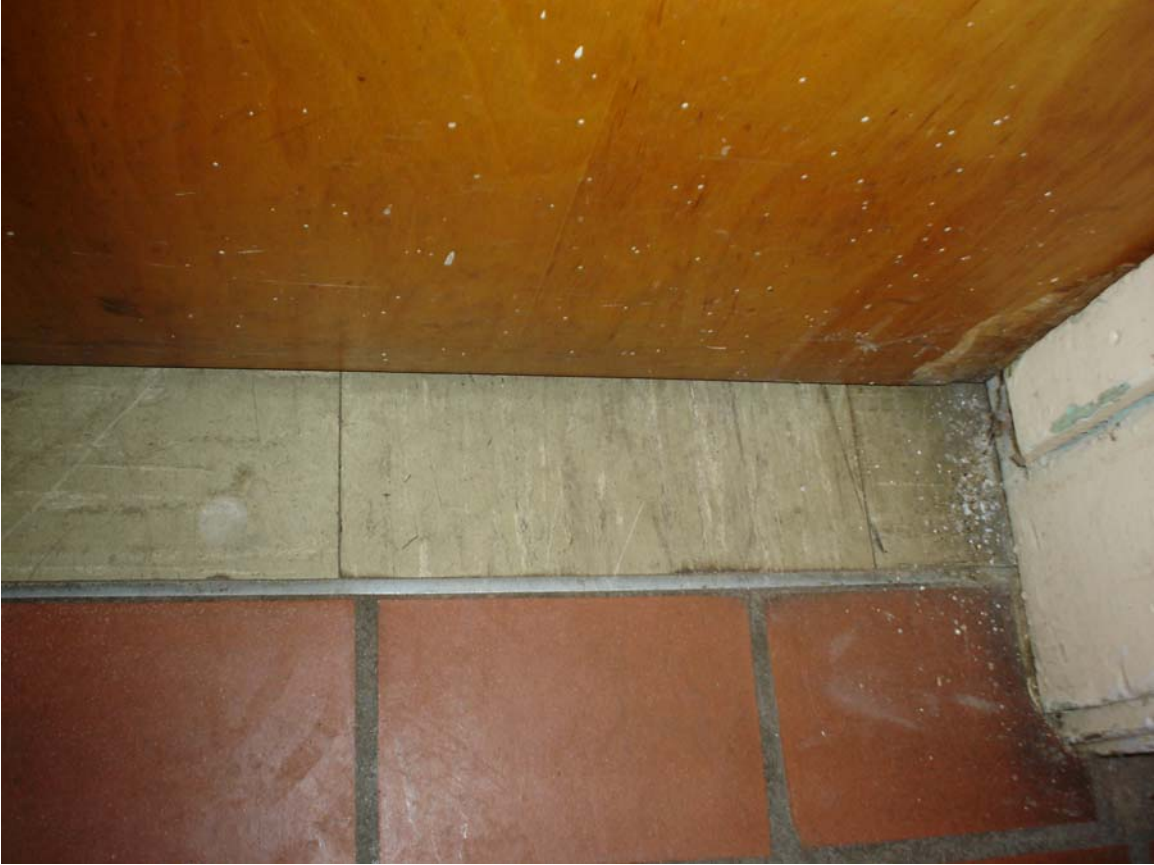
Photo 11 – Asbestos-containing 9” x 9” beige floor tile with cream and tan streaks and associated mastic

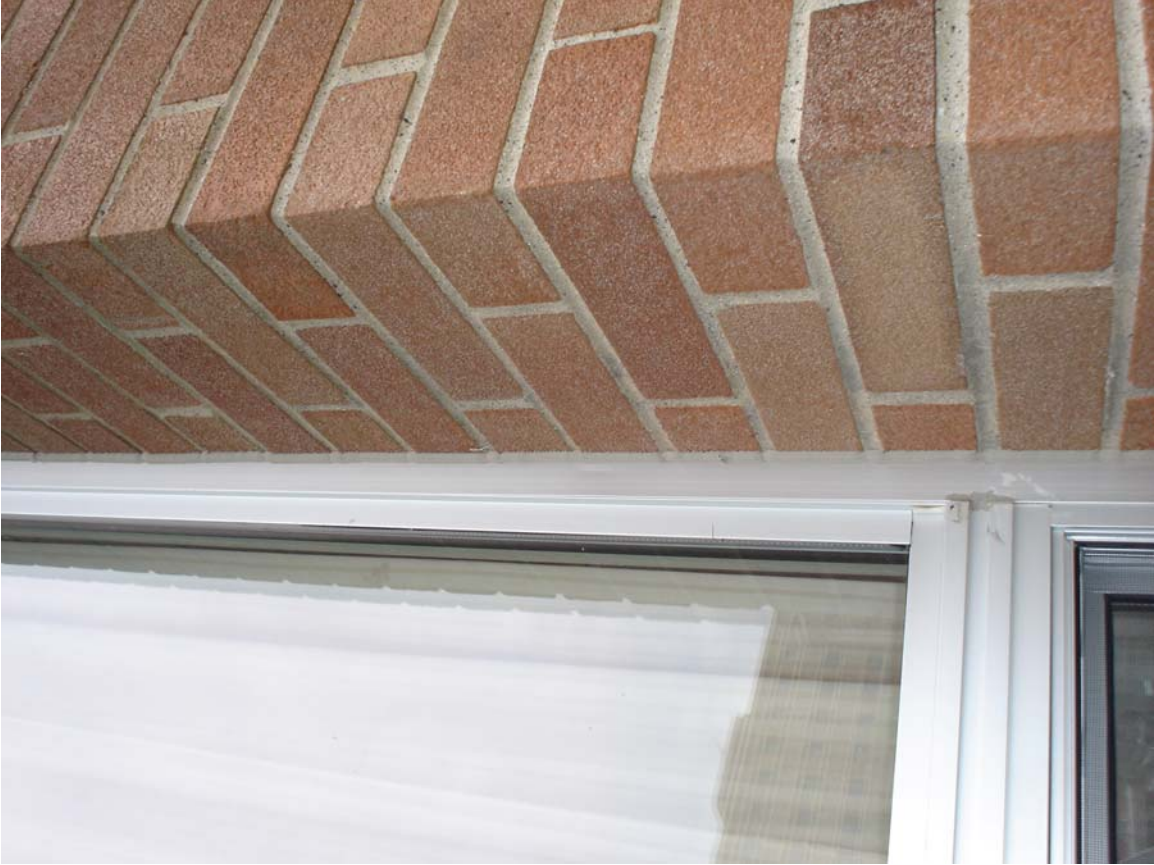
Photo 12 – Assumed asbestos-containing window
and door frame caulk compound

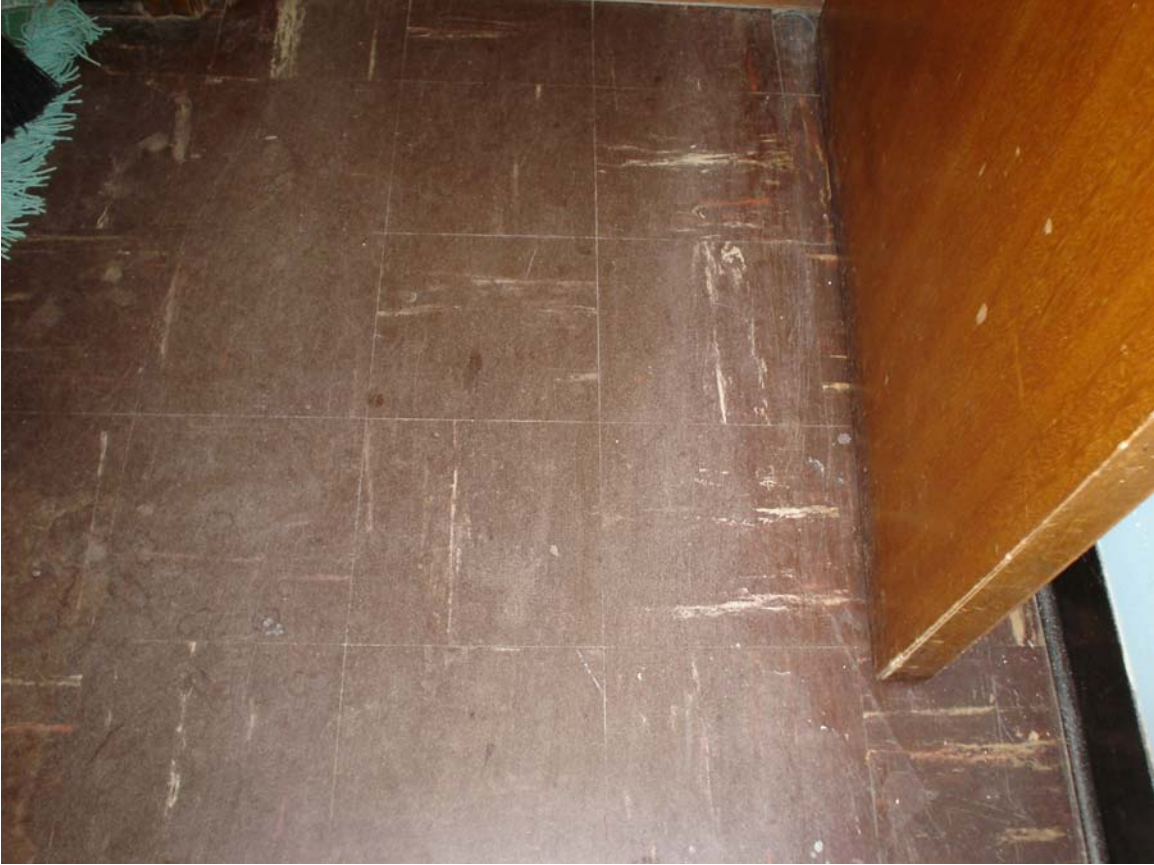
Photo 14 – Asbestos-containing 9” x 9” dark brown floor tile with cream and rust streaks and associated mastic

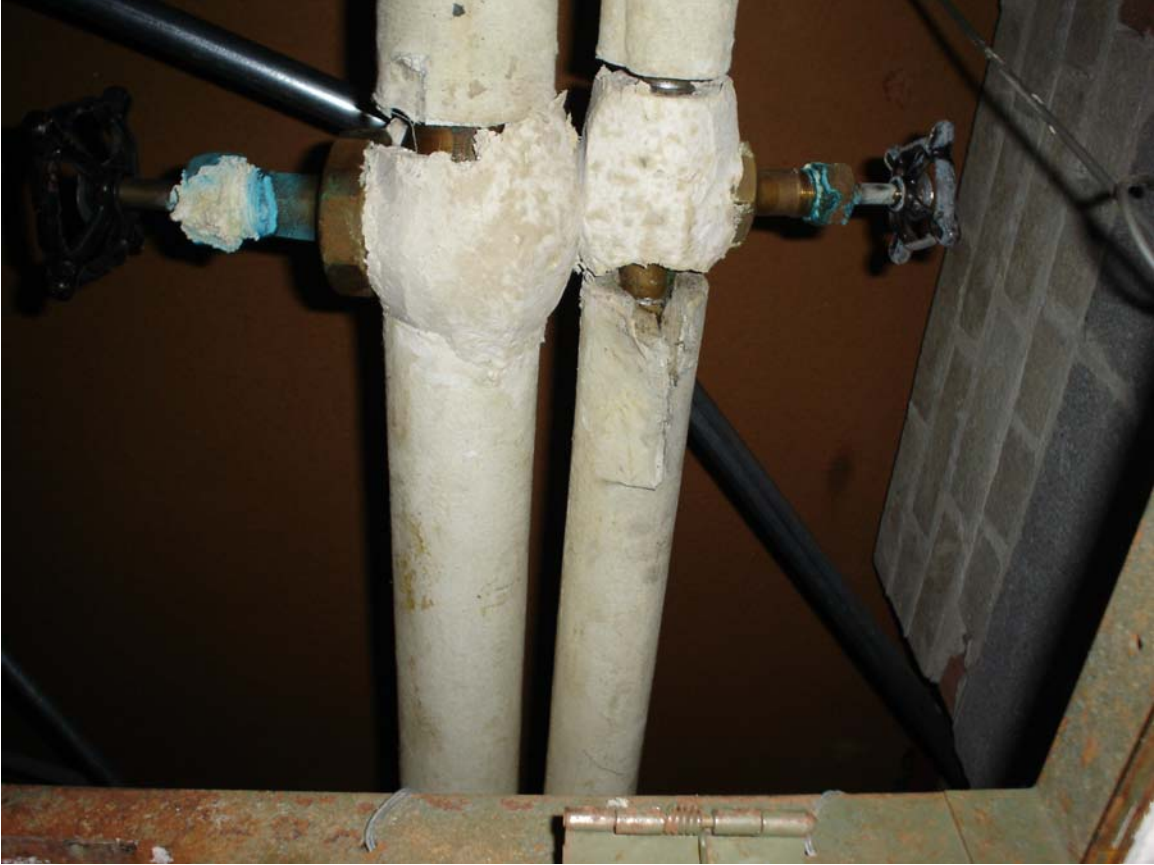
Photo 15 – Asbestos-containing steam/condensate supply and return pipe straight, pipe joint and hanger insulation
