Owen Hall Photo Log

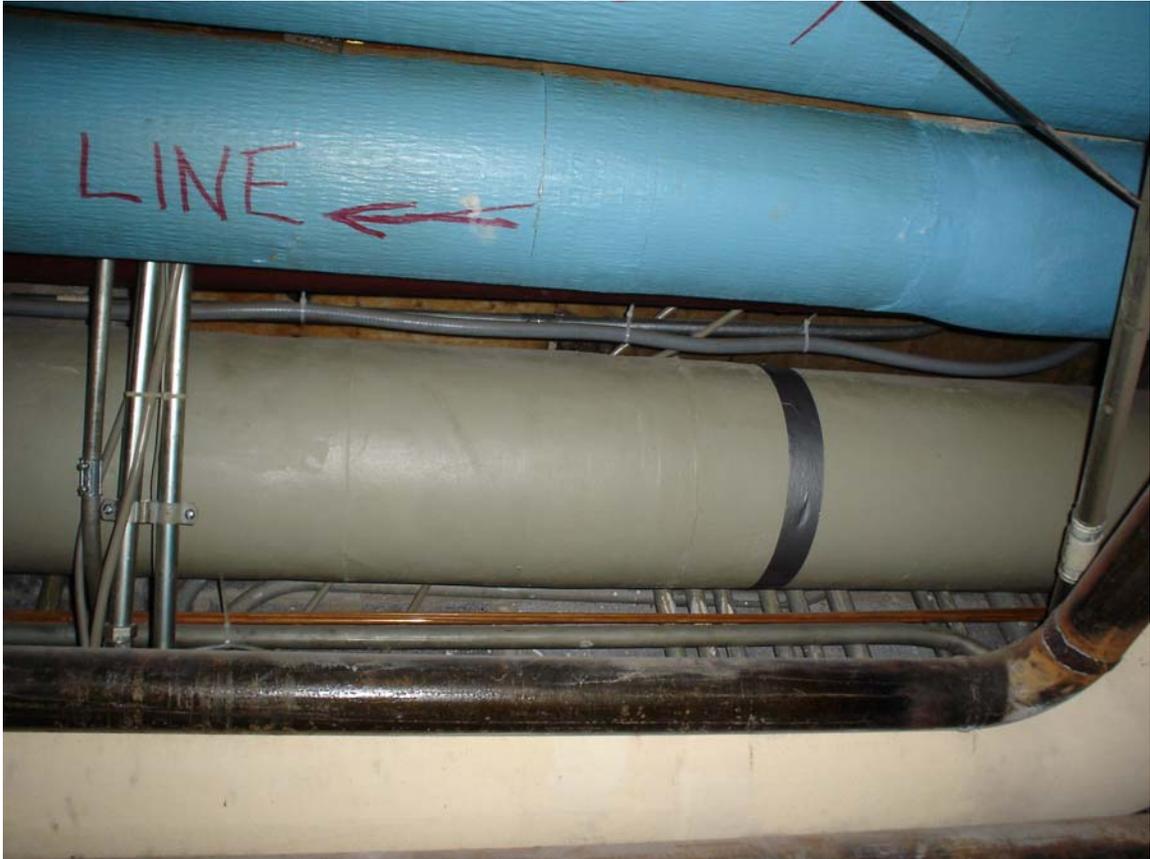
HA #1 – Asbestos-containing steam/condensate supply and return pipe straight insulation

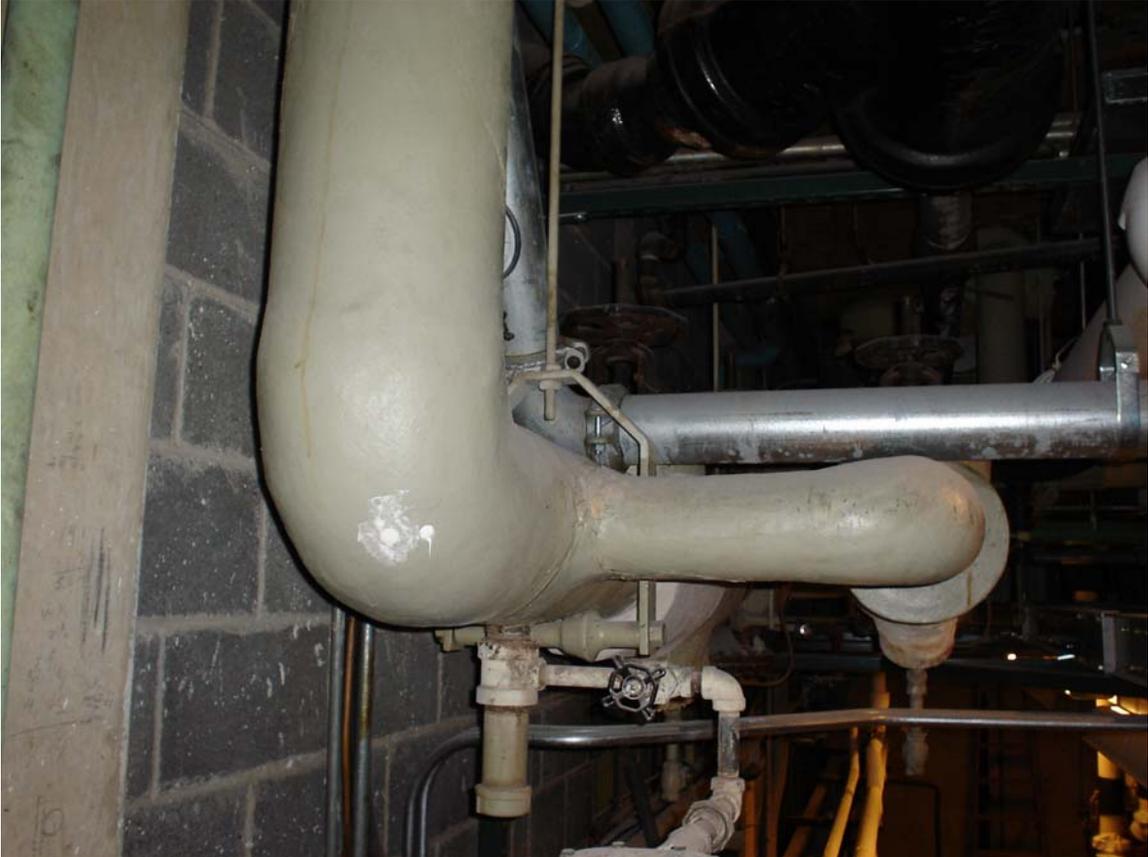
HA #2 – Asbestos-containing steam/condensate supply and return pipe joint and hanger insulation

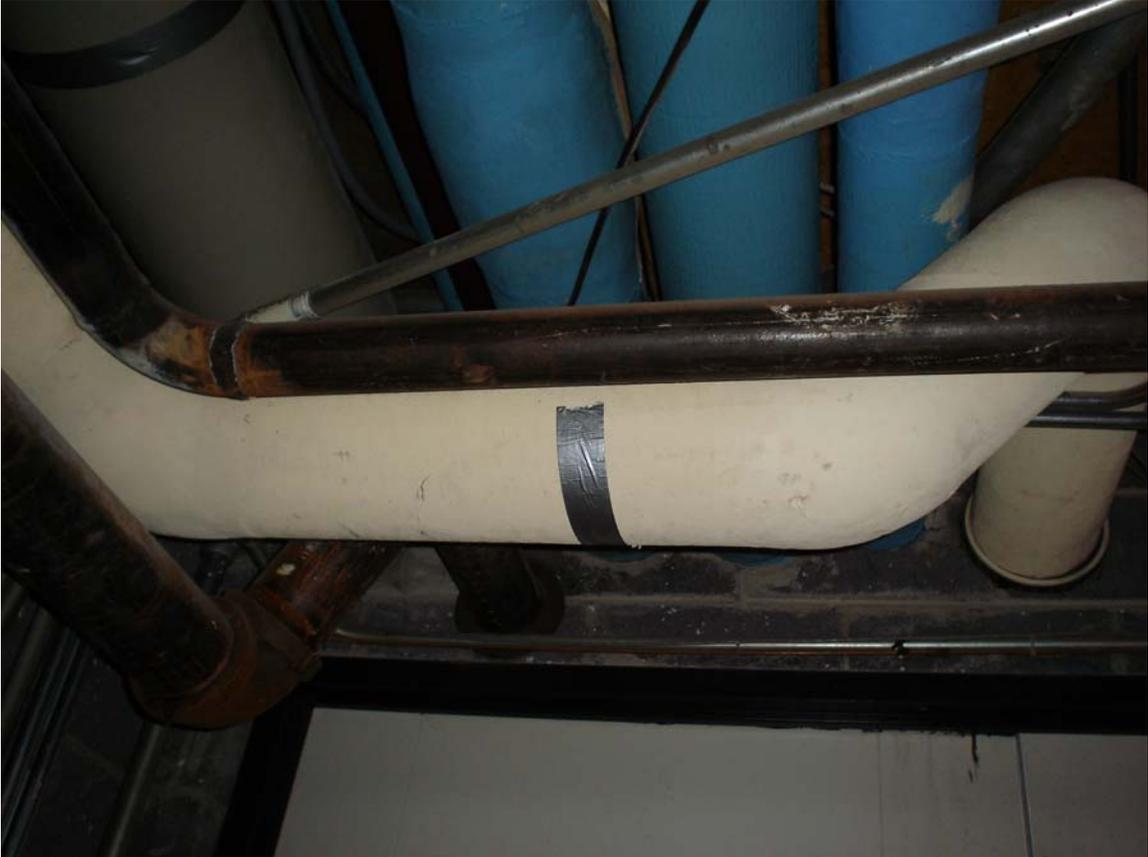
HA #3 – Non asbestos-containing canvas wrap on fiberglass pipe straight insulation

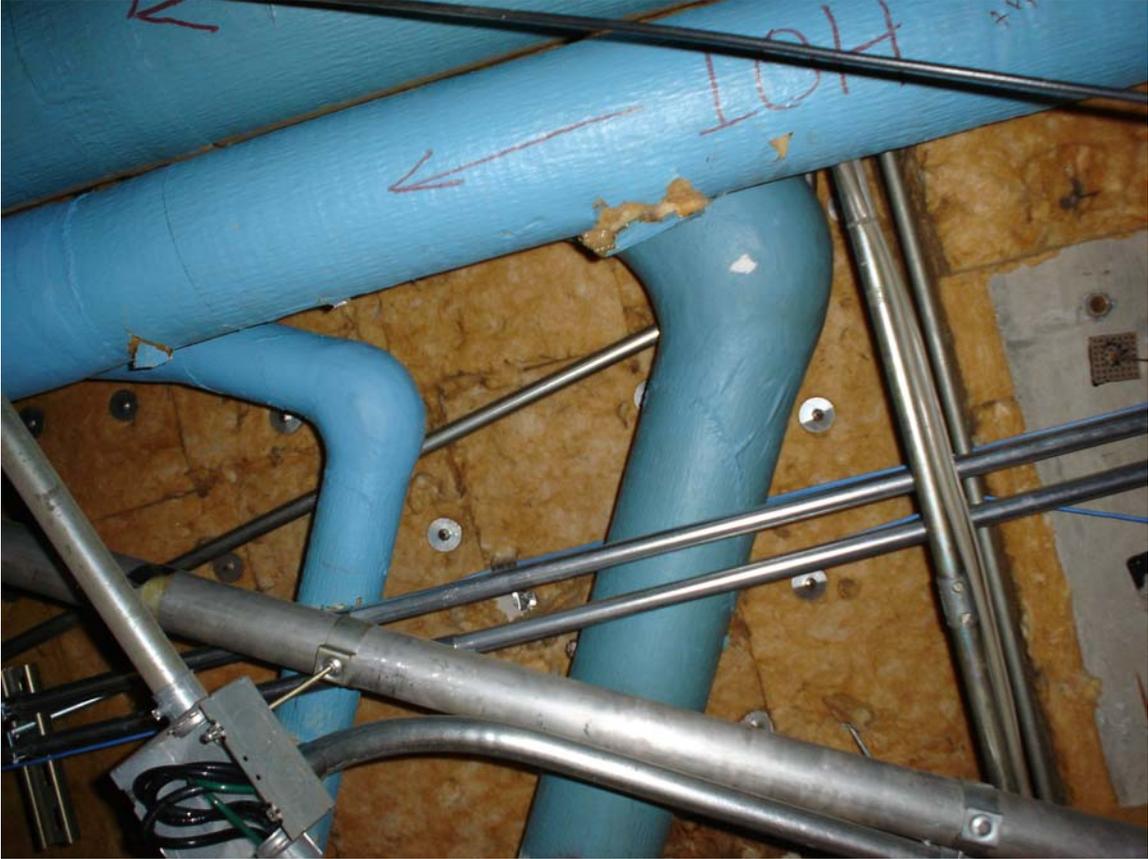
HA #4 – Asbestos-containing domestic water supply and return pipe joint and hanger insulation

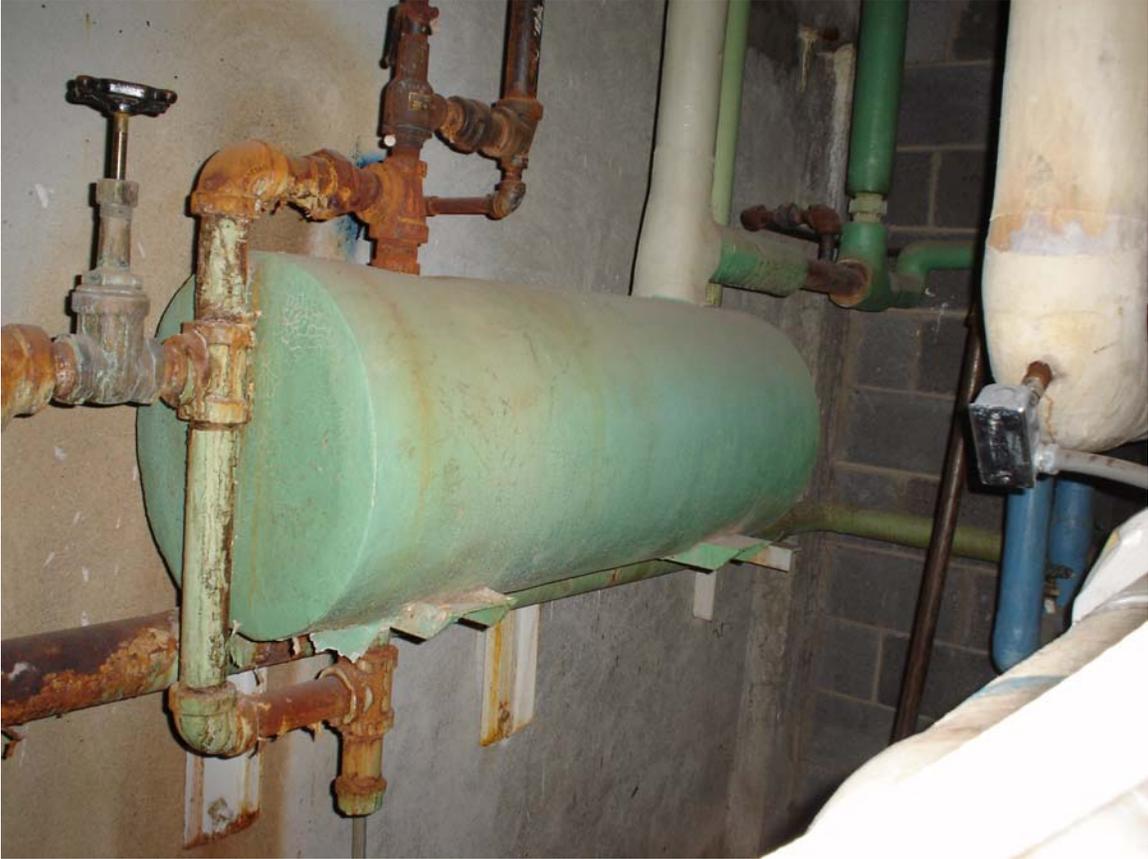
HA #5 – Asbestos-containing hot water holding tank insulation

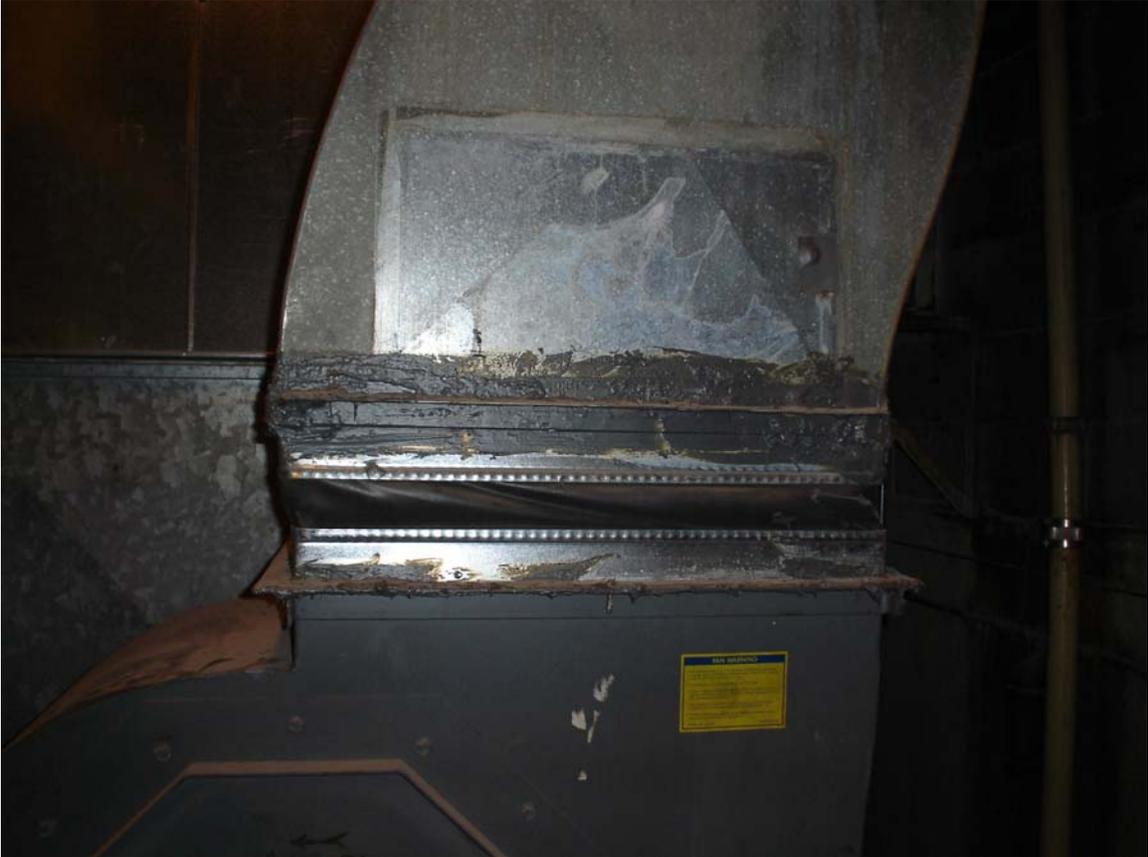
HA #6 – Non asbestos-containing gray HVAC duct caulk compound

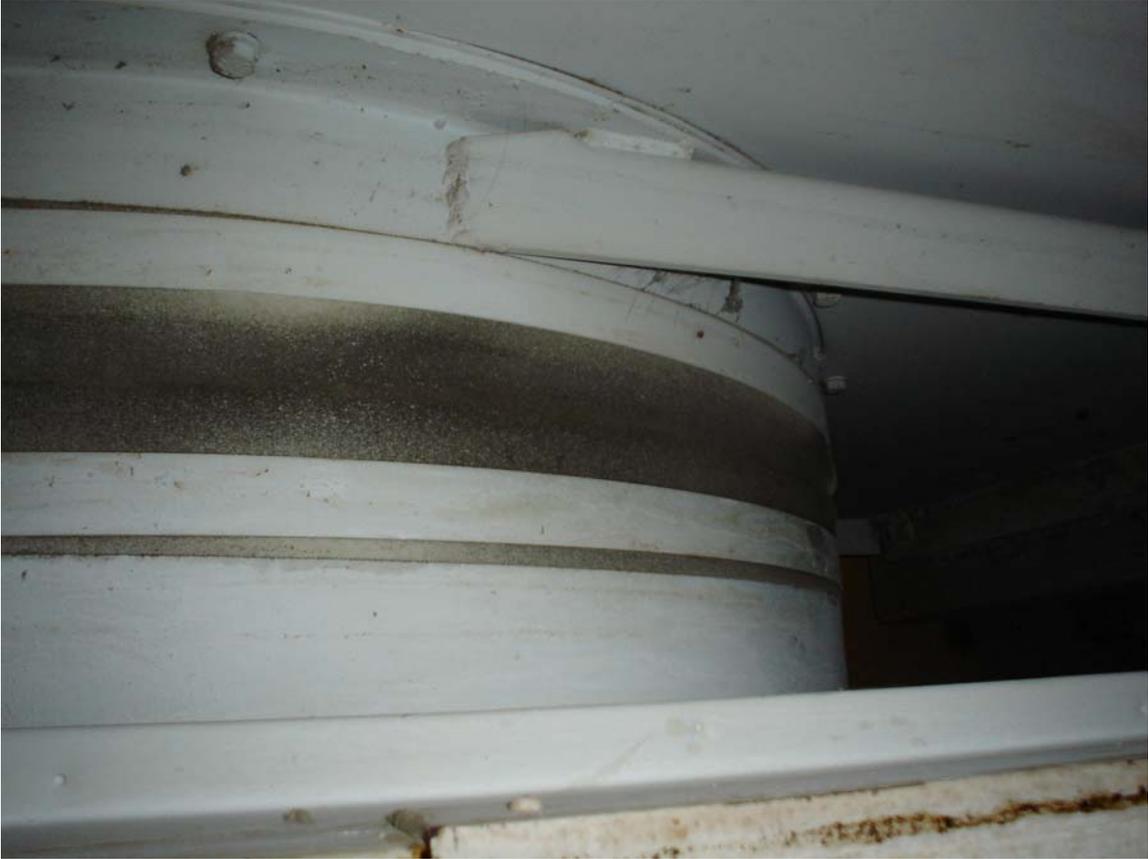
HA #7 – Non asbestos-containing ventilation duct expansion cloth

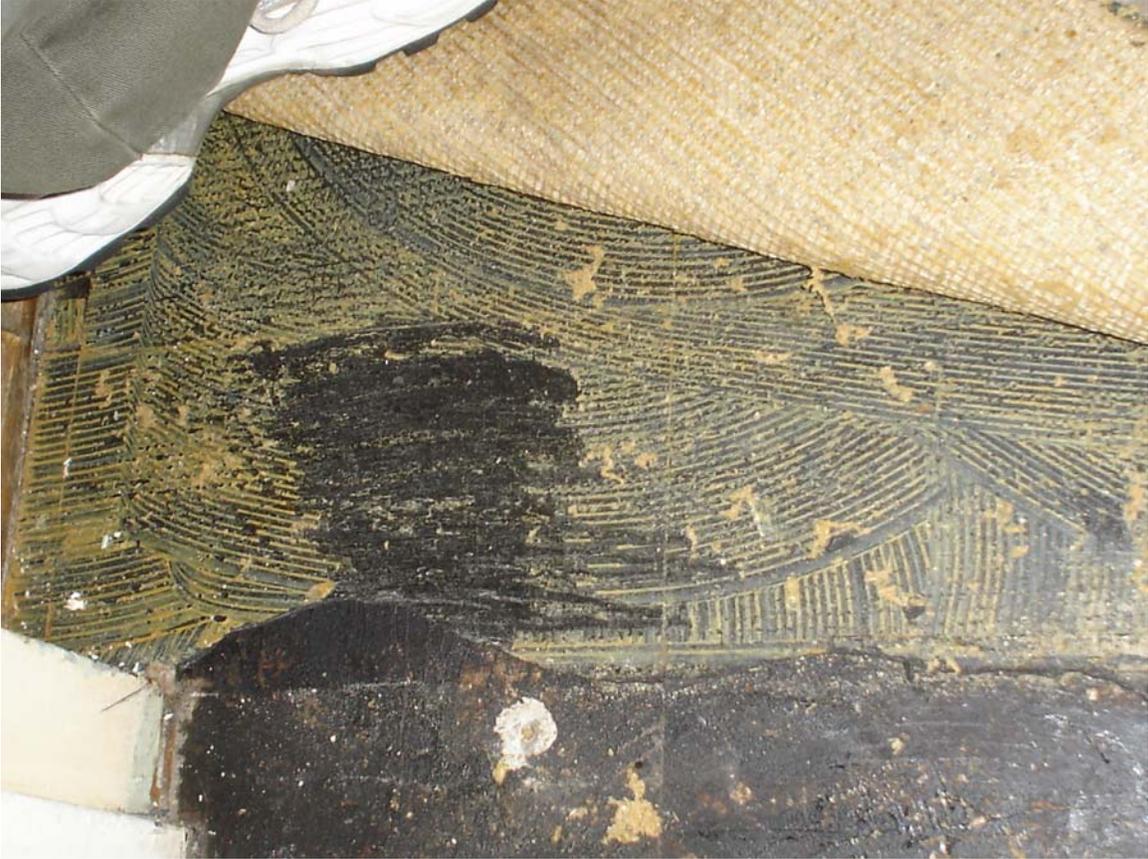
HA #8 – Asbestos-containing 9” x 9” black floor tile with cream streaks and associated non asbestos-containing mastic

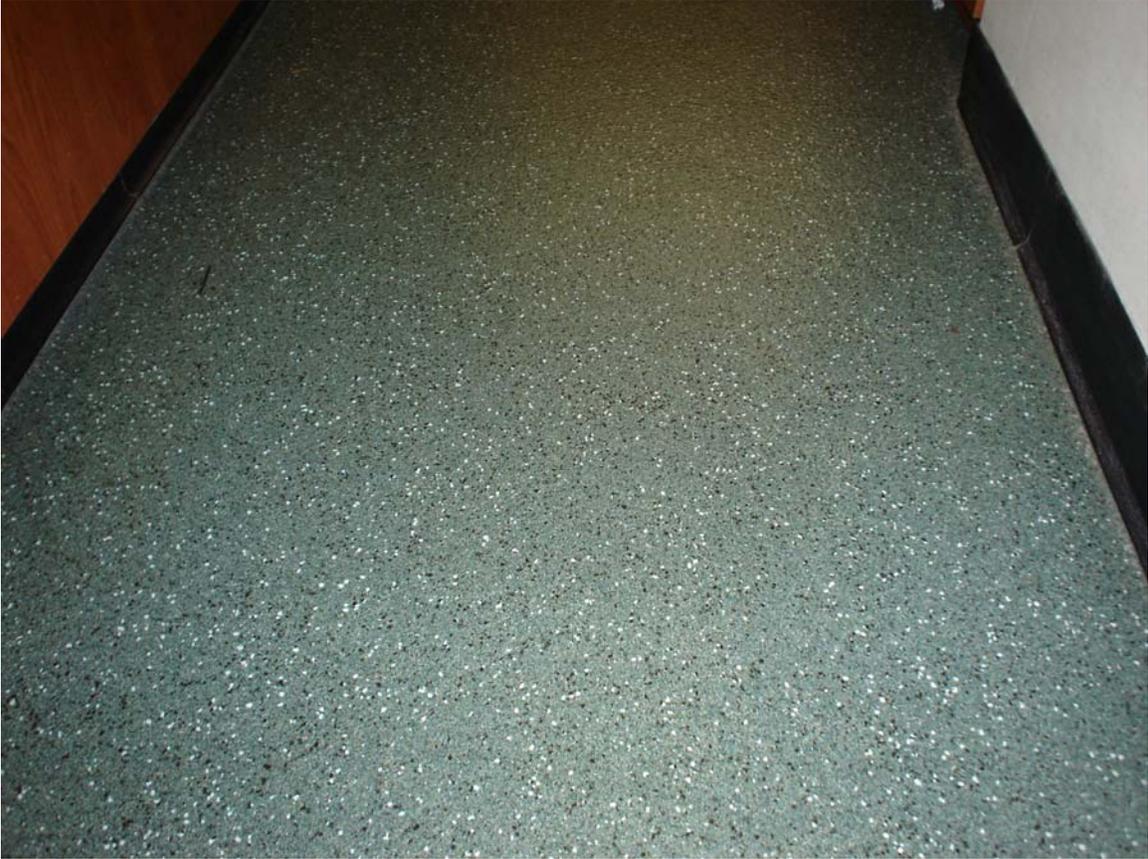
HA #9 - Non asbestos-containing 4" black cove molding  
and associated mastic

HA #33 – Non asbestos-containing green flooring with black and white  
specks and associated asbestos-containing mastic

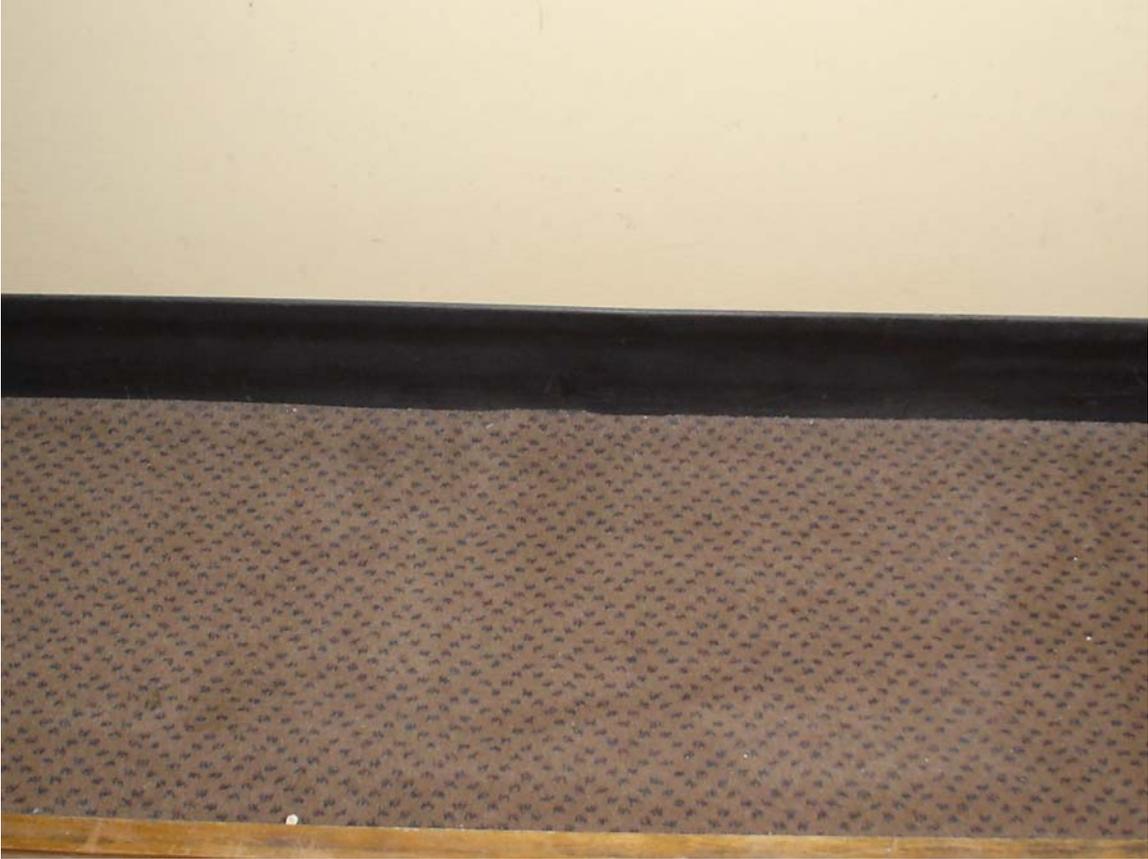
HA #10 – Non asbestos-containing smooth plaster

HA #15 – Non asbestos-containing 4” brown cove molding  
and associated mastic

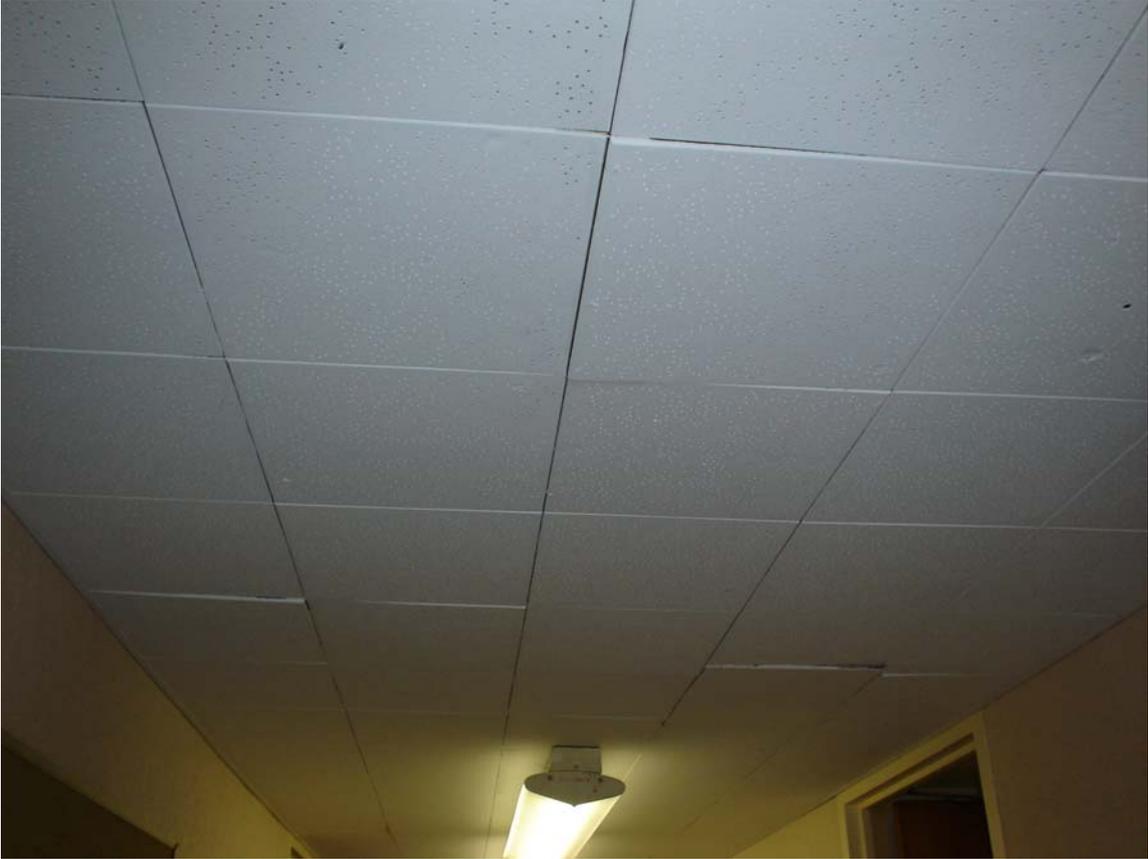
HA #11 – Non asbestos-containing 12” x 12” white ceiling tile  
with pin holes and associated glue pods

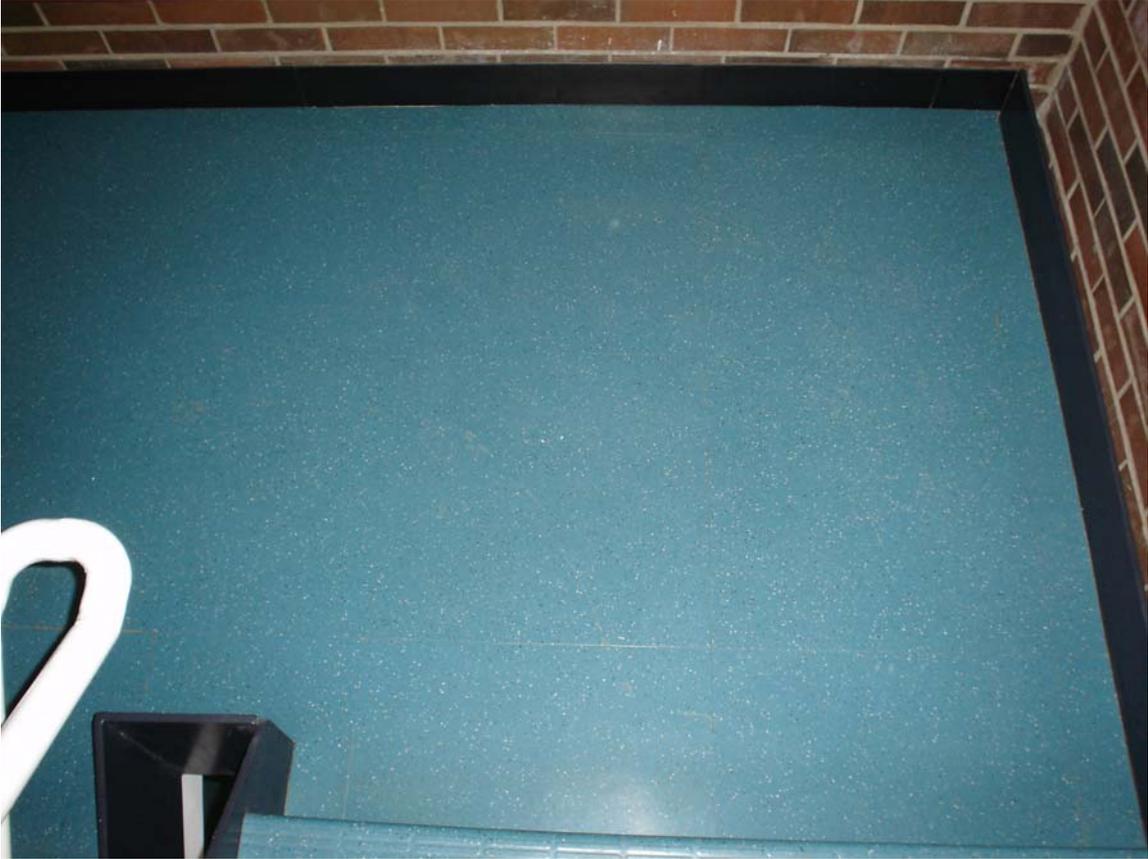
HA #12 – Non asbestos-containing 18” x 18” green vinyl flooring with cream and black specks and associated mastic

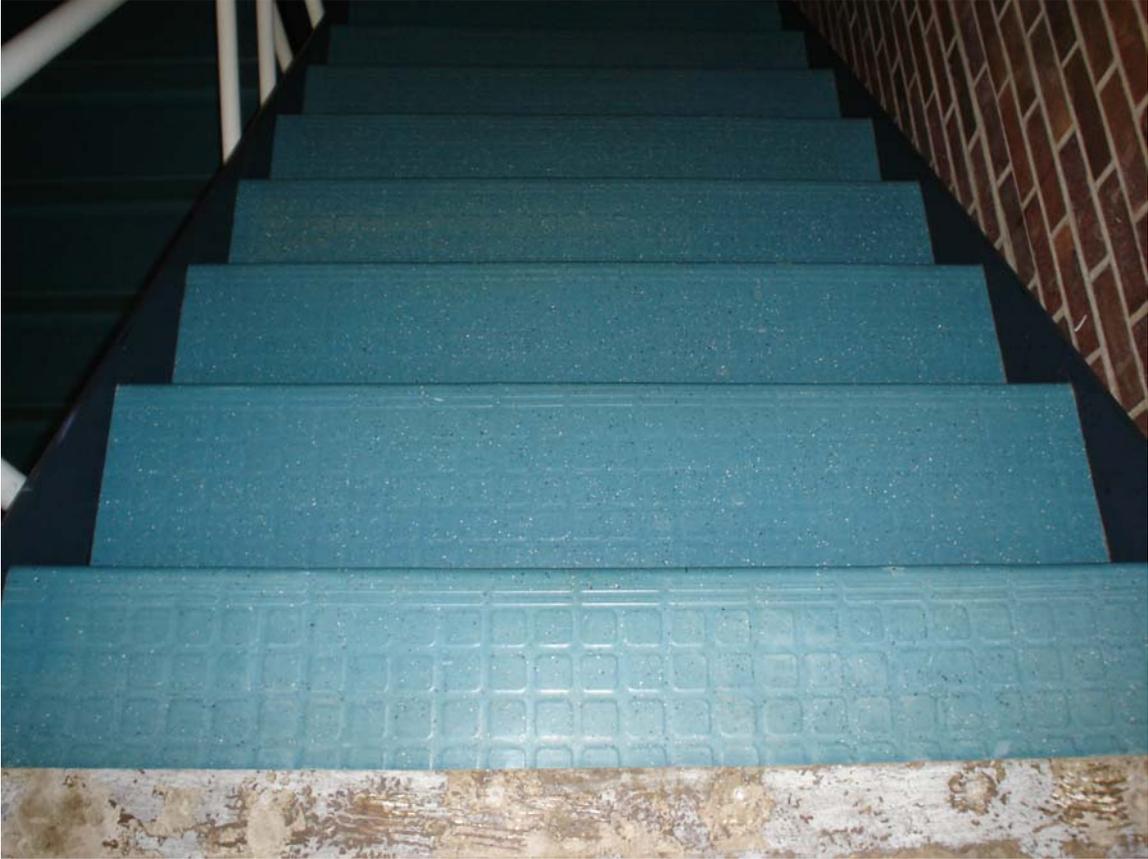
HA #13 – Non asbestos-containing green stair tread with cream and black specks and associated mastic

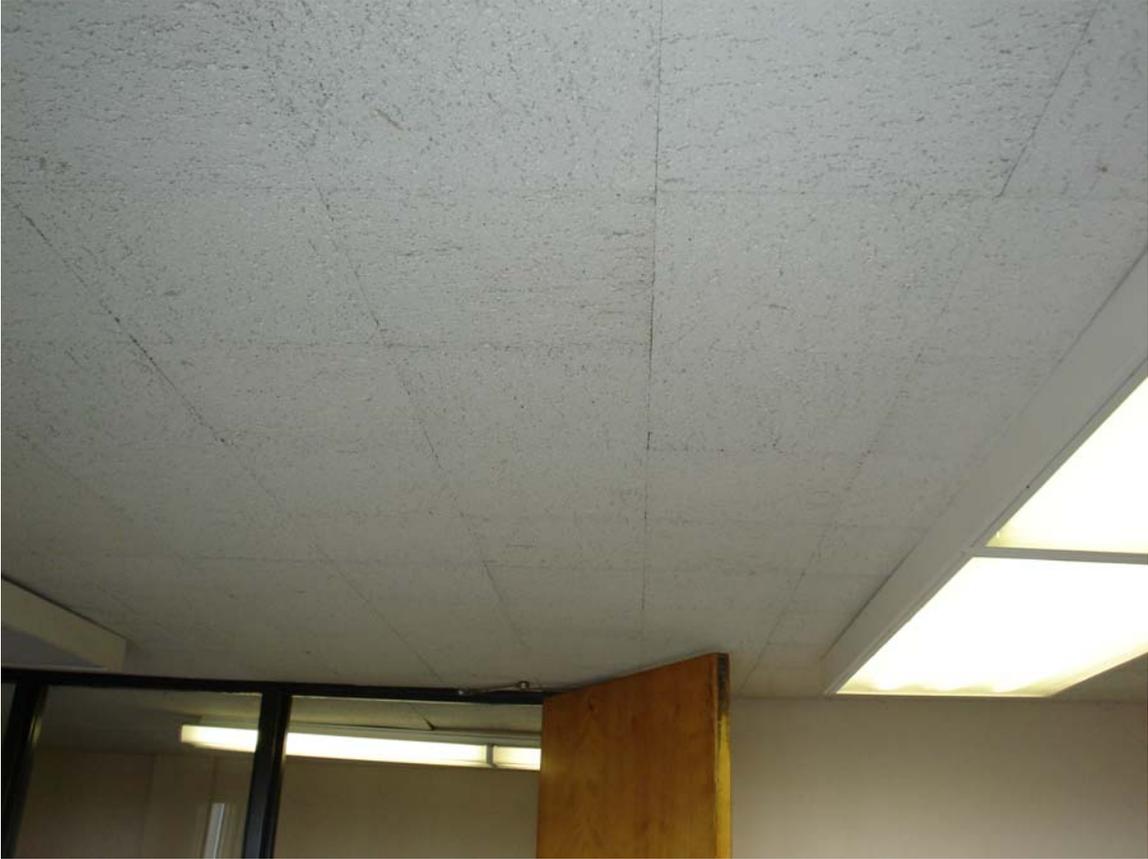
HA #14 – Non asbestos-containing 12” x 12” white ceiling tile  
with fissures and associated glue pods

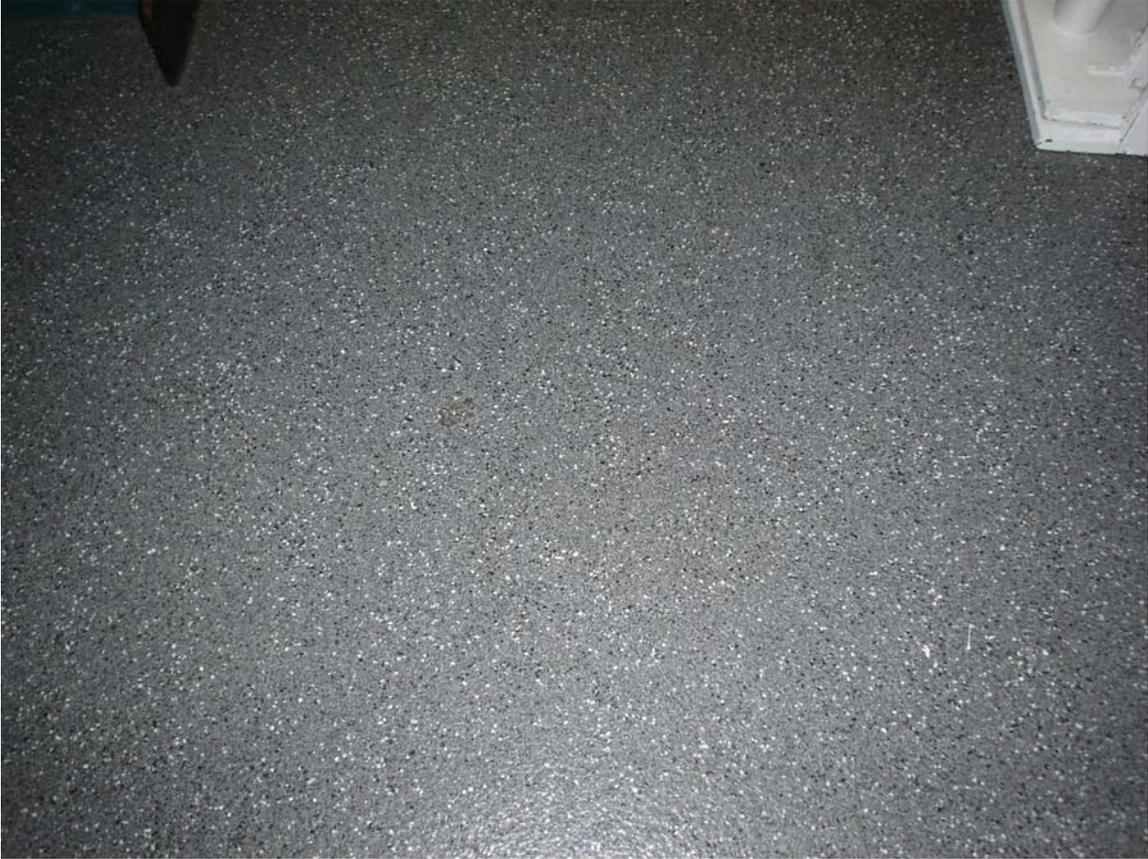
HA #16 – Non asbestos-containing gray vinyl flooring  
with black and white specks and associated mastic

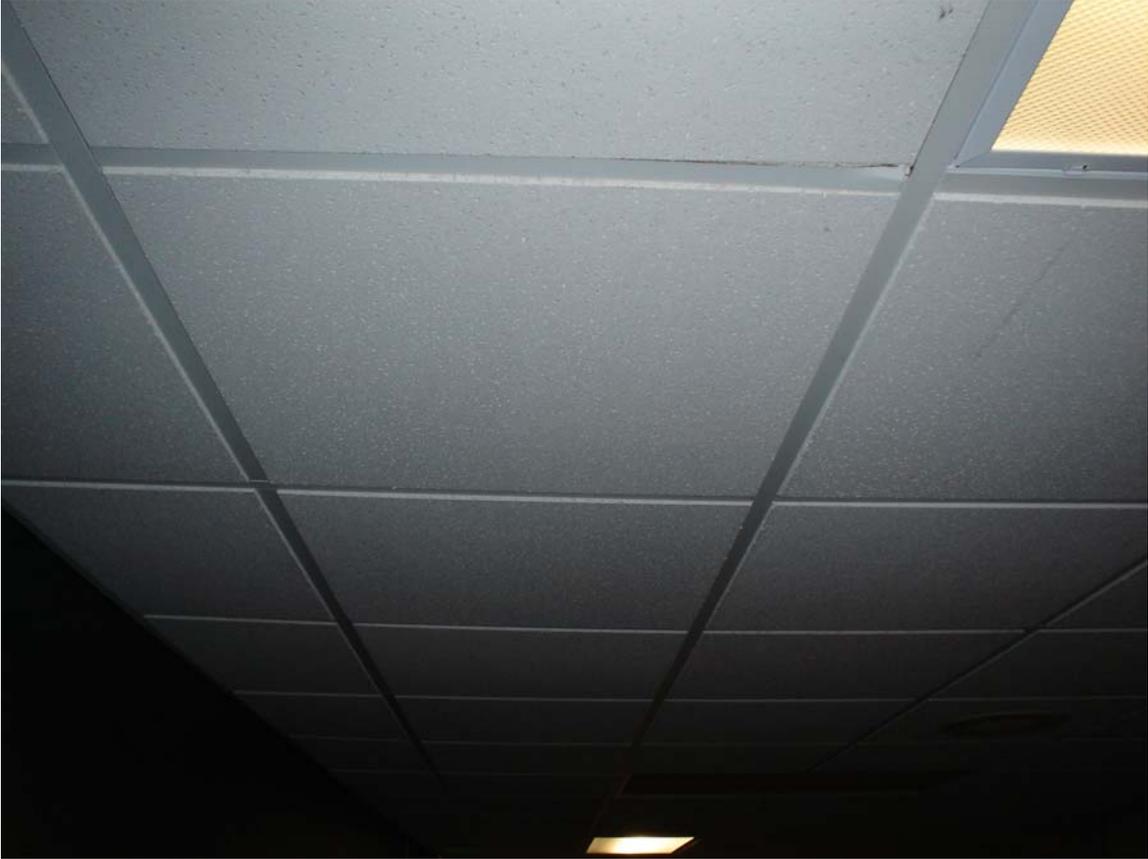
HA #17 – Non asbestos-containing 2' x 2' white drop ceiling tile  
with pin holes and fissures

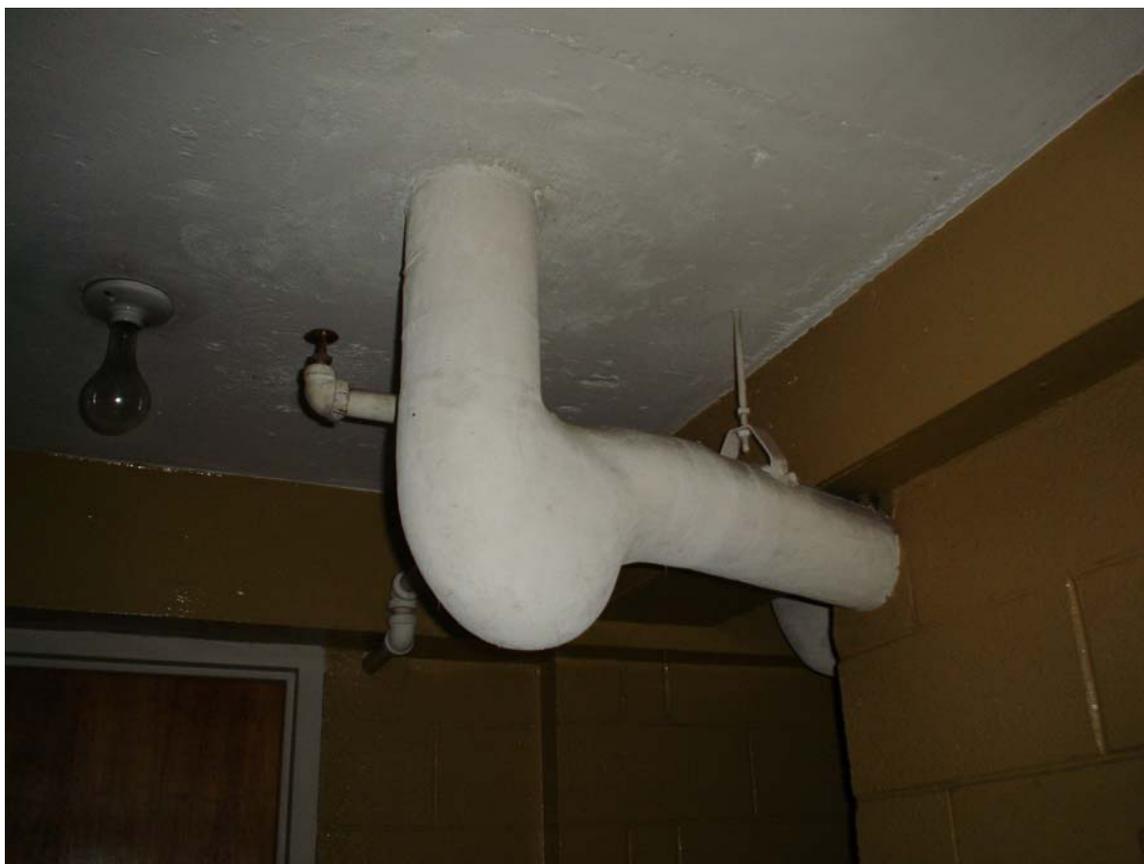
HA #18 – Asbestos-containing drain pipe joint and hanger insulation

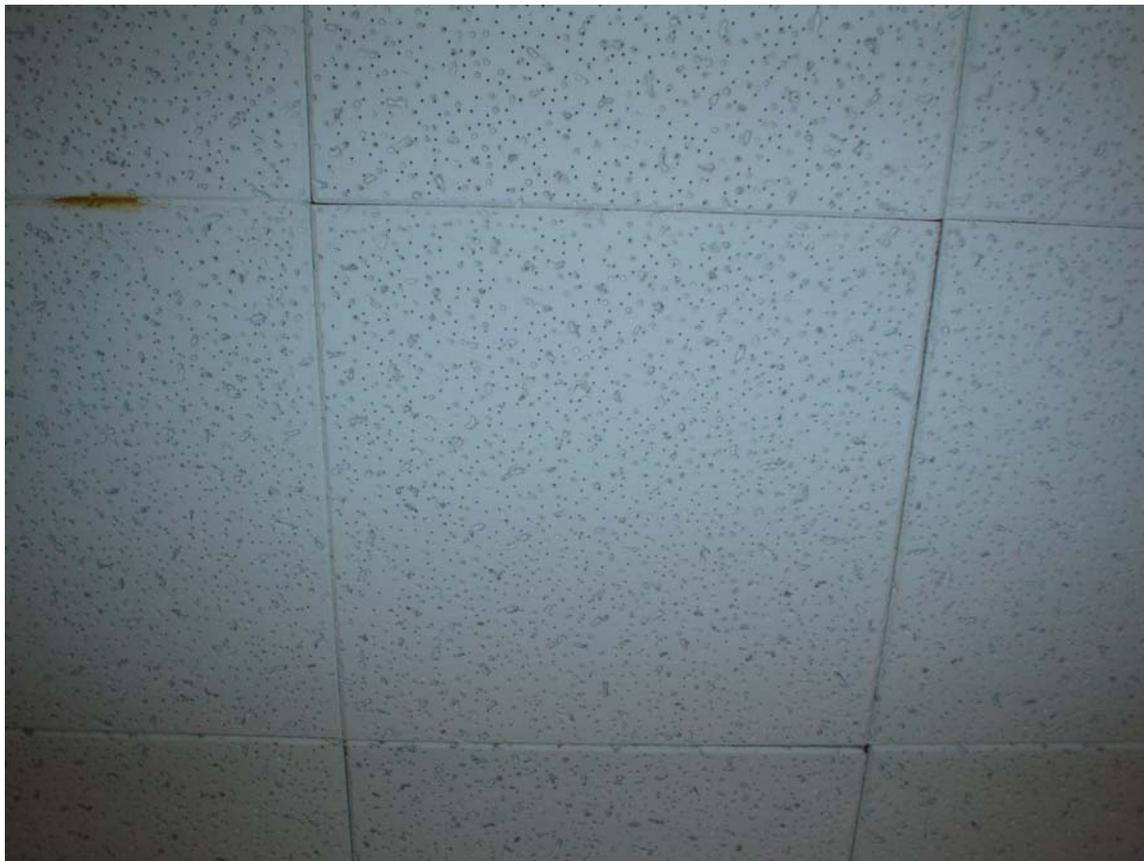
HA #19 – Non asbestos-containing 12” x 12” white ceiling tile  
with pin holes and fissures and associated glue pods

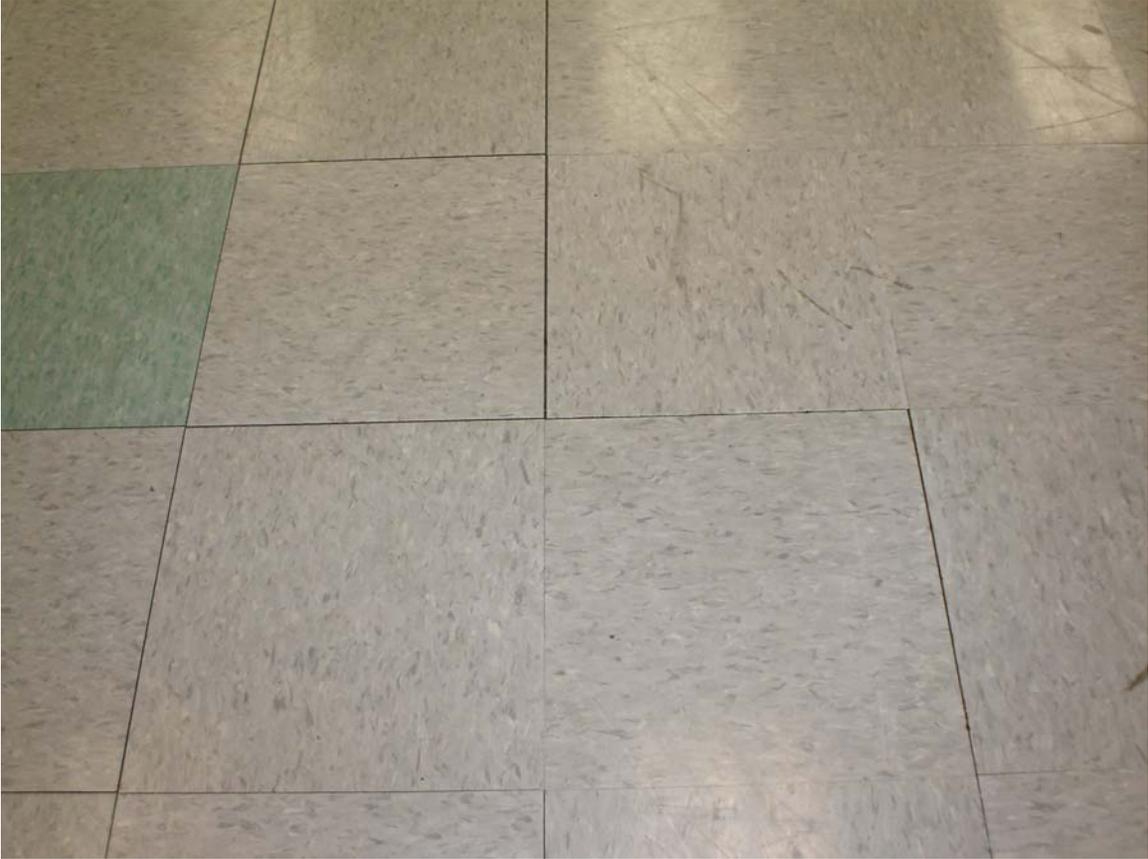
HA #20 – Non asbestos-containing 12” x 12” light gray floor tile  
with marble pattern and associated mastic

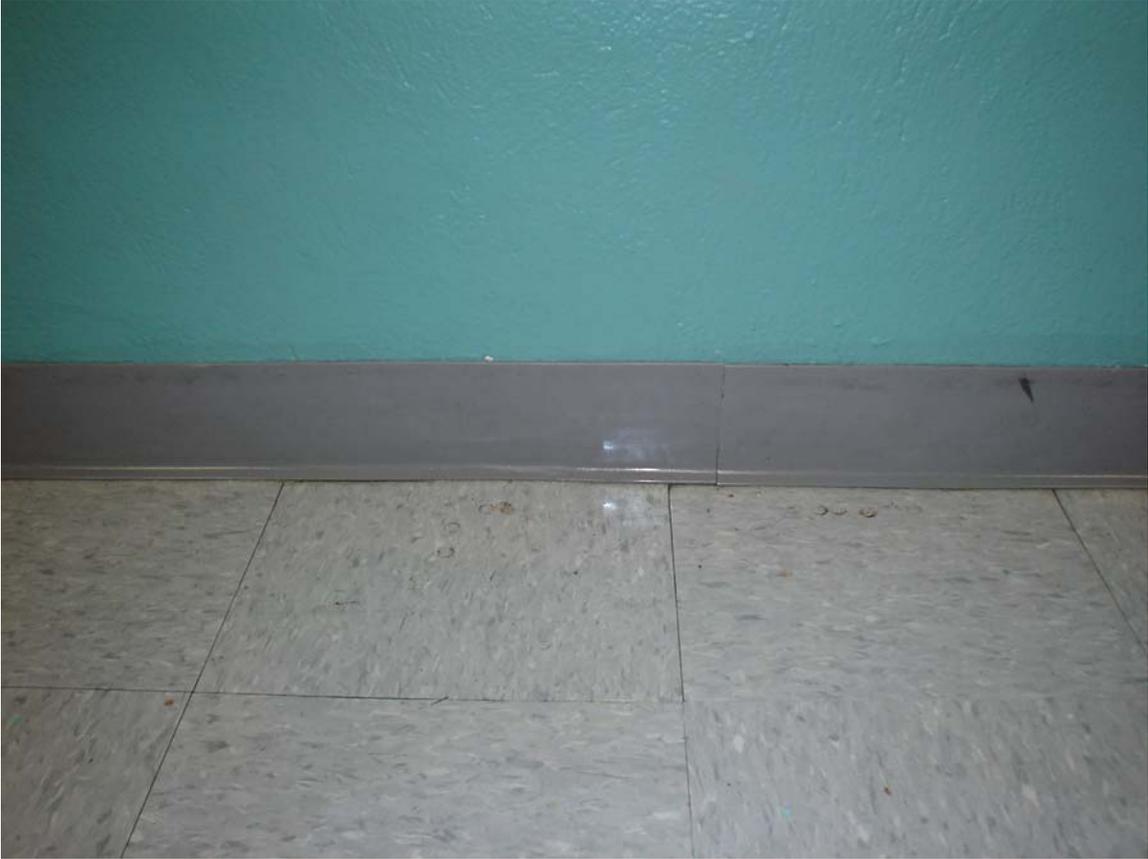
HA #21 – Non asbestos-containing 4” gray cove molding  
and associated mastic

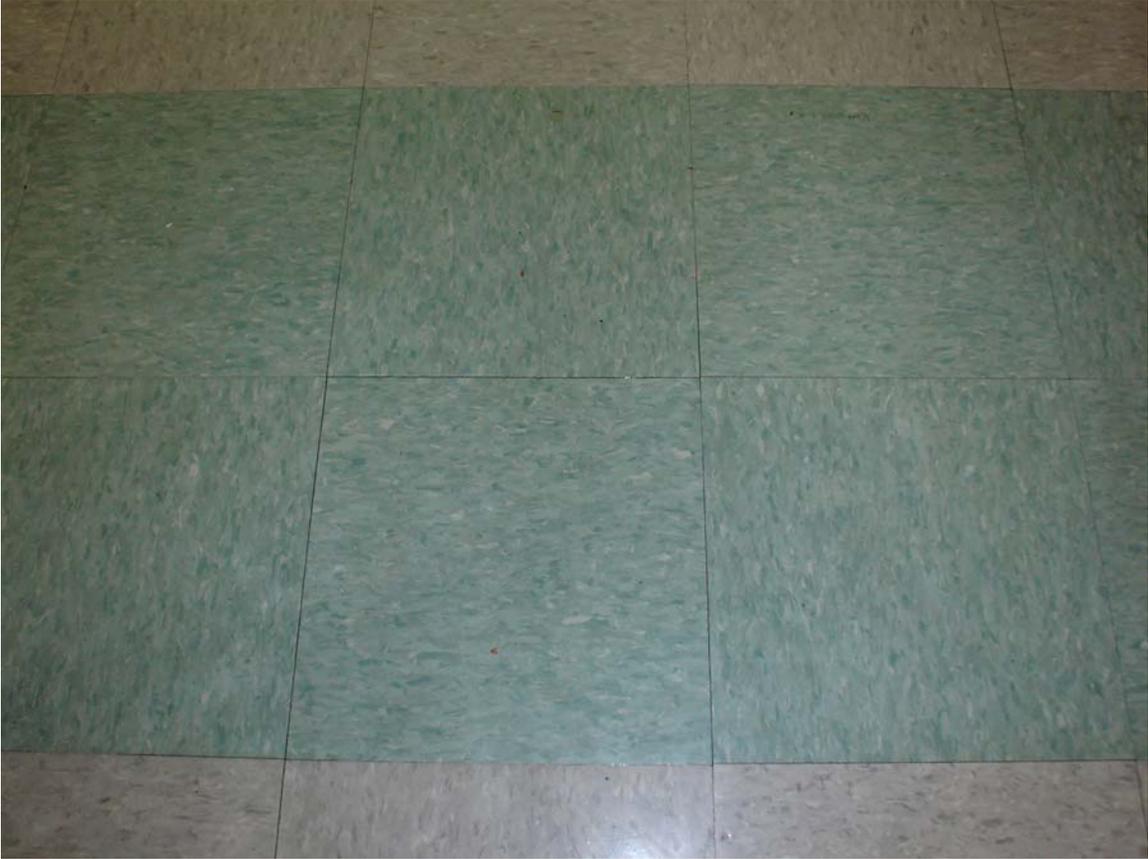
HA #22 – Non asbestos-containing 12” x 12” green floor tile  
with marble pattern and associated mastic

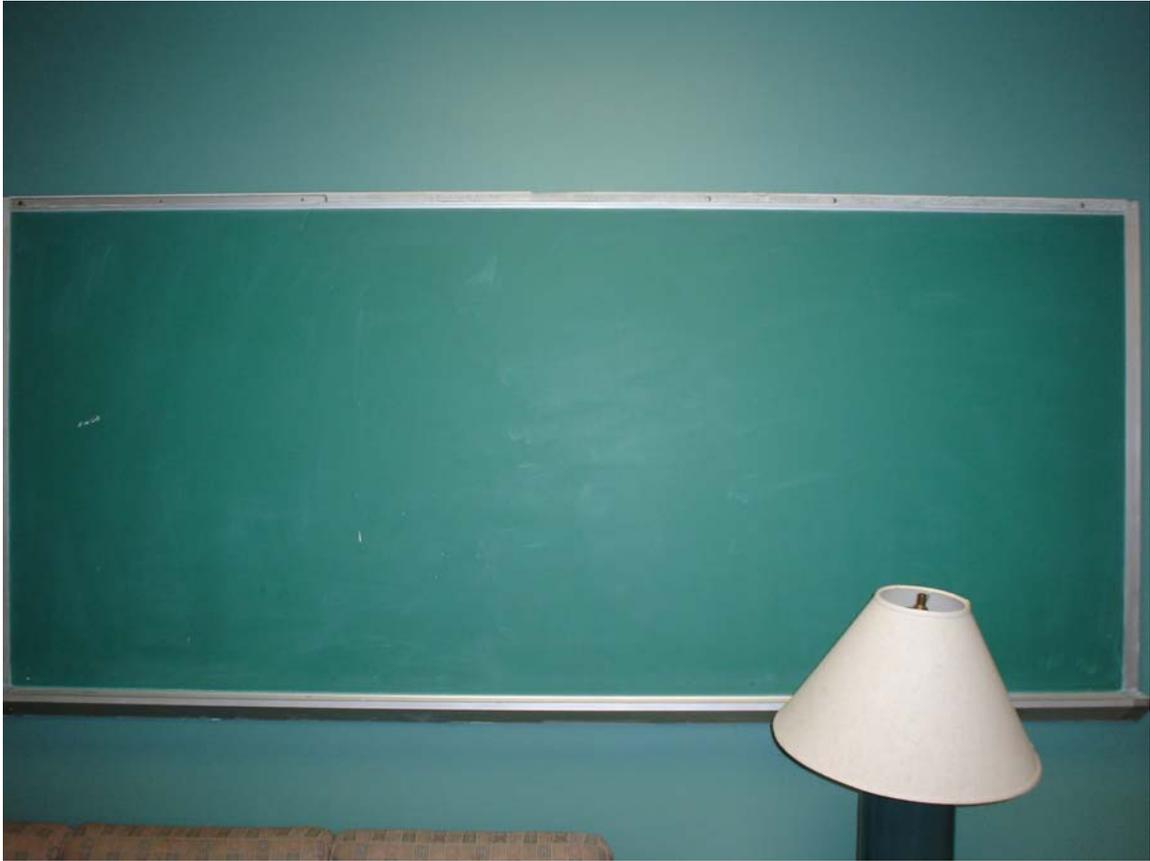
HA #24 – Assumed asbestos-containing chalkboards  
and associated glue pods

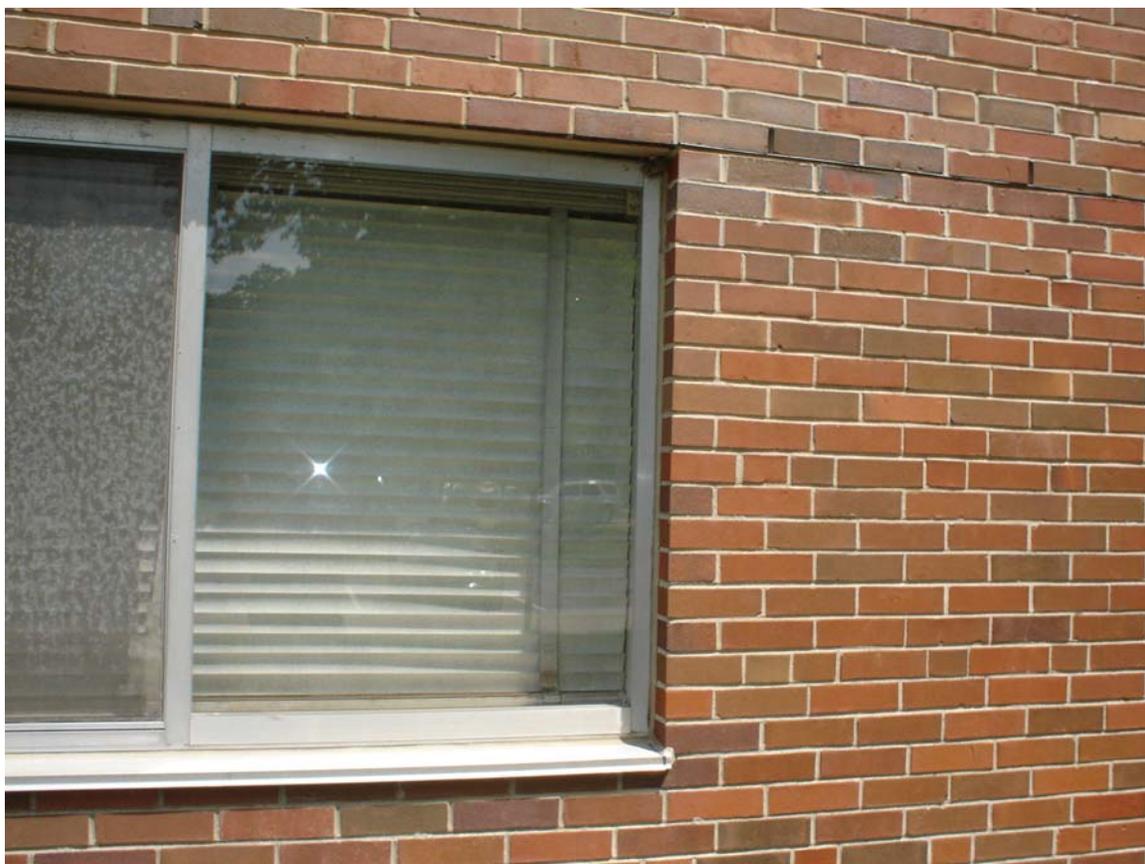
HA #25 – Assumed asbestos-containing window  
and door frame caulk compound
