Owen Hall Photo Log

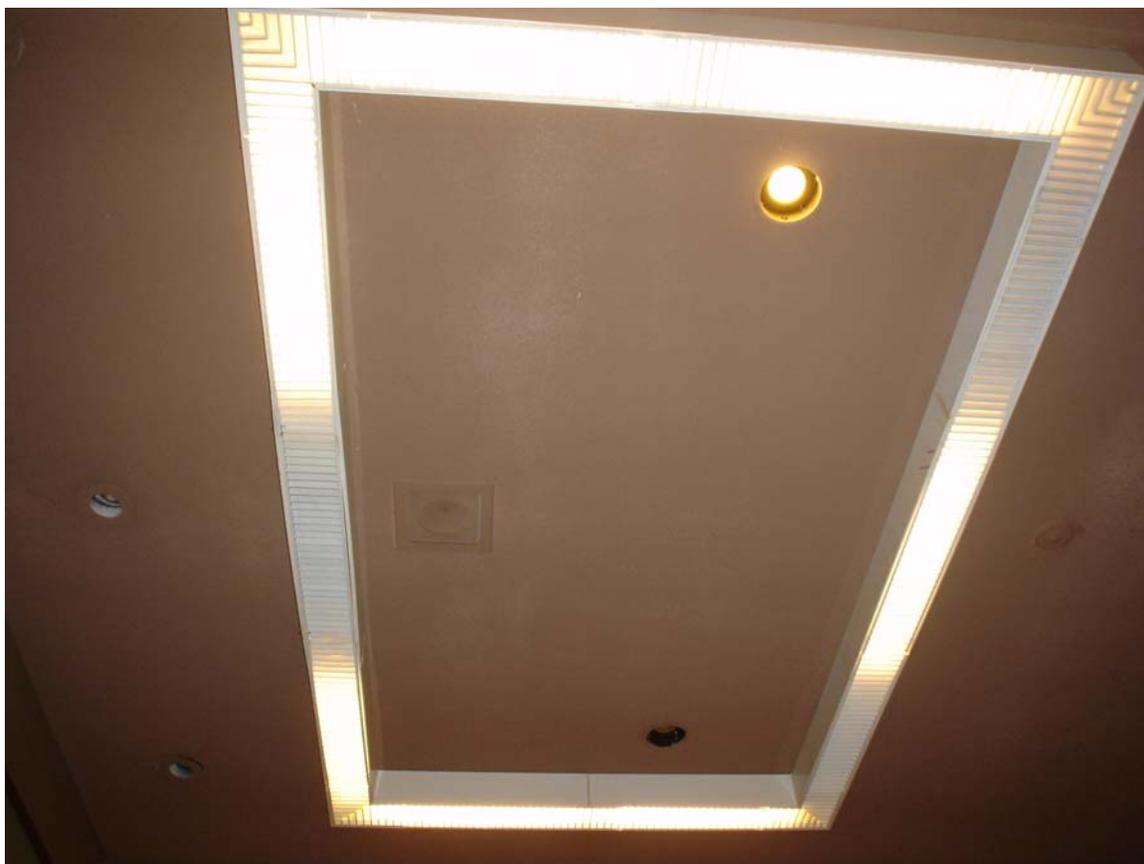
HA #26 – Asbestos-containing spray-on acoustical ceiling plaster

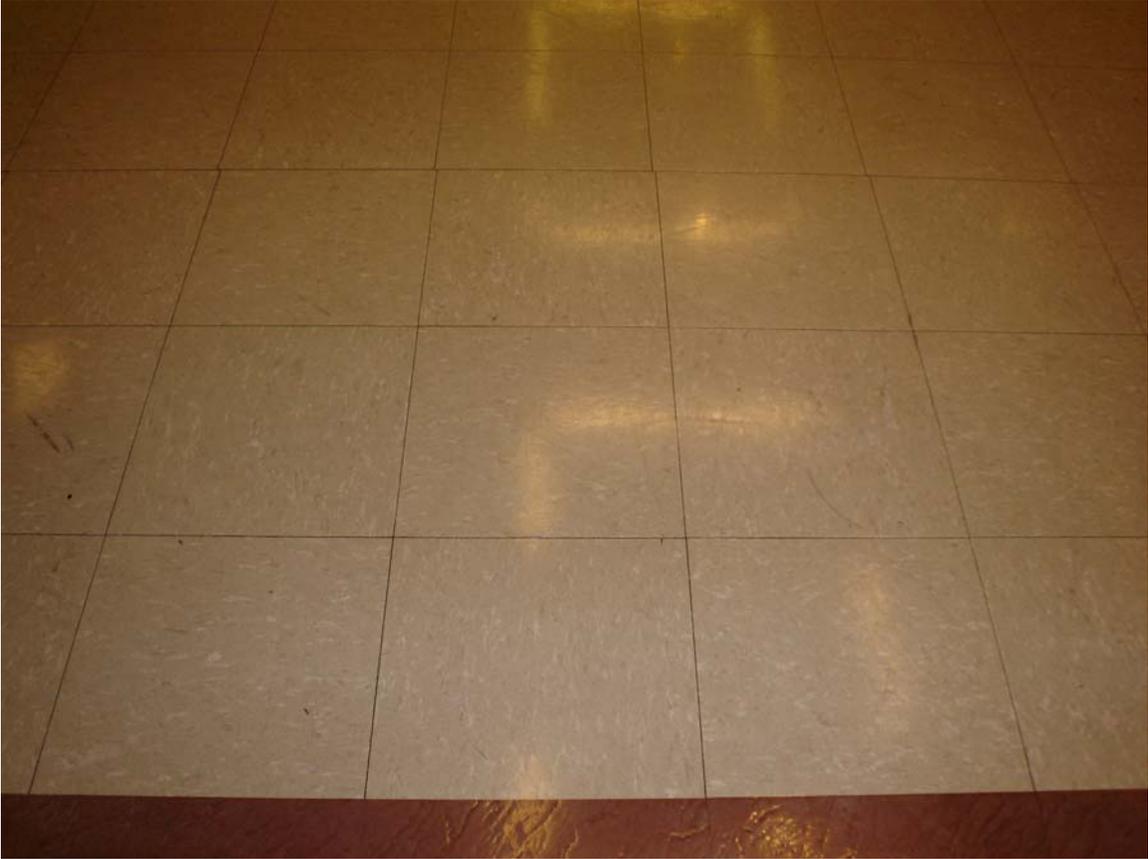
HA #27 – Asbestos-containing 12” x 12” beige floor tile  
with marble pattern and associated mastic

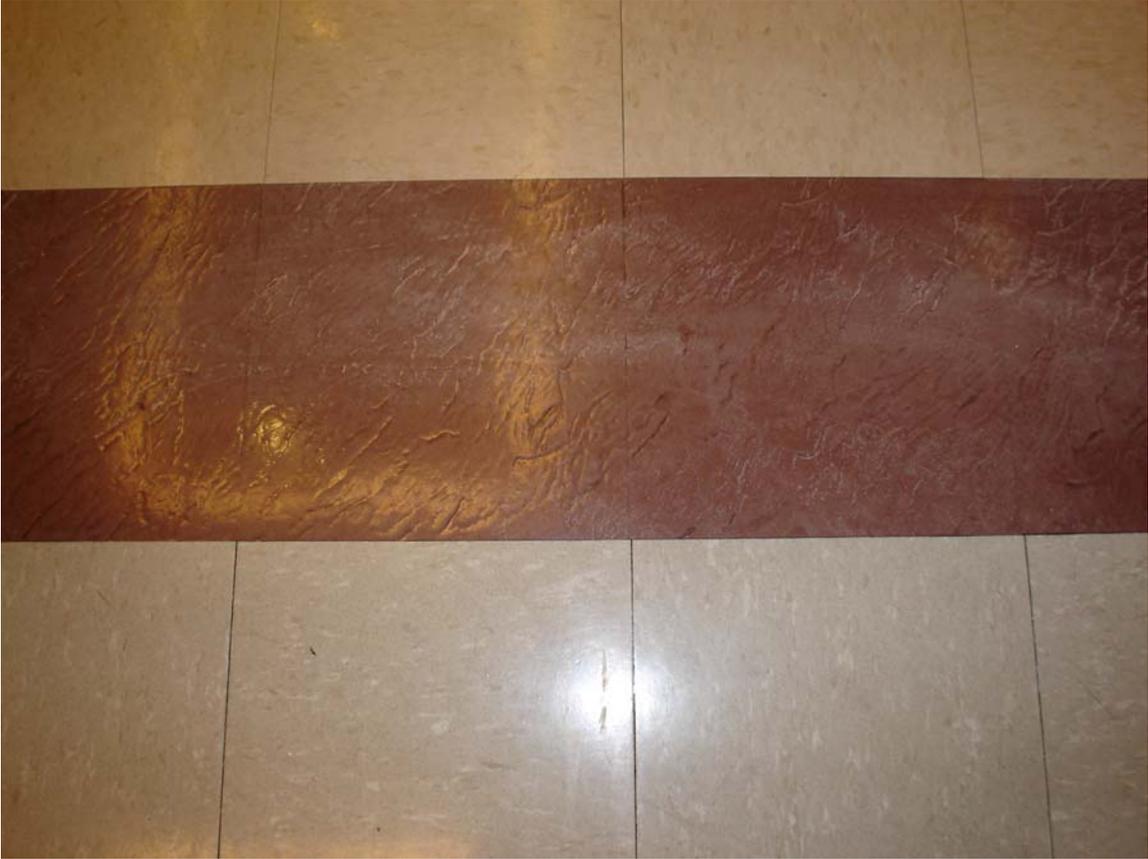
HA #28 – Asbestos-containing 12” x 12” maroon floor tile  
and associated mastic

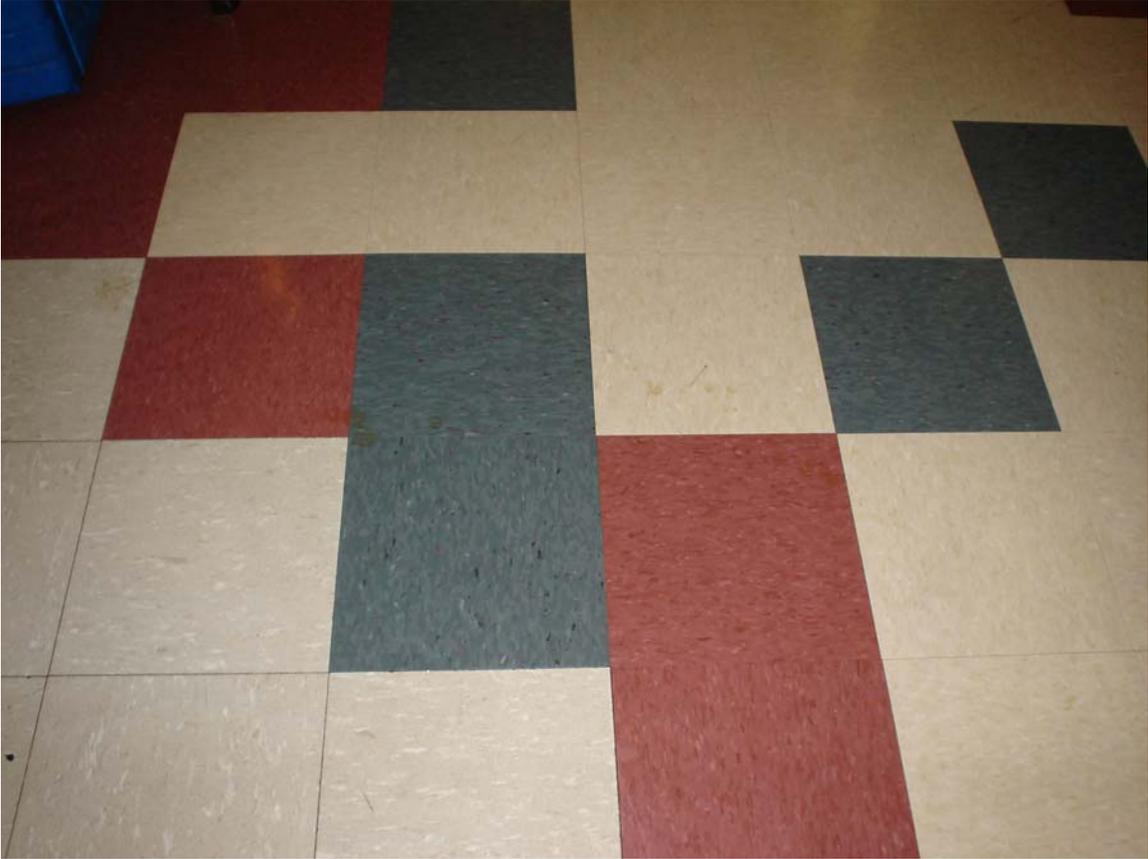
HA #29 – Non asbestos-containing 12” x 12” tan floor tile with marble pattern and associated asbestos-containing mastic

HA #30 – Non asbestos-containing 12” x 12” dark green floor tile with marble pattern and associated asbestos-containing mastic

HA #31 – Non asbestos-containing 12” x 12” red floor tile with marble pattern and associated asbestos-containing mastic

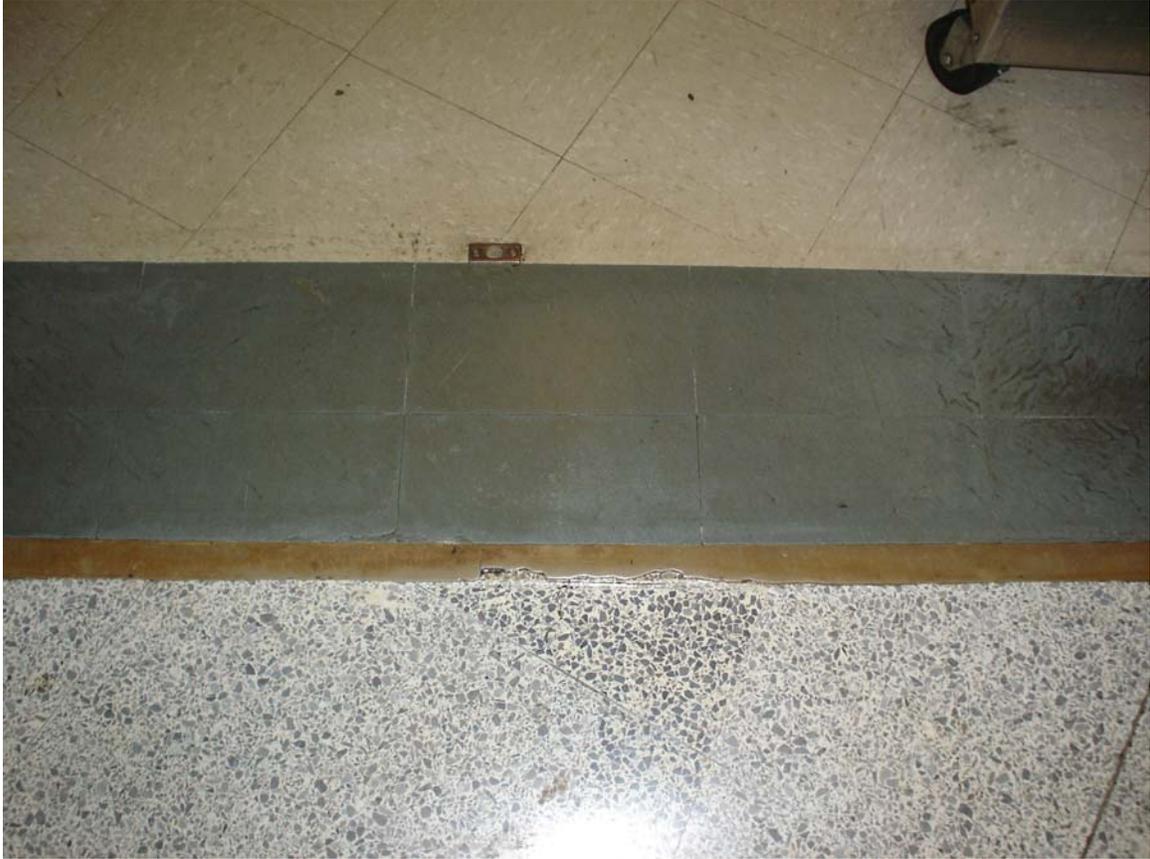
HA #32 – Asbestos-containing 12” x 12” forest green floor tile  
and associated mastic

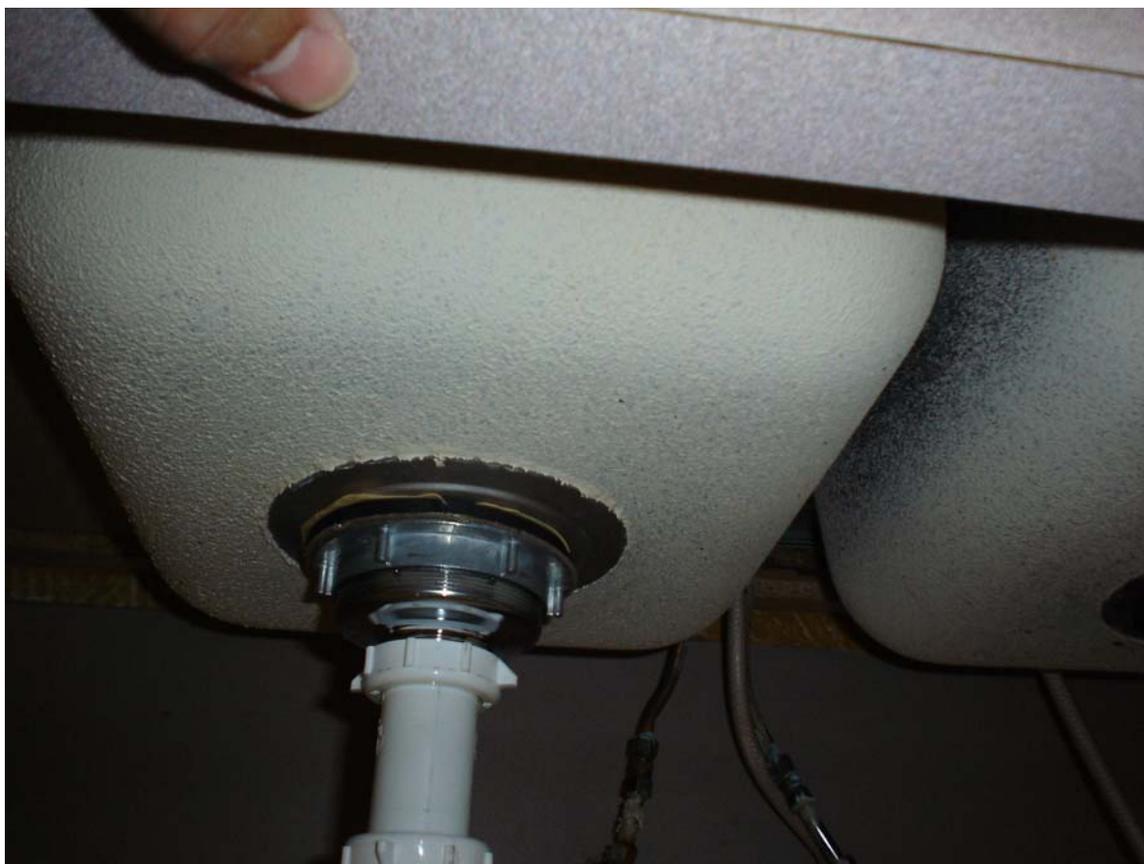
HA #35 – Non asbestos-containing white sink undercoating

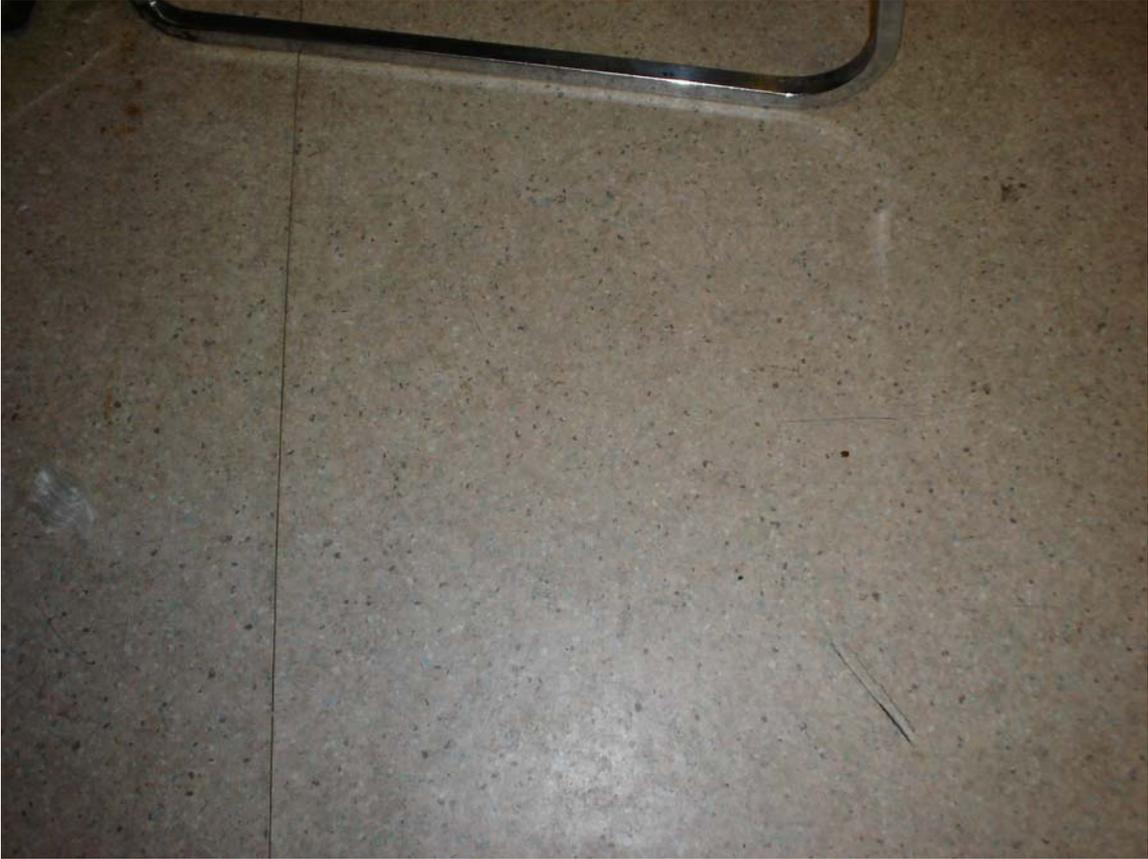
HA #36 – Non asbestos-containing tan vinyl flooring  
with mosaic pattern and associated mastic

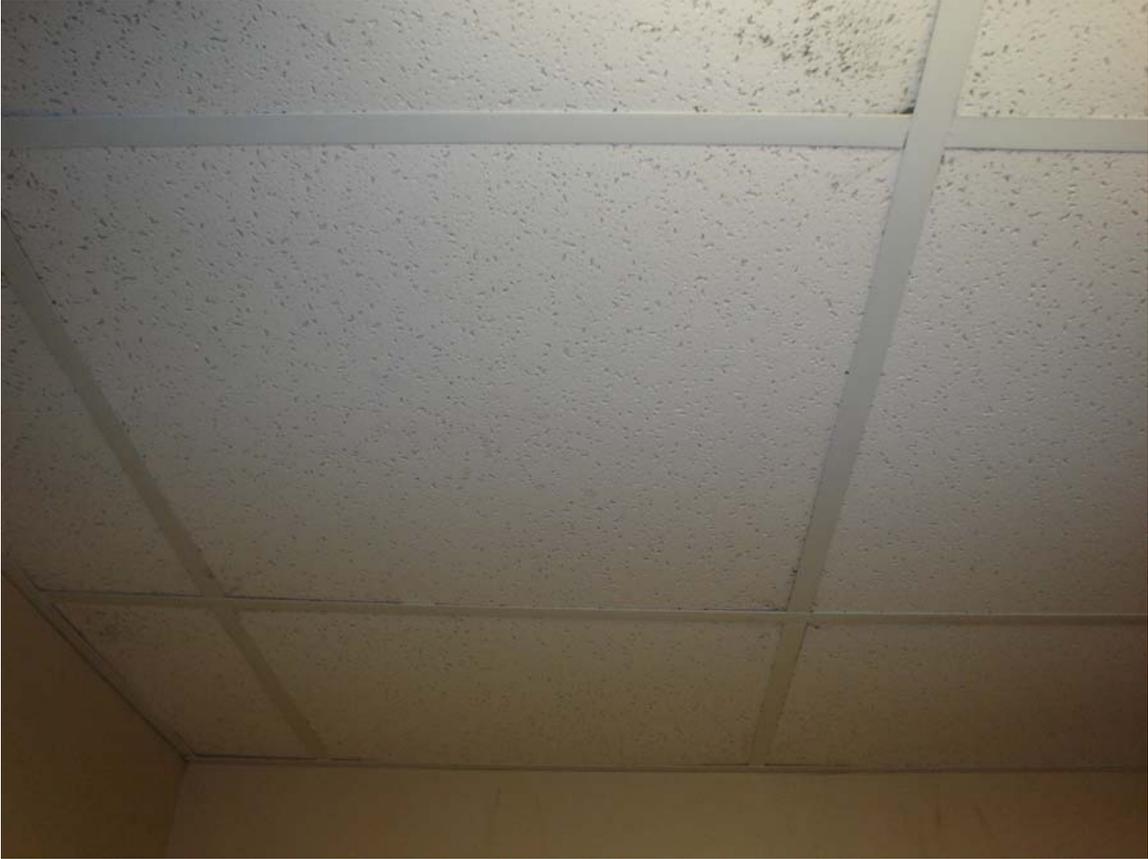
HA #37 – Non asbestos-containing 2' x 2' white lay-in ceiling tile  
with pin holes and fissures

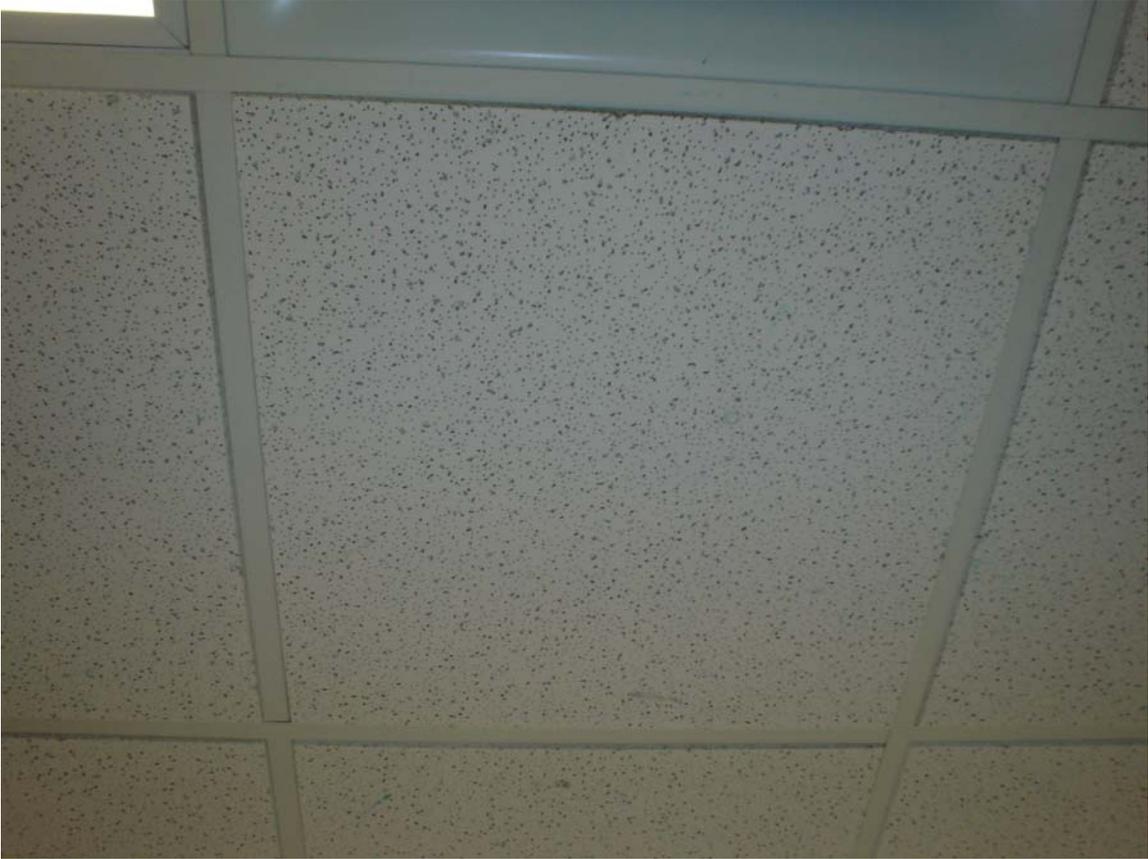
HA #38 – Non asbestos-containing 2' x 2' white lay-in smooth gypsum board ceiling tile

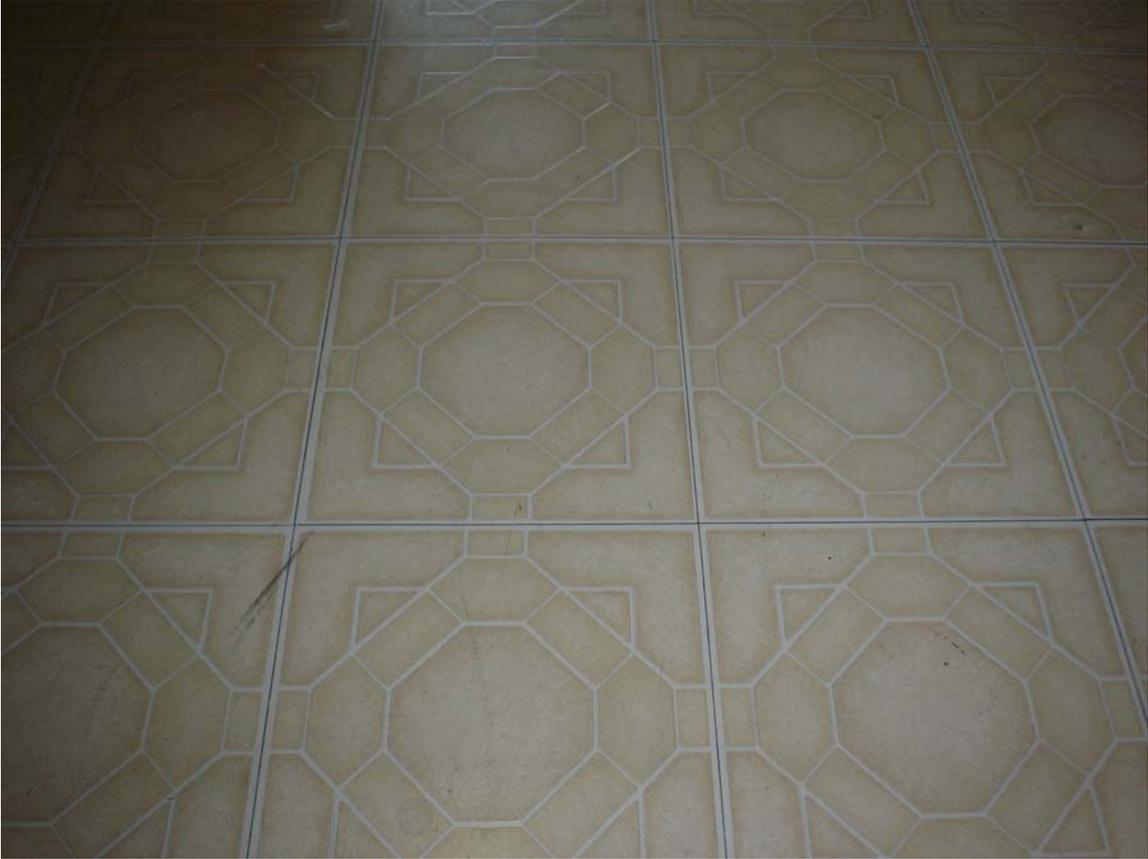
HA #39 – Non asbestos-containing 12” x 12” tan floor tile  
and associated asbestos-containing mastic

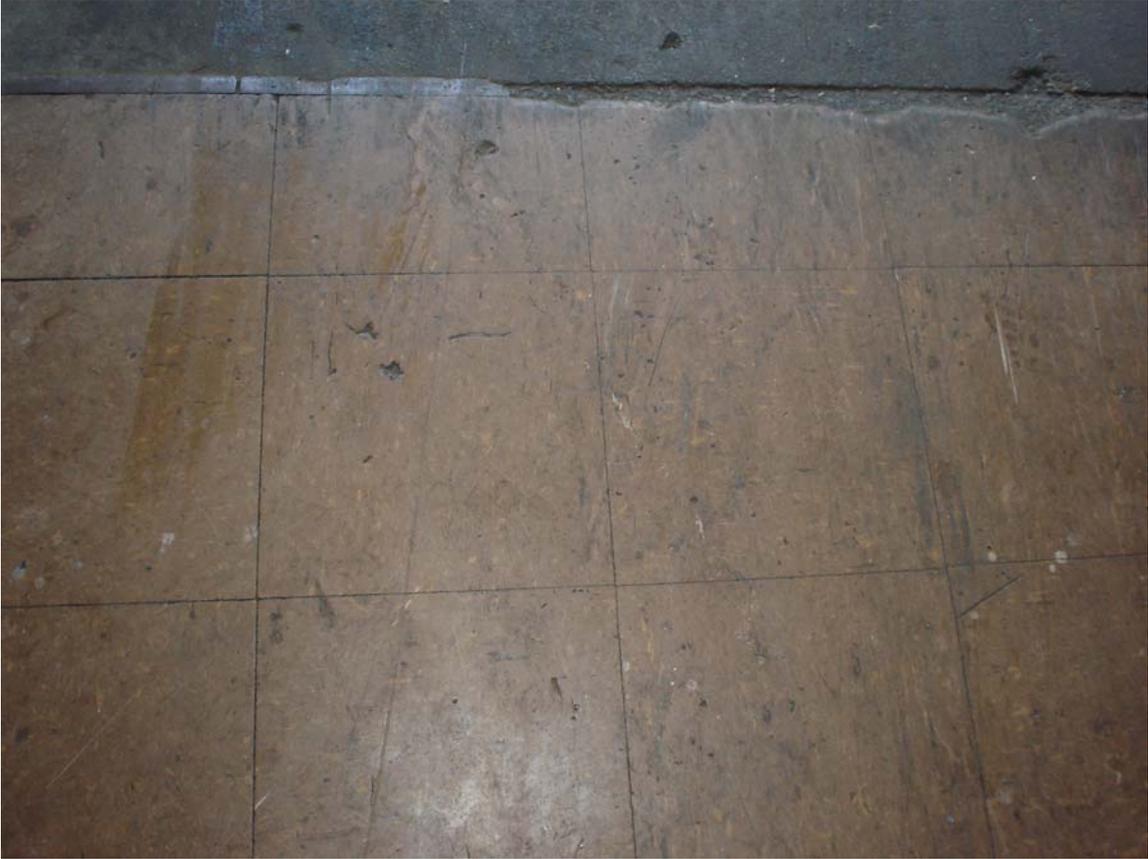
HA #40 – Non asbestos-containing 12” x 12” chocolate floor tile  
with yellow and rust streaks and associated mastic

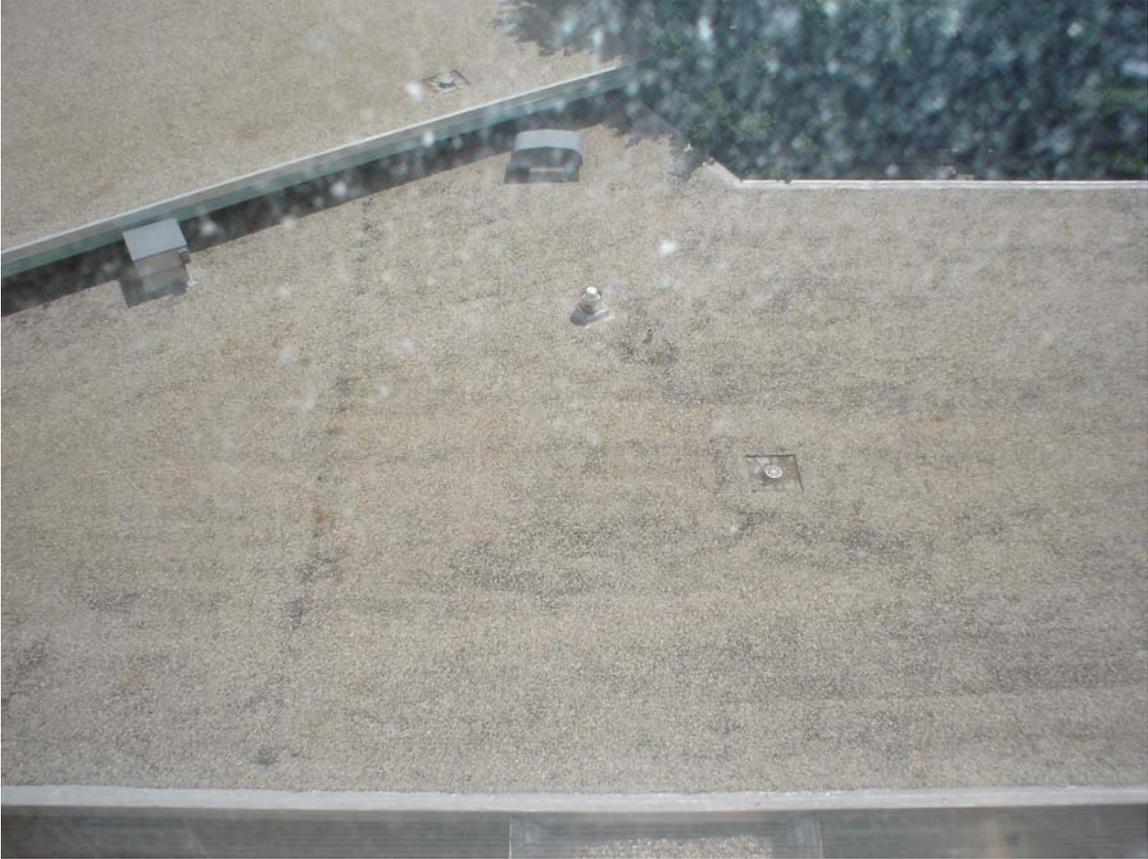
HA #43 – Assumed asbestos-containing roofing products/materials
