MSU Case Hall  
East Lansing, Michigan

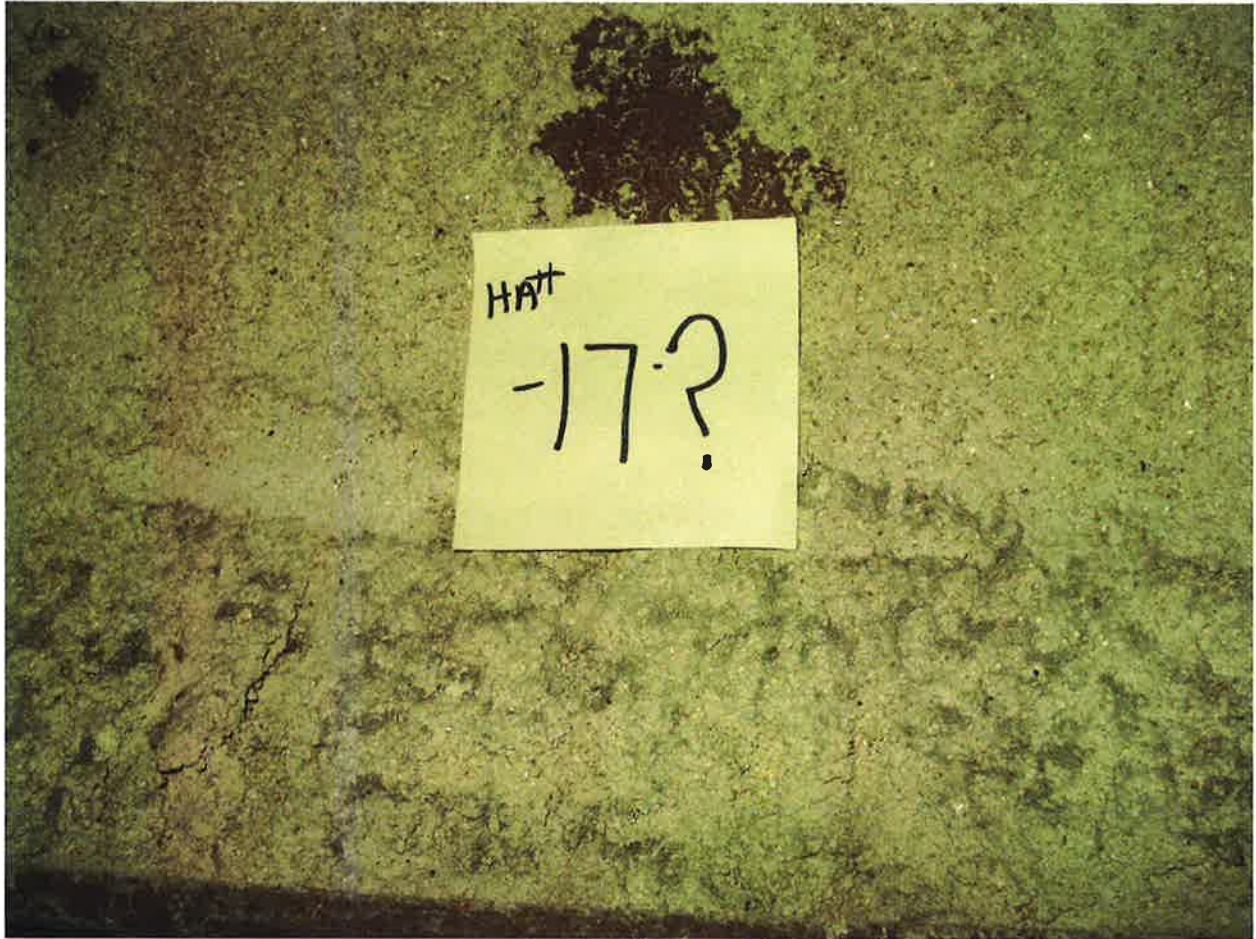
HA #17 – Non asbestos containing troweled on material (tan)  
(Room 31 and 42)

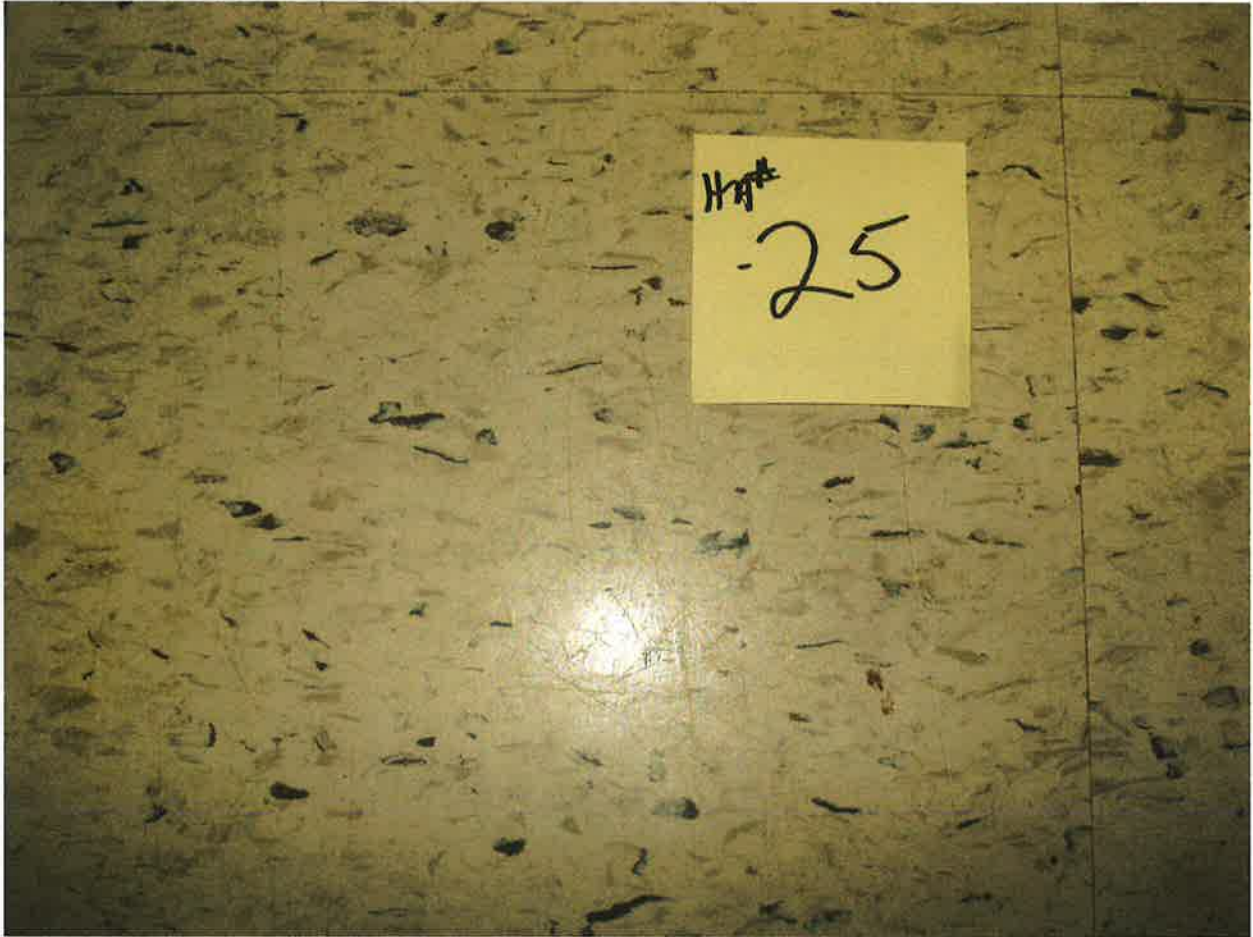
HA #25 – Non asbestos containing 12” x 12” white floor tile  
with black and gray specks and associated mastic

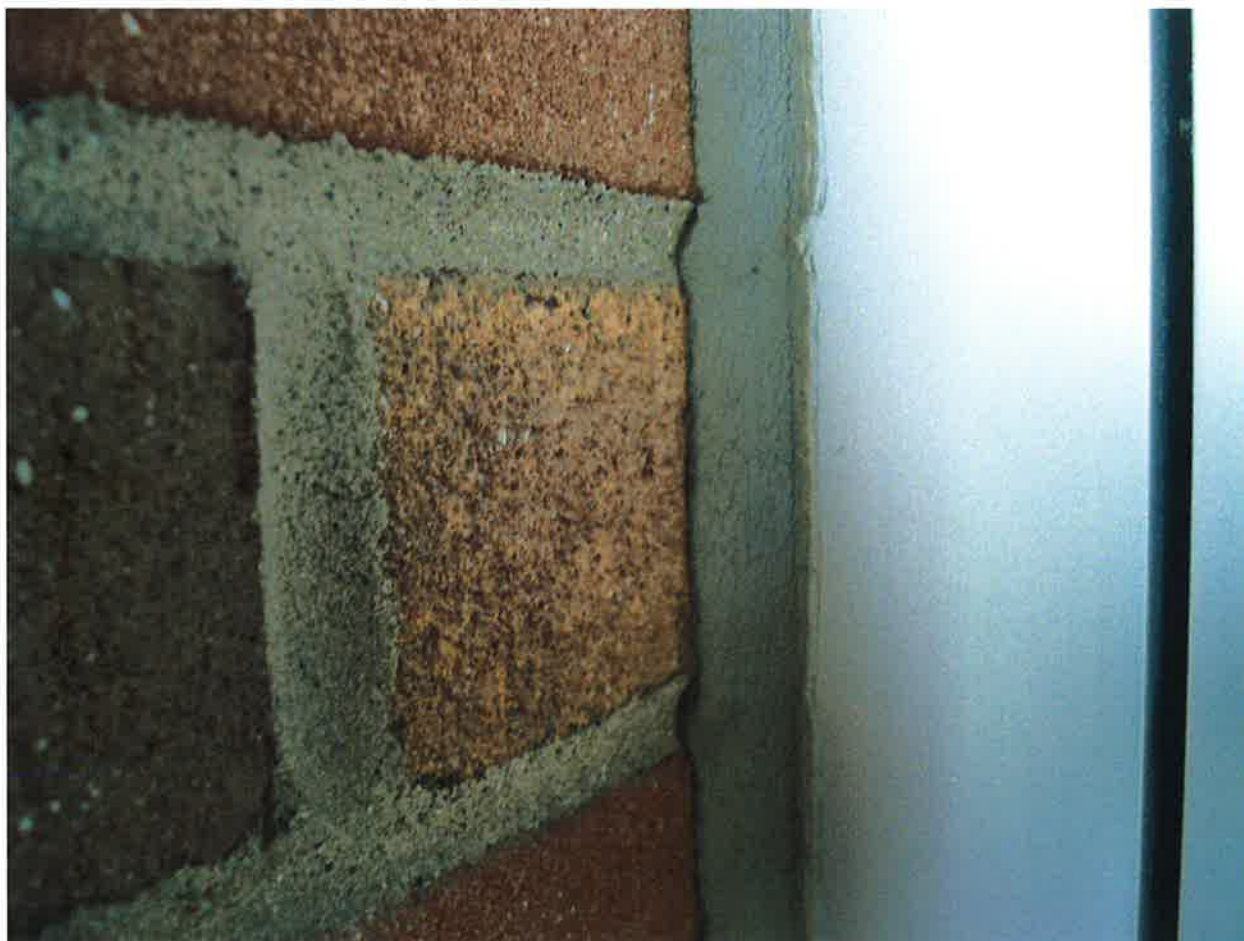
HA #34 – Non asbestos containing gray window and door frame caulk compound

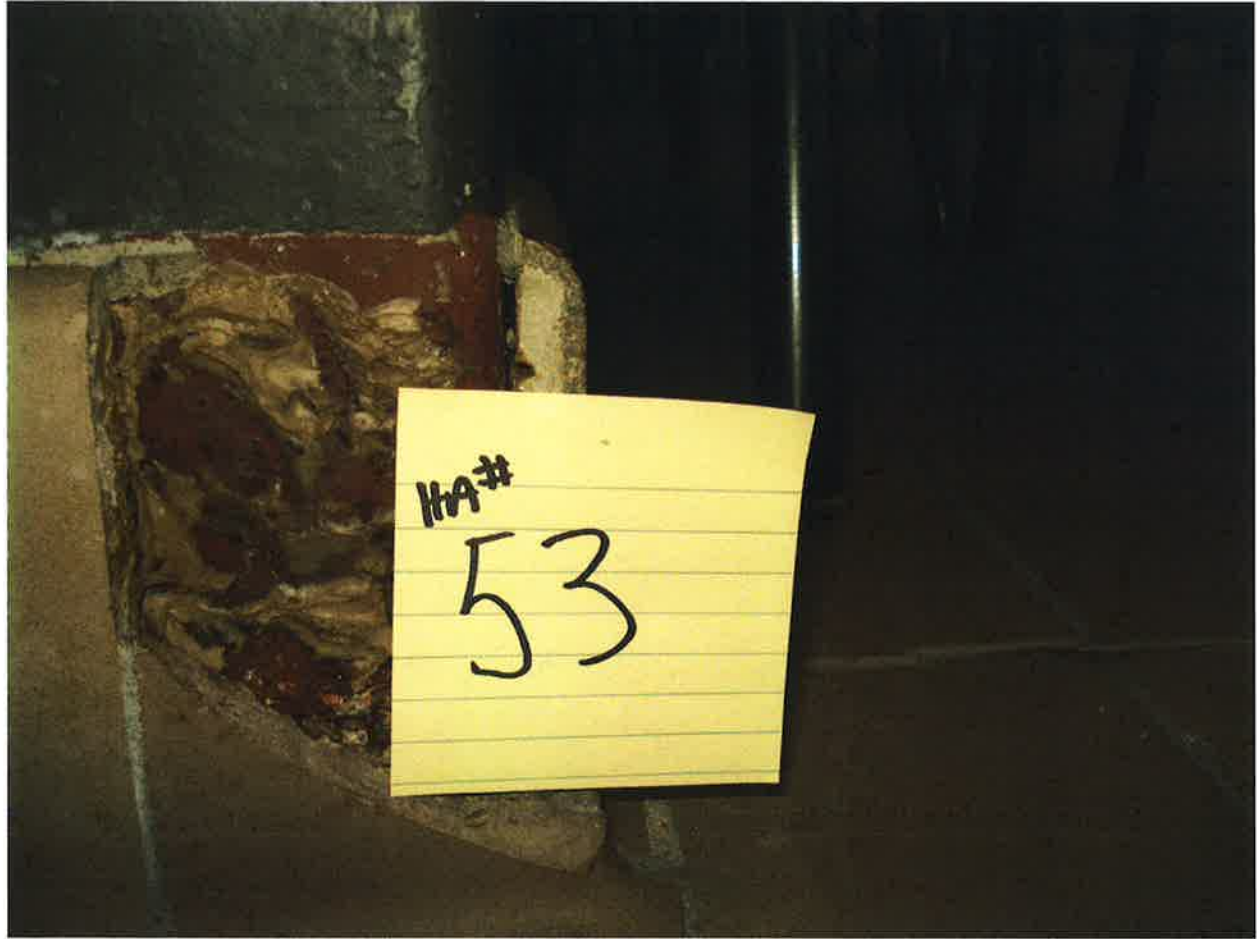
HA #53 – Non asbestos containing ceramic tile  
bedding compound associated with 6" x 6" tan ceramic floor tile

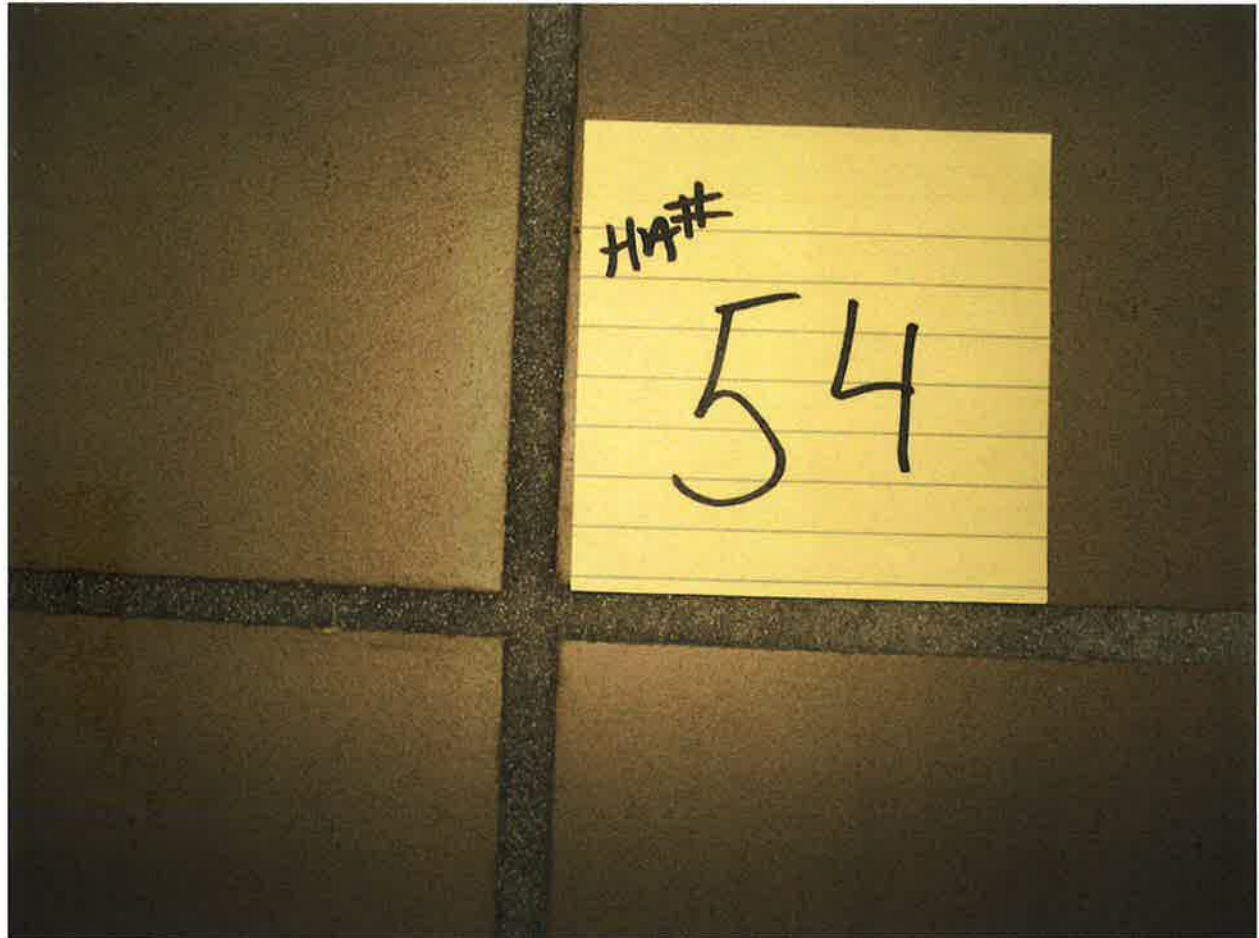
HA #54 – Non asbestos containing ceramic tile grout compound  
associated with 6" x 6" tan ceramic floor tile

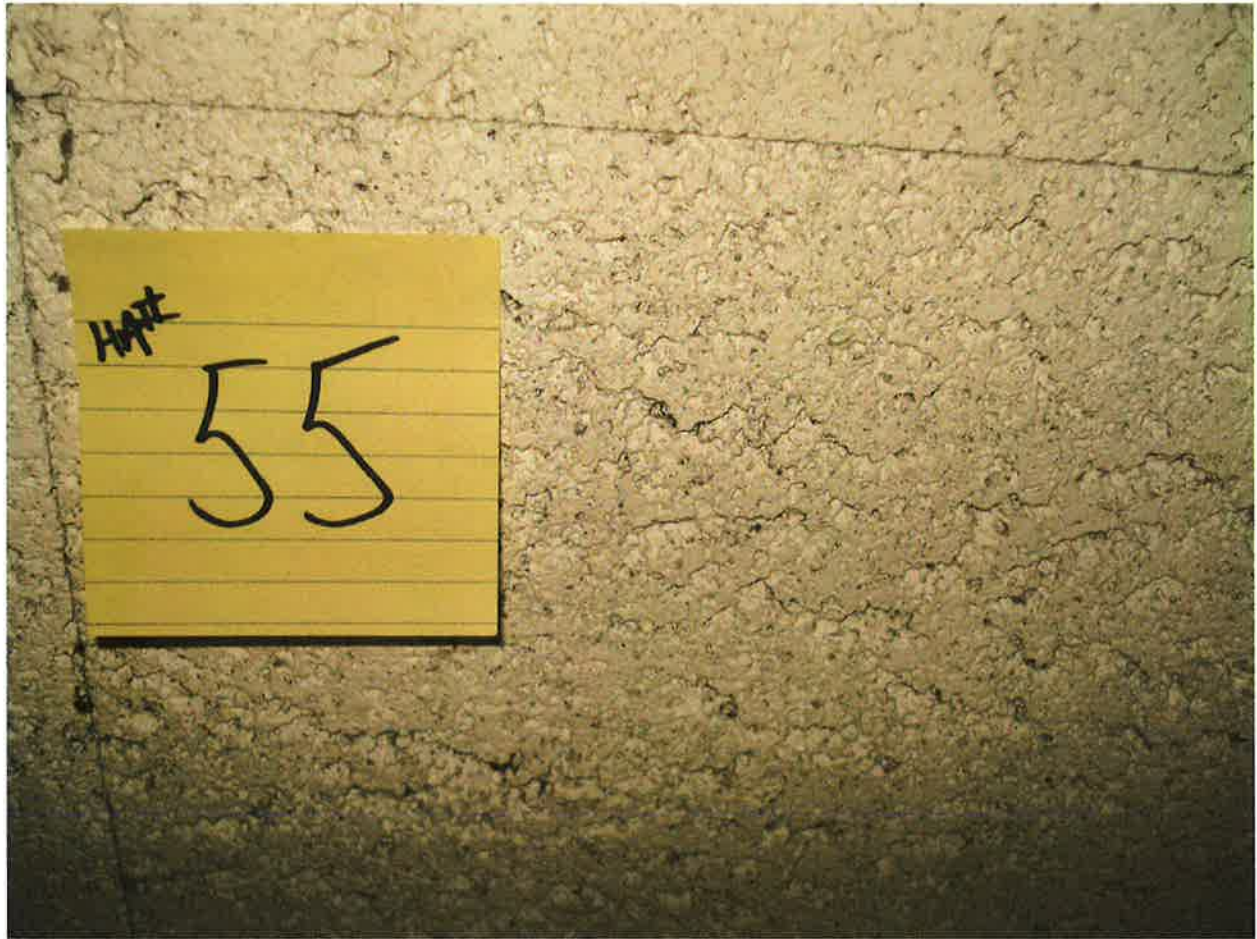
HA #55 – Non asbestos containing white spline  
ceiling tile with fissures

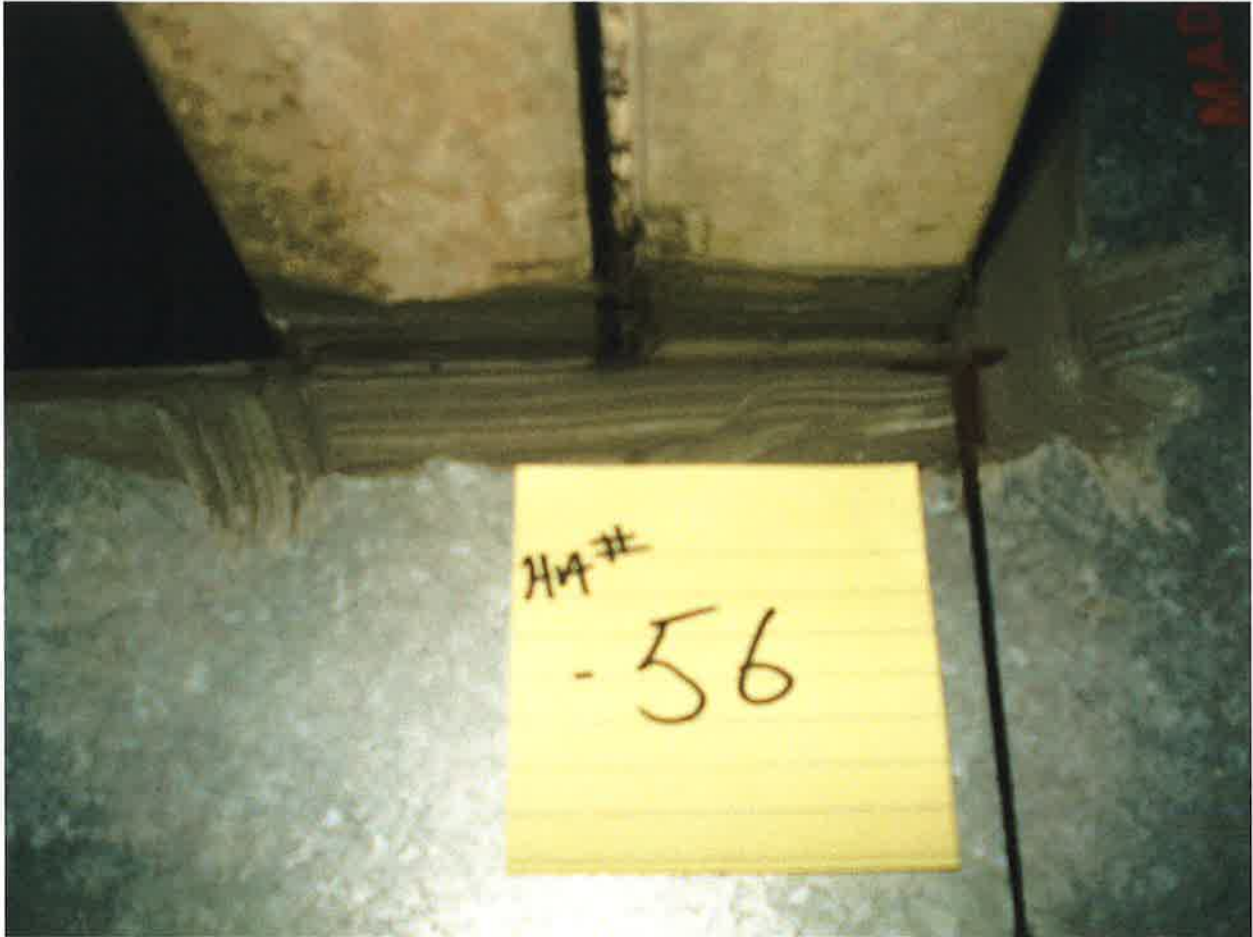
HA #56 – Non asbestos containing gray duct caulk compound

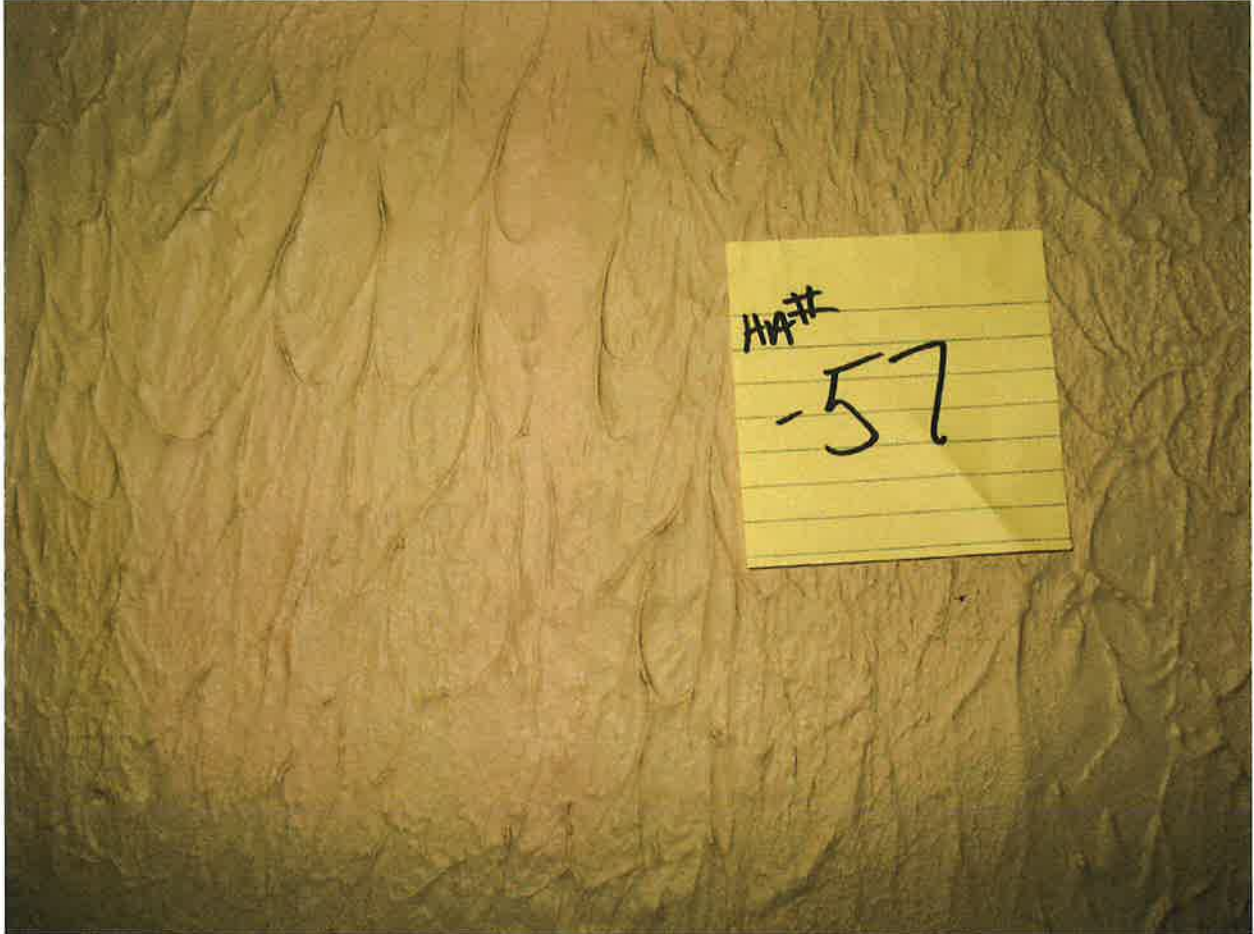
HA #57 – Non asbestos containing heavy textured wall plaster

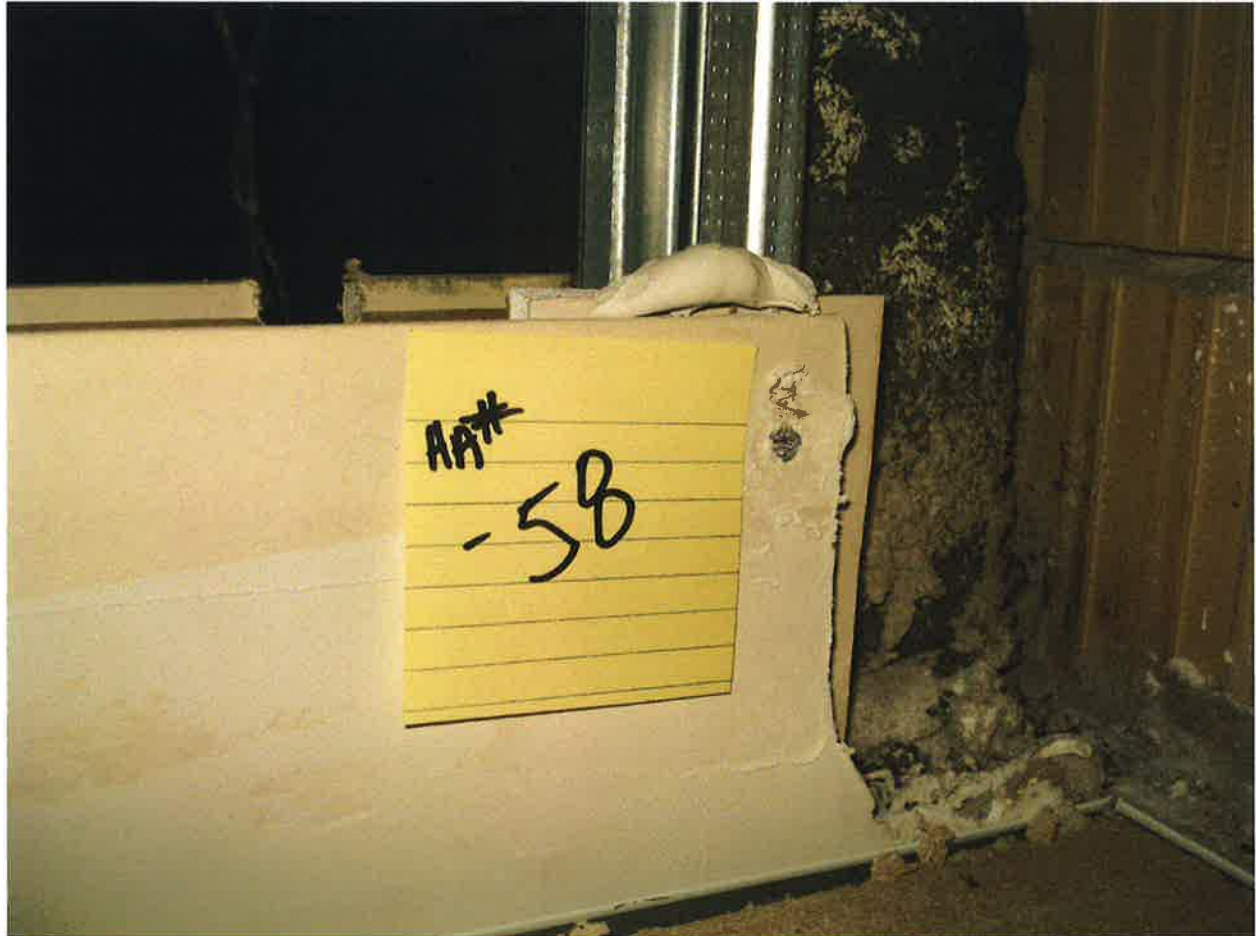
HA #58 – Non asbestos containing drywall joint compound

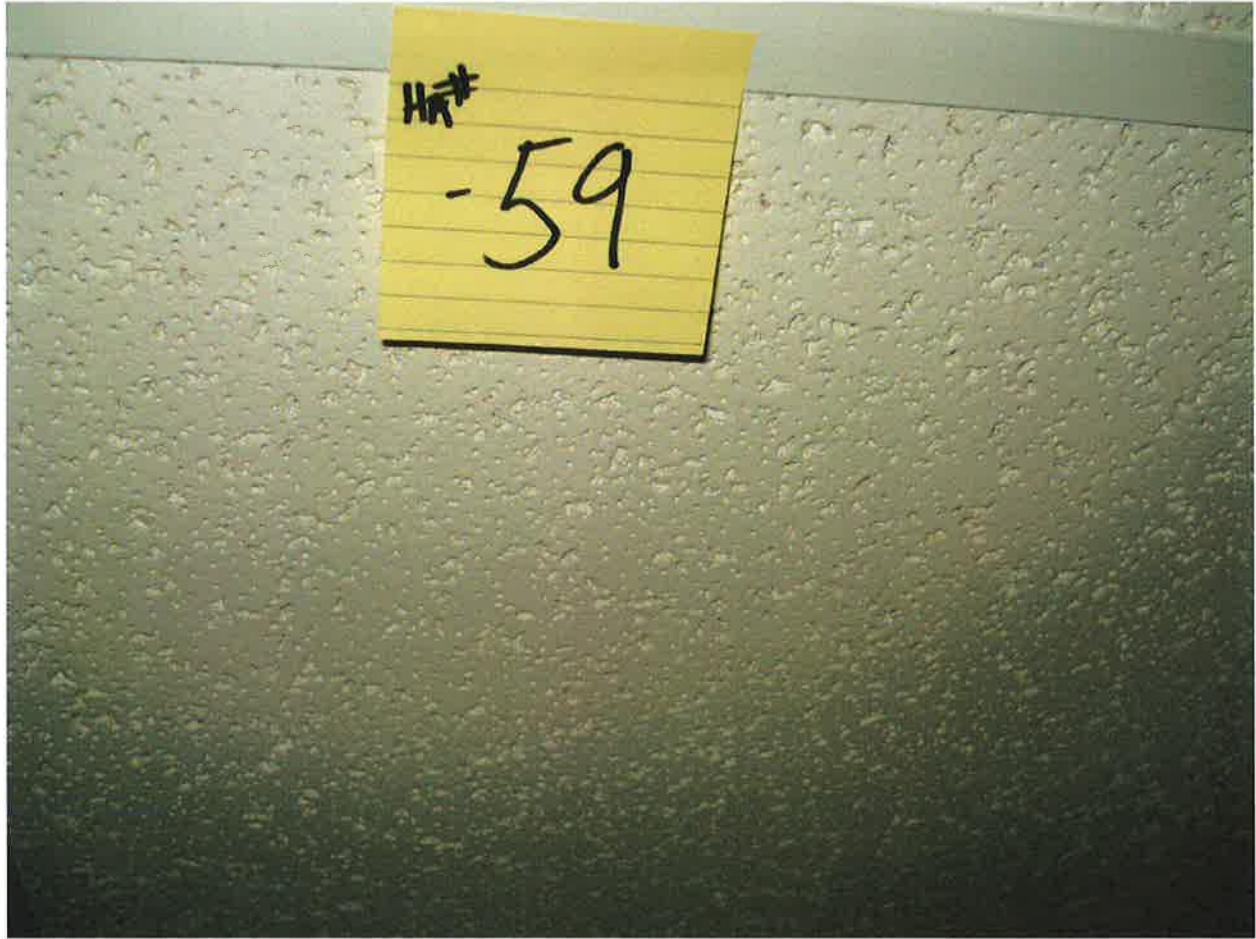
HA #59 – Non asbestos containing 2' x 2' white lay-in ceiling tile with pin holes and random gouge pattern

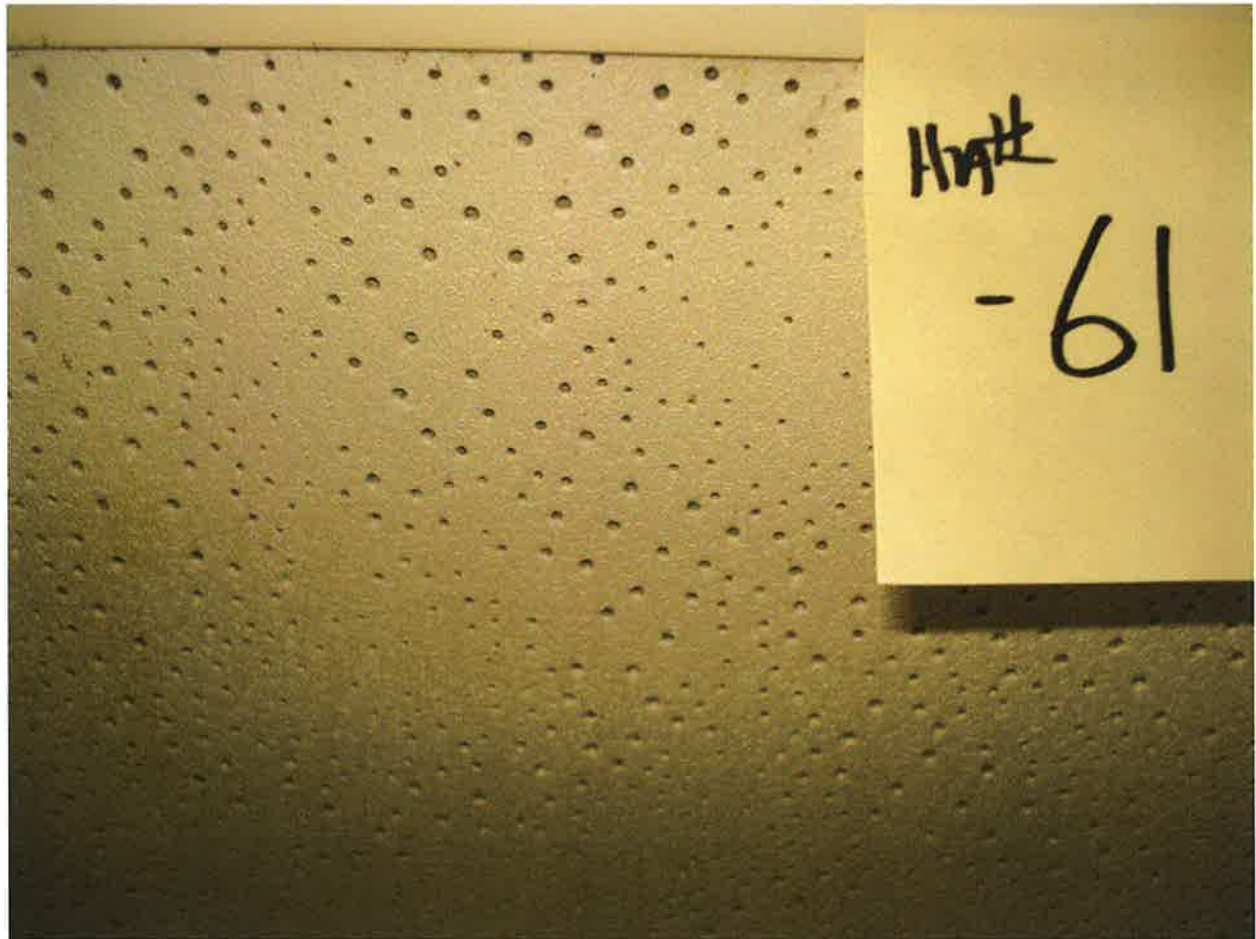
HA #61 – Non asbestos containing 2' x 2' white lay-in ceiling tile with random pin holes

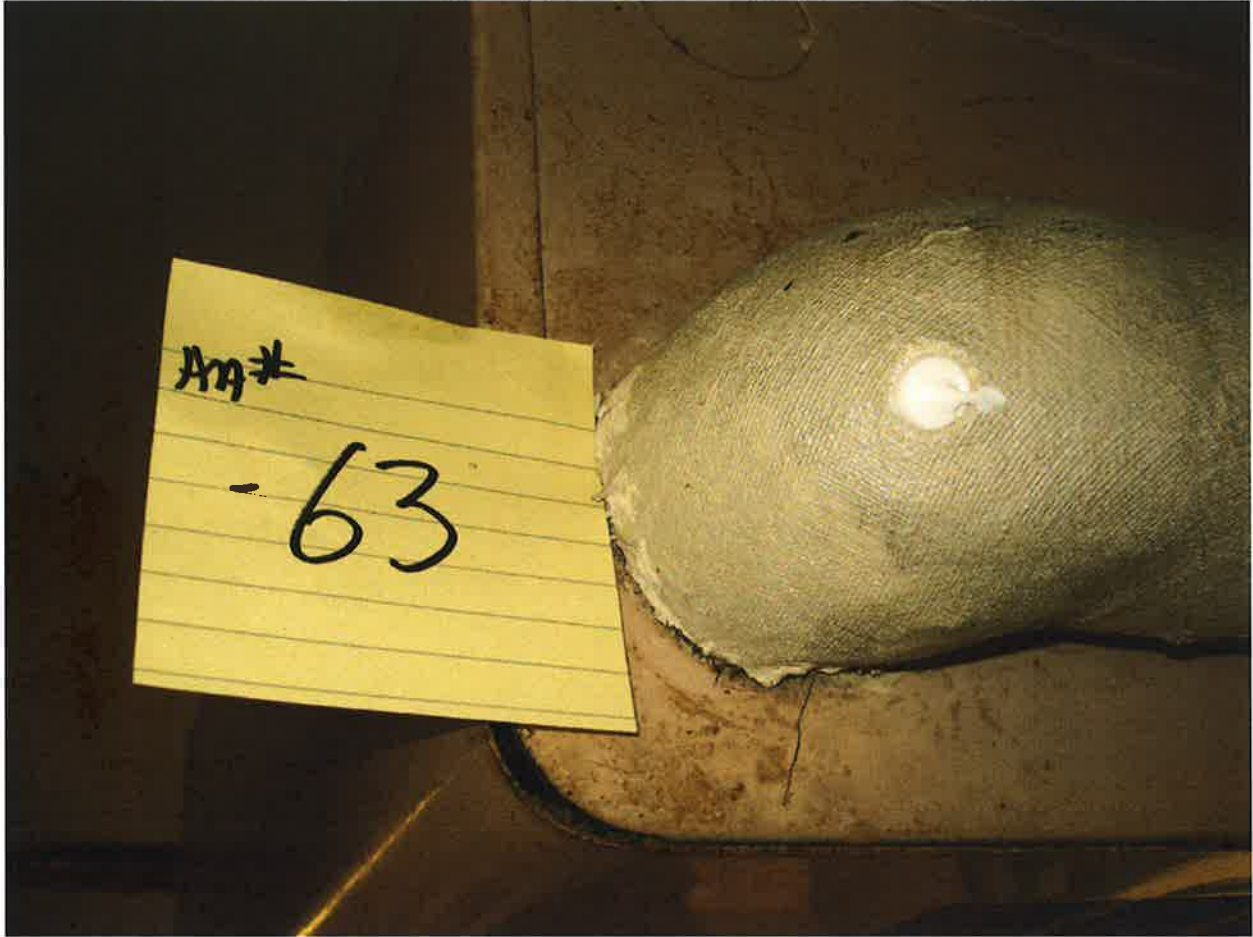
HA #63 – Non asbestos containing hot heating water supply pipe joint and hanger insulation

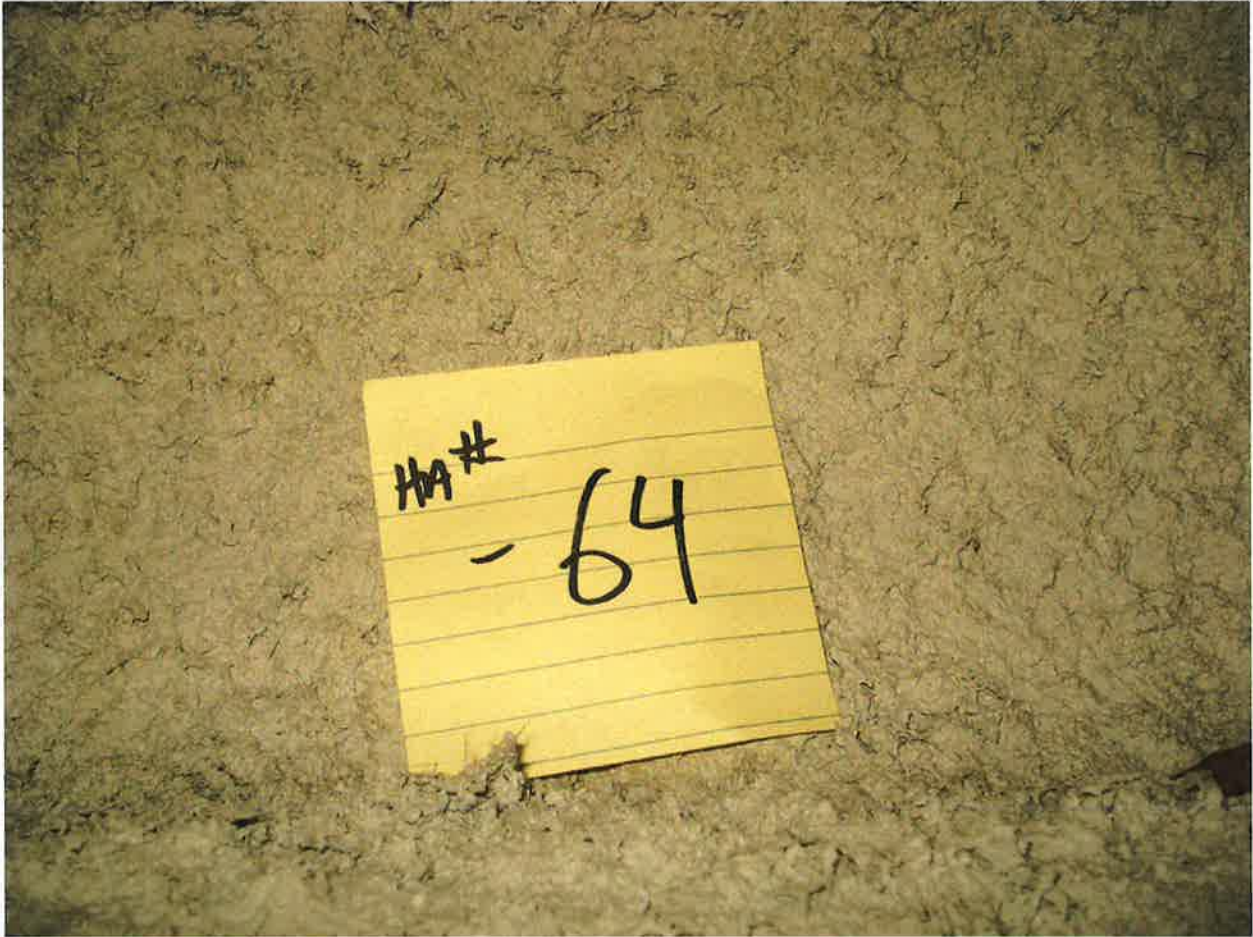
HA #64 – Non asbestos containing gray spray  
applied fireproofing

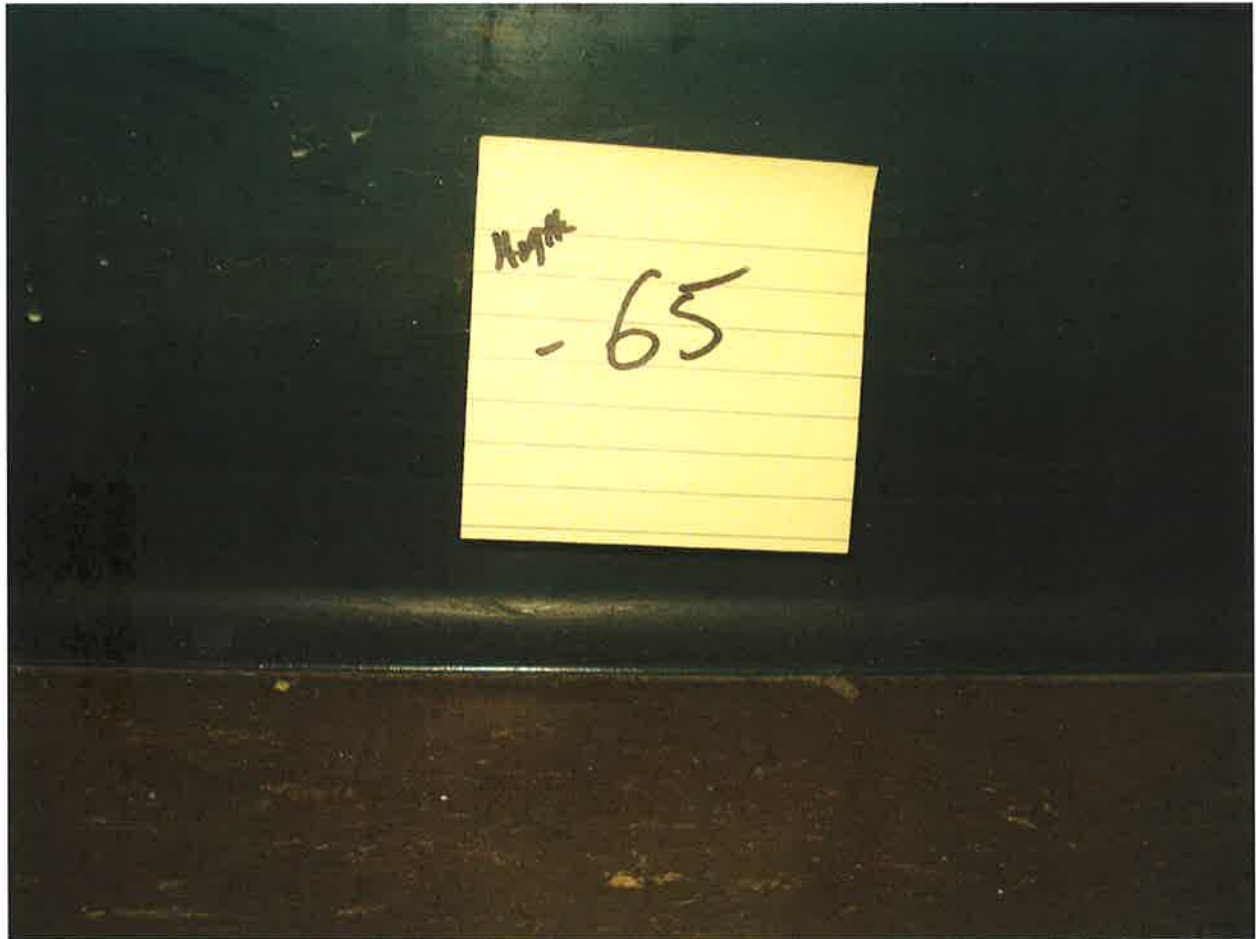
HA #65 – Non asbestos containing 6” black  
baseboard and associated mastic

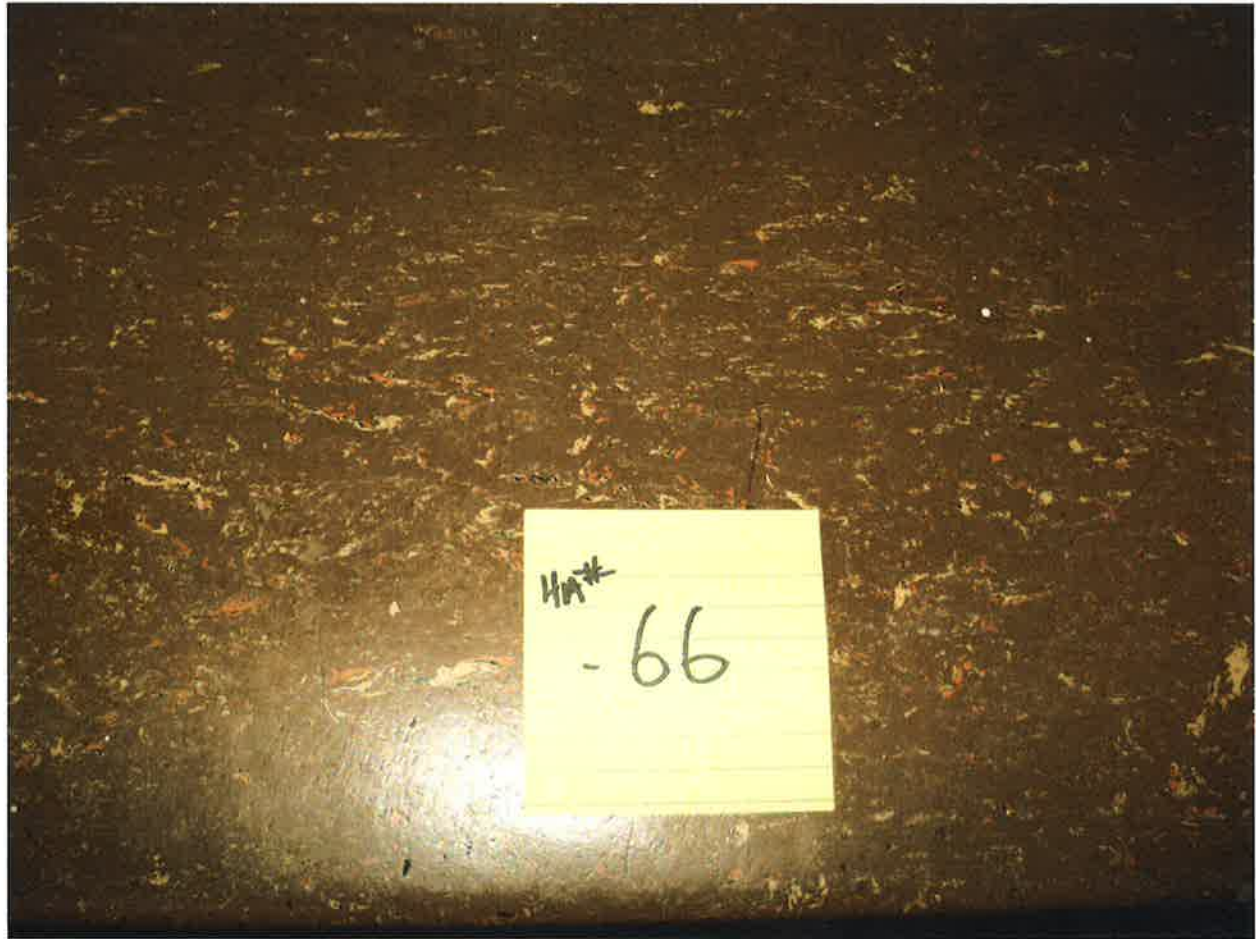
HA #66 – Non asbestos containing brown stair tread  
with pink and yellow streaks (<1% Chrysotile) and non asbestos containing  
associated mastic

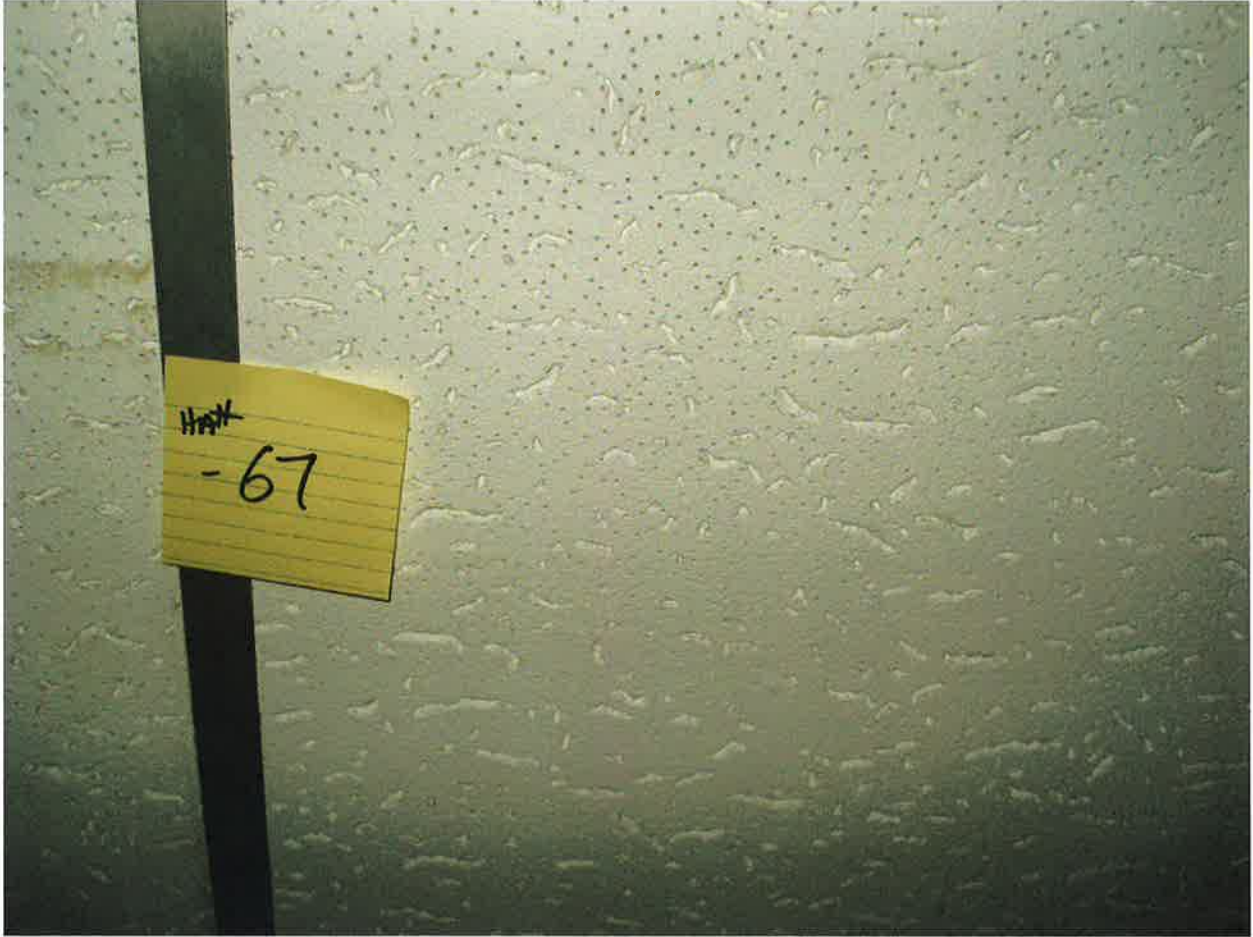
HA #67 – Non asbestos containing 2' x 4' white lay-in ceiling tile  
with pin holes and fissures

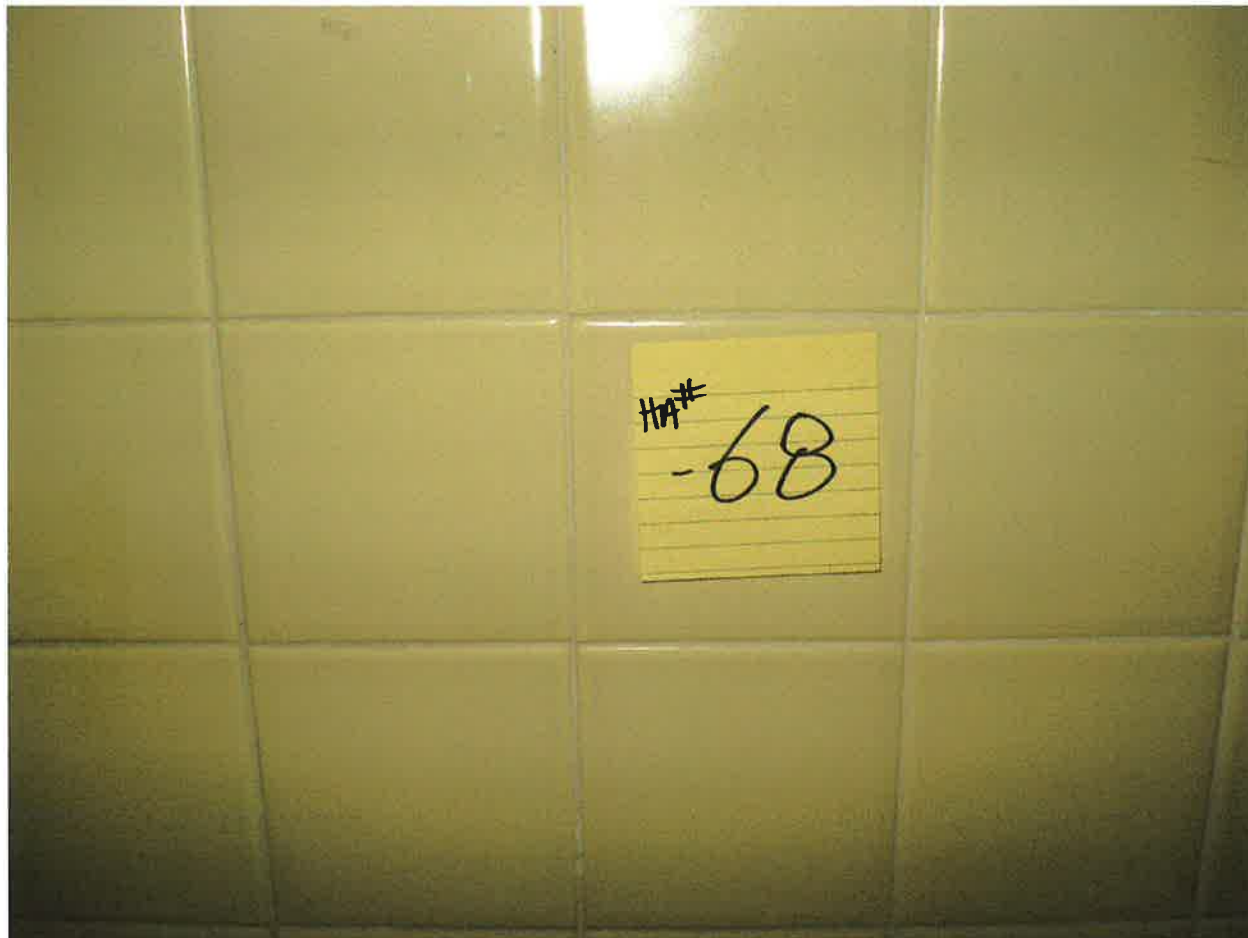
HA #68 – Non asbestos containing 4” x 4” ceramic wall tile  
bedding compound (<1% Chrysotile)

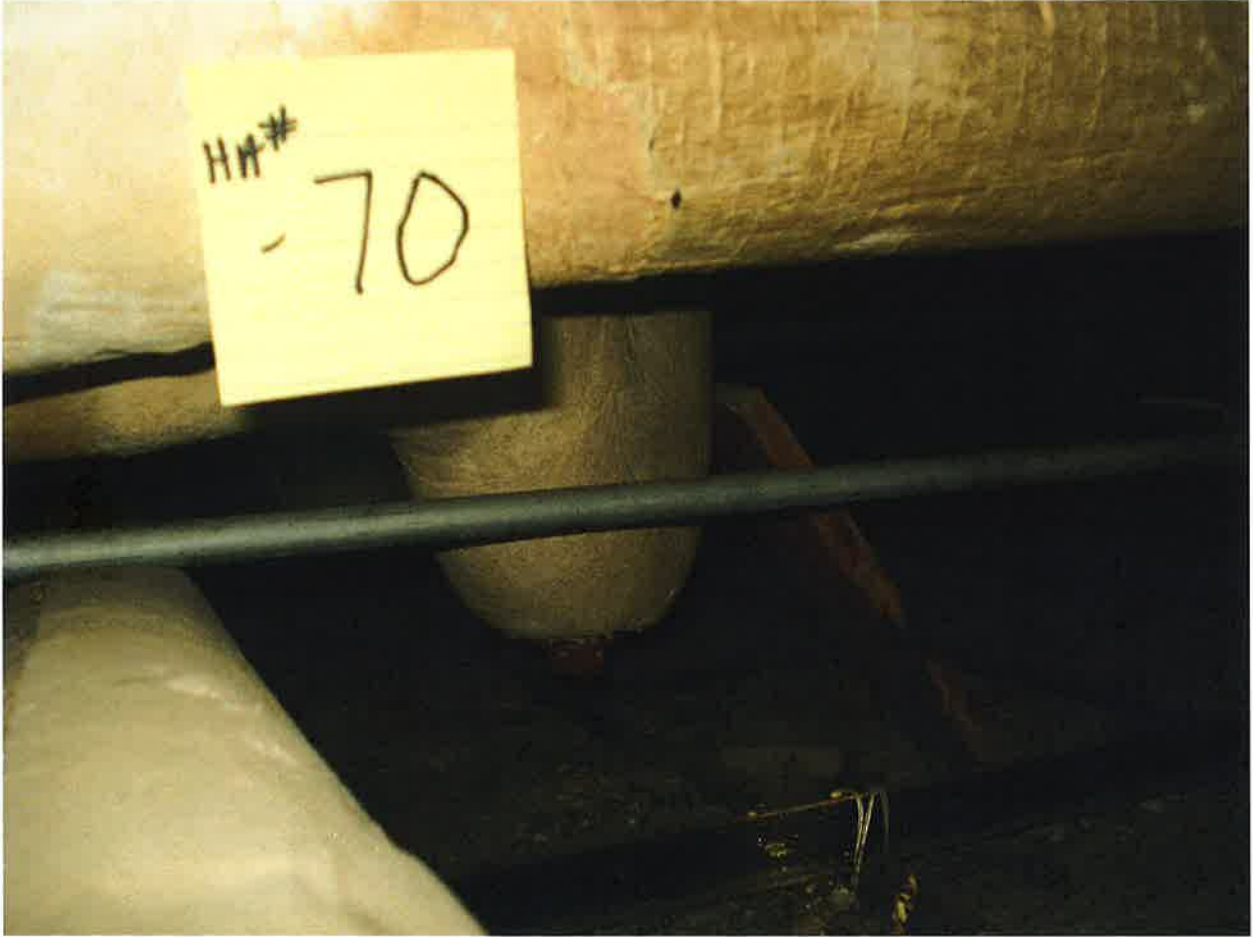
HA #70 – Asbestos containing drain line  
pipe joint and hanger insulation

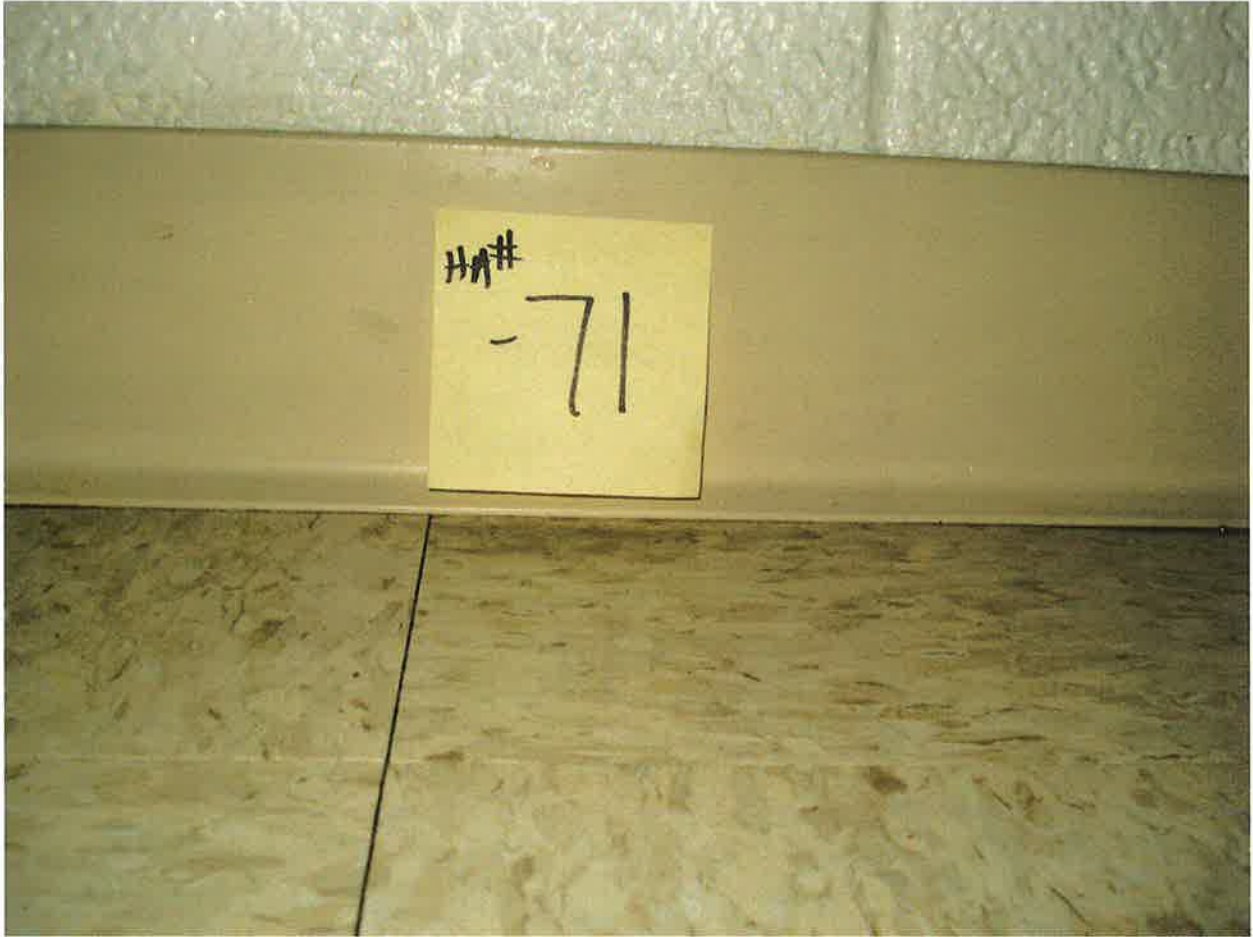
HA #71 – Non asbestos containing 4” tan  
baseboard and associated mastic
