MSU Case Hall  
East Lansing, Michigan

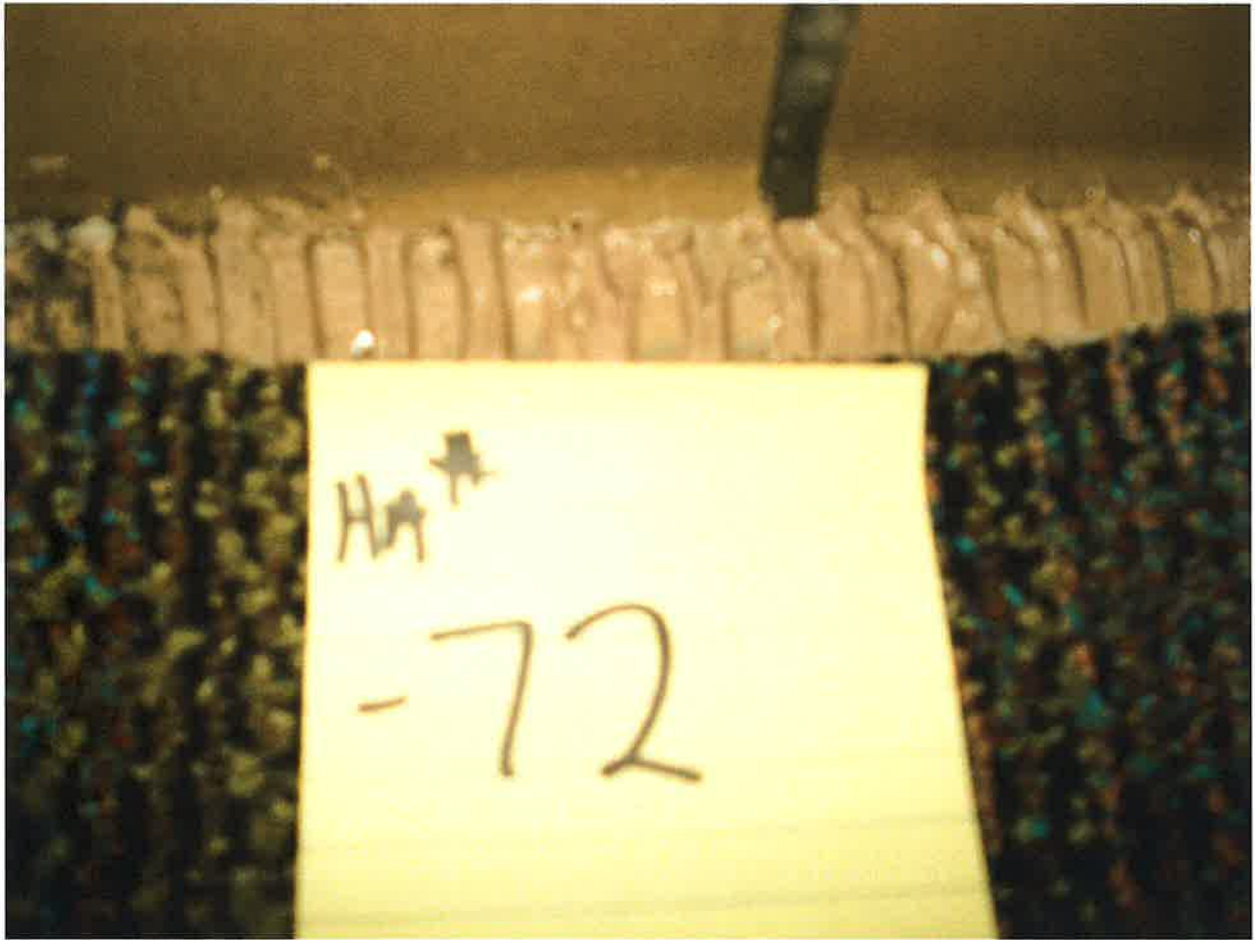
HA #72 – Non asbestos containing tan carpet mastic

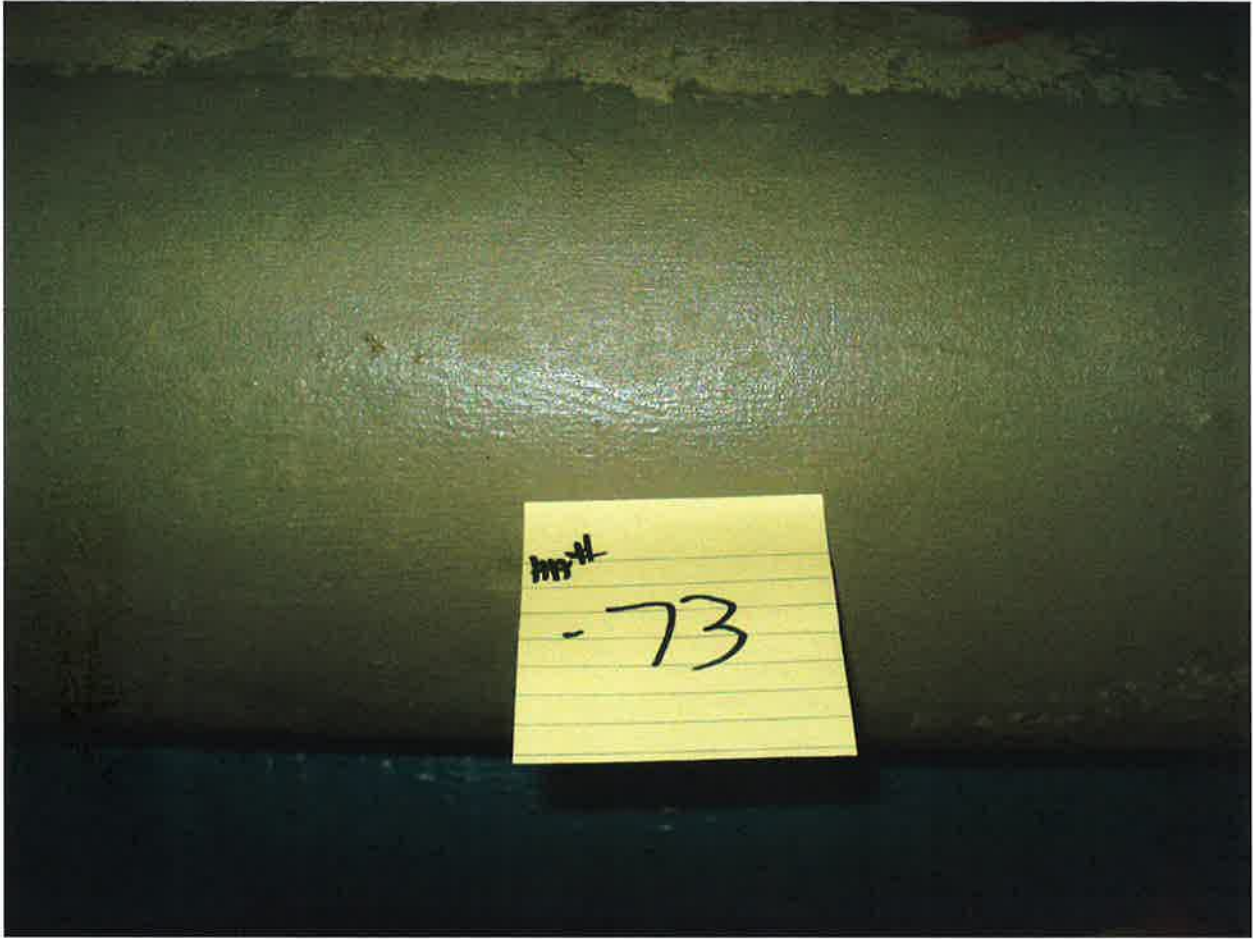
HA #73 – Asbestos containing steam and condensate supply and return pipe straight insulation (mag insulation)

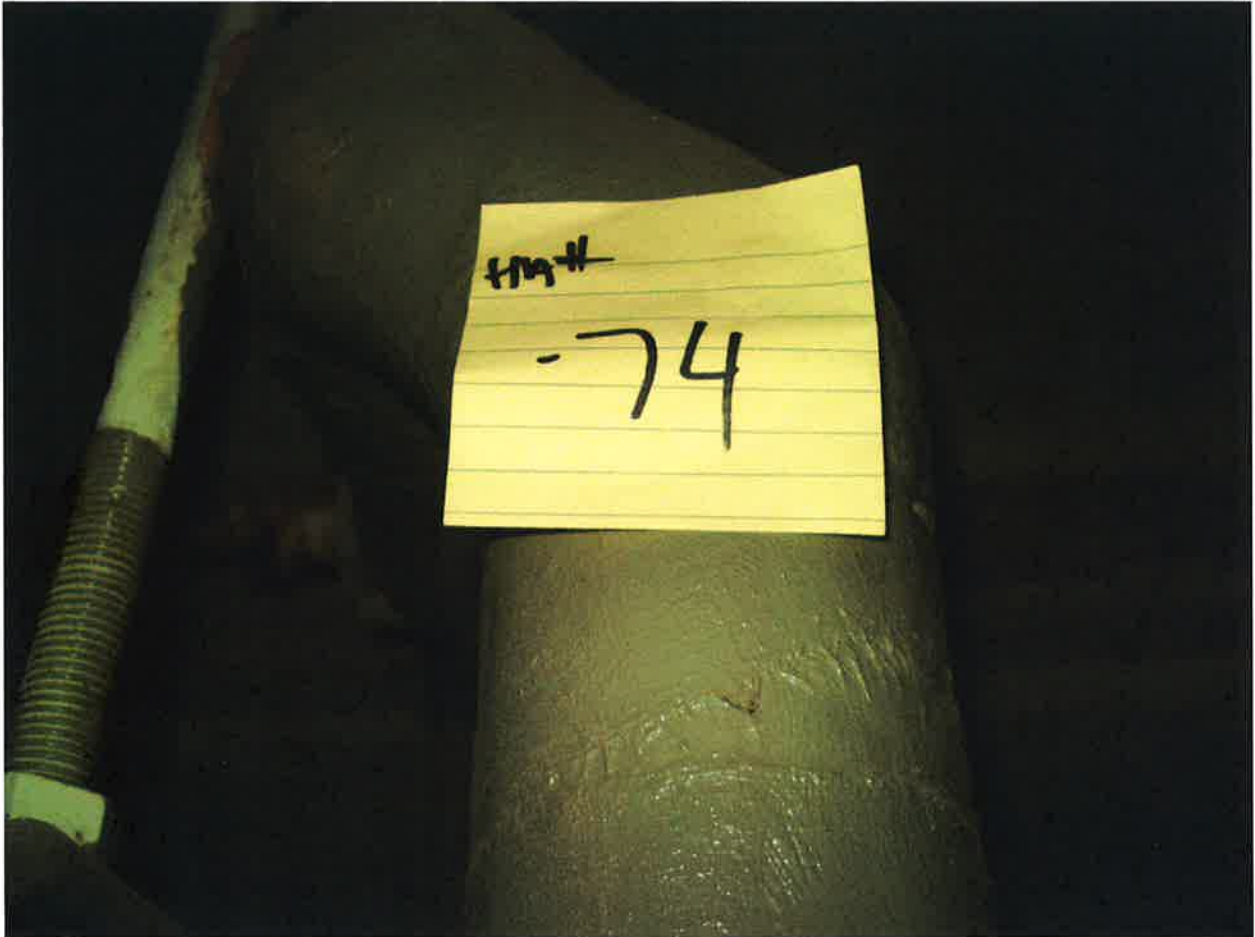
HA #74 – Non asbestos containing steam and condensate  
supply return pipe joint and hanger insulation

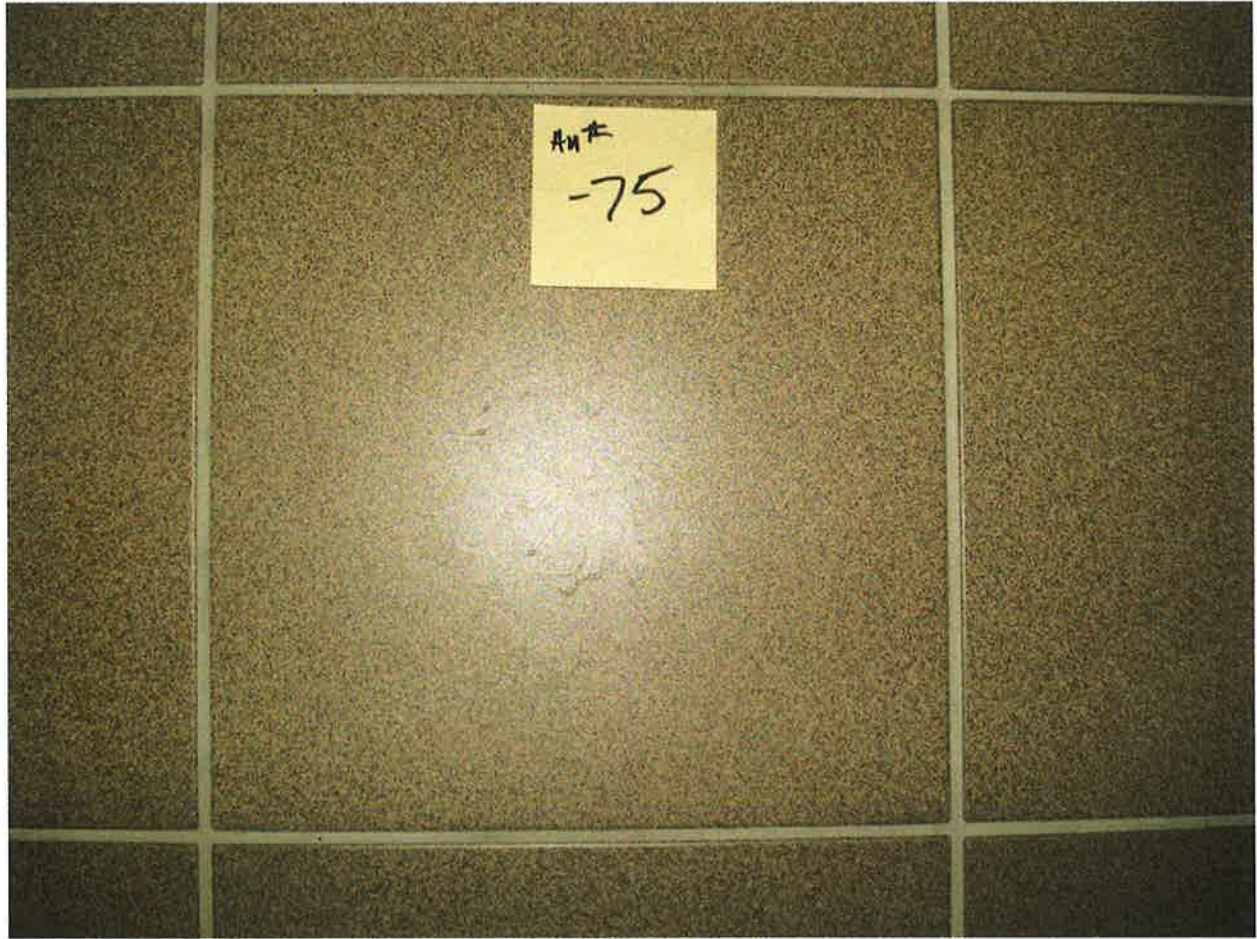
HA #75 – Non asbestos containing 12” x 12” tan ceramic  
floor tile bedding compound

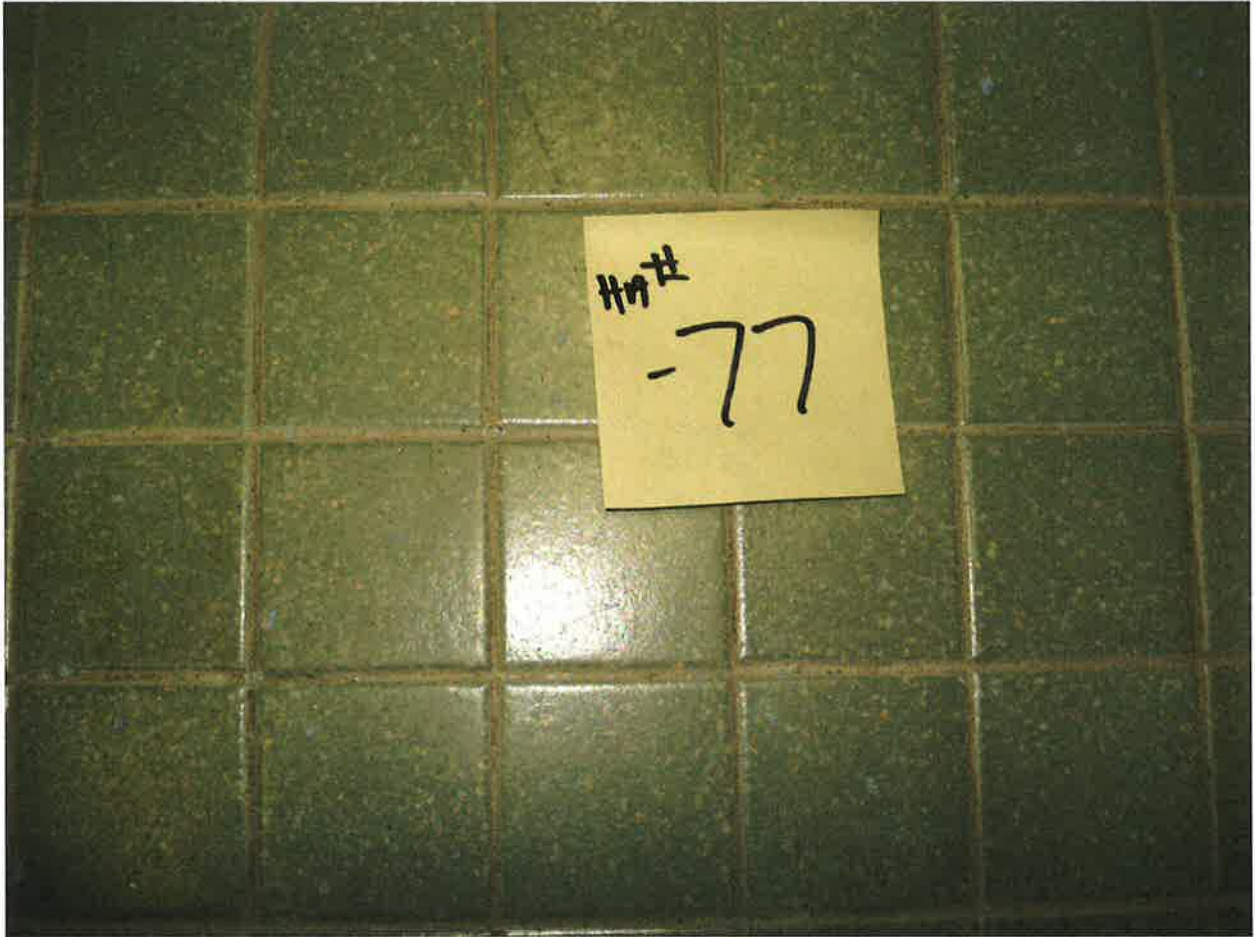
HA #77 – Non asbestos containing 2” x 2” ceramic floor tile bedding compound

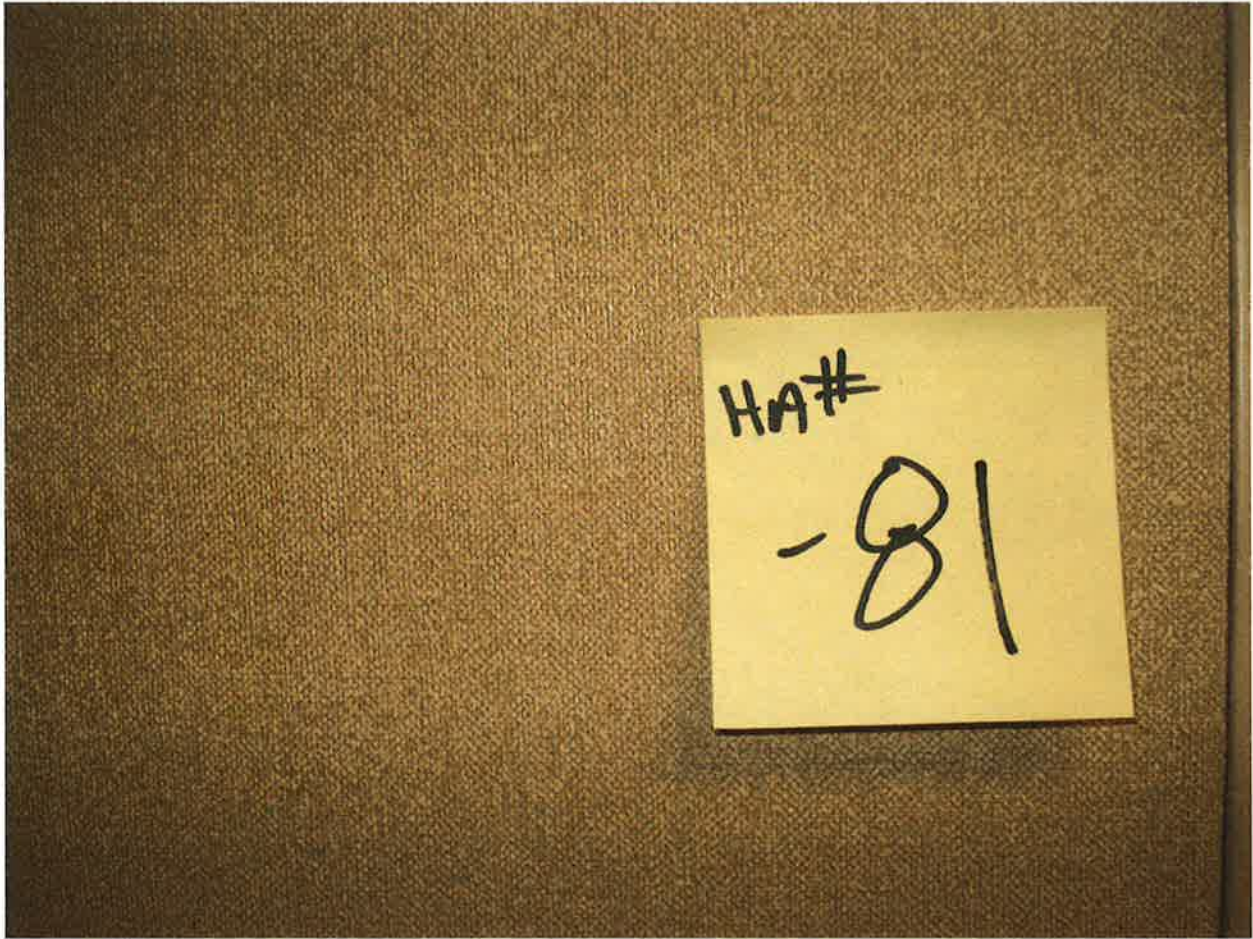
HA #81 – Non asbestos containing mauve wallpaper  
and associated glue

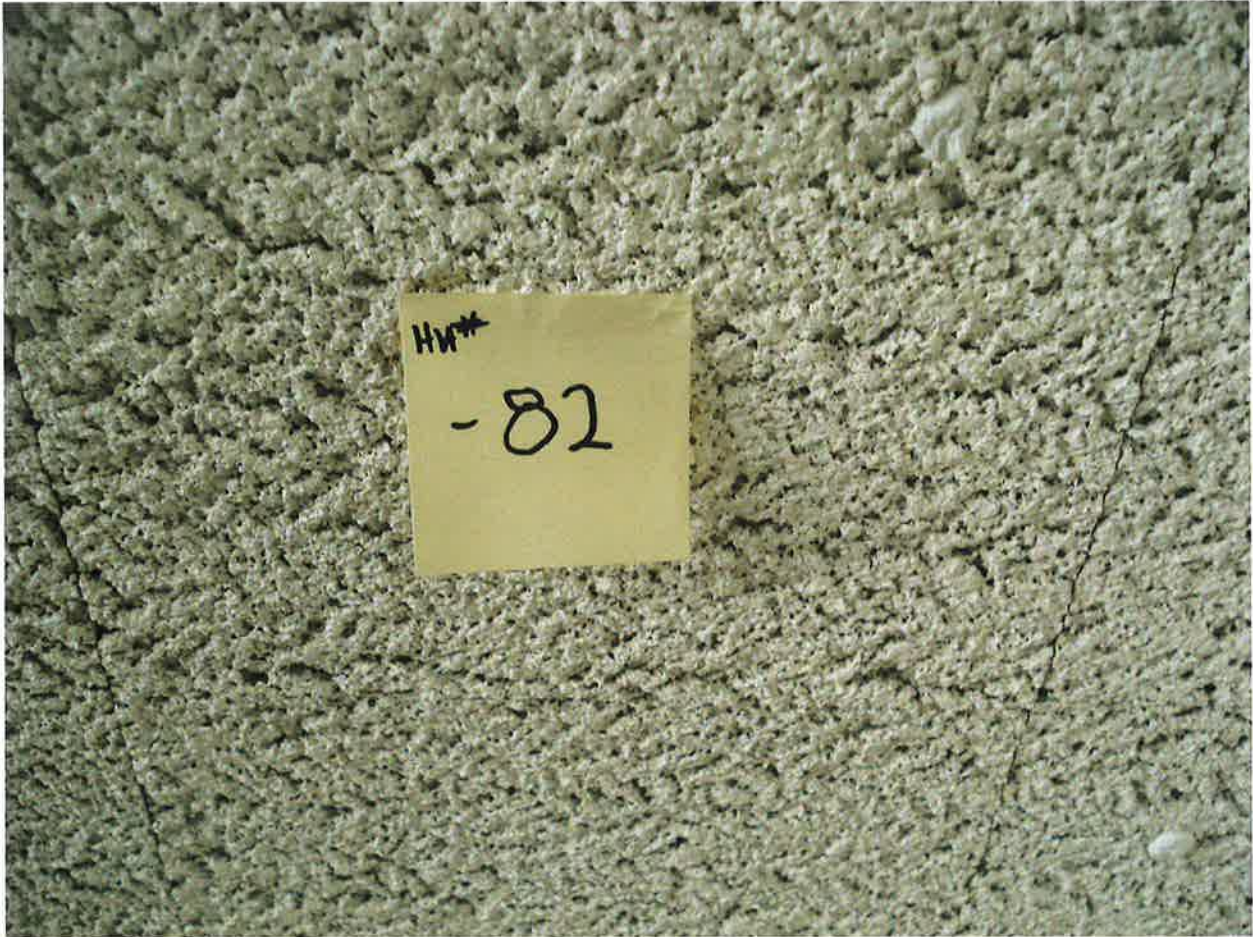
HA #82 – Non asbestos containing 12” x 12” white ceiling tile  
with deep texture and associated glue pods

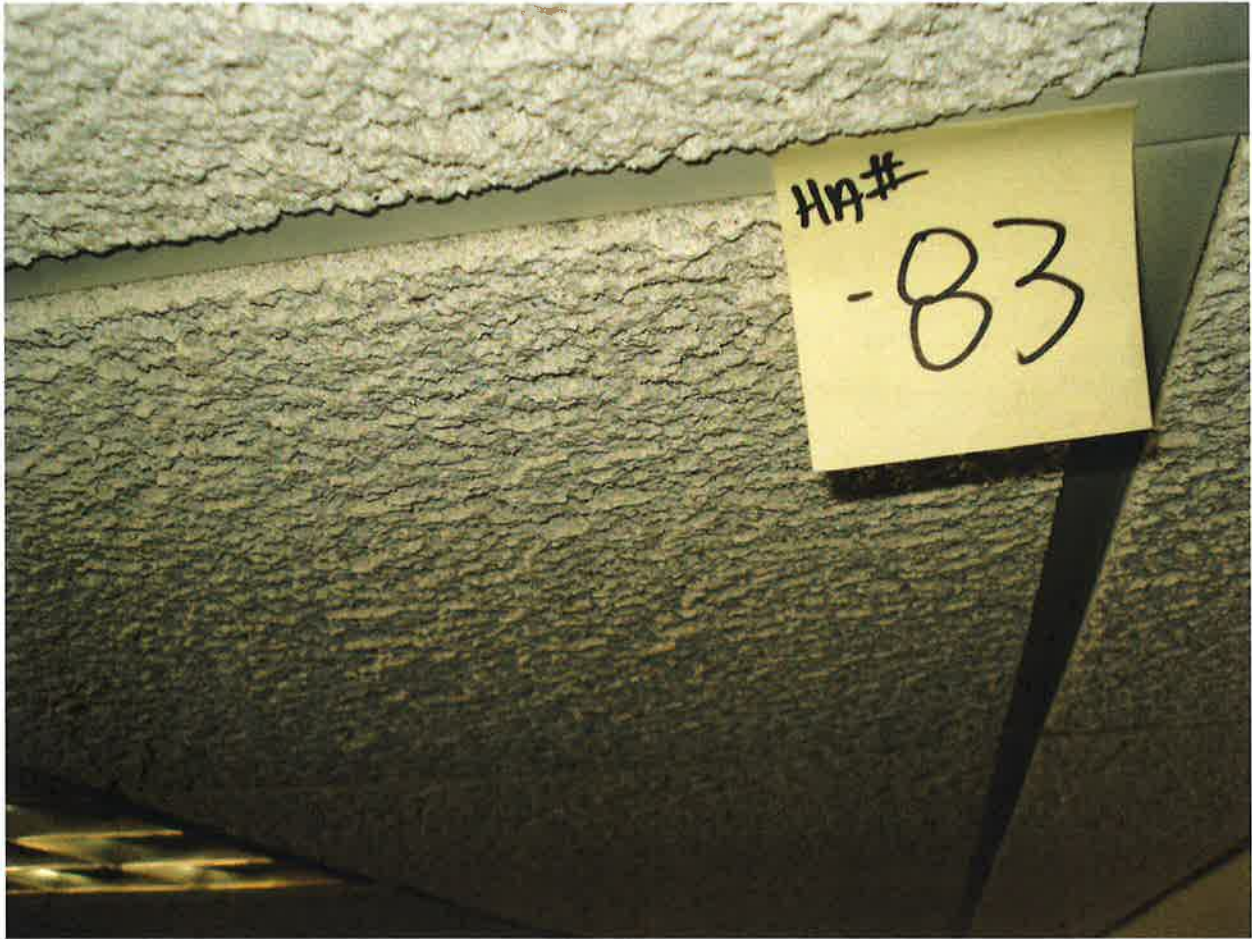
HA #83 – Non asbestos containing 2' x 2' white drop-in ceiling tile  
with deep texture

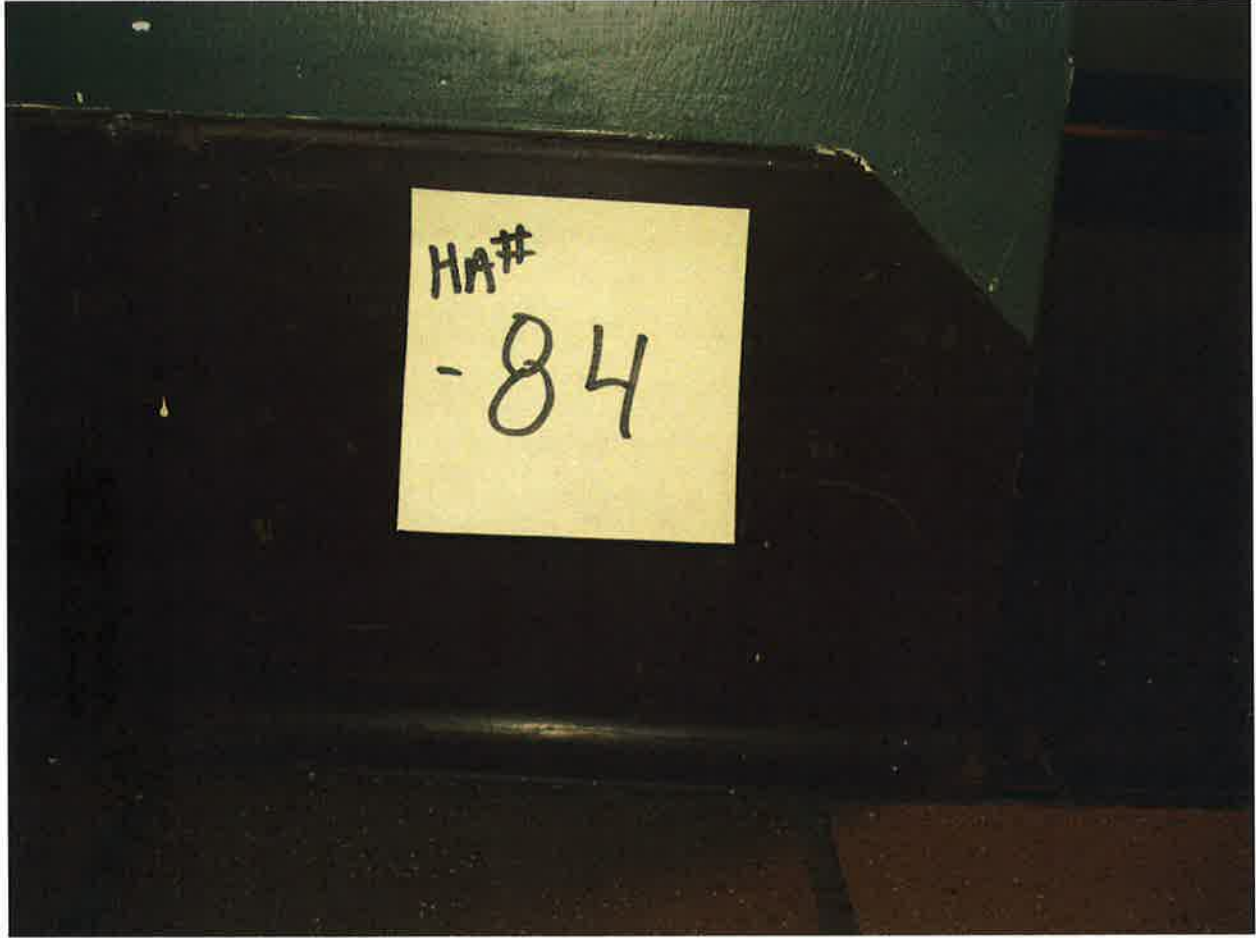
HA #84 – Non asbestos containing 6” brown  
baseboard and associated mastic

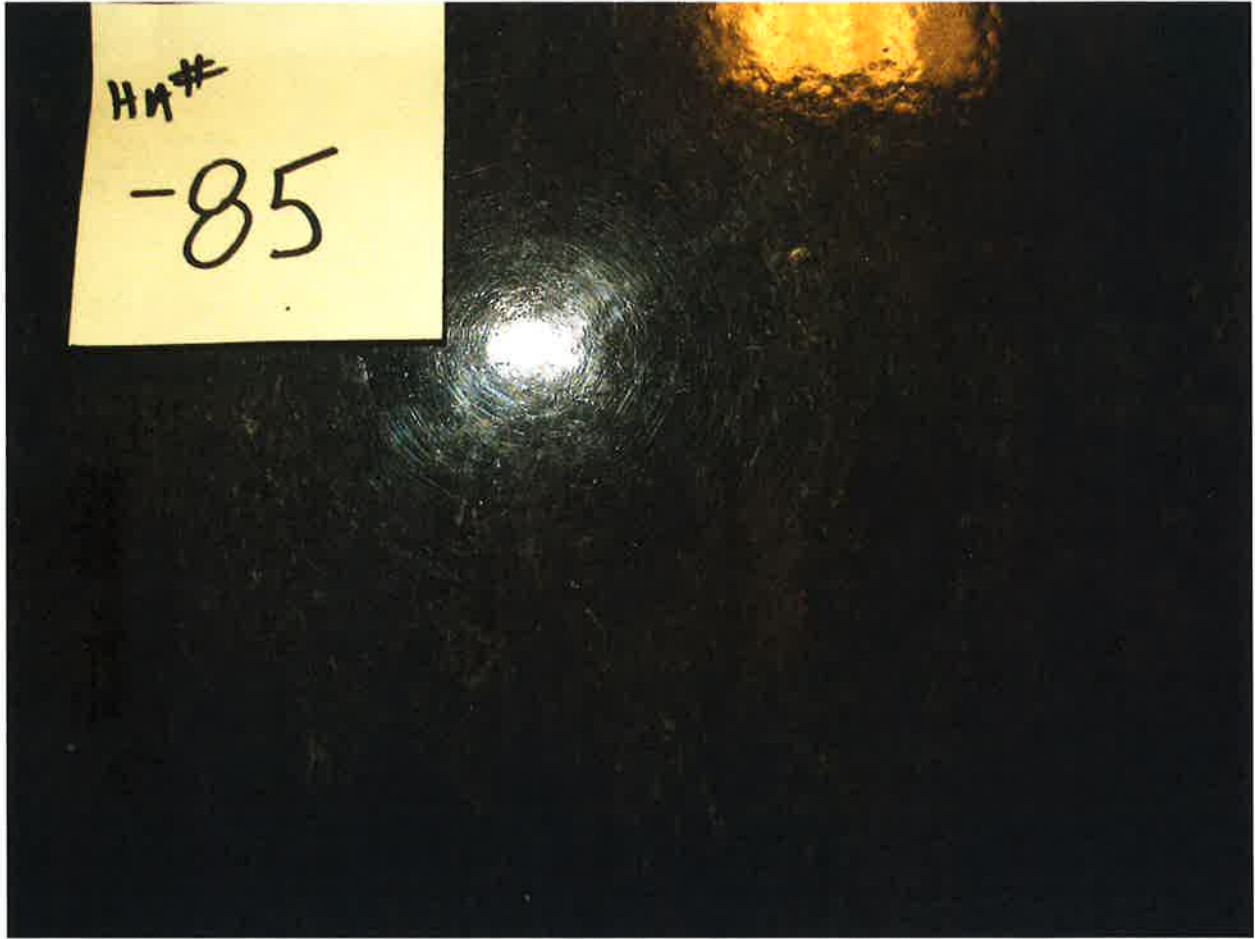
HA #85 – Non asbestos containing black and gray rolled-on linoleum and associated mastic

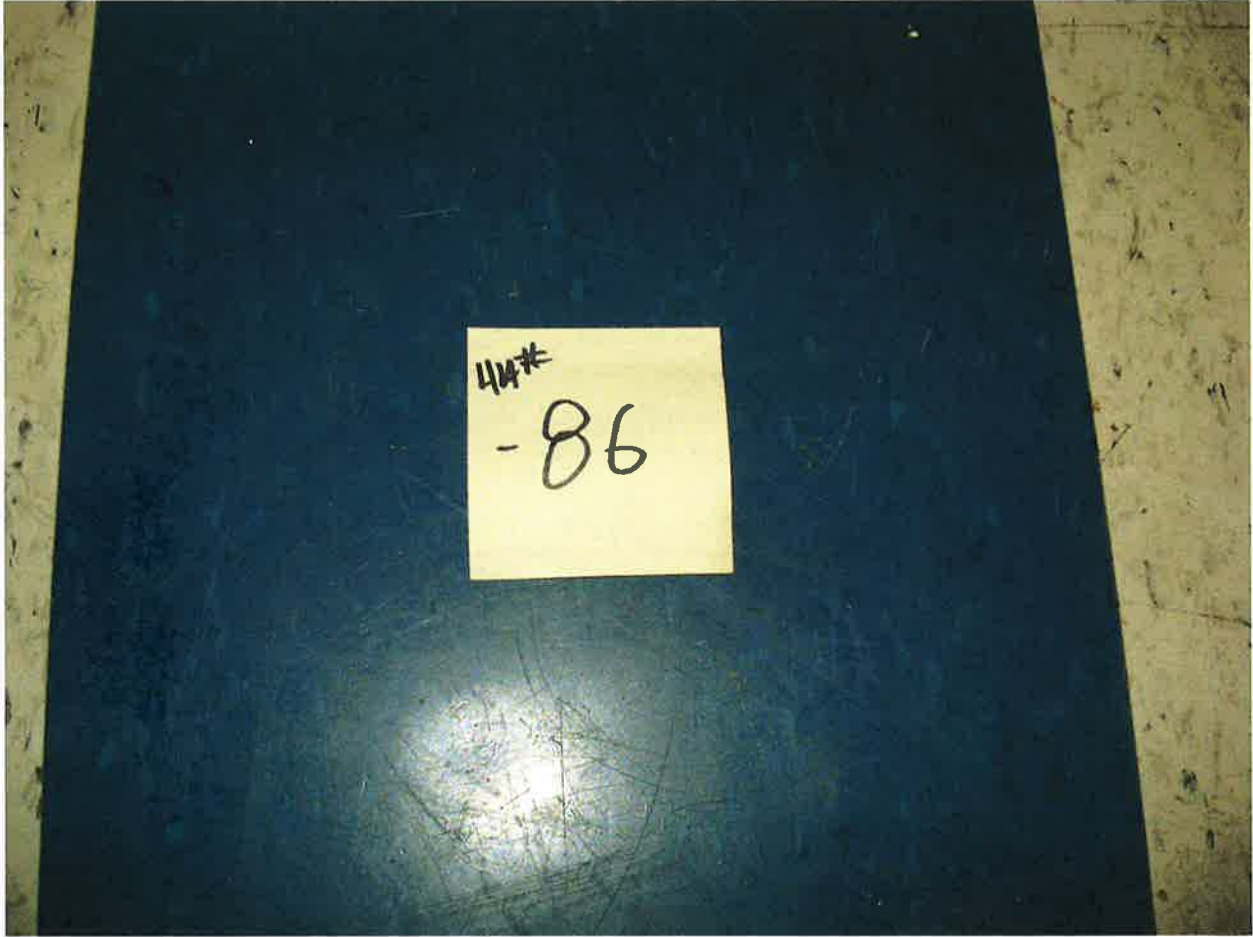
HA #86 – Non asbestos containing 12” x 12” blue floor tile  
with marble pattern and associated mastic

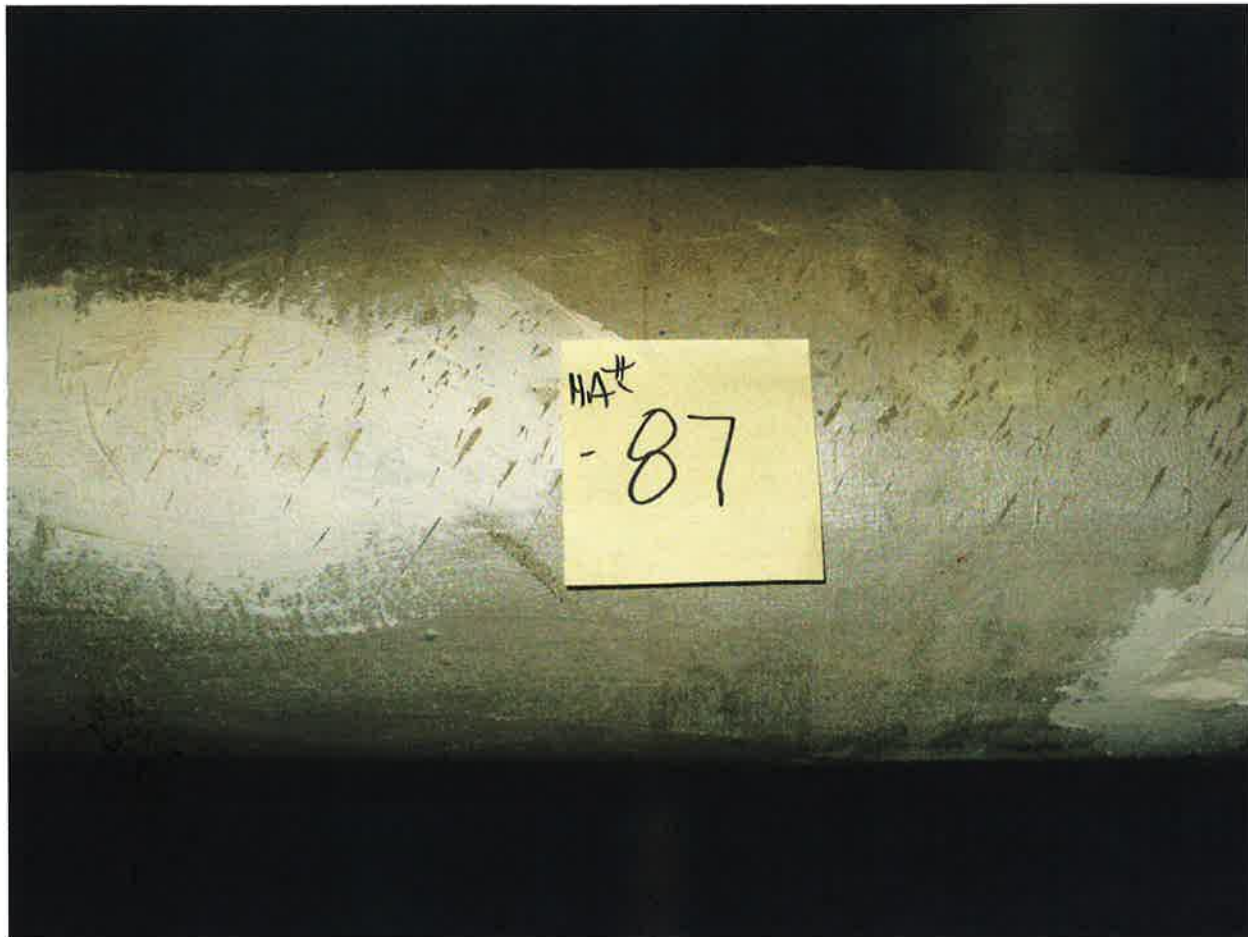
HA #87 – Asbestos containing hot heating water supply pipe straight insulation (mag insulation)

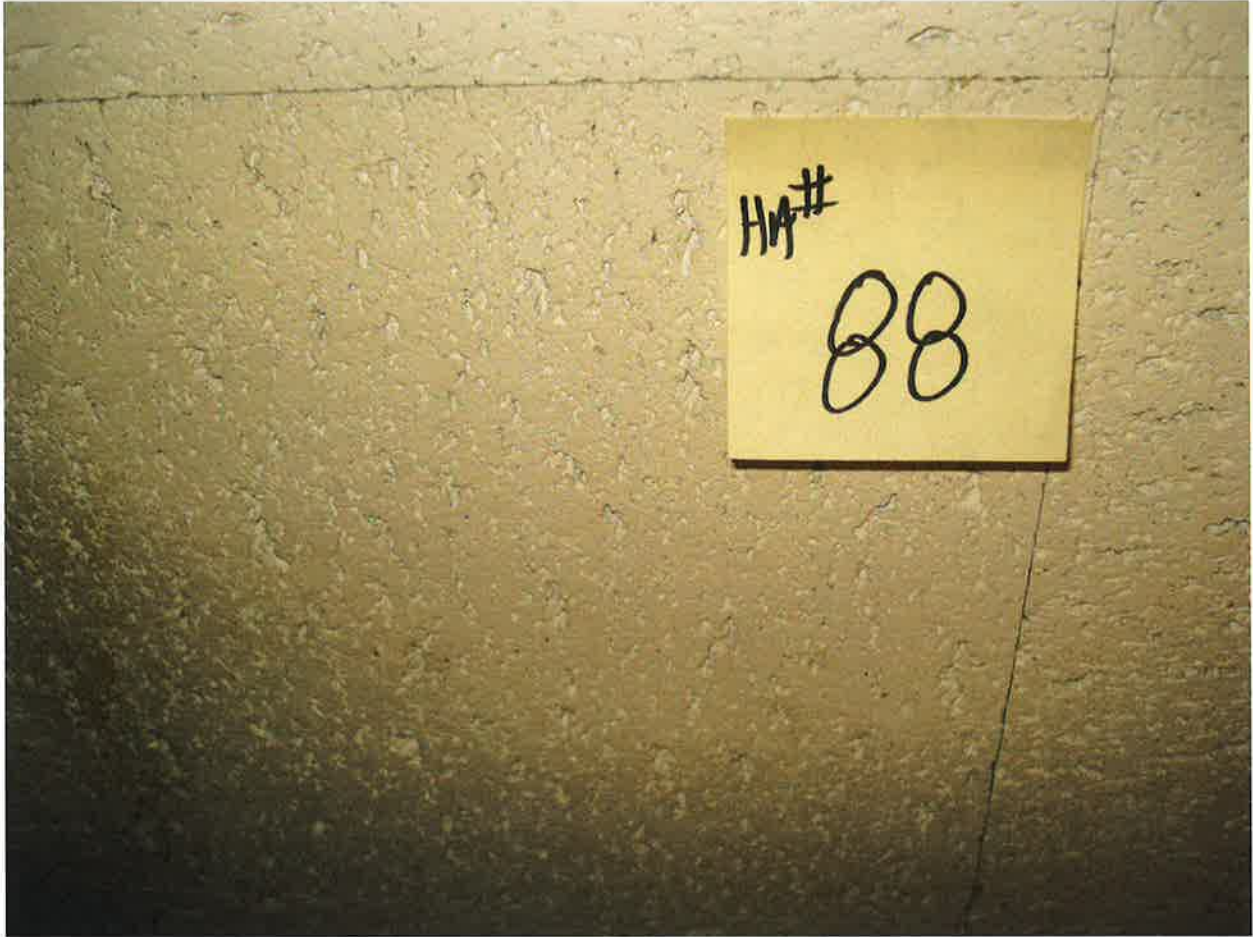
HA #88 – Non asbestos containing 12” x 12” white ceiling tile  
with fissures and associated glue pods

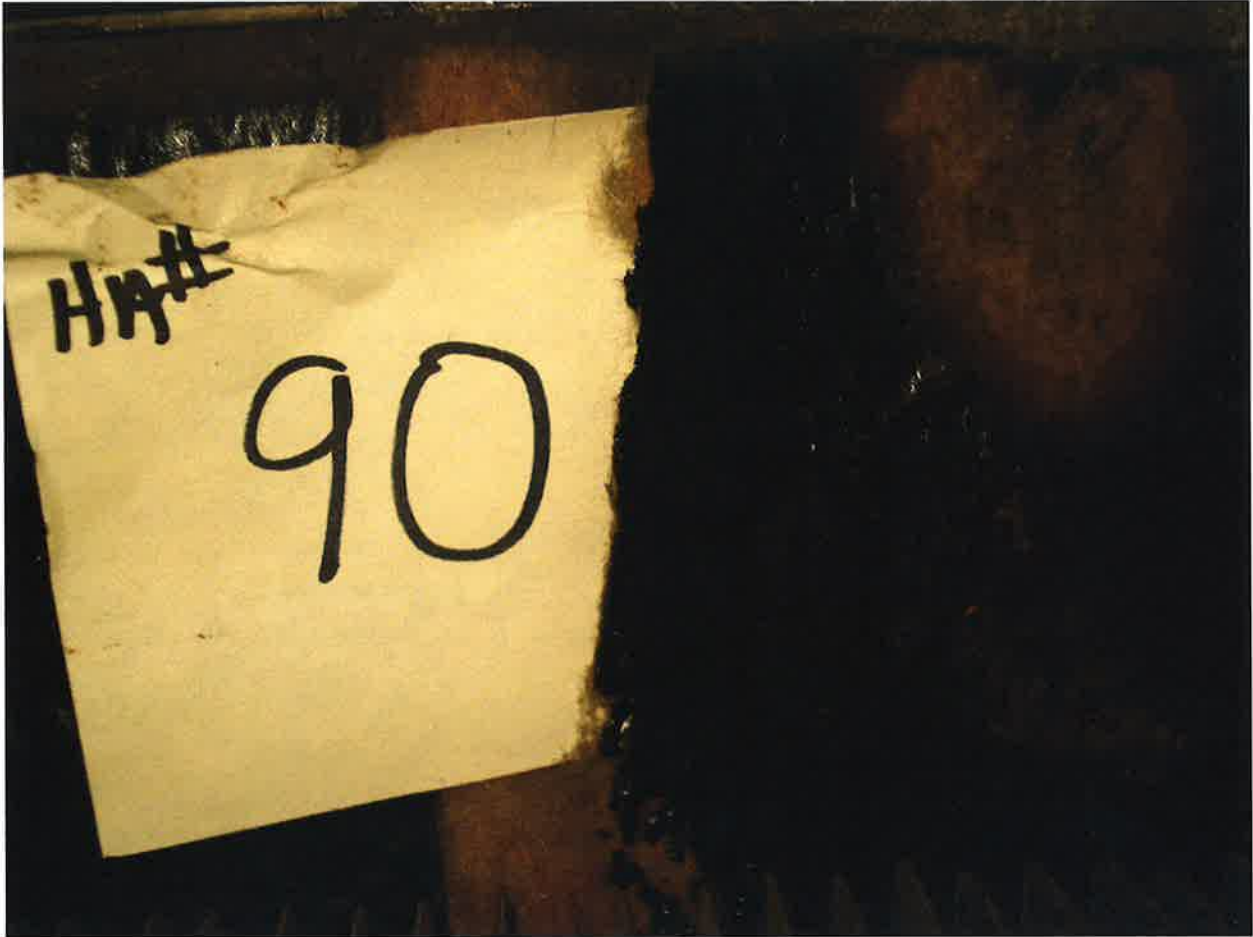
HA #90 – Non asbestos containing black tar  
paper on fiberglass insulation squares

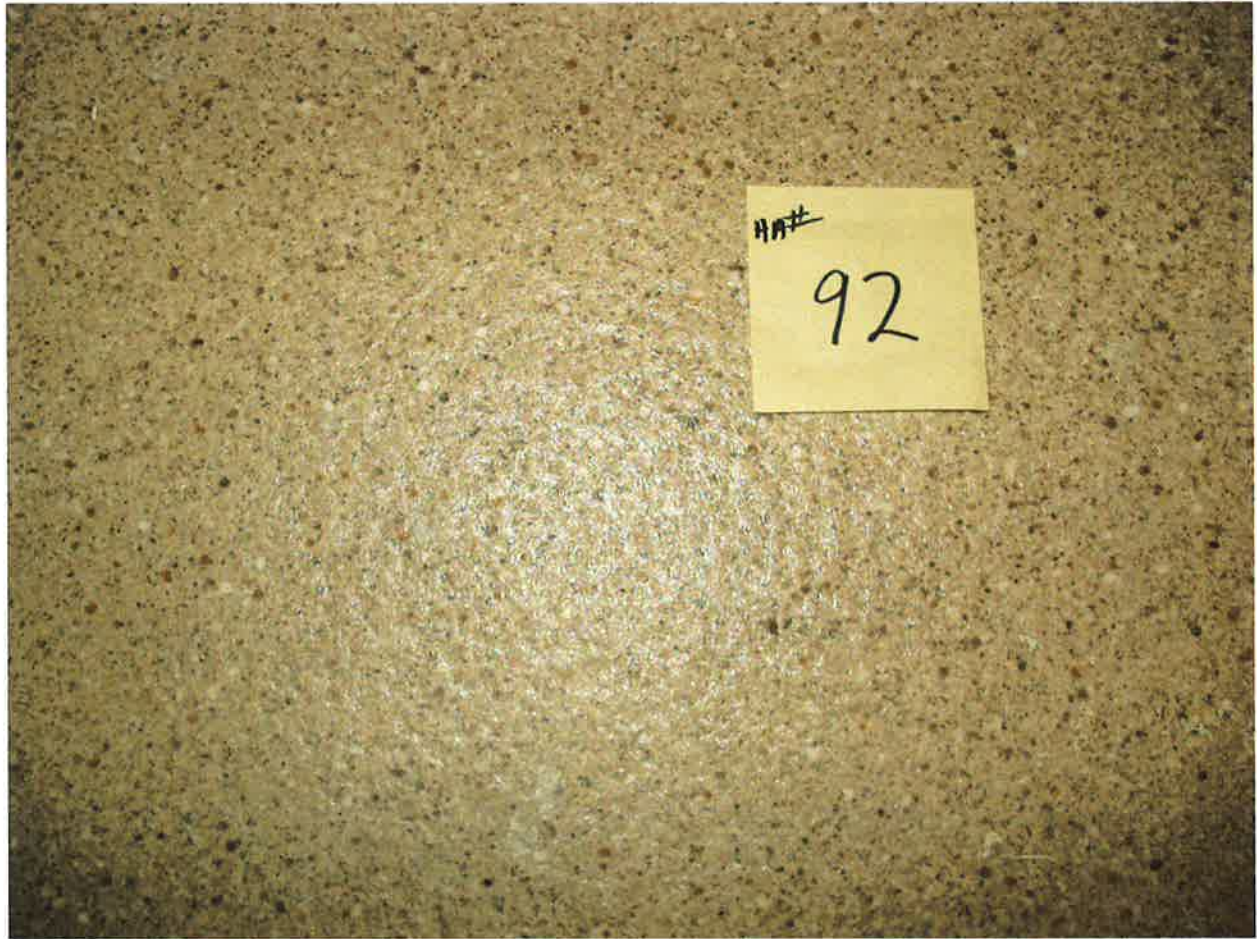
HA #92 – Assumed asbestos containing tan linoleum with brown and white specks and associated mastic

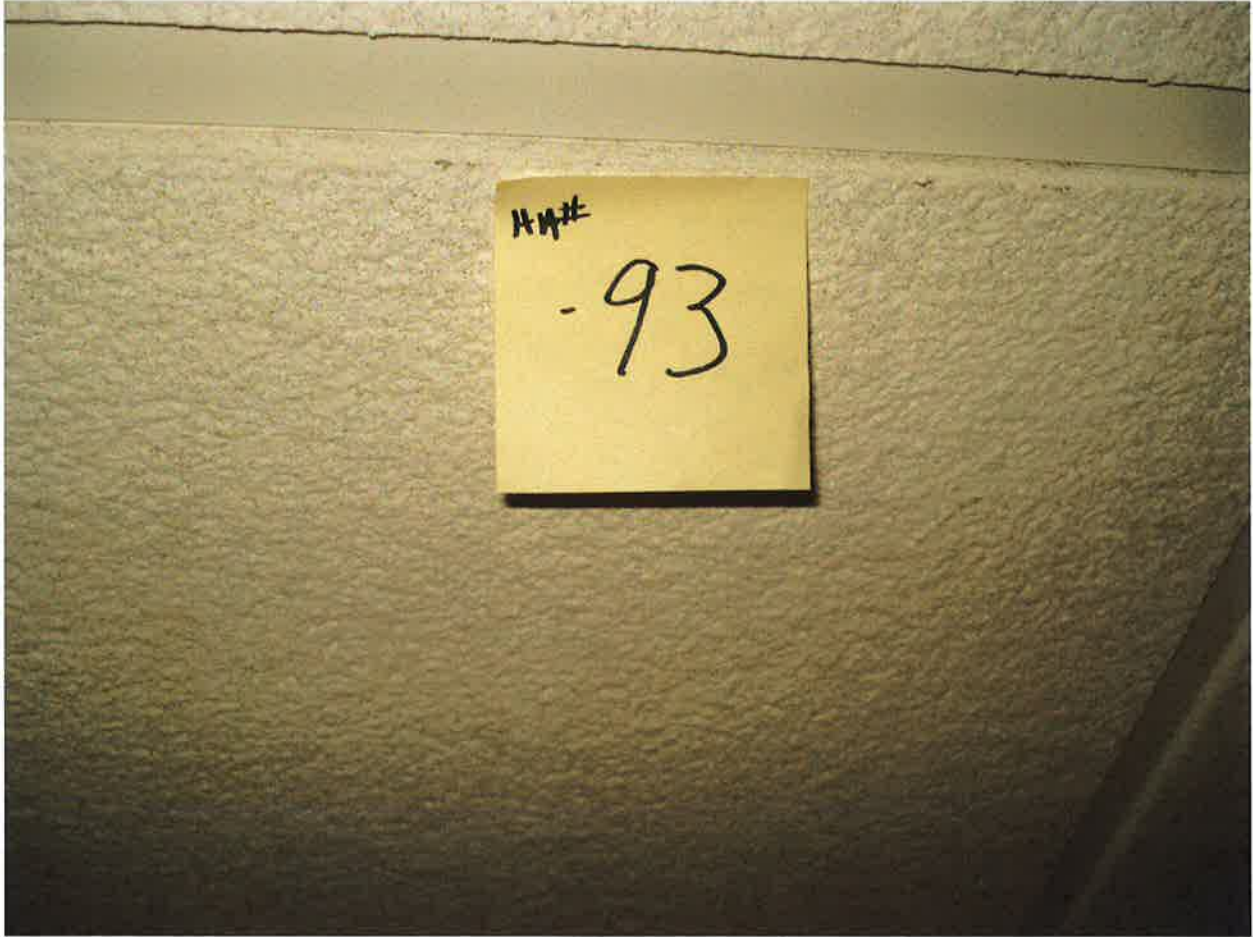
HA #93 – Non asbestos containing 2' x 2' white drop-in ceiling tile with rough texture

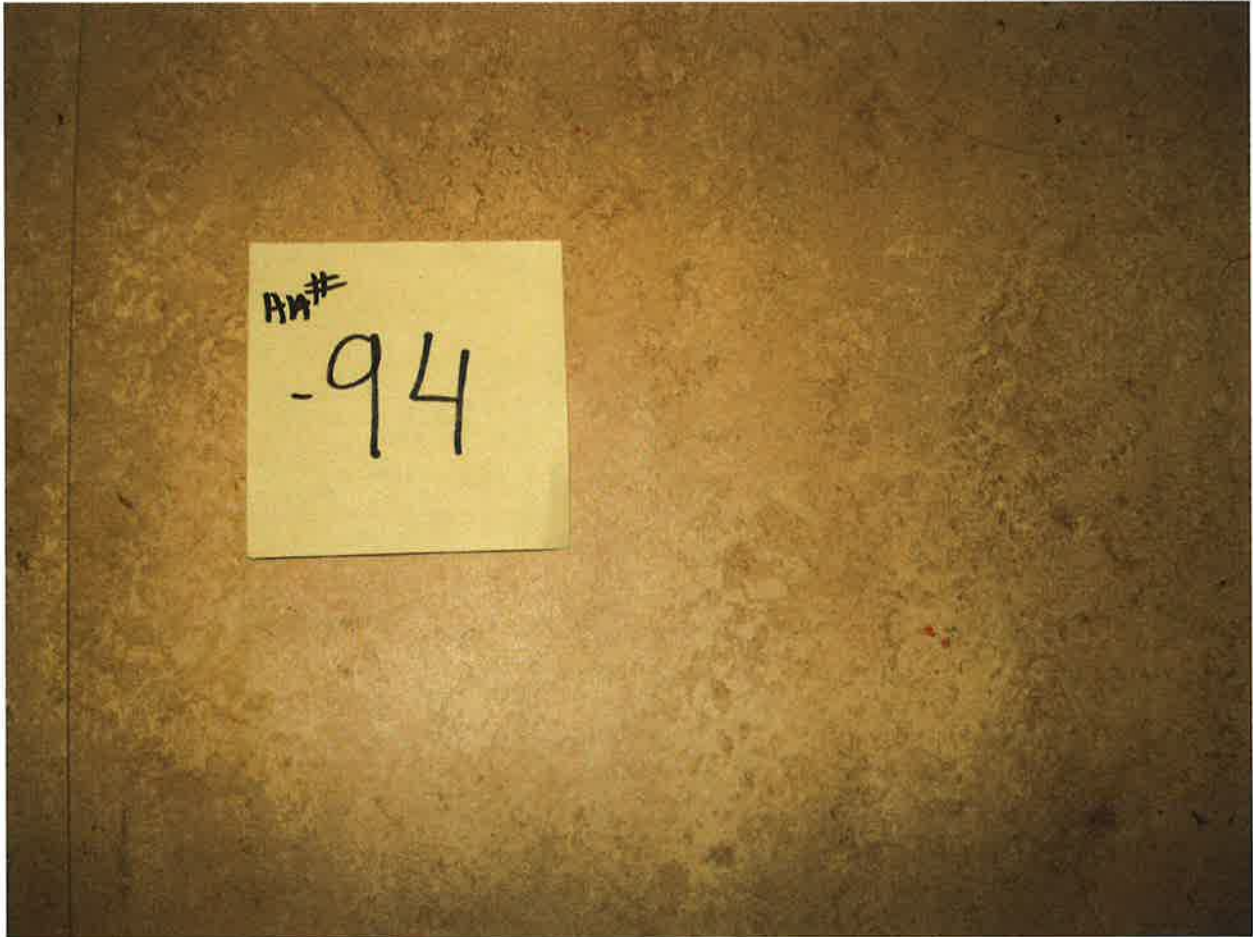
HA #94 – Non asbestos containing 12” x 12” tan swirl  
pattern floor tile and associated mastic

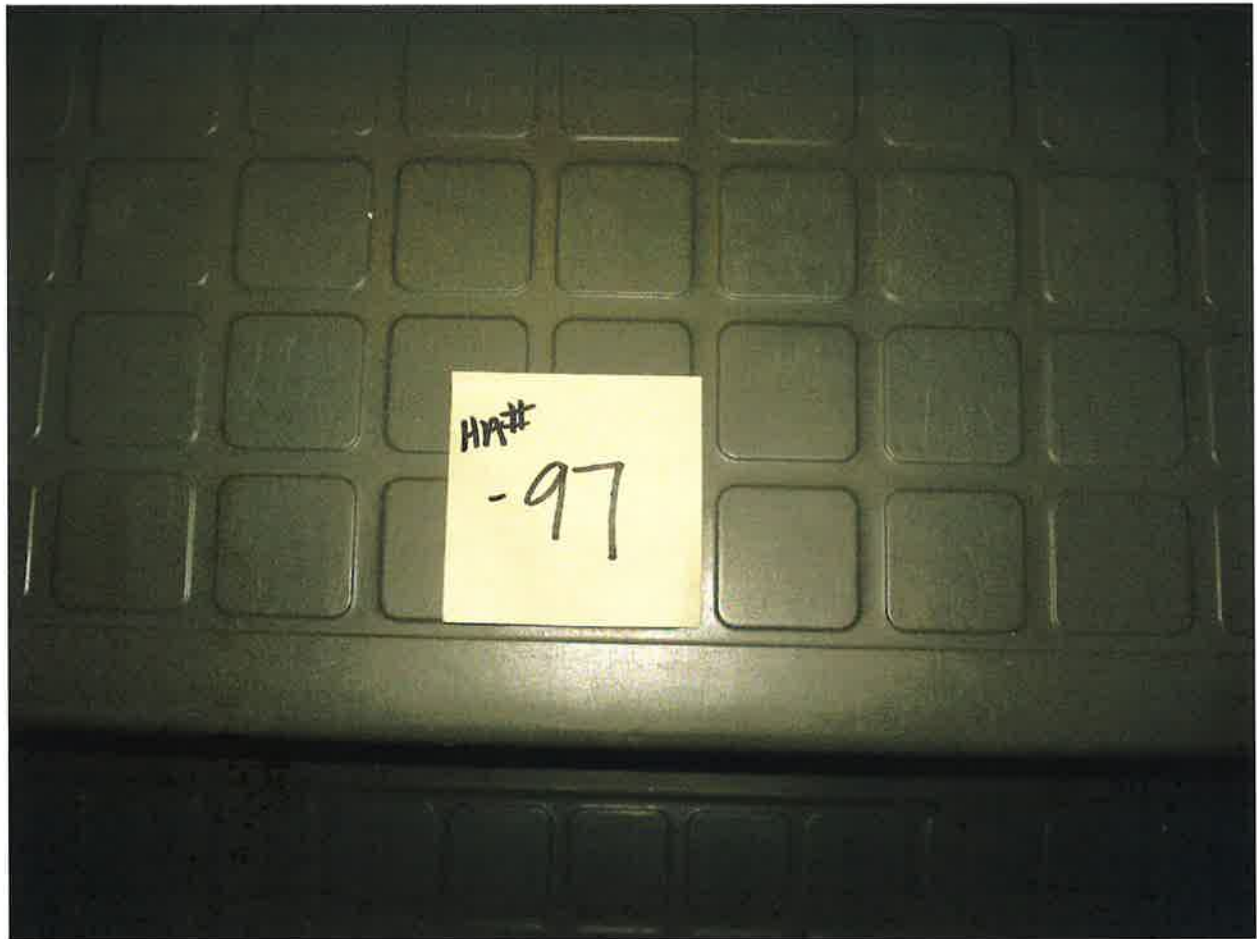
HA #97 – Non asbestos containing gray stair tread  
and associated mastic

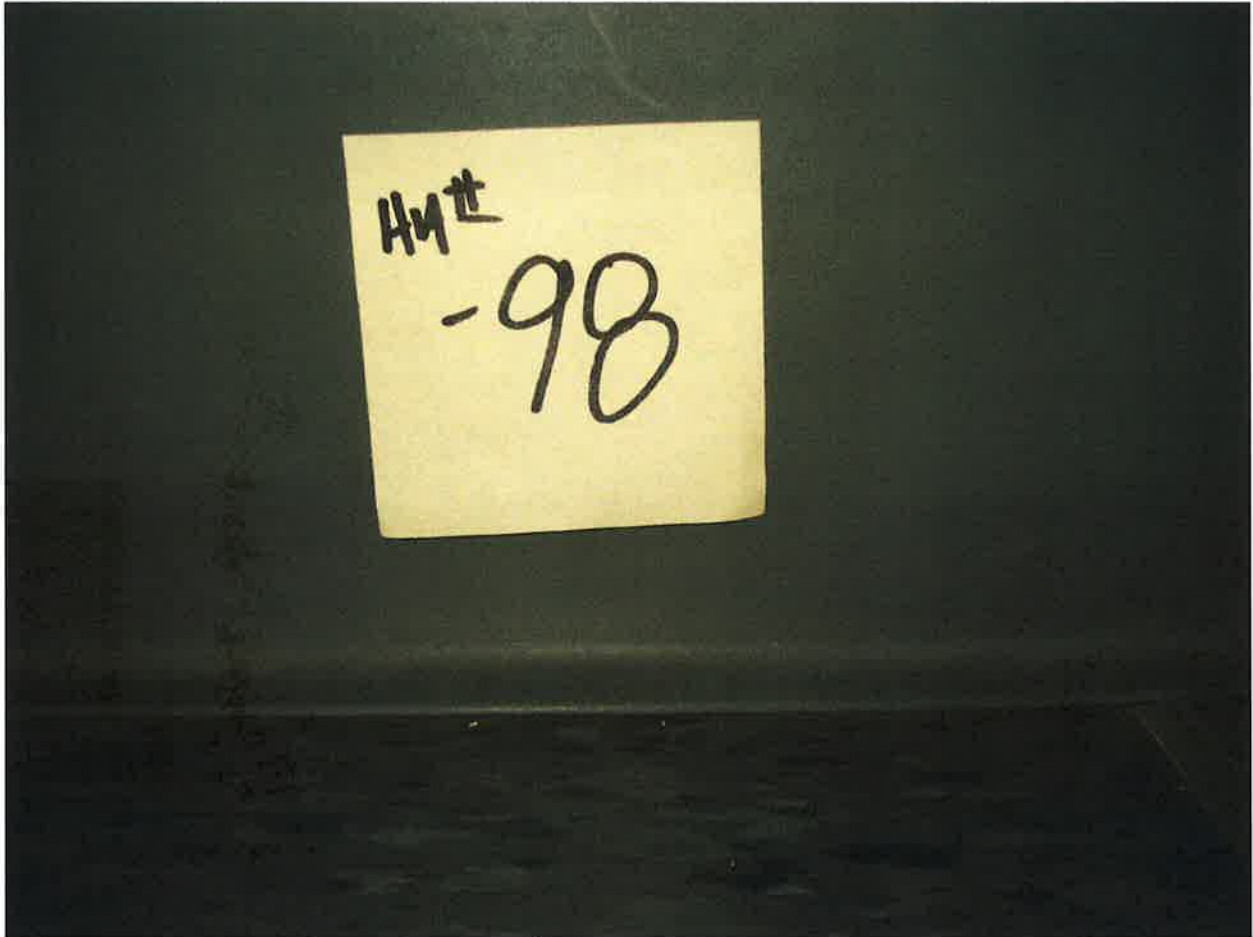
HA #98 – Non asbestos containing 6” gray baseboard  
and associated mastic
