MSU Case Hall  
East Lansing, Michigan

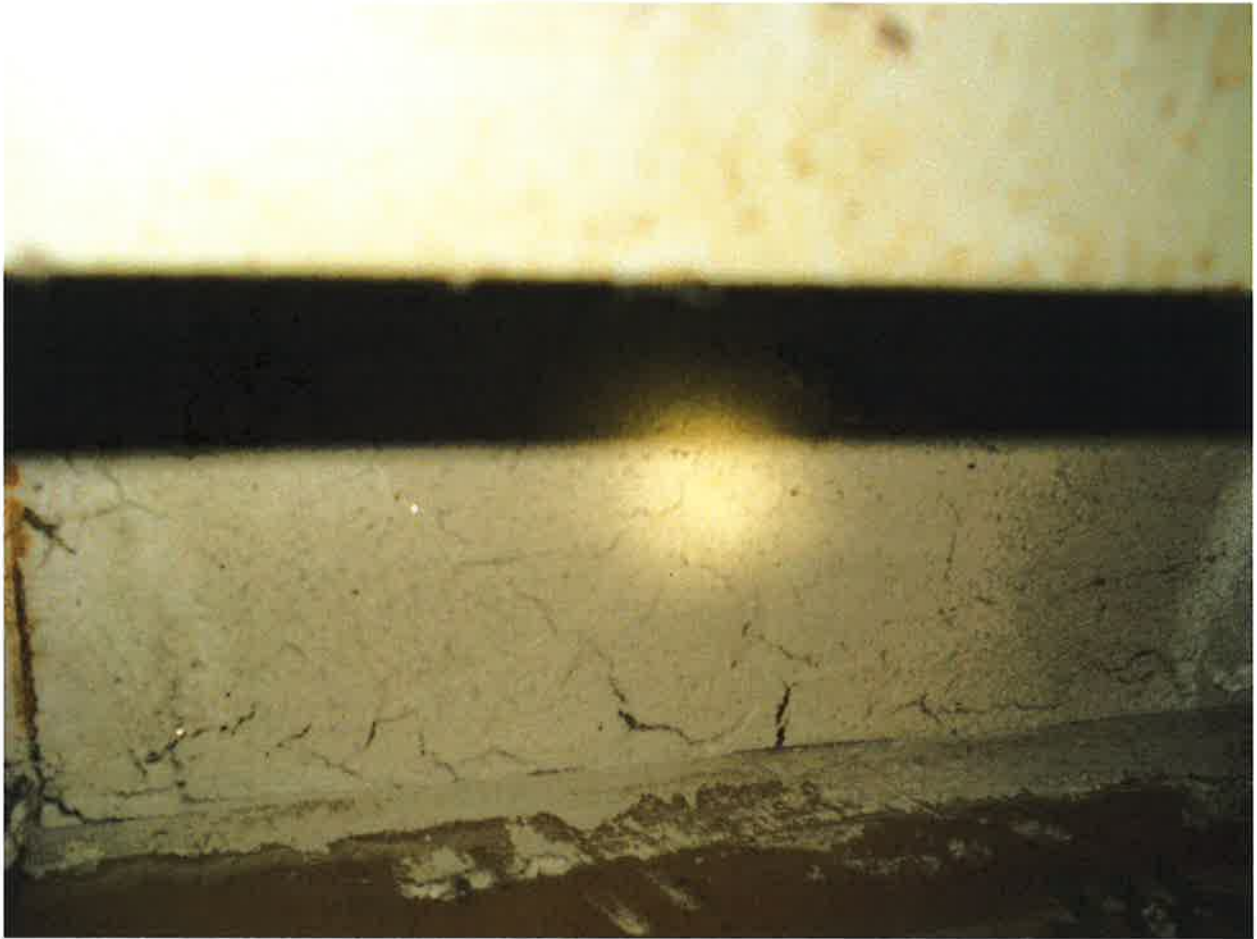
HA #99 – Asbestos containing troweled on beam material (white)

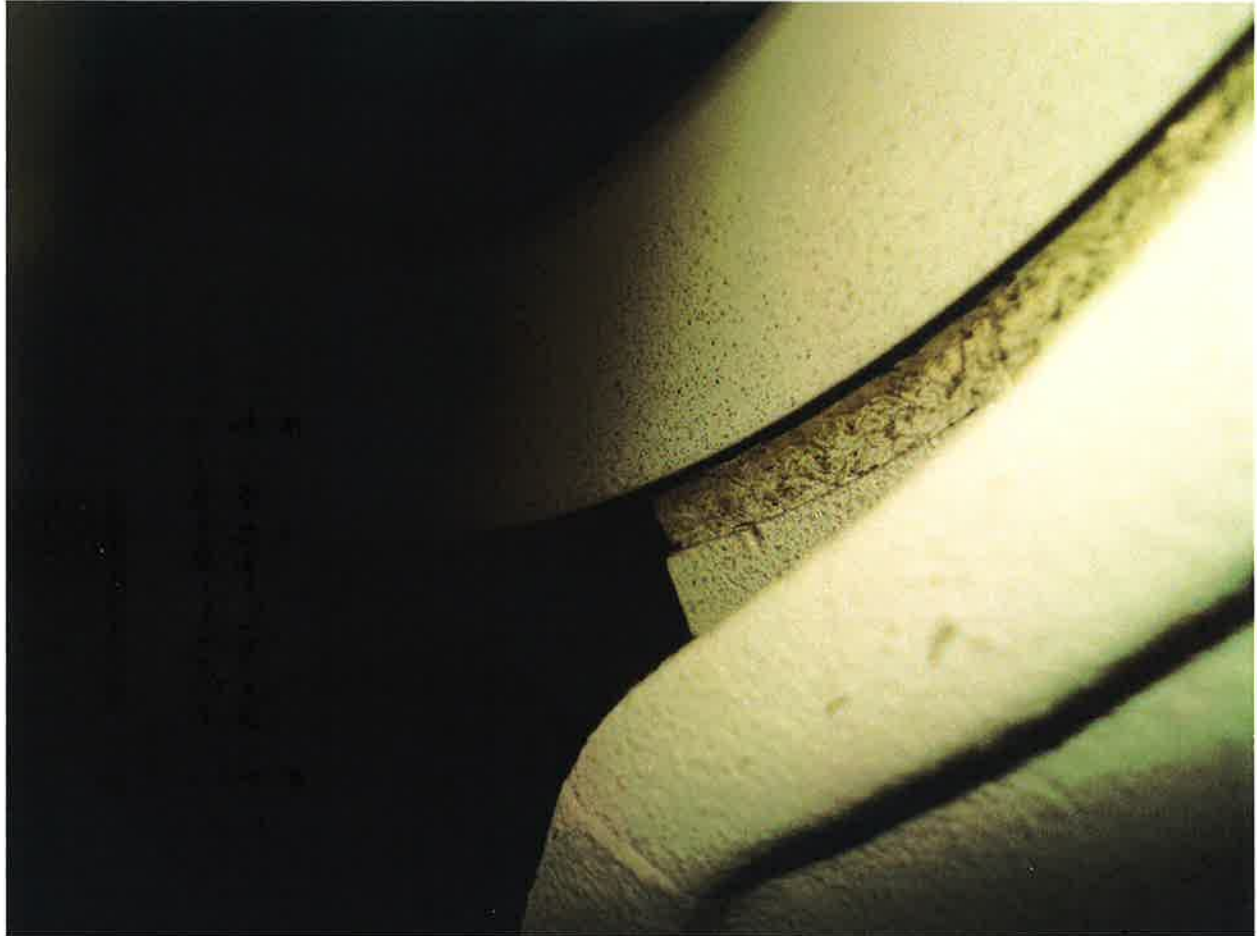
HA #89 – Assumed asbestos-containing freight elevator brake
