Akers Hall Photo Log

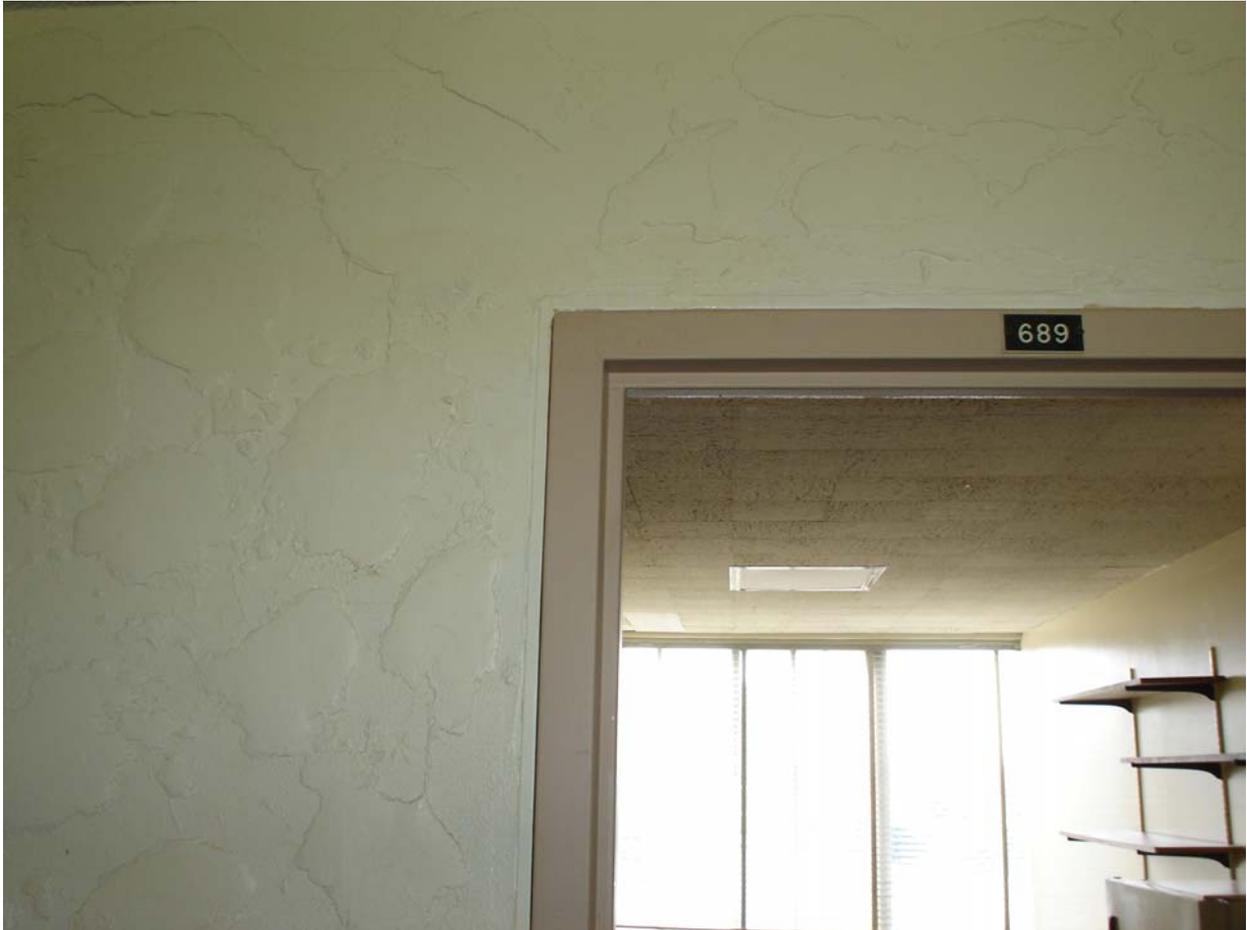
HA #2
Non asbestos-containing textured plaster

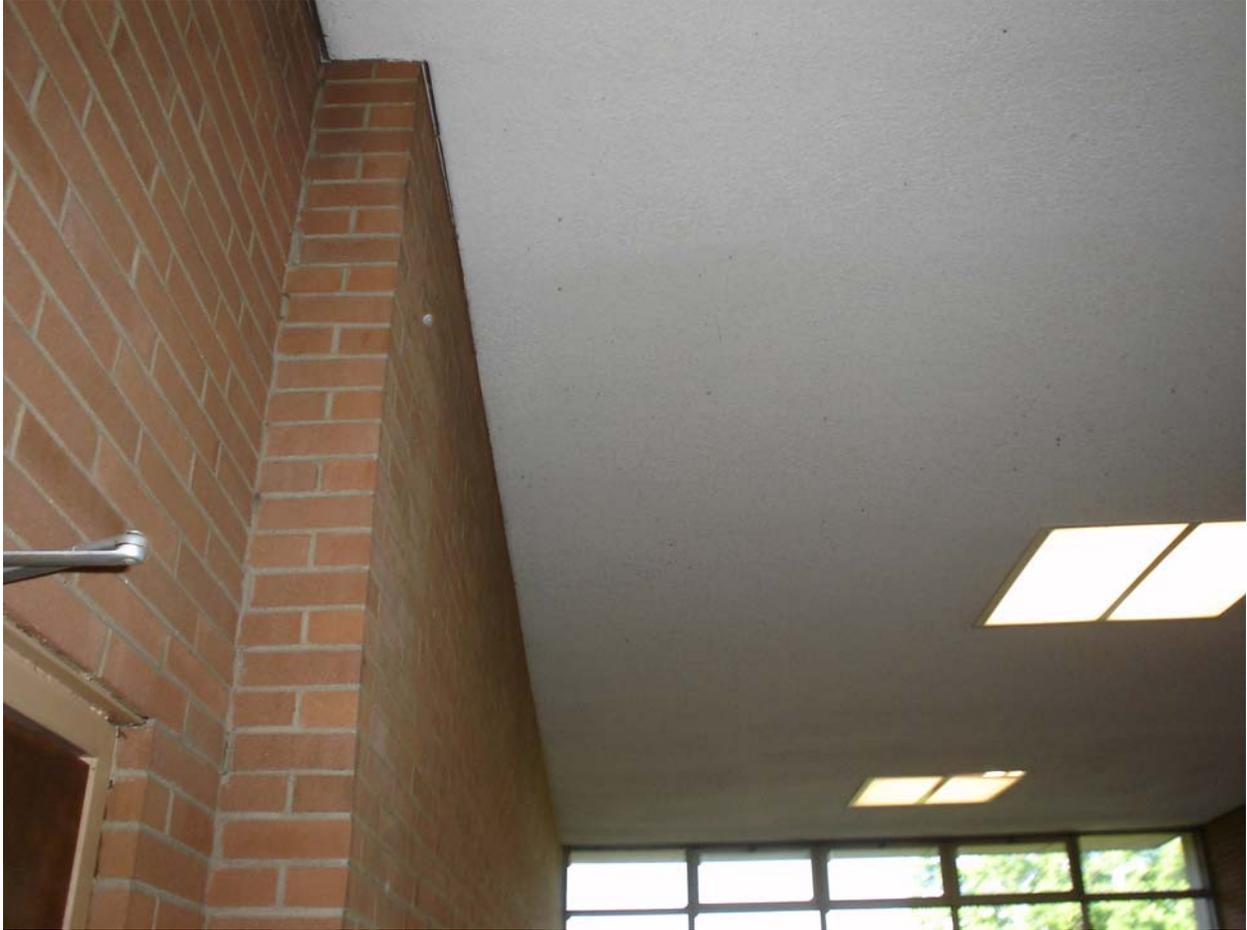
HA #3
Asbestos-containing spray-on acoustical plaster

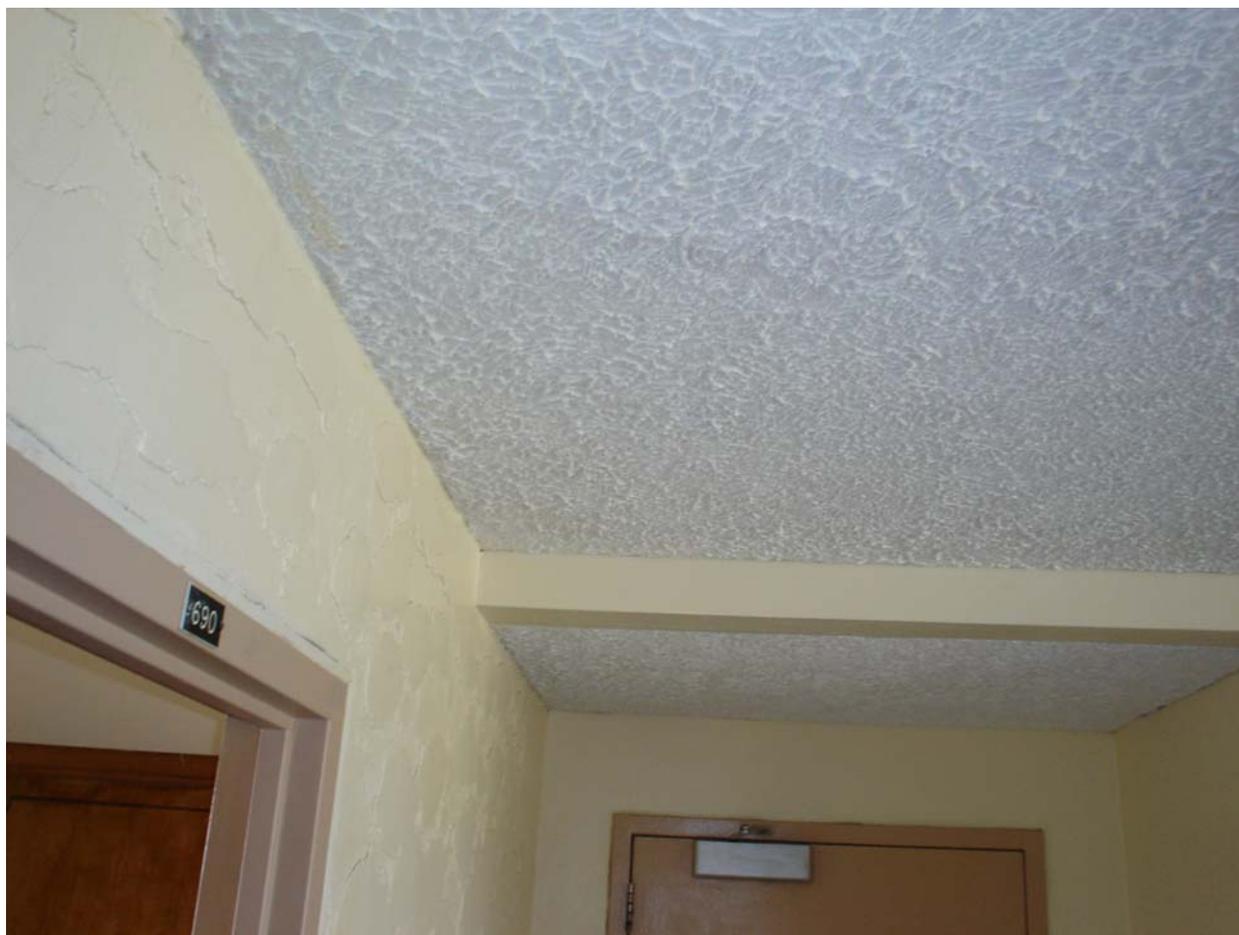
HA #4
Non asbestos-containing white stipple plaster

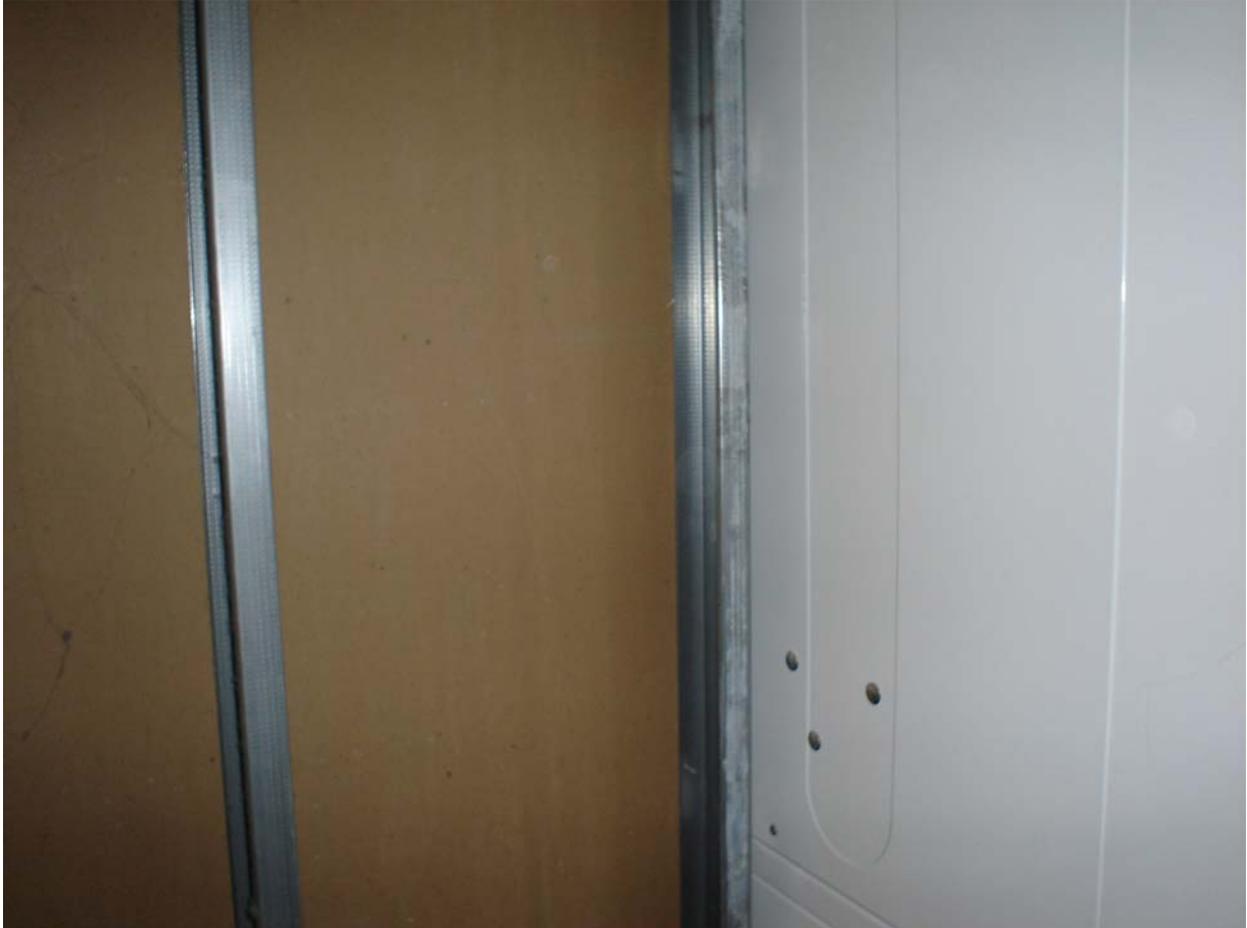
HA #5
Non asbestos-containing drywall

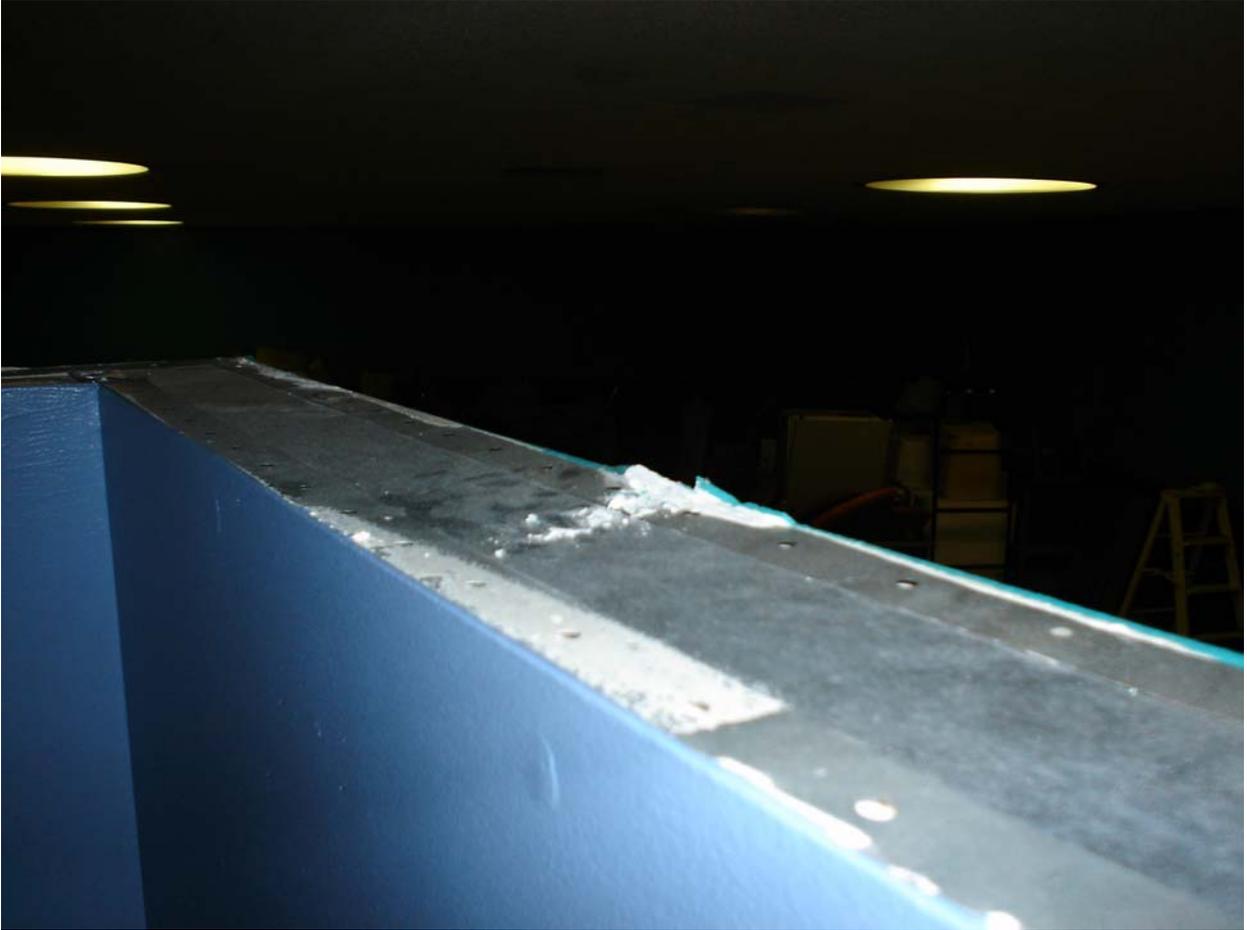
HA #6
Non asbestos-containing drywall joint compound

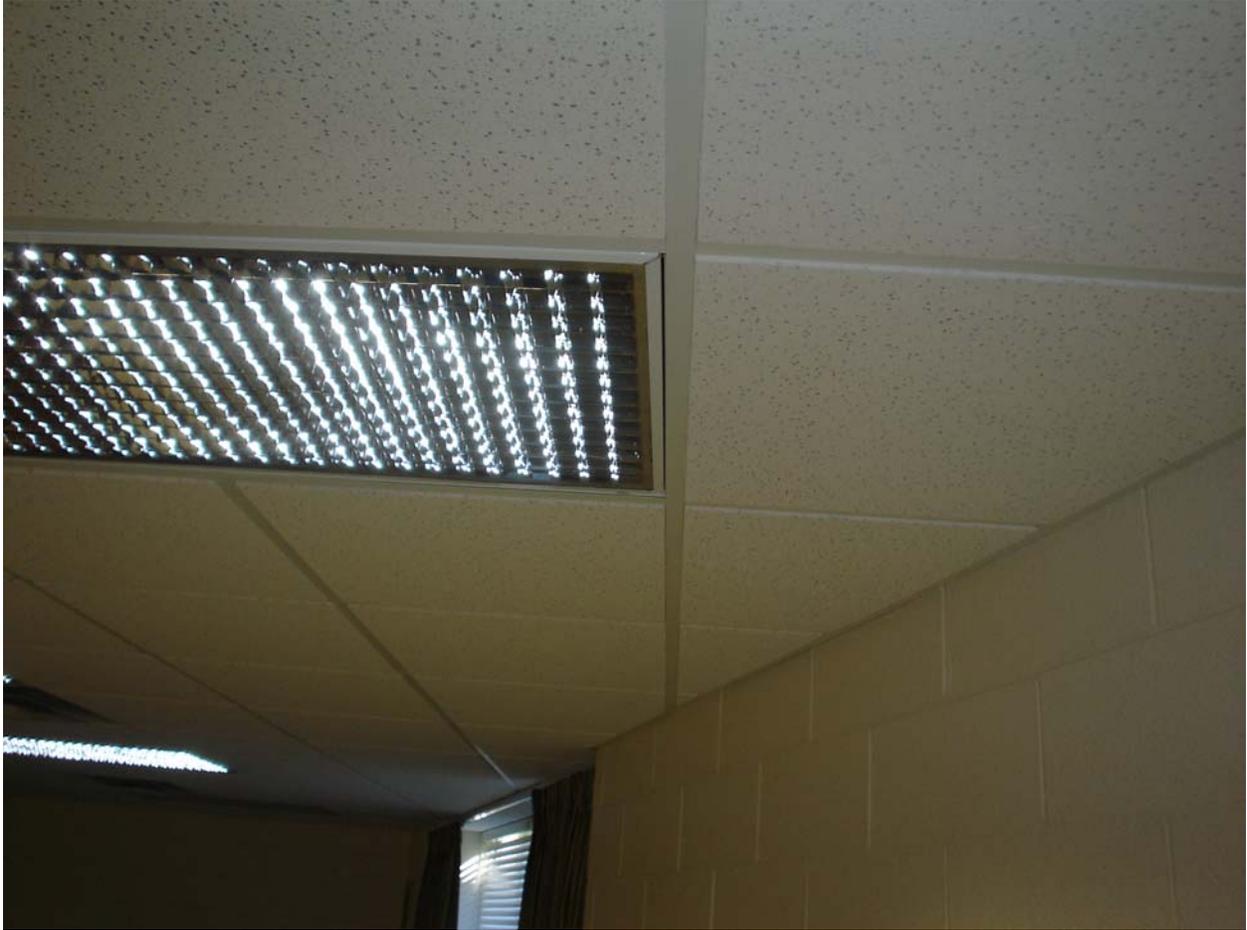
HA #7
Non asbestos-containing 2' x 2' white drop-in ceiling tile
with pin holes and fissures

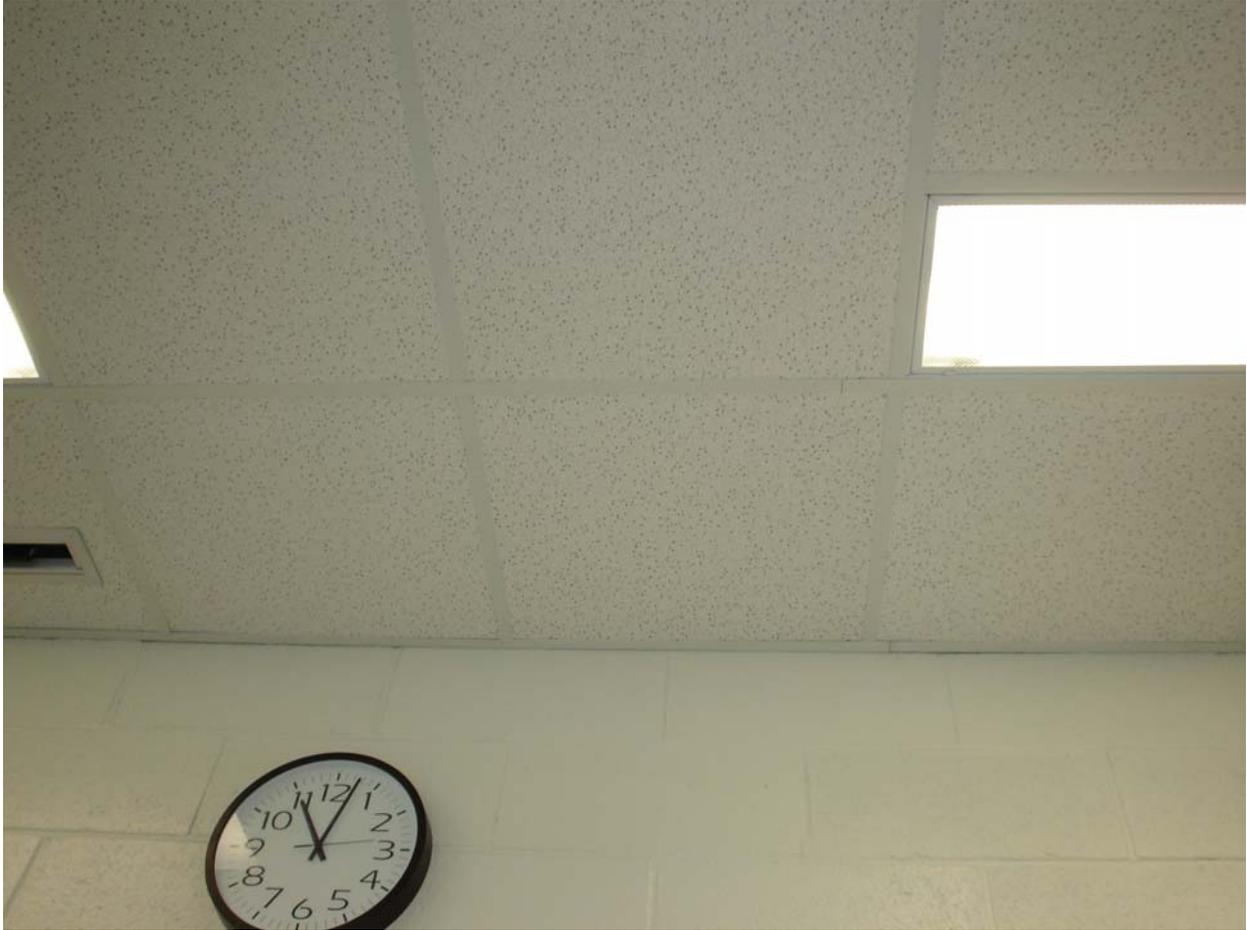
HA #8

Non asbestos-containing 2' x 2' white lay-in ceiling tile with pin holes

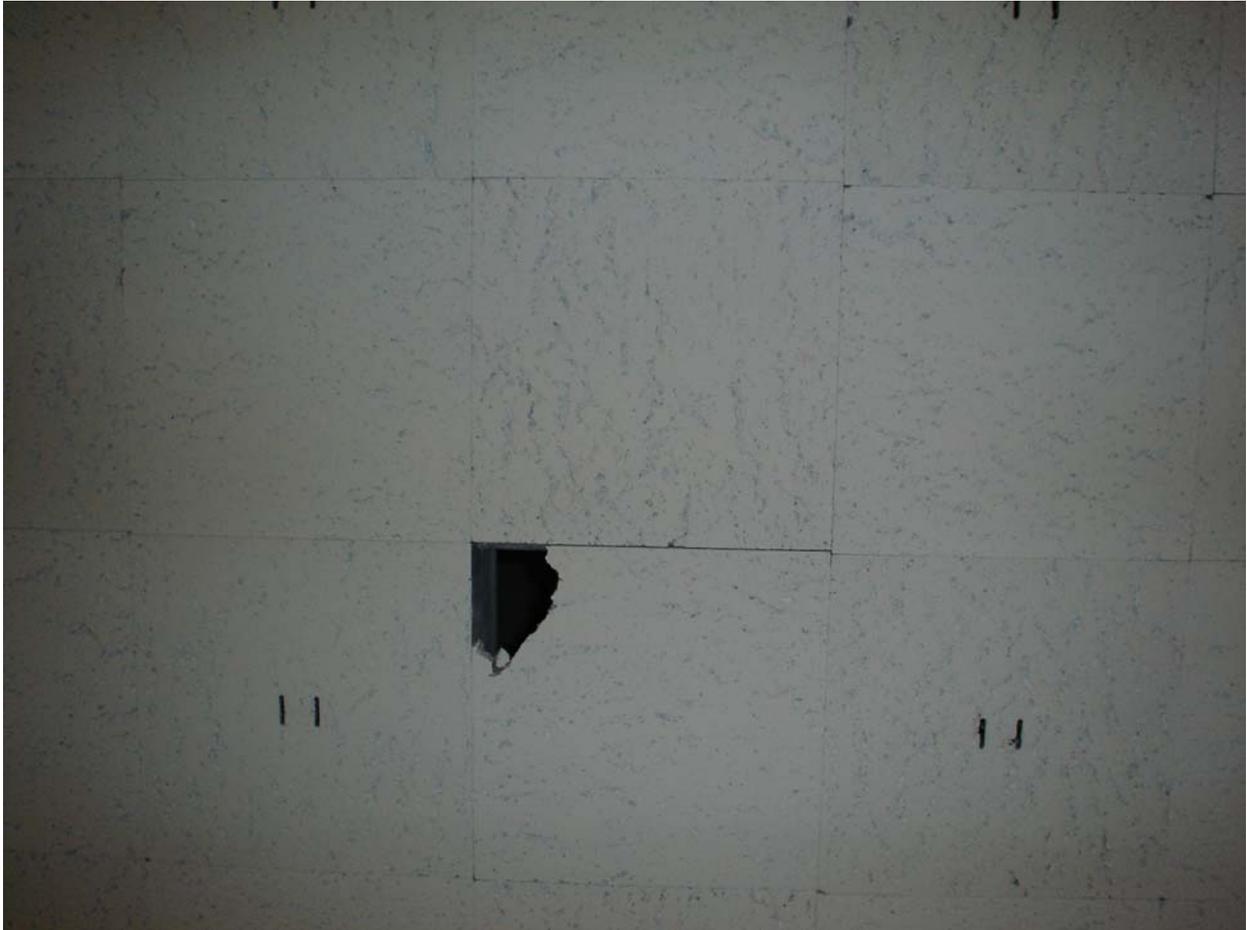
HA #9
Non asbestos-containing 12" x 12" white splined ceiling tile
with pin holes and fissures

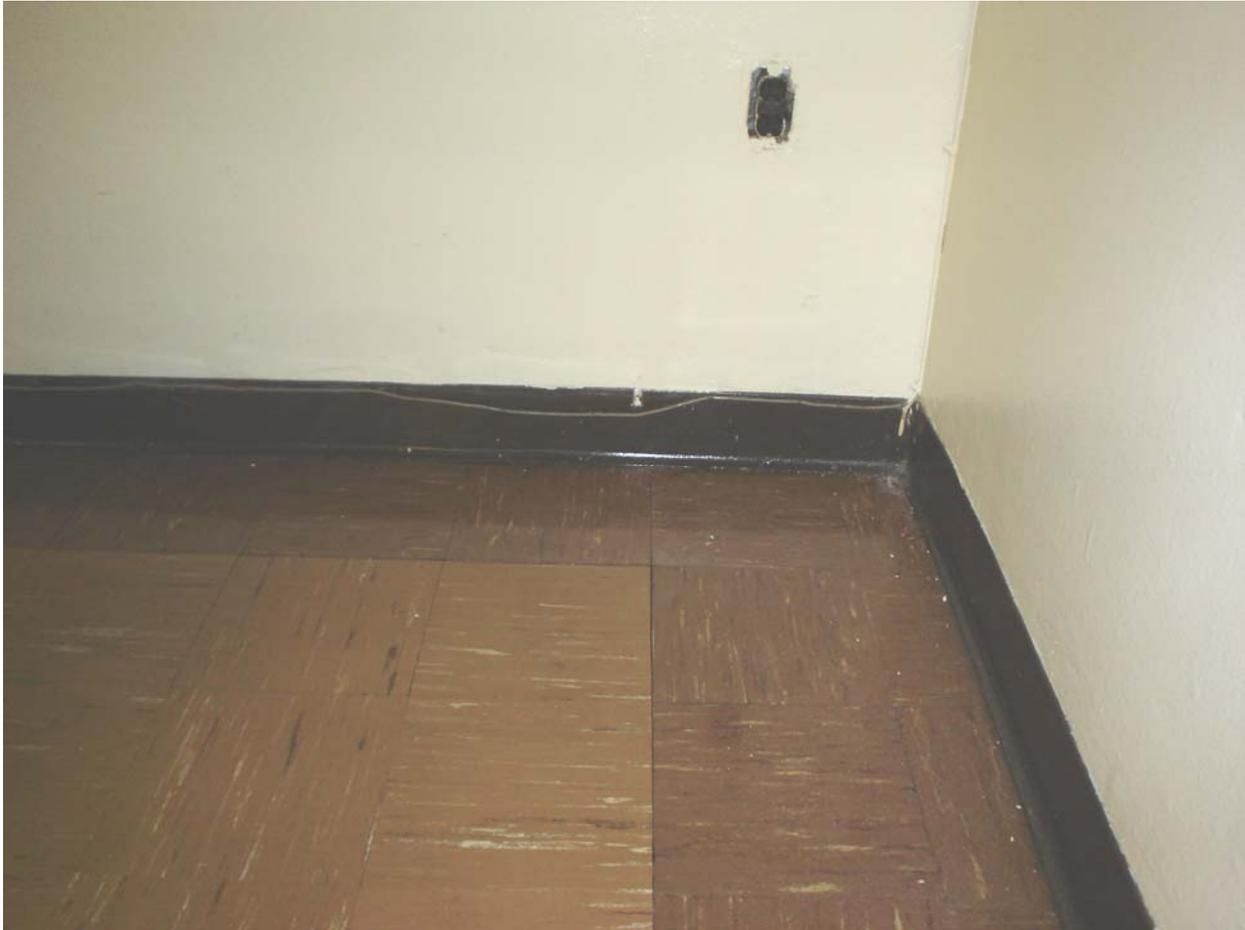
HA #10

Non asbestos-containing 4" brown cove molding and associated mastic

HA #18

Asbestos-containing 9" x 9" dark tan floor tile
with cream and rust streaks and associated non asbestos-containing mastic

HA #19

Asbestos-containing 9" x 9" chocolate brown floor tile
with cream and rust streaks and associated mastic

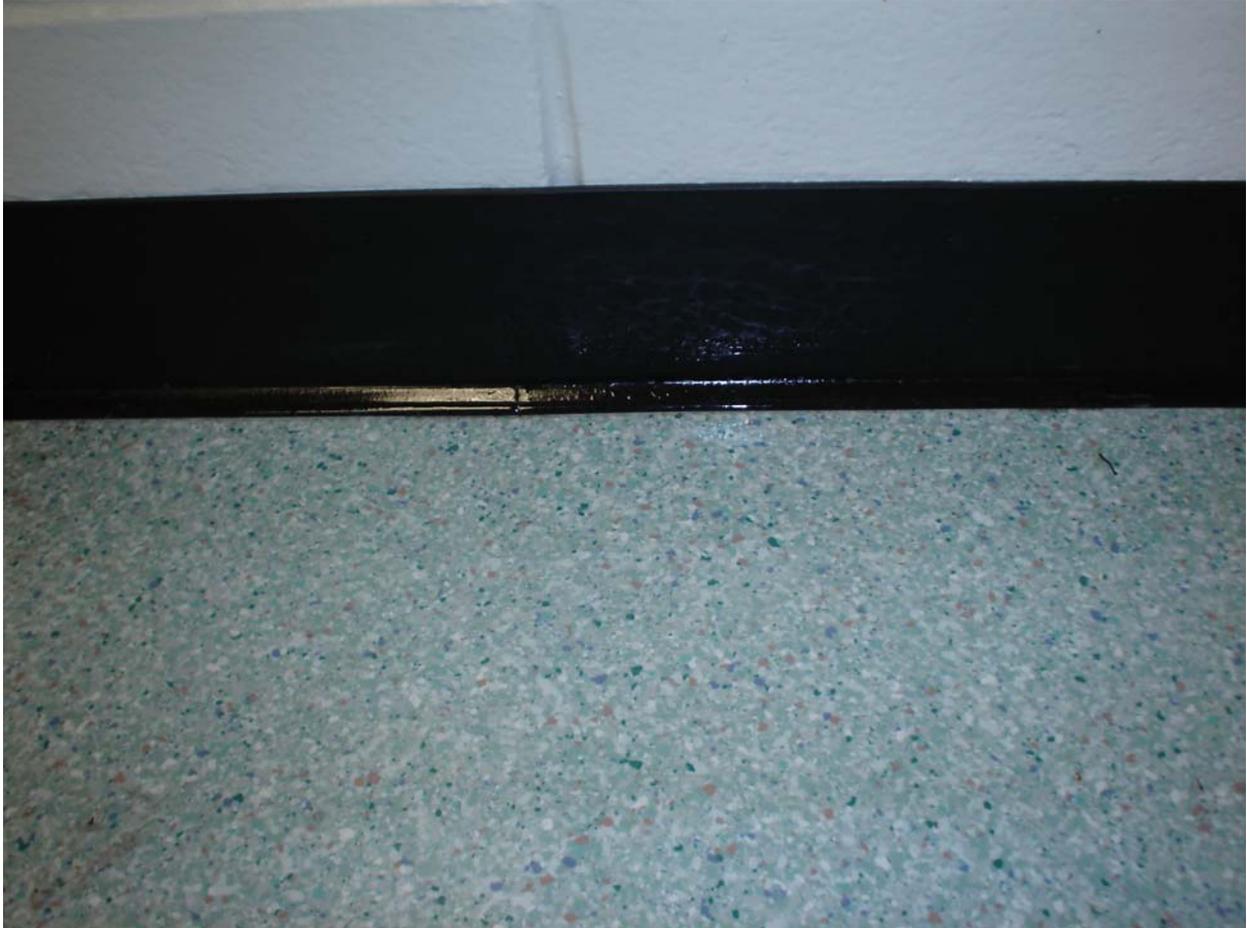
HA #11

Non asbestos-containing 4" black cove molding and associated mastic

HA #23

Non asbestos-containing light green linoleum
with mosaic pattern and associated mastic

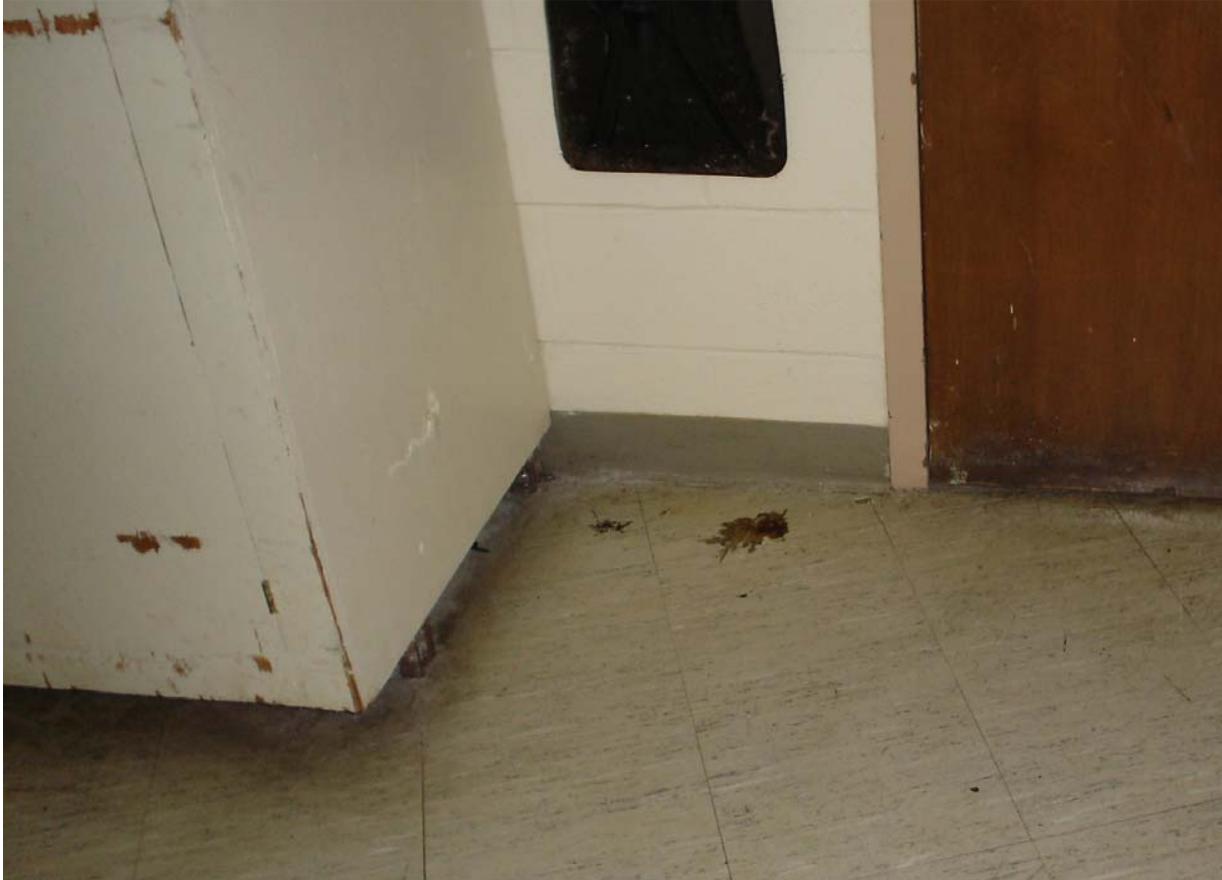
HA #12

Non asbestos-containing 4" gray cove molding and associated mastic

HA #15

Non asbestos-containing 12" x 12" cream floor tile
with white and gray streaks and associated mastic

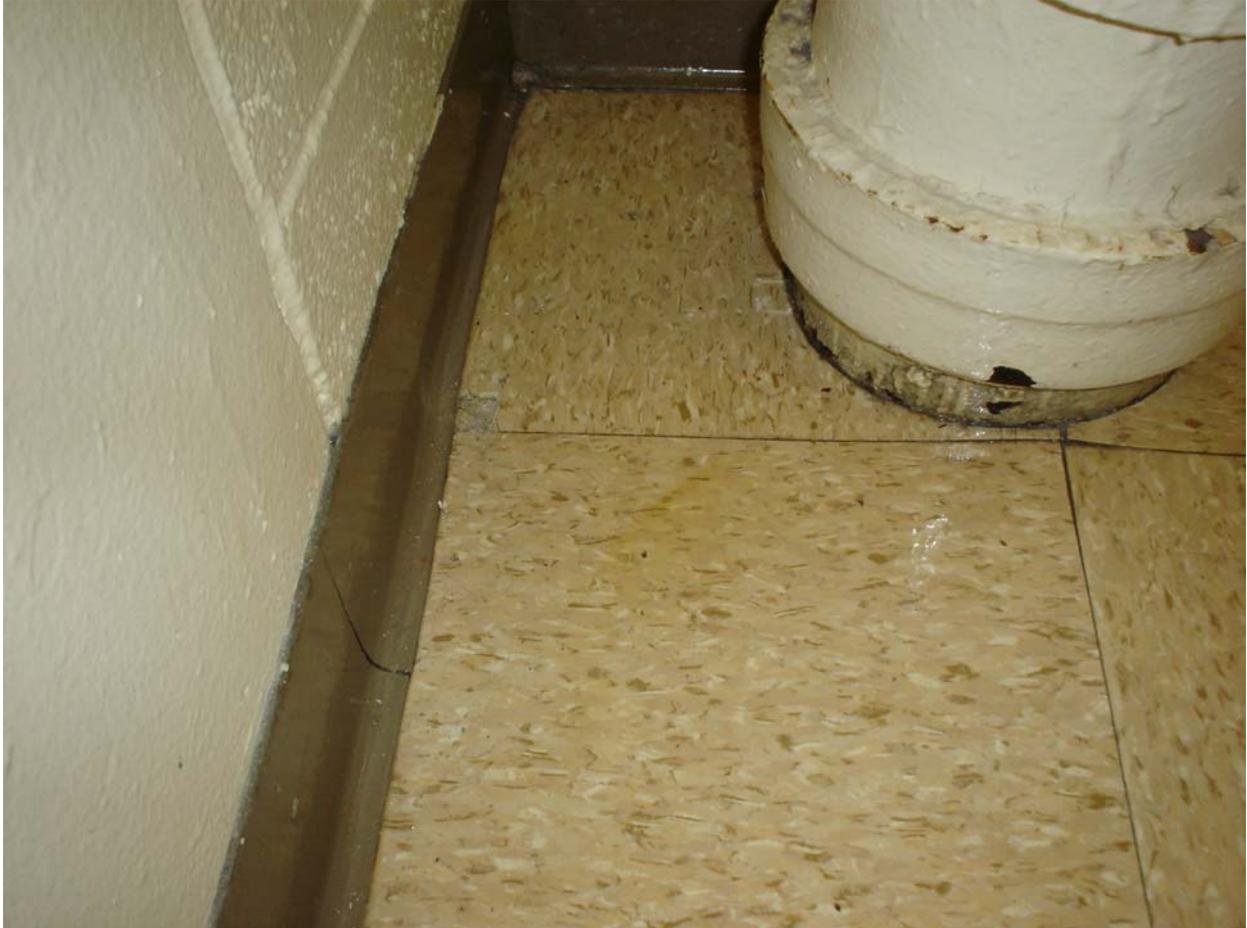
HA #13
Non asbestos-containing 12" x 12" tan floor tile with marbled pattern
and associated mastic

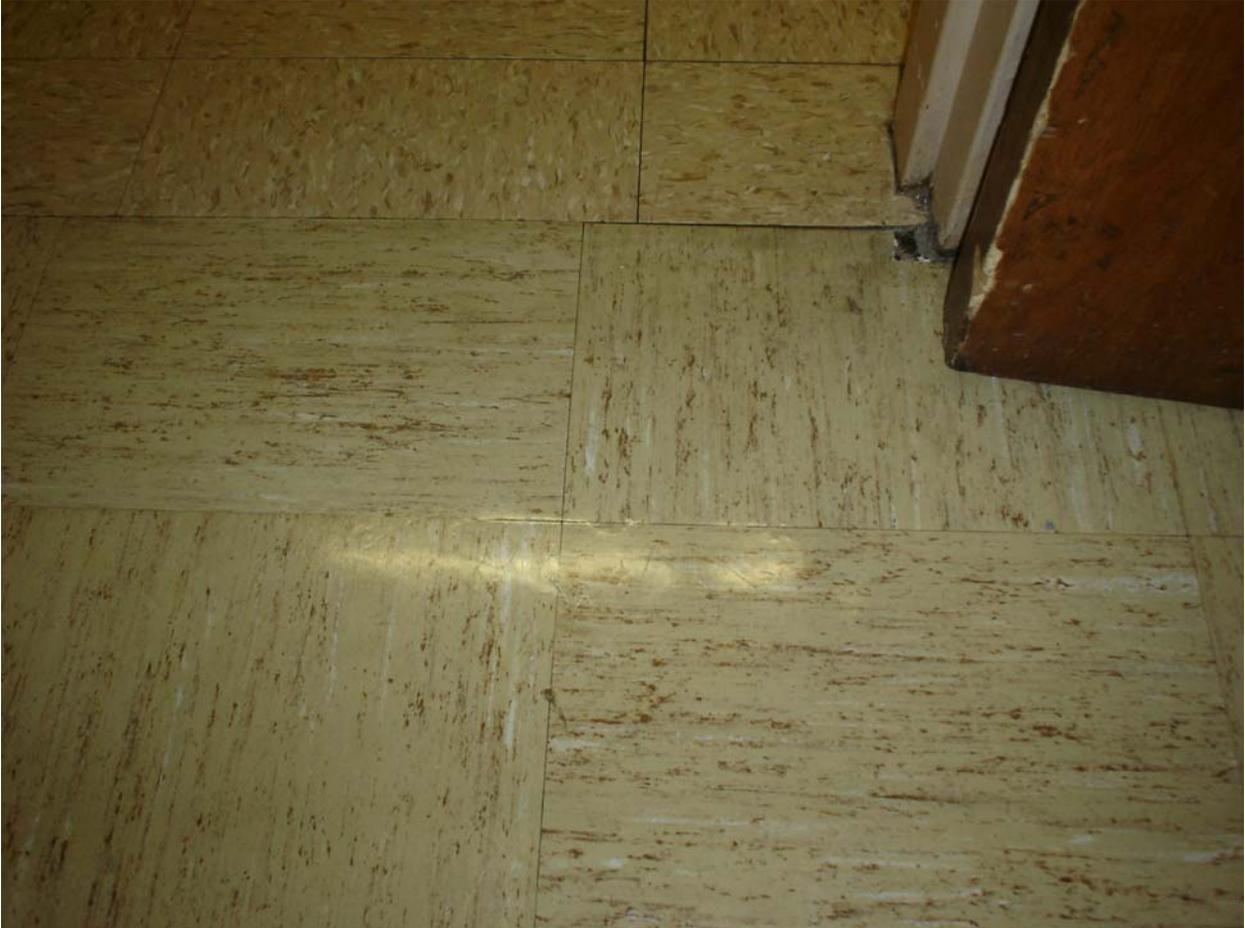
HA #14

Non asbestos-containing 12" x 12" tan floor tile with cream and rust streaks
and associated mastic

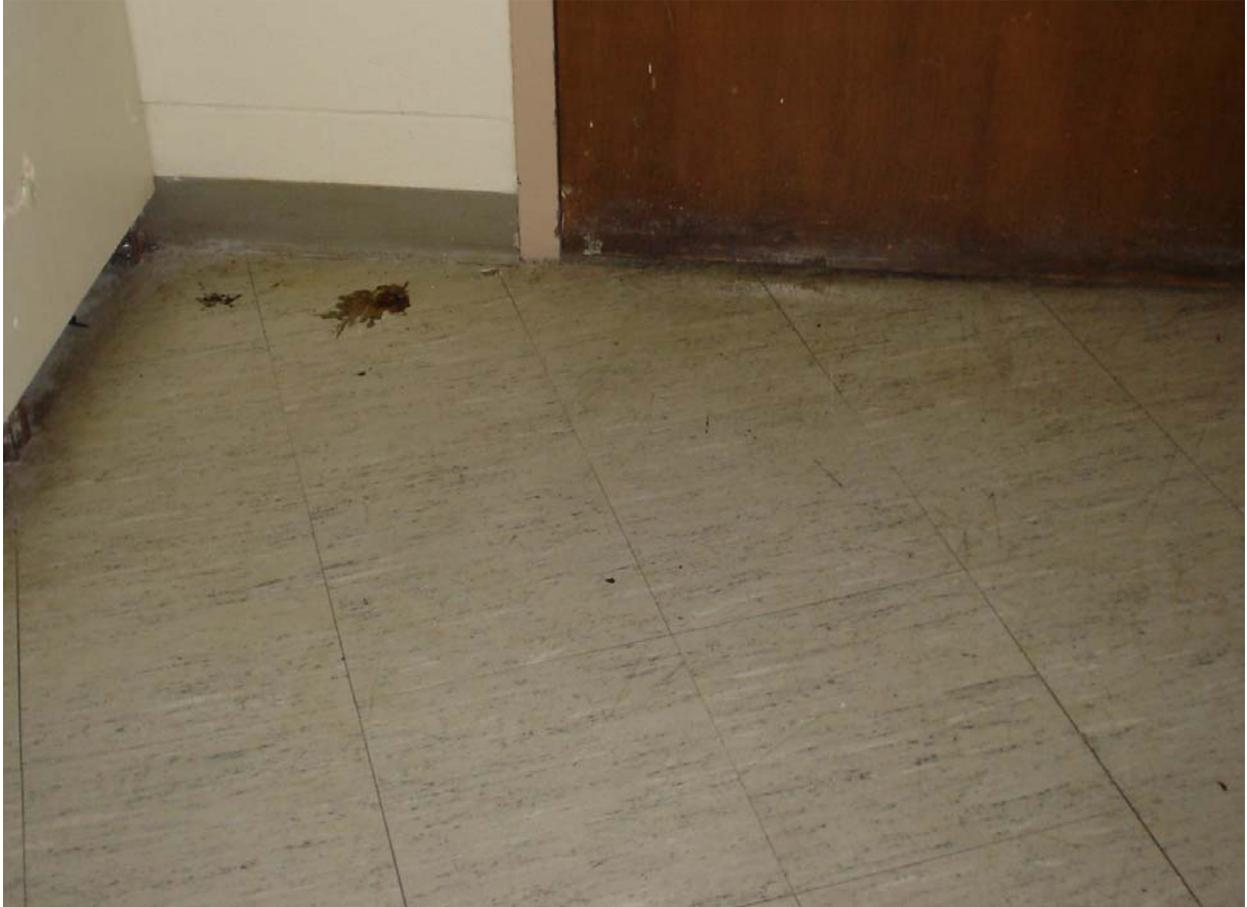
HA #15
Non asbestos-containing 12" x 12" cream floor tile
with white and gray streaks and associated mastic

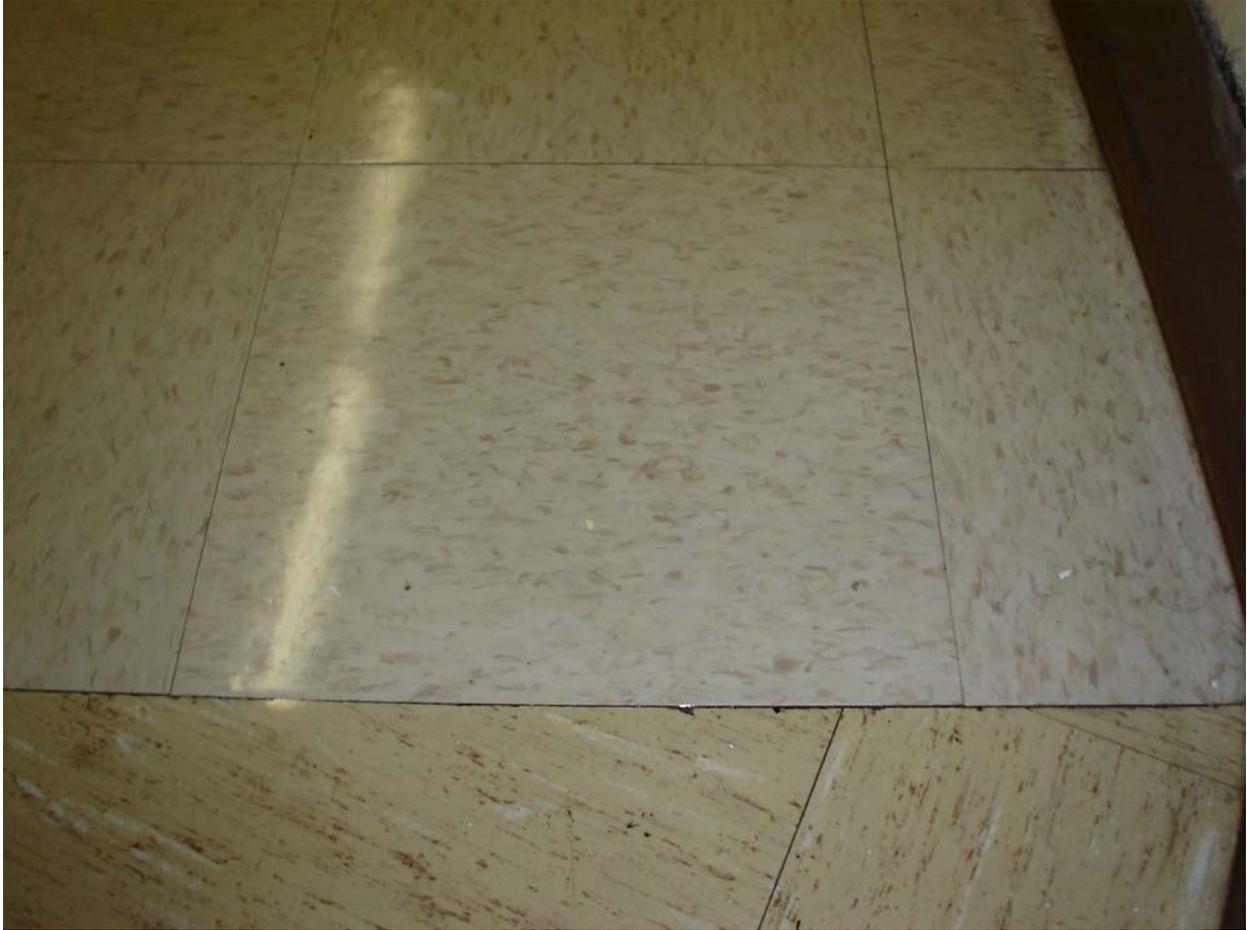
HA #16
Non asbestos-containing 12" x 12" white floor tile
with tan marble pattern and associated mastic

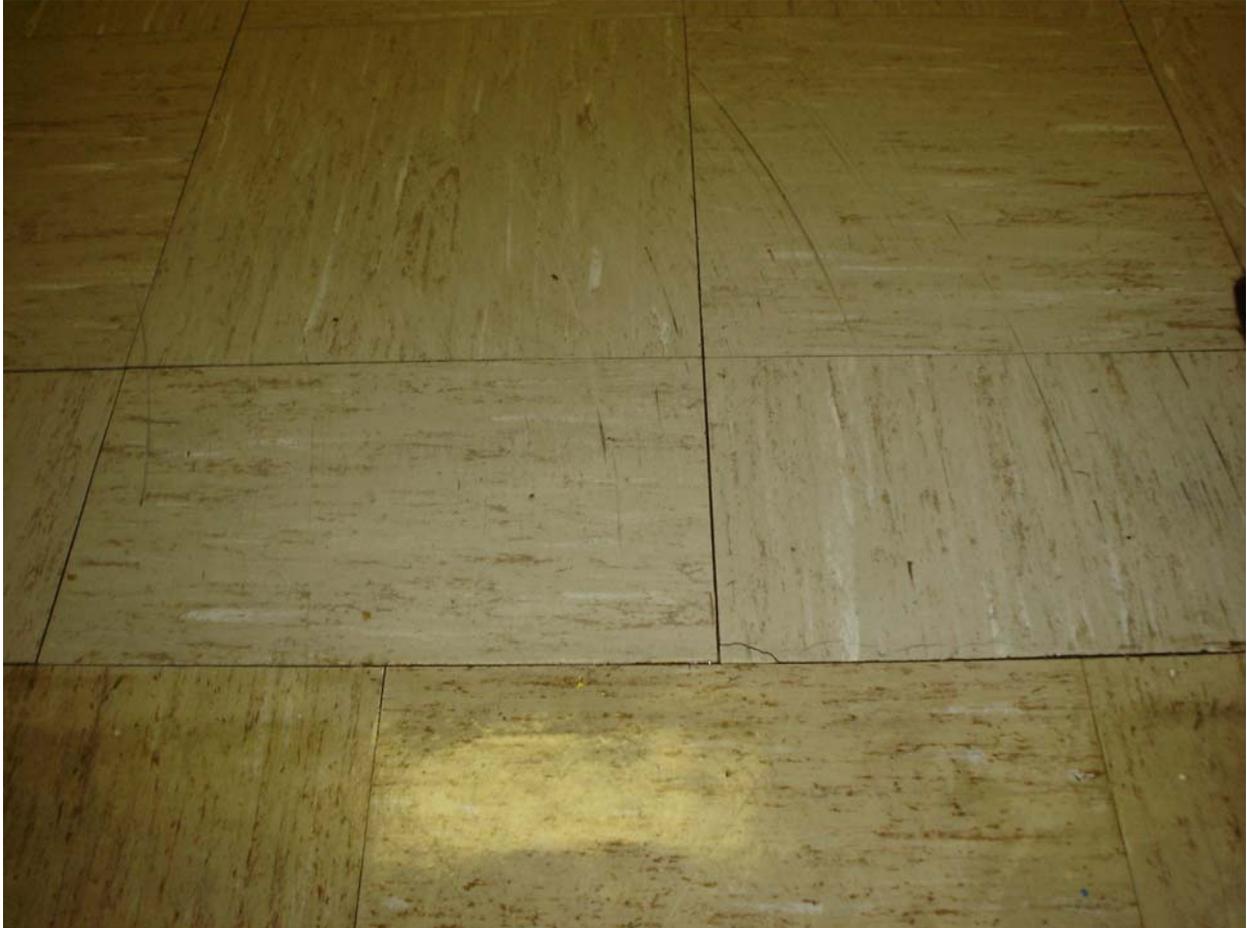
HA #17
Asbestos-containing 12" x 12" light cream floor tile
with tan and cream streaks and associated non asbestos-containing mastic

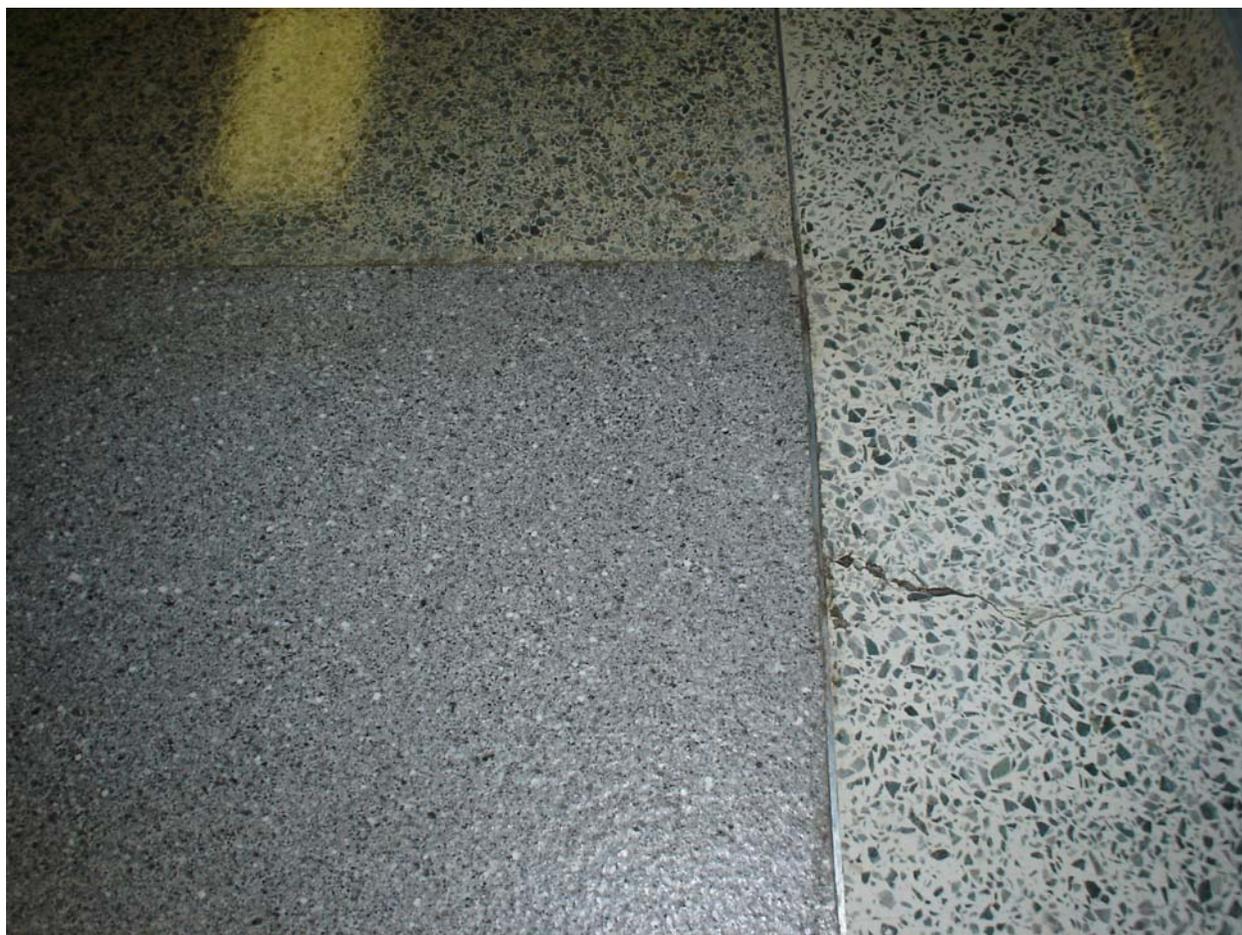
HA #20
Non asbestos-containing gray flooring
with black and white specks and associated mastic

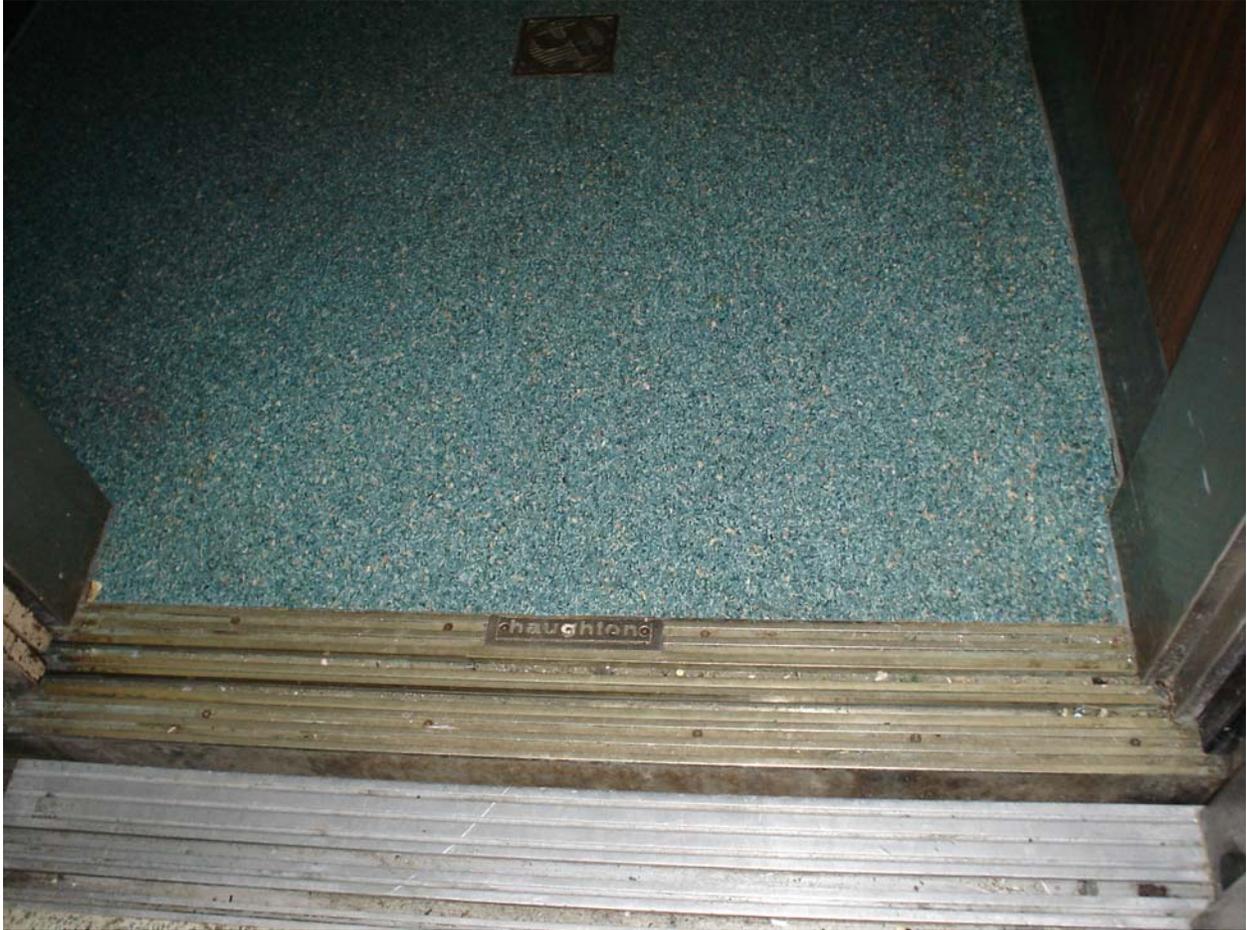
HA #21
Non asbestos-containing green linoleum
with tan and black specks and associated mastic

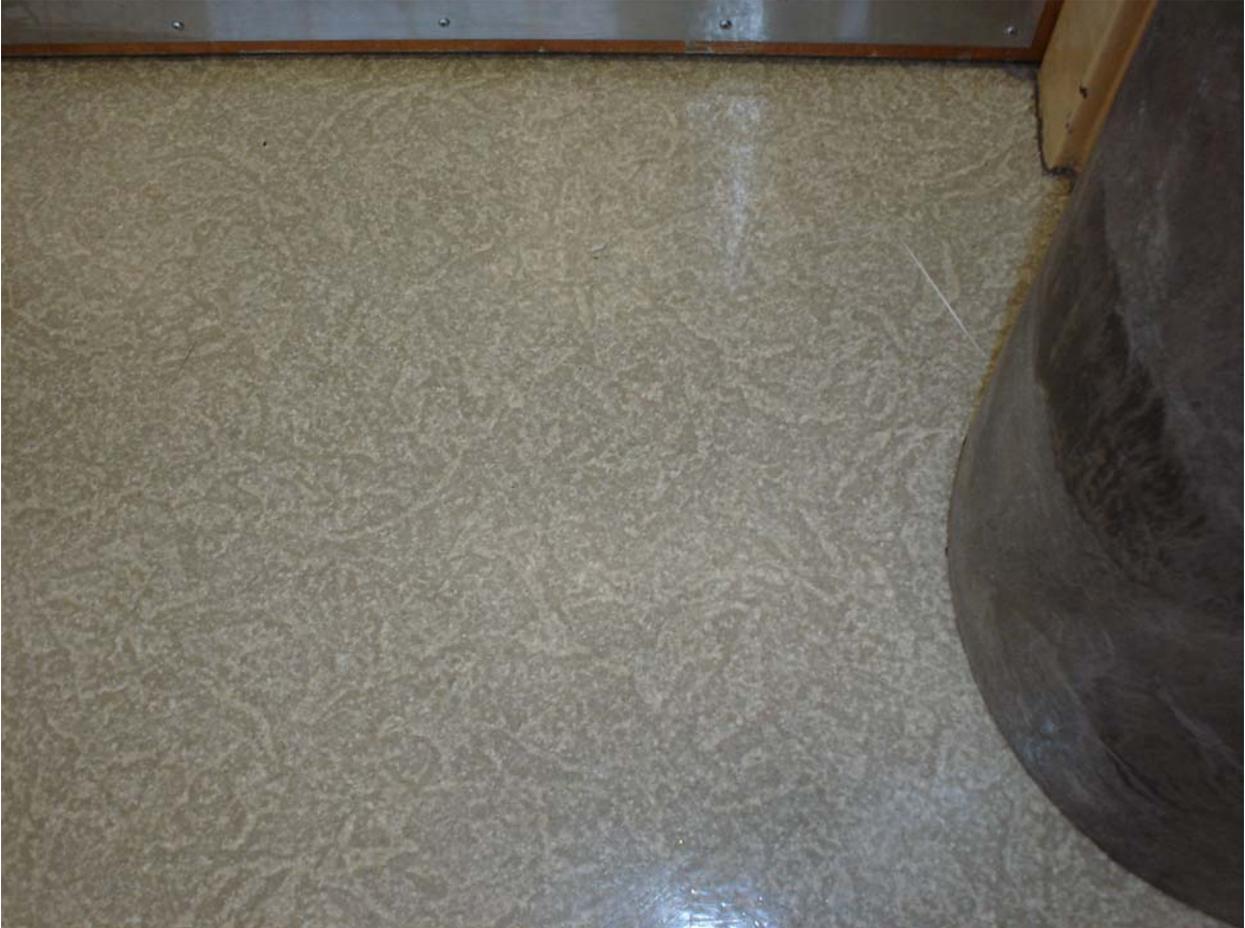
HA #22

Non asbestos-containing tan linoleum with cream swirls and associated mastic
