Akers Hall Photo Log

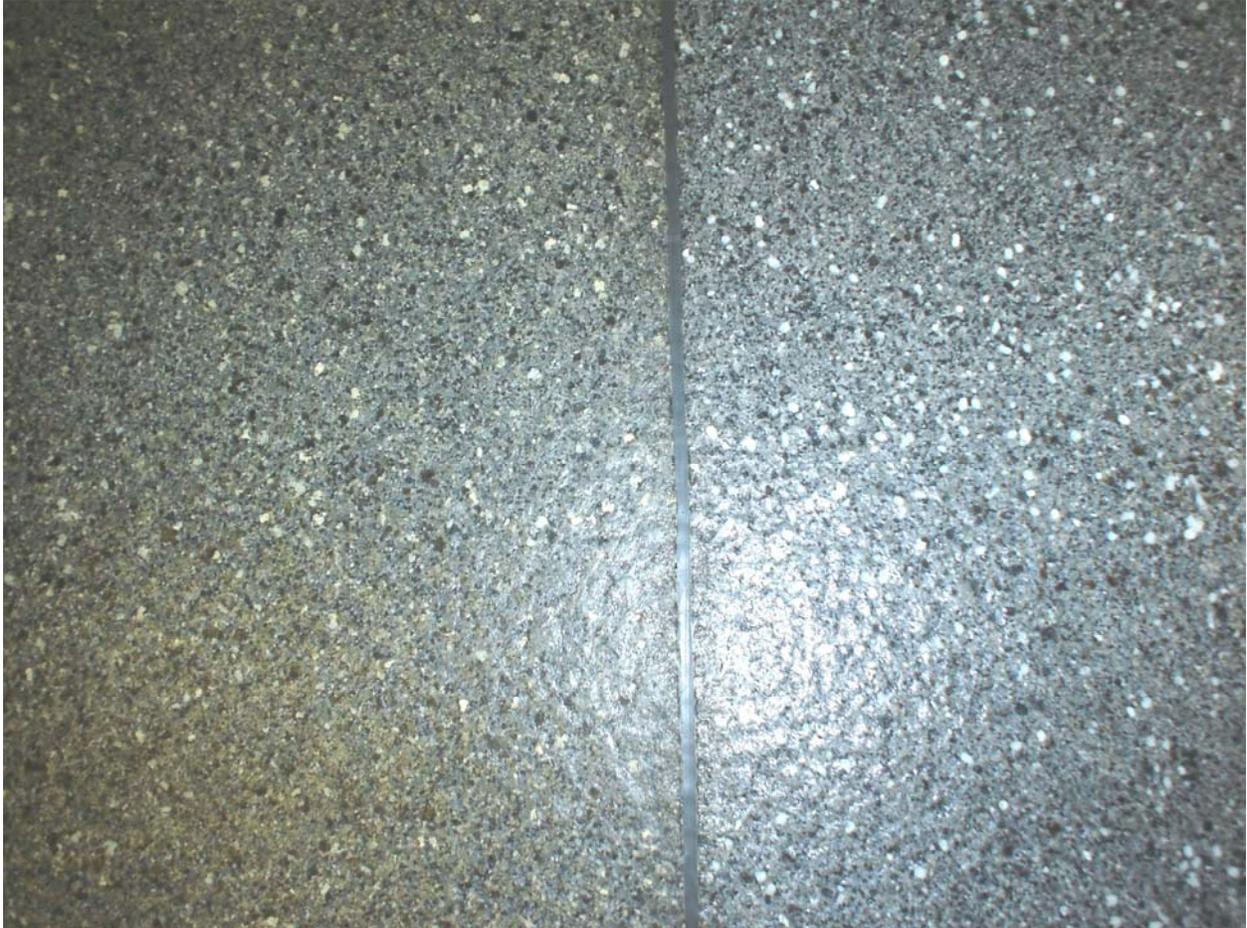
HA #24

Non asbestos-containing dark green linoleum
with black and cream specks and associated mastic

HA #49

Non asbestos-containing forest green linoleum
with black, cream and light green specks and associated mastic.

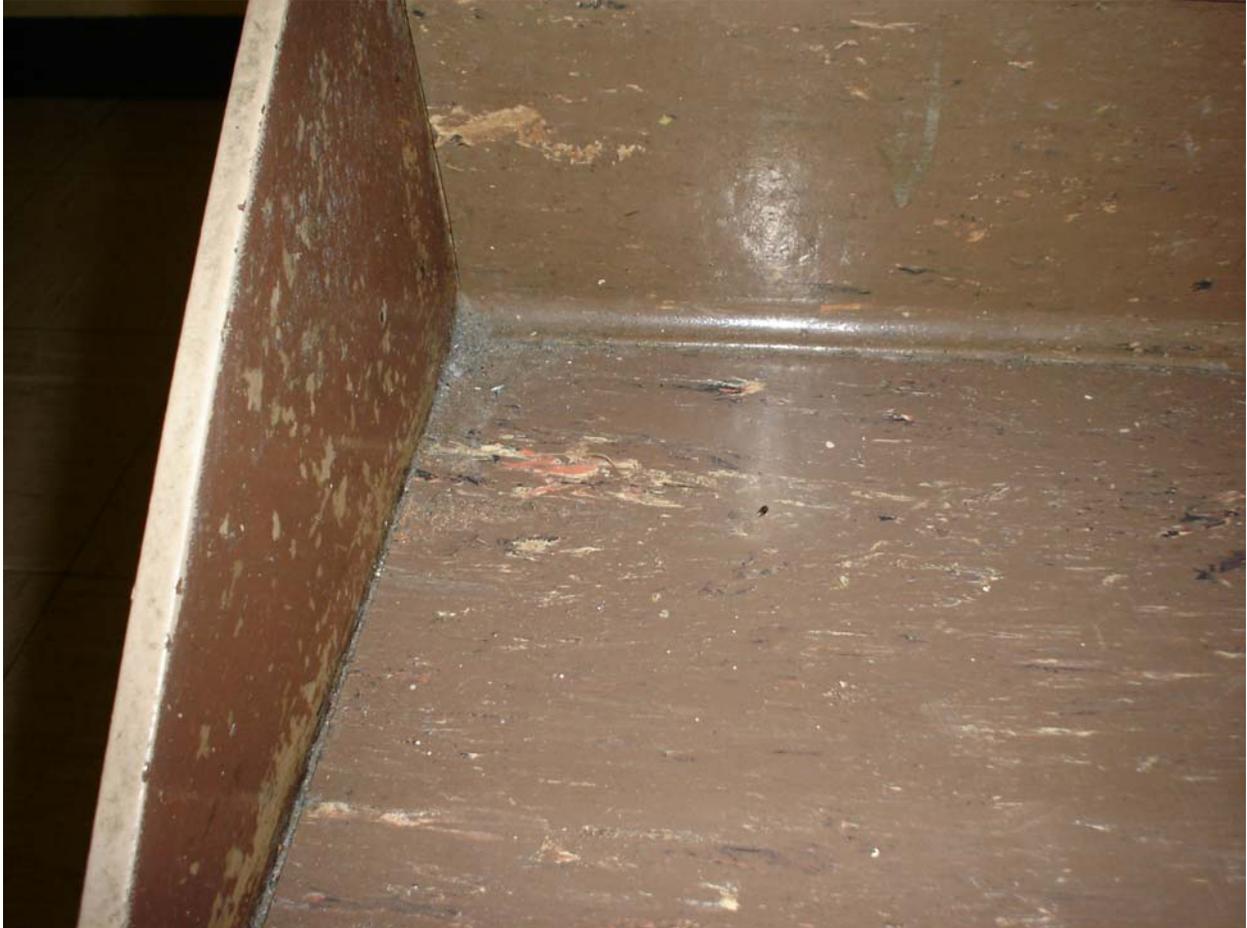
HA #25
Non asbestos-containing chocolate vinyl stair tread
with black, cream and pink streaks and associated asbestos-containing mastic

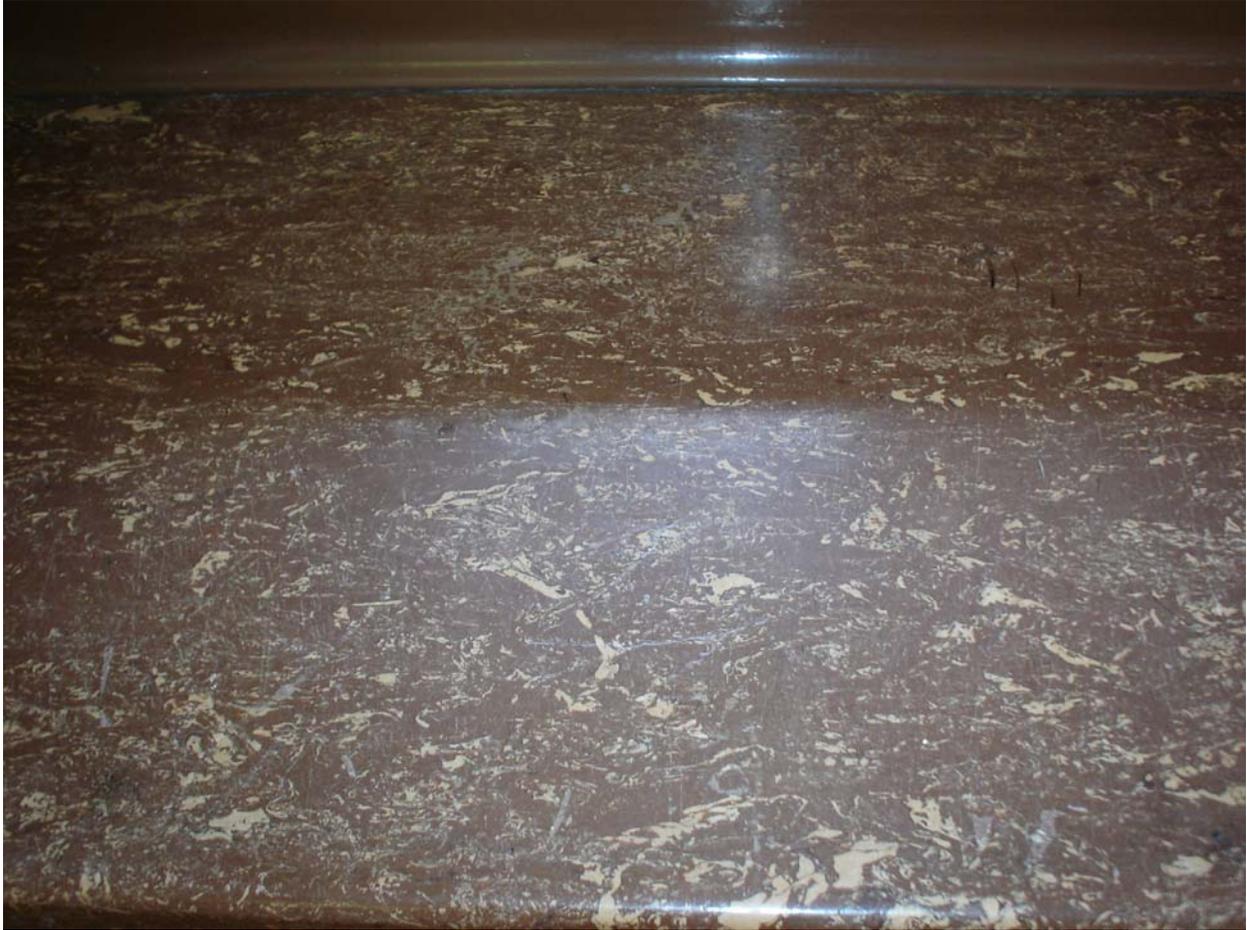
HA #26
Non asbestos-containing chocolate vinyl stair tread
with cream streaks and associated mastic

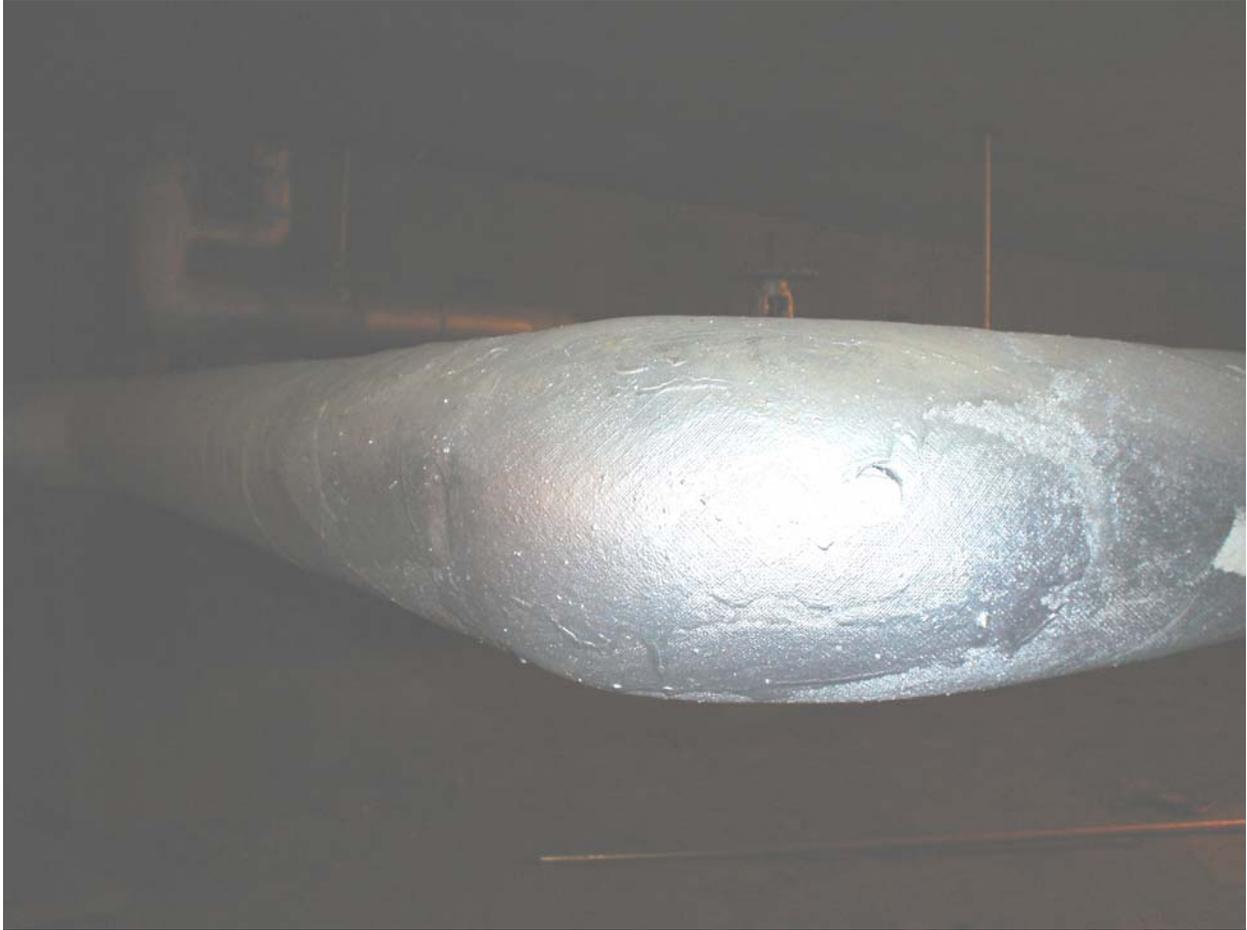
HA #28

Non asbestos-containing steam/condensate supply and return pipe joint insulation

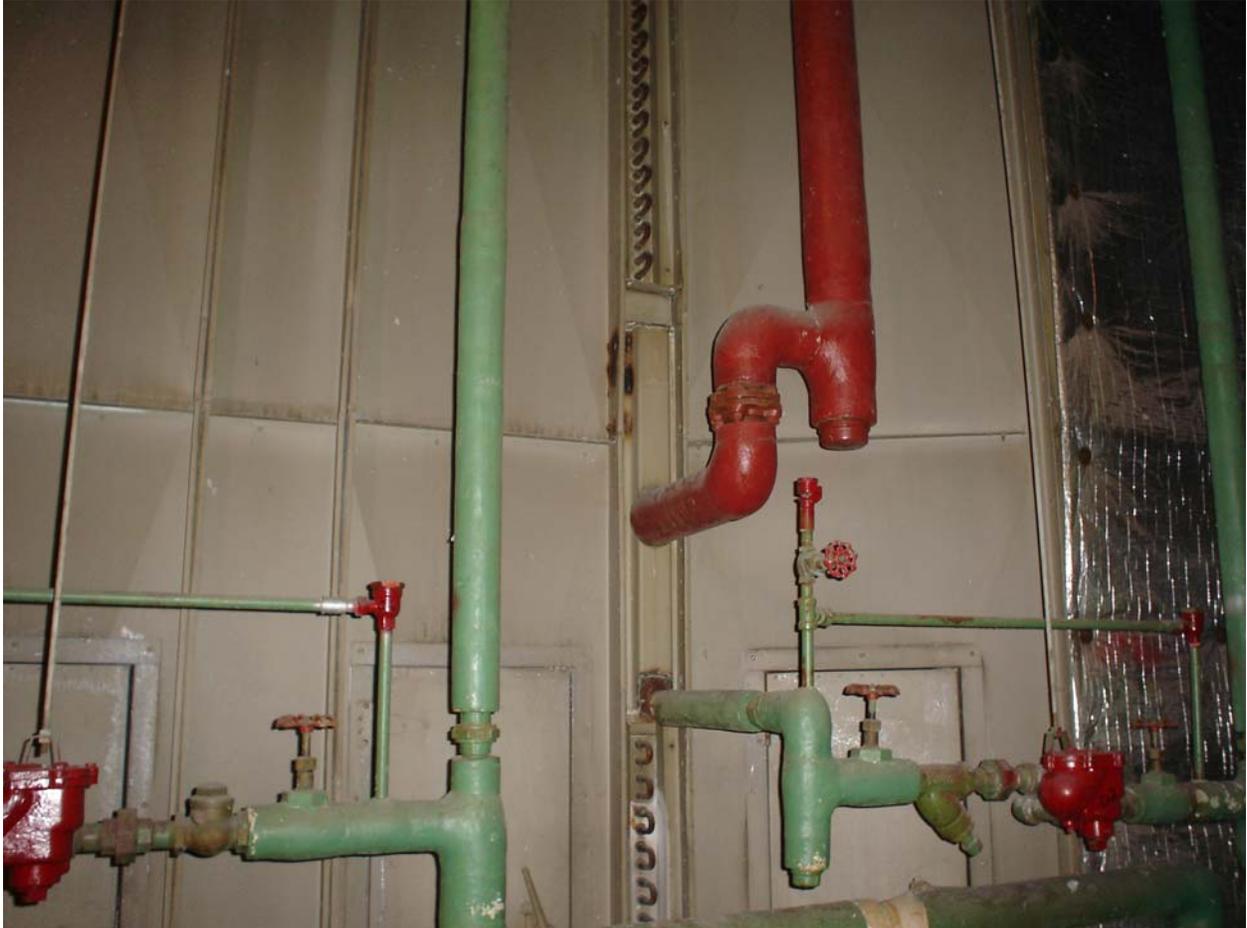
HA #28

Non asbestos-containing steam/condensate supply and return pipe joint insulation

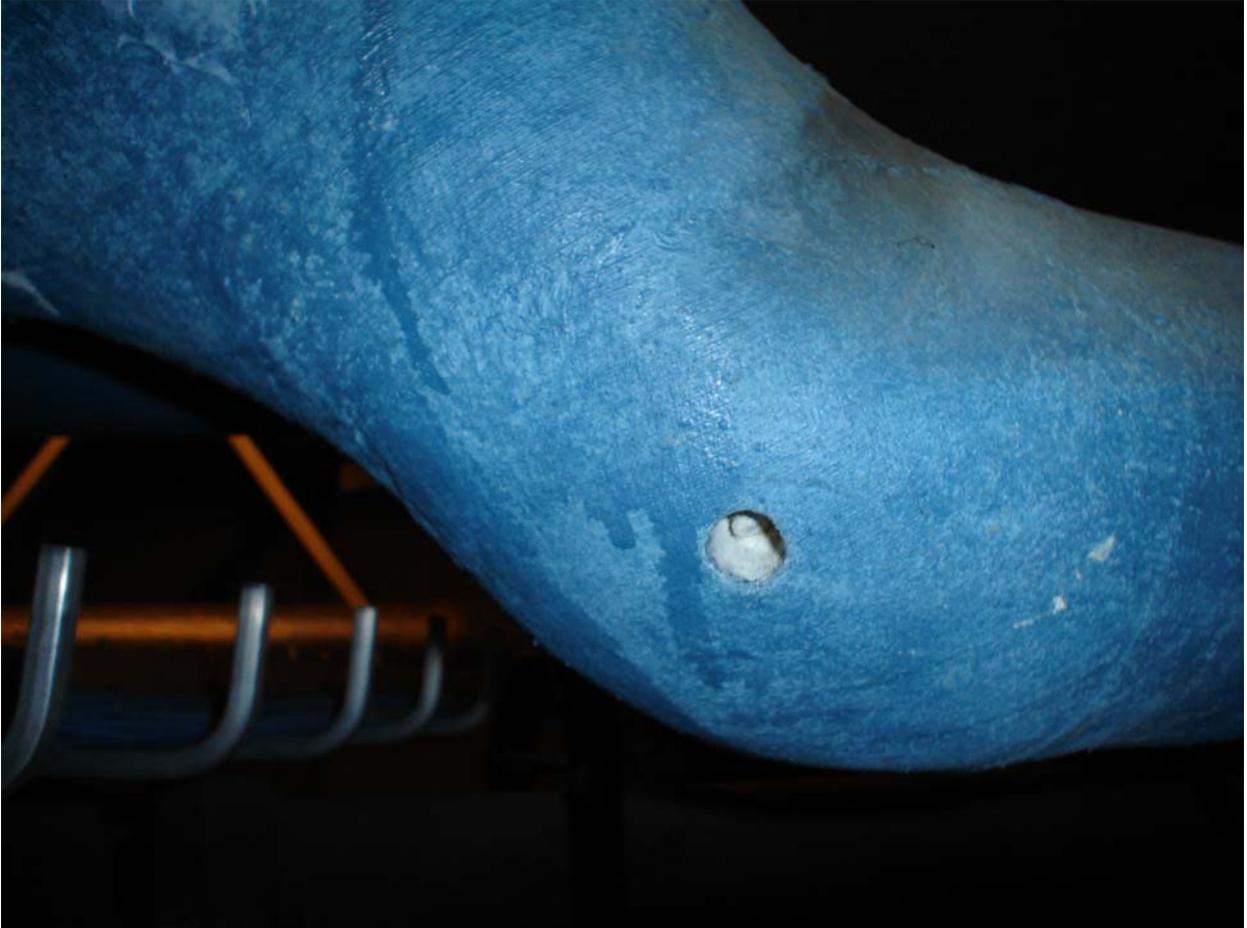
HA #30
Asbestos-containing domestic water supply and return
pipe joint and hanger insulation

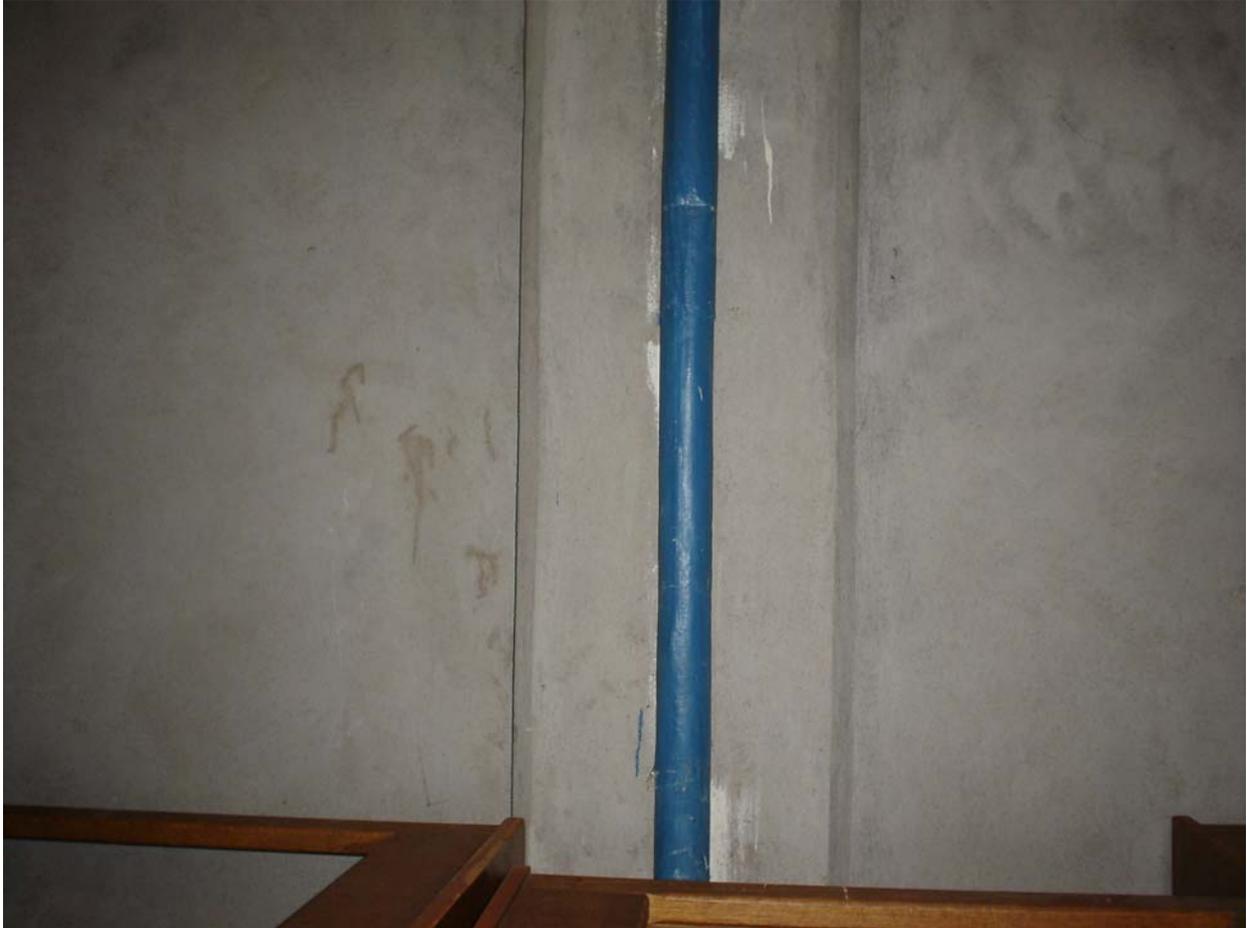
HA #33

Non asbestos-containing canvas wrap on fiberglass pipe straight insulation

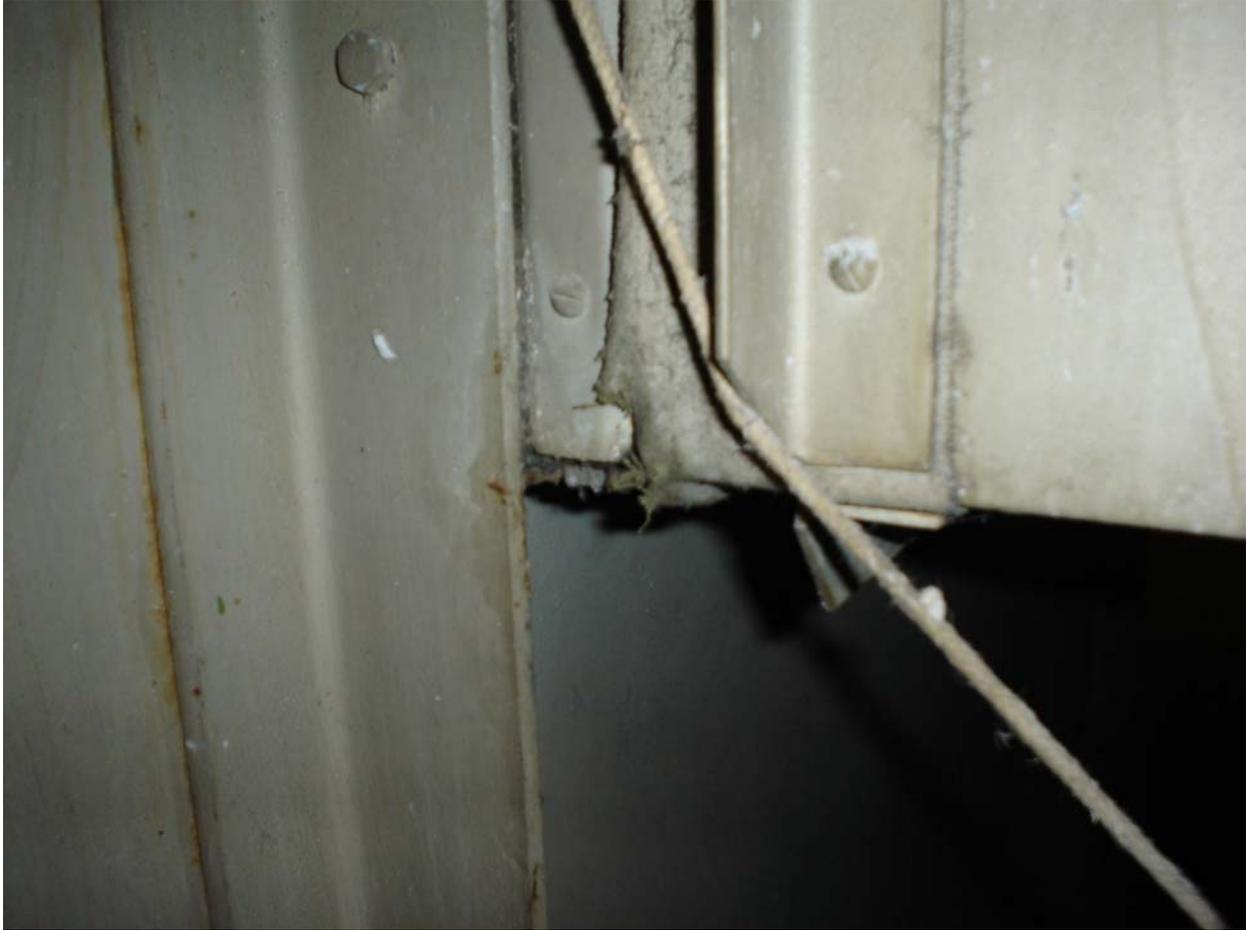
HA #34
Asbestos-containing white ventilation duct expansion cloth

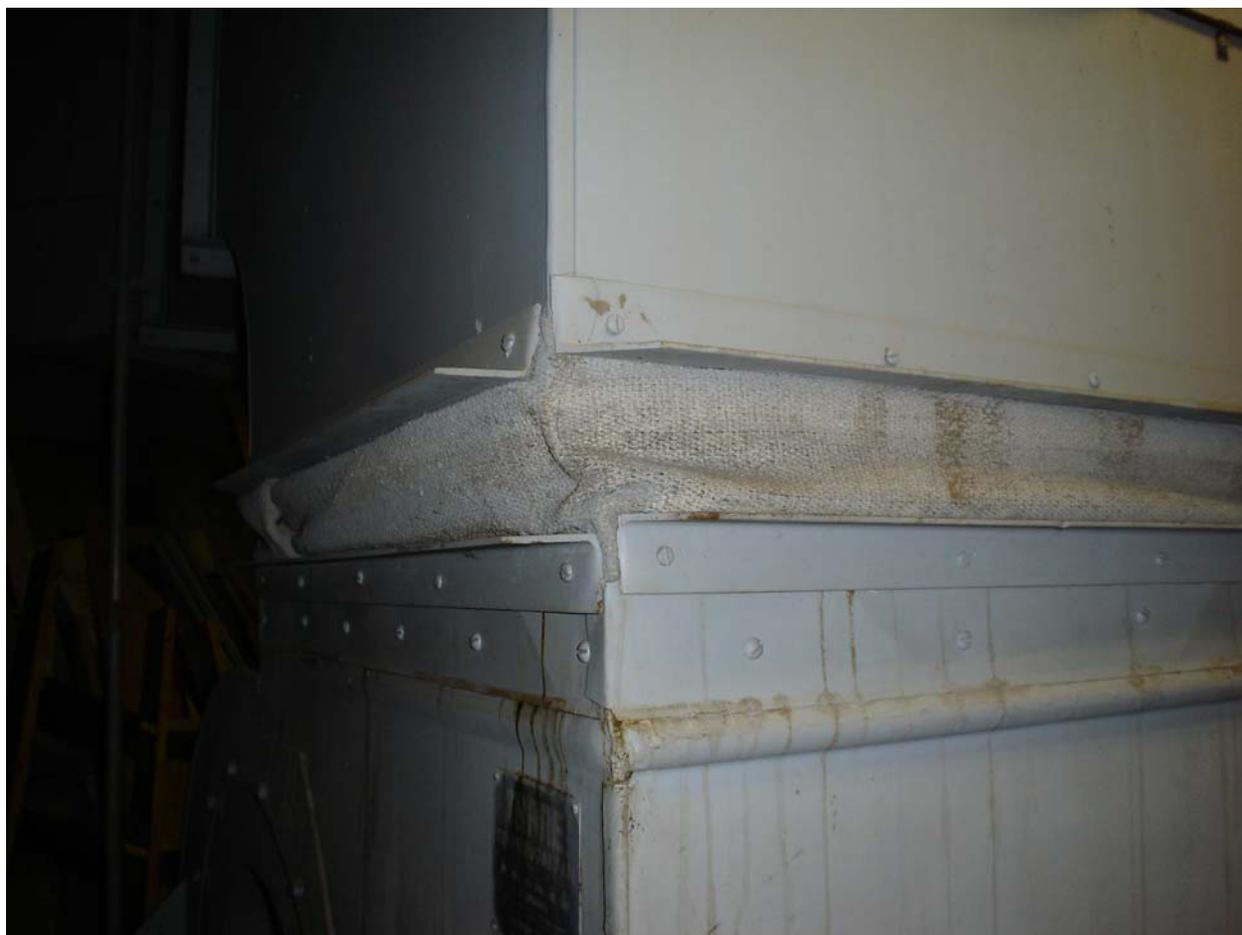
HA #34
Asbestos-containing white ventilation duct expansion cloth

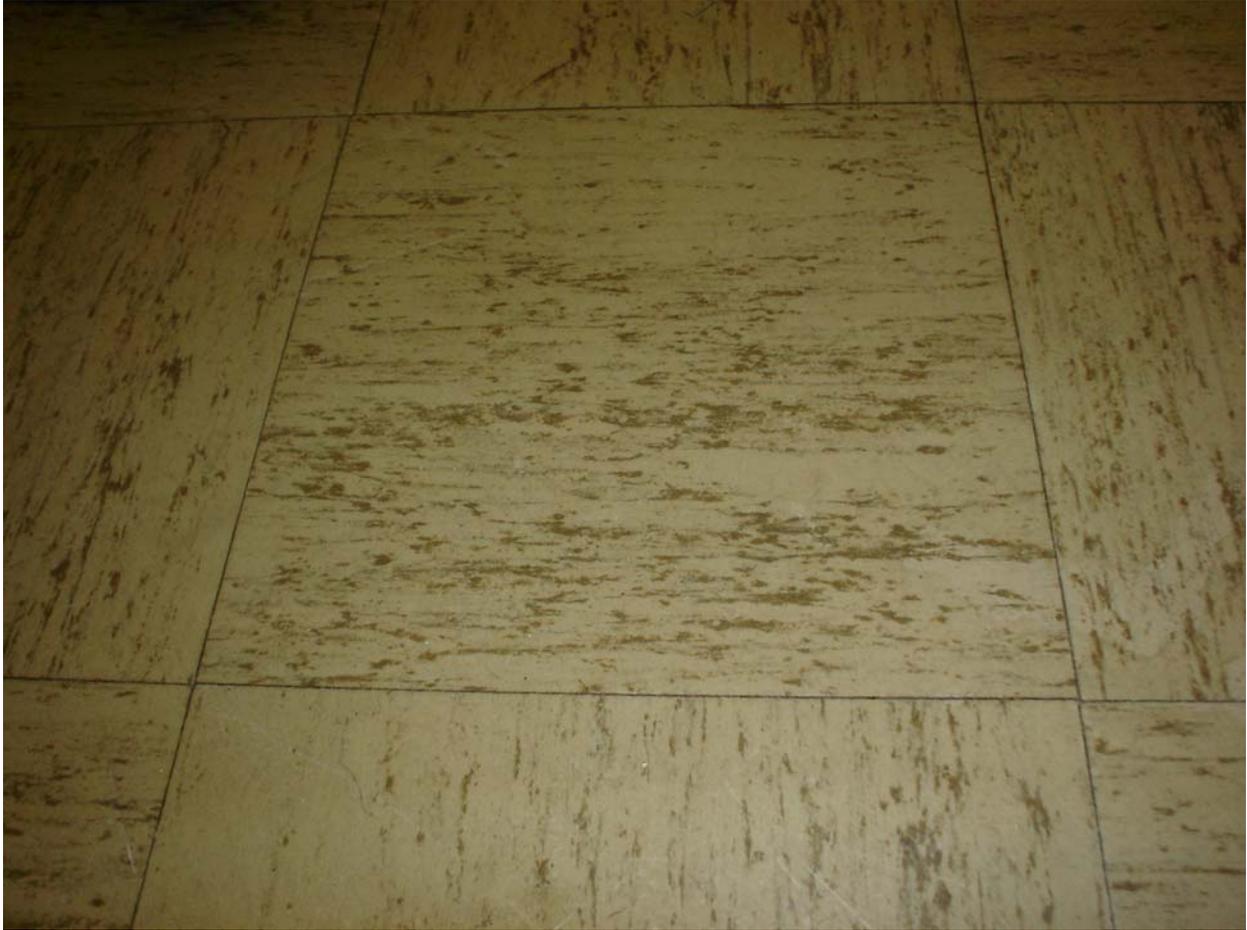
HA #39
Non asbestos-containing 9” x 9” cream floor tile
with rust streaks and associated mastic

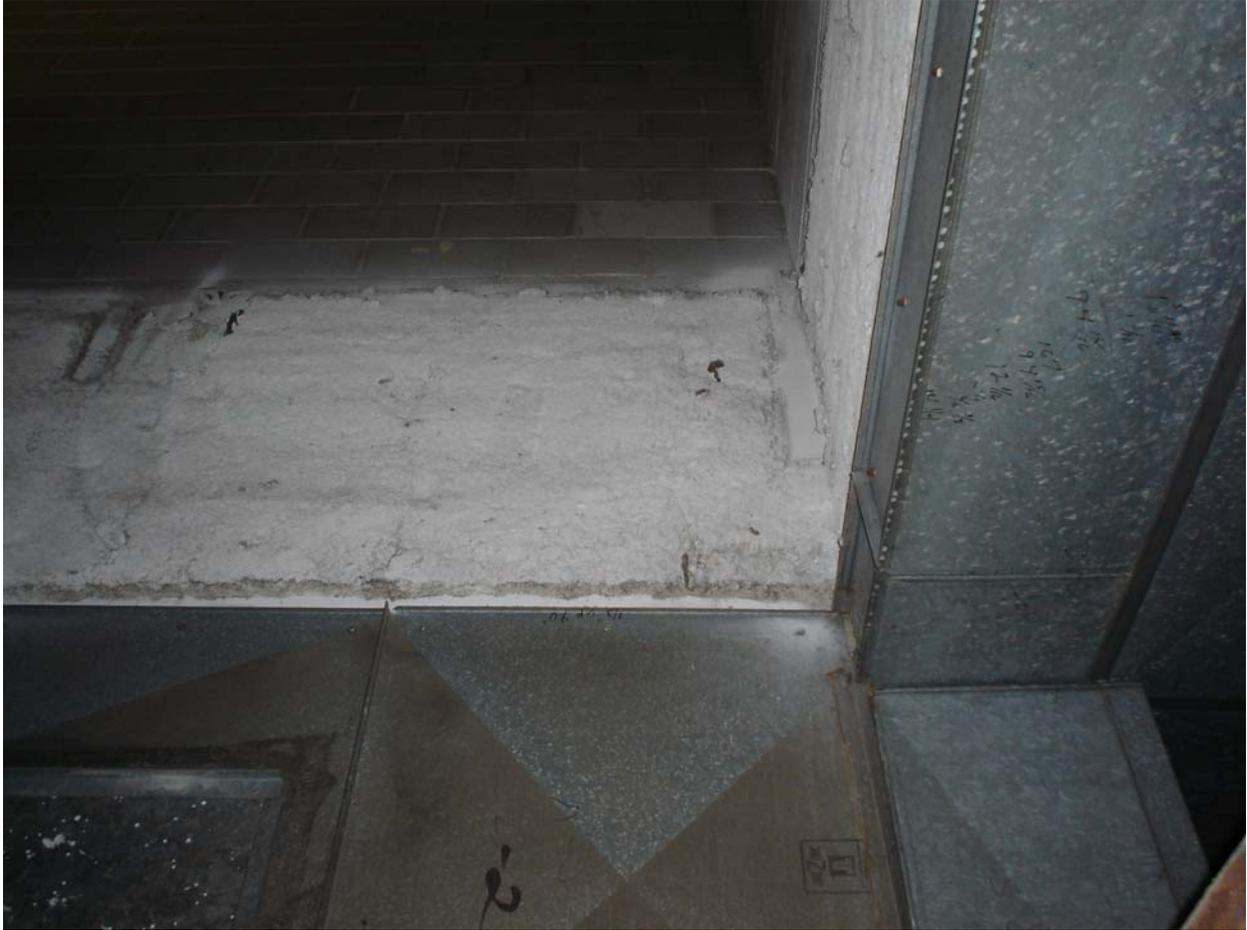
HA #40
Asbestos-containing spray-on fireproofing

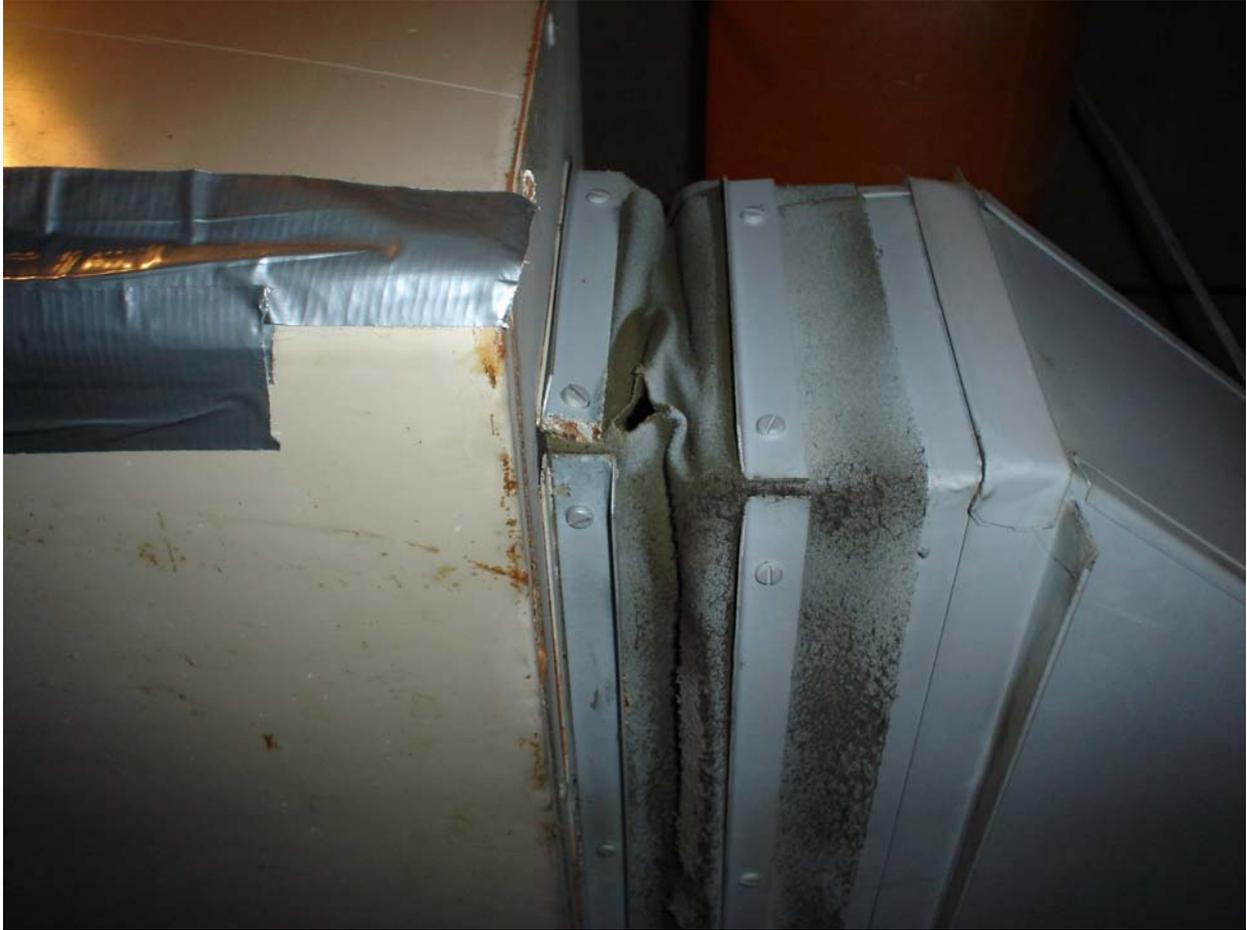
HA #41
Non asbestos-containing black ventilation duct expansion cloth

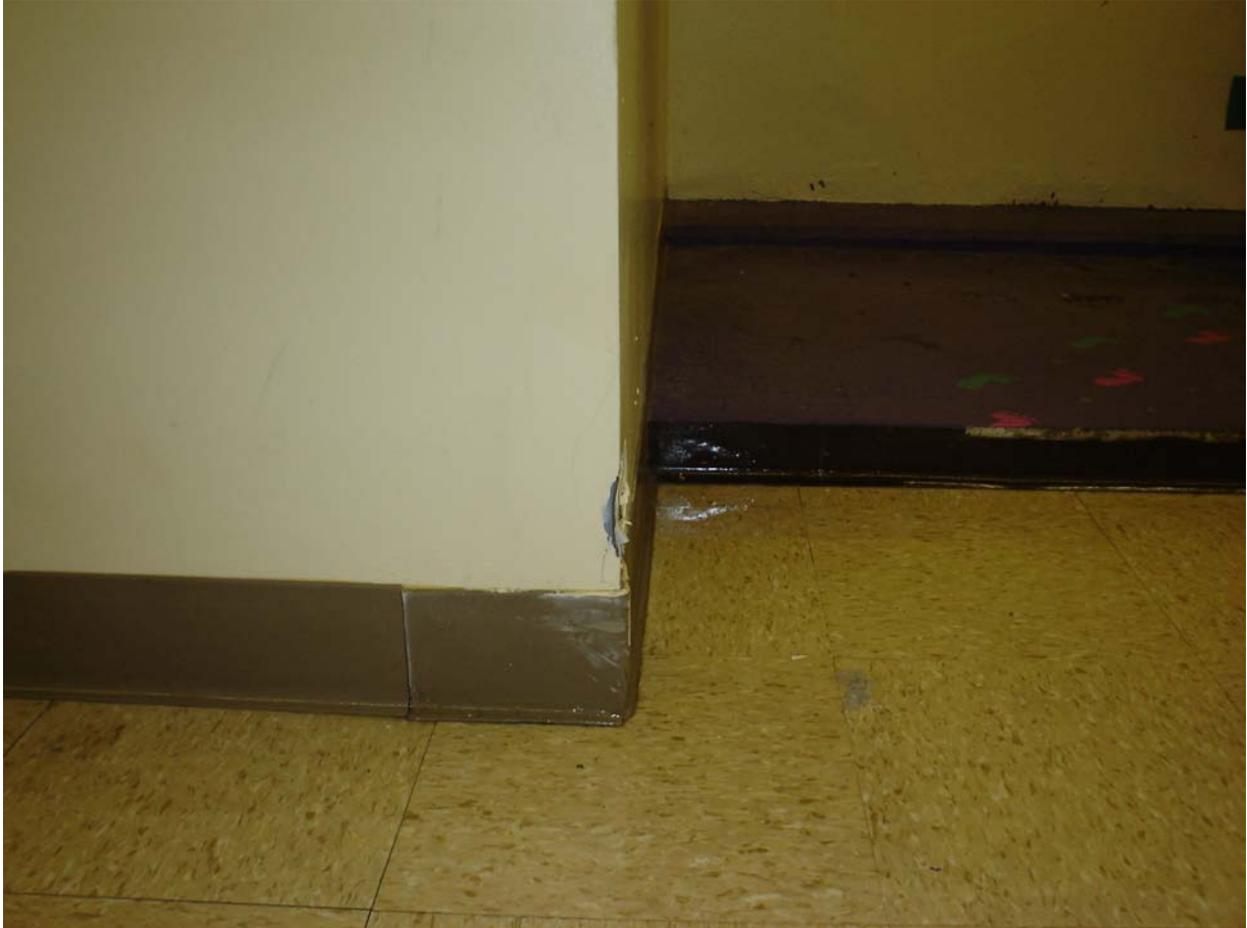
HA #42

Non-asbestos containing 4" tan cove molding and associated mastic

HA #1

Asbestos-containing plaster (smooth)

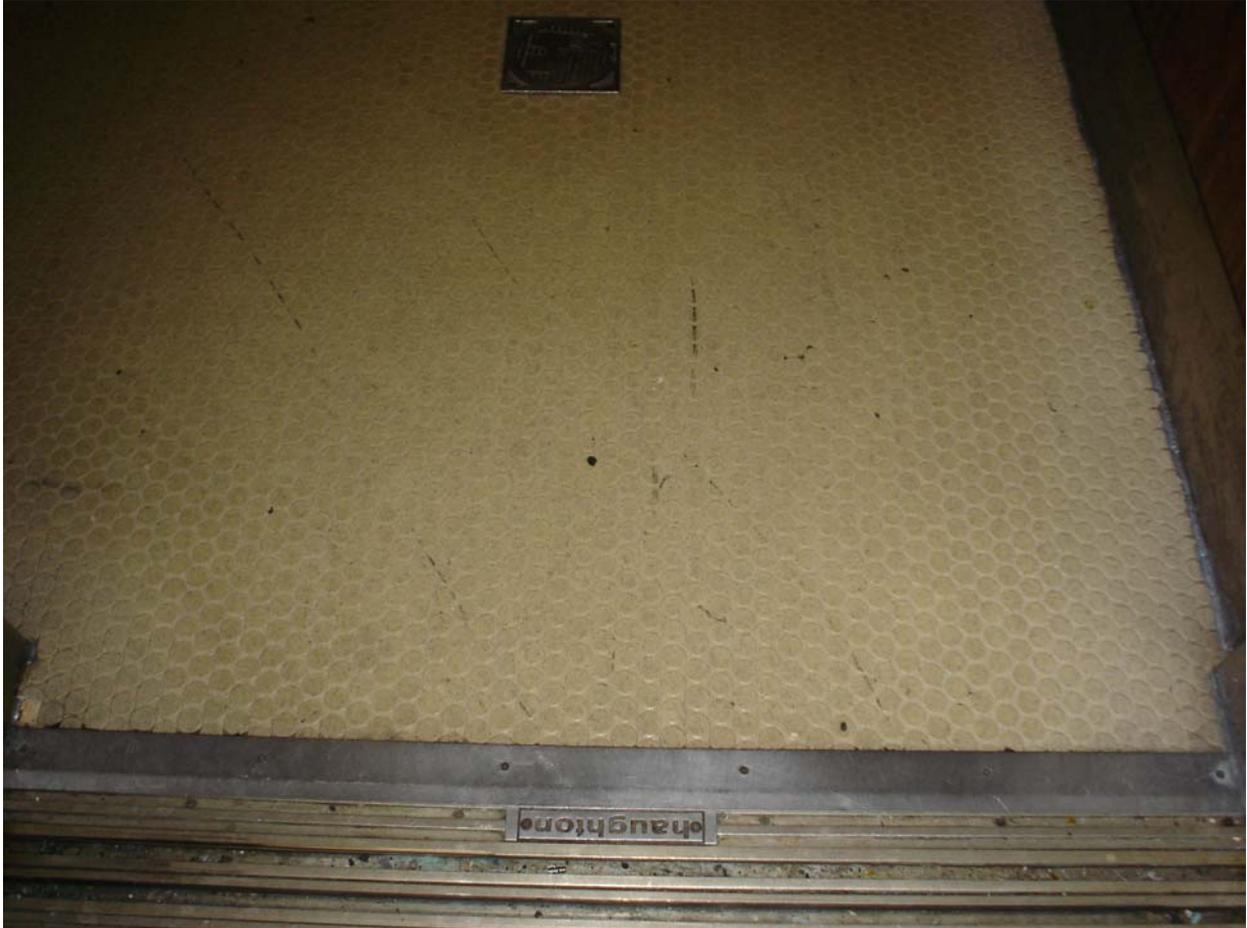
HA #43
Non asbestos-containing light tan linoleum
with bubble pattern and associated mastic

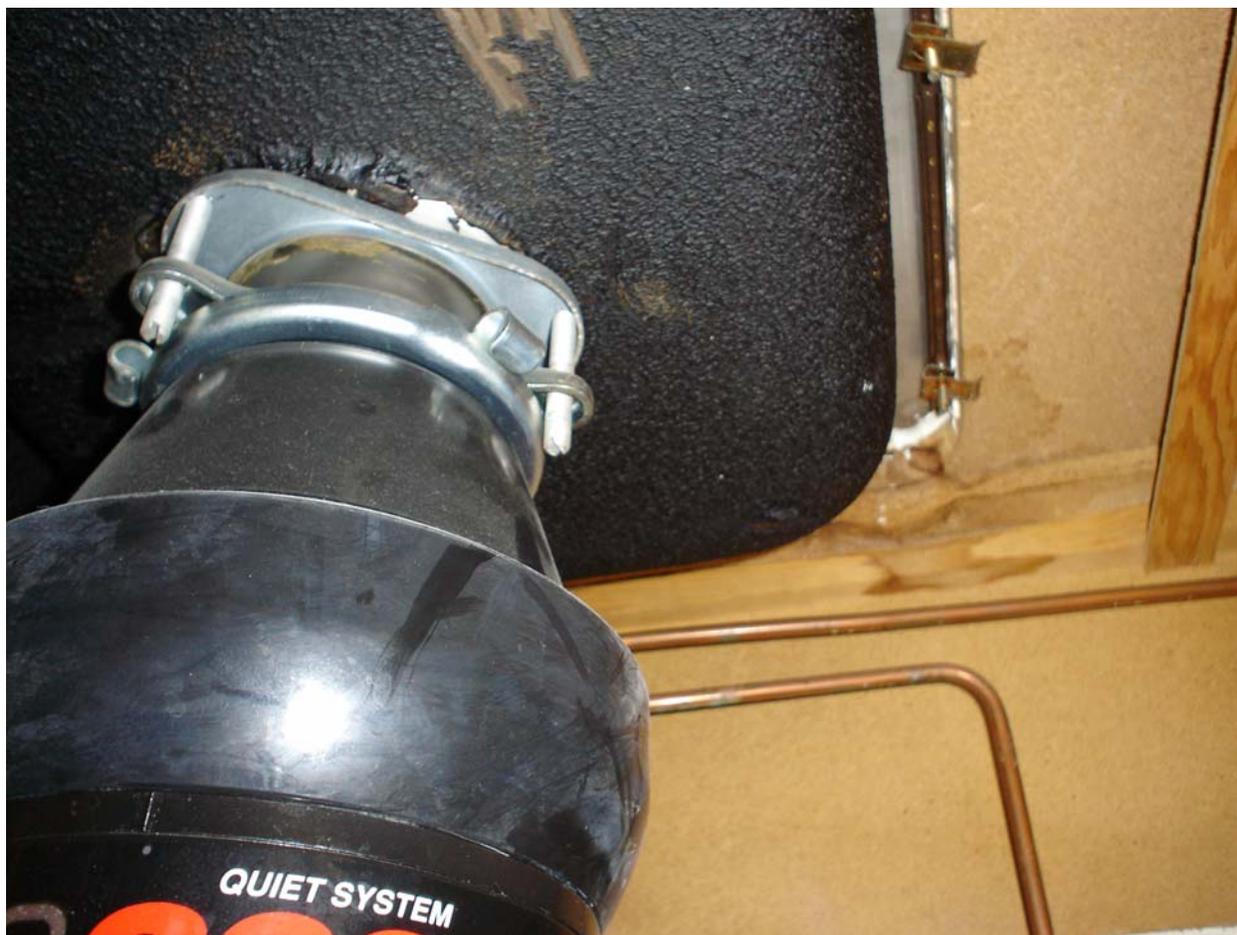
HA #44
Non asbestos-containing black sink undercoating

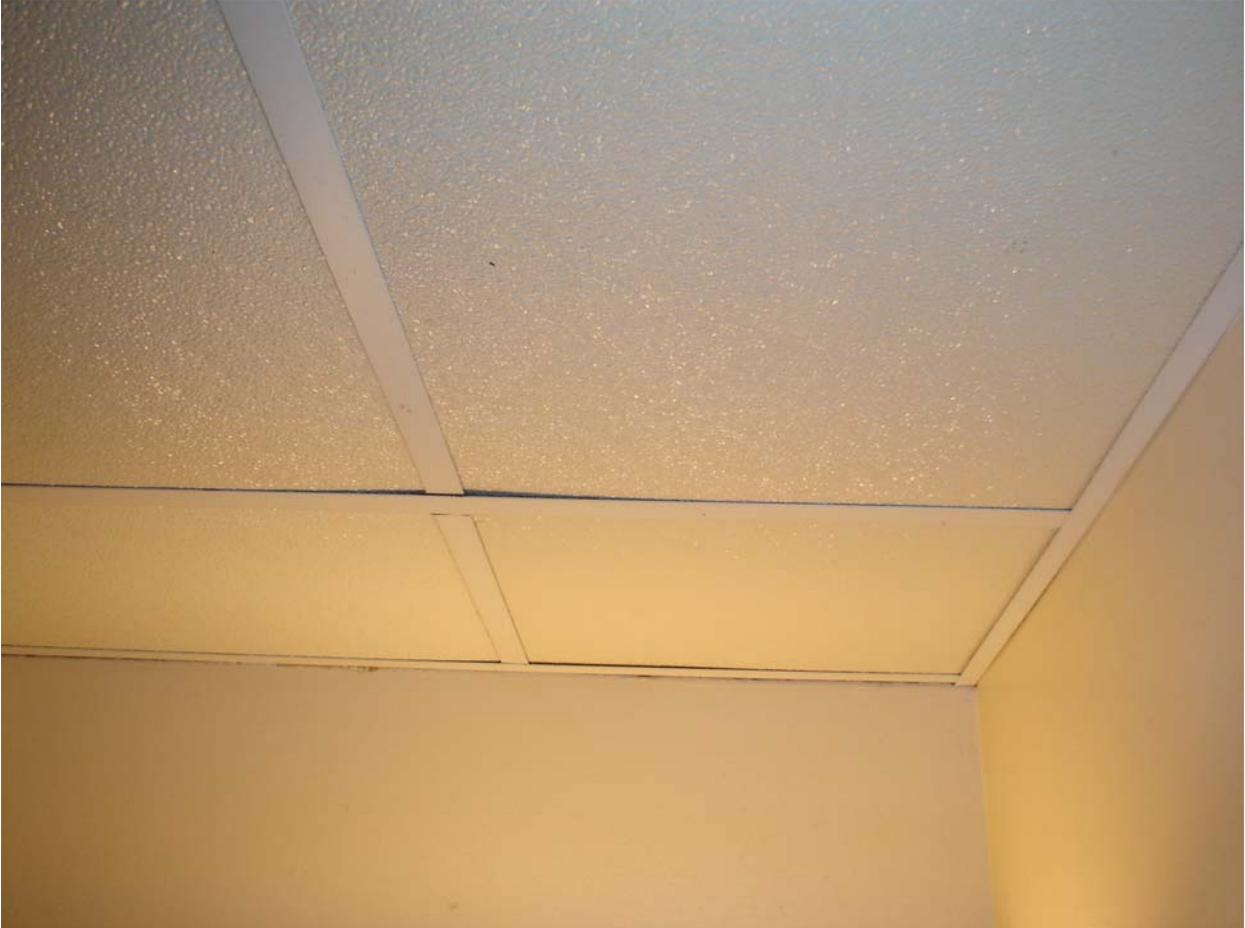
HA #45

Non asbestos-containing 2' x 2' white lay-in ceiling tile with smooth texture

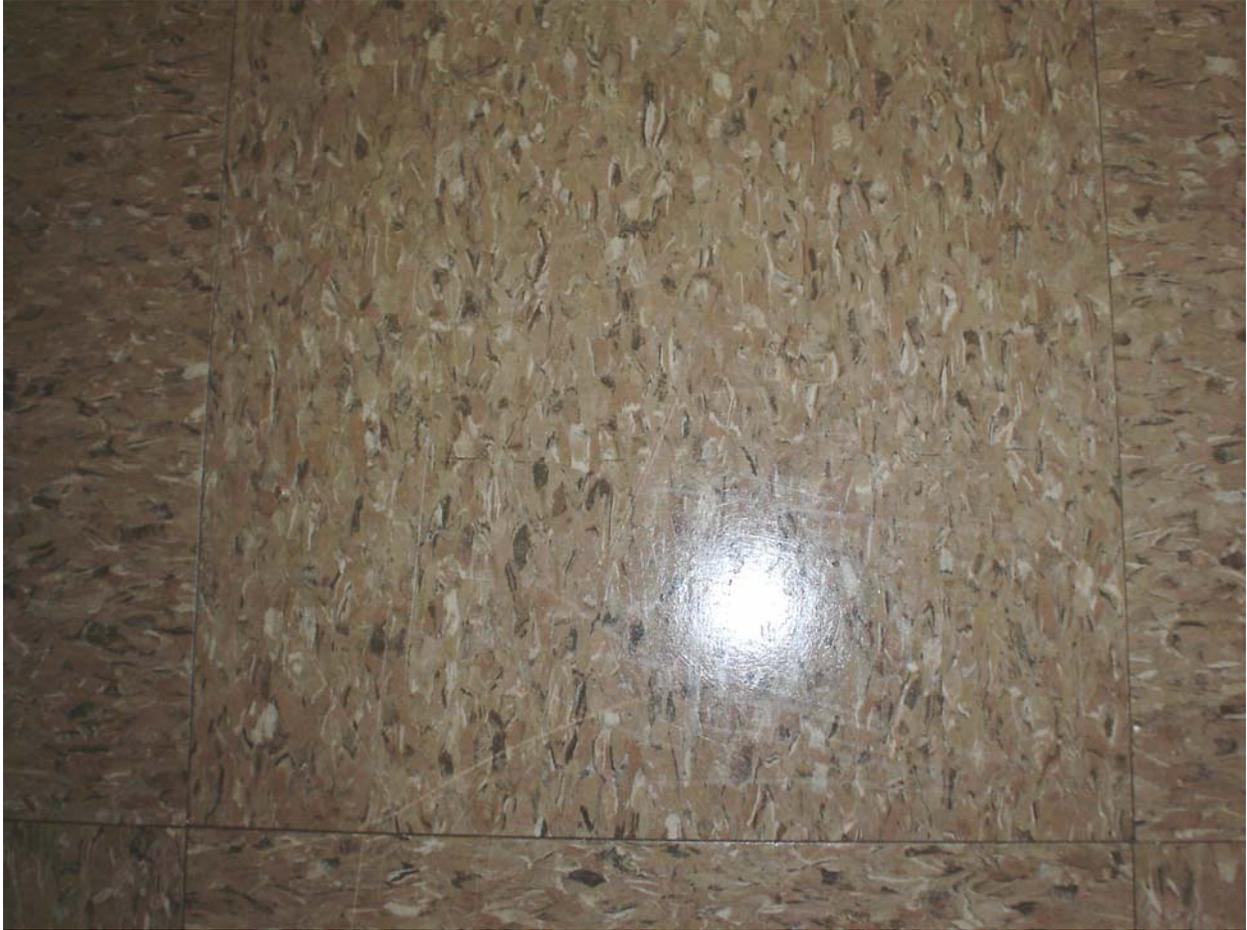
HA #46
Non asbestos-containing 12" x 12" brown floor tile
with marble pattern and associated mastic

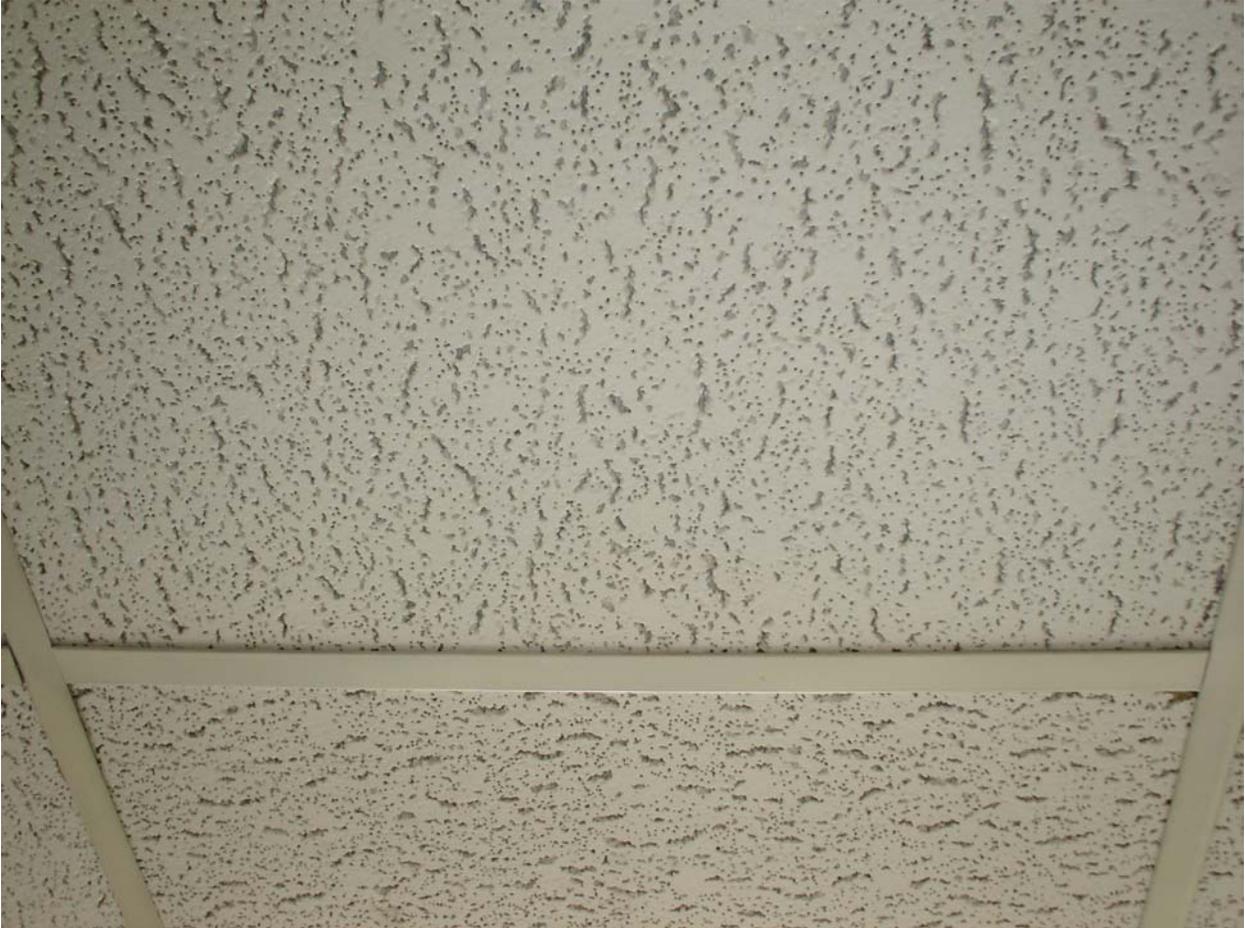
HA #47
Non asbestos-containing 2' x 2' white lay-in ceiling tile
with pin holes and fissures

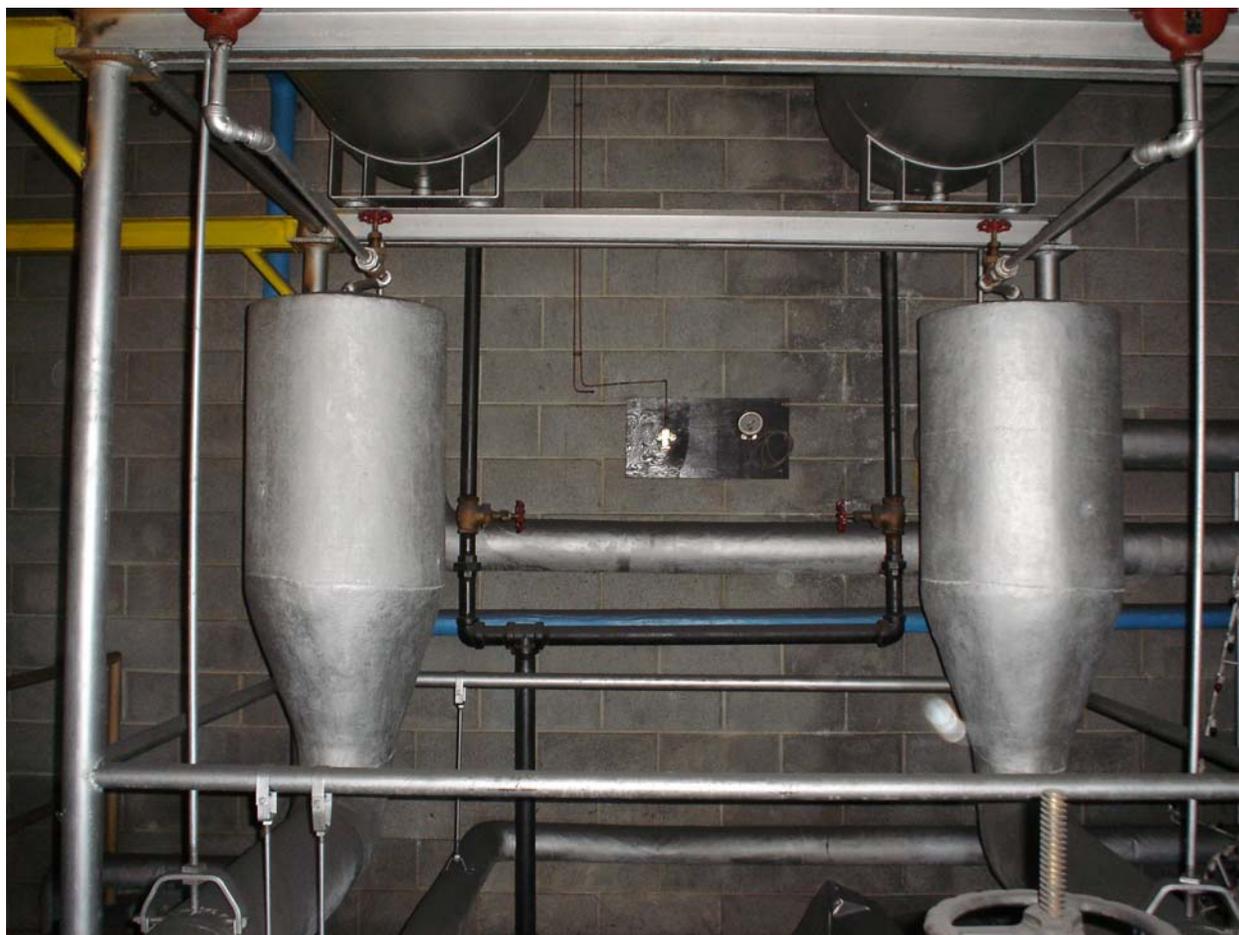
HA #48
Asbestos-containing silver expansion tanks
