Akers Hall Photo Log

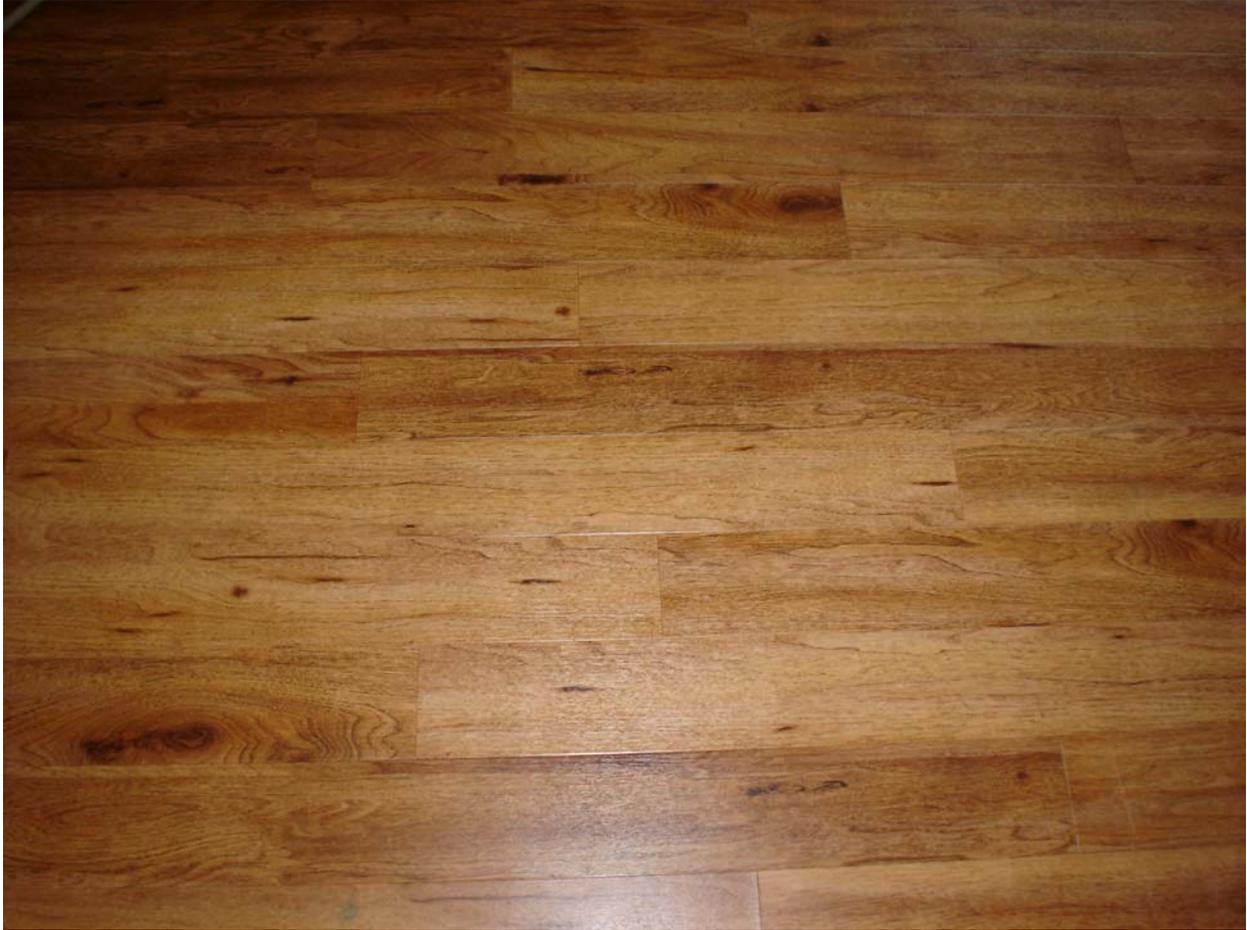
HA #50
Non asbestos-containing wood grain vinyl flooring
and associated asbestos-containing mastic
