Michigan State University
Botany Field Lab (Plant Pathology) - Asbestos Inspection Photo Log

Plant Pathology (#452)

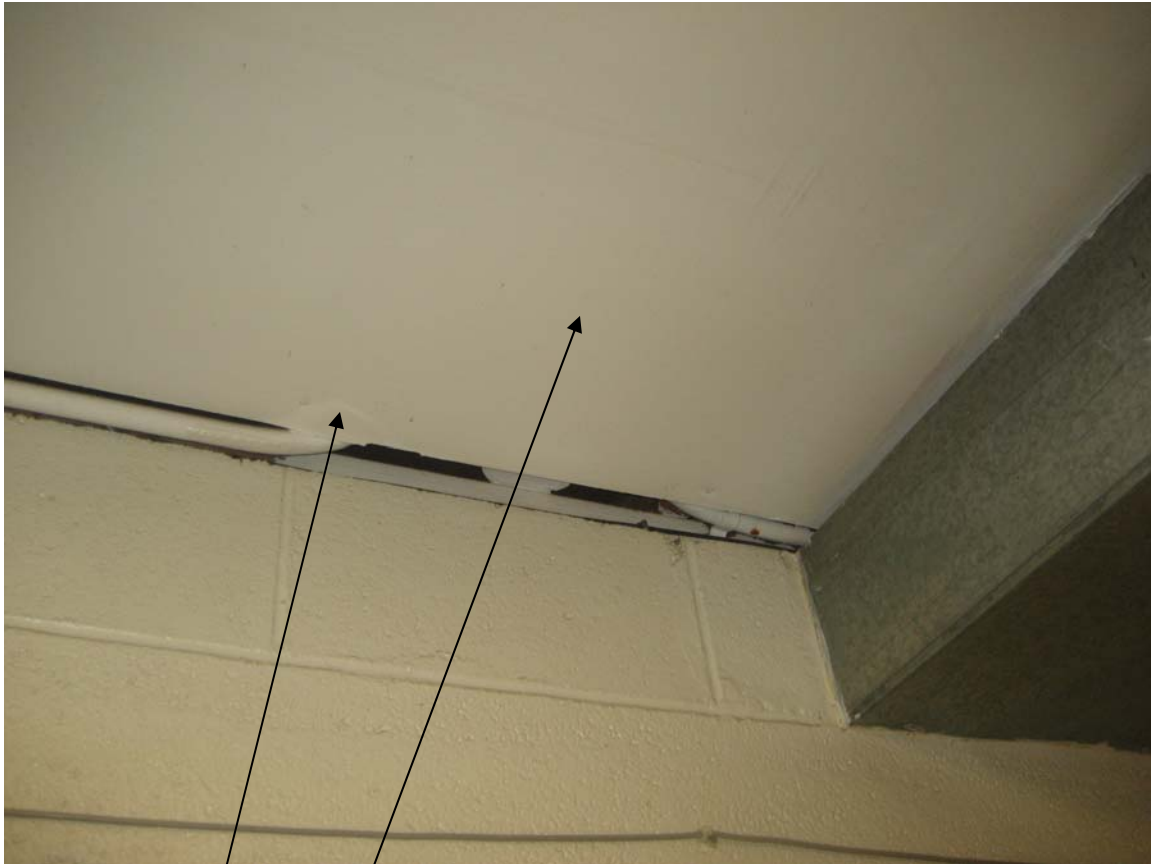
HA #1 – Non asbestos containing drywall

HA #2 – Non asbestos containing drywall joint compound

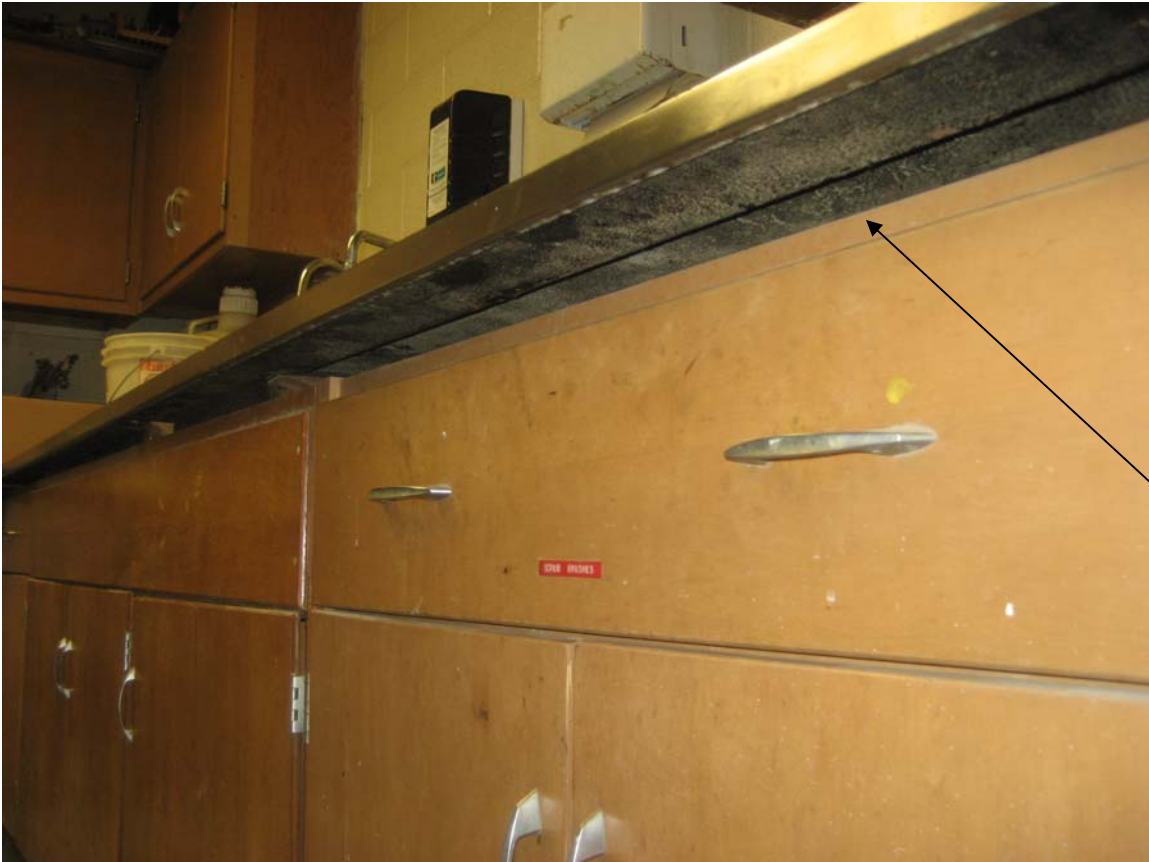
HA #3 – Asbestos containing sink and lab bench undercoating

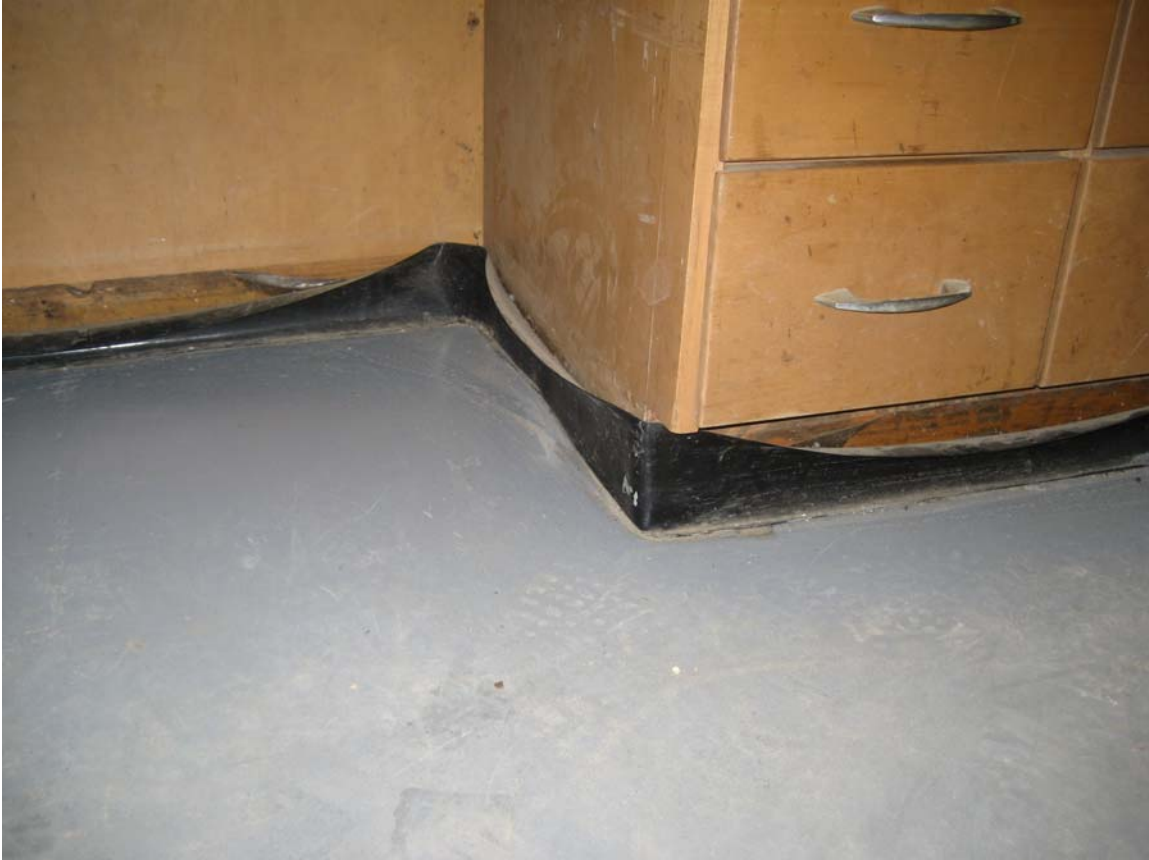
HA #4 – Non asbestos containing 4” black cove molding and associated mastic

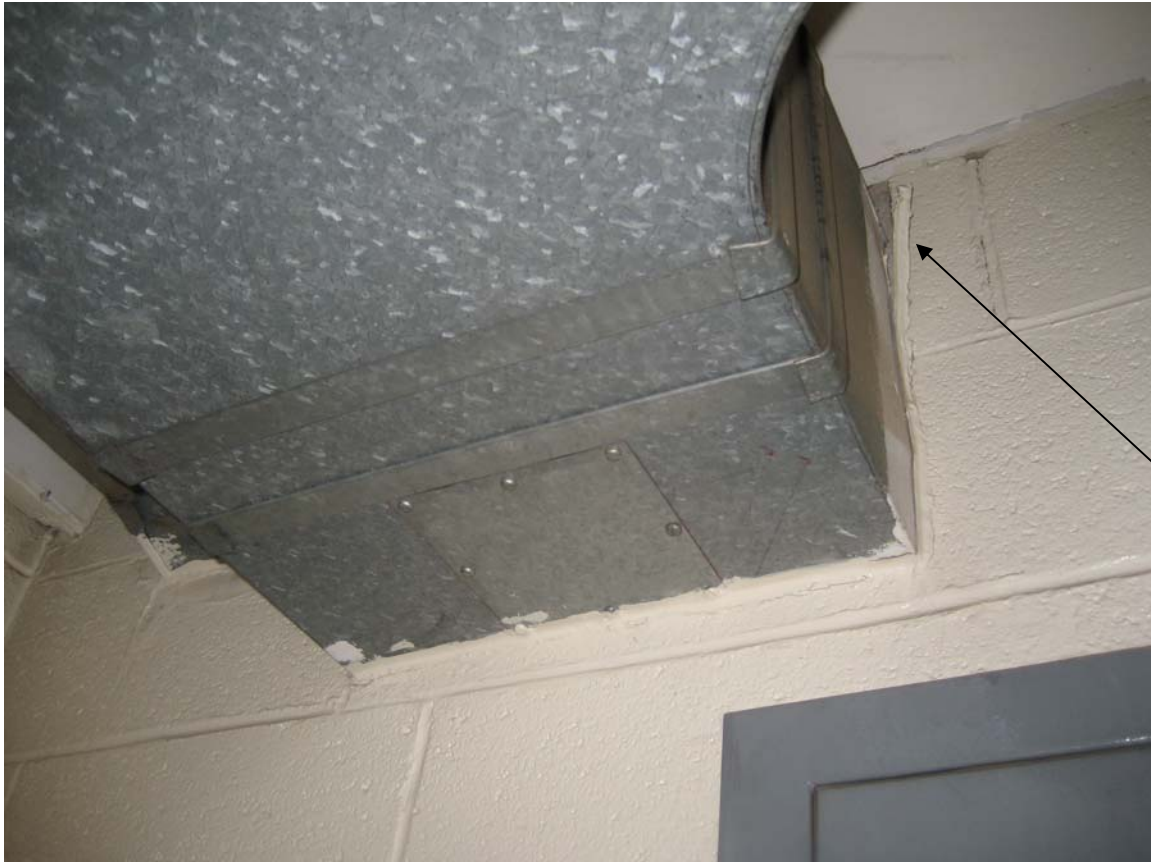
HA #5 – Non asbestos containing white caulk around duct

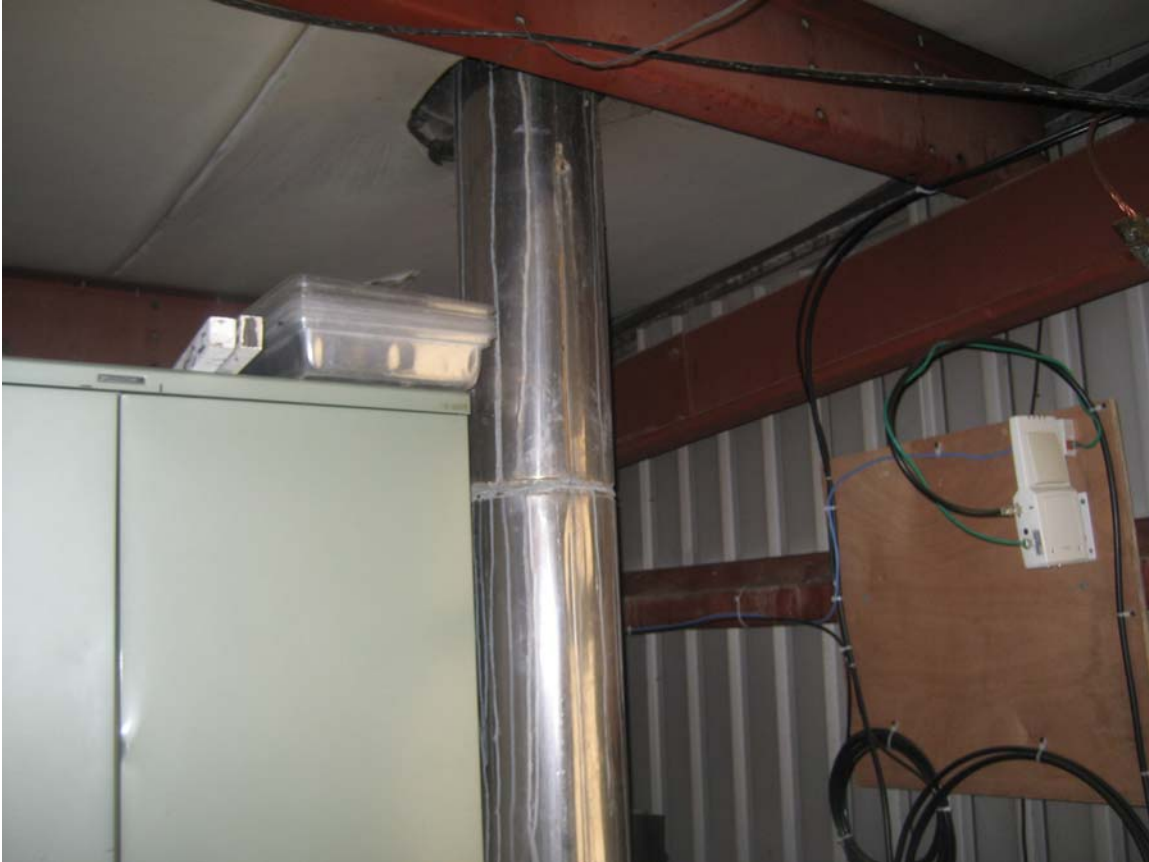
HA #6 – Assumed asbestos containing silver furnace exhaust

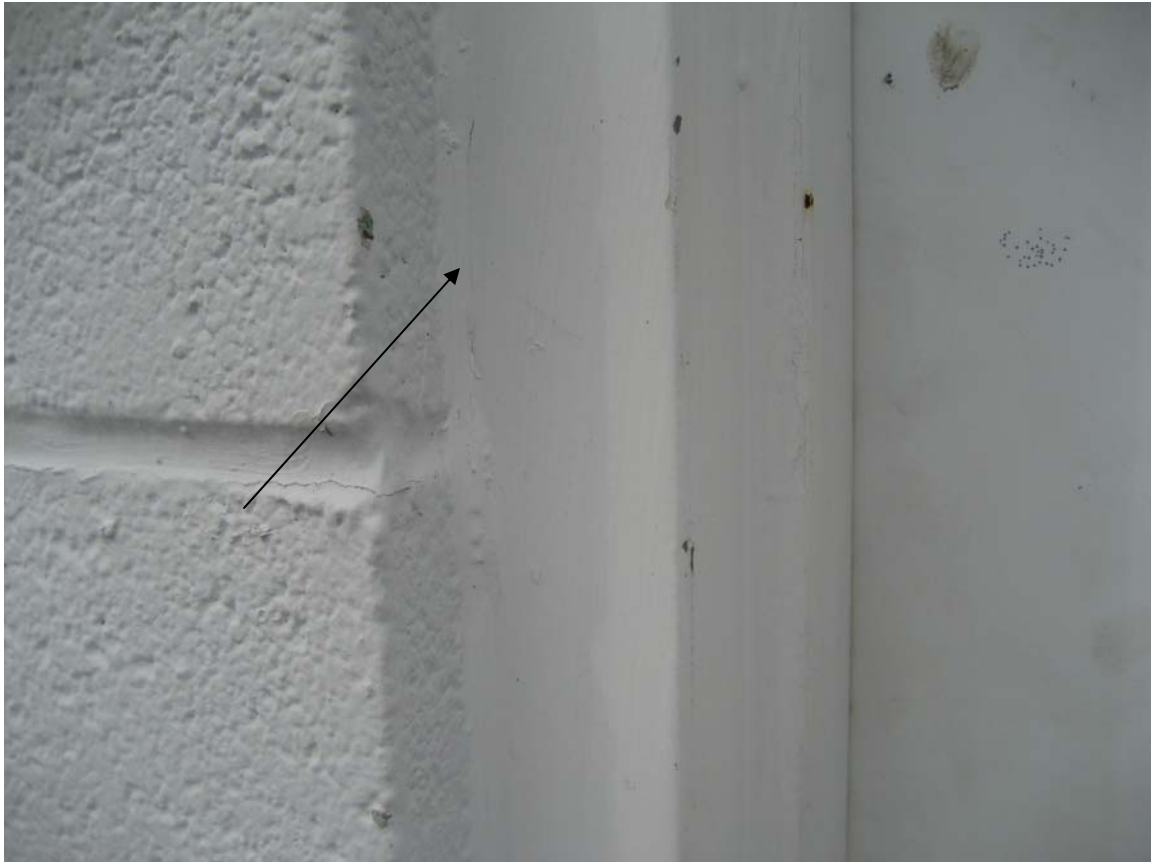
HA #7 – Non asbestos containing white exterior caulk

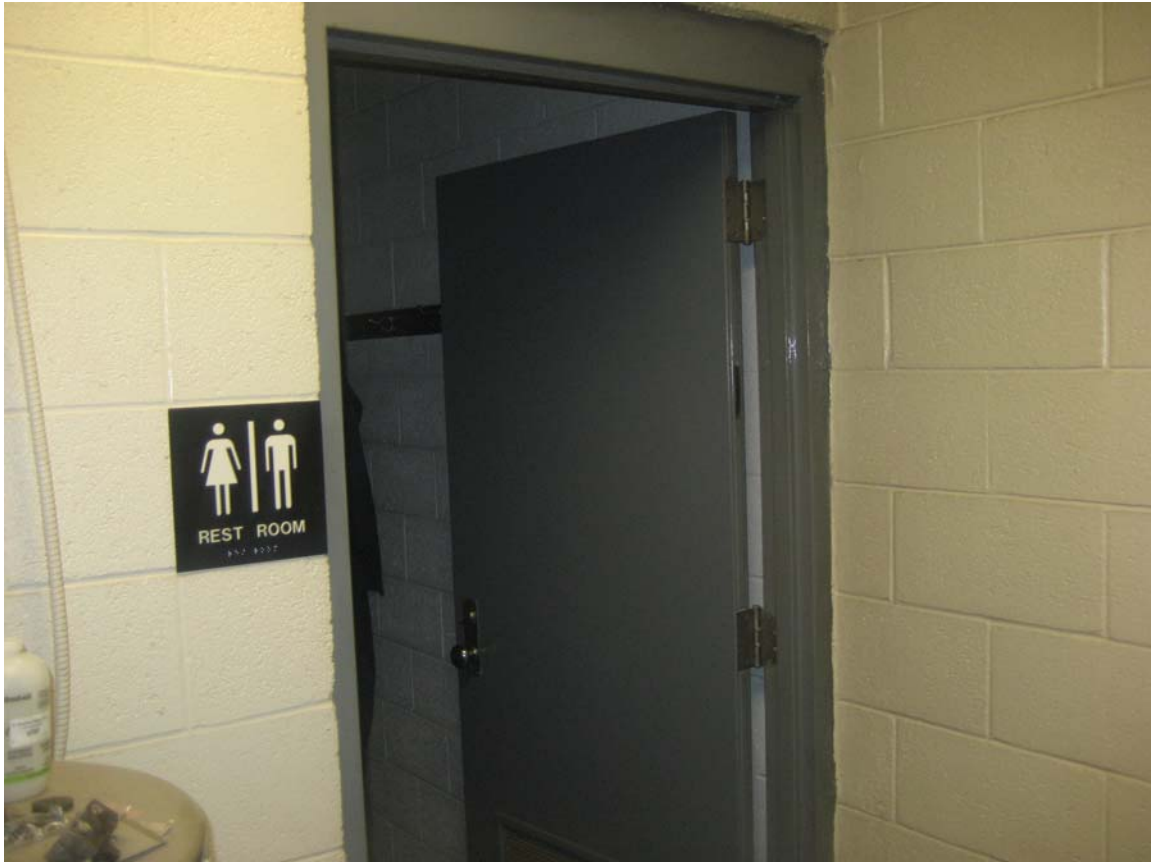
HA #8 – Assumed asbestos containing fire door and frame

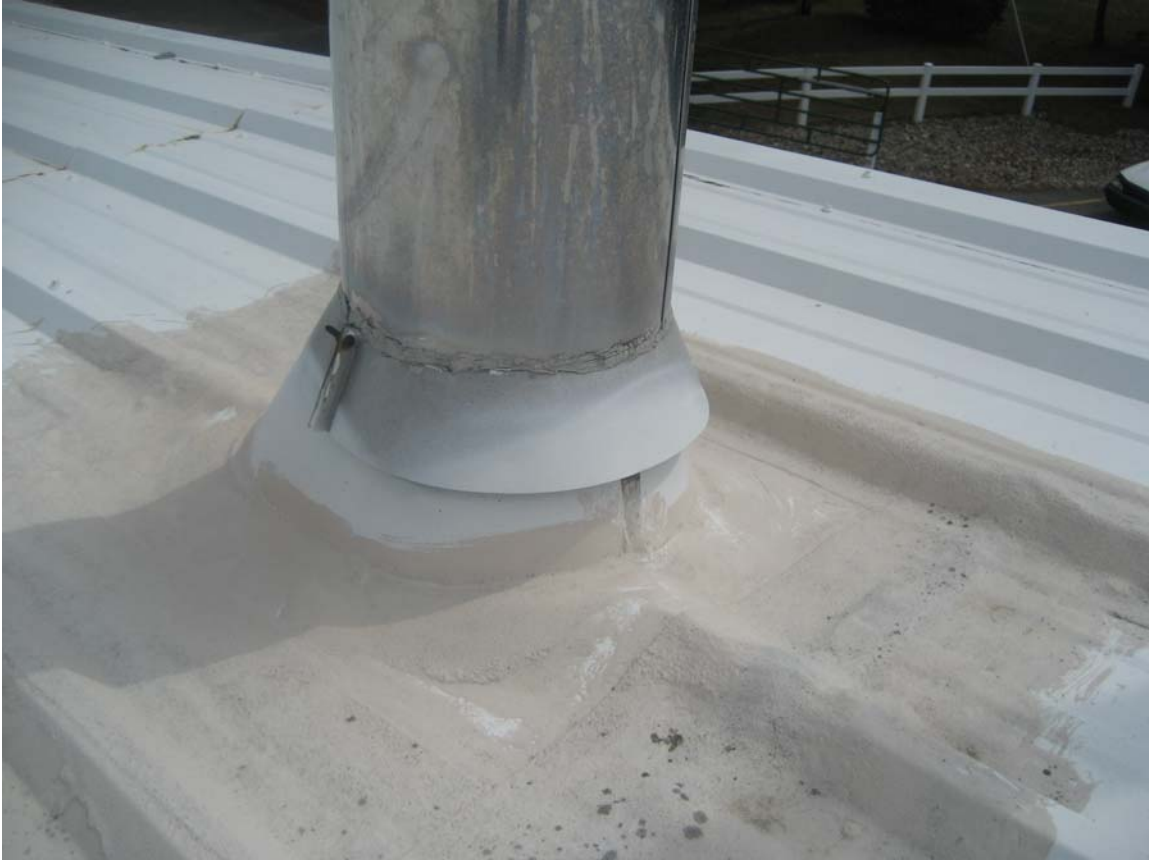
HA #9 – Assumed asbestos containing roofing caulk
