Beef Cattle Research Center Photo Log

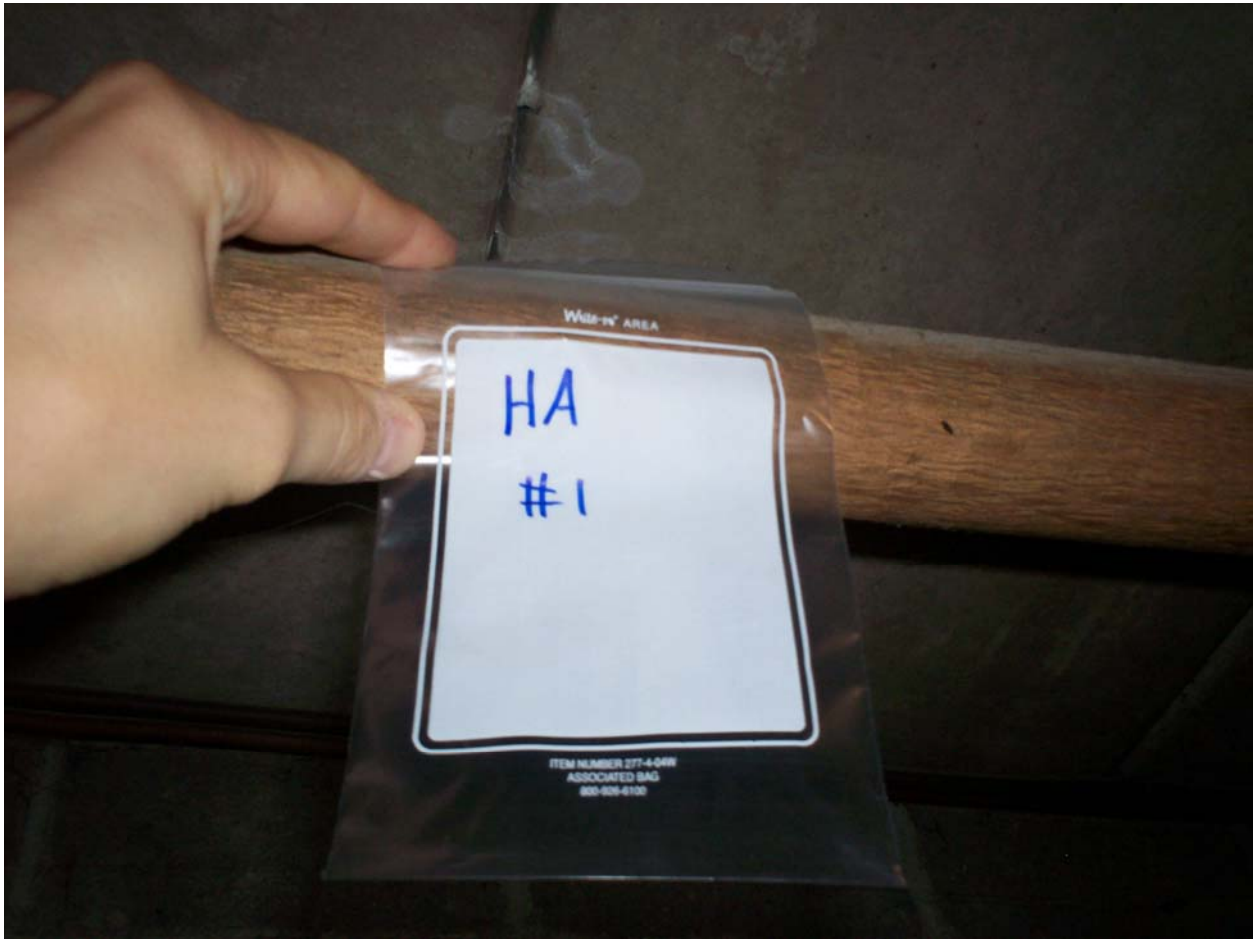
HA #1 – Non asbestos containing domestic water supply pipe straight insulation (fiberglass) wrap

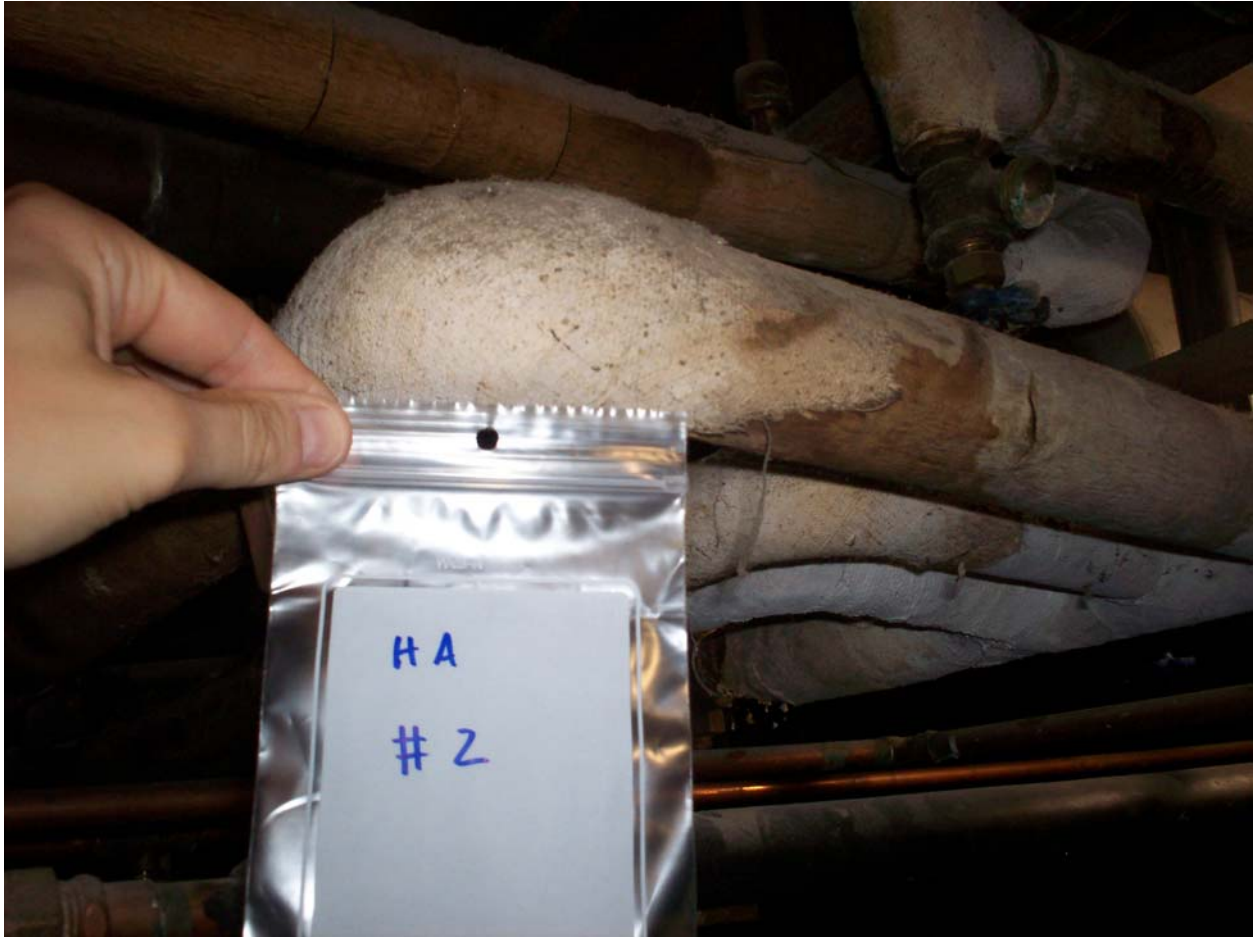
HA #2 – Asbestos containing domestic water supply pipe joint and hanger insulation

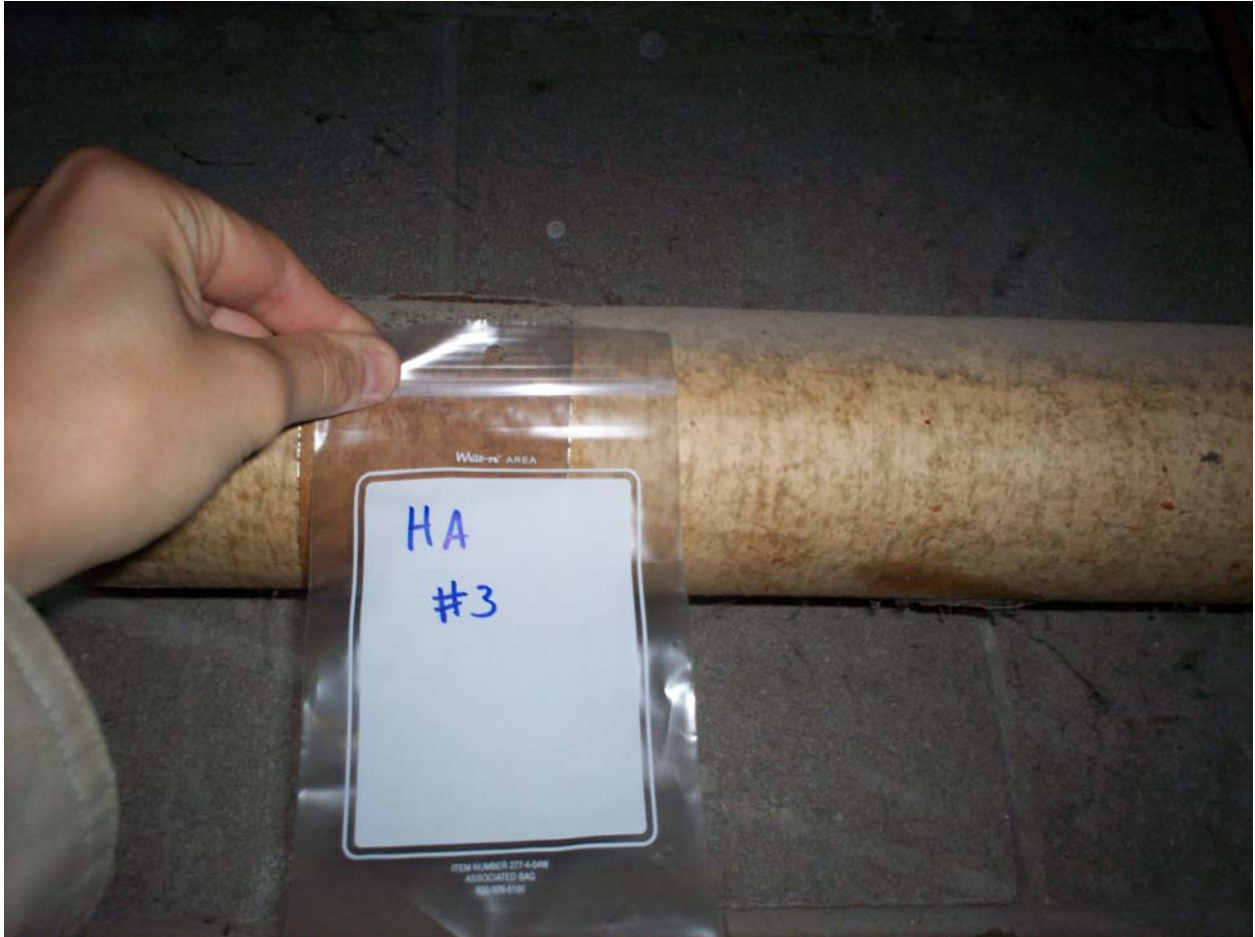
HA #3 – Non asbestos containing steam/condensate pipe straight insulation (fiberglass) wrap

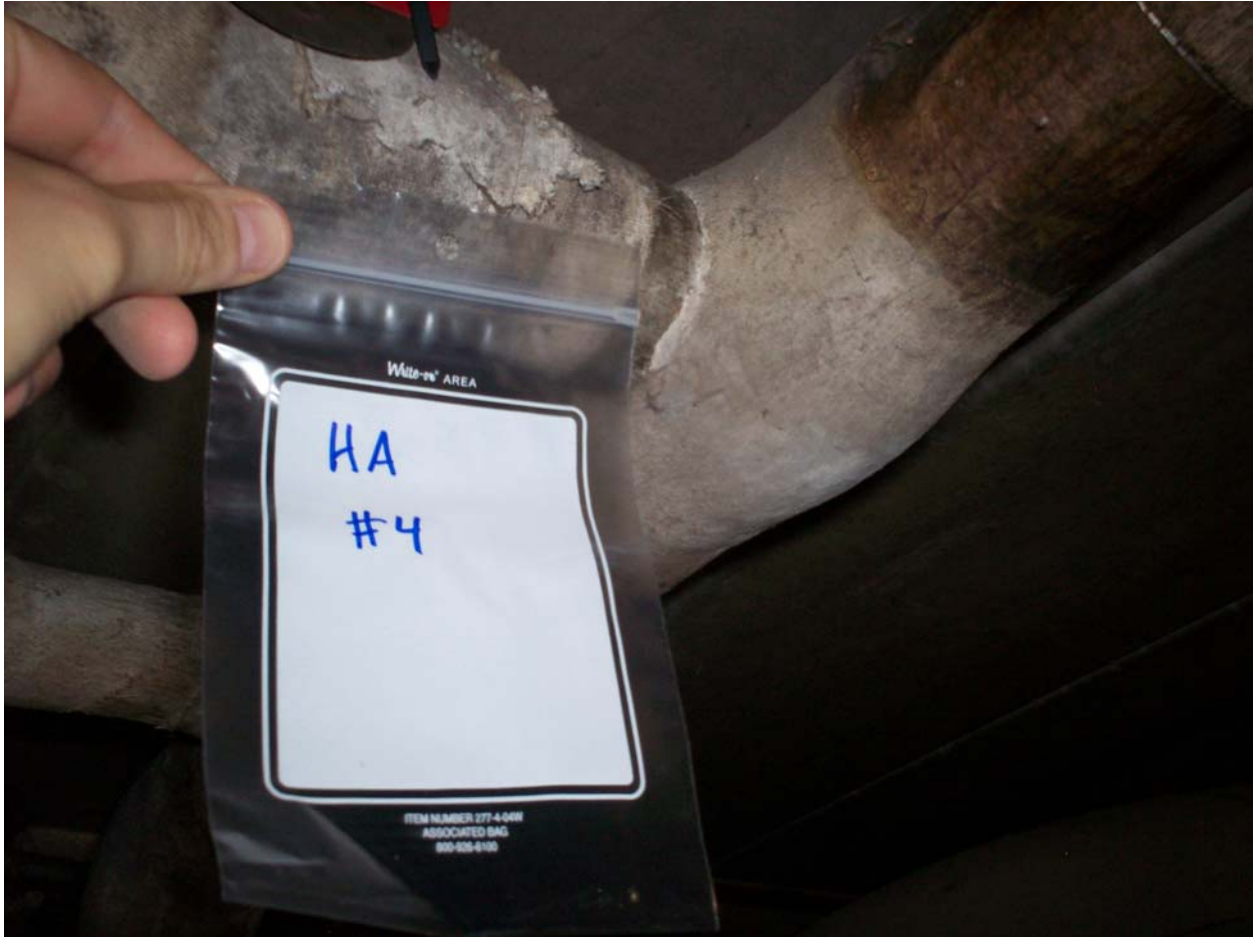
HA #4 – Asbestos containing steam/condensate pipe joint and hanger insulation

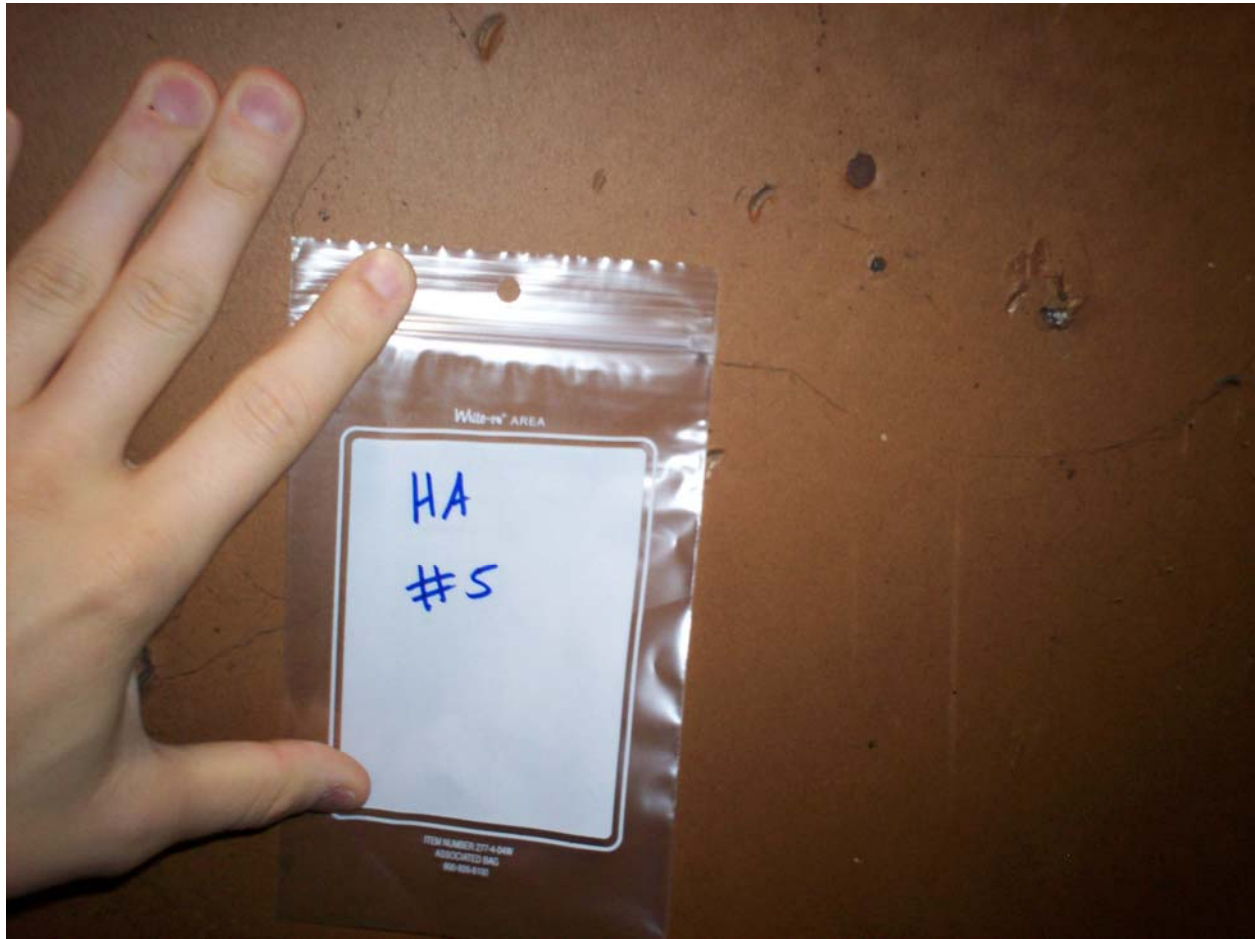
HA #5 – Non asbestos containing drywall

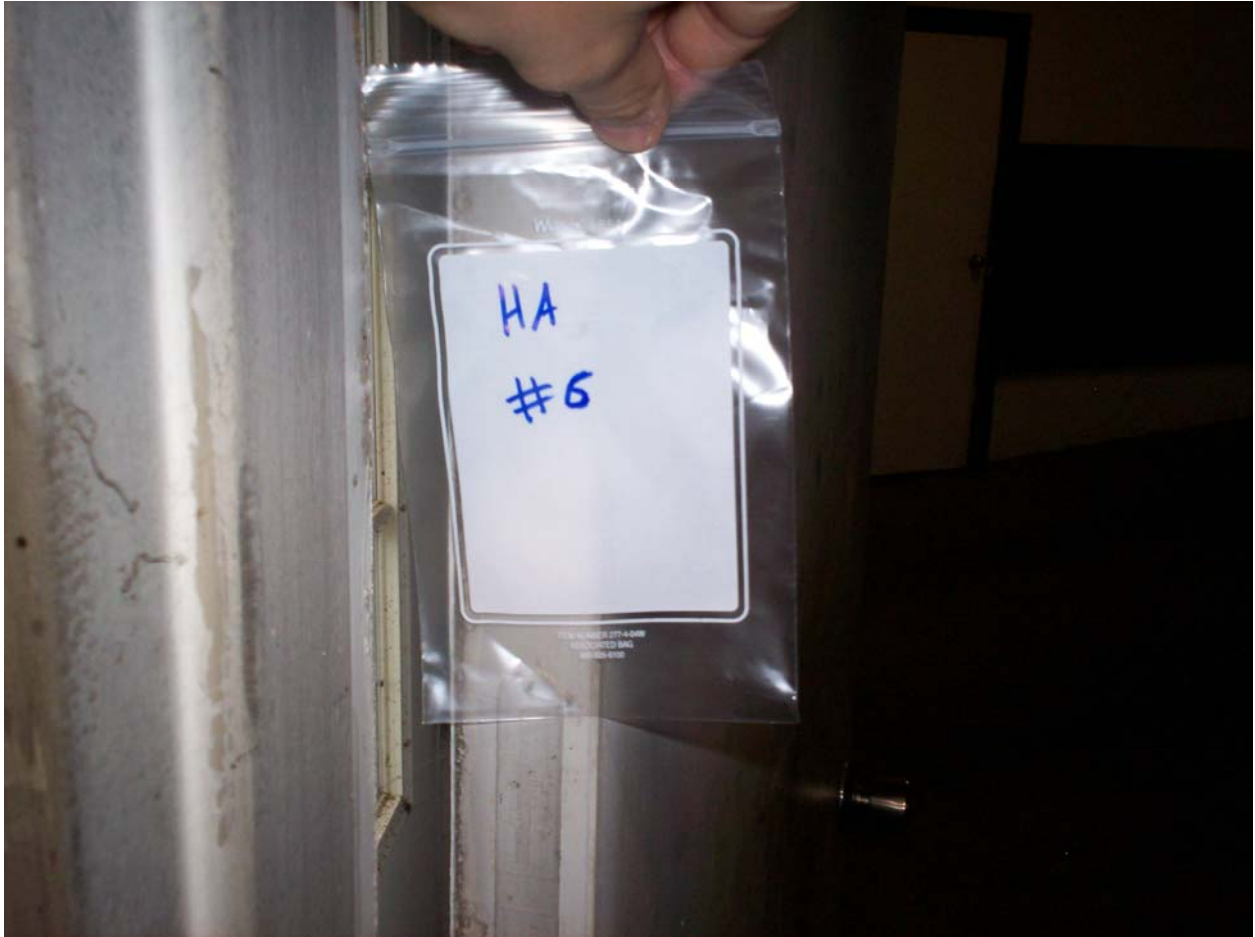
HA #6 – Assumed asbestos containing fire door and frame

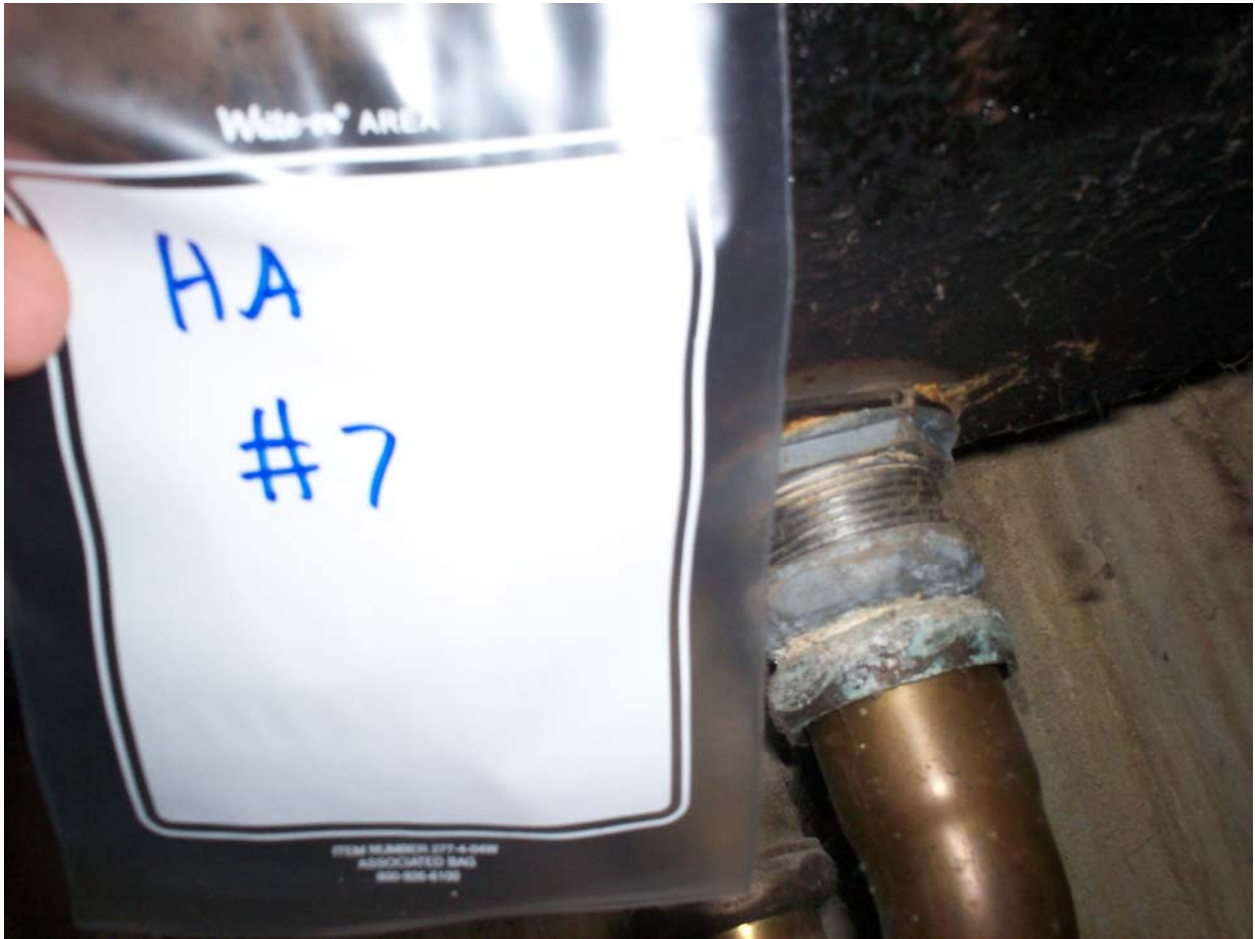
HA #7 – Asbestos containing black sink undercoating

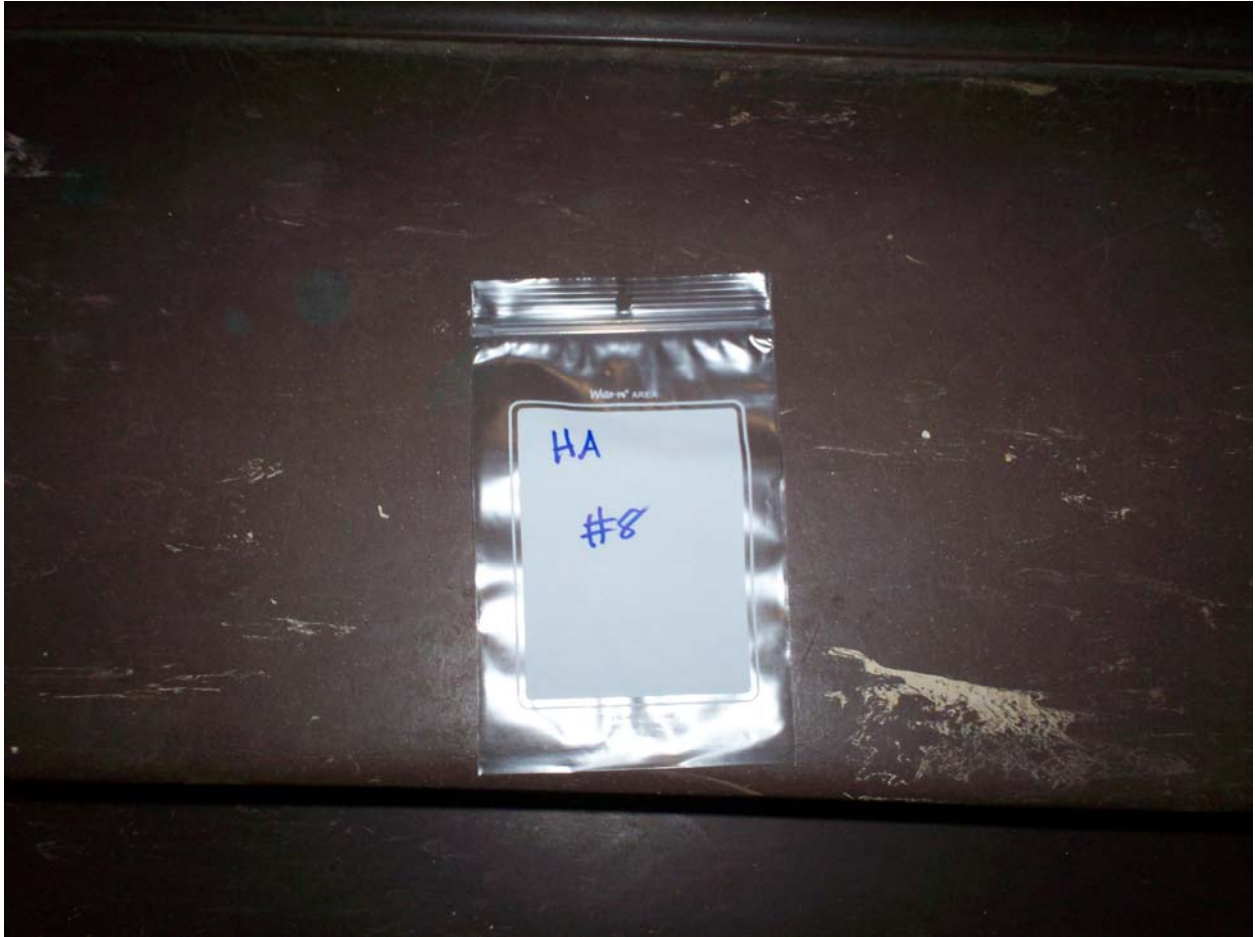
HA #8 – Assumed asbestos containing brown stair tread with white streaks and associated mastic

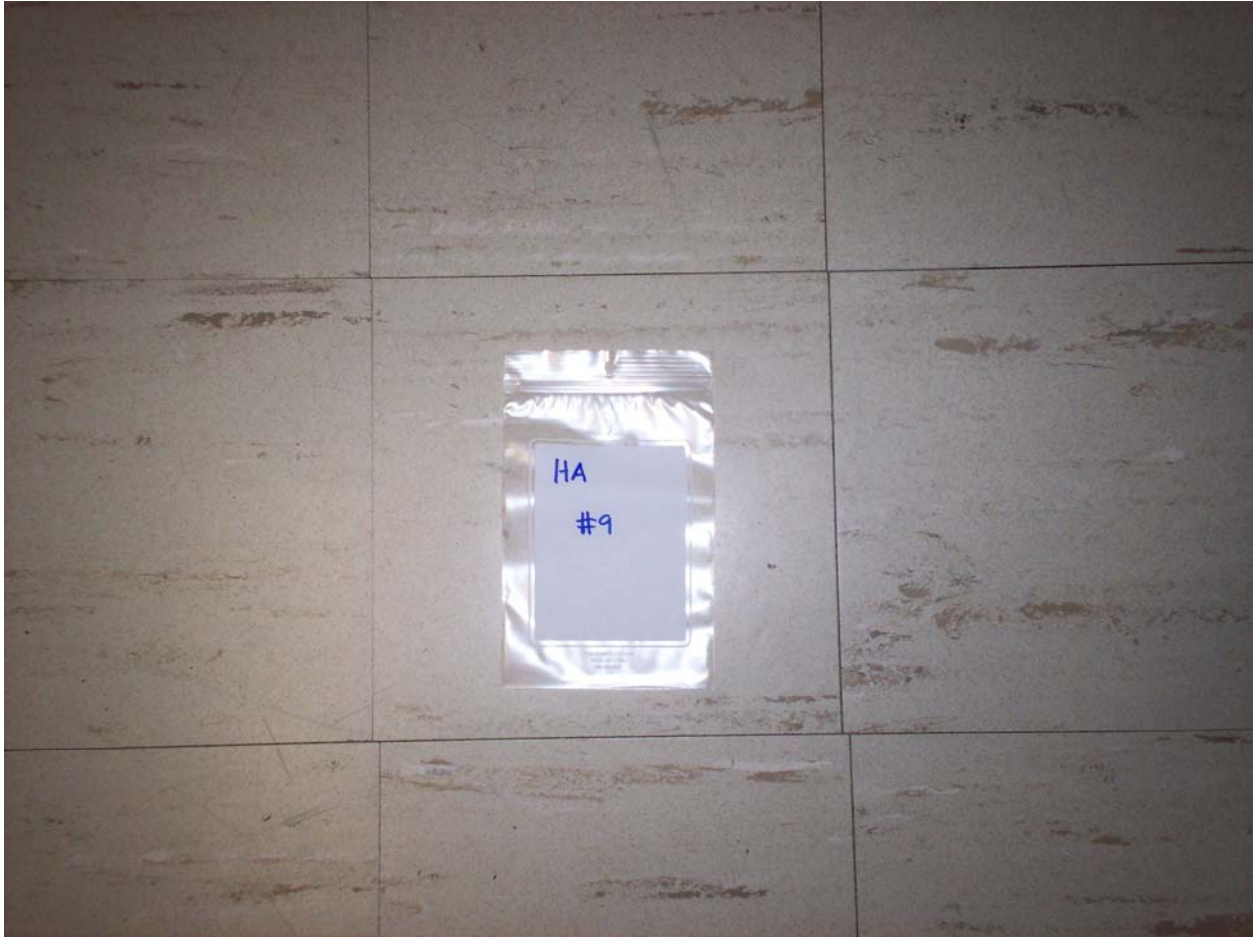
HA #9 – Asbestos containing 9” x 9” cream floor tile with white and brown streaks and associated non asbestos containing mastic

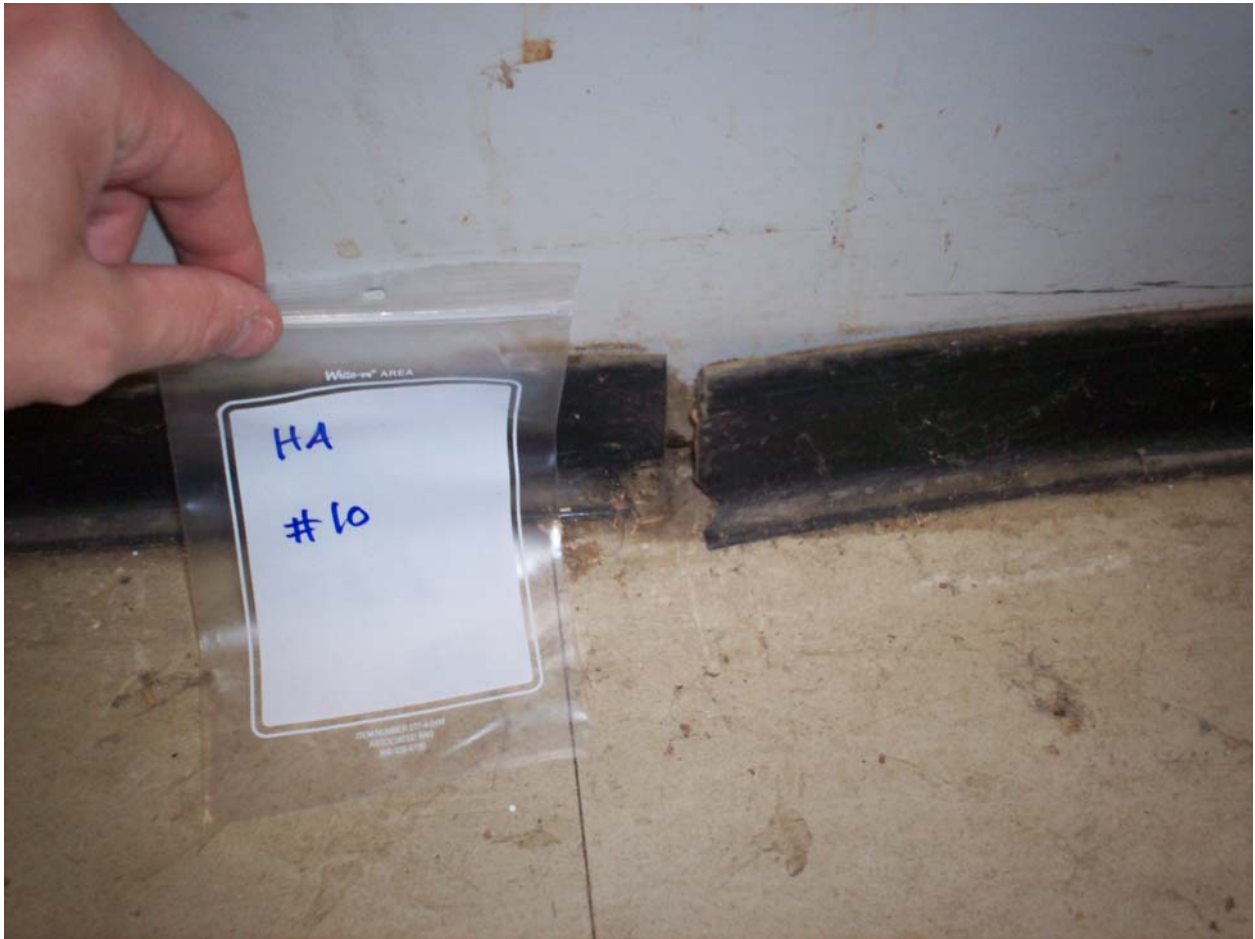
HA #10 – Non asbestos containing 3” black cove molding and associated mastic

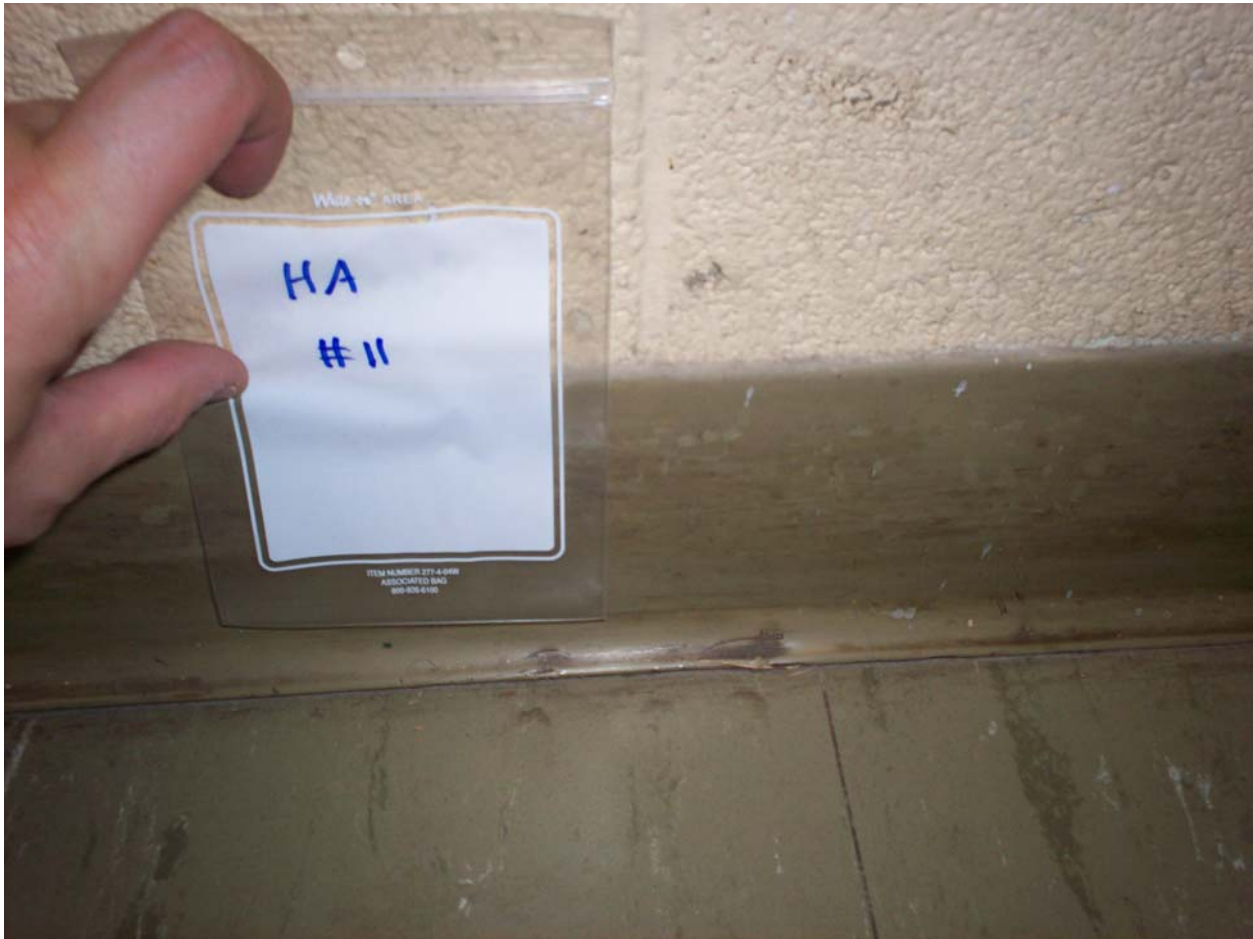
HA #11 – Non asbestos containing 4” green cove molding and associated mastic

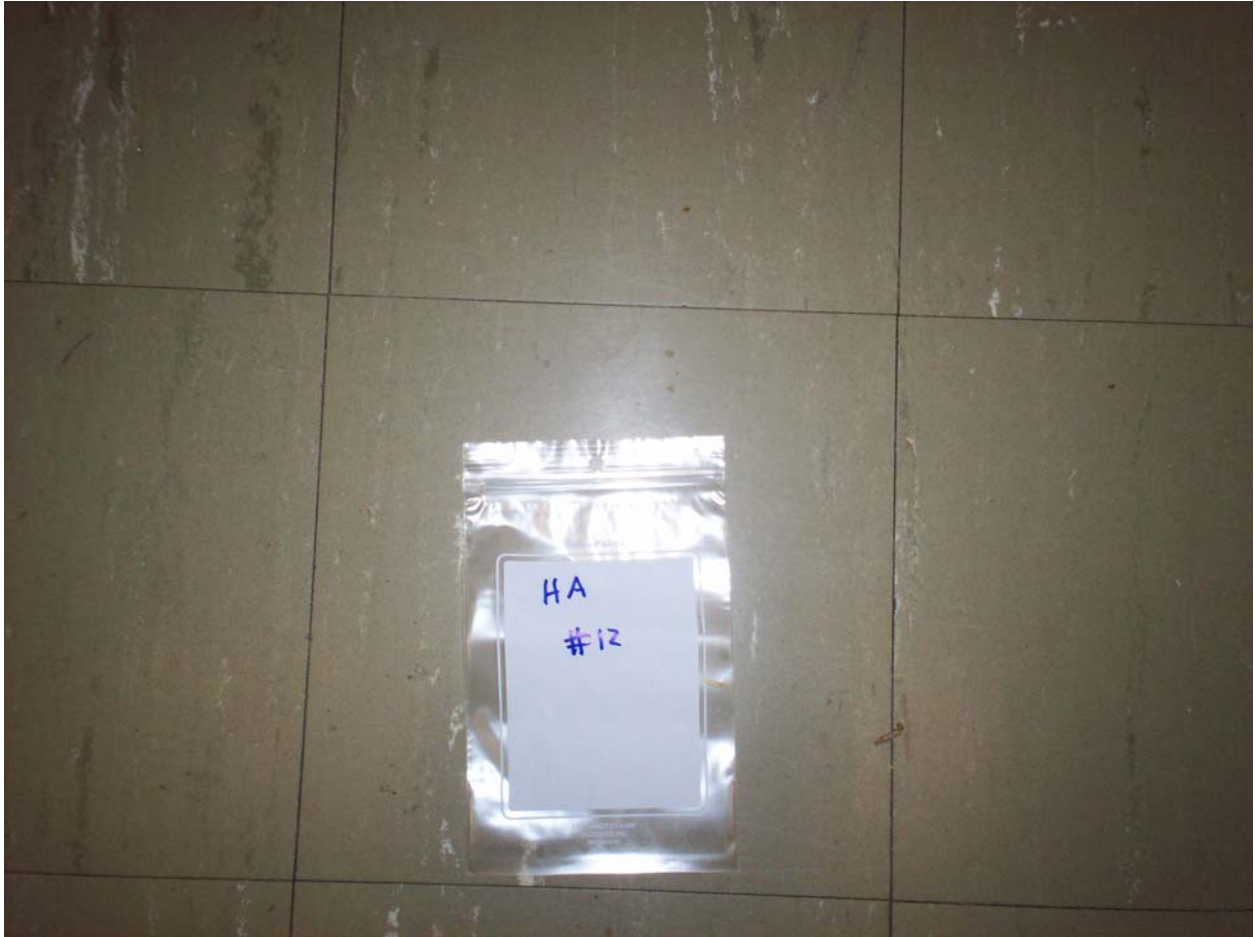
HA #12 – Asbestos containing 9” x 9” green floor tile with white streaks and associated non asbestos containing mastic

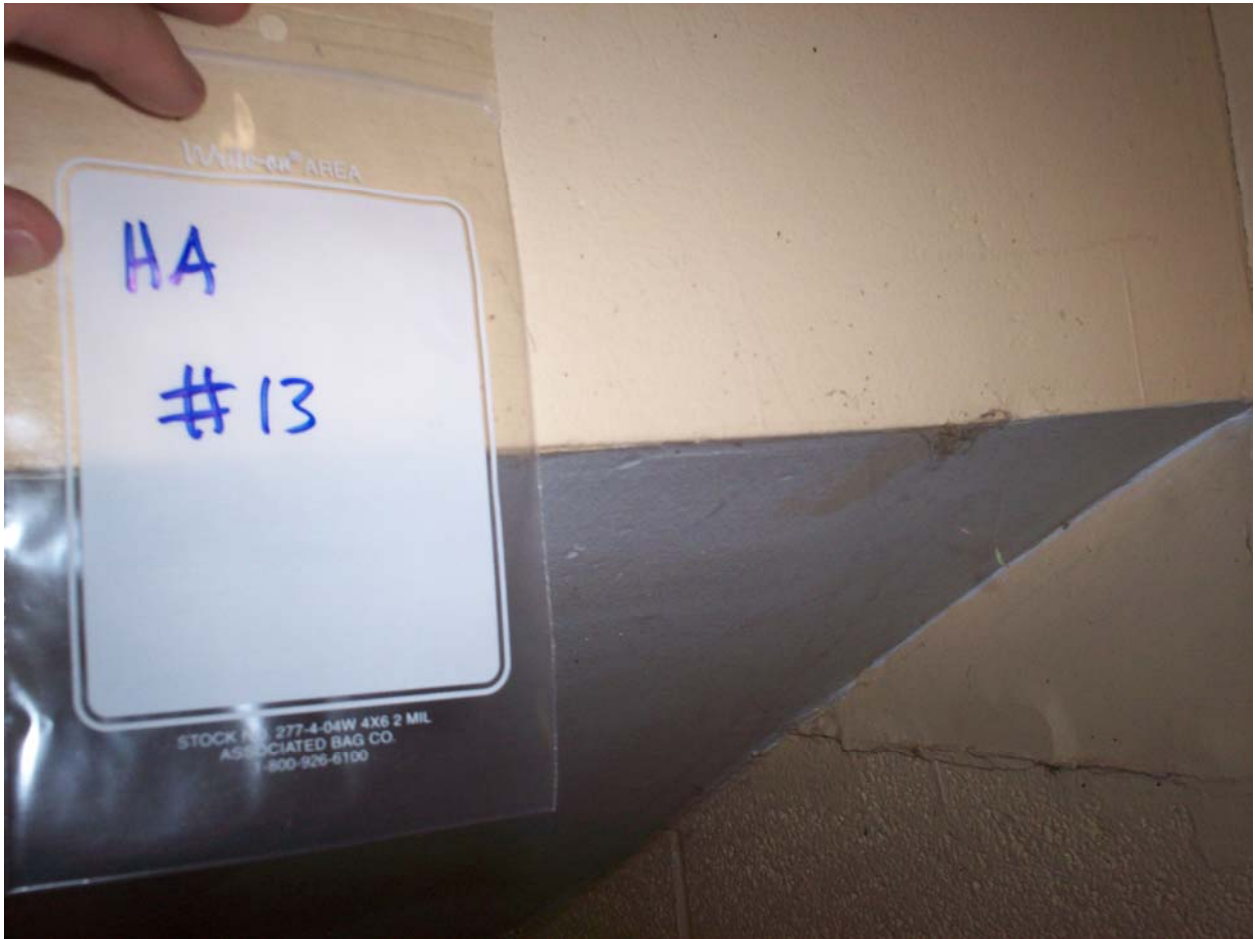
HA #13 – Asbestos containing drywall joint compound

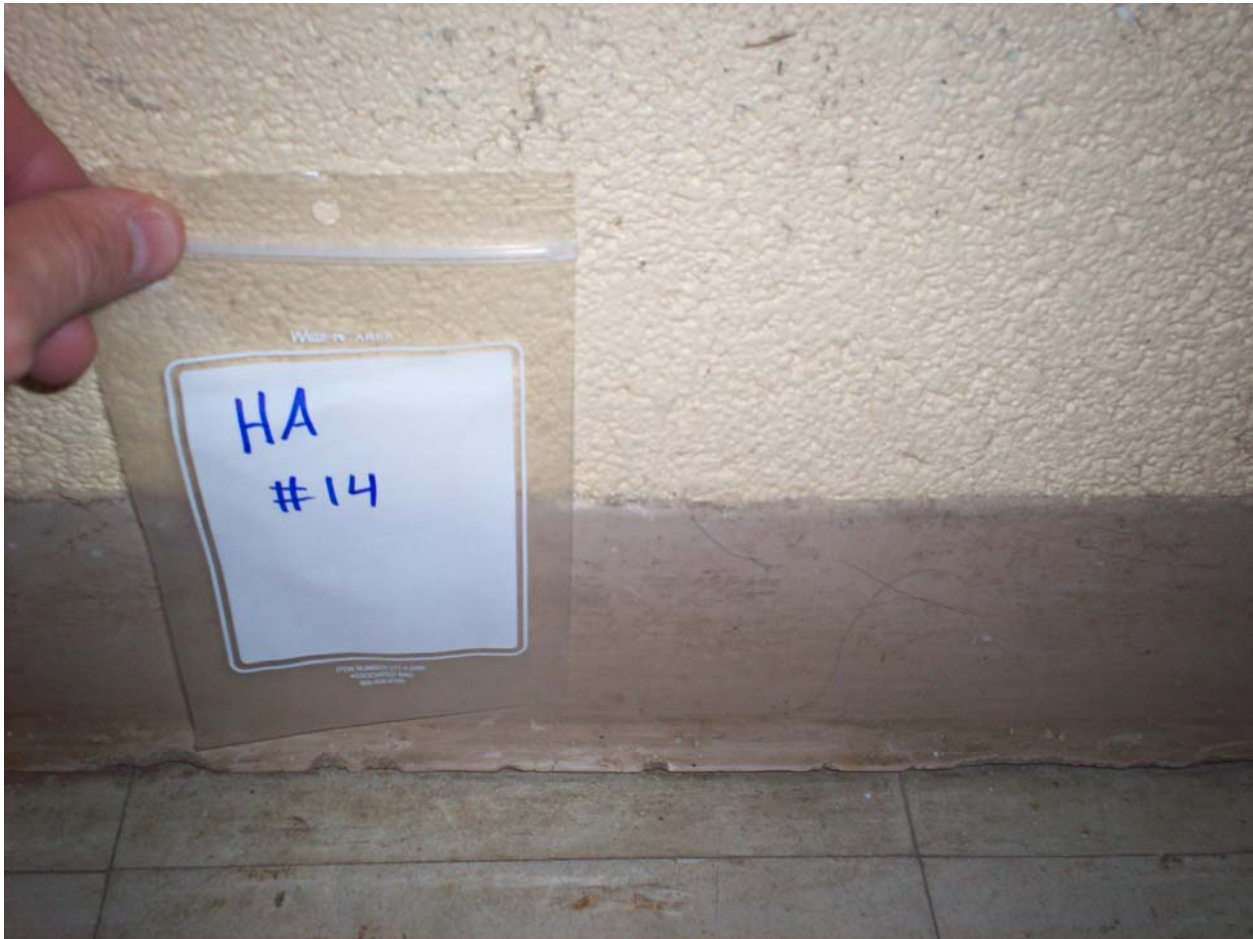
HA #14 – Non asbestos containing 4” tan cove molding and associated mastic

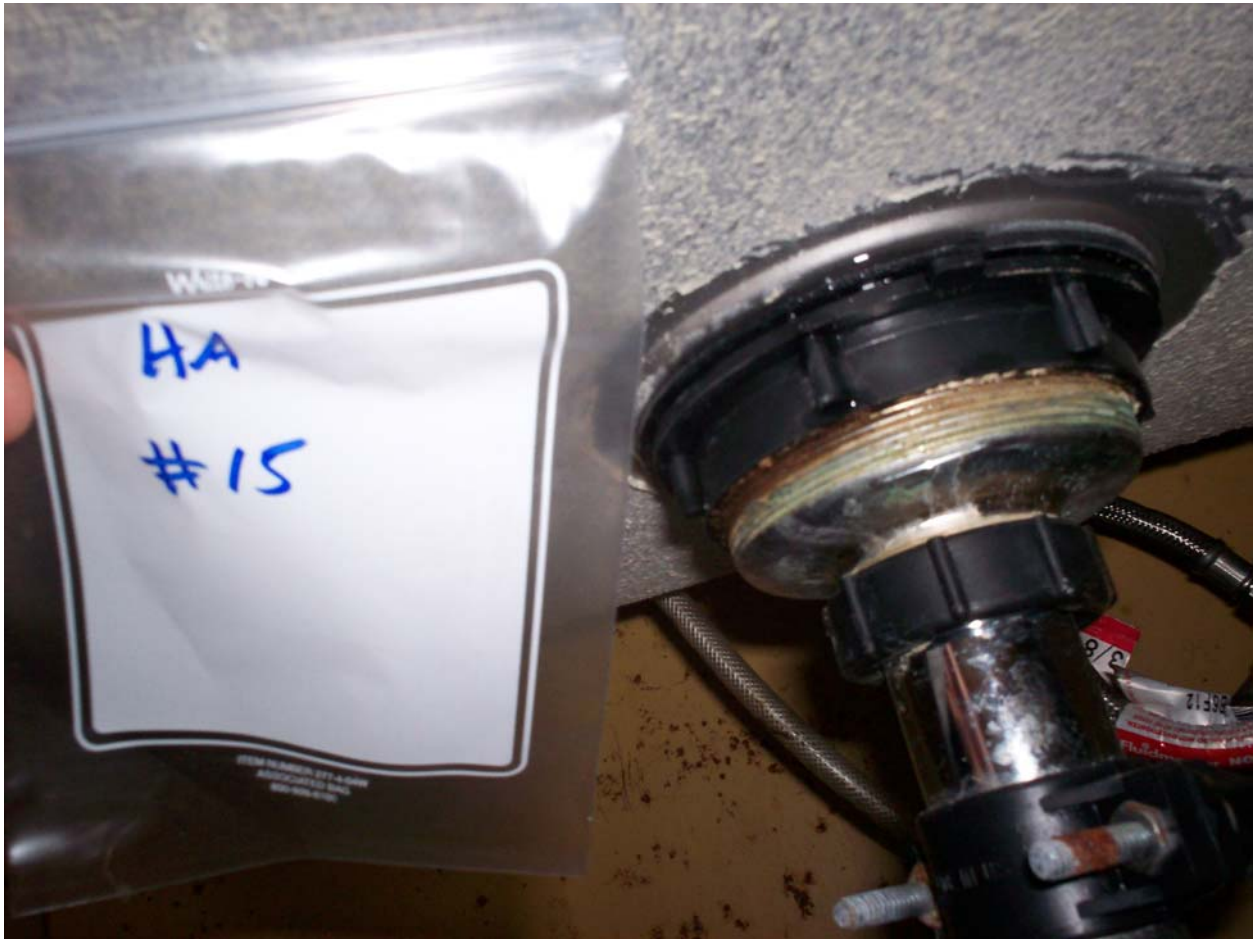
HA #15 – Non asbestos containing white sink undercoating

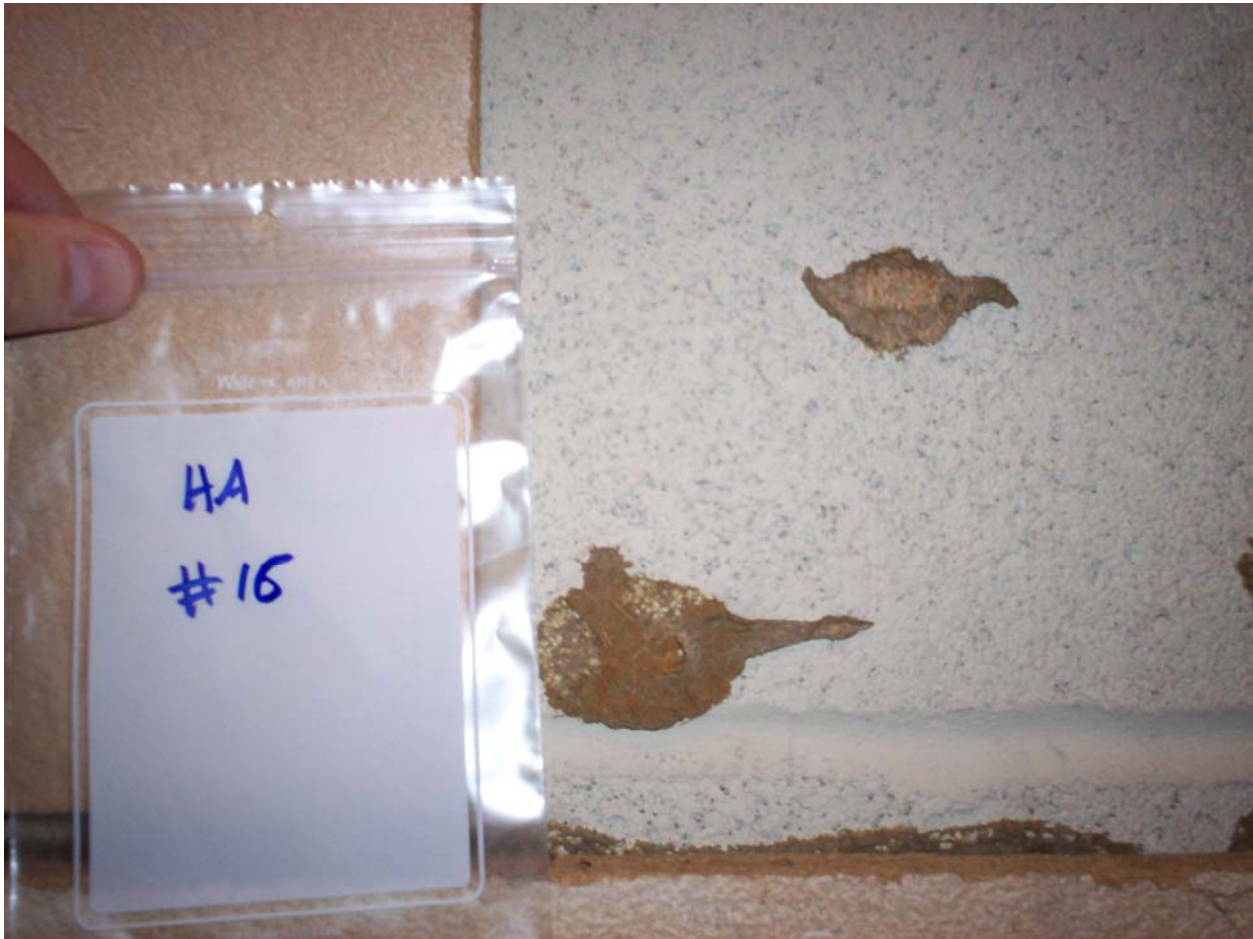
HA #16 – Asbestos containing wallboard glue pods

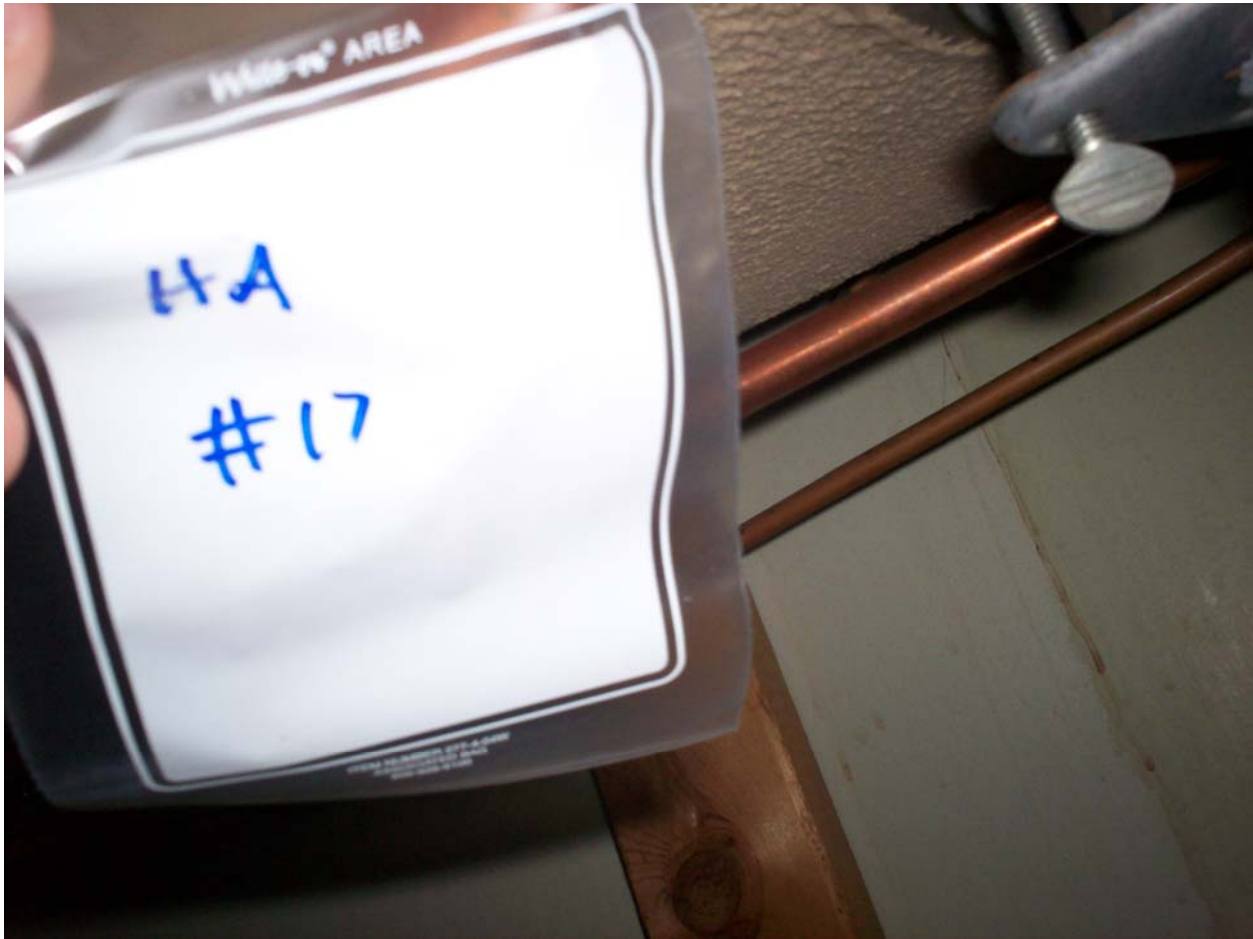
HA #17 – Asbestos containing tan sink undercoating
