Michigan State University Asbestos Inspection Photo Log

River Water Intake Station (#515)

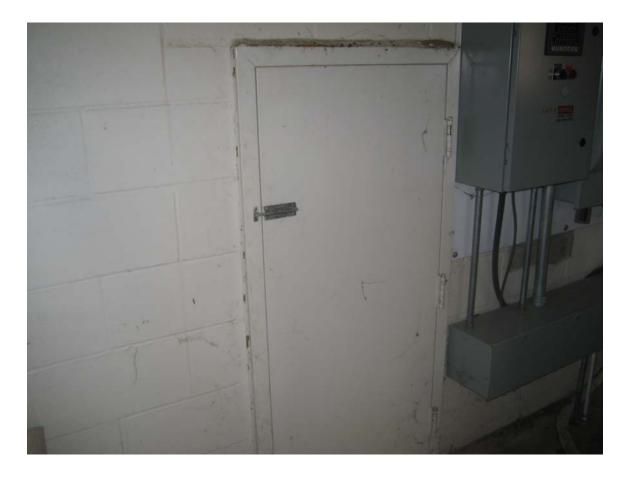
HA #1 – Assumed Fire Door and Frame

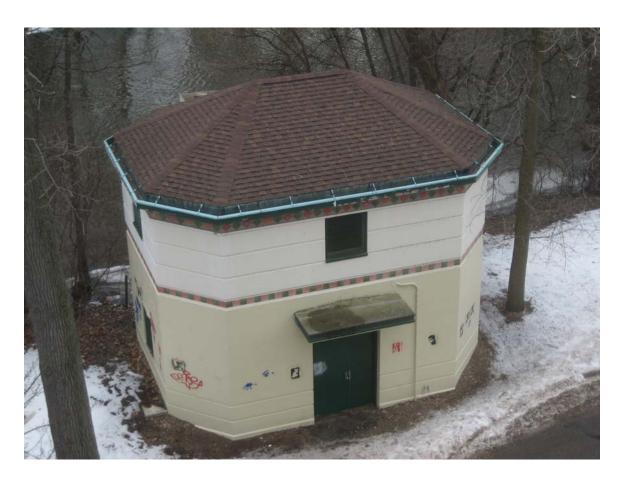
HA #2 – Assumed Roofing Materials and Products
